# Engineer's Report on Improvements to the Main Tiles, Drainage District No. 120 Hardin County, Iowa

# **Engineer's Report on Improvements to Main Tiles, Drainage District No. 120 Hardin County, Iowa**

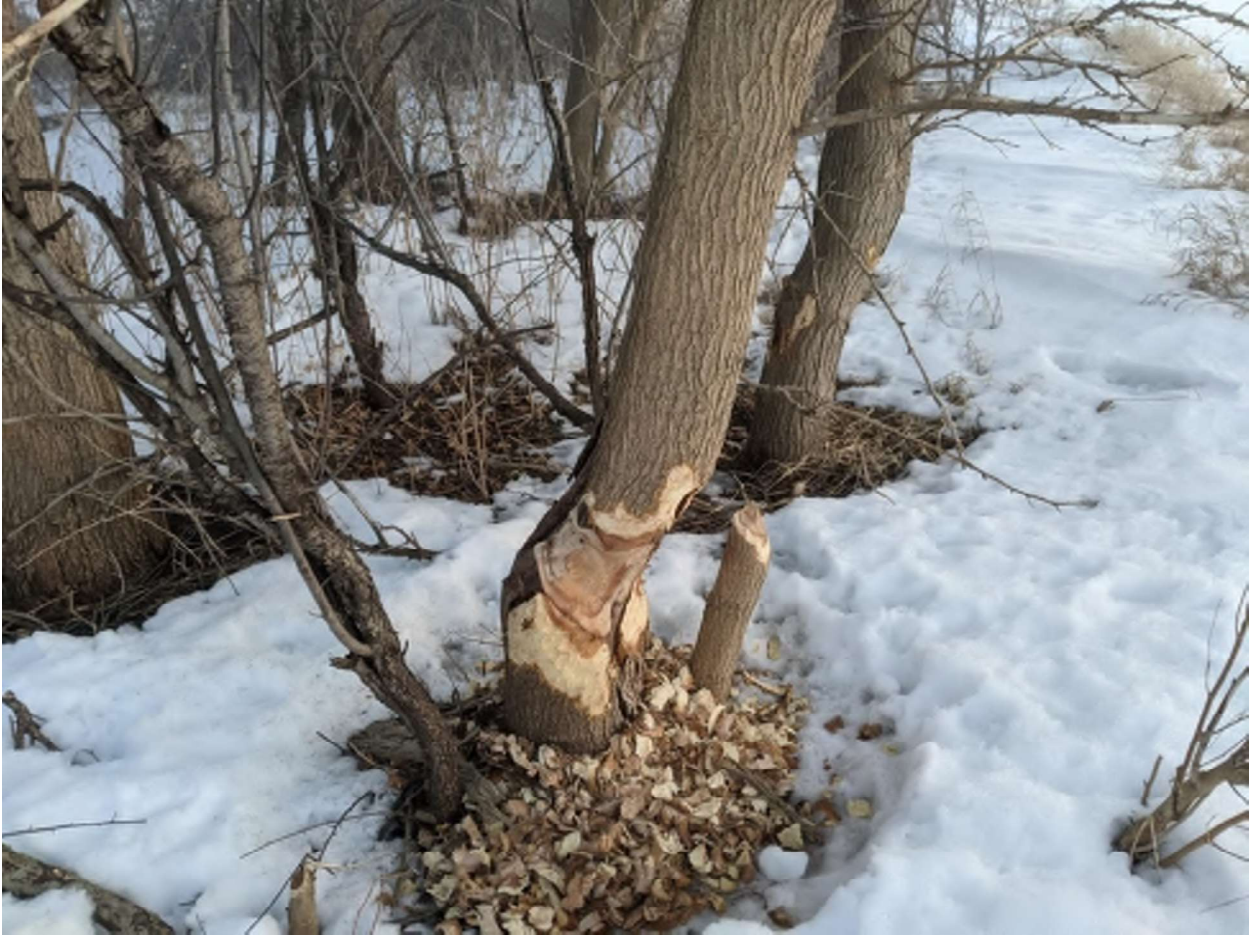
*Figure 8: Signs of beaver action.*

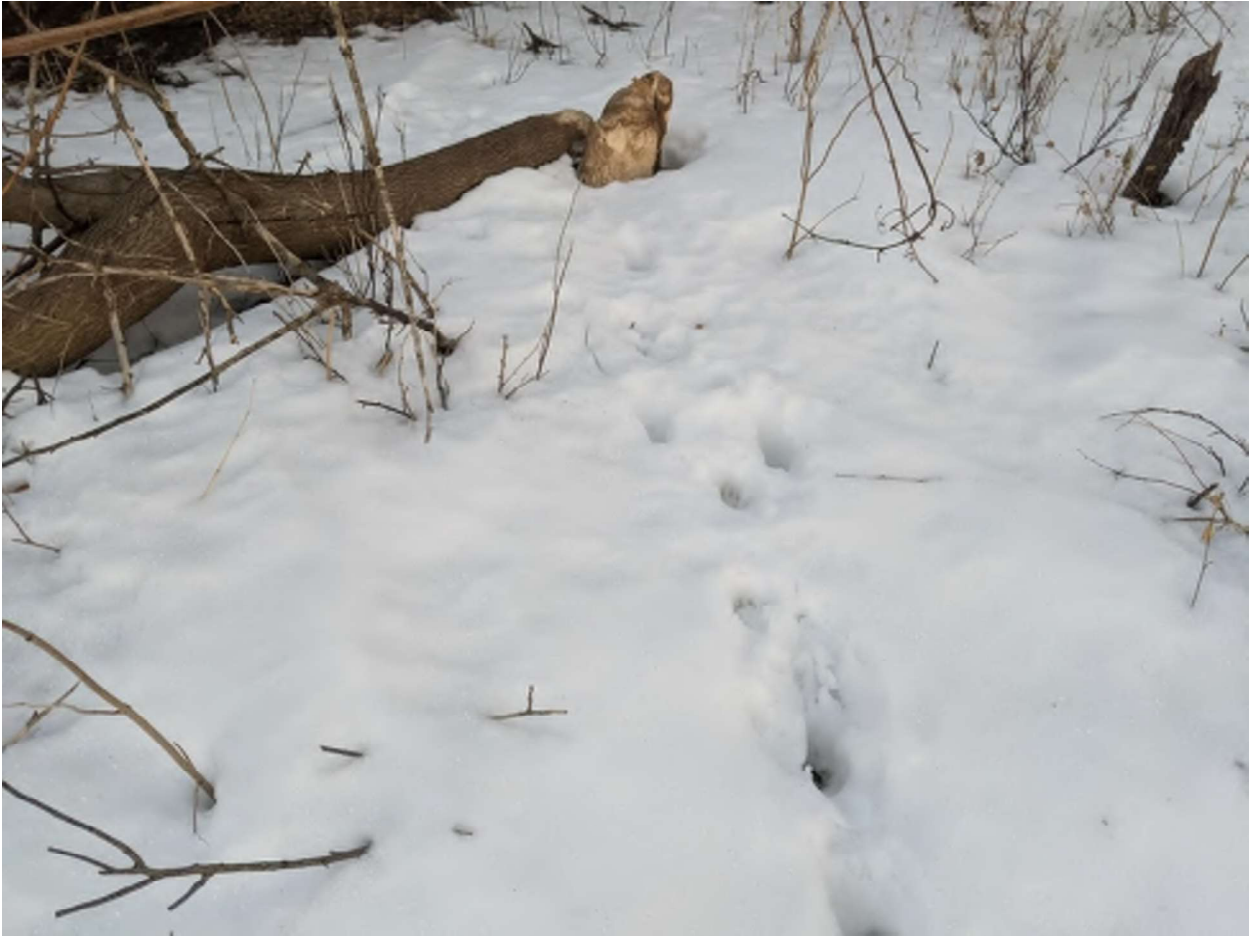
Figure 9: Signs of beaver action.

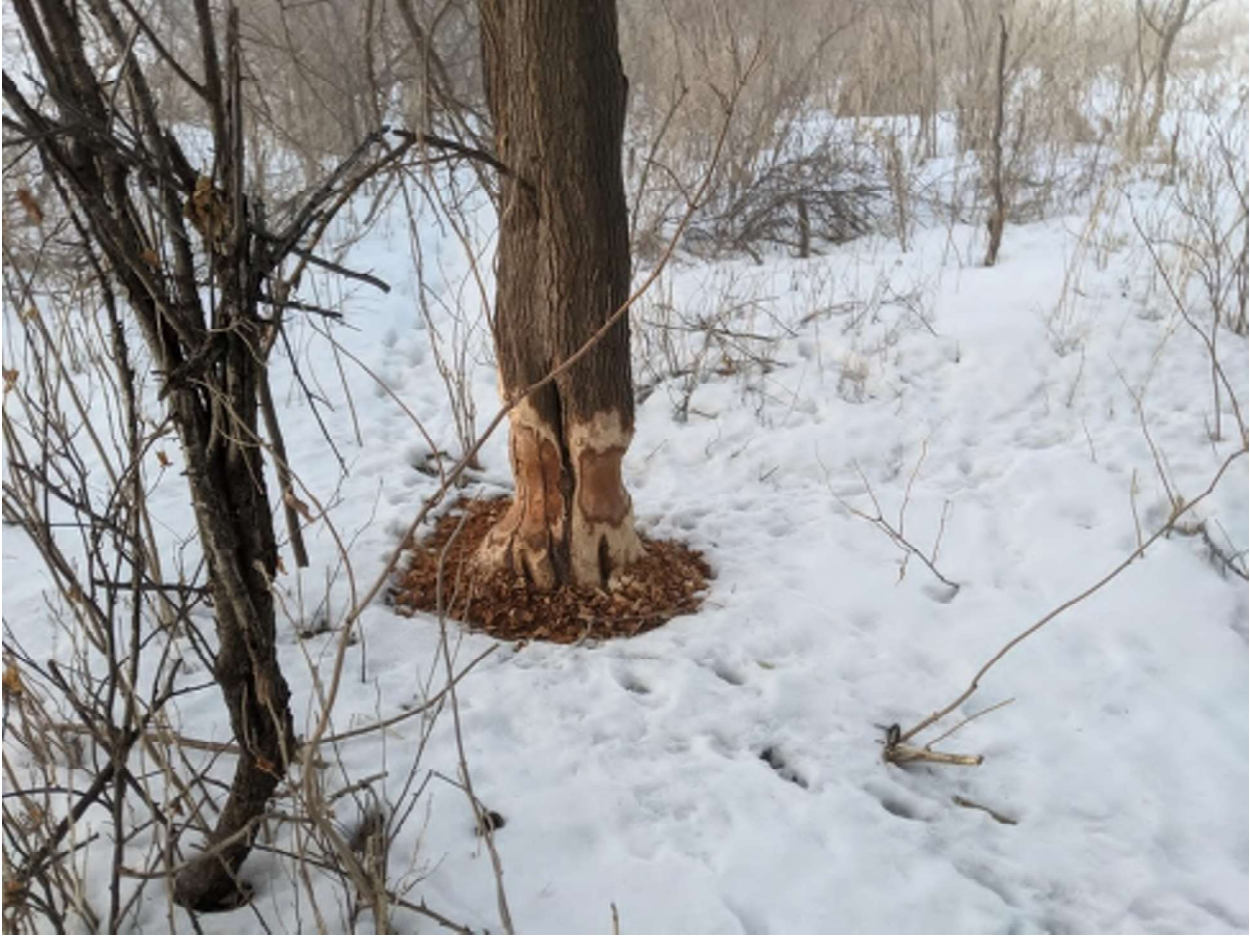
Figure 10: Signs of beaver action.

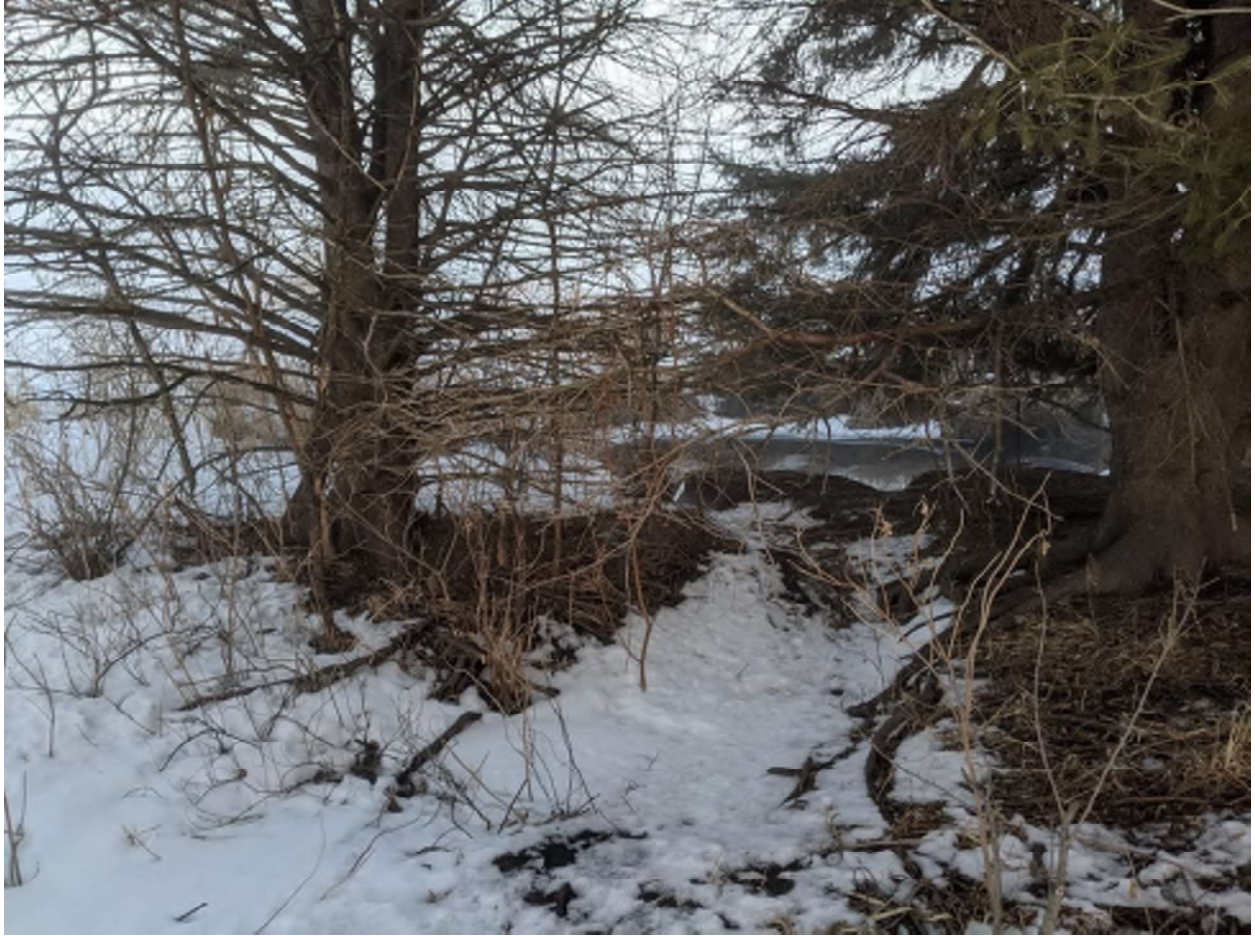
*Figure 11: Pooling between beaver dam and 1922 Main tile outlet.*

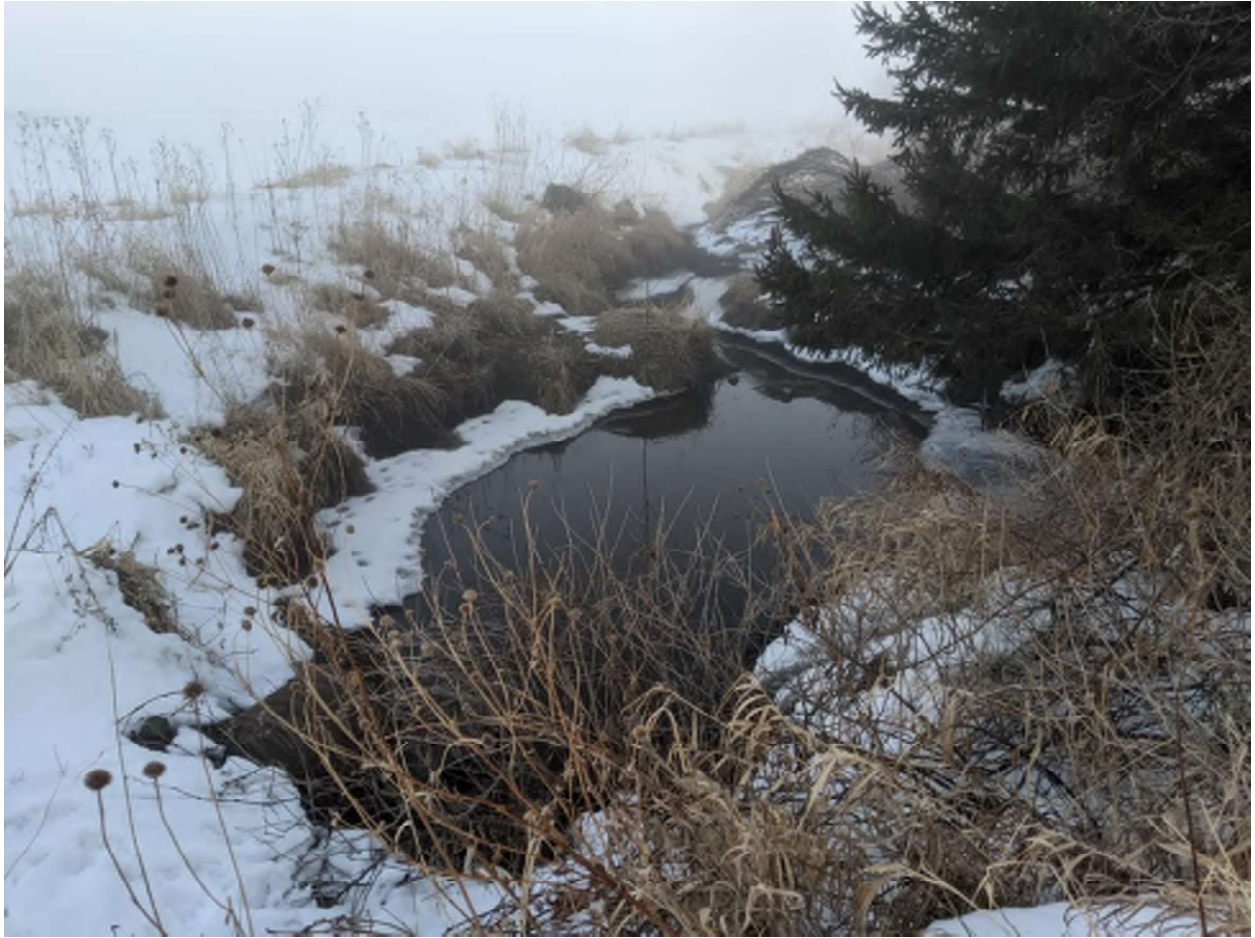
*Figure 12: Pooling between beaver dam and 1922 Main tile outlet.*

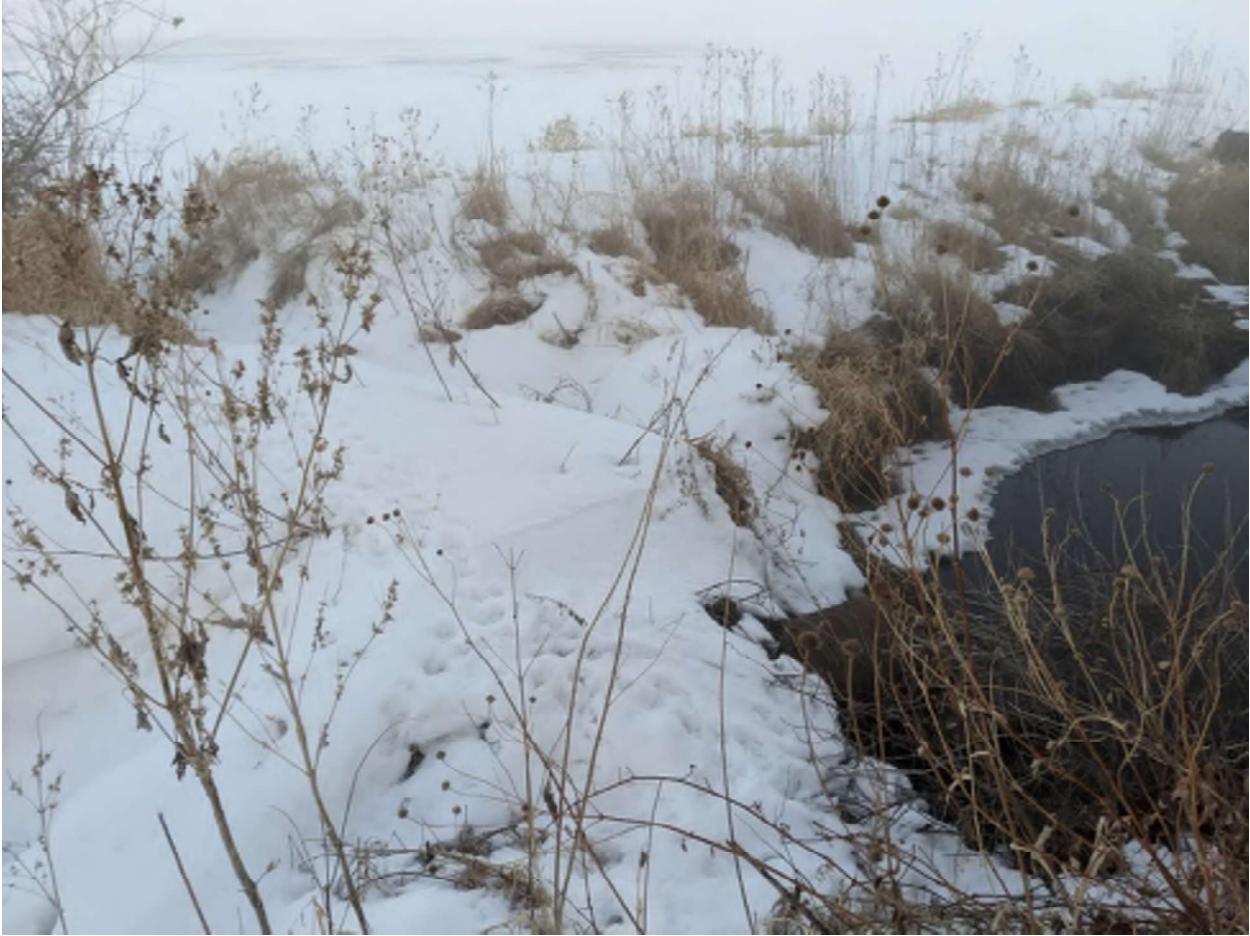
Figure 13: 1922 Main tile outlet.
