Drainage District:

#121

Investigation Summary:

Project Diary

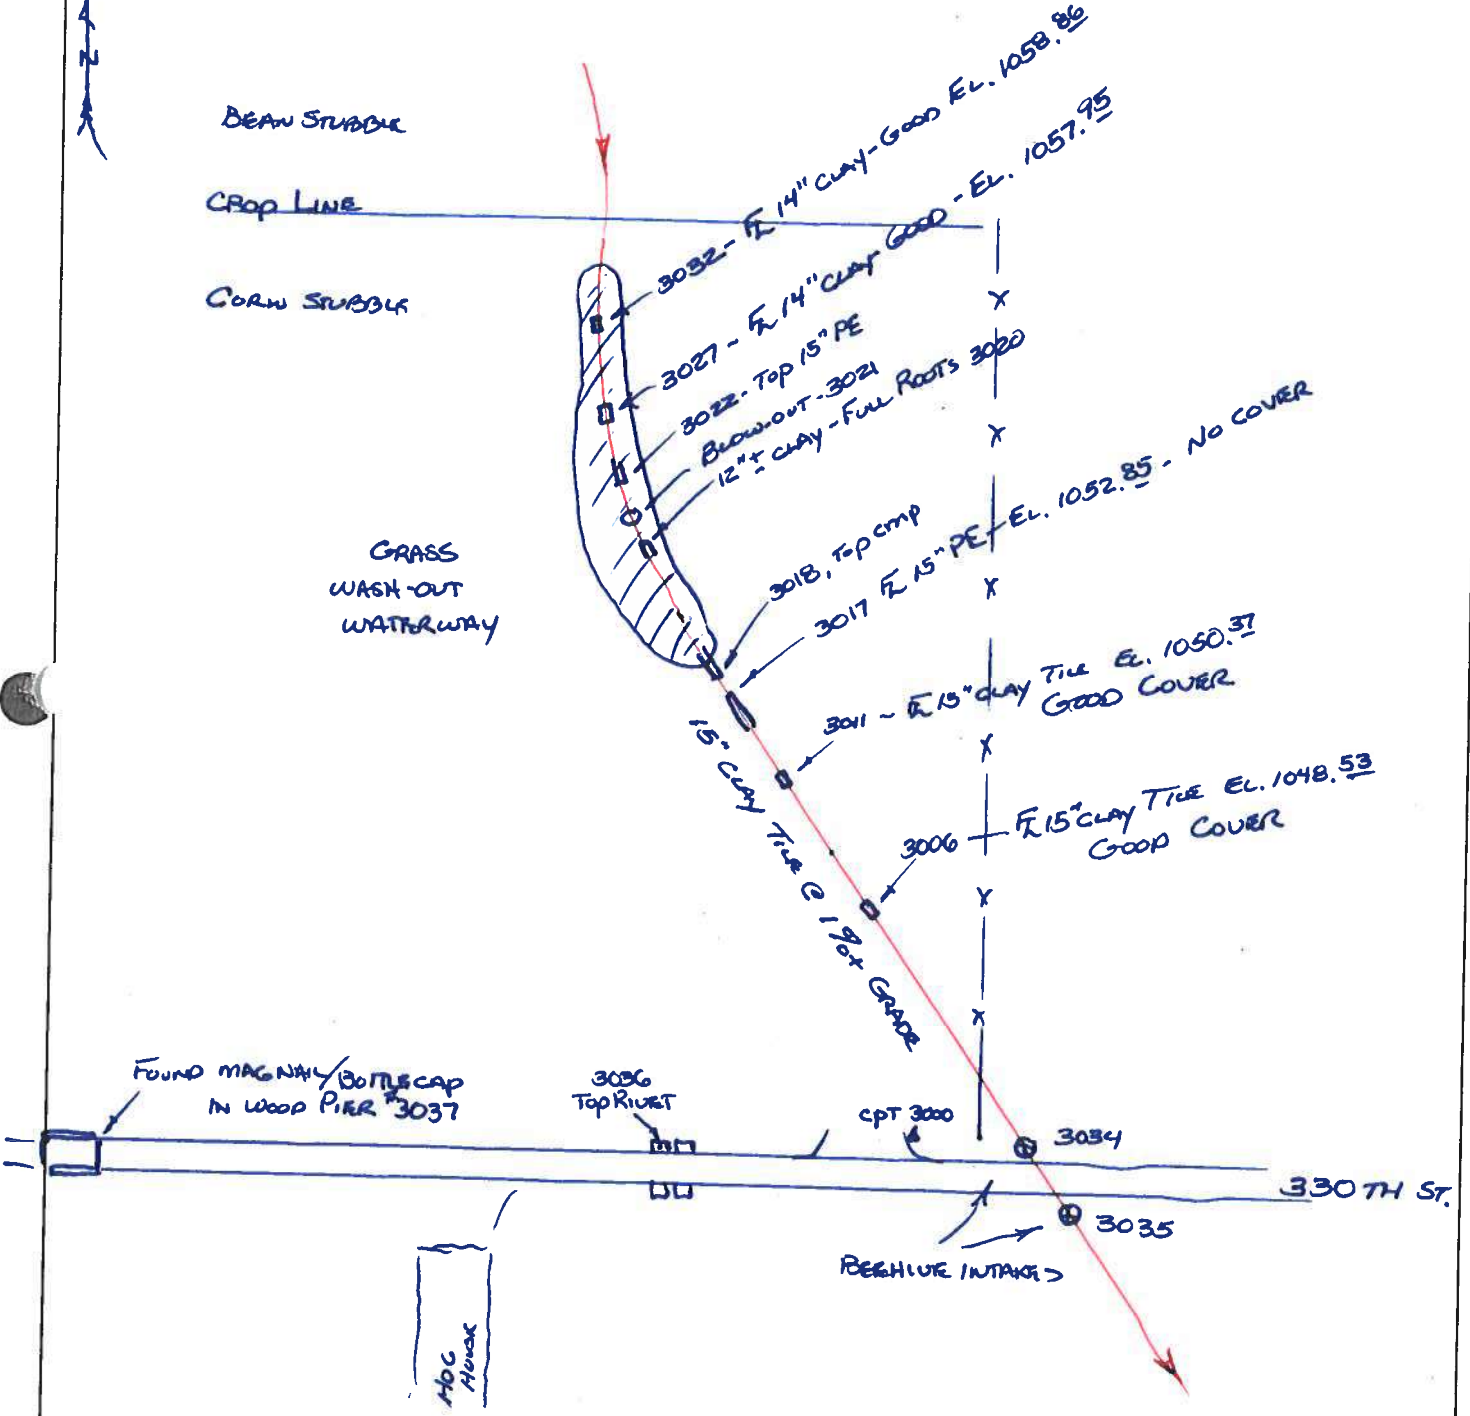
3011 - 3020 = 460' 3020 - 3027 = 250'

Roots @ Blow-out # 3020

2. Changes or Extra Work Ordered:			
<p style="margin-left: 40px;">PROBABLY NEED TO REPAIR TILE FROM $\approx 3011 \pm$ TO $3027 \pm$ (700') WITH 15" HDPE DUAL WALL. NEED TO FLATTEN GRADE TO GET DEPTH @ 3017 OR SHIFT ALIGNMENT TO NE TO GET MORE COVER. EXISTING FALL IS 8' = 1.1% GRADE</p>

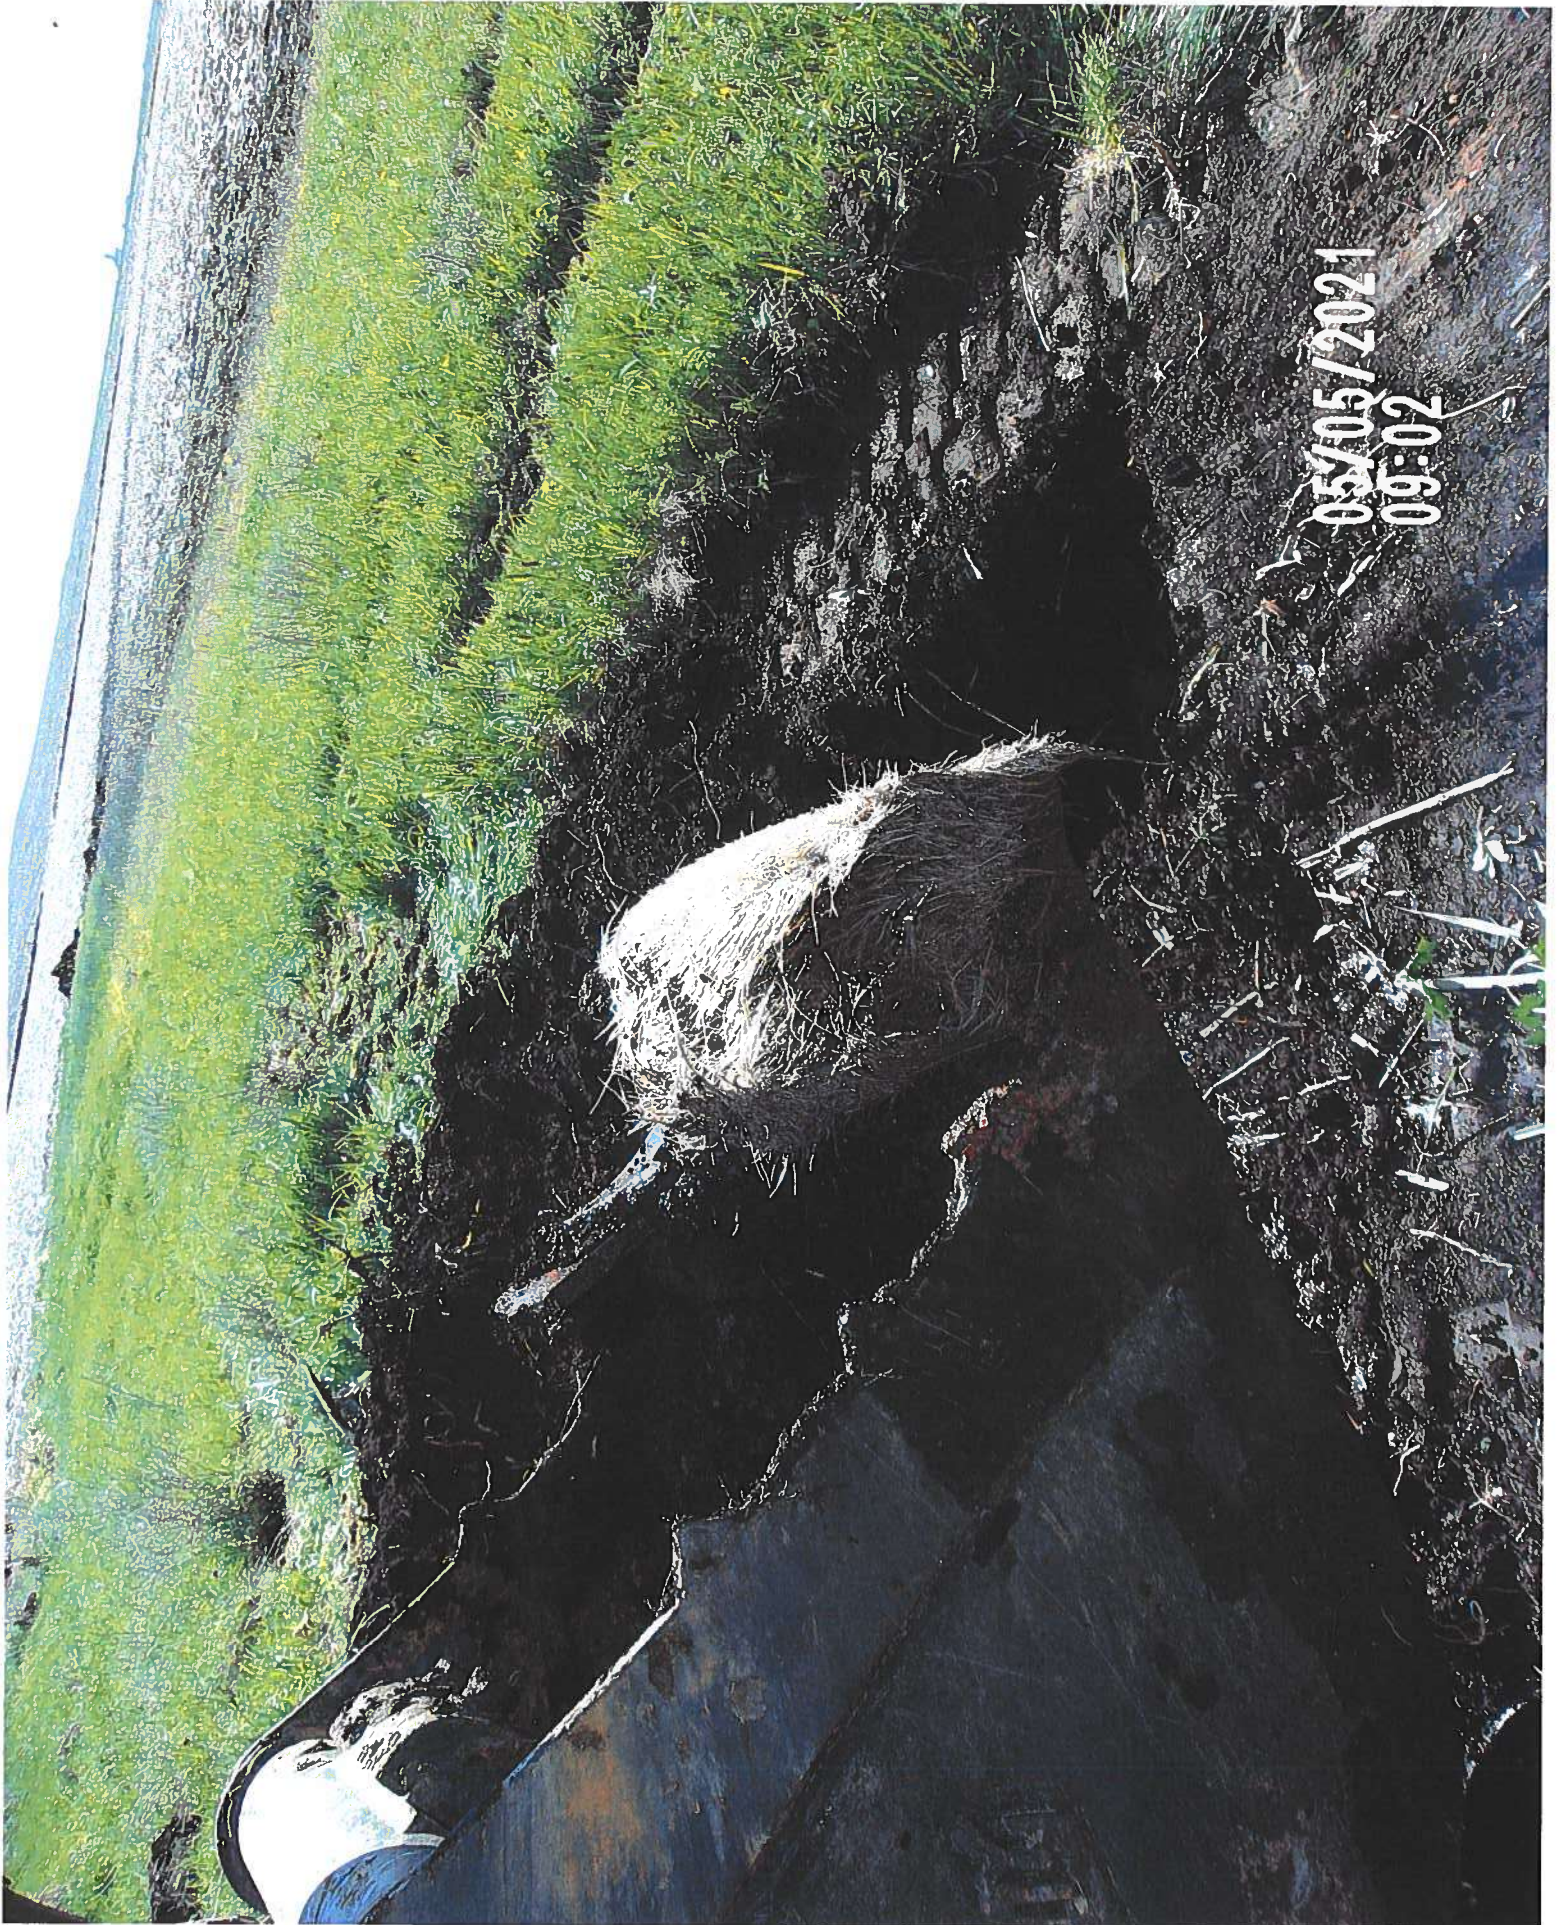
PE-CLAY COLLAPSE TO Cmp @ 2017-2018
