Drainage Work Order Request For Repair

Hardin County

Work Order #: WO00000295

CONSTRUCTION ENGINEERING
OBSERVATION REPORT

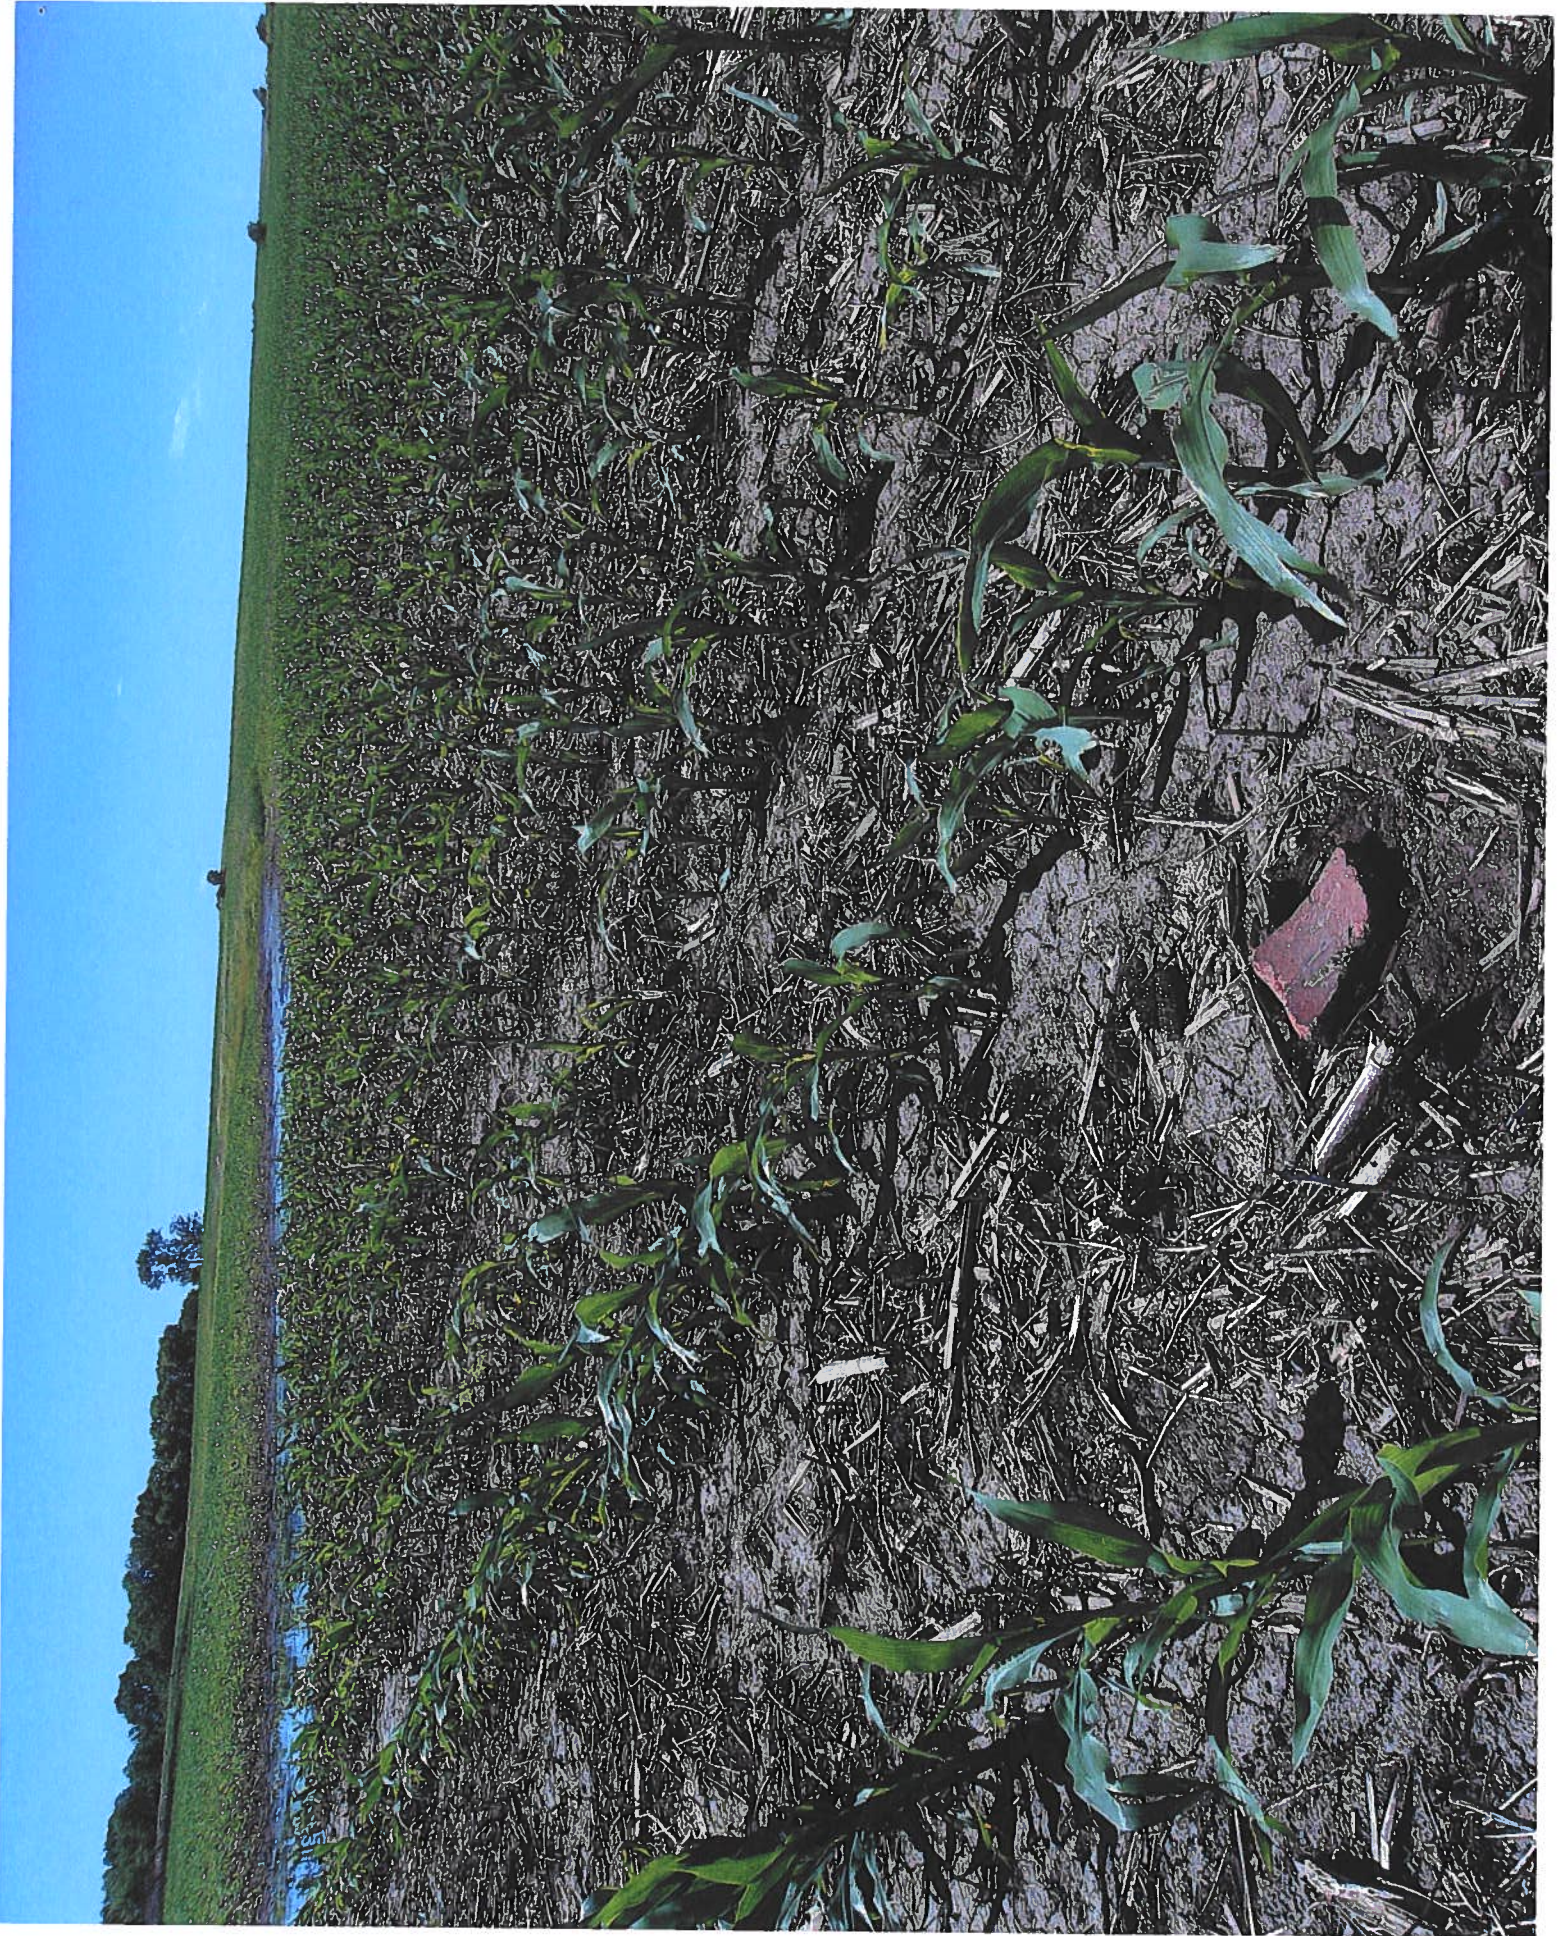
LOOKING NW ON TILE ROUTE

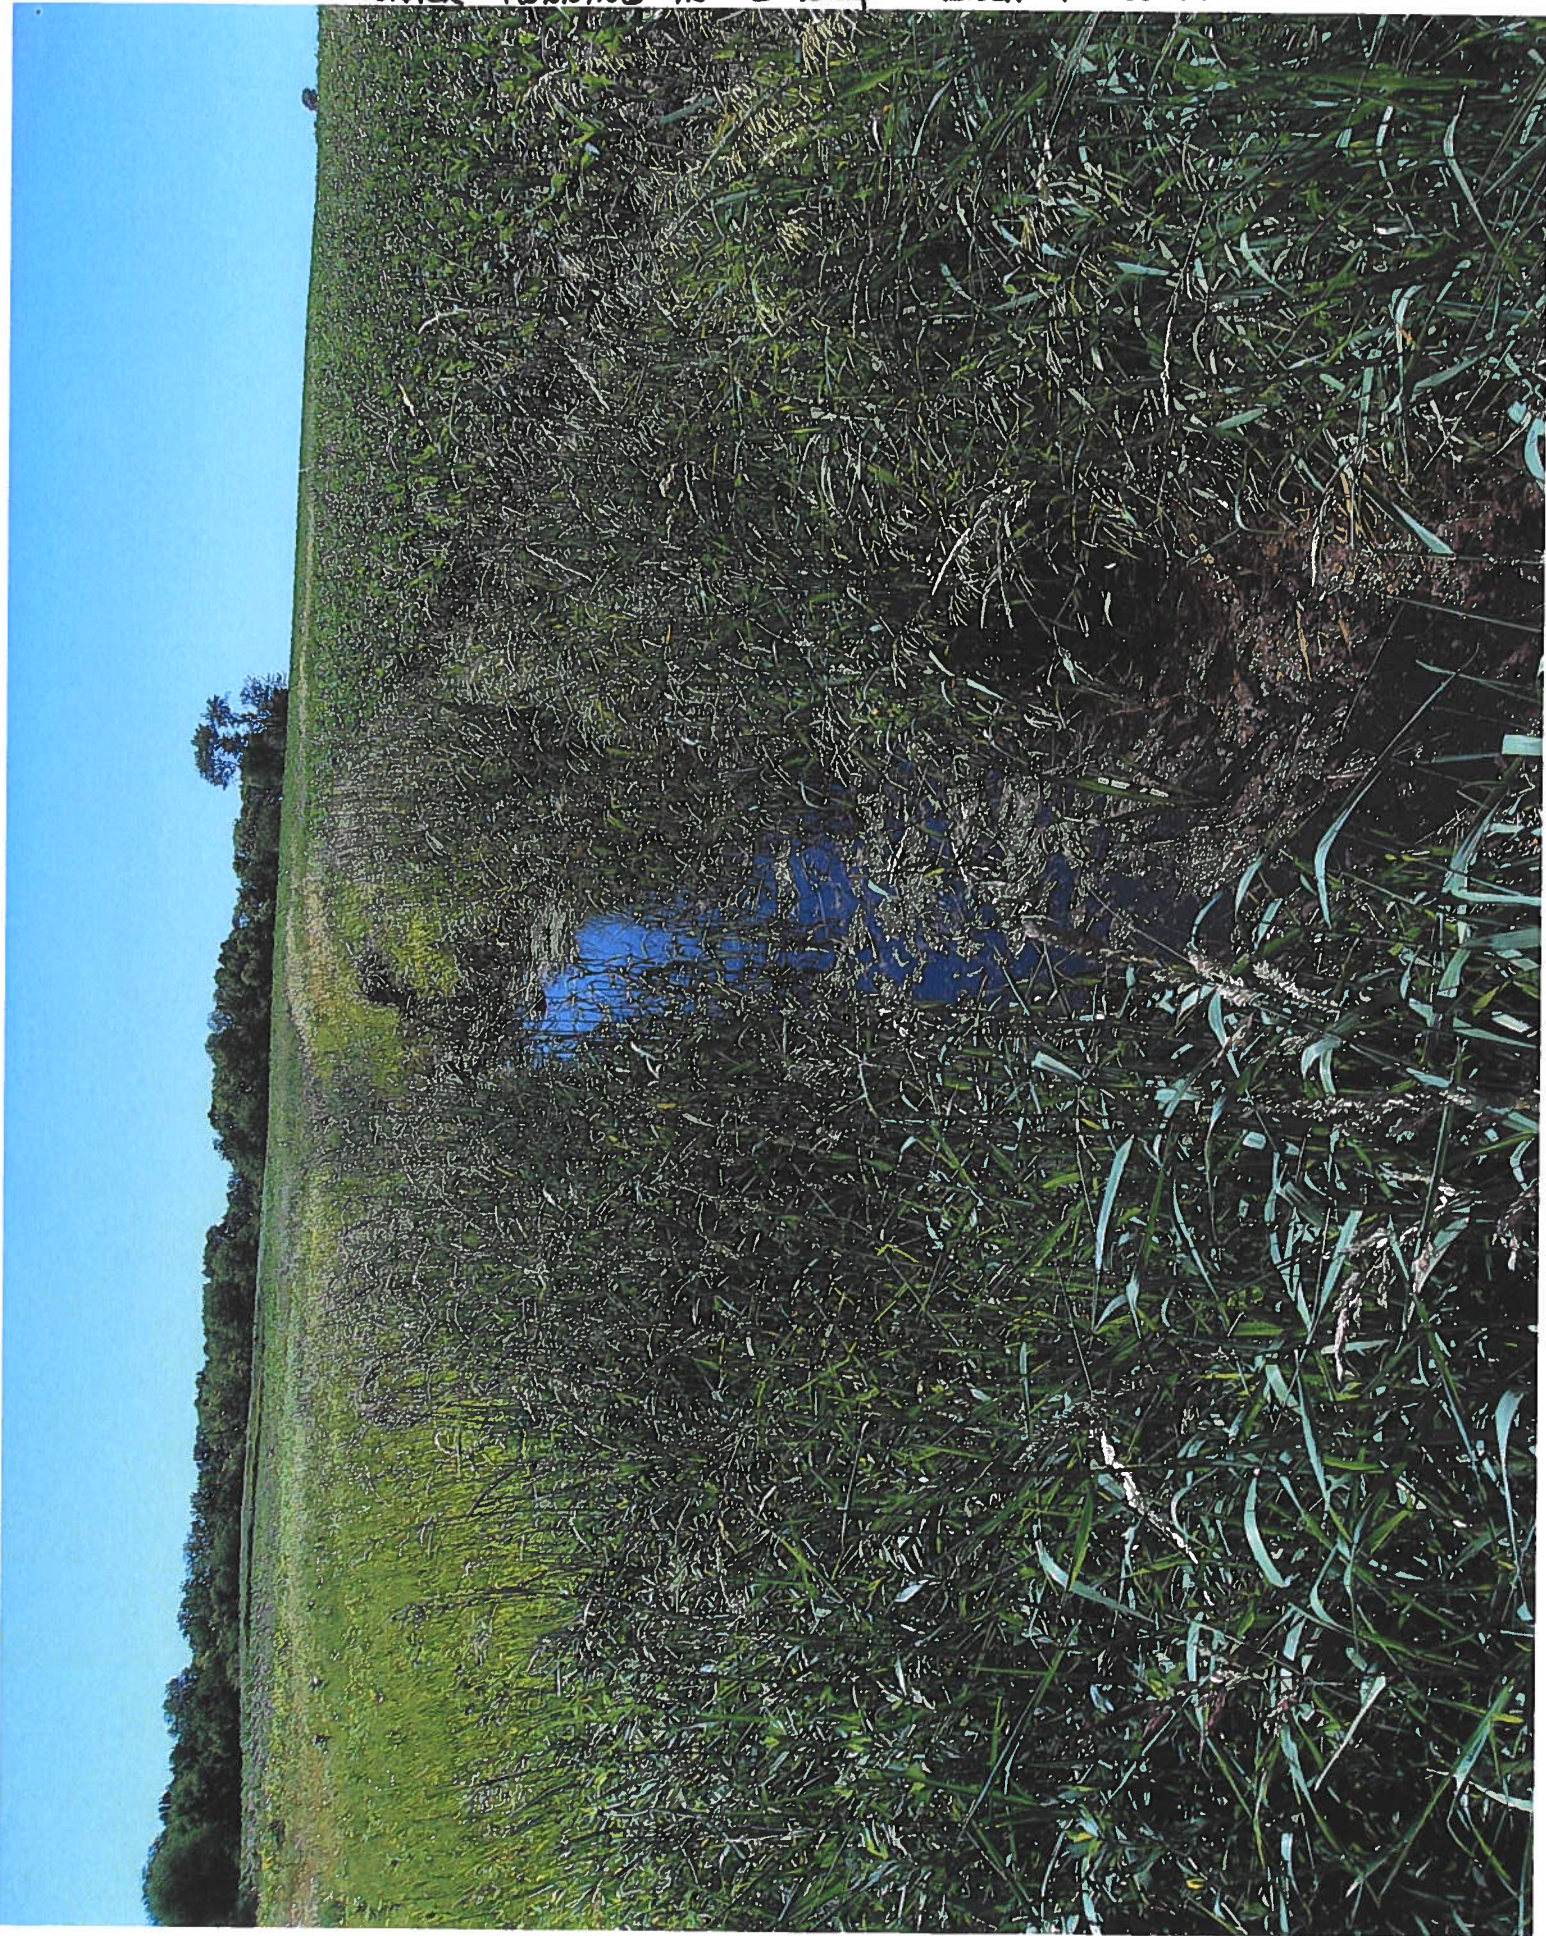
Parked @ 1/4 1/4 cor, WALKED TILL ROUTE FOLLOWING CHANOS IN FIELD 12" + CLAY. FOUND NOISY WATER RUNNING OUT OF GRASS SWALE TO N. SIDE OF 40 ACRES. IT LOOKS LIKE TILE IS VERY SHALLOW OR REMOVED IN SWALE AREA. SOME WATER IN SWALE IS 2' DEEP. I HAVE NO IDEA WHY TILE DOESN'T RUN TO CREEK

WATER RUNNING IN 2' DEEP TRENCH IN SWALE

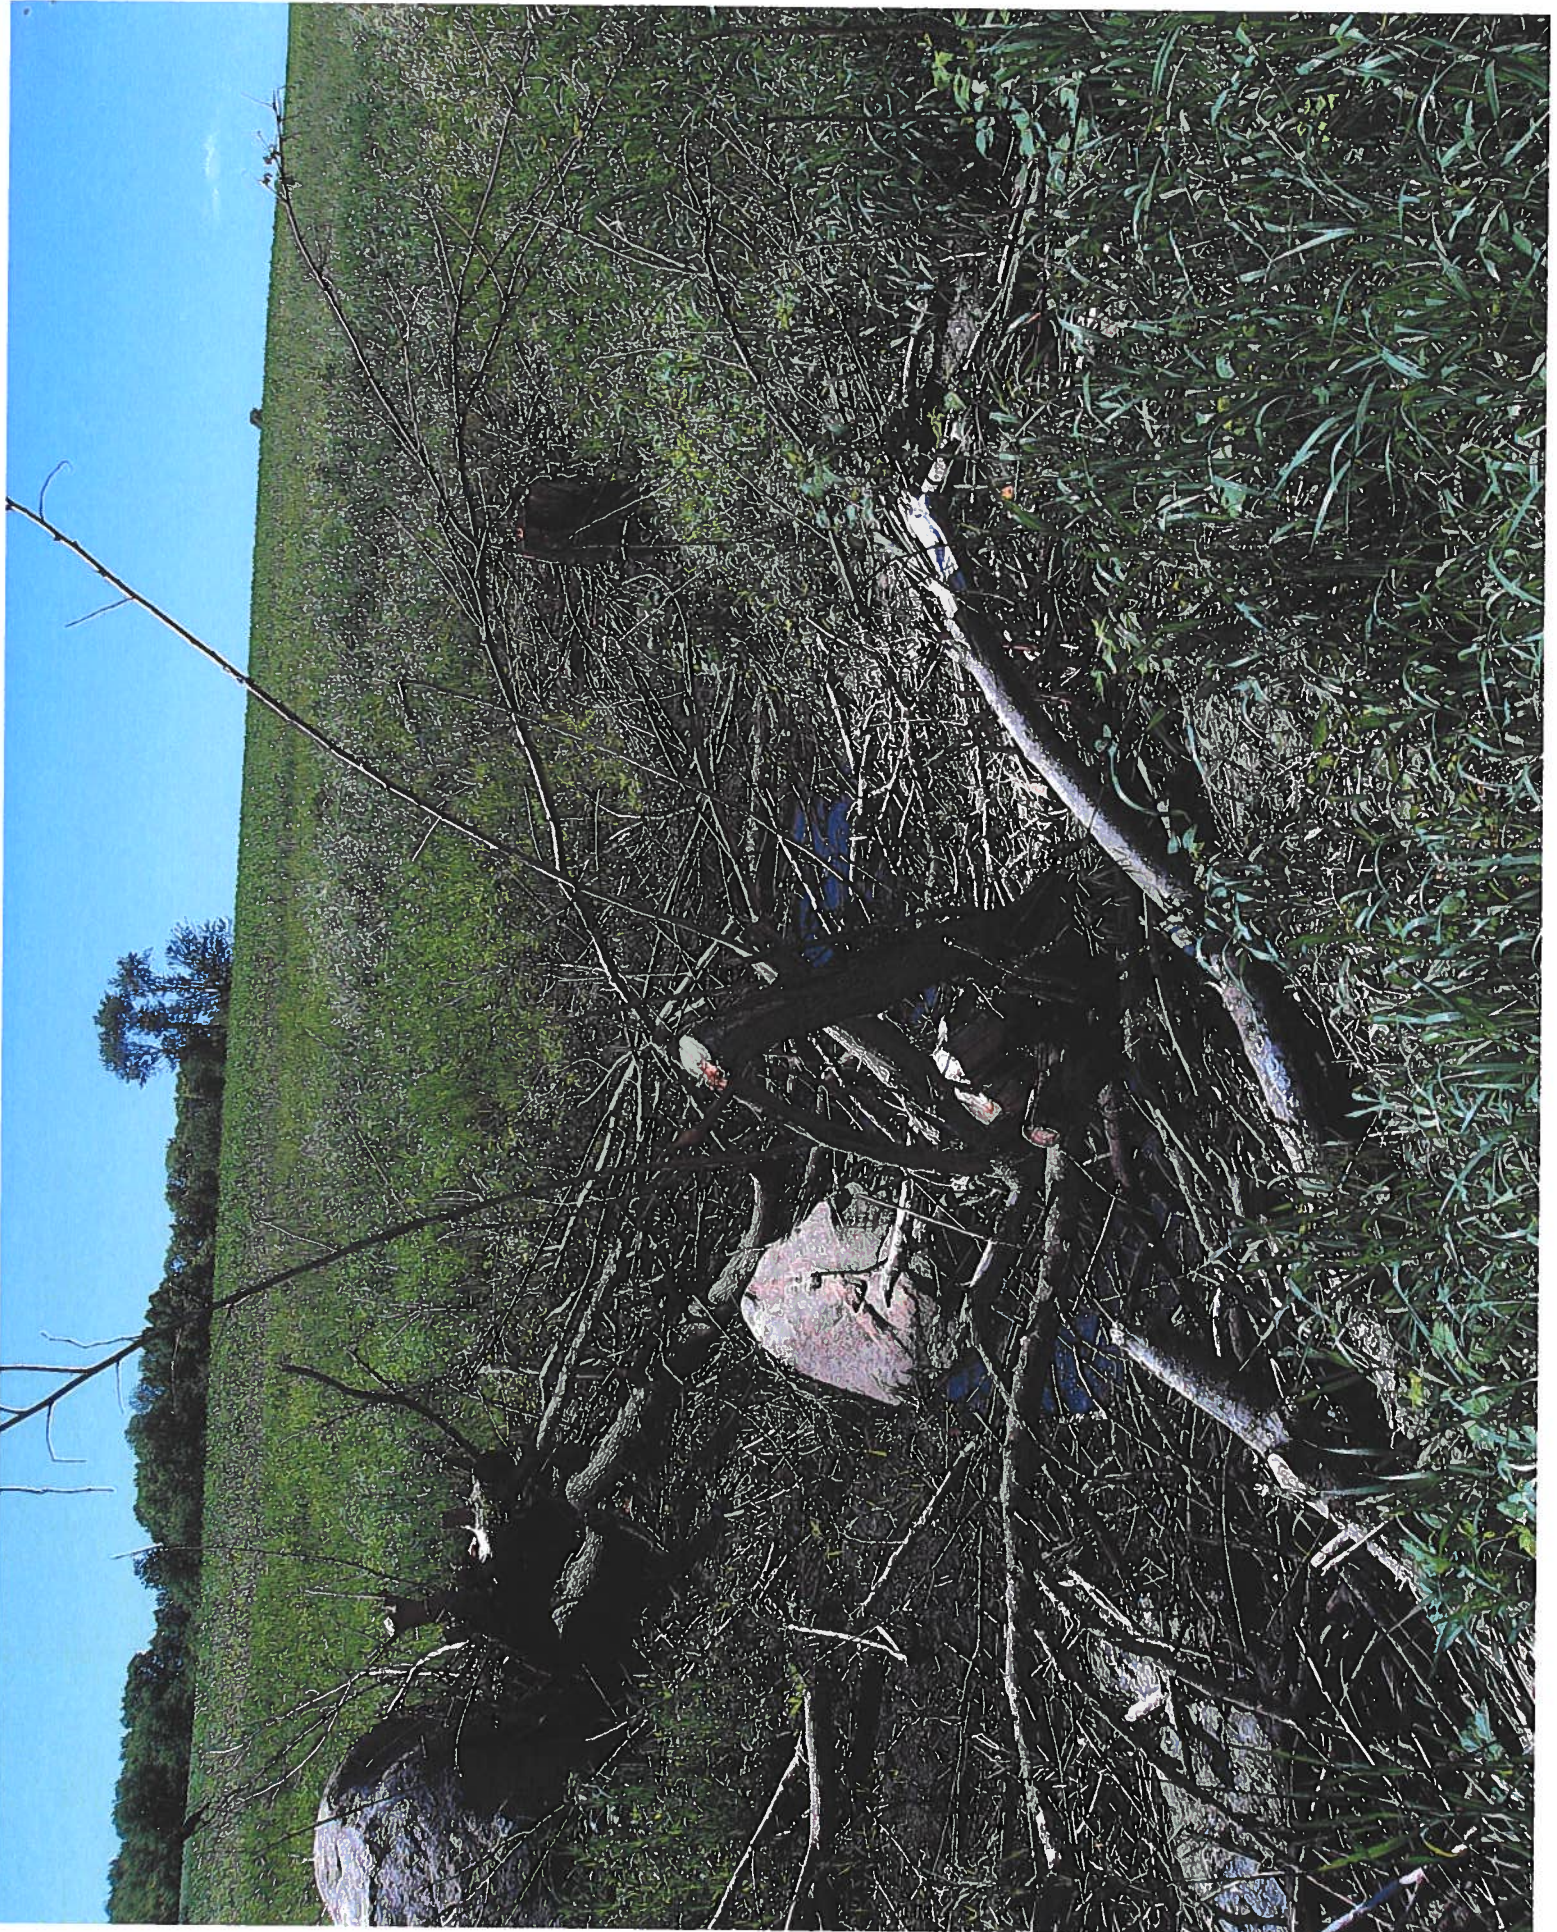
TREES JUST DOWNSTREAM FROM Blow-out
