Drainage Work Order Request For Repair

Drainage District: DDs\DD 14 (51027)

CONSTRUCTION ENGINEERING
OBSERVATION REPORT

LOCATION: DD#14 MAIN LOCATED SWNE & NWSE 34-88-22 HARDIN COUNTY. INVESTIGATE & TEMPORARILY REPAIR 3 TILE BLOWOUTS

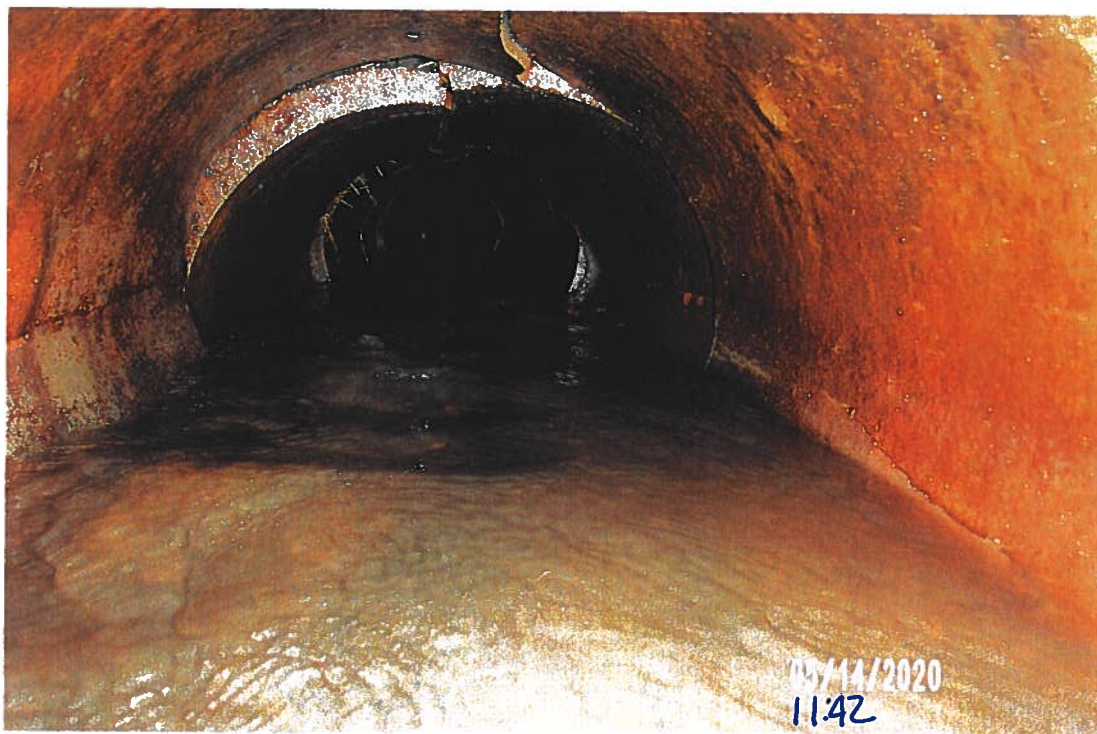
PICTURE 354I IS LOOKING SW INSIDE CLAY TILE DOWNSTREAM INSIDE BLOWOUT 2S SHOWING NEXT COUPLE SECTIONS IN BAD SHAPE WITH CRACKS AND LEAVING DOWN. FROM GPS# 118

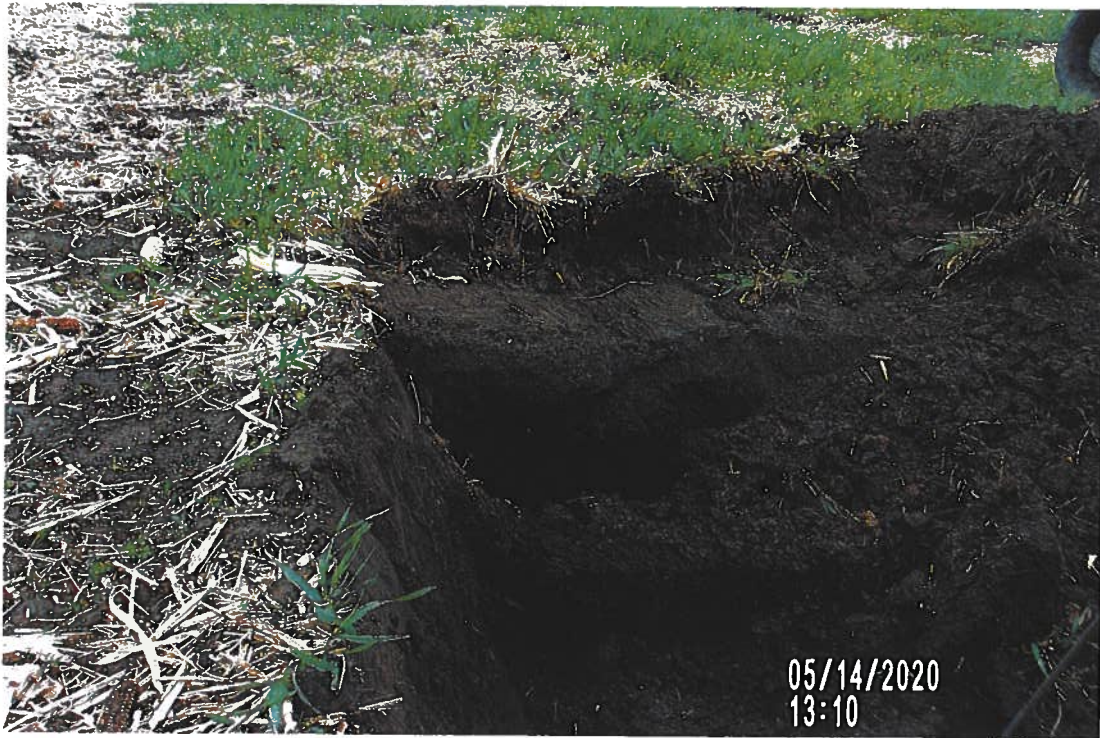
PICTURE# 3549 IS LOOKING NW SHOWING VOID UNDER GRASS WATERWAY THAT HAD NEVER SURFACED YET. ONLY 1.0' TO 1.5' OF SOIL OVER VOID @ 537.1' WHERE TILE COMPLETELY

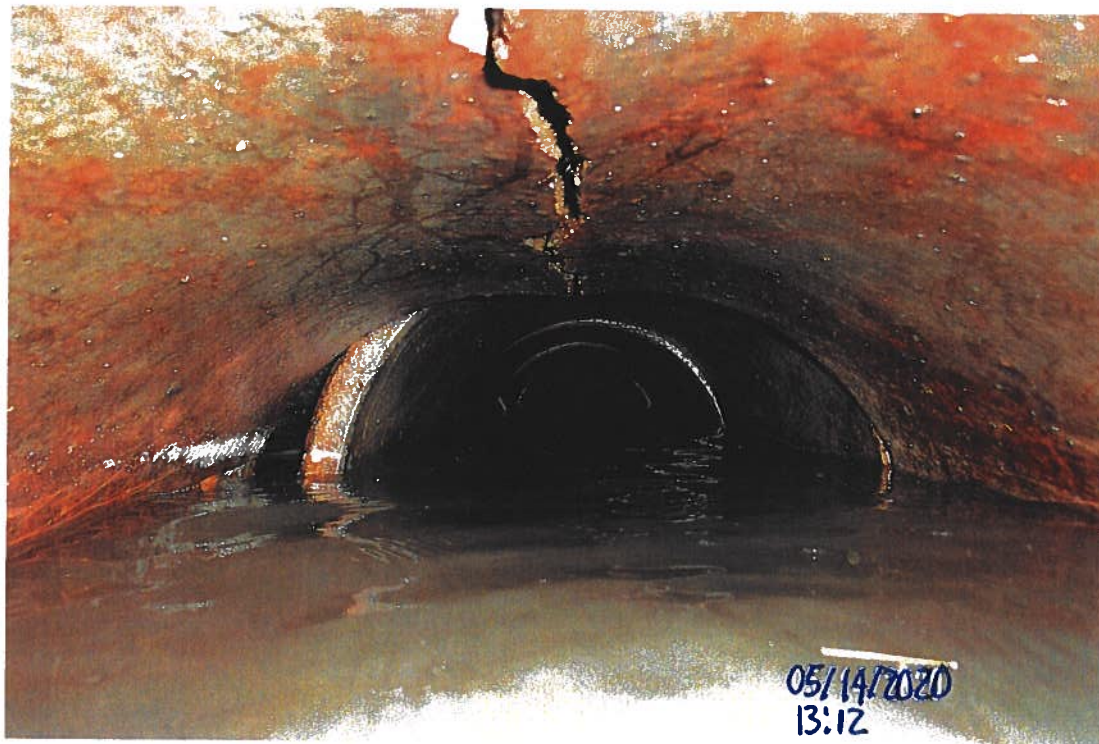
PICTURE # 3551 IS LOOKING NW SHOWING 1ST SECTION OF TILE WITH SEVERE LONGITUDINAL CRACK AND CAVING DOWN. UPSTREAM FROM GPS# 138 WITH SEVERAL OTHER TILE CRACKED AND CAVING DOWN SEVERAL FEET UPSTREAM.

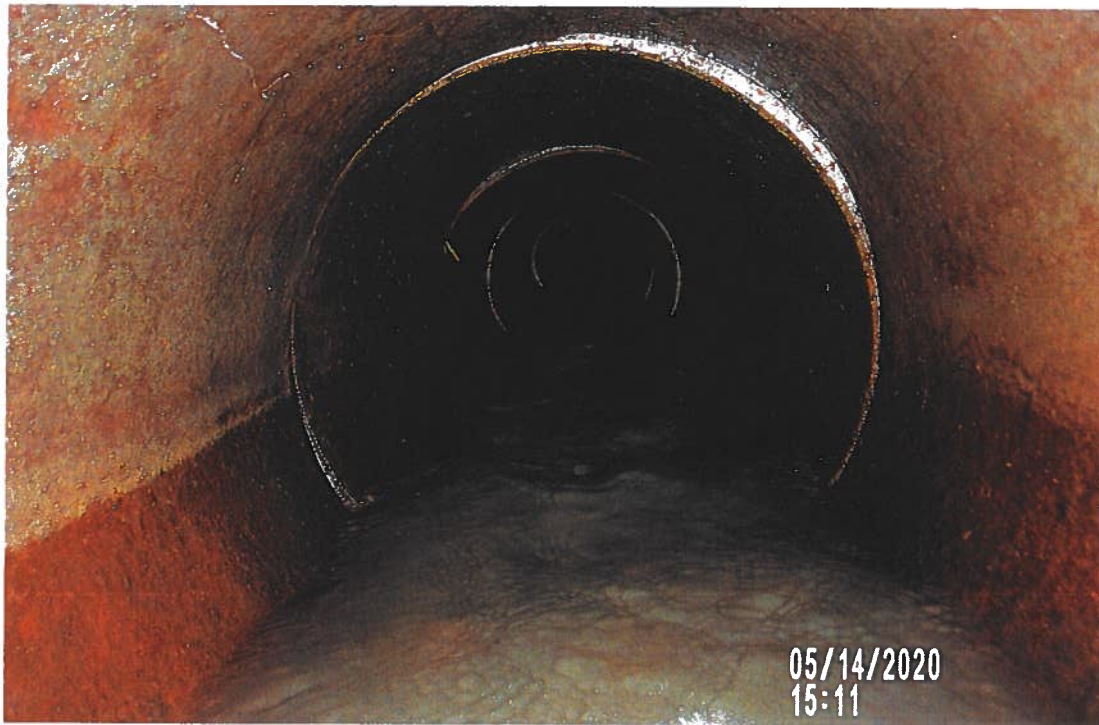
PICTURE # 3562 IS LOOKING SE INSIDE CLAY TILE FROM GPS# 175 IN TILE BLOWOUT # 2N SHOWING TILE WITH FINE CRACKS BUT NOT CAVING DOWN

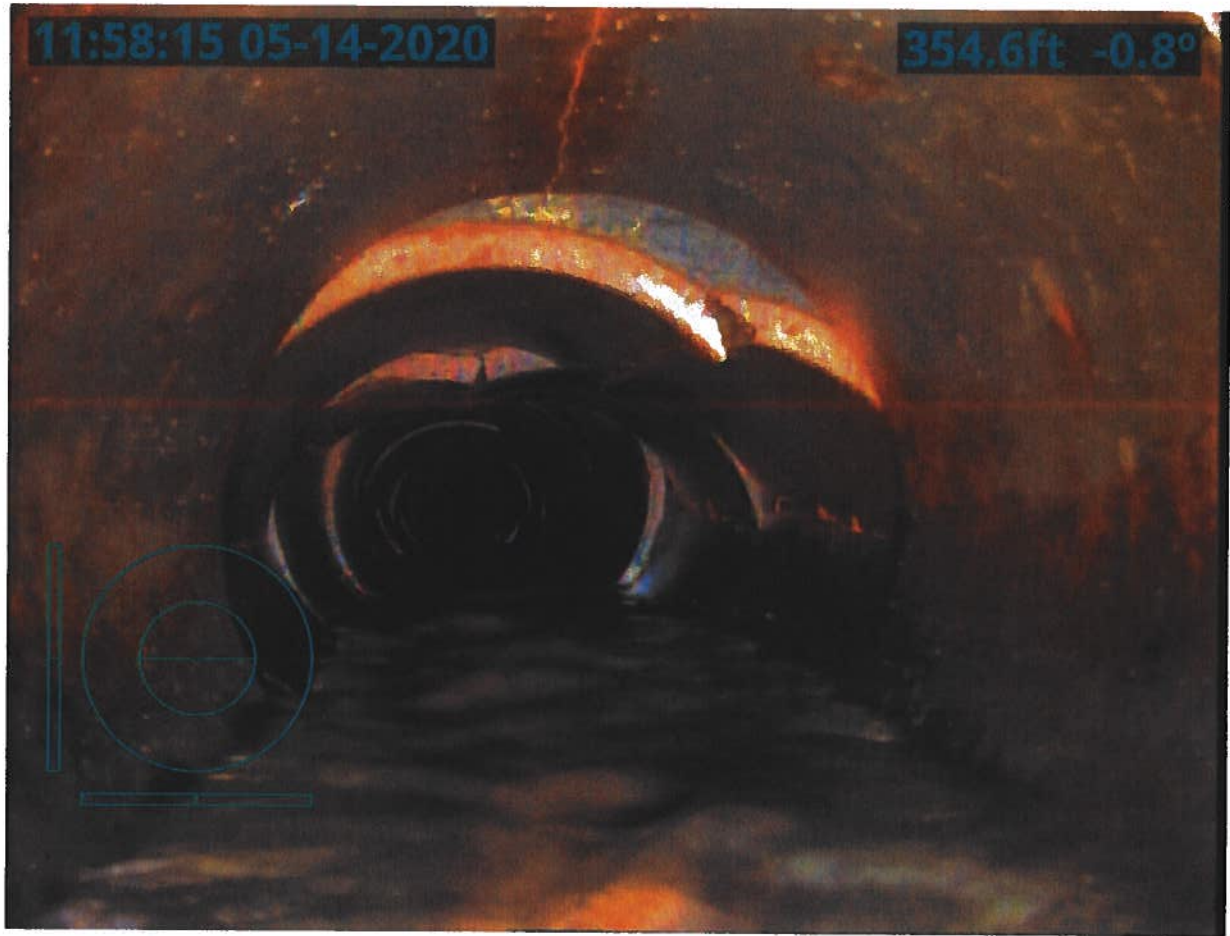
11:58:15 05-14-2020

| Video Ref | Dist (ft) | Cont Defect | Code | Photo Ref | Diameter/ Dimension | Clock | | Intrusion | | Remarks |
|---|---|---|---|--|---|---|---|---|---|---|
| 0:36:50 | 354.6 | | B | 2020_05_14-11_58_15_678.jpg | | 11 | 12 | | | MORE STELLAR CONDITION PIPE |

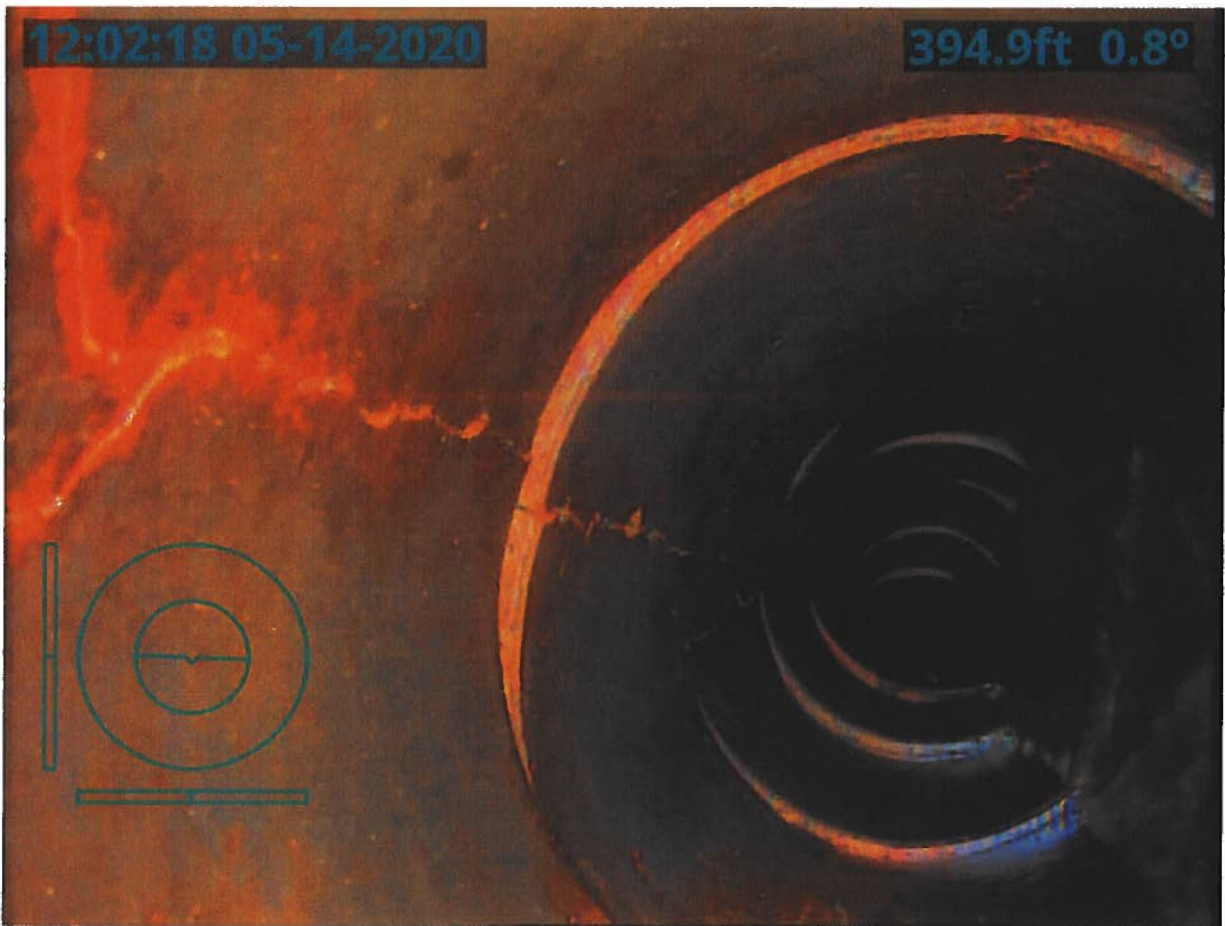
12:02:18 05-14-2020

| Video Ref | Dist (ft) | Cont Defect | Code | Photo Ref | Diameter/ Dimension | Clock | | Intrusion | | Remarks |
|---|---|---|---|--|---|---|---|---|---|---|
| 0:39:47 | 394.9 | | CM | 2020_05_14-12_02_18_136.jpg | | 11 | 12 | | | CRACKS |

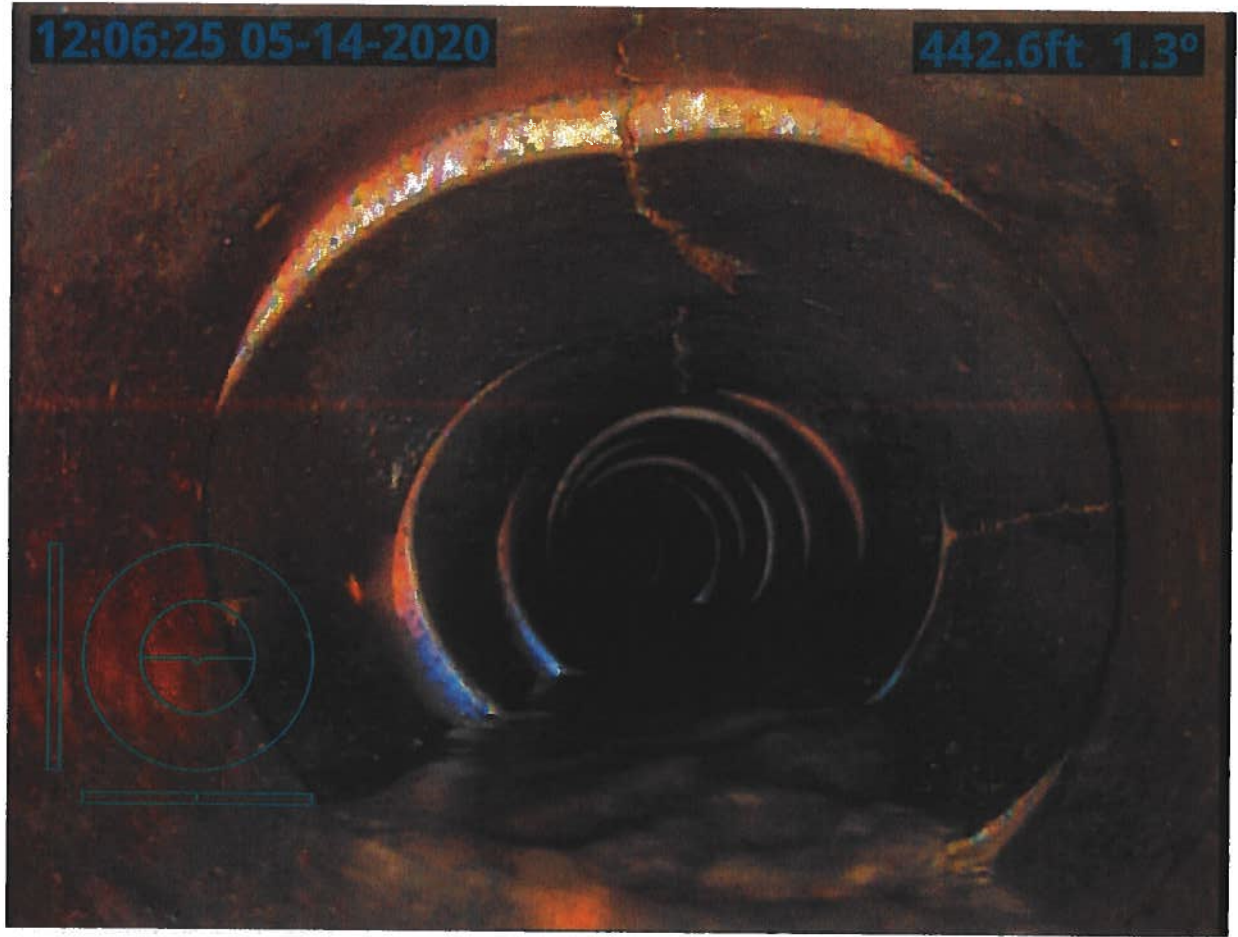
12:06:25 05-14-2020

| Video Ref | Dist (ft) | Cont Defect | Code | Photo Ref | Diameter/ Dimension | Clock | | Intrusion | | Remarks |
|---|---|---|---|--|---|---|---|---|---|---|
| 0:42:27 | 442.6 | | CM | 2020_05_14-12_06_25_077.jpg | | 11 | 12 | | | CRACKS ALL AROUND |

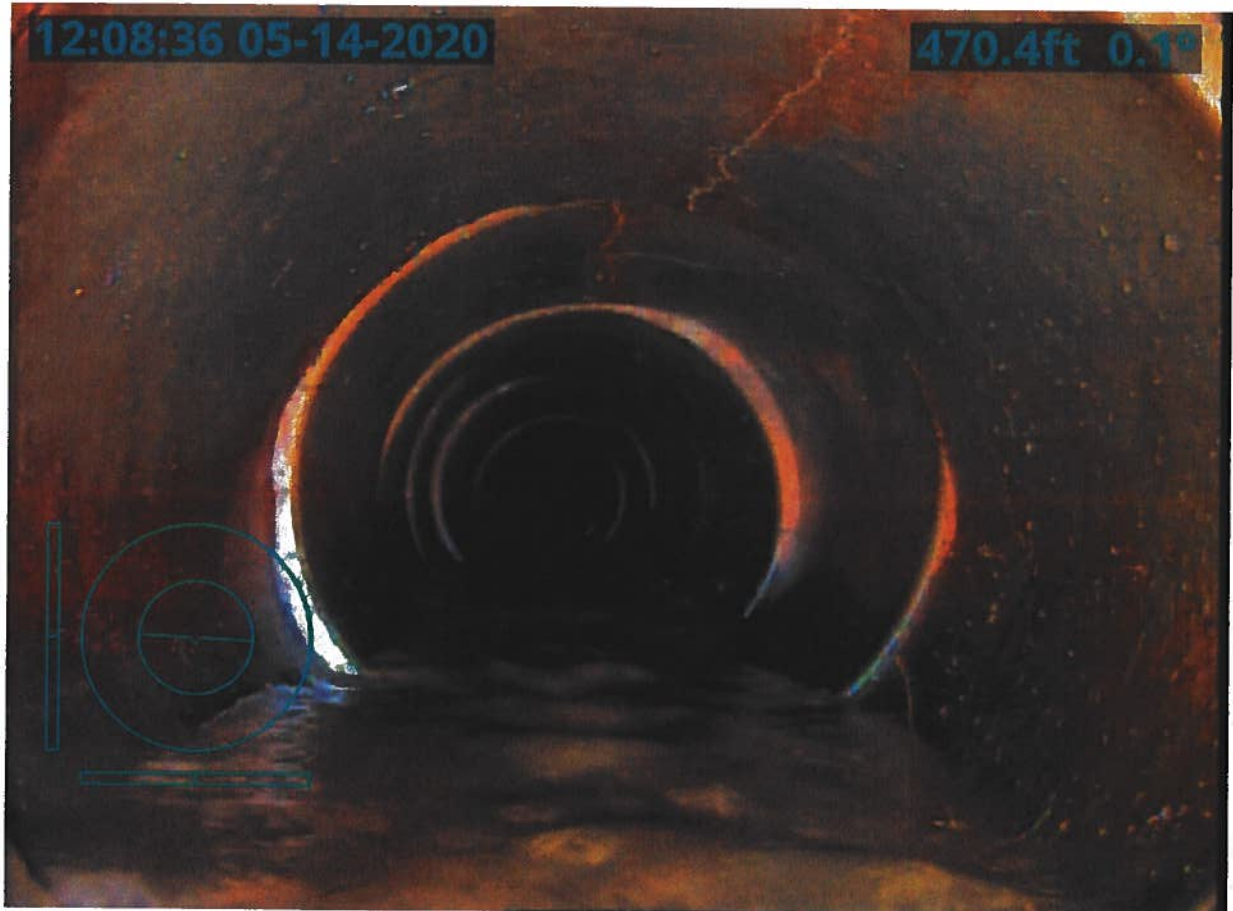
12:08:36 05-14-2020

| Video Ref | Dist (ft) | Cont Defect | Code | Photo Ref | Diameter/ Dimension | Clock | | Intrusion | | Remarks |
|---|---|---|---|--|---|---|---|---|---|---|
| 0:44:01 | 470.4 | | CM | 2020_05_14-12_08_37_024.jpg | | 12 | 02 | | | CRACKED TOP |
