## Drainage District:

#14

## Investigation/Repair Summary:

# Drainage Work Order Request For Repair

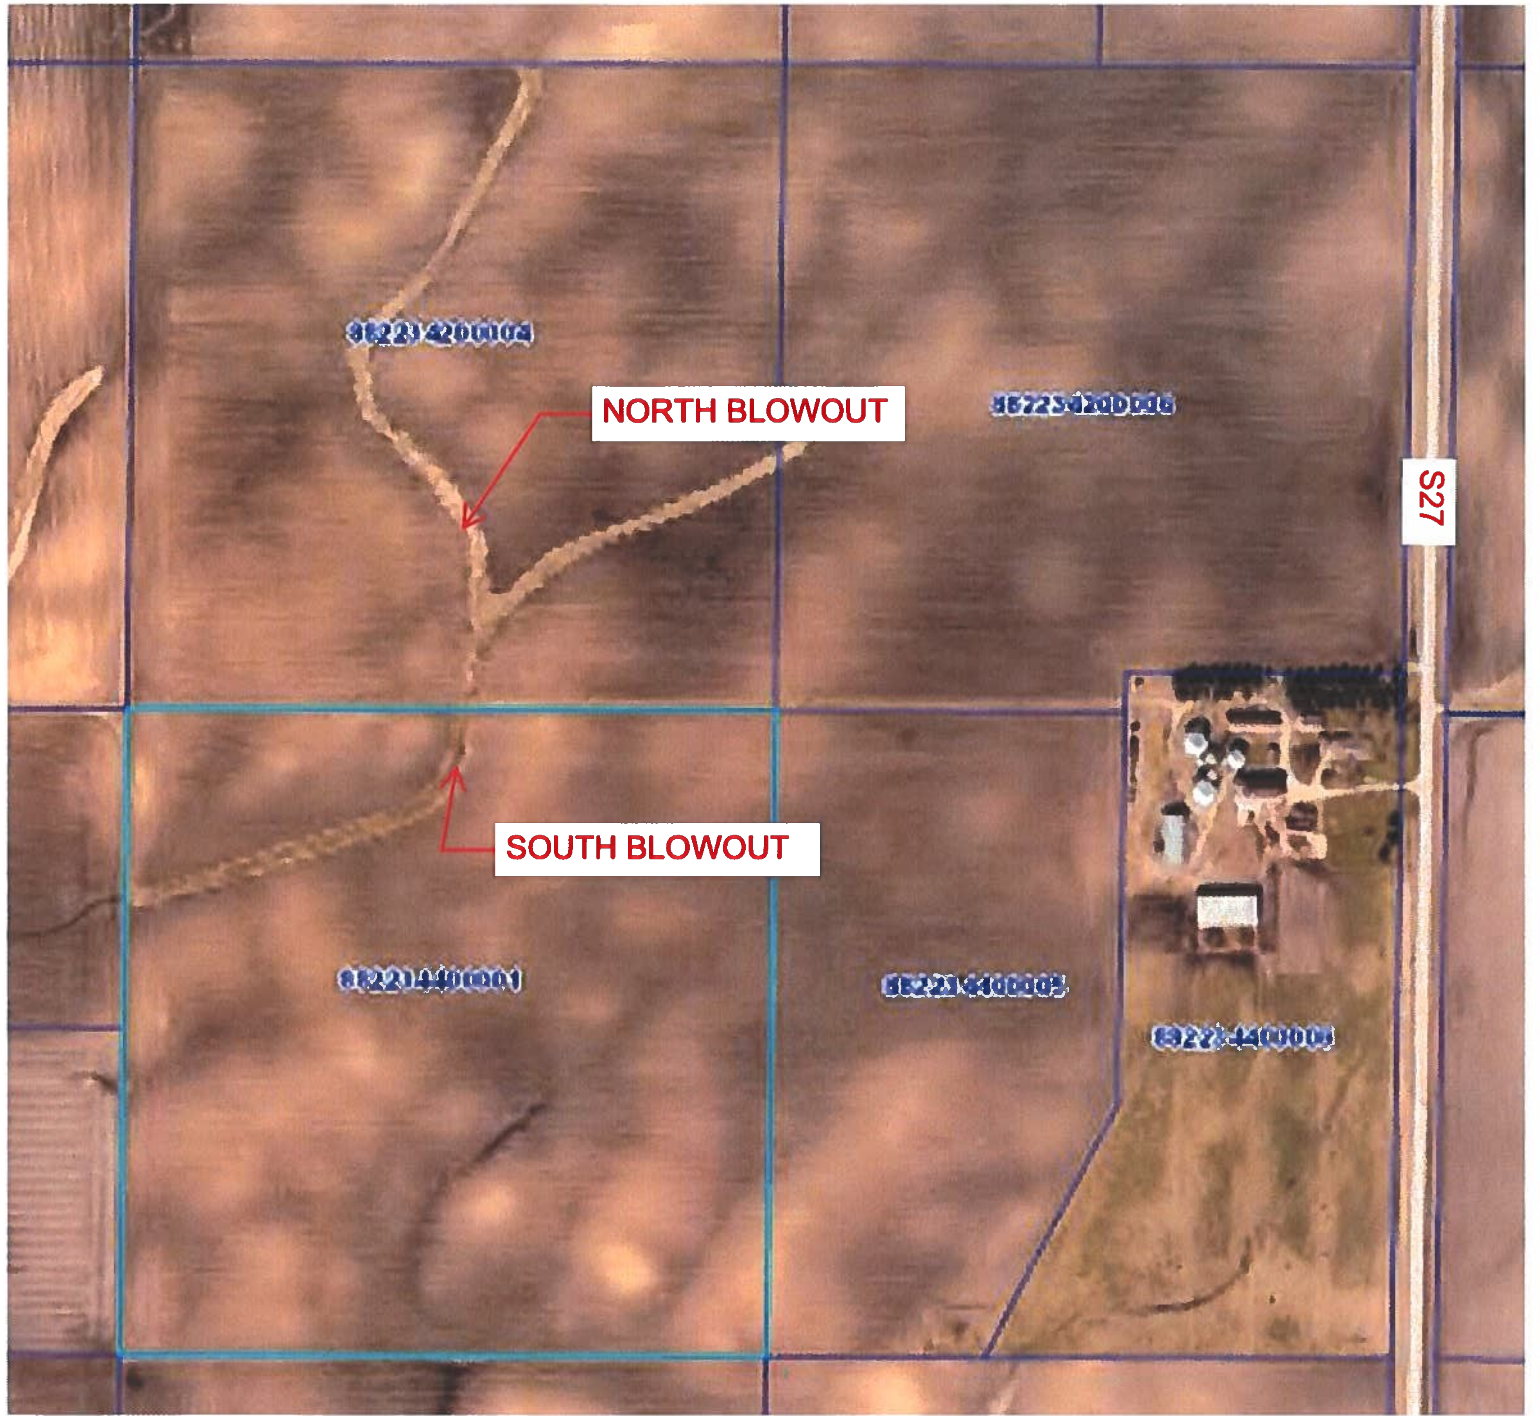
**NORTH BLOWOUT**

**SOUTH BLOWOUT**

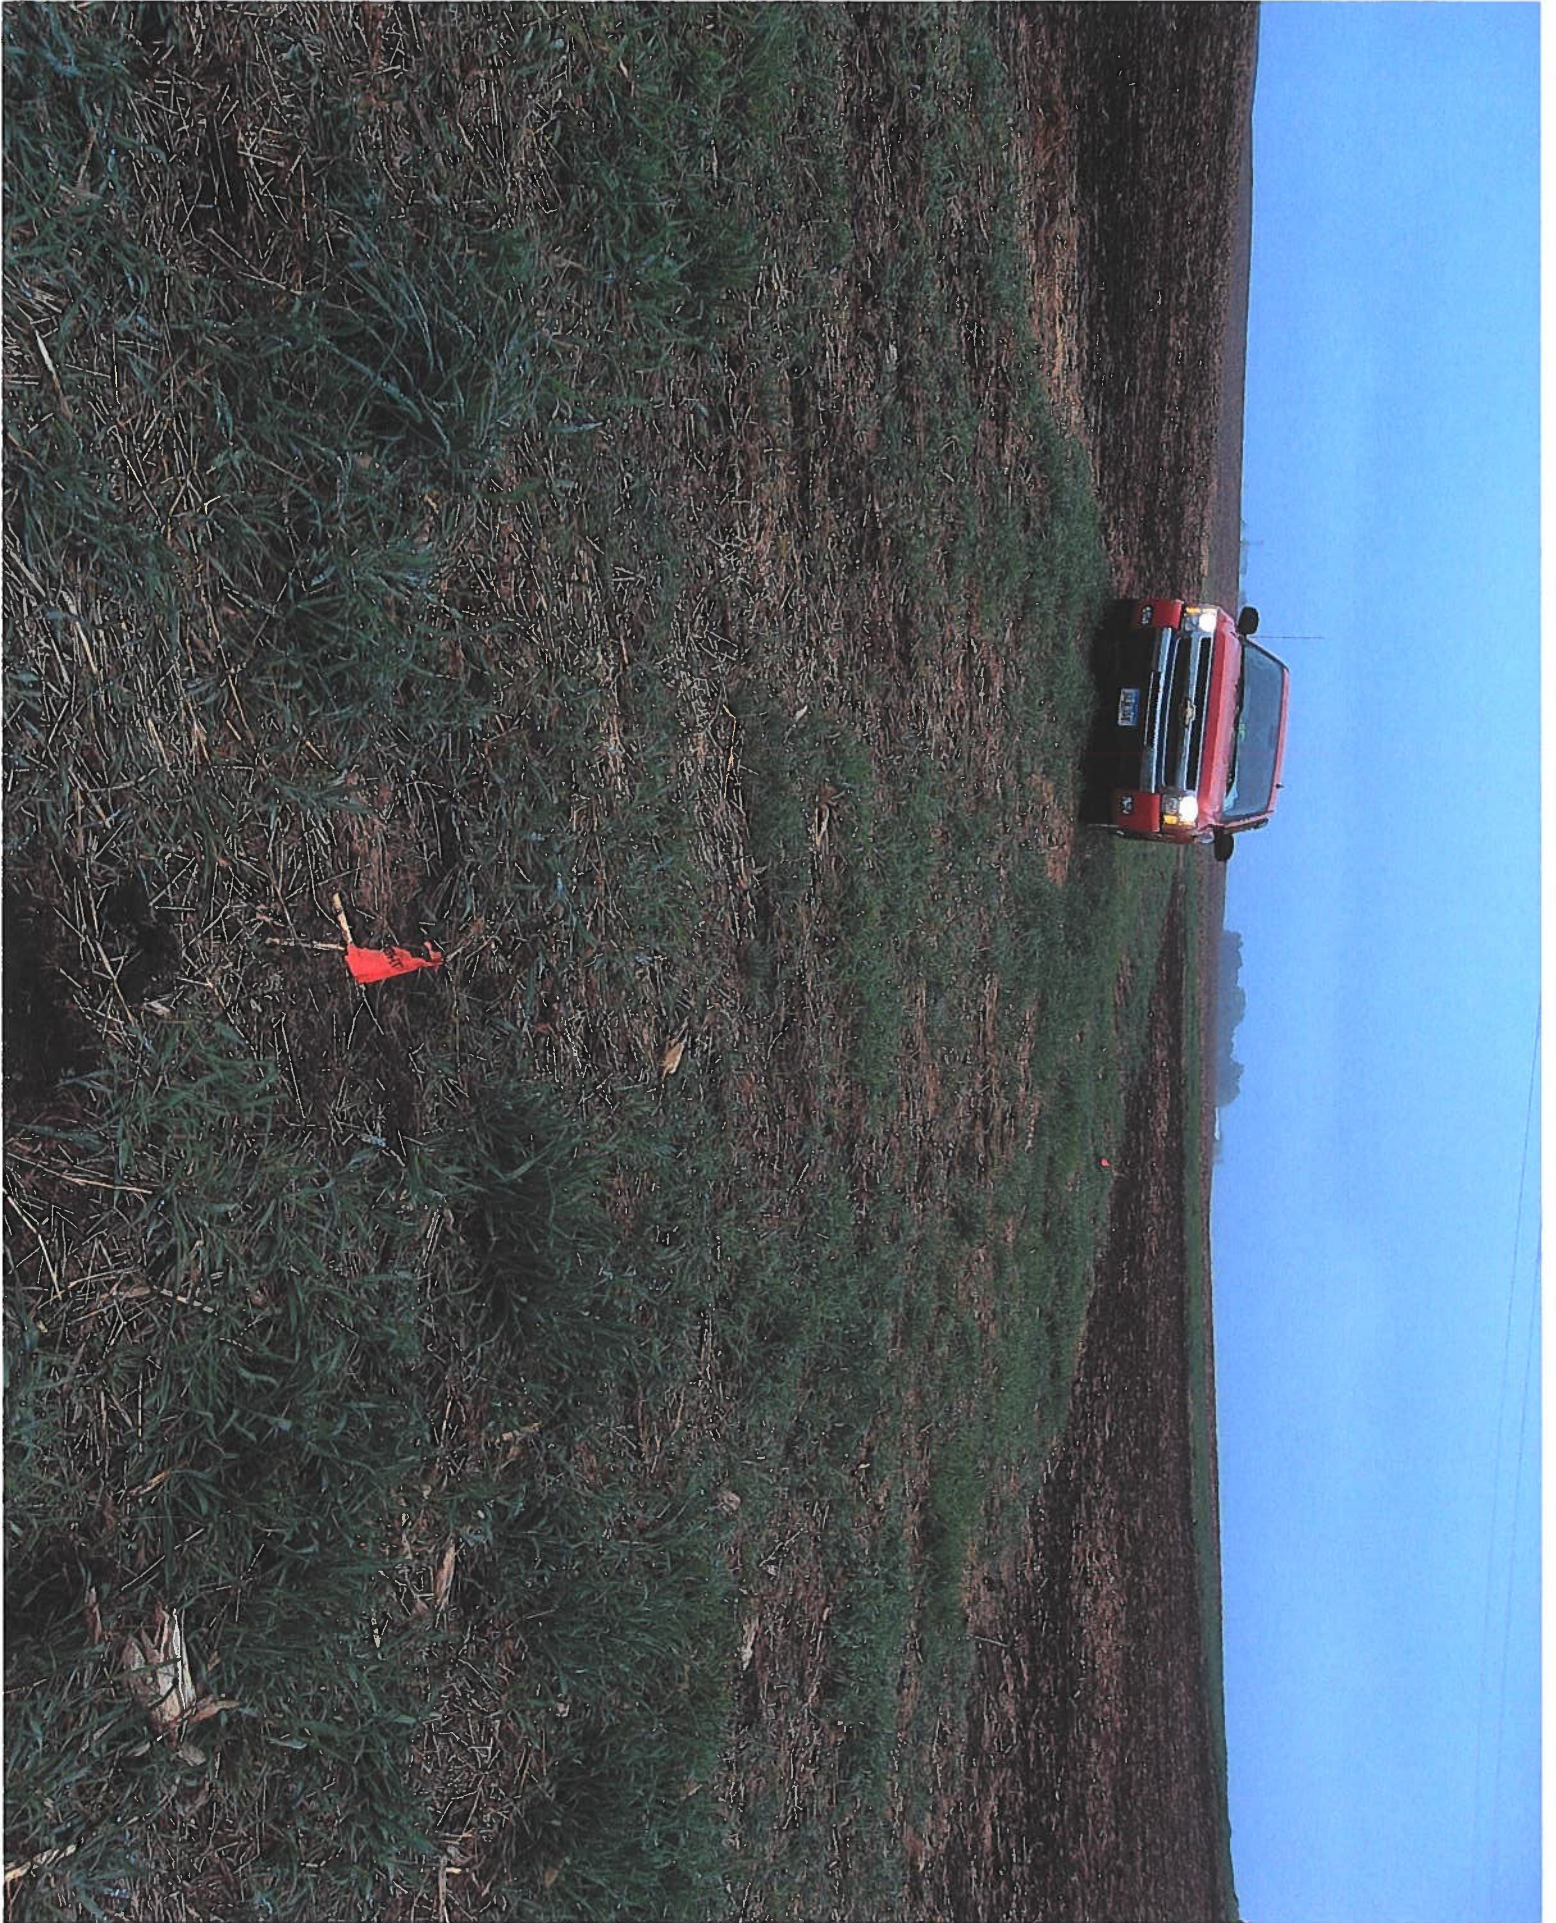
2 Blow-outs To South

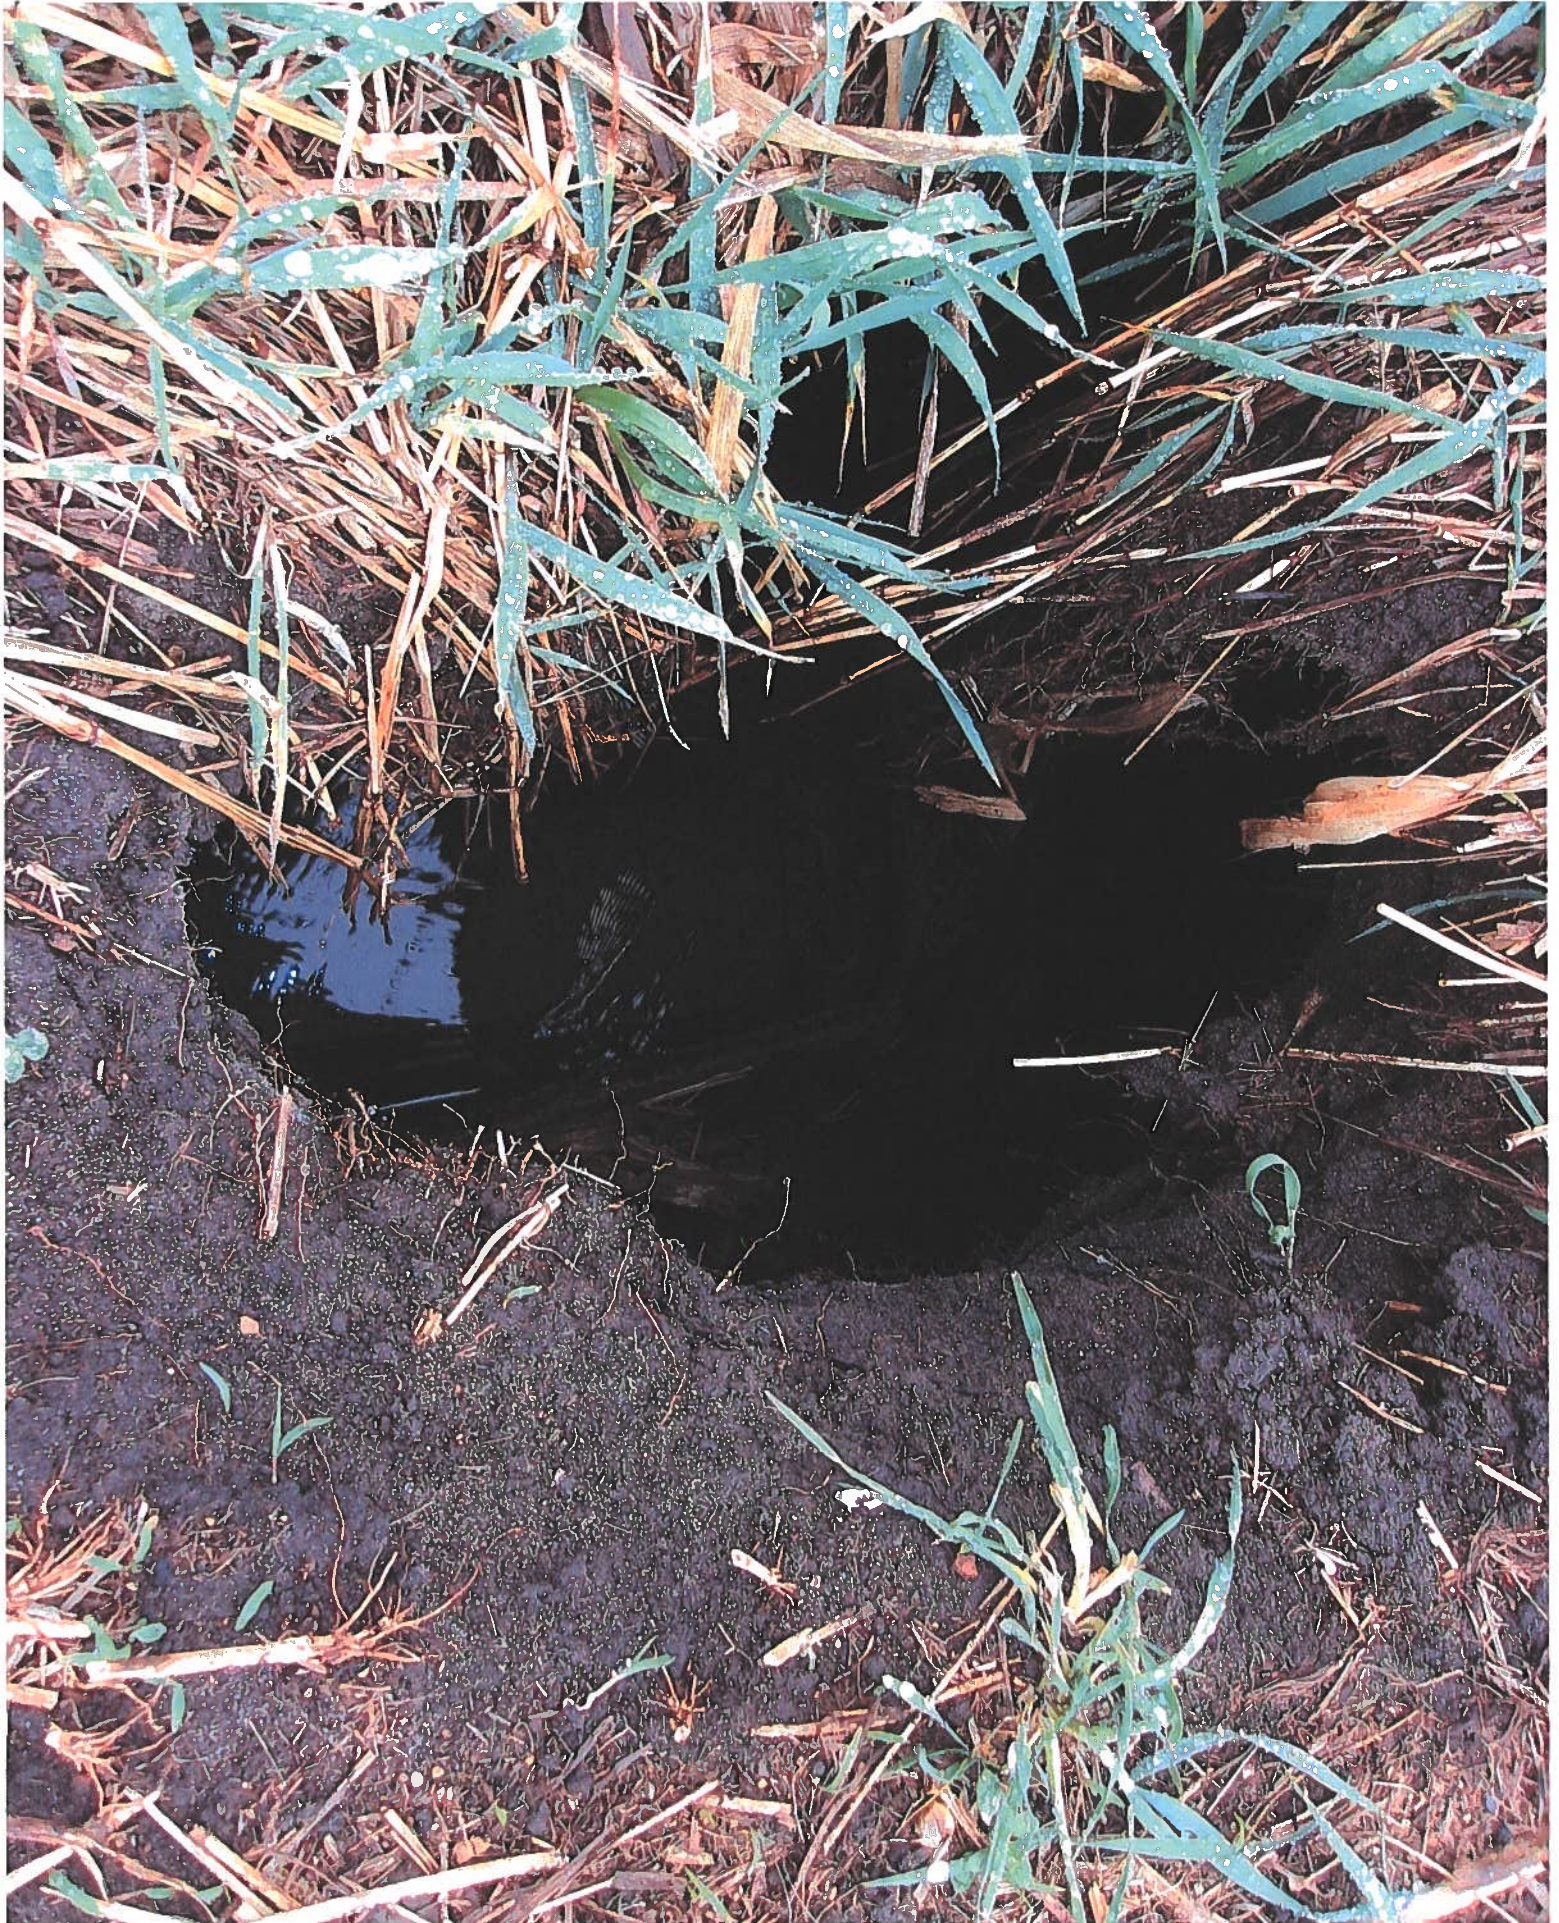
Collapsed Clay Tine

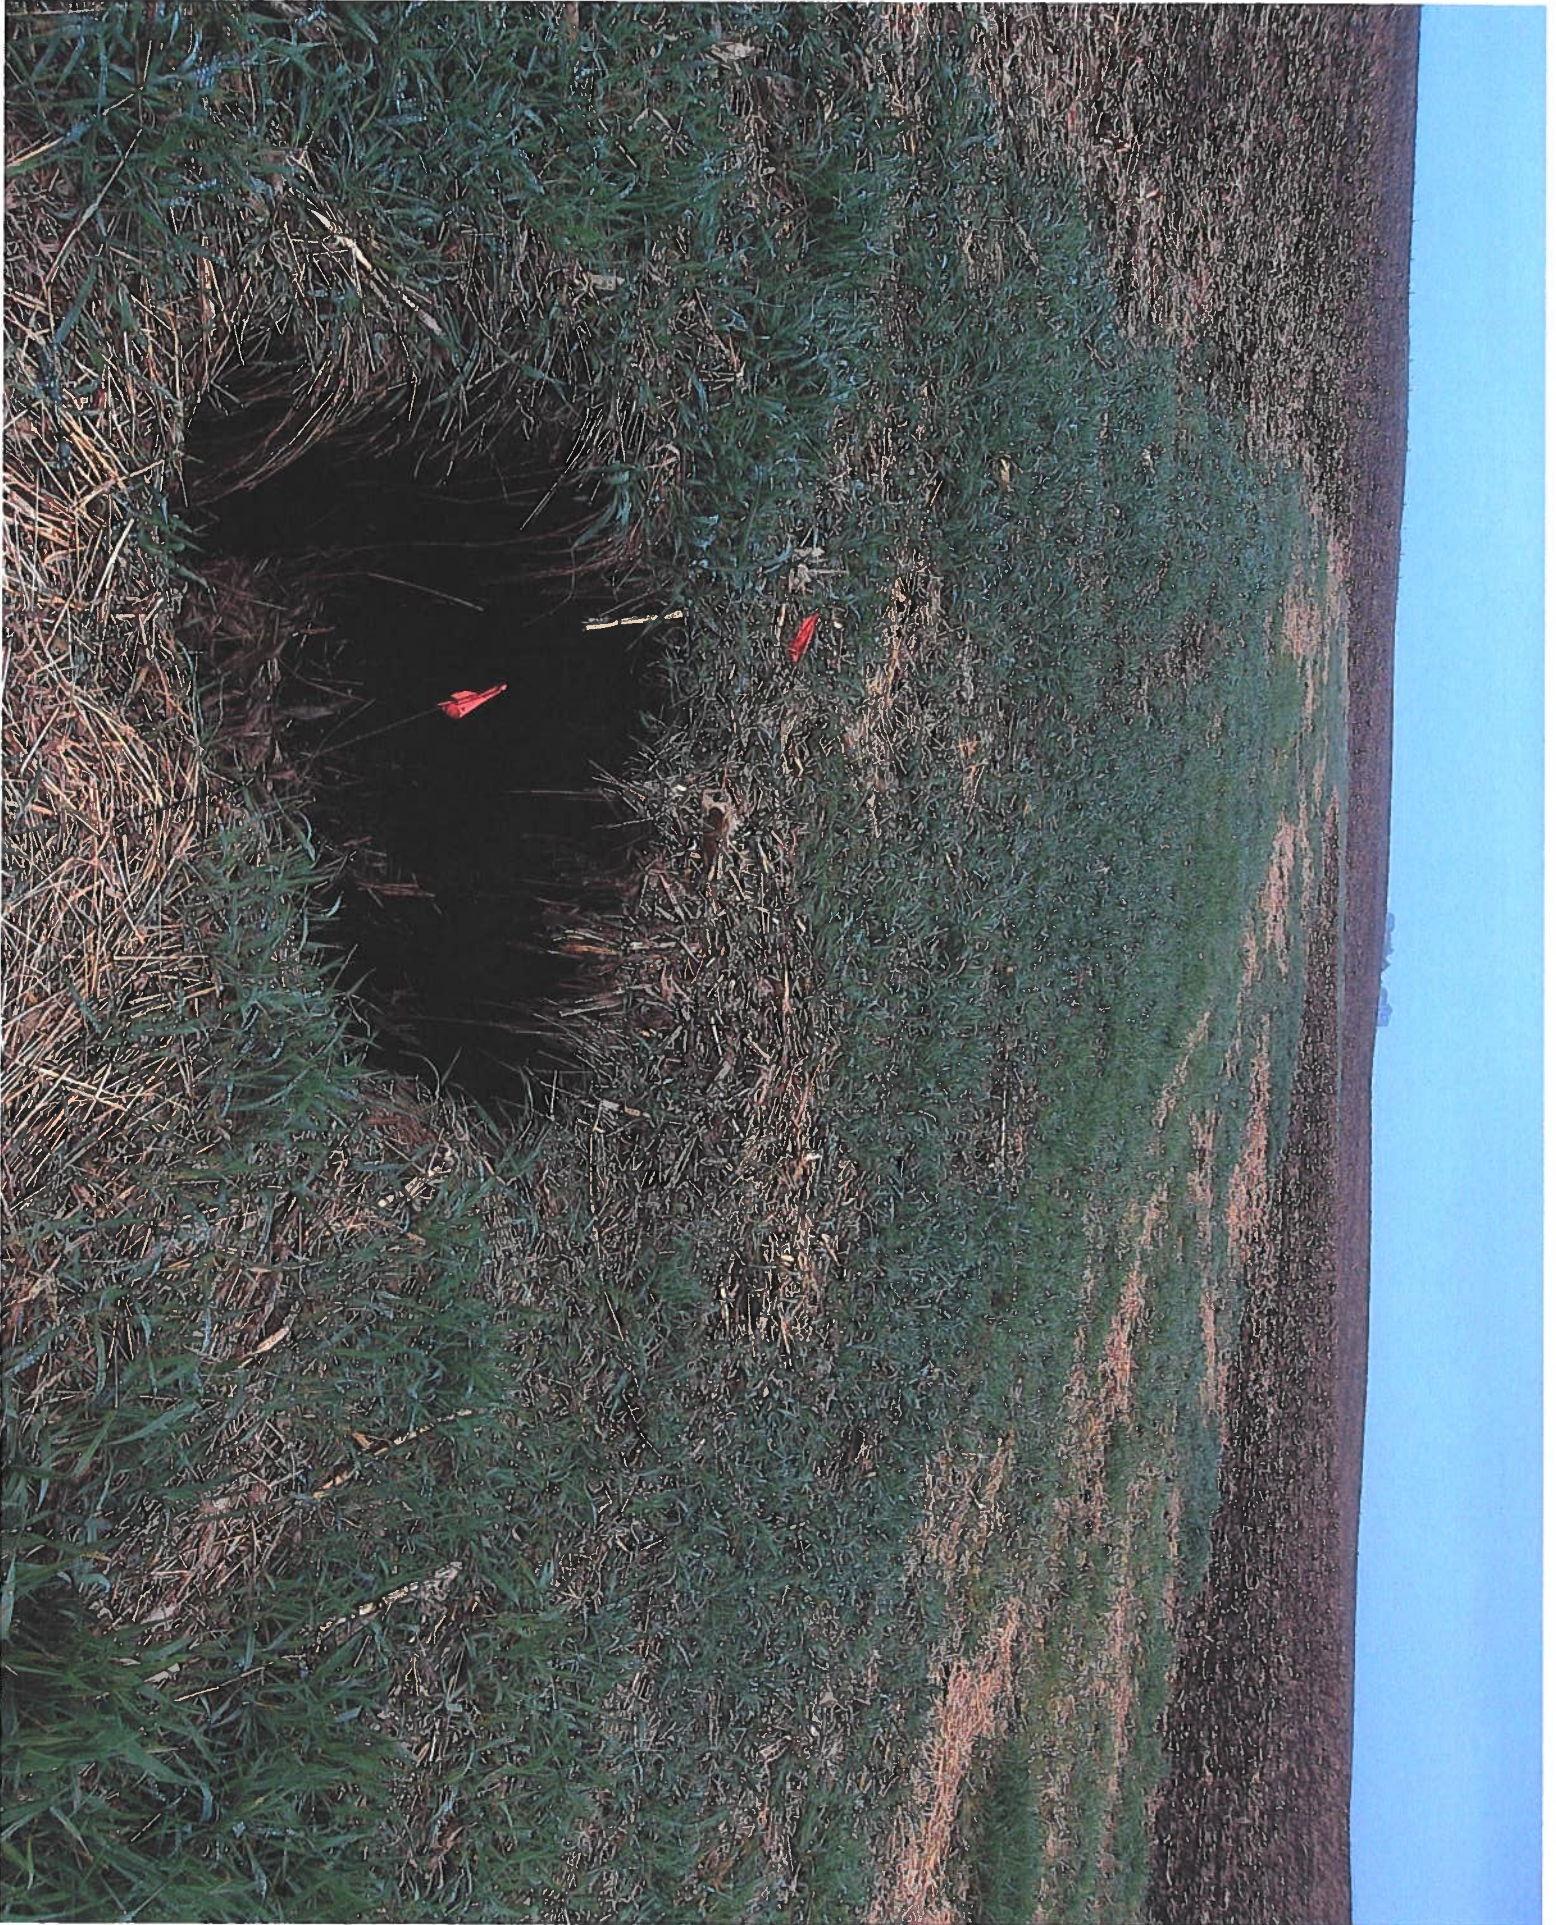
NORTHERN MOST Blow-out, COLLAPSED TILE 15"  $\phi$  ±
