Drainage District:

#14 Main and Lateral 2

Investigation/Repair Summary:

CONSTRUCTION ENGINEERING
OBSERVATION REPORT

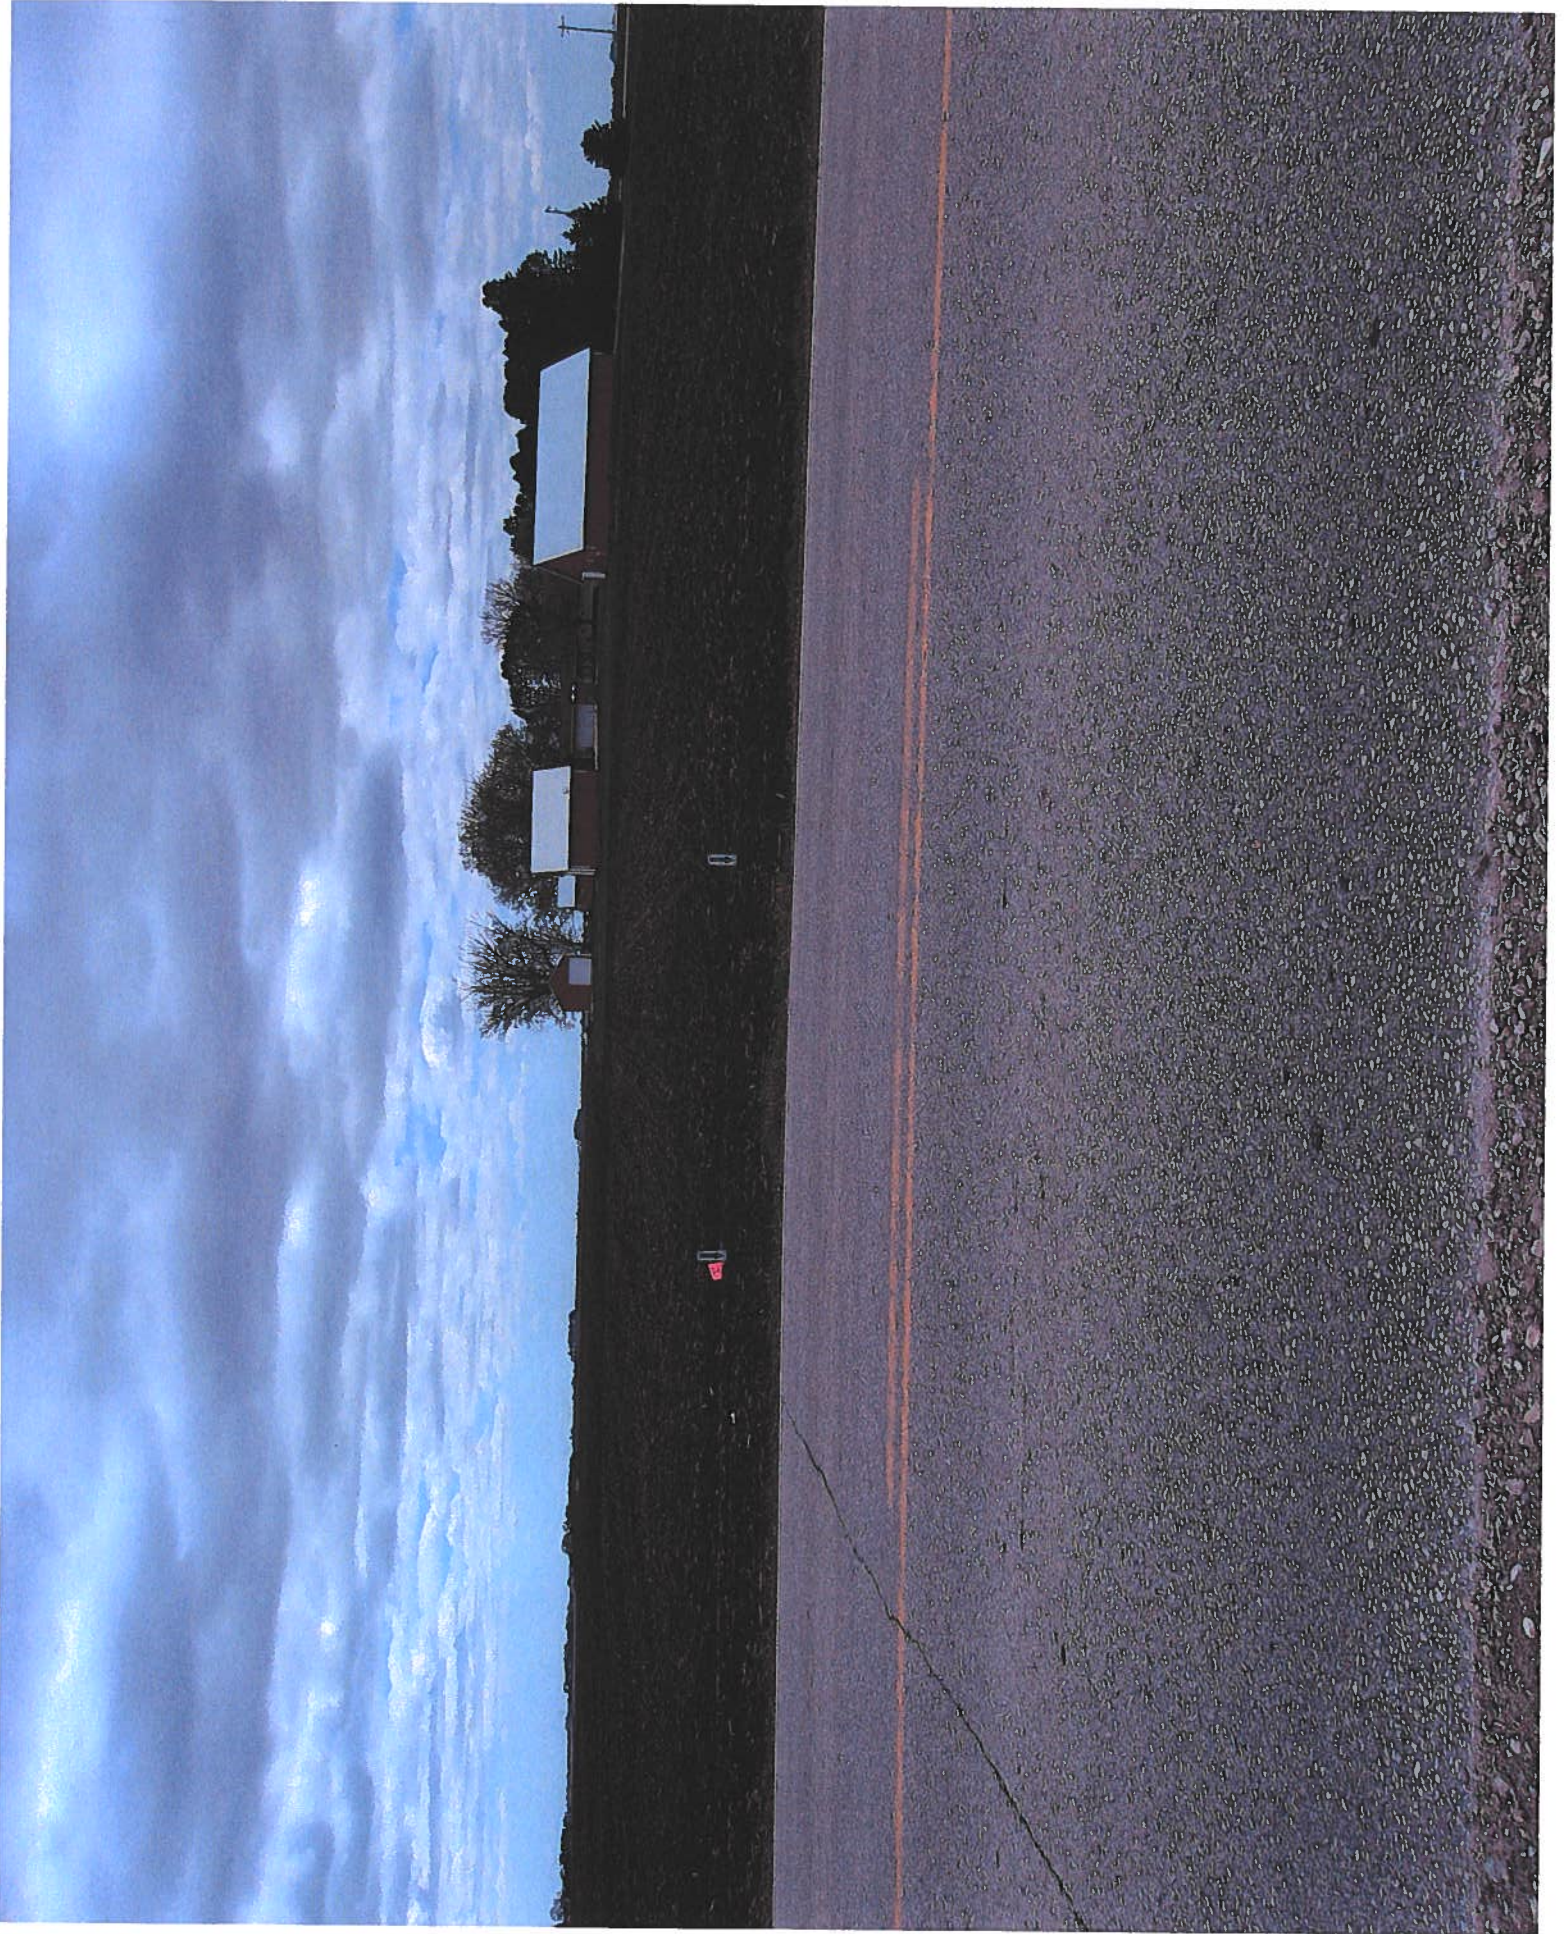
LOOKING WEST OVER S27 ON LATZ

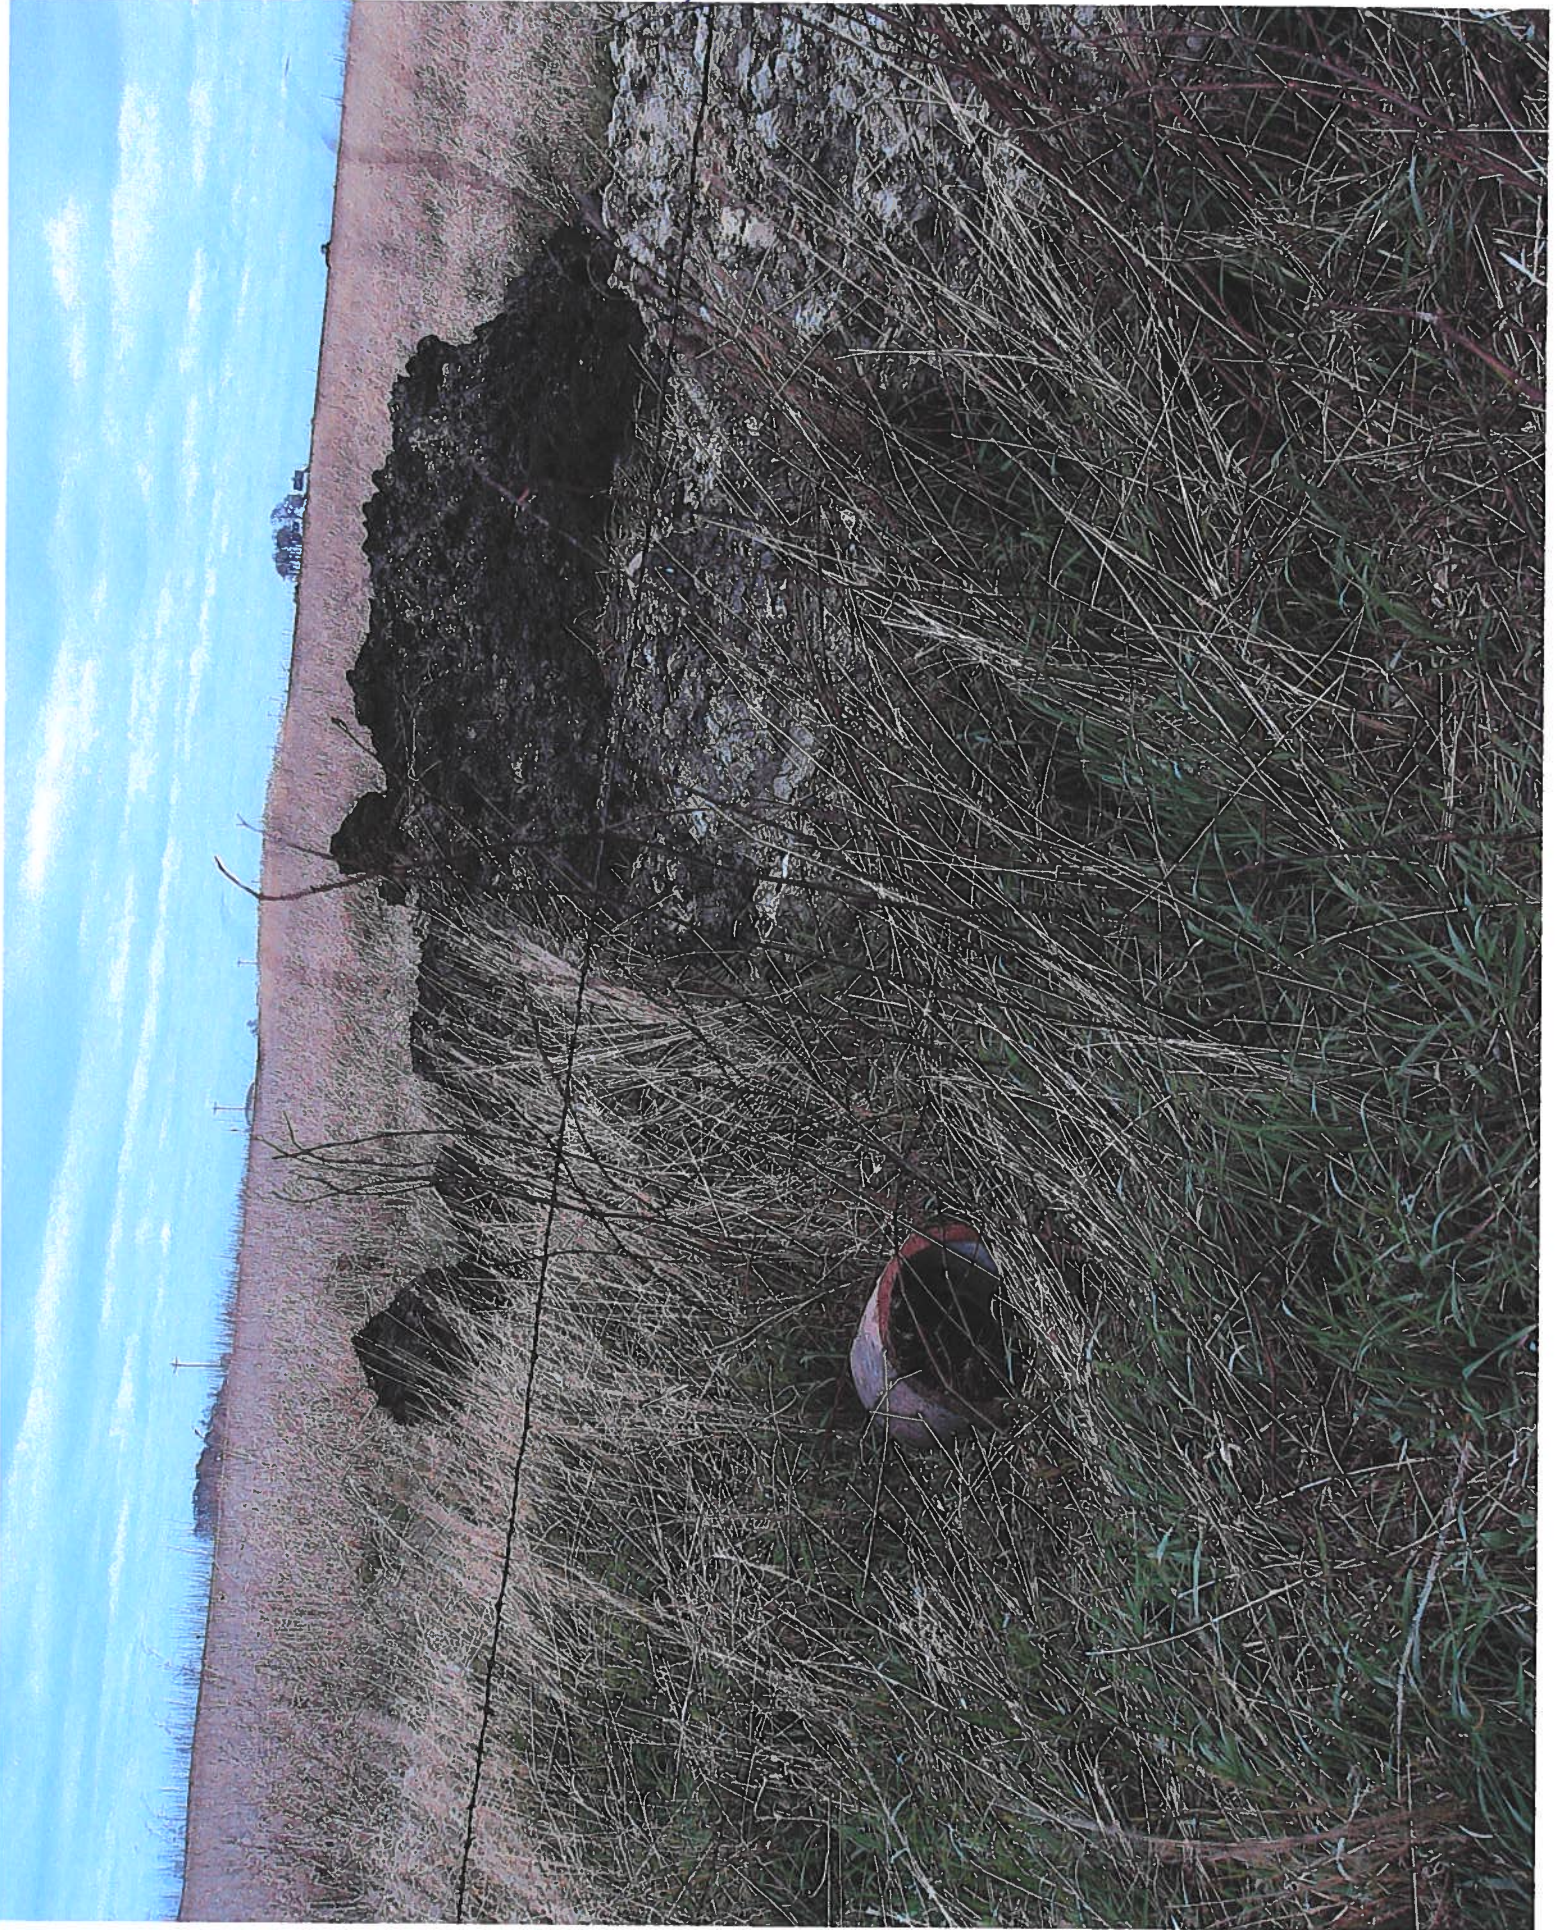
LOOKING E. @ 10" CLAY ON LAT 2, E. OF S27

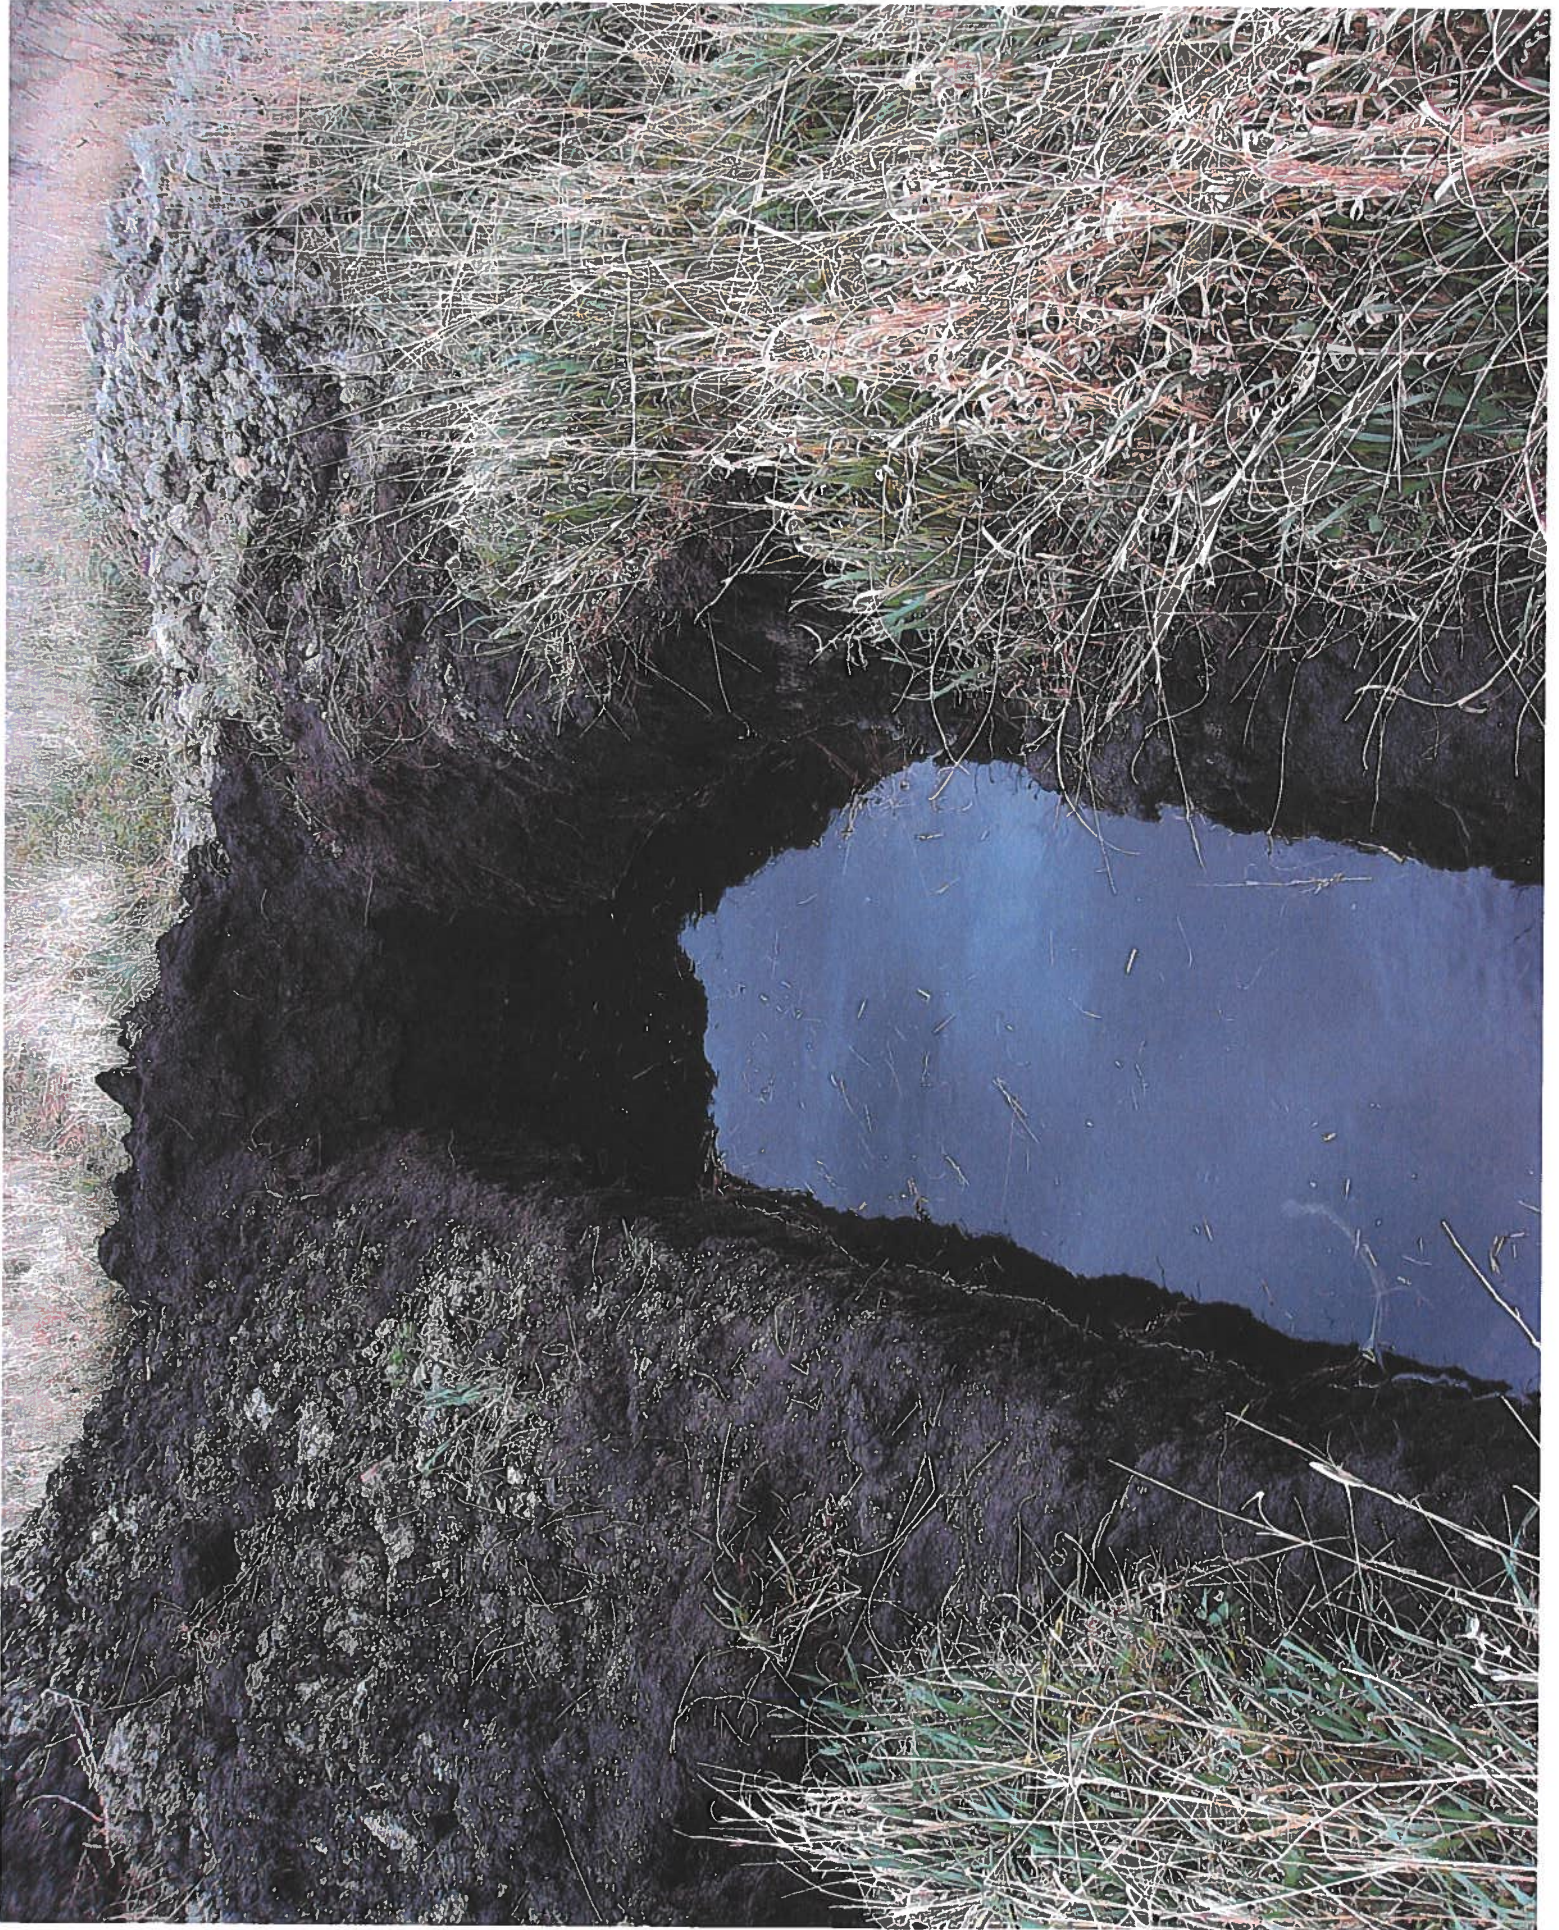
TRENCH ON LAT 2, E SIDE S27

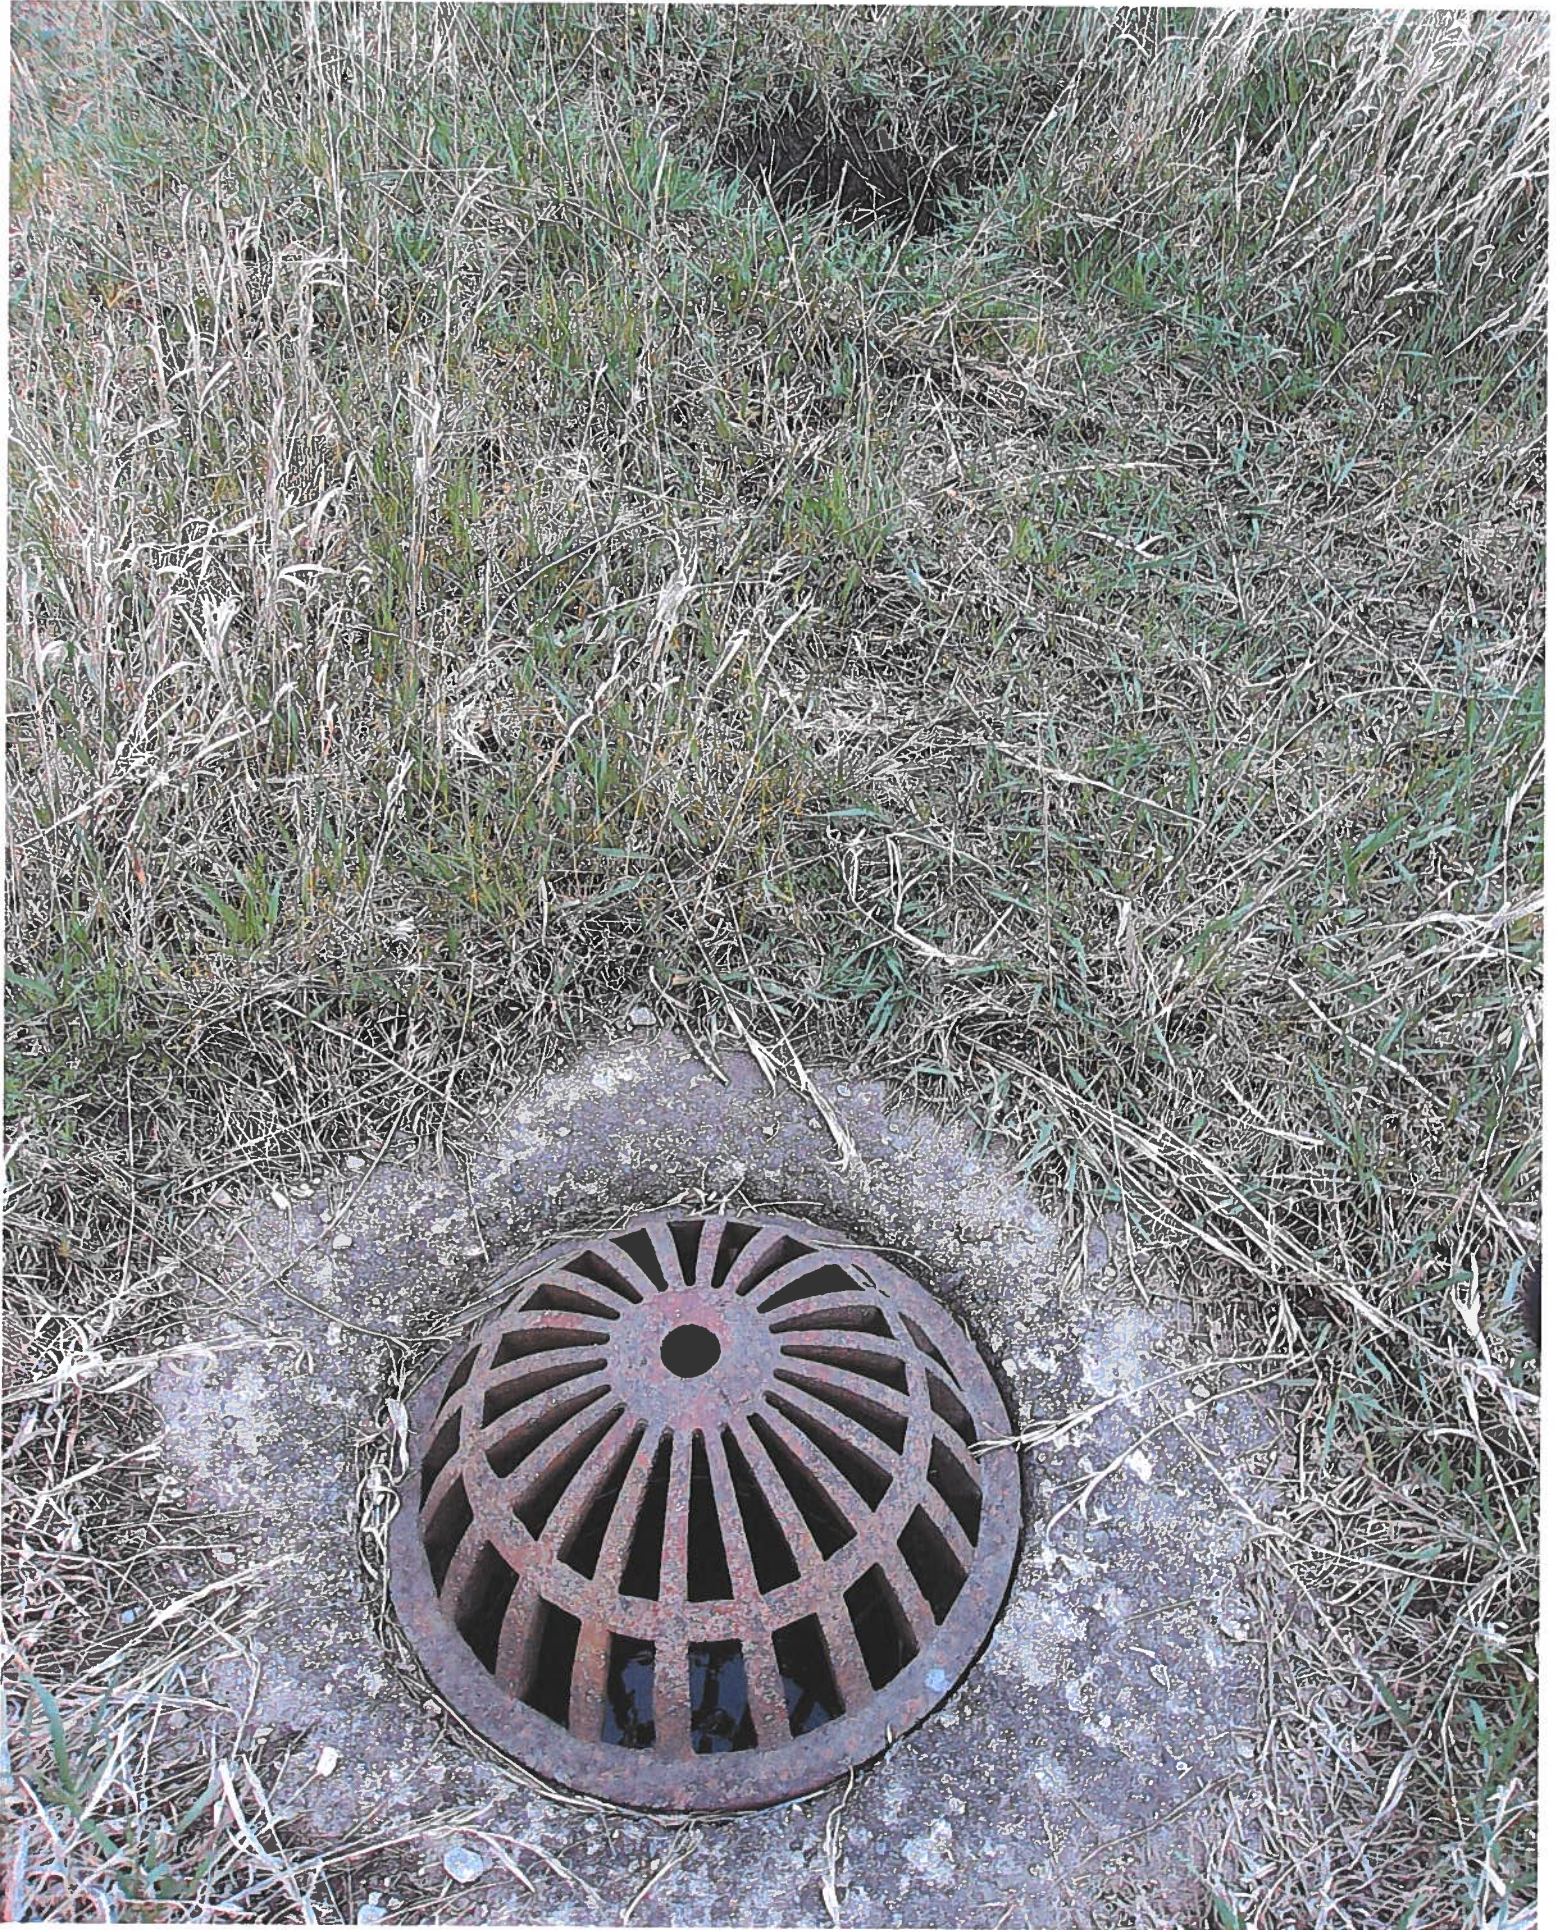
LOOKING EAST @ BEEHIVE WITH HOLE ON LAT2, S. SIDE D41 BY CRP

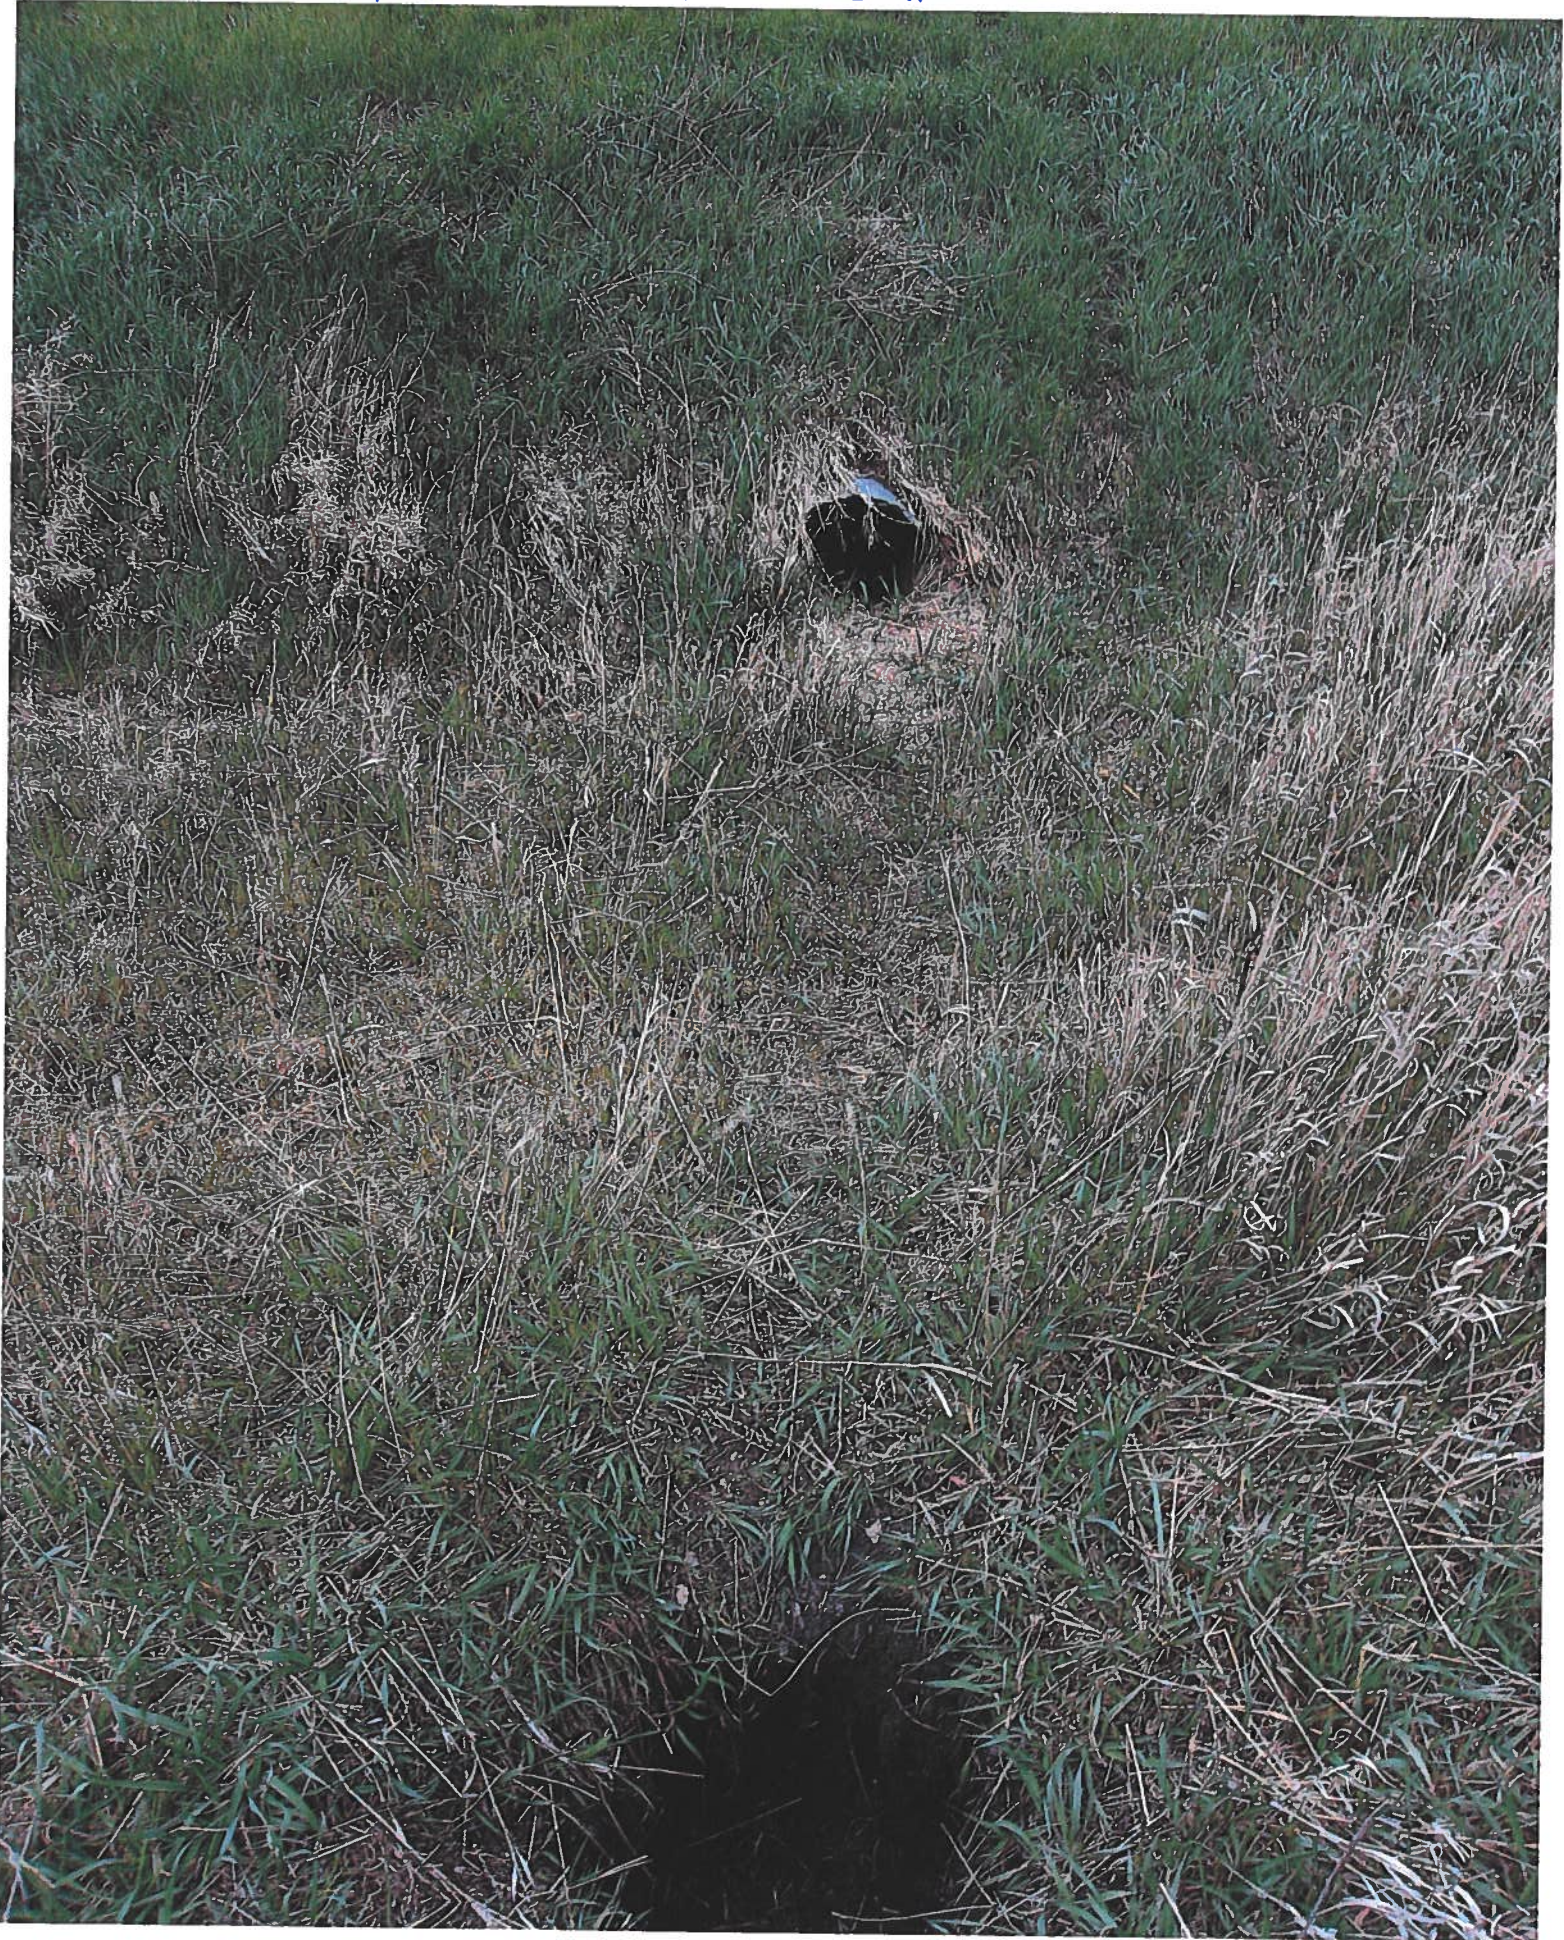
S. SIDE D41 , HOLE ON LAT 2 , LOOKING N.

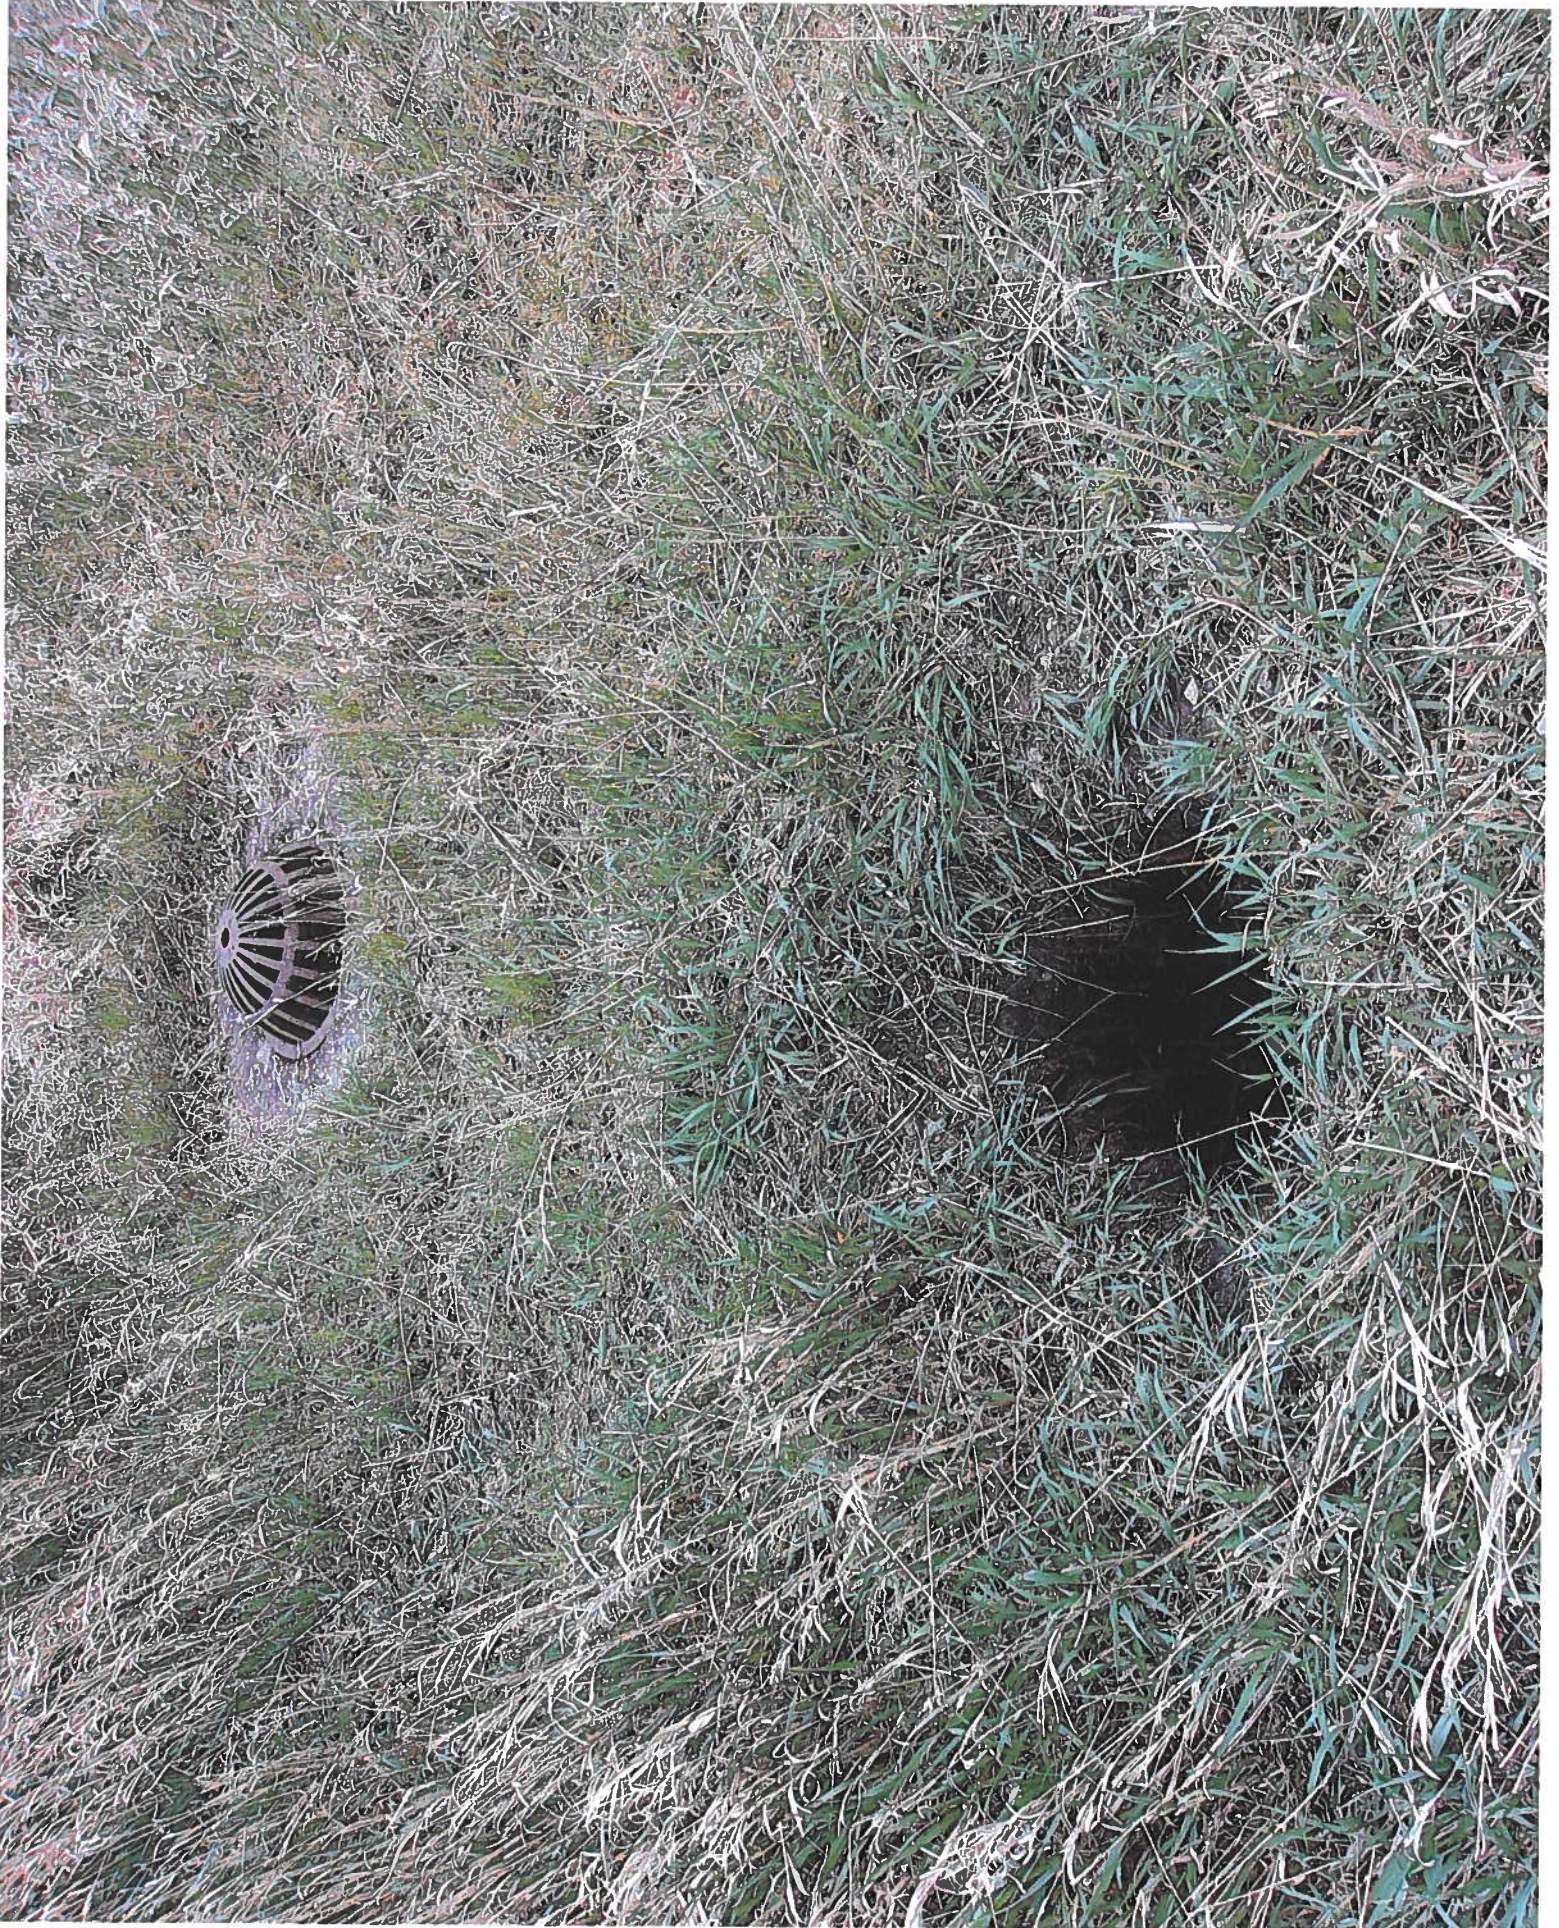
LOOKING WEST ON S. DITCH D41

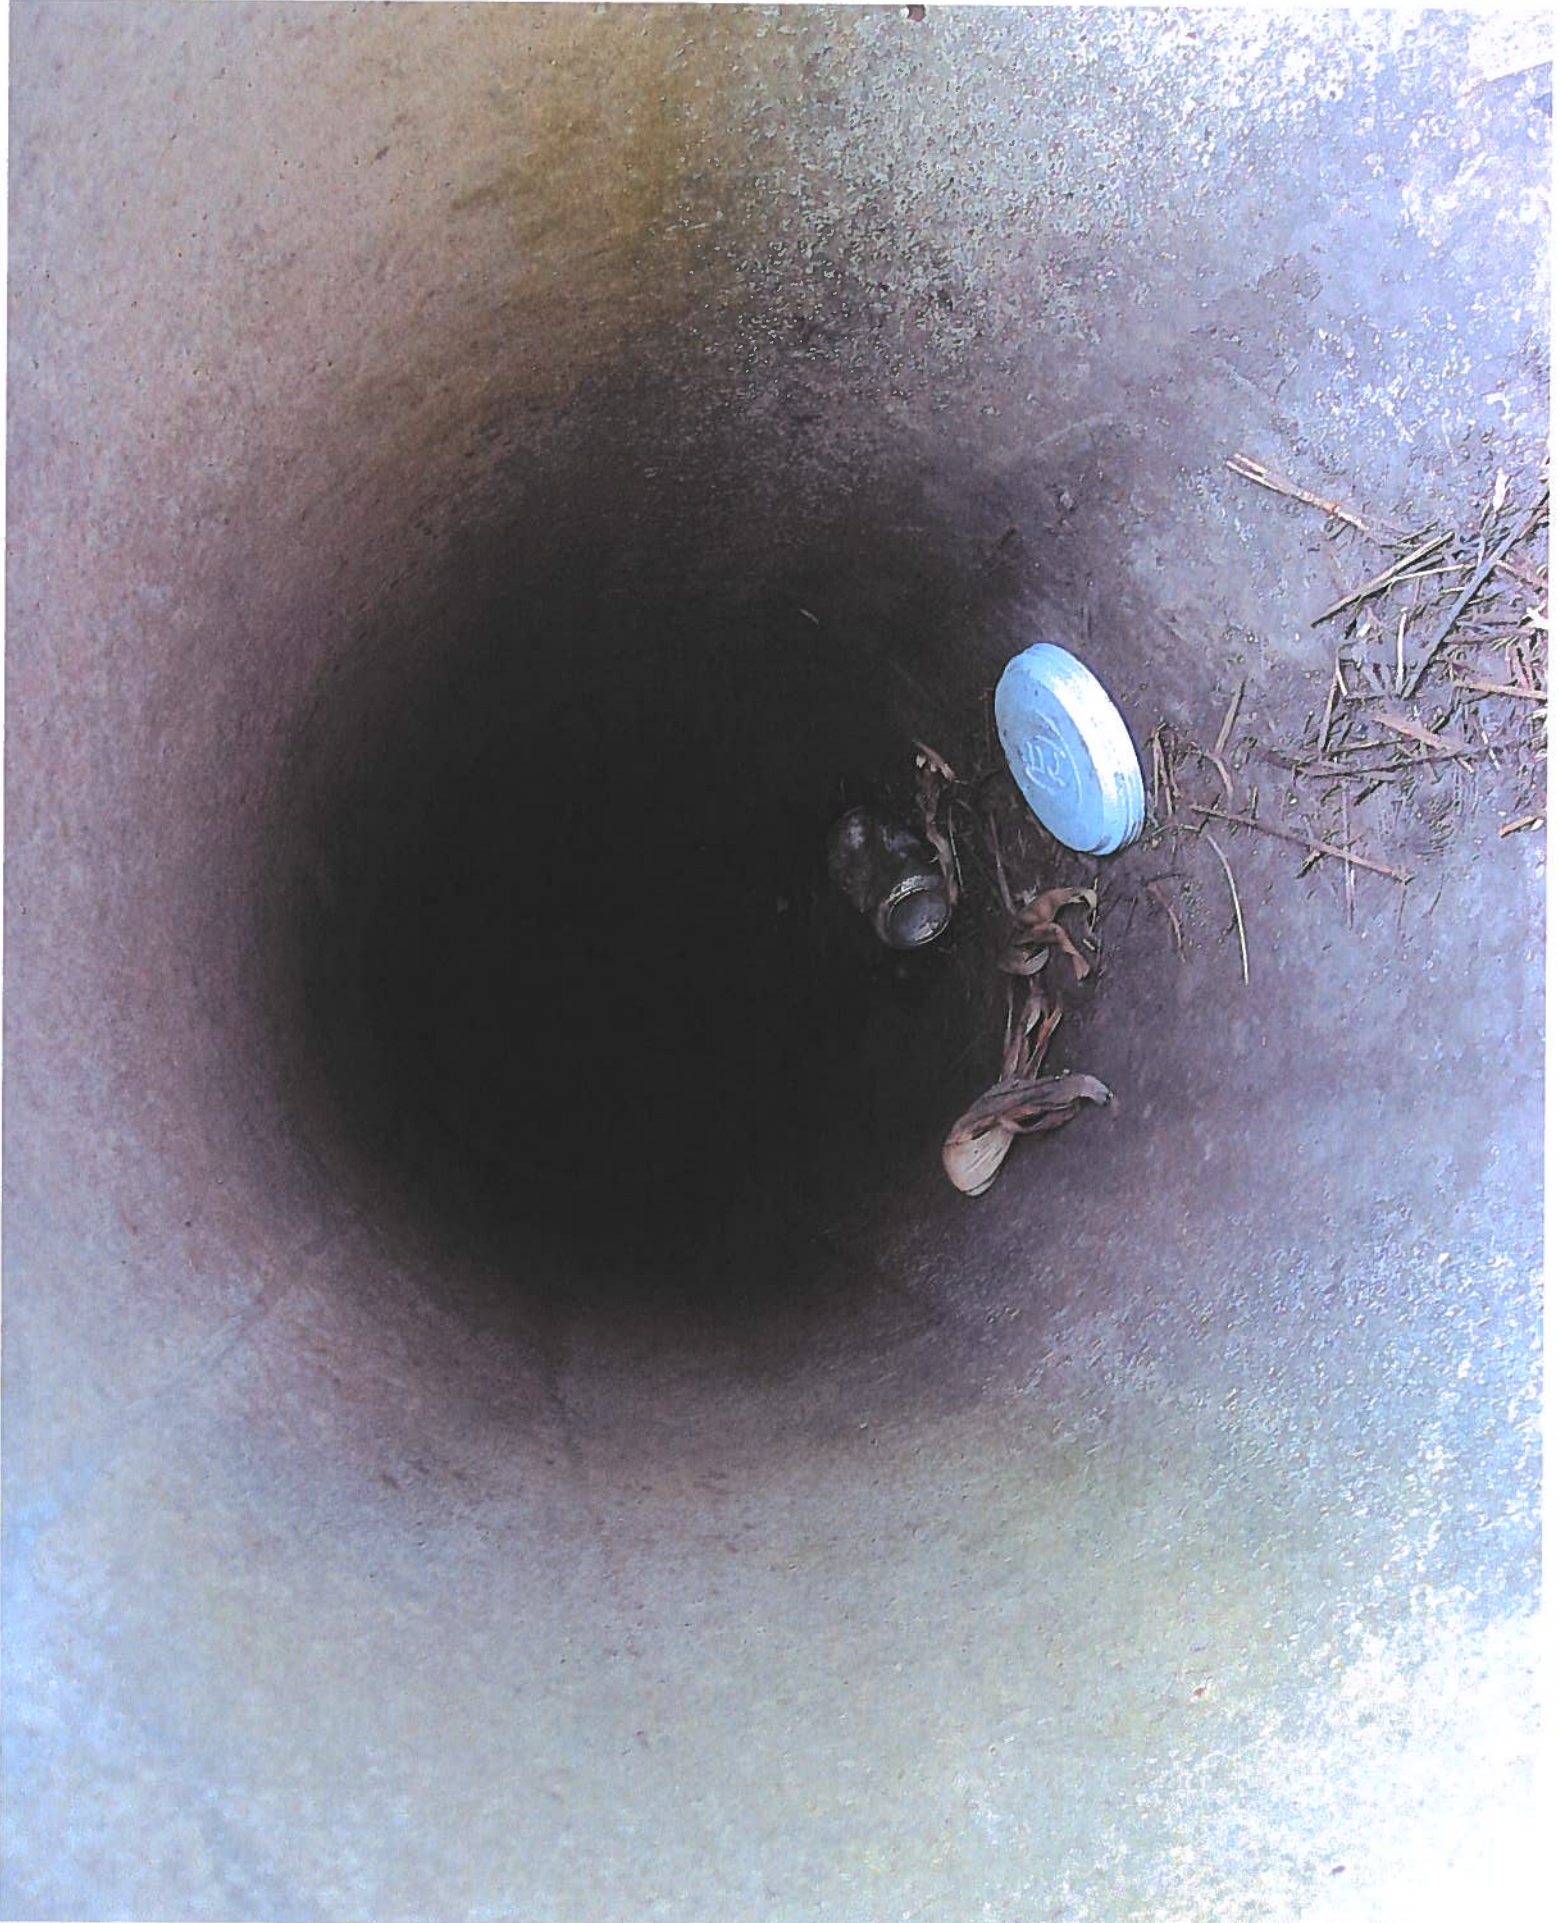
SURF. DRAIN RCP WITH SUCK HOLE OVER TOP RCP AND LAT 2
