Drainage District:

#14 Main and Lateral 2

Investigation/Repair Summary:

CONSTRUCTION ENGINEERING
OBSERVATION REPORT

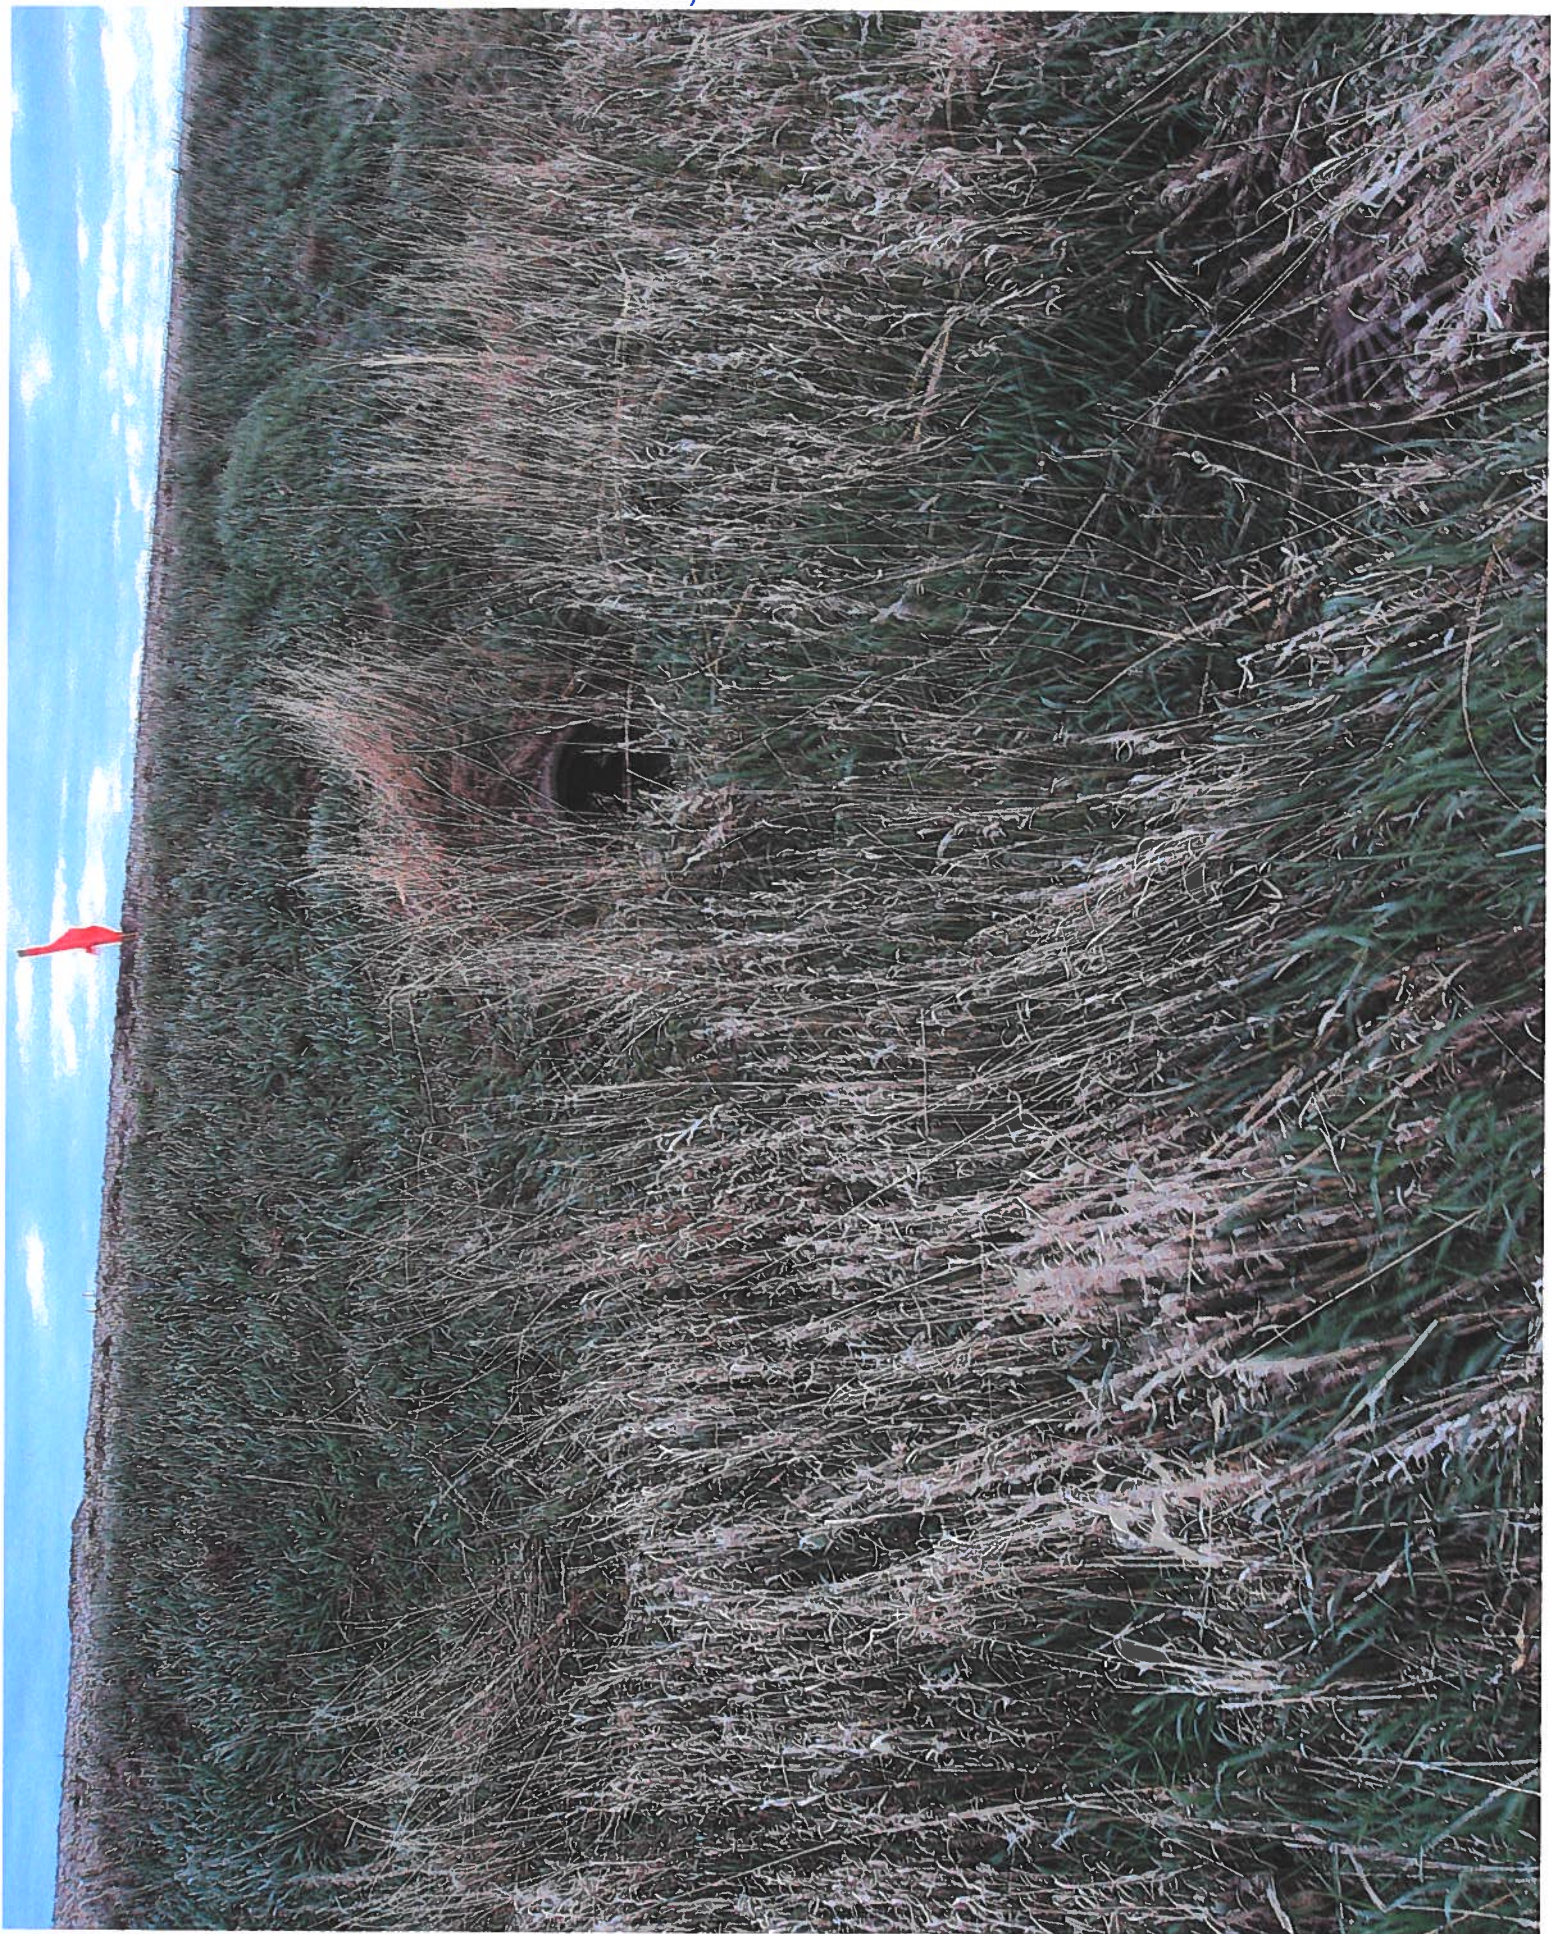
LOOKING S. ON LAT 2 ROUTE, FLAG ON SIXK HOLE ON N.S.H. D41

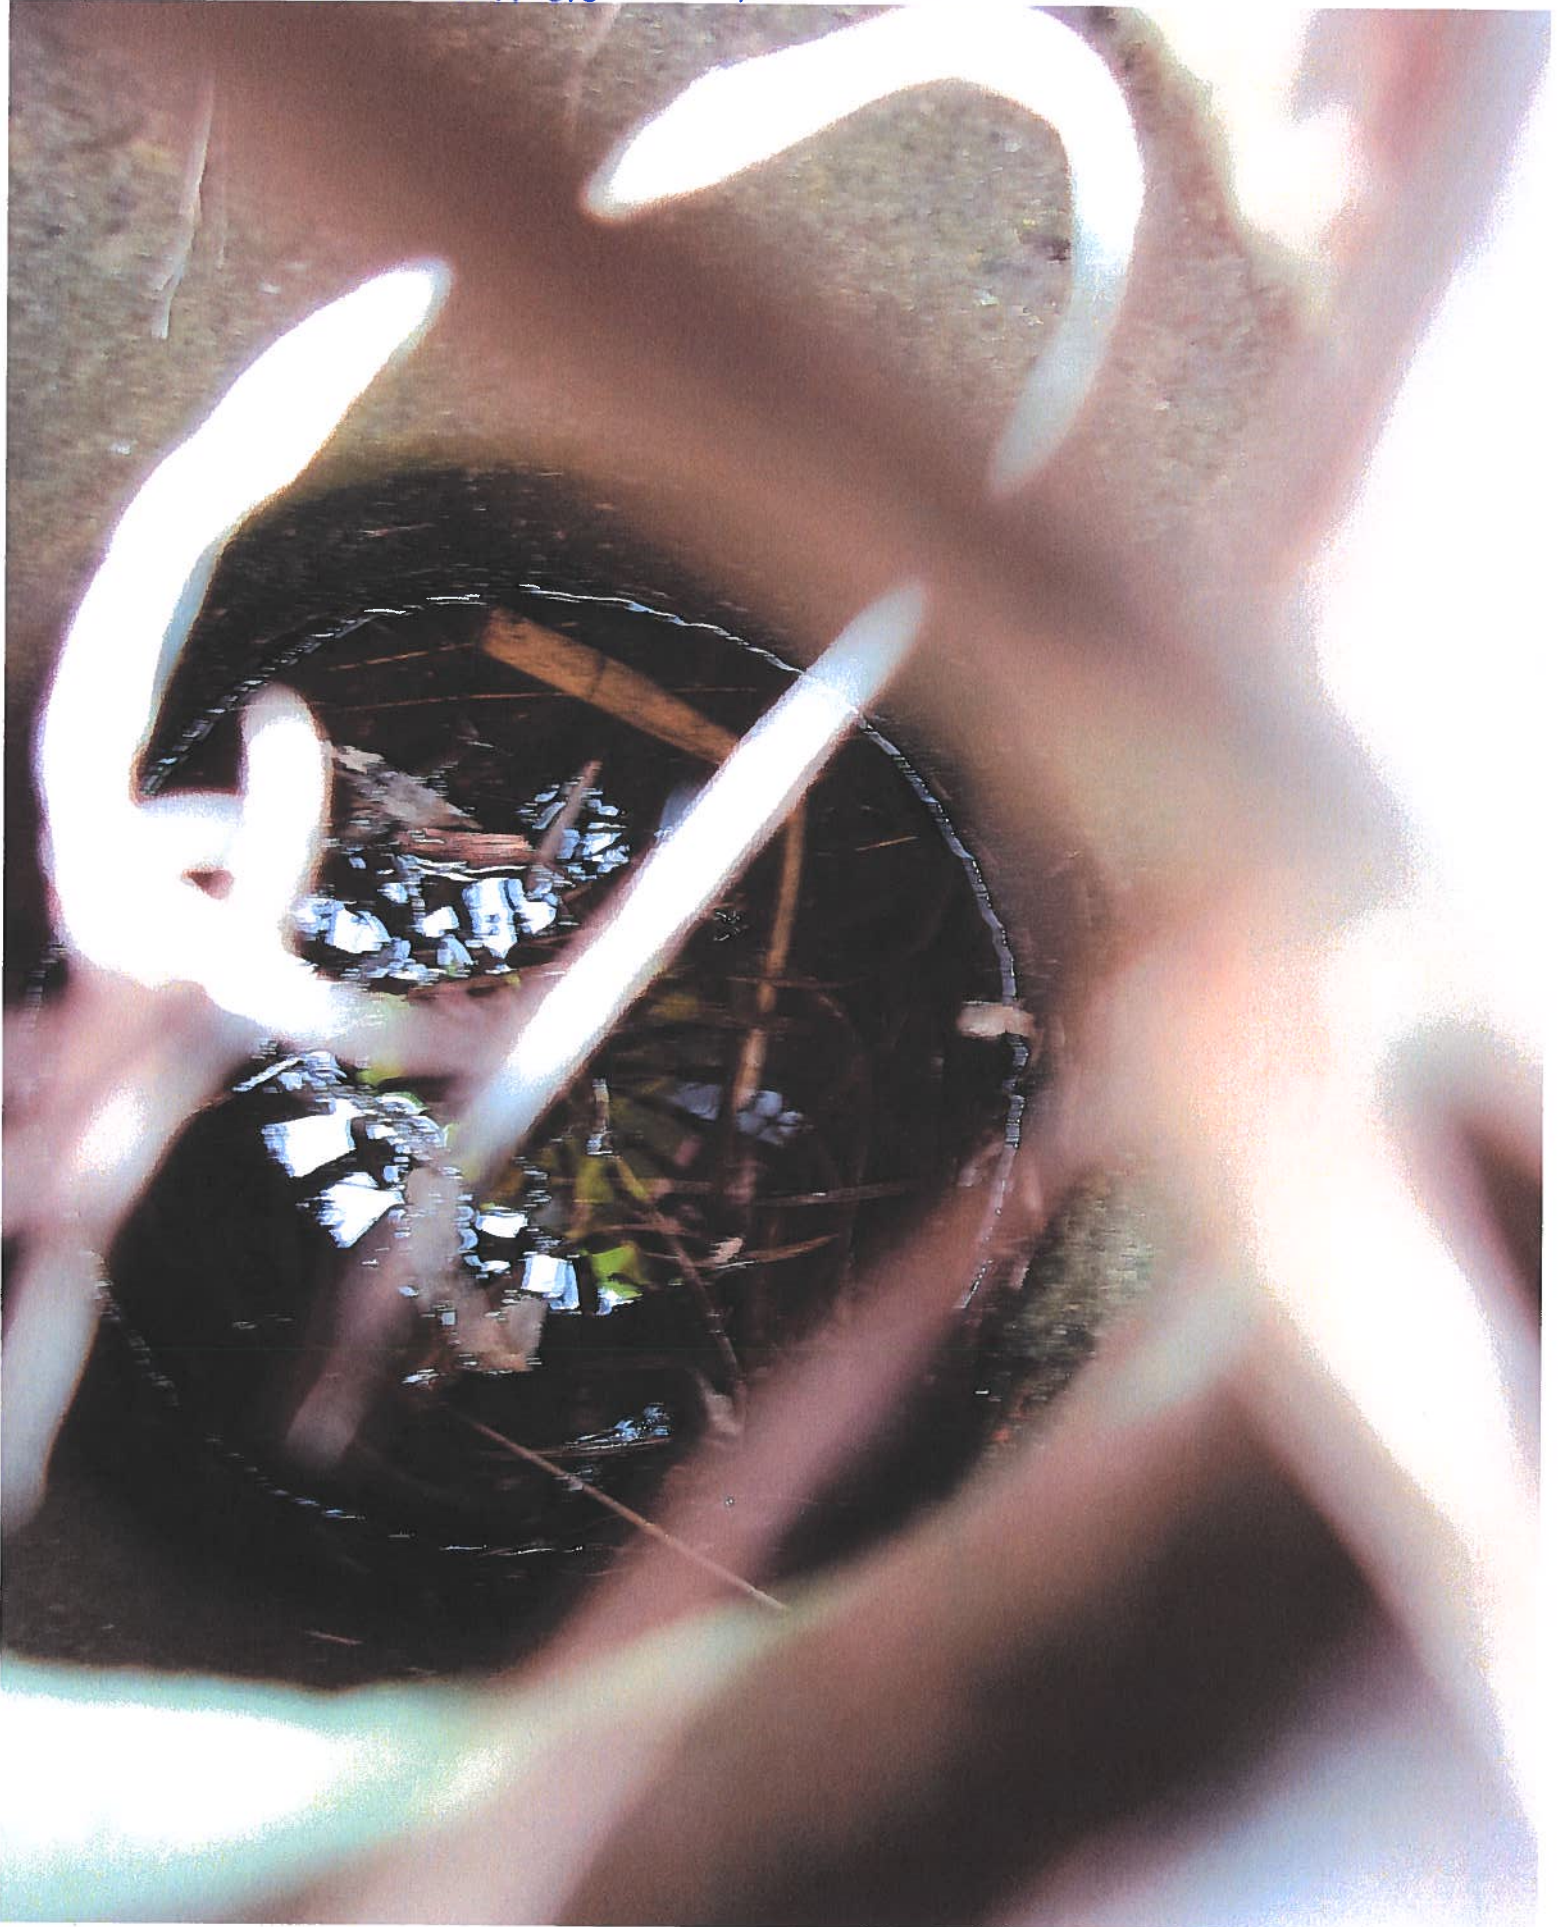
INTAKE ON N. SIDE D41 ON LAT 2, FULL OF WATER

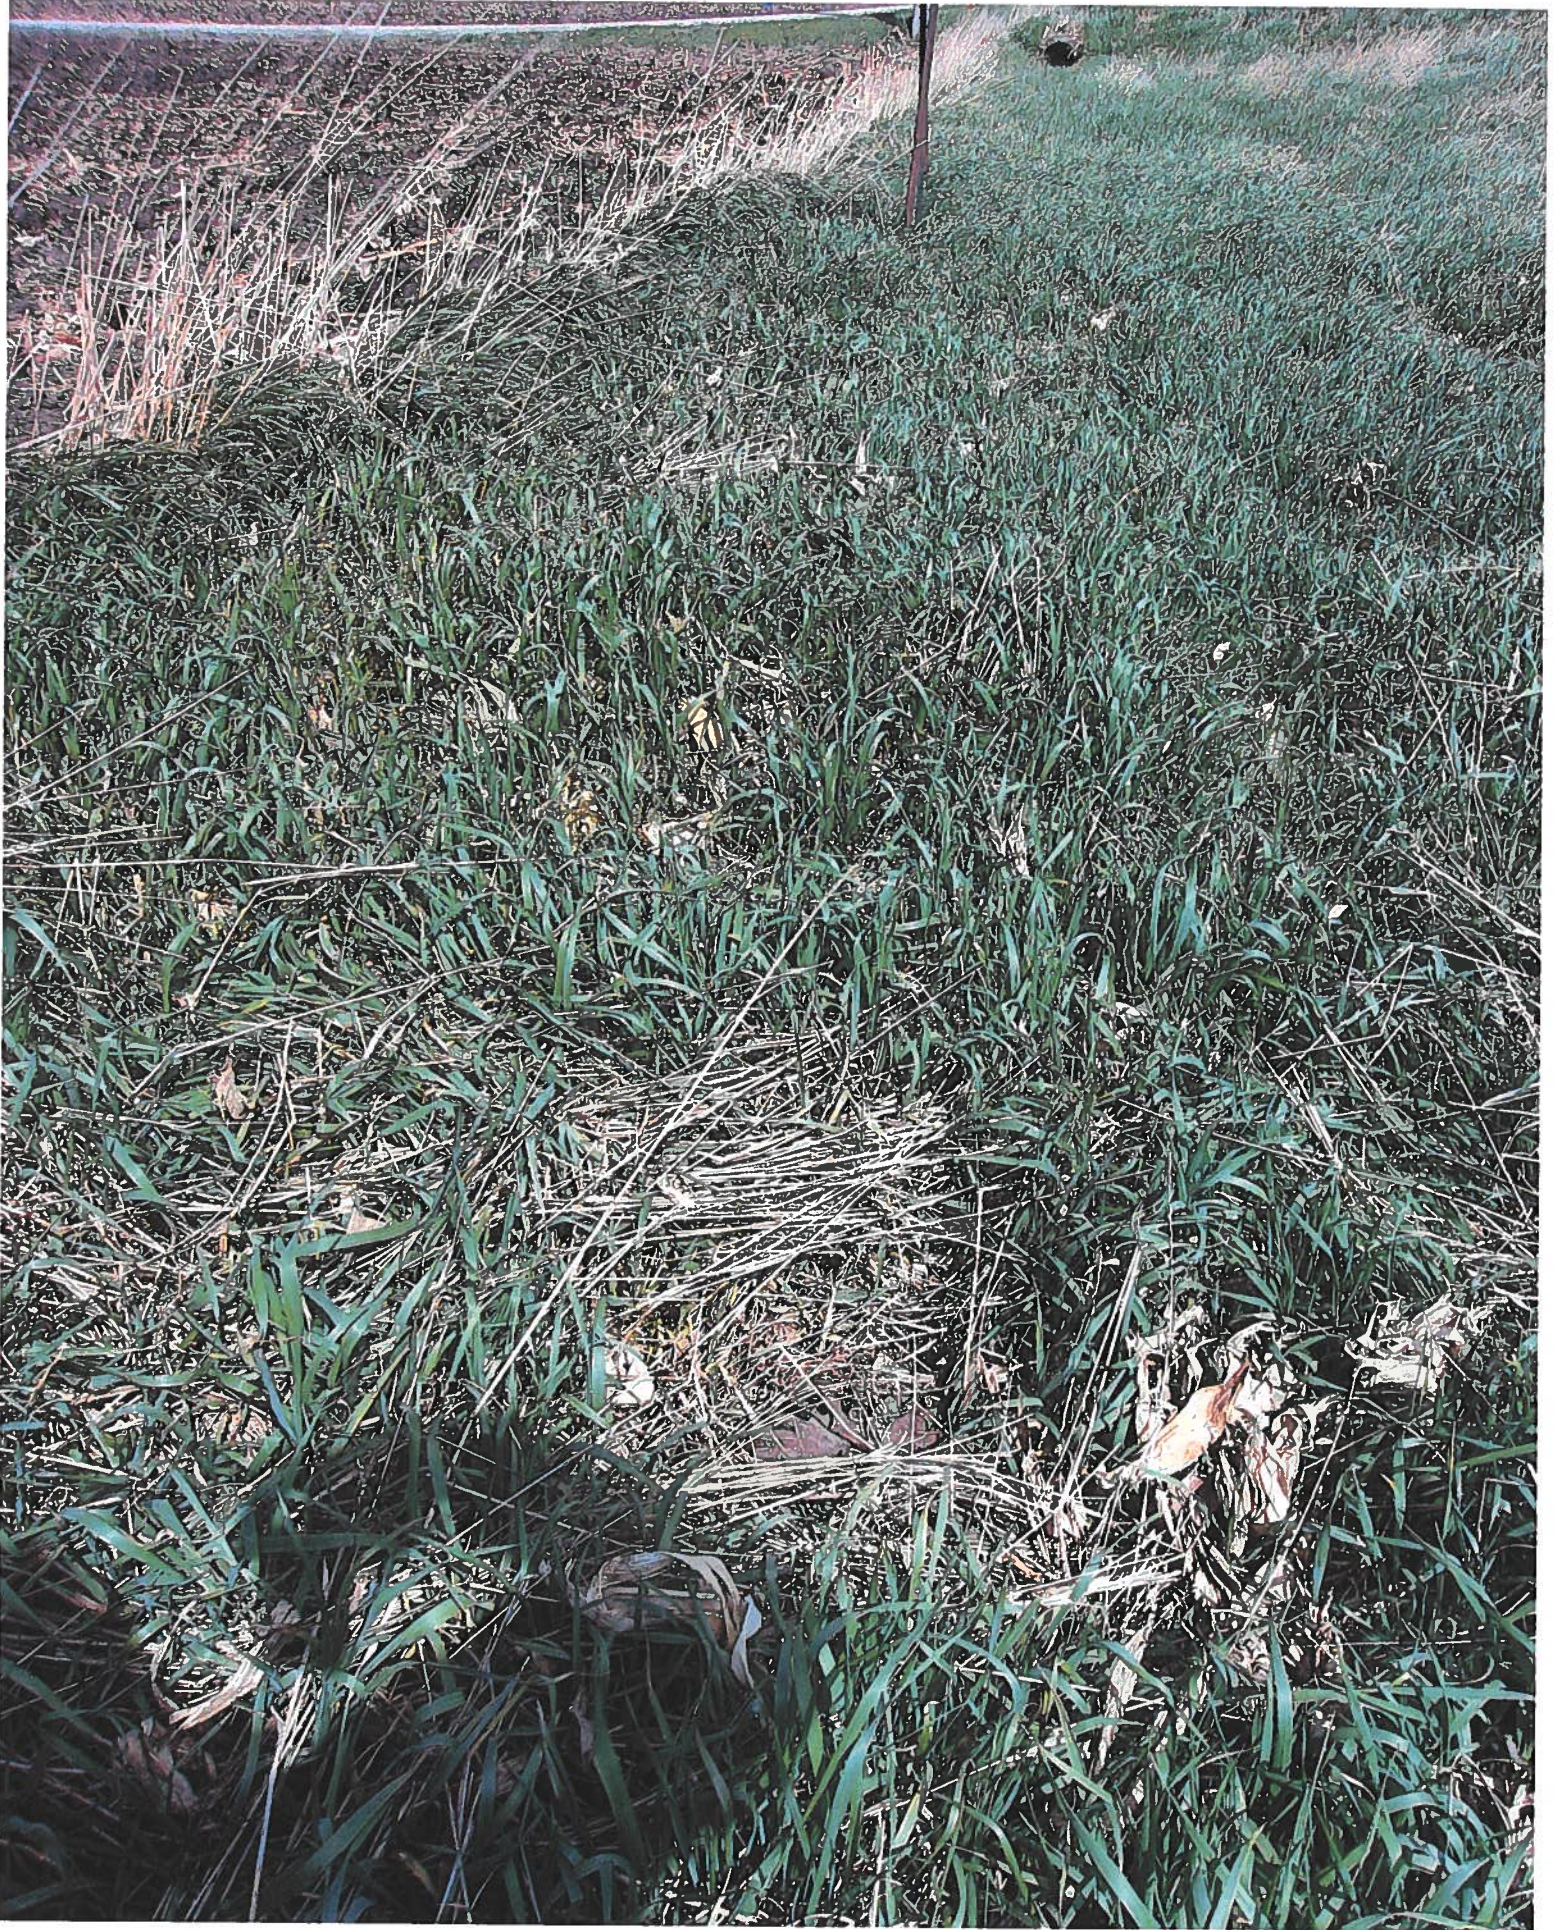
LOOKING E @ S27, BEEHIVE IN N DITCH D41

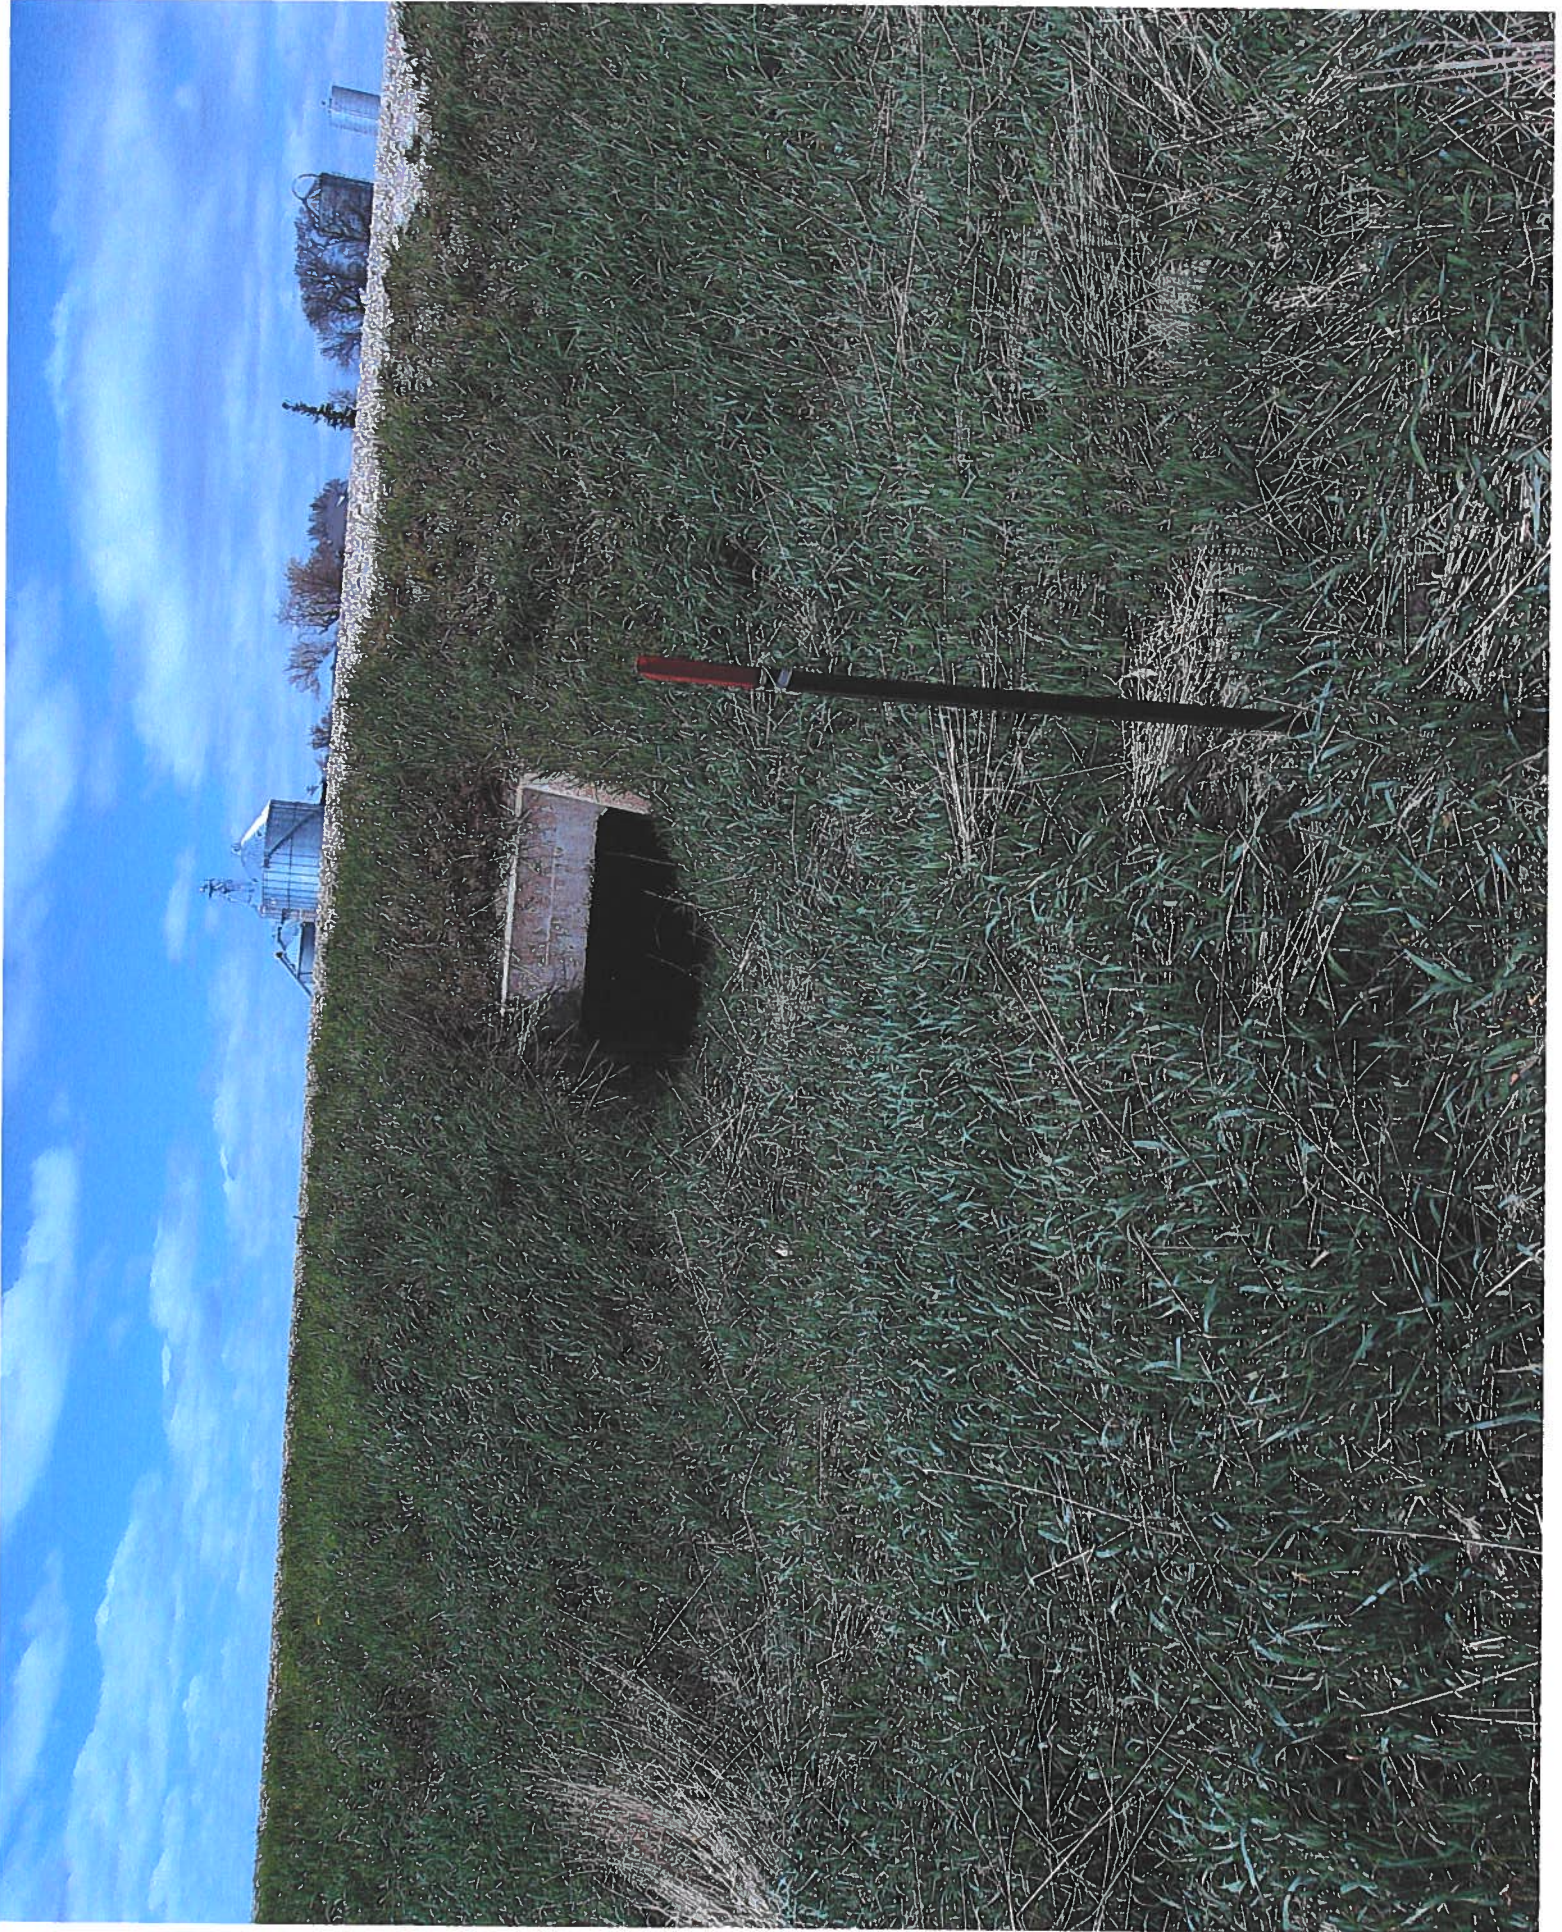
LOOKING UPSIDEAM ON MAIN, S. OF D41, TRST SET ON MAIN BY REPAIR

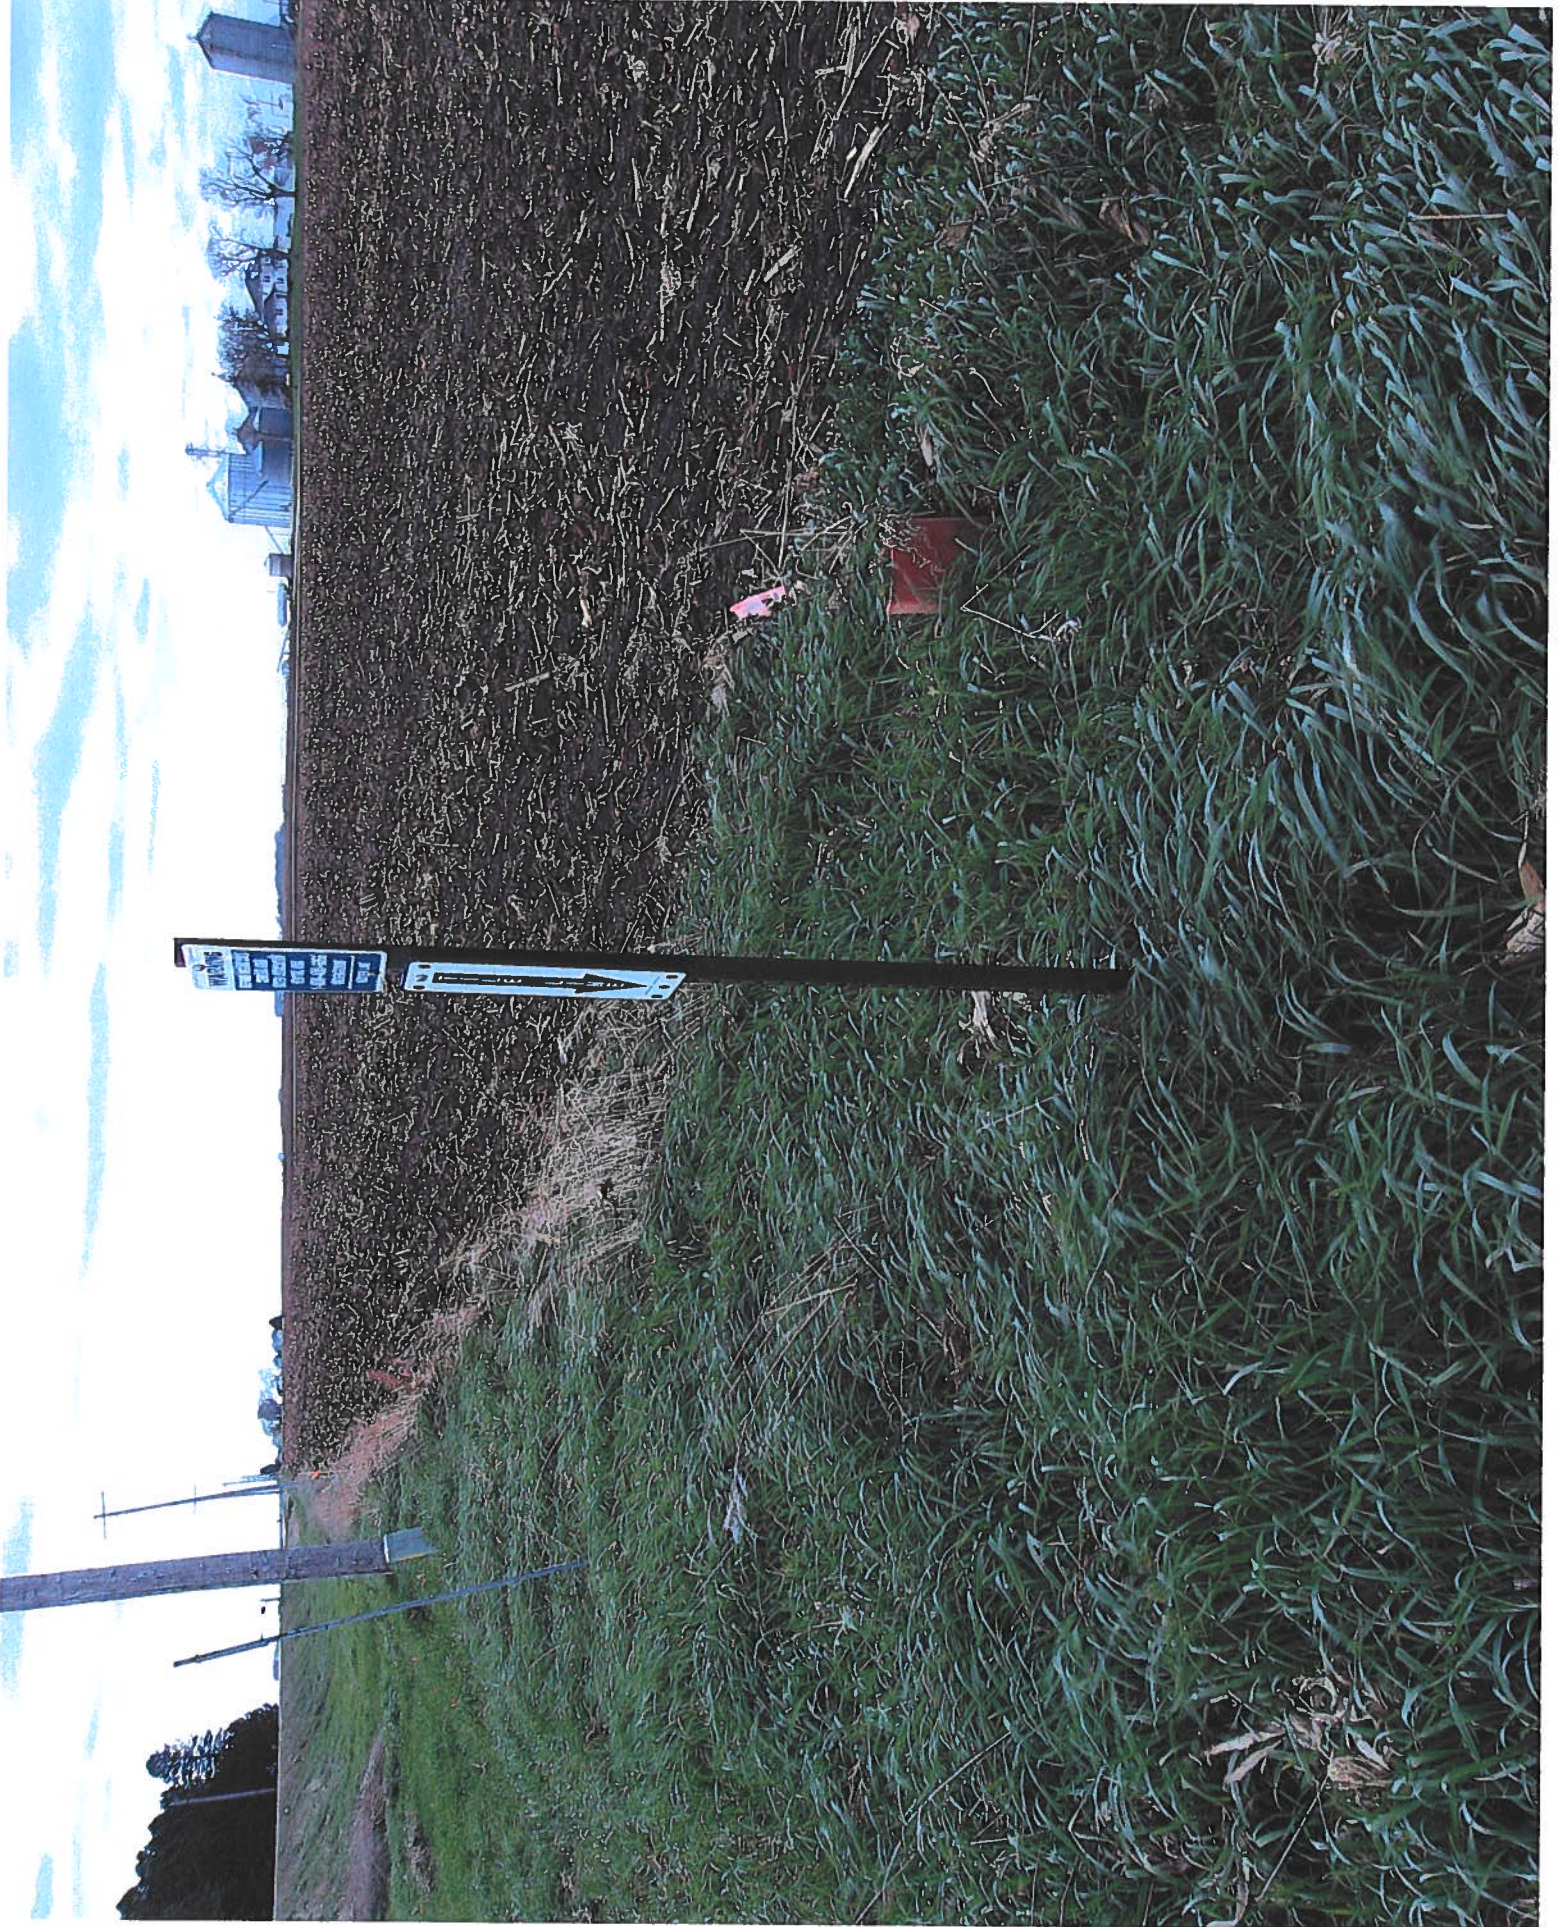
Looking W. on N R/W D41, Just W. of S27

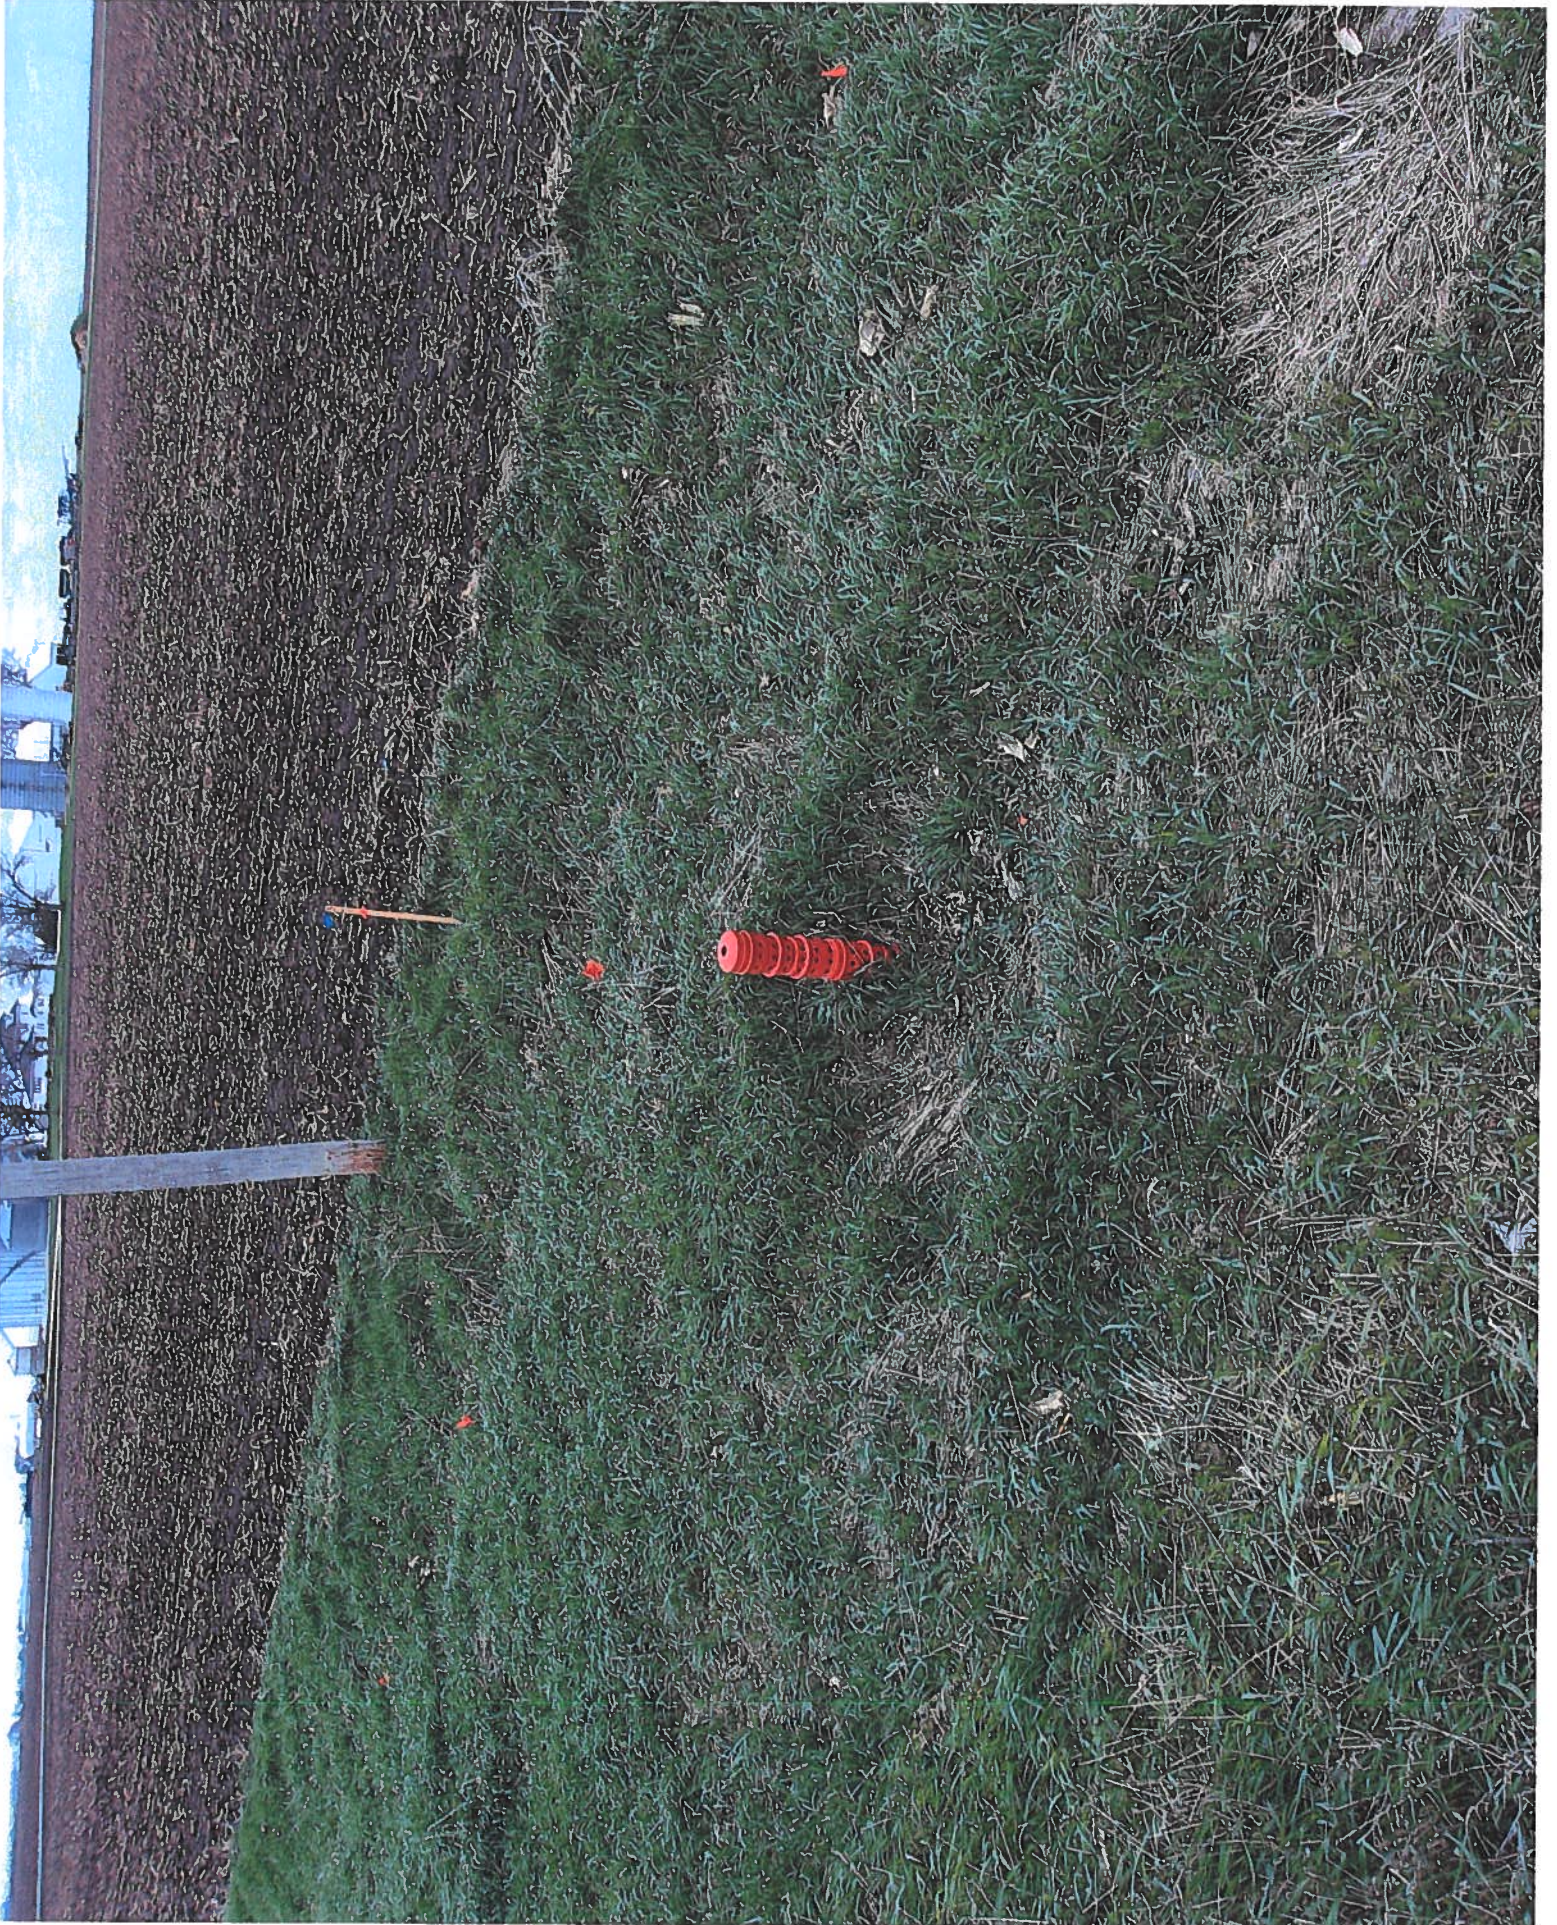
ORANGE HICK ON LAT 2? ON N DITCH D41

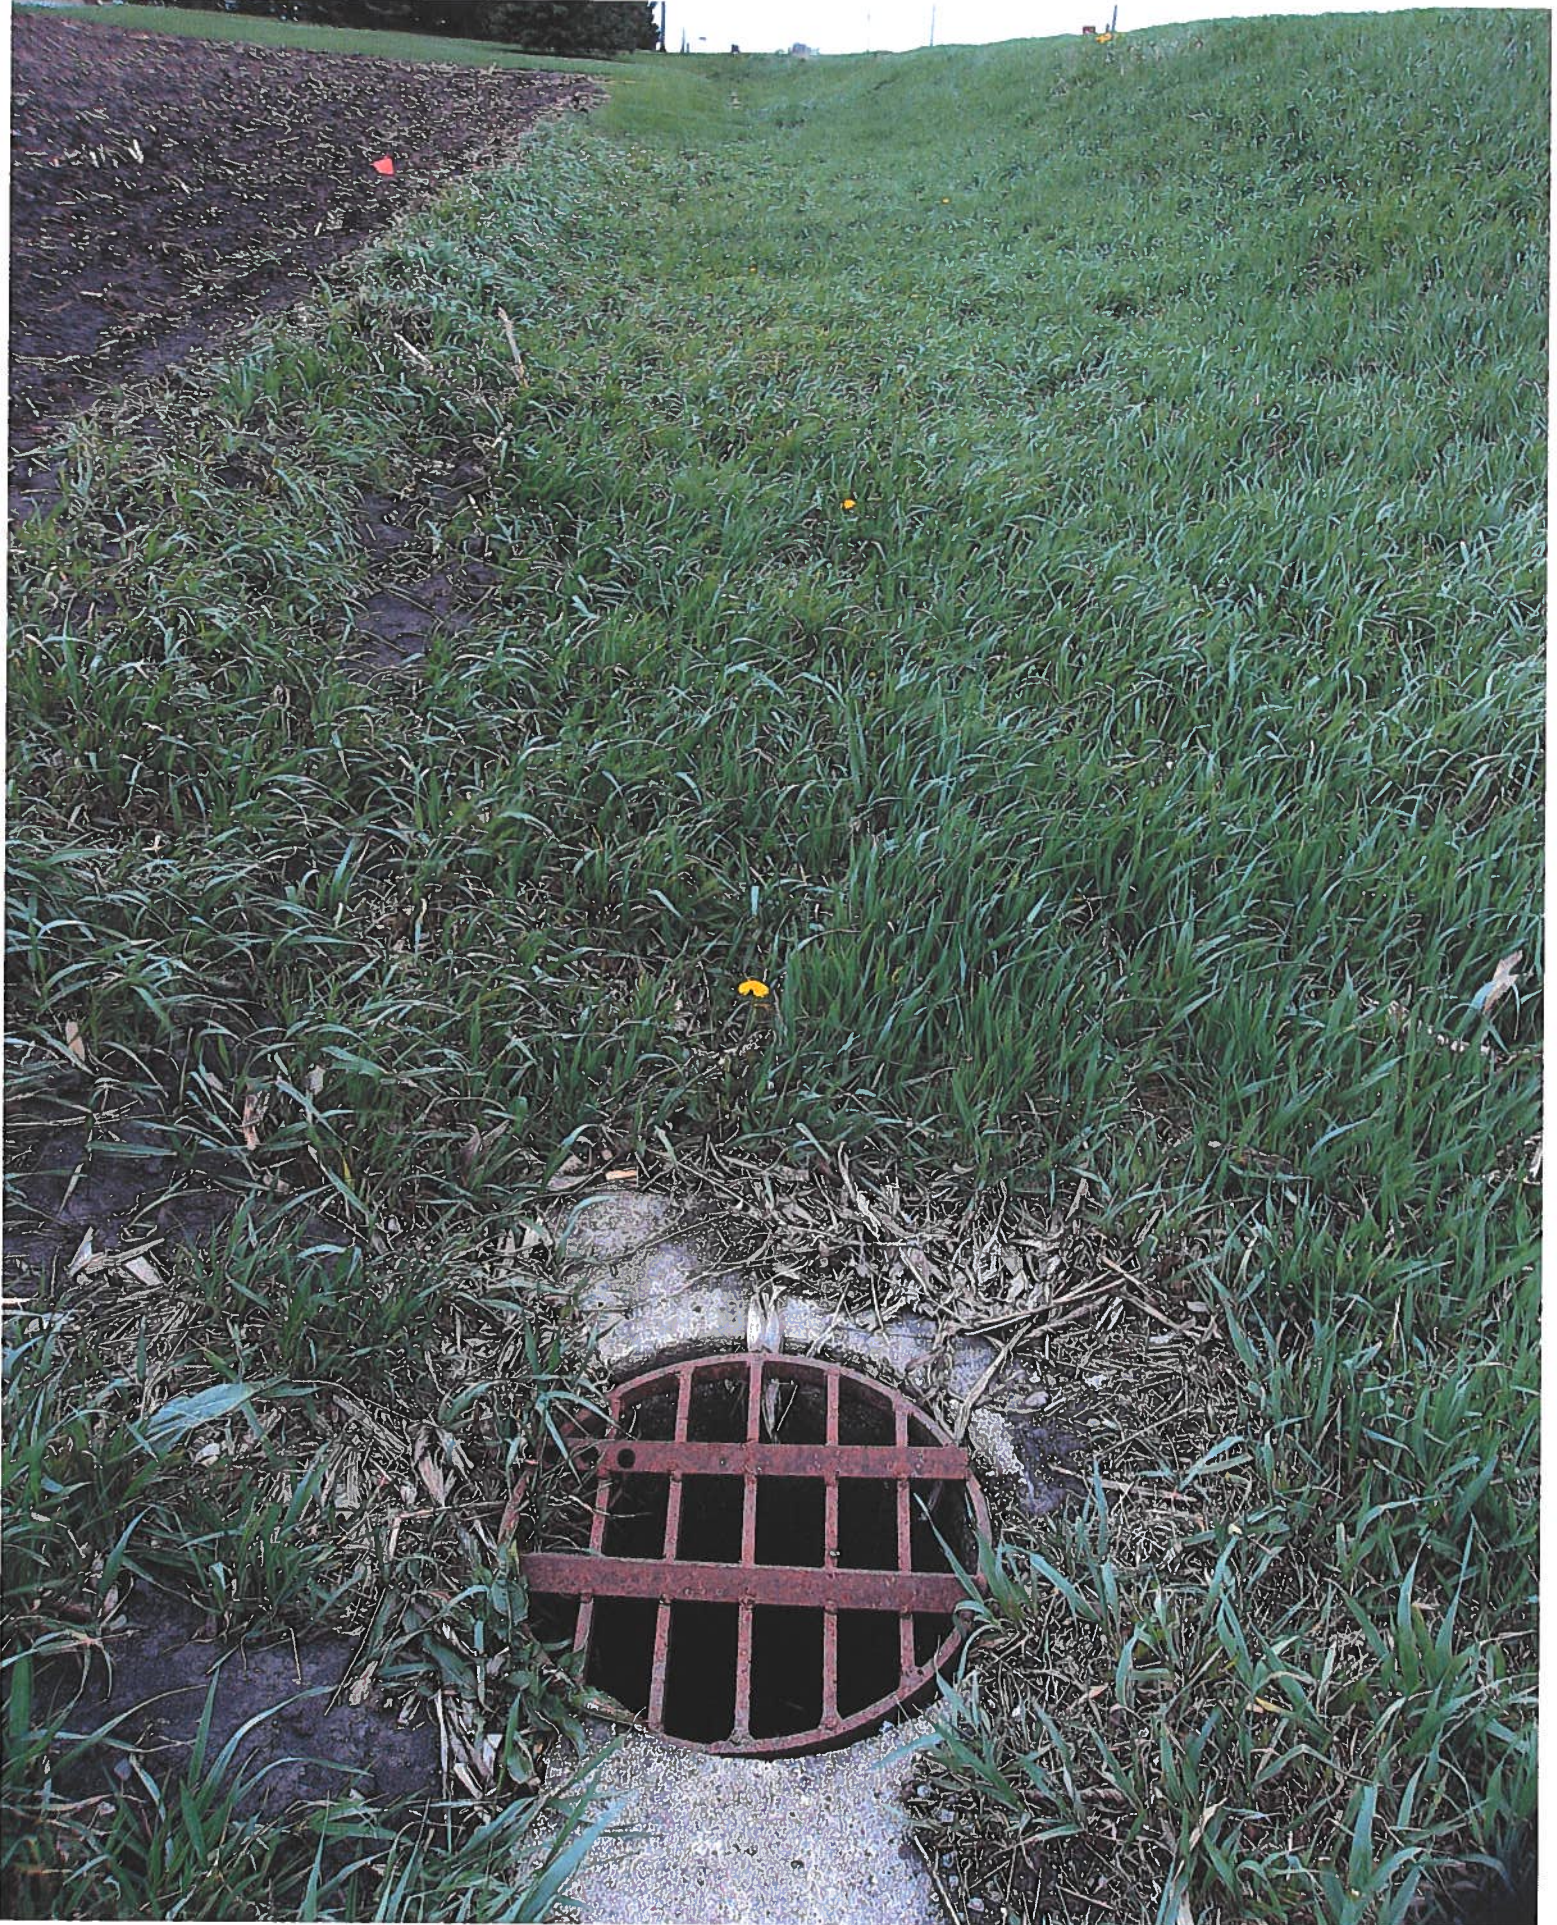
Dry INTAKE ON LAT 2 , S. ditch 041 (inv. of S27)
