Drainage District:

#14 Main and Lateral 2

Investigation/Repair Summary:

CONSTRUCTION ENGINEERING
OBSERVATION REPORT

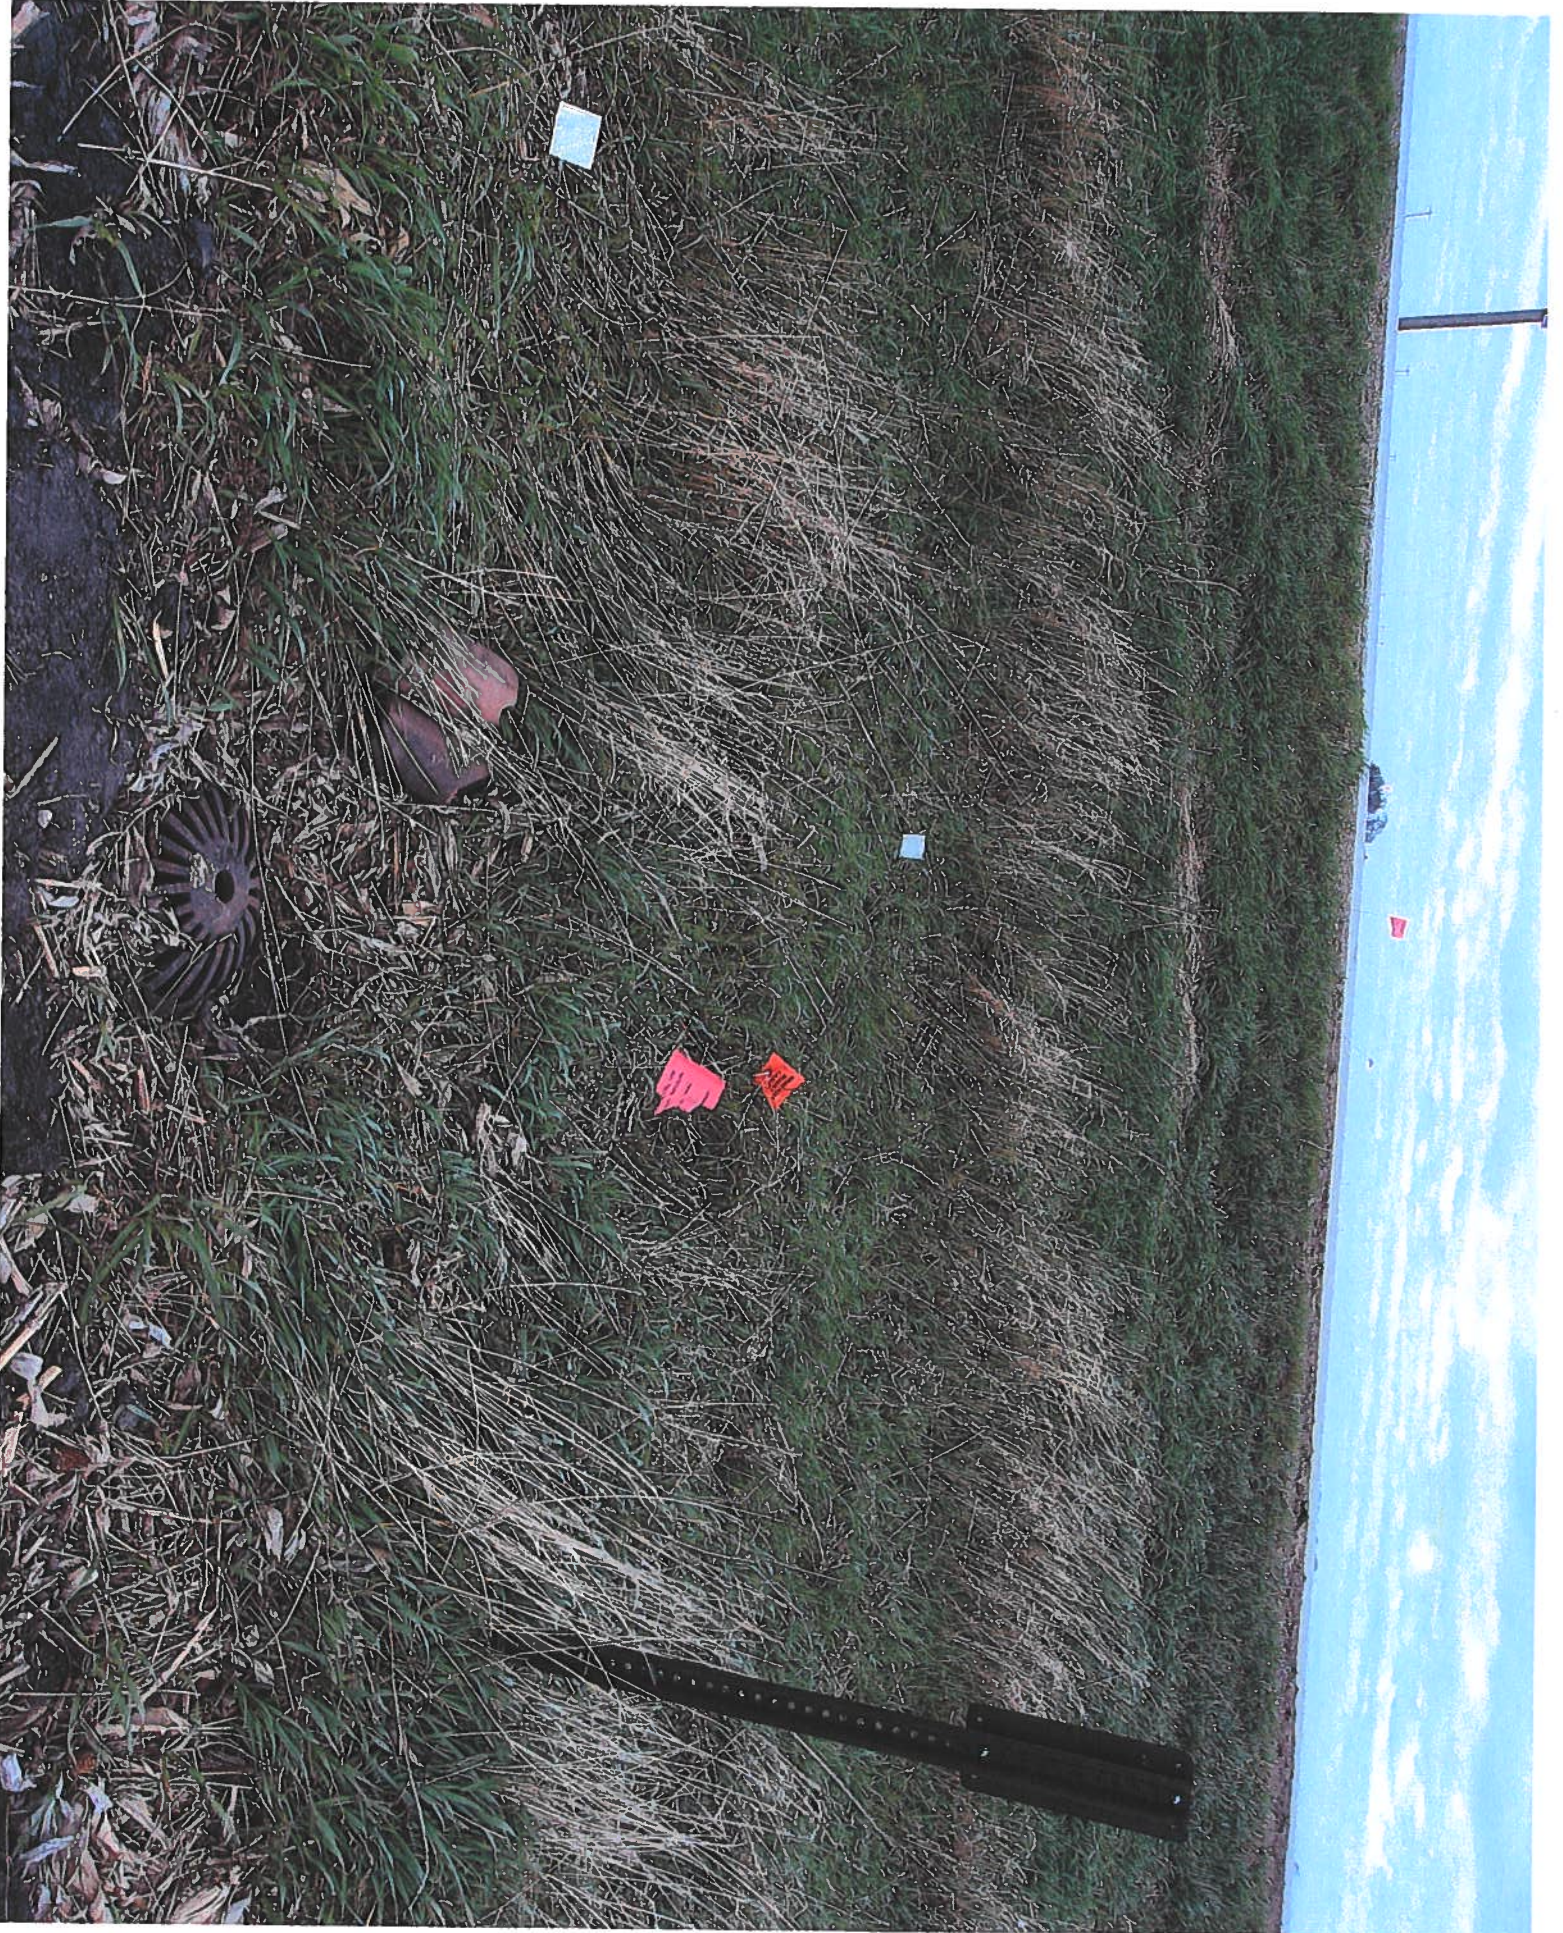
LAT 2, WRET BEEHIVE, W. SIDE S27
