# Drainage Work Order Request For Repair

## Hardin County

### Investigation and Repair Summary:

JOB # 6844 DD14 SURVEY

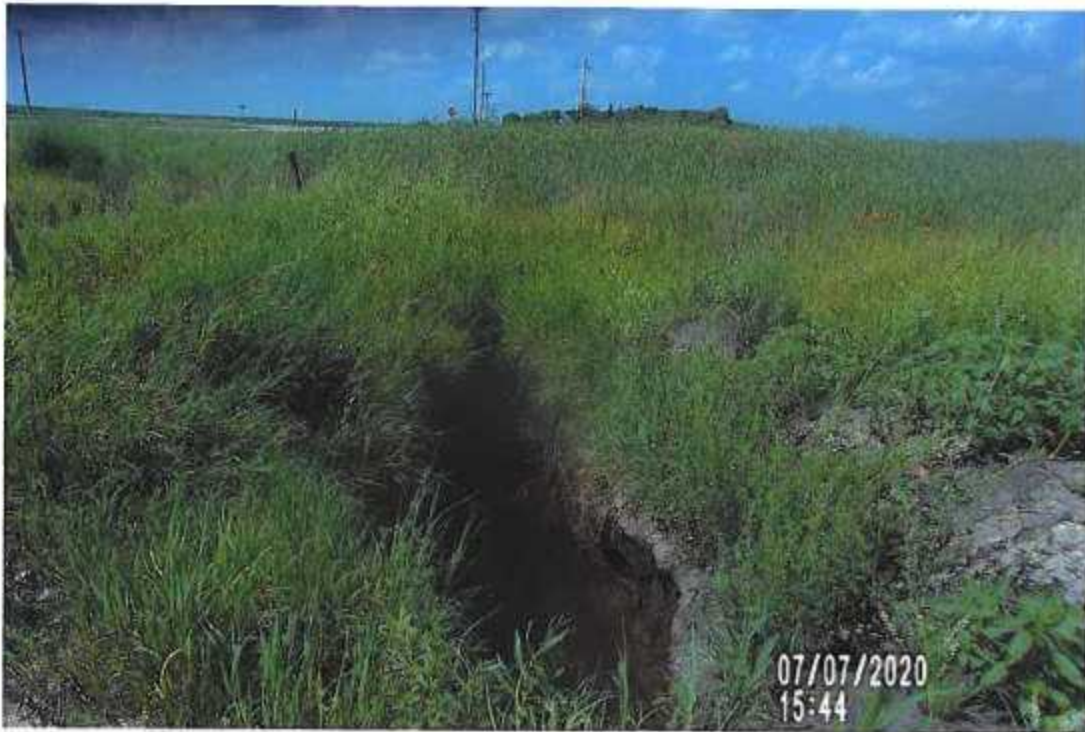
PICTURE # 4048 IS LOOKING NORTH ALONG EAST ROW FENCE  
322'± SOUTH OF CO HWY D-41 SHOWING WATER SITING IN HOLE

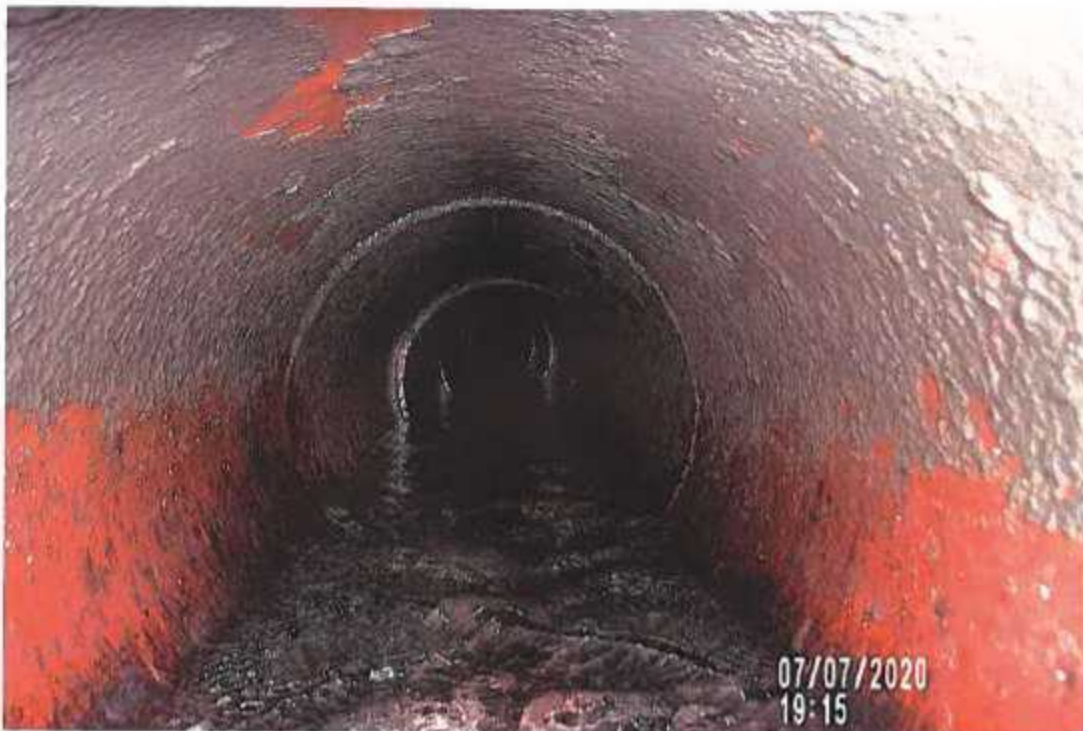
PICTURE # 4049 IS LOOKING NW UPSTREAM INSIDE 14" CLAY  
TILE (GPS# 248 1.28' TOPTOFL). TILE IS IN GOOD SHAPE  
WITH 3" FLOW (5.1" DEEP)

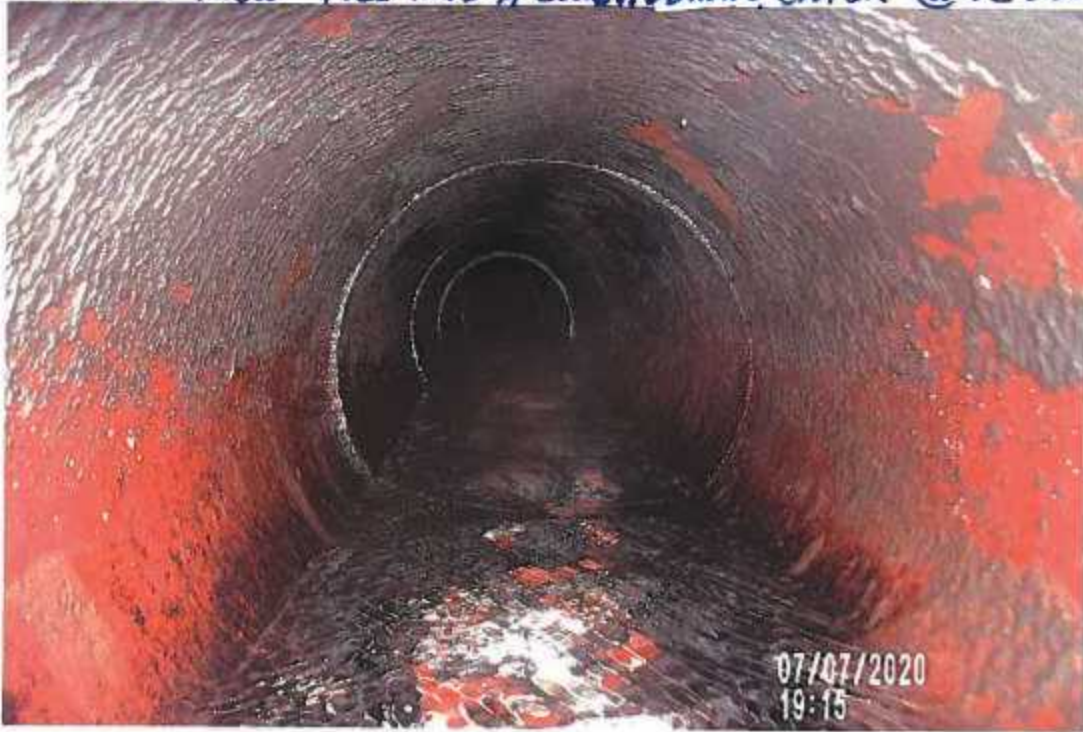
PICTURE # 4050 IS LOOKING NW, DOWN STREAM INSIDE 14" CLAY  
(5.1'±DEEP)  
TILE (GPS# 247 1.24' TOPTOFL) TILE IN GOOD SHAPE  
WITH 3" FLOW TILE HAS A LONGITUDINAL CRACK @ 12 O'CLOCK BUT  
NOT CAVING DOWN

NOT  
CAVING  
DOWN

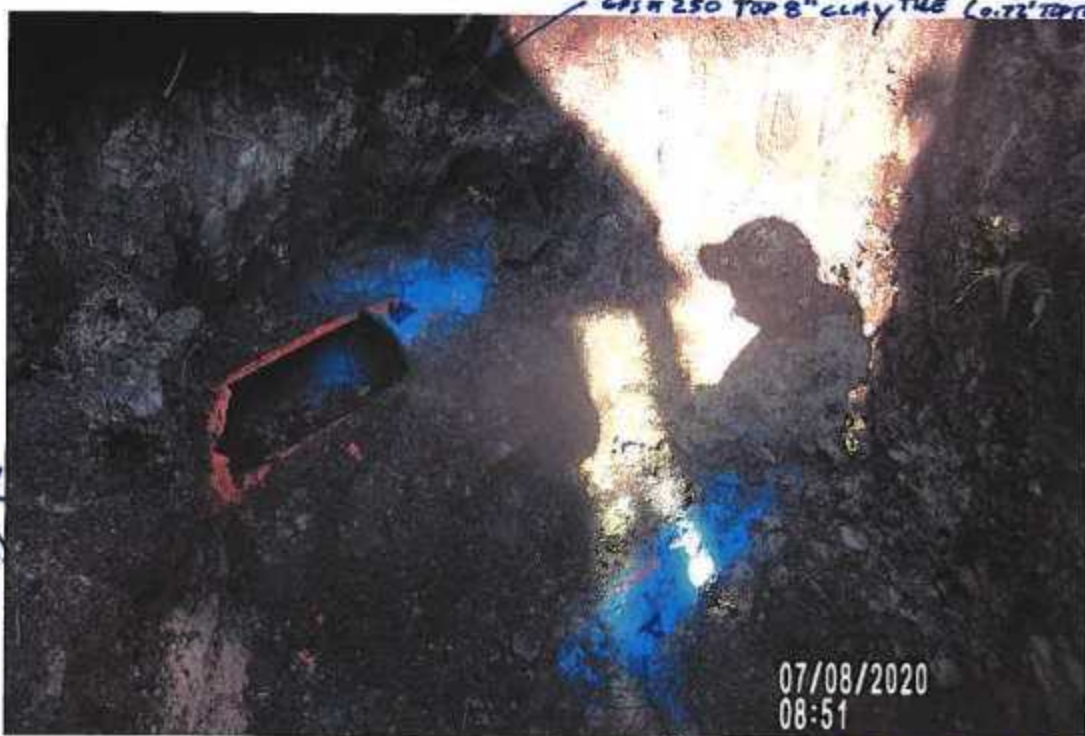
PICTURE# 4051 IS LOOKING SW SHOWING 8" CLAY TILE THAT WAS DAMAGED WHILE EXCAVATING TO EXPOSE 14" CLAY @ LOCATION WHERE WATERMAIN GOES UNDER TILE

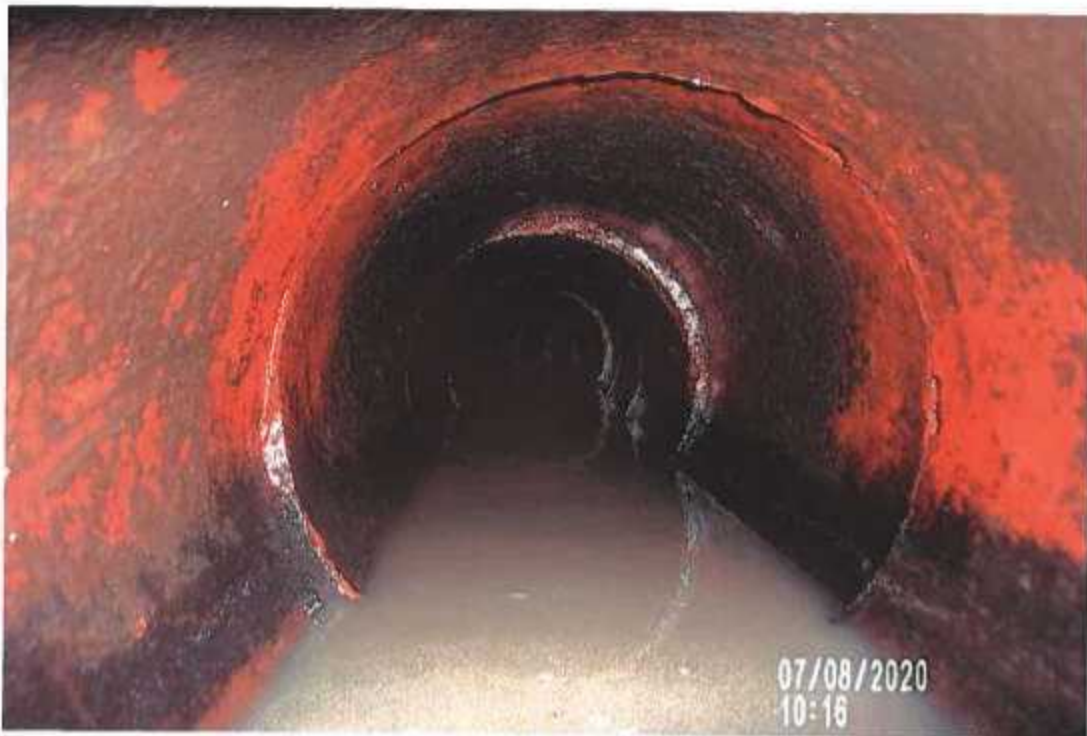
PICTURE # 4055 IS LOOKING <sup>NW</sup> DOWNSTREAM INSIDE 8" CLAY TILE  
FROM GPS # 255' SHOWING TILE IN GOOD CONDITION WITH 3/4" OF  
WATER AND NOT MUCH FLOW. TILE IS 3.1'± DEEP.

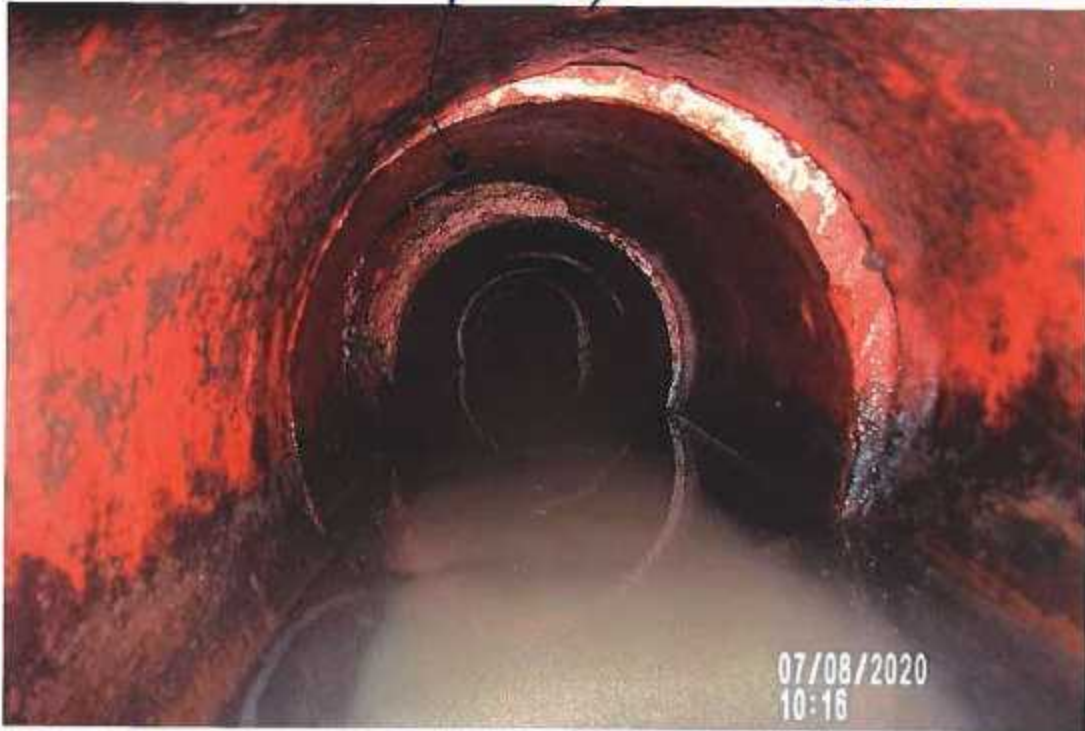
PICTURE# 4056 IS LOOKING SE UPSTREAM INSIDE 8" CLAY TILE  
SHOWING TILE IN GOOD CONDITION WITH 3/4" WATER IN FL &  
NOT MUCH FLOW. TILE IS 3.1' ± DEEP.  
↑ 6" CLAY TILE INLET FROM BEEHIVE INTAKE.

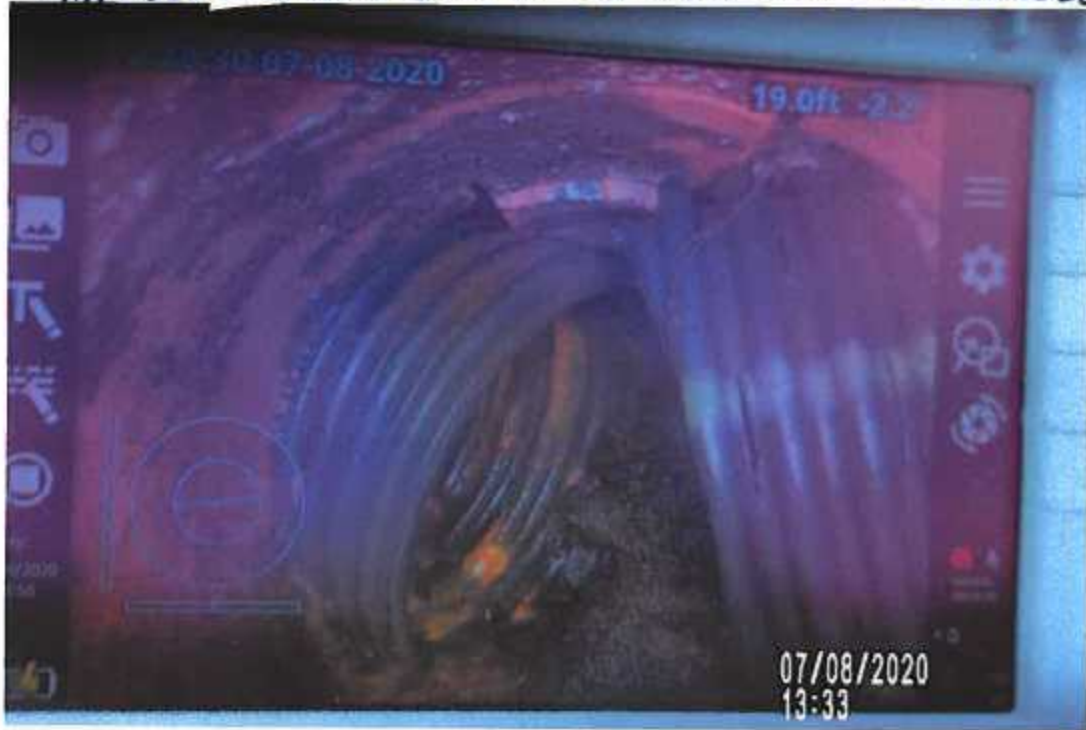
PICTURE # 4060 IS LOOKING UPSTREAM INSIDE 8" CLAY TILE @ 2 1/3' UPSTREAM FROM BEEHIVE INTAKE SHOWING 5" PERF SW HOPE TILE FROM EAST & FROM WEST CONNECTING AT SAME LOCATION WITH SIDES CRACKED AND TOP CAVING DOWN WITH TILE PLUGGED UPSTREAM WITH SOIL & ROOTS

WITH SOIL & ROOTS

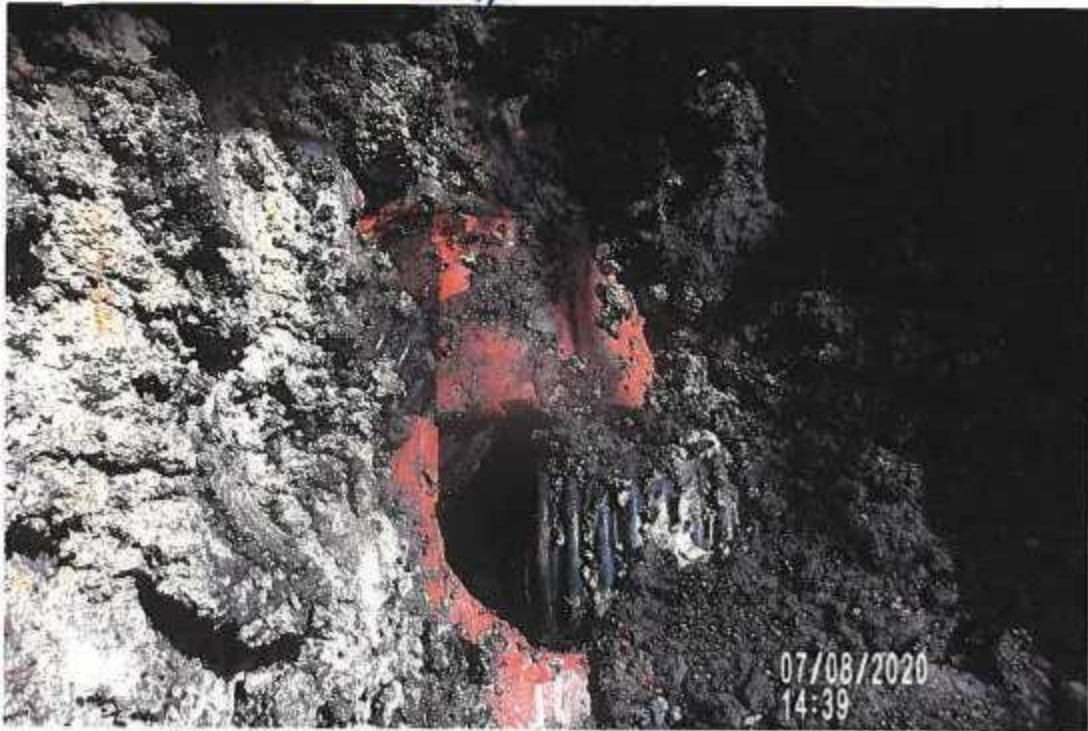
PICTURE # 4062 IS LOOKING SE AT TOP VIEW OF 5" HDPE  
SW PERF TILE FROM WEST & EAST TIEING INTO SAME LOCATION  
INTO BROKEN 8" CLAY TILE AND PLUGGED LINE

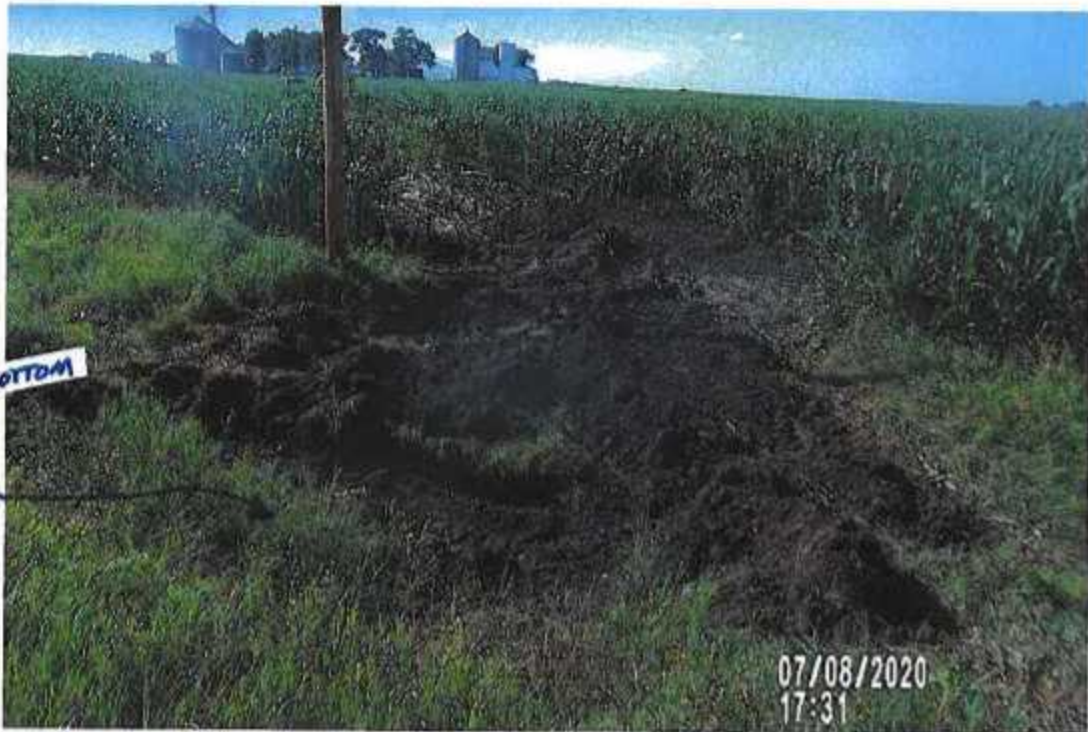
6" HICKEN BOTTOM  
FILL FULL OF  
SOIL &  
6" CLAY TILE  
OUTLET  
& ROCK  
& FULL  
OF SOIL

- 6" HILKEN BOTTOM FULL OF SOIL ALONG WITH OUTLET TILE BEING  
CRACKED AND FULL OF SOIL (MAY NEED REPLACED SOMETIME)

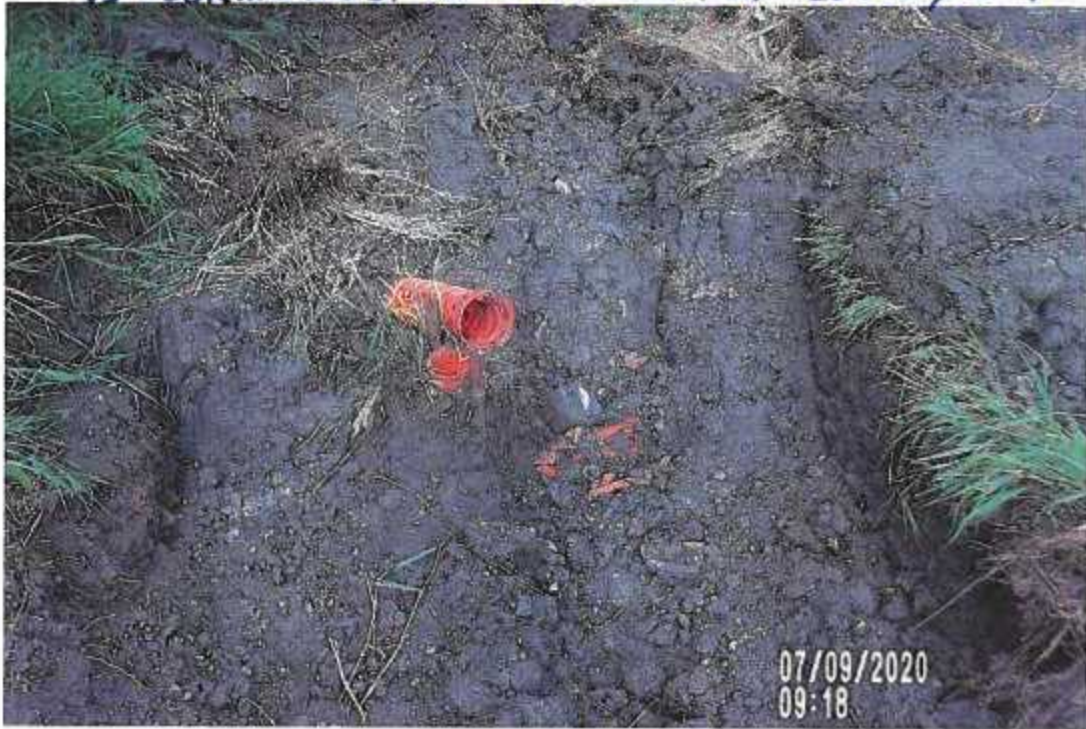
(GPS#269)  
PICTURE# 4090 SHOWING 6" HICKEN BOTTOM WITH TOP COMPLETELY  
BROKE OFF AND FL COMPLETELY FULL OF SOIL WITH 6" CLAY  
TILE OUTLET BROKE AND COMPLETELY FULL OF SOIL. PICTURE  
IS LOOKING WEST IN NORTH DITCH OF CO HWY 041

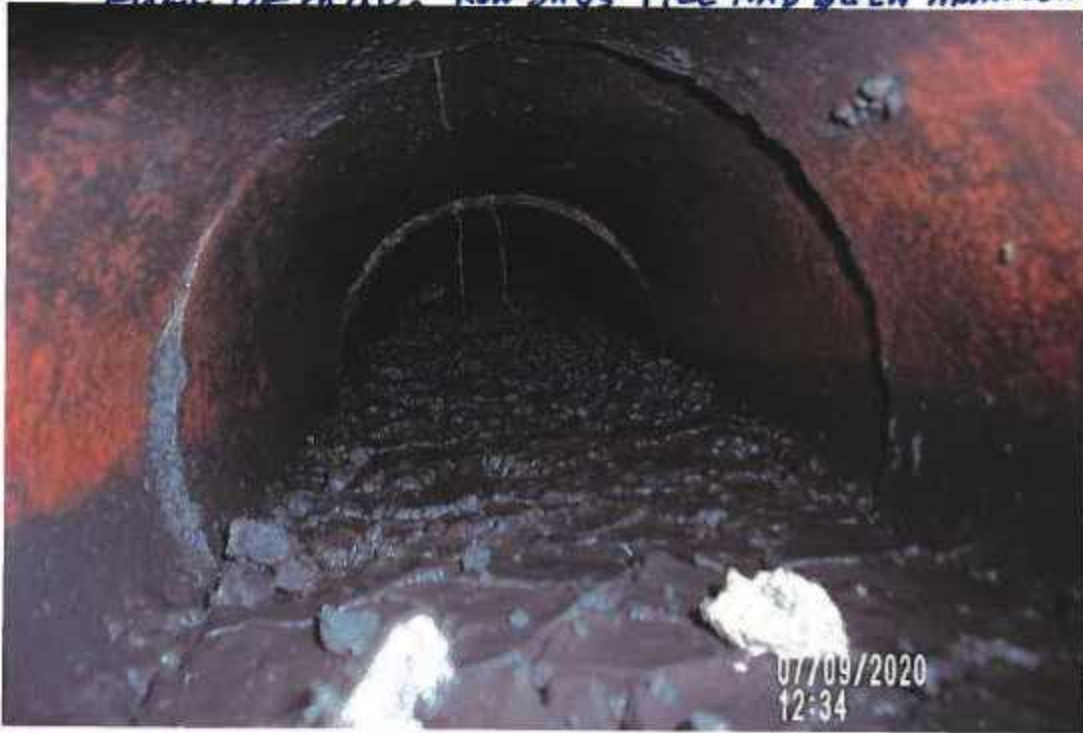
PICTURE #4098 IS LOOKING SE DOWNSTREAM - FROM GPS #251  
 TOP 8" CLAY TILE (0.75' TOP TO FL) AFTER ANOTHER DAMAGED  
 4.0' SECTION OF TILE WAS REMOVED. 2" MUD IN FL TO COMPLETELY  
 FULL OF MUD. RON SAYS TILE HAS BEEN ABANDONED BUT

WILL CONNECT  
 TOGETHER  
 IN CASE  
 ANY TILE  
 UPSTREAM  
 IS CONNECTED  
 YES  
 N  
 ↓

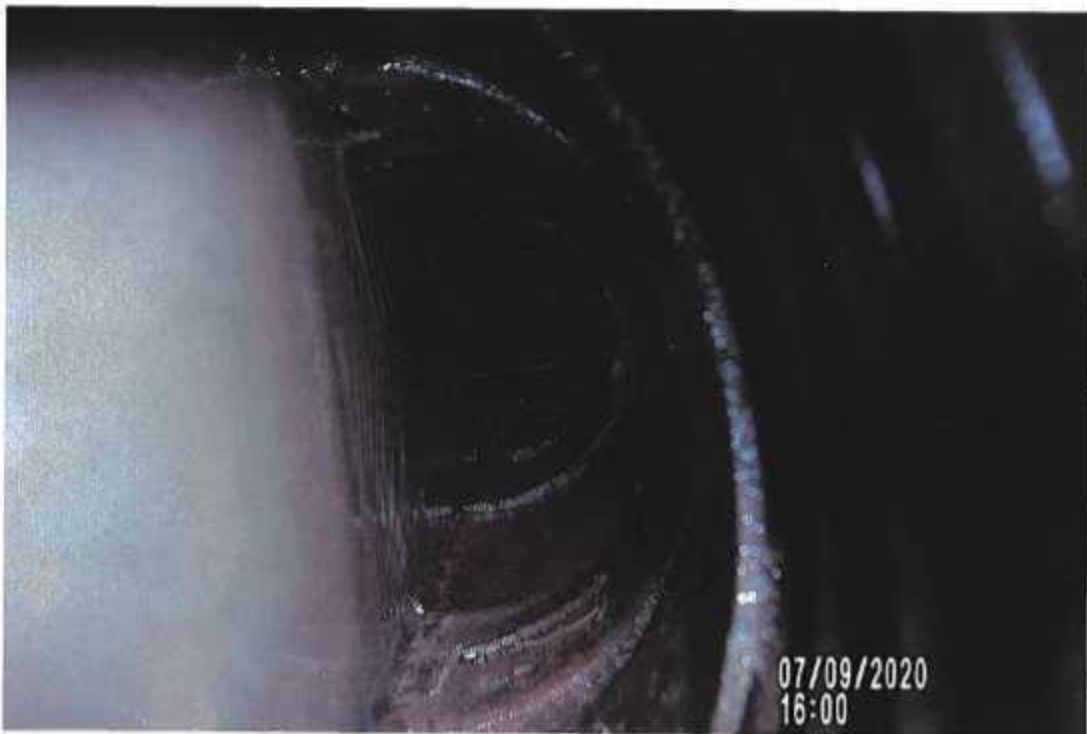
PICTURE # 4117 IS LOOKING DOWNSTREAM (FROM GPS # 311) INSIDE 8" TILE SHOWING CHANGE OF MATERIAL. TILE LOOKS GOOD SHAPE WITH WATER LEVEL AT 4" (SLOW FLOW). ALSO FLOWLINE HAS SOFT MUCK BUT SHOULD PUSH OUT NOW TILE OPEN.

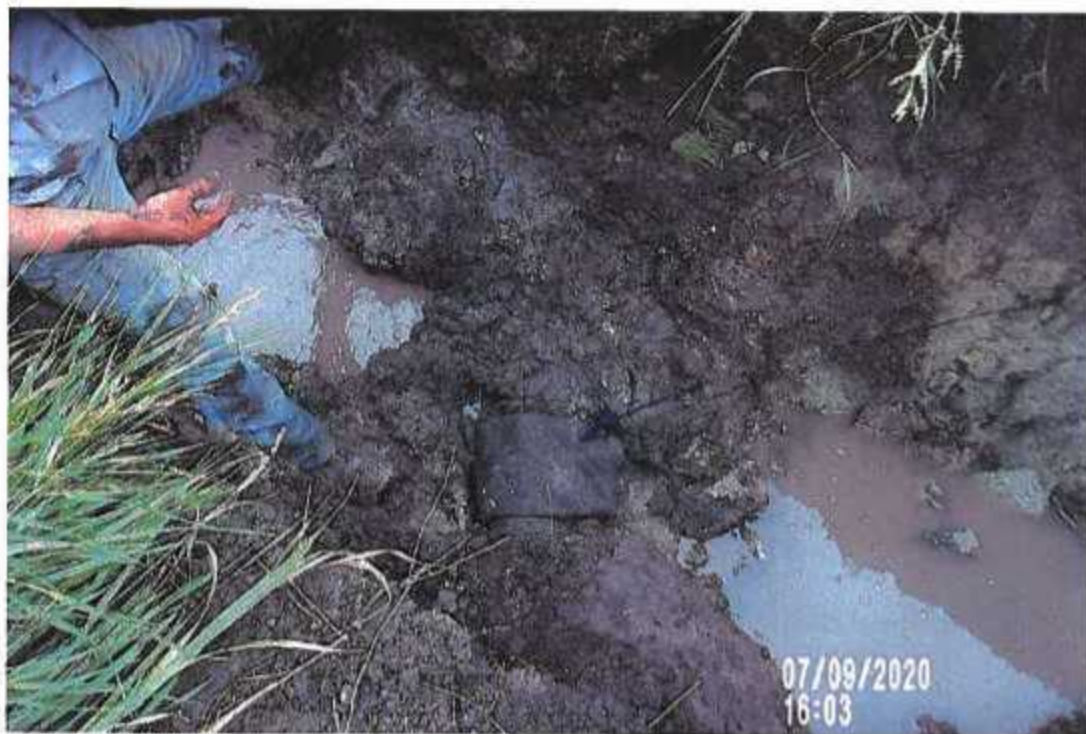
PICTURE # 4119 IS LOOKING UPSTREAM (FROM CPS#311) INSIDE 2" TILE  
SHOWING TILE IN GOOD SHAPE BUT CHANGED TO CLAY WITH  
WATER LEVEL AT 4" (SLOW FLOW). ALSO FLOWLINE HAS SOFT MUCK  
BUT SHOULD FLUSH OUT NOW THAT IT IS  
OPEN.

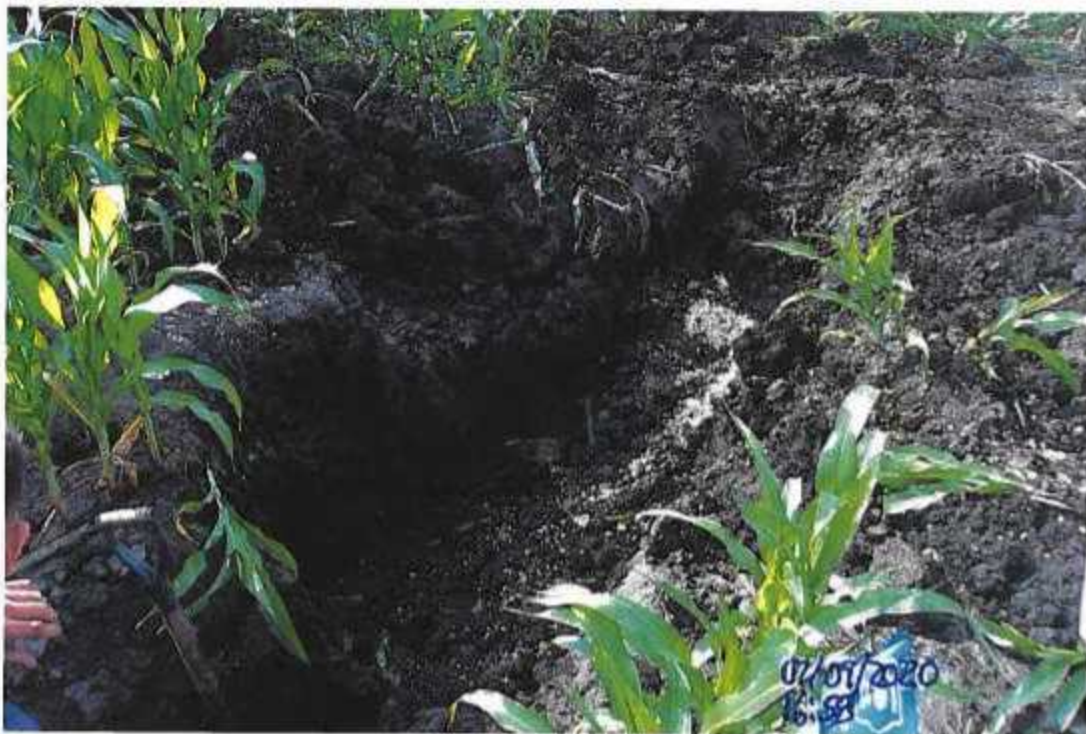
PICTURE #4122 IS LOOKING NW SHOWING 4" SW HOPE PERF TILE THAT NEEDS REPLACED AFTER CUTTING TILE WHILE EXCAVATING TO CHECK LAT #2 TILE FLOW STATUS ON EAST SIDE OF CO HWY S-27.

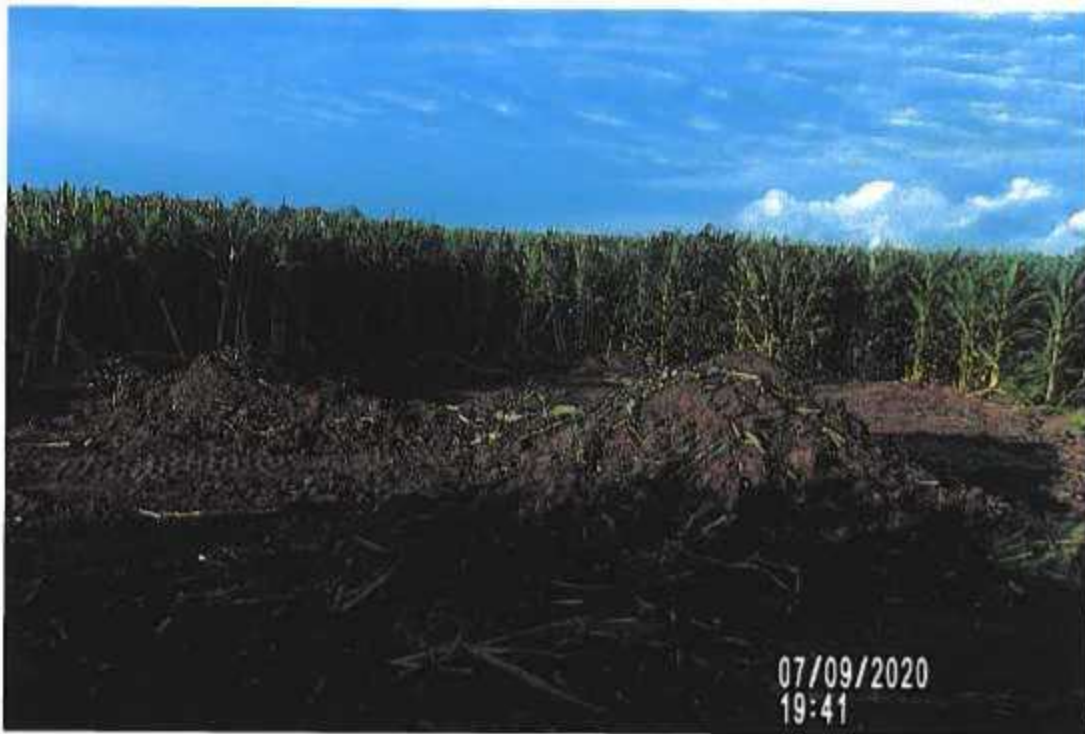
PICTURE# 4129 IS LOOKING EAST IN NORTH DITCH OF  
CO HWY D41 SHOWING DITCH STILL NEEDS GRADED.

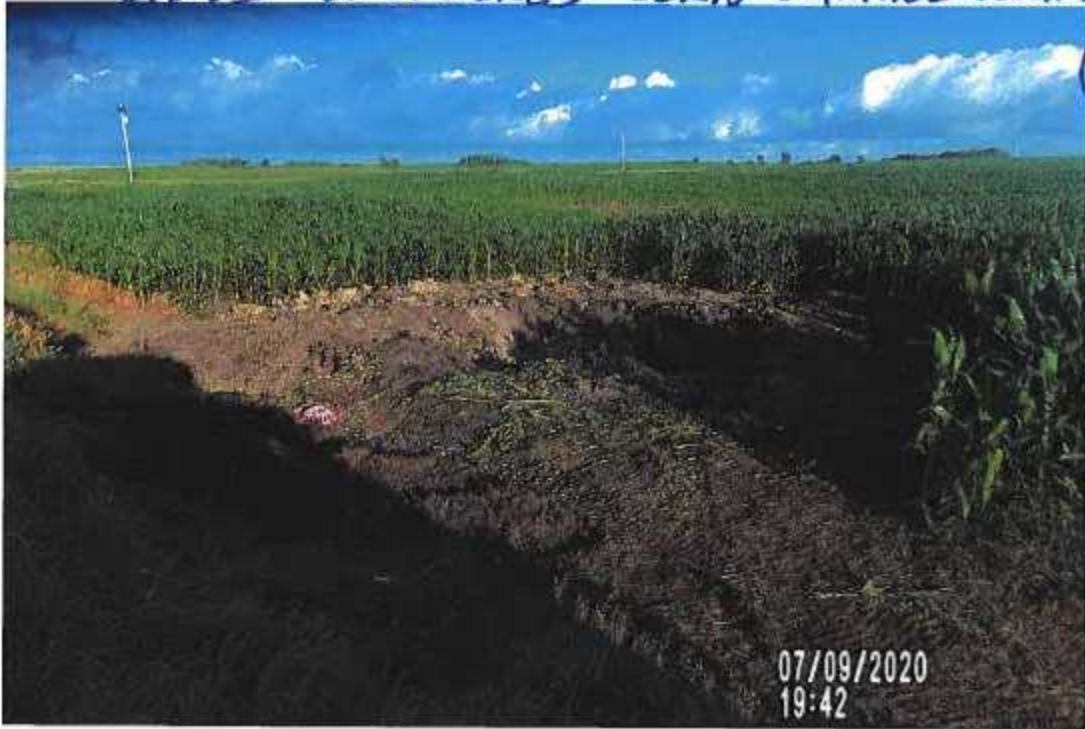
- 14" CLAY TILE REPAIR (N OF D4) SOIL WAS MIXED WITH CORN STALKS  
NOW EXTRA SOIL BUT WILL SETTLE DUE TO STALKS MIXED WITH SOIL.

PICTURE# 4130 IS LOOKING EAST SHOWING PILE OF  
EXTRA SOIL THAT WAS USED TO BACKFILL (14" CLAY TILE NORTH OF  
TILE TRENCH. CORN STALKS WERE MIXED WITH SOIL CREATING  
VOIDS AND EXTRA SOIL AREA WILL SETTLE DUE TO THIS. CO HWY D41)

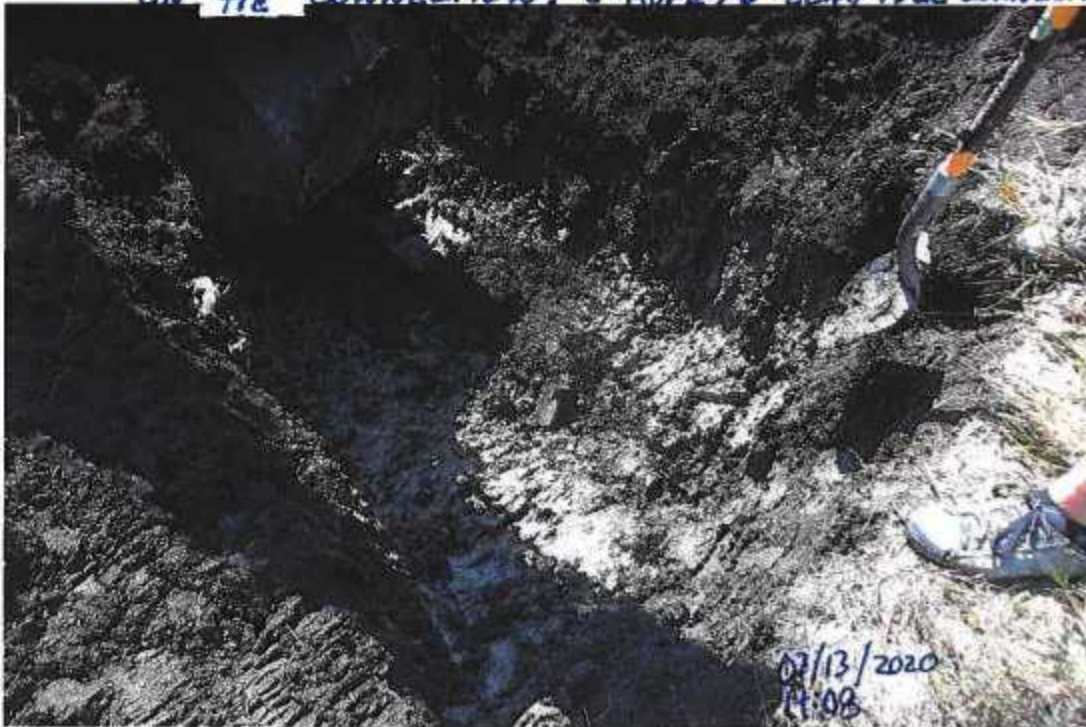
PICTURE# 4142 IS LOOKING SE SHOWING 6" HDPE PERF TILE CONNECTION TO 6" CLAY TILE EAST OF BEEHIVE INTAKE. PICTURE SHOWS CREW EXCAVATING TO CHECK ON TILE CONNECTION. 6" HDPE / 6" CLAY TILE CONNECTION CLAY TILE BROKE & WILL NEED REPLACED.

TILE BROKE & WILL NEED REPLACED.
