**ENGINEER'S REPORT
ON REPAIRS TO THE
MAIN OPEN DITCH
DRAINAGE DISTRICT
NO. 18
HARDIN COUNTY,
IOWA**

Engineer's Report on Repairs to the Main Open Ditch of Drainage District No. 18, Hardin County, Iowa

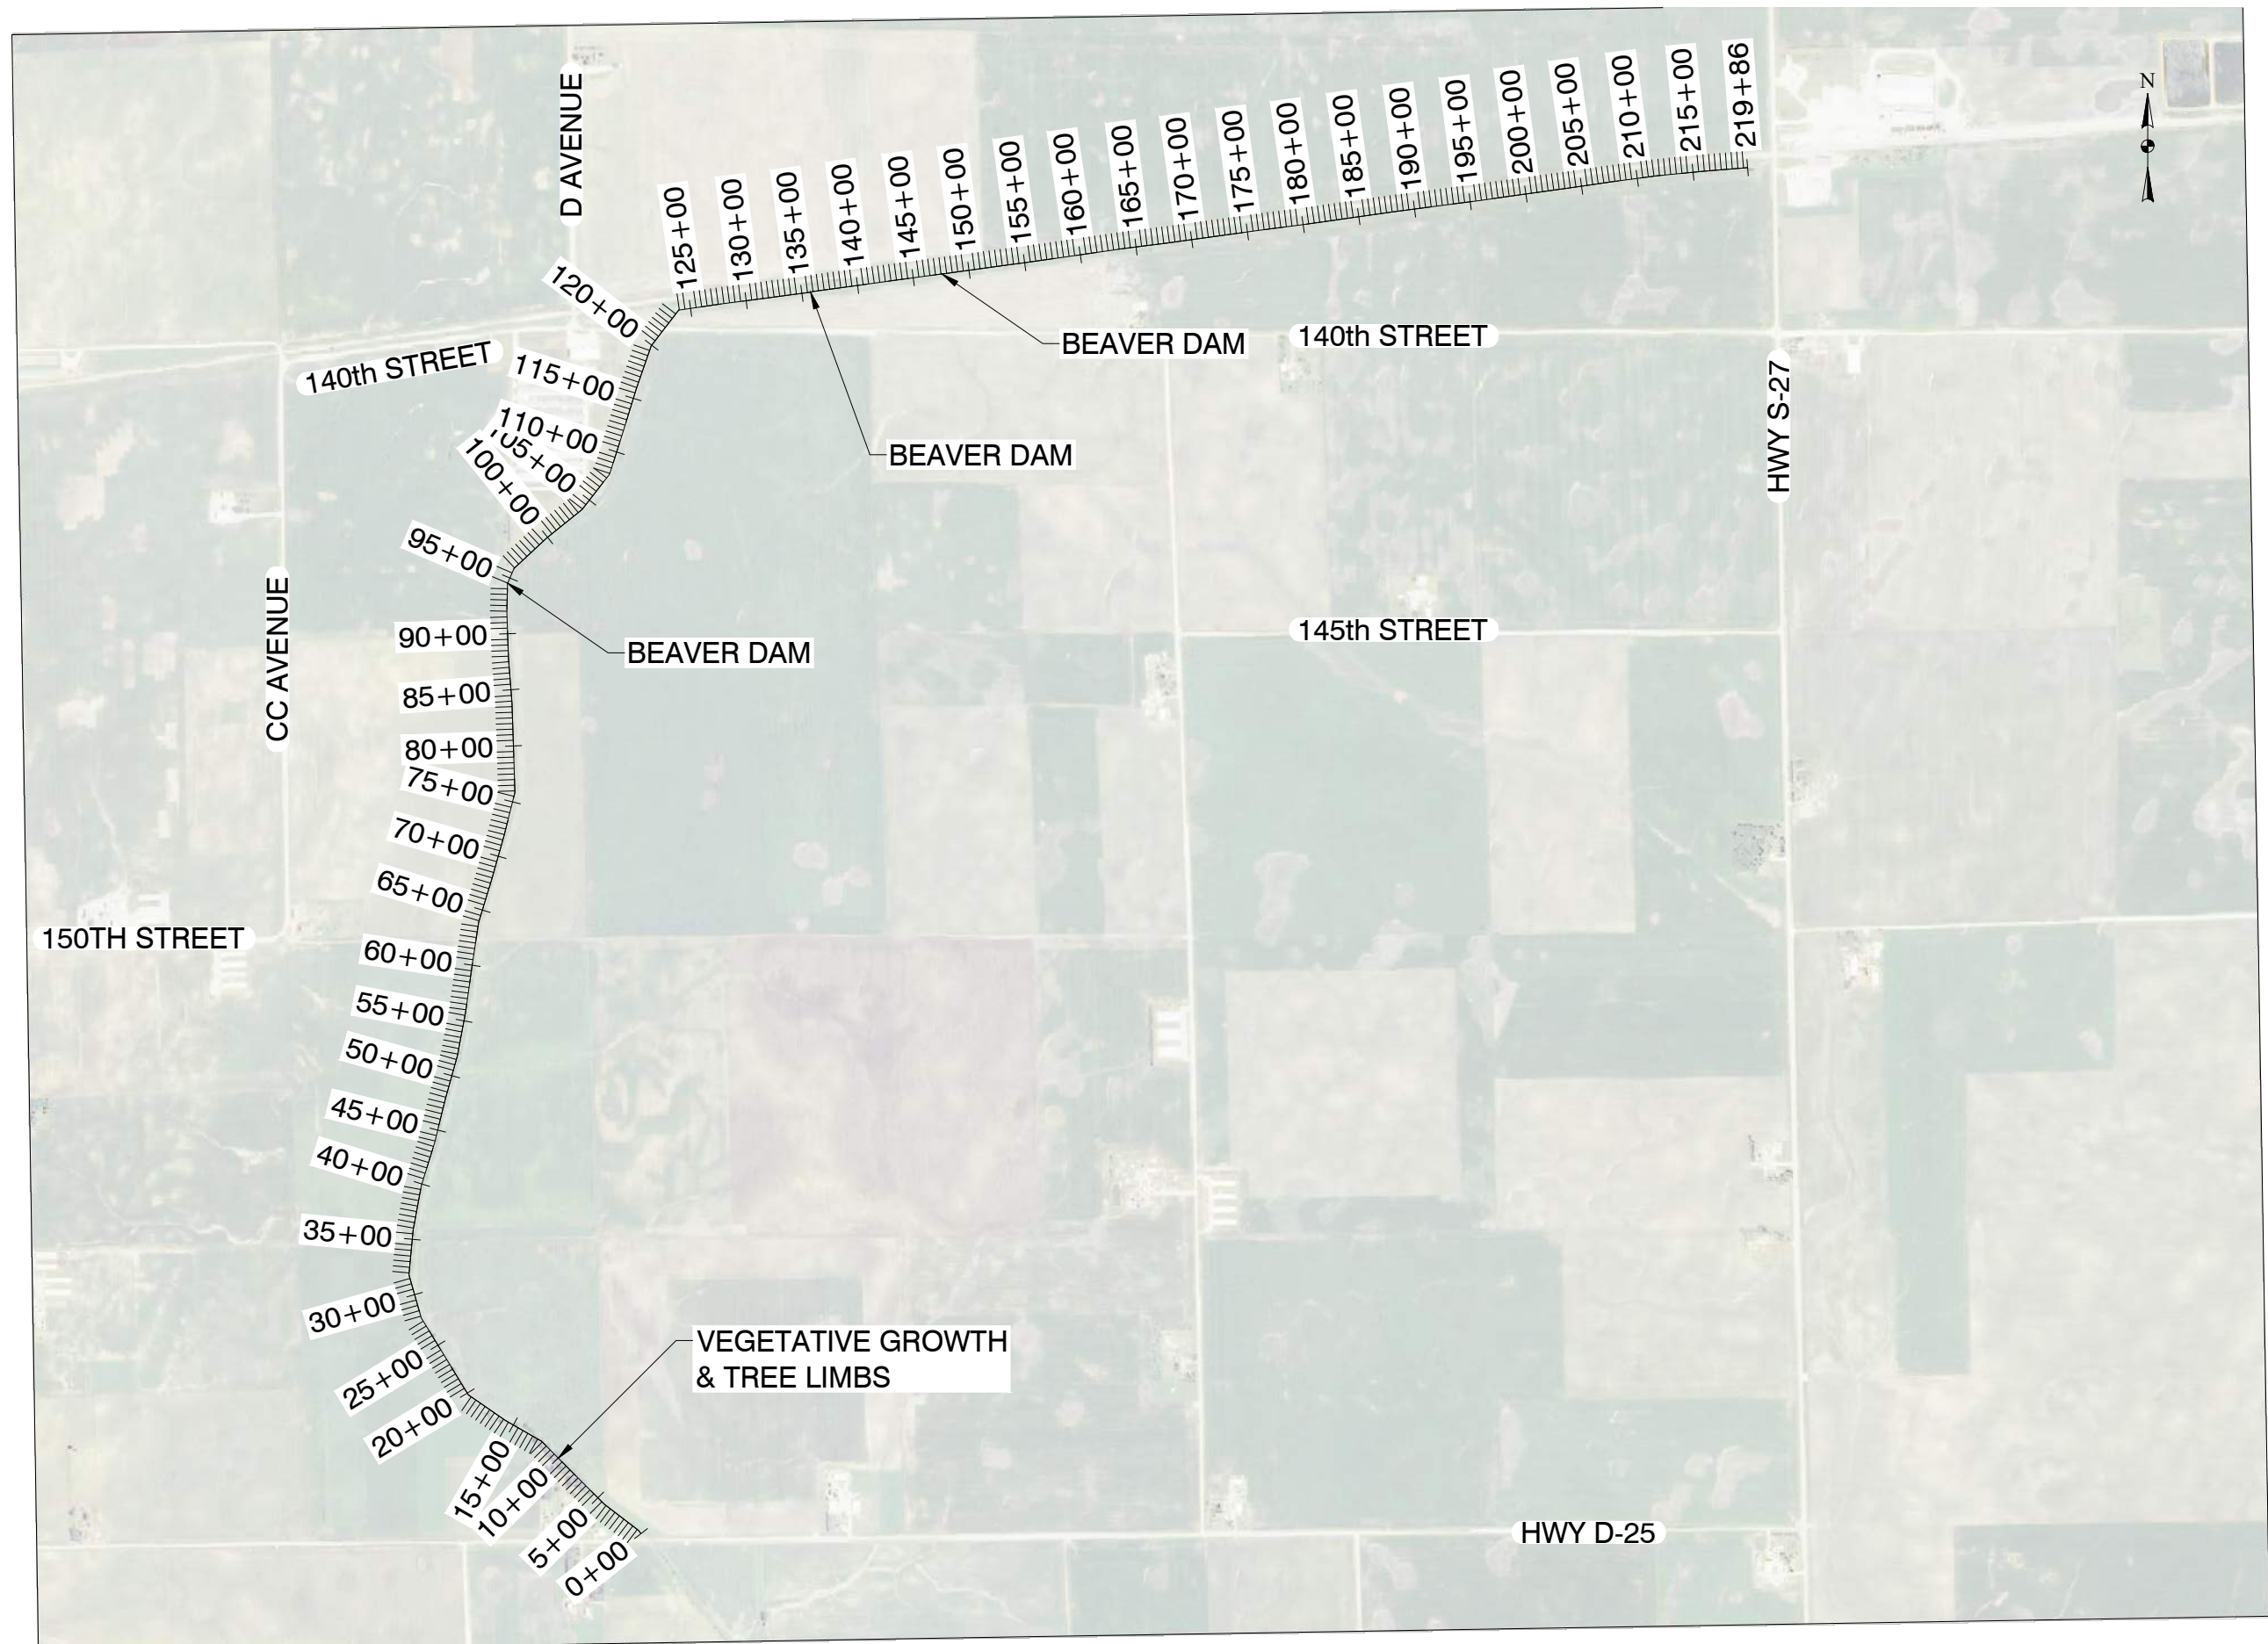
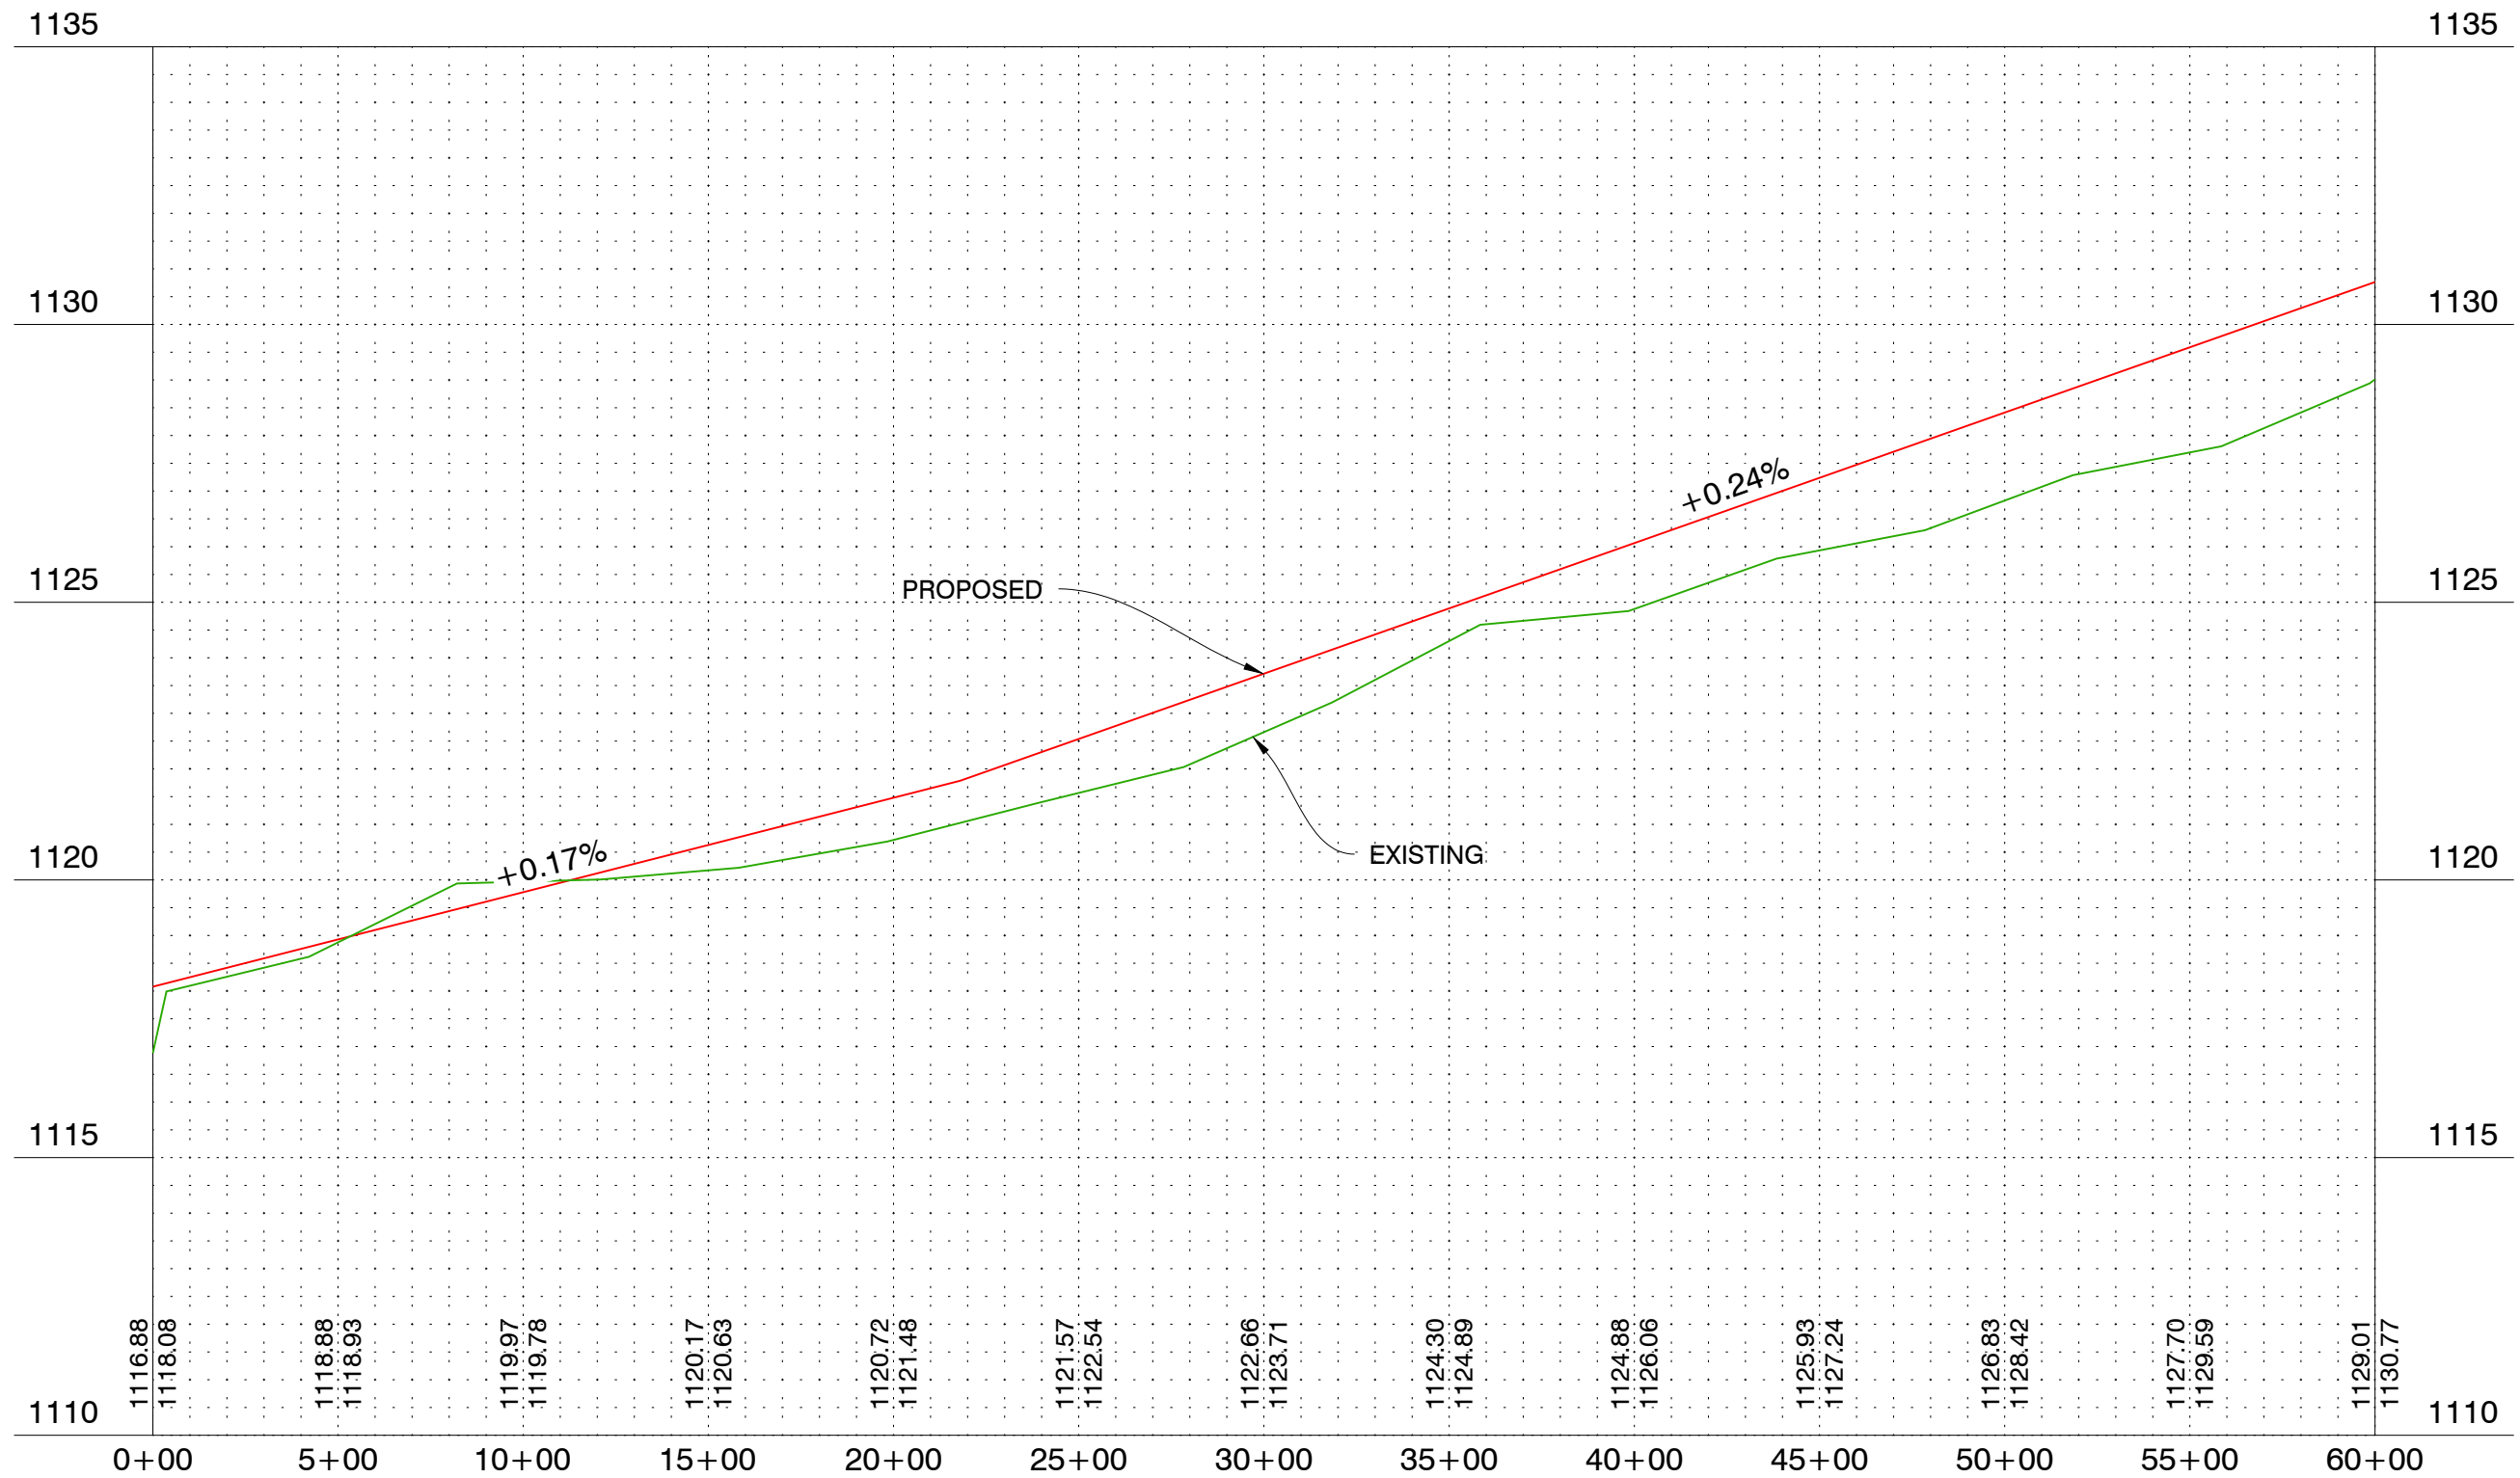
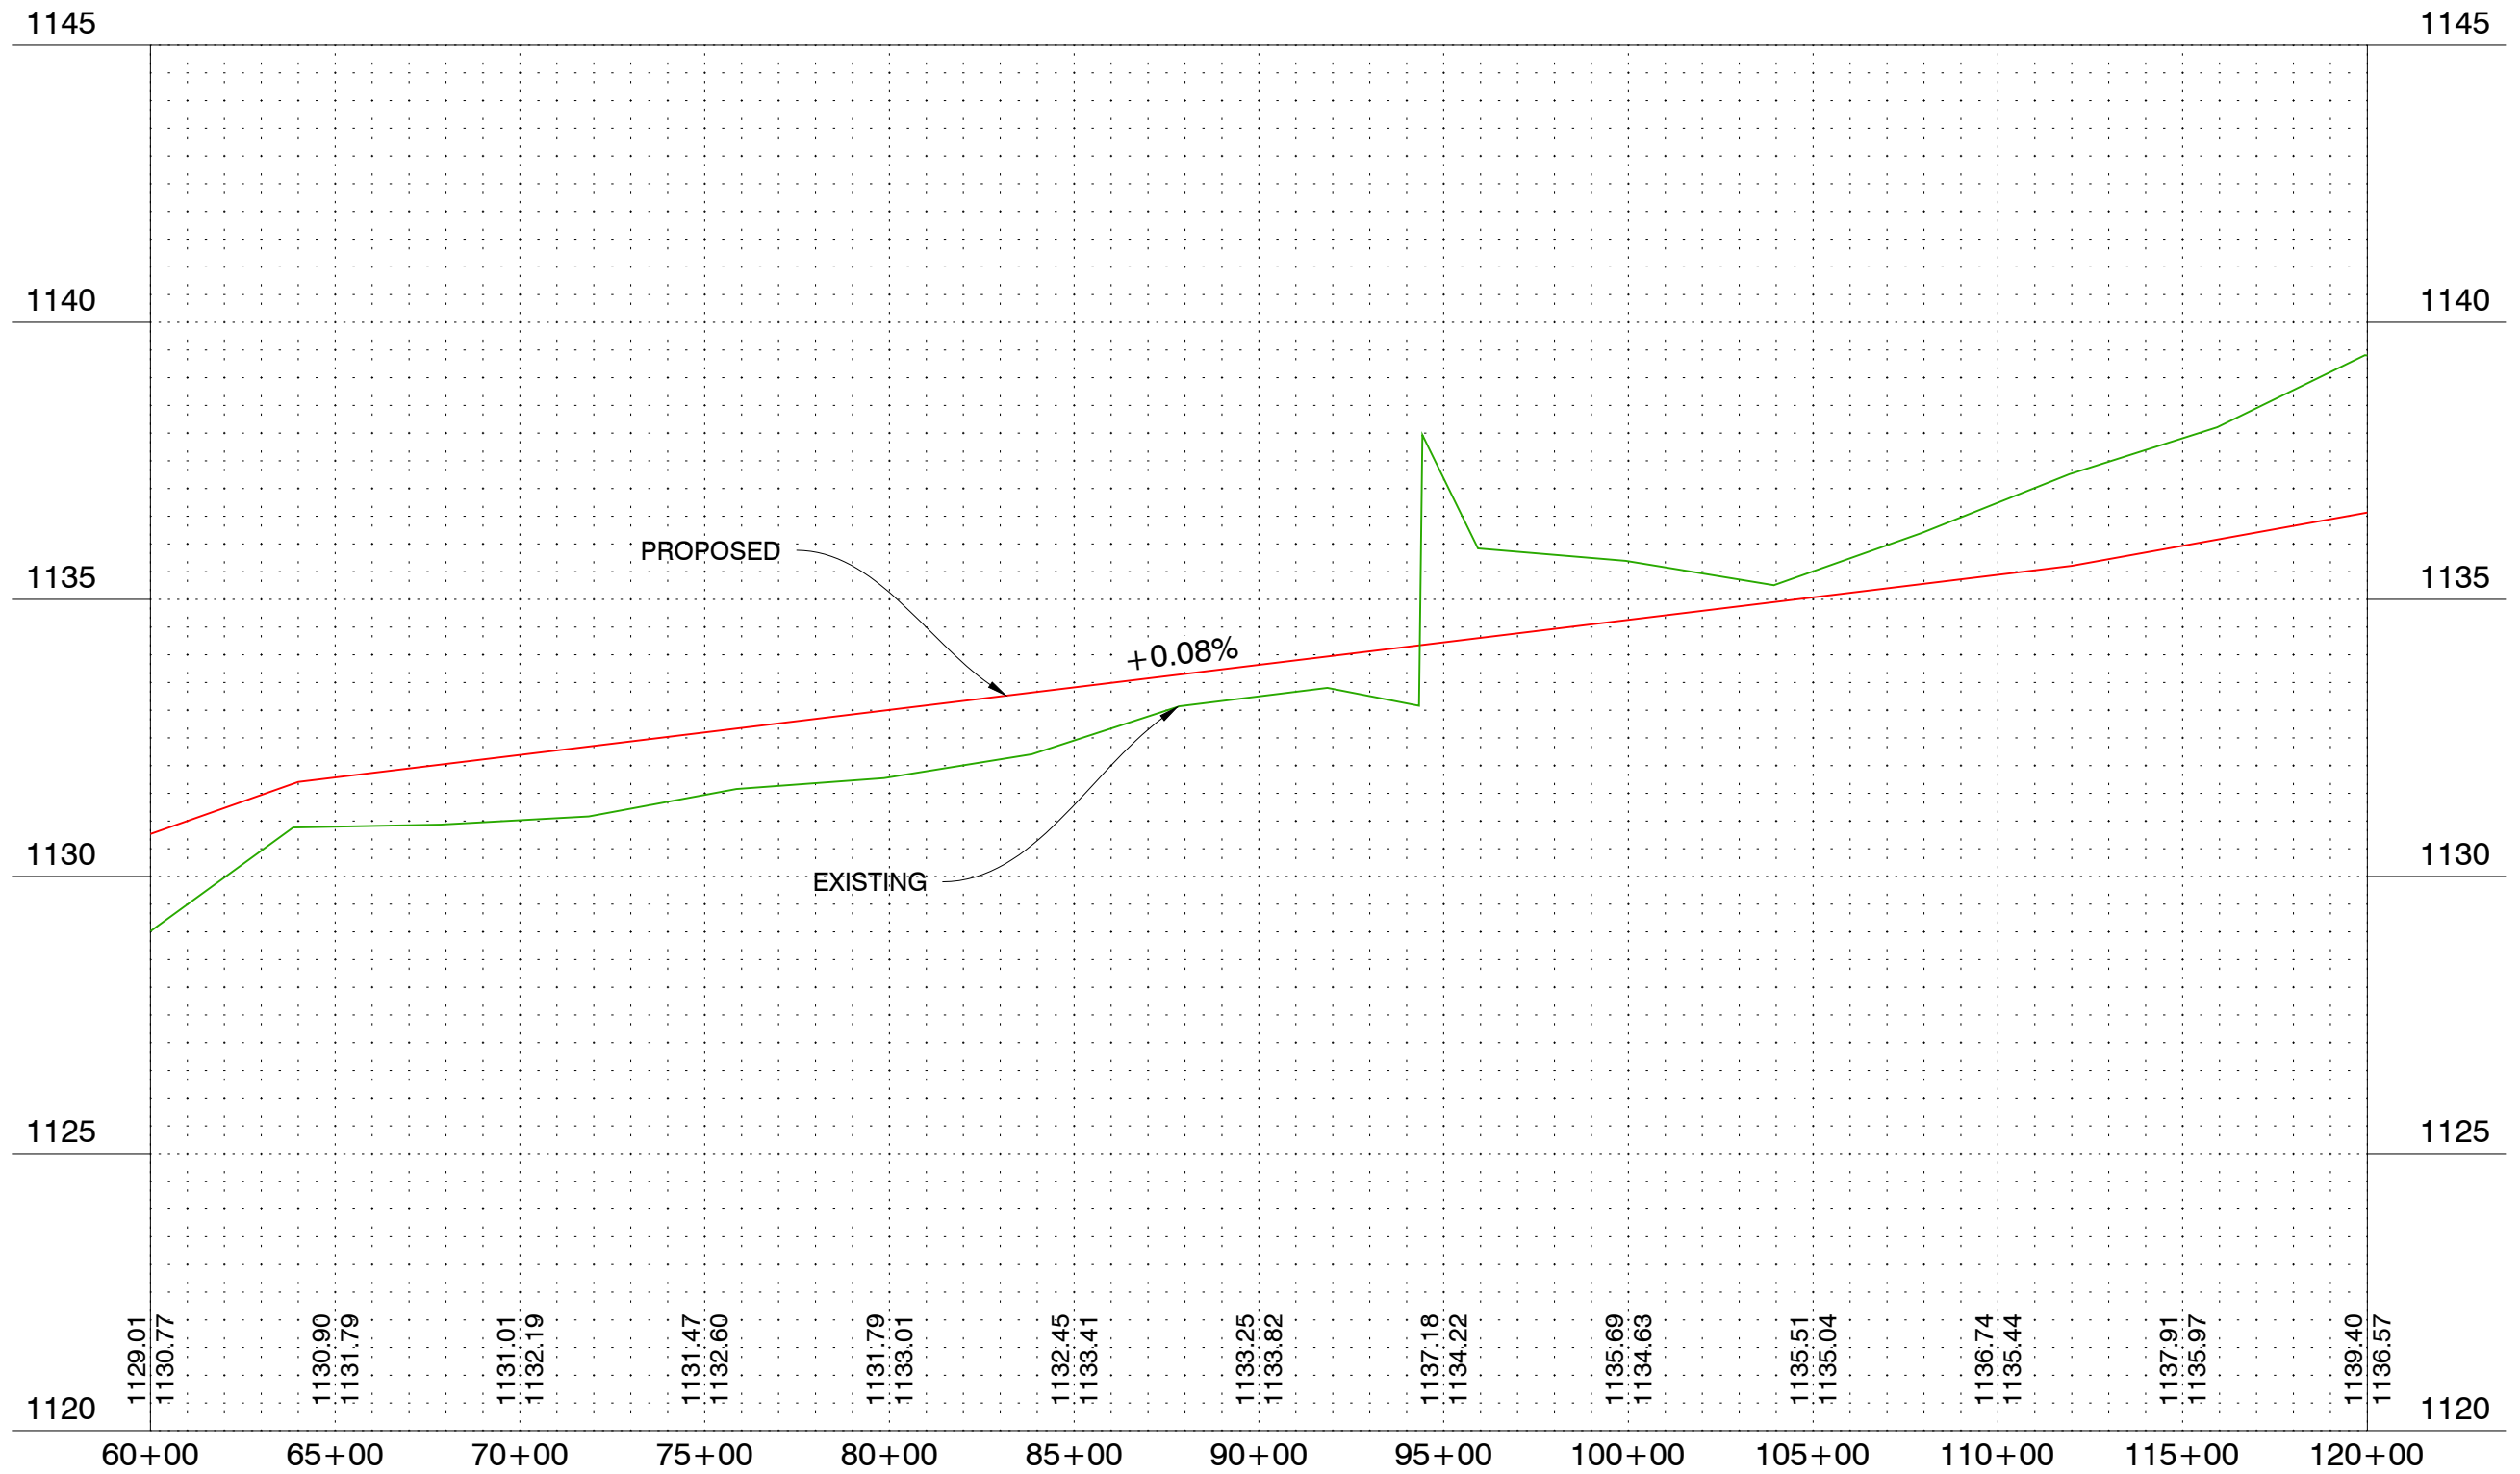
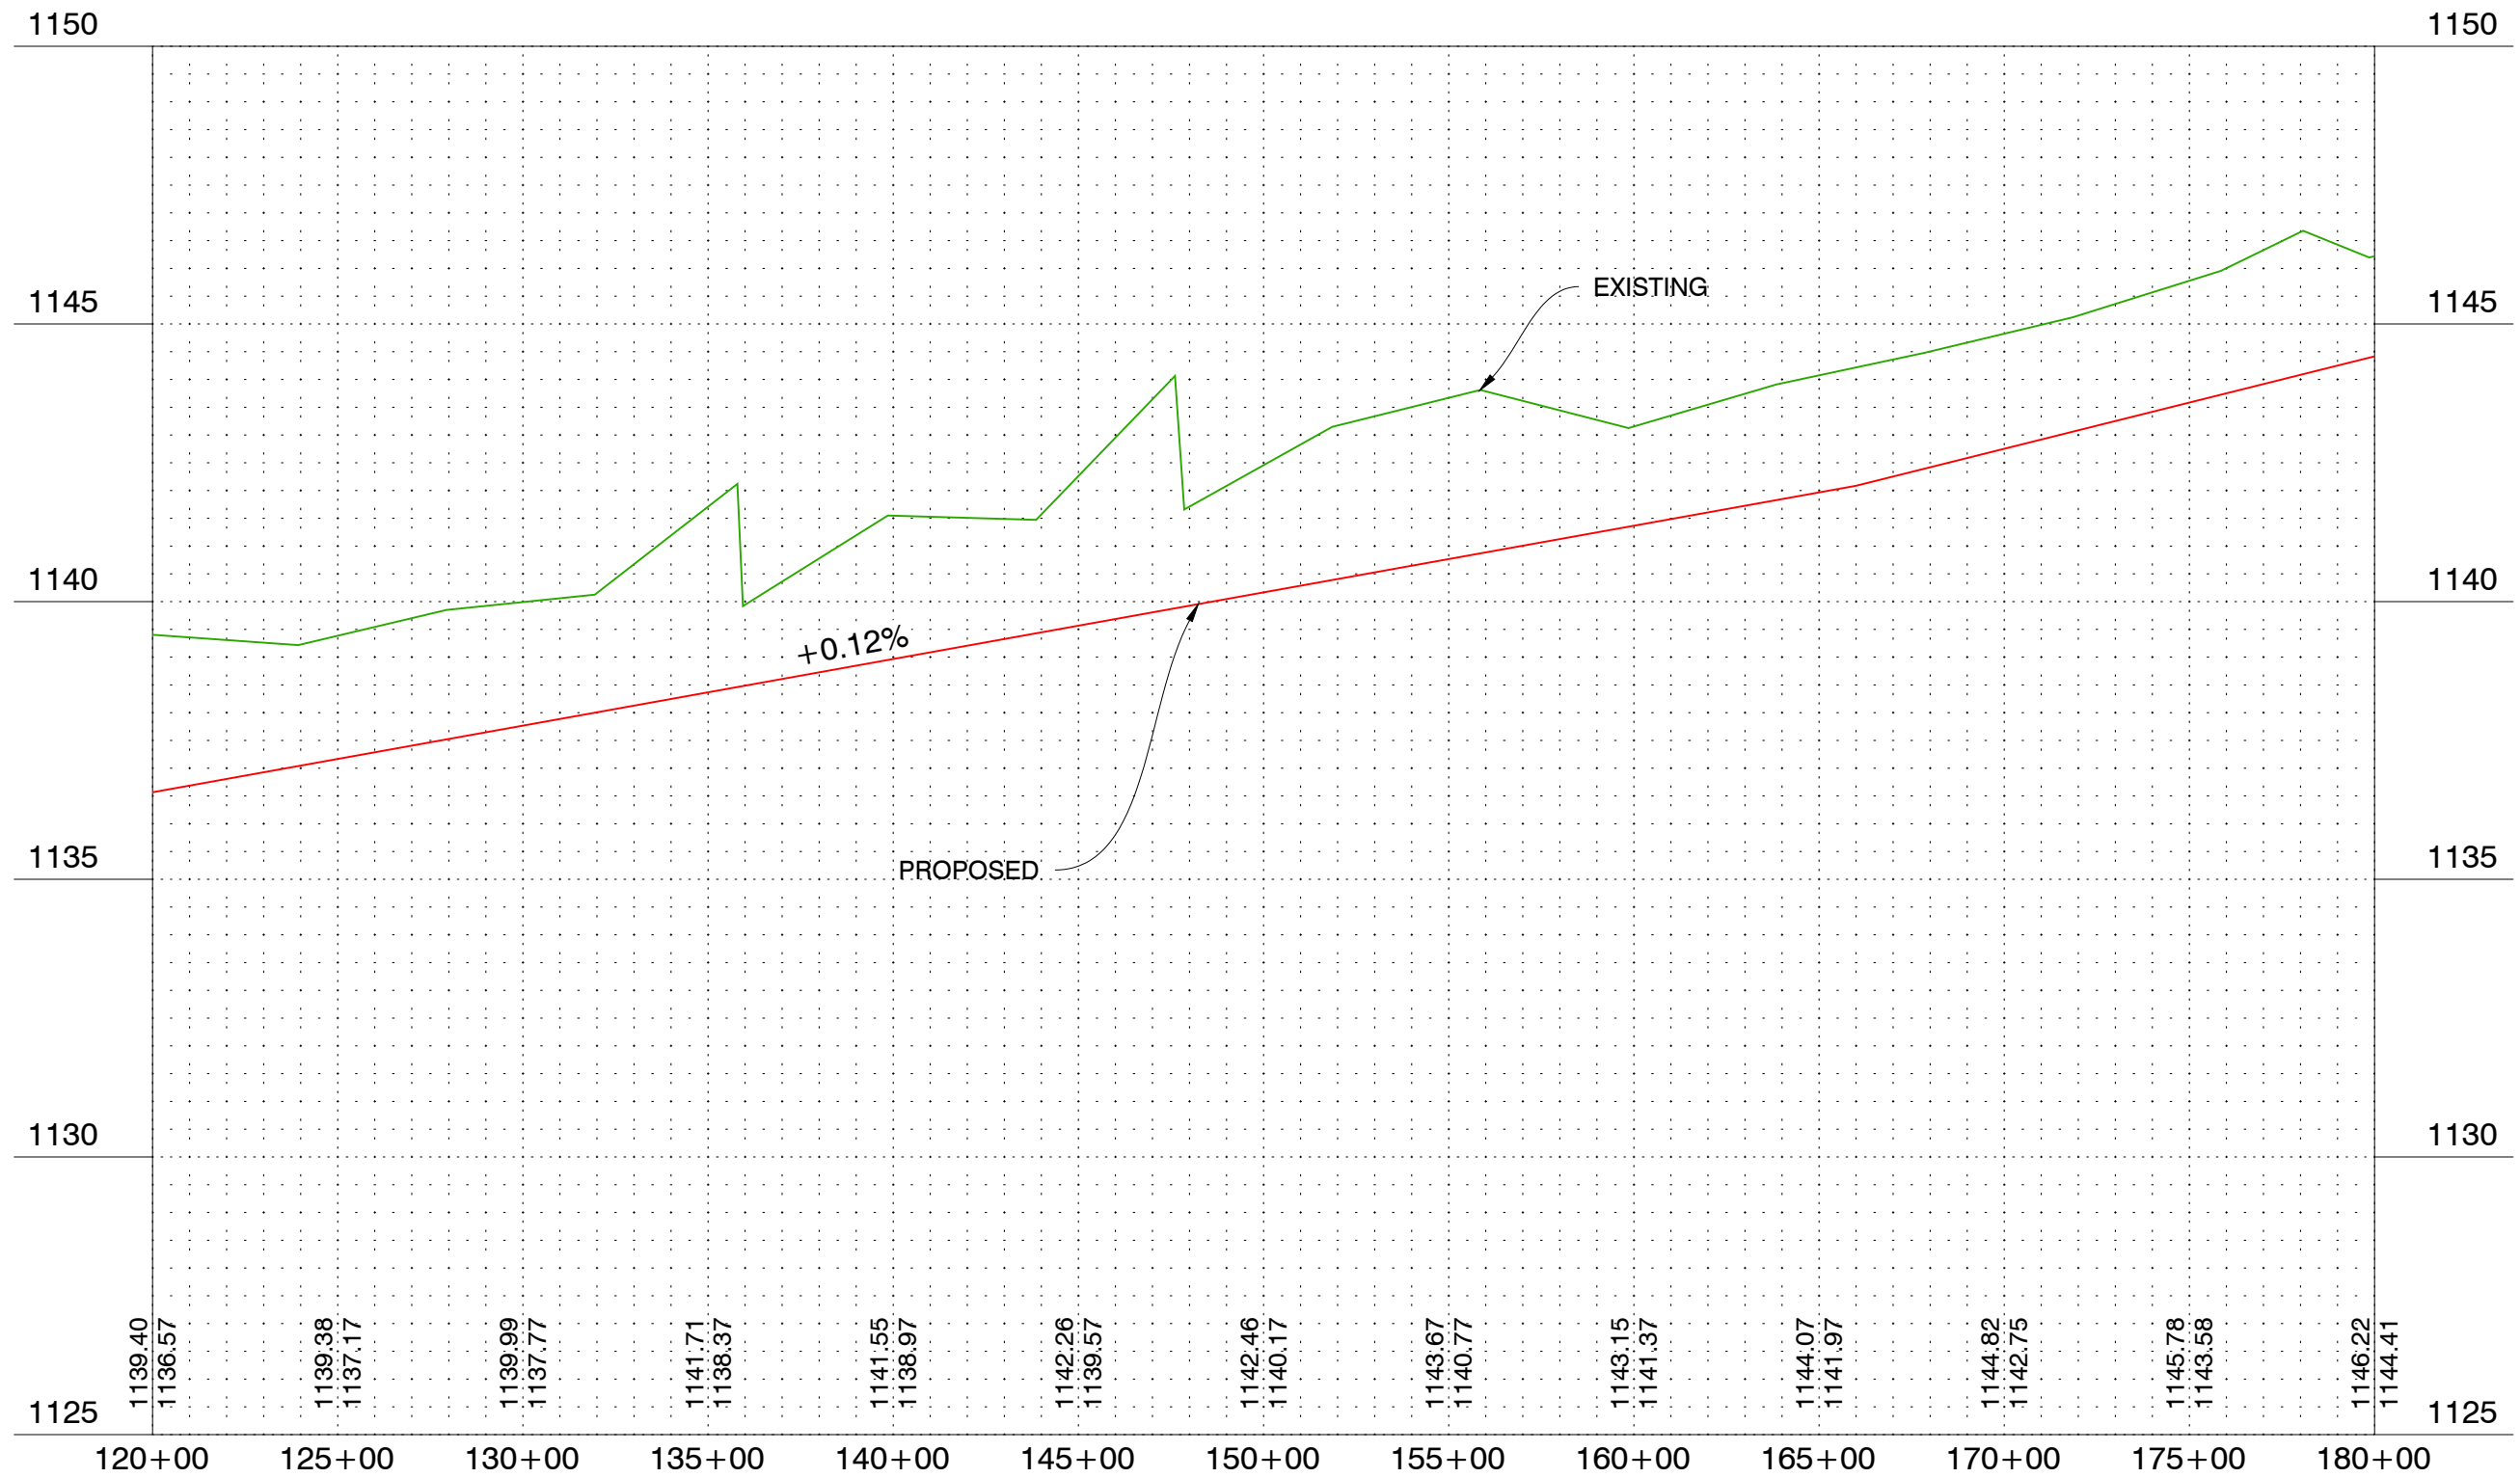
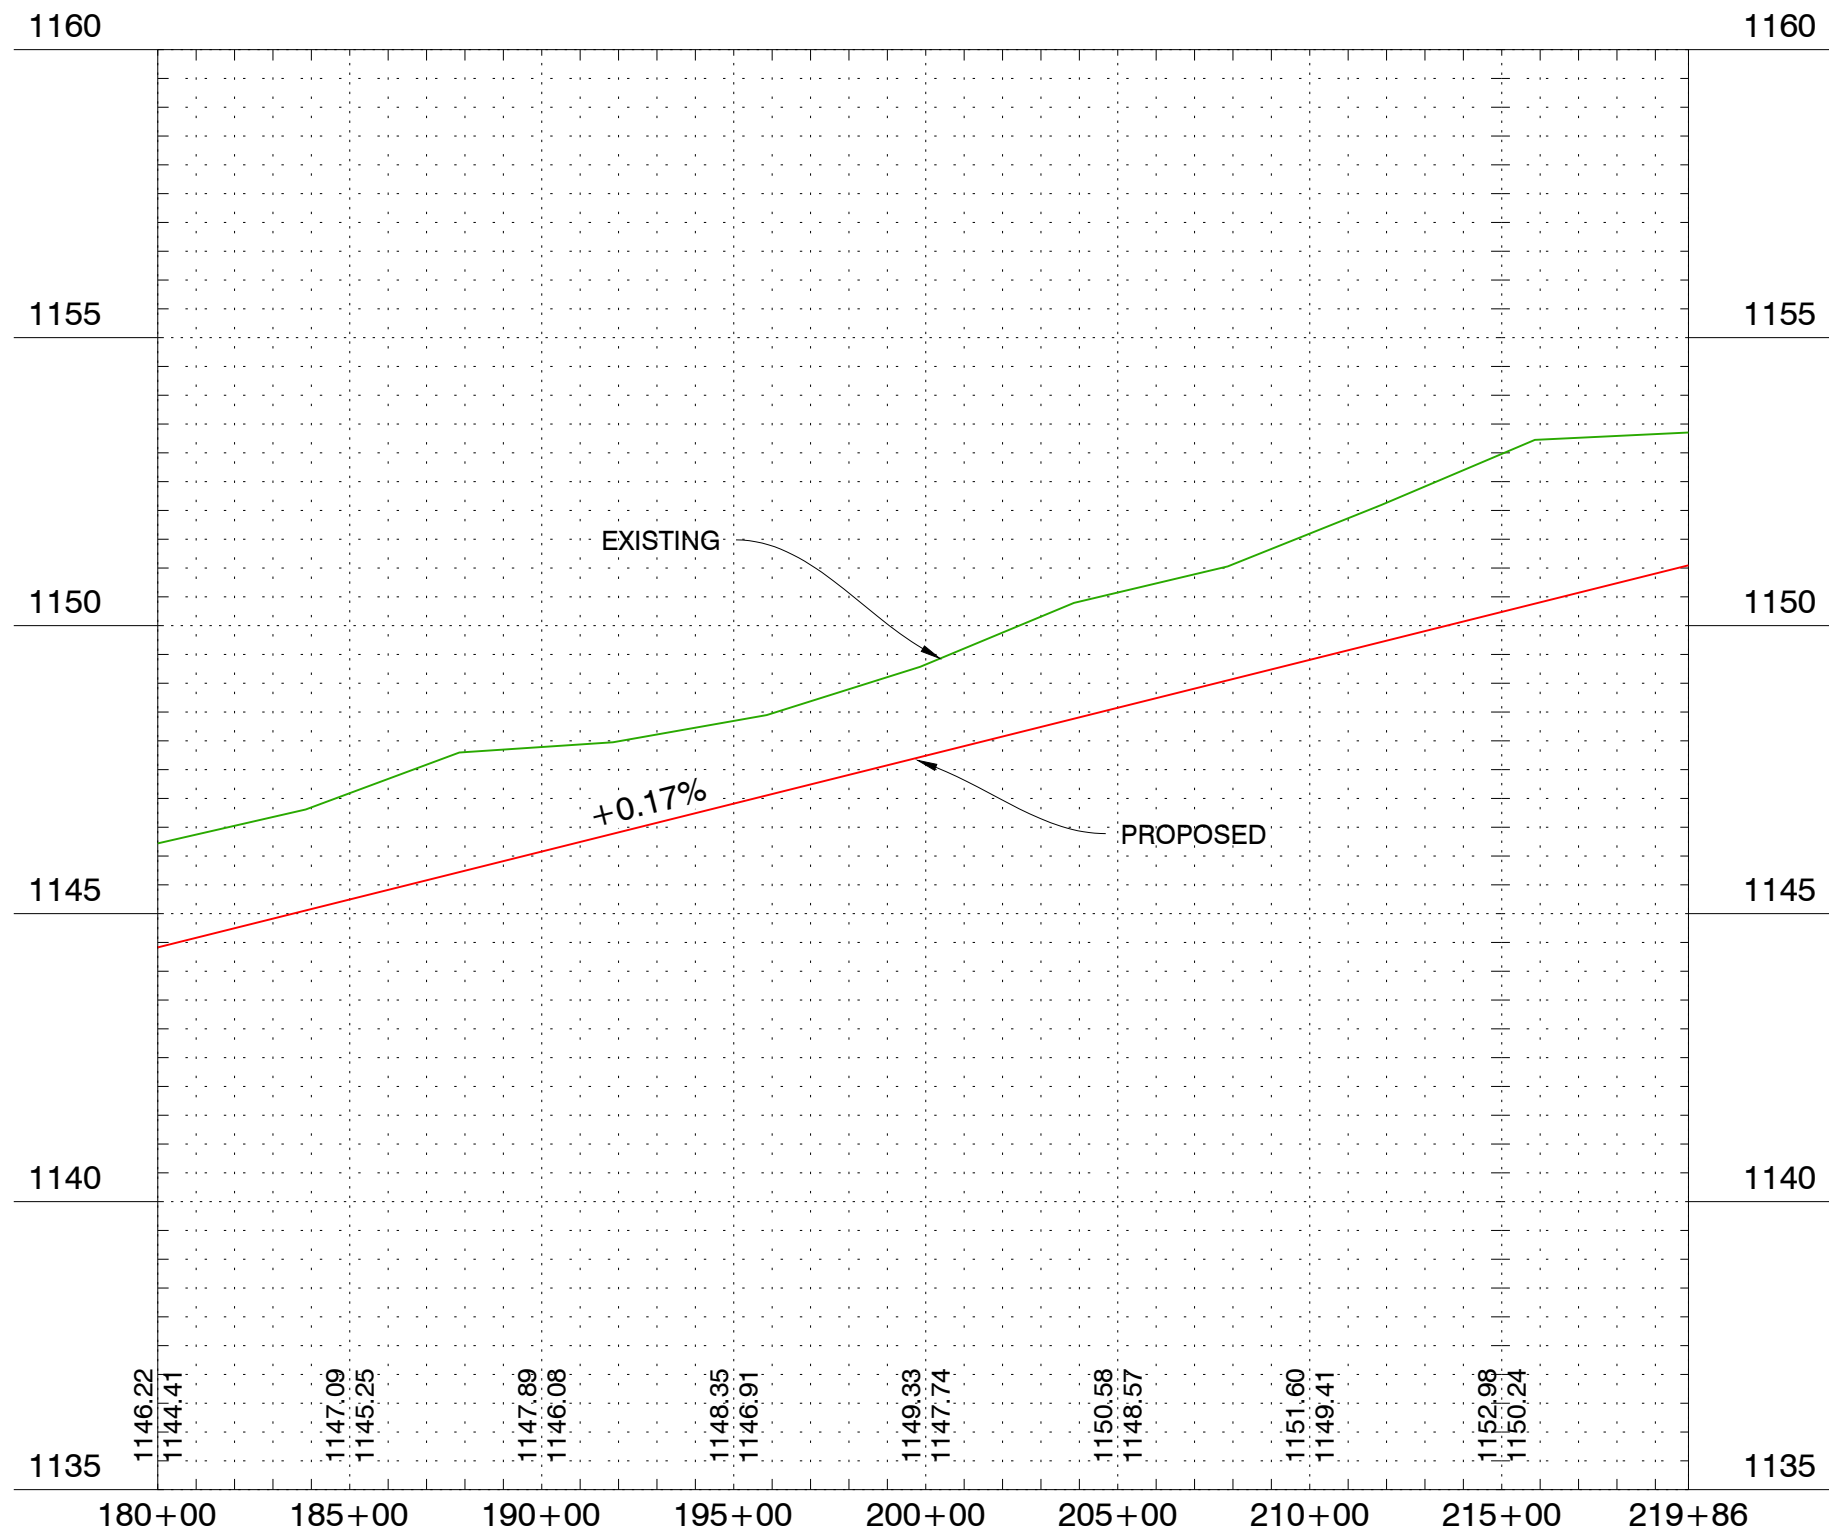
APPENDIX D

Using the above survey information, a profile of the main open ditch existing flowline was generated. For comparison purposes, it was necessary to plot the design grade in effect on the profile. Comparison of the two then allowed for approximation of where and how much siltation is in the open ditch. For reference, a copy of said preliminary profile is included in Appendix D.

A. Using the above mentioned profile, the main open ditch has significant siltation along its length between Sta. 94+00 until it's point of termination at Sta. 219+86 (approximately 12,586 feet). This siltation ranges in depth from $\frac{1}{4}'\pm$ to $4'\pm$ with the most extreme siltation being associated with beaver dams and the general siltation depth at around $2\frac{1}{2}'\pm$. Downstream of Sta. 94+00 the Main open ditch was found to have generally scoured itself of siltation, with only one point of siltation appearing approximately 900' upstream of the outlet.

Without a cleanout, the silt will reduce the cross-sectional area of the ditch through soil deposition into the ditch bottom. A reduction in the cross-sectional area directly results in a reduction in the volume of water that the ditch can convey. This in turn backs water and silt up into the tiles that outlet into the main open ditch. This effect was visible as the main tile outlet and private tile outlets where the soil base of such were below the flow line (silted in). In two cases, the private tile outlets were almost entirely submerged in siltation. In normal-flow conditions, water will submerge most, if not all, of these outlets. It is unclear if there are other existing tile outlets which are partially or totally covered. For reference, the preliminary Main open ditch profile is included in Appendix D.

B. At a minimum of three areas within the Main open ditch, three beaver dams were observed to have been constructed. Due to the time between when the observation was completed and the time of reporting, this number may have fluctuated. The depth of water may also affect the visibility of these structures, as high flow would obscure visibility of smaller dams. These dams reduce drainage by backing water into said tile outlets and slow water. This thereby decreases water velocity and encourages siltation. For reference, a map of the Main open ditch showing said beaver dams is included in Appendix D.

- C. Along the length of the main open ditch, there are two areas of heavy vegetative growth, and intermittent areas of light (trees and brush) which can impede drainage in three ways. First, when any of these trees die or lose limbs, the resulting debris can enter the drainage ditch, intertwine, and create “jams”, which reduces the volume of water that the ditch can convey. Tree-fall limbs may also divert the flow directly into the face bank, causing erosion and/or sloughs, which is visible in at least one case closer to the outlet of the district. Second, the roots of said trees naturally seek water sources. As such, said roots can infiltrate and plug tile lines which discharge into said open ditch. Obviously, the trees and the tile lines must be in the same vicinity for this to happen. Finally, trees provide an ample building material for beaver, who construct dams. Due to the existence of beavers in the main open ditch already, continued tree growth will only encourage more beaver activity. For reference, a map of the Main open ditch and said vegetative growth is included in Appendix D.
