**ENGINEER'S
REPORT ON
REPAIRS TO
MAIN TILE,
DRAINAGE
DISTRICT NO. 67
HARDIN COUNTY**

Engineer's Report on Repairs to Main Tile, Drainage District No. 67 Hardin County, Iowa

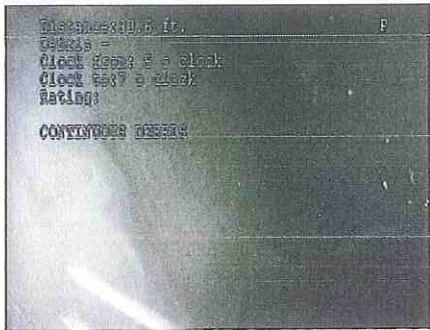
30.6 ft.	U	36.6 ft.	5 / 7	Debris (SILT) IN FLOWLINE, JOINT OFFSET (VERT), HEAVY ROOT INFILTRATION (END) - PIPE ROUND	CONTINUOUS DEBRIS
----------	---	----------	-------	--	--------------------------

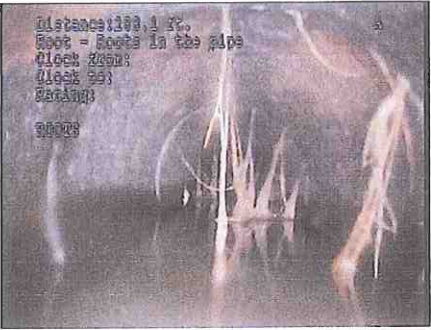
Distance	Dire Length	From/To Code	Modifier/Severity	Rating	Comments
288.1 ft.	U	/	Root	INFILTRATION (START) - PIPE ROUND	ROOTS

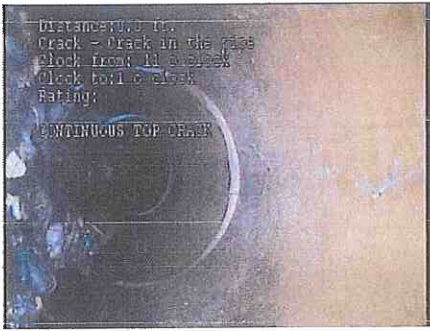
Distance	Dir.	Length	From/To Code	Modifier/Severity	Rating	Comments
0.0 ft.	D	279.5 ft.	11 / 1	Crack, TOP AND SIDE (START), DEBRIS (SILT, RAILROAD GRADE, AND SHATTERED TILE) IN FLOWLINE. CONTINUED SILT IN FLOWLINE (START) - PIPE ROUND		CONTINUOUS TOP CRACK

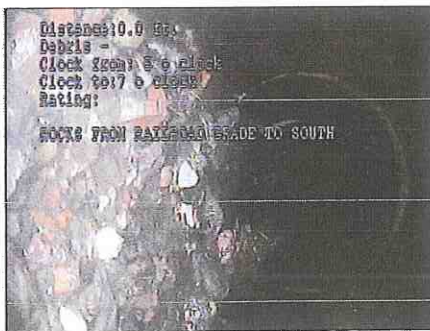
0.0 ft. D 465.3 ft. 5 / 7 Debris

**ROCKS FROM
RAILROAD GRADE
TO SOUTH**

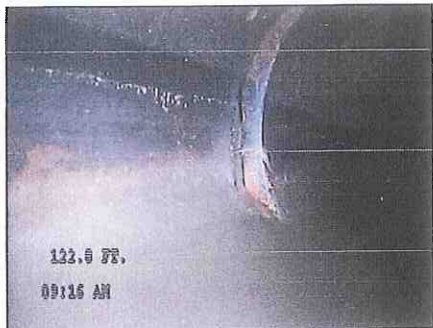
122.8 ft. D **7 / 10** **Joint Offset**, SOIL VISIBLE IN GAP (TWO IN A ROW), TOP CRACK (END) - PIPE ROUND **OFFSET**

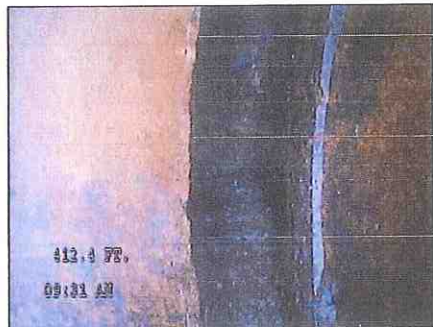
412.4 ft.	D	7 / 11	Joint - Separated		LARGE VOID
-----------	---	--------	-------------------	--	-------------------
