**HARDIN COUNTY, IOWA**

**ENGINEER'S REPORT  
ON REPAIRS OR  
IMPROVEMENTS TO  
MAIN TILE  
DRAINAGE DISTRICT  
NO. 9  
HARDIN COUNTY,  
IOWA**

**Engineer's Report on Repairs or Improvements  
to Main Tile, Drainage District No. 9  
Hardin County, Iowa**

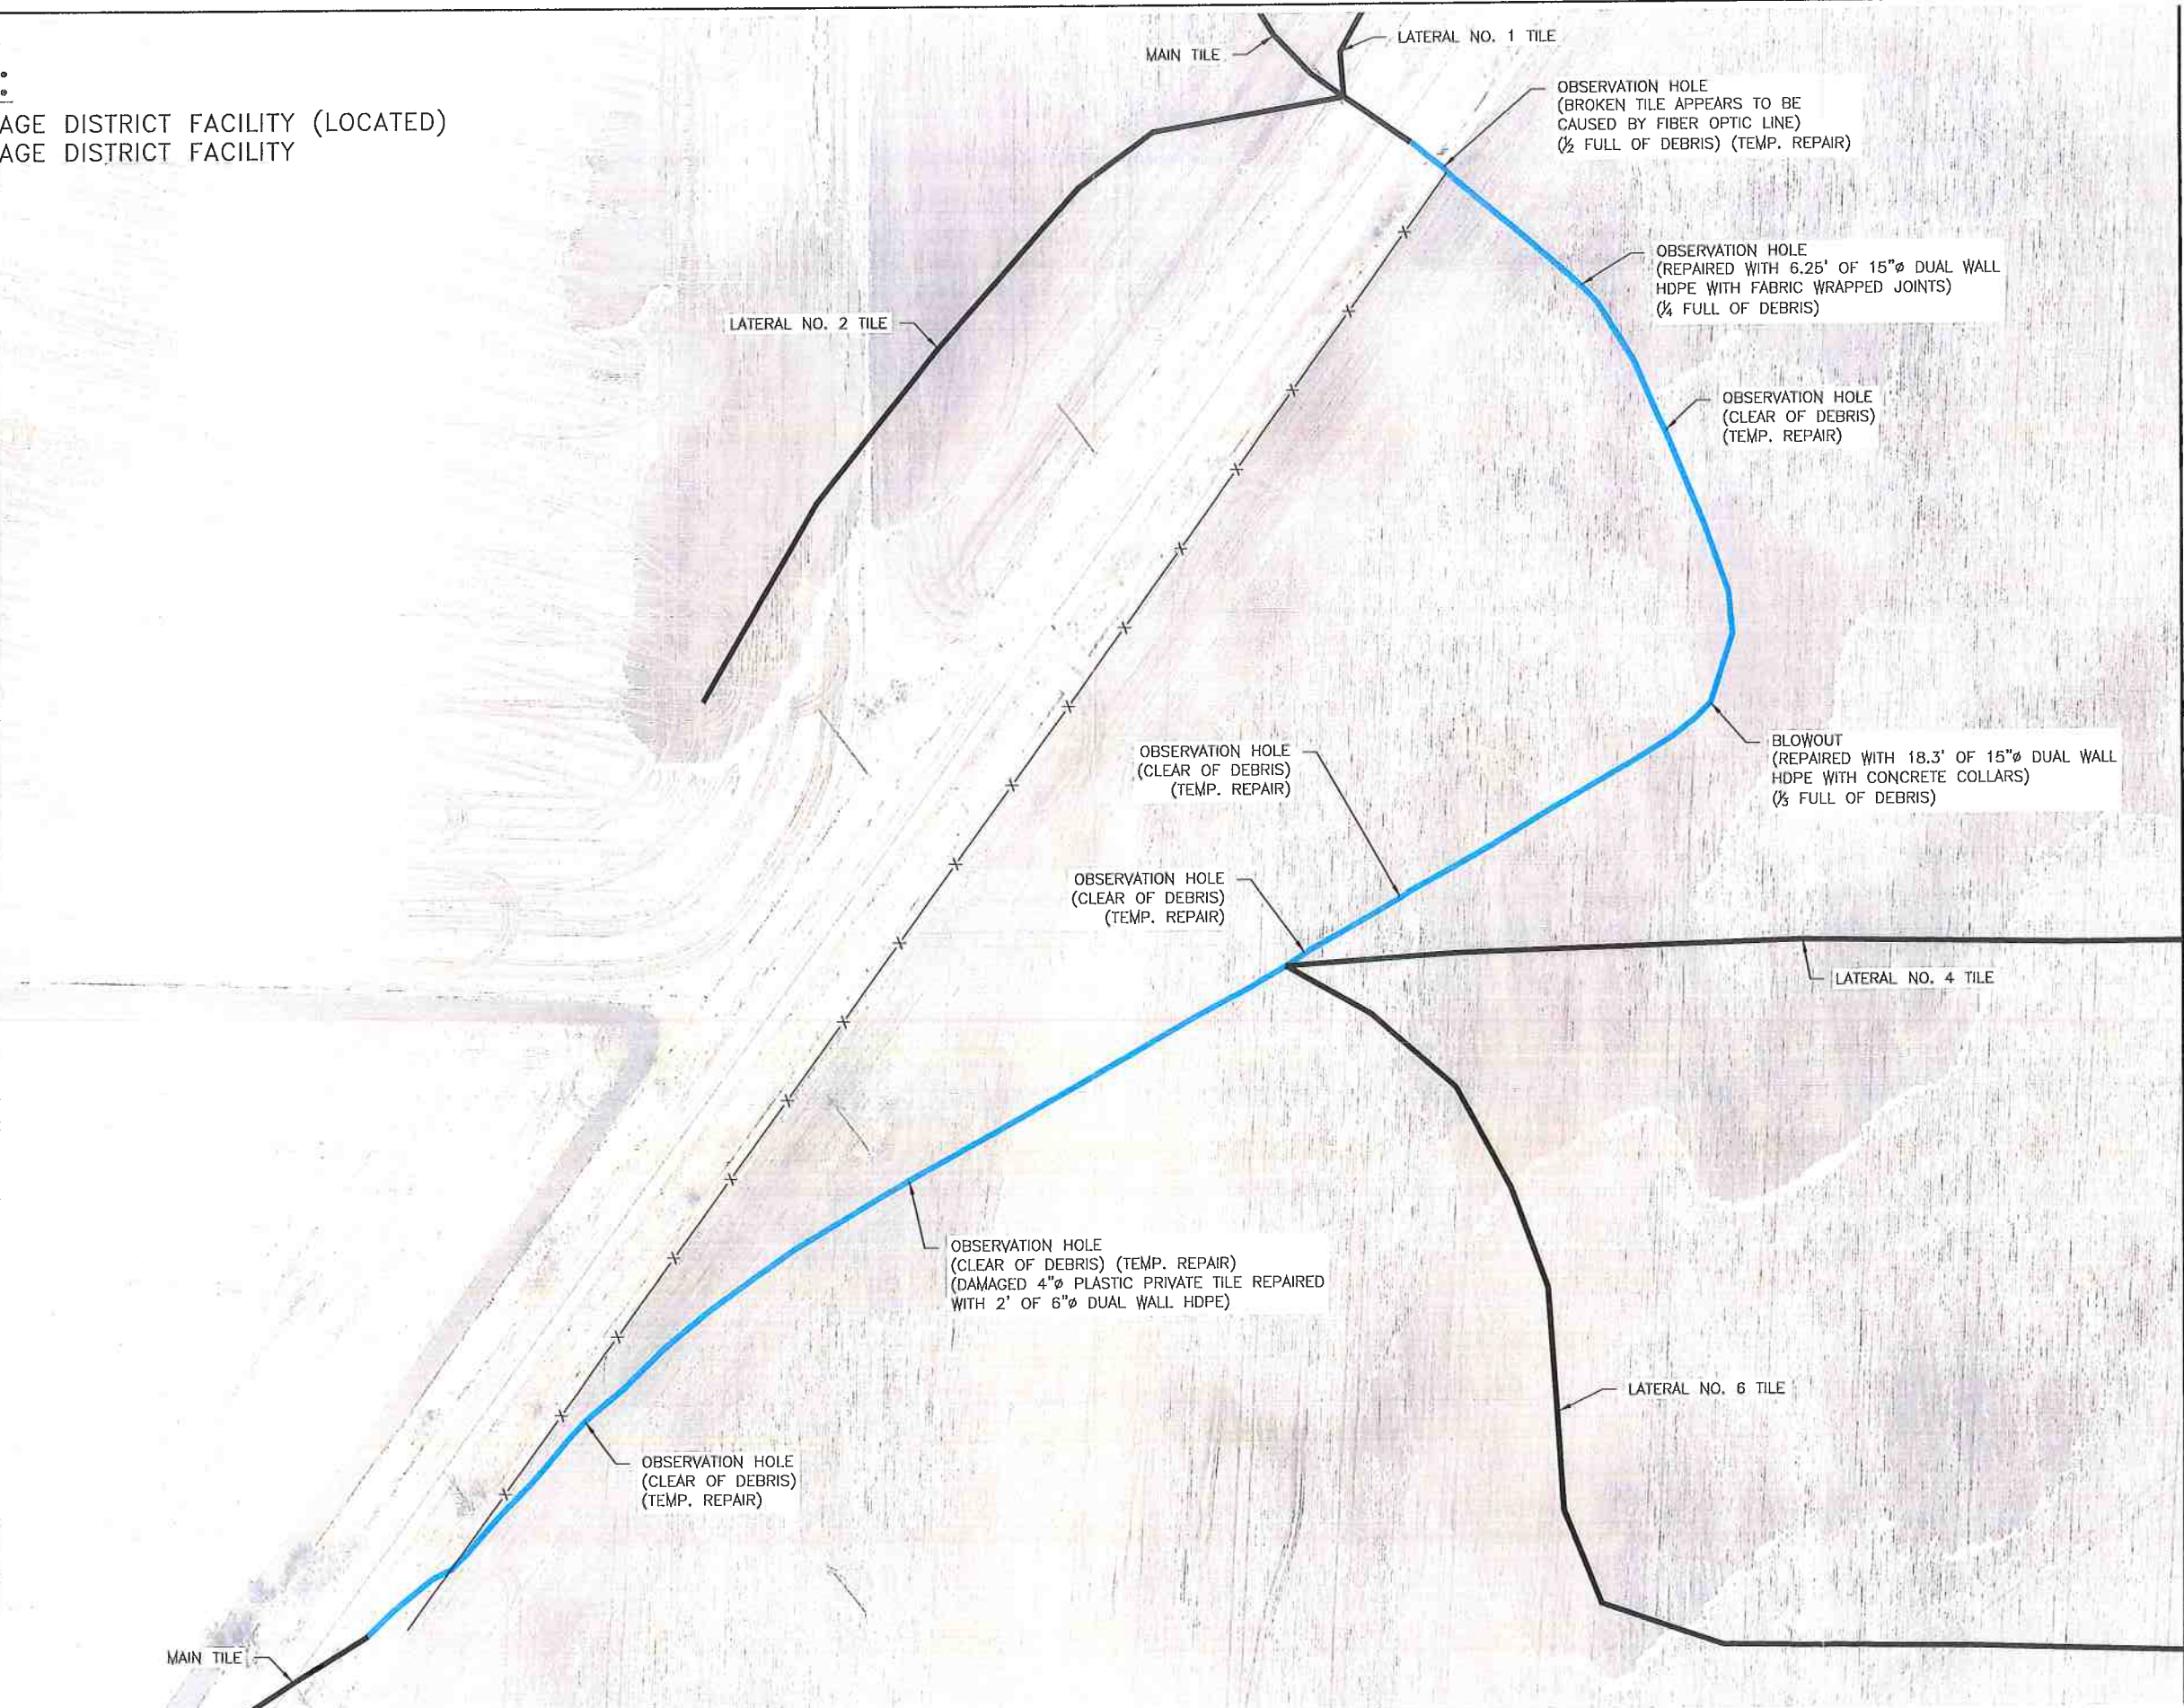
## SPOT REPAIRS

- Tenant in SW¼ Section 6, Township 89 North, Range 22 West reported two blowouts/sinkholes on Main tile.
- Visually searched area and found one blowout/sinkhole, approximately 225 feet southeast of railroad right of way (see attached spot repair map).

- Tile blowout/sinkhole is missing one section of VCP tile and is 1/3 full of debris.
- Located Main tile upstream for 590'± and downstream for 1430'± from blowout/sinkhole.

- Upstream found broken VCP tile in sinkhole/blowout just downstream of railroad. The tile appears to have possibly been broken when fiber optic line was installed (see attached spot repair map).

- Repaired first blowout/sinkhole with 18.3' of 15" Dual Wall HDPE tile with concrete collars.
- Repaired observation hole approximately 150' south railroad right of way with 6.25' of 15" Dual Wall HDPE tile with fabric wrapped joints.

The unrepaired broken tile in the railroad right of way is severely limiting the drainage upstream and will eventually cause additional blowouts/sinkholes and ponding. Moving forward, we would recommend abandoning the current railroad crossing, install a new crossing meeting Union Pacific Railroad standards/permits to restore the drainage to its original design or install a bypass tile on the north side of the railroad right of way. Based on either of these options, it is my opinion that the construction cost would be well over \$50,000. This cost is high enough that a hearing and engineering report would be required.

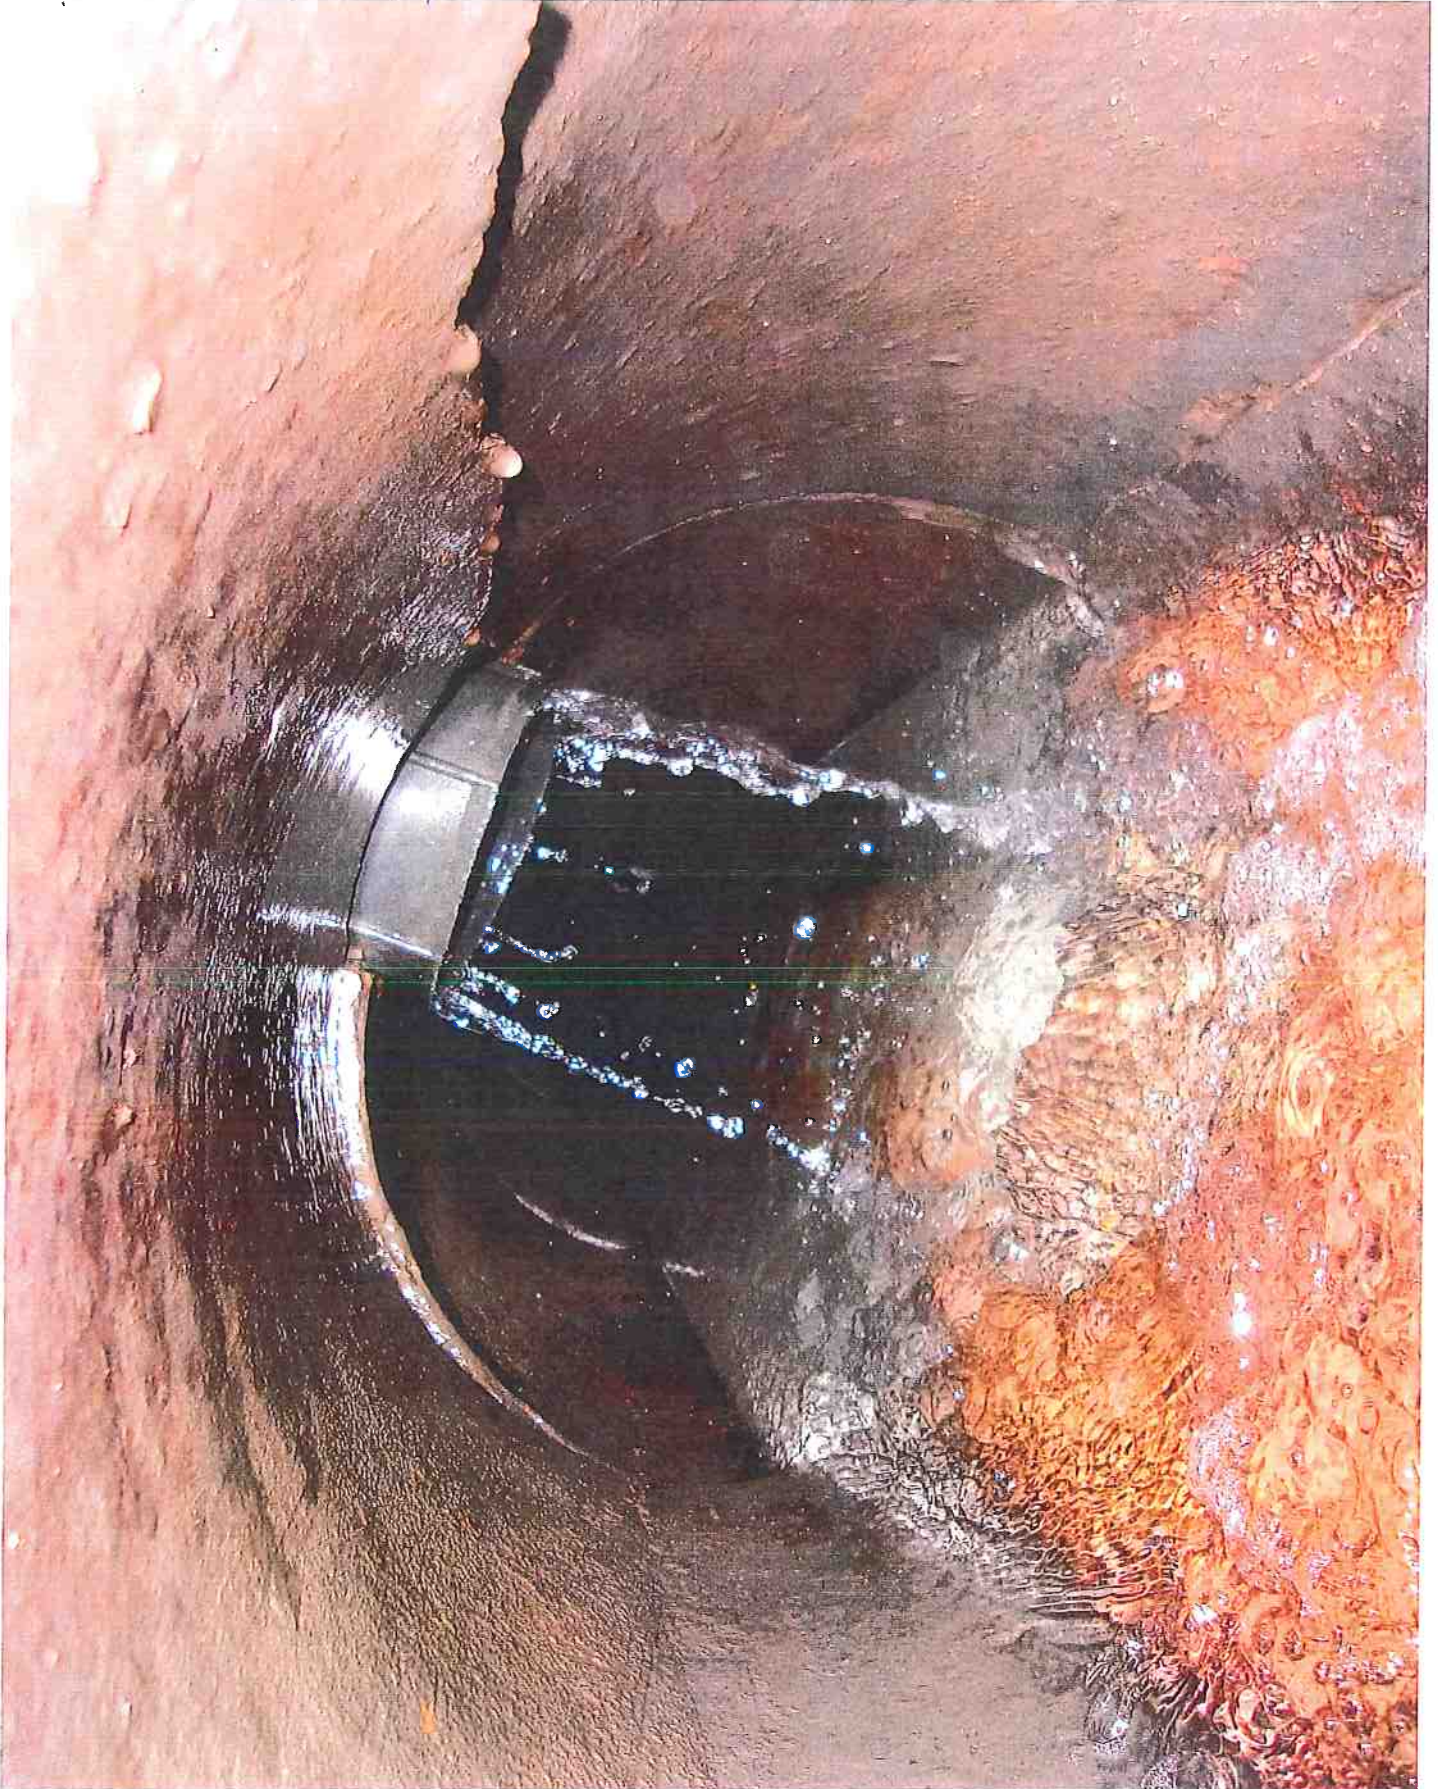
UPSTREAM FROM #321, HOOKED 4" PE WITH BUCKET, REPAIR WITH SNAP COUPLER

12:15 P.M., RANDY AND NICK SHOWS UP WITH PARTS TO REPAIR 4" PLASTIC TILE ACCIDENTALLY HACKED DURING EXPLORATION DIG @ #321. BUT IT'S A 5", RANDY WENT BACK TO GET PARTS FOR A 5", CAN'T FIND ANY. USED A 2' PIECE OF 6" DUAL WALL SLIP OVER THE 5" SINGLE WALL TIGHT FIT WITH FABRIC OVER. THEY ALSO PUT A CHUNK OF DUAL WALL AND FABRIC OVER INSPECTION HOLE AND BACKFILLED. PILES OF DIRT ARE FROZEN, 1' THICK. HARD TO BACKFILL.

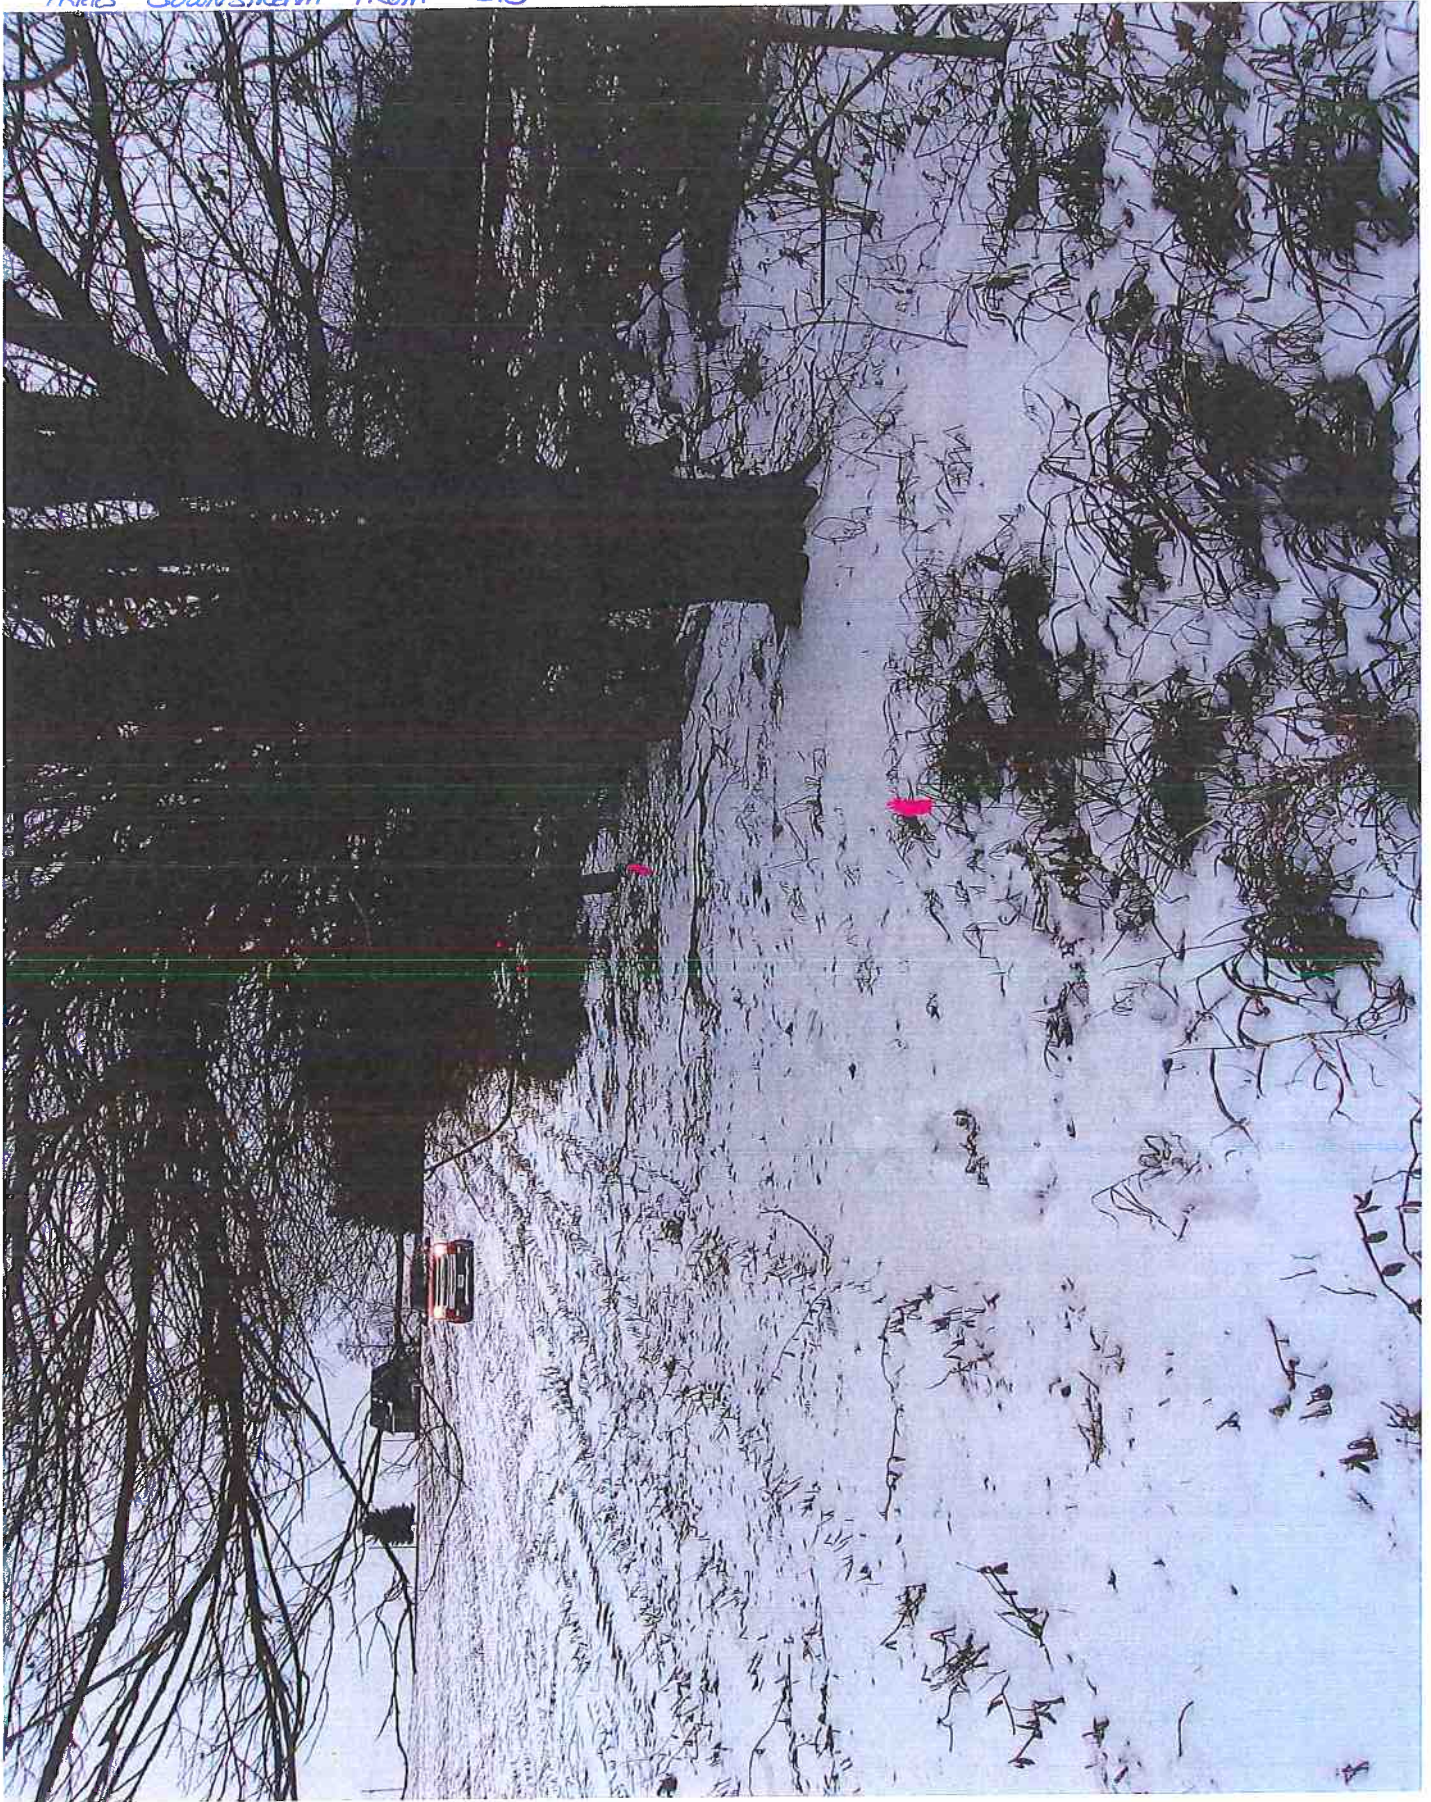
- At the last excavation (near the downstream limits of investigation), the tile could not be located downstream (i.e. underneath the existing railroad) due to apparent tree growth inside the railroad right of way.

TREES DOWNSTREAM FROM #313

- For the above option, trees within 50' of the locations of the existing or replaced Main tile inside railroad right of way would be removed to stop infiltration of tree roots.

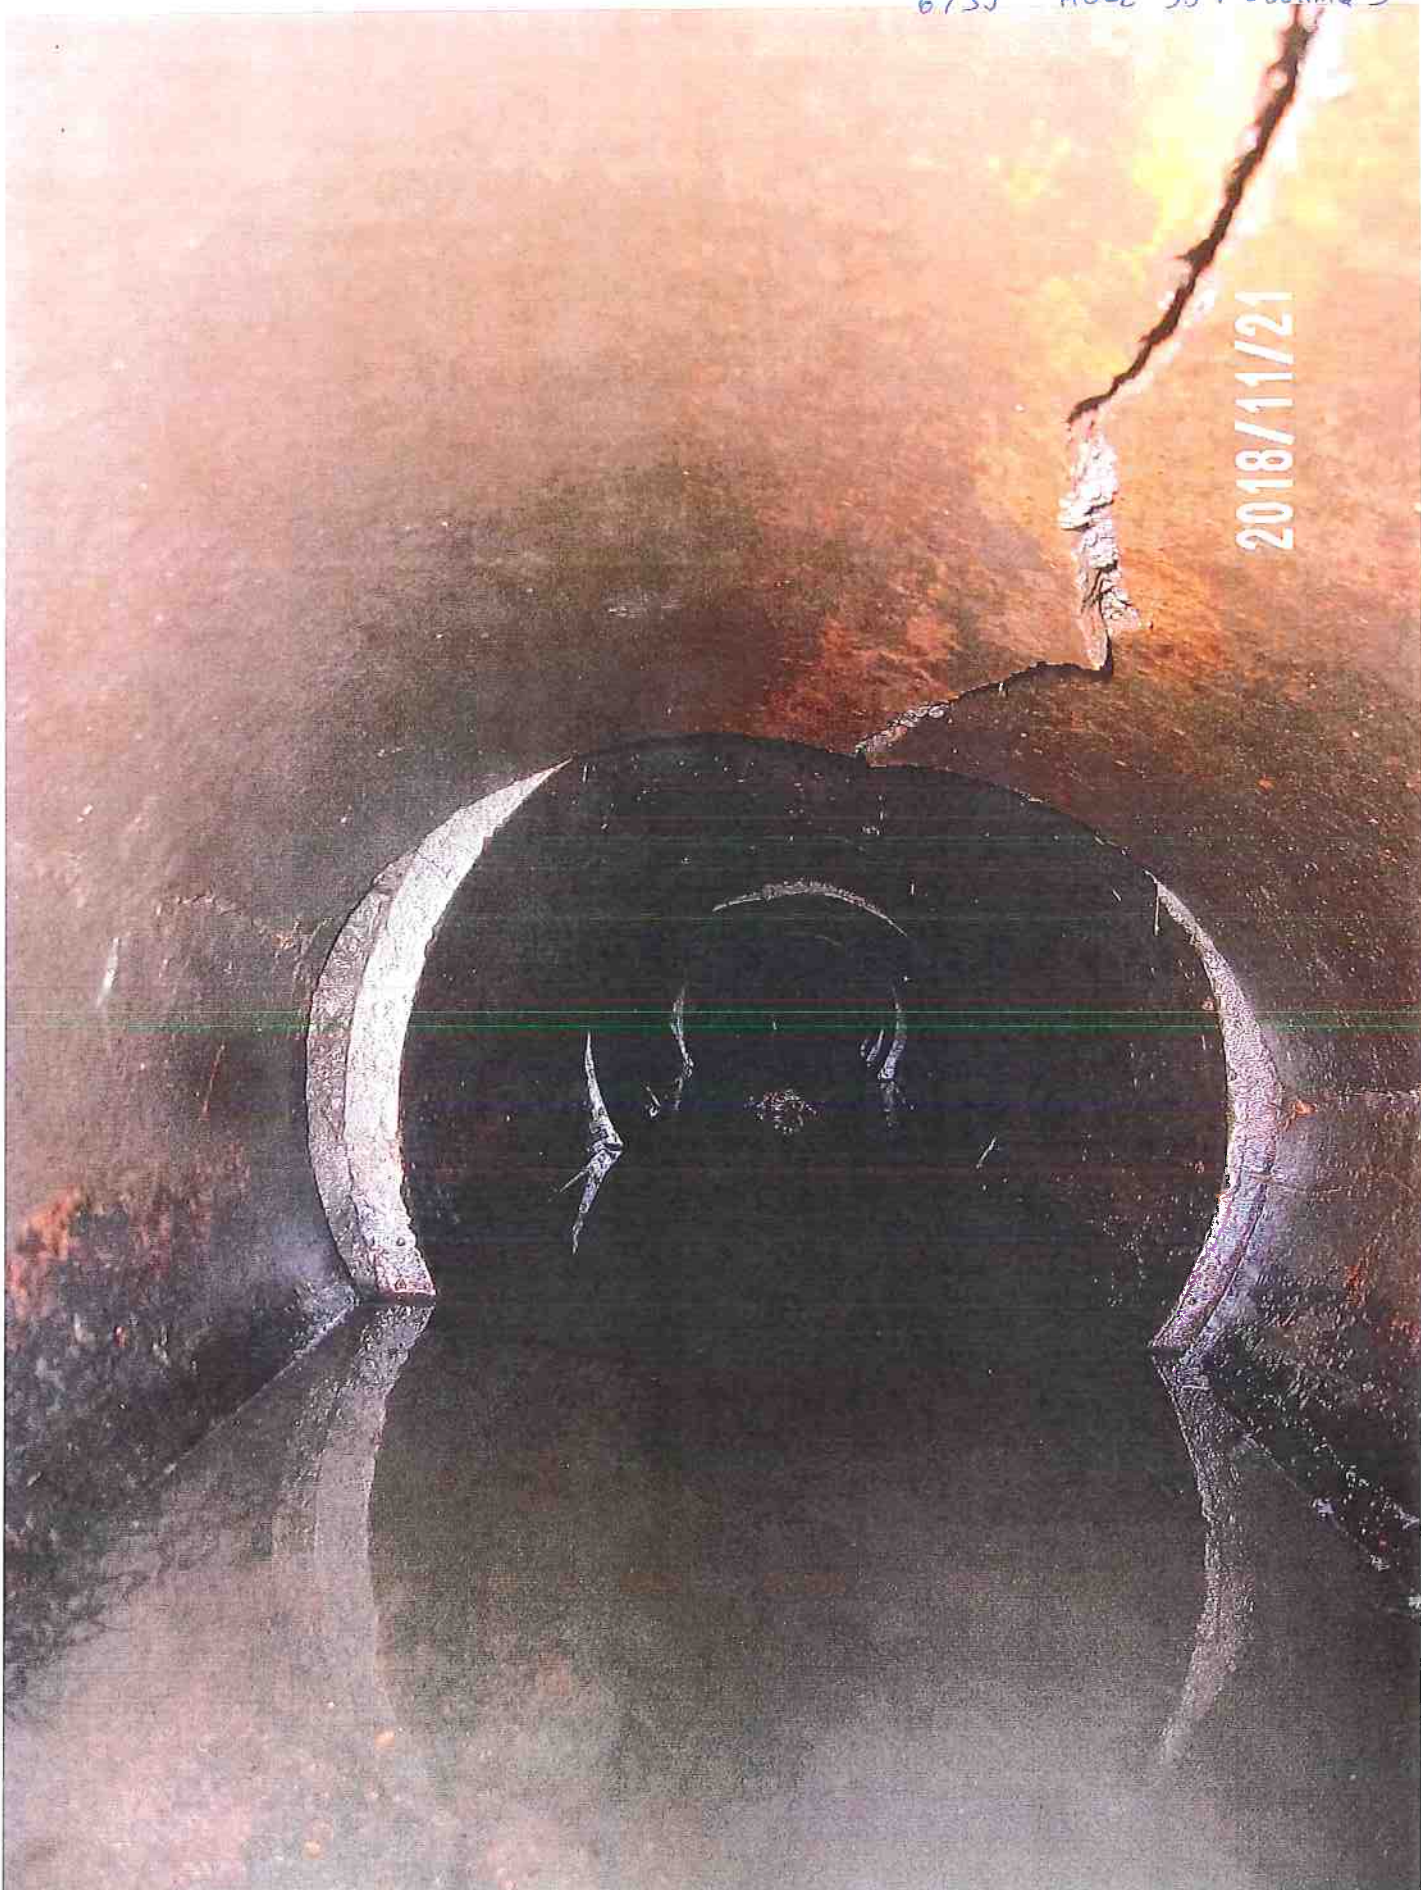
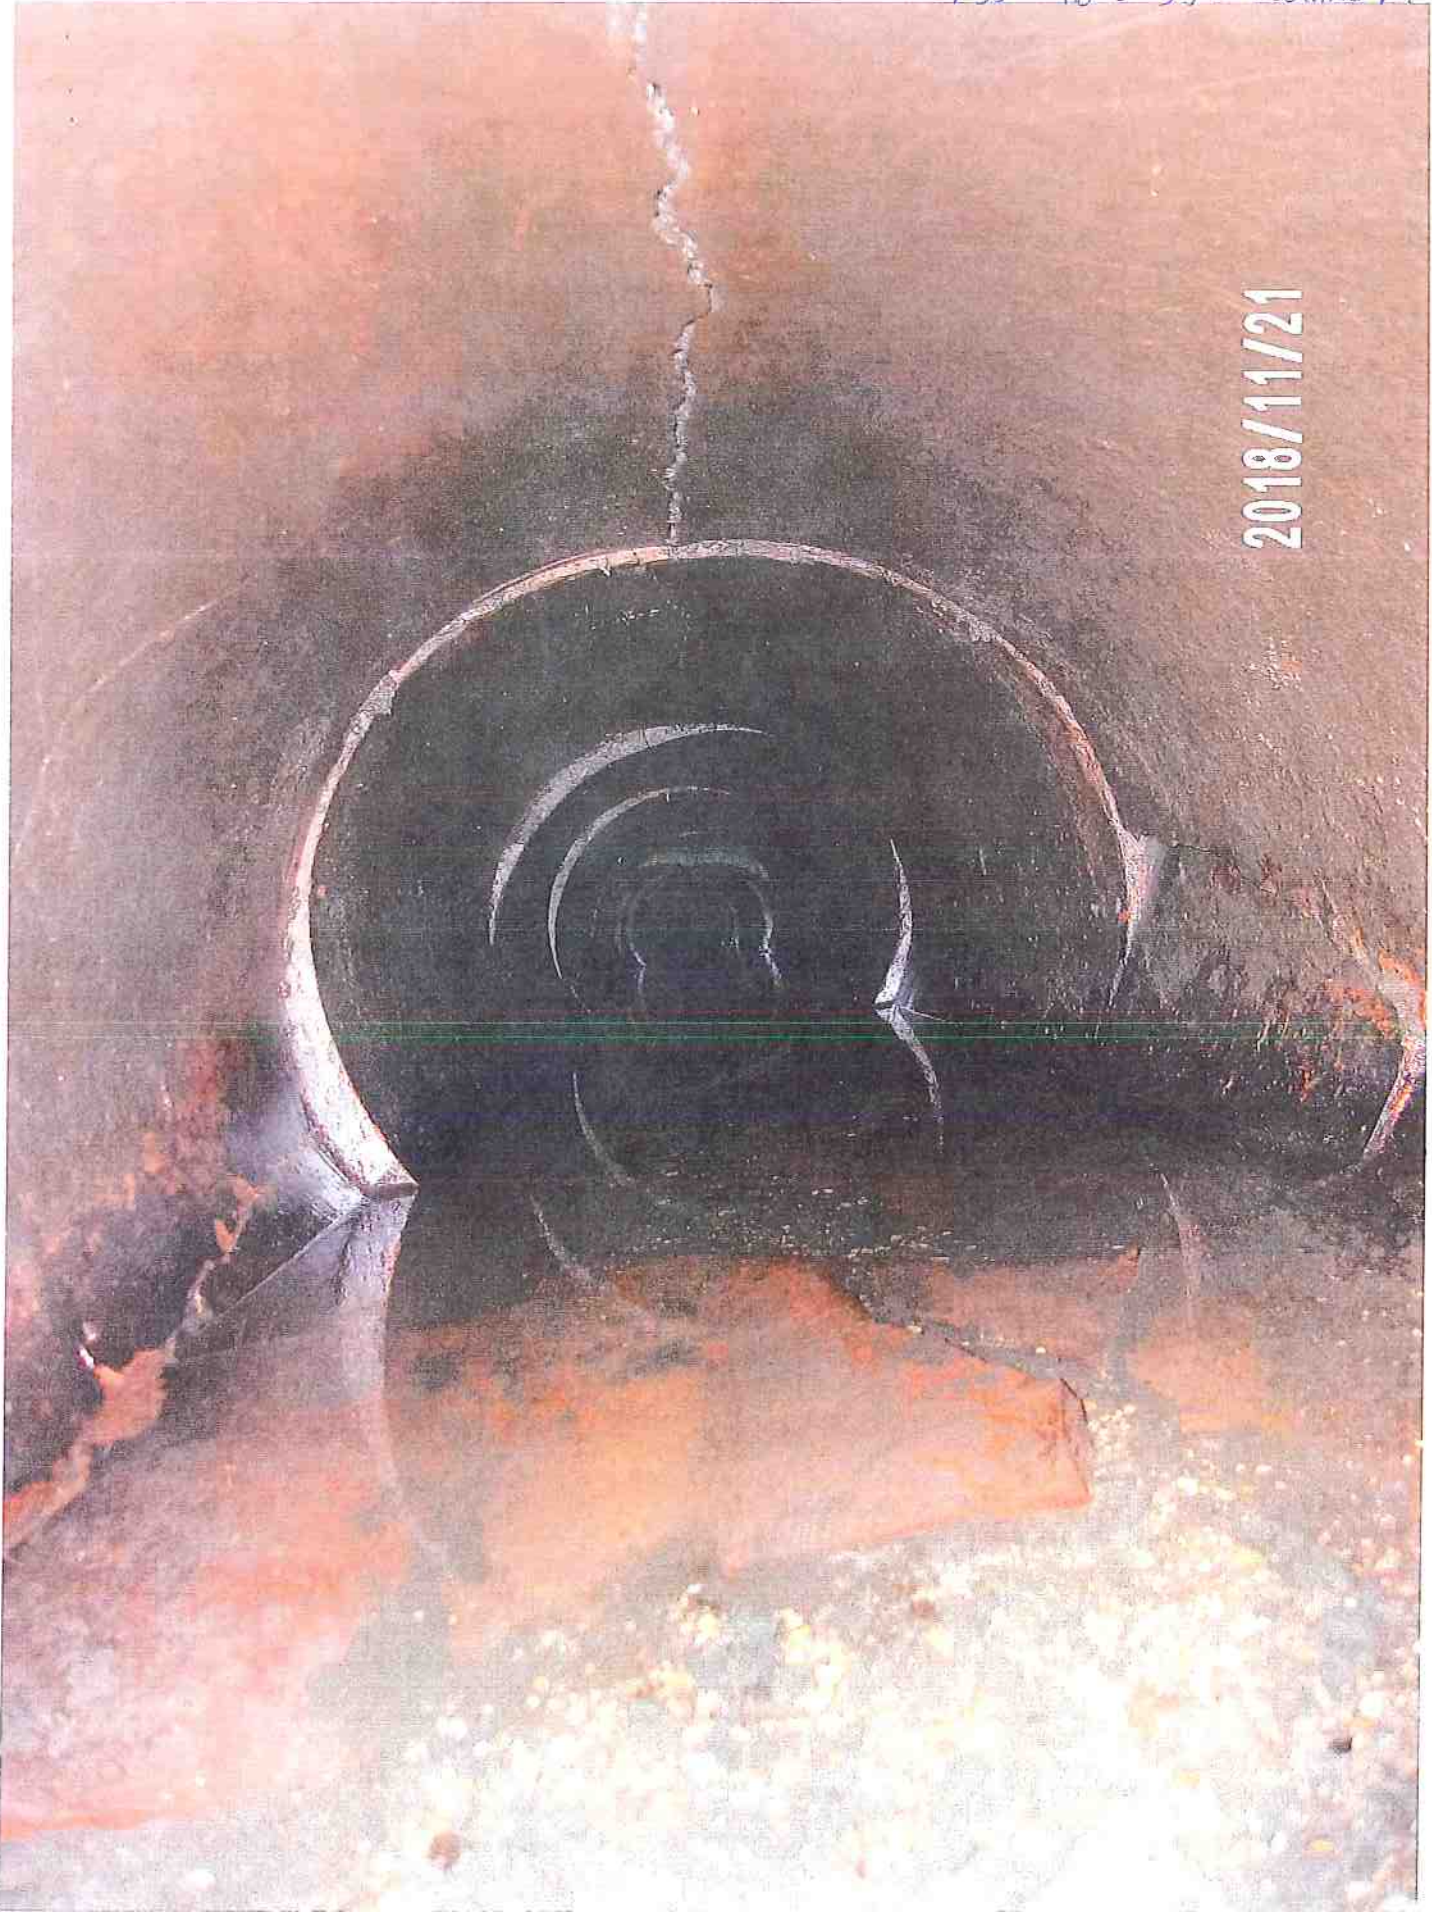
10:45 OPENED HOLE #354 CONTRACTOR BROKE 1 PIECE OF TILE W/ BACK HOE BOTH TILE UP & DOWN STREAM HAVE MULTIPLE LATERAL CRACKS TILE IS FLOWING 3"-4" CLEAN WATER LOCATED TO THE OPEN TILE @ #344

1:30 P.M. WENT TO HOLE #354 WITH BROKEN CLAY TILE. TOOK OUT 75" OF BROKEN CLAY TILE AND REPAIRED IT WITH 15" DUAL WALL HDPE AND FABRIC JOINTS (6'3")

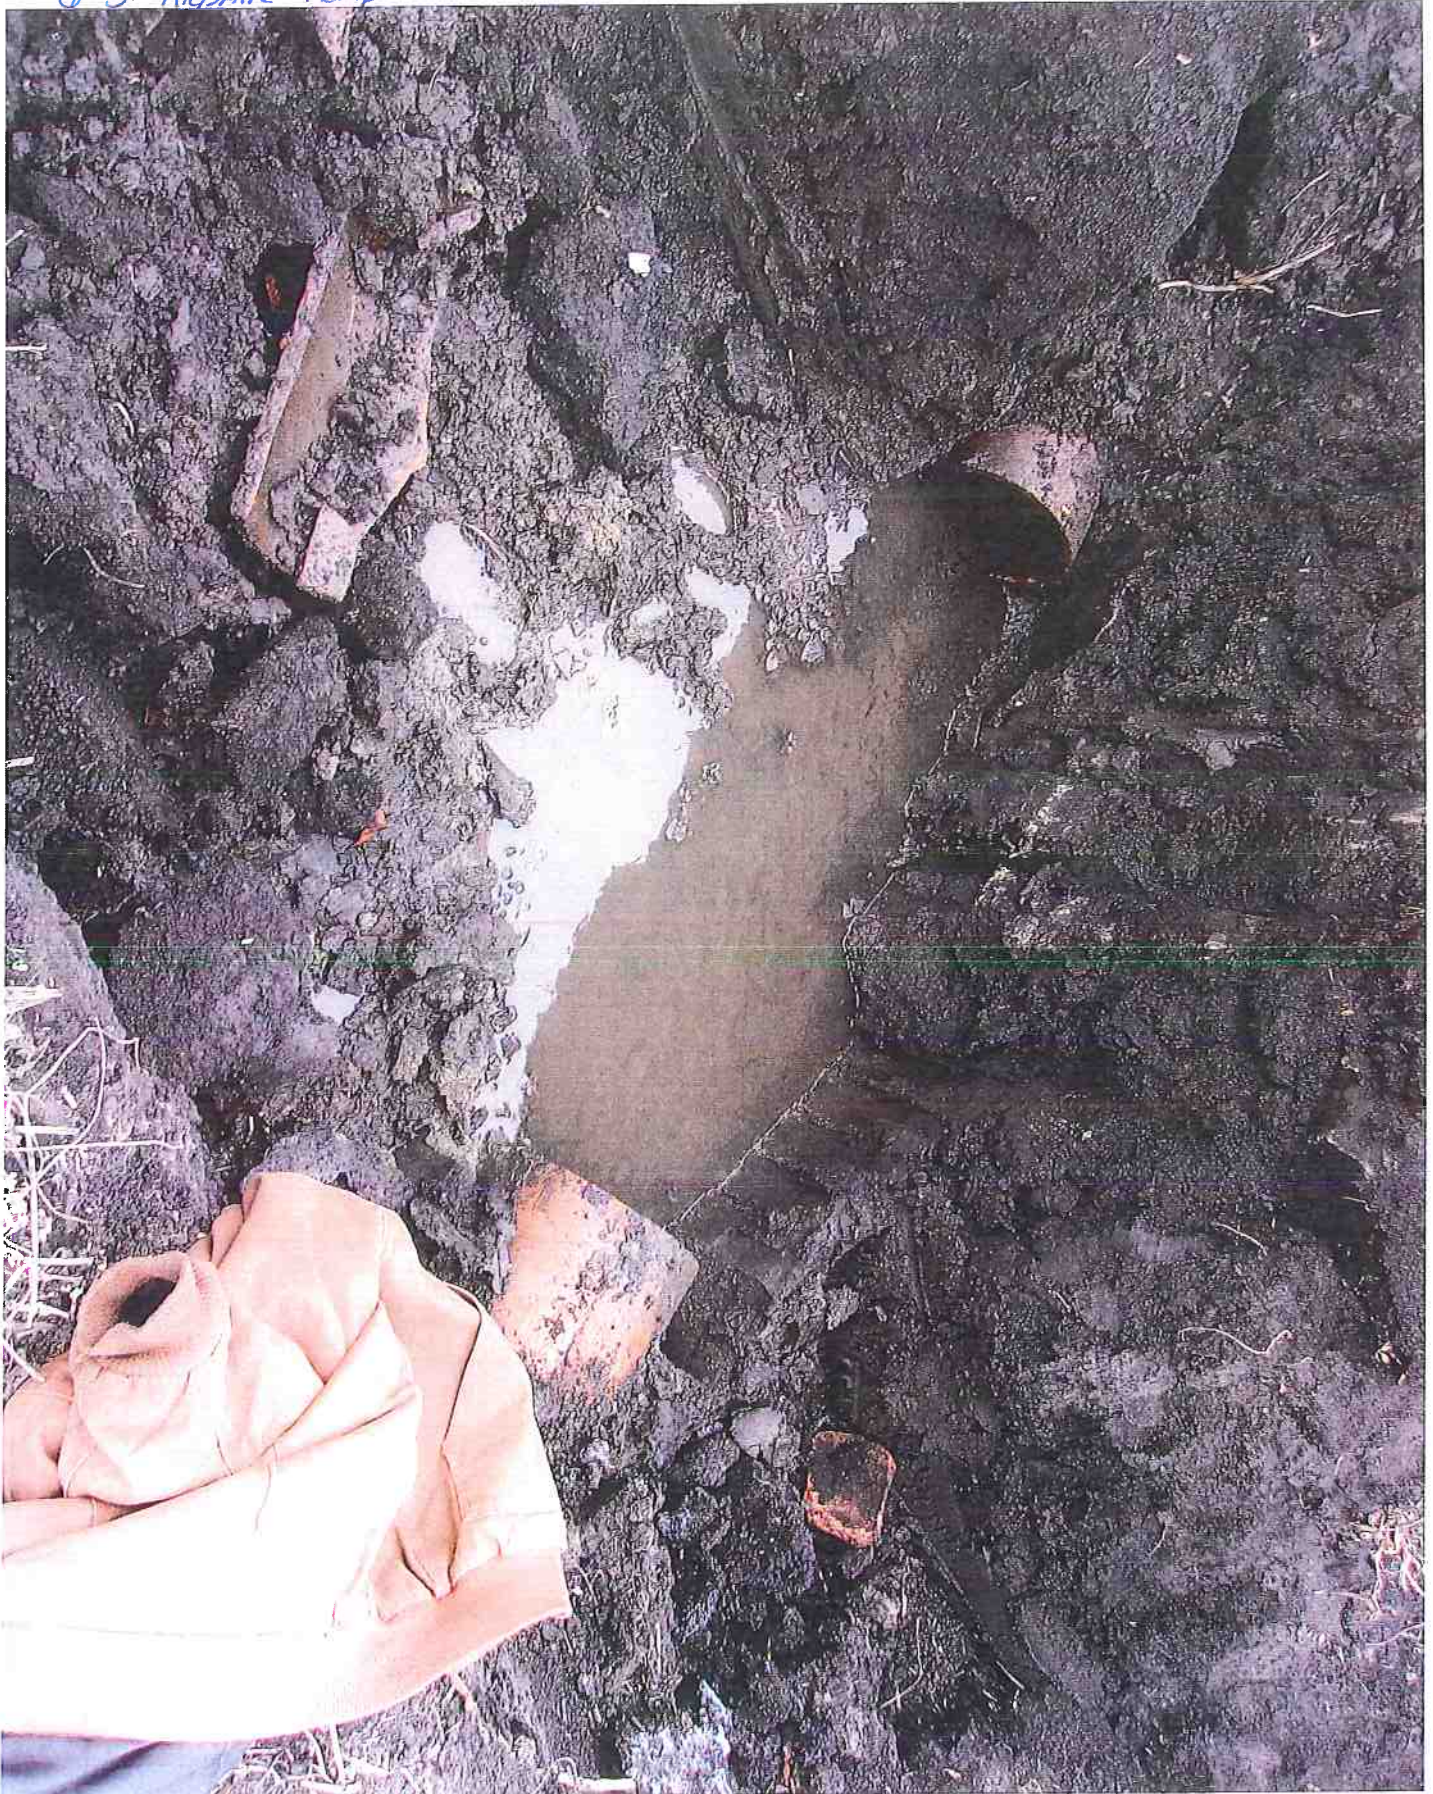
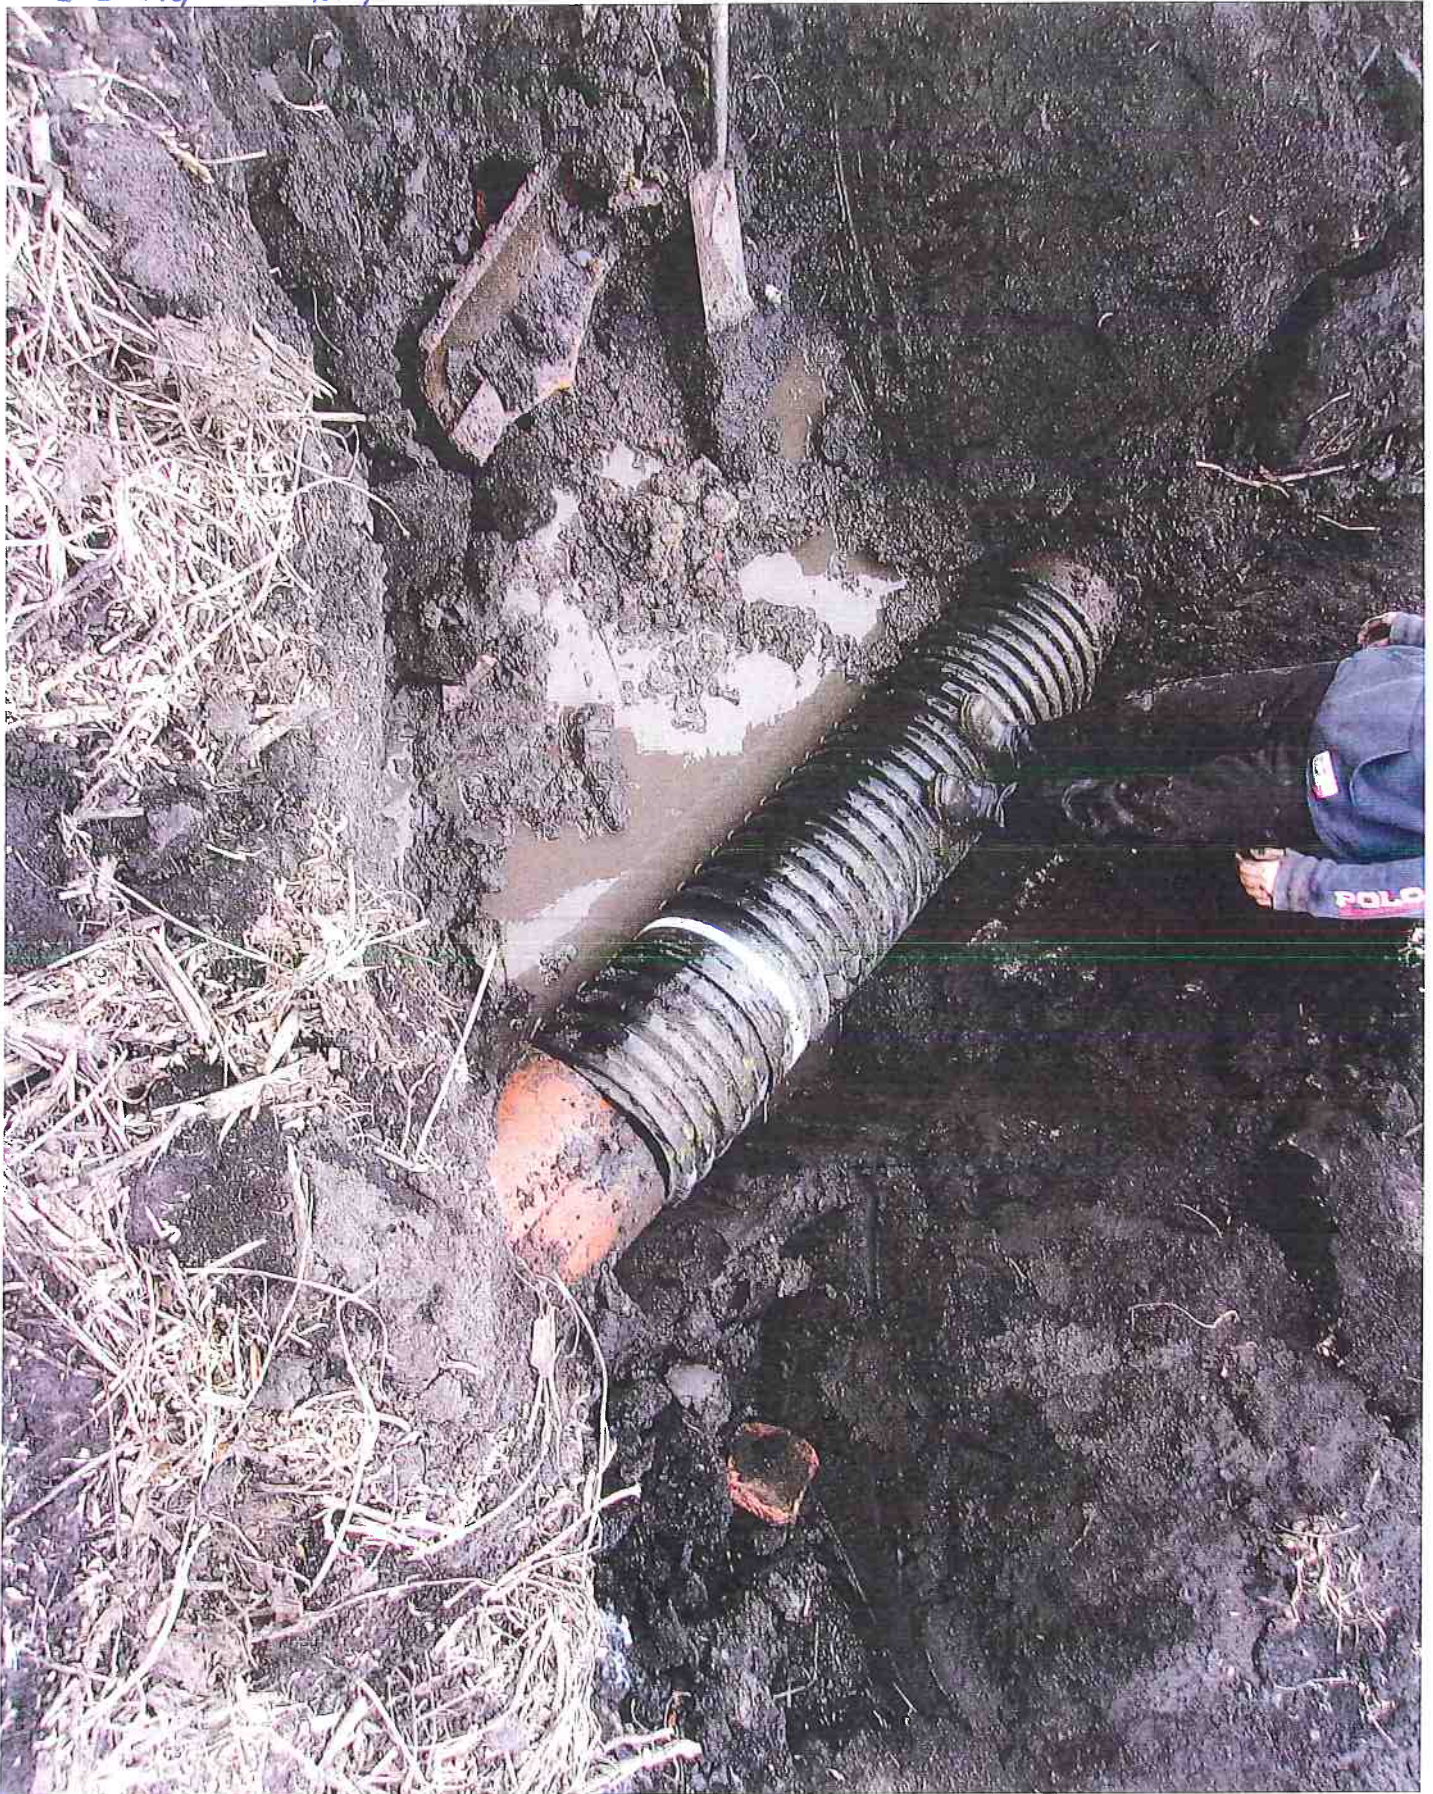
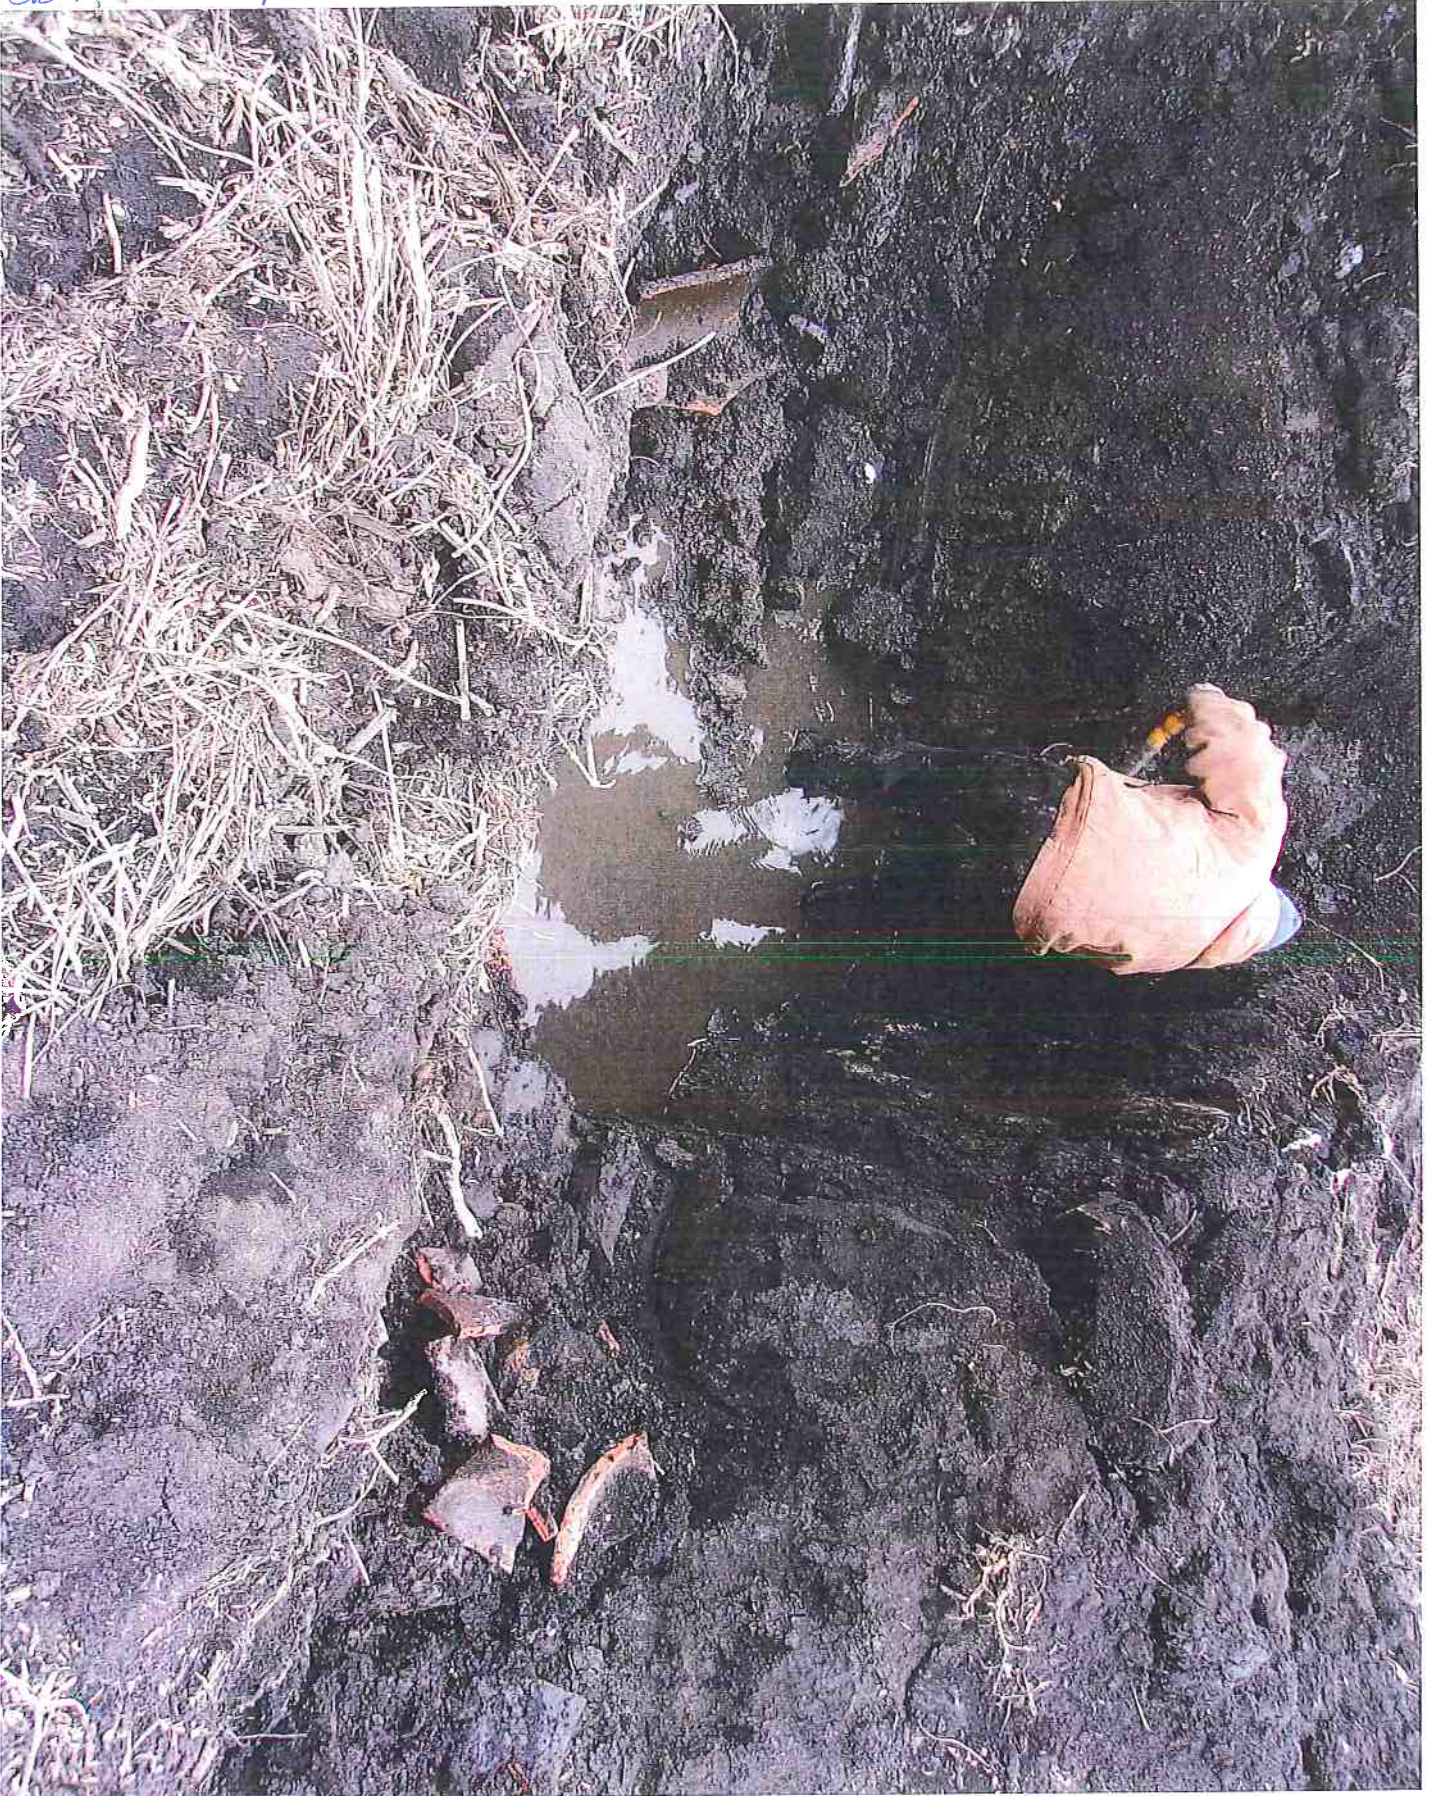
6' 3" Repair Temp
