**HARDIN COUNTY, IOWA**

**ENGINEER'S REPORT  
ON REPAIRS OR  
IMPROVEMENTS TO  
MAIN TILE  
DRAINAGE DISTRICT  
NO. 9  
HARDIN COUNTY,  
IOWA**

**Engineer's Report on Repairs or Improvements  
to Main Tile, Drainage District No. 9  
Hardin County, Iowa**

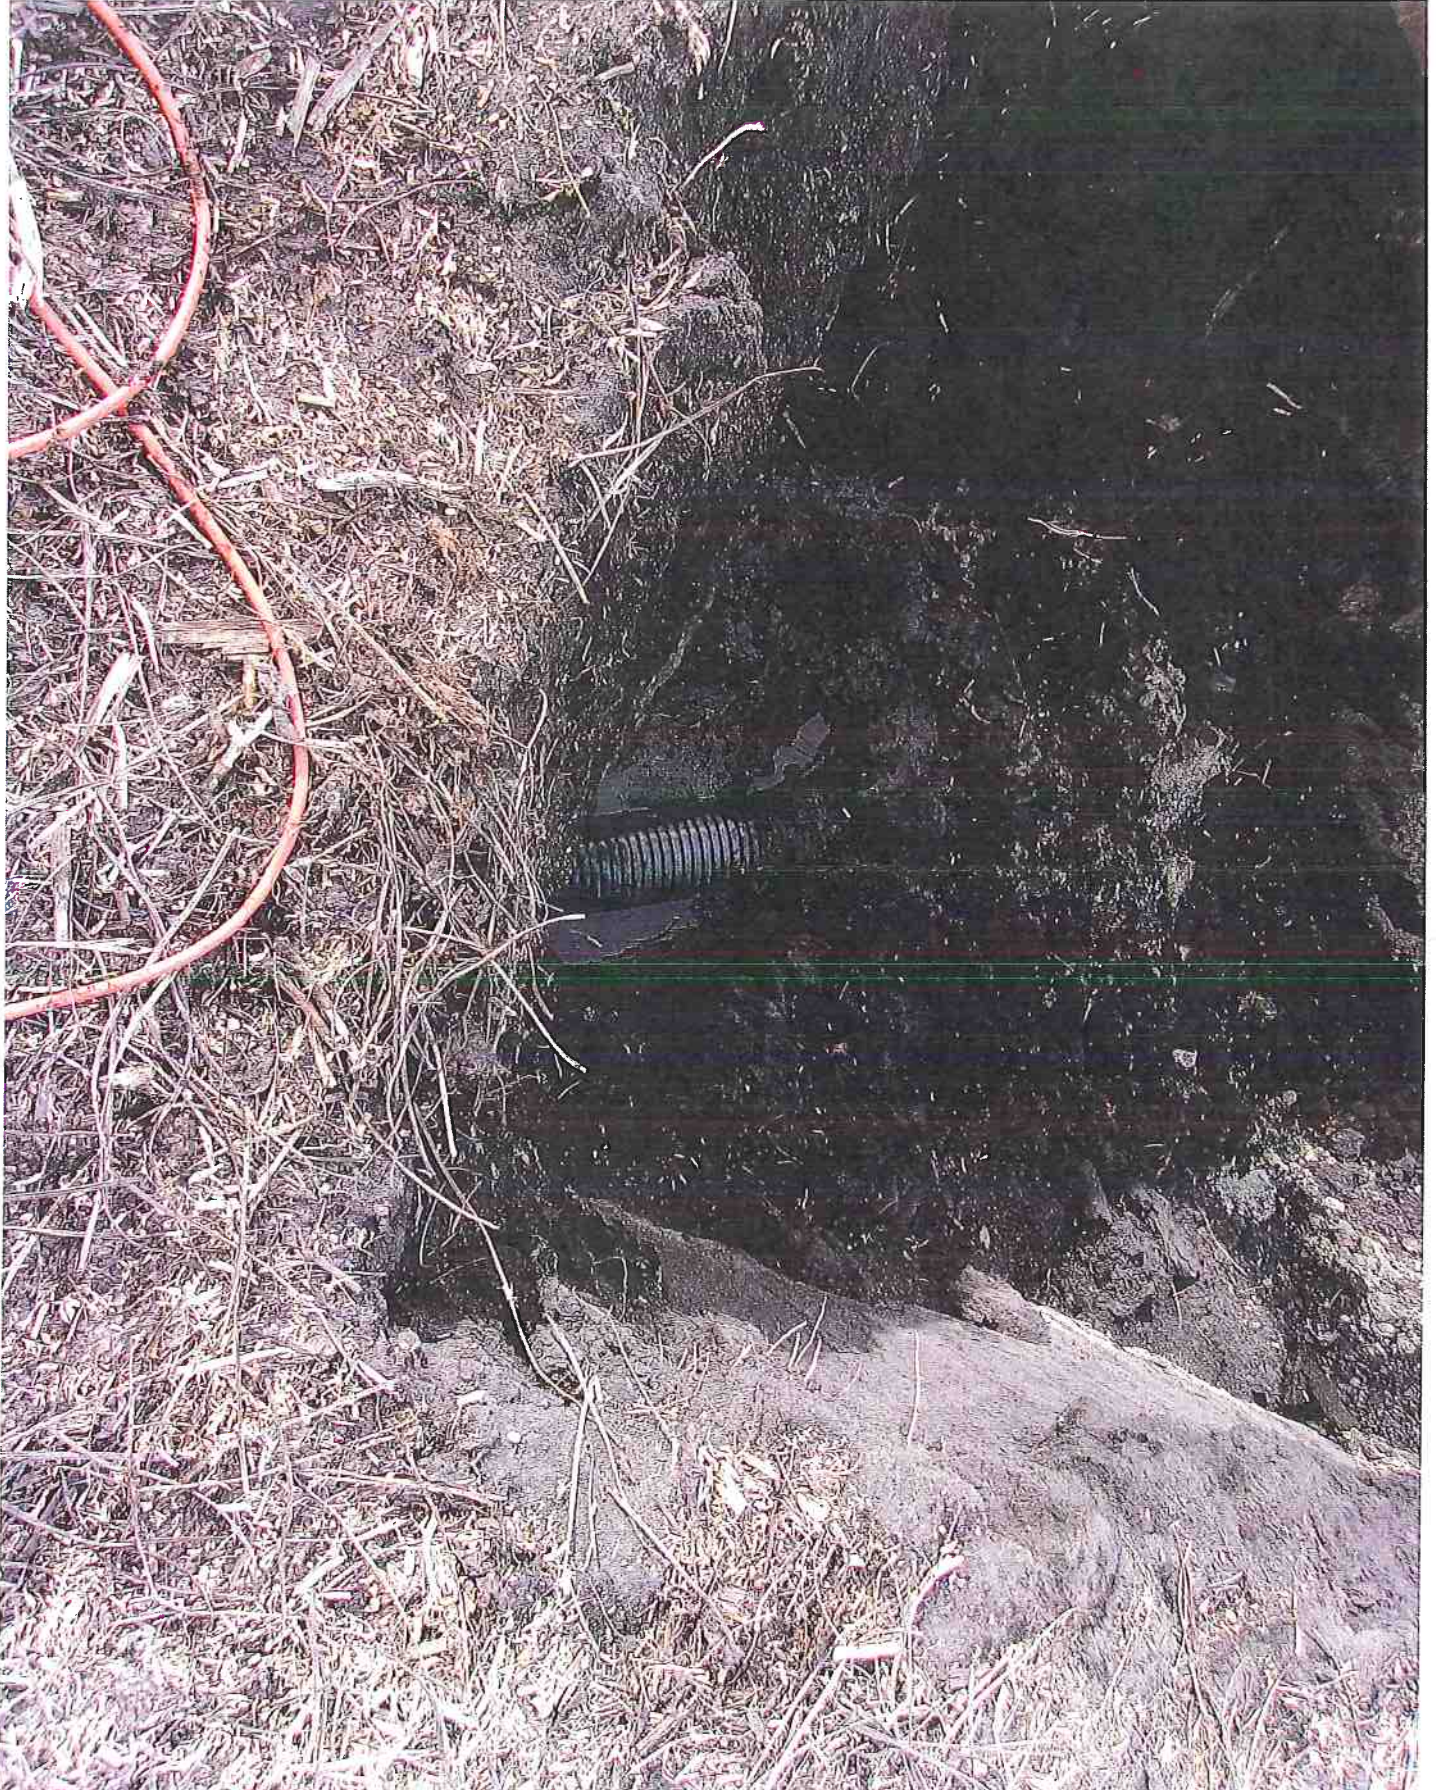
PRIVATE TIE REPAIR ● 5" IPE WITH 6" HOPE OVER TOP

12:15 P.M., RANDY AND NICK SHOWS UP WITH PARTS TO REPAIR 4" PLASTIC TILE ACCIDENTALLY HACKED DURING EXPLORATION DIG @ #321. BUT IT'S A 5", RANDY WENT BACK TO GET PARTS FOR A 5", CAN'T FIND ANY. USED A 2' PIECE OF 6" DUAL WALL SLIP OVER THE 5" SINGLE WALL TIGHT FIT WITH FABRIC OVER. THEY ALSO PUT A CHUNK OF DUAL WALL AND FABRIC OVER INSPECTION HOLE AND BACKFILLED. PILES OF DIRT ARE FROZEN, 1' THICK. HARD TO BACKFILL.

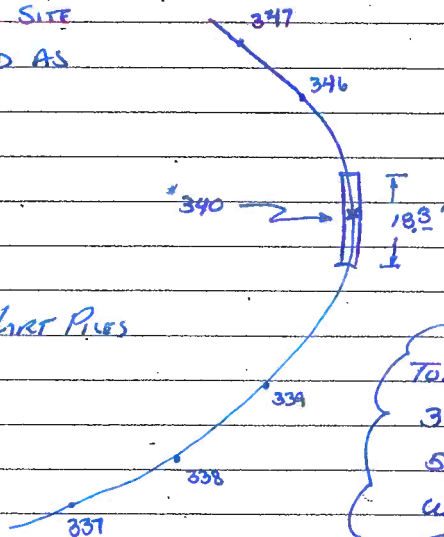
WILL NEED TO PUSH FROZEN DIRT PILES IN WHEN THAWED OUT.

FURTHER ACTION NEEDED

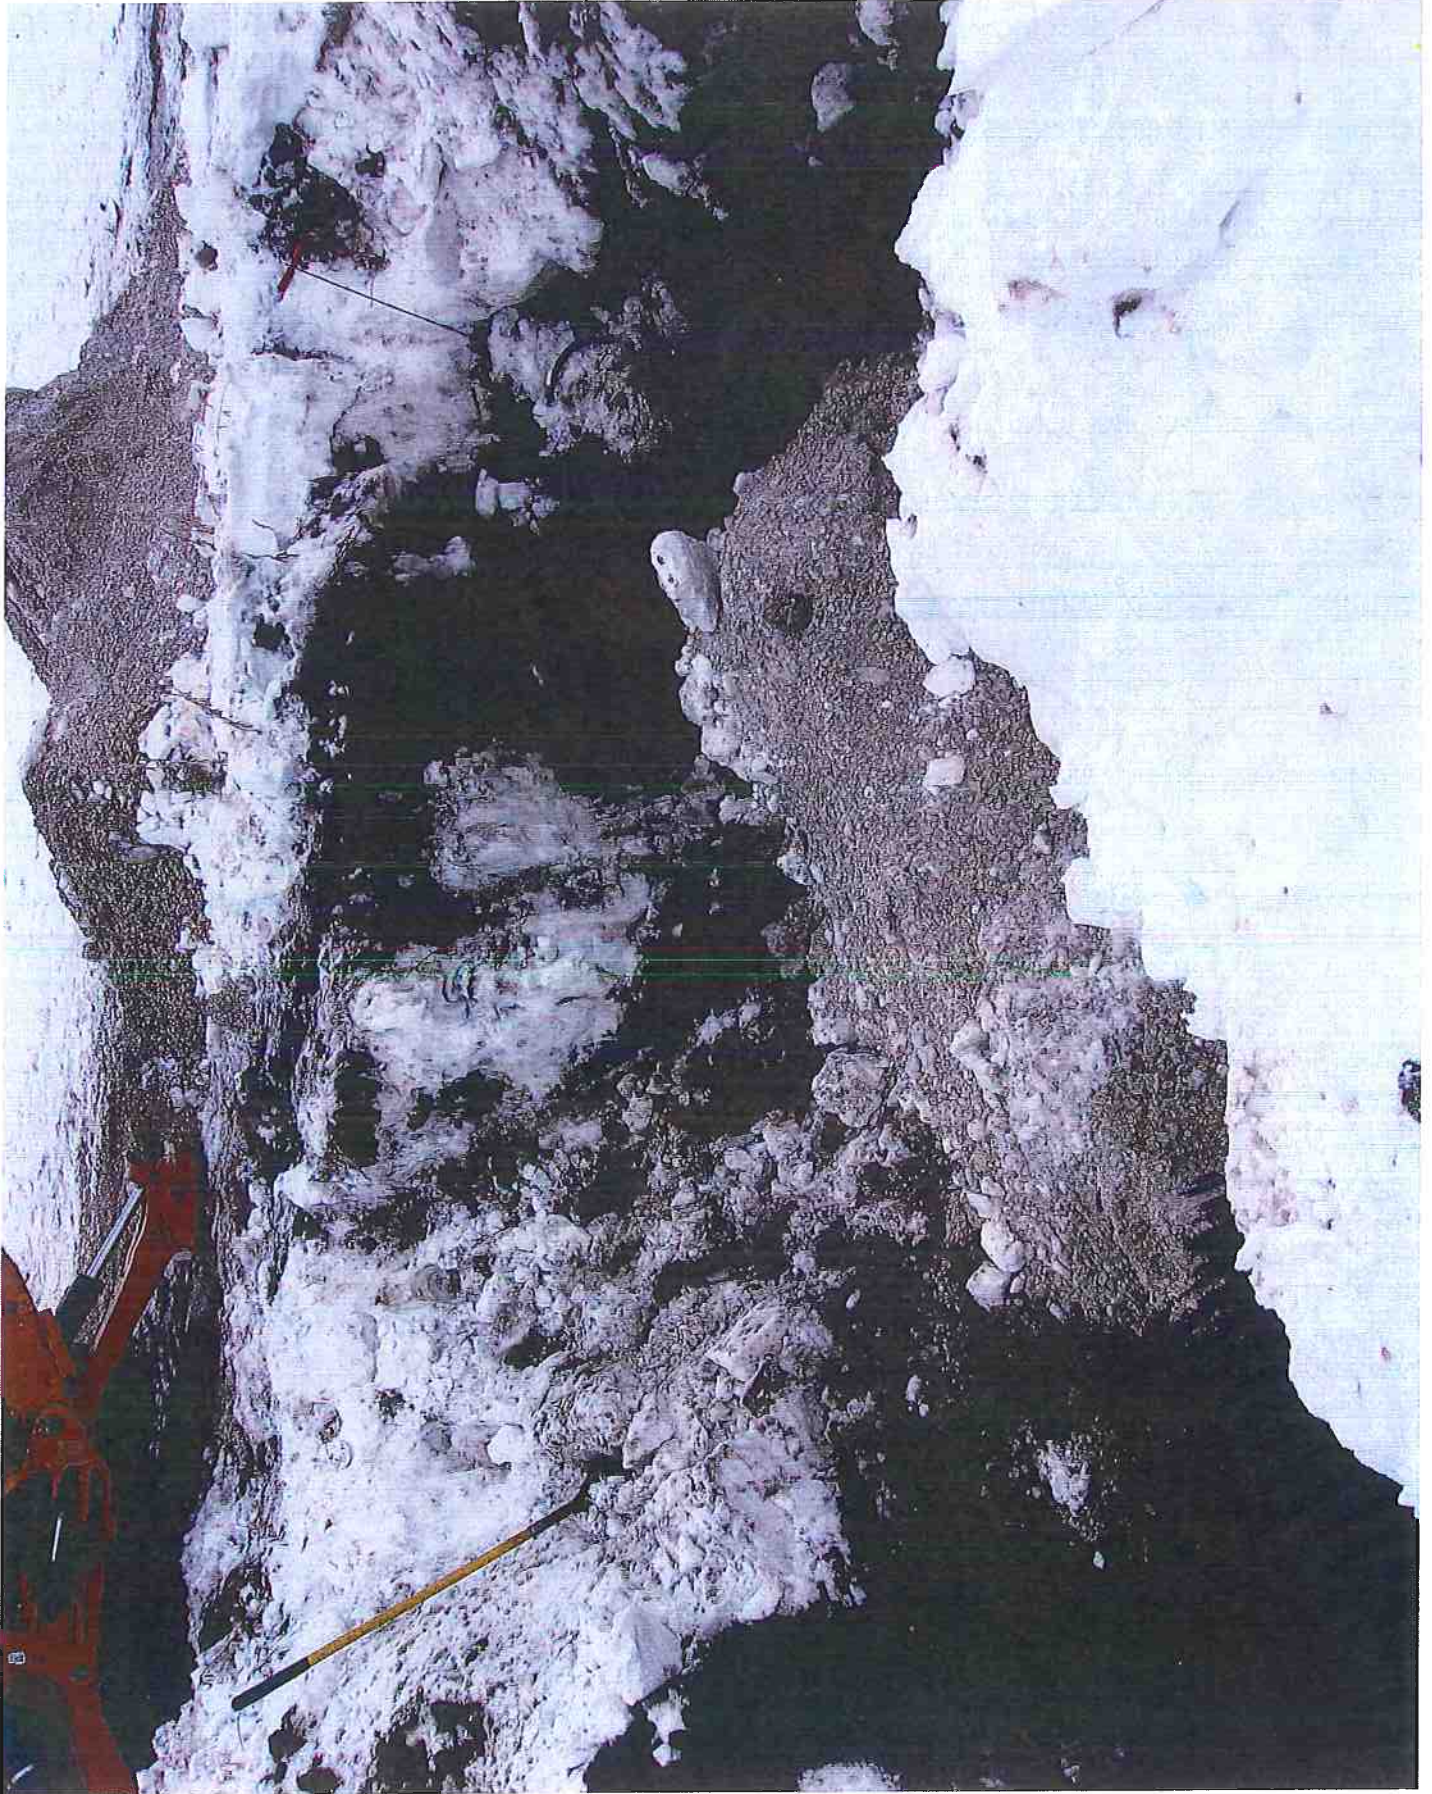
PLACING ROCK AROUND 15" HDPE

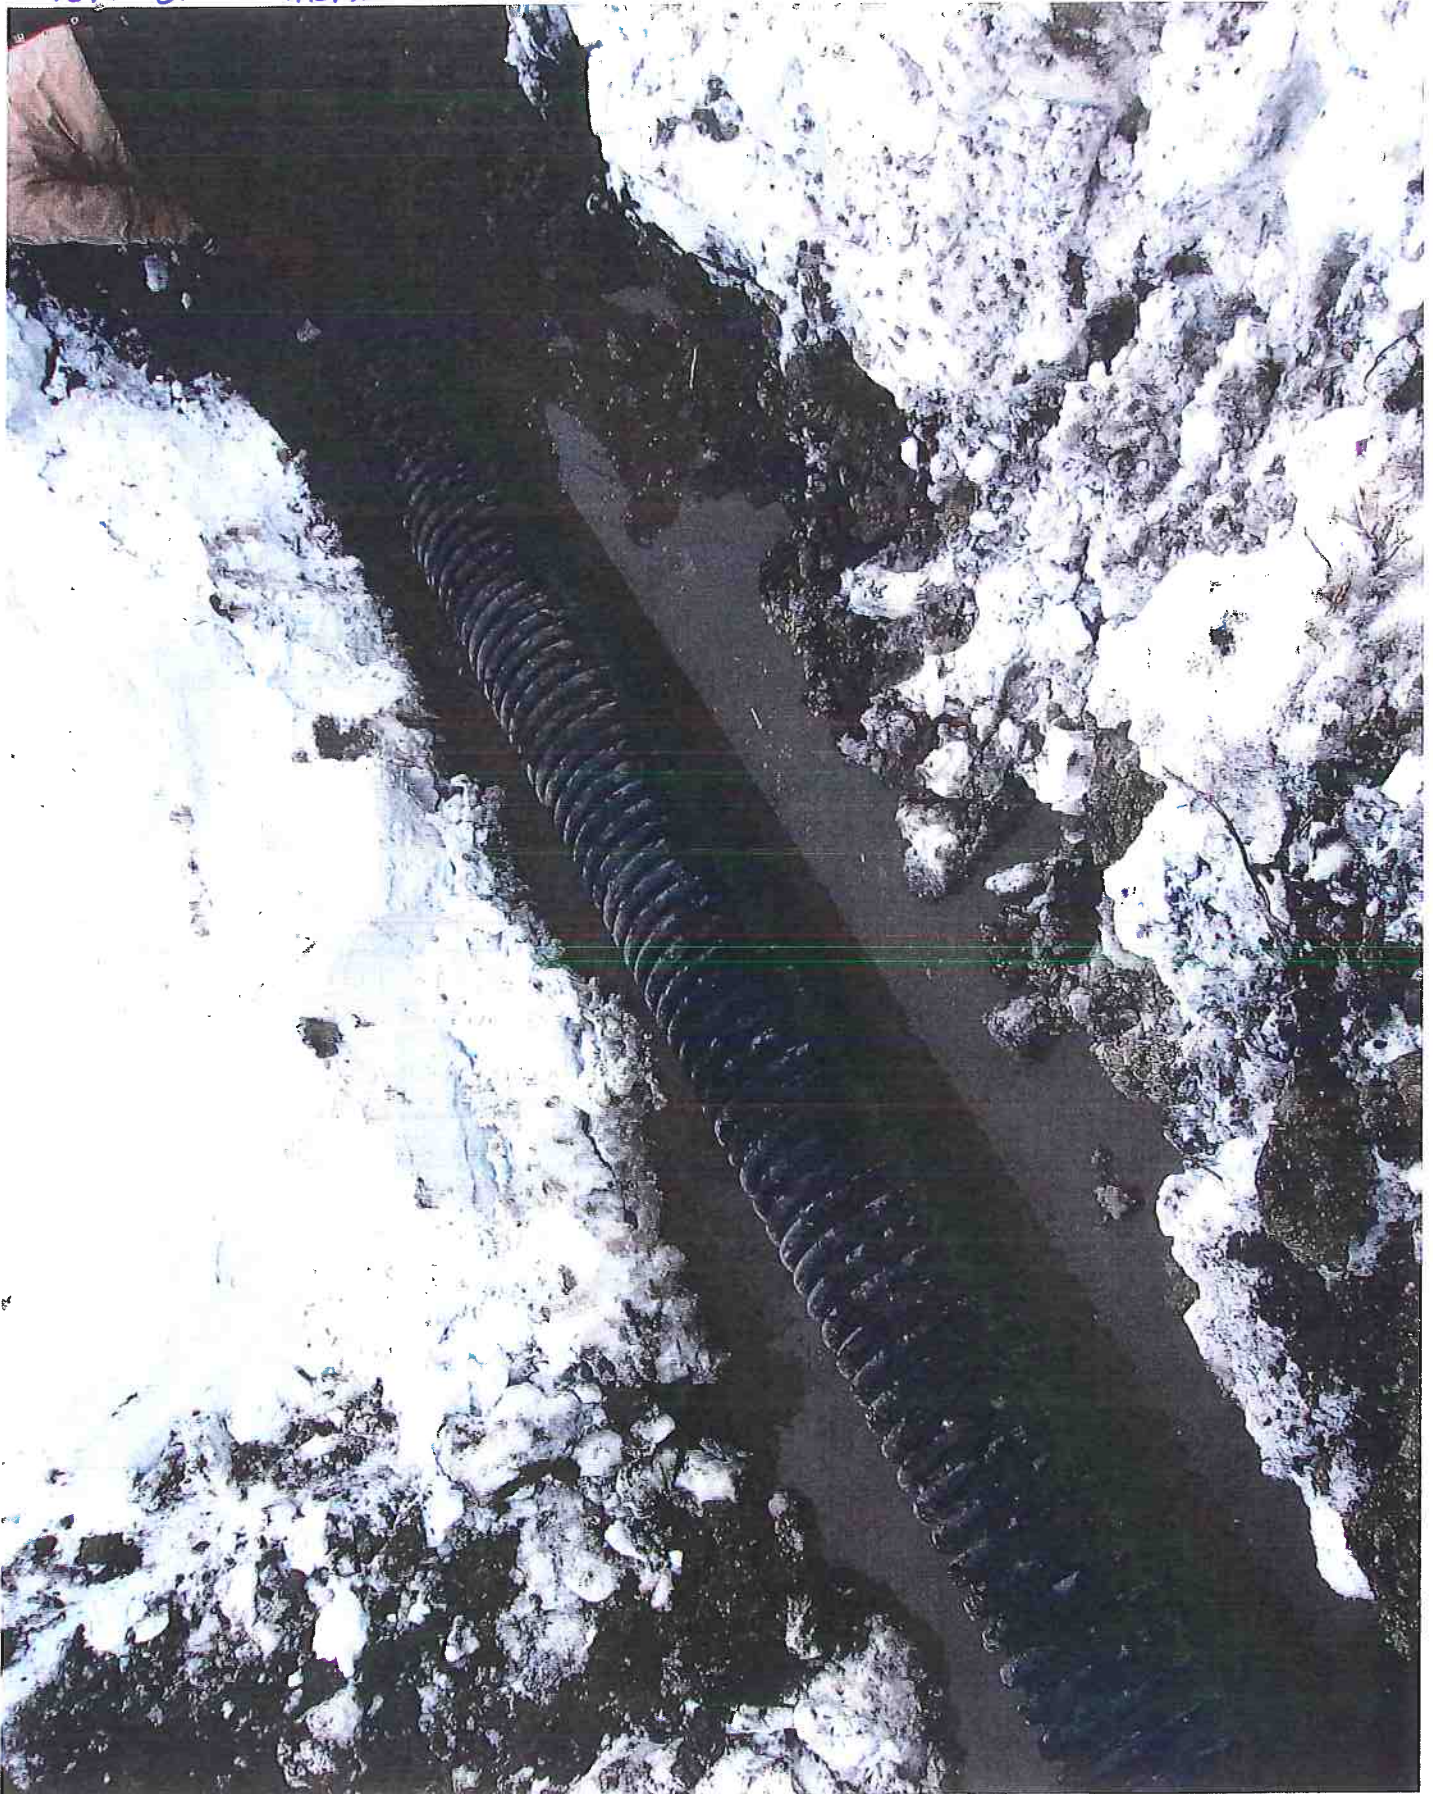
18.3' OF 15" HDPE DUAL WALL

TOTAL FOR TODAY 3/8/19  
3 MEN + BACKHOE = 5 HRS.  
5 TON 1" CLEAN ROCK  
WIRE MESH  
FABRIC  
18.3' OF OVAL WALL 15" HOPE  
12 BAGS CONC.
