9

## Repair Summary:

**DRAINAGE DISTRICT #9**  
 HARDIN, IOWA

**SPOT REPAIRS**

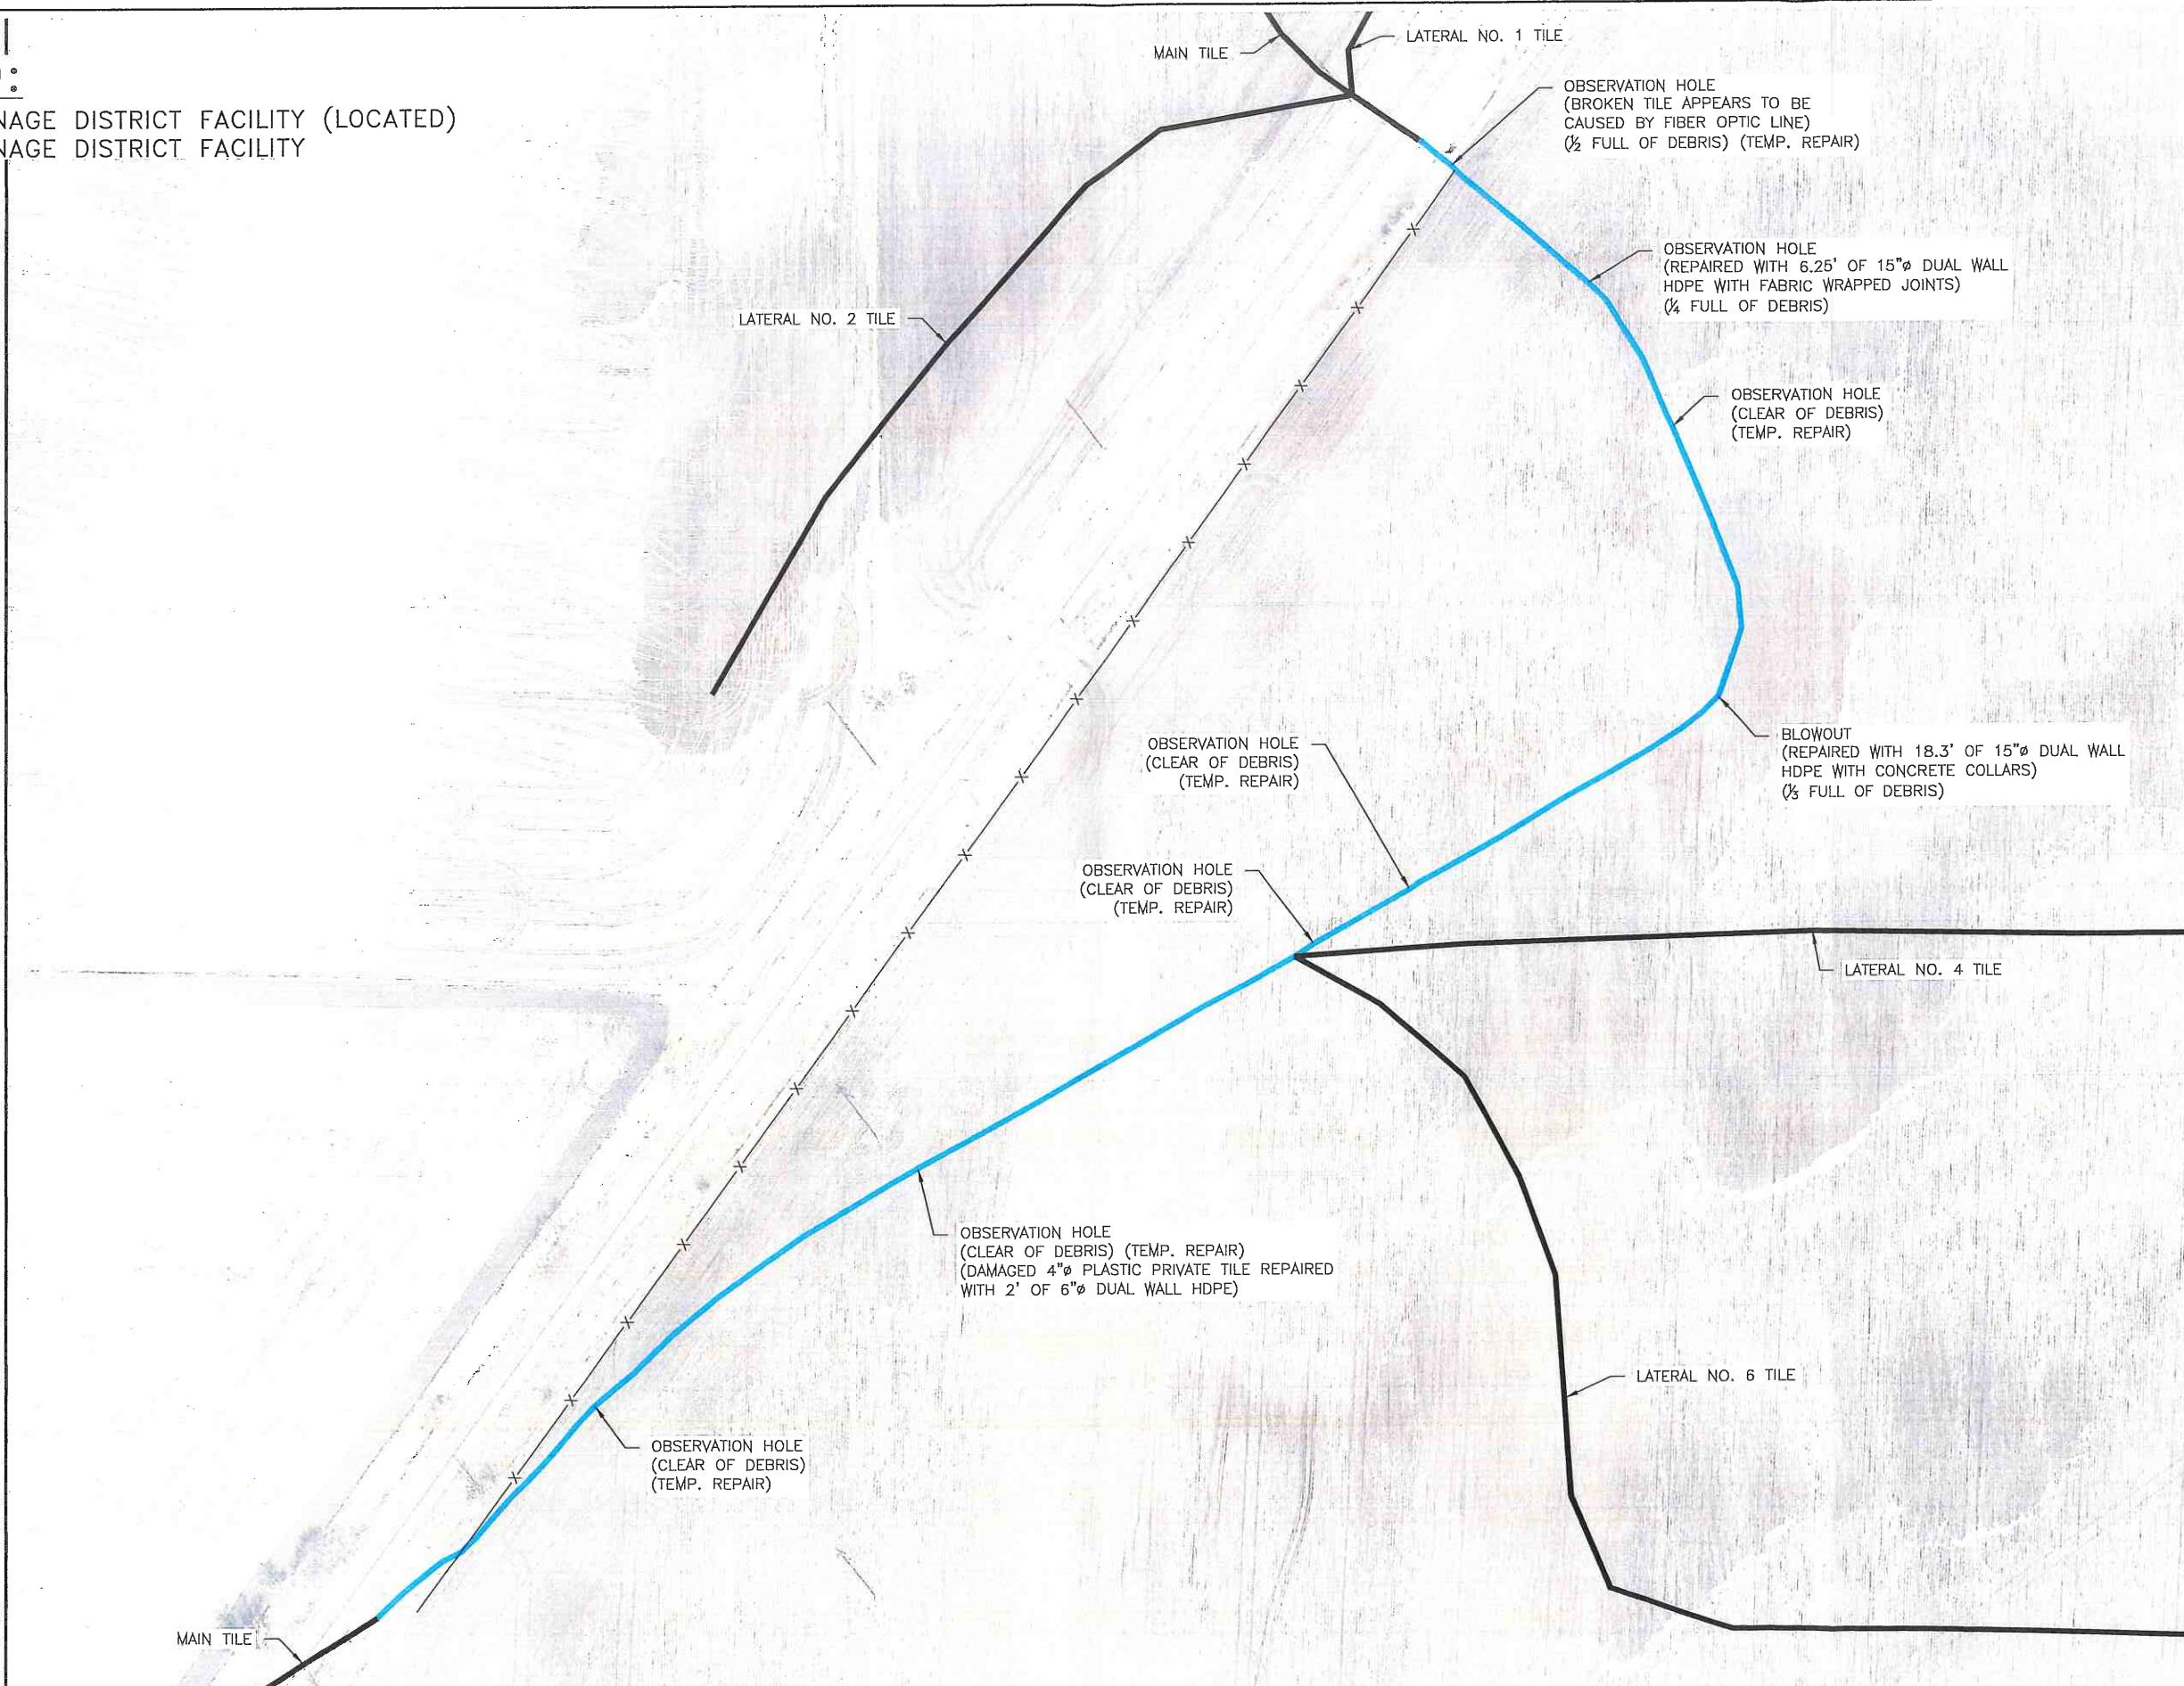
- Tenant in SW¼ Section 6, Township 89 North, Range 22 West reported two blowouts/sinkholes on Main tile.
- Visually searched area and found one blowout/sinkhole, approximately 225 feet southeast of railroad right of way (see attached spot repair map).

- Upstream found broken VCP tile in sinkhole/blowout just downstream of railroad. The tile appears to have possibly been broken when fiber optic line was installed (see attached spot repair map).

The unrepaired broken tile in the railroad right of way is severely limiting the drainage upstream and will eventually cause additional blowouts/sinkholes and ponding. Moving forward, we would recommend abandoning the current railroad crossing, install a new crossing meeting Union Pacific Railroad standards/permits to restore the drainage to its original design or install a bypass tile on the north side of the railroad right of way. Based on either of these options, it is my opinion that the construction cost would be well over \$50,000. This cost is high enough that a hearing and engineering report would be required.

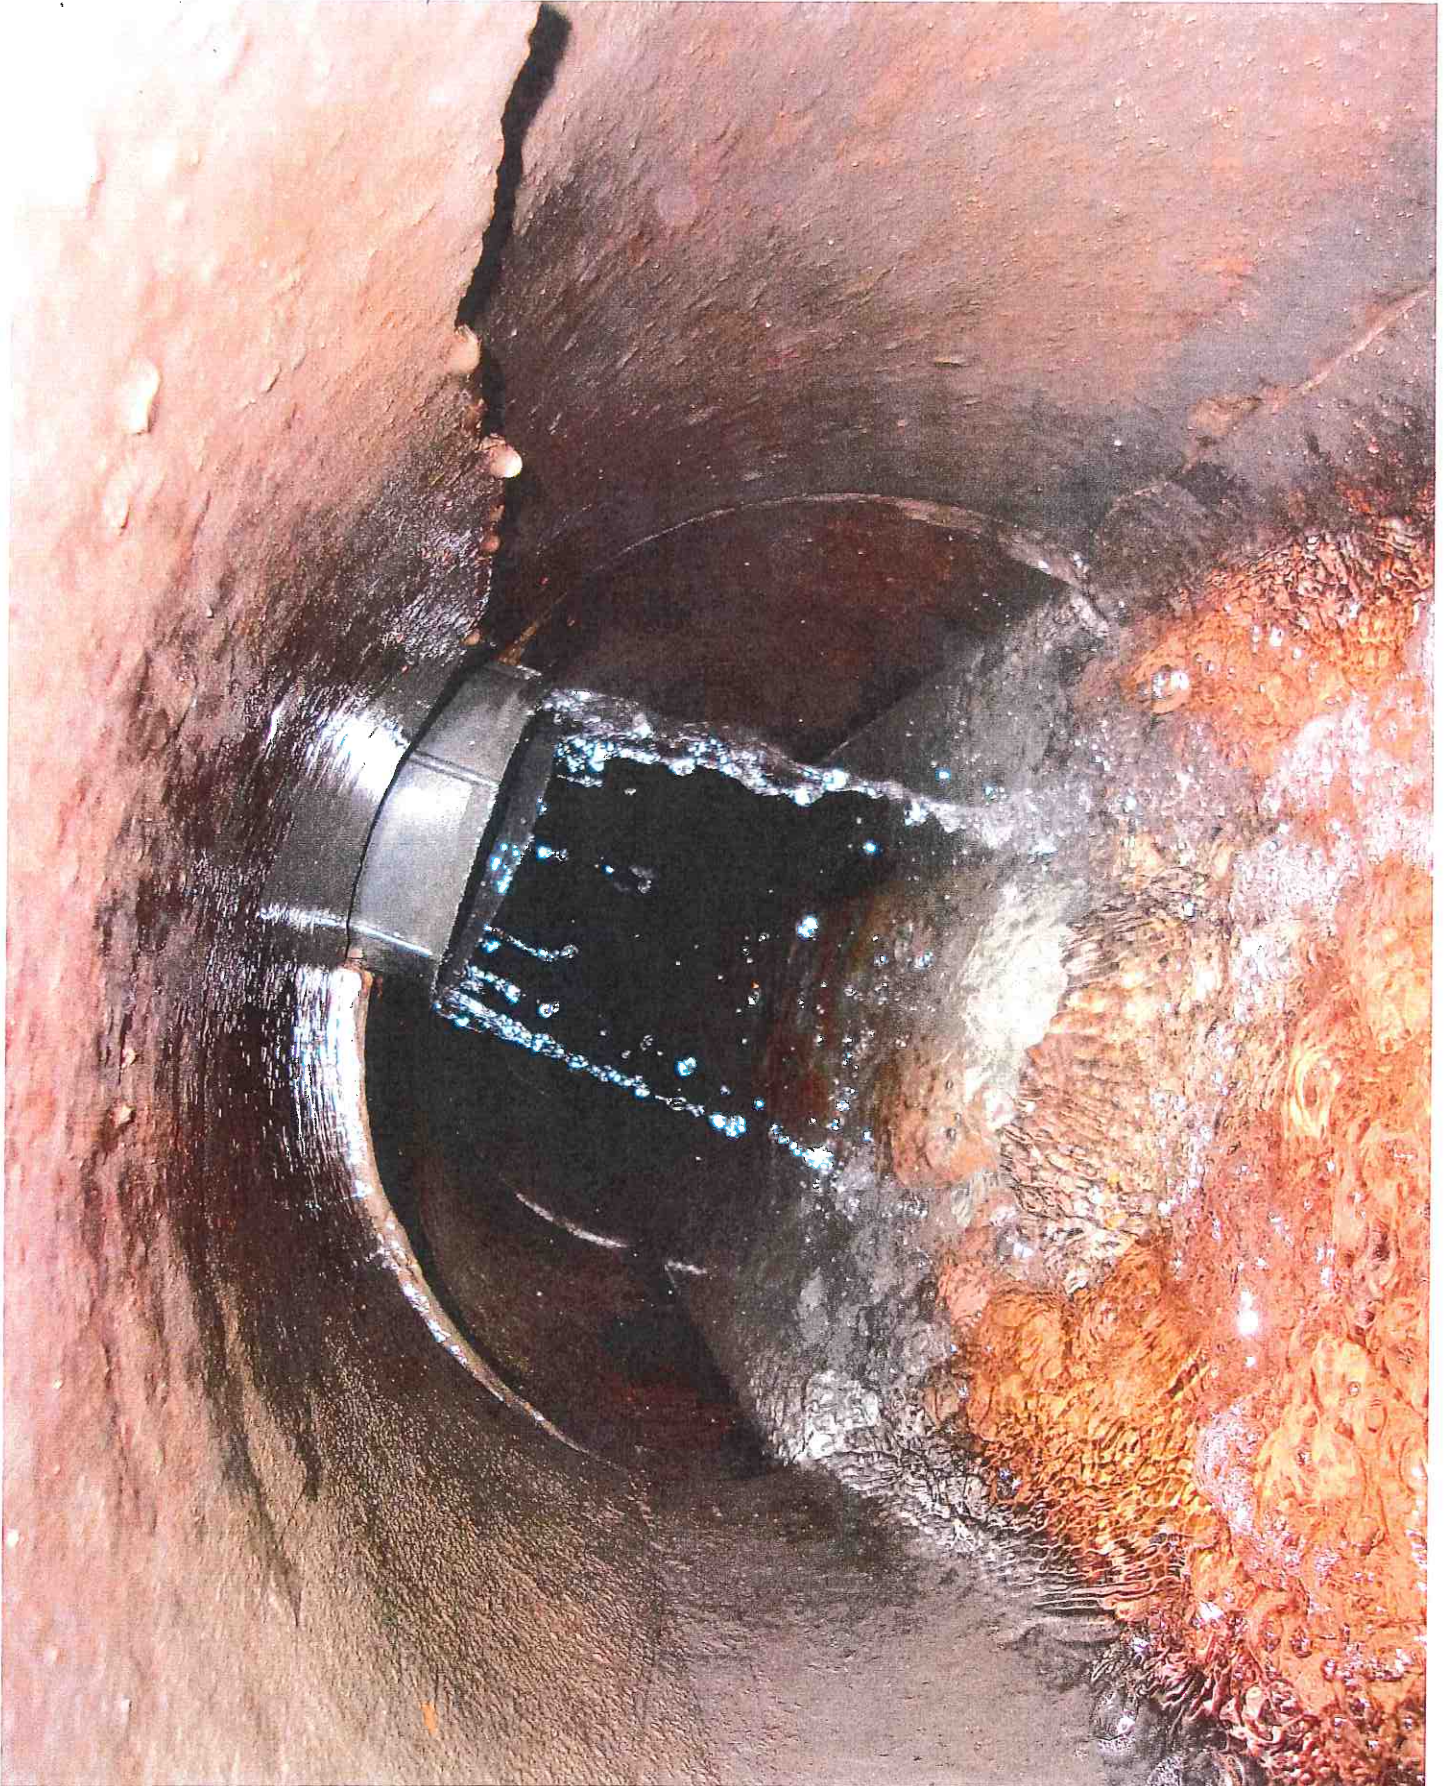
UPSTREAM FROM #321, HOOKED 4" PE WITH BUCKET, REPAIR WITH SNAP COUPLER

12:15 P.M., RANDY AND NICK SHOWS UP WITH PARTS TO REPAIR 4" PLASTIC TILE ACCIDENTALLY BROKEN DURING EXPLORATION DIG @ #321. BUT ITS A 5", RANDY WENT BACK TO GET PARTS FOR A 5", CAN'T FIND ANY. USED A 2' PIECE OF 6" DUAL WALL SHIP OVER THE 5" SINGLE WALL TIGHT FIT WITH FABRIC OVER. THEY ALSO PUT A CHUNK OF DUAL WALL AND FABRIC OVER INSPECTION HOLE AND BACK FILL. PILES OF DIRT ARE FROZEN, 1' THICK. HARD TO BACKFILL.

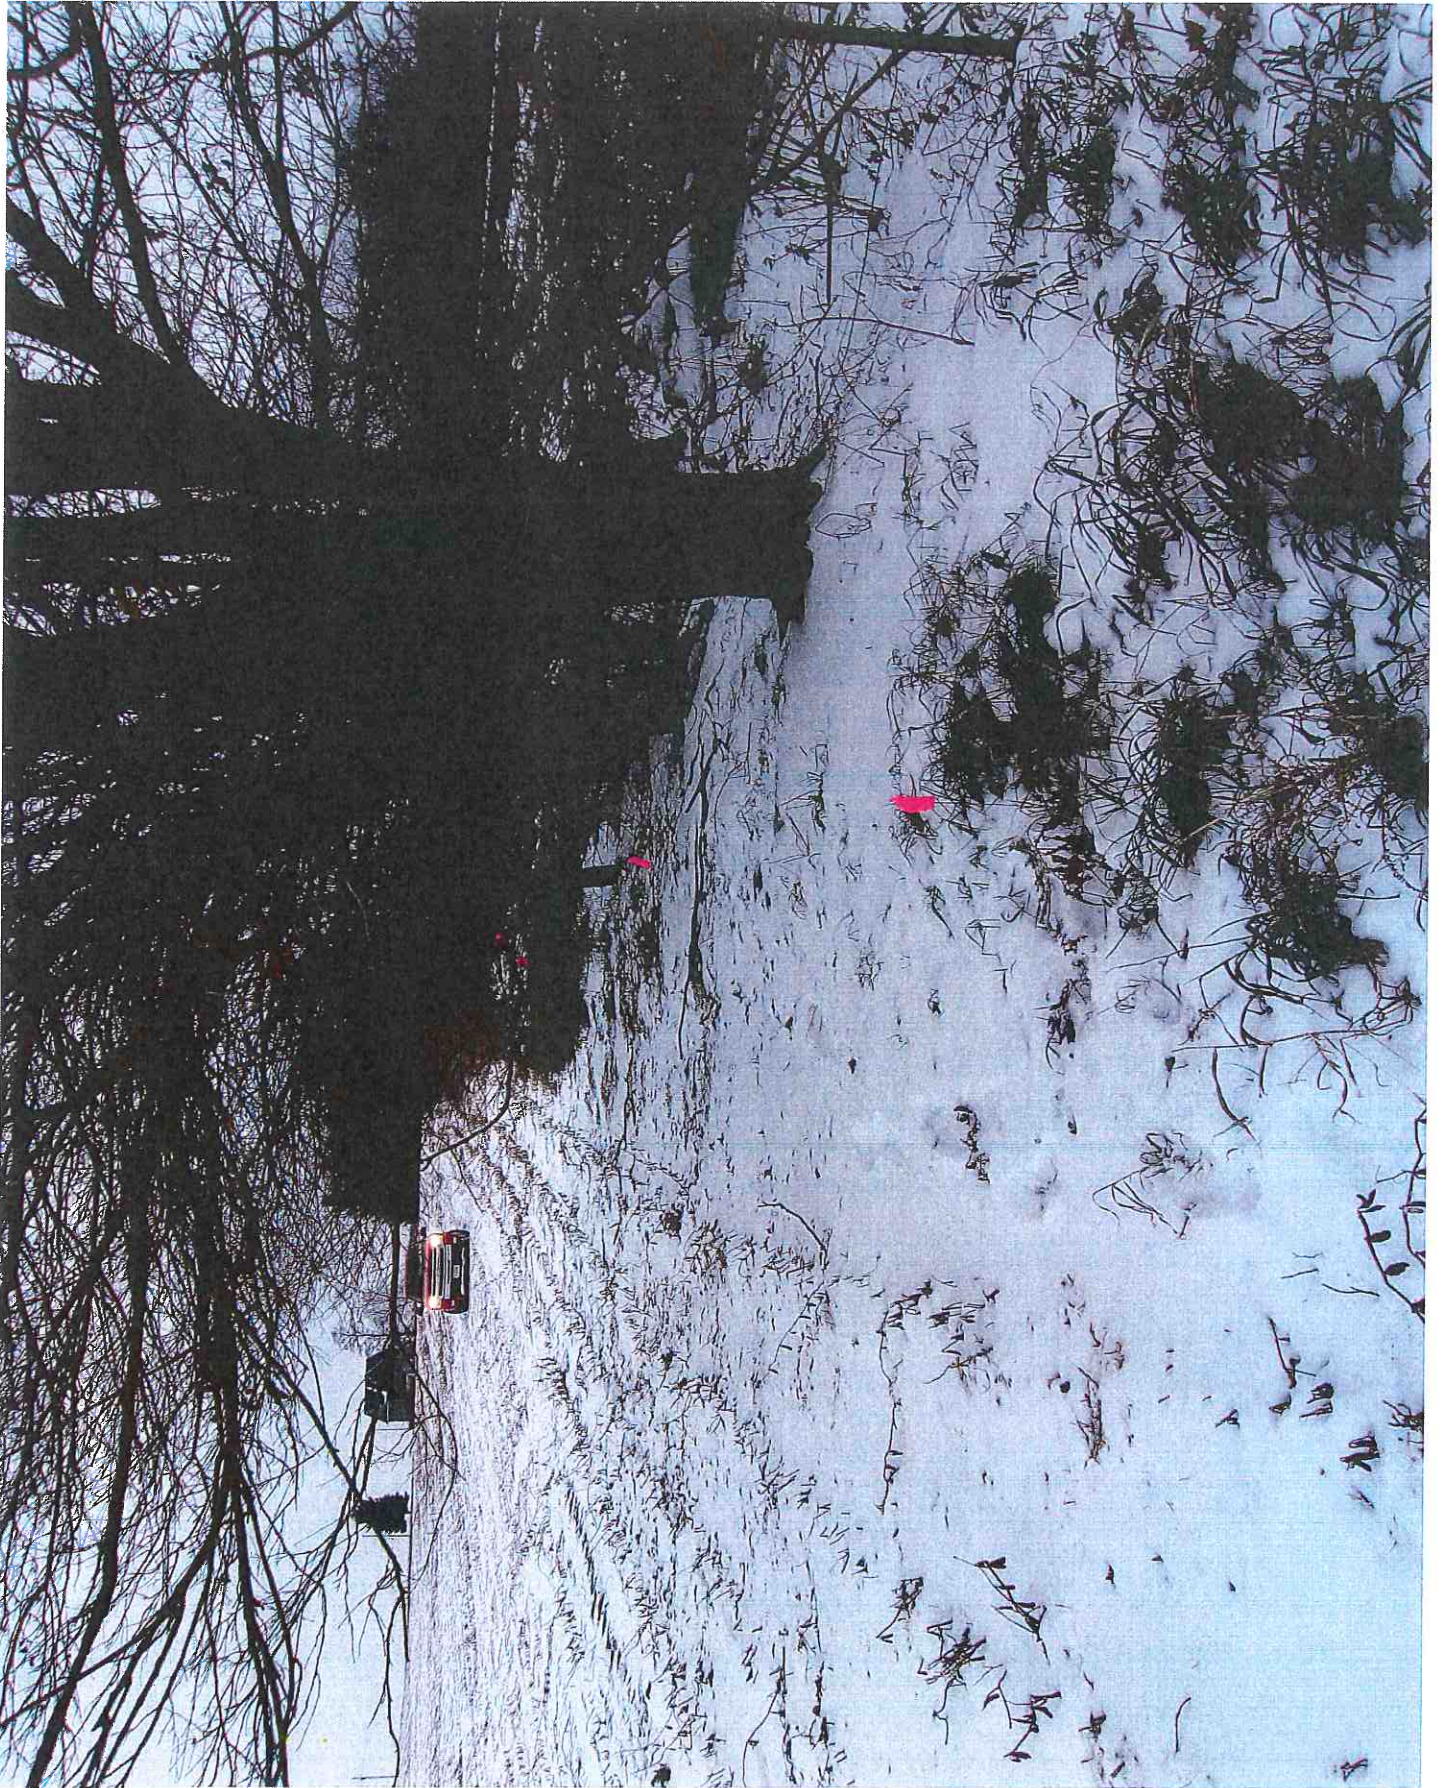
TREES DOWNSTREAM FROM #313

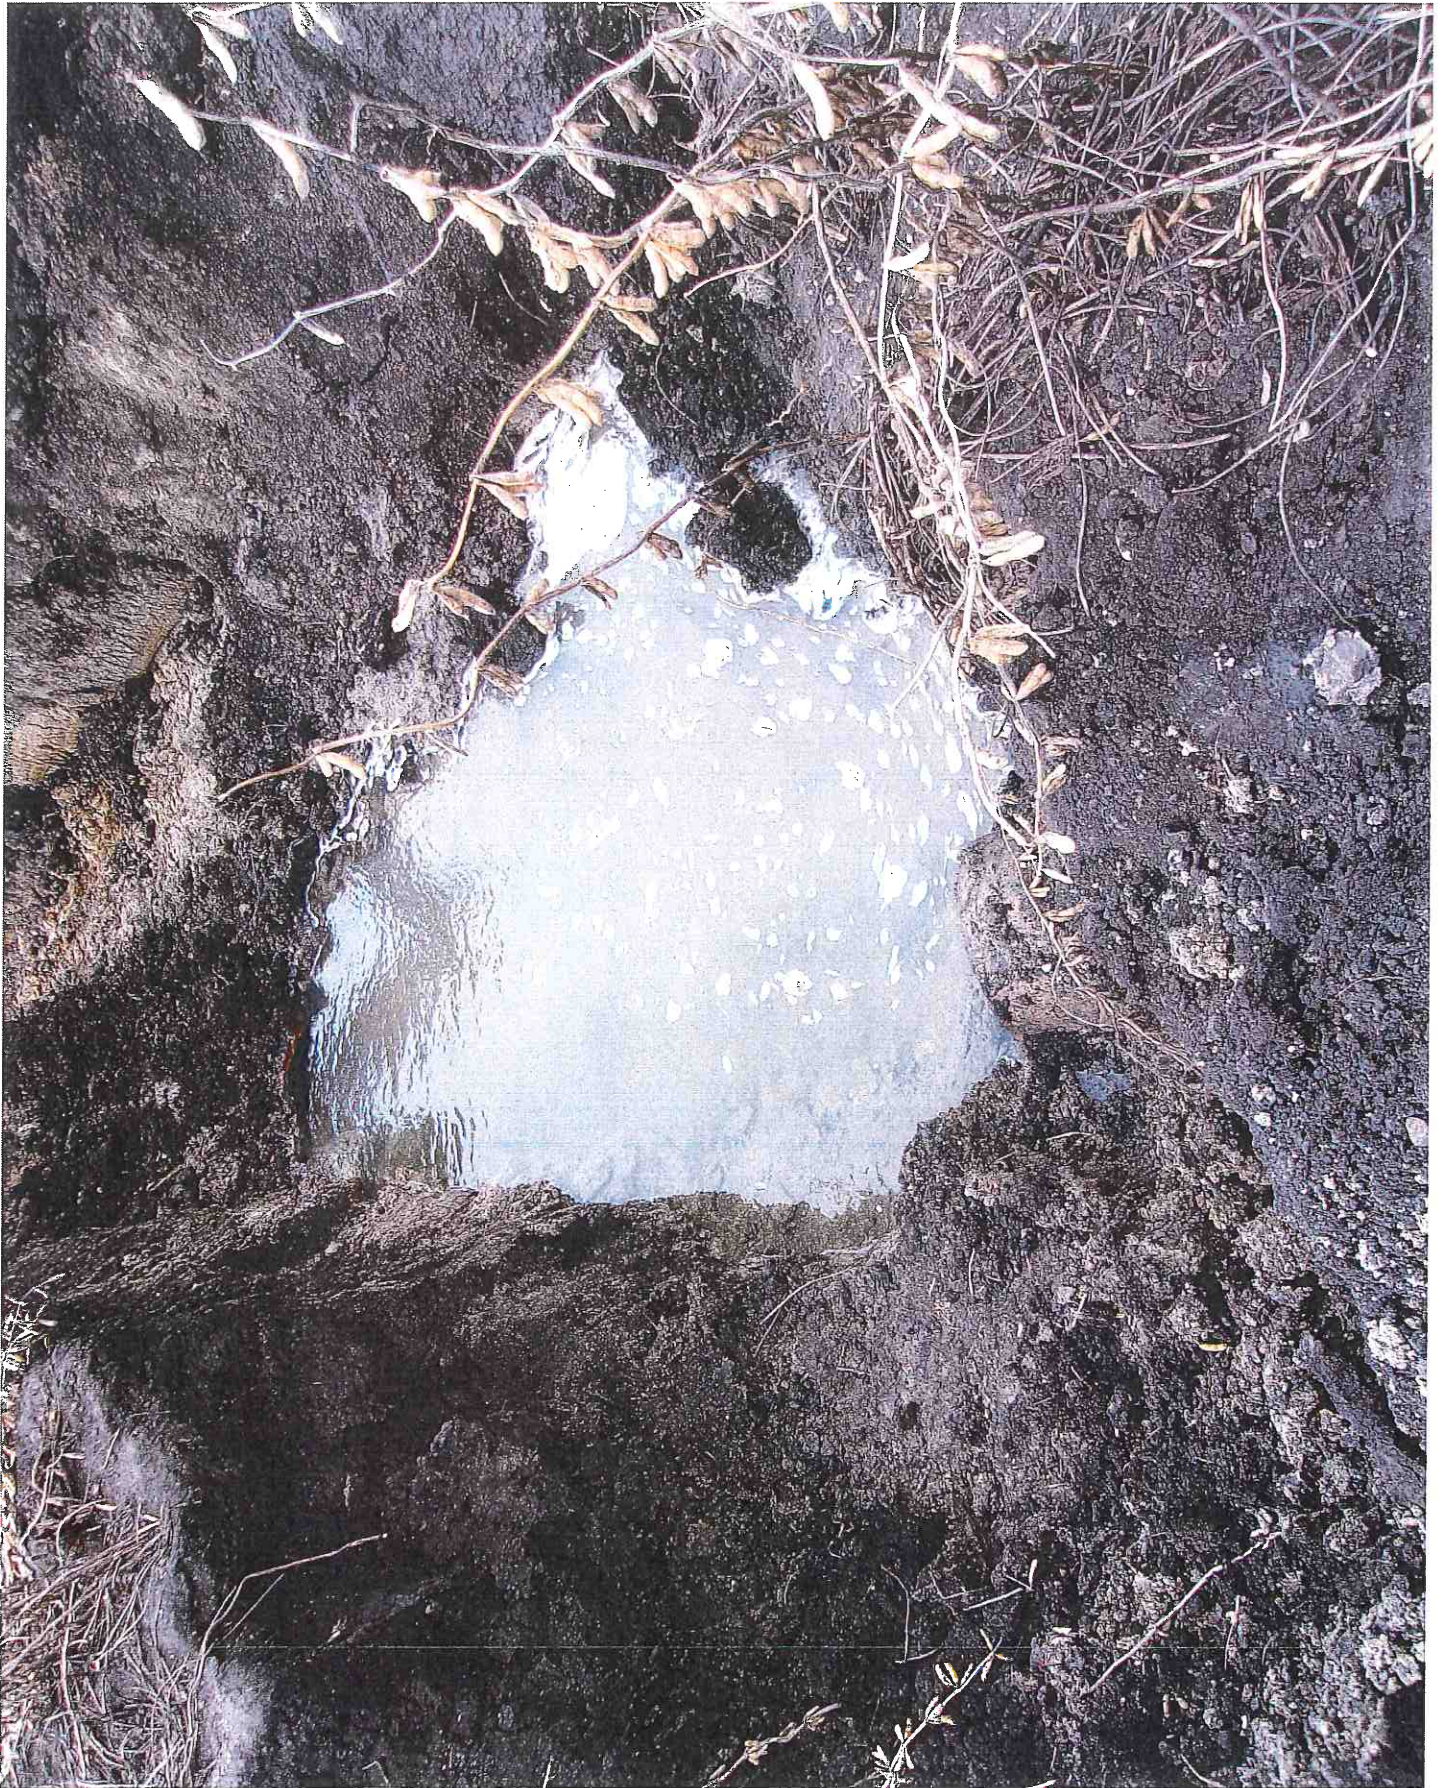
Blow-out Hole @ #340

- Tile blowout/sinkhole is missing one section of VCP tile and is 1/3 full of debris.
- Located Main tile upstream for 590'± and downstream for 1430'± from blowout/sinkhole.

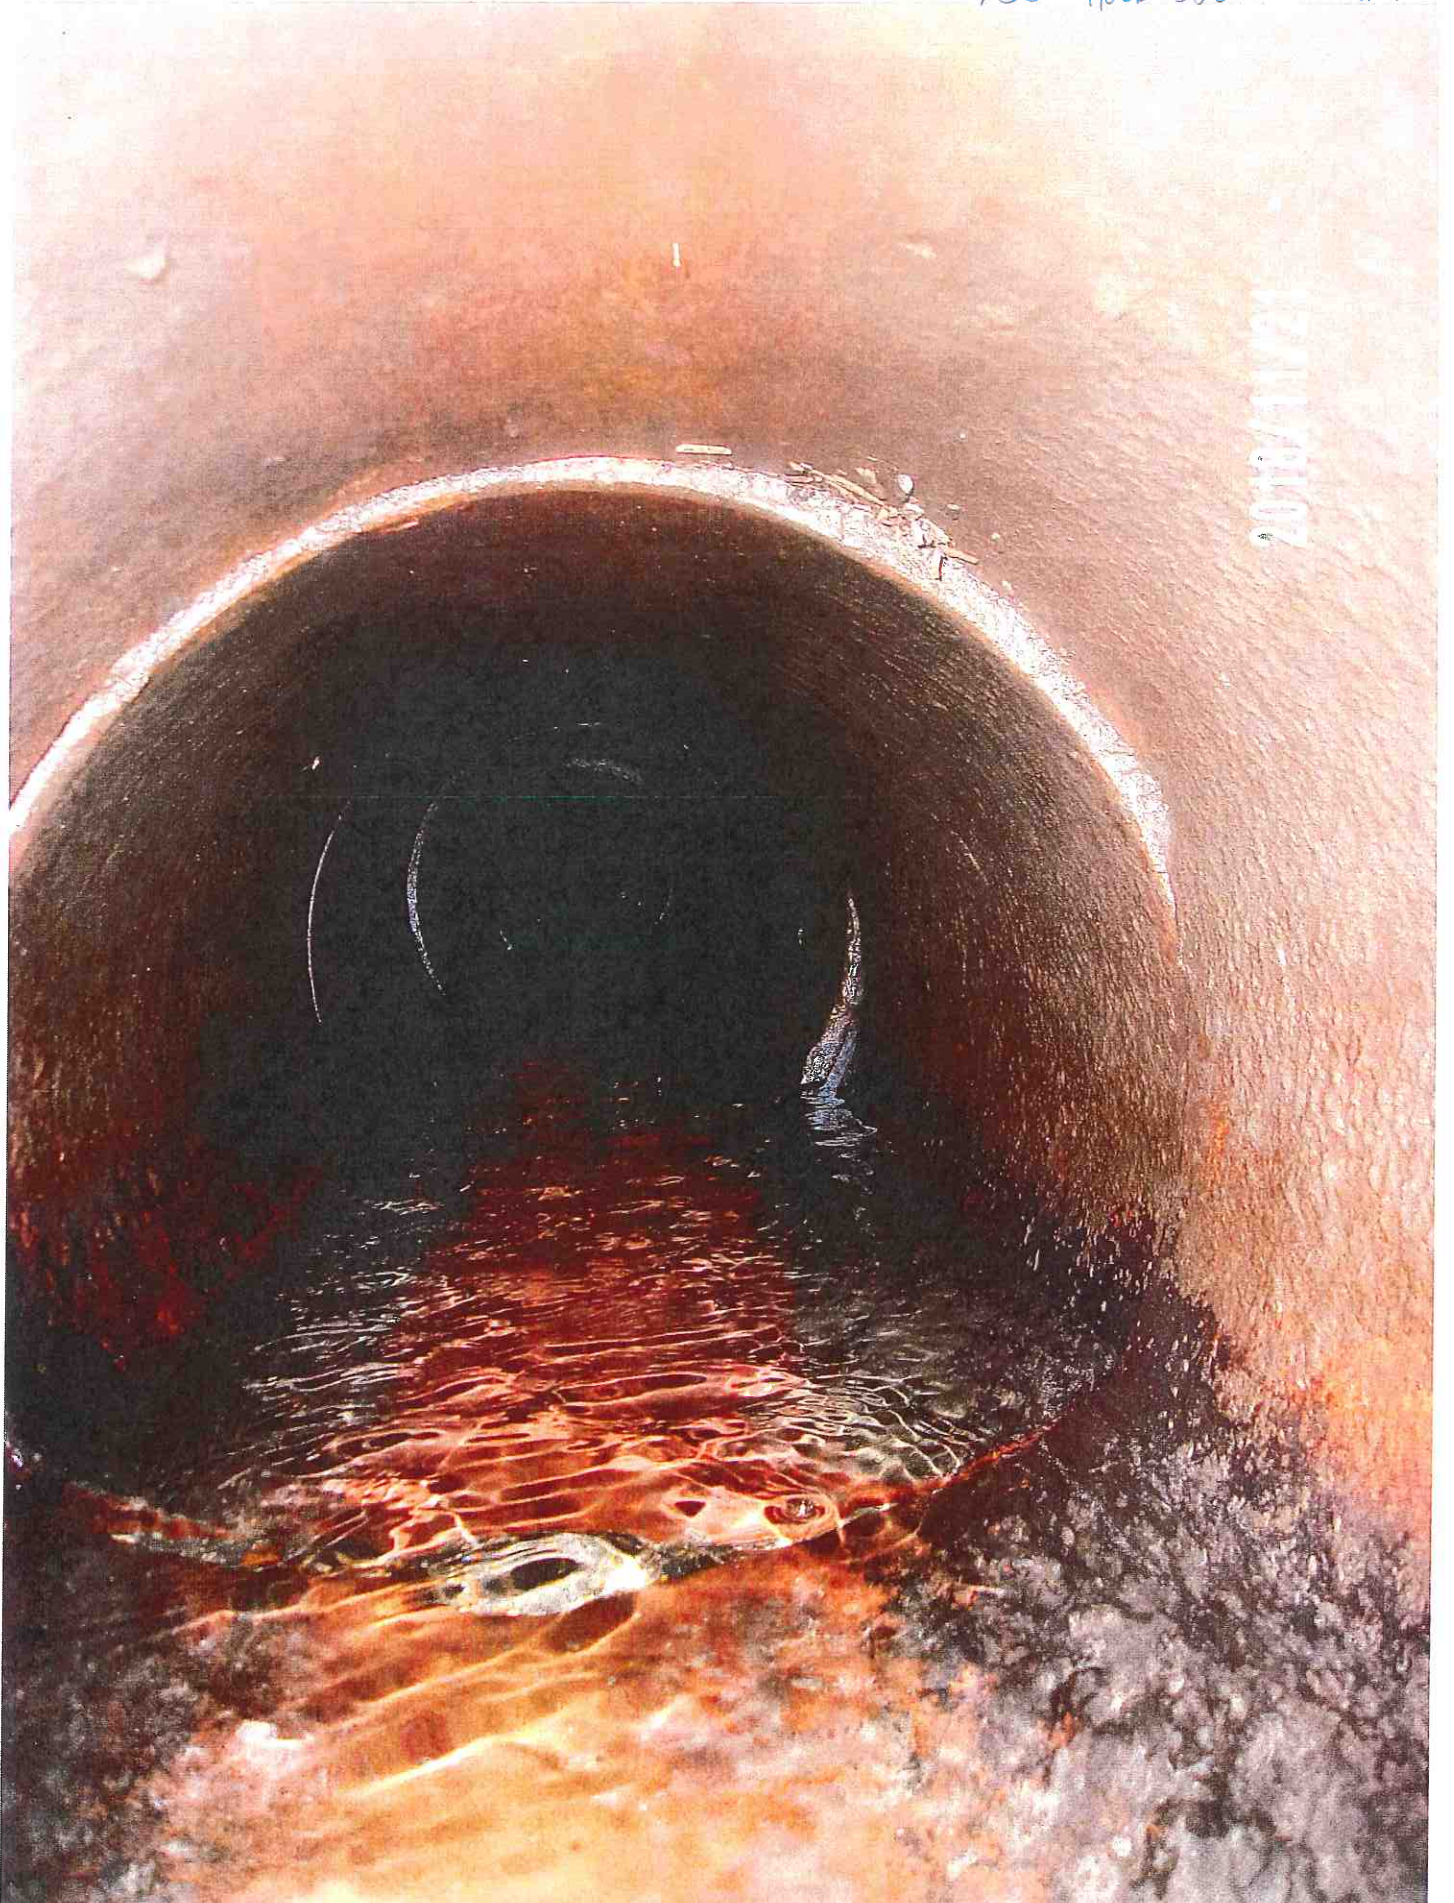
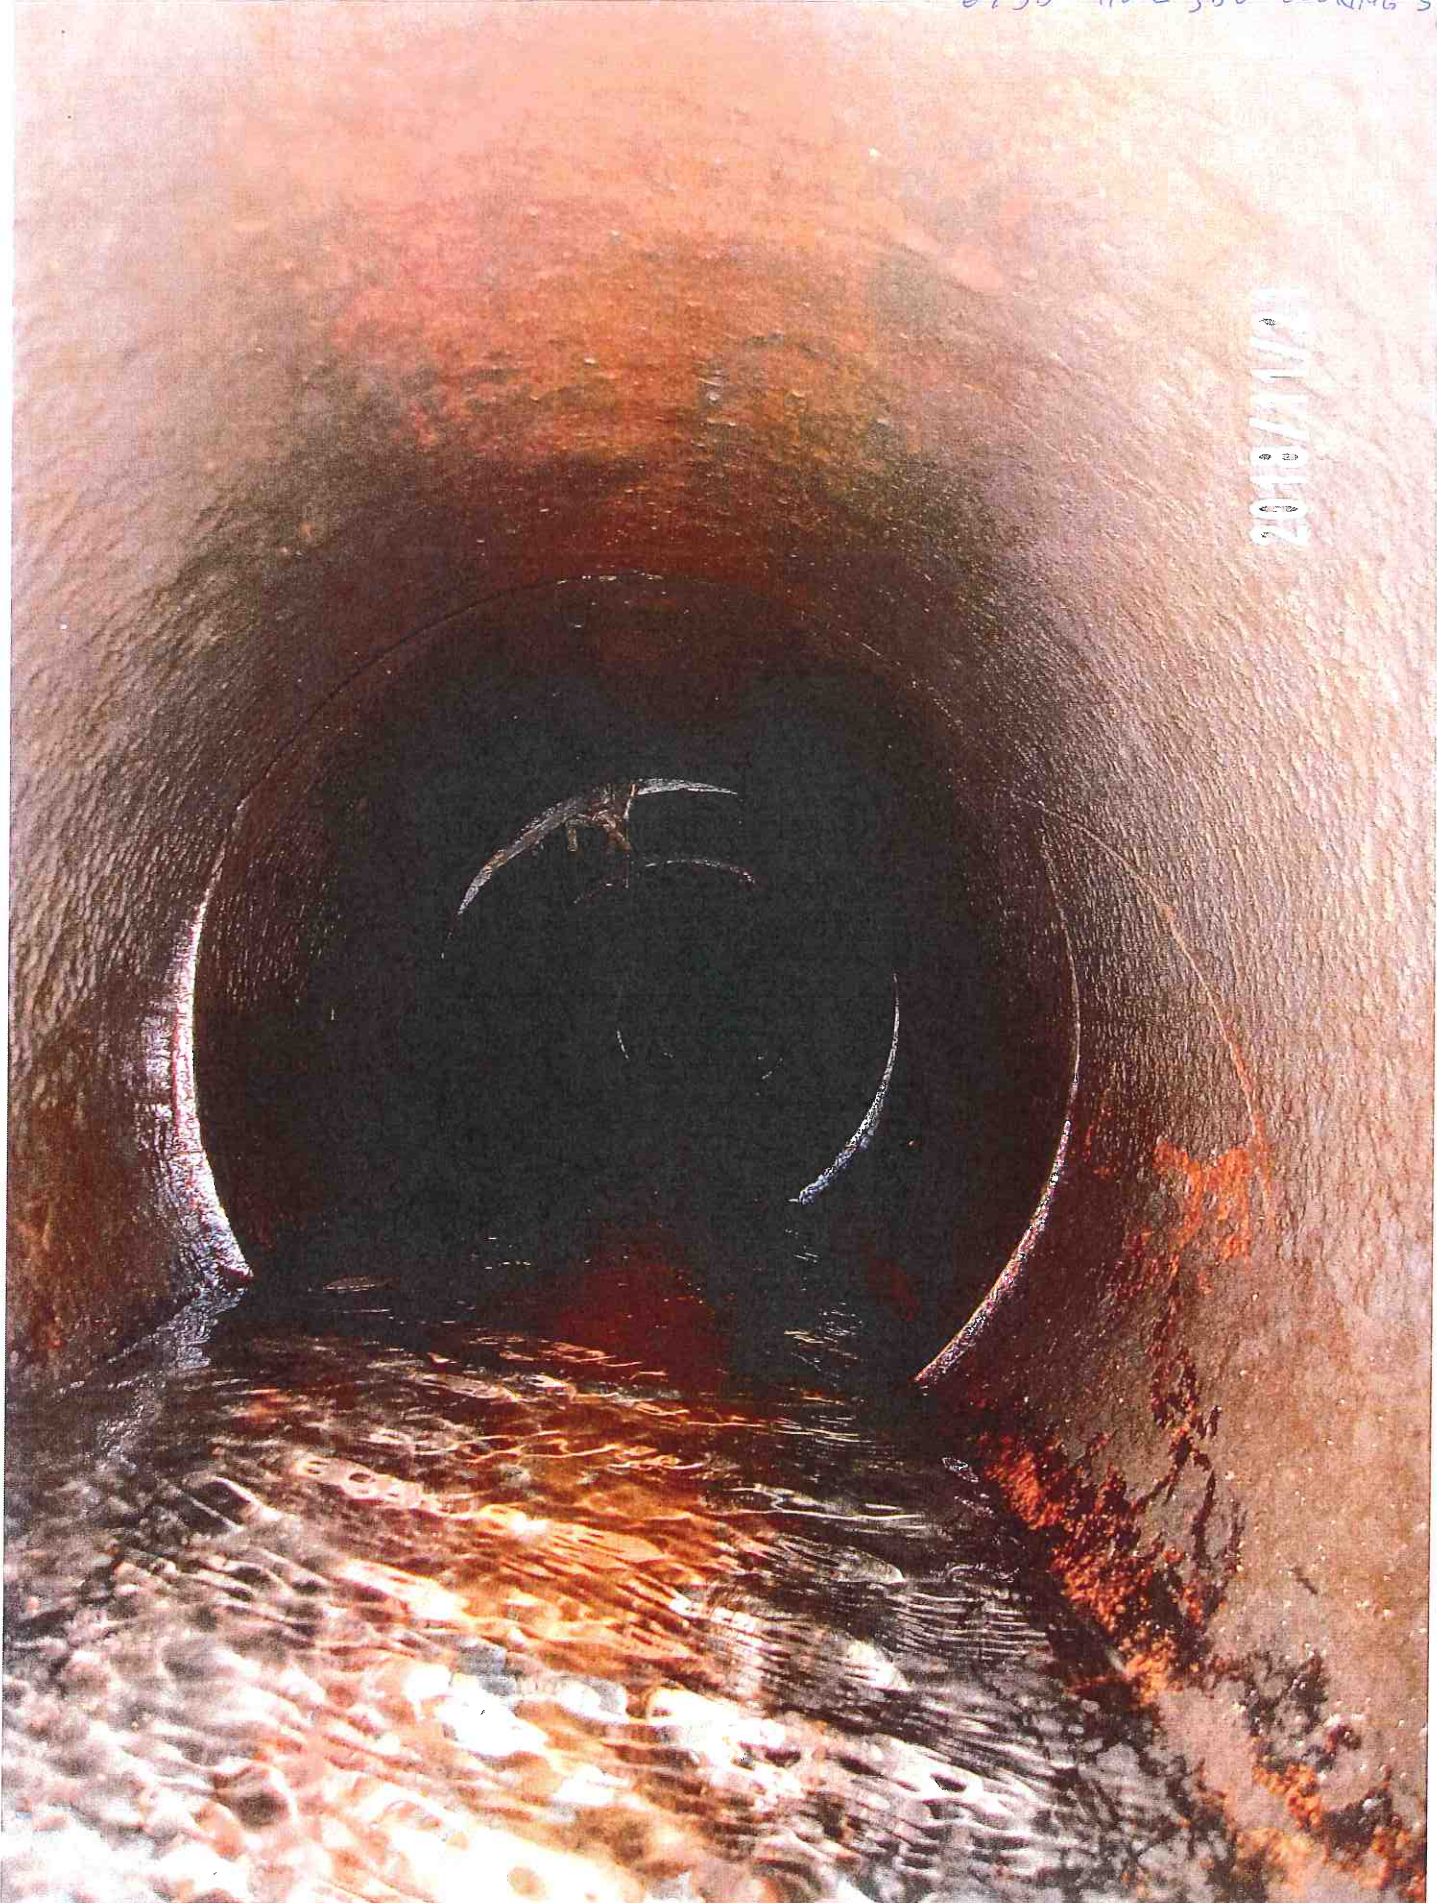
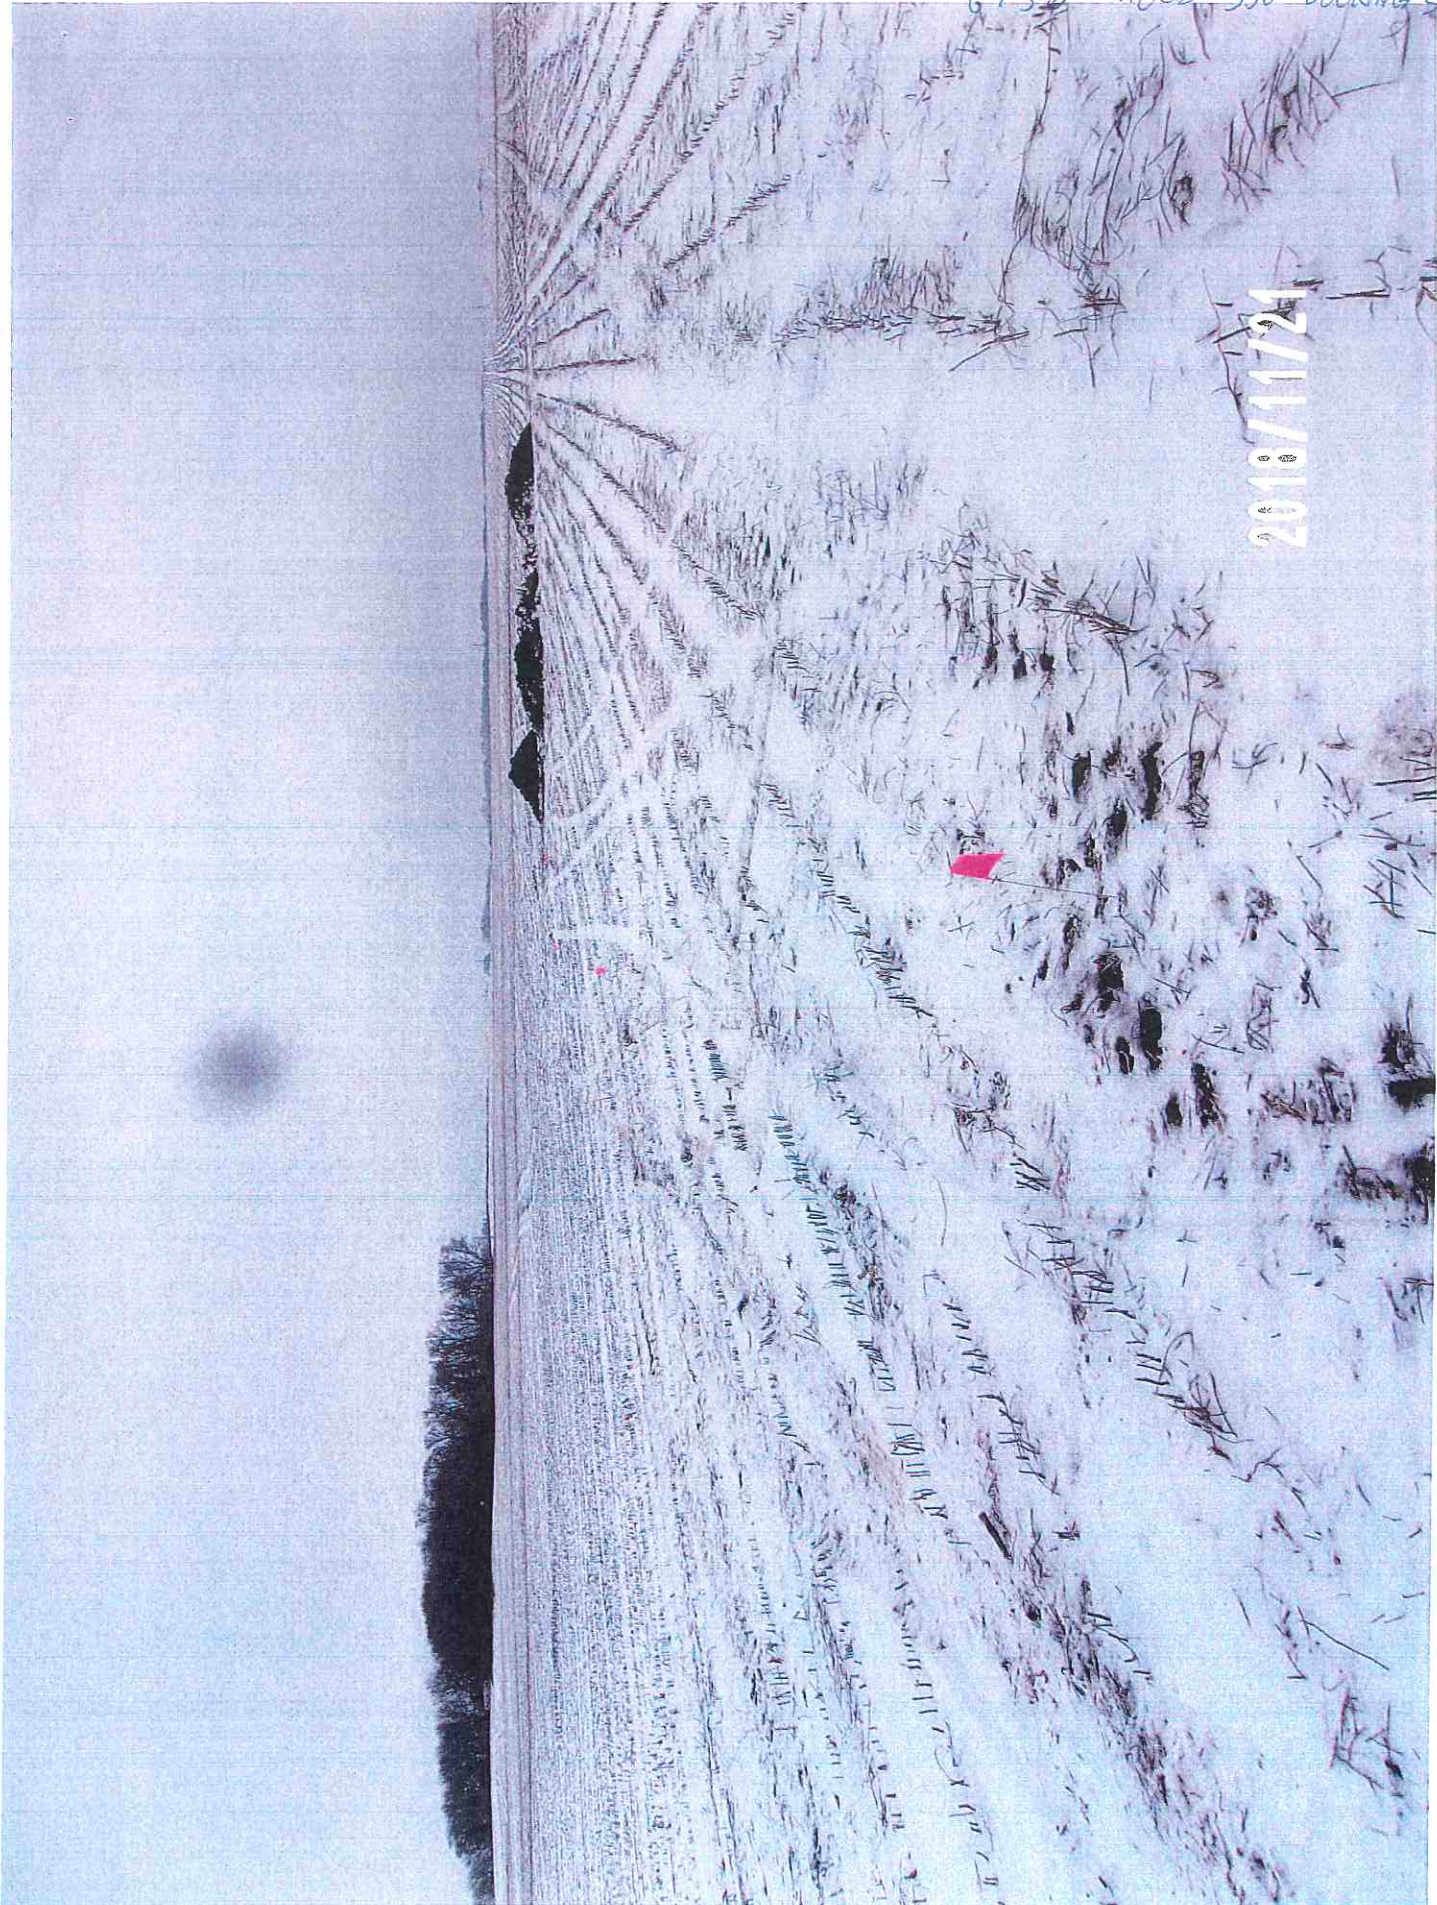
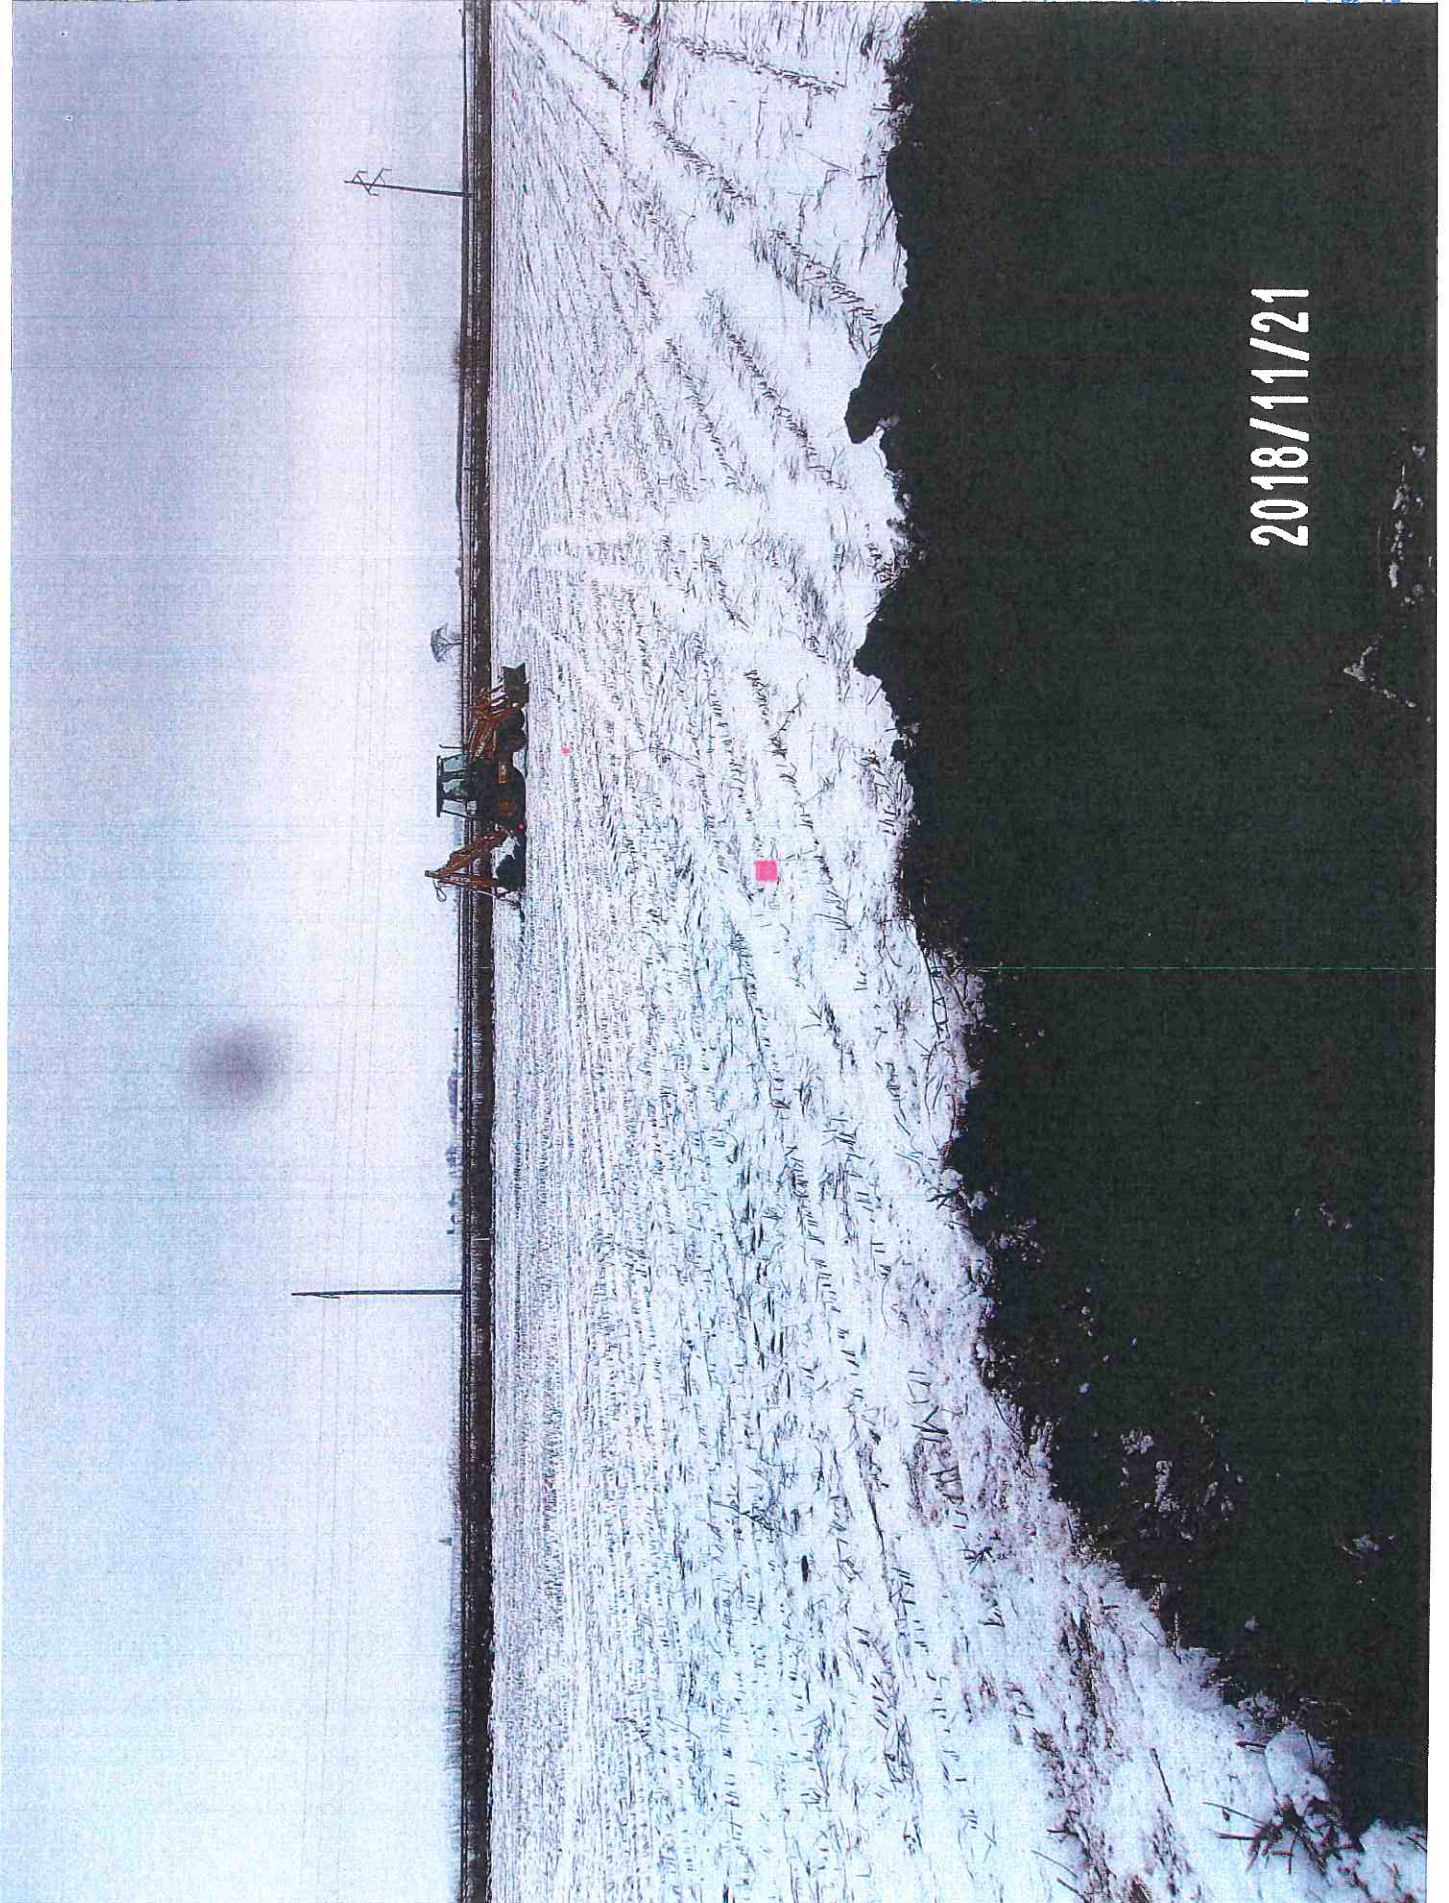
6735 HOLE 350 LOOKING N

10:00 OPENED HOLE #350 3"-4" CLEAN WATER FLOWING THROUGH PIPE.
