9

## Repair Summary:

**DRAINAGE DISTRICT #9**  
 HARDIN, IOWA

**SPOT REPAIRS**

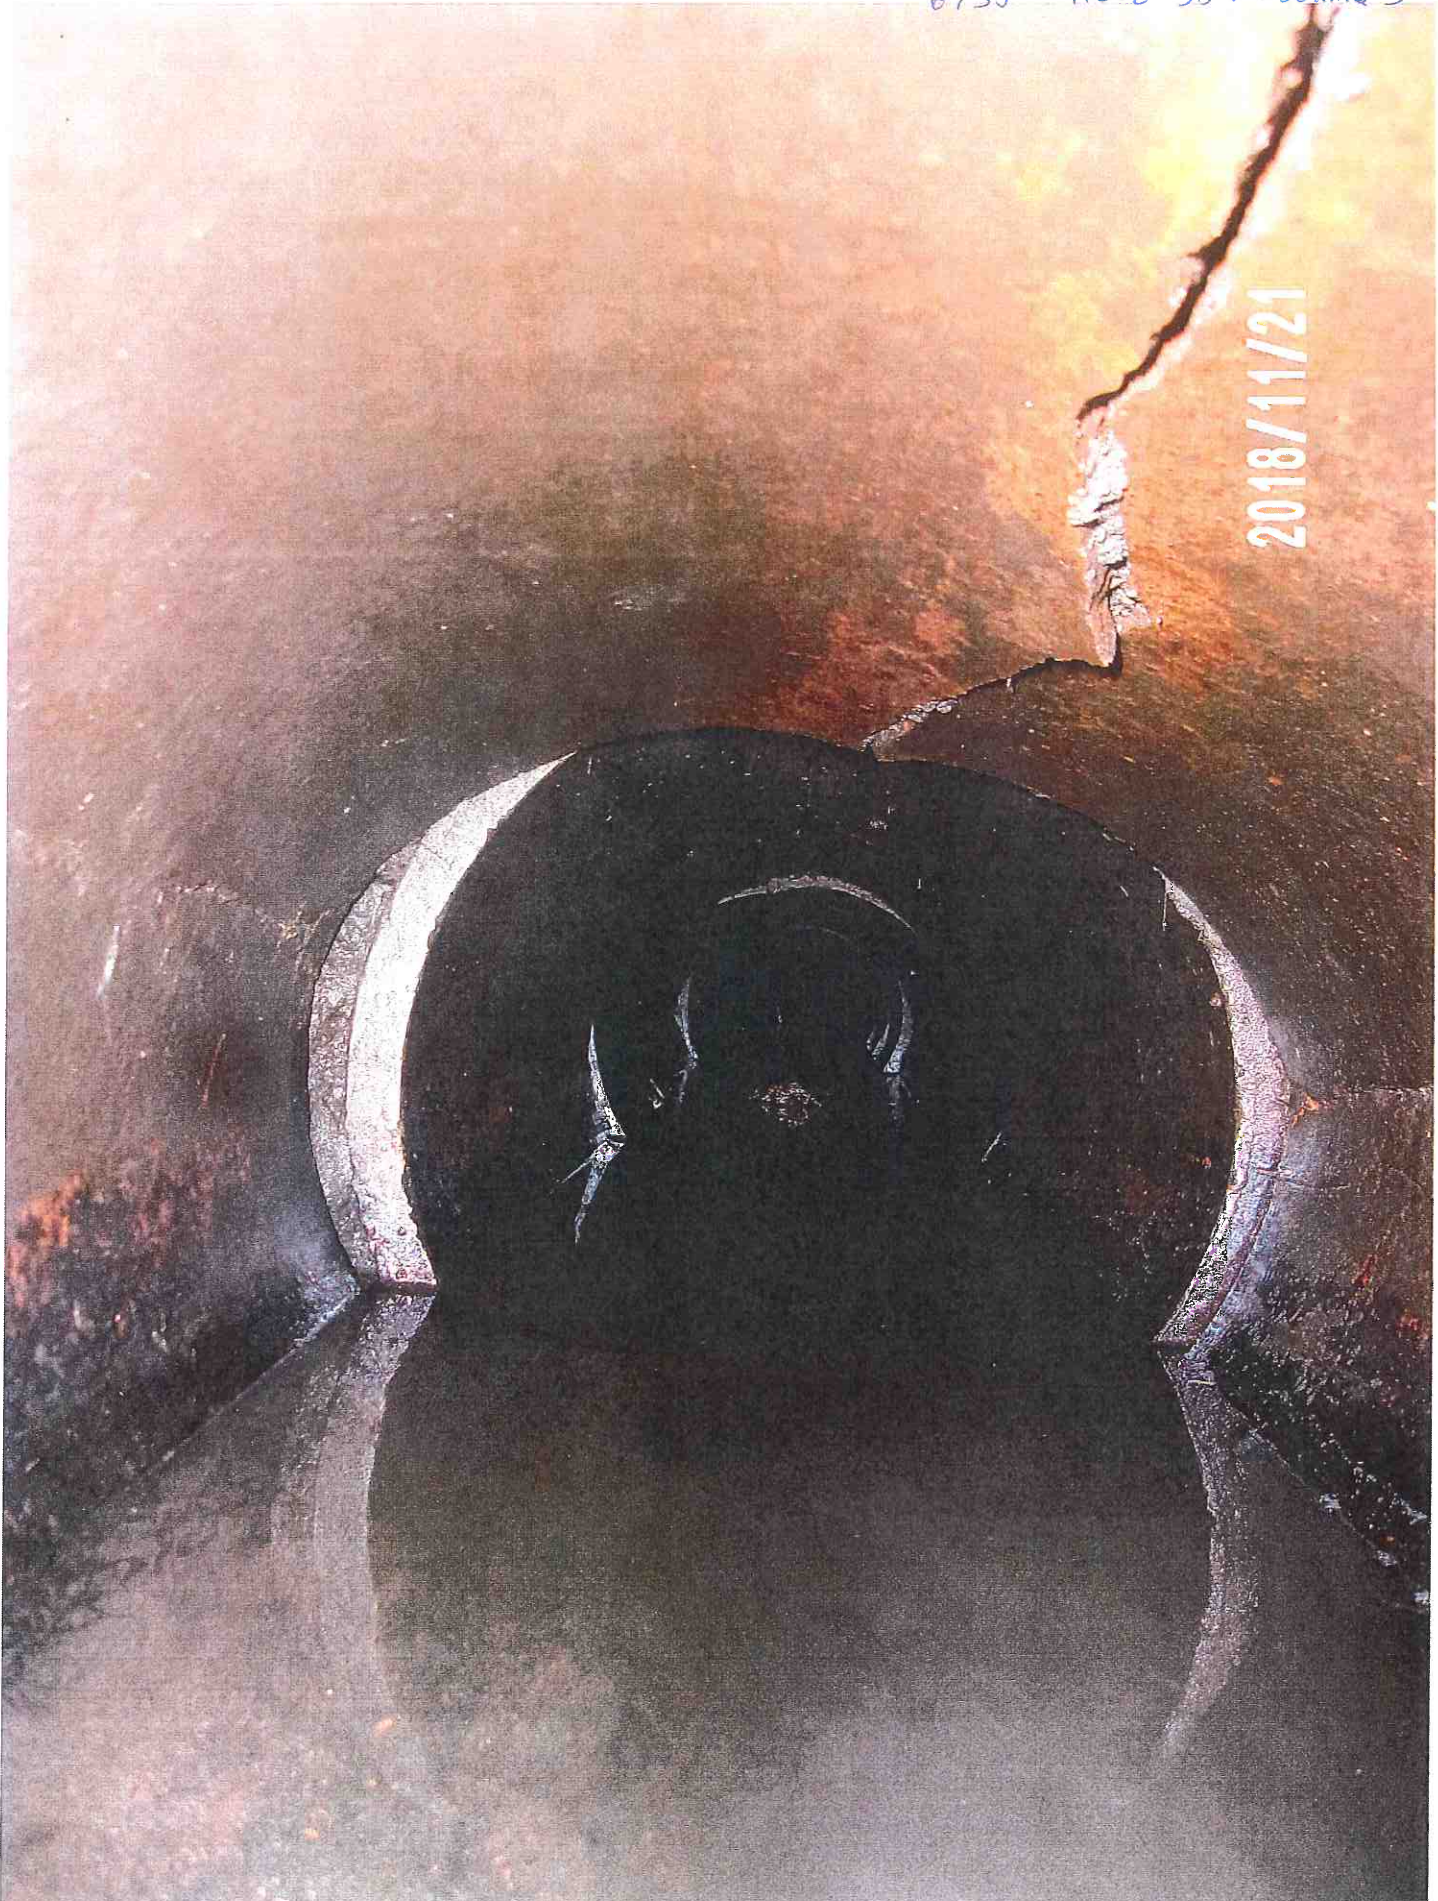
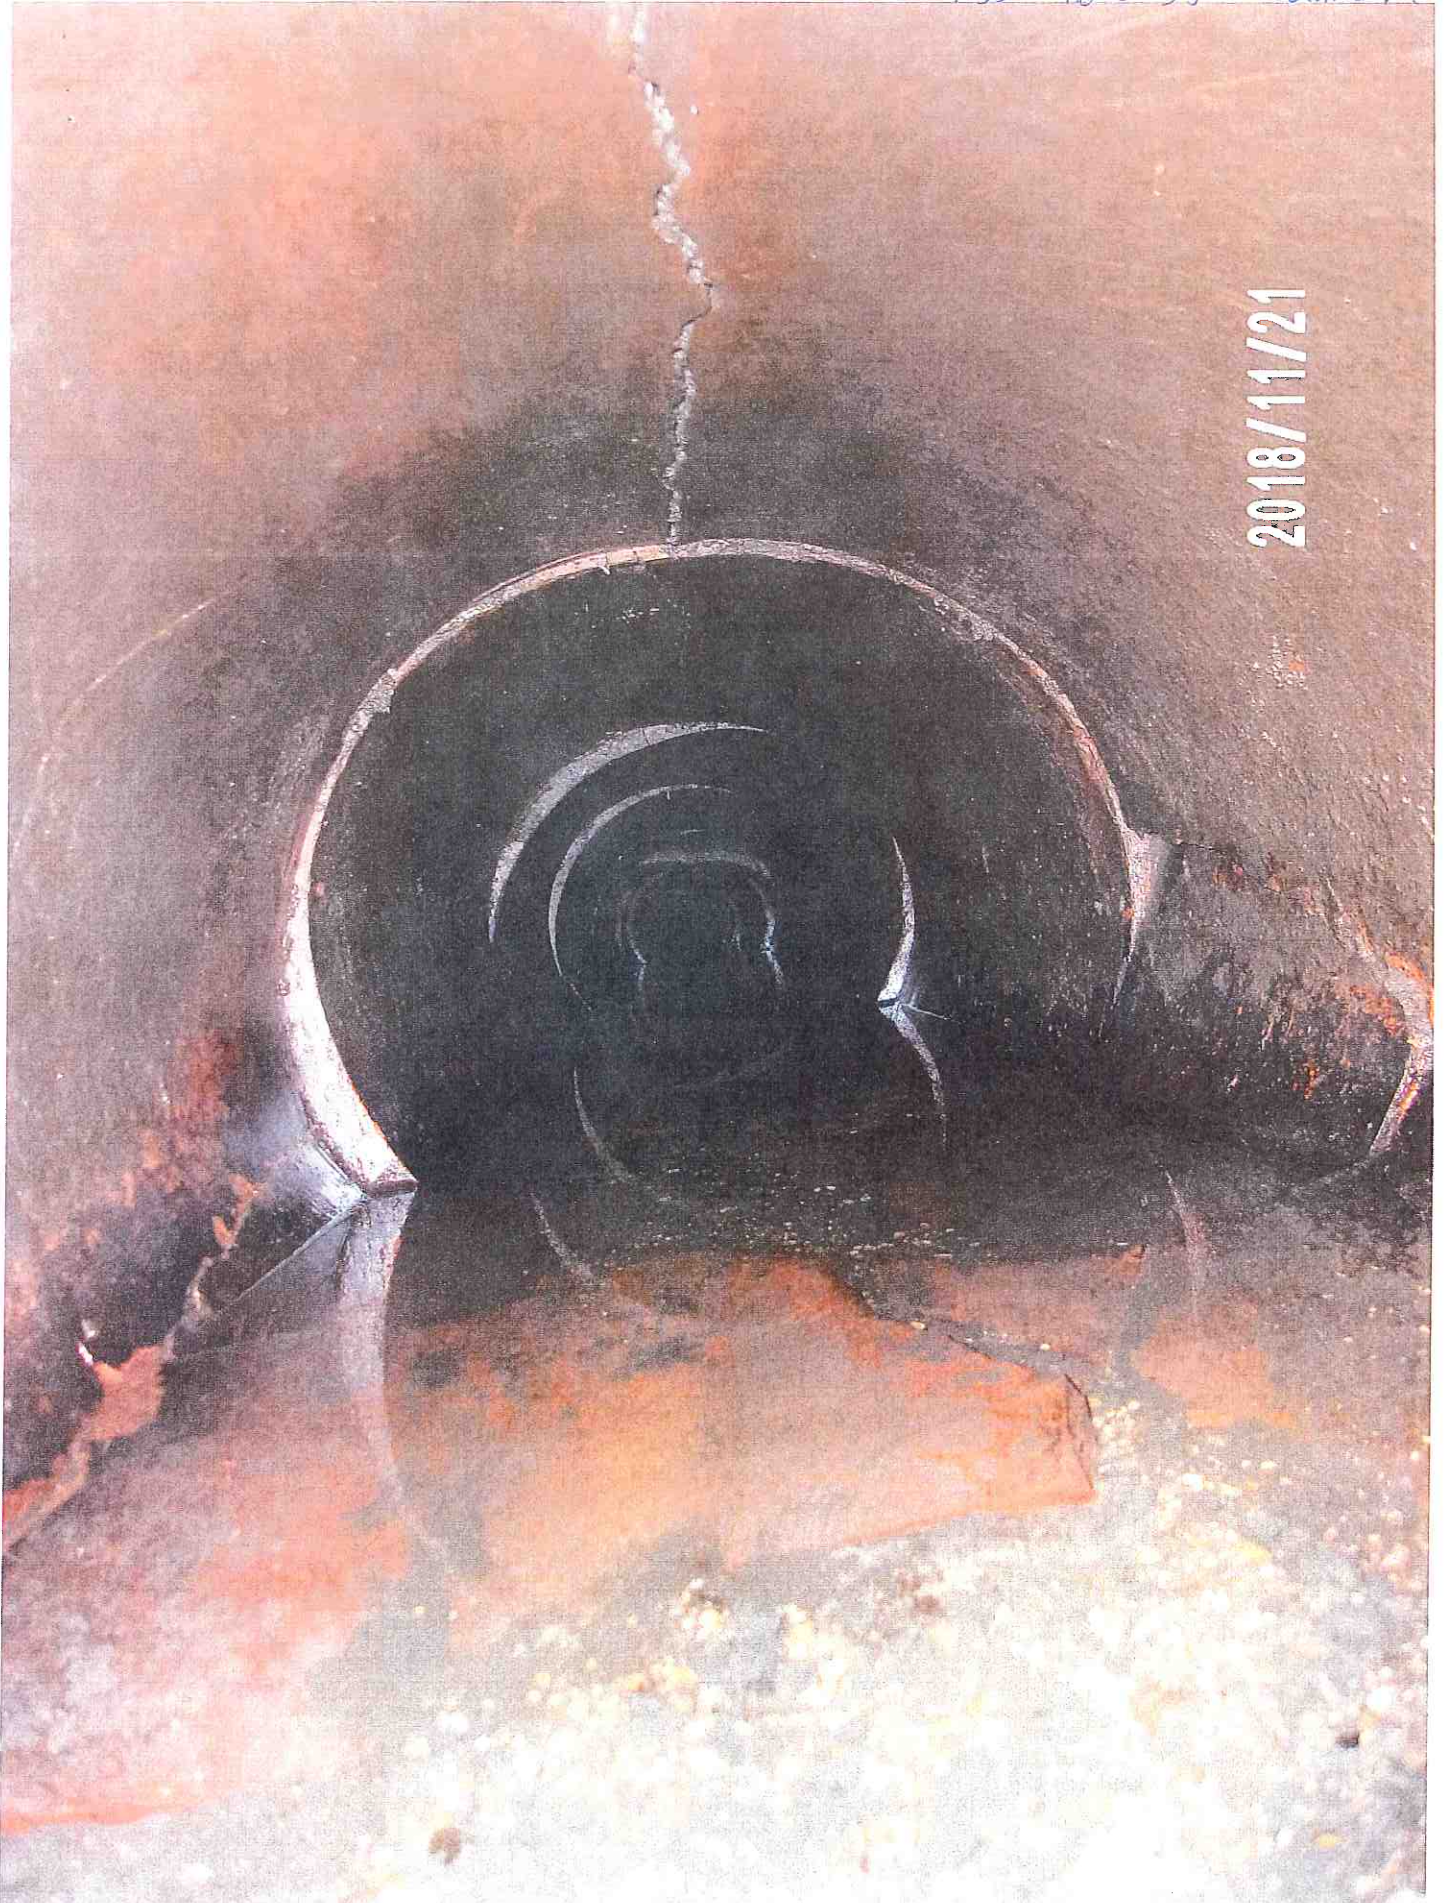
6735 HOLE 354 LOOKING S

10:45 OPENED HOLE #354 CONTRACTOR BROKE 1 PIECE OF TILE W/ BACK HOE BOTH TILE UP & DOWN STREAM HAVE MULTIPLE LATERAL CRACKS TILE IS FLOWING 3"-4" CLEAN WATER LOCATED TO THE OPEN TILE @ #344

1:30 P.M. WENT TO HOME #354 WITH BROKEN CLAY TILE. TOOK OUT 75" OF BROKEN CLAY TILE AND REPAIRED IT WITH 15" DUAL WALL HDPE AND FABRIC JOINTS (6'3")

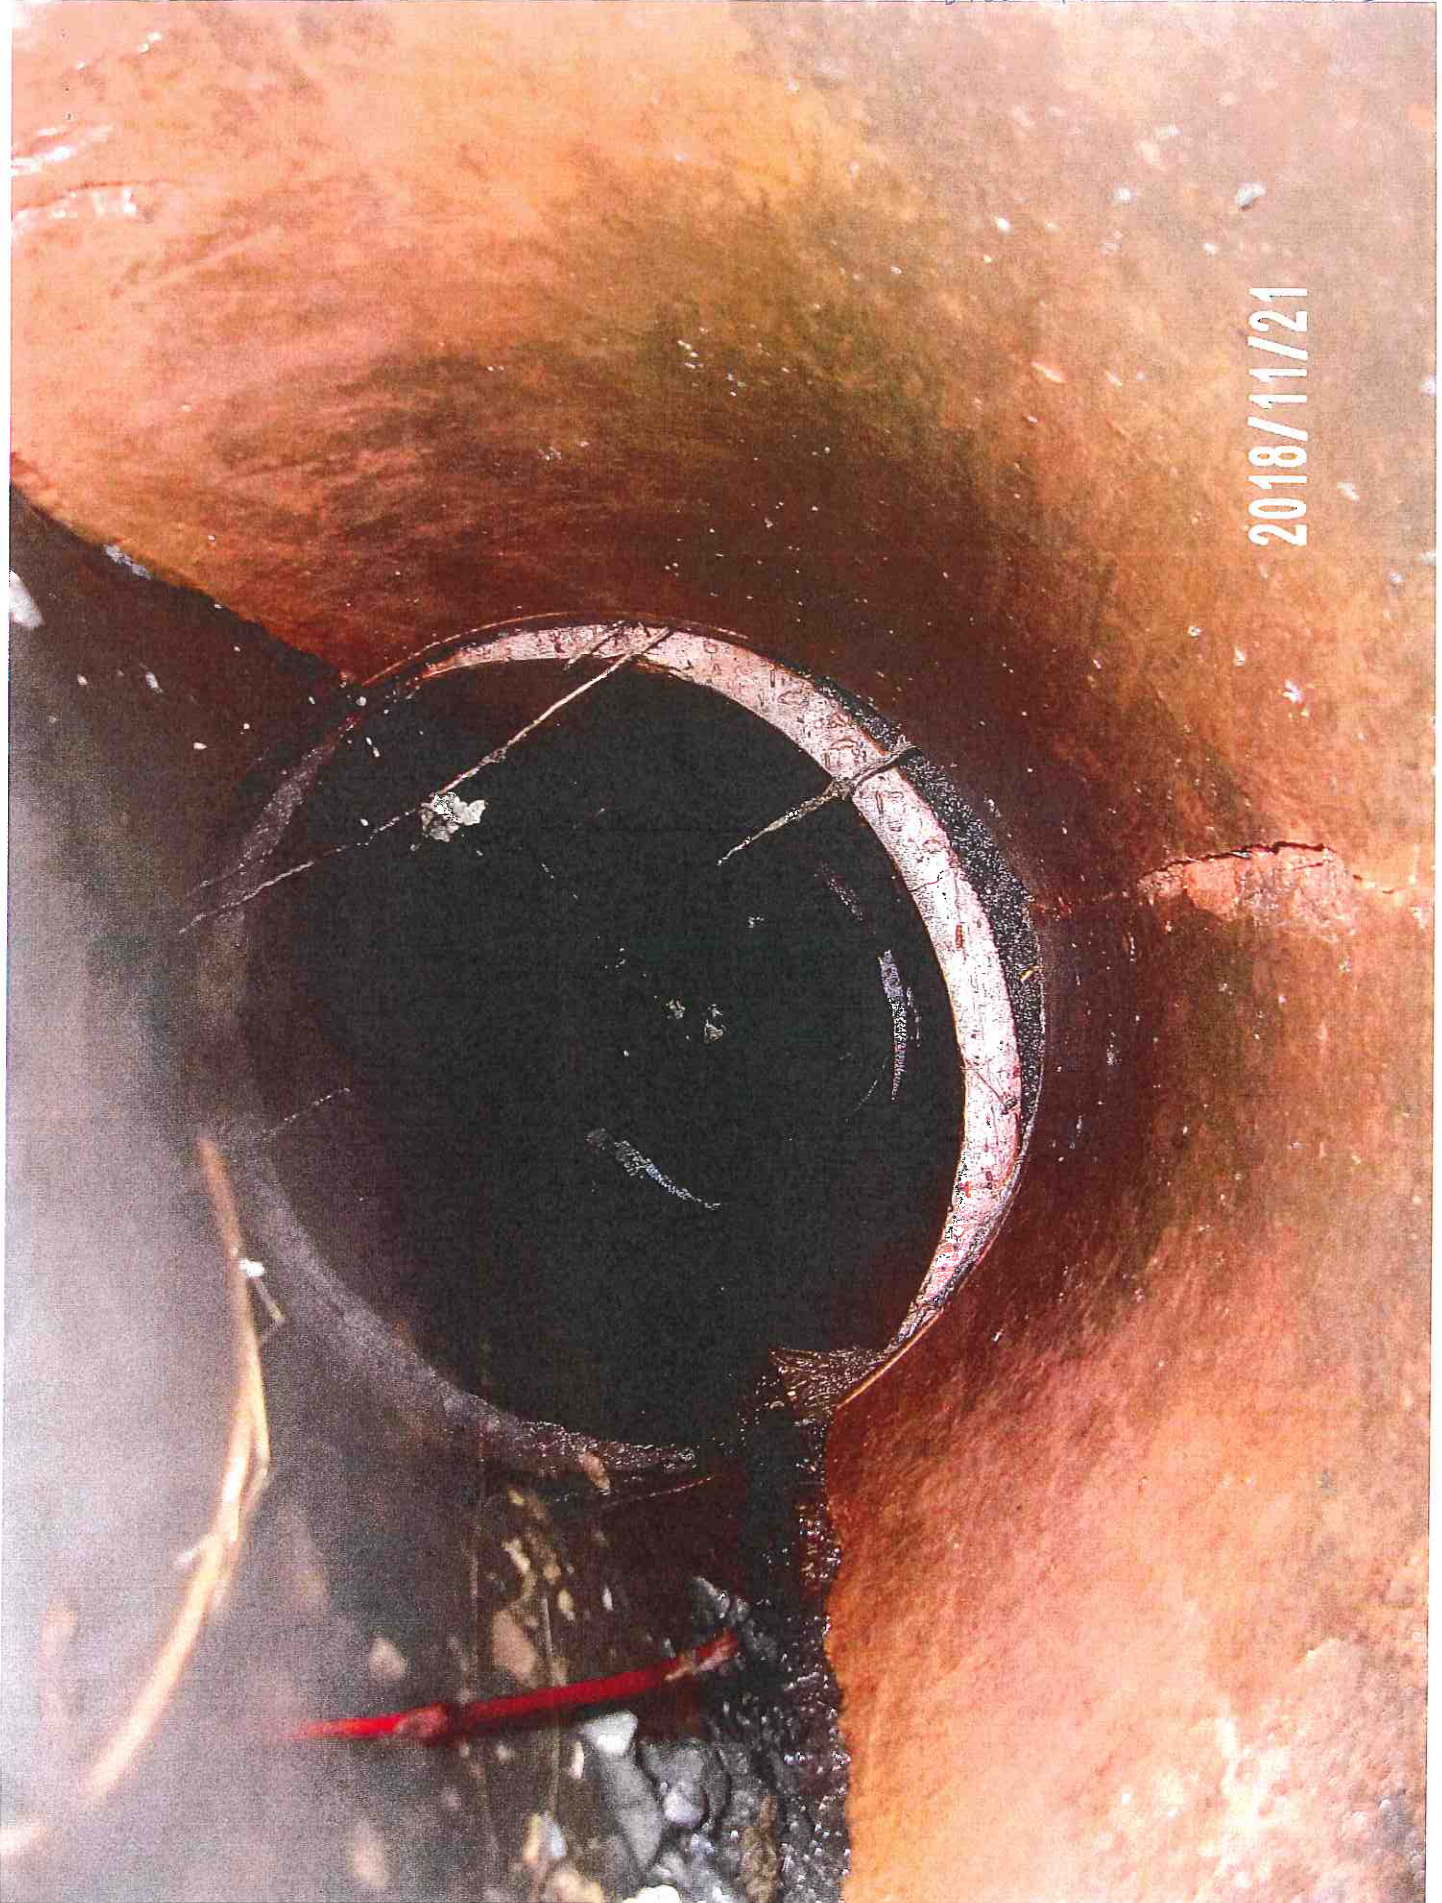
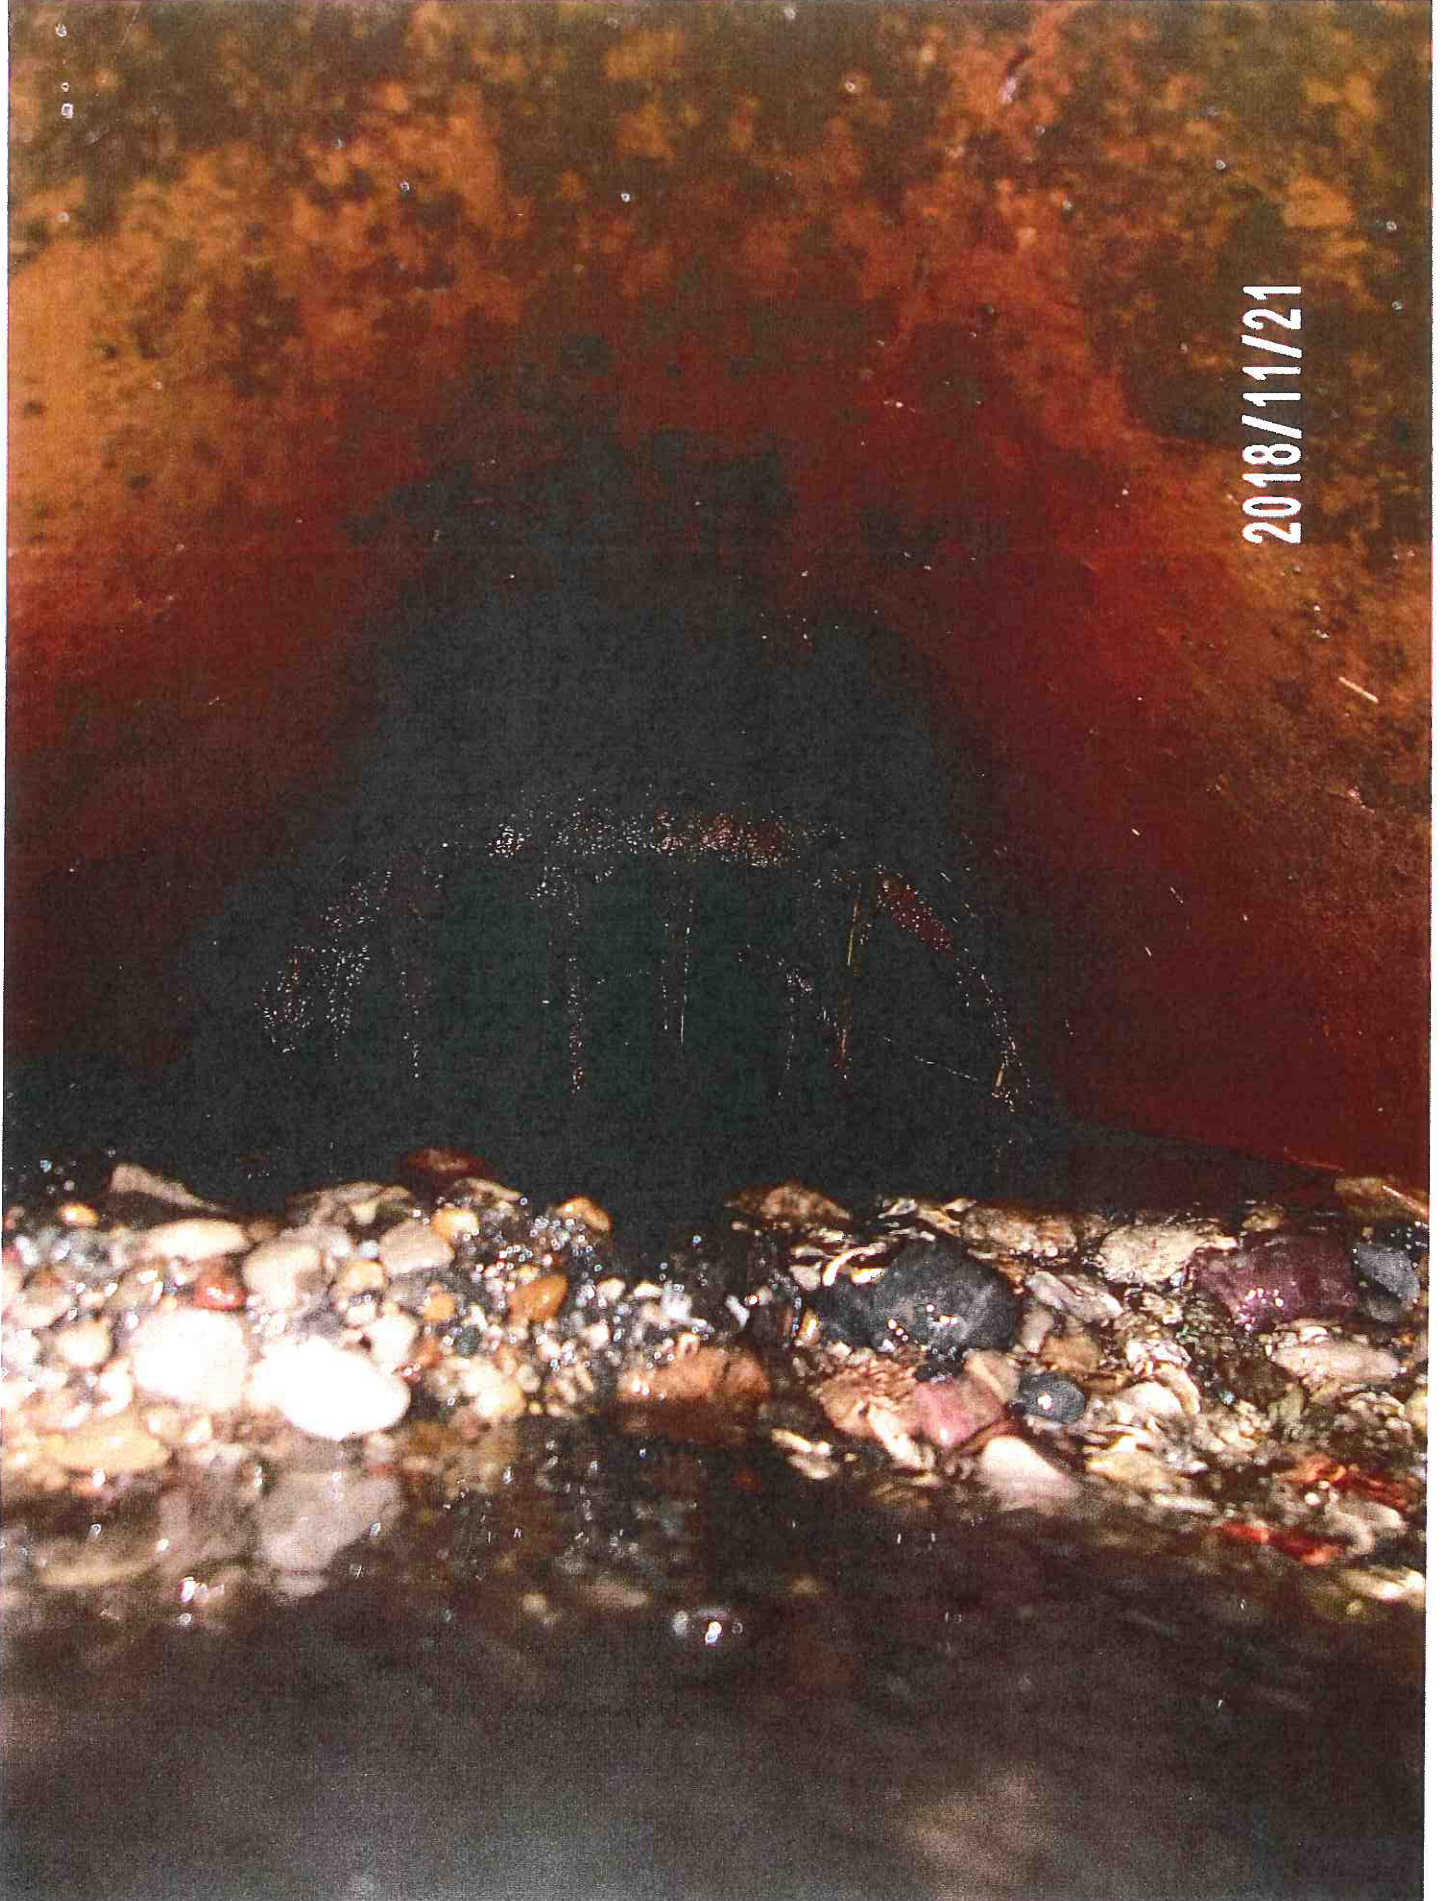
6725 HOLE 344 LOOKING S

11:00 HOLE 344 DOWN STREAM IS HALF FULL OF DIRT UPSTREAM IS 3/4 FULL ROCK W/ A TRICKLE OF WATER WATER AT THIS SPOT IS SLOW MOVING @ 7" DEEP

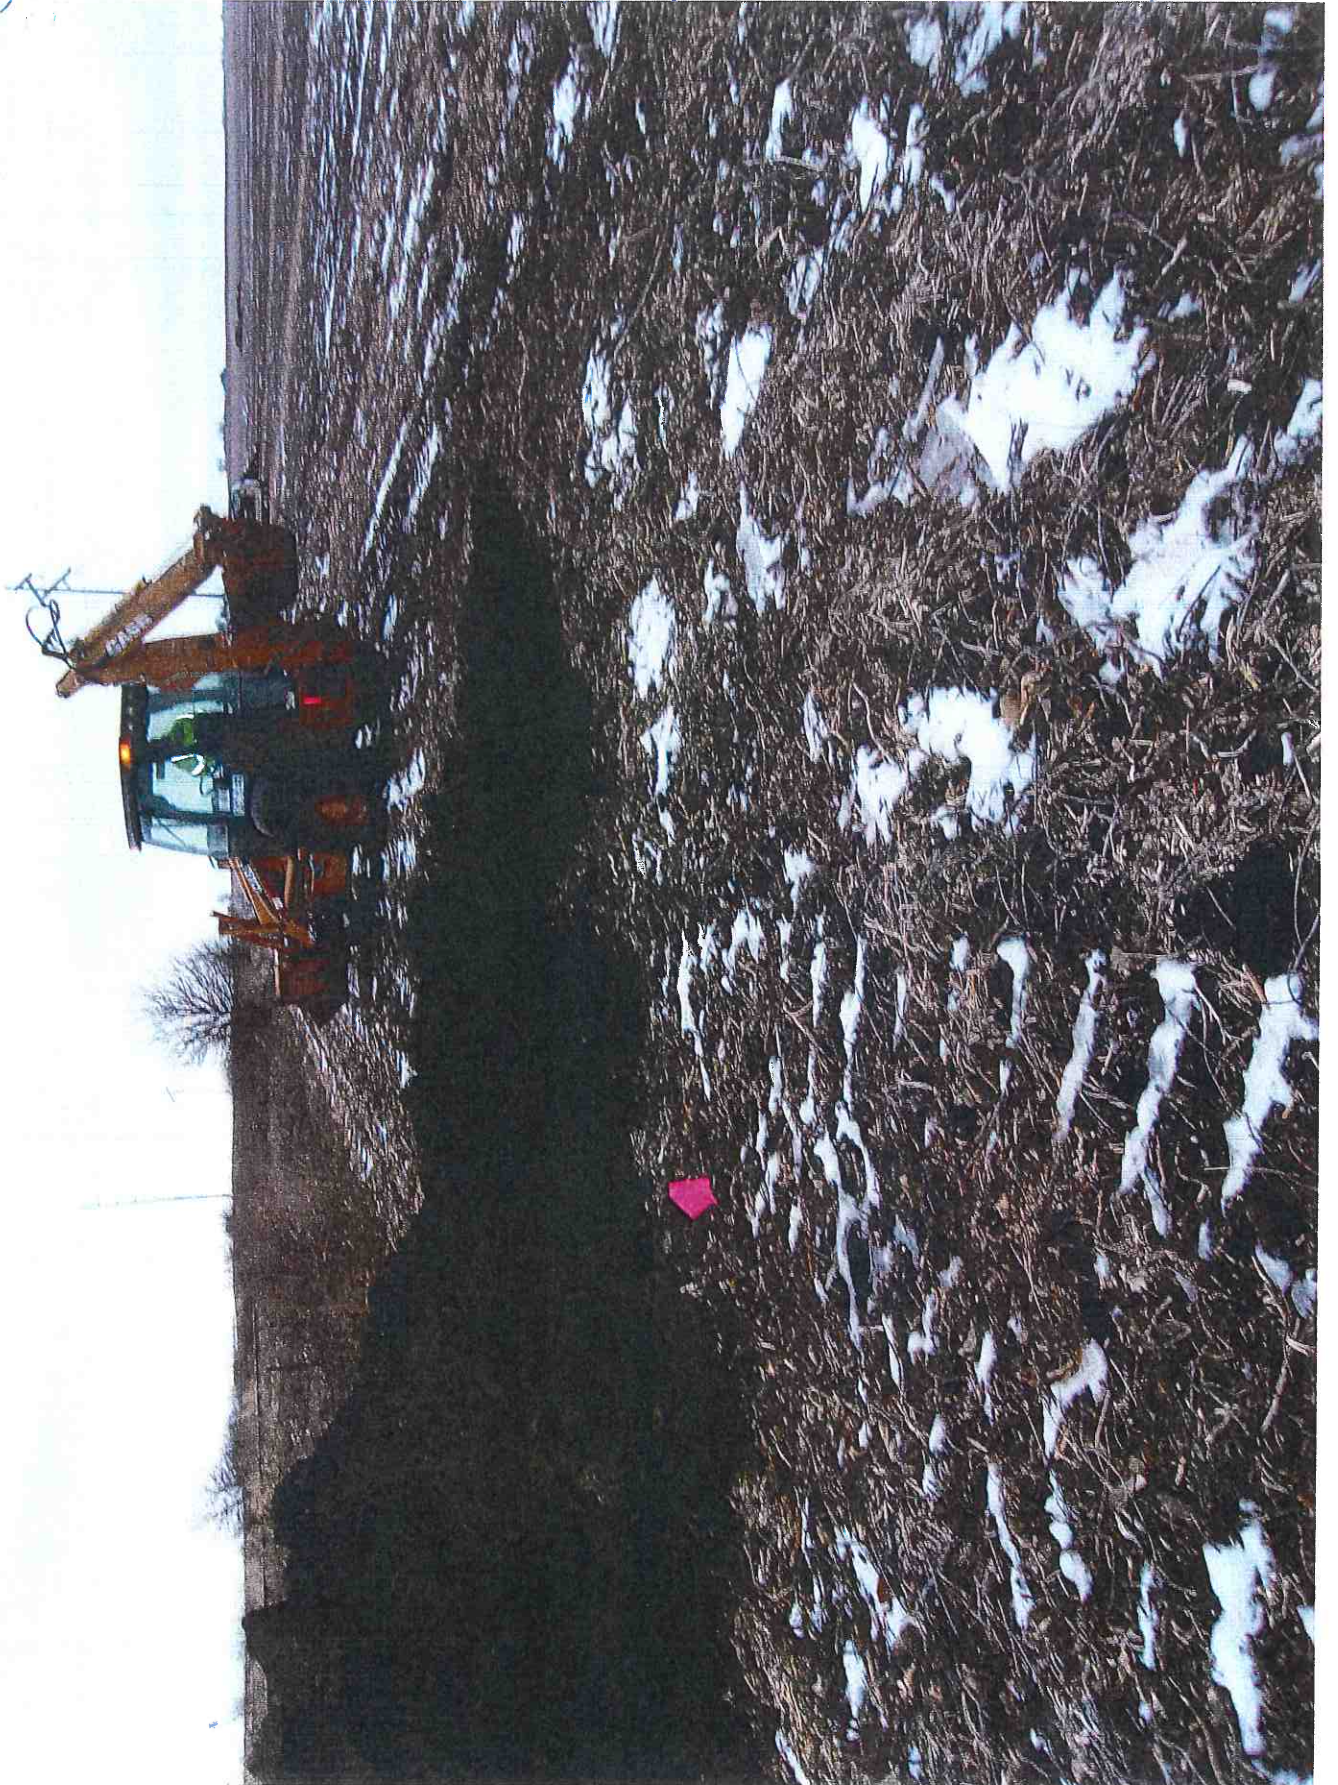
RANDY BROWN AND BACKHOE TO DO TEMP FIXES ON DD 9

Cloudy, scattered showers, 35°, Breezy from S.E.  
ARRIVED @ JOB @ 9:30, No crew on site.  
EMERGENCY CREW ARRIVED @ 10:00 A.M. STARTED TEMP. REPAIRS ON ACCESS INSPECTION  
6" x 6" HOLES IN TILE BY LAYING A 12" x 12" PIECE OF DUAL WALL AND FABRIC  
OVER HOLE AND BACKFILLING WITH NO COMPRESSION, MINIMAL BUCKET COMPRESSION  
PANOSY BREWEN SAID HE WOULD NOT DO THIS LONGER 20' REPAIR WITHOUT  
TILE IS FULL OF DIRT, HE COULDN'T GET ANY PIPE TODAY.  
LEFT JOB @ 10:30 FOR DD125W

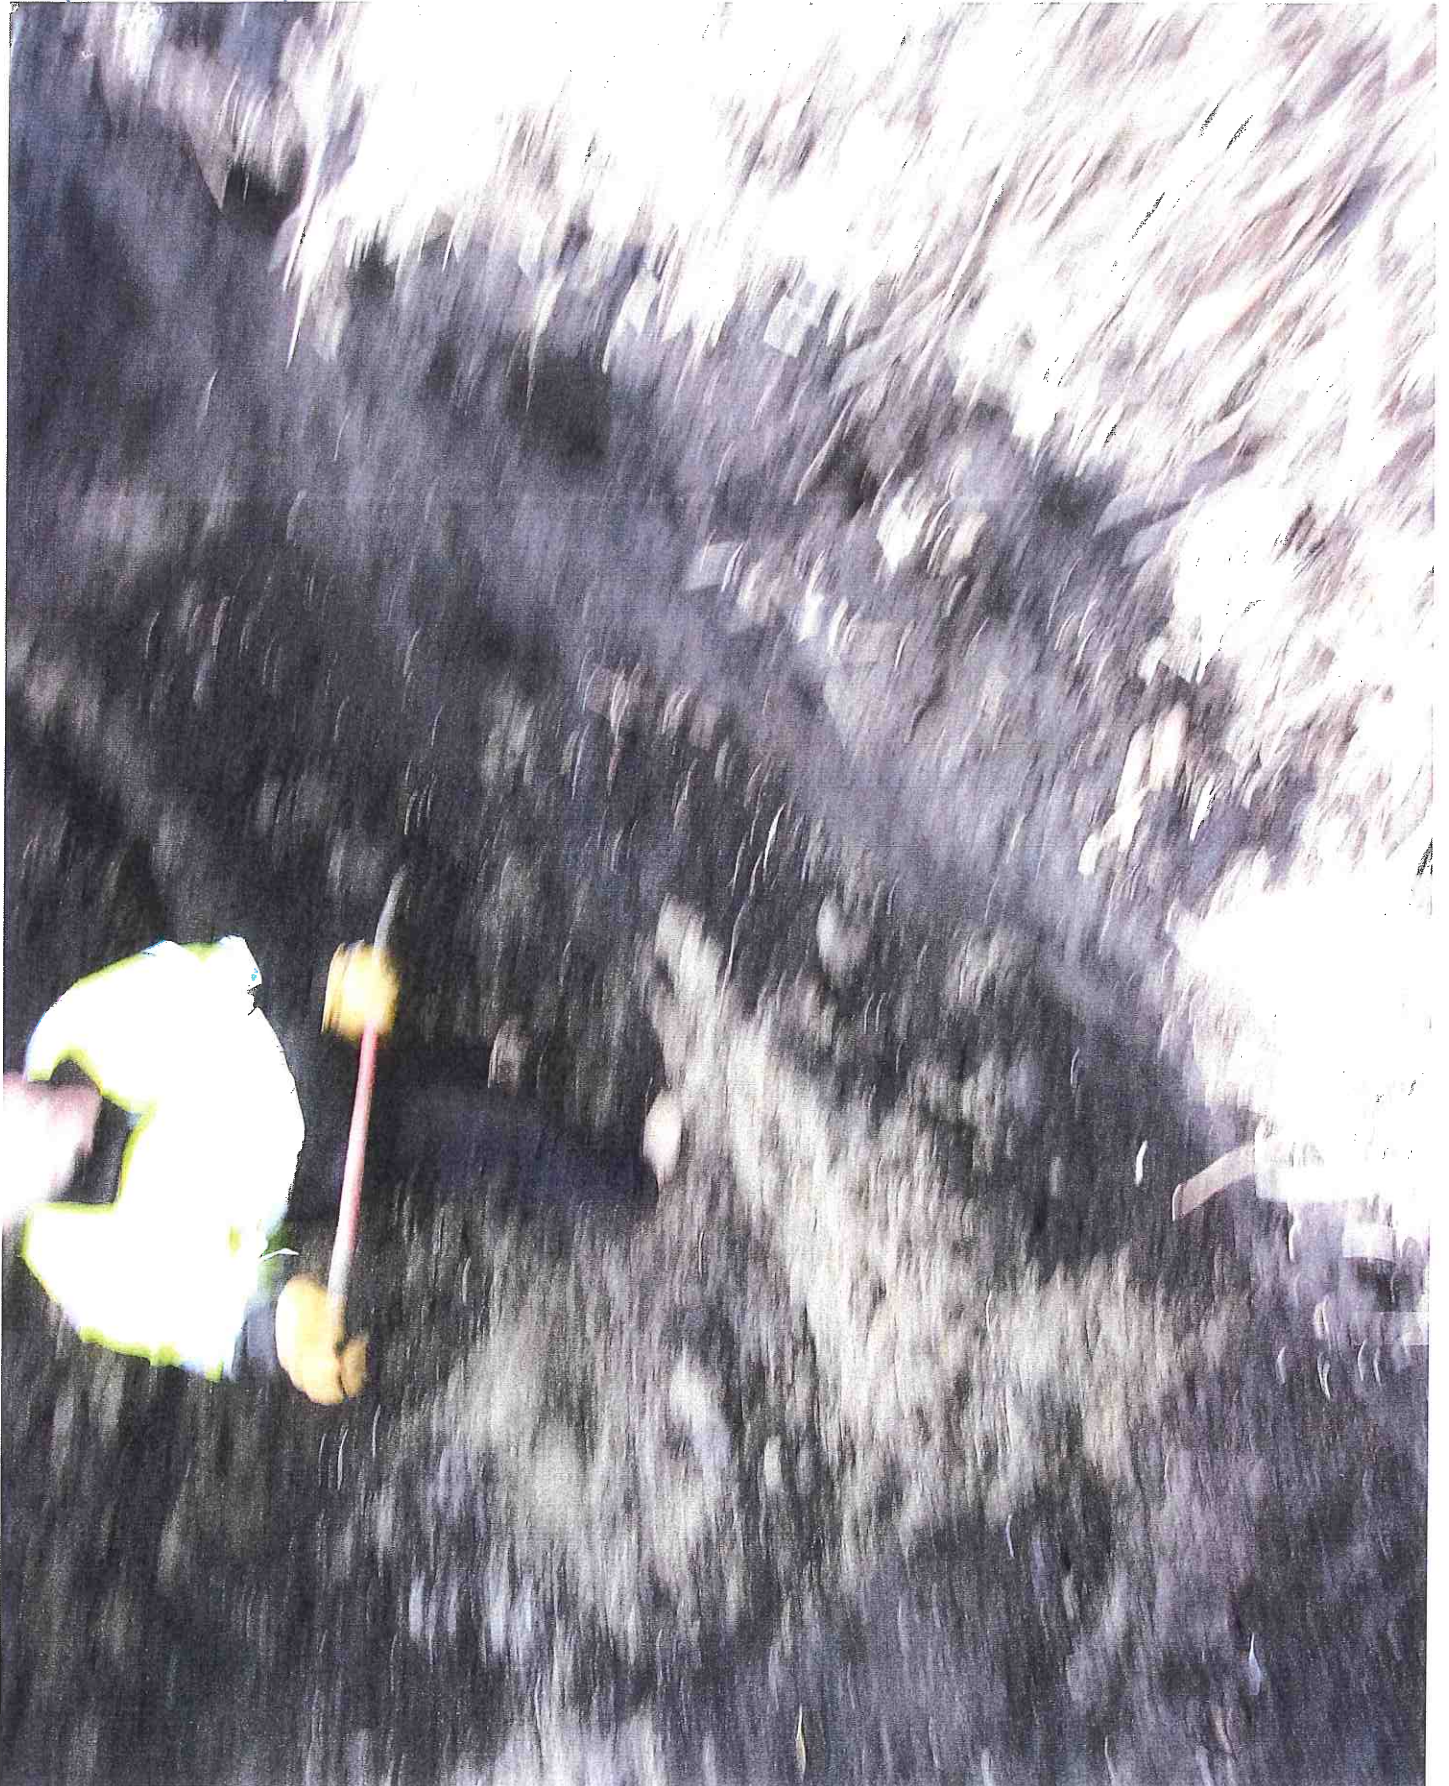
REPAIRING TEMP FIX'S

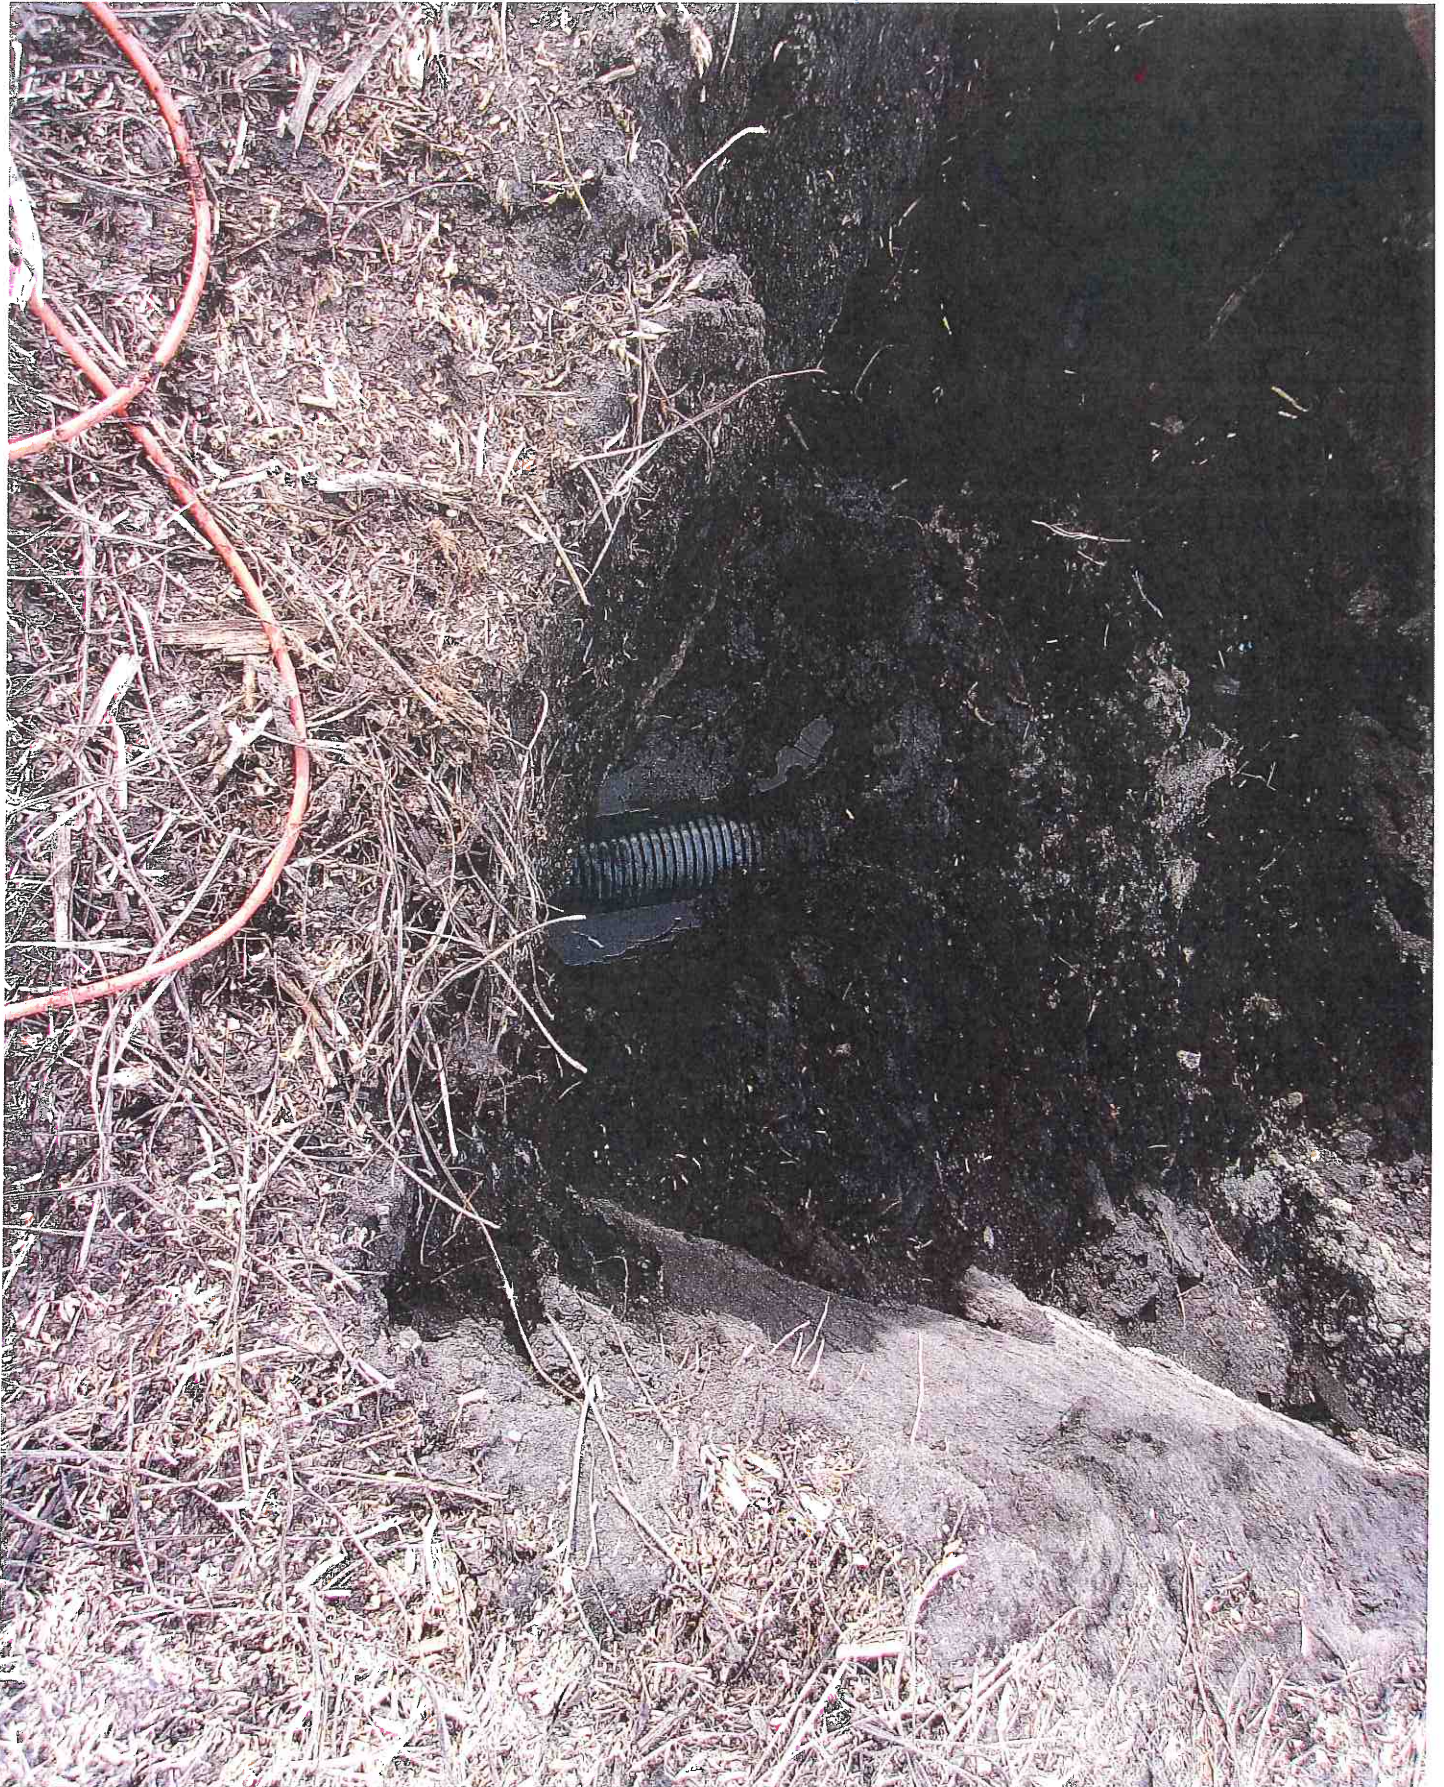
PRIVATE TILE REPAIR @ 5" IPE WITH 6" HOPE OVER TOP

12:15 P.M., RANDY AND NICK SHOWS UP WITH PARTS TO REPAIR 4" PLASTIC TILE ACCIDENTALLY BROKEN DURING EXPLORATION DIG @ #321. BUT ITS A 5", RANDY WENT BACK TO GET PARTS FOR A 5", CAN'T FIND ANY. USED A 2' PIECE OF 6" DUAL WALL SHIP OVER THE 5" SINGLE WALL TIGHT FIT WITH FABRIC OVER. THEY ALSO PUT A CHUNK OF DUAL WALL AND FABRIC OVER INSPECTION HOLE AND BACK FILL. PILES OF DIRT ARE FROZEN, 1' THICK. HARD TO BACKFILL.

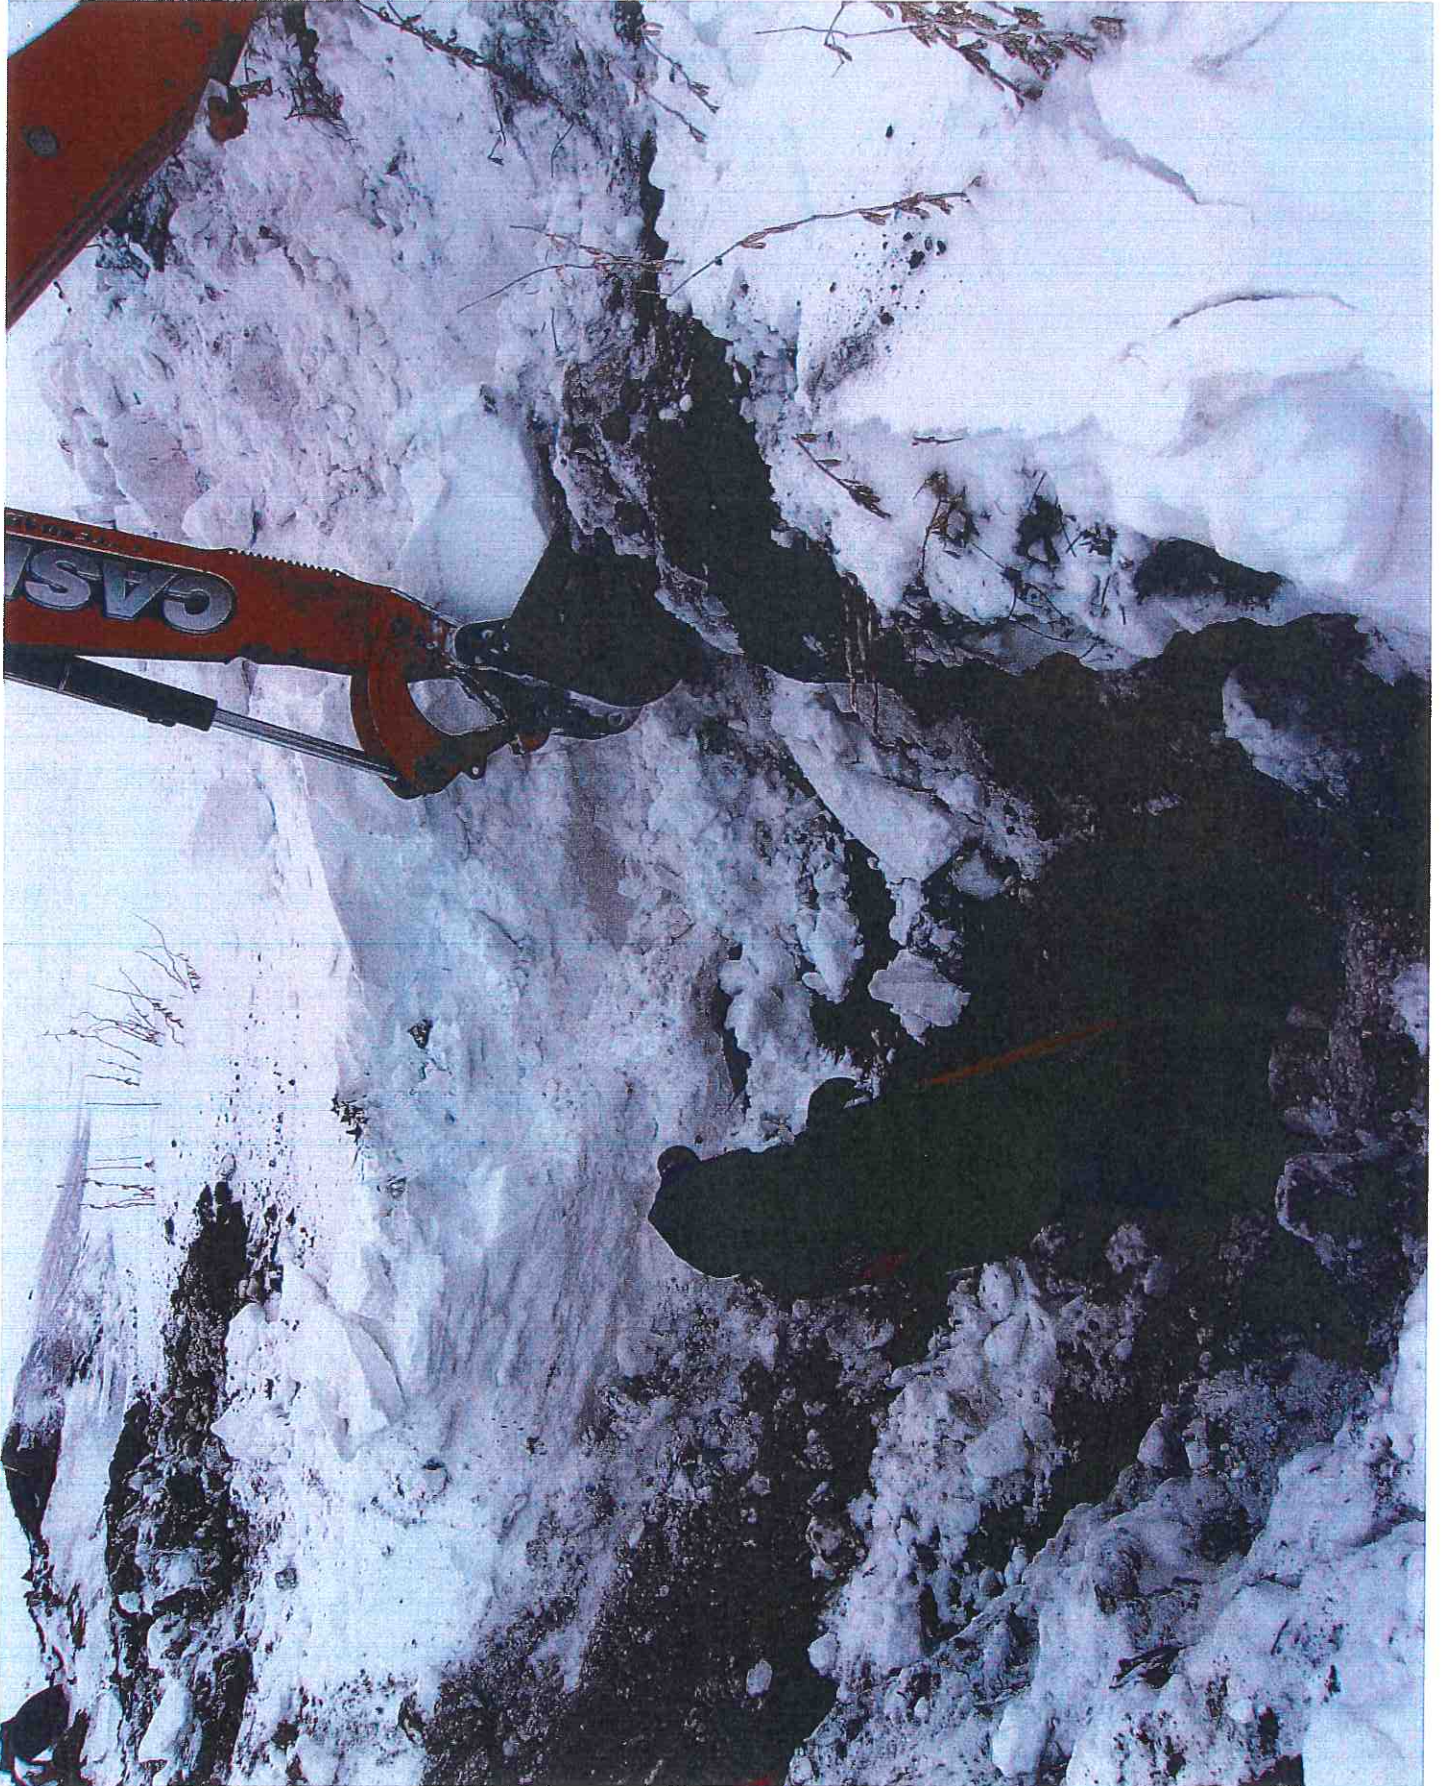
EASTING HOLE FROM RANNEY BROWN #340 IS FULL OF SNOW, LEVEL FULL!

REMOVING SNOW FROM EXISTING HOLE @ #340
