9

## Repair Summary:

**DRAINAGE DISTRICT #9**  
 HARDIN, IOWA

**SPOT REPAIRS**

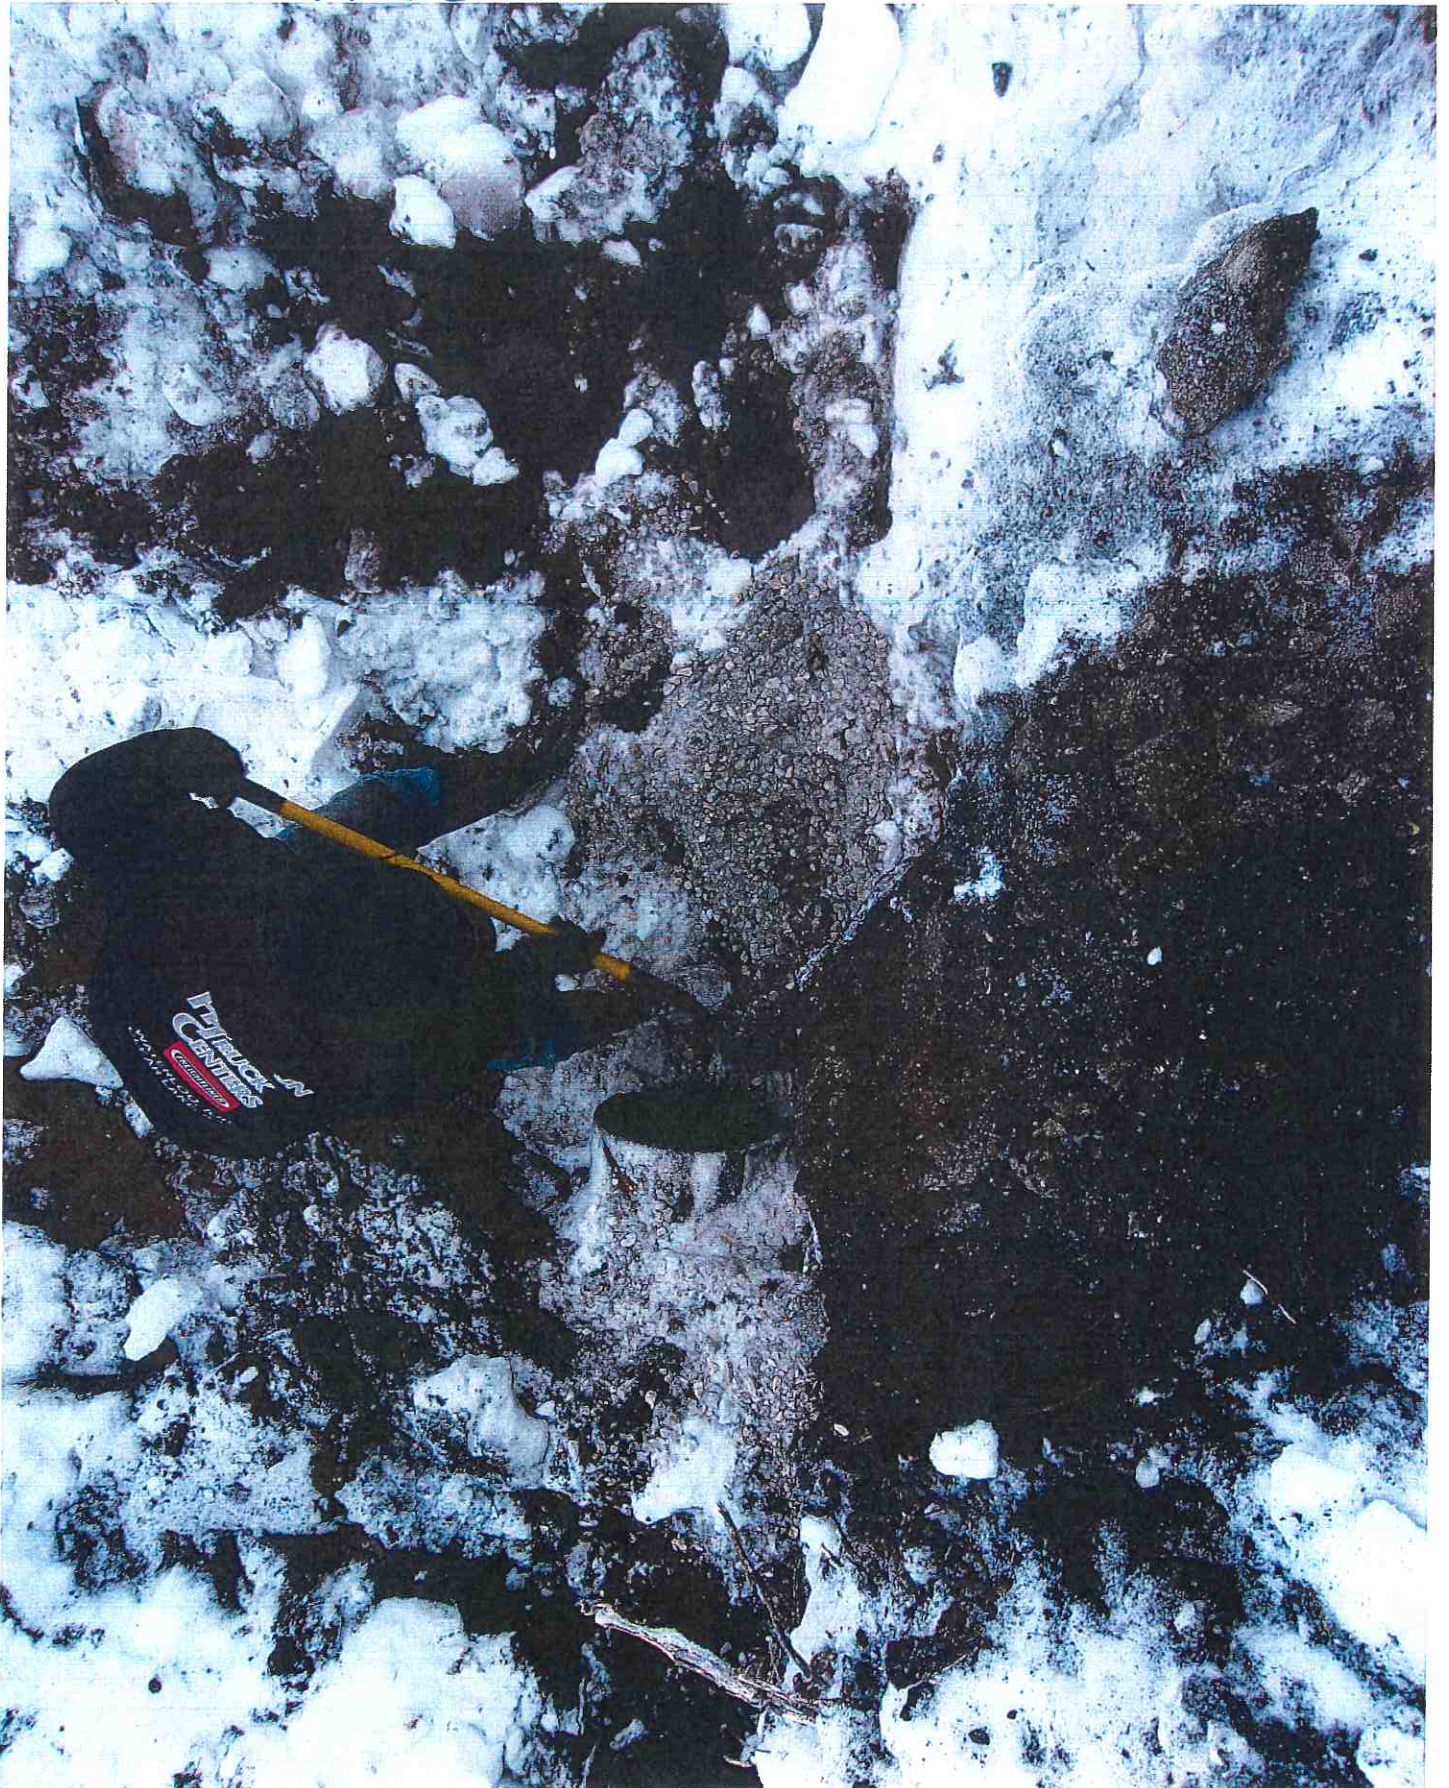
PLACING BROODING ROCK @ F

11:30 A.M., BEDDING ROCK @ F IS IN PLACE. 18'4" BETWEEN ENDS ON CLAY TILE.

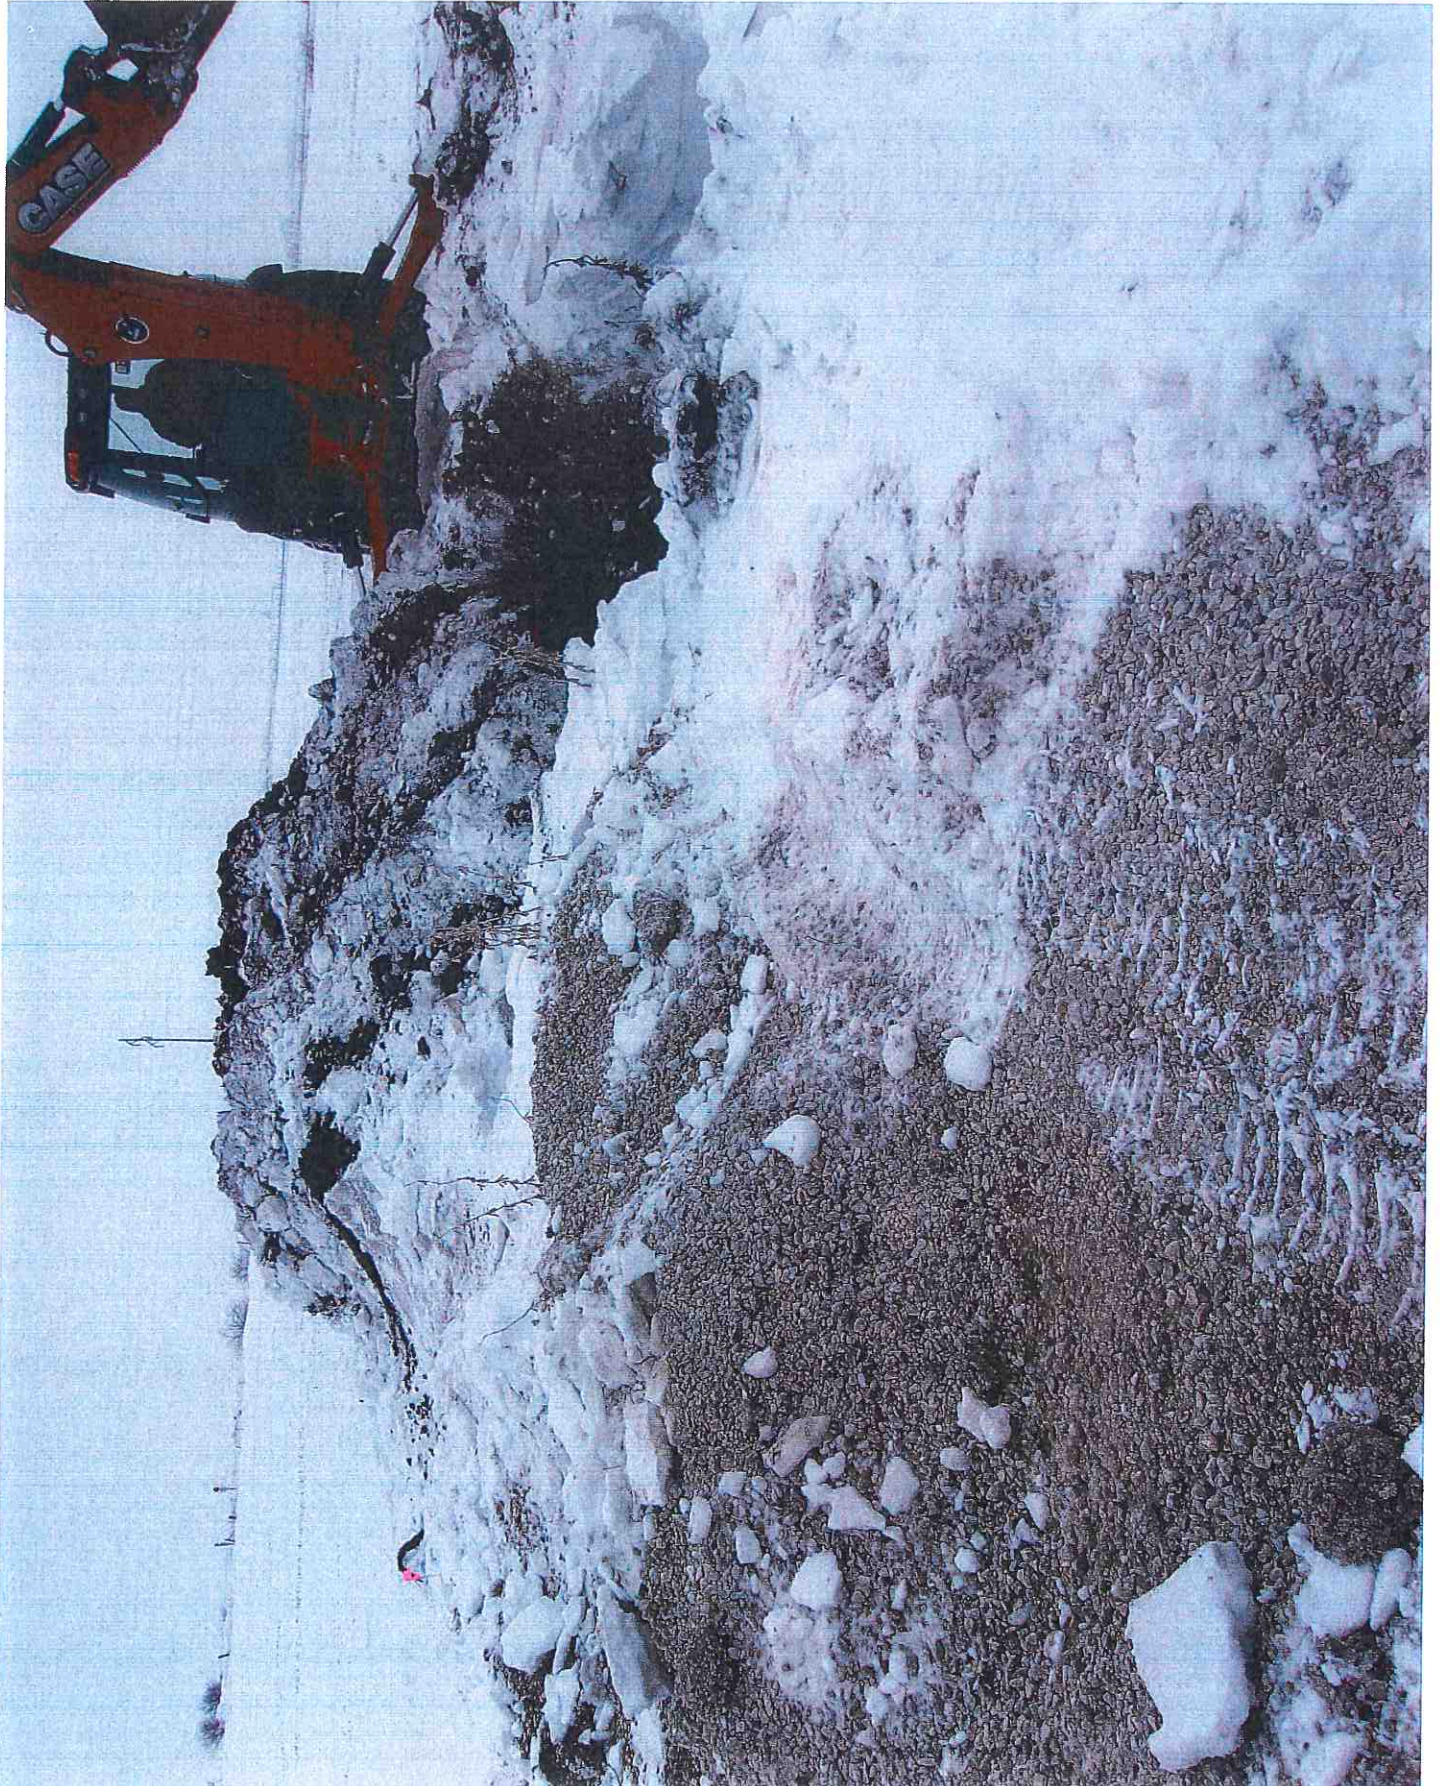
Cloudy, Foggy, 25°, Wind From S.E., RAIN PREDICTED FOR TOMORROW. 1/2' OF SNOW ON GROUND, LOTS OF ICE. 2' OF FROZEN EARTH IN FIELDS

CONDITIONS @ JOB SITE

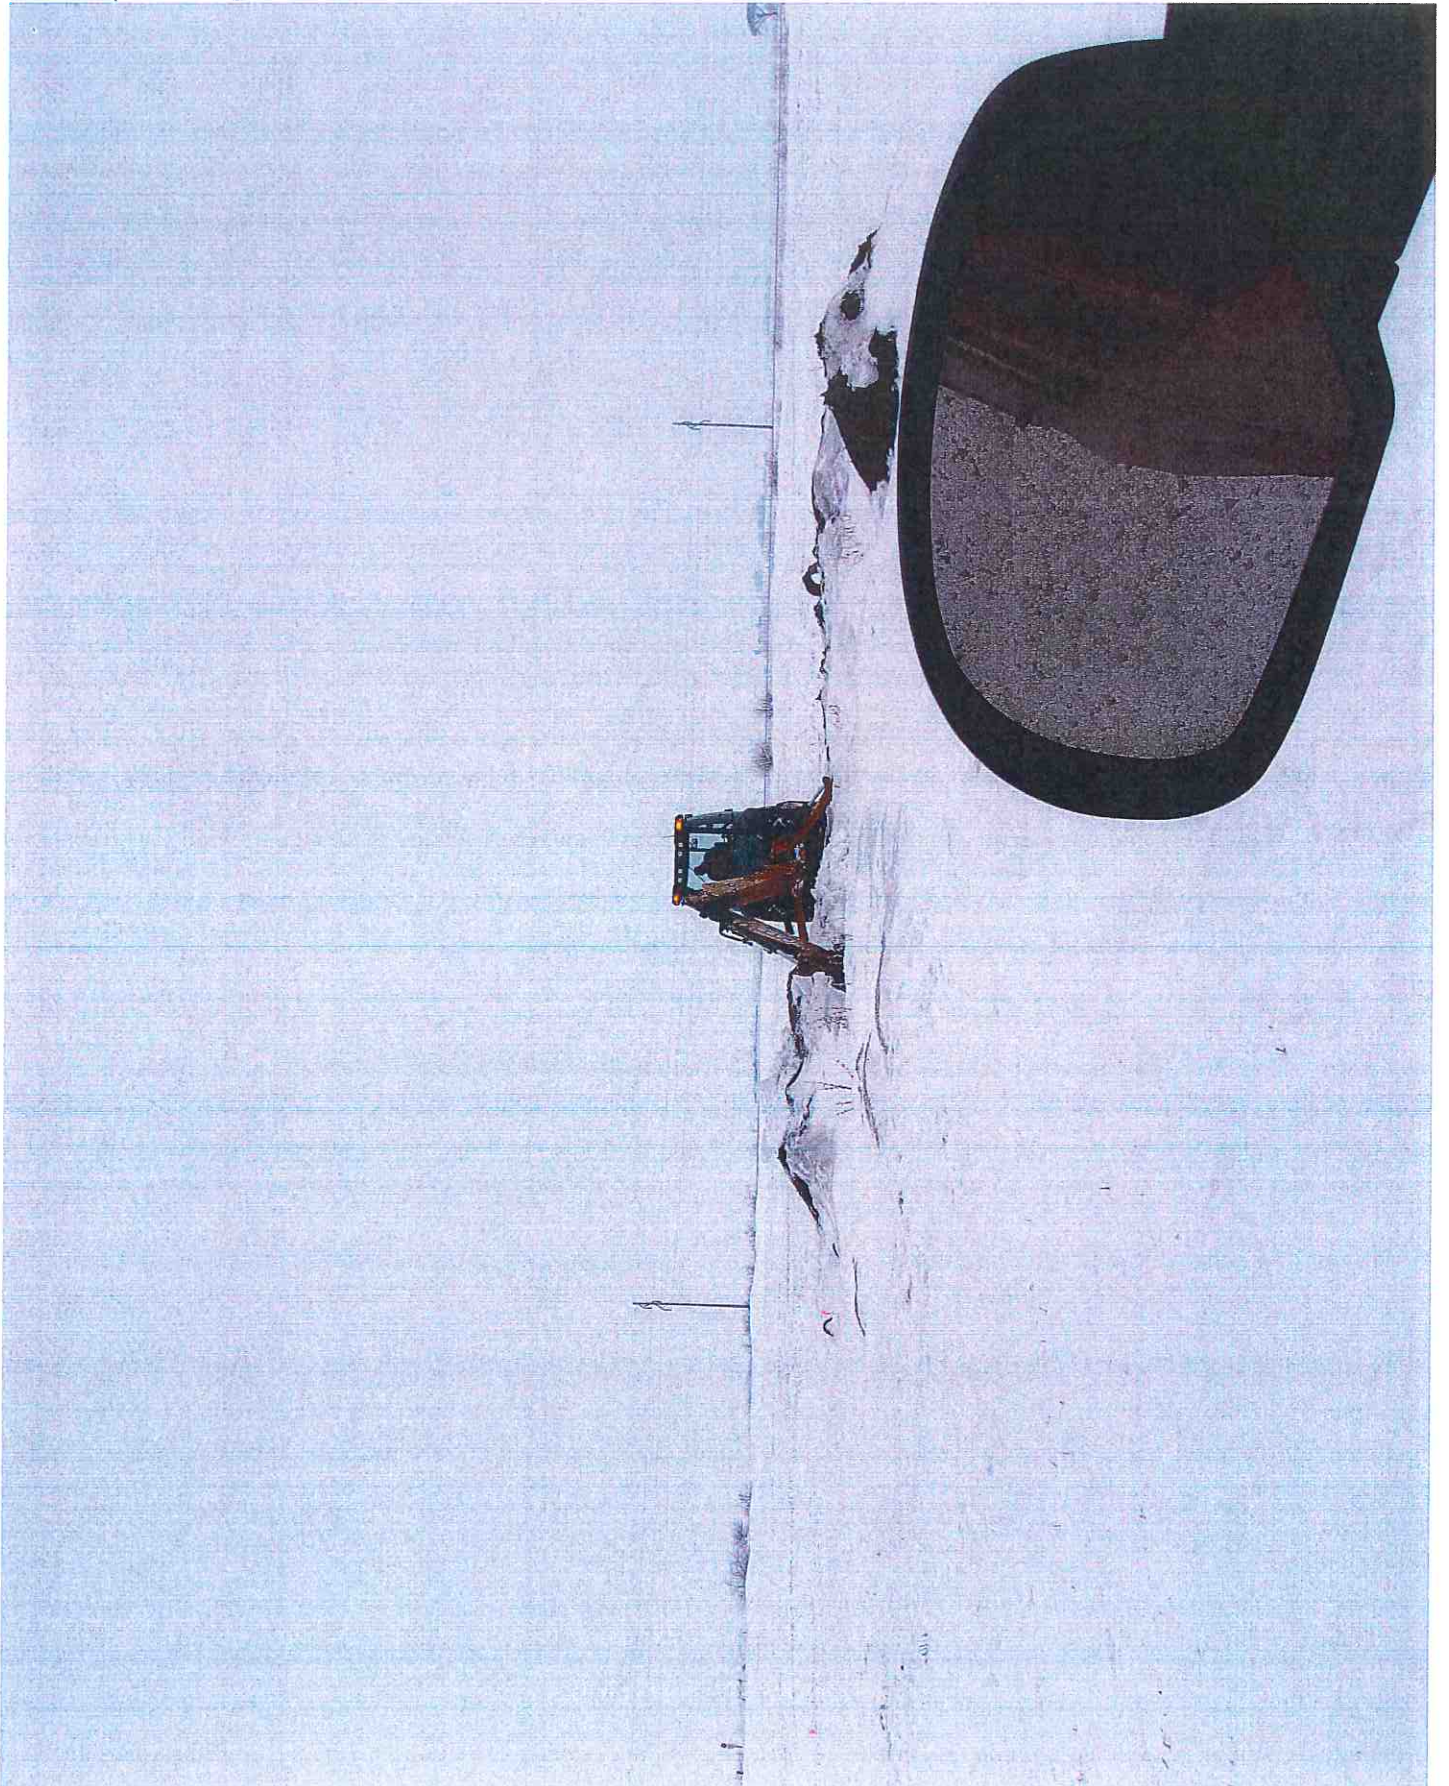
CONDITIONS @ JOB SITE #340

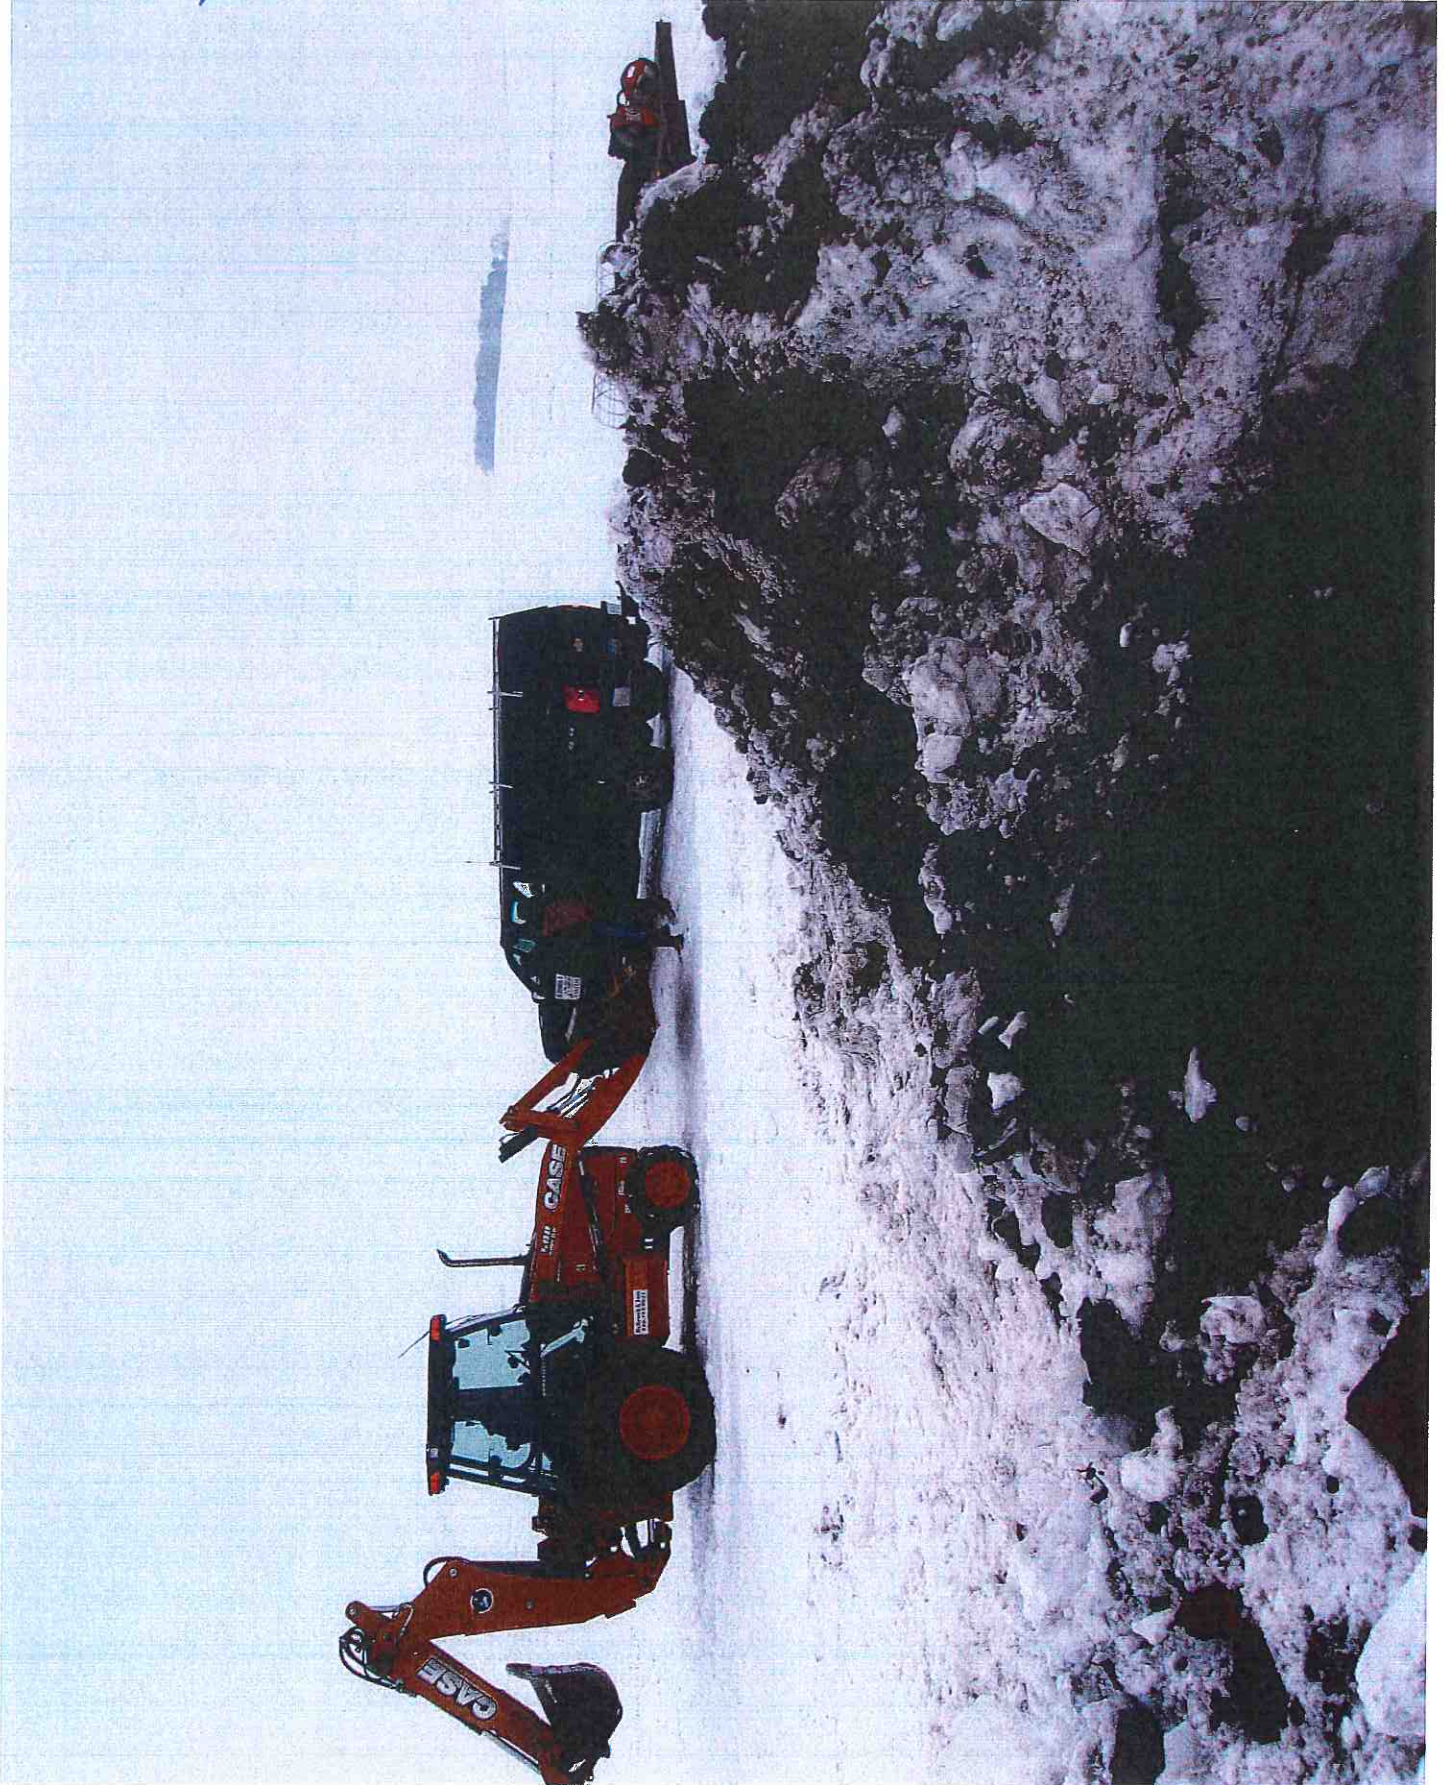
LOADING UP 12 BAGS CONE FOR 3/4 COLARS

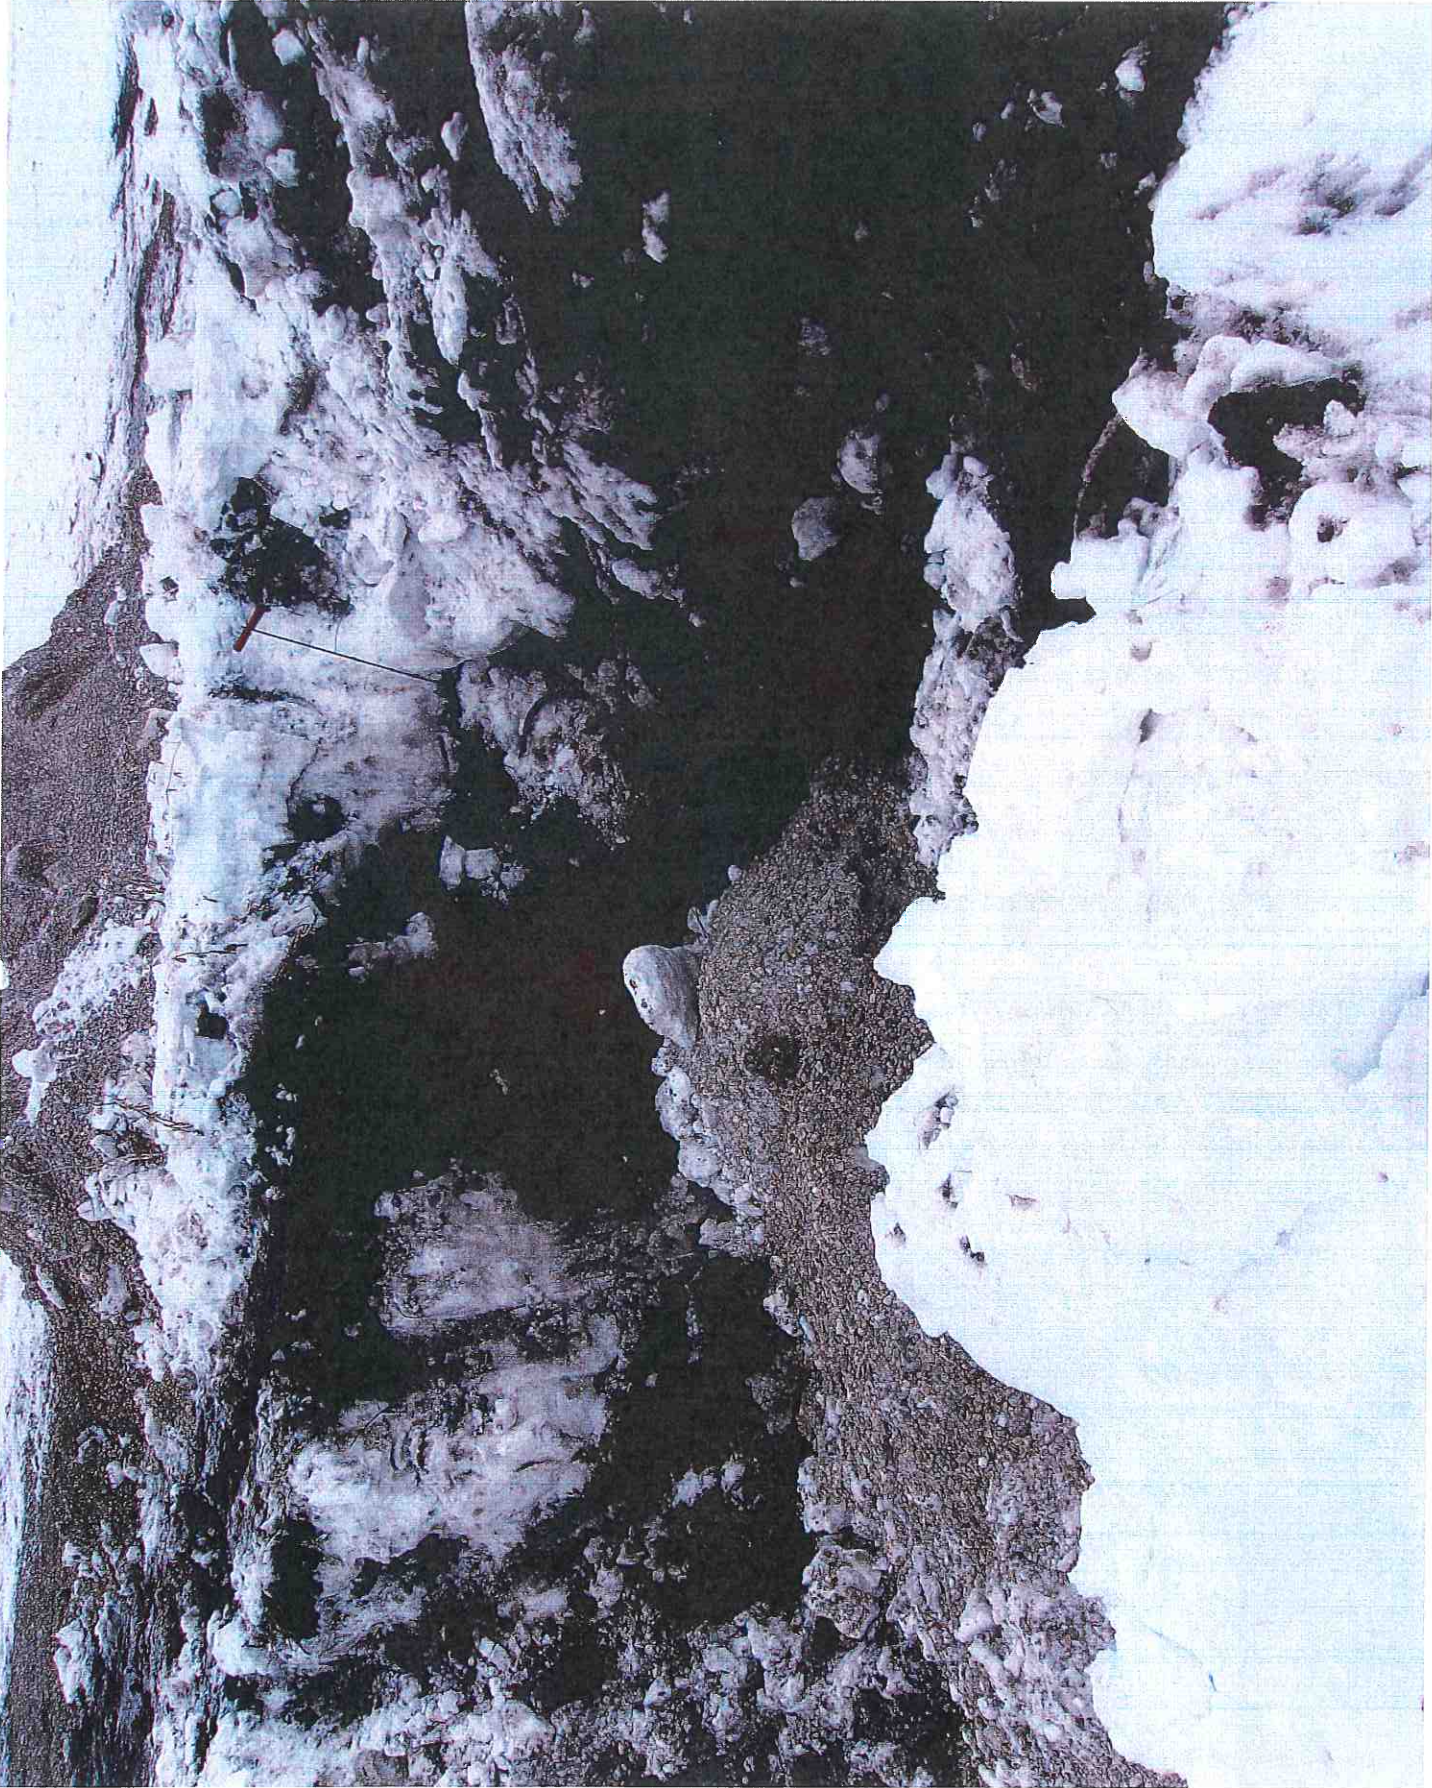
6 TON BRIDGING ROCK USED

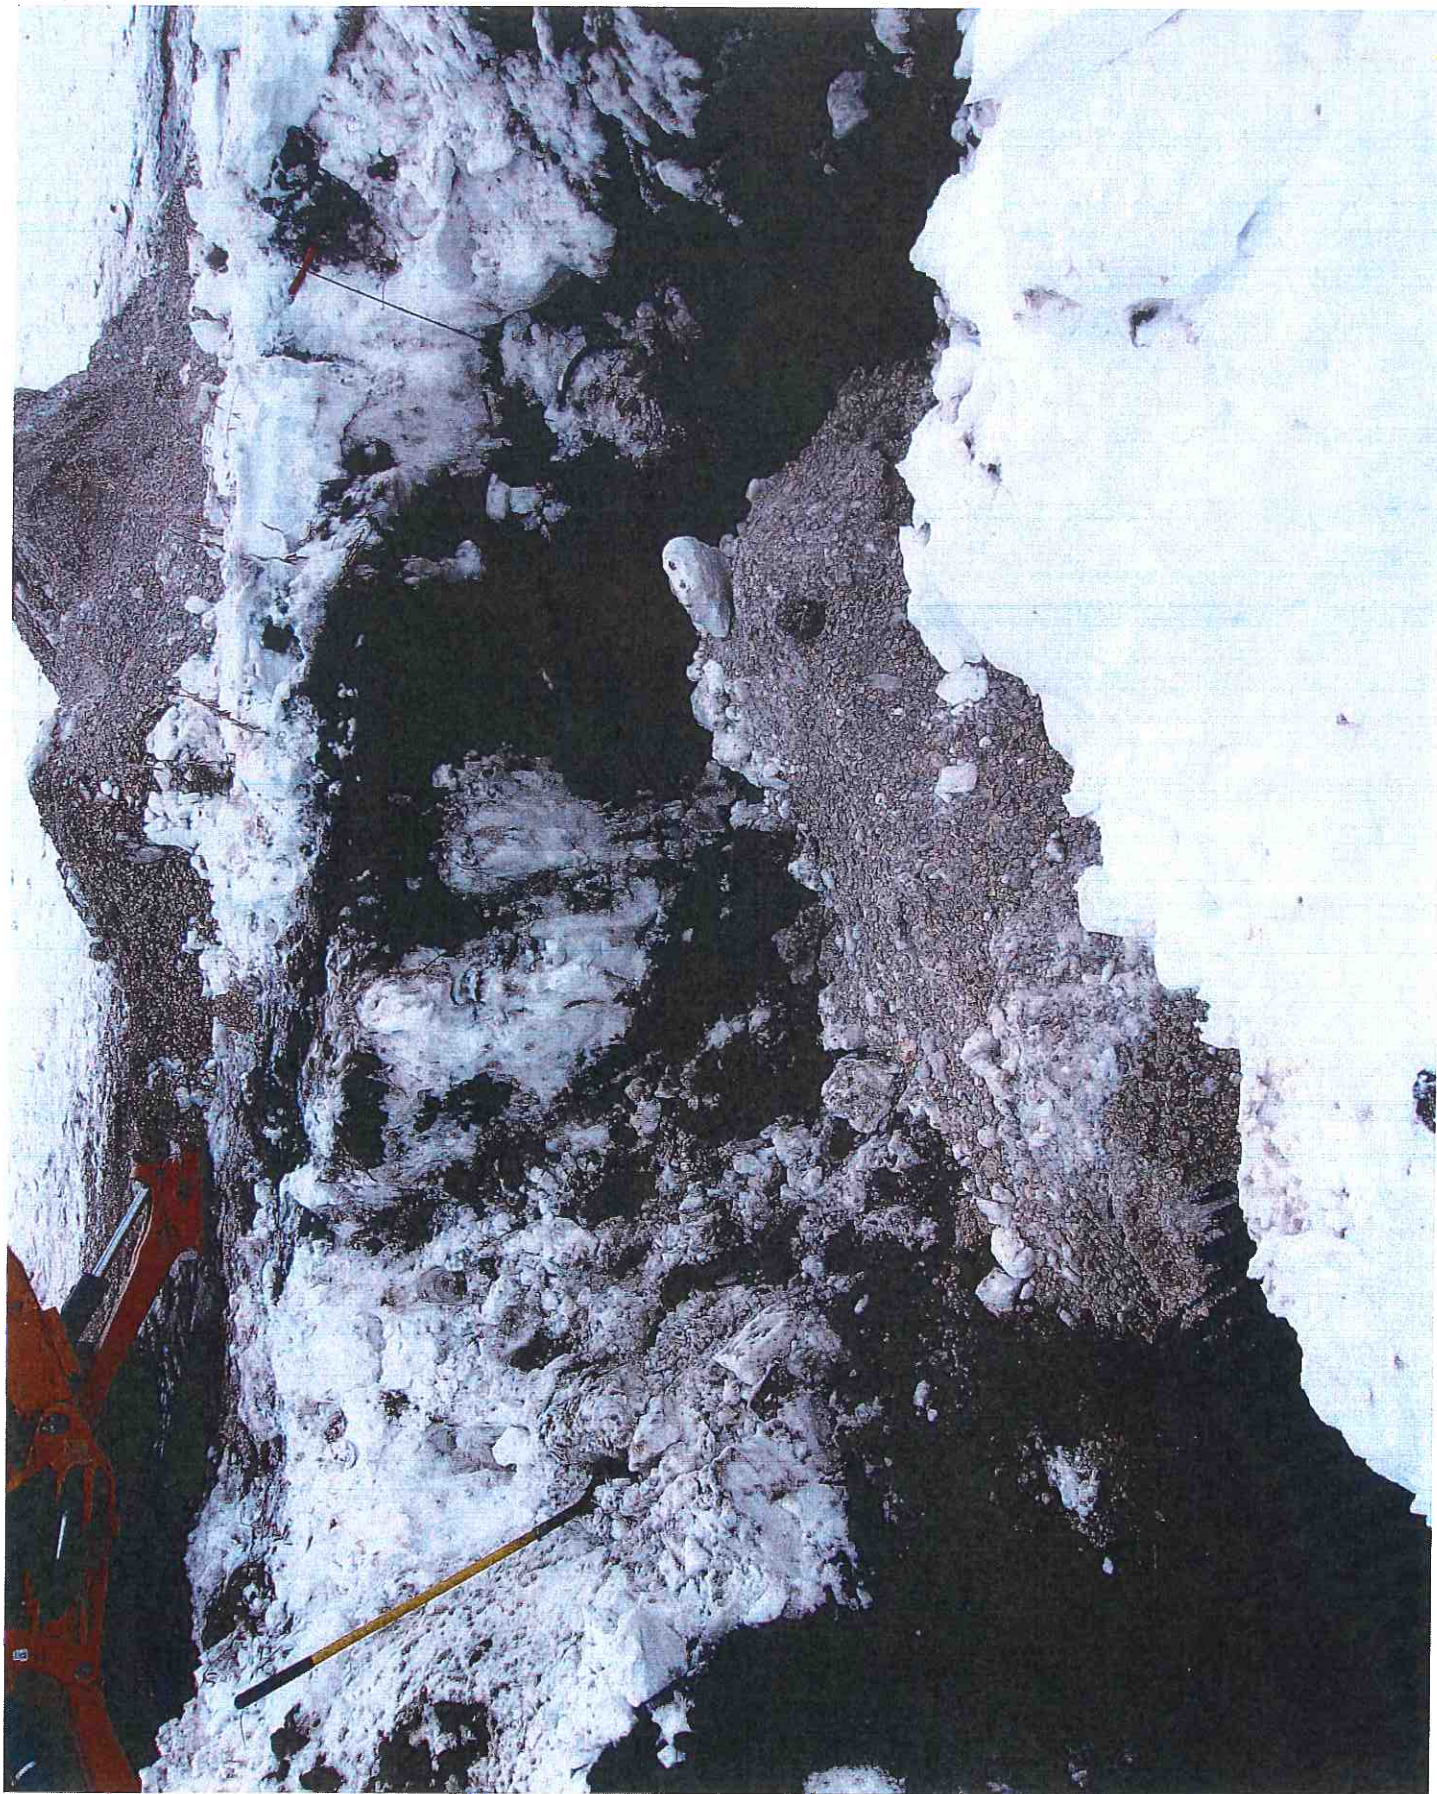
PLACING ROCK AROUND 15" HOPE

1:30, TILE IN PLACE, BACK FILLED WITH ROCK.

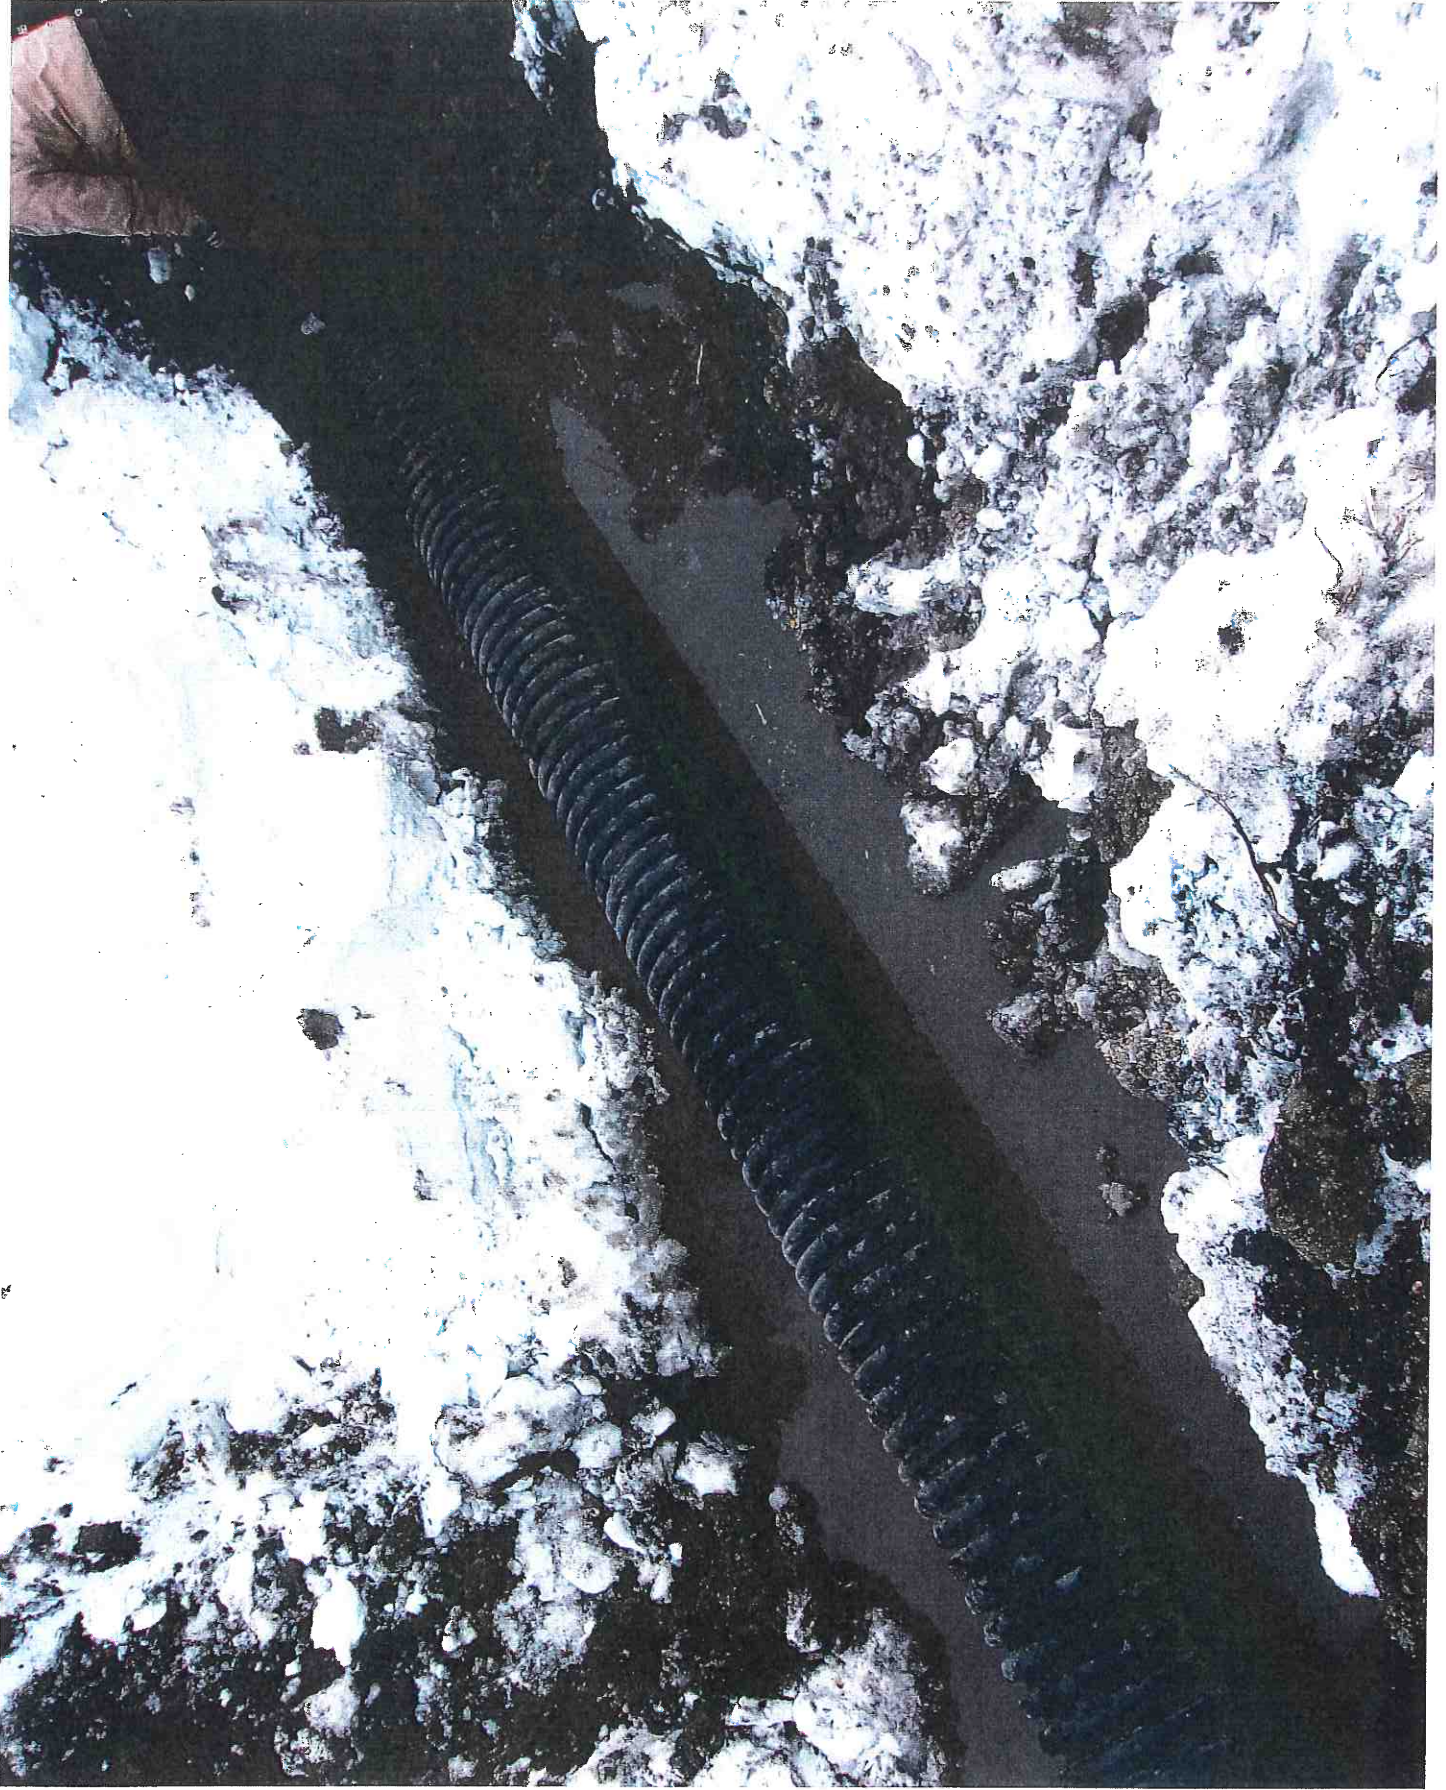
18.3' OF 15" HDPE dual Wall

8:30 ARRIVED @ JOB SITE @ "RACINE" GHOST TOWN. CONTRACTOR "McDOWELLS" ARE ON SITE 3 MEN + RUBBER TIRE BACKHOE. PLAN IS TO REMOVE BROKEN 14" CLAY TILE (ALREADY EXPOSED BY RANNEY BROWN), AND REPAIR PERMANENTLY WITH 15" HOPE DUAL WALL / ROCK / CONC. COLLARS. BARE MINIMUM IS TO GET HOPE IN PLACE WITH ROCK AND FABRIC OVER CONNECTIONS. BACK FILL MATERIAL ON SITE MAY BE TO FROZEN. WOULD HAVE TO POUR COLLARS @ A LATER DATE. 1" OF RAIN IS PREDICTED TOMORROW AND THIS COULD WASH MORE DIRT IN TILE.
