MINUTES
PUBLIC HEARING ON ENGINEER'S REPORT
ON REPAIR OR IMPROVEMENTS TO MAIN
DRAINAGE DISTRICT 102, HARDIN COUNTY
AND
PUBLIC HEARING ON ENGINEER'S REPORT ON
REPAIR OR IMPROVEMENTS TO LATERAL 7 TILE
DRAINAGE DISTRICT 102, HARDIN COUNTY

AUGUST 10, 2016 AT 11:30 A.M.
HARDIN COUNTY COURTHOUSE

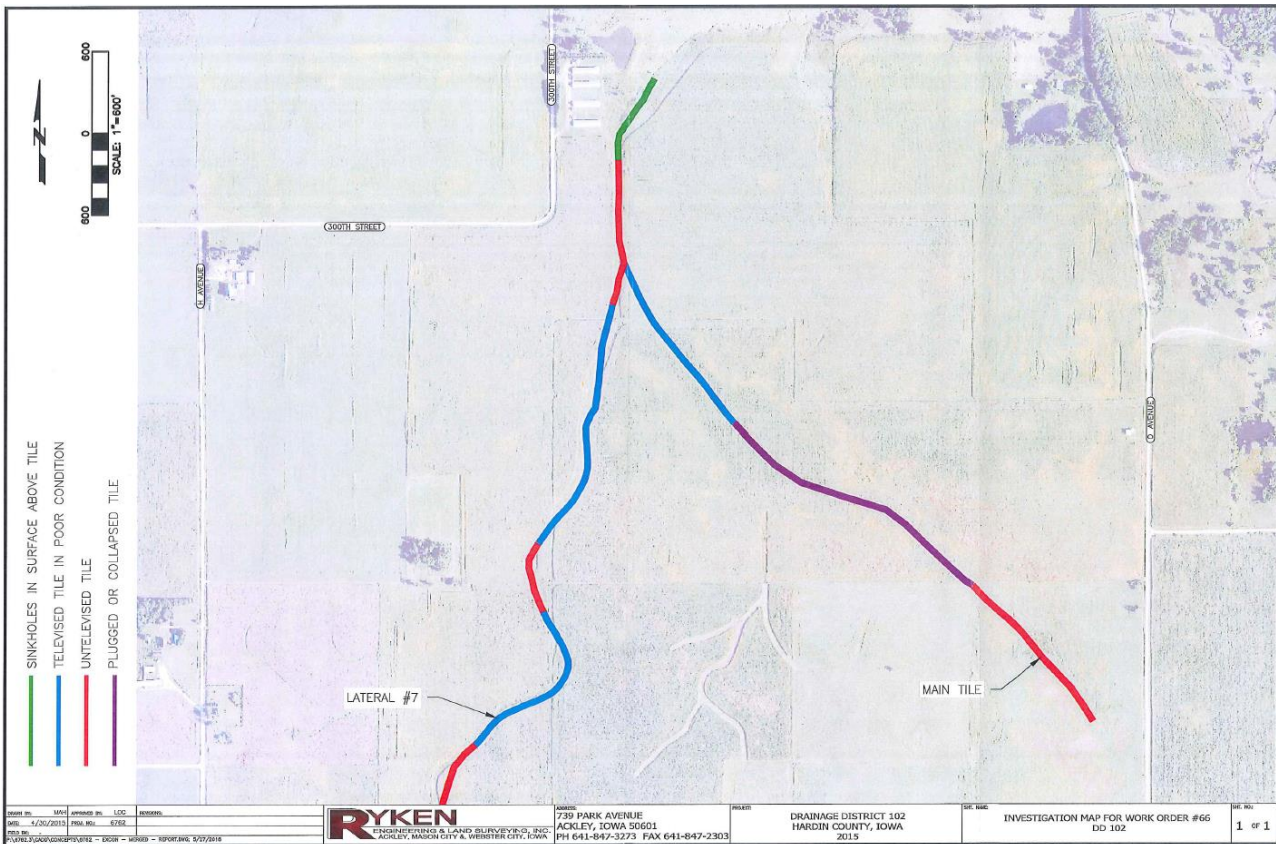
Due to requests for repairs, Ryken Engineering was asked to investigate the entire length of the main. They attempted to televise the area in purple (as shown below), but it was plugged with dirt. They were able to televise the area in blue but the entire tile was in poor physical condition. The area in red was not televised at all. They were able to walk the area in green and found several sinkholes at the surface.

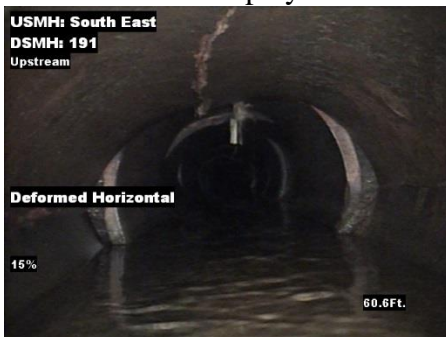
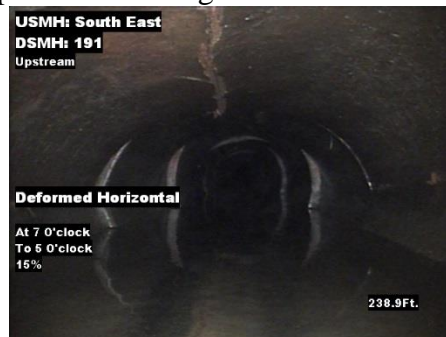
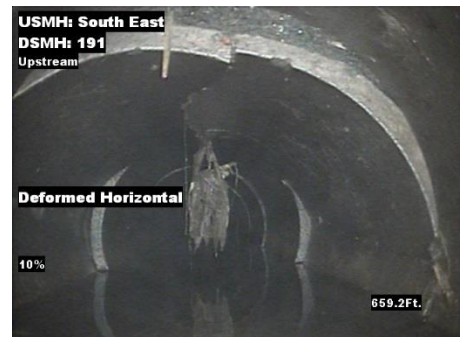
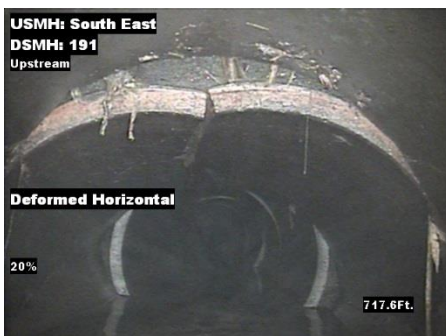
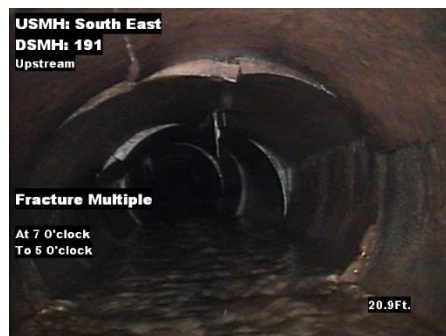
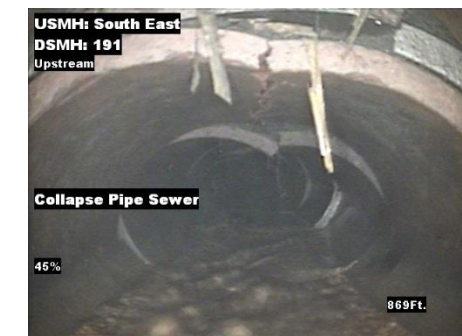
Gallentine then displayed televising pictures showing the current condition of the tile:

Gallentine explained that the drainage coefficient of the tile installed at good conditions, not the current state of the tile, is about 0.12" per acre per day at the outlet and 0.95" per acre per day upstream. It is the Engineer's opinion that the main tile is undersized when compared to current agricultural demands. He also stated the district has experienced an extremely high level of repairs on a regular basis (an average of every 10½ months over the past 62 years). These factors in addition to the requests within the first 4-5 years indicate possible inferior material during the 1917 construction or improper construction methods.

Gallentine further explained the repair option as provided in the Engineer's Report. The repair method would remove the entire existing main tile and install the same size at approximately the same location and reconnect any private tile. This would keep the drainage coefficient as stated above with an estimate of \$568,260.

- Remove the entire length of the existing main tile and install new dual tile at about 10-15 feet apart from each other at approximately the same location with interconnects. The advantage of dual tile over one larger tile is the added soil cover, which Gallentine stated would be about 1 foot. This method has an estimate of \$985,155.60 for ½" drainage coefficient and \$1,183,578 for 1" coefficient.
- Remove the entire length of the existing main tile and install a new larger tile at approximately the same location. The estimate for this method is \$608,487 for ½" drainage coefficient and \$777,876 for 1" coefficient.
- Remove the entire length of the existing main tile and install an open ditch (approximately 200' wide) at an estimate of \$753,918 for a drainage coefficient of 8.8' at the outlet and 75' upstream.

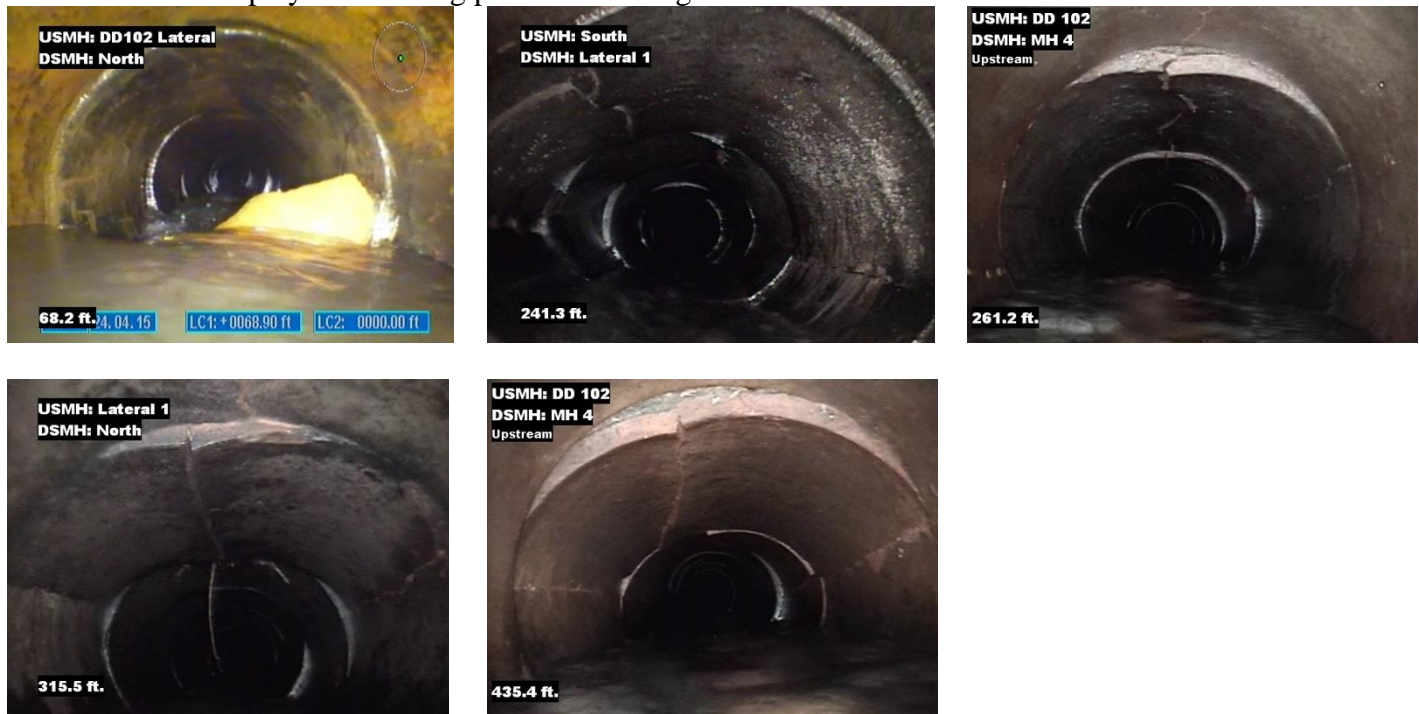
Gallentine then displayed televising pictures showing the current condition of the tile:

Gallentine explained that the drainage coefficient of the tile installed at good conditions, not the current state of the tile, is about 0.29" per acre per day at the lower end and 0.73" per acre per day at the upper end. The current size of tile ranges from 8" – 18". It is the Engineer's opinion that the lateral 7 tile is undersized when compared to current agricultural demands. He also stated the district has experienced an extremely high level of repairs on a regular basis (an average of every 10½ months over the past 62 years). These factors in addition to the requests within the first 4-5 years indicate possible inferior material during the 1917 construction or improper construction methods.

Gallentine further explained the repair option as provided in the Engineer's Report. The repair method would remove the entire existing main tile and install the same size at approximately the same location and reconnect any private tile. This would keep the drainage coefficient as stated above with an estimate of \$480,150 with road authorities paying \$2,750 of that amount.

- Remove the entire length of the existing lateral 7 tile and install new dual tile. This method has an estimate of \$852,588 for ½" drainage coefficient and \$988,020 for 1" coefficient.
- Remove the entire length of the existing lateral 7 tile and install a new larger tile at approximately the same location. The estimate for this method is \$516,780 for ½" drainage coefficient (10"-24" tile) and \$588,390 for 1" coefficient (15"-30" tile).
- Remove the entire length of the existing main tile and install an open ditch at an estimate of \$670,758 for a drainage coefficient with approximately 13.5 acres of right of way obtained.
