AGENDA
REGULAR DRAINAGE MEETING
April 17, 2019
8:30AM

Drainage Work Order Request For Repair Hardin County

Repair Summary:

CONSTRUCTION ENGINEERING
OBSERVATION REPORT

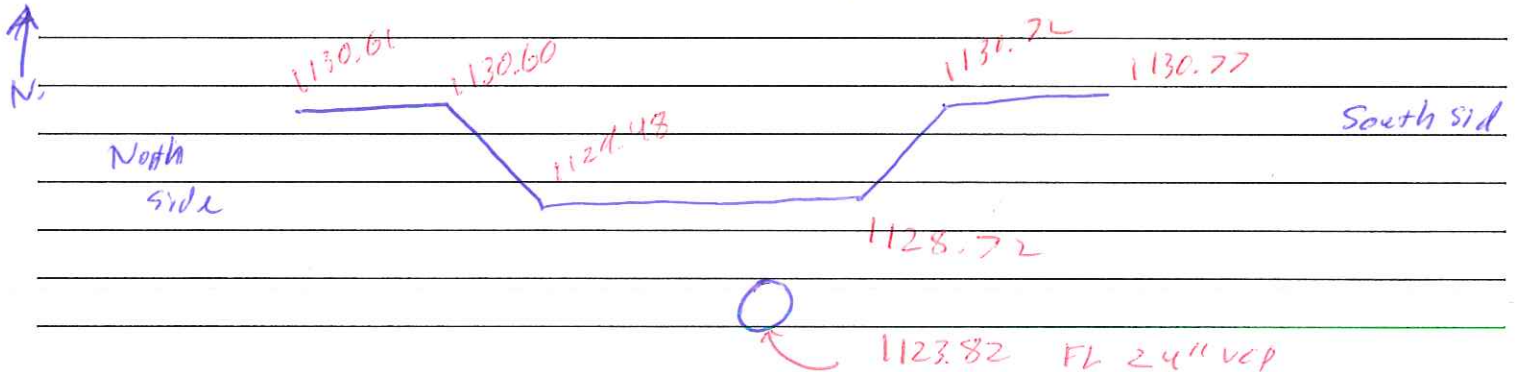
1:00 - Found out let of 24" in Head wall

- out let is completely submerged

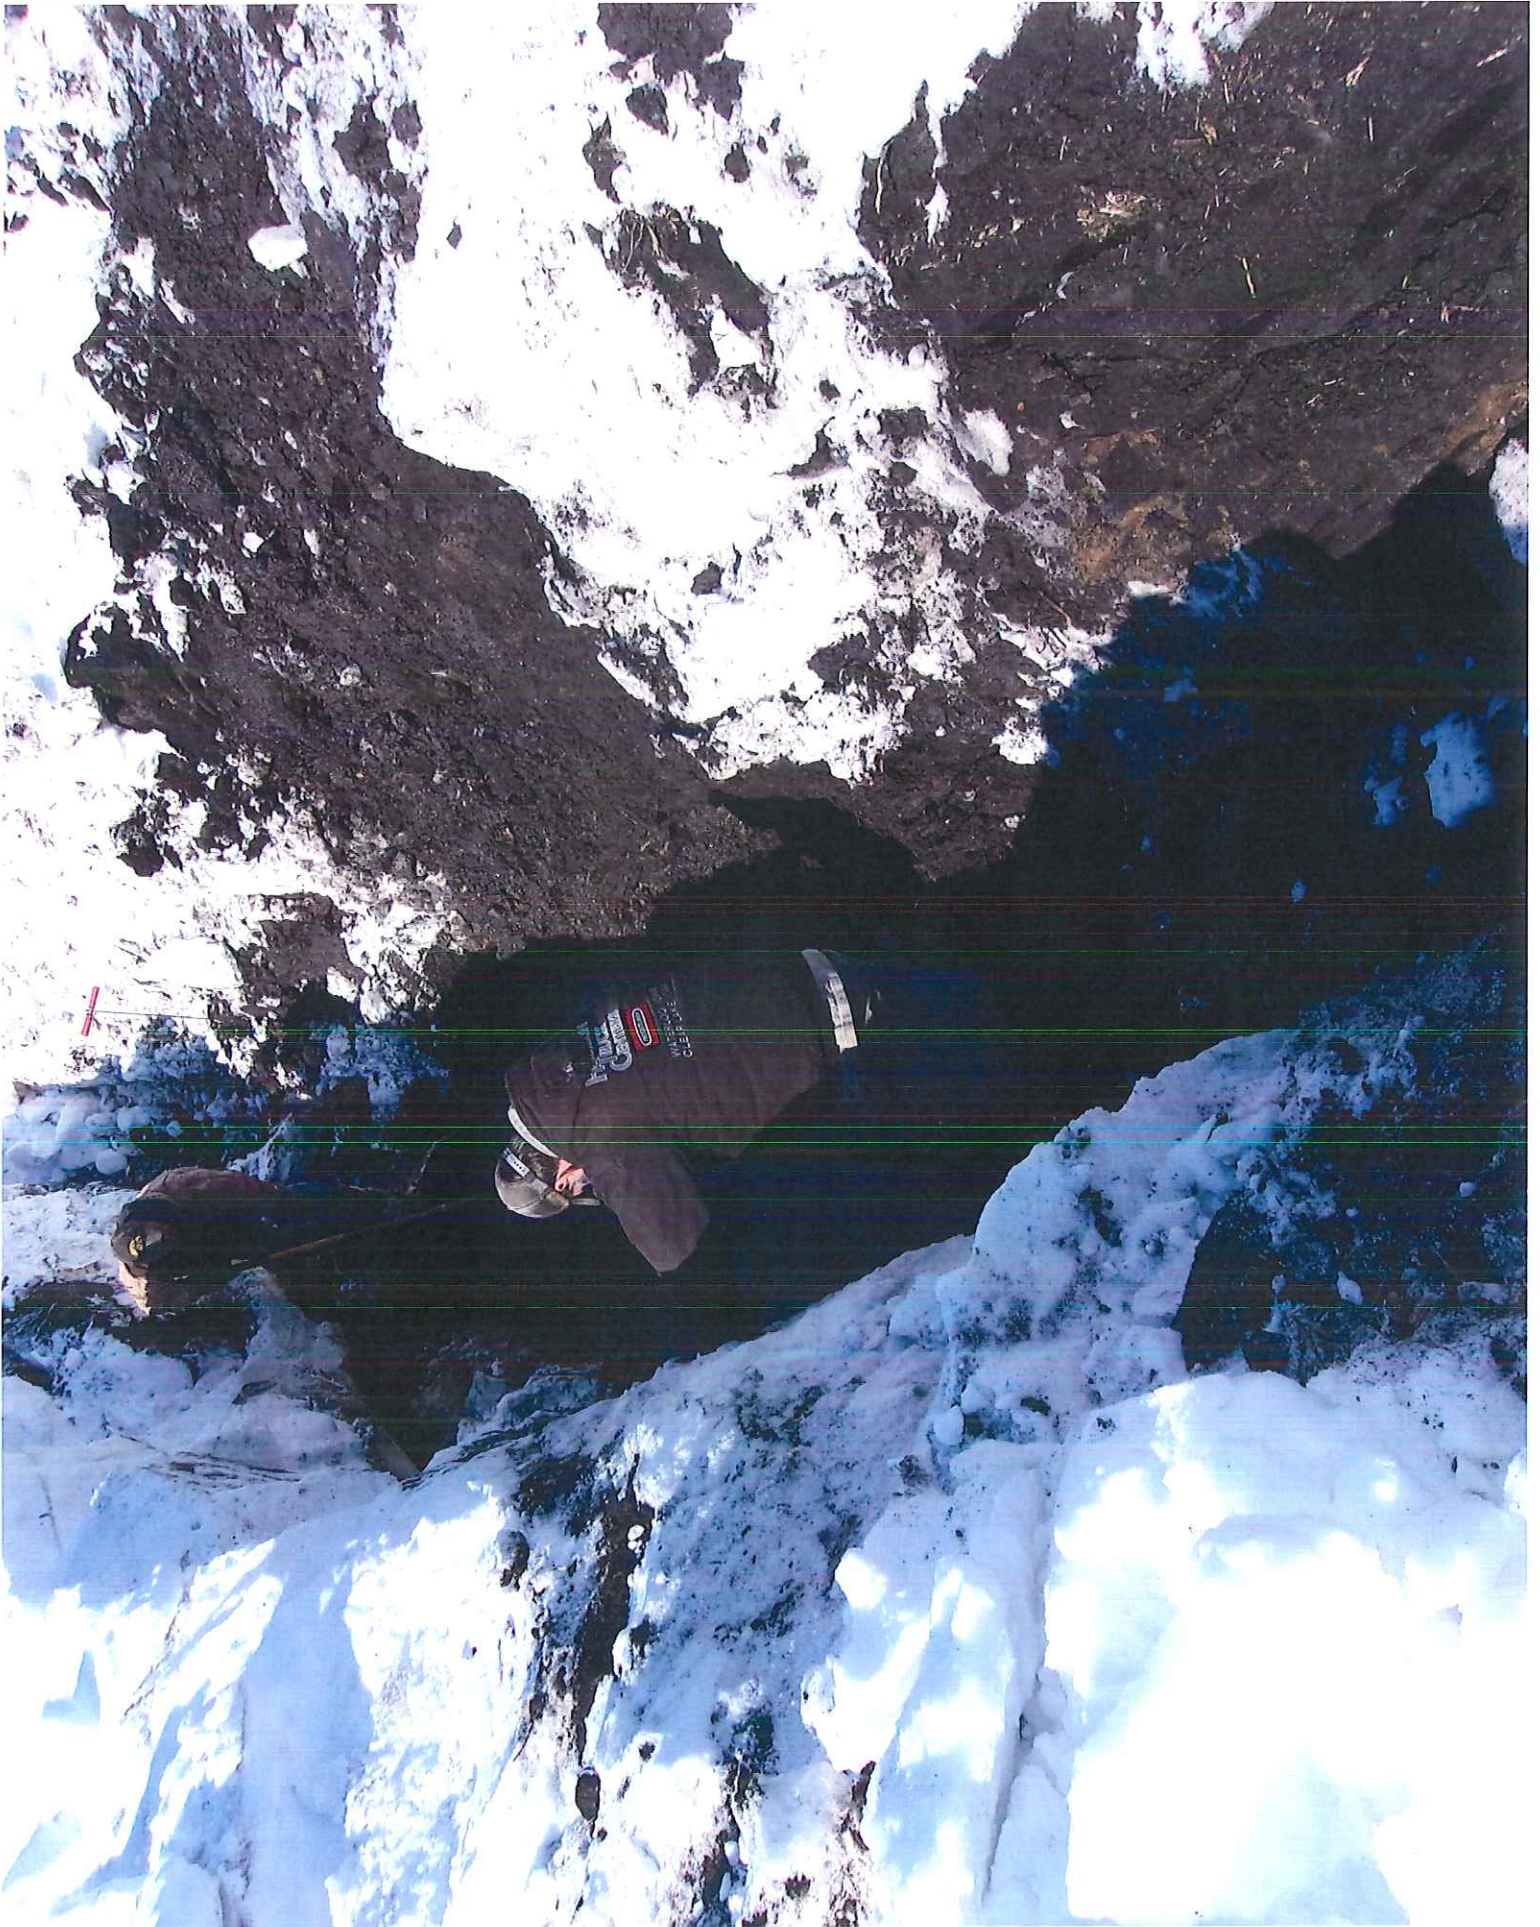
TAKING OUT OLD TILE

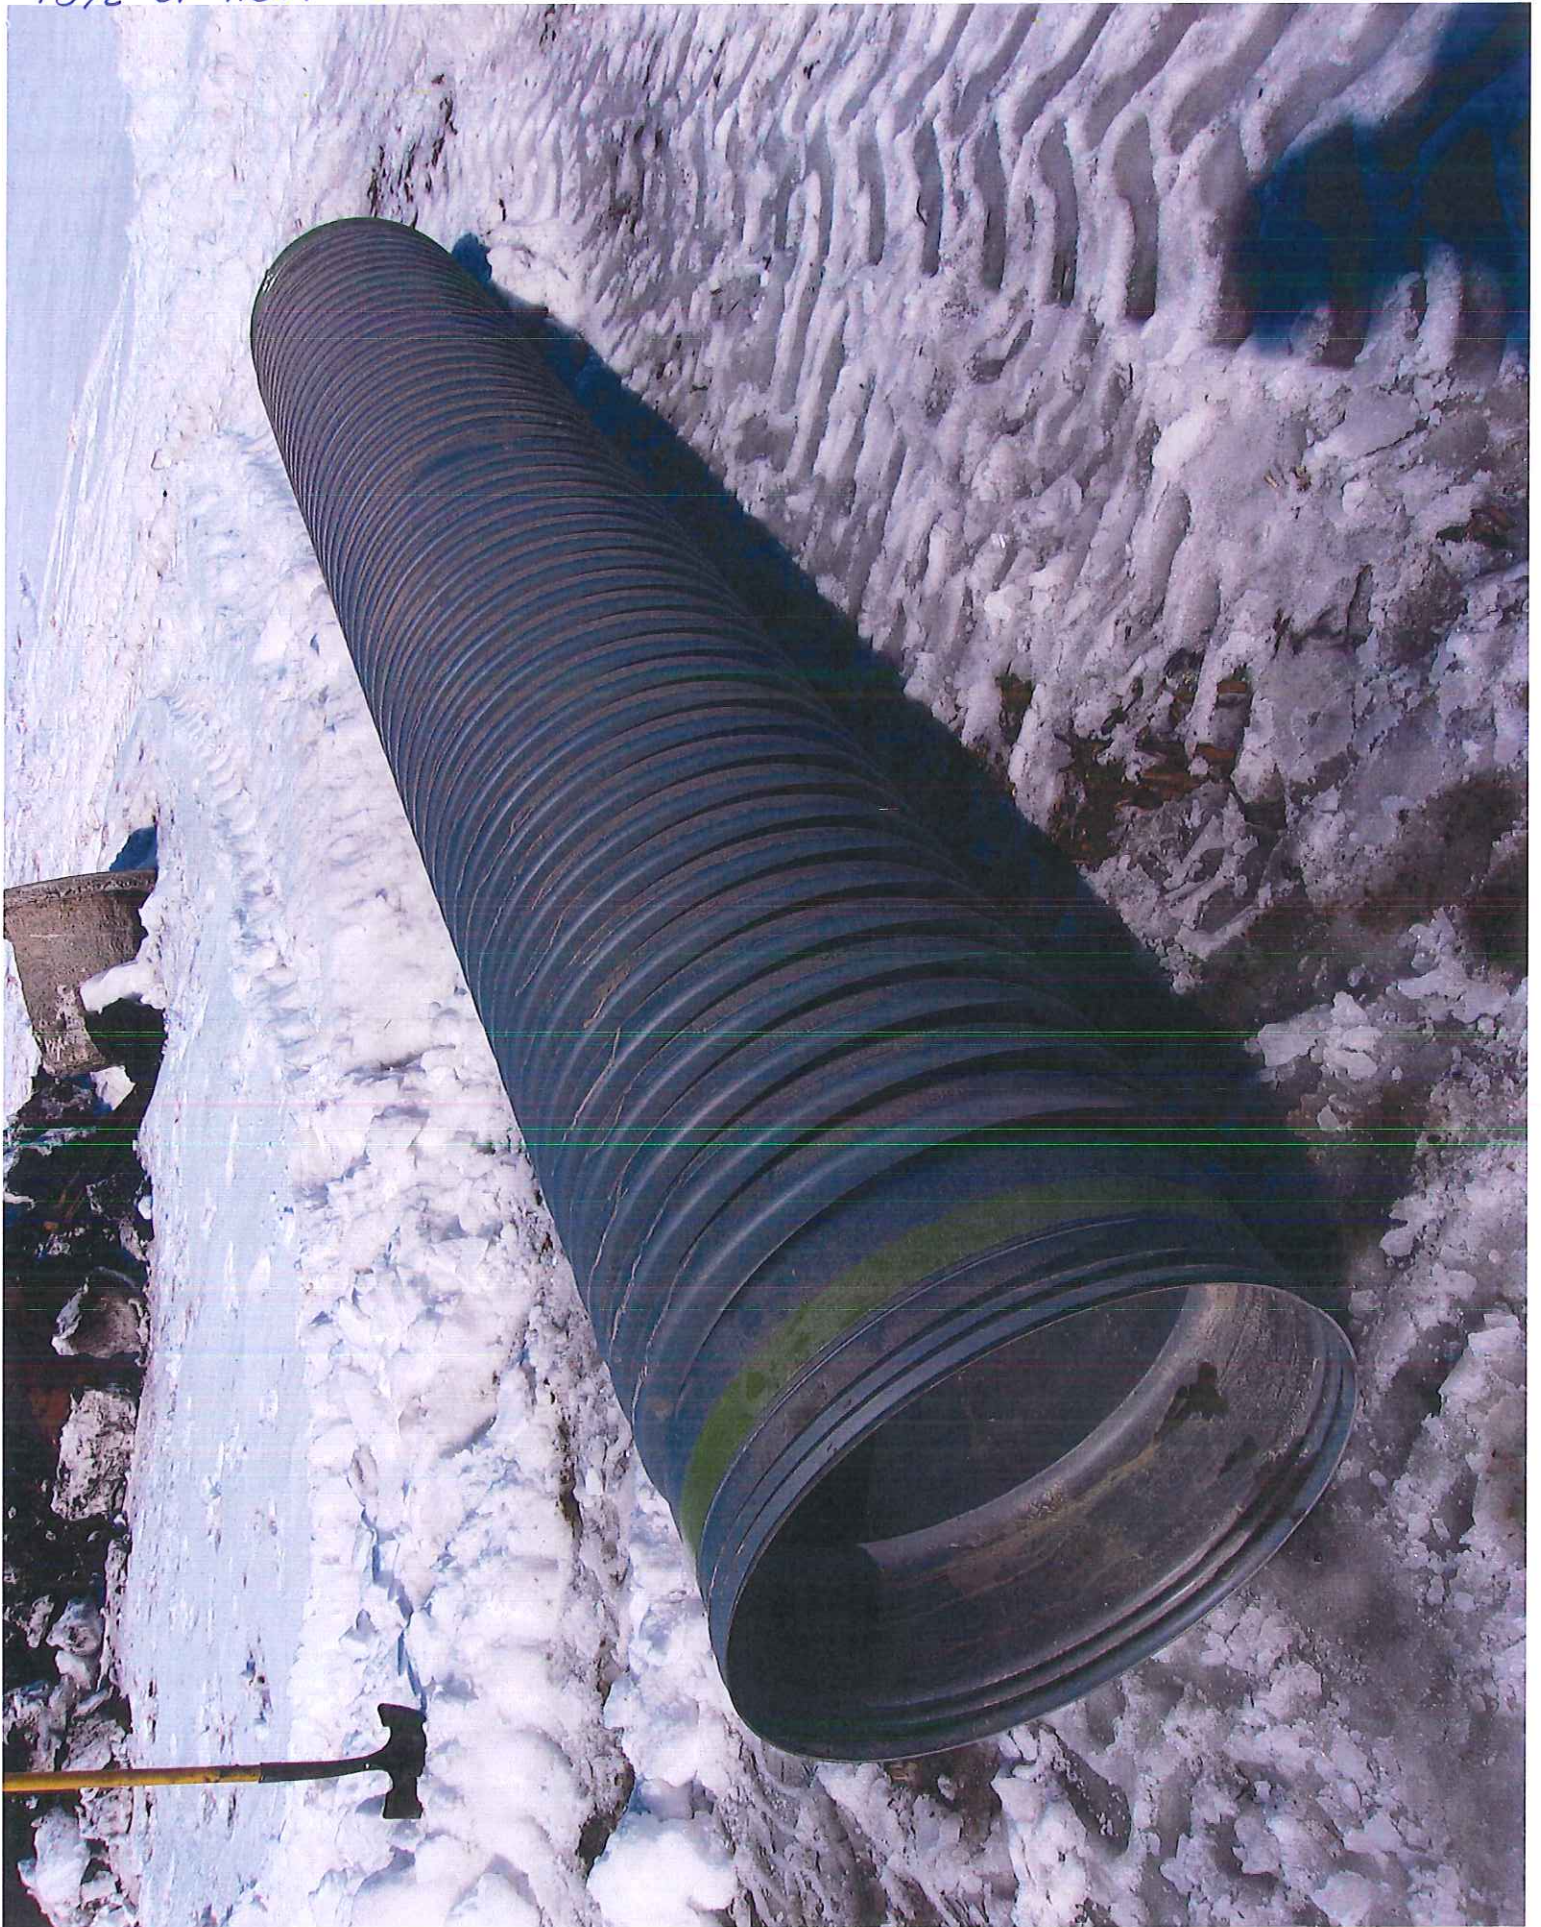
13 1/2' OF HDPP (LEFT OVER FROM DD7 F JOB)

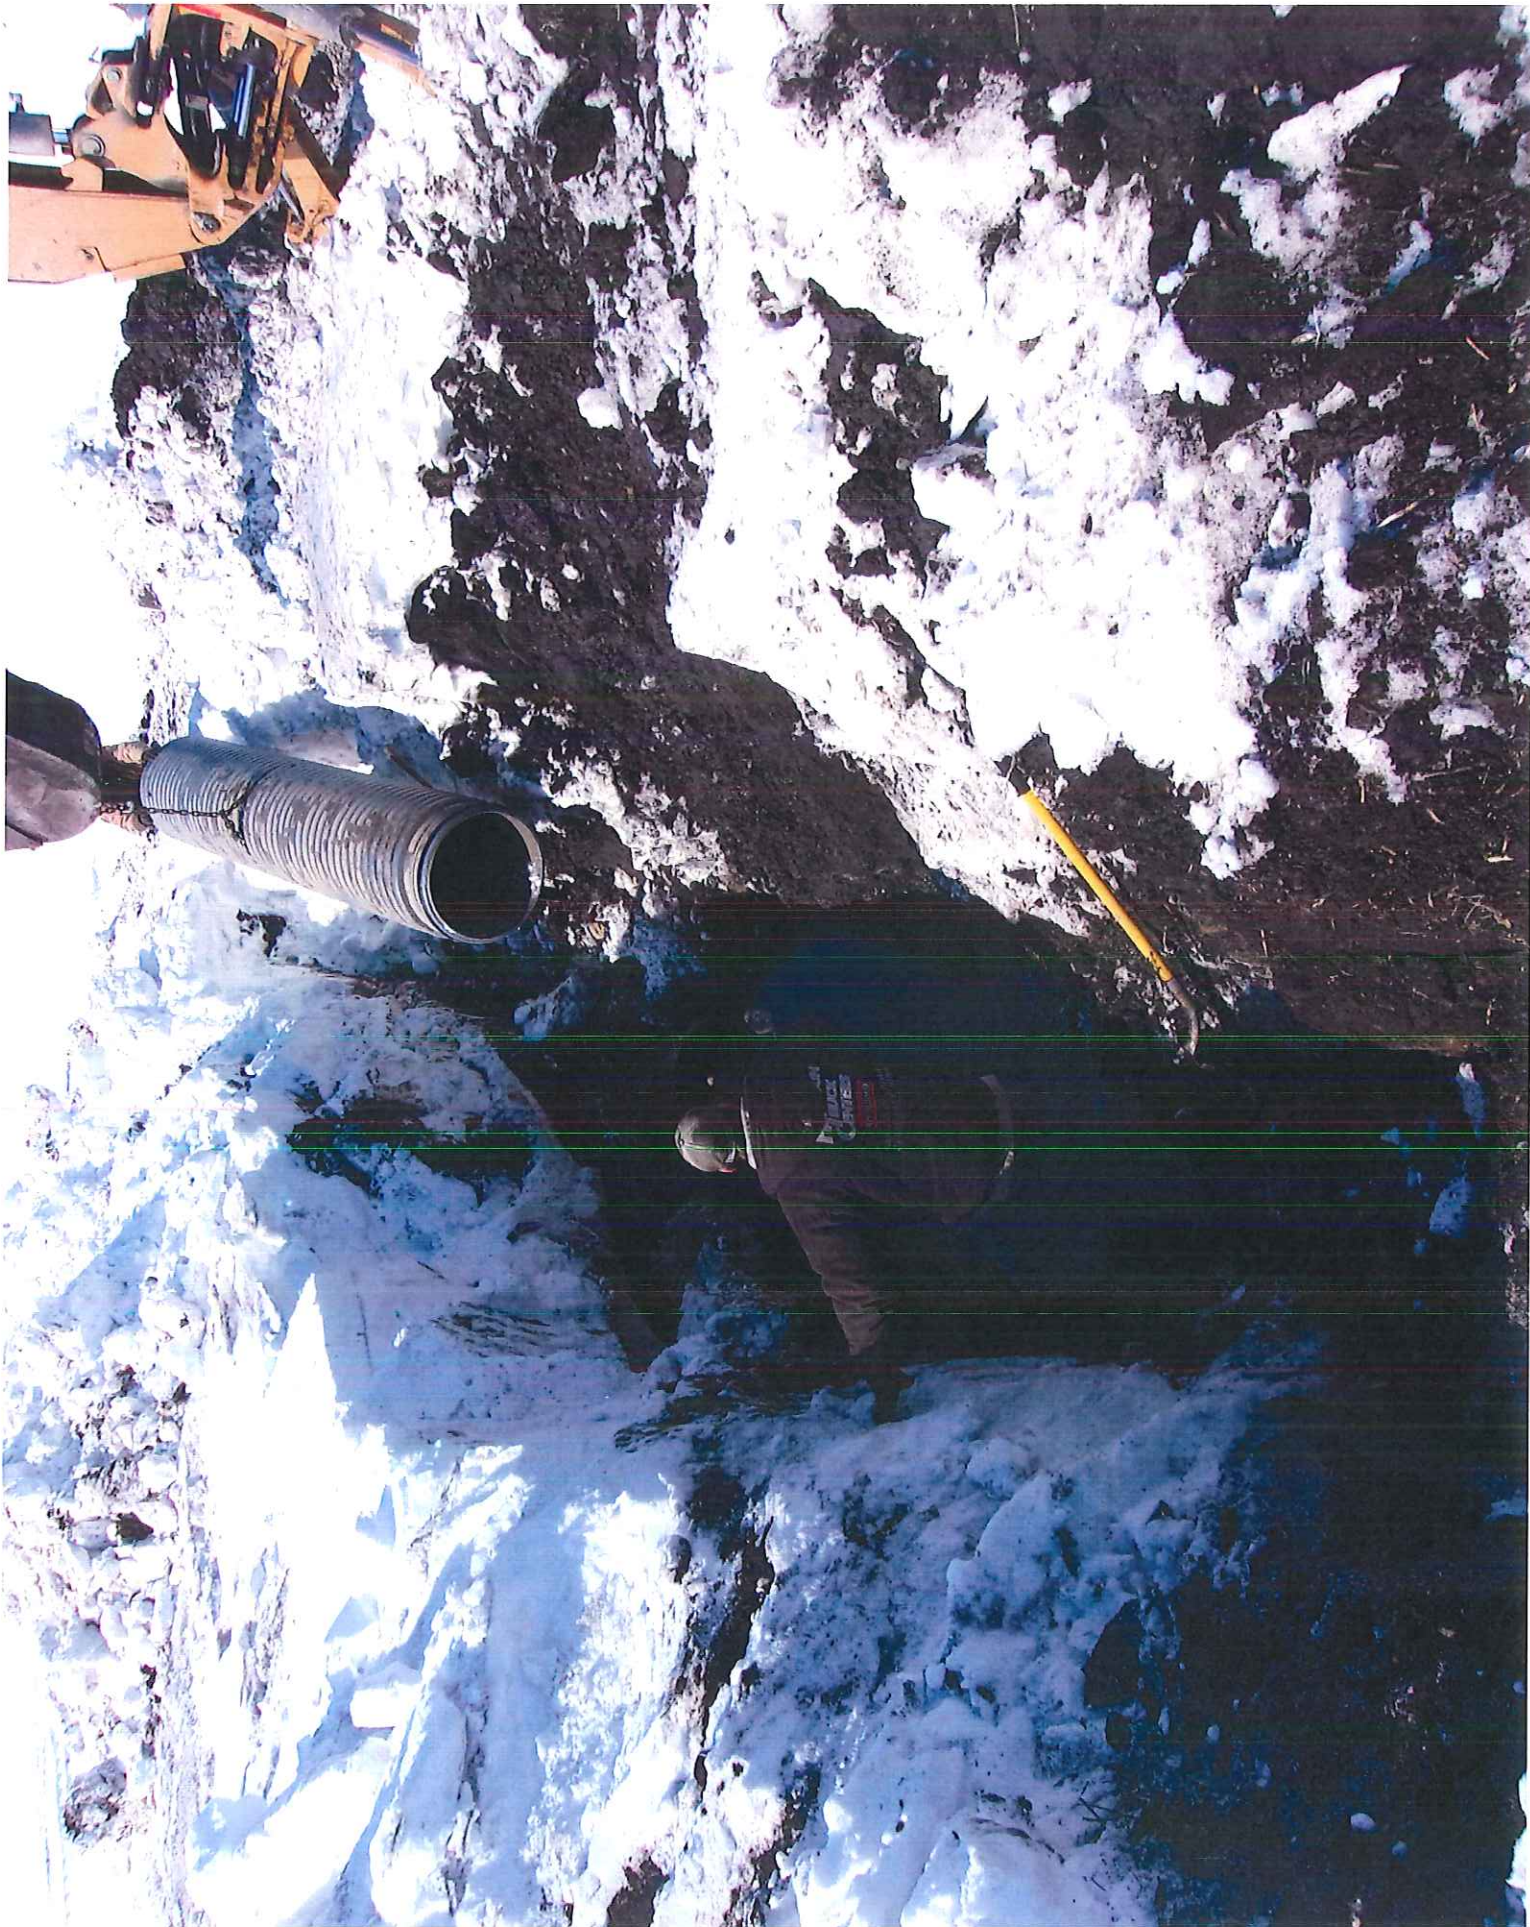
13 1/2' OF HDPP PIPE USED IN REPAIR

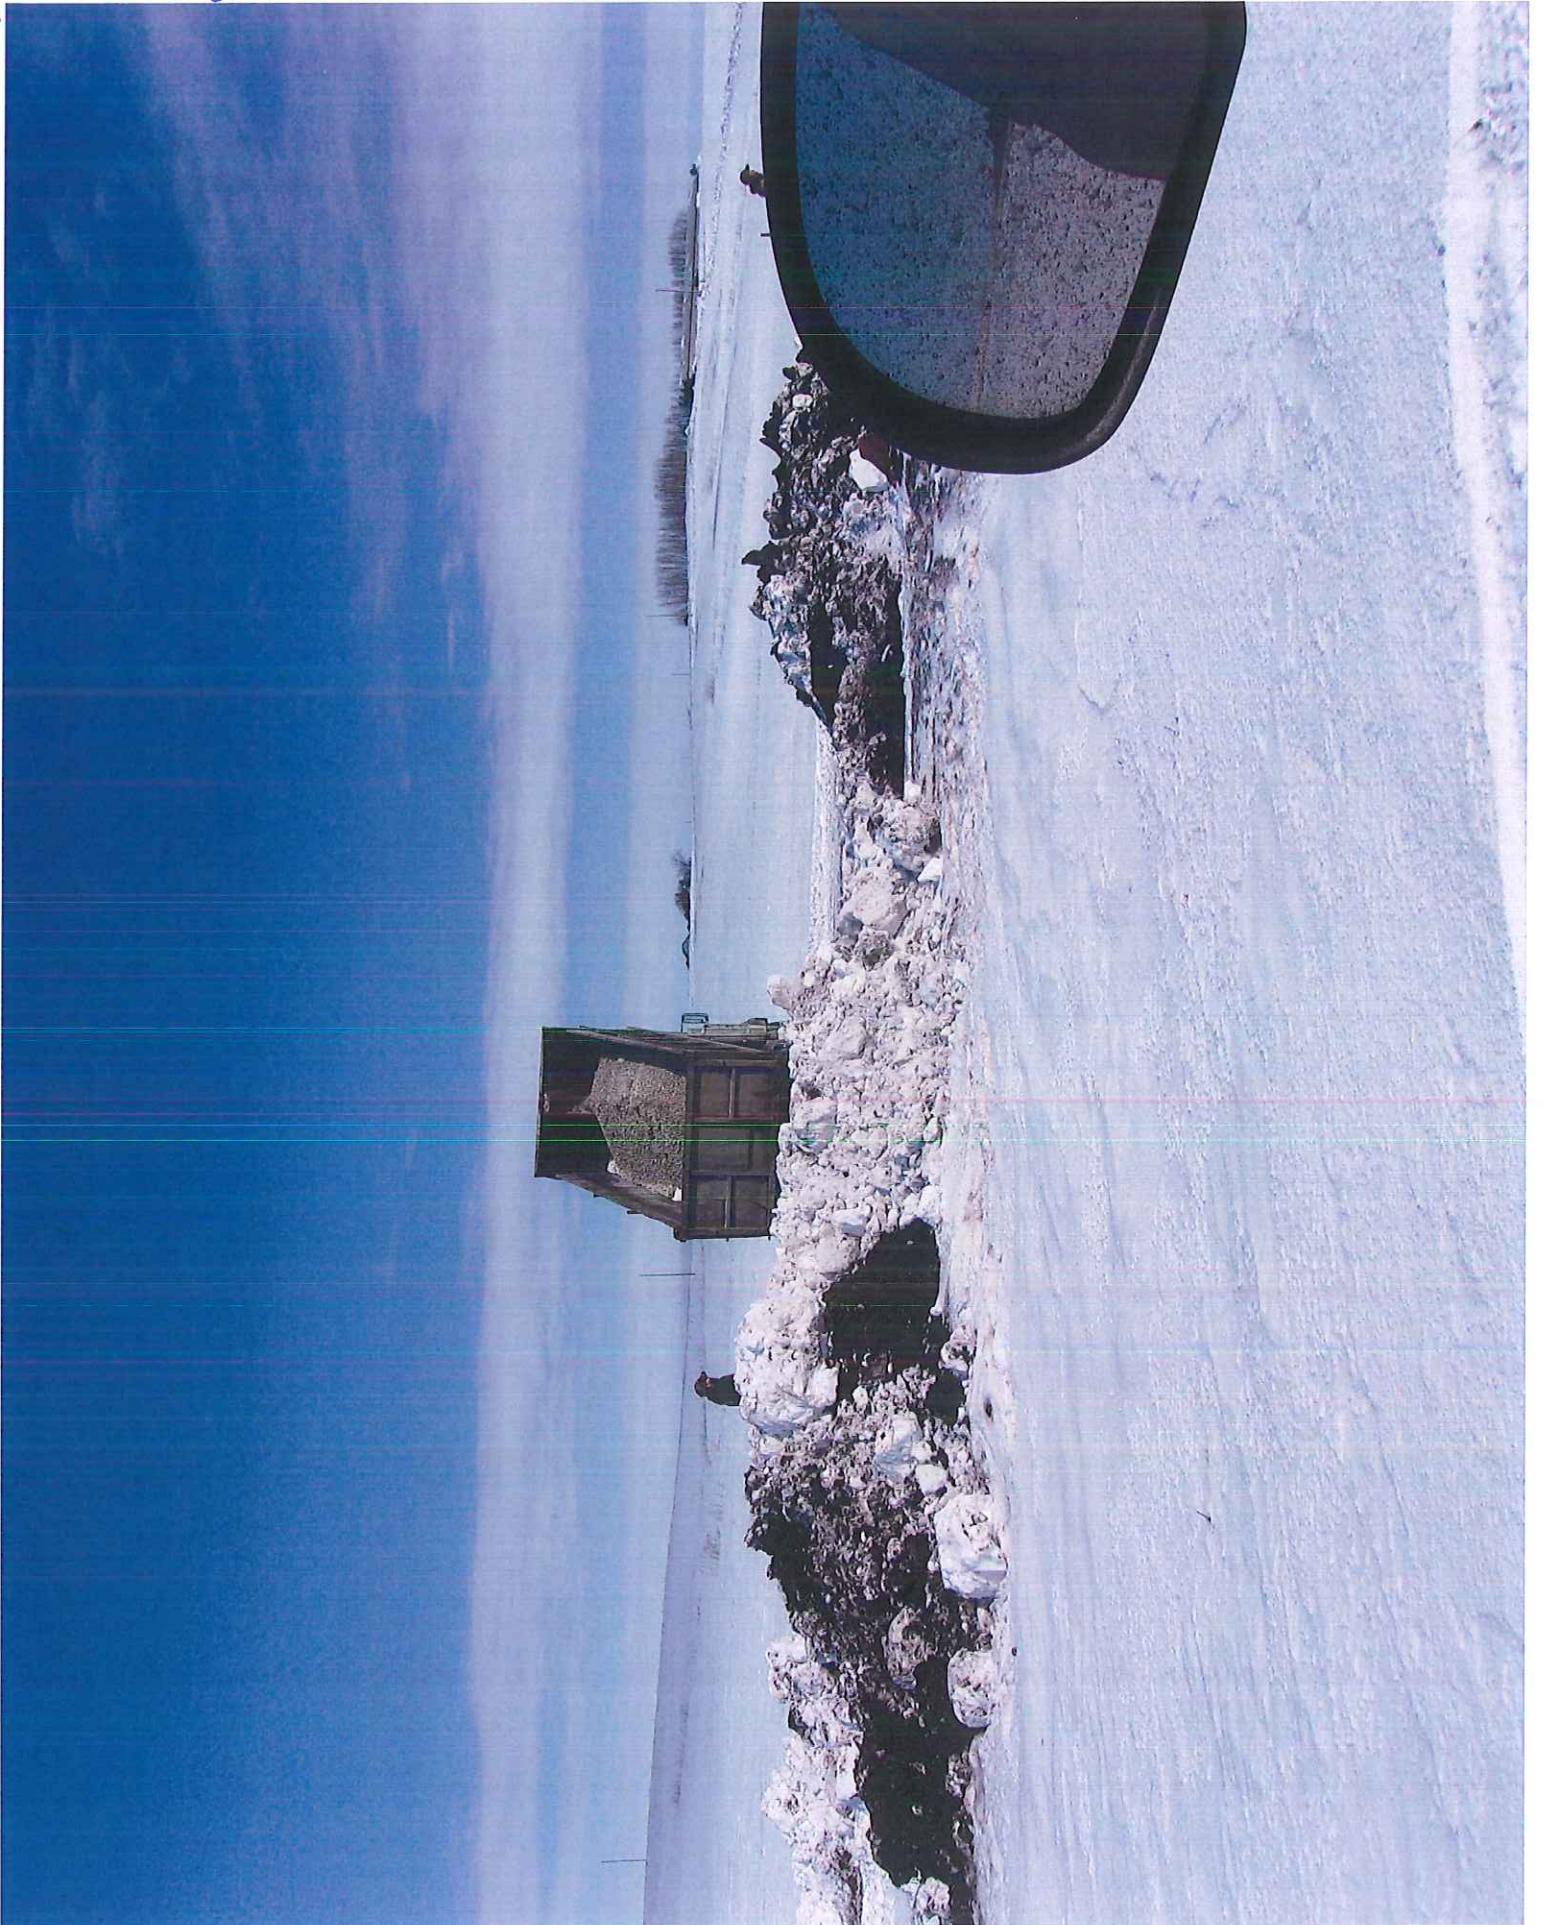
5-6 TON OF 1" STONE FOR BREDDING

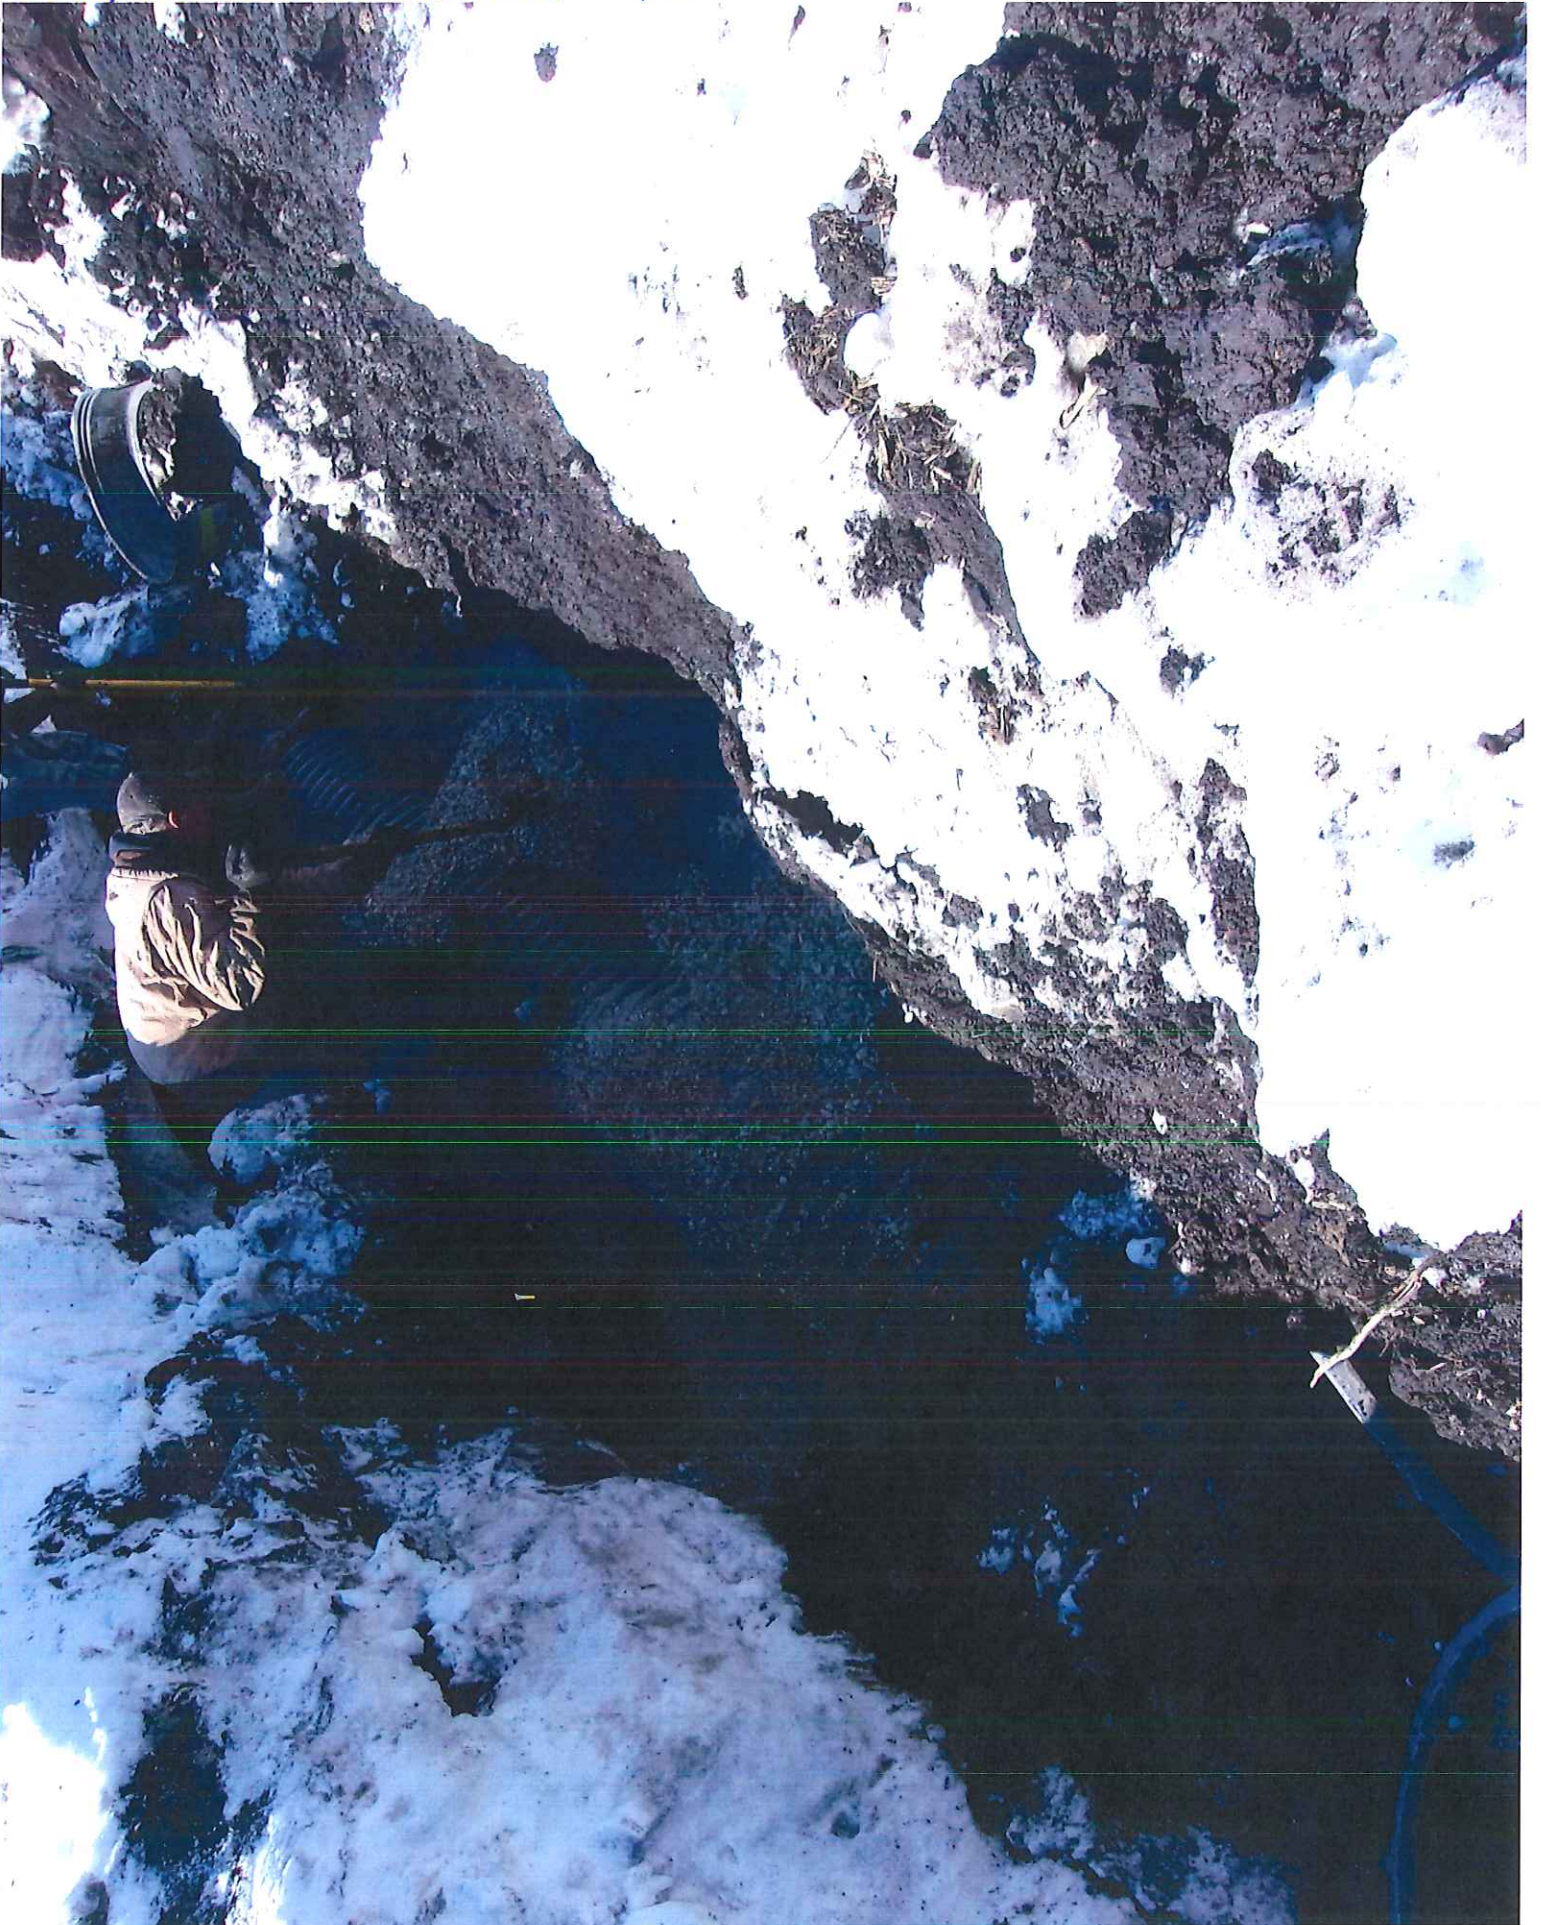
"Chomping" Rock Around HOPP Pipe

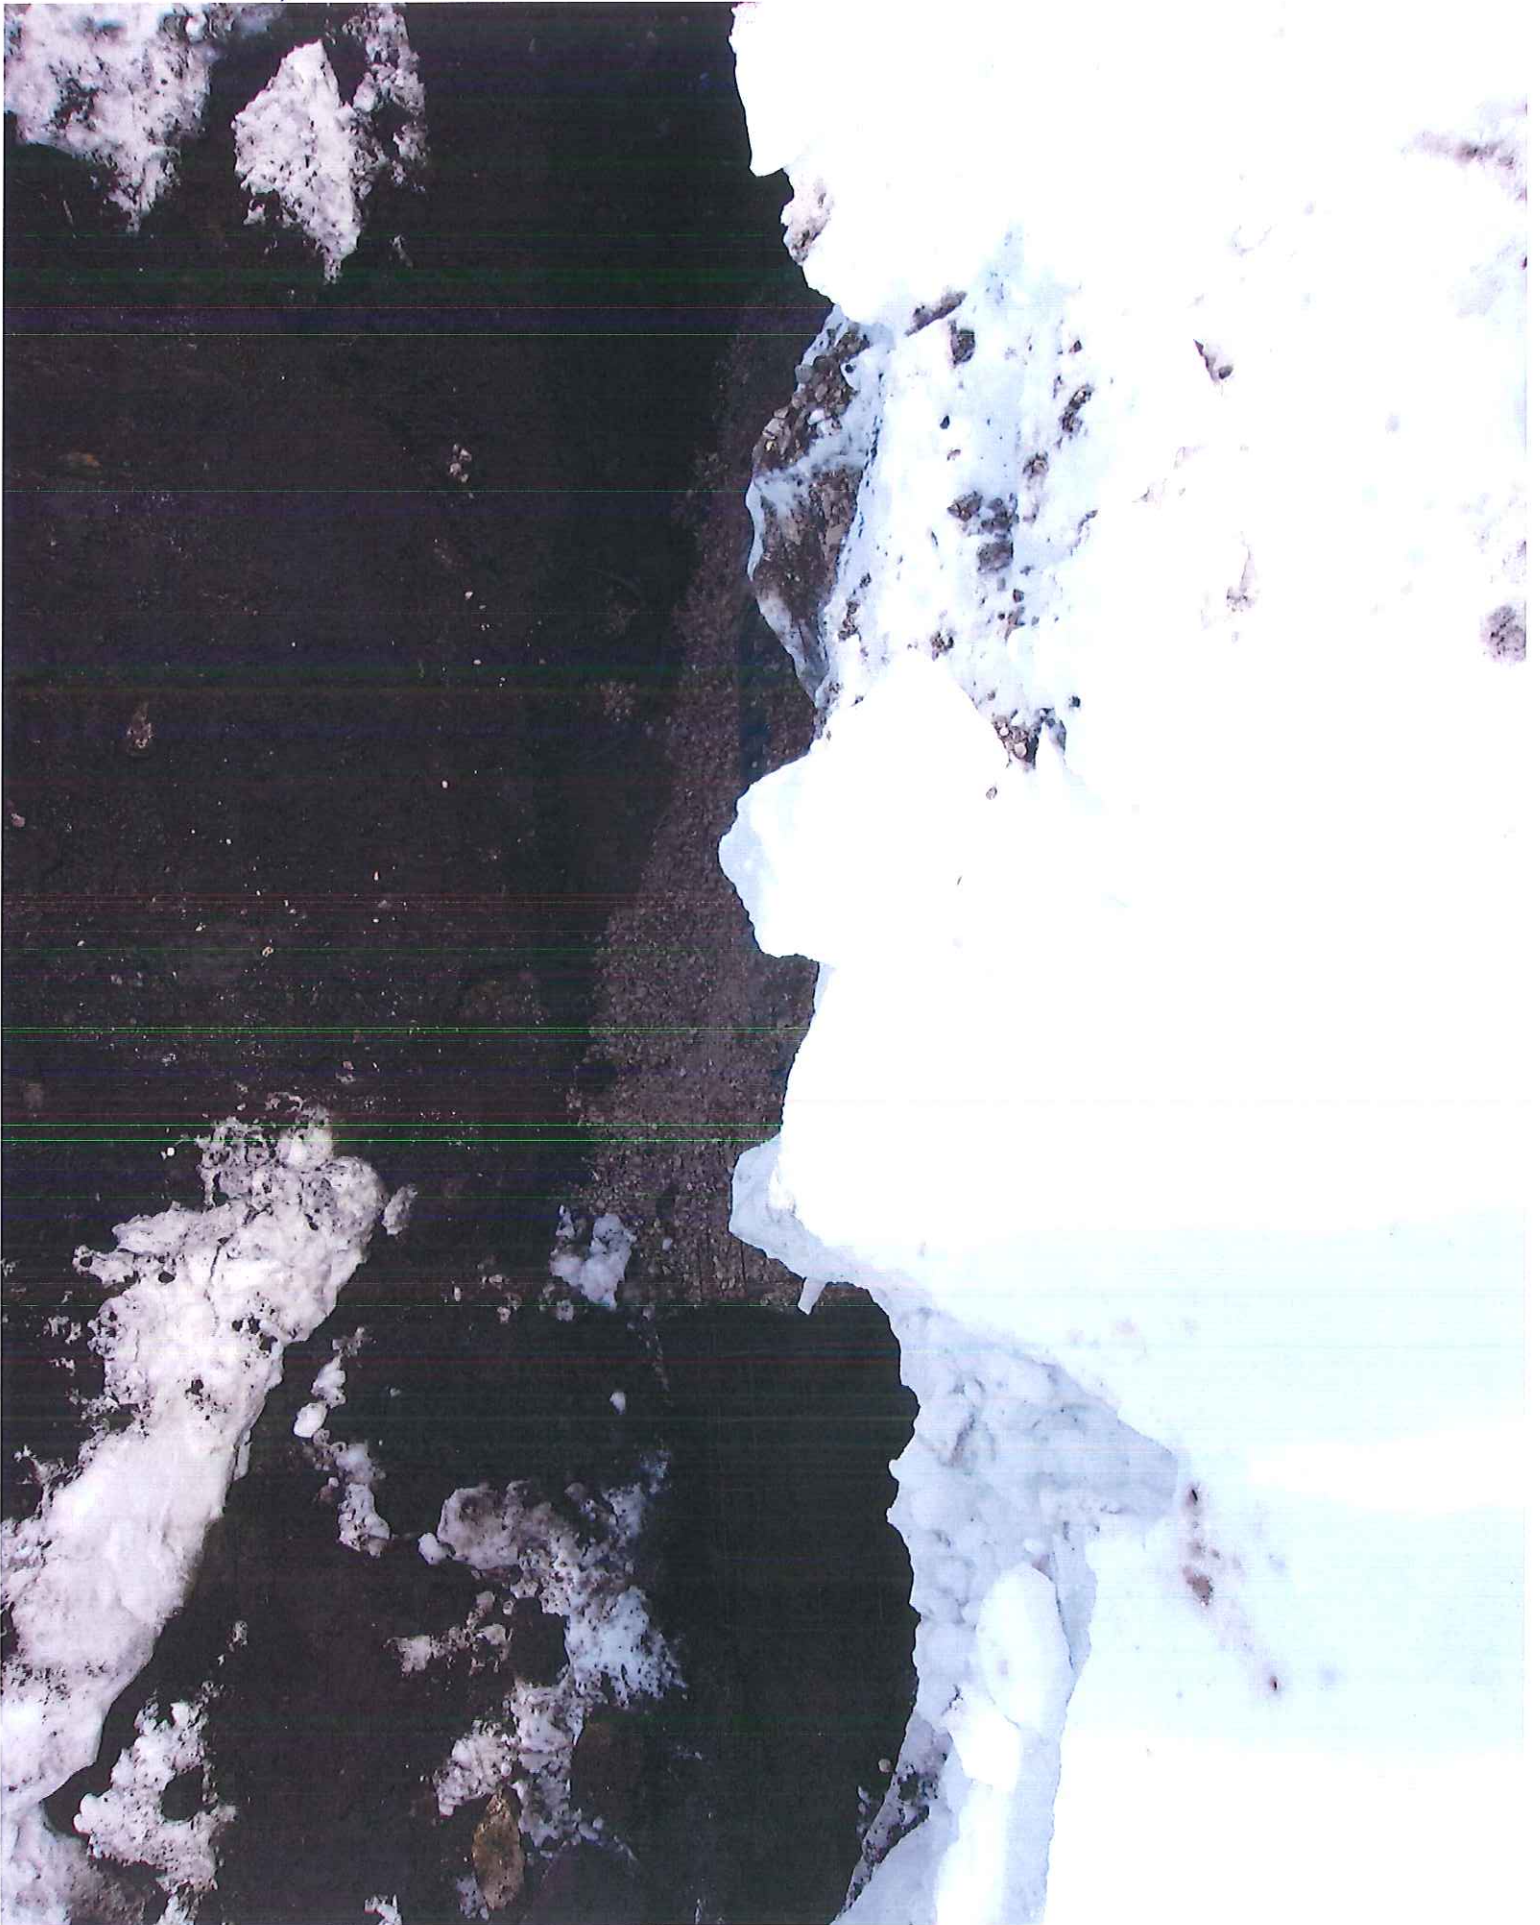
COWARS READY FOR CONC.

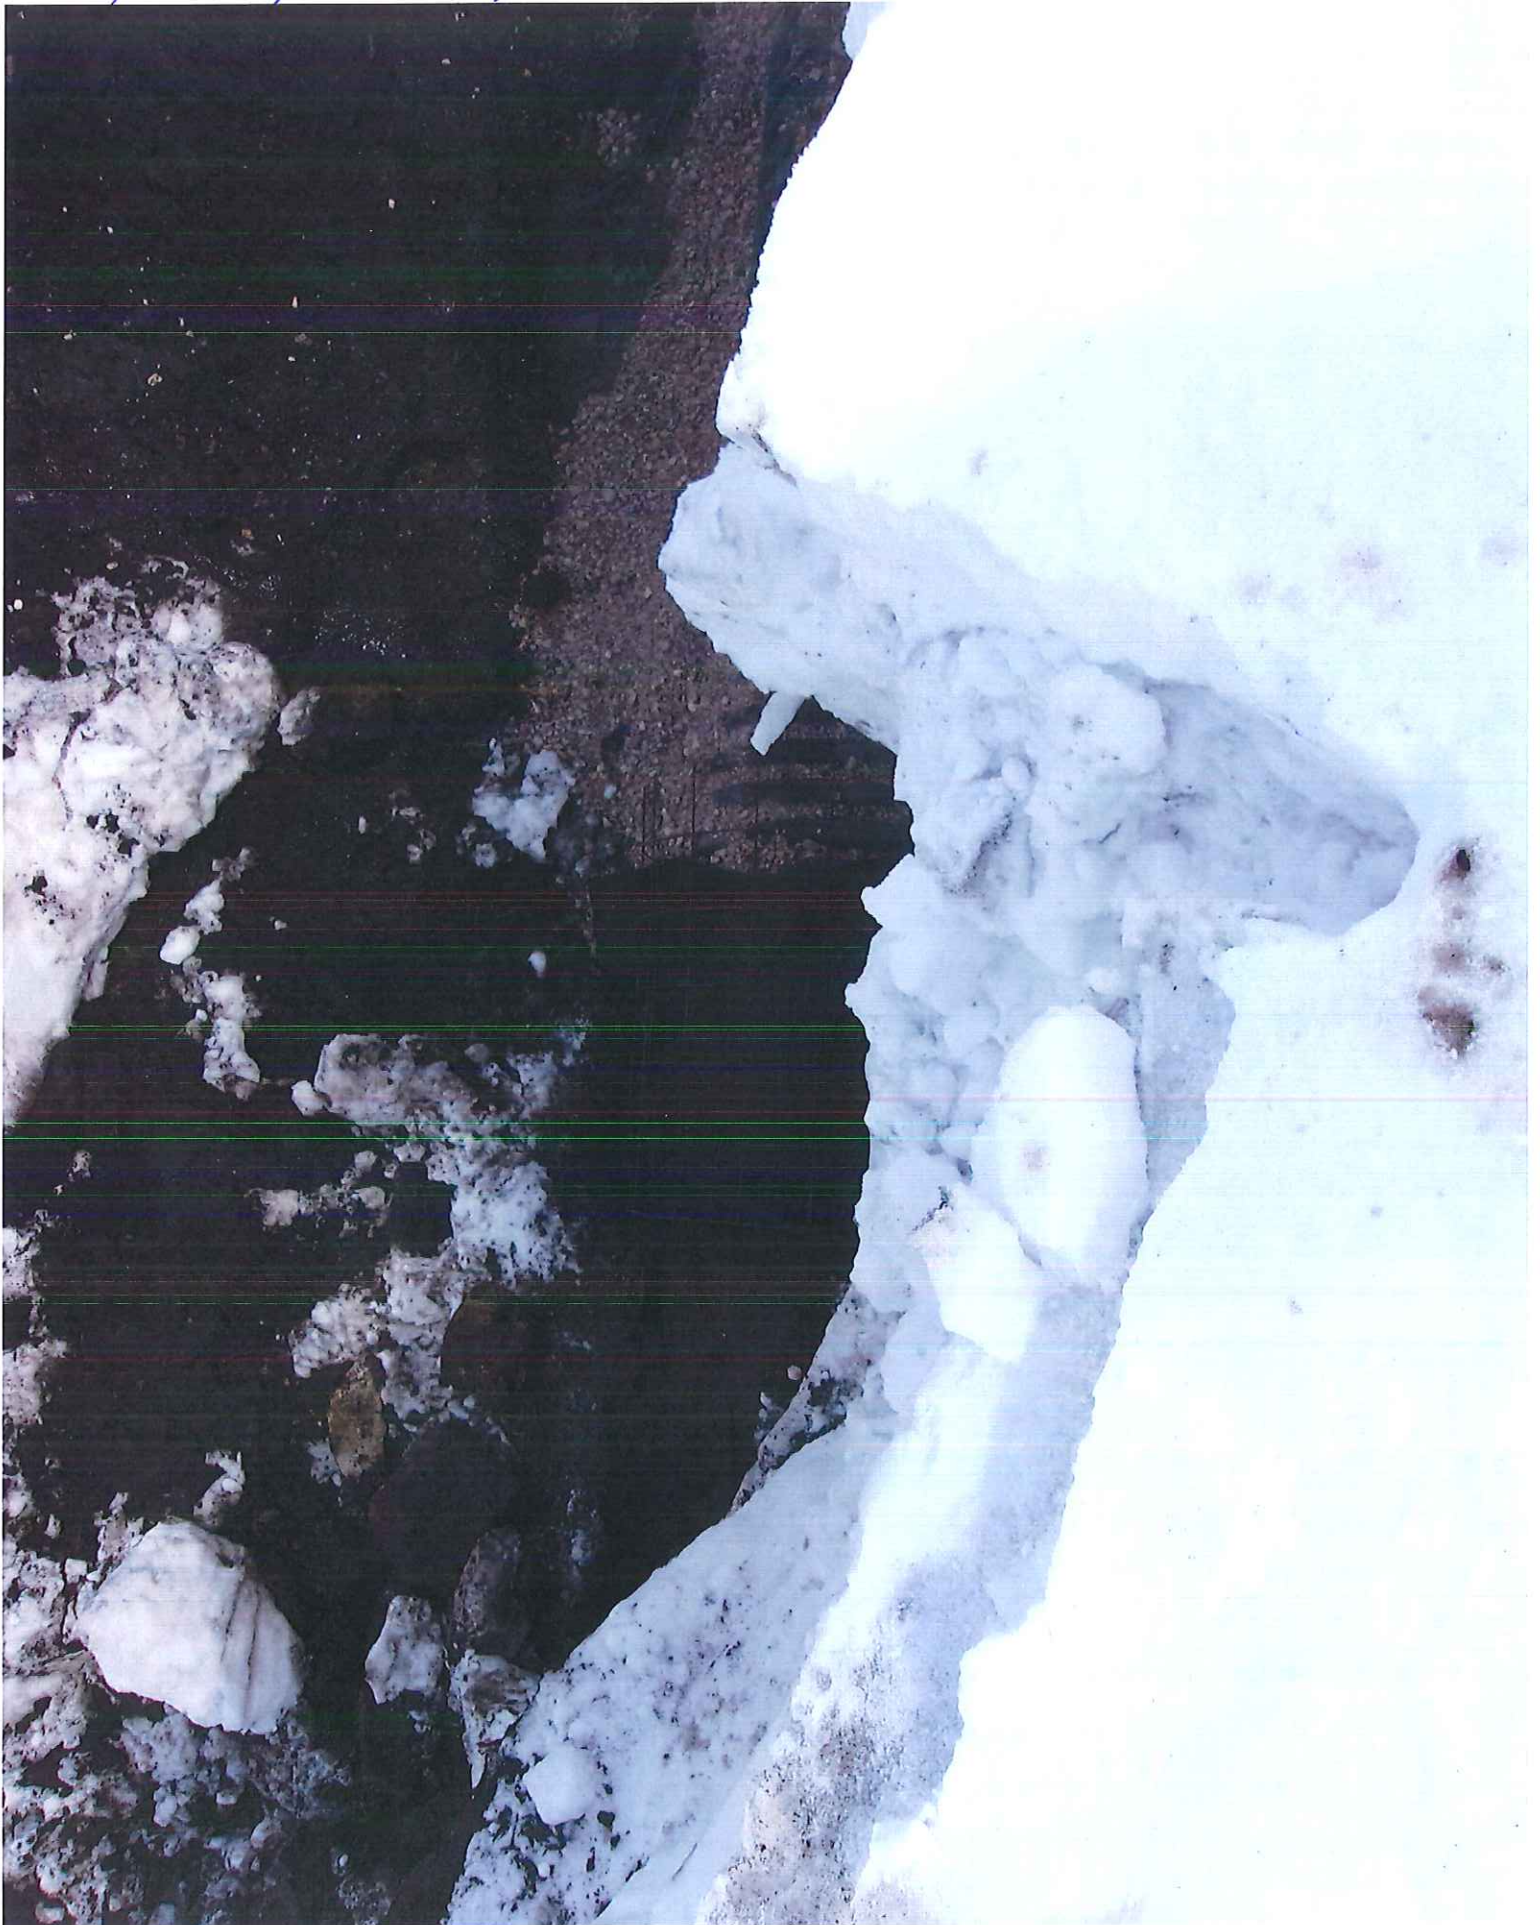
ROCK / FABRIC / WIRE MESH, ALL USED IN HDPP INSTALLATION
