AGENDA
REGULAR DRAINAGE MEETING
April 17, 2019
8:30AM

Drainage Work Order Request For Repair Hardin County

Repair Summary:

CONSTRUCTION ENGINEERING
OBSERVATION REPORT

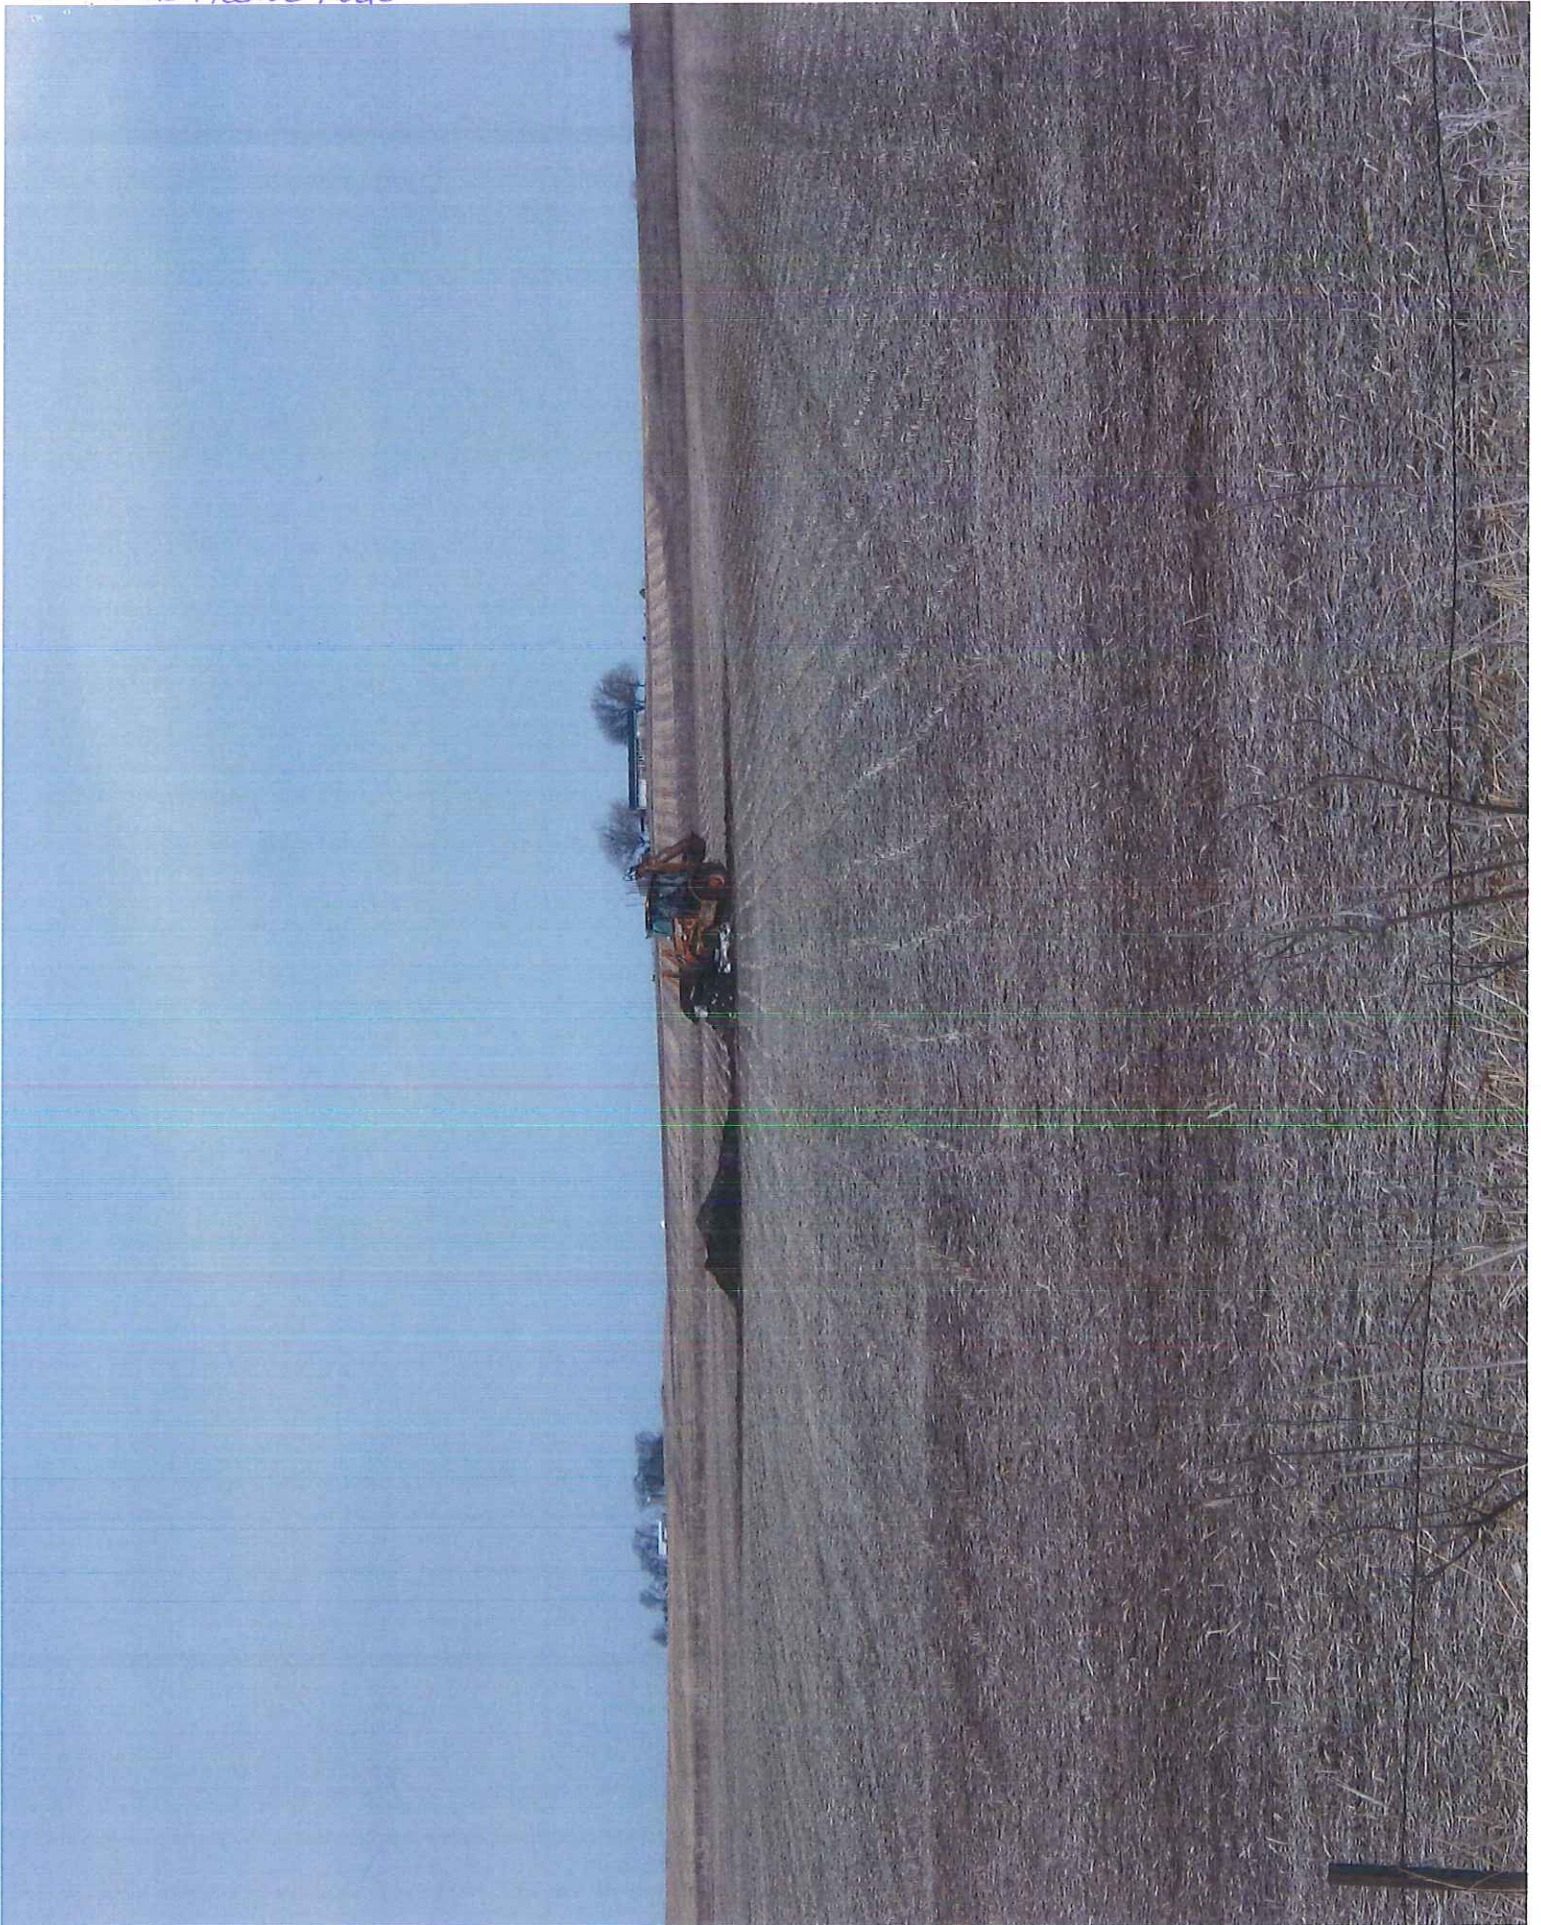
SUNNY, 40°, CALM, MUDDY CONDITIONS BUT DRYING.
9:15, ARRIVED @ REPAIR SITE, BACKHOE AND OPERATOR ARE FILLING
REPAIR HOLE ORIGINALLY DUG BY RANDY BROWN, REPAIRED BY McDOWELL CONST. AND
BACKFILLED. 9:30 BACKHOE IS 1/2 DONE, USING BUCKET COMPACTOR TO GET CURT IN.

BACKHOE FILING HOUR
