AGENDA
REGULAR DRAINAGE MEETING
Wednesday, August 5, 2020 9:30 AM
Large Conference Room

9. DD 48 - WO 237 - Discuss W/ Possible Action - Repair Summary

[DD 48 WO 237 - 6486.4 - REPAIR SUMMARY - 08_03_20.PDF](#)

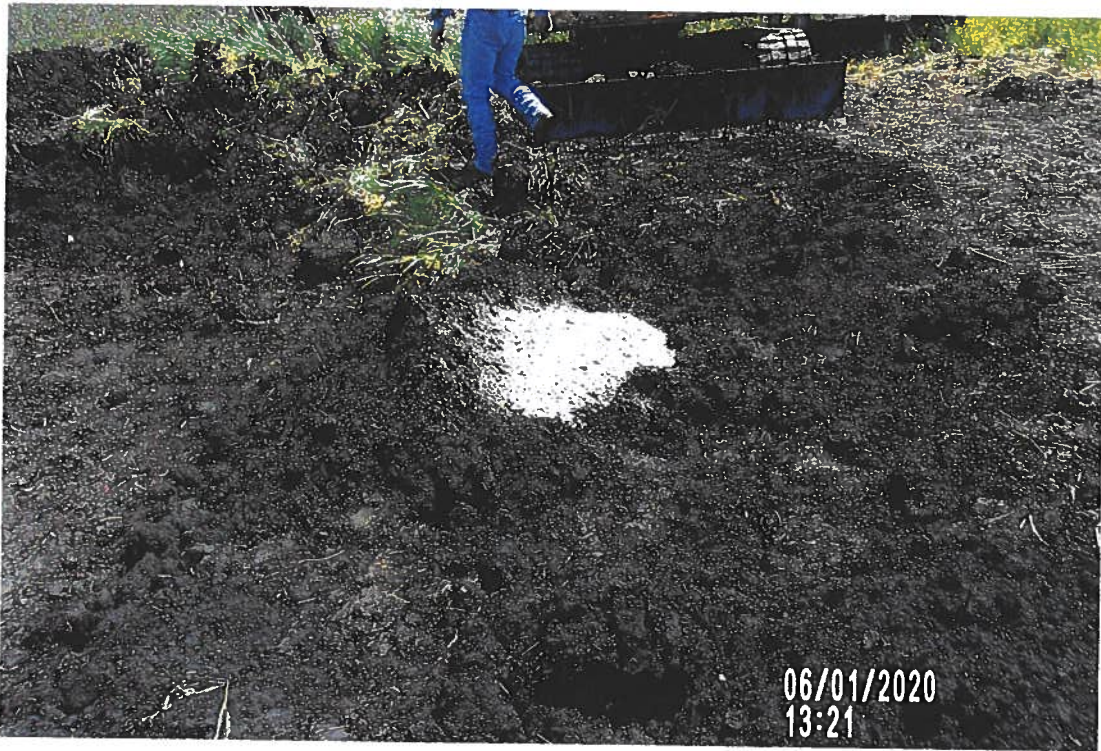
PICTURE #3621 IS LOOKING NE SHOWING 2 BAGS OF 60 LB QUIKRETE CONCRETE & 2.0'x2.0' PIECE OF FABRIC PLACE OVER EXISTING HOLE TORE IN TOP OF EXISTING 24" CMP.

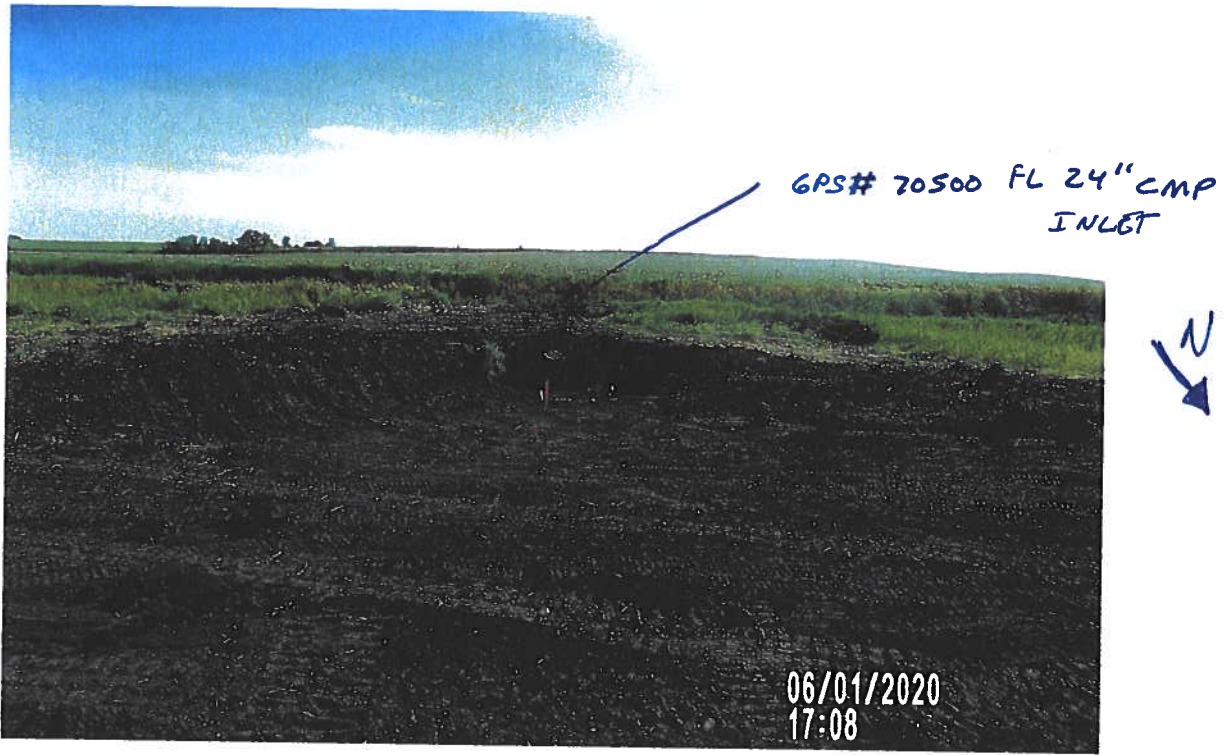
PICTURE # 3631 IS LOOKING SW SHOWING EXISTING 24" CMP
SURFACE DRAIN INLET WITH STRAIGHTENED MANGLED END.
LOOKS LITTLE ROUGH. CREW HAS BACKFILL SOIL AROUND
CMP INLET BUT STILL NEEDS COMPACTED.
GPS # 70500 FL 24"
CMP INLET

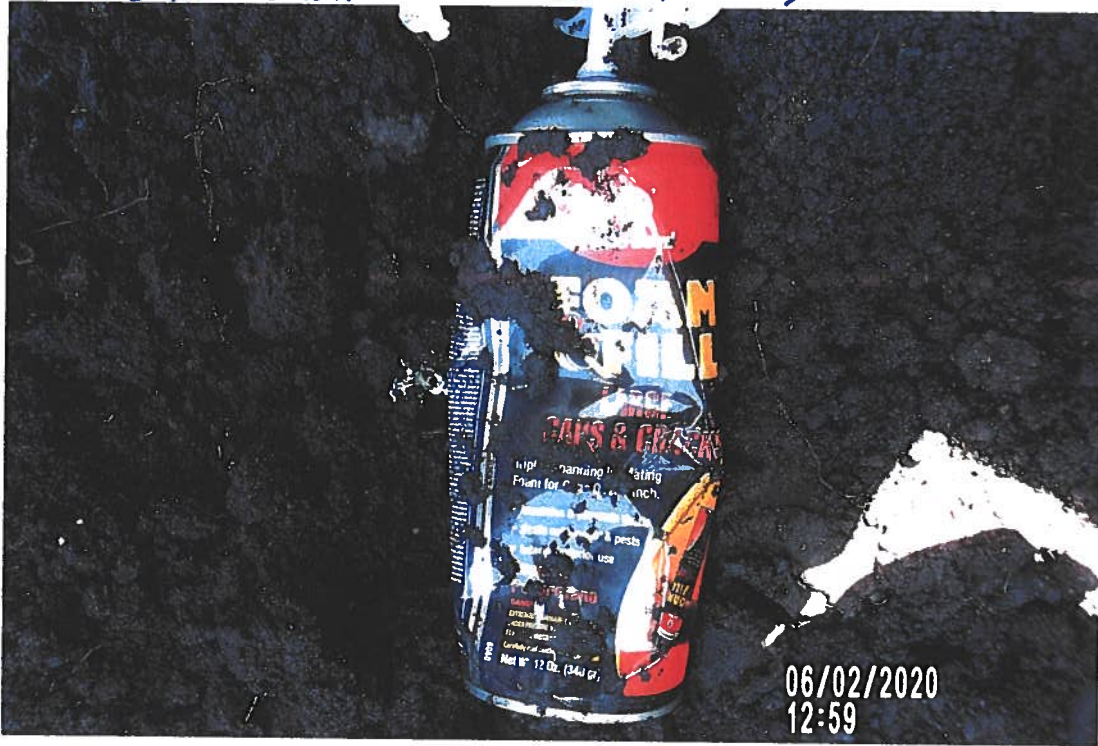
PICTURE # 3636 IS LOOKING EAST SHOWING CREW USING FOAM FILL TO SEAL BETWEEN HDPE ANTISEEP COLLAR AND 24" CMP SURFACE DRAIN, (SUDAS SHOWS SHOULD BE BITUMINOUS MATERIAL)

PICTURE # 3638 SHOWING FOAM FILL USED TO SEAL VOID BETWEEN HDPE ANTISEEP COLLAR AND CMP SURFACE DRAIN (OBSERVER INFORMED CREW THAT SUDAS CALLS FOR BITUMINOUS MATERIAL AND THIS IS WHAT CREW BROUGHT BACK)

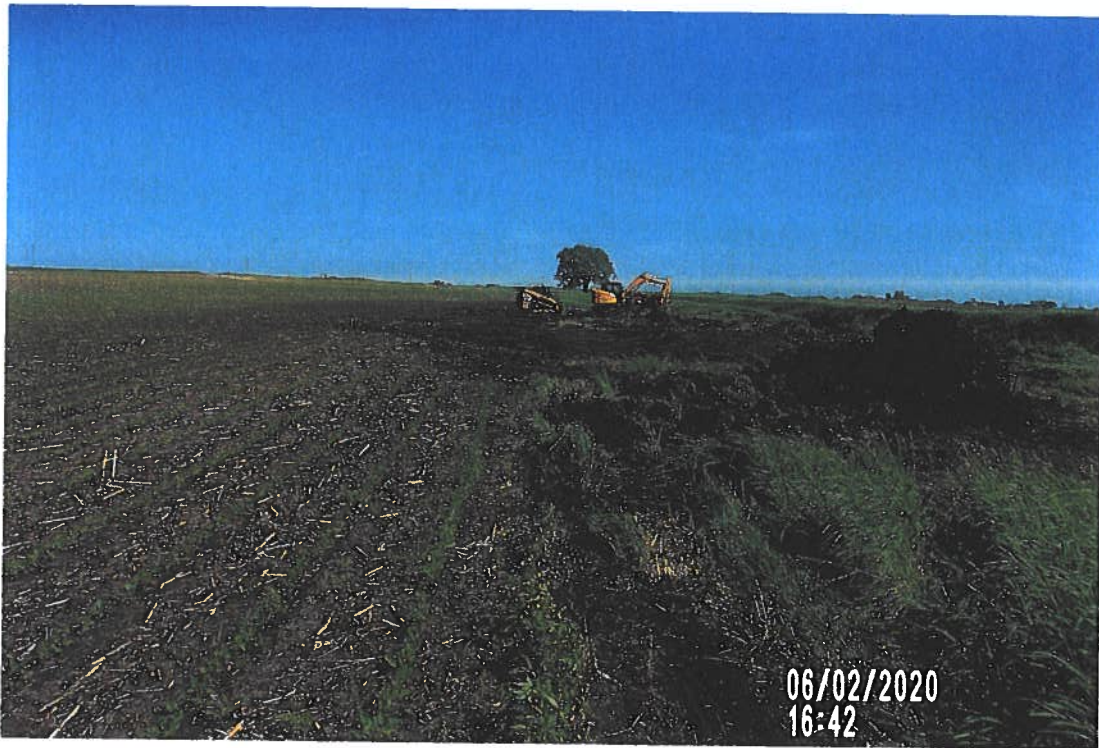
PICTURE #3641 IS LOOKING SE AT 0.14' AC OF BEAN
DAMAGE DURING REPAIR

In additional discussion on the motion, Granzow directed the Drainage Clerk verify with the landowner seeding and grading was done, verify if there is a crop damage claim on the 0.14 acres and bring that back on next week's agenda for review.

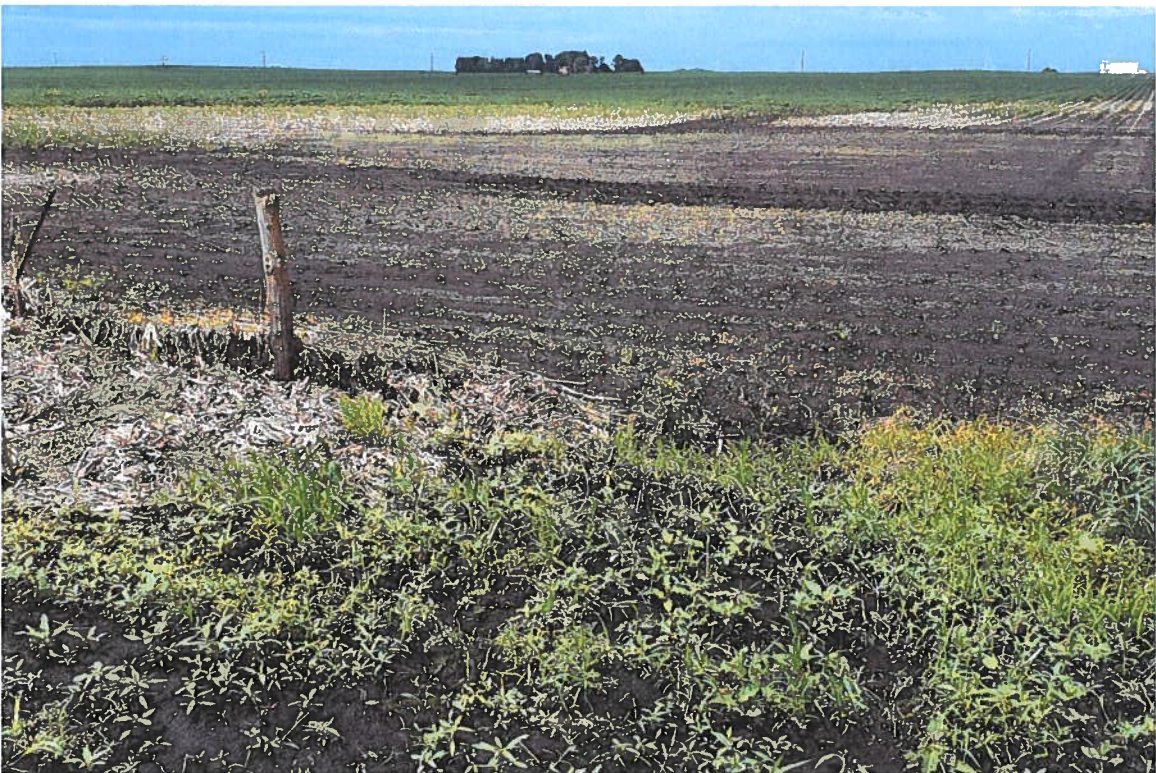
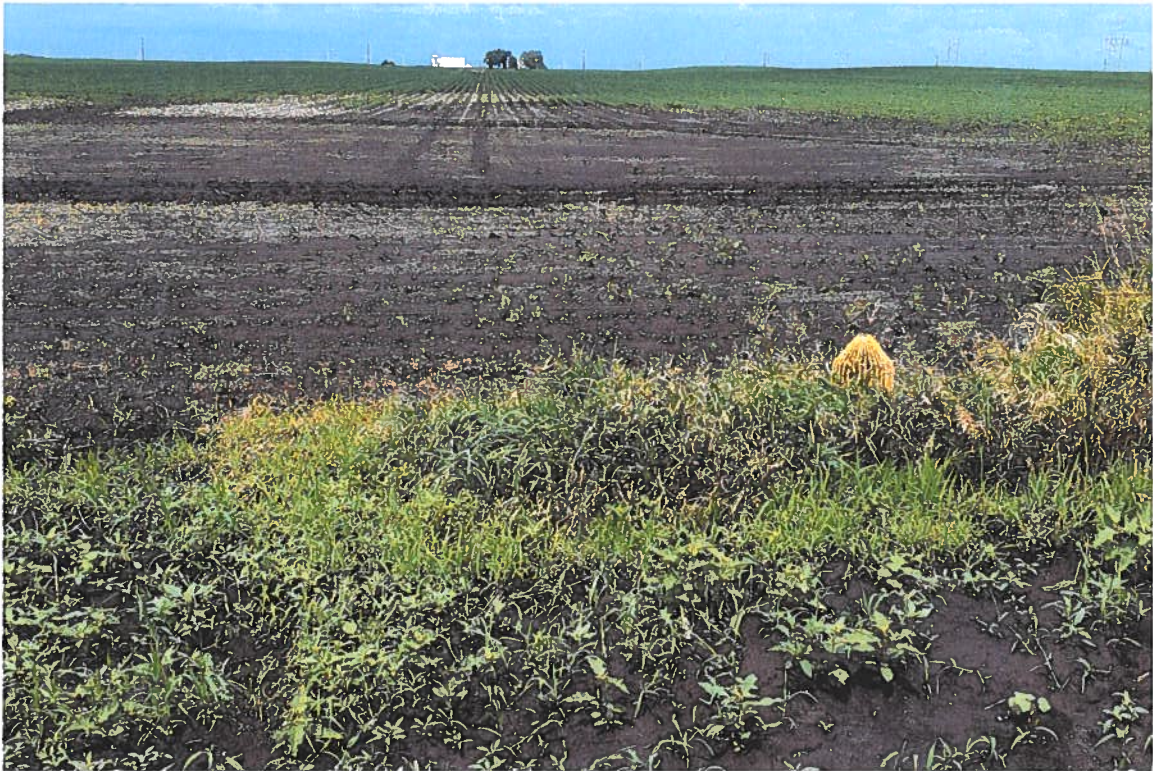
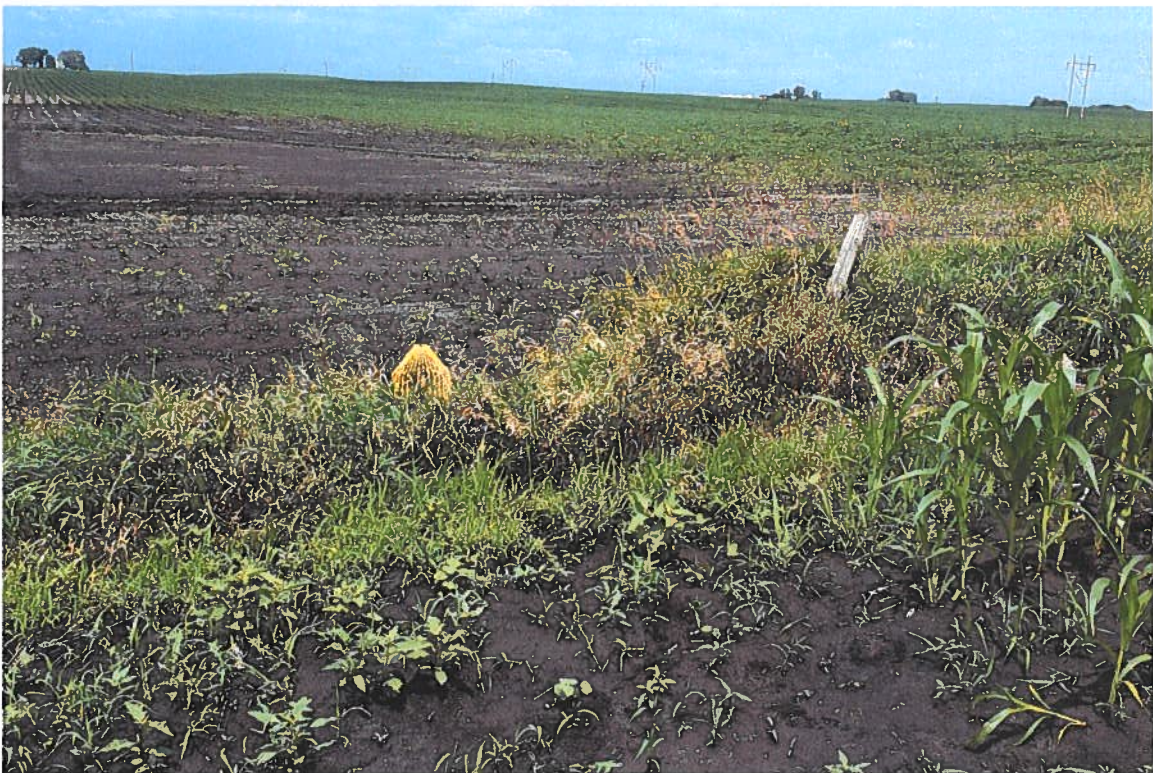
7-15-2020 W side of missing
soil "hump"

7-15-2020 middle of missing soil "hump"

7-15-2020 East side of missing soil "hump"

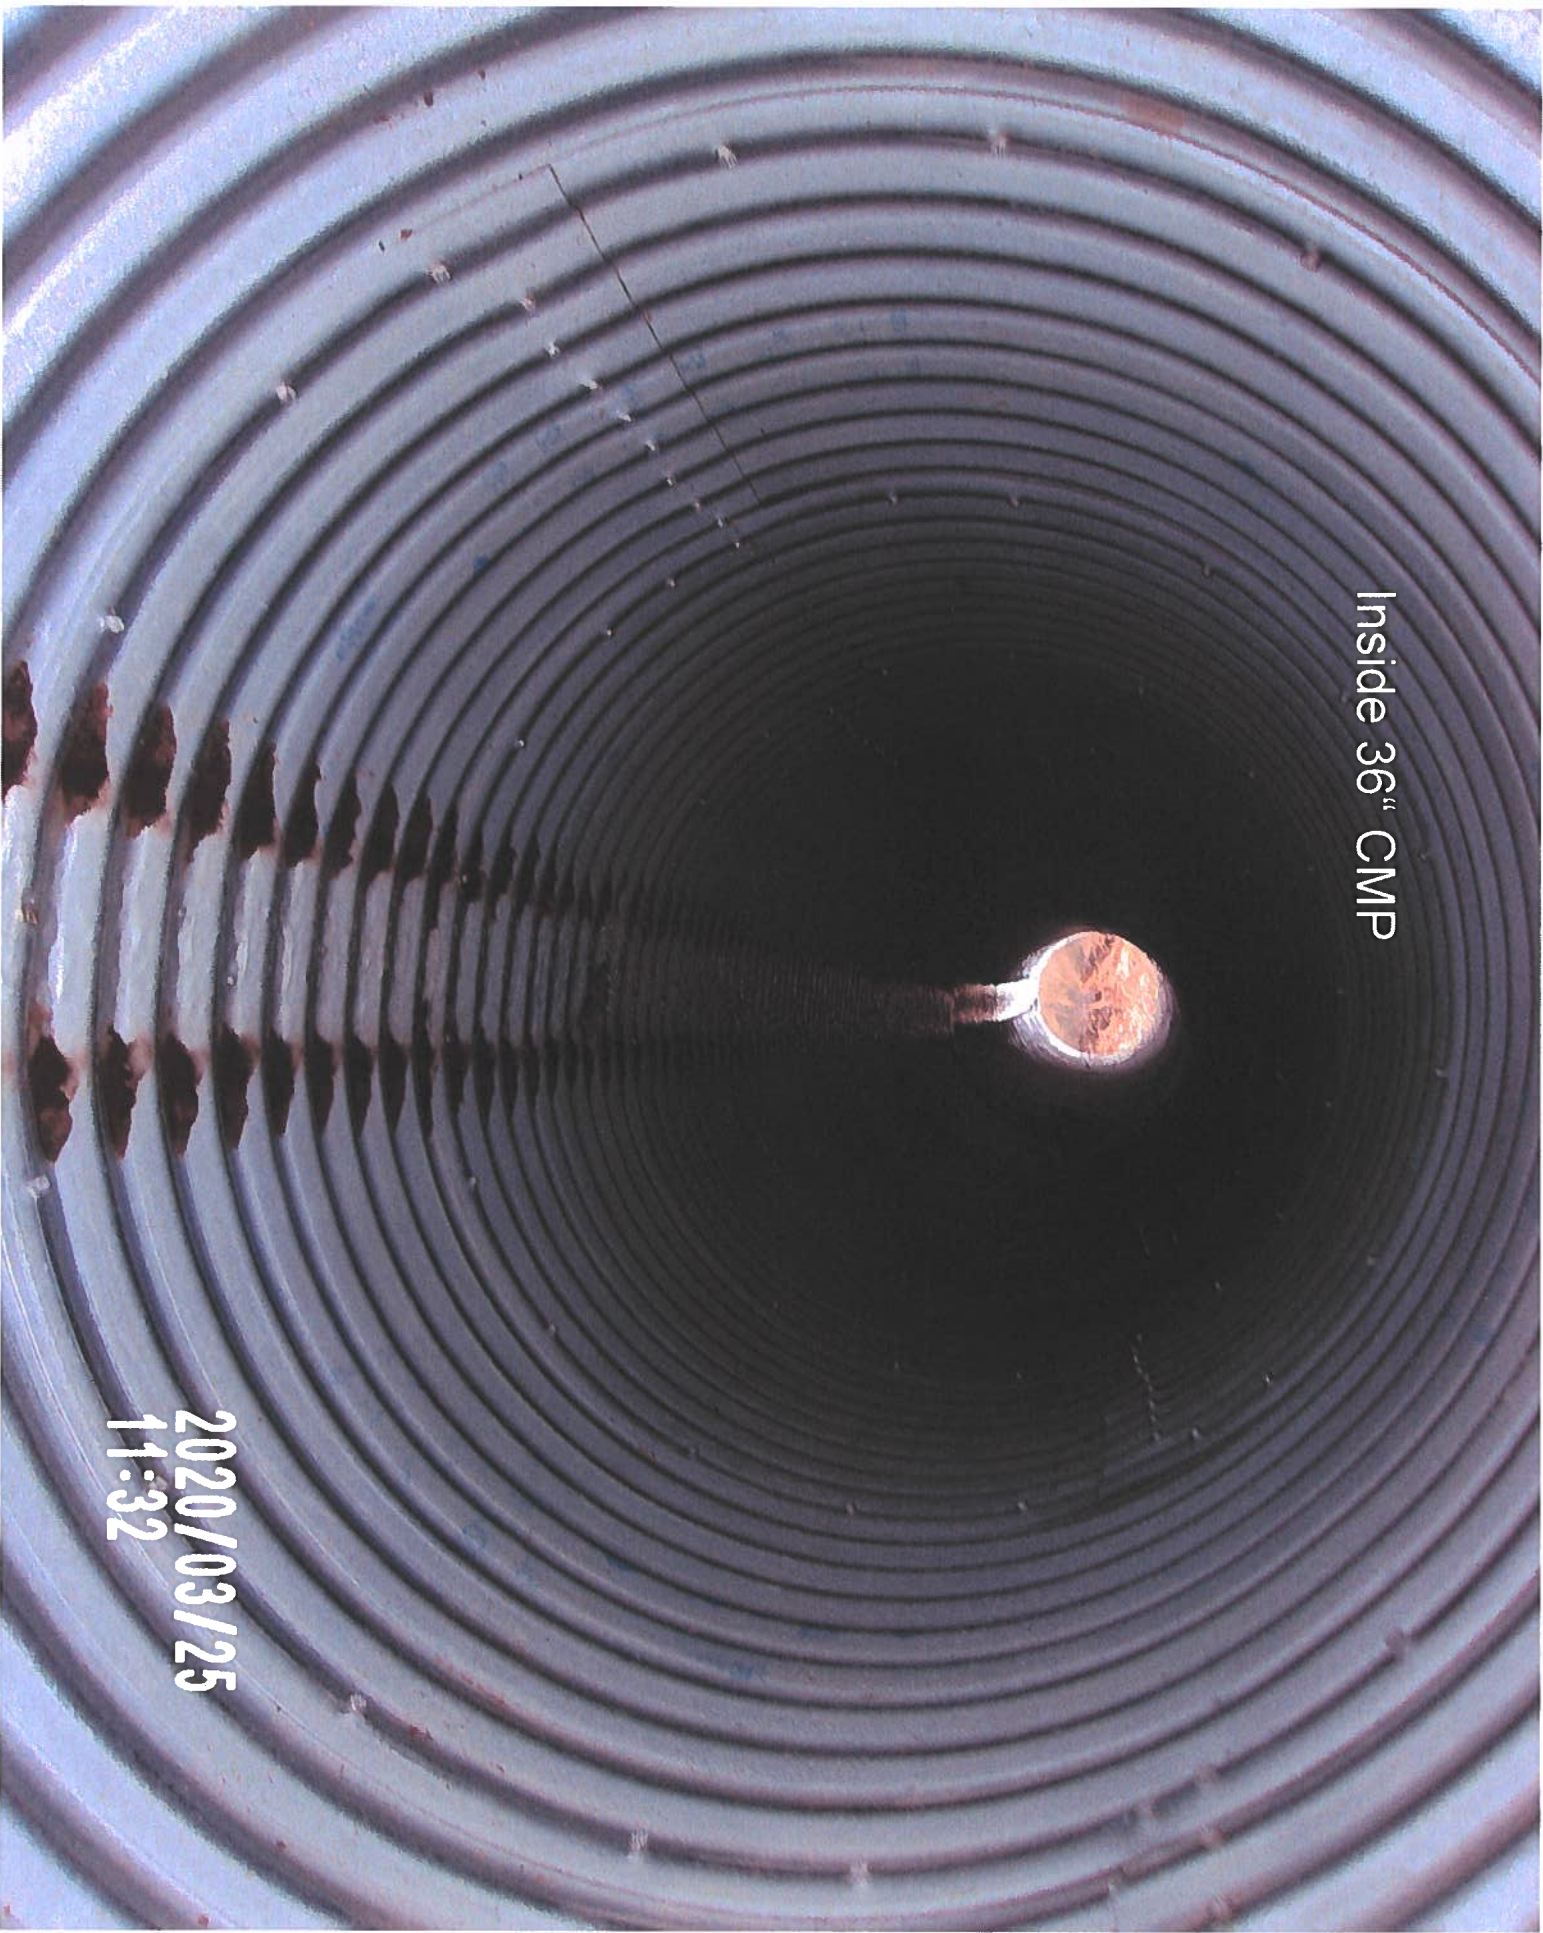
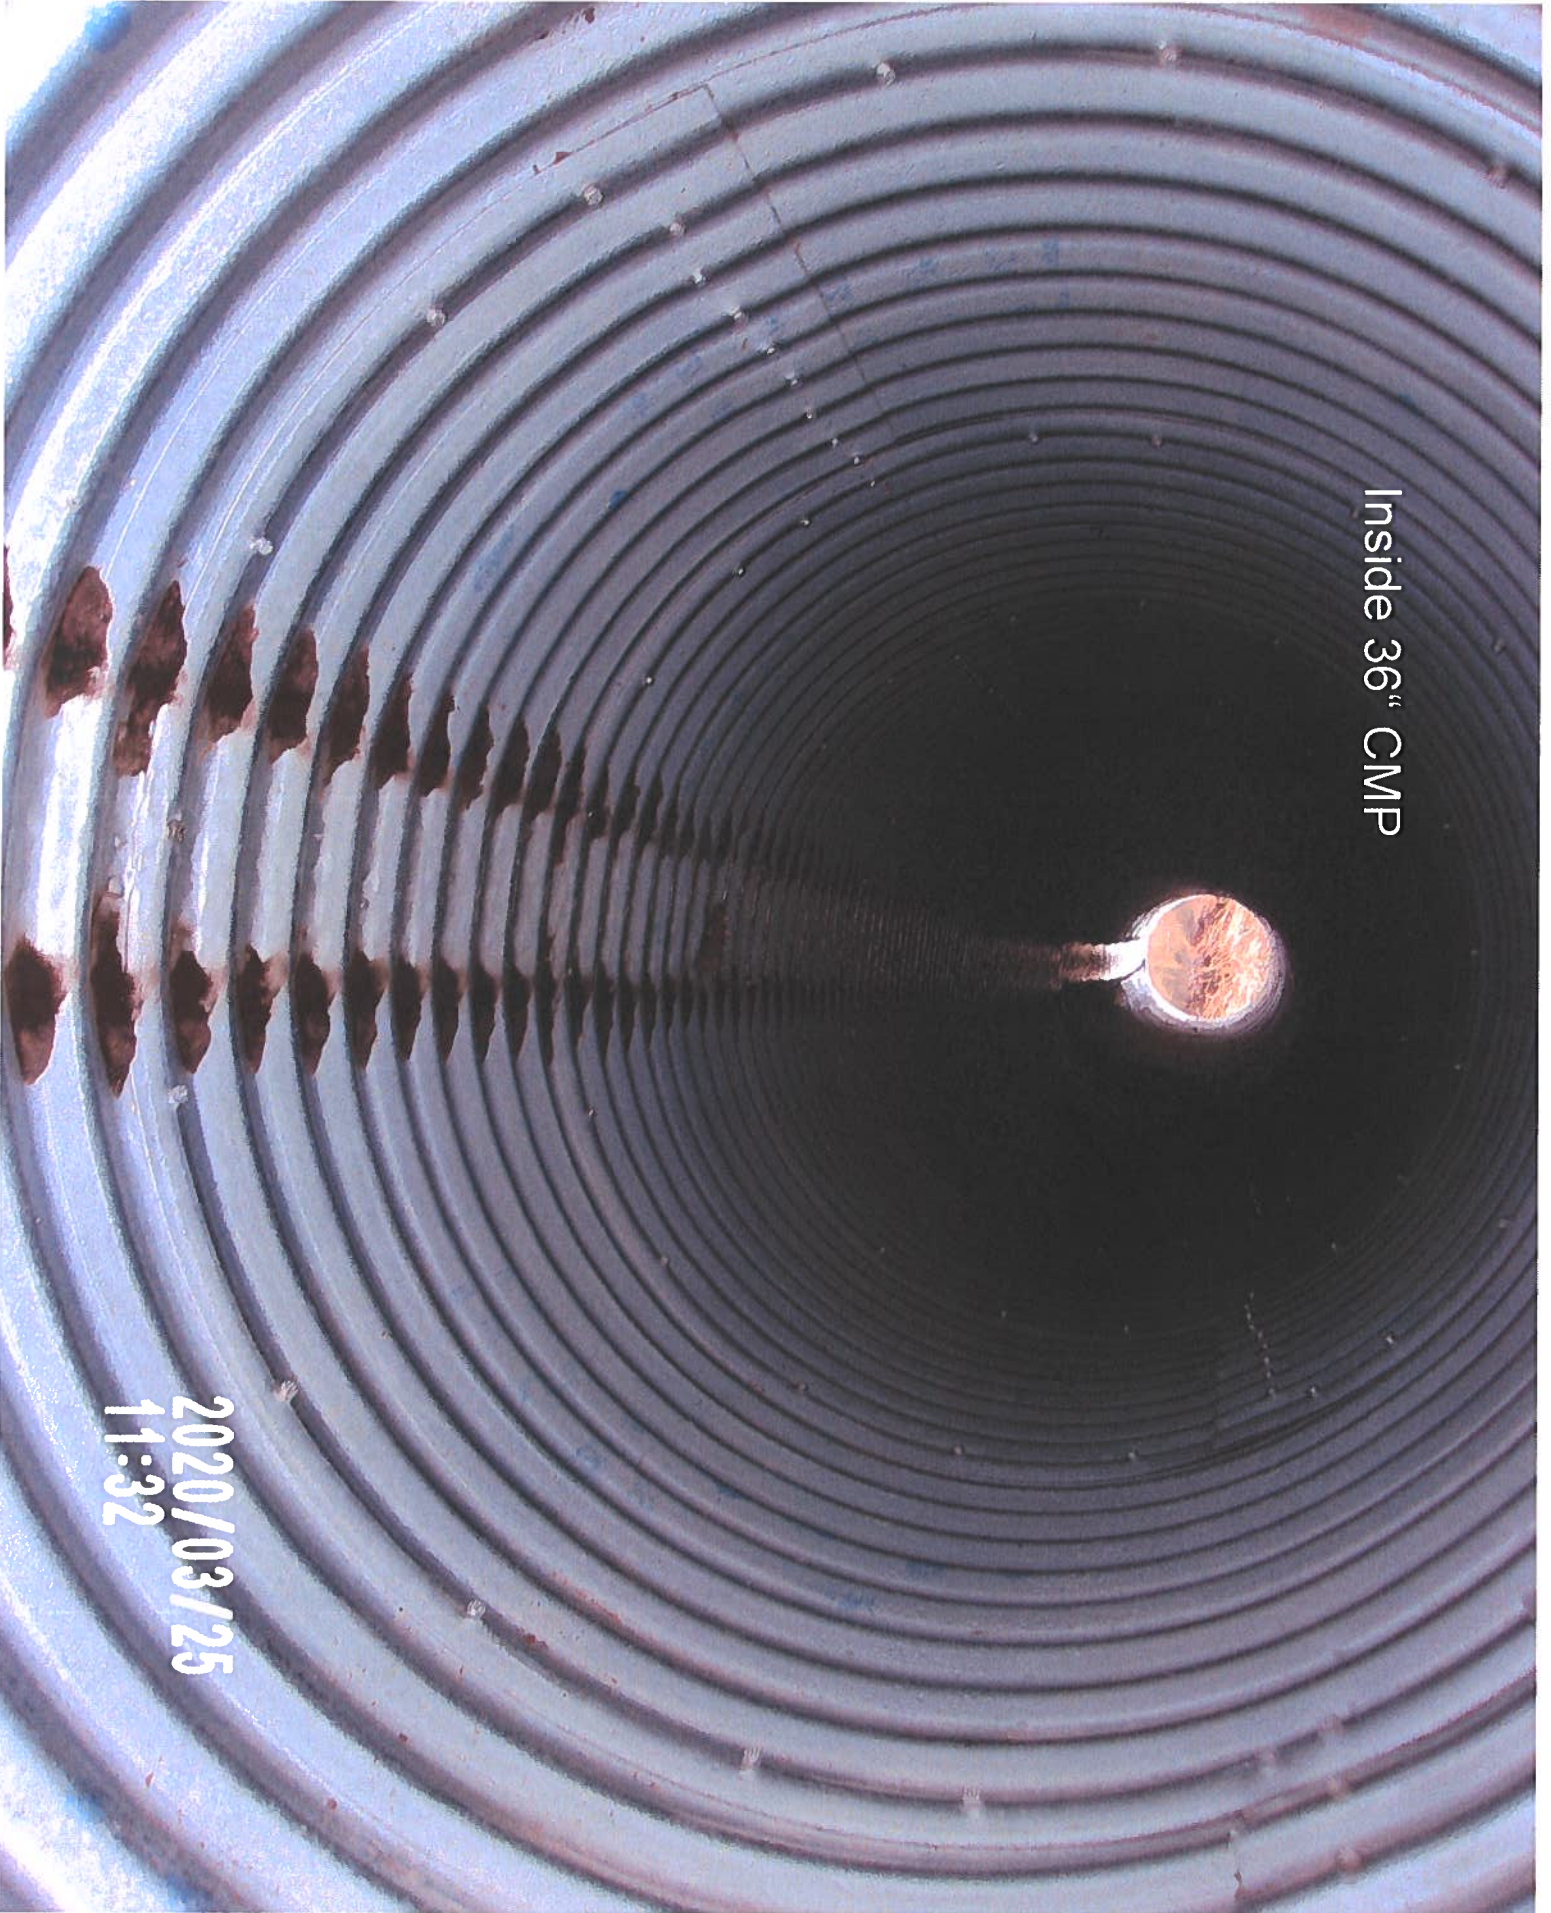
Inside 36" CMP
