AGENDA
REGULAR DRAINAGE MEETING
Wednesday, December 23, 2020 9:30 AM

[2020-4 DD 128 ONLY - UTILITY CROSSING SUMMARY 12_11_20.PDF](#)

REGULAR DRAINAGE MEETING
Wednesday, December 16, 2020 9:30 AM

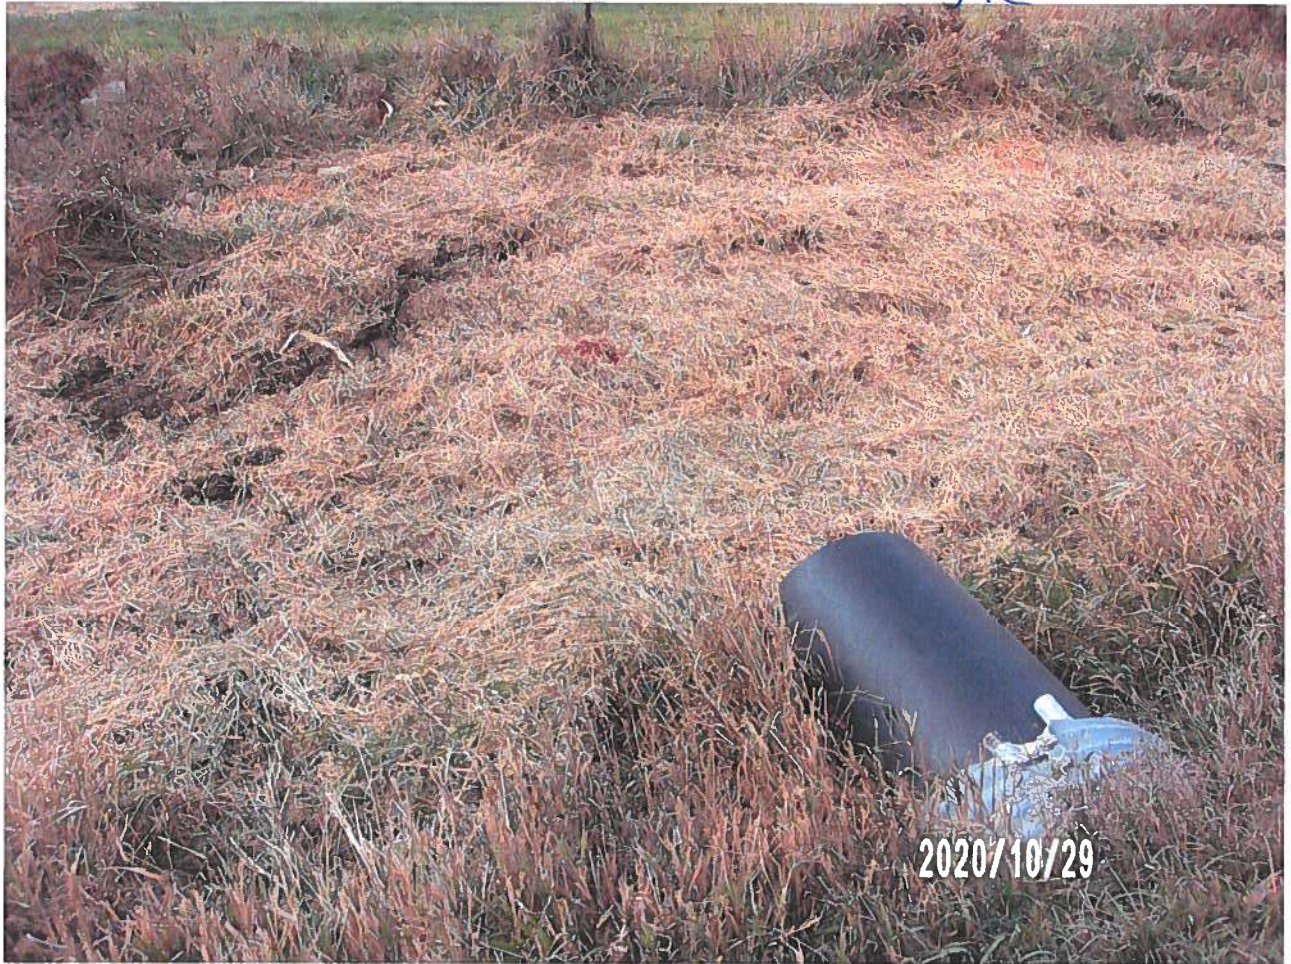
342

The clearance between the Lateral 3 tile and the utility reported location is only 1/2 foot, which is no guarantee that the District tile wasn't impacted as this clearance is solely based on a located depth, and not an exposed depth. It is recommended that the utility expose their line to definitively determine no damage was done to the district facility. The District Trustees may also request the utility to lower their installation.

A piece of the Lateral 3 tile was found to be broken in the observation excavation, with the VCP material in generally poor condition. CGA recommends an investigation into the condition of the tile in this area be conducted while the repair is being completed.
