**AGENDA**  
**REGULAR DRAINAGE MEETING**  
**Wednesday, October 21, 2020 9:30 AM**  
**Large Conference Room**

[DD 14 WO 291 INVESTIGATION SUMMARY 10\\_07\\_20.PDF](#)

## Investigation and Repair Summary:

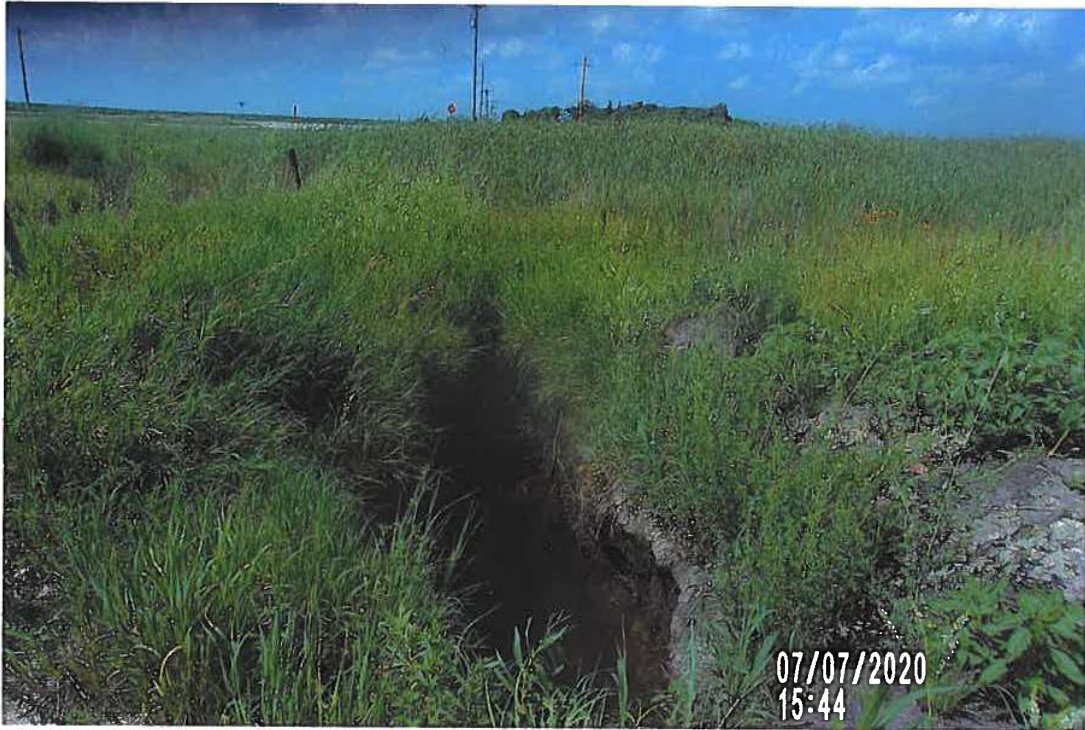
PICTURE # 4048 IS LOOKING NORTH ALONG EAST ROW FENCE  
322'± SOUTH OF CO HWY D-41 SHOWING WATER SITING IN HOLE

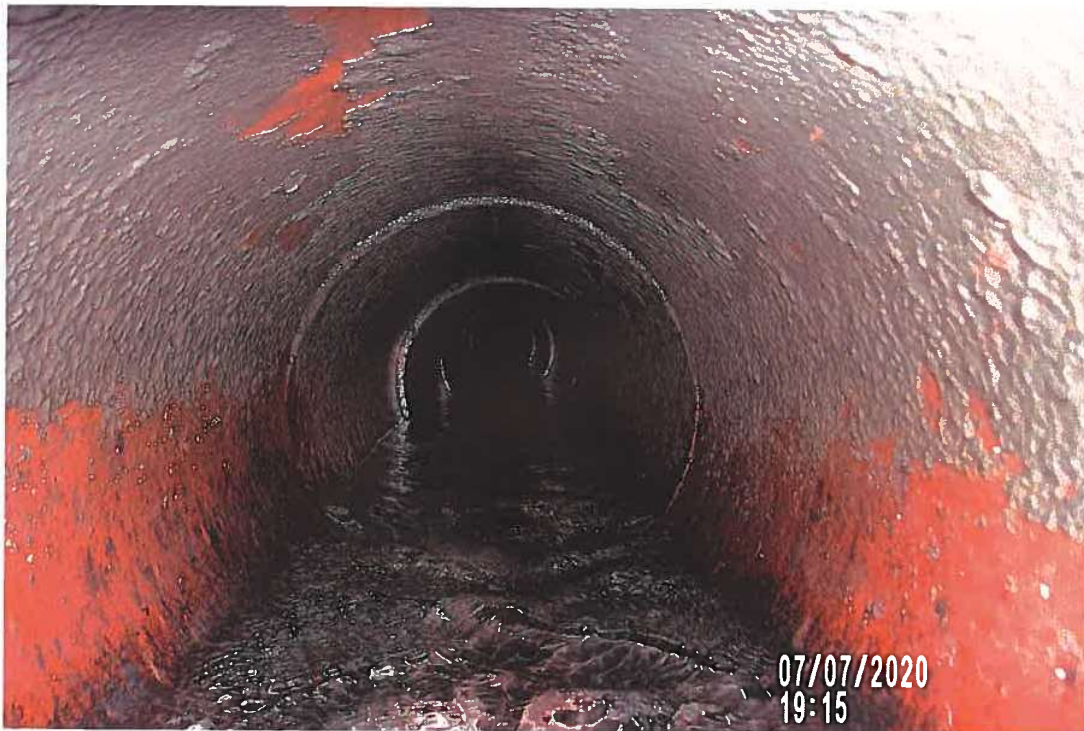
PICTURE # 4049 IS LOOKING NW UPSTREAM INSIDE 14" CLAY  
TILE (GPS# 248 1.28' TOPTOFL). TILE IS IN GOOD SHAPE  
WITH 3" FLOW (5.1" DEEP)

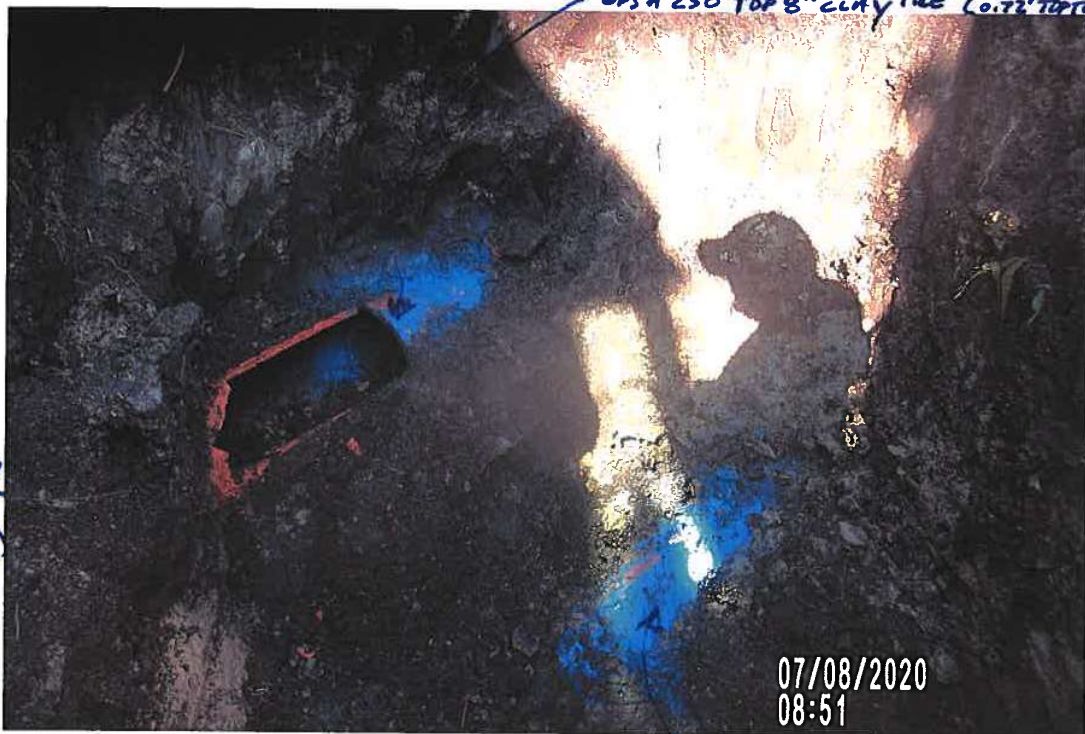
PICTURE# 4051 IS LOOKING SW SHOWING 8" CLAY TILE THAT WAS DAMAGED WHILE EXCAVATING TO EXPOSE 14" CLAY @ LOCATION WHERE WATERMAIN GOES UNDER TILE

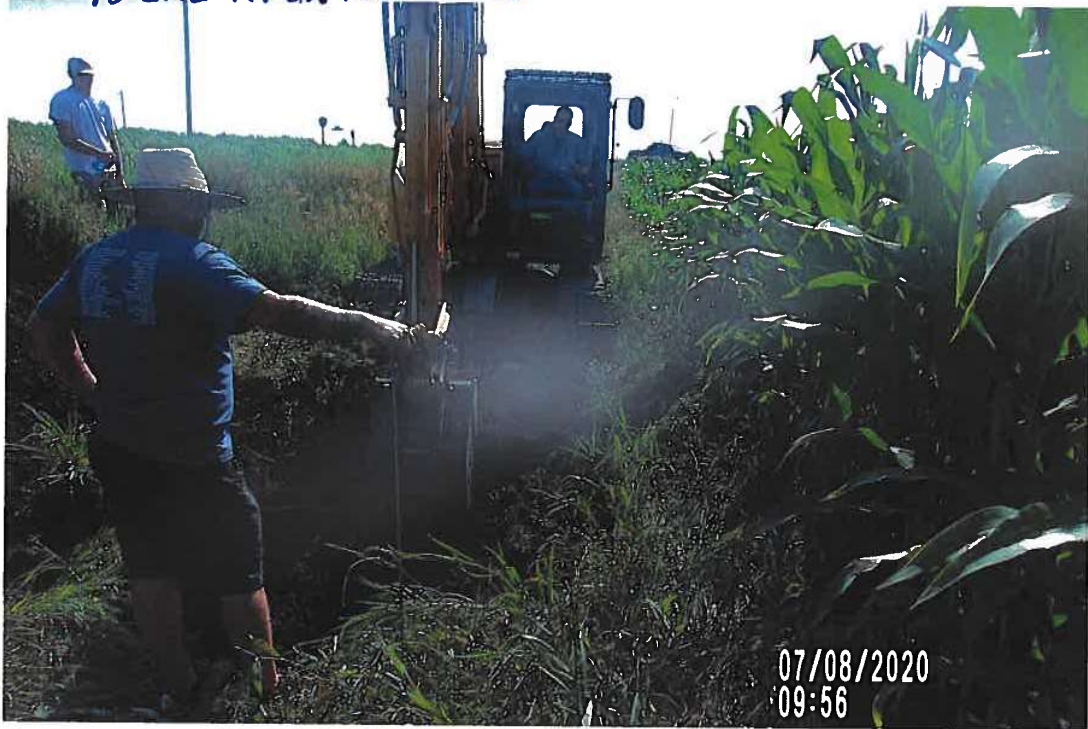
PICTURE #4054 IS LOOKING EAST IN SOUTH DITCH CO HWY 04/  
297<sup>E</sup> WEST OF E CO HWY S-27 SHOWING CREW EXPOSING LATZ TILE  
WEST OF BEEHIVE INTAKE SO CREW CAN RUN LOCATE CABLE UPSTREAM  
TO CHECK FOR PLUGGED TILE.

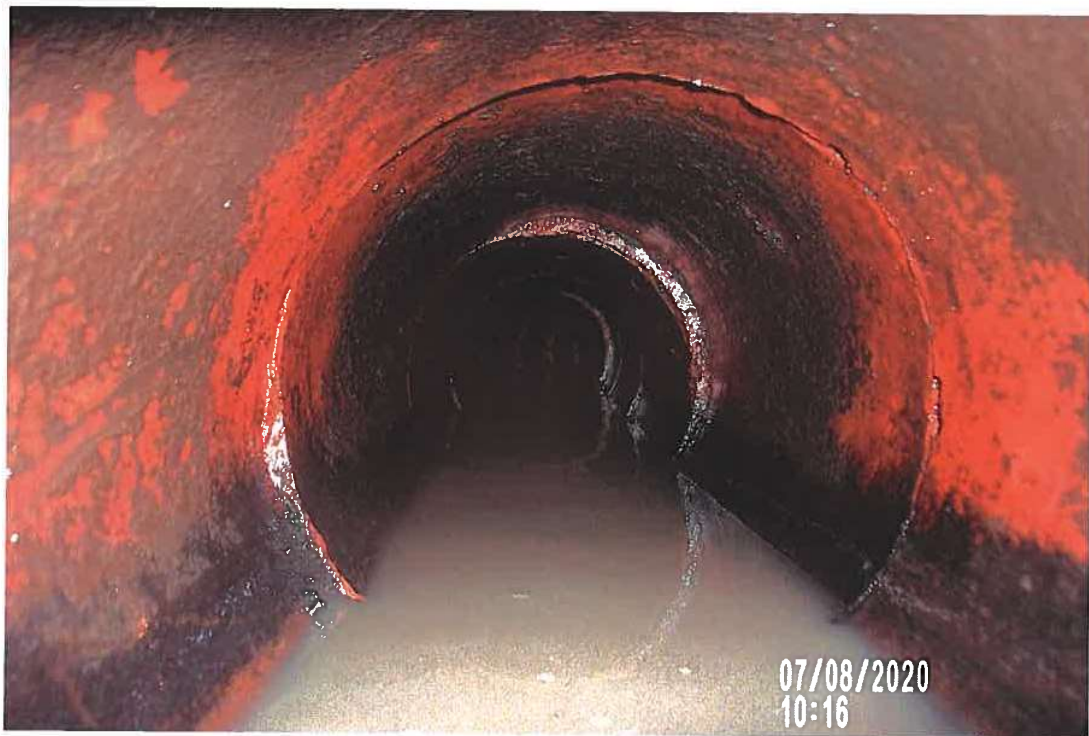
PICTURE #4055 IS LOOKING <sup>NW</sup> DOWNSTREAM INSIDE 8" CLAY TILE  
FROM GPS # 255' SHOWING TILE IN GOOD CONDITION WITH <sup>3</sup>/<sub>4</sub>" OF  
WATER AND NOT MUCH FLOW. TILE IS 3.1' ± DEEP.

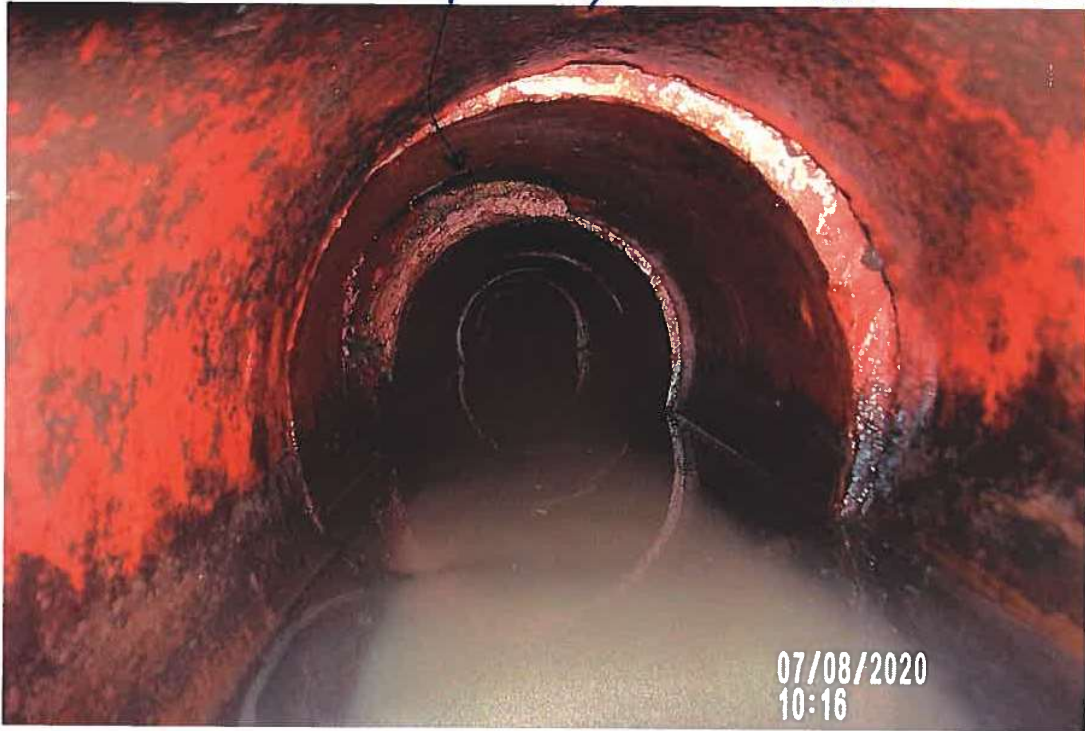
PICTURE# 4056 IS LOOKING SE UPSTREAM INSIDE 8" CLAY TILE  
SHOWING TILE IN GOOD CONDITION WITH 3/4" WATER IN FL &  
NOT MUCH FLOW. TILE IS 3.11' ± DEEP.  
↑ 6" CLAY TILE INLET FROM BEEHIVE INTAKE.

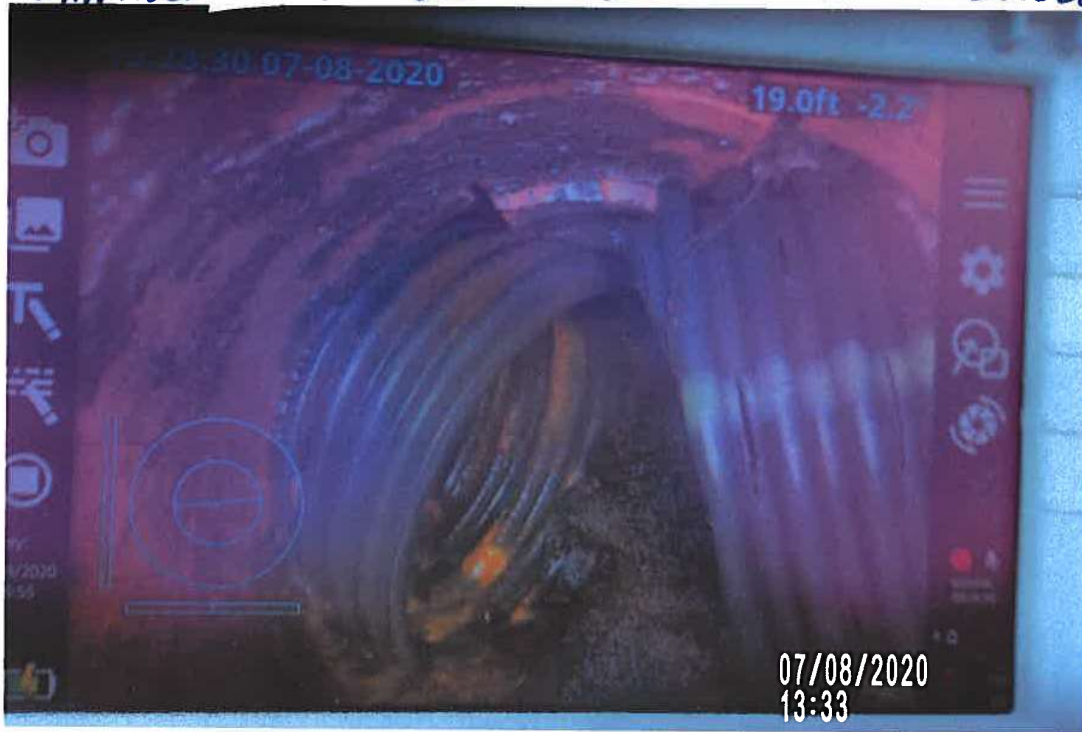
PICTURE # 4060 IS LOOKING UPSTREAM INSIDE 8" CLAY TILE @ 2 1/3' UPSTREAM FROM BEEHIVE INTAKE SHOWING 5" PERF SW HOPE TILE FROM EAST & FROM WEST CONNECTING AT SAME LOCATION WITH SIDES CRACKED AND TOP CAVING DOWN WITH TILE PLUGGED UPSTREAM WITH SOIL & ROOTS

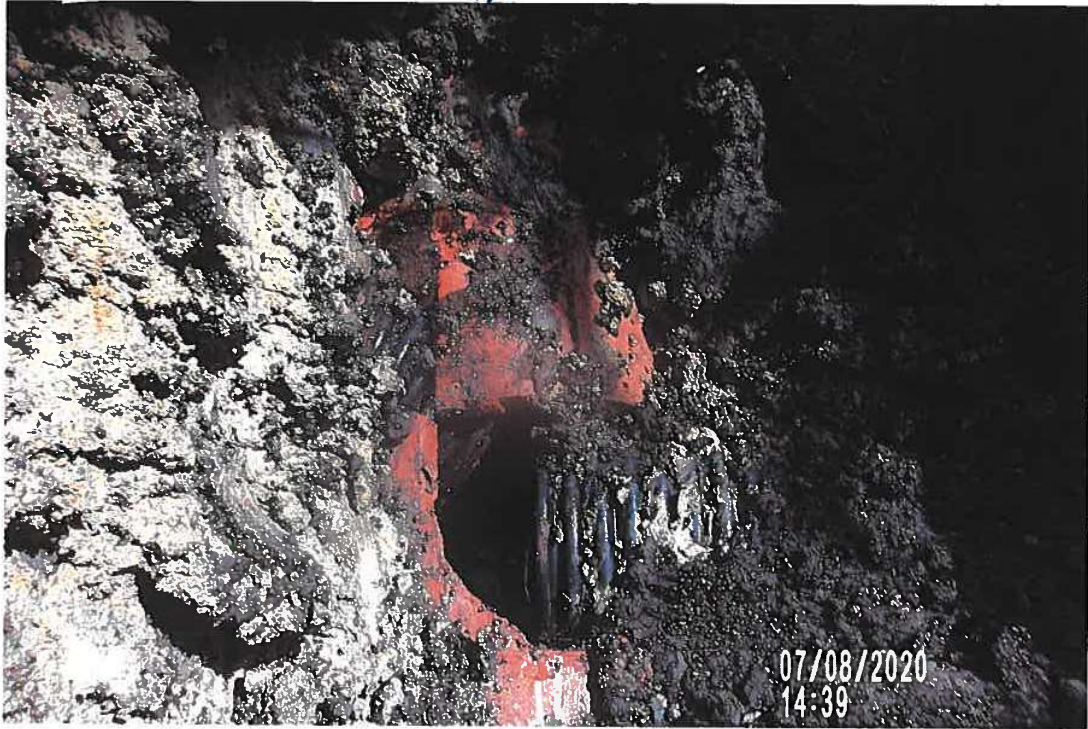
PICTURE # 4062 IS LOOKING SE AT TOP VIEW OF 5" HDPE SW PERF TILE FROM WEST & EAST TIEING INTO SAME LOCATION INTO BROKEN 8" CLAY TILE AND PLUGGED LINE

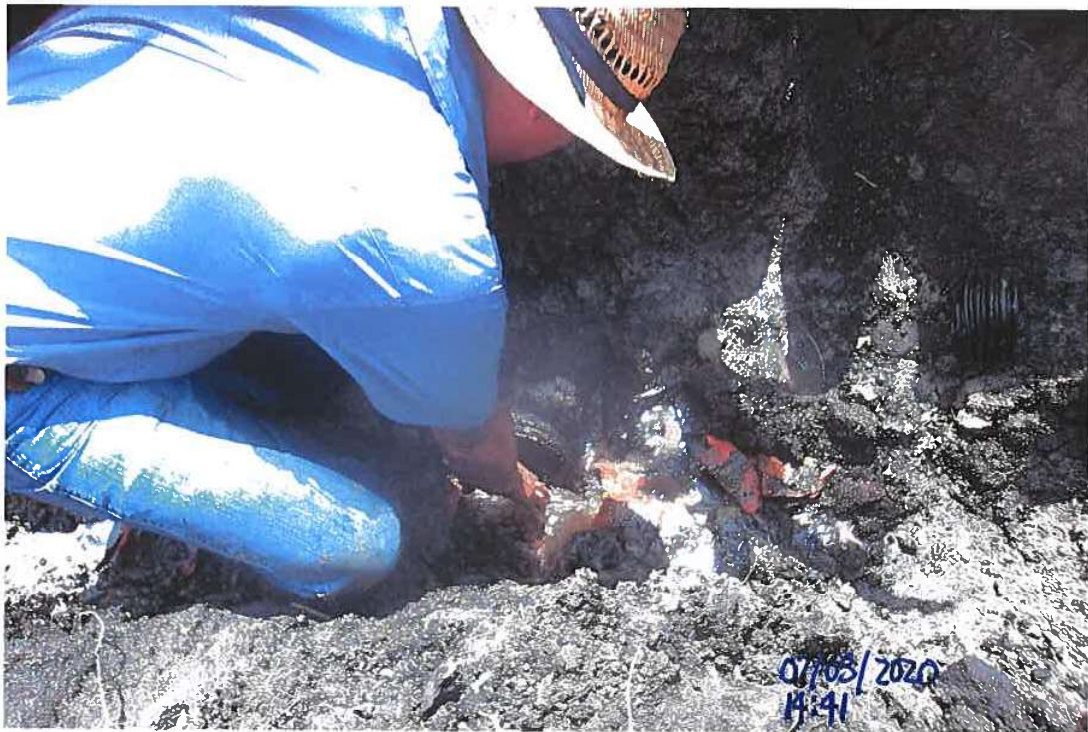
PICTURE # 4064 IS LOOKING SW SHOWING WATER GUSHING FROM UPSTREAM END OF 8" CLAY TILE AT 5" HDPE TILE CONNECTIONS AFTER BLOCKAGE REMOVED

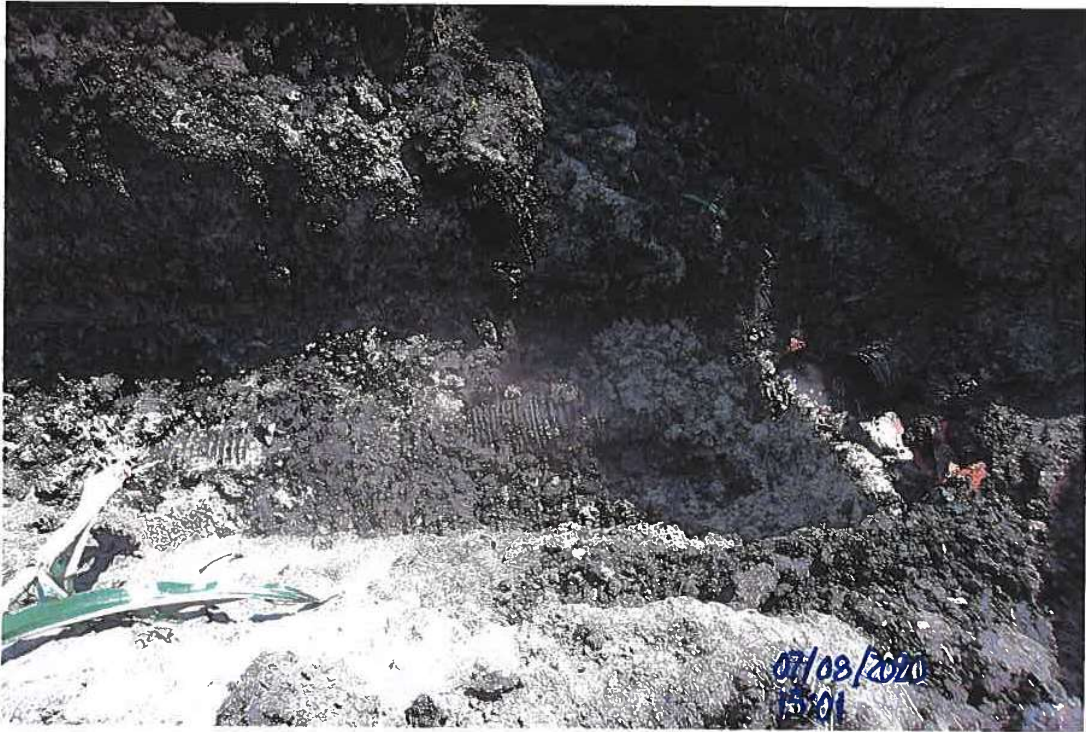
PICTURE# 4065 IS LOOKING SOUTH SHOWING 5" HOPE TILE CONNECTION WITH 5" HOPE TILE FROM WEST HAVING A SAC OR HUMPE UP IN A SPOT.

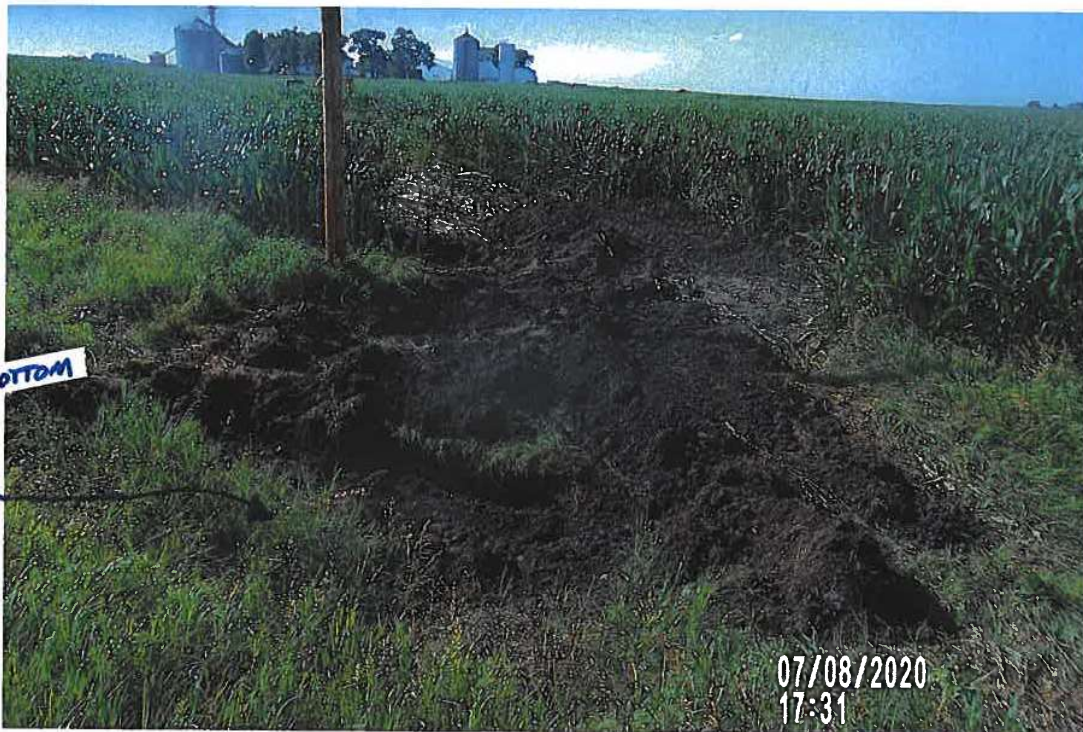
6" HICKEN BOTTOM  
R<sub>2</sub> FULL OF  
SOIL &  
6" CLAY TILE  
OUTLET  
BROKEN  
& FULL  
OF SOIL

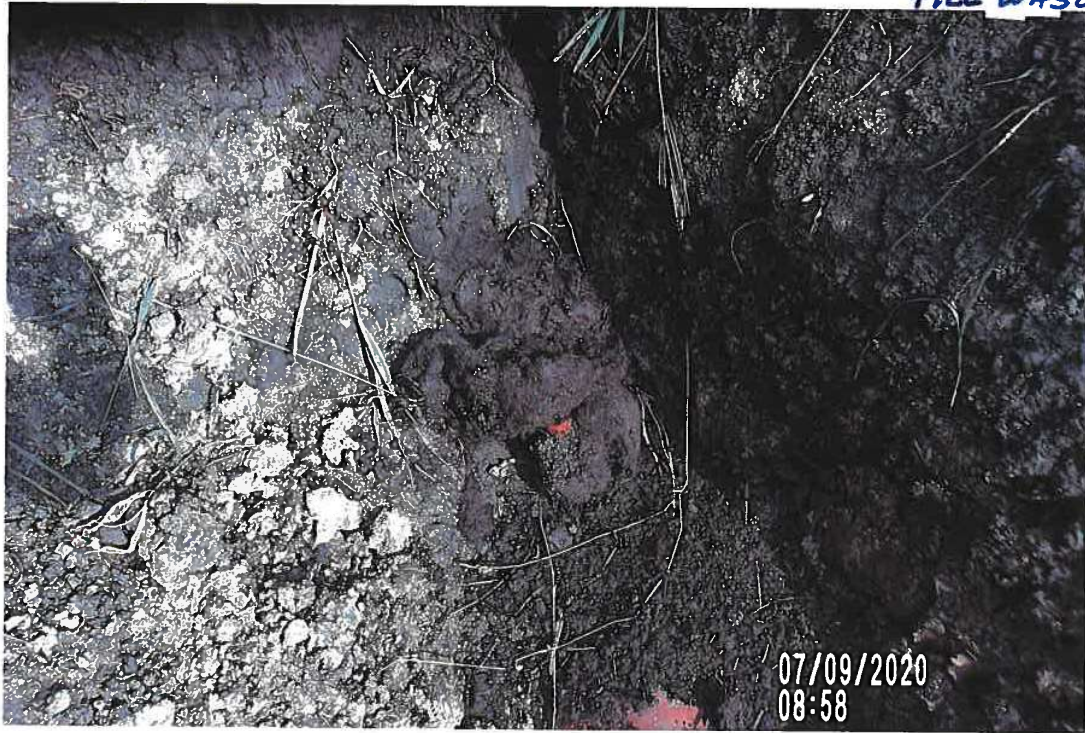
PICTURE # 4088 SHOWING PILE OF DEBRIS PULLED OUT OF TILE  
(WHERE 8" CLAY TILE SECTION WAS ROLLED OUT IN SOUTH DITCH OF  
CO HWY 041) BEFORE IT WENT DOWNSTREAM AFTER PLUGGED  
TILE WAS OPENED

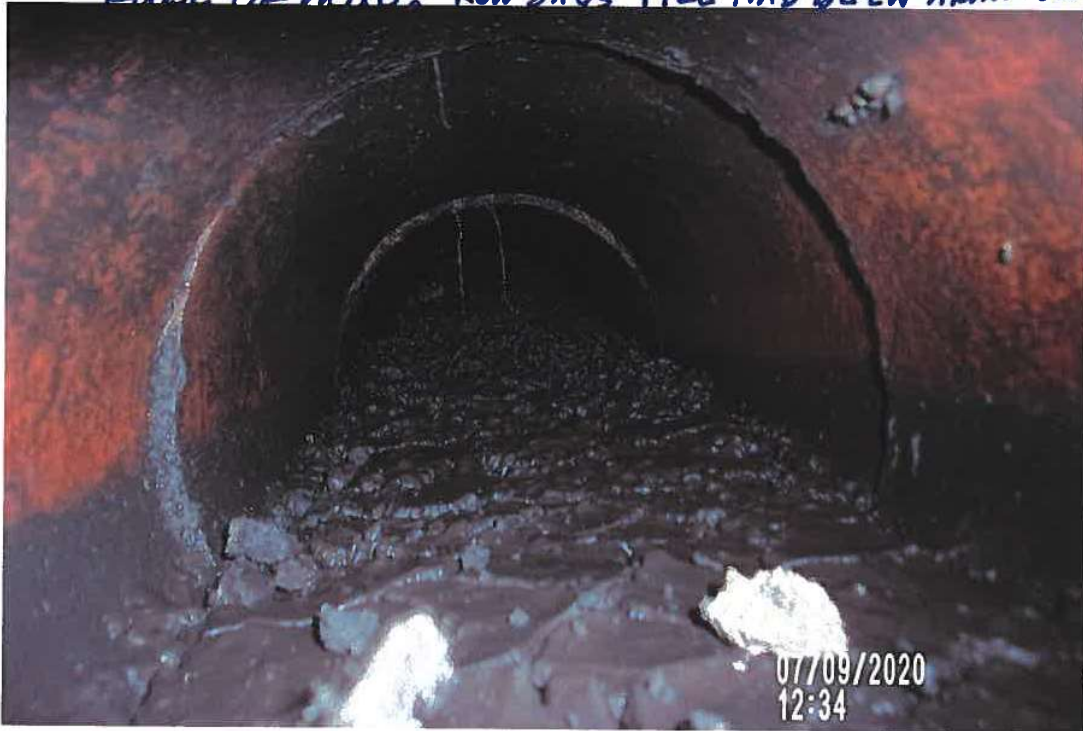
PICTURE #4098 IS LOOKING SE DOWNSTREAM FROM GPS #251  
 TOP 8" CLAY TILE (0.75' TOP TO FL) AFTER ANOTHER DAMAGED  
 4.0' SECTION OF TILE WAS REMOVED. 2" MUD IN FL TO COMPLETELY  
 FULL OF MUD. RON SAYS TILE HAS BEEN ABANDONED BUT

WILL CONNECT  
 TOGETHER  
 IN CASE  
 ANY TILE  
 UPSTREAM  
 IS CONNECTED  
 YES  
 N  
 ↓

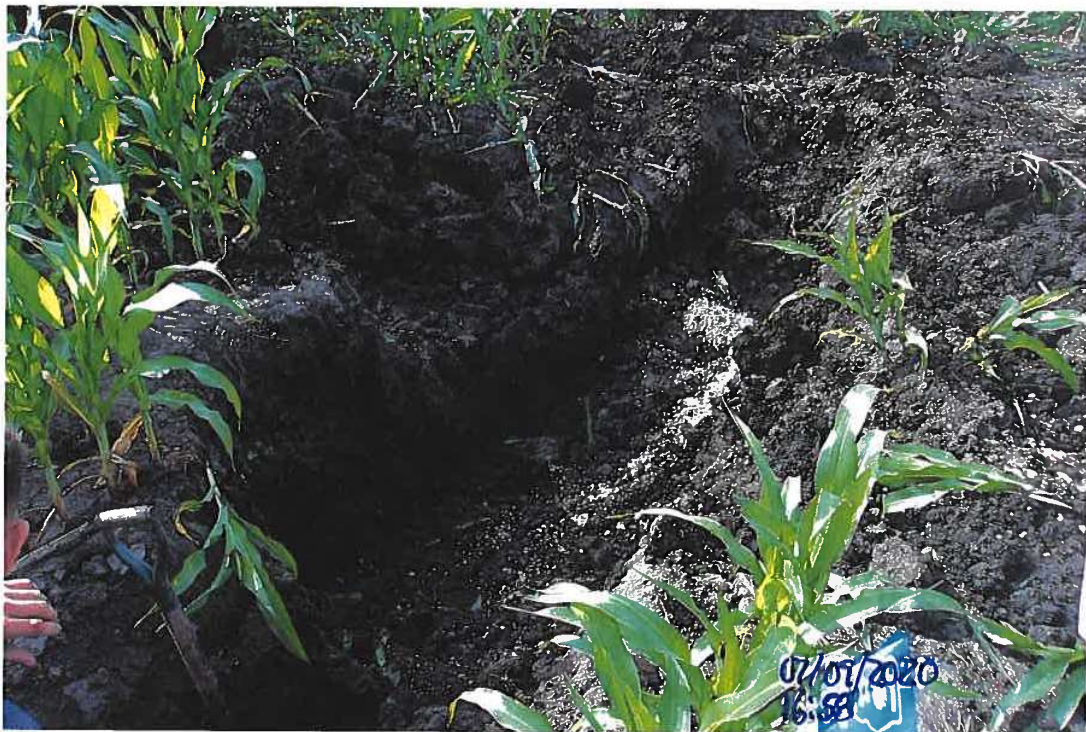
PICTURE #4122 IS LOOKING NW SHOWING 4" SW HOPE PERF TILE THAT NEEDS REPLACED AFTER CUTTING TILE WHILE EXCAVATING TO CHECK LAT #2 TILE FLOW STATUS ON EAST SIDE OF CO HWY S-27.

PICTURE # 4123 IS LOOKING NORTH SHOWING 9.8 LF OF 4" HDPE SW PERF TILE INSTALLED WITH 4" HDPE INTERNAL COUPLERS AND OFF TO SIDE SOME FOR FIRMER GROUND & BEDDED WITH ROCK UNDER. GPS # 312 TOP EXISTING 4" HDPE PERF TILE

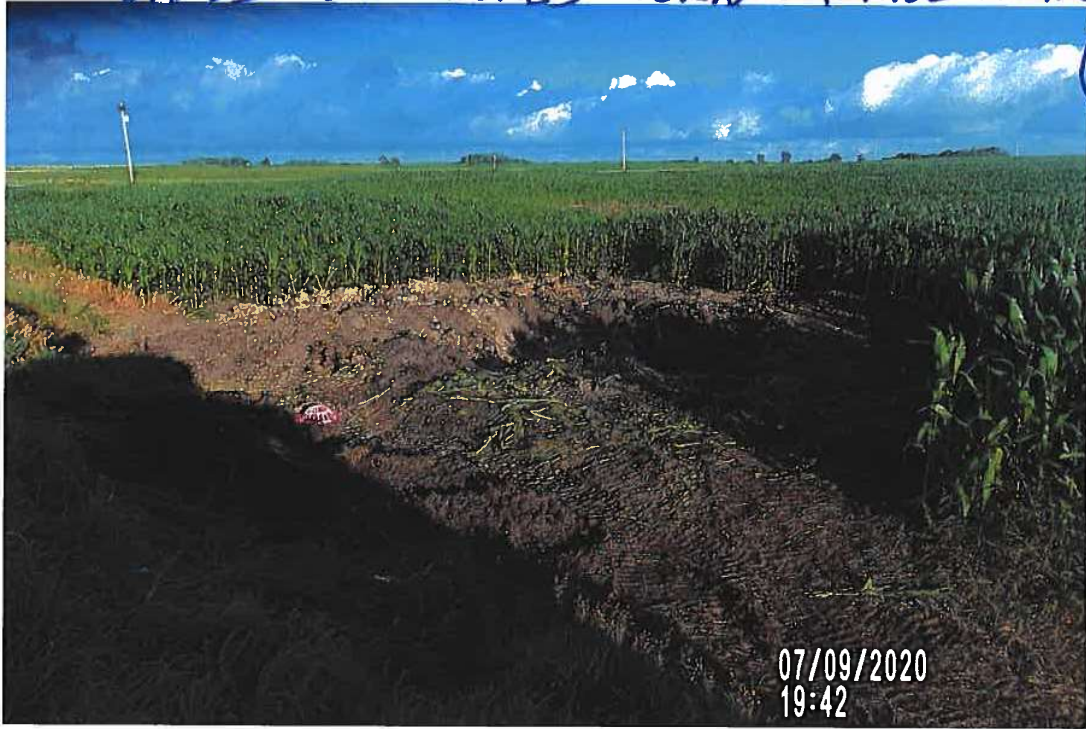
PICTURE#4131 IS LOOKING SE SHOWING 5" HOPE TIE IN  
TRENCH THAT NEEDS BACK FILLED YET. PICTURE  
SHOWS 0.051 ACRES CORN DAMAGE DURING REPAIR

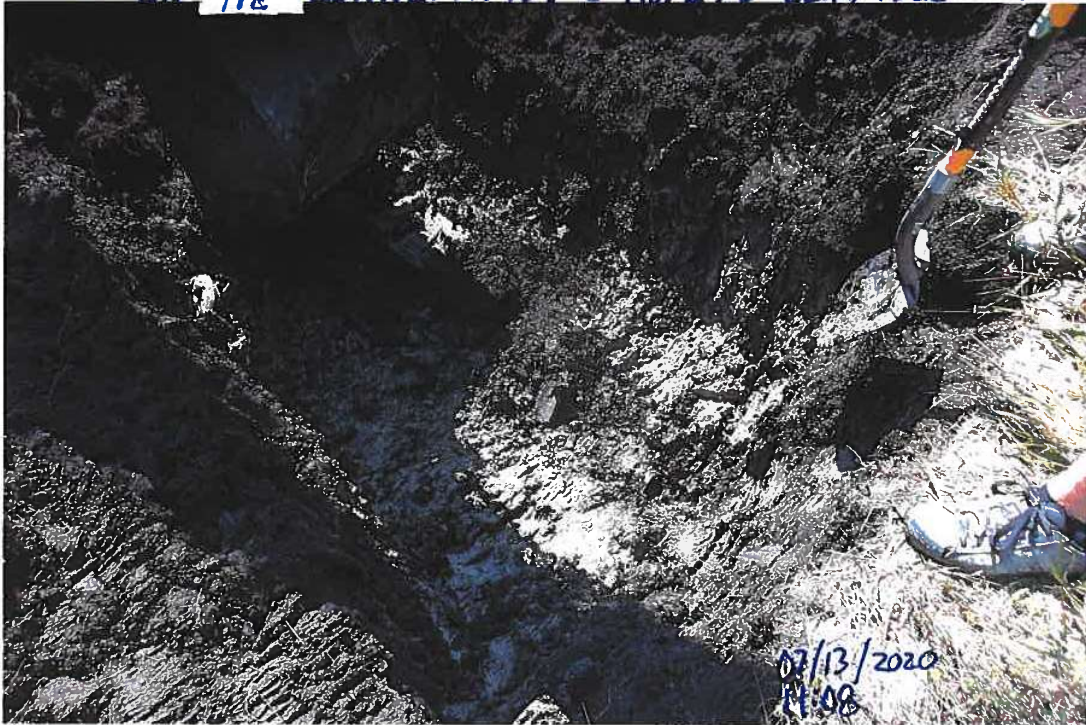
PICTURE# 4142 IS LOOKING SE SHOWING 6" HDPE PERF TILE CONNECTION TO 6" CLAY TILE EAST OF BEEHIVE INTAKE. PICTURE SHOWS CREW EXCAVATING TO CHECK ON TILE CONNECTION. 6" HDPE / 6" CLAY TILE CONNECTION CLAY TILE BROKE & WILL NEED REPLACED.

TILE BROKE & WILL NEED REPLACED.
