**AGENDA**  
**REGULAR DRAINAGE MEETING**  
**Wednesday, March 11, 2020 9:30 AM**

7. DD 100 WO 248 - Discuss W Possible Action - Repair Summary

## Repair Summary:

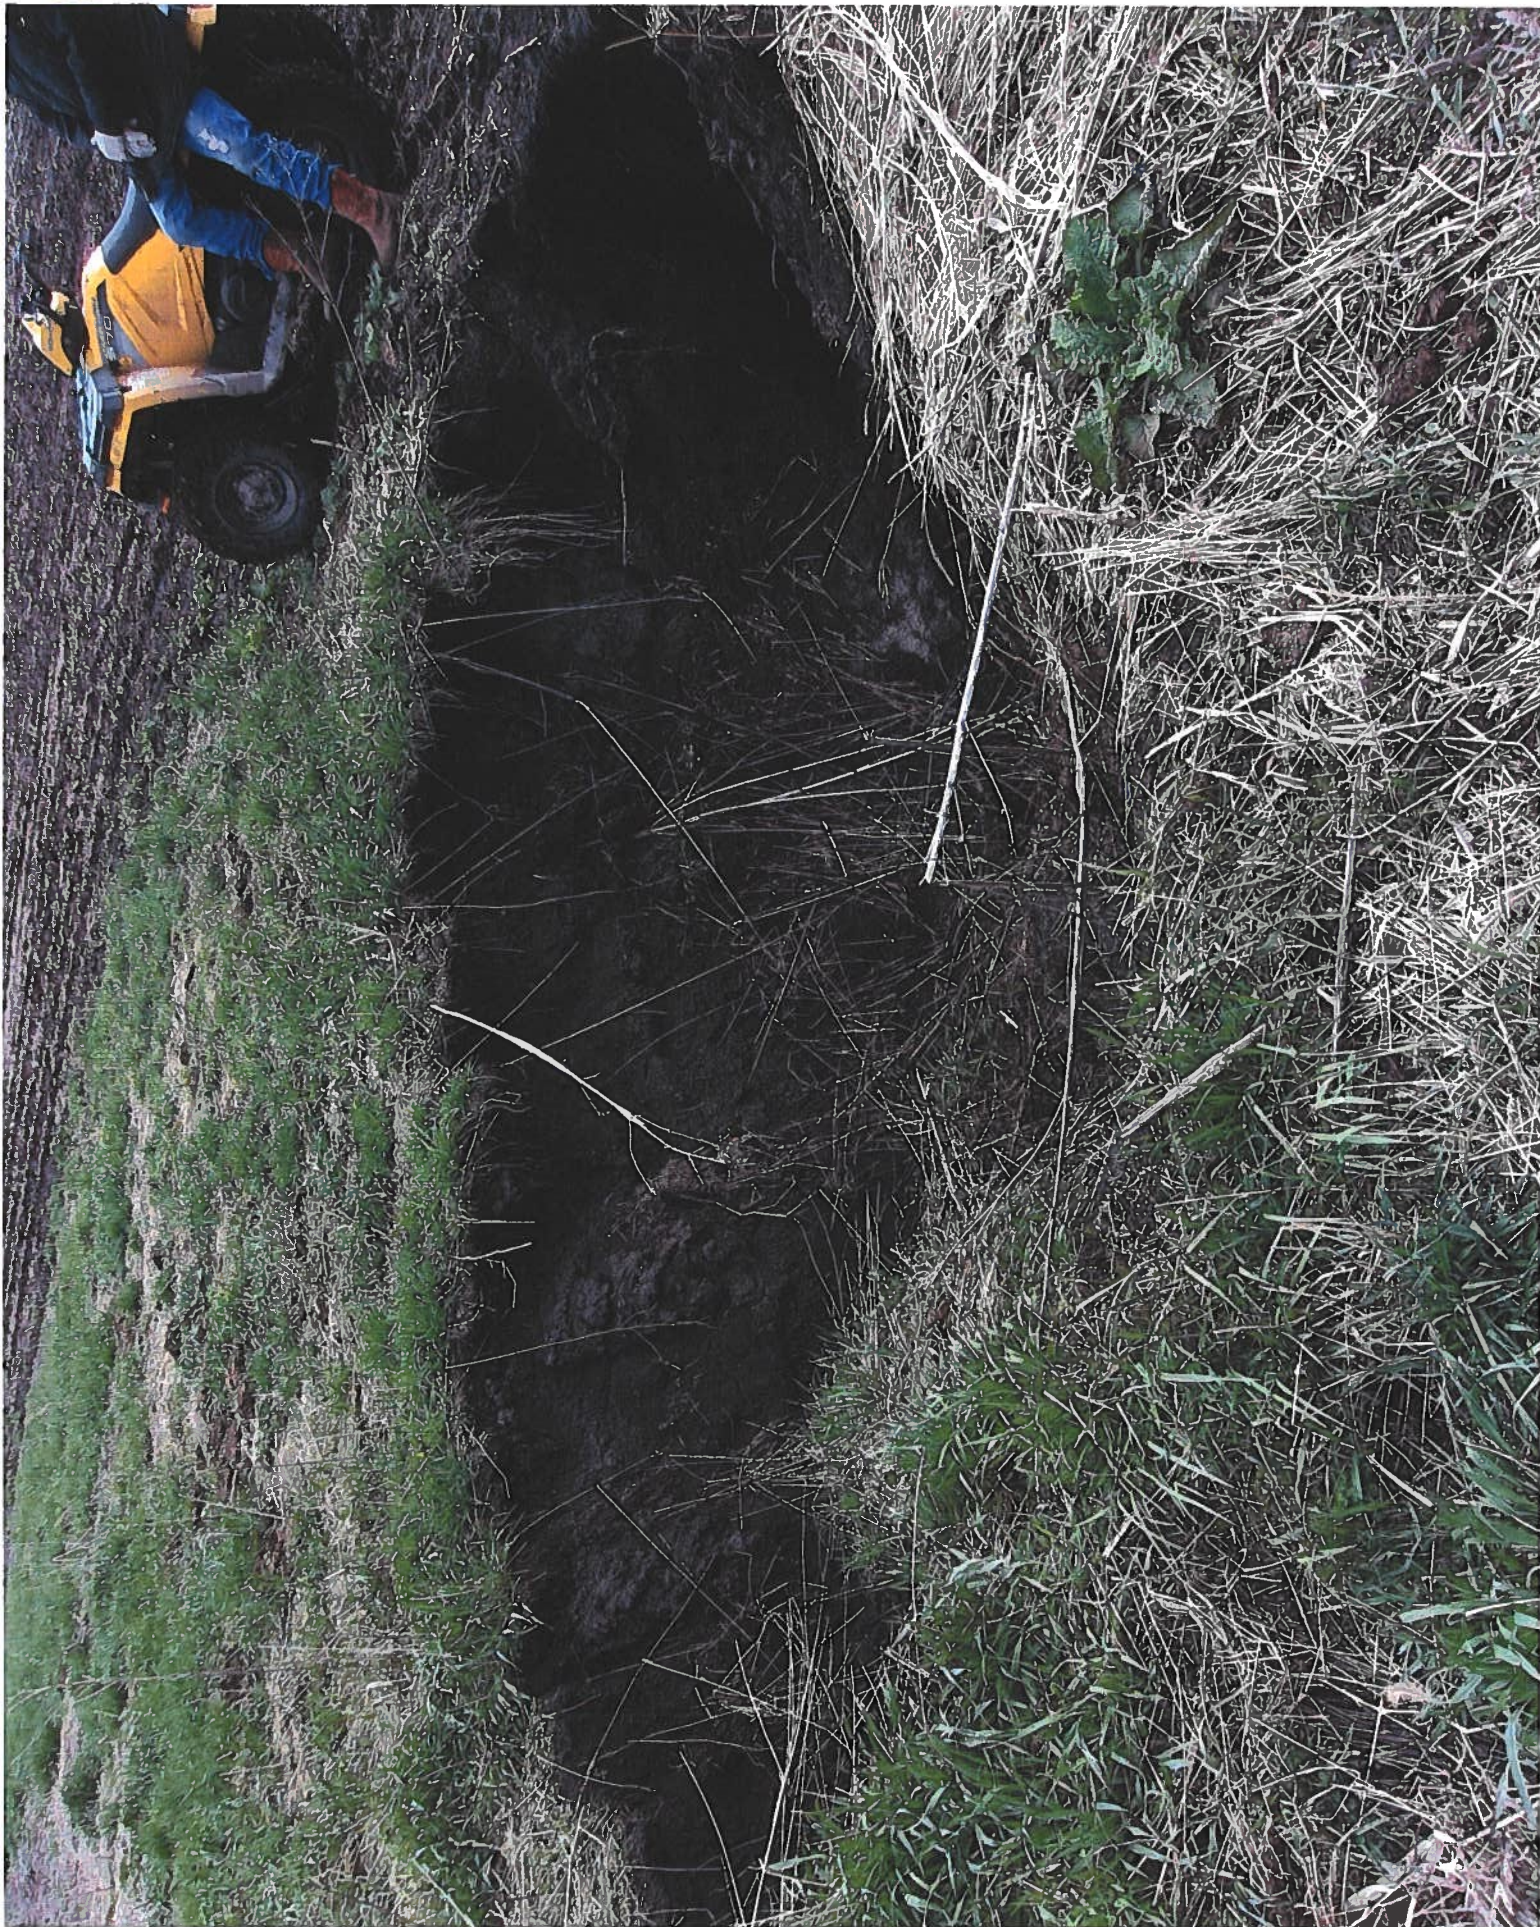
Blow-out Hole on DD 100, MEASURED 12" TILE

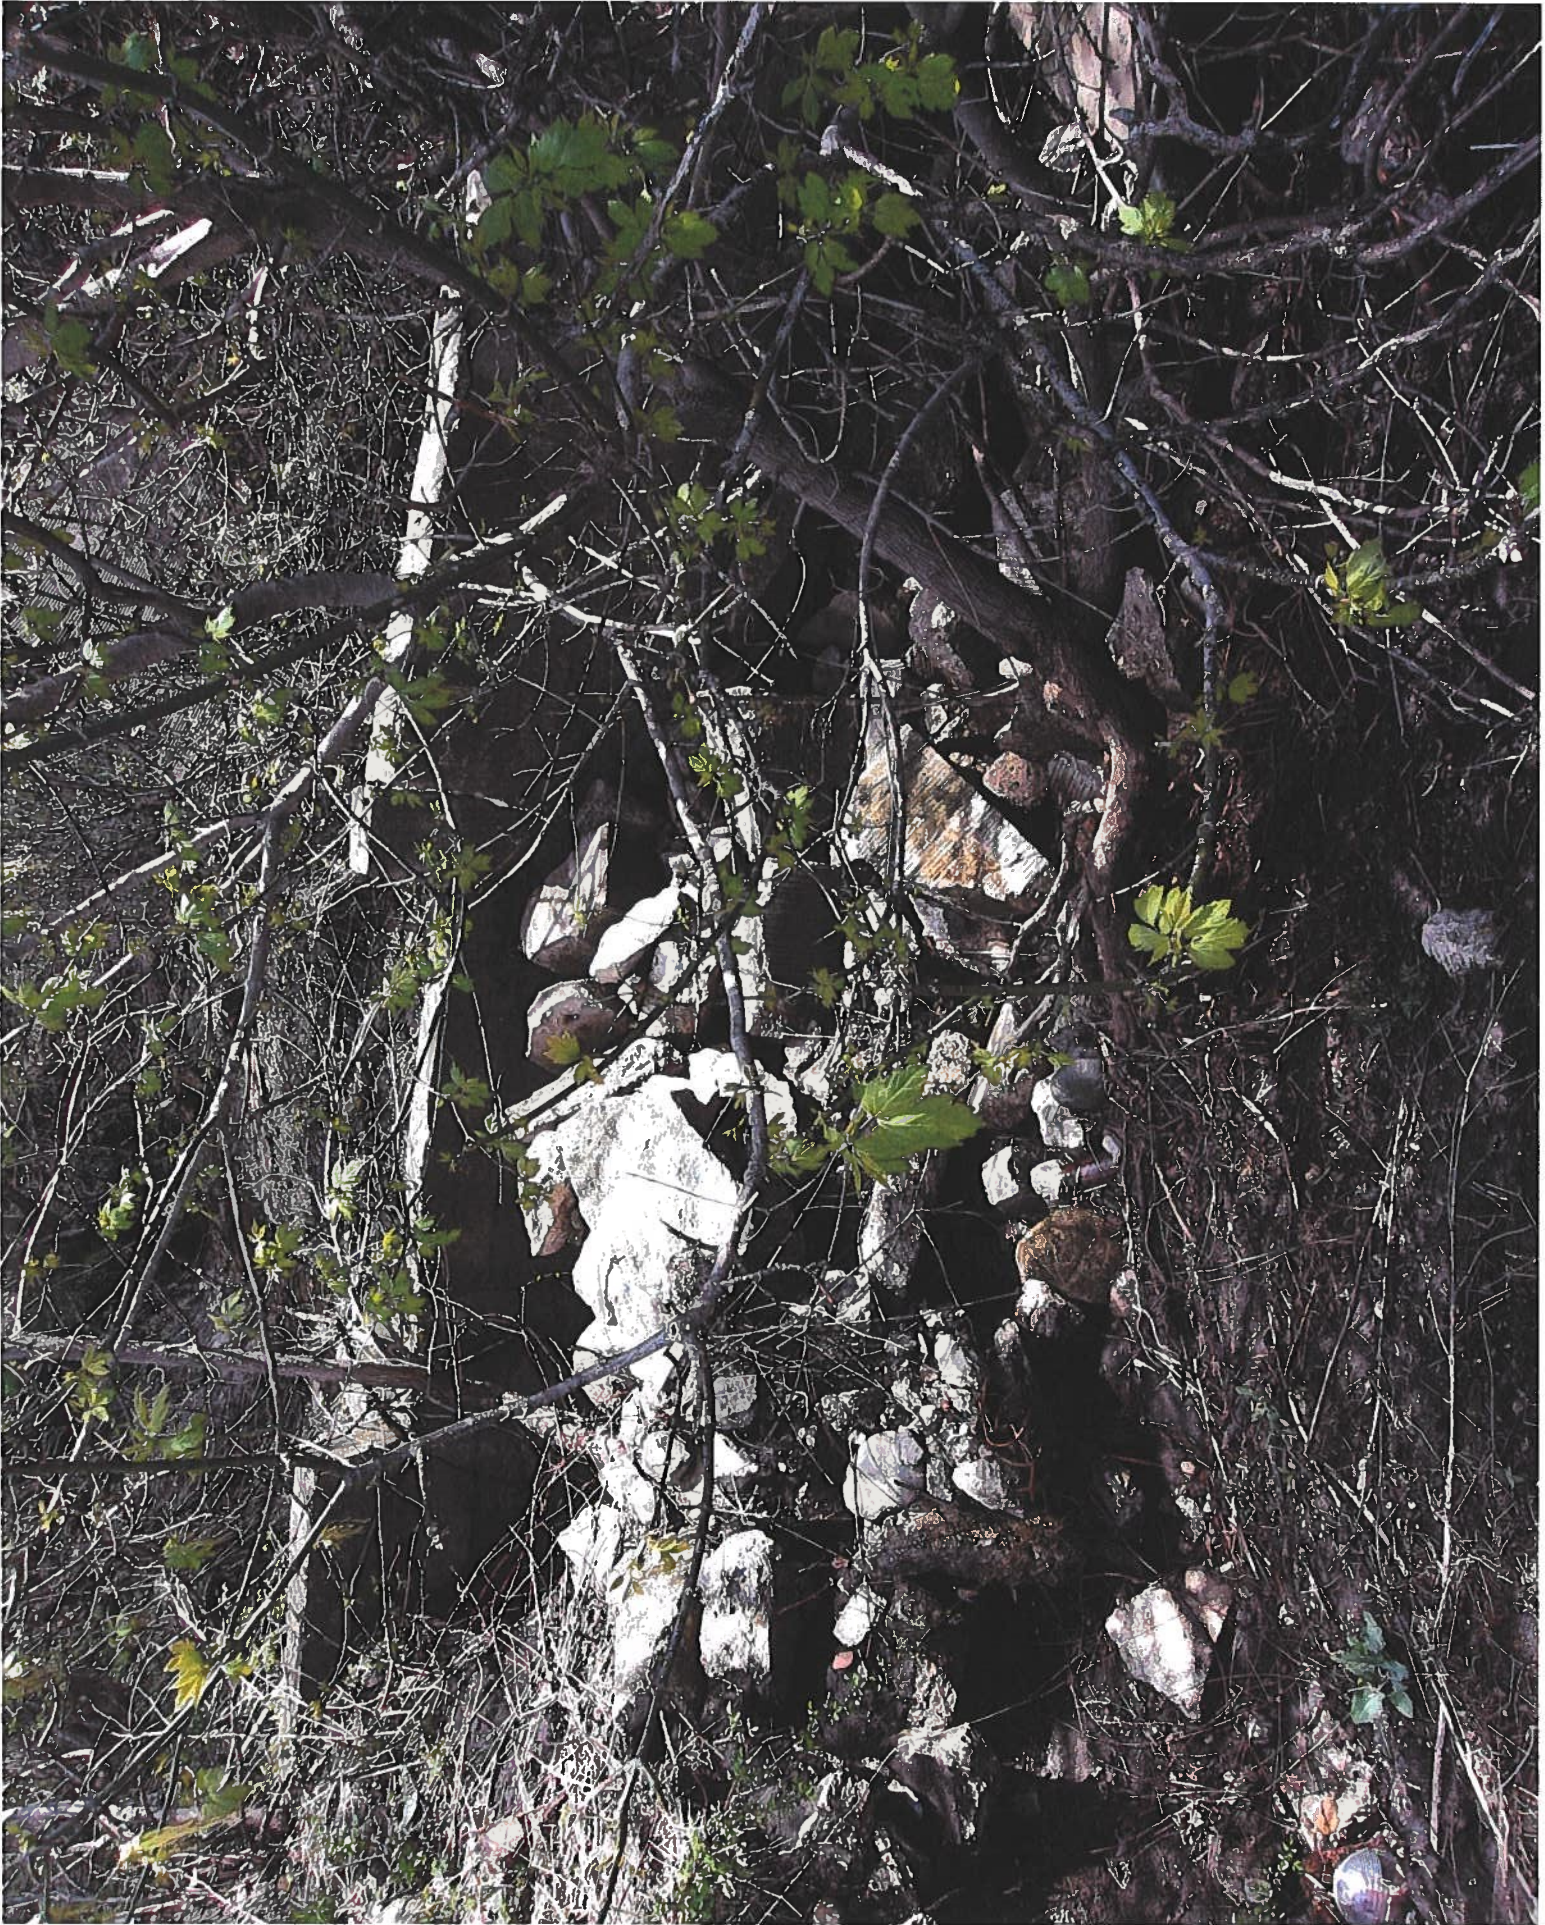
Looking downstream @ Headwall Outlet

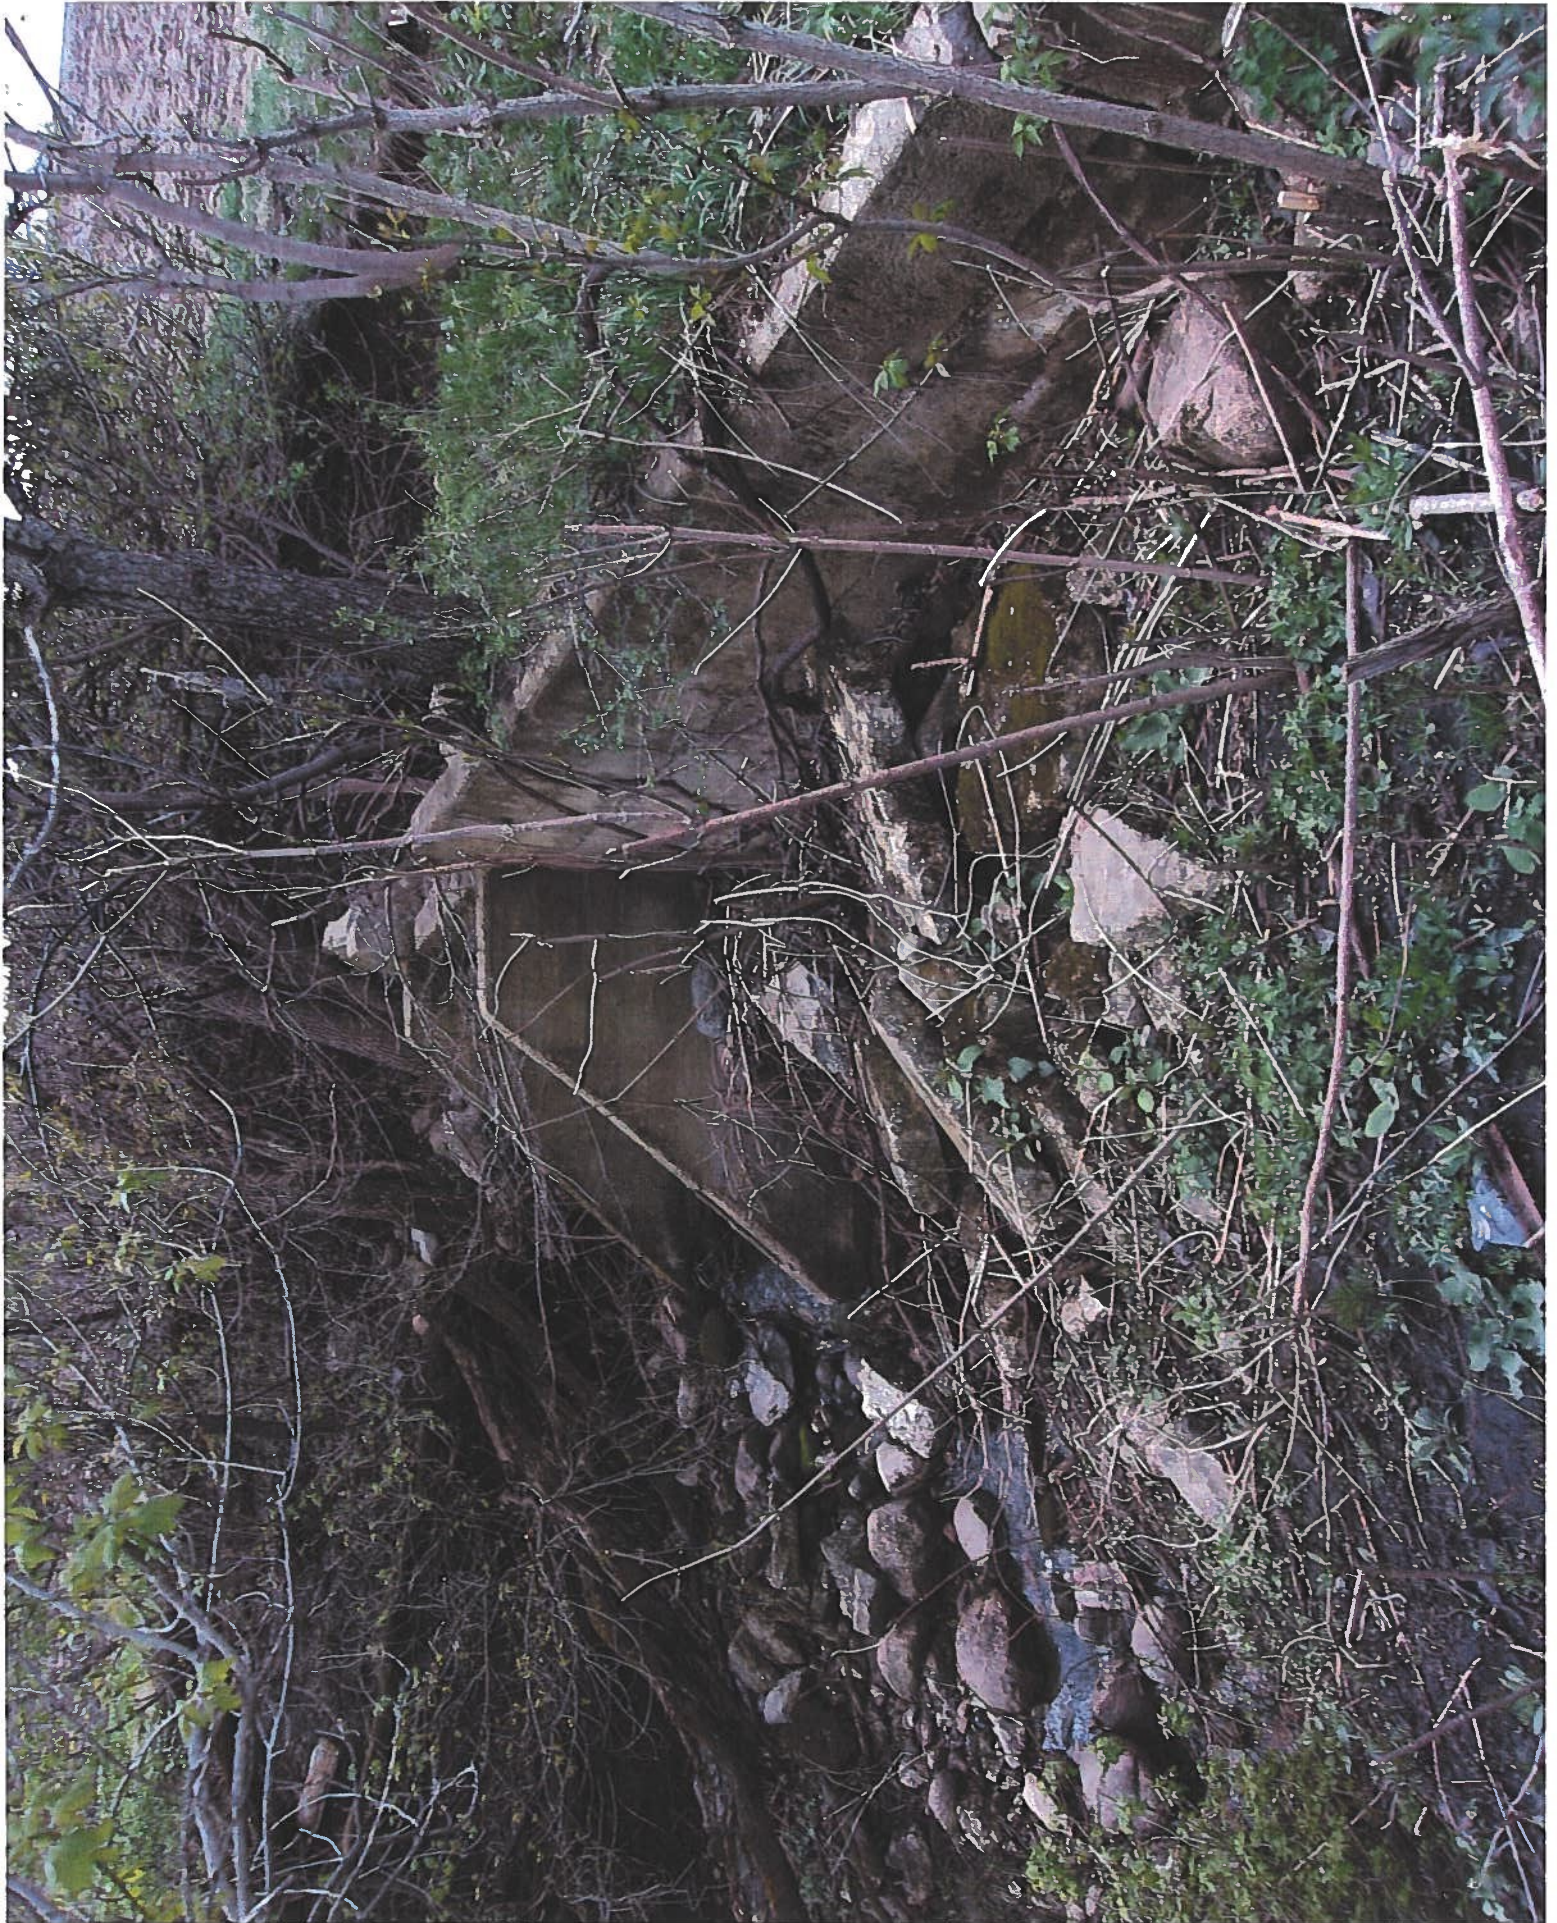
HEADWALL COULD BE SALVAGED

1. Frozen soil backfill may need to be re-graded and/or additional soil imported once spring thaw has occurred.
2. Due to the condition of the CMP tile outlet and concrete headwall, the longevity of the same before a structural failure and/or large-scale erosion take place is in question. CGA recommends said outlet be replaced with a new CMP outlet with rodent guard, trees around headwall cut, stumps of the same be treated to prevent regrowth, regrading upstream of headwall to correctly channel overland water flow, and installation of stone revetment upstream and downstream of headwall. It is the opinion of CGA that the construction costs for this work would be approximately \$10,000 to \$20,000.

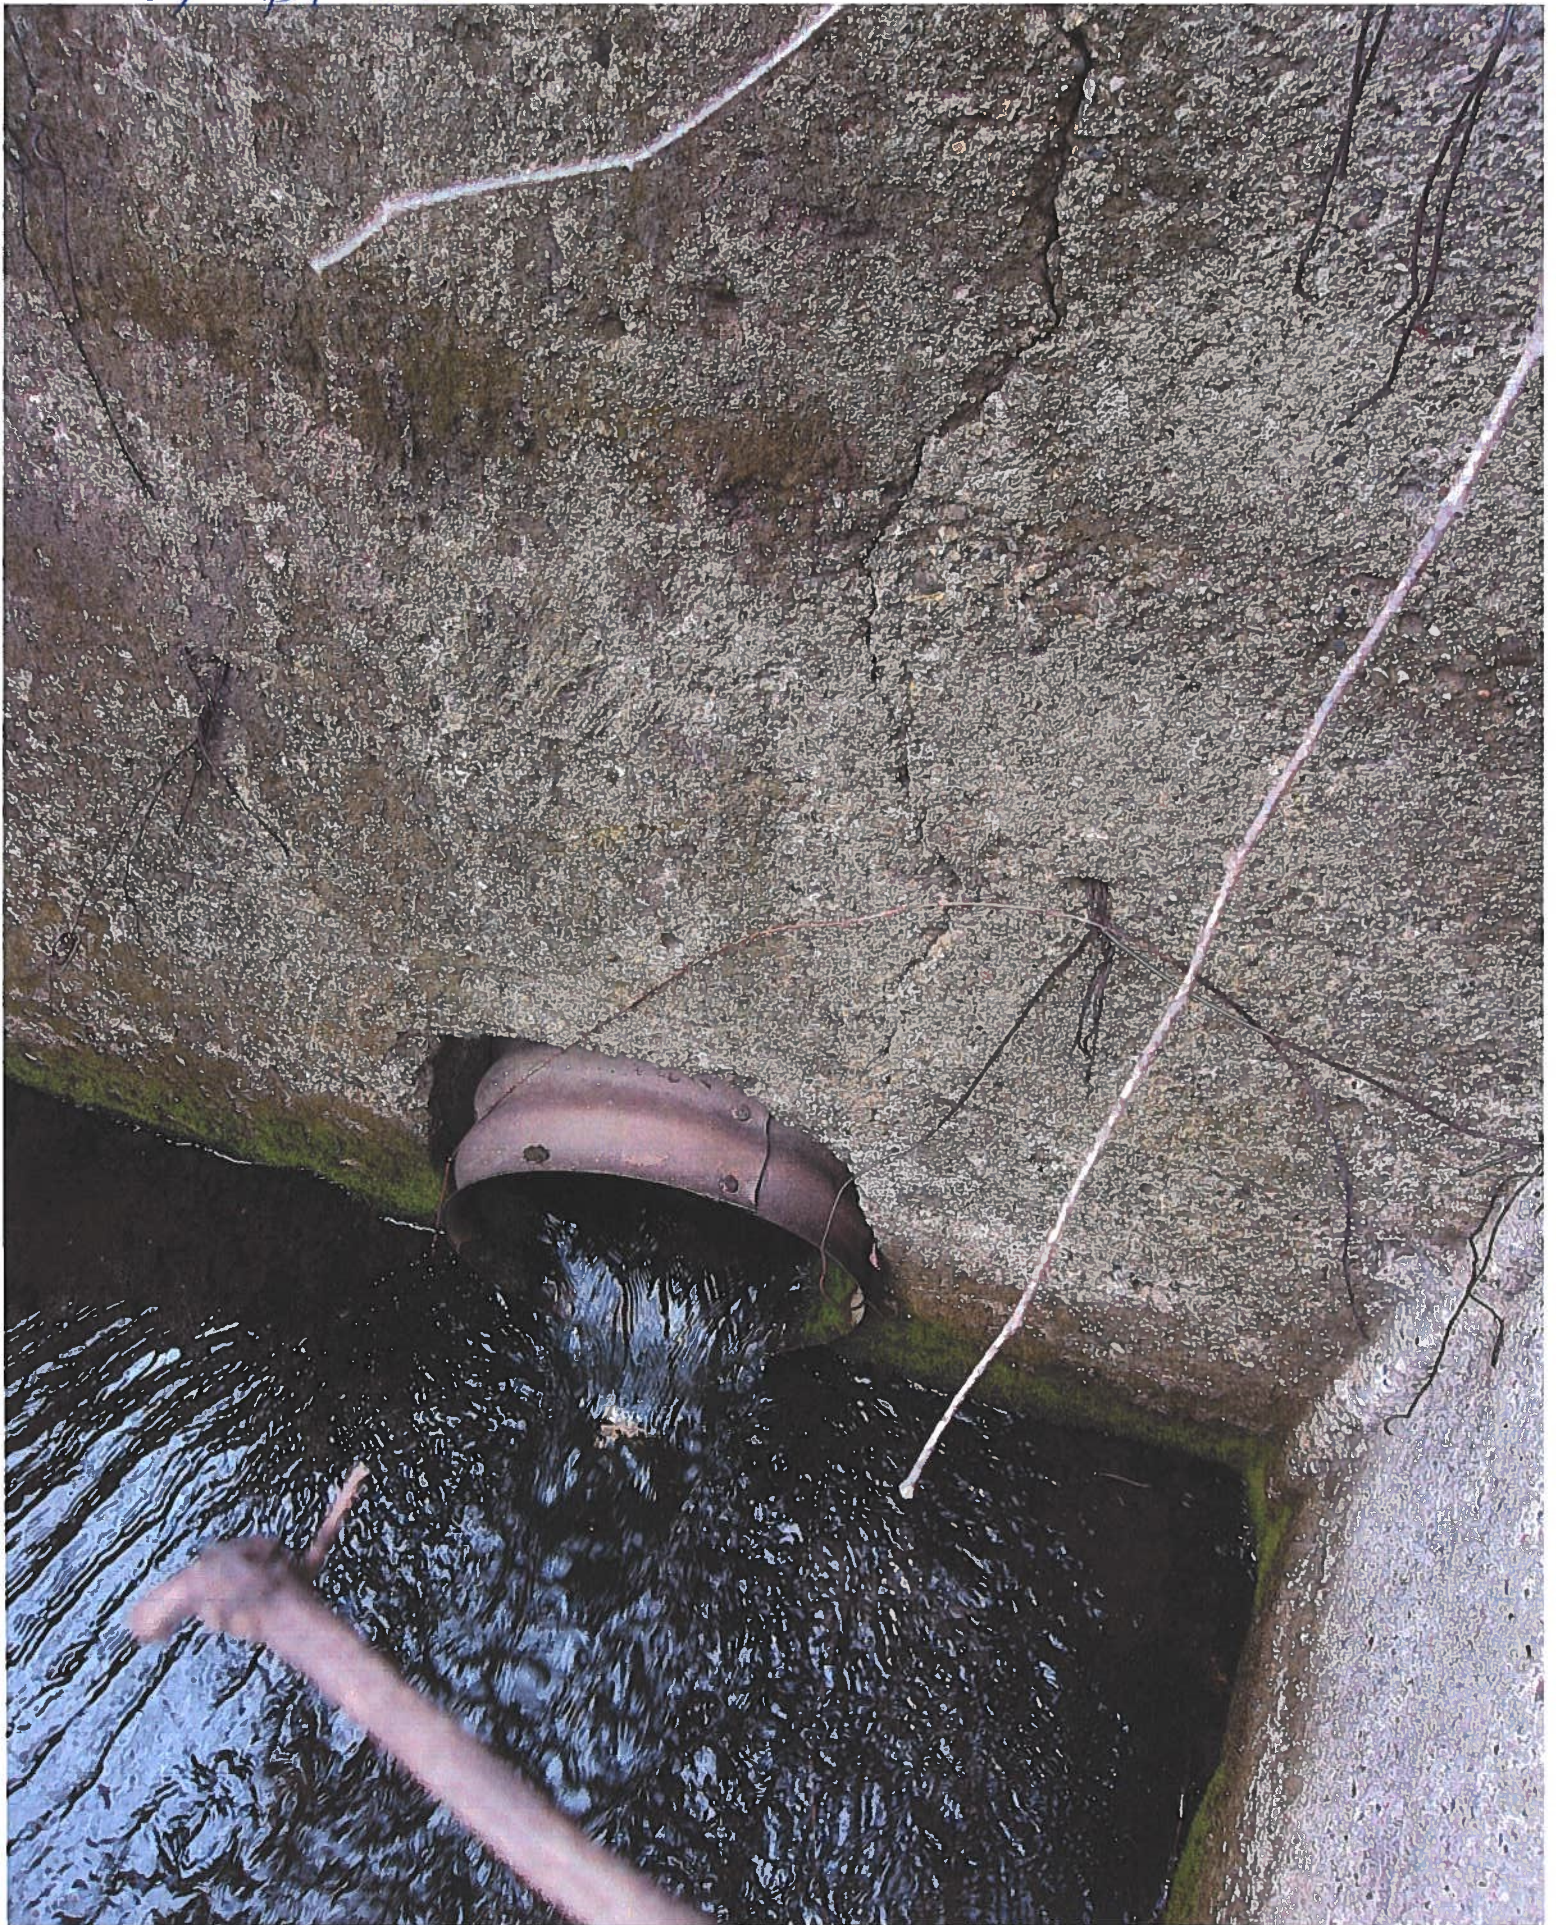
OLD Rusty cnp, DD 100 OUTLET

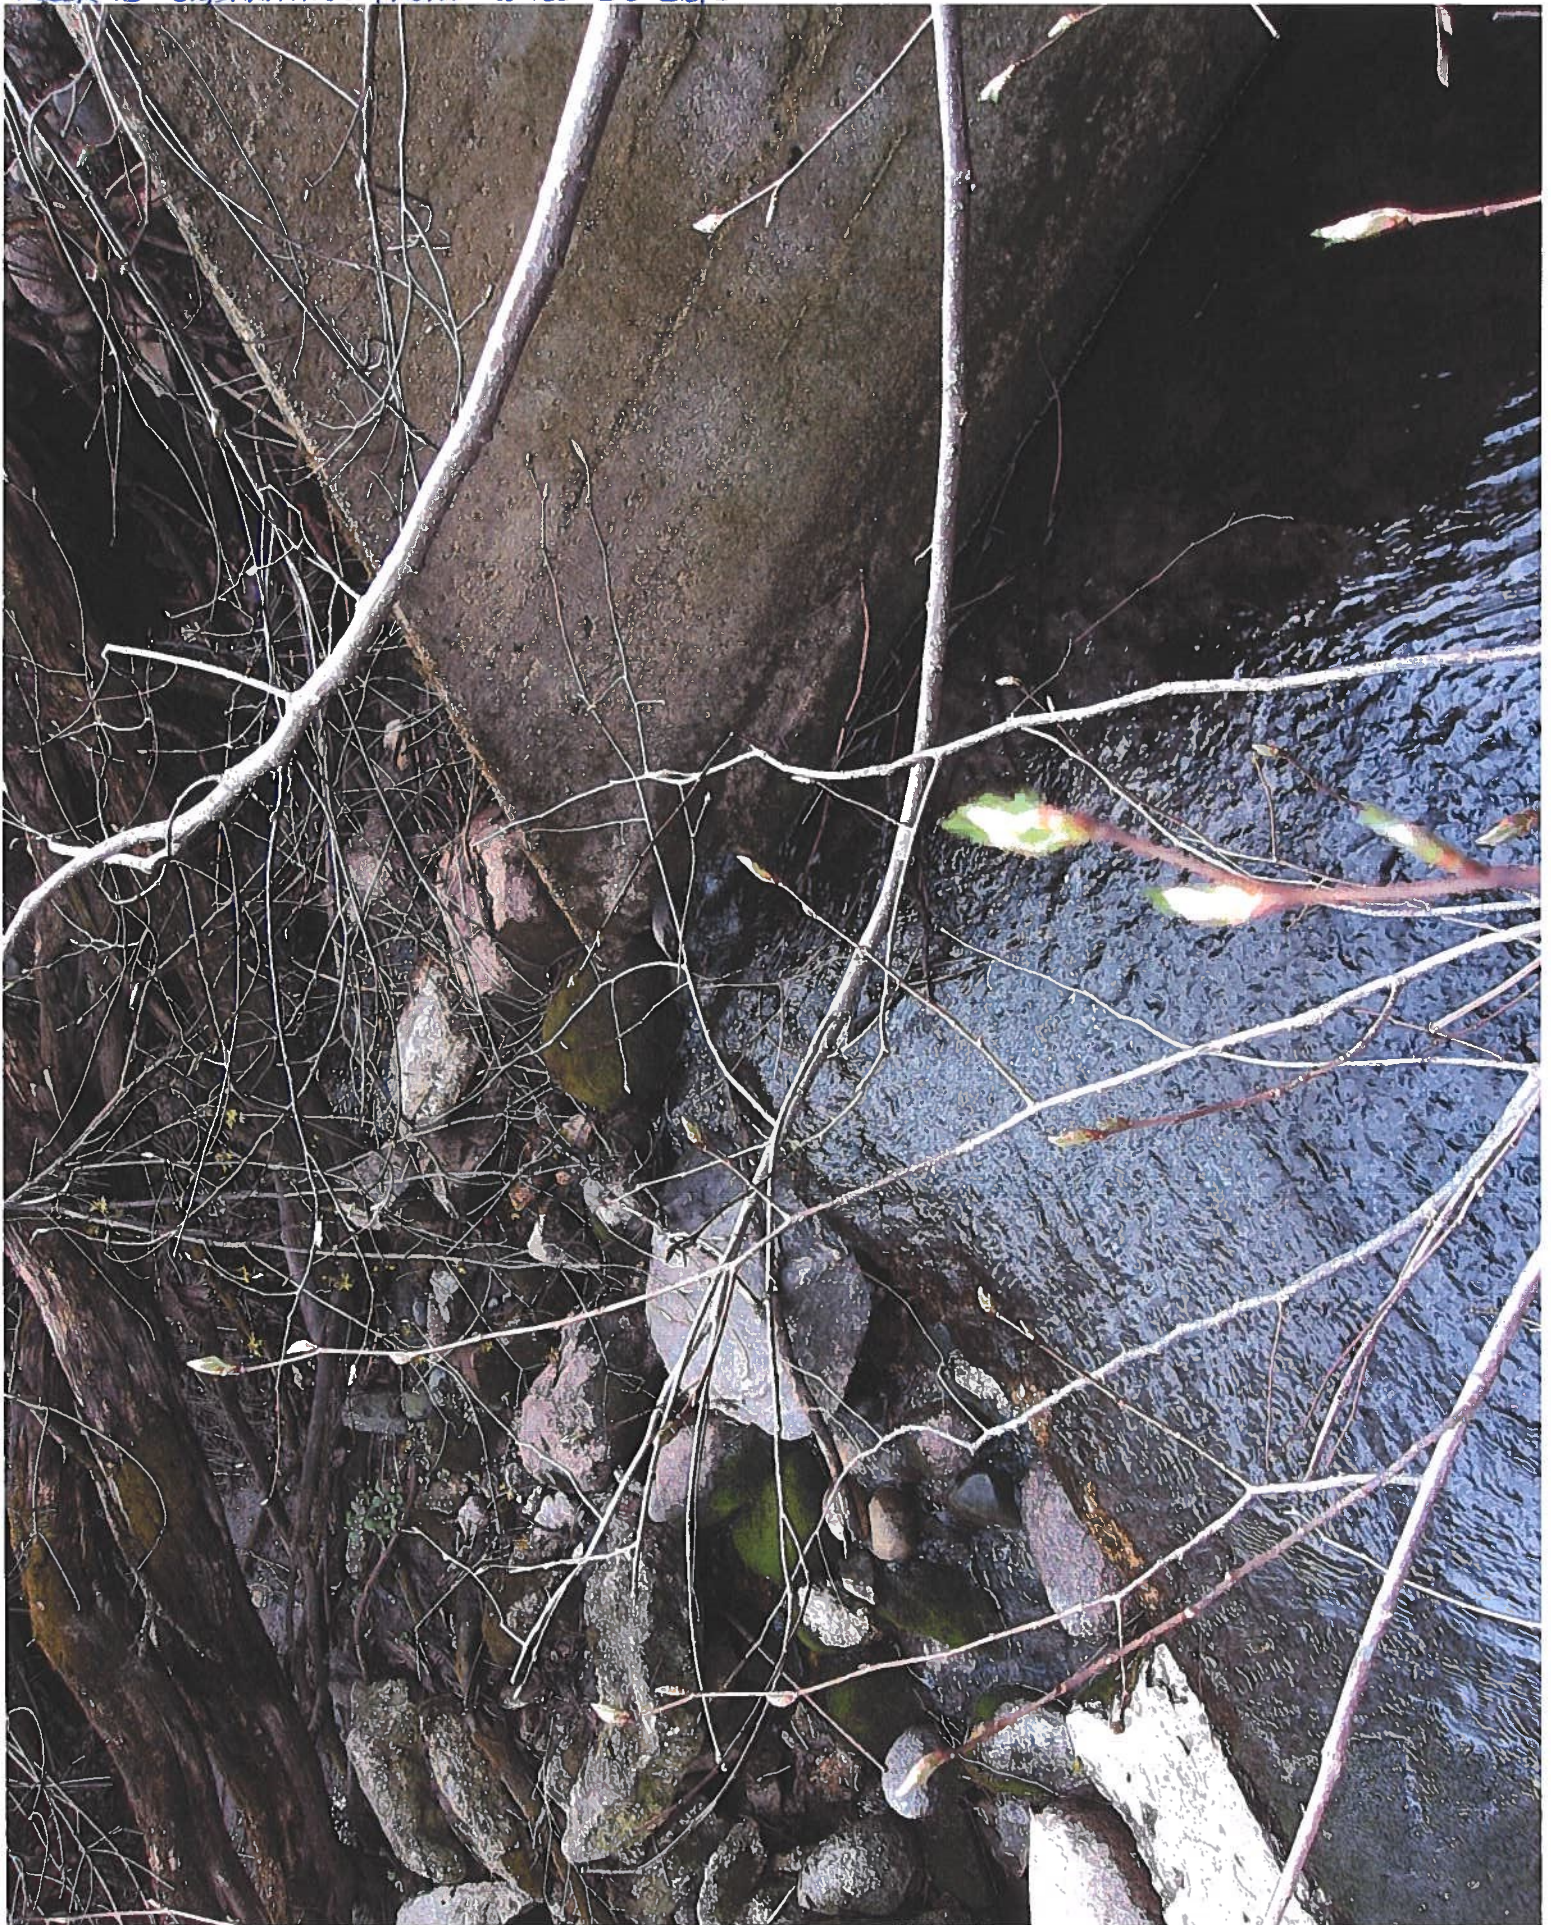
Floor IS SEPARATING FROM WALL GUSSETS

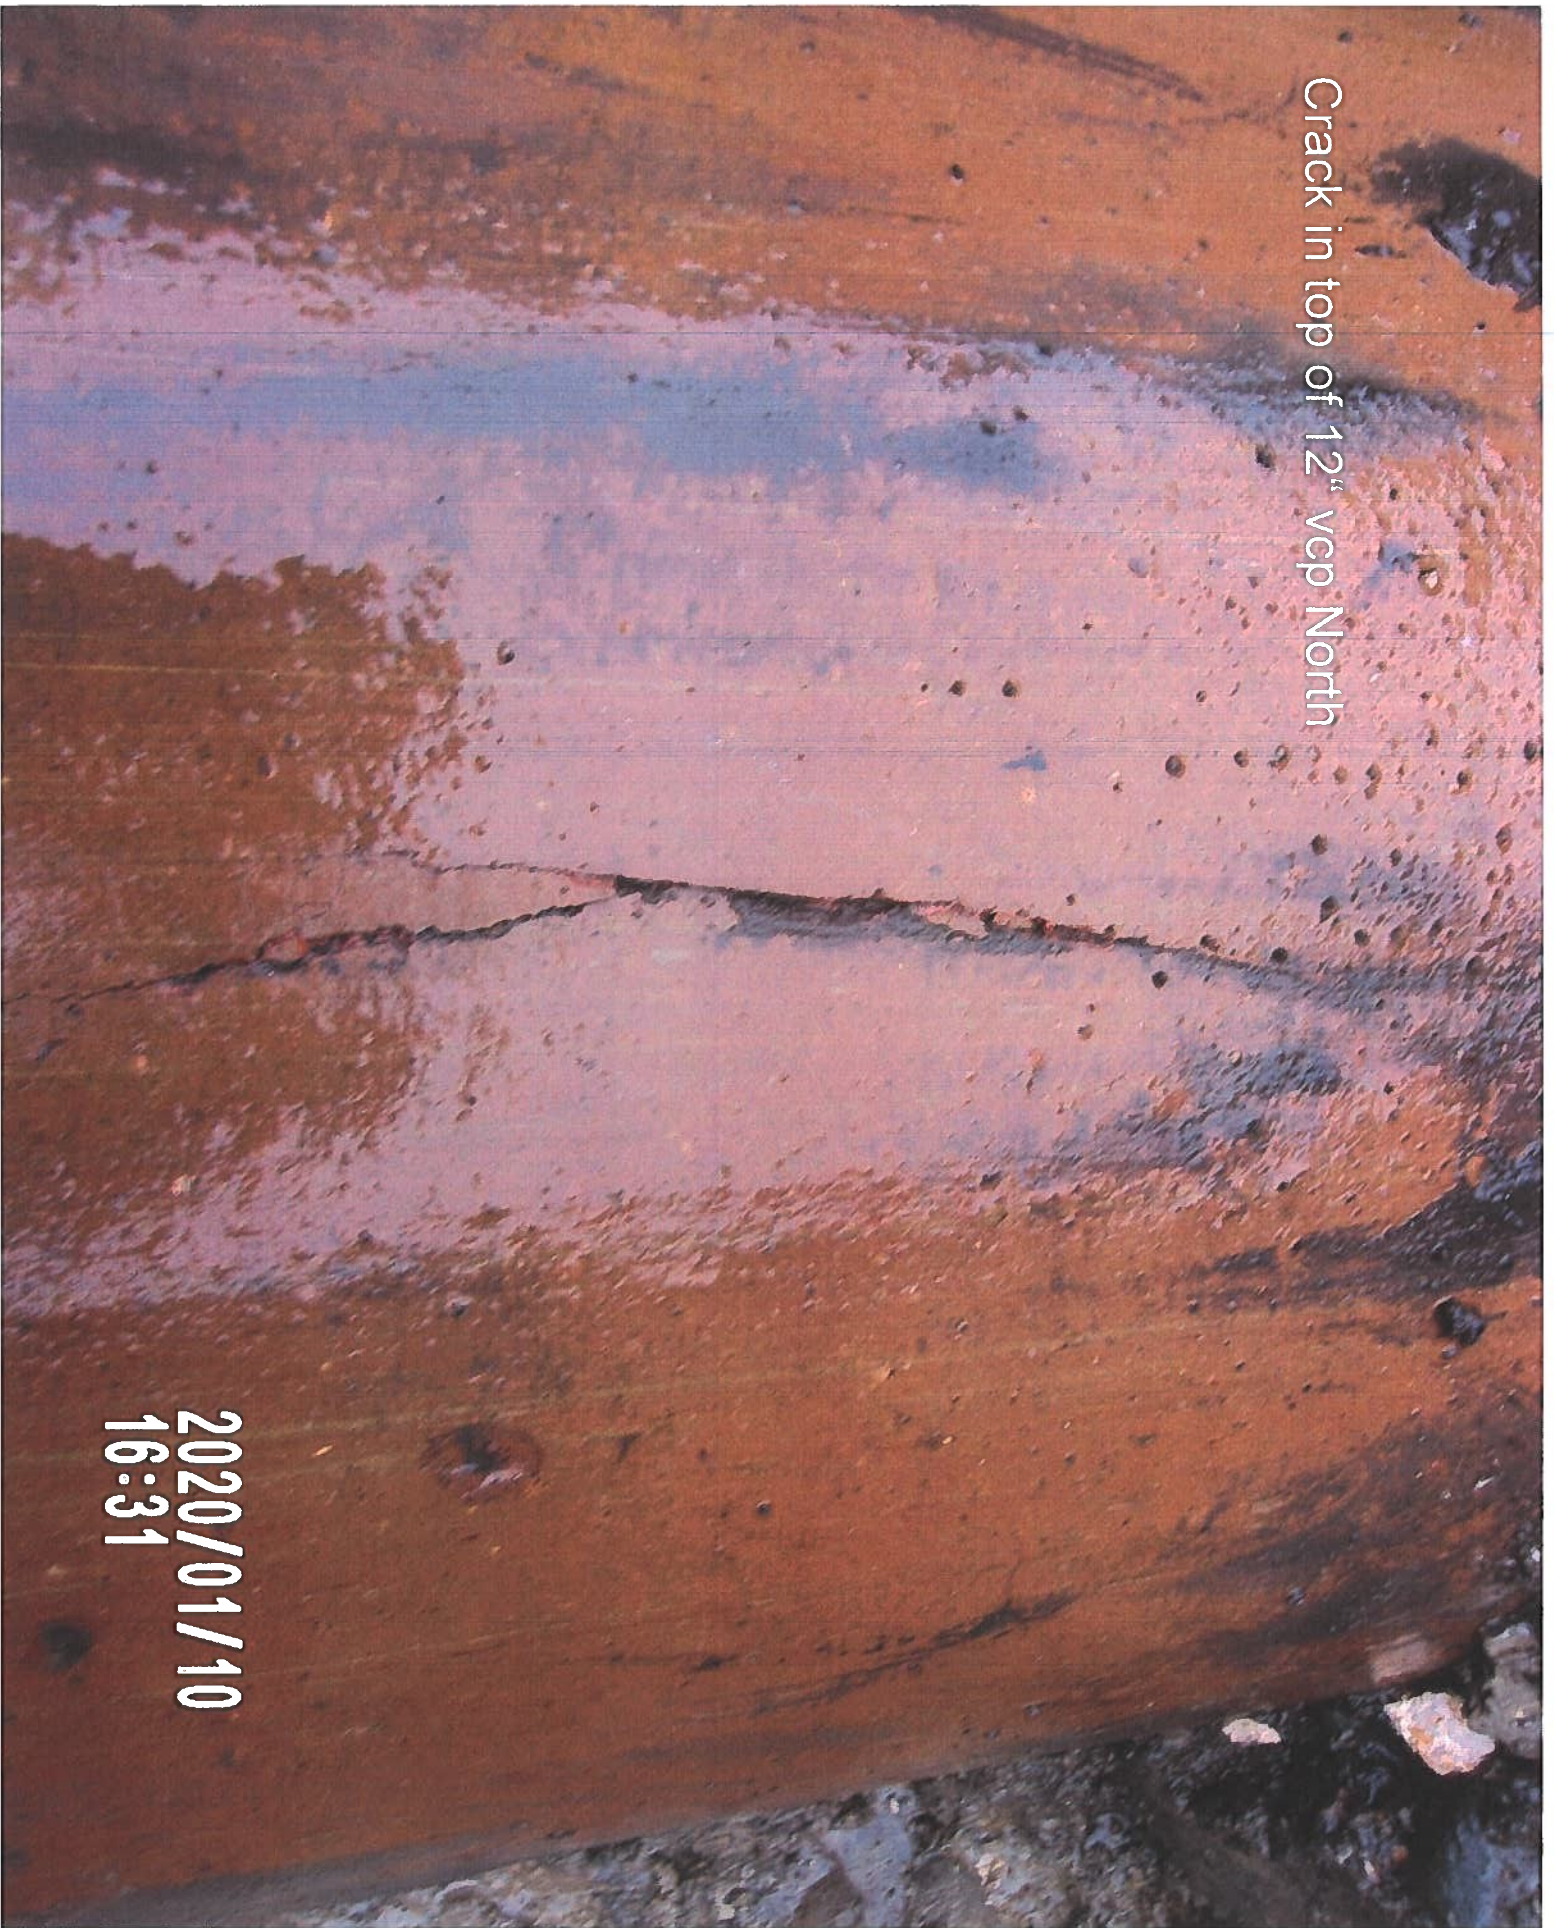
Crack in top of 12" vcp North

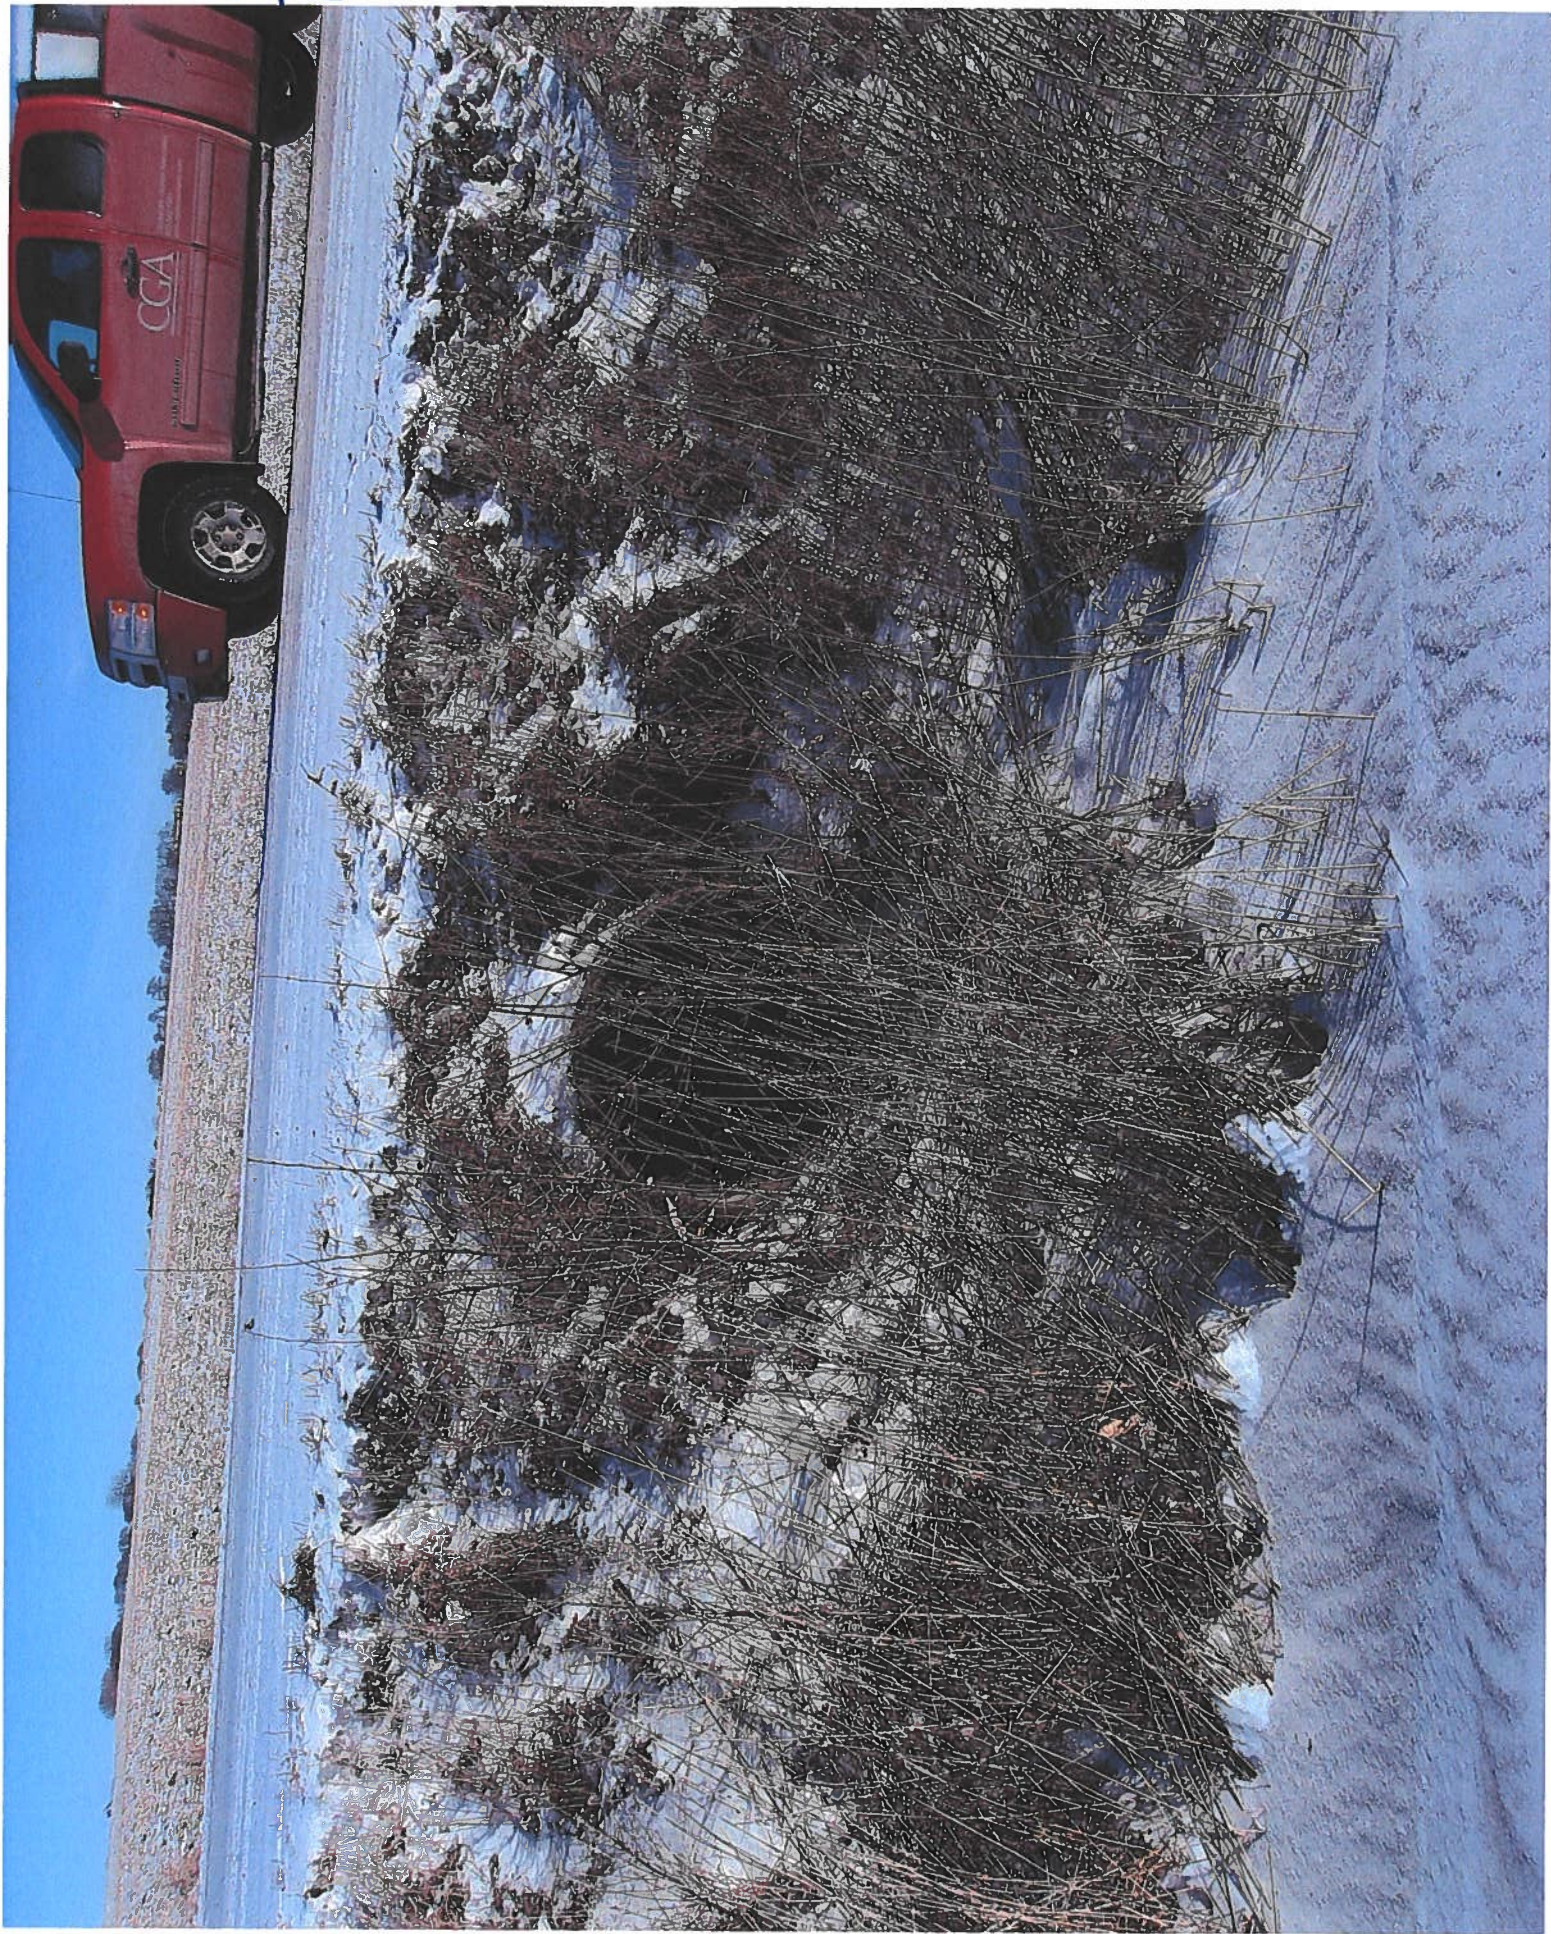
RCP @ W. SIDE ROAD
