**AGENDA**  
**REGULAR DRAINAGE MEETING**  
**Wednesday, March 11, 2020 9:30 AM**

7. DD 100 WO 248 - Discuss W Possible Action - Repair Summary

## Repair Summary:

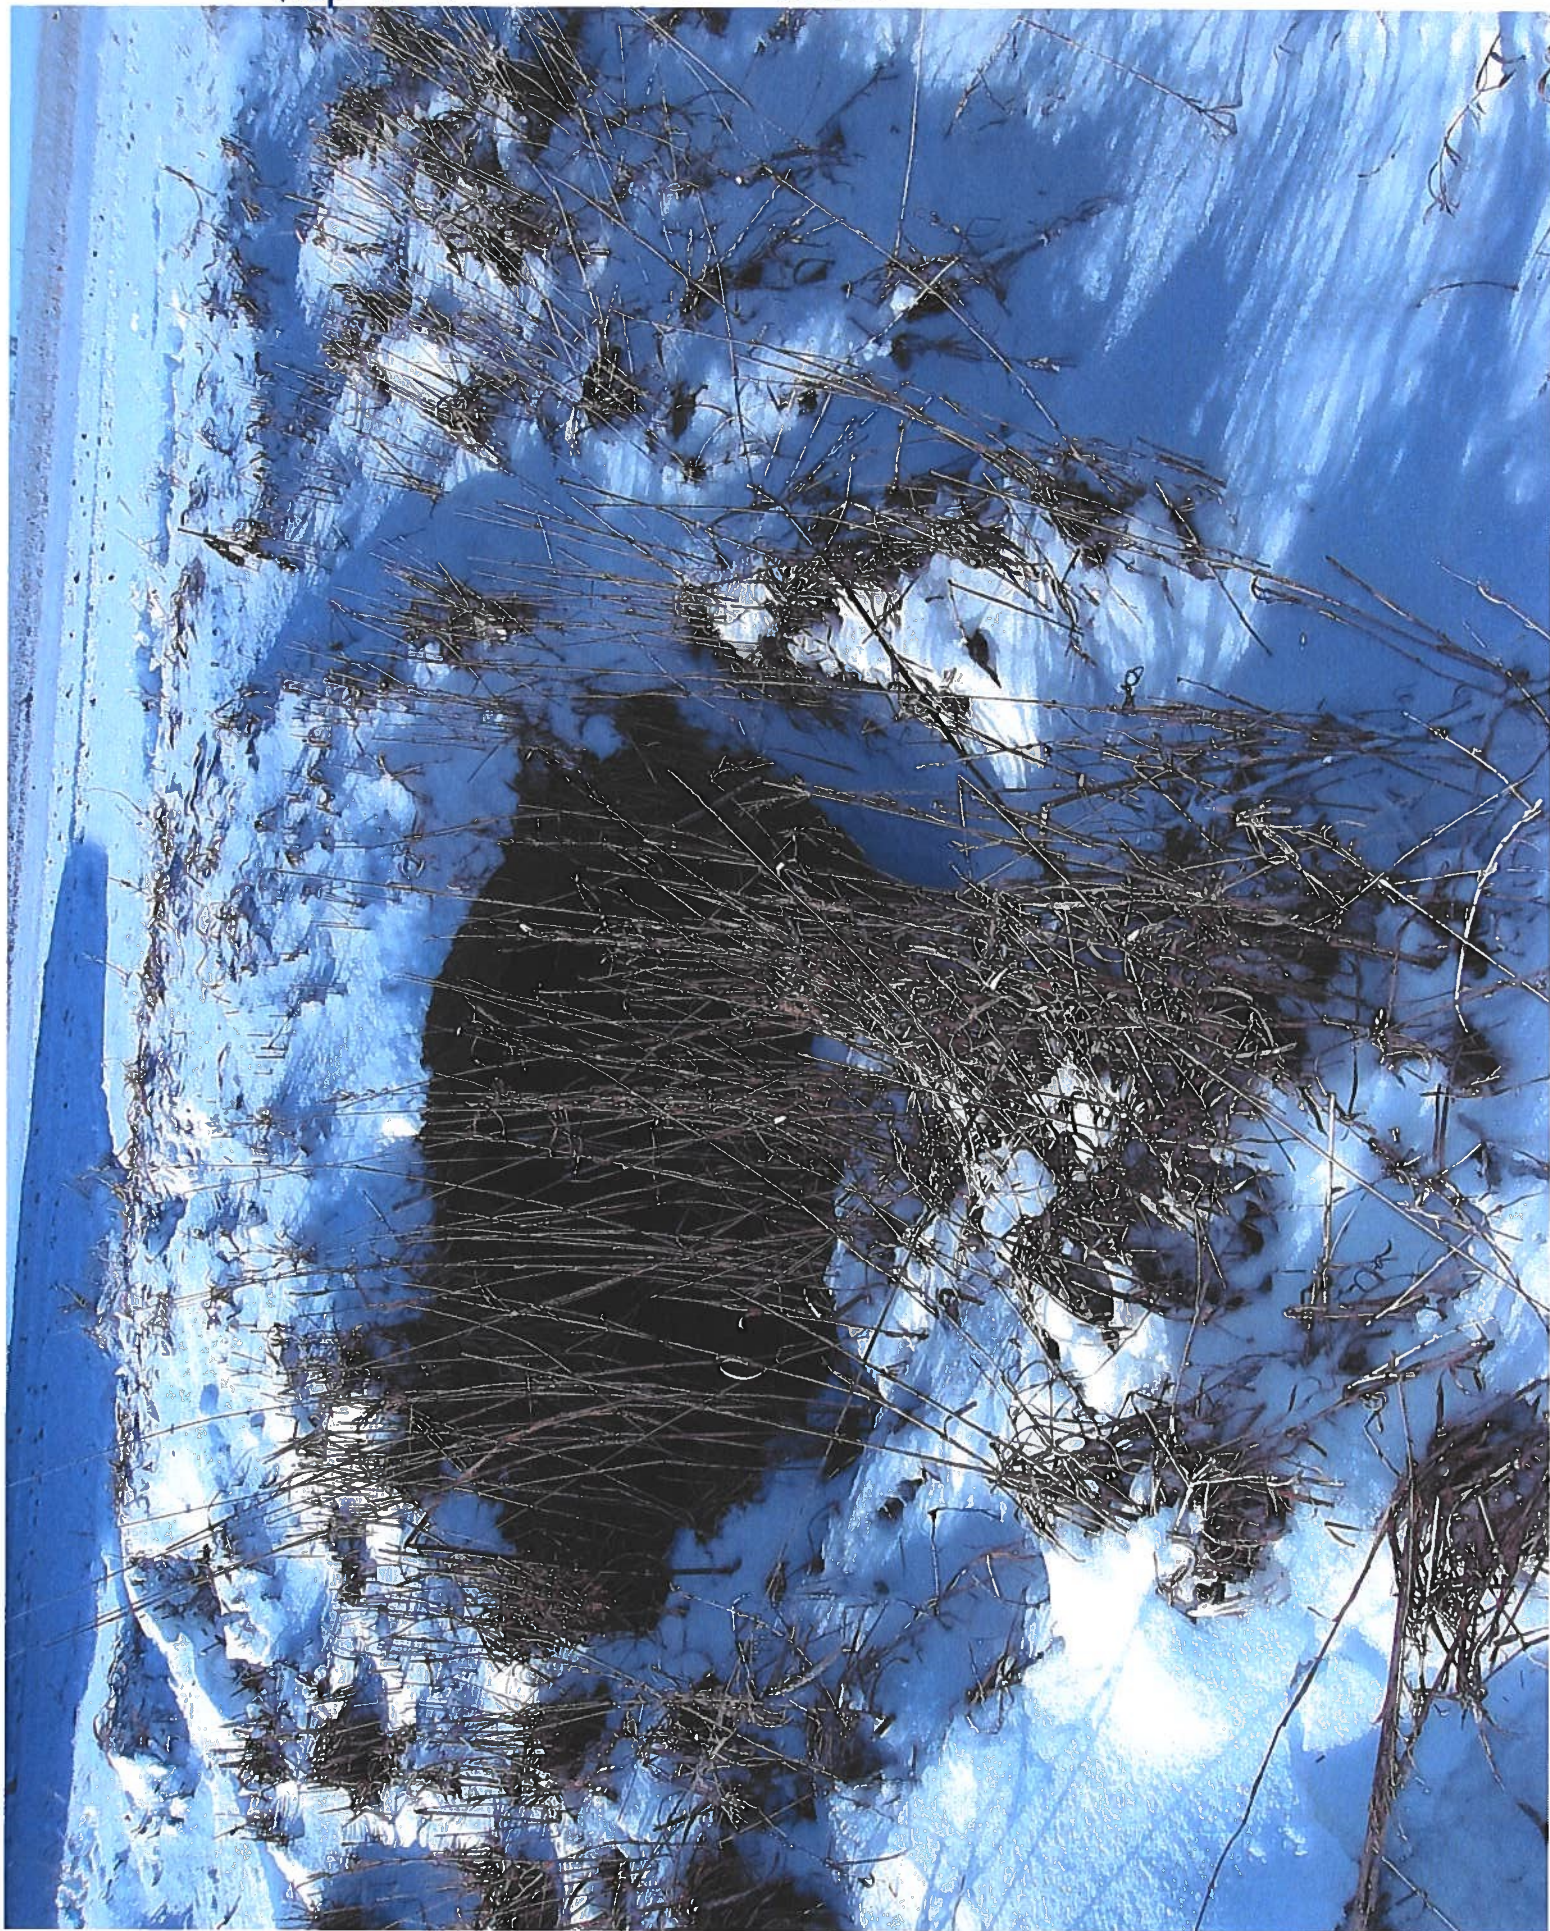
RCP @ E. SHORE ROAD (downstream), 2' RESTRICTION

1. Direct excavation of blowouts/sinkholes for both the Branch 2C (west of AA Avenue) and Main (south of County Hwy D25) tiles to determine the cause of the blowouts/sinkholes and repair accordingly.
2. Since the road culvert is most likely not a district facility, direct secondary roads to clean out the plugged culvert and clean out road ditches as necessary to properly handle surface water.

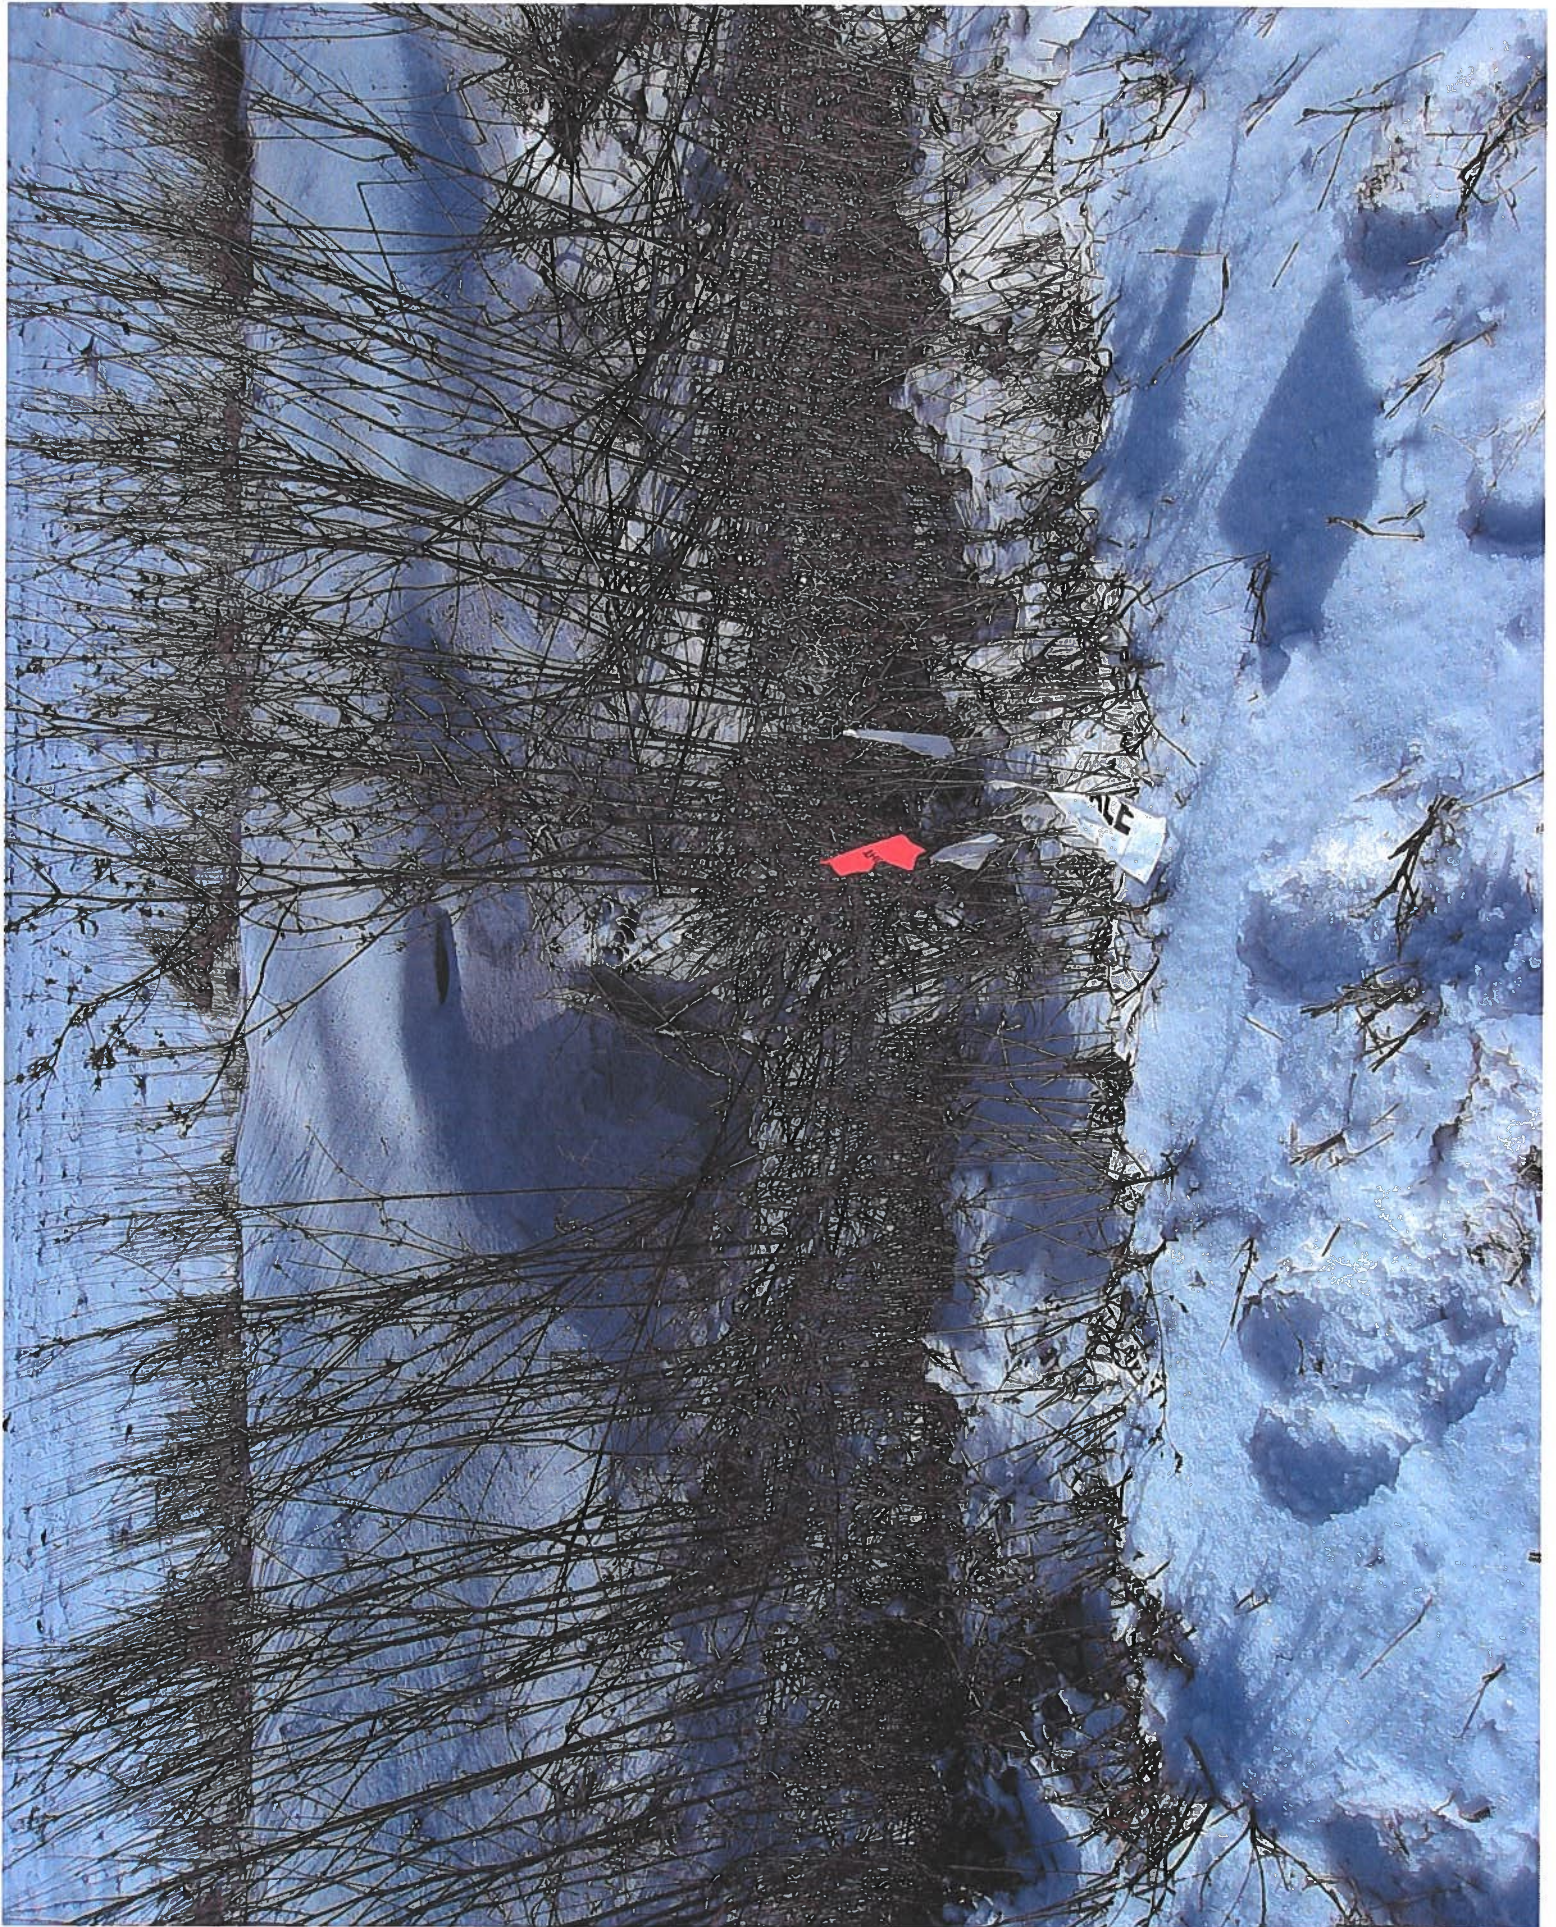
BLOW-OUT ON W. SIDE ON PRIVATE LINE, BERTHME IN DITCH

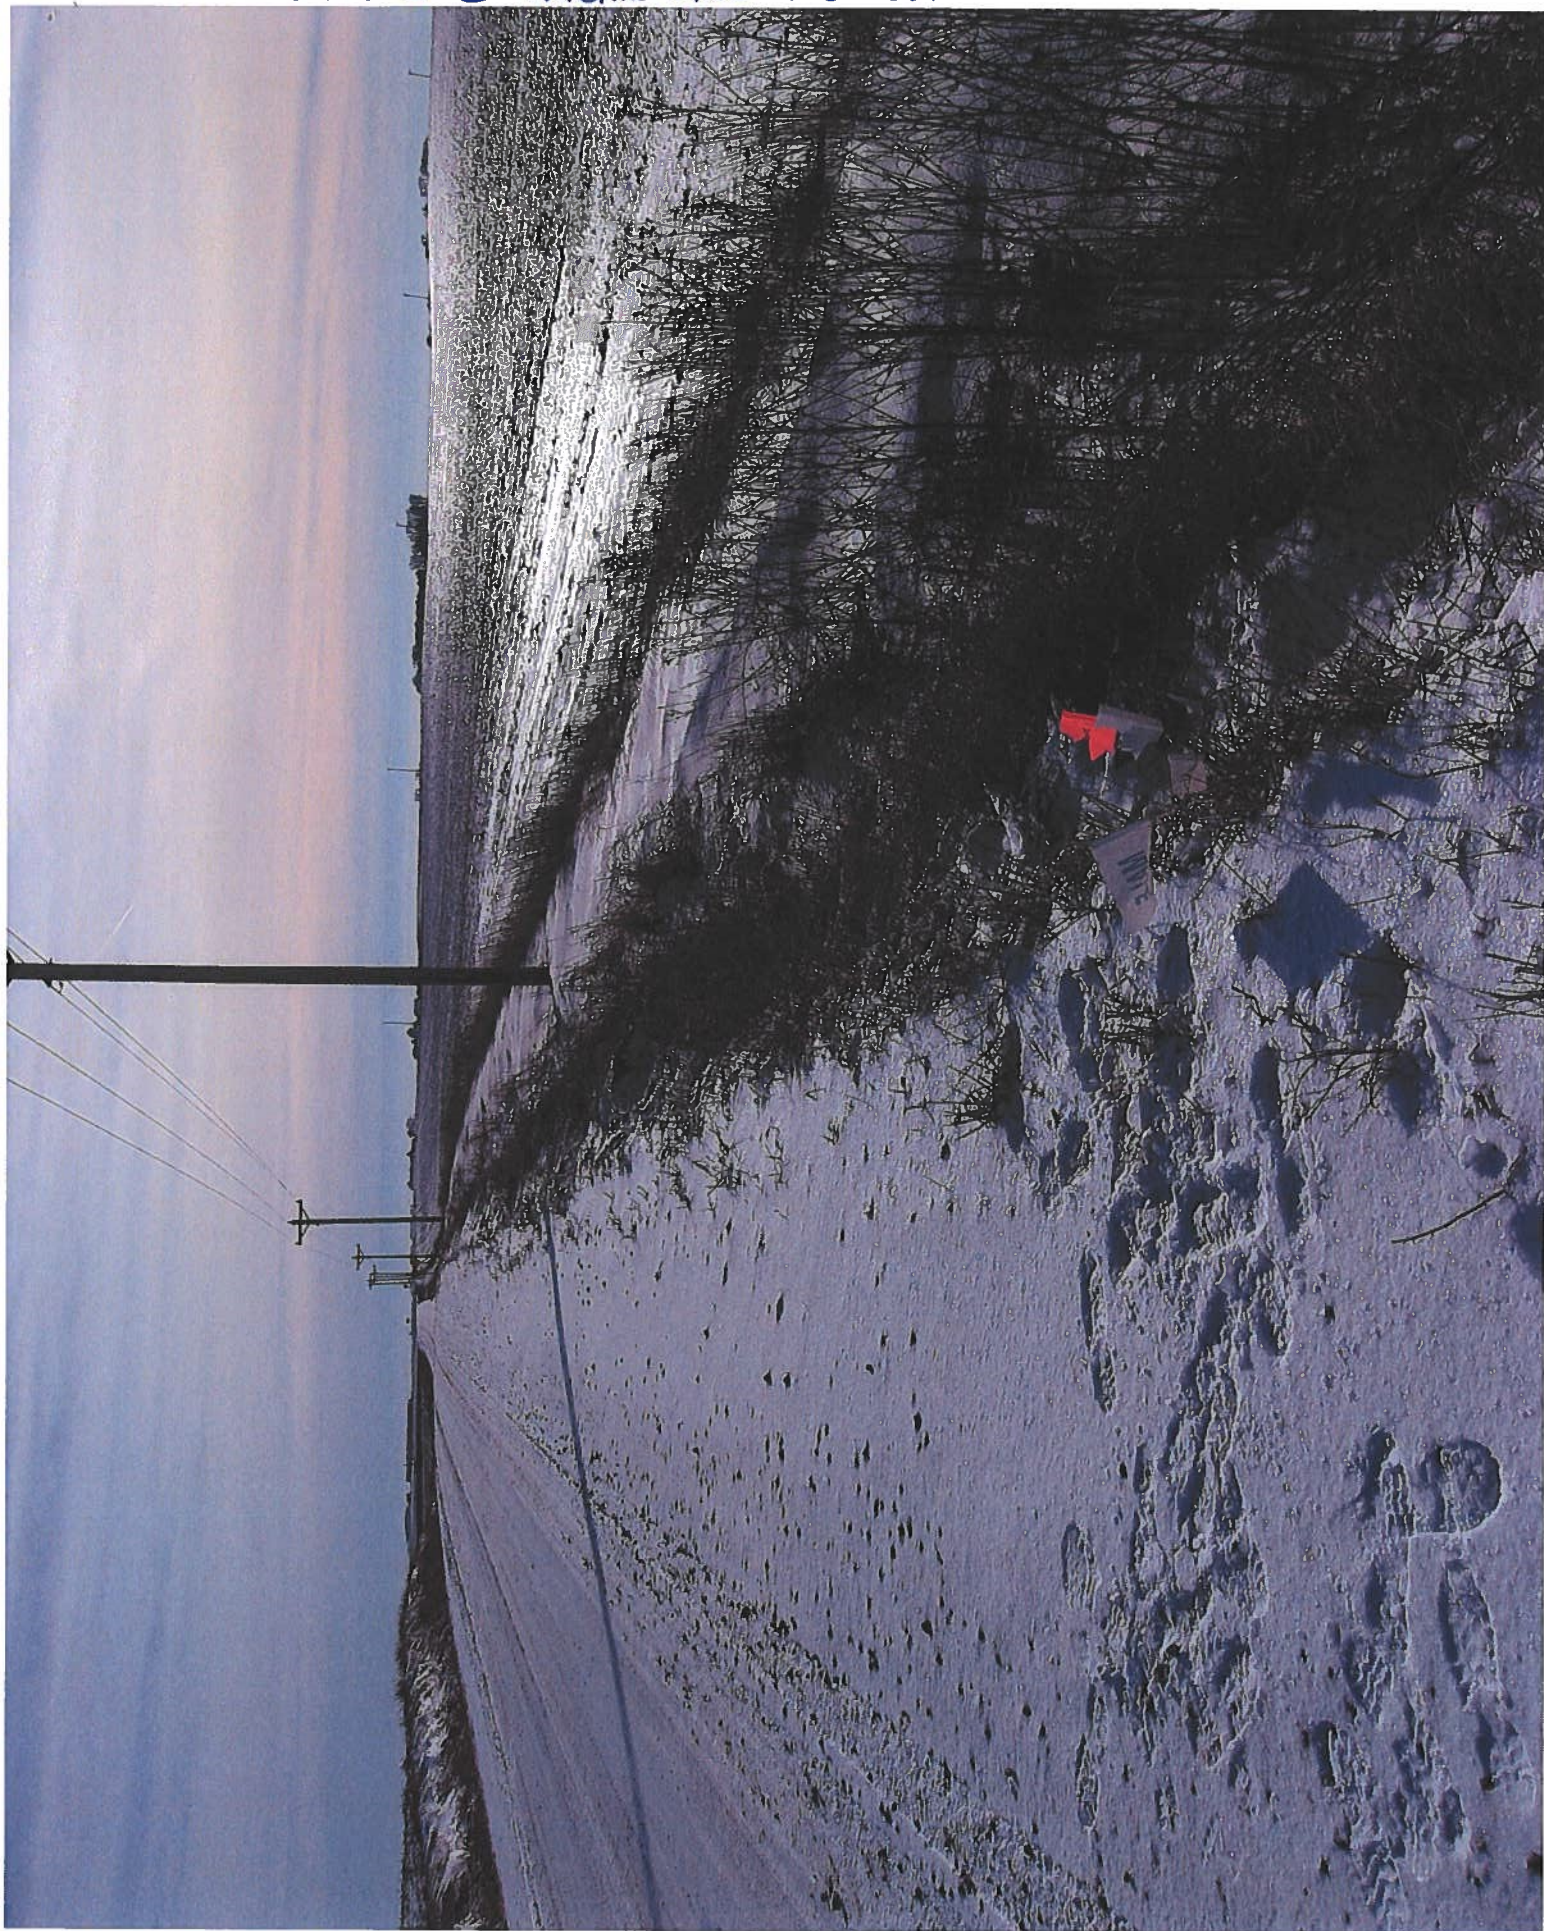
LOOKING S. @ PRIVATE LINE BLOW-OUT

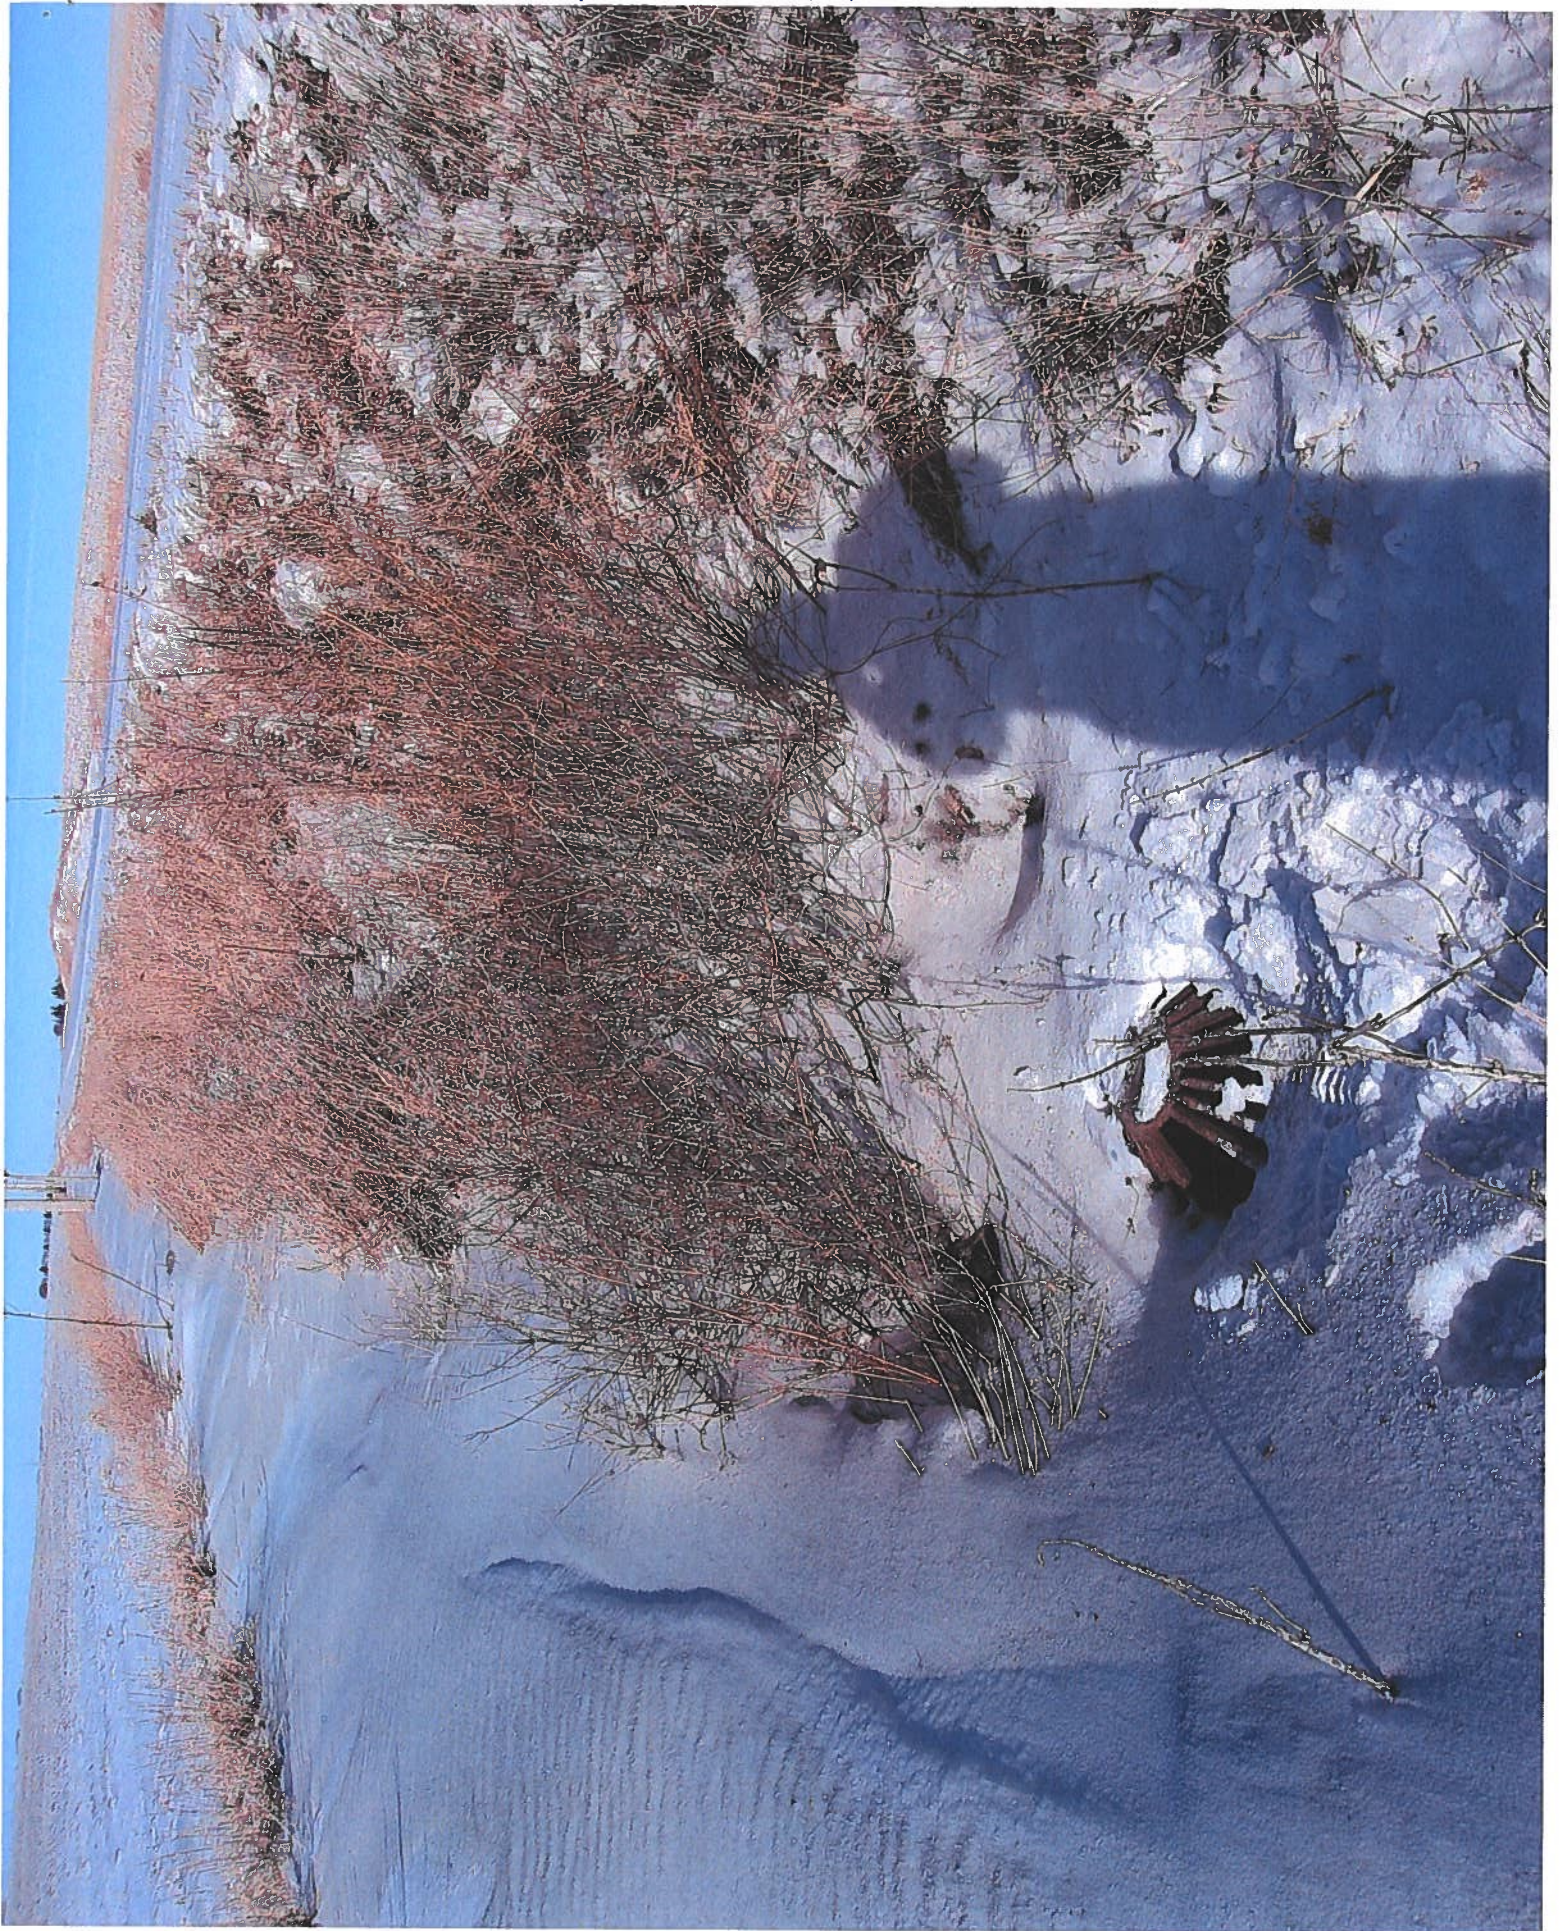
BEEHIVE ON MAIN, W. SIDE AA AVE.

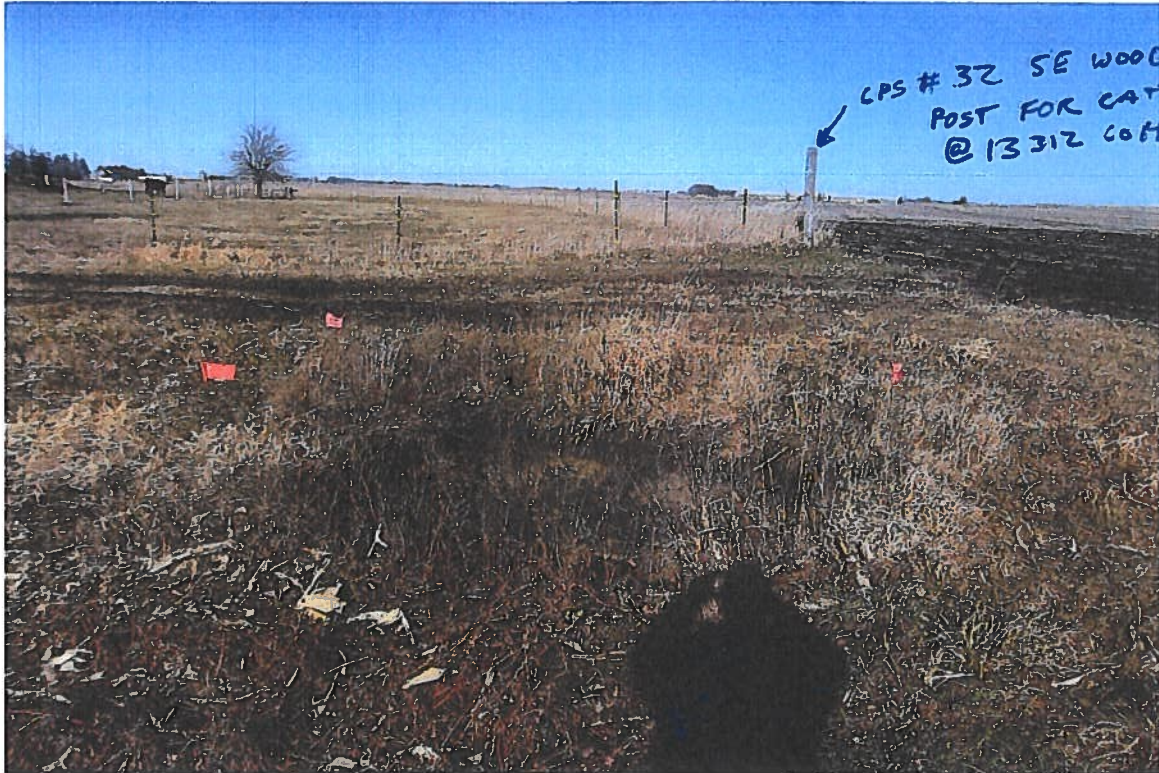
PICTURE# 2413 IS LOOKING NORTH SHOWING 9.0' Ø TILE BLOWOUT  
 3.7' ± DEEP (18.0' ± WEST & 39.5' ± SOUTH OF SE CATTLE PASTURE,  
 WOOD CORNER POST

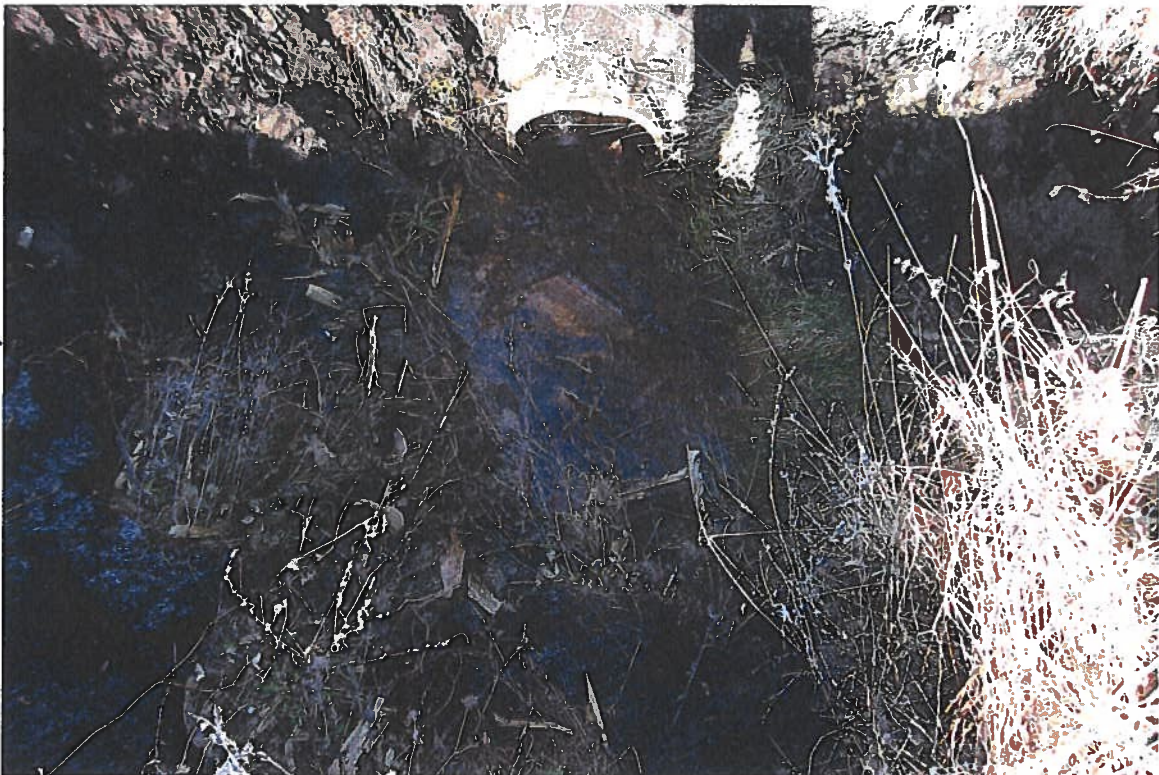
PICTURE# 2414 IS LOOKING NORTH INTO TILE BLOWOUT SHOWING  
 NORTH END 18" CLAY TILE TIE IN CRACKED & CAVING DOWN WILL NEED  
 TO REMOVE IT.

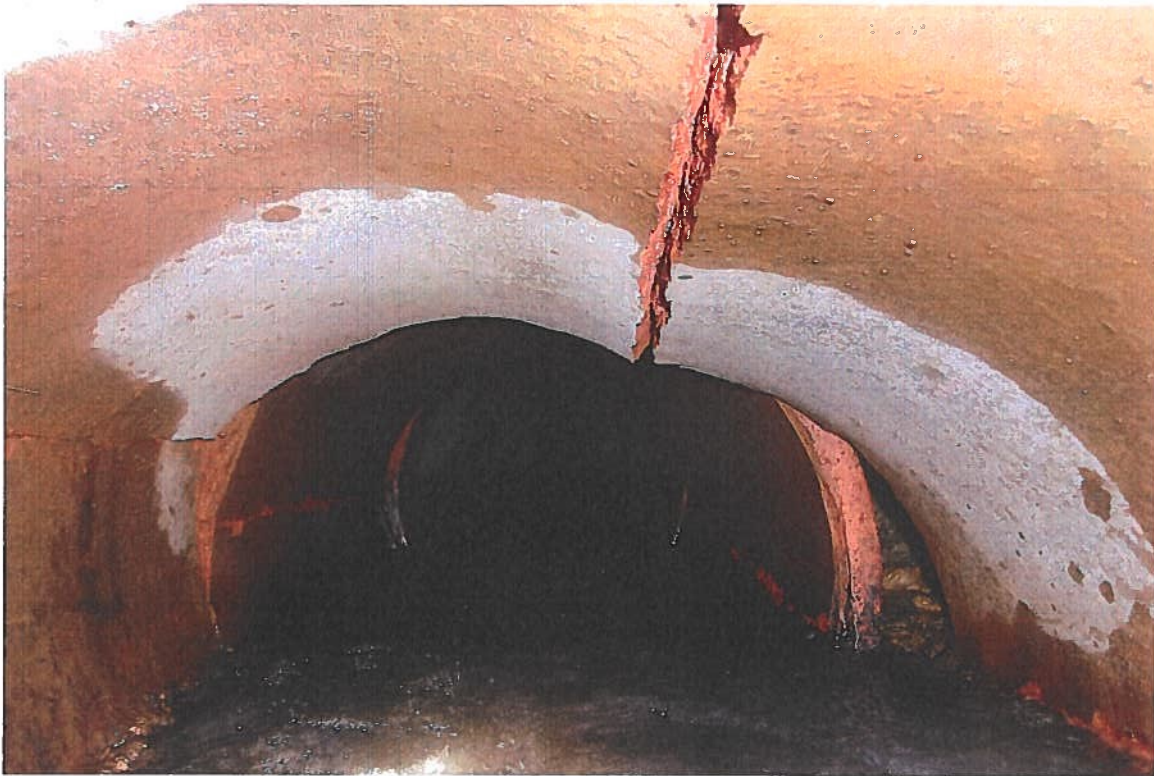
PICTURE# 2416 IS LOOKING NORTH DOWNSTREAM INSIDE 18" EXISTING  
CLAY TILE COLLAPSING DOWN @ 12 O'CLOCK AND VOID IN LOWER  
RIGHT CORNER

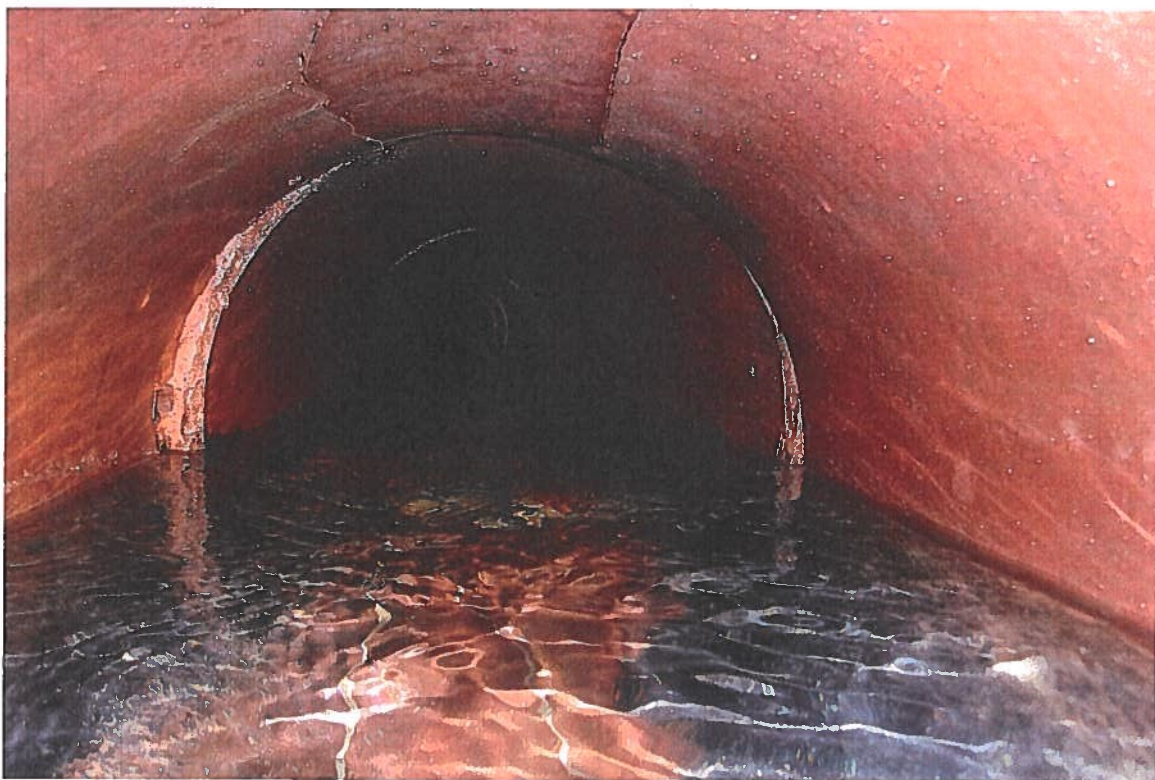
PICTURE# 2417 IS LOOKING SOUTH UPSTREAM INSIDE 18" EXISTING  
CLAY TILE TIE IN ON SOUTH END. DUE TO CRACK IN TILE @ 12 O'CLOCK  
WILL HAVE CREW REMOVE ANOTHER SECTION OF CLAY TILE.

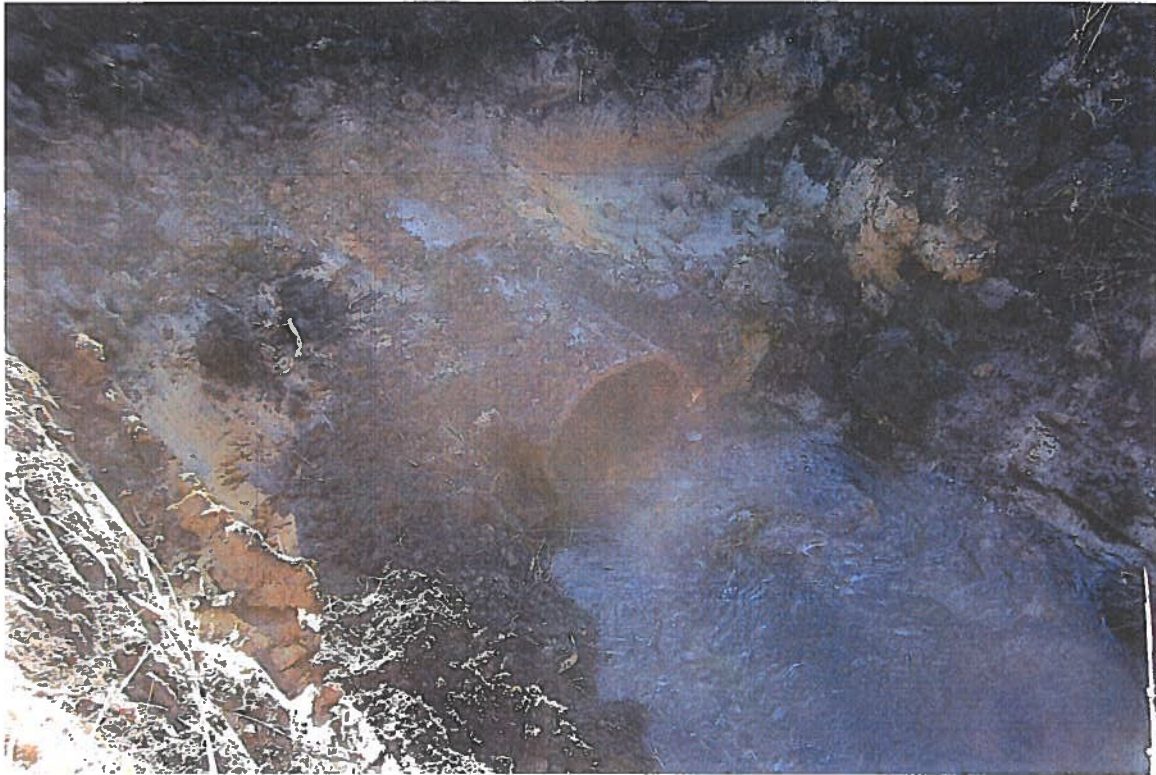
PICTURE # 2419 IS LOOKING SW ON SOUTH END SHOWING CRACK  
ON TOP & JT O/S ON SOUTH END FOR TILE THAT WILL  
BE REMOVED.

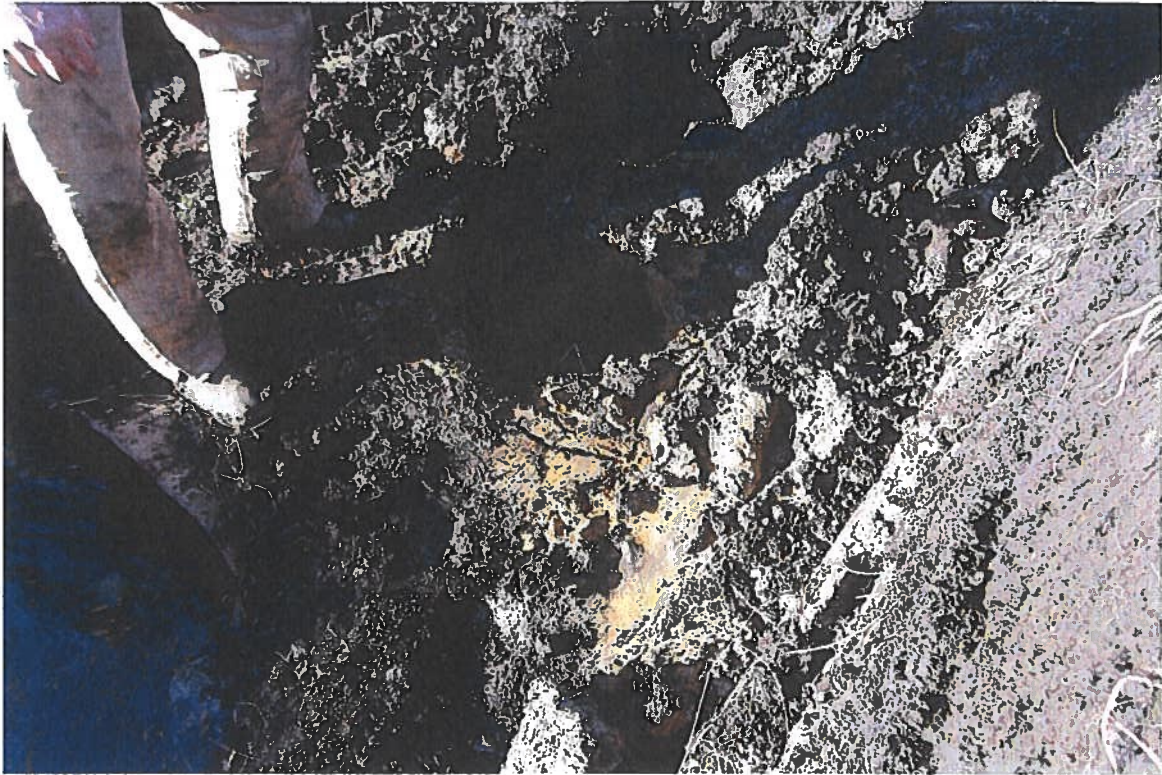
PICTURE# 2424 IS LOOKING NW SHOWING VOID ON EAST SIDE  
OF TILE ON NORTH END TIE IN

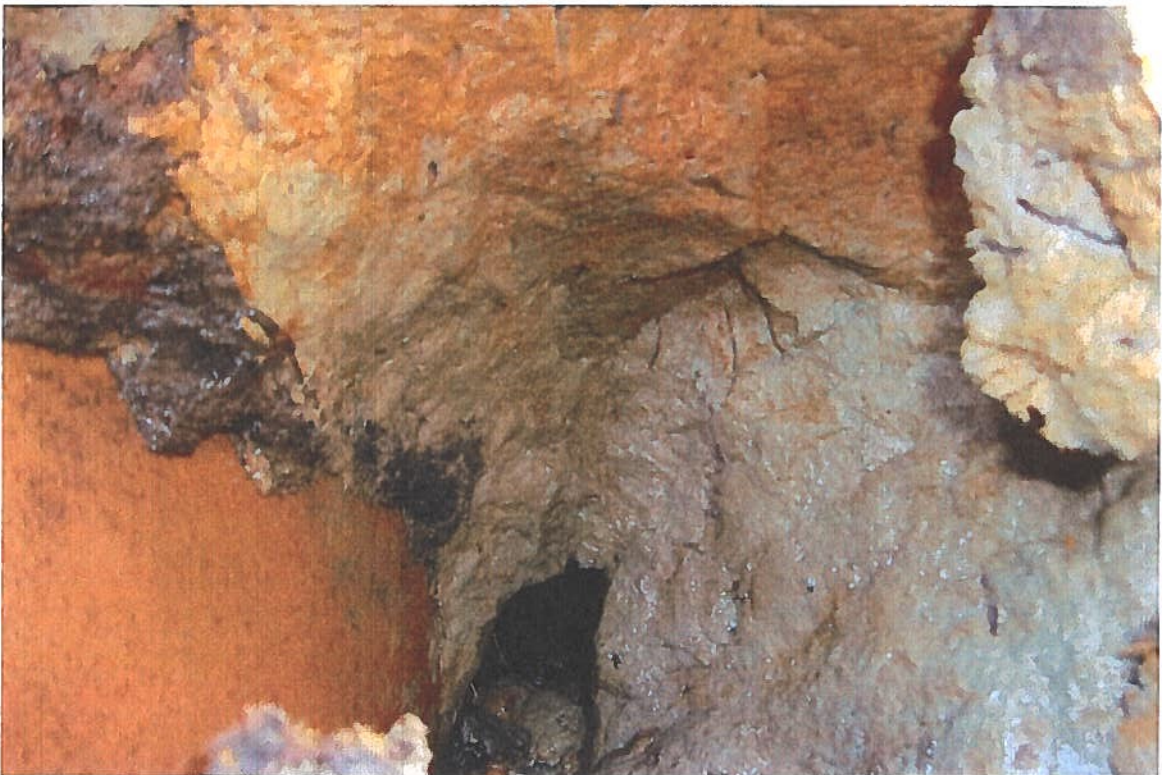
PICTURE# 2425 IS LOOKING NORTH ON EAST SIDE OF TILE  
SHOWING INSIDE VOID ON EAST SIDE OF TILE.

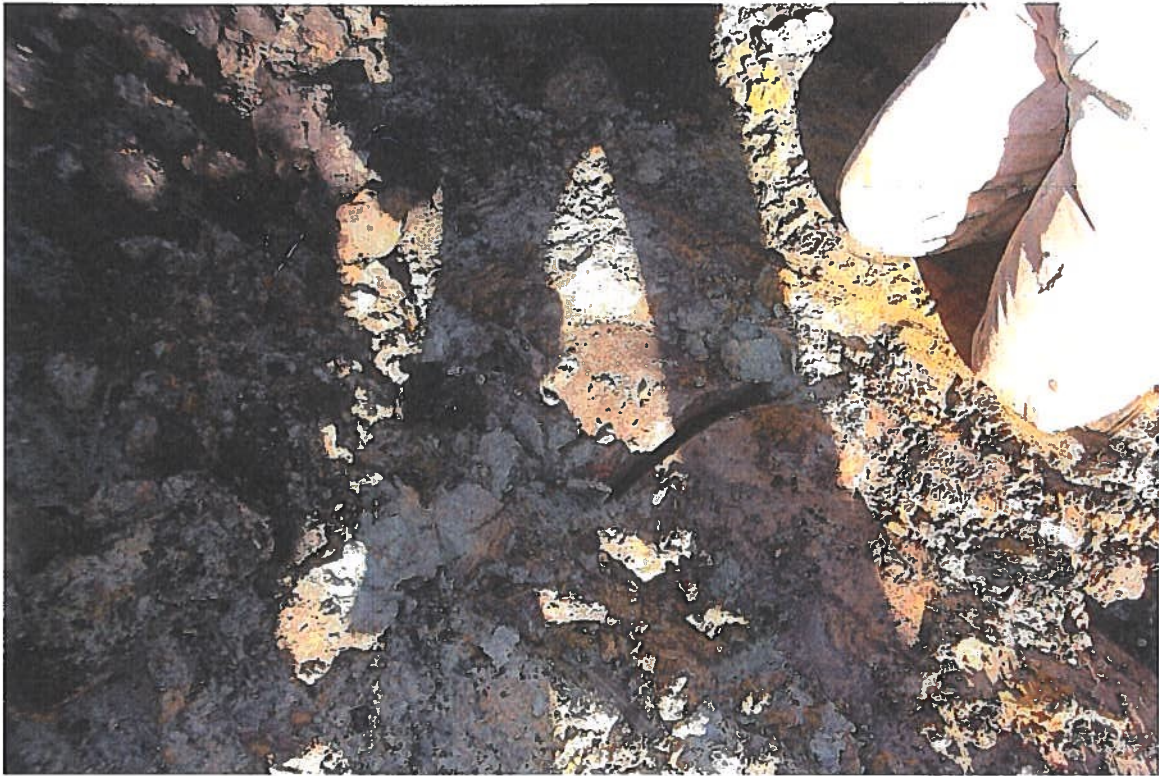
PICTURE # 2426 IS LOOKING NE SHOWING WIDE JOINT  
BETWEEN TILE SECTIONS ON NORTH END  
WHERE VOID WAS ON EAST SIDE.

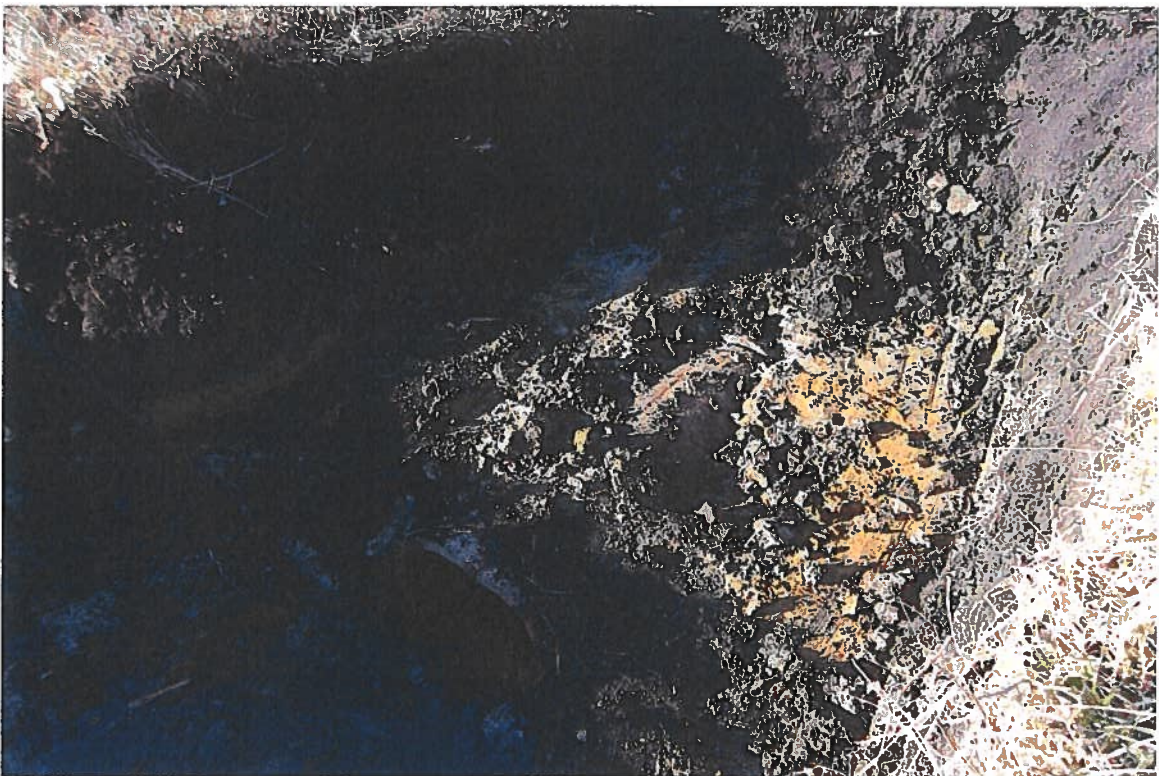
PICTURE# 2428 IS LOOKING NORTH DOWNSTREAM INSIDE  
NORTH END EXISTING 18" CLAY TILE I/N (1.58' TOP TO FL)  
TILE IS CRACKED ON TOP BUT NOT CAVING DOWN.
