**AGENDA
DRAINAGE DISTRICT 167
LANDOWNER MEETING
JULY 25, 2018 AT 11:00 A.M.**

Drainage Work Order Request For Repair Hardin County

Work Order #: WO00000208

Investigation Summary:

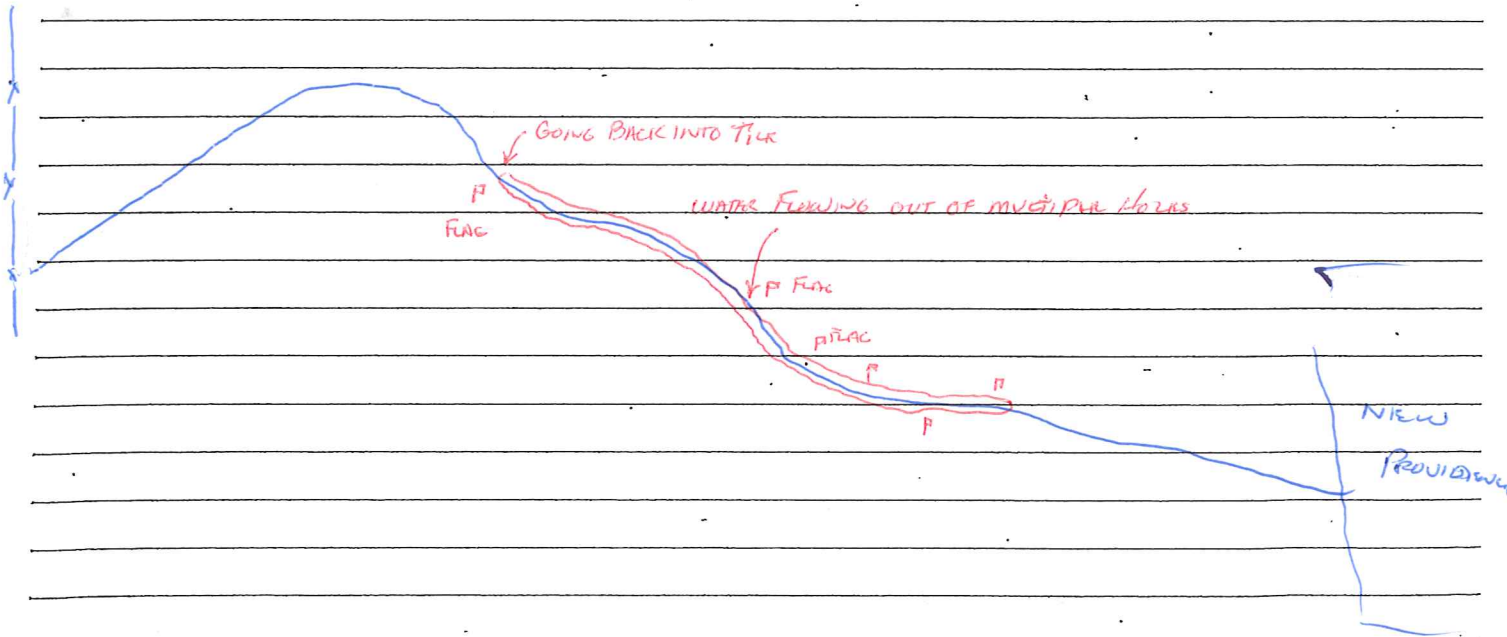
Partly Sunny, 65°, Windy From East, Rain Earlier
Arrived @ Job Site 9:00 A.M., called and talked to Robert Jensen,
He met me and drove his pickup out to Blow-outs Found 6"± clay tile
1 1/2 - 2' deep, Blowing out water in multiple places (6 or more) All look to
be joints. Must have a collapse down stream causing water to surge up thru
butt joints and then go back into tile past the collapse or blockage.
This looks to be the S. main
Find and fix blockage ASAP, the rest of tile should be OK.
Talked to Robert about shifting swage or tile route to get more cover.
This will be a on going problem with the minimum cover this butt joint tile
has.
