**AGENDA**  
**PUBLIC HEARING ON ENGINEER'S REPORT ON REPAIRS TO**  
**MAIN TILE, DRAINAGE DISTRICT 67, HARDIN COUNTY**

**ENGINEER'S  
REPORT ON  
REPAIRS TO  
MAIN TILE,  
DRAINAGE  
DISTRICT NO. 67  
HARDIN COUNTY**

# Engineer's Report on Repairs to Main Tile, Drainage District No. 67 Hardin County, Iowa

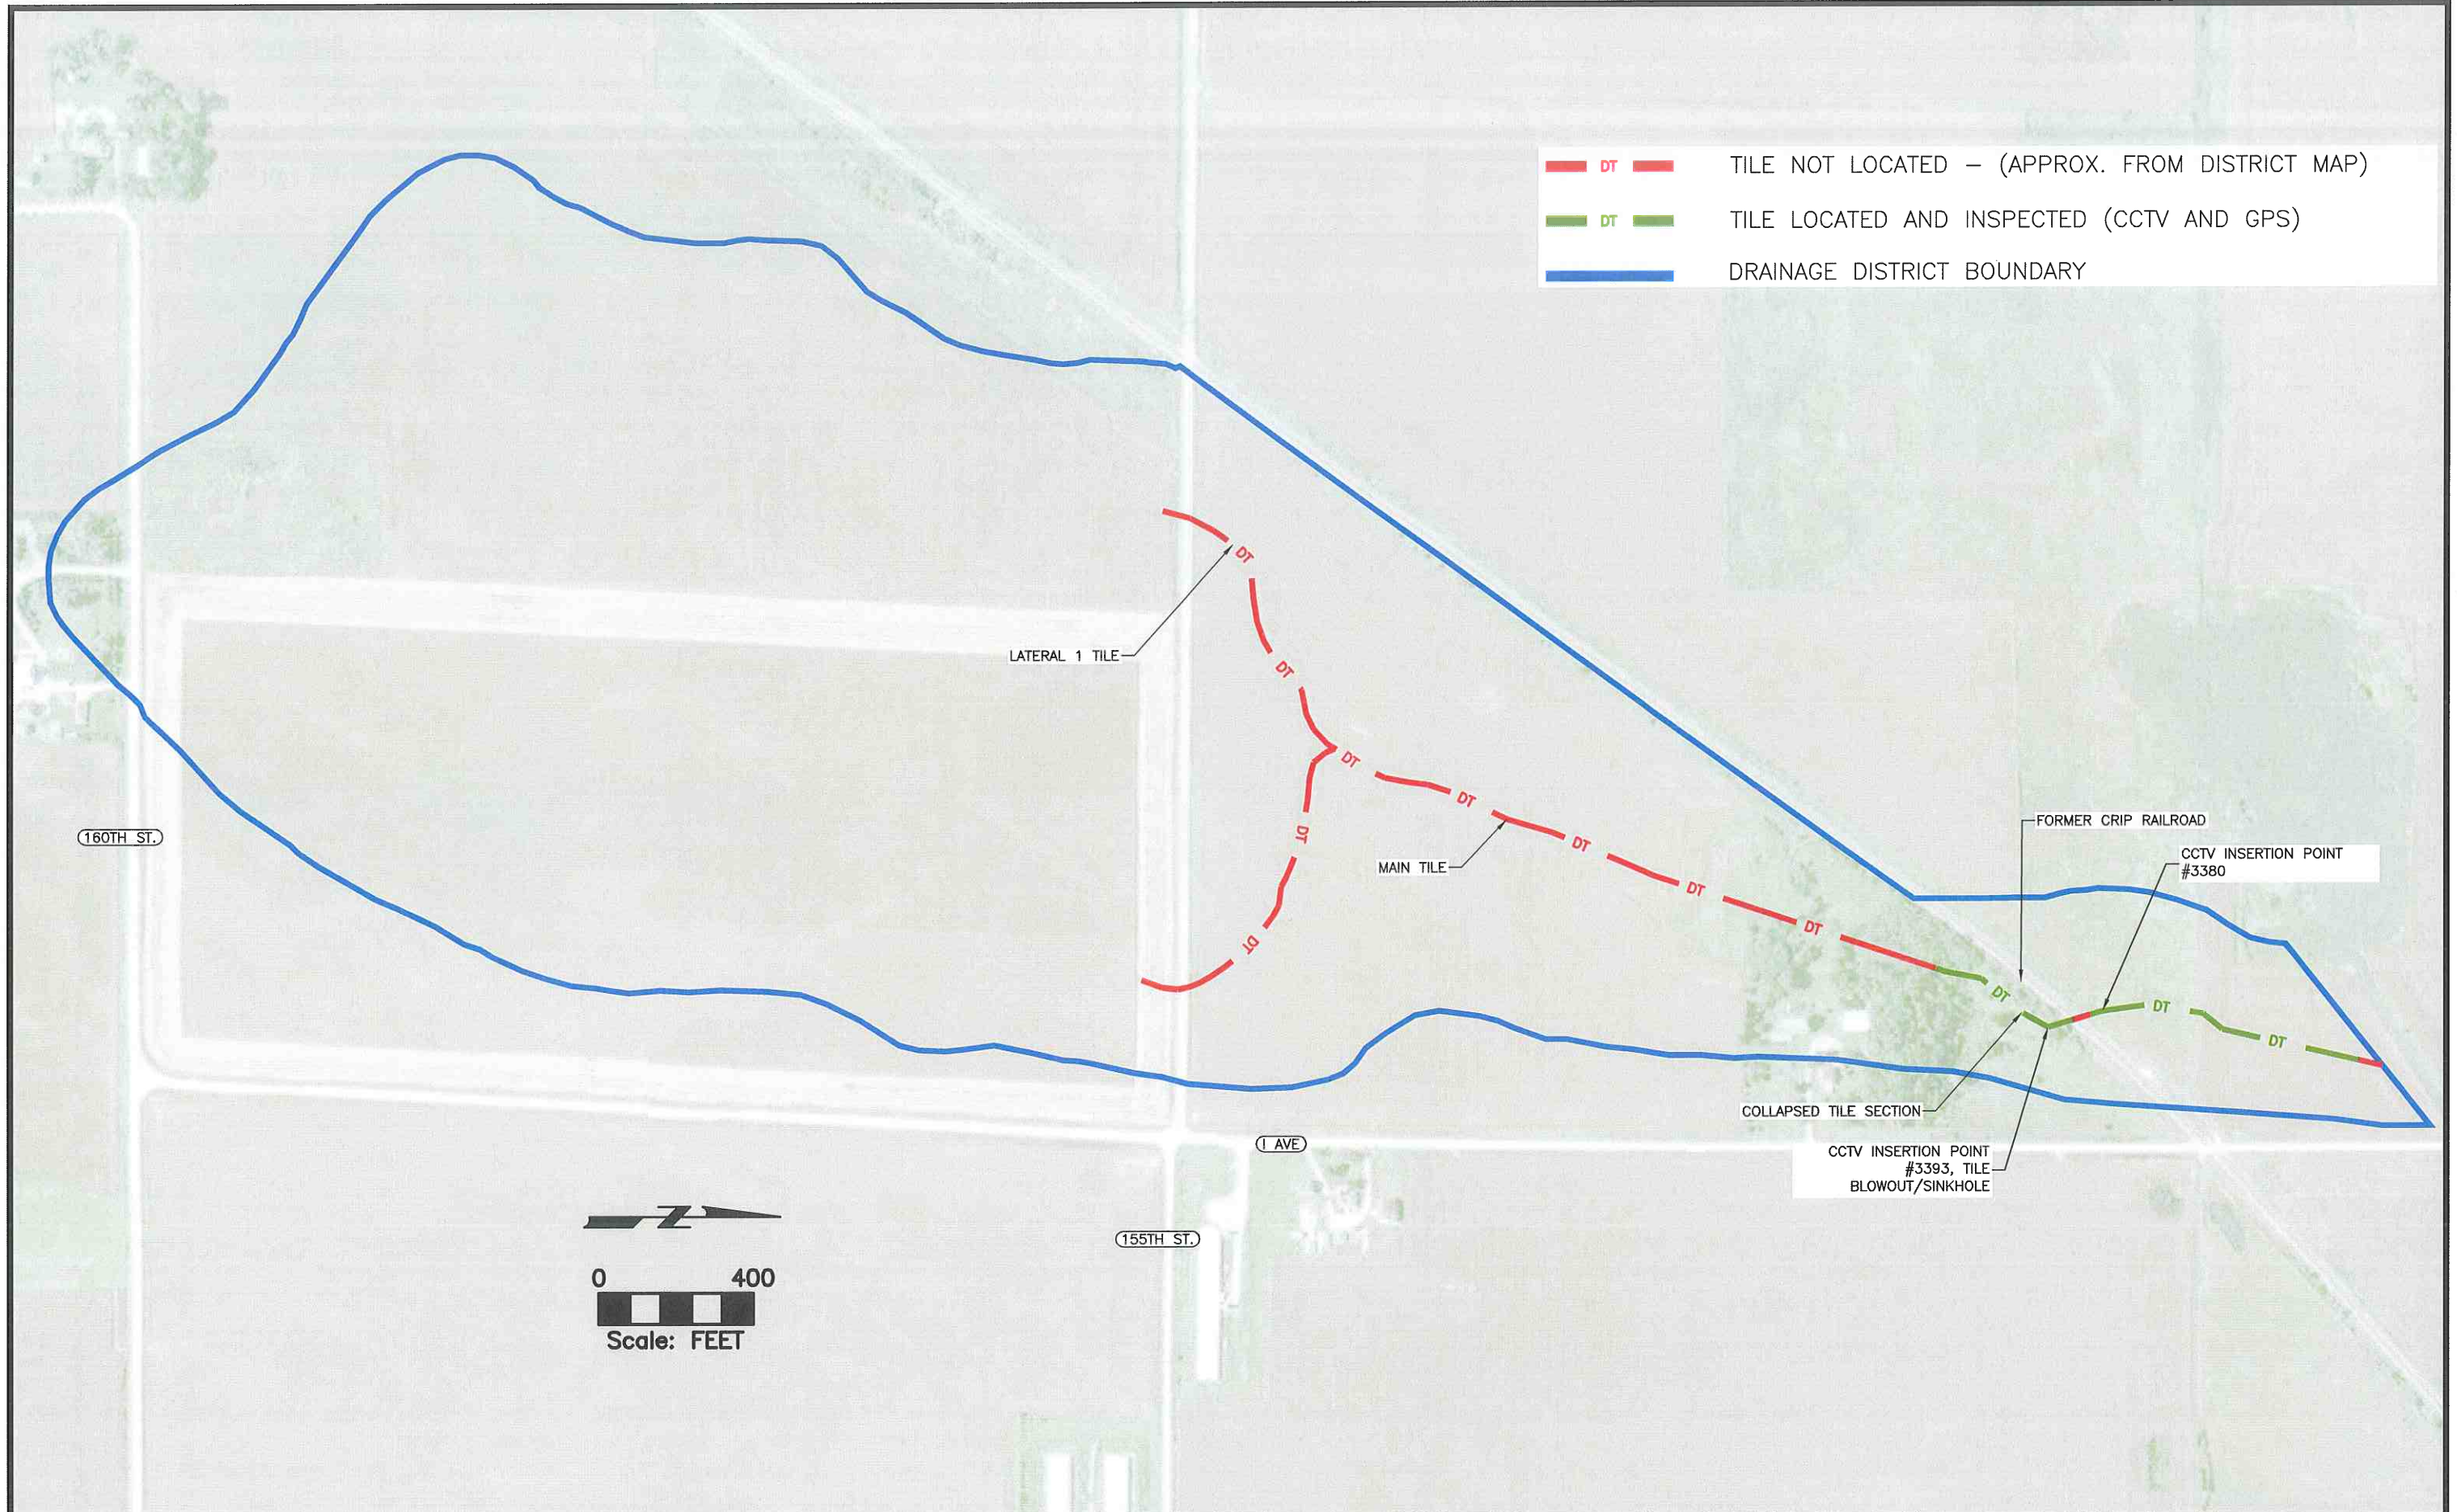
4.0 DISCUSSION AND CONCLUSIONS – Based on the above, it is obvious that the Main tile in the areas of investigation has exceeded its useful lifecycle. Much, if not all the existing VCP tile is cracked which is definitely an indication of nearing the end of lifecycle. More concerning are the many issues listed that restricted drainage and expose the district to potential liability from a tile collapse under the existing railroad tracks. These are an indication of the pipe exceeding its useful lifecycle. Said CCTV inspection and visual observations identified the following key issues:

- 1 full collapsed tile.
- 1 radially cracked tile.
- 10 partially collapsed tile.
- 30 offset joints with voids, rocks, or soil visible.
- 48' of previous repair with single wall HDPE. 5' of this is deformed.
- 609'± of soil and debris in flowline.
- Unable to CCTV inspect under railroad tracks due to debris. Said debris appears to be entering under said railroad tracks, which could indicate a tile collapse under said railroad tracks.

- For the lower end of the Main tile, remove and replace the existing tile only at the locations of the key issues identified above.
- The above repairs would be in the same location as the existing Main tile in order to preserve connections with private tile. The exception to this would be the railroad crossing, where the location of the Main tile would be dictated by railroad standards. For reference, the route and locations are shown on the map included in Appendix D.

- For the lower end of the Main tile, remove and replace the existing tile for the entire length of investigation.
- The above repairs would be in the same location as the existing Main tile in order to preserve connections with private tile. The exception to this would be the railroad crossing, where the location of the Main tile would be dictated by railroad standards. For reference, the route and locations are shown on the map included in Appendix E.

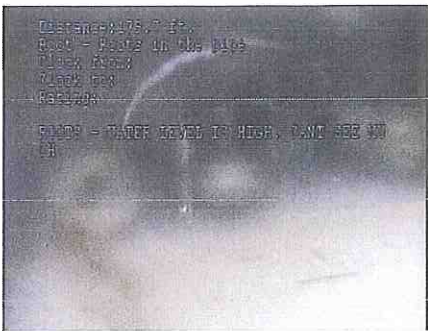
Distance	Dire Length	From/To Code	Modifier/Severity	Rating	Comments
179.7 ft.	U	/	Root		ROOTS - WATER LEVEL IS HIGH. CANT SEE MUCH

1+82 COLLAPSE LIKELY - PIPE V SHAPED

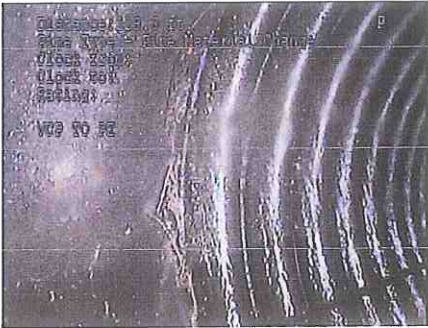
Distance	Dire Length	From/To Code	Modifier/Severity	Rating	Comments
229.3 ft.	U	/	Pipe Type, VCP -> SW HDPE - PIPE ROUND		VCP TO PE

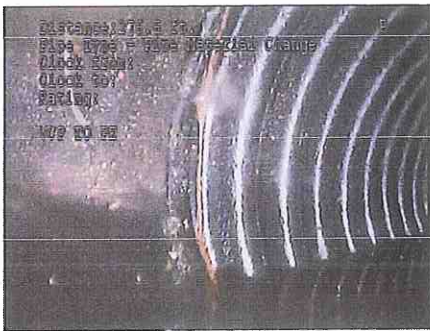
276.6 ft.	U	/	Pipe Type, VCP -> SW HDPE - PIPE ROUND		VCP TO PE
-----------	---	---	--	--	-----------

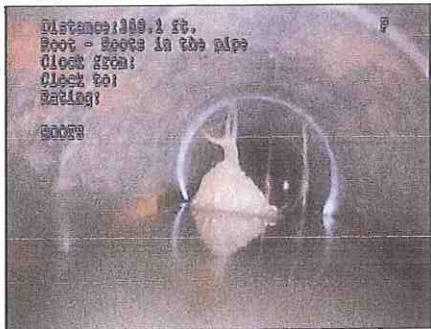
308.1 ft.	U	/	Root	3+19 PIPE SAGGING, SOIL VISIBLE IN JOINT - PIPE V SHAPED	ROOTS
-----------	---	---	------	--	-------

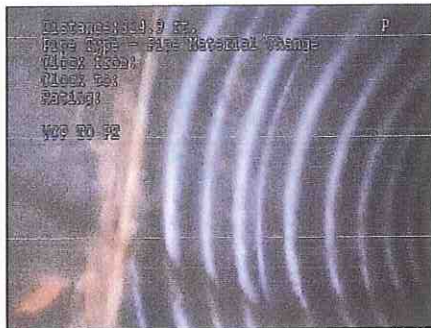
324.9 ft.	U	/	Pipe Type	VCP -> SW HDPE - PIPE EGG SHAPED	VCP TO PE
-----------	---	---	-----------	----------------------------------	-----------

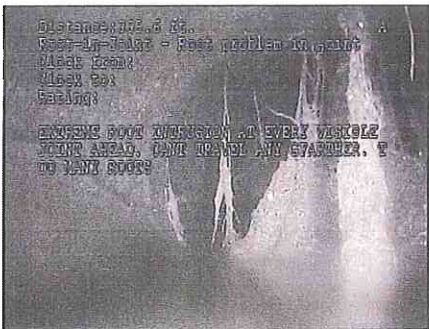
335.6 ft.	U	/	Root-in-Joint, ROOTS TOO HEAVY TO TRAVERSE		EXTREME ROOT INTRUSION AT EVERY VISIBLE JOINT AHEAD. CANT TRAVEL ANY GFARTHER. TOO MANY ROOTS
-----------	---	---	--	--	---

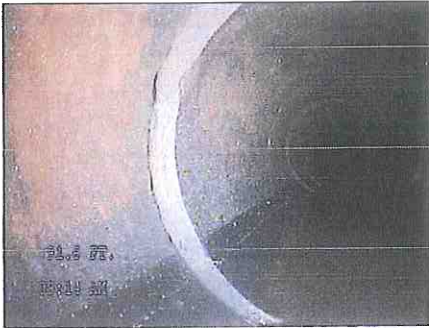
Distance	Dire Length	From/To Code	Modifier/Severity	Rating	Comments
91.6 ft.	D	7 / 1	Joint Offset		SOIL VISIBLE IN GAP - PIPE ROUND <b>SEVERE OFFSET</b>

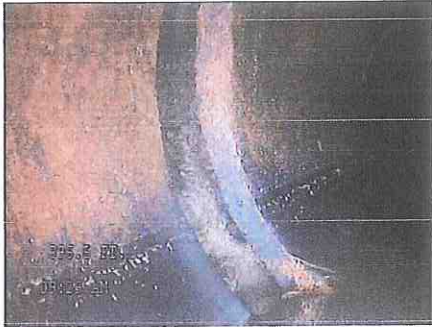
Distance	Dire Length	From/To Code	Modifier/Severity	Rating	Comments
396.5 ft.	D	/	Joint - Separated, SOIL VISIBLE - PIPE ROUND		<b>WIDE / SOIL SHOWING</b>

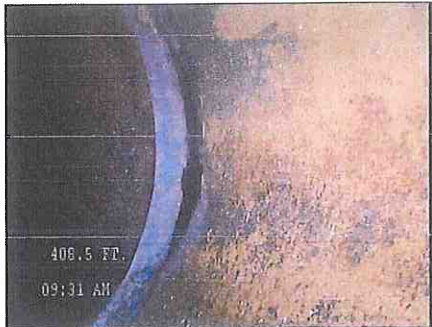
408.5 ft.	D	/	Joint Offset, JOINT OFFSET, SOIL VISIBLE IN GAP (THREE IN A ROW) - PIPE ROUND		<b>WIDE</b>
-----------	---	---	---	--	-------------

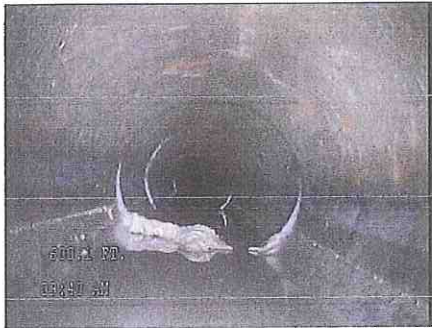
600.1 ft.	D	5 / 8	Root	- PIPE ROUND		<b>ROOTS</b>
			6+31	JOINT OFFSET - PIPE ROUND		
			6+76	JOINT OFFSET (TWO IN A ROW) - PIPE ROUND

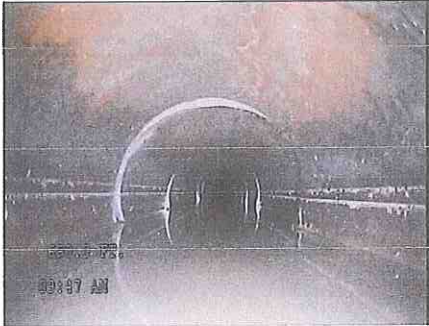
Distance	Dire Length	From/To Code	Modifier/Severity	Rating	Comments
690.0 ft.	D	/	END OF SURVEY , LOSS OF TRACTION - PIPE ROUND		END OF SURVEY/INSPECTION. UNABLE TO GO ANY FARTHER. SOMETHING UNDER THE WATER/MUD IS STOPPING TRACTOR

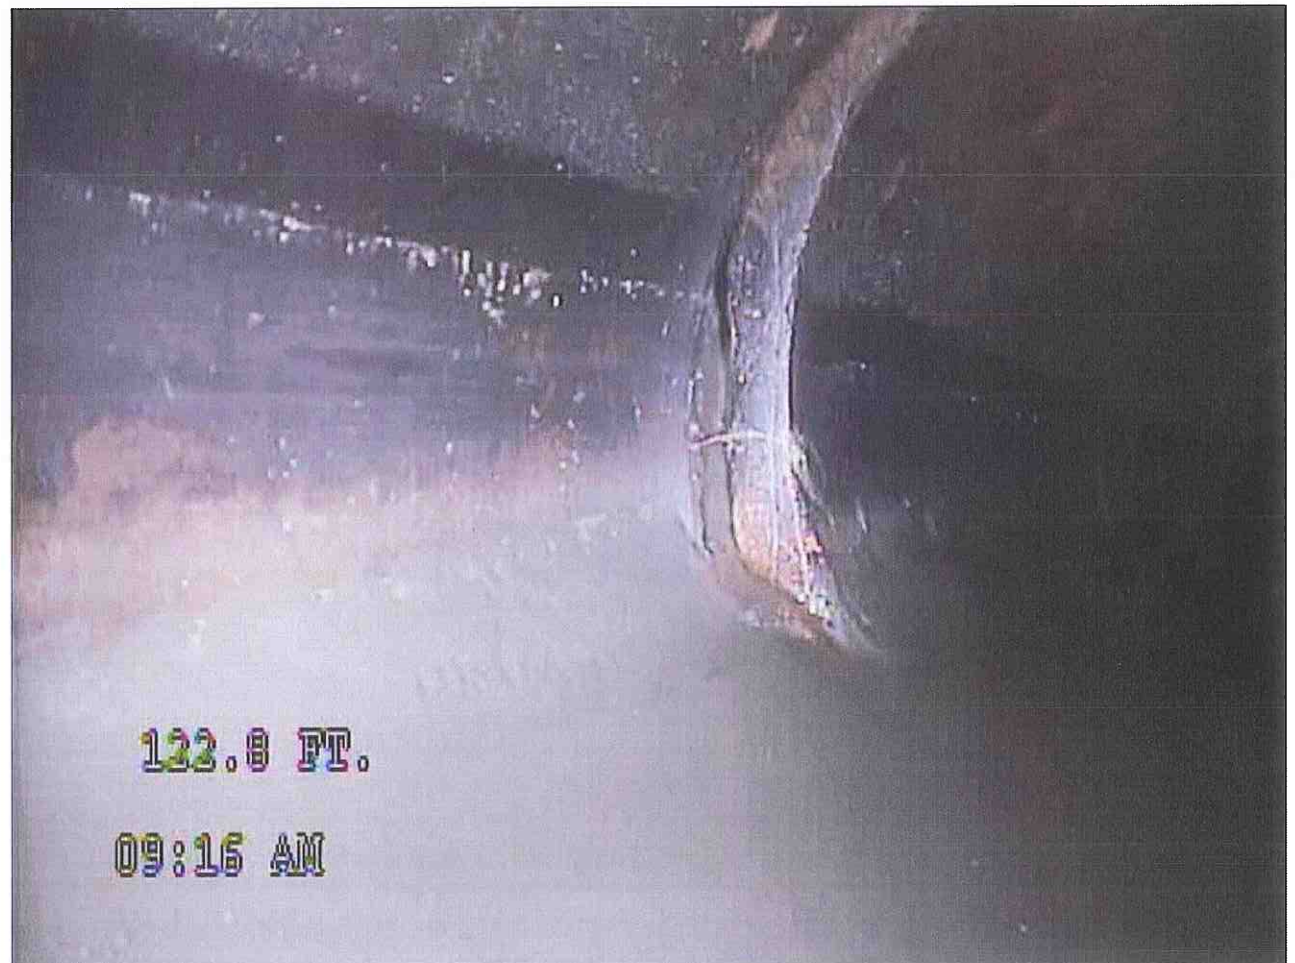
122.8 FT.

**122.8 ft. D**      **7 / 10 Joint Offset**      **SOIL VISIBLE IN GAP (TWO IN A ROW), TOP CRACK (END) - PIPE ROUND**      **OFFSET**

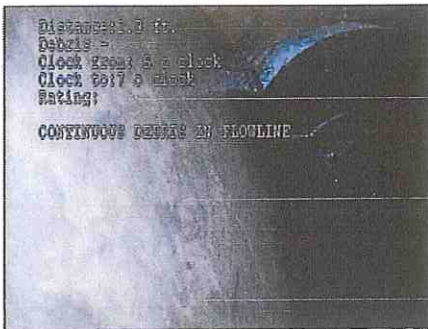
2.3 ft.	U	29.6 ft.	5 / 7	Debris		CONTINUOUS DEBRIS IN FLOWLINE
---------	---	----------	-------	--------	--	-------------------------------

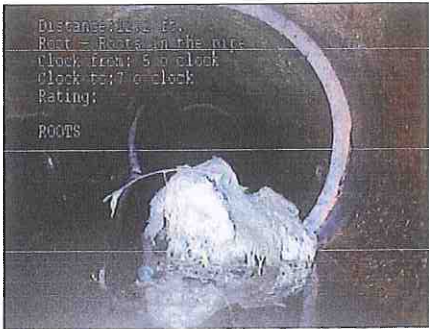
Distance	Dire Length	From/To Code	Modifier/Severity	Rating	Comments
12.2 ft.	U	5 / 7	Root, JOINT OFFSET - PIPE ROUND		ROOTS

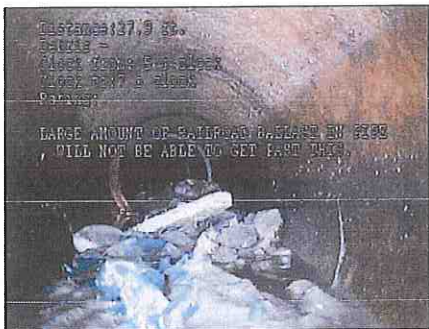
27.9 ft.	U	5 / 7	Debris		LARGE AMOUNT OF RAILROAD BALLAST IN PIPE, WILL NOT BE ABLE TO GET PAST THIS.
----------	---	-------	--------	--	--

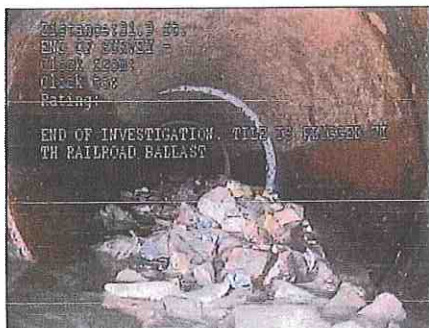
31.9 ft.	U	/	END OF SURVEY, DEBRIS TOO DEEP.		END OF INVESTIGATION. TILE IS PLUGGED WITH RAILROAD BALLAST
----------	---	---	---------------------------------	--	---
