AGENDA
REGULAR DRAINAGE MEETING
JANUARY 2, 2018

Drainage District:

Repair Summary:

CONSTRUCTION ENGINEERING
OBSERVATION REPORT

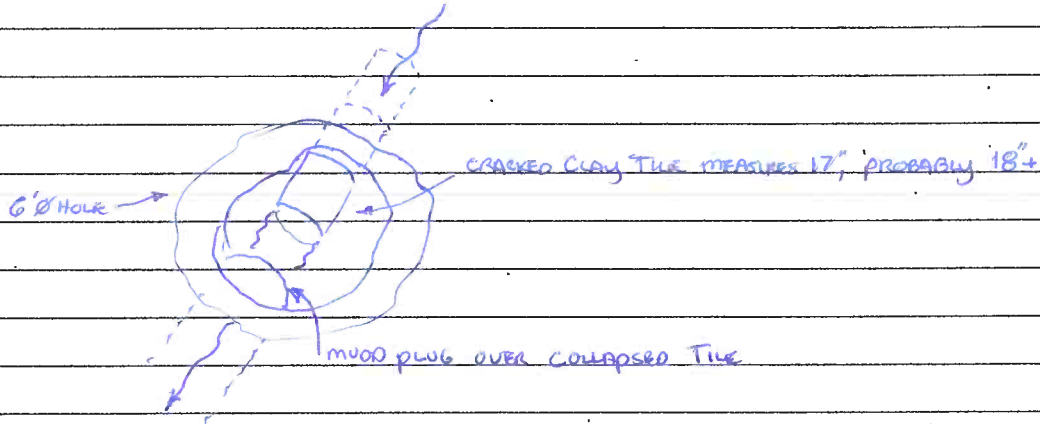
ARRIVED @ Randy SILVEST FARM, PARKED IN FARM DRIVE, NE OF HIS HOUSE, WALKED TO HOLE JUST NW OF HIS FARM ACARRAGE. FOUND 6' Ø HOLE WITH BROKEN 18"± CLAY TILE RUNNING 1/2 FULL ± FROM NE TO SW. TILE HAS 45-50' OF COVER. TOOK PIC. UPSTREAM (DOWNSTREAM BLOCKED BY MUDD + DIRT.

Fix ASAP, CROPS ARE OUT

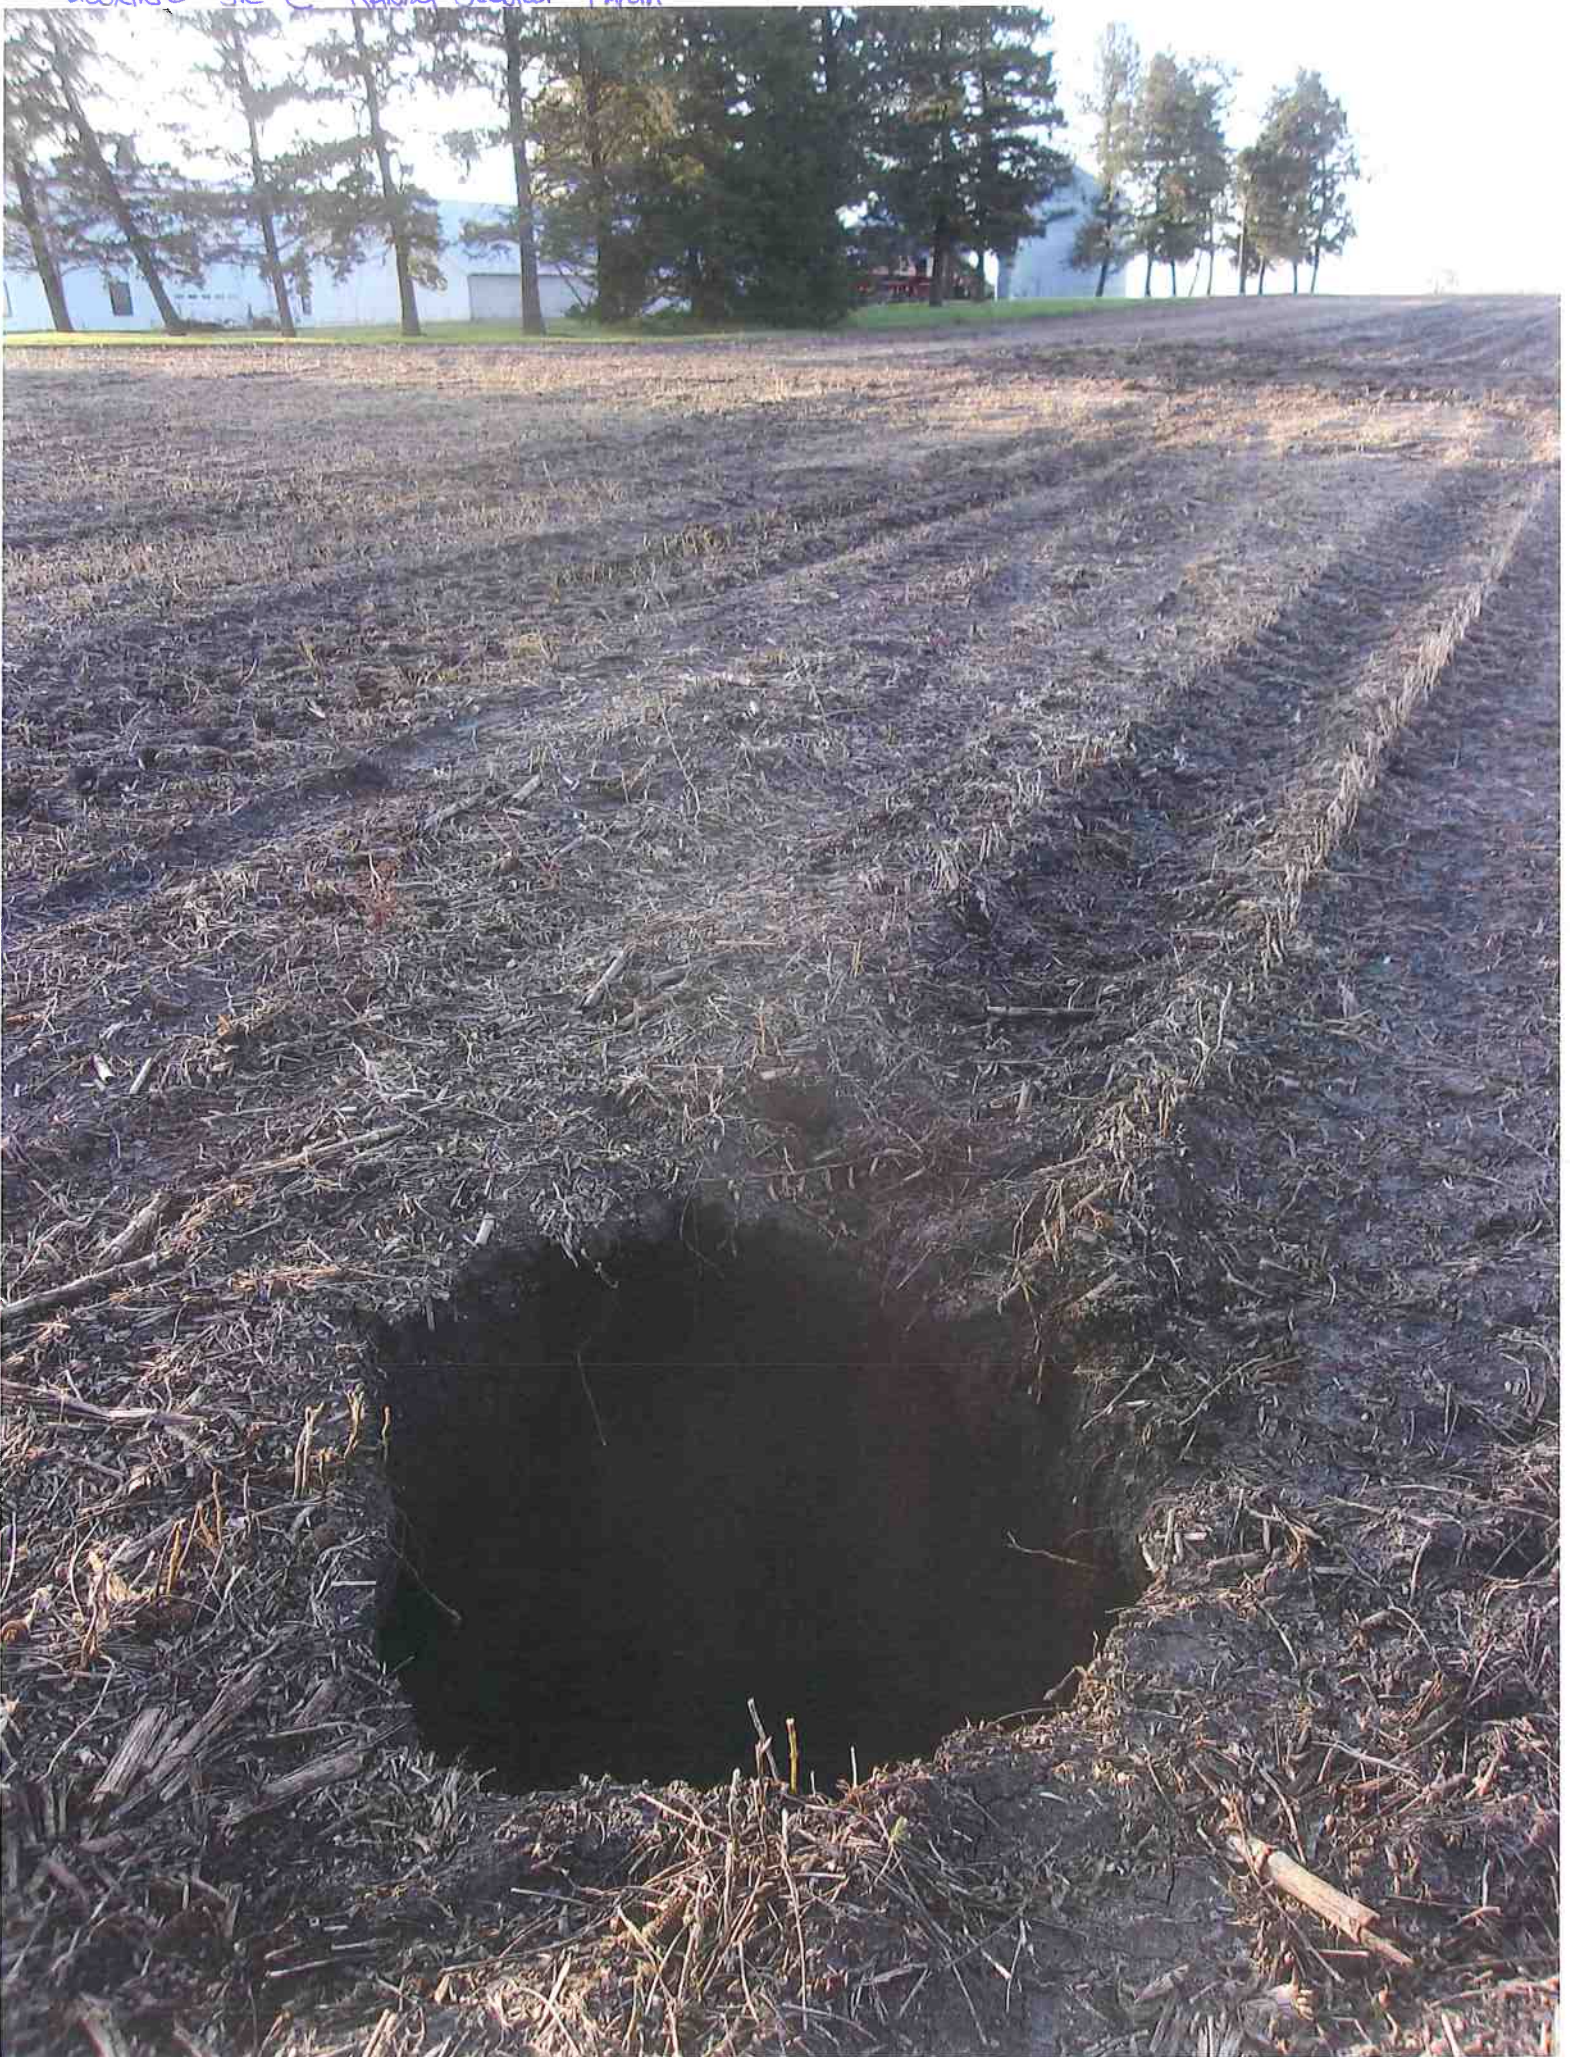
Looking SE @ Randy Scurst Farm

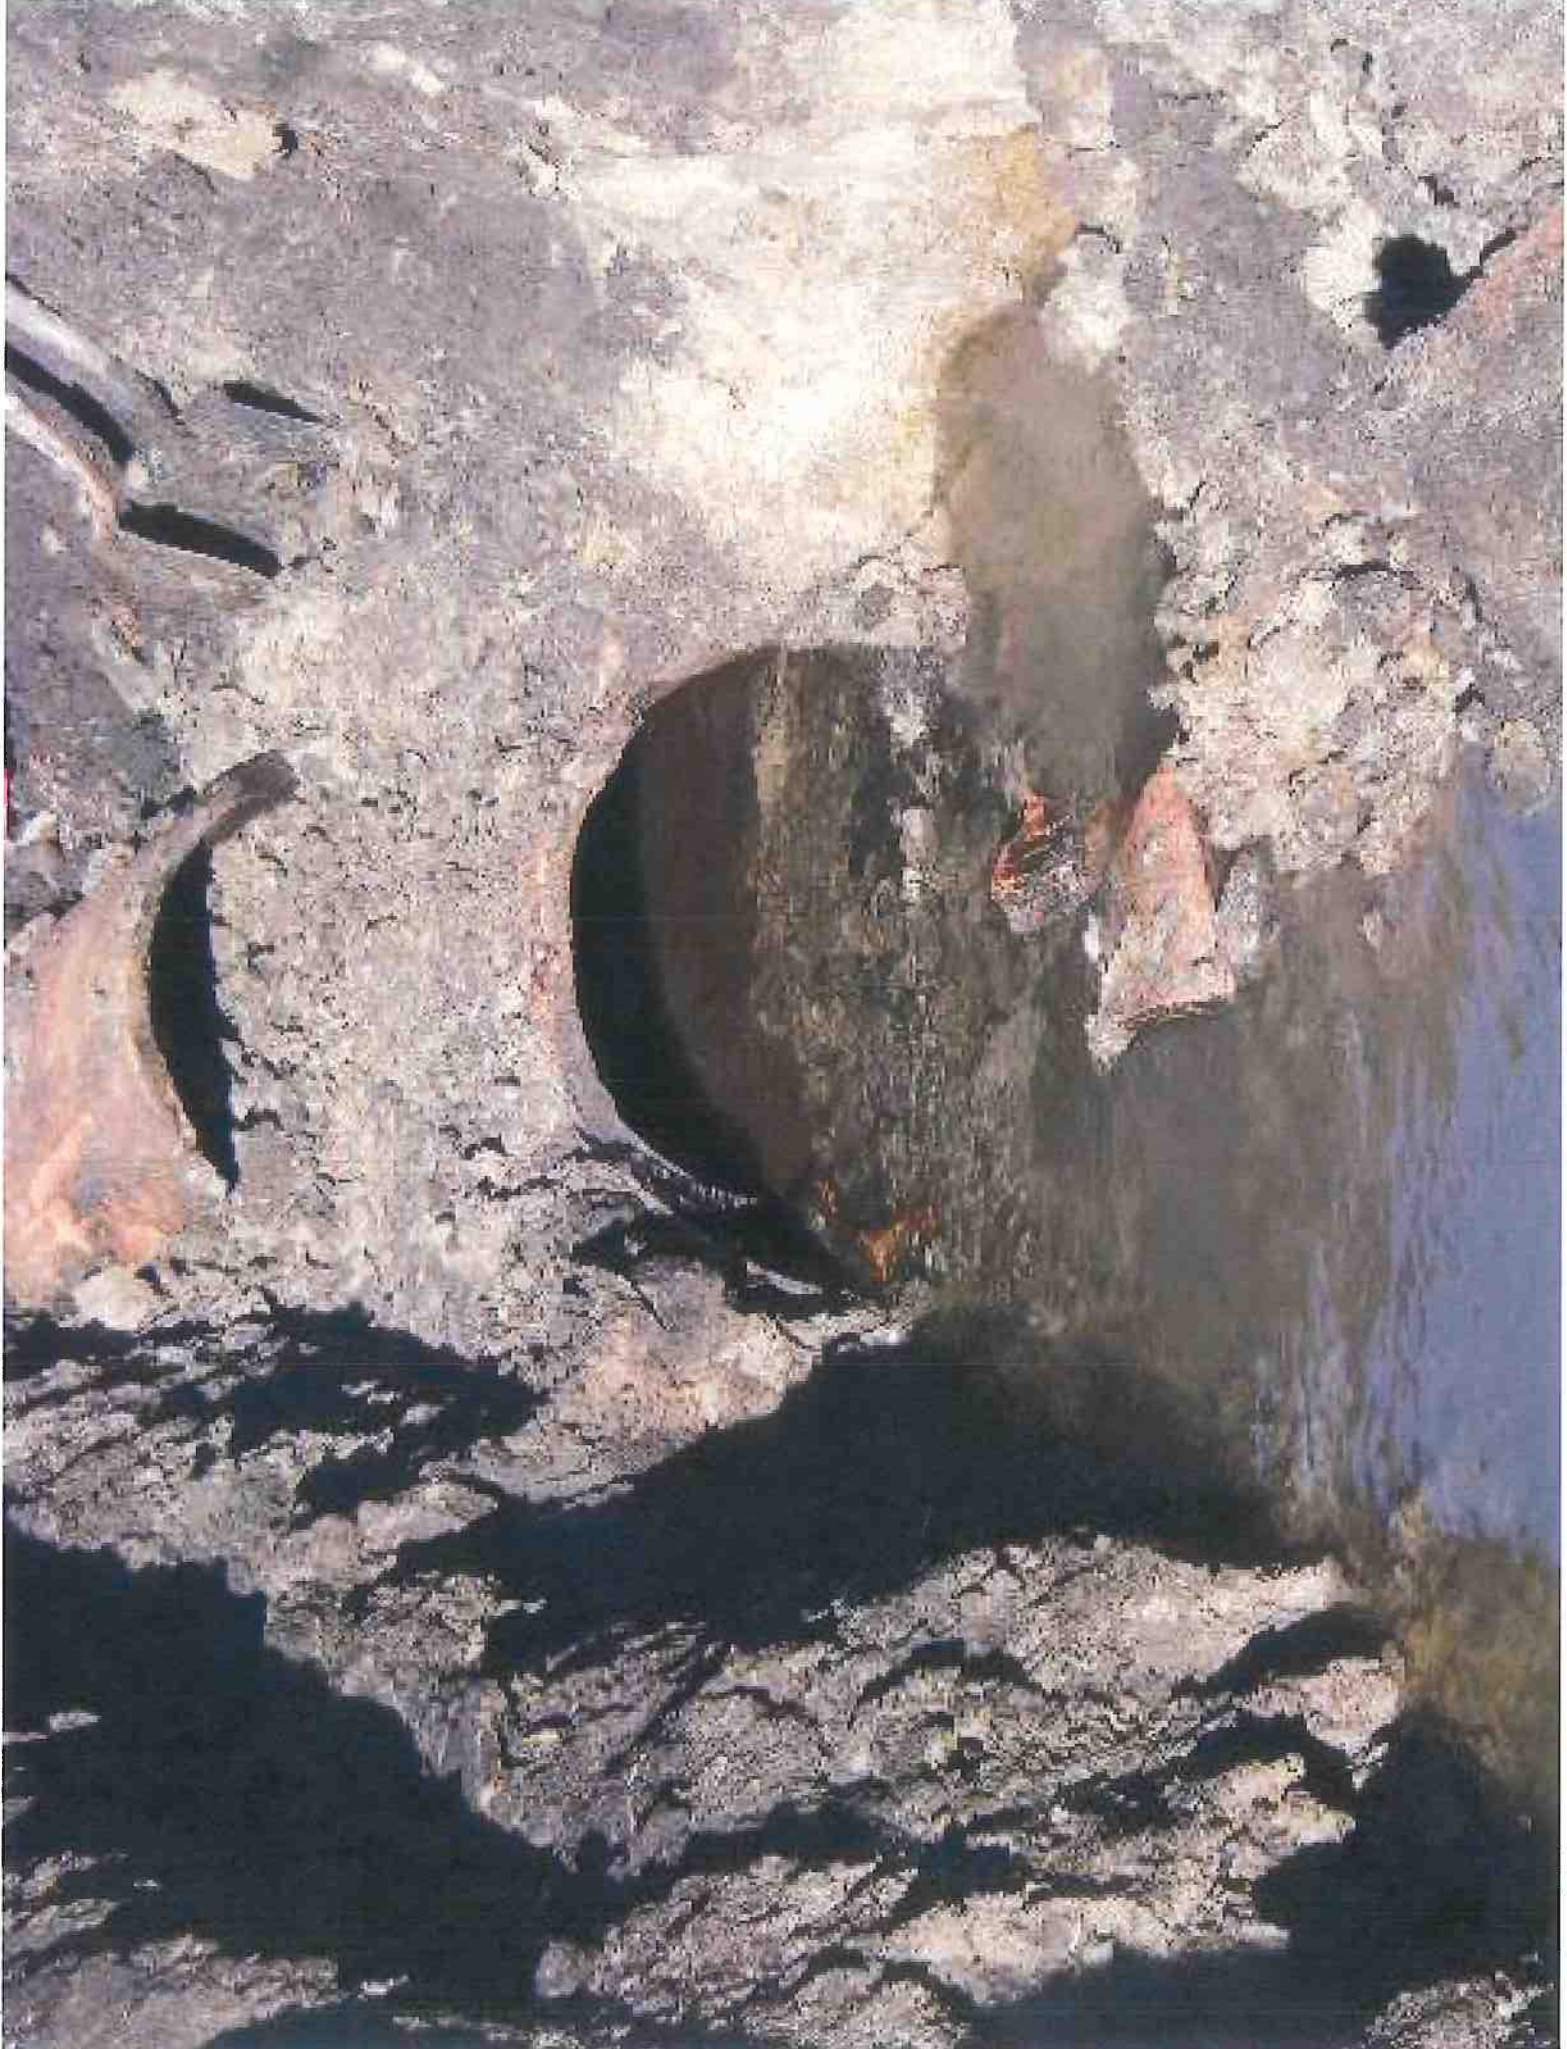
UPSTREAM TIER @ GPS #130

2:00 P.M. START TV UPSTREAM @ GPS #130 [12' LAT. RT. 12" CLAY] [CONTINUOUS BROKEN TOPS/HINGED]
 [13.0' SIZE REDUCTION?] END TV SHOT "Y" IN MAIN GPS #131
 LEFT JOB 3:00 P.M.

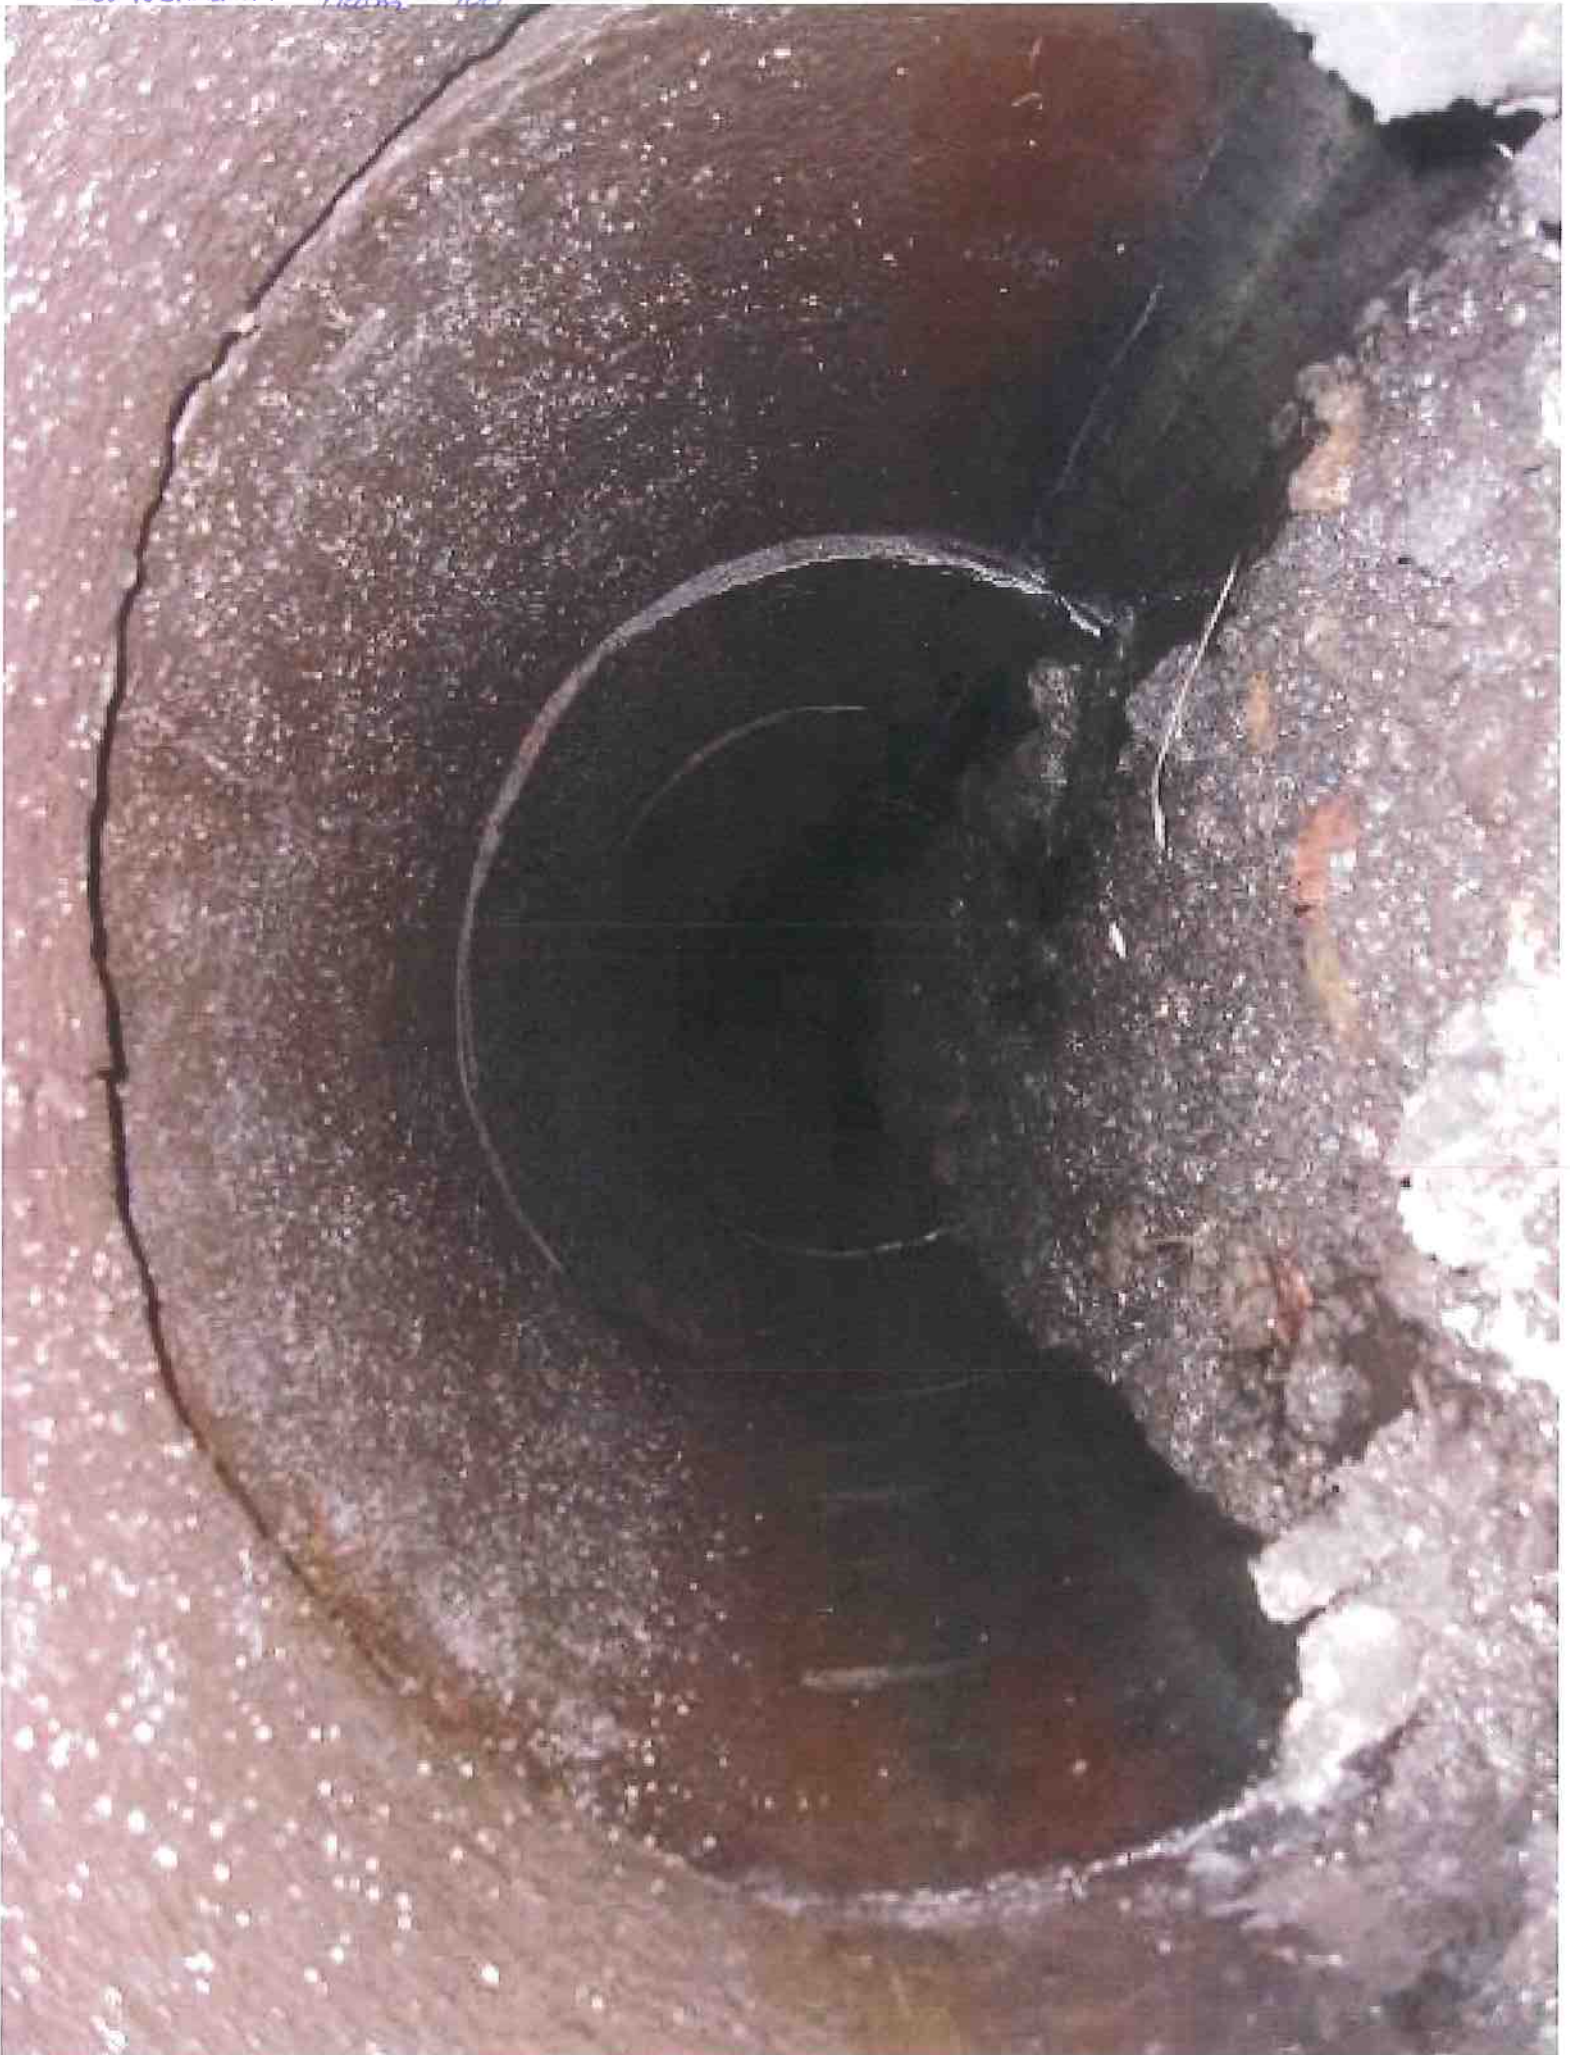
downstream From #100

STARTED TV @ GPS #100 DOWNSTREAM ON 24" CLAY TILE, [0.00' TOP CRACK] AIRIAL FX,
 [140' HINGE TOP/SIDE CRACK], [180' VERY BAD PIPE], [35' TOP BROKEN REPAIR], [51' TOP CRACK], [90' OLD REPAIR]
 [109' SOIL INFILTRATION] [144' OLD REPAIR] [194, LAT. RT.] [262' SIDE CRACKS] CONTINUOUS TOP CRACK
 [311' TILE IN FX] **STAGNANT WATER** [341' DEBRIS IN FX?] MULTIPLE CLAY TILE CHARDS.
 [392' GOOD TILE] [438' CHARD IN FX] [471' TOP CRACK CONTIN] [569' MUD, CHARDS IN FX] [583' BAD ALIGNMENT]
 [606' CHARD IN FX] [TOP CRACK] [627' CHARD/ROCK IN FX] MORE CHARDS [640' BAD TILE CRACKS] [644' BAD TILE]
 [932' LAT. LT. CLAY] [944' BAD TILE] [978' CHARD IN FX] [984' CHARD IN FX] BAD TILE.
 [1016' BAD HINGE TOP] 1023, COLLAPSED TILE FRESH CRACK [1047' BOTTOMS UP] [1049' LAT. RT.]
 [1070' MISSING TILE] [1087' BAD TILE] 1098 4" PLASTIC FROM TOP & INTRUSION, INTAKE?
 [1114' GOOD TILE] 1145' TOP CRACK [1228' BAD JOINT] 1239' LAT TOP [1252' CHARDS IN FX] TOP CRACK

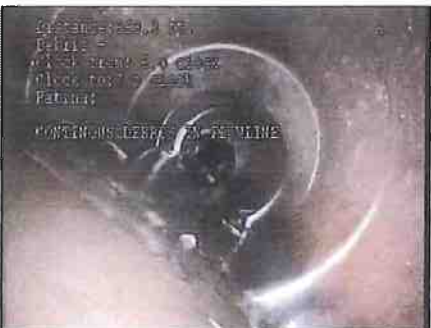
569.3 ft.	D	106.3 ft. 5 / 7	Debris		CONTINUOUS DEBRIS IN FLOWLINE
-----------	---	-----------------	--------	--	--------------------------------------

5+70 => CONTINUE JOINT OFFSET - DEBRIS IN FLOWLINE

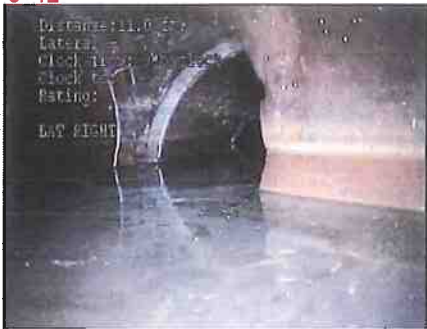
0+12

Distance	Dir. Length	From/To Code	Modifier/Severity	Rating	Comments
44.0 ft.	U	3 /	Lateral - VCP TILE - NON INTRUDING		LAT RIGHT

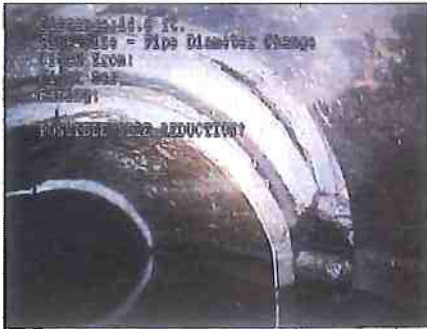
Distance	Dire Length	From/To Code	Modifier/Severity	Rating	Comments
14.6 ft.	U	/	Pipe Size		POSSIBLE SIZE REDUCTION?

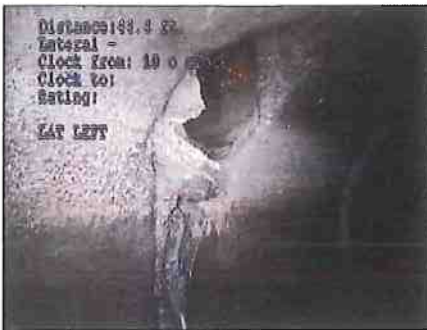
44.4 ft.	U	10 /	Lateral - VCP TILE - NON INTRUDING - END SURVEY		LAT LEFT
----------	---	------	---	--	----------

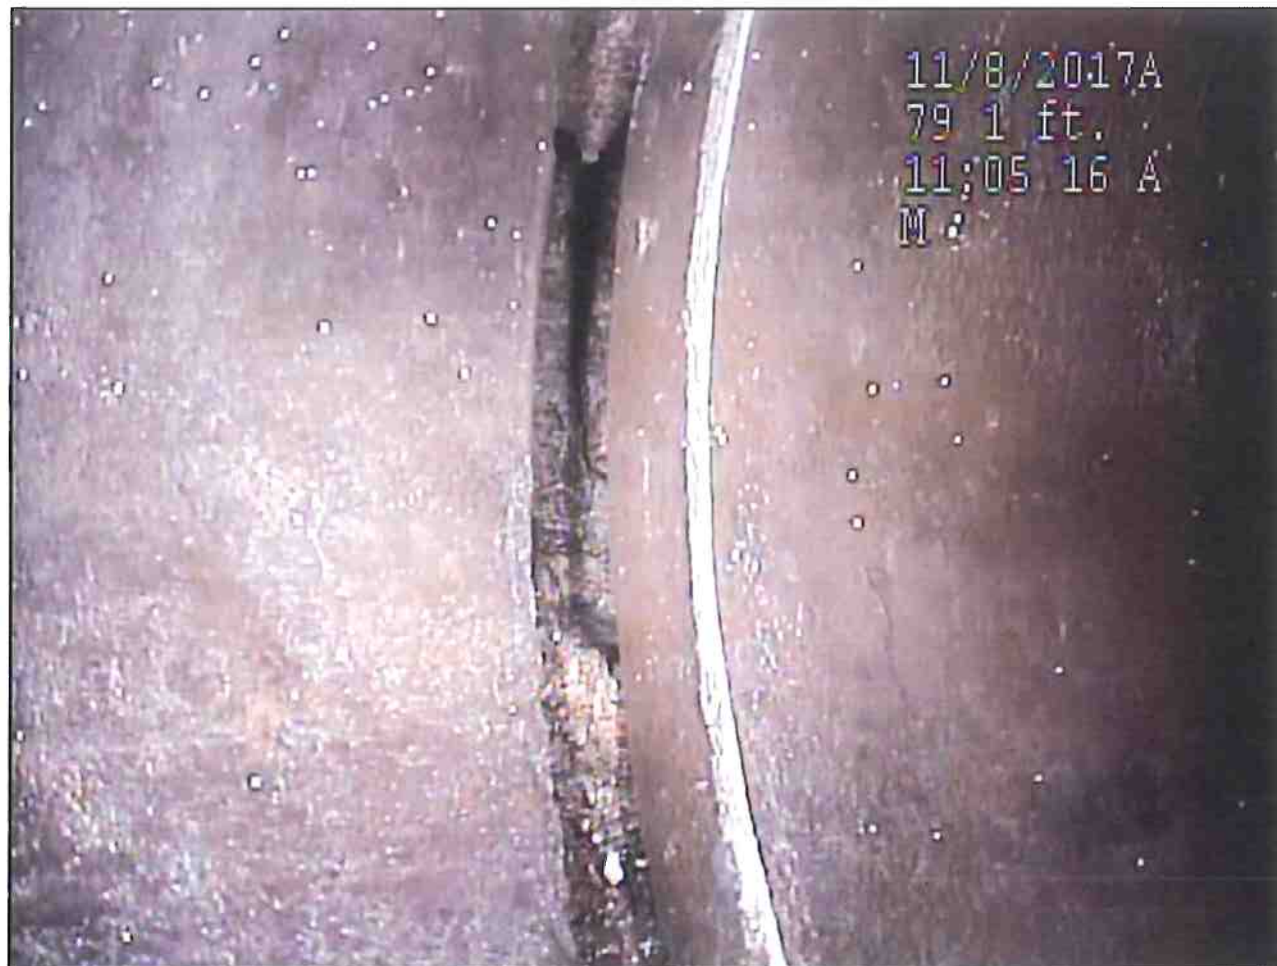
11/8/2017A
79 1 ft.
11:05 16 A
M

79.2 ft.	D		7 / 11	Joint - Separated - CONTINUE TOP CRACKED - CONTINUE JOINT OFFSETS - PIPE ROUND		WIDE JOINT/VOID
----------	---	--	--------	---	--	-----------------

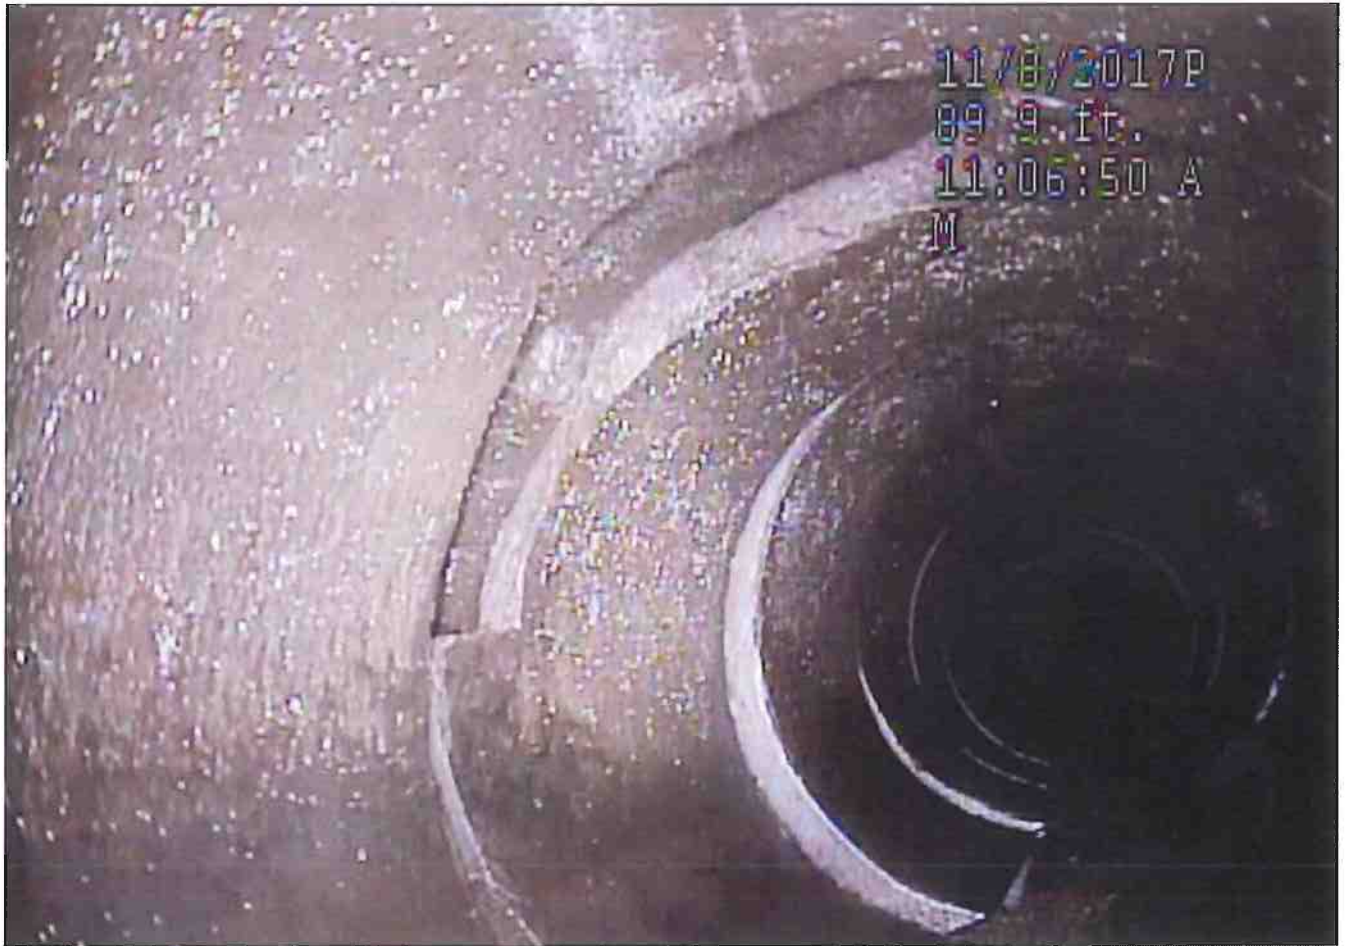
11/8/2017P
89 9 ft.
11:06:50 A
M

89.9 ft.	D		10 / 12	Broken		BROKEN AND REPAIRED WITH ANOTHER TILE OVER TOP
0+90 => CONTINUE TOP CRACKED - CONTINUE JOINT OFFSETS - REPAIRED TOP - ROUND						
0+94 => CONTINUE TOP CRACKED - END JOINT OFFSETS - PIPE ROUND

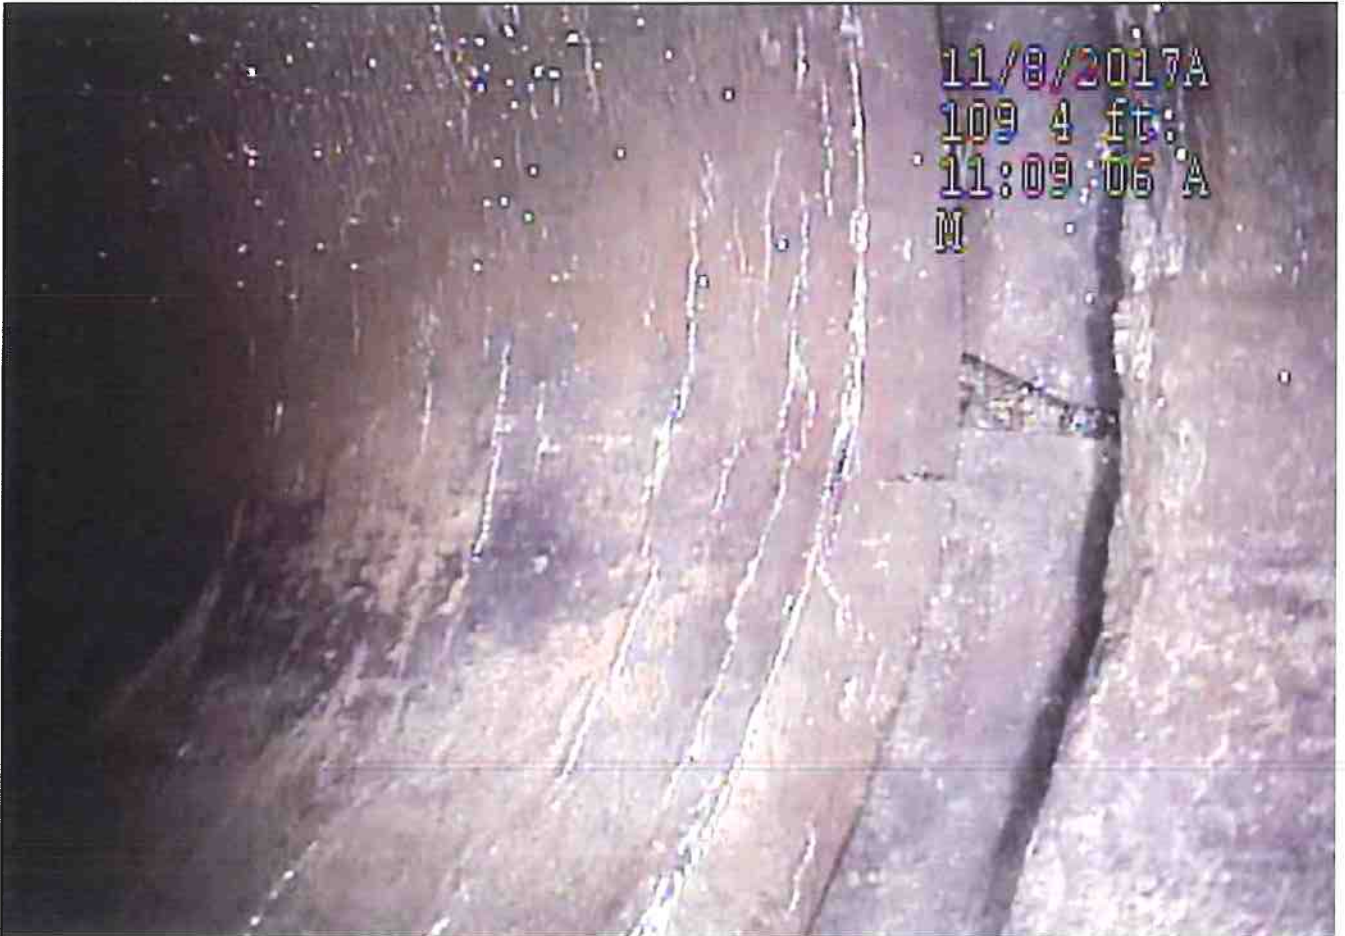
11/8/2017A
109 4 ft.
11:09:06 A
M

109.4 ft. D **3 / 6 Infiltration**
 1+10 => END TOP CRACK - JOINT GAP - REPAIRED WITH BRICK BATS - PIPE ROUND
 1+20 => START TOP CRACK - PIPE ROUND

SOIL INFILTRATING INTO PIPE FROM WIDE JOINT

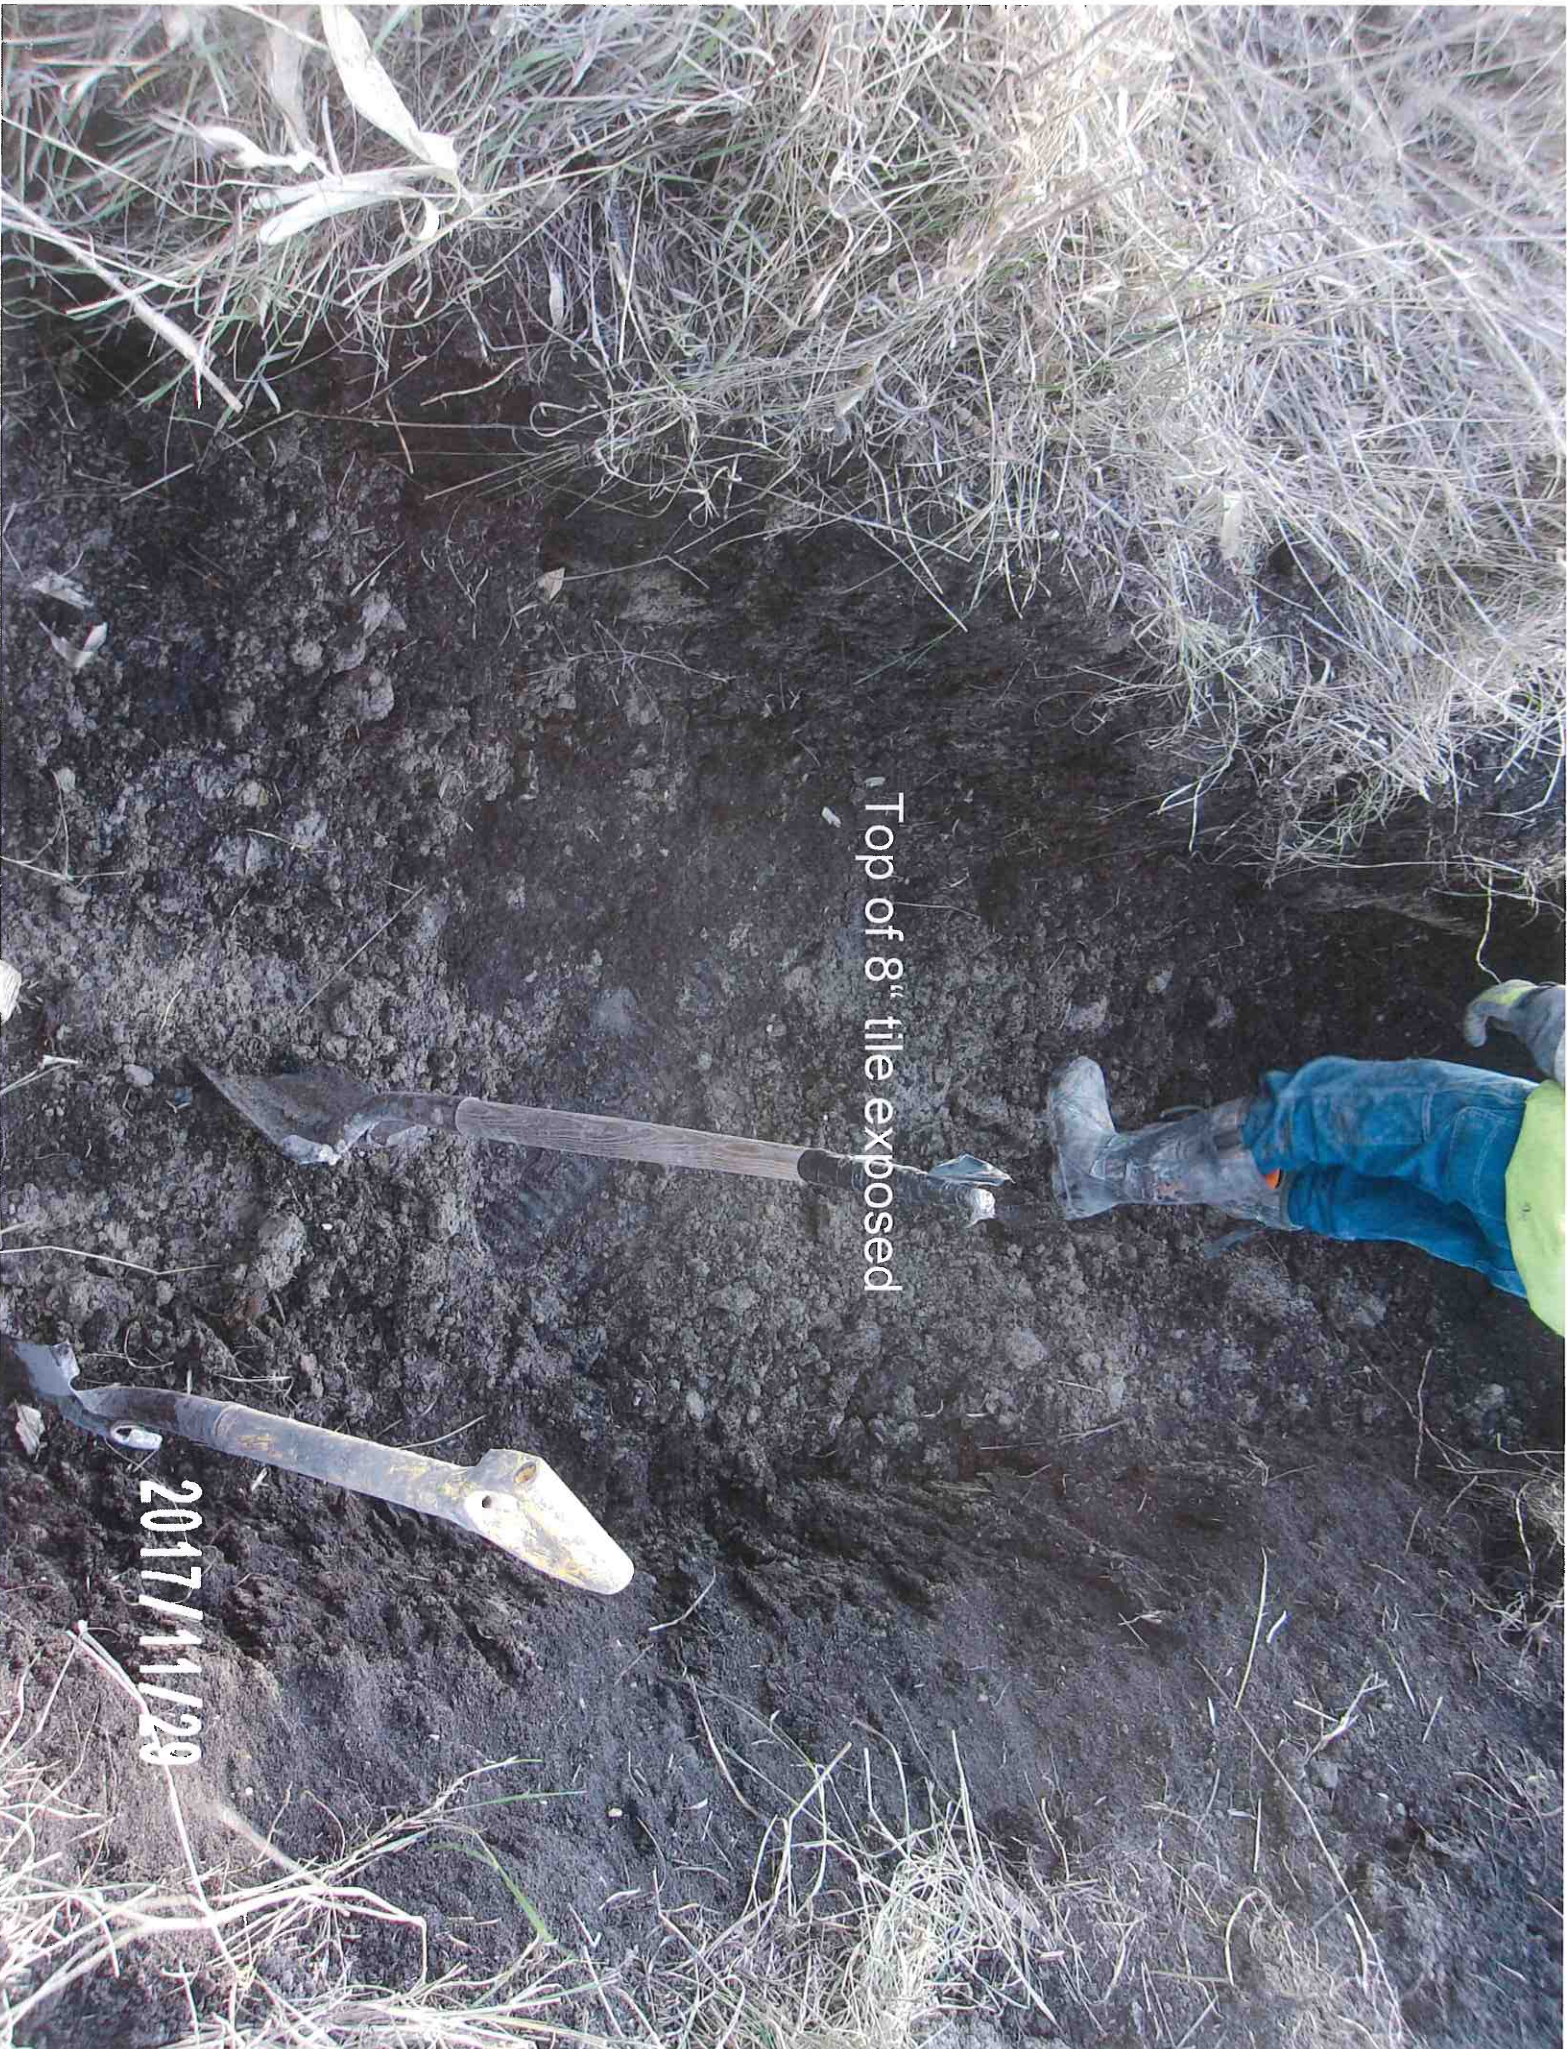
Top of 8" tile exposed

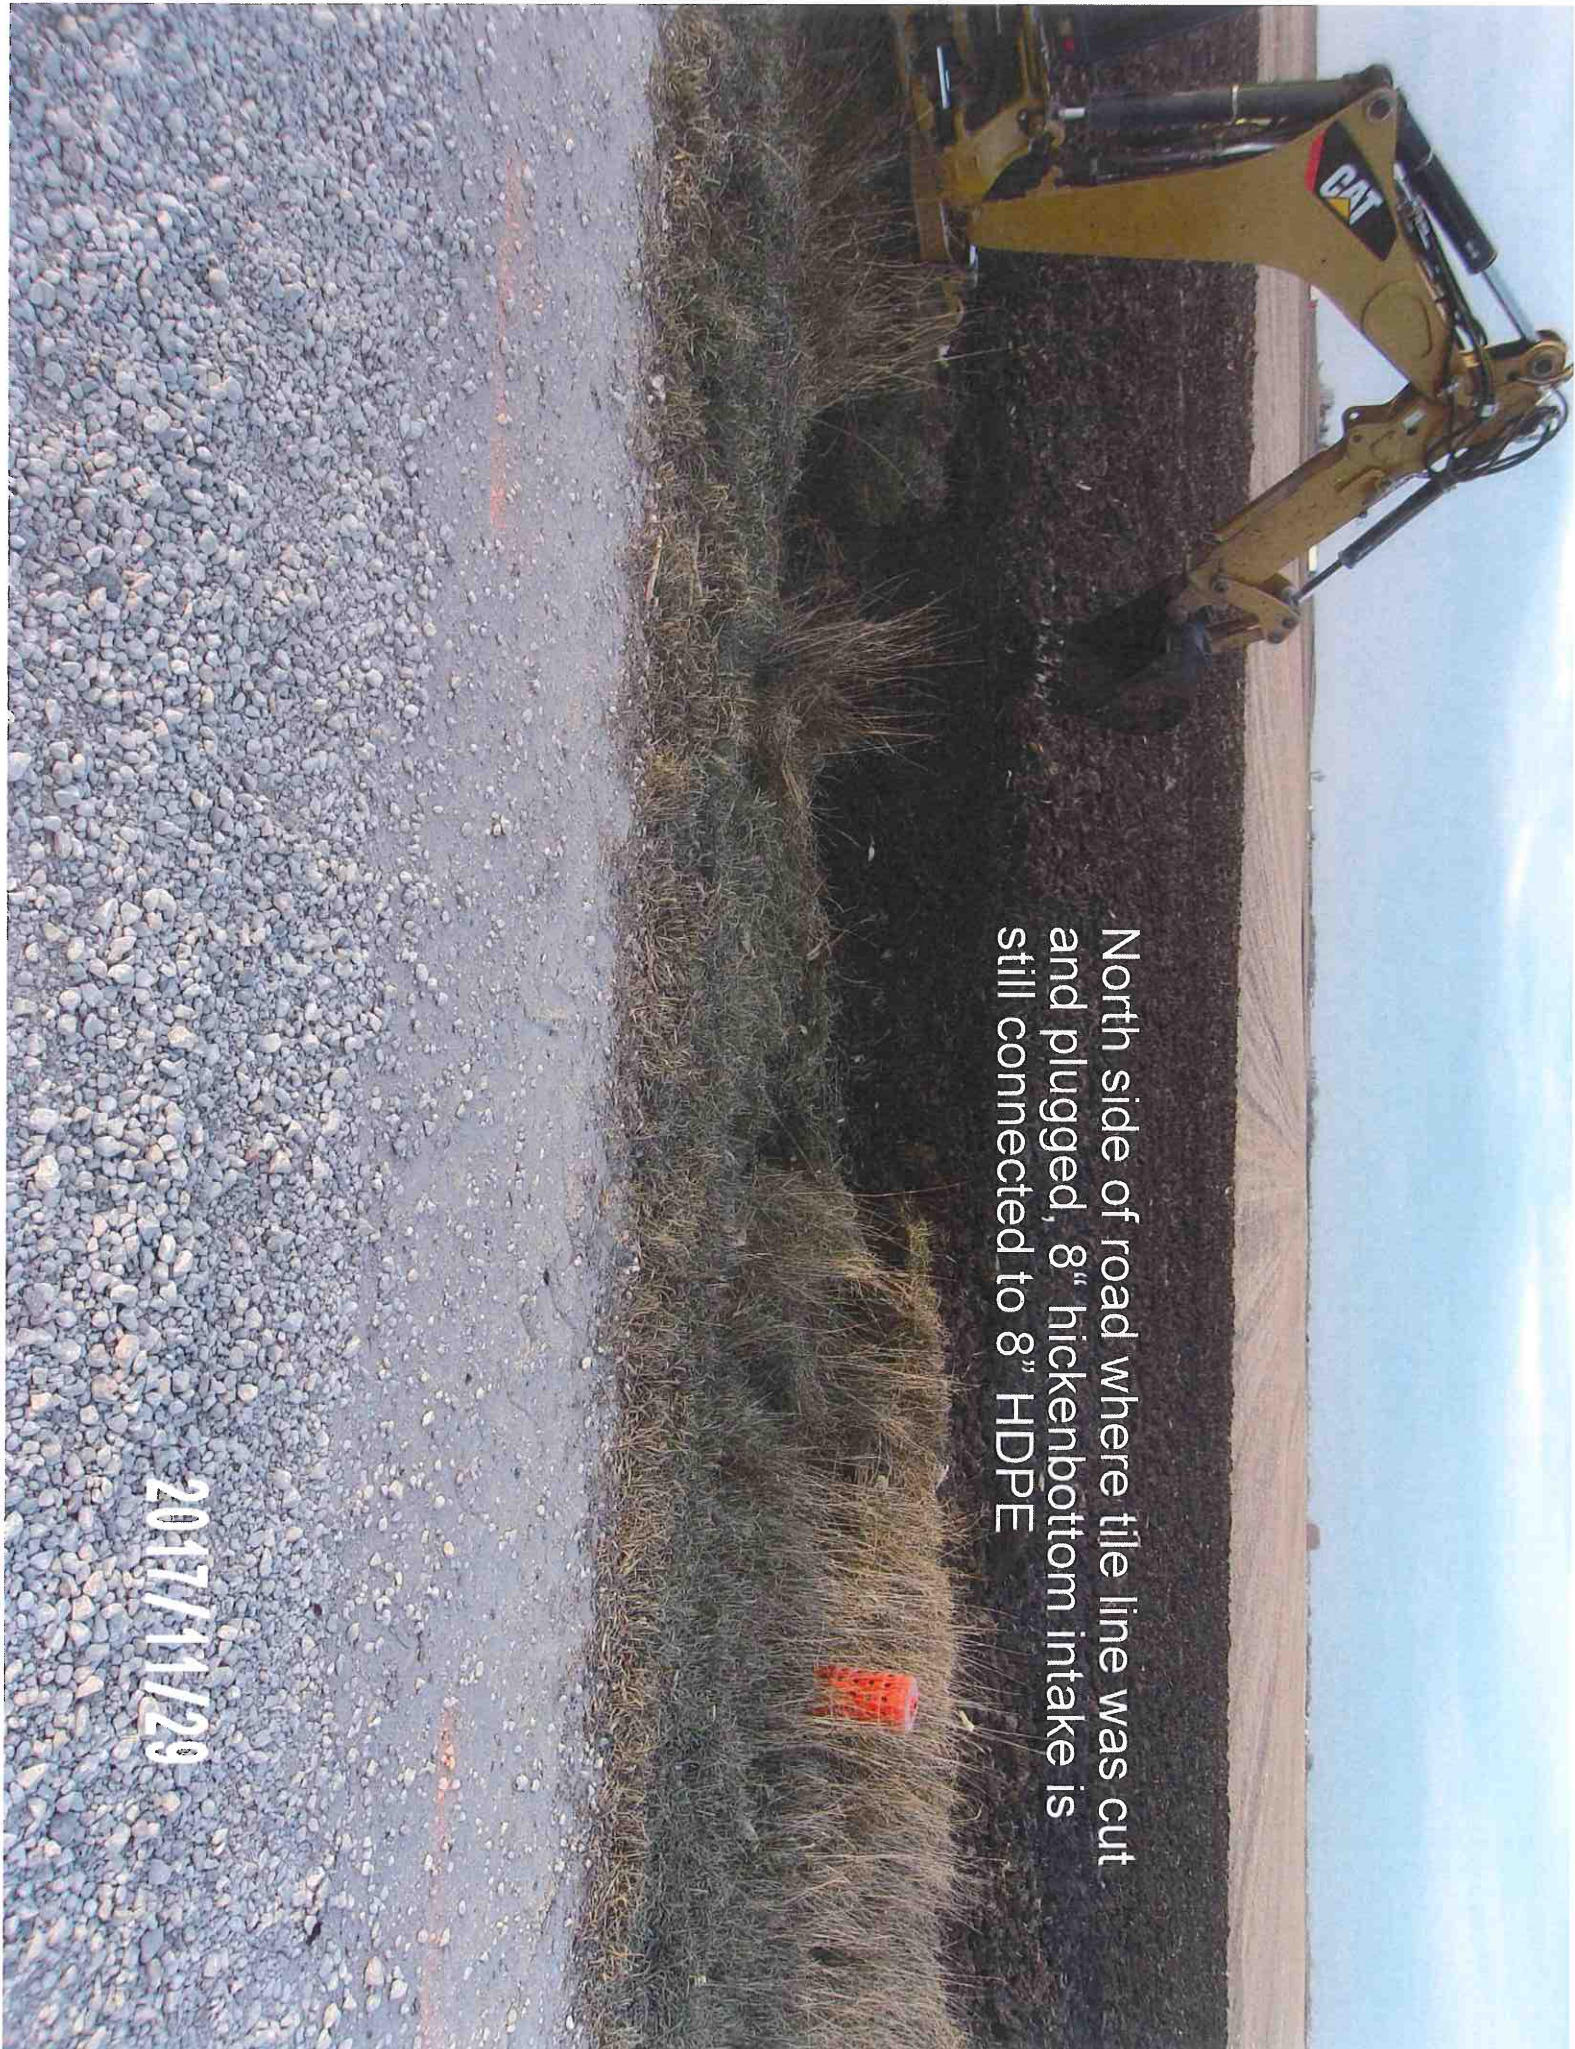
North side of road where tile line was cut
and plugged, 8" hickenbottom intake is
still connected to 8" HDPE
