**AGENDA**  
**REGULAR DRAINAGE MEETING**

# REGULAR DRAINAGE MEETING

## Drainage District:

## Repair Summary:

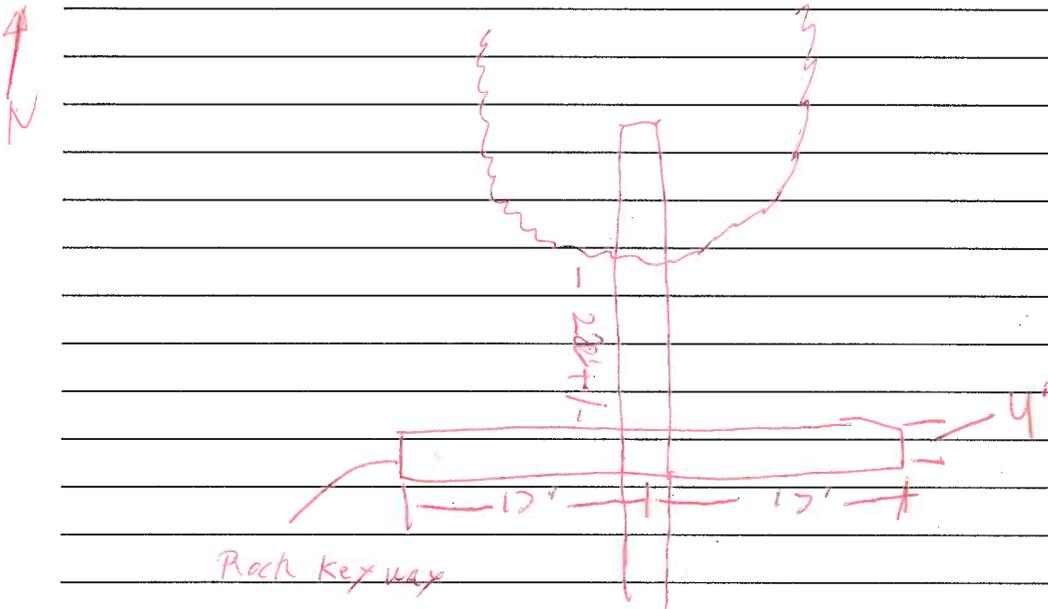
Rock Keyway

10:30 - get to site, 1 man working with excavator  
11:00 - 2nd man showed up, also 2nd load of Rip-Rap showed up

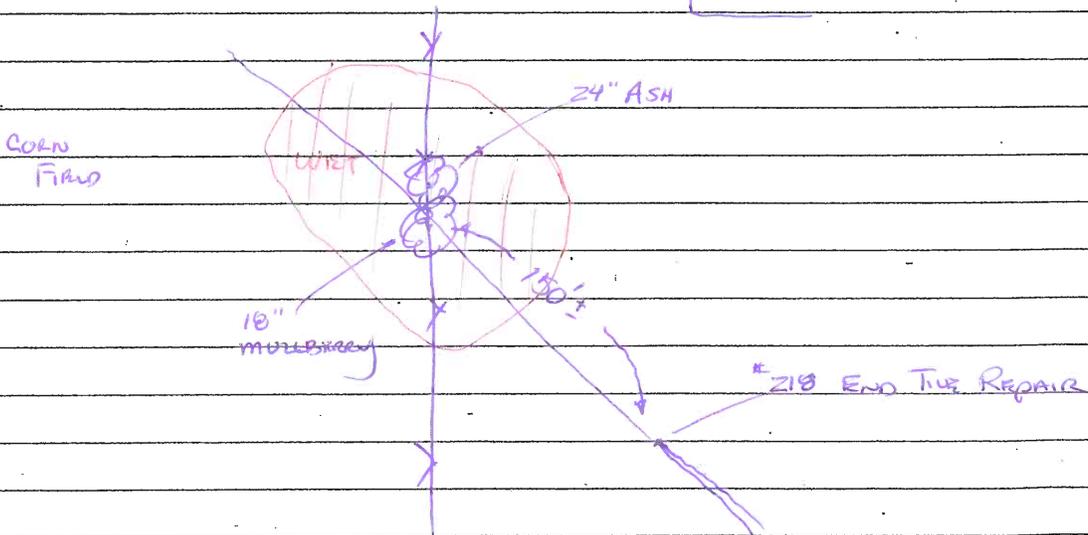
- Landowner in NW¼ SW¼ Section 22, Township 86 North, Range 22 West reported water boiling out of ground in area of fenceline beside field near previous repair.
- Visual observation found soil to be totally saturated in area where Lateral 3 tile intersects said fenceline. Adjacent to said intersection, two trees were found to be growing within the fenceline.
- This area is approximately 150 feet upstream of upstream end of previous tile repair.

TALKED TO LAVERN SIEVERS LIKE ABOUT WET SPOT @ TREE IN FENCE LINE. HE NEEDS TO HAVE IT FIXED ASAP TO GET CROPS OUT, OR HE WOULD TRY TO FIX IT.

WALKED OUT TO PLACE WHERE TILE REPLACEMENT ENDED, WALKED UPSTREAM @ WHITE FLAG AREA, TOTALLY SATURATED GROUND @ TREE LOCATION. IM SURE TILE GOES UNDER A 24" ASH, AND 18" MULBERRY. TREES NEED TO BE REMOVED AND TILE REPLACE FROM #218 @ TILE REPLACEMENT TILL ROOT BOX LOCATION 150'±

Based on the above, it appears that tree roots have plugged the Lateral 3 tile. Therefore, CGA recommends the following:

- Remove trees from area affecting Lateral 3 tile and either remove or treat stumps to prevent regrowth.
- Excavate and replace affected Lateral 3 tile with dual wall HDPE and concrete collars. This could be either just at the tree location or from the previous repair upstream to the tree location.
- It is the opinion of CGA that the total construction cost of these repairs would be approximately \$5,000 to \$12,000 (depending on which option is selected). This cost is low enough that neither a hearing nor an engineer's report would be required.

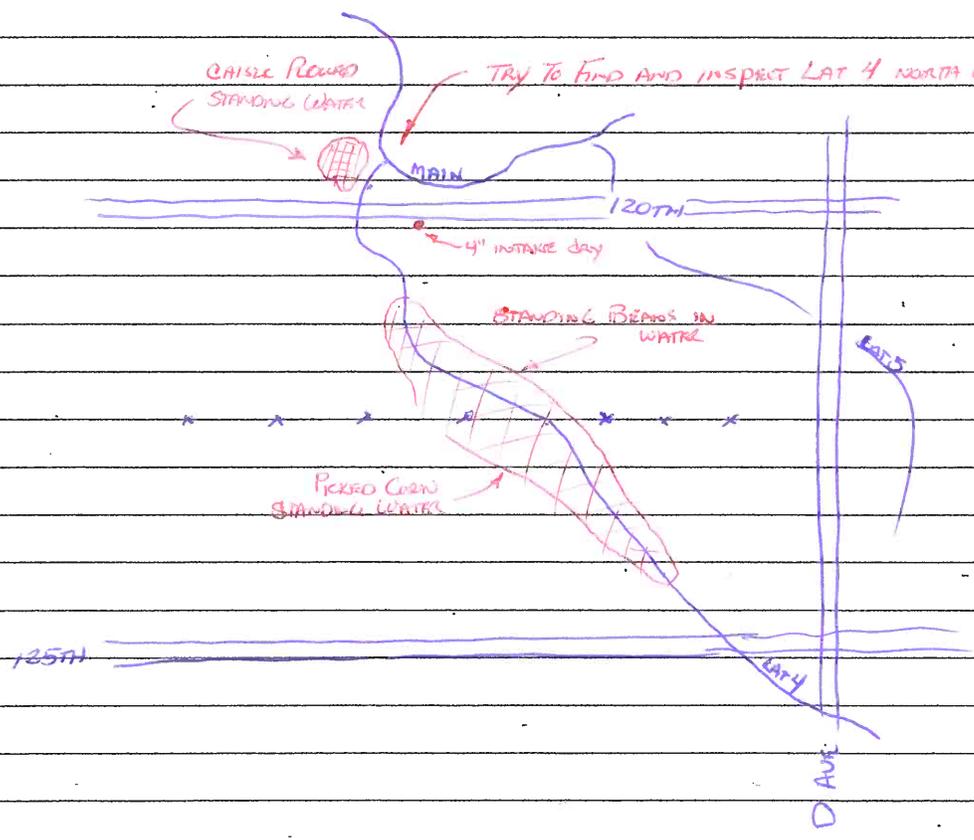
- Called landowner on November 1, 2018 and left message with no response to date.
- Visual observation found standing water along the presumed route of the Lateral 4 tile on both sides of the fenceline between landowner and neighbor to the north. Landowner has harvest corn at location of standing water, but neighbor to the north has unharvested beans in the standing water.

- Visual observation also found standing water just north of 120<sup>th</sup> Street at the presumed connection of the Lateral 4 tile and the Main tile in the SW¼ SE¼ of Section 10.

- Drainage intake in the south ditch of 120<sup>th</sup> Street (offset from Lateral 4) was observed to be dry.
- Aerial photography indicates the area north of 120<sup>th</sup> Street to have been wet within the last 5 years as well.

RAIN, MUD, STANDING WATER

LOOKED @ SITE WITH STANDING WATER SW OF HOG HOUSE. CORN HAS BEEN PICKED. GOING DOWN STREAM ON LAT 4, THERE IS STANDING BEANS IN WATER JUST S. OF 120TH ST., ALSO THERE IS STANDING WATER JUST N. OF 120TH @ MAIN (20") AND LAT 4 (14"). THIS IS PROBABLY THE FIRST PLACE TO INVESTIGATE. THEN WORK UPSTREAM. THERE IS A 4" PE INTAKE RISER IN S. DITCH OF 120TH ST., NOT ON LAT 4 AND IS DRY. COULD NOT SEE ANY OTHER WET AREAS ON MAIN TO LAT 1 (BIG 4)

- If landowner does not have a contractor on call, assign project to the lottery system.
- Starting on north side of 120<sup>th</sup> Street and working upstream, excavate Lateral 4 tile at regular intervals to determine cause of standing water.

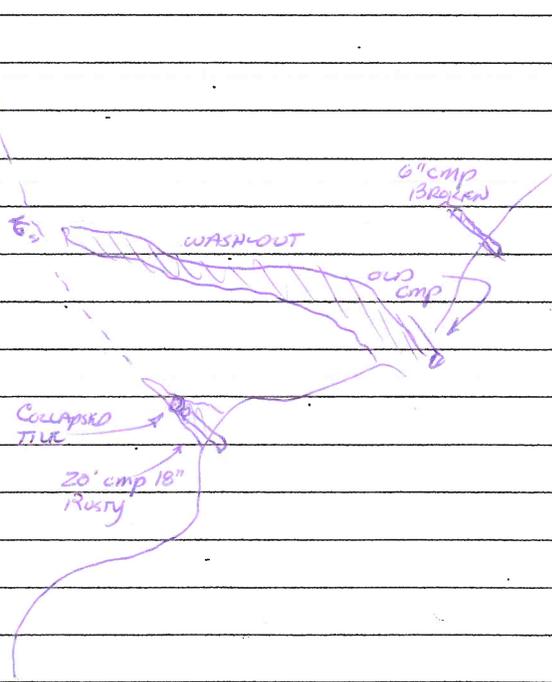
- Landowner in NE¼ Section 15 Township 86 North, Range 20 West reported an eroded outlet possibly due to beaver activity from previous year.
- Visual observation found 20 feet of 18-inch rusty CMP (presumed Main tile outlet) washed out and exposed due to erosion. Just upstream, found a collapsed section of presumed Main tile.
- Visual observation also found large area eroded to east due to overland flow of water with possible eroded surface drain. Erosion area begins near presumed Main tile path upstream of existing outlet.
- Finally, visual observation tree in vicinity of Main tile outlet.

Found 20' sec of 18" rusty comp, disconnected from tile, maybe a collapsed tile @ comp connection, all dirt is washed away from comp. Would like to see a 40' section of 24" alum. comp with riprap protection @ outlet bank. Old tile route to east has long wash-out with old comp remnants to east of working outlet.

A Box Elder Tree should also be taken care of and removed.

- Remove tree and either treat stump or remove stump to prevent regrowth.
- Remove existing rusty CMP Main tile outlet and excavate Main tile upstream far enough to install new 40-foot long CMP Main tile outlet with rodent guard.
- Install said new outlet and armor bank around the same with revetment stone.
- Total estimated construction cost will be between \$10,000-\$15,000 depending on amount of Main tile that needs to be replaced at collapsed section of Main tile.
- If desired the eroded area to the east could be repaired, but it is unclear at this point if this is the responsibility of the Drainage District or not and what regulatory permitting there would be.

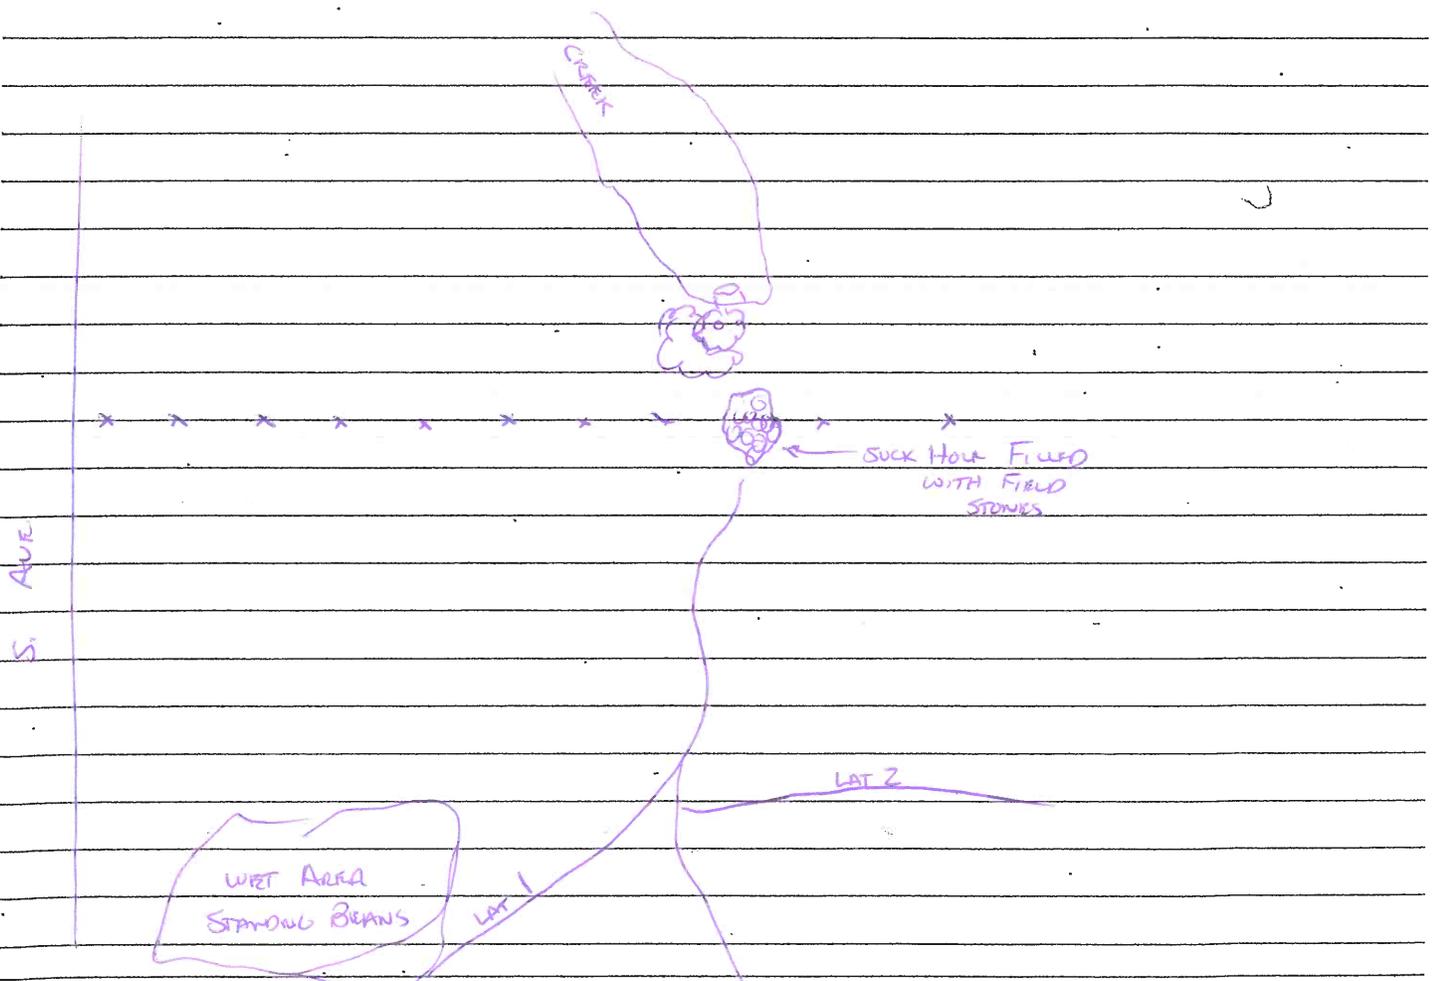
- Landowner reported a 3 feet deep depression between the fence and creek east of S Avenue in the SW¼ of Section 5 Township 89 North, Range 19 West.
- Visual observation found rusty 15-inch CMP (presumed Main tile) outlet with tree and brush in the immediate vicinity of said outlet.
- Visual observation also found blowout/sinkhole upstream (on presumed Main tile route) in fenceline. Tile is not visible since blowout/sinkhole is filled with approximately 15 tons of field stone.
- Finally, visual observation found that there are unharvested beans upstream in standing water on presumed route of Lateral 1 tile.

RAIN, mud, 42°, windy from SE.

drove to E-W Fence Ln, E. of S. Ave @ 00165 outlet, found 15" cmp  
rusty with Hackberry 6" tree on top. Plum brush also in area  
40' S. (upstream) from outlet, tire must be collapsed and farmers have  
put 15 tons of field stone in hole. farther upline to SW, I think lat 1,  
beans are standing in water. many have collapsed tire on lat 1,
