**PUBLIC HEARING AGENDA
ENGINEER'S REPORT ON REPAIRS OR IMPROVEMENTS TO MAIN TILES
DRAINAGE DISTRICT 167, HARDIN COUNTY, IOWA
MARCH 6, 2019 AT 1:00 P.M.**

**ENGINEER'S REPORT
ON REPAIRS OR
IMPROVEMENTS TO
MAIN TILES
DRAINAGE DISTRICT
NO. 167
HARDIN COUNTY,
IOWA**

Engineer's Report on Repairs or Improvements to Main Tiles, Drainage District No. 167 Hardin County, Iowa

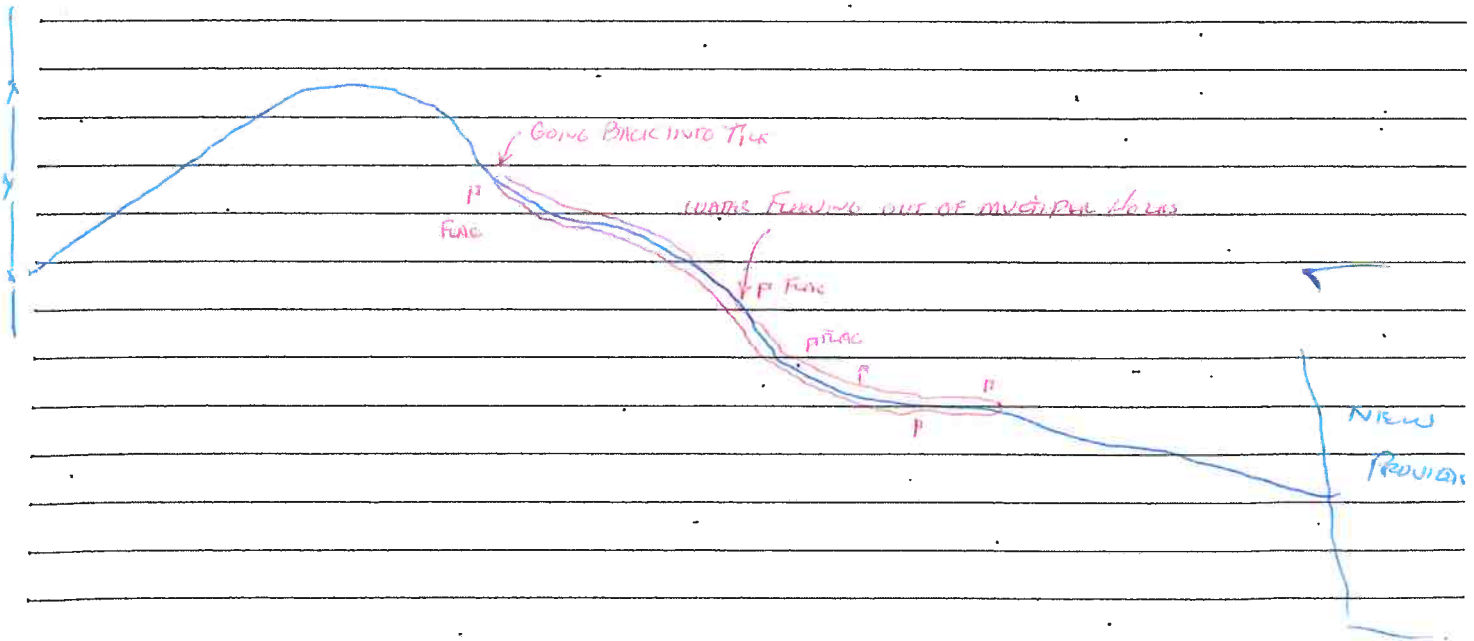
Partly Sunny, 65°, Windy From East, Rain Earlier
Arrived @ Job Site 9:00 AM, Called and Talked to Robert Jensen,
He met me and drove his pickup out to Blow-outs Found 6" clay tile
1 1/2 - 2' deep, Blowing out water in multiple places (6 or more) All look to
be joints, must have a collapse down stream causing water to surge up thru
butt joints and then go back into tile past the collapse or blockage.
This looks to be the S. main
Find and fix blockage ASAP, the rest of tile should be OK.
Talked to Robert about shifting swale or tile route to get more cover.
This will be a on going problem with the minimum cover this butt joint tile
has.
