### DD 121 Landowners Meeting

# Drainage Work Order Request For Repair

## Investigation/Repair Summary:

CONSTRUCTION ENGINEERING  
OBSERVATION REPORT

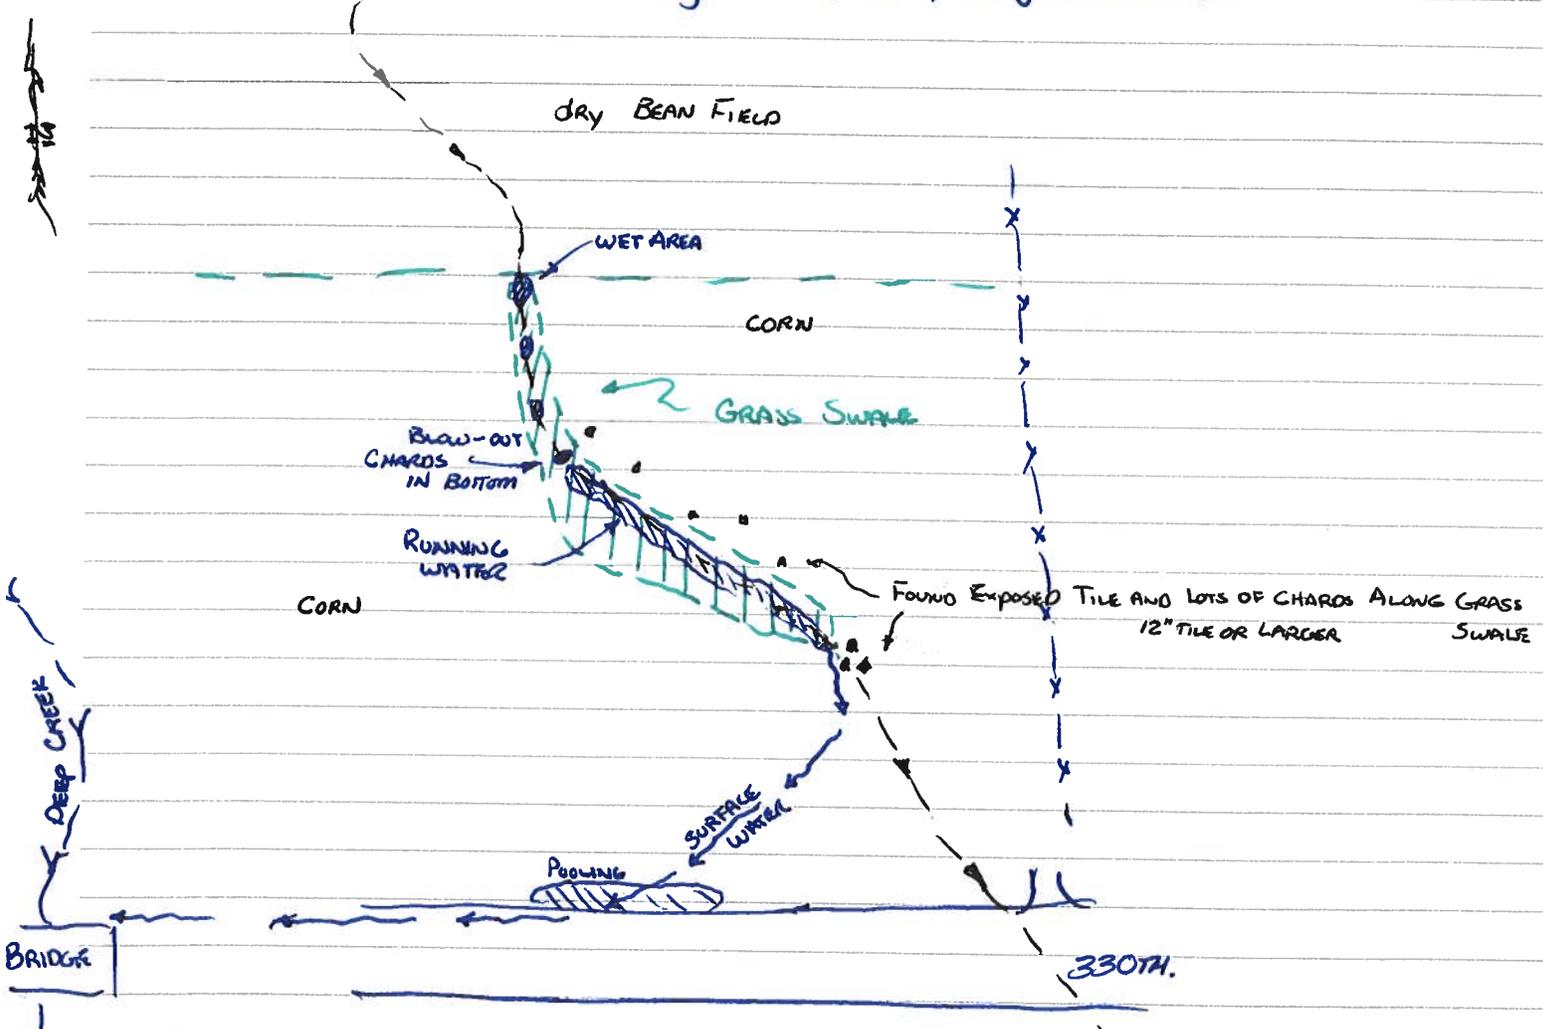
Parked @ 1/4 1/4 cor, WALKED TILE ROUTE FOLLOWING CHARDS IN FIELD 12" + CLAY. FOUND NOISY WATER RUNNING OUT OF GRASS SWALE TO N. SIDE OF 40 ACRES. IT LOOKS LIKE TILE IS VERY SHALLOW OR REMOVED IN SWALE AREA. SOME WATER IN SWALE IS 2' DEEP. I HAVE NO IDEA WHY TILE DOESN'T RUN TO CREEK

Due to the lack of soil cover over the tile, broken pieces of tile found in the field, and recently cut trees, CGA recommends locating and CCTV inspecting the tile in both directions from the blowout/sinkhole as the observed issue may be due to a larger-scale deterioration of the Main tile's physical condition.
