**AGENDA  
DRAINAGE DISTRICT 34  
LANDOWNER MEETING  
February 12, 2020 10:00 AM**

# Drainage Work Order Request For Repair

## Drainage District:

**D.D. 34 REPAIR MAP**  
HARDIN COUNTY, IOWA

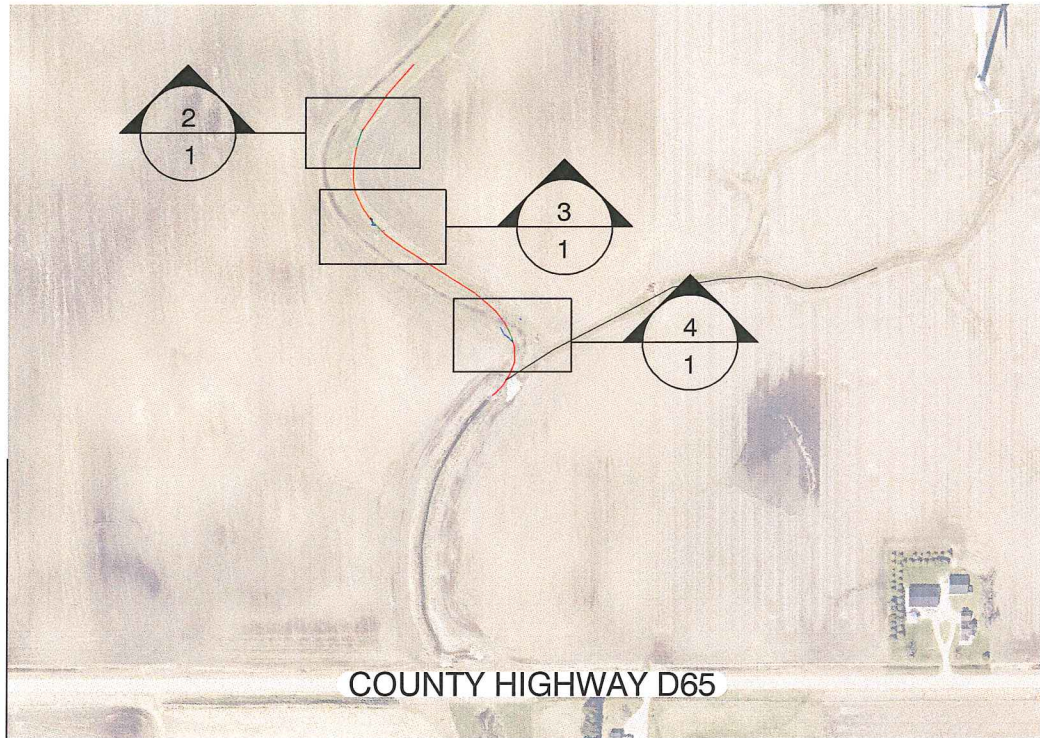
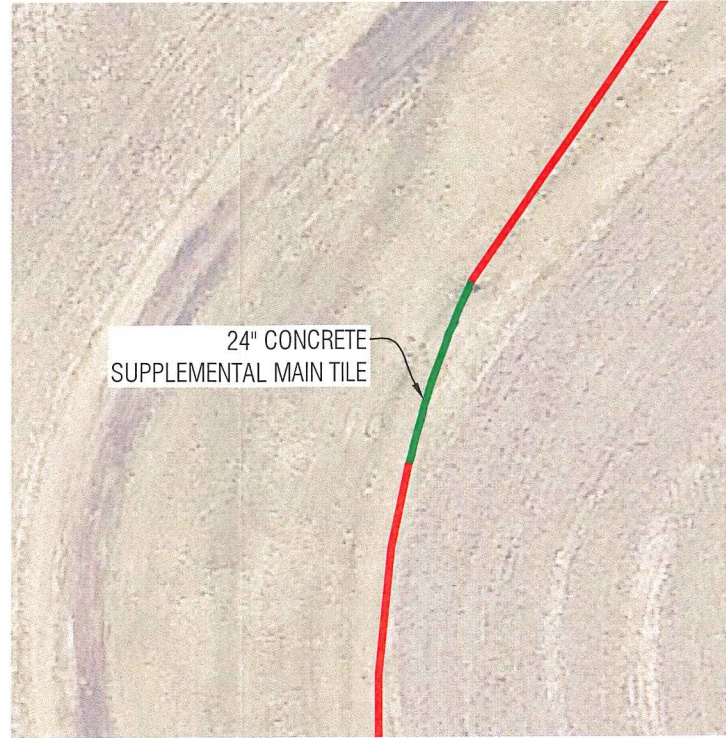
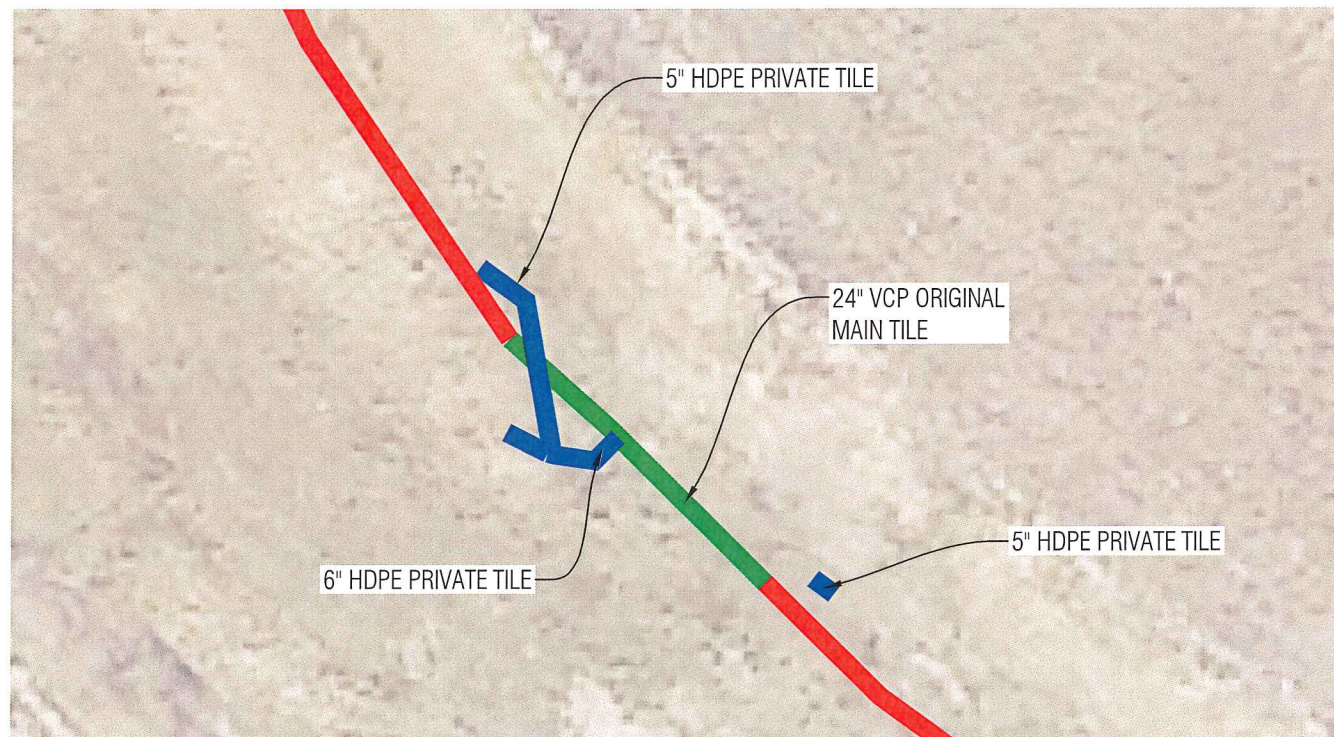
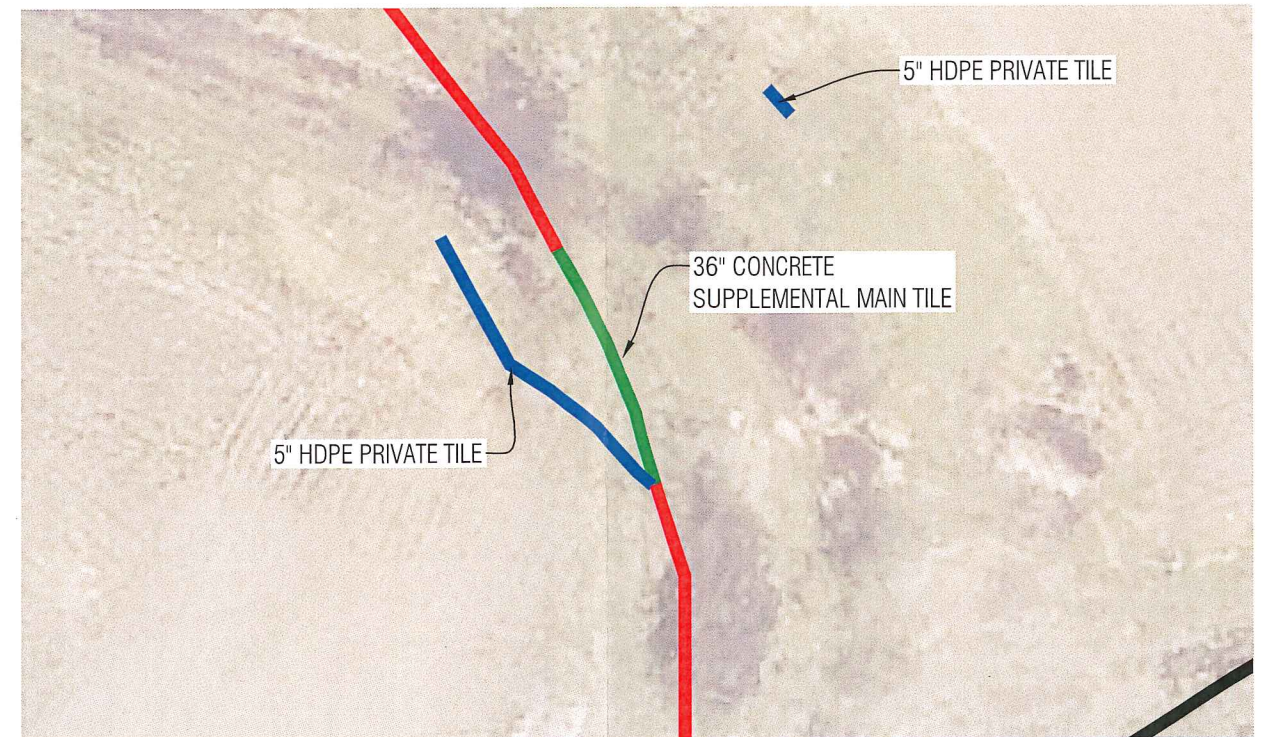
- Visual observation found multiple sinkholes/blowouts along the original and supplemental Main tiles. Some are due to wide joints and another due to a collapsed private lateral.

- Excavation of the two northernmost sinkholes/blowouts found the supplemental 24-inch concrete Main tile collapsed and two wide joints nearby. Excavations of the other two sinkholes (to the south) revealed multiple wide joints between sections of the supplemental 36-inch concrete main tile and original 24-inch VCP Main tile, as well as broken private tile near its juncture with the Main tiles.

- The stretch of collapsed 24-inch supplemental Main tile was repaired with rock bedding and backfill, dual wall HDPE tile, and concrete collars. Wide joints were repaired with engineering fabric and partial concrete collars.

- Private laterals were repaired due to damage/removal while completing other repairs to the Main tile. Private laterals that were 6-inches were repaired with dual wall HDPE tile and 5-inch laterals were repaired with single wall HDPE tile. HDPE was attached to existing private tiles and the Main tile with factory couplers.

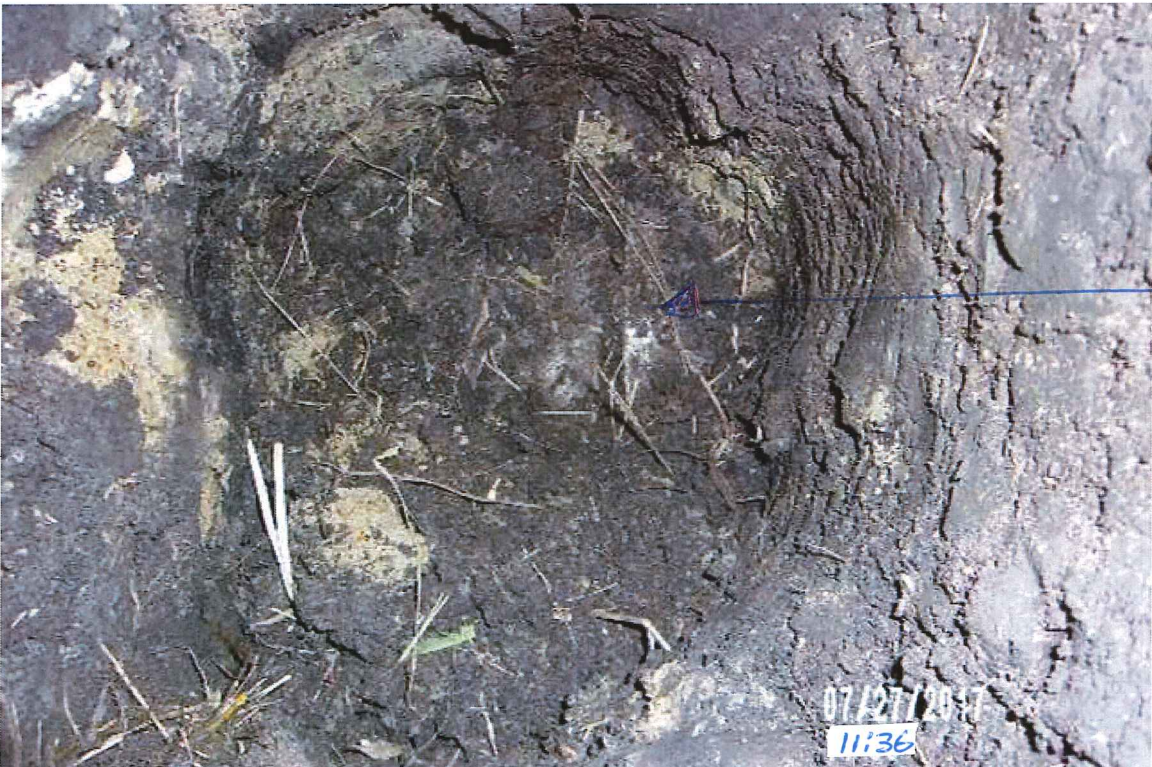
1ST BLOWOUT HOLE SOUTH

2ND BLOWOUT HOLE SOUTH

TOP CONCRETE PIPE @ JOINT

PICT # 6067 IS LOOKING WEST AT EXPOSED CONCRETE PIPE  
IS 1ST TILE BLOWOUT HOLE SOUTH. UNSURE OF CAUSE FOR BLOWOUT,  
POSSIBLE PIPE JOINT SUCKING SOIL ON SIDES

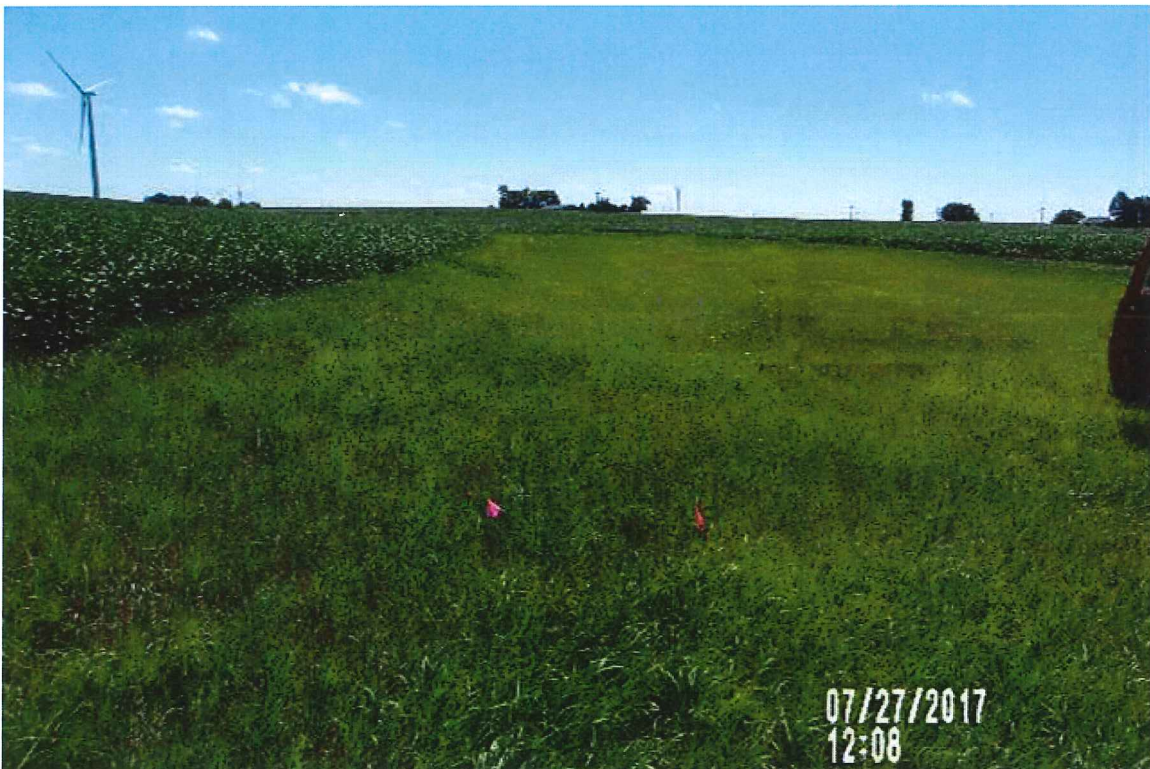
GPS# 5105  
TOP CONCRETE  
PIPE

PICT 6068 IS LOOKING SE AT 3RD TILE BLOWOUT HOLE  
SOUTH.

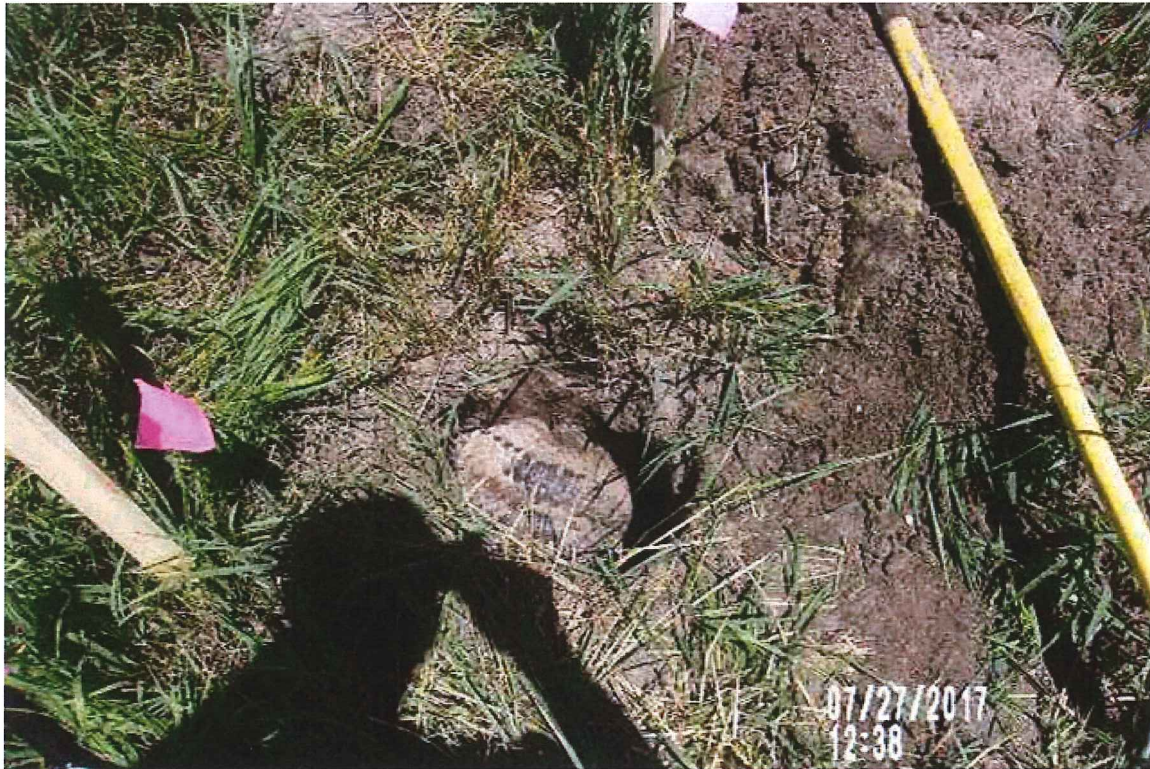
3RD TILE BLOWOUT HOLE SOUTH HAD A 1.5' Ø X 1.0' DEEP HOLE.  
EXCAVATING HOLE WAS A LOT OF LOOSE SAND. FOUND  
4" SINGLE WALL CPP PERFORATED TILE COLLAPSED WITH  
A TEAR IS SOUTH SIDE OF TILE. ALL SOIL WAS FIRM  
UNDBR TILE AND ON EAST & WEST SIDES OF BLOWOUT  
TOP OF COLLAPSED TILE IS ONLY 1.5' DEEP.

PICT# 6069 IS LOOKING NE SHOWING COLLAPSED 4" SINGLE WALL PERFORATED TILE IN 3RD TILE BLOWOUT HOLE SOUTH WITH TOP OF TILE ONLY 1.5' DEEP

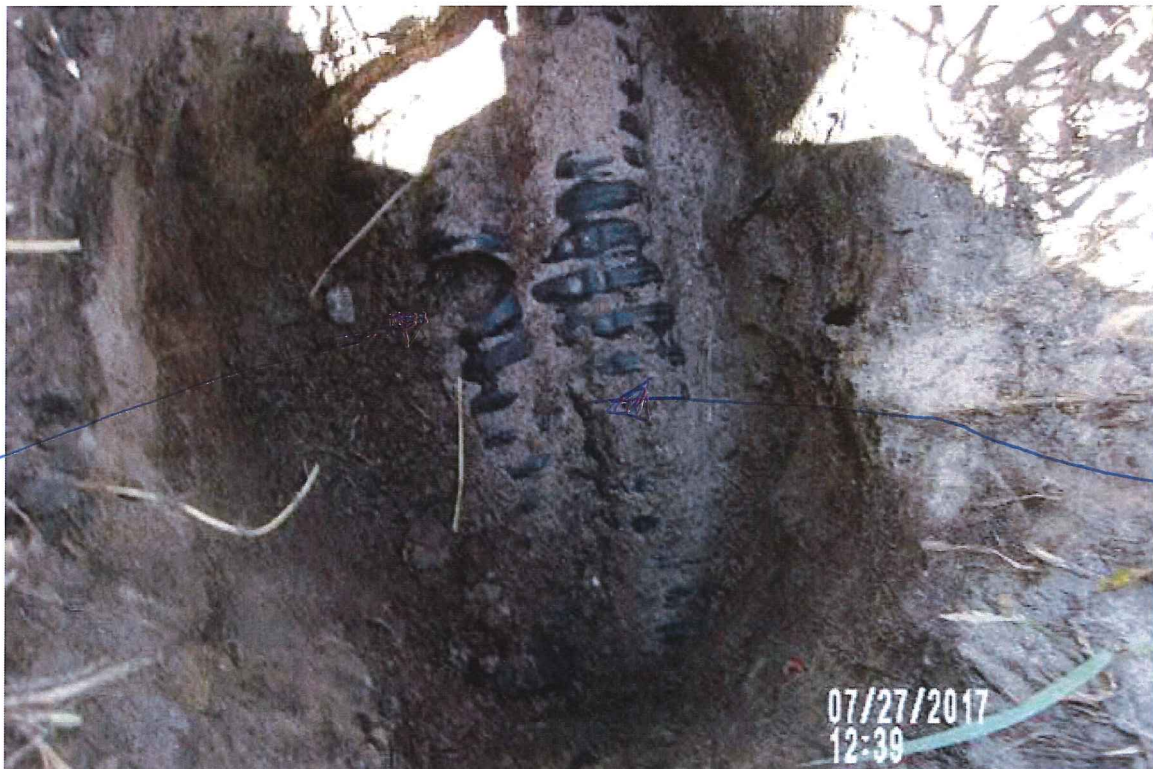
PICT# 6070 IS LOOKING NW SHOWING COLLAPSED 4" PERFORATED PLASTIC TILE WITH TEAR IN SOUTH SIDE OF TILE

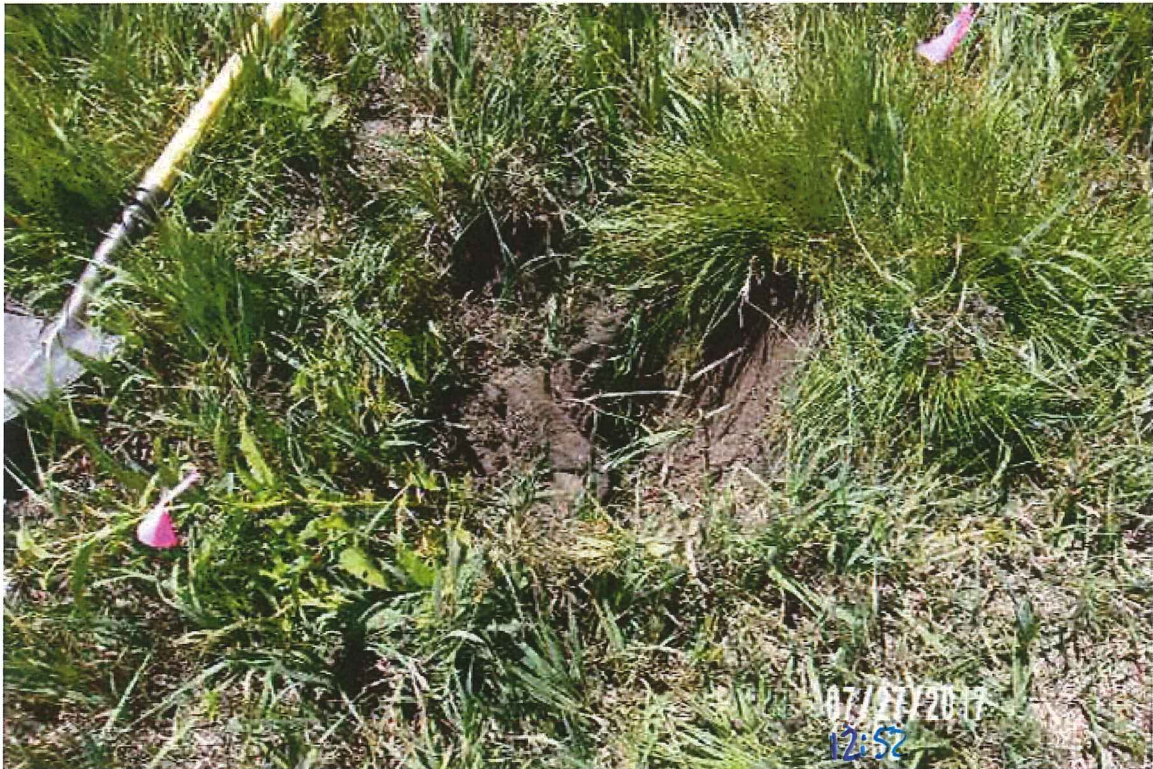
PICT# 6071 IS LOOKING SOUTH WEST AT 4th TILE BLOWOUT HOLE SOUTH. PICTURE SHOWS ENGINEERING FABRIC IN TILE BLOWOUT HOLE.

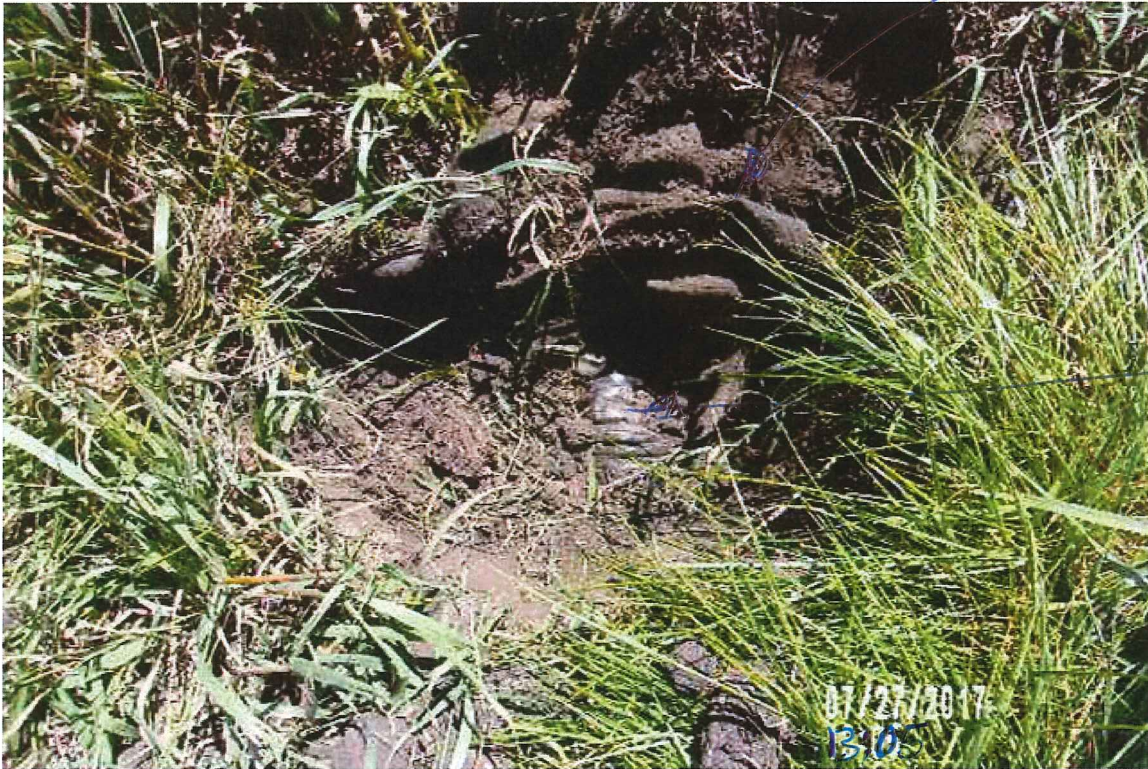
PICT# 6074 IS LOOKING AT CUT THROUGH 4" SW PERF CPP  
IN 4TH TILE BLOWOUT HOLE SOUTH

ENGINEERING  
FABRIC FOR SILT  
FENCE

CUT THROUGH  
4" SINGLE  
WALL CPP  
PERFORATED  
TILE  
WITH SILT  
FENCE

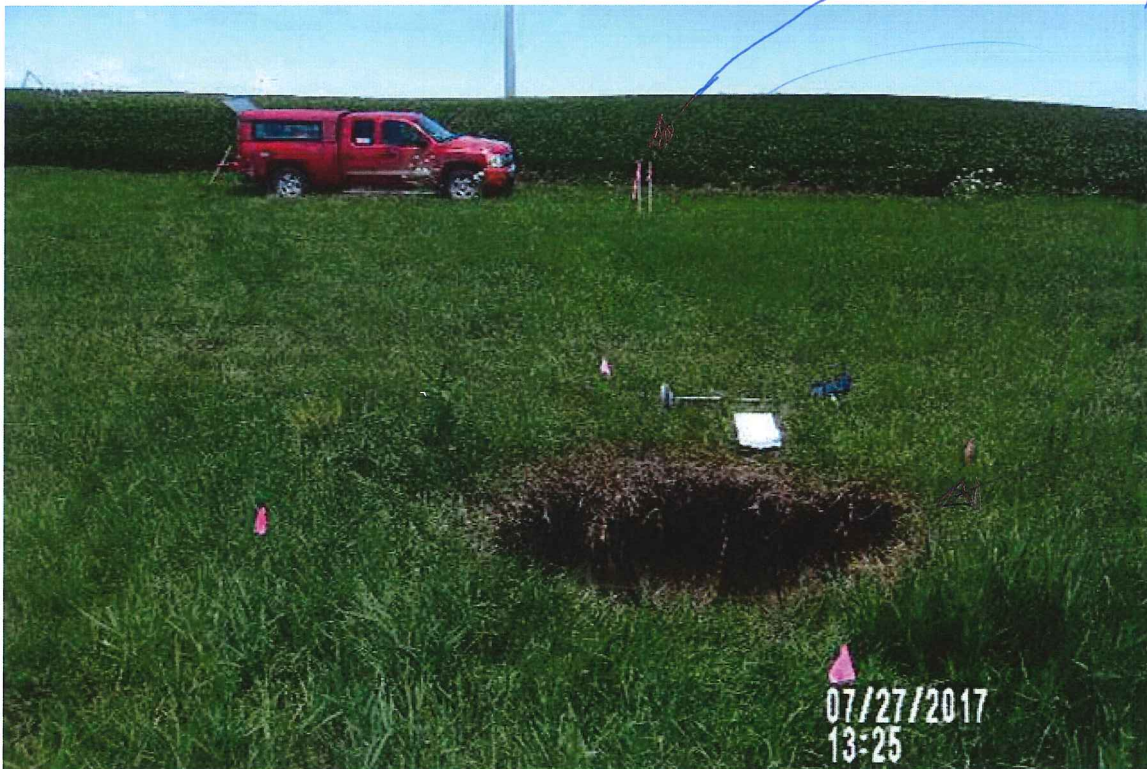
4TH TILE BLOWOUT  
HOLE  
SOUTH

5TH TILE  
BLOWOUT  
HOLE  
SOUTH

PICT# 6075 IS LOOKING NE SHOWING 4TH & 5TH TILE BLOWOUT  
HOLES SOUTH

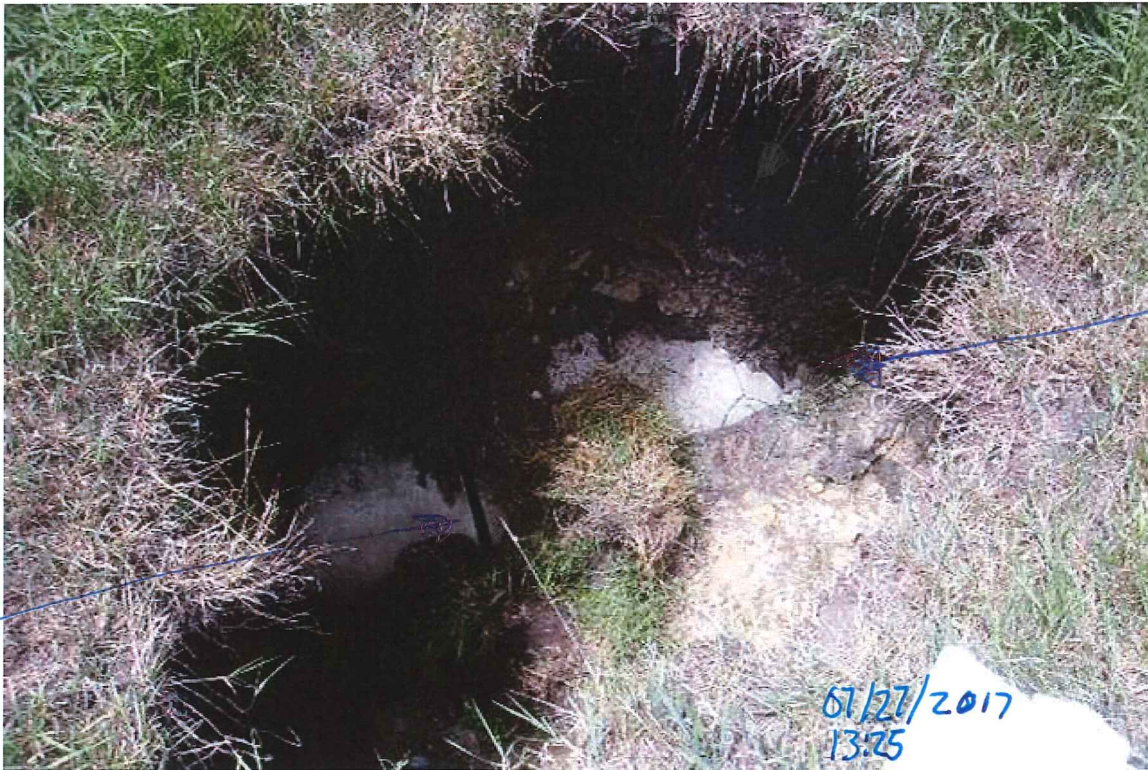
BLOWOUT <sup>WAS</sup> CAUSED BY WIDE JOINT THAT SUCKED ENGINEERING FABRIC INTO PIPE WITH NEXT JOINT ON NW ALSO. LOOKS LIKE IT WAS STARTING TO SUCK ENGINEERING FABRIC INTO PIPE AT JOINT TOO.

PICT# 6076 IS LOOKING NW AT 5th TILE BLOWOUT SOUTH

GPS# 5114  
CONCRETE PIPE  
WIDE JOINT  
SUCKED  
ENGINEERING  
FABRIC  
INTO PIPE  
ALONG WITH  
SOIL

THIS CONCRETE  
PIPE JOINT  
LOOKS LIKE  
ITSUCKED  
ENGINEERING  
FABRIC  
INTO PIPE  
TOO

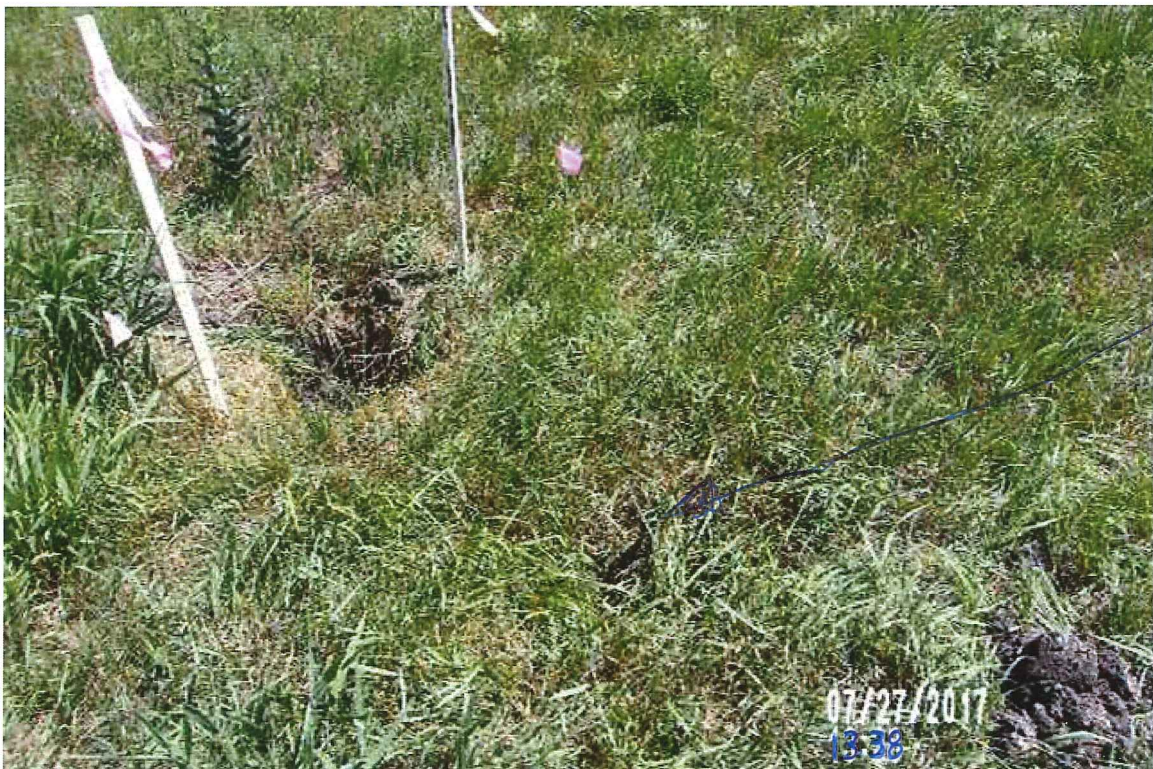
GPS#5105  
0.5' Ø  
X 0.5' DEEP  
TILE BLOWOUT

PICT# 6080 IS LOOKING NE SHOWING ADDITIONAL TILE BLOWOUT HOLE BETWEEN 1ST AND 2ND TILE BLOWOUT HOLE SOUTH

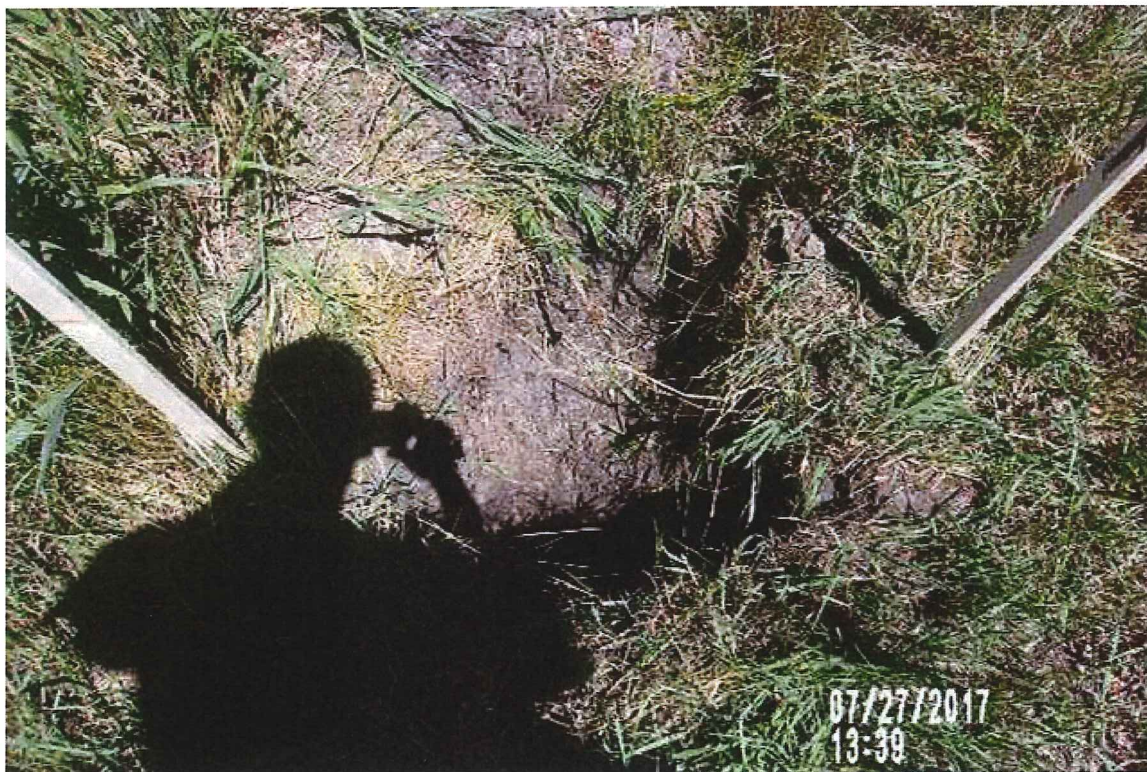
PICT#6081 IS LOOKING NE AT ZND TILE BLOWOUT HOLE  
SOUTH

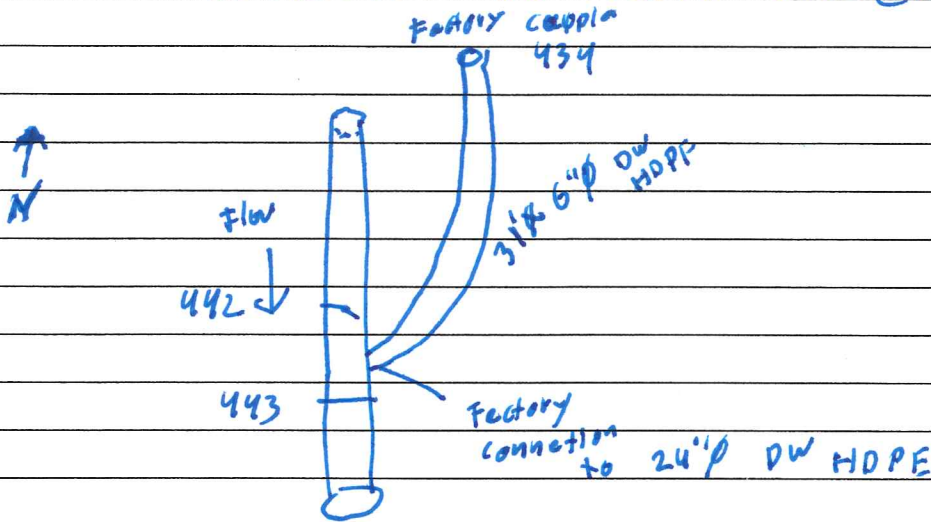
- installed 31' 6" DW HDPE tile with connection to main tile (conc.)

- crew was backfilling holes.  
- told crew they need to seed after backfilling
