AGENDA
REGULAR DRAINAGE MEETING
Wednesday, August 19, 2020 9:30 AM
Large Conference Room

[DD 48 WO 237 - 6486.4 - REPAIR SUMMARY - 08_03_20.PDF](#)

[DD BIG 4 LAT 4 - WO 195 - 5585.1 - REPAIR SUMMARY - 08_03_2020.PDF](#)

[DD BIG 4 MAIN - WO 247 - 5734.1 - REPAIR SUMMARY - 08_03_2020.PDF](#)

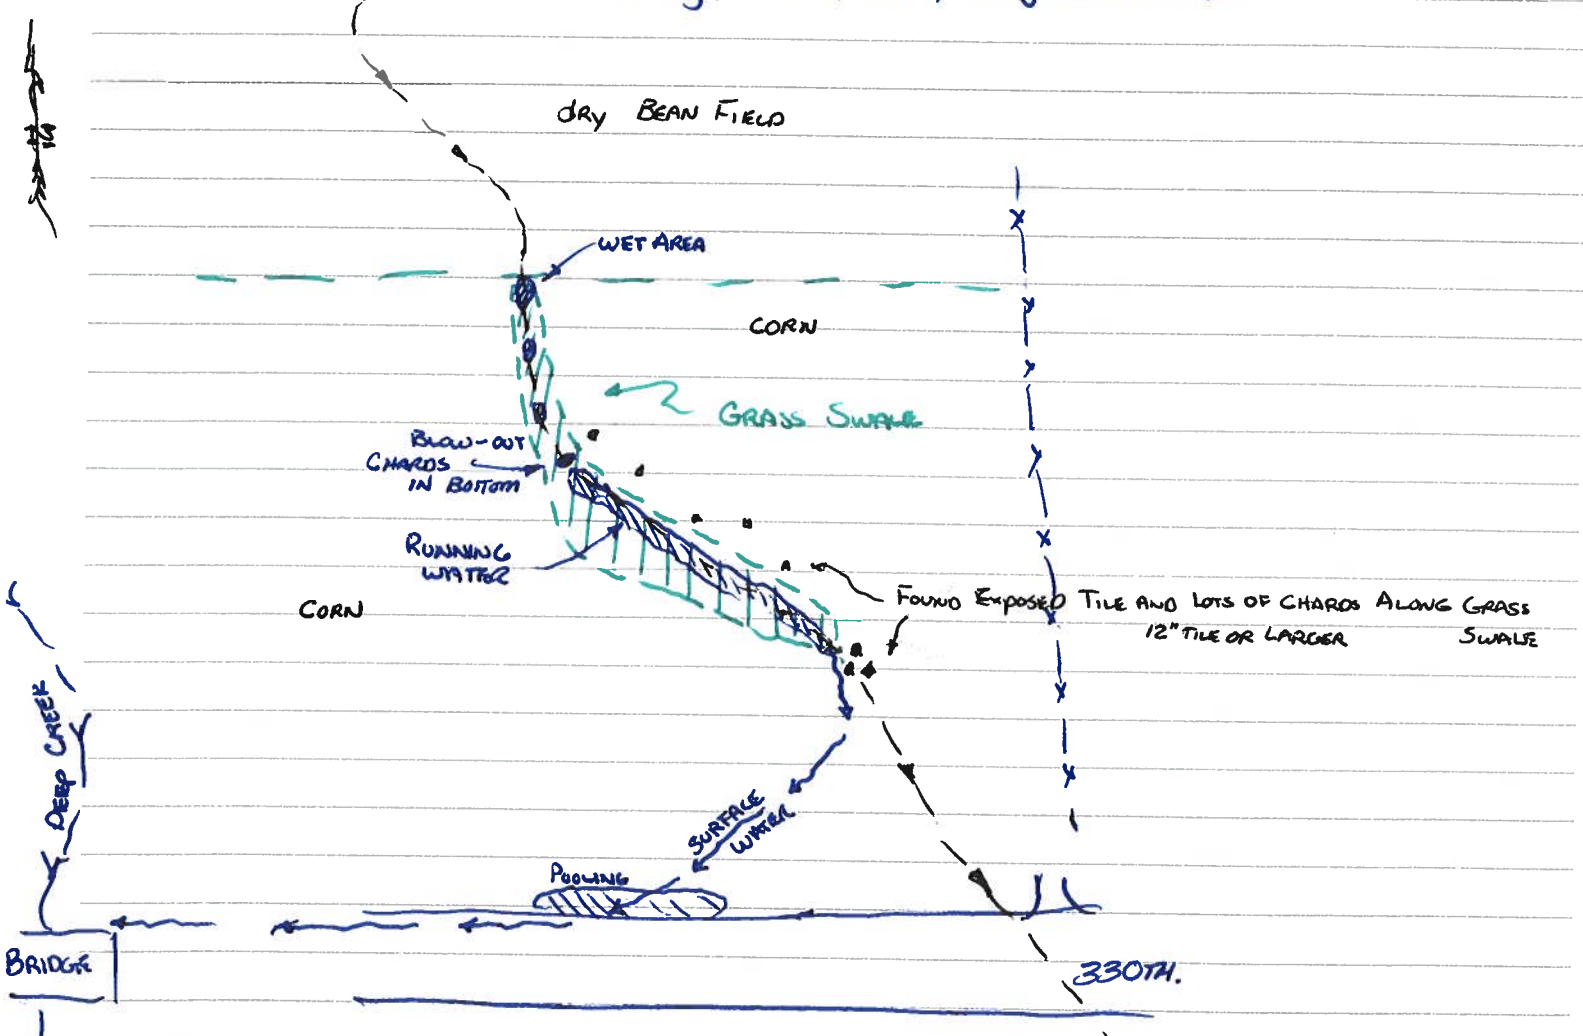
Parked @ 1/4 1/4 cor, WALKED TILE ROUTE FOLLOWING CHARDS IN FIELD 12" + CLAY. FOUND NOISY WATER RUNNING OUT OF GRASS SWALE TO N. SIDE OF 40 ACRES. IT LOOKS LIKE TILE IS VERY SHALLOW OR REMOVED IN SWALE AREA. SOME WATER IN SWALE IS 2' DEEP. I HAVE NO IDEA WHY TILE DOESN'T RUN TO CREEK

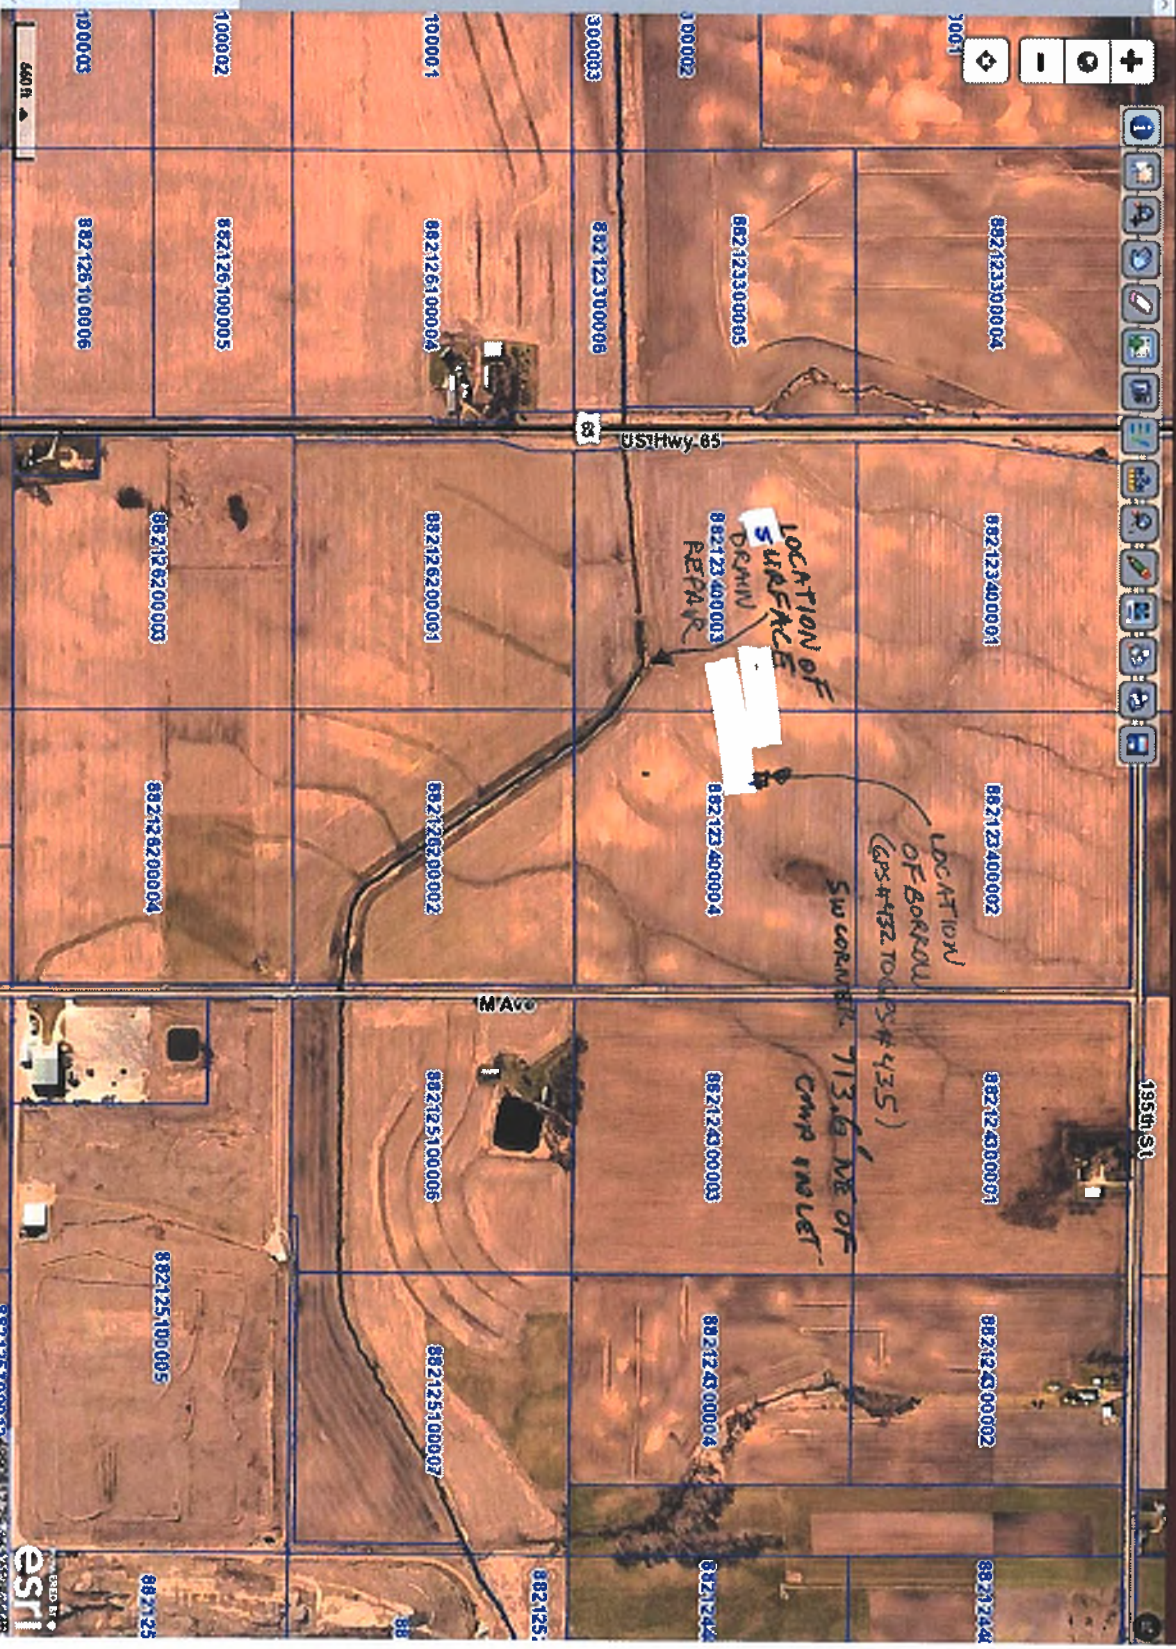
PICTURE# 3370 IS LOOKING SE AT 36" CMP INLET SHOWING DRAINAGE DITCH BANK ERODED AROUND SURFACE DRAIN INLET

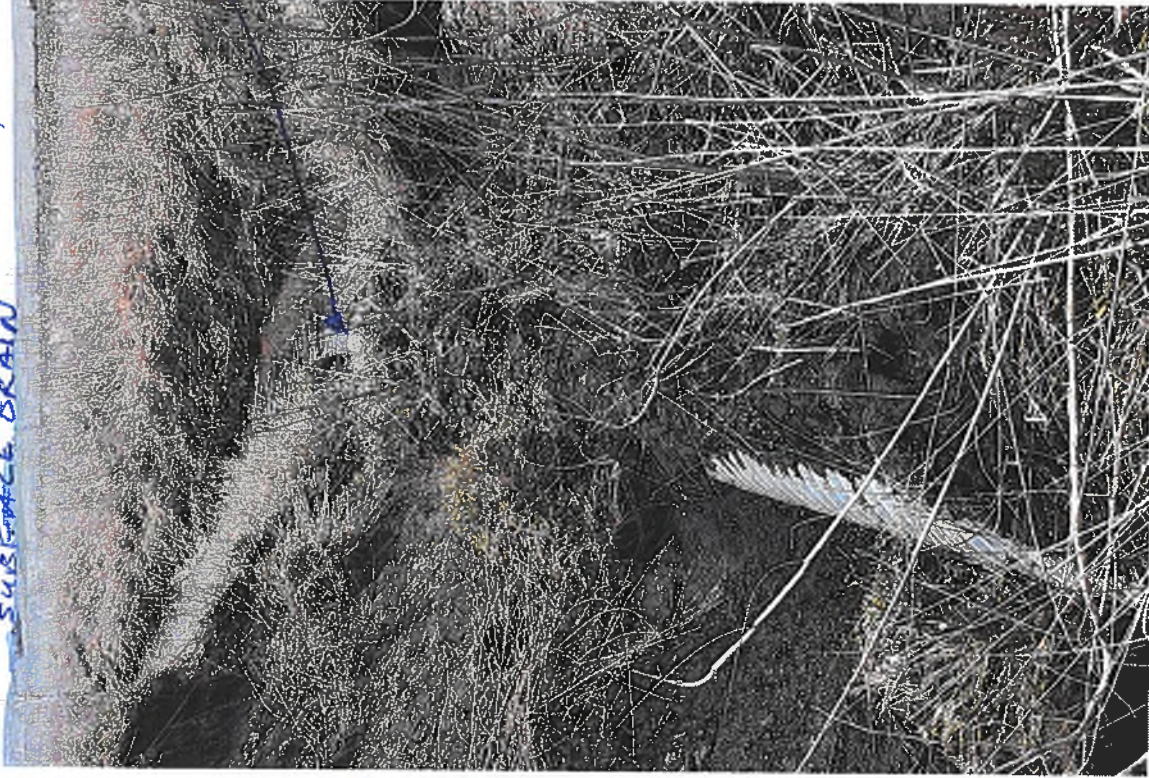
PICTURE #2 IS LOOKING SE FROM WEST SIDE OF SURFACE DRAIN ON TOP OF NORTH DRAINAGE DITCH BANK SHOWING GROUND ERODED AWAY AROUND SURFACE DRAIN

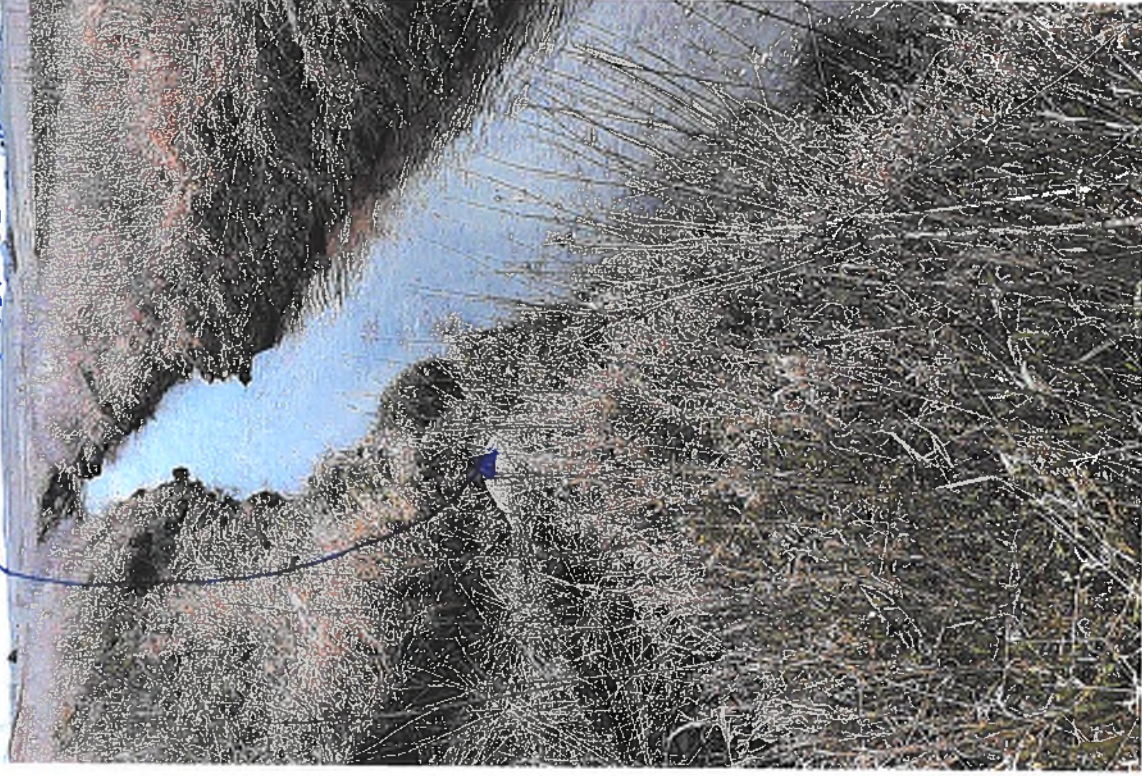
PICTURE #3 IS LOOKING SE SHOWING DRAINAGE DITCH & OUTLET OF 36" CMP WITH DRAINAGE BANK ERODED, GPS# 401 TOP 36" CMP 3.0' TOP TO FL

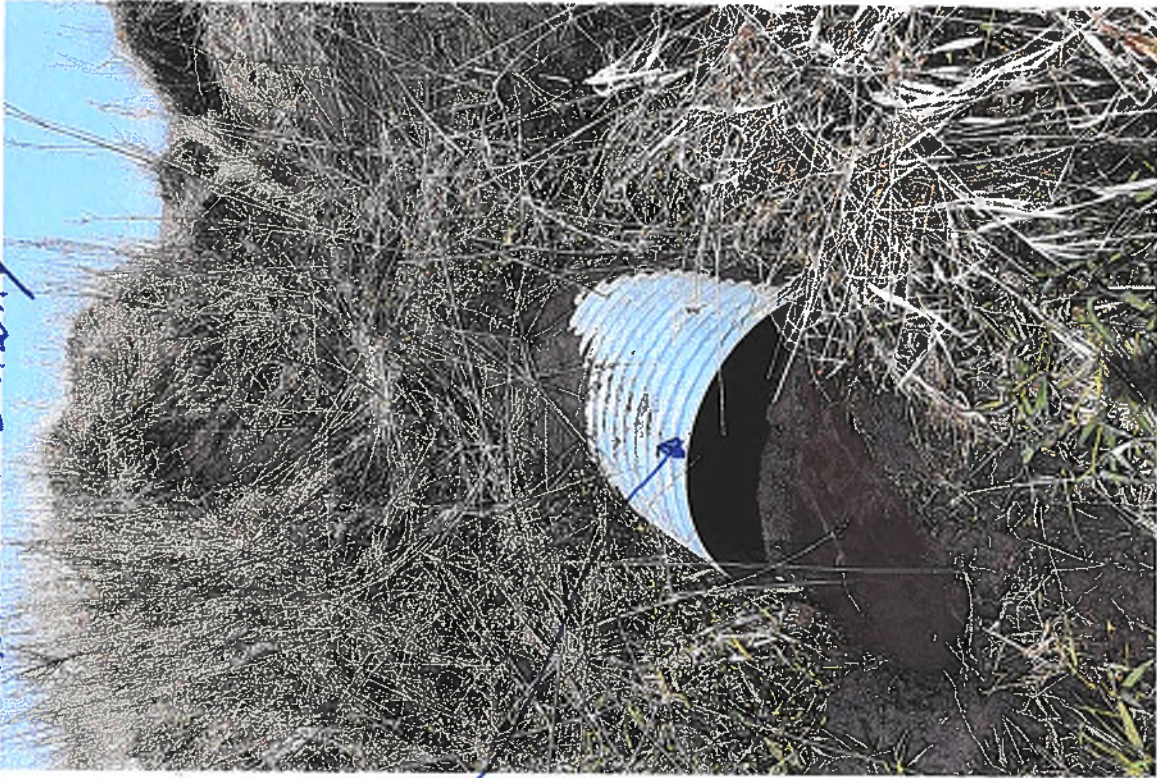
PICTURE # 4 LOOKING NW SHOWING
OUTLET OF 36" CMP WITH 18" OF MUCK
IN FLOWLINE & DRAINAGE DITCH
BANK ERODED AWAY

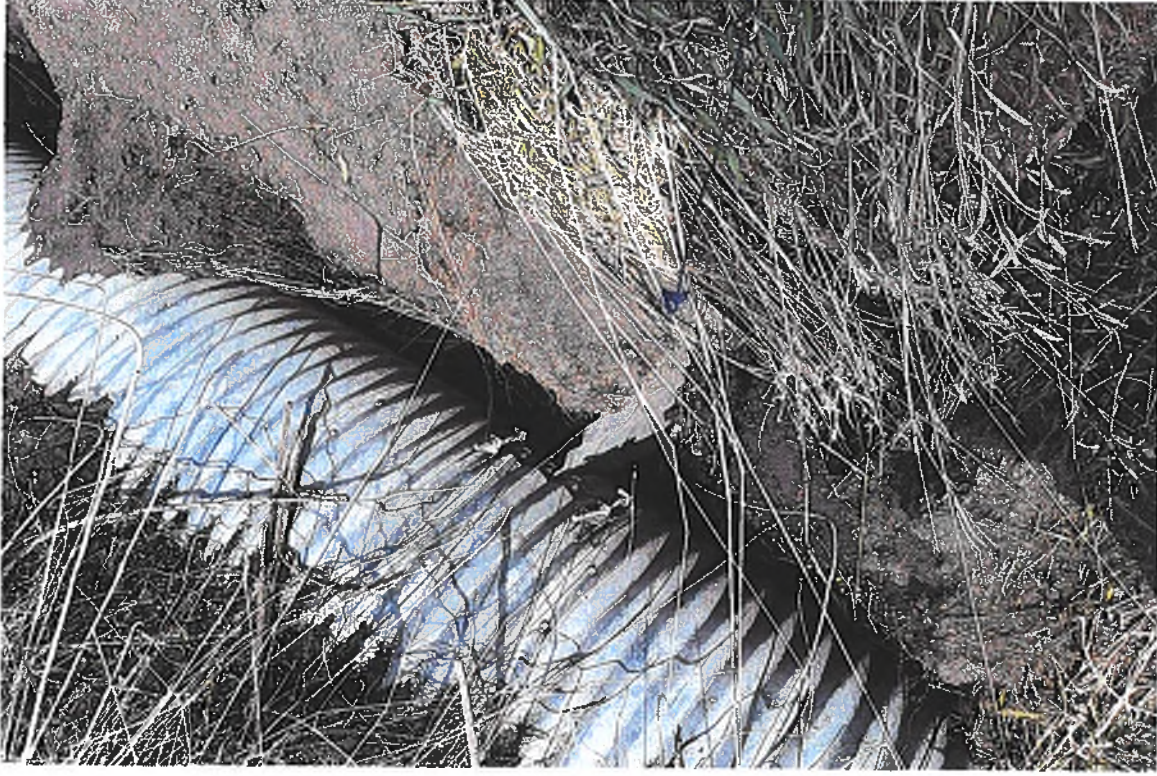
PICTURE # 5 IS LOOKING NW ON EAST SIDE
OF 36" CMP AT DRAINAGE DITCH ERODED
WITH METAL ANTI SEEP COLLAR EXPOSED

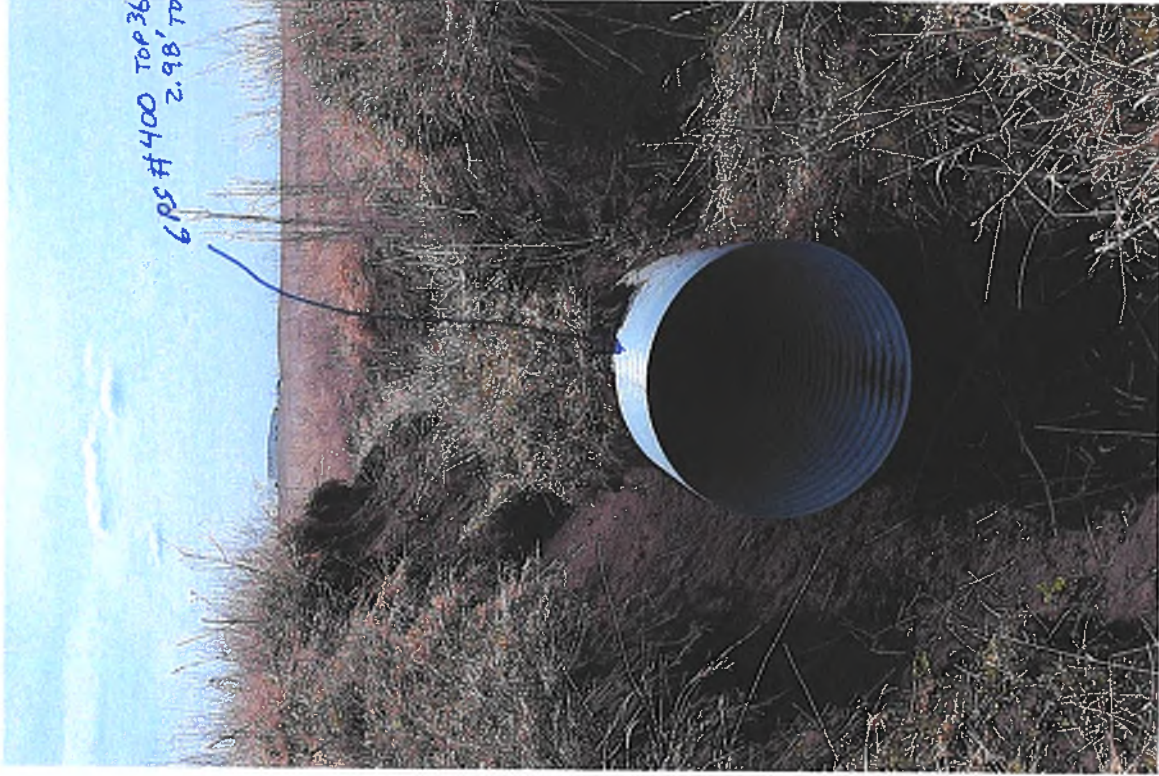
PICTURE #6 IS LOOKING SE AT 36" CMP INLET
SHOWING DRAINAGE DITCH BANK ERODED AROUND
SURFACE DRAIN INLET.

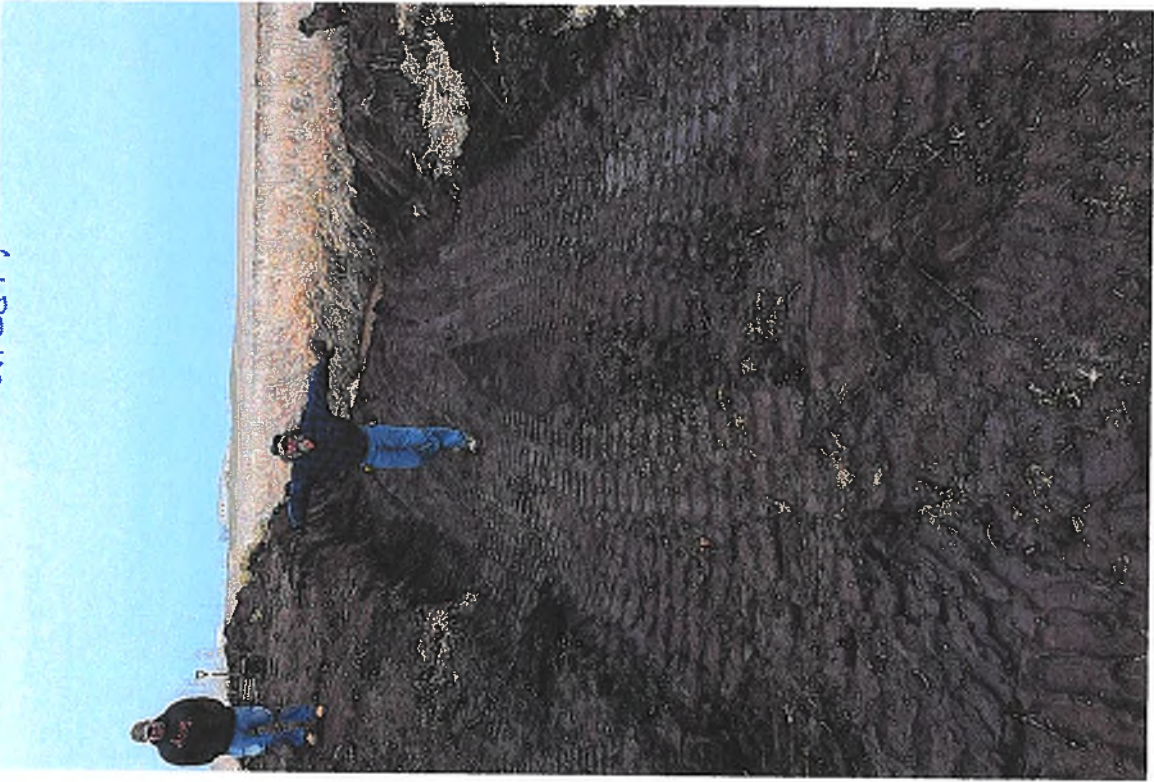
PICTURE# 18 IS LOOKING SE SHOWING
EXISTING SUBGRADE AFTER MINI
EXCAVATOR RAN OVER WITH TRACKS.
SOIL IS SOFT NEAR OUTLET,

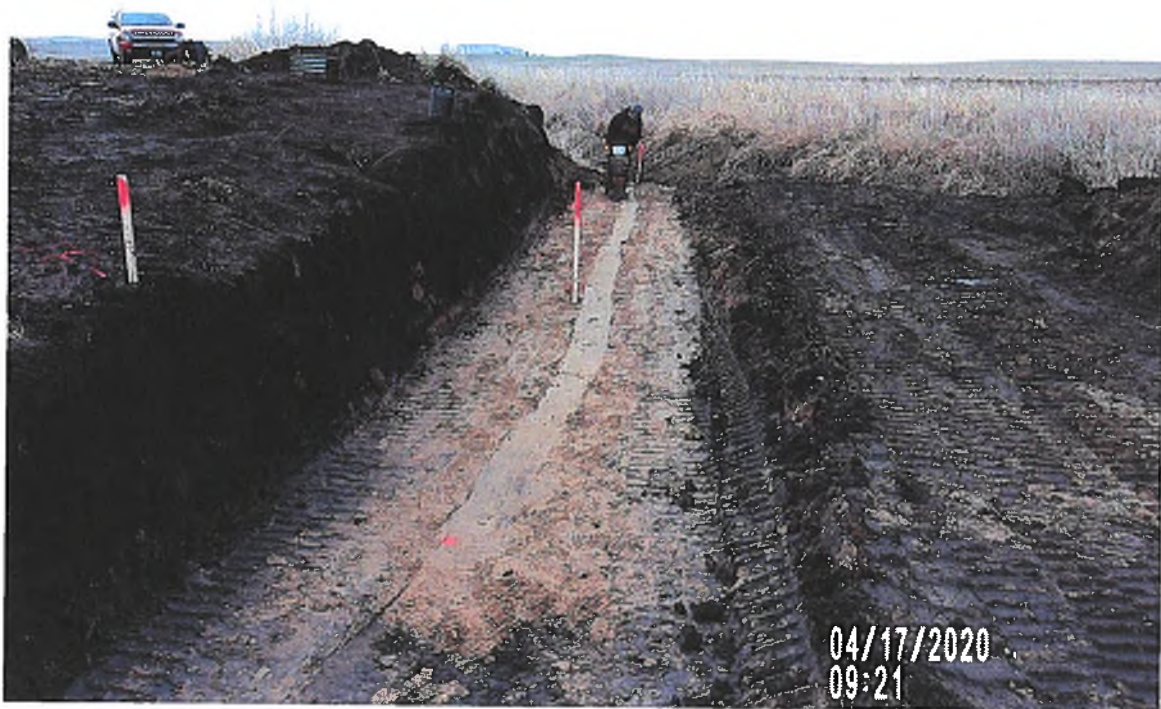
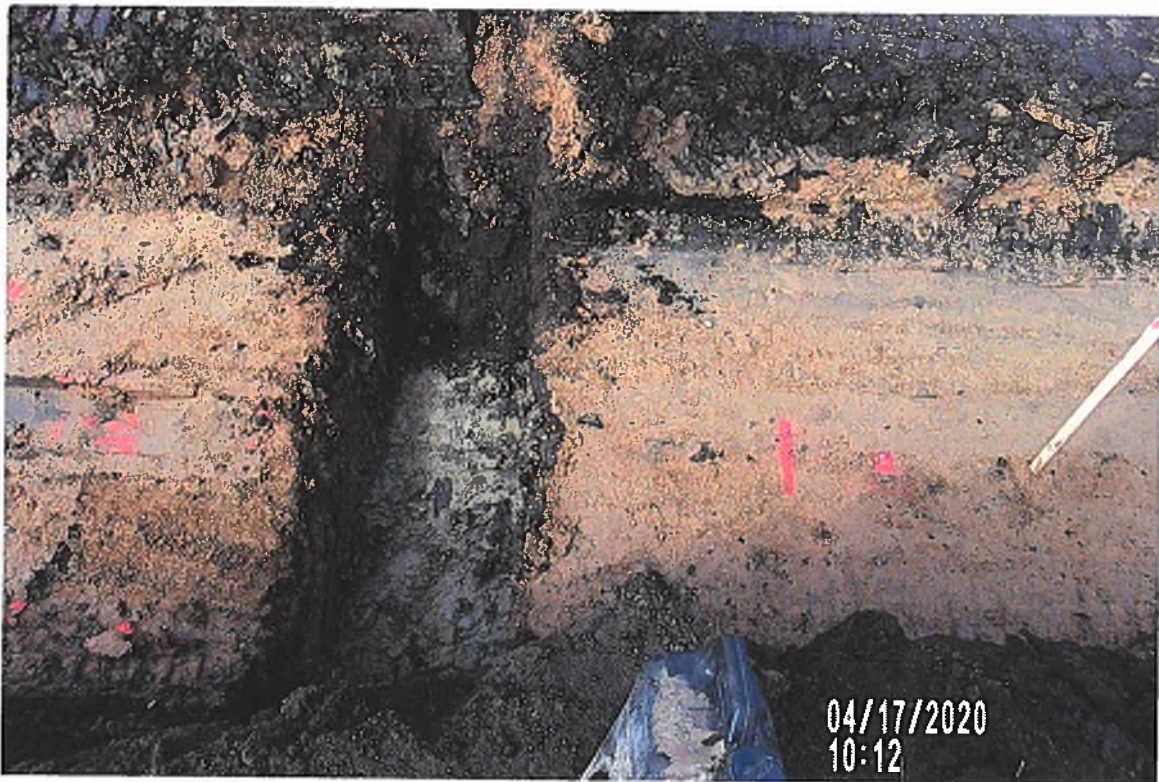
PICTURE # 3371 IS LOOKING SE SHOWING CREW JUMPING JACK VIBRATORY
PLATE COMPACT SOIL BELOW 36" CMP SURFACE DRAIN.

PICTURE # 3372 IS LOOKING SW SHOWING 1.0' X 7.0' WIDE TRENCH
FOR ORIGINAL METAL ANTI SEEP COLLAR 7.0' ± SE OF NORTHEAST
END OF CMP SURFACE DRAIN. BOTTOM OF TRENCH IS CLAY.

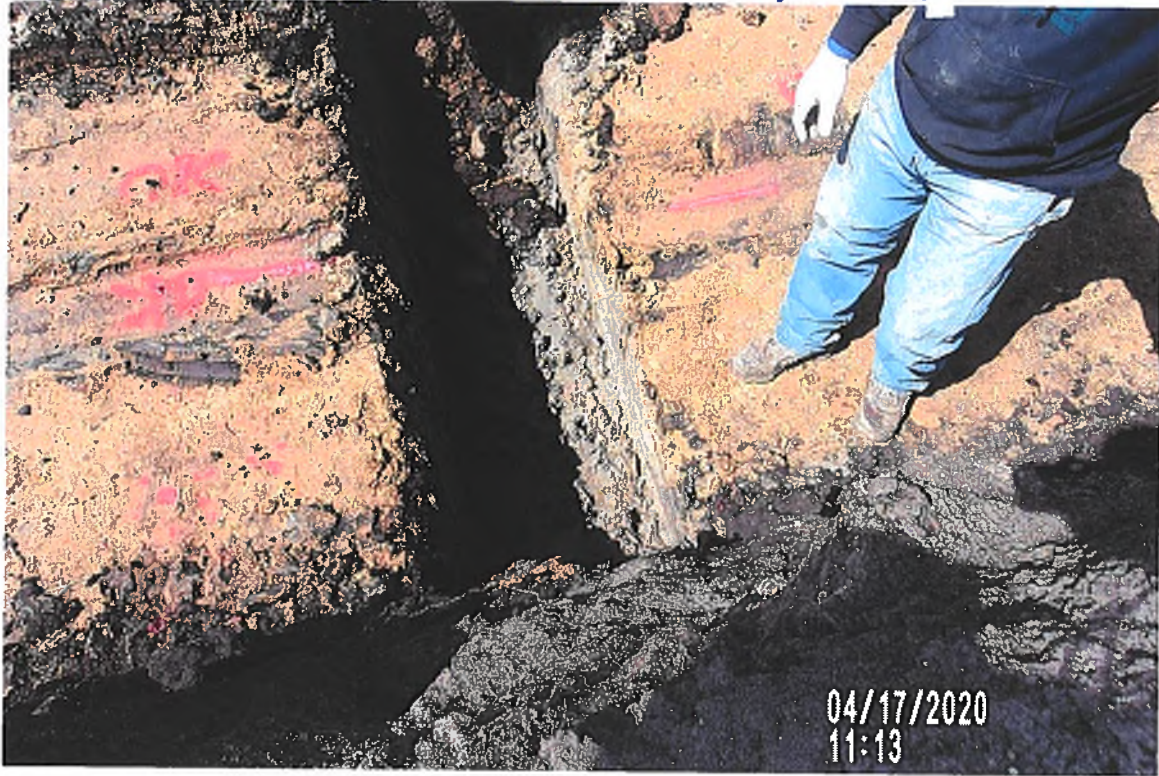
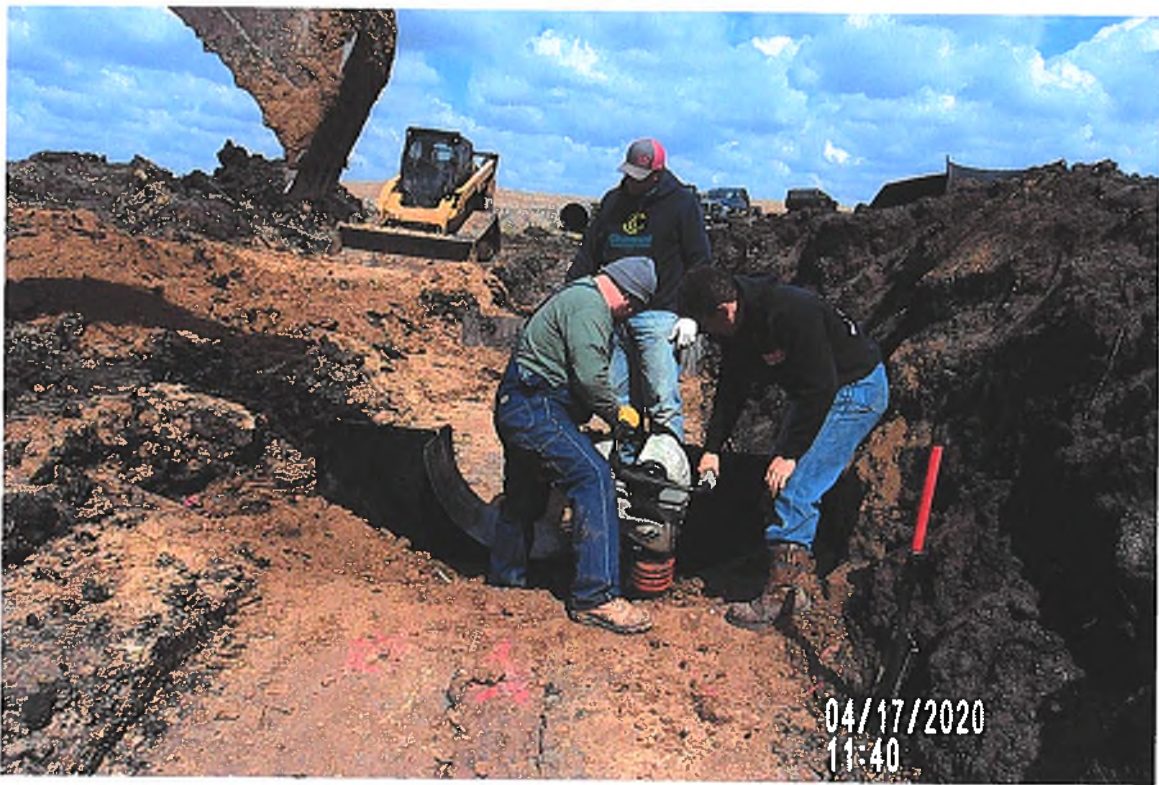
PICTURE # 3375 IS LOOKING NW AT 14.0' WIDEX 7.0' LONG TRENCH 19.0' SE OF NORTH END OF CMP SURFACE DRAIN FOR HDPE ANTISEEP COLLAR. BOTTOM OF TRENCH WAS SAND, OVER, EXCAVATED, ADDED LIMY CLAY TO BOTTOM OF TRENCH AND JUMPING JACK COMPACTED. BOTTOM OF TRENCH UP TO BOTTOM OF HDPE ANTISEEP COLLAR.

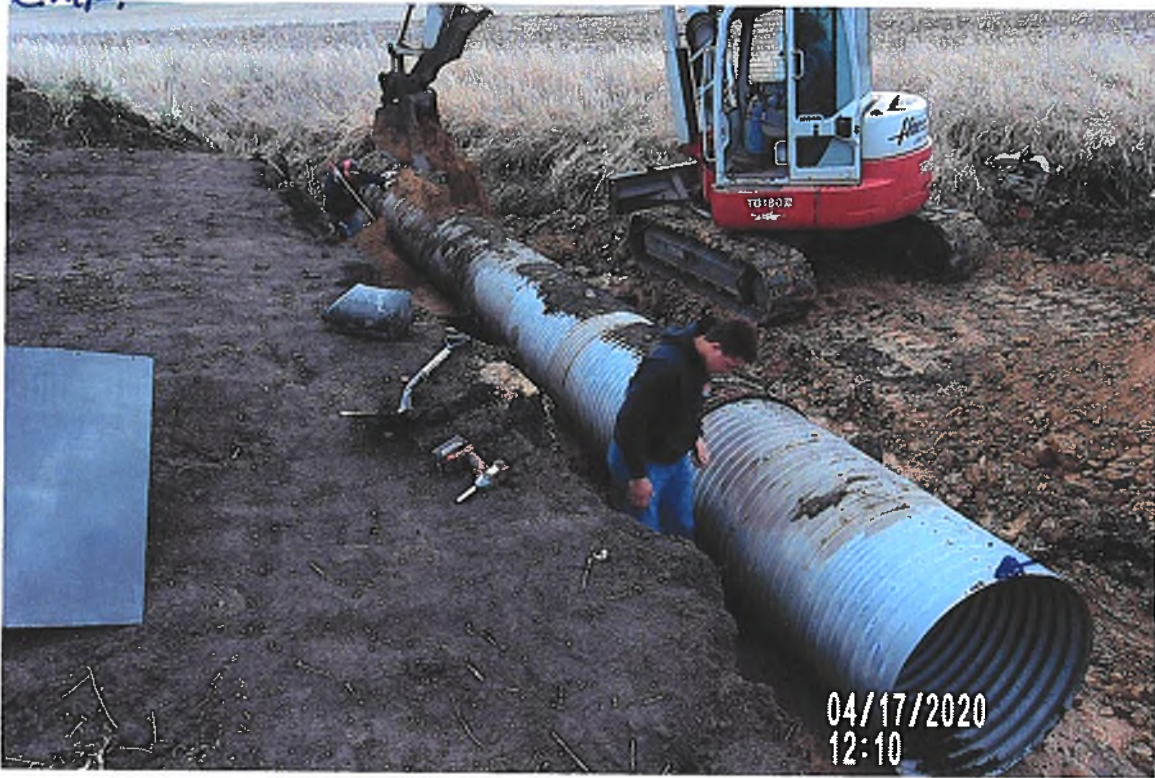
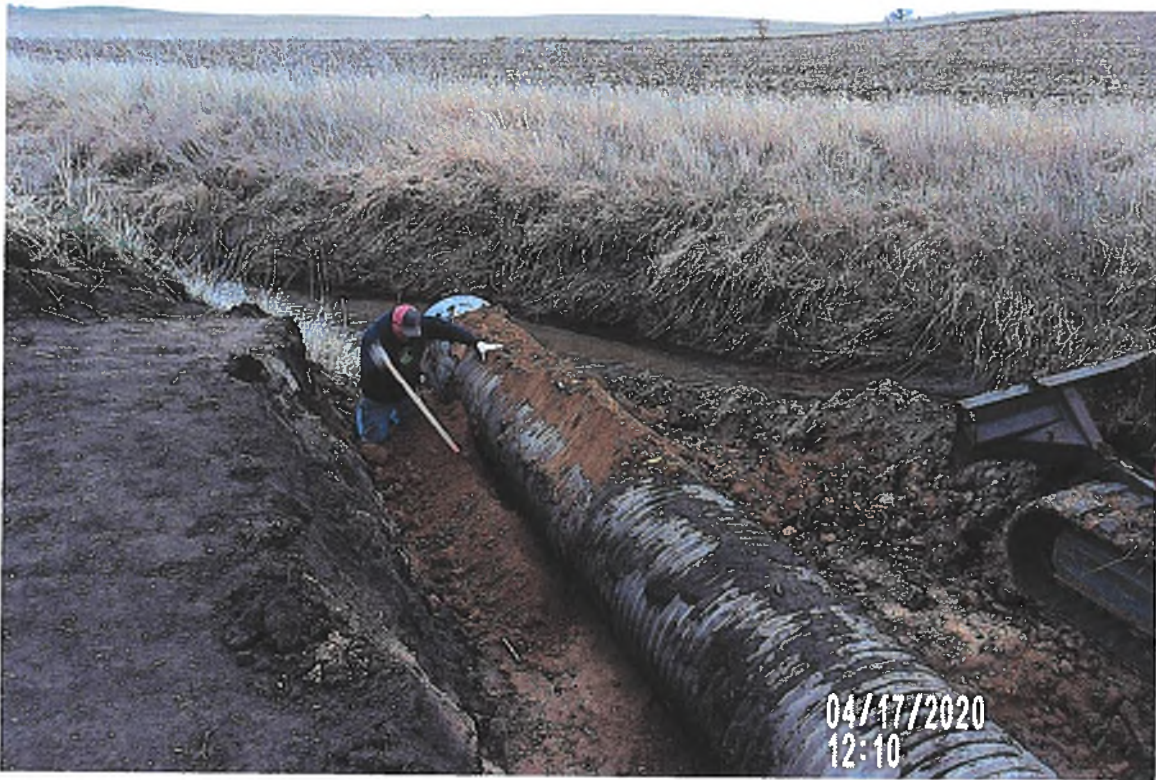
PICTURE #3379 IS LOOKING SW SHOWING 36" CMP SURFACE DRAIN SET IN PLACE WITH CREW BACKFILLING LIMY CLAY AROUND SURFACE DRAIN AND TAMPING SOIL UNDER HAUNCH OF CMP.

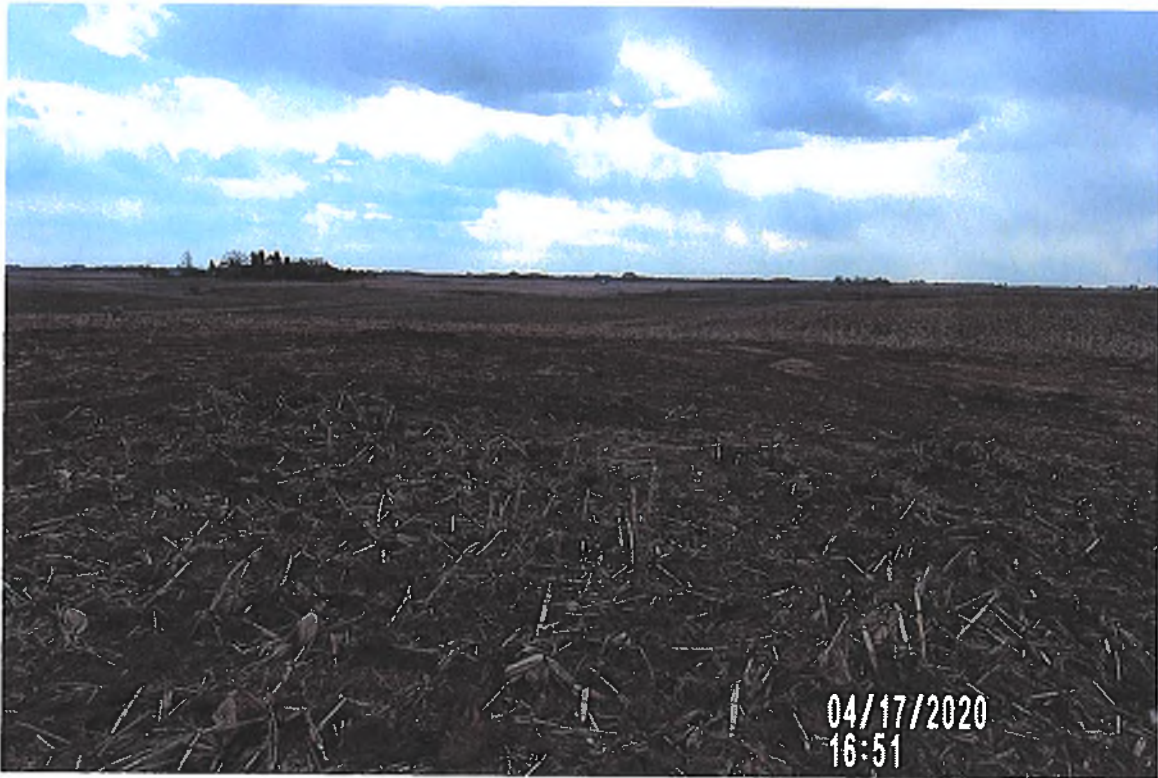
PICTURE # 3399 IS LOOKING SW AT BORROW AREA
BACK FILLED AND DRESSED UP.

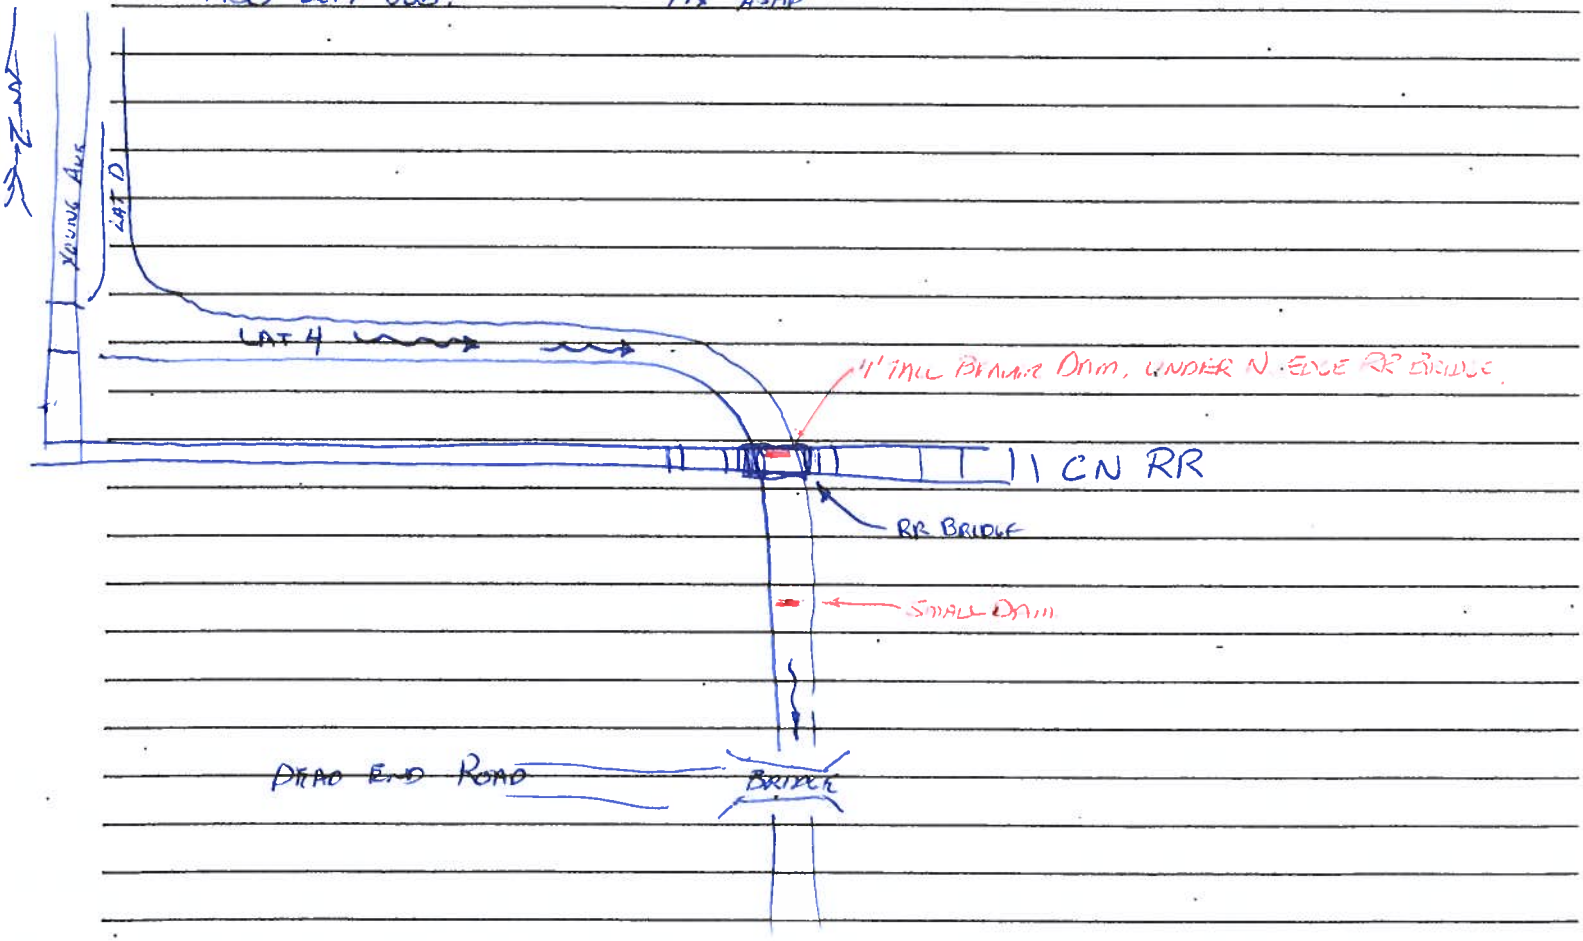
9:15 AM. Drove in on Young, S. of RR Tracks, E. on Dead End Road to old Wood Bridge.
Drove N on W side of DD4. Found small earthen dam 200' N. of bridge.
Drove N to RR tracks finding 4' high curbstumps/sticks, / dirt dam under new RR bridge just under N. edge of bridge. Beavers are living N. of this.
Ditch is deep enough that extending a rubber tire backhoe won't work. Need long stick.
9:30 LEFT JOB. Fix ASAP

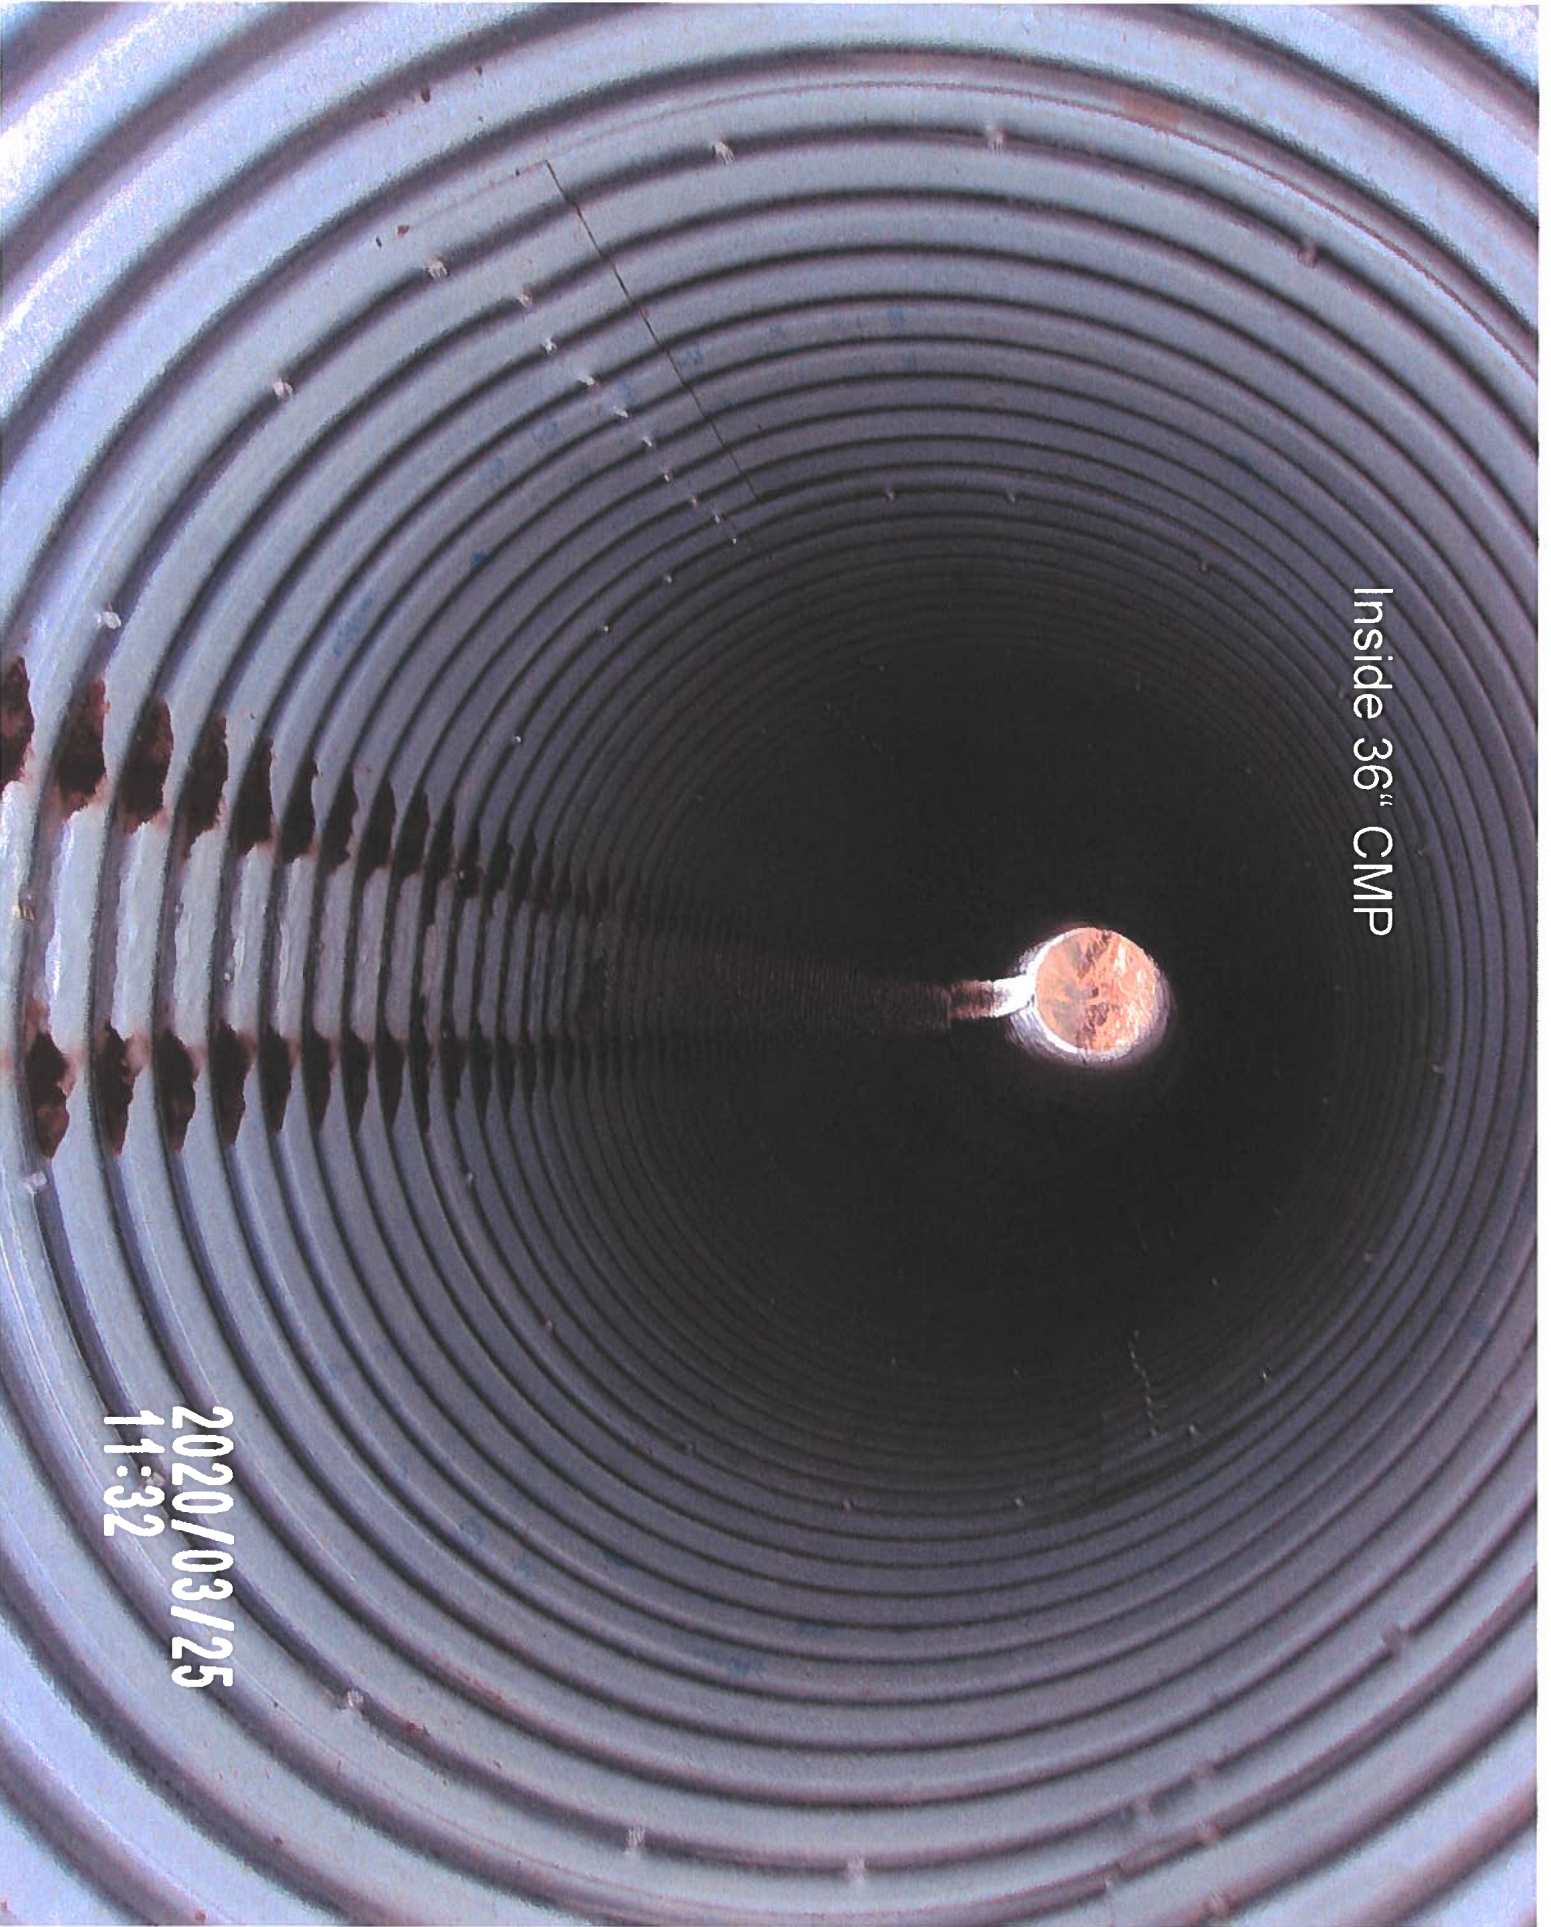
Inside 36" CMP

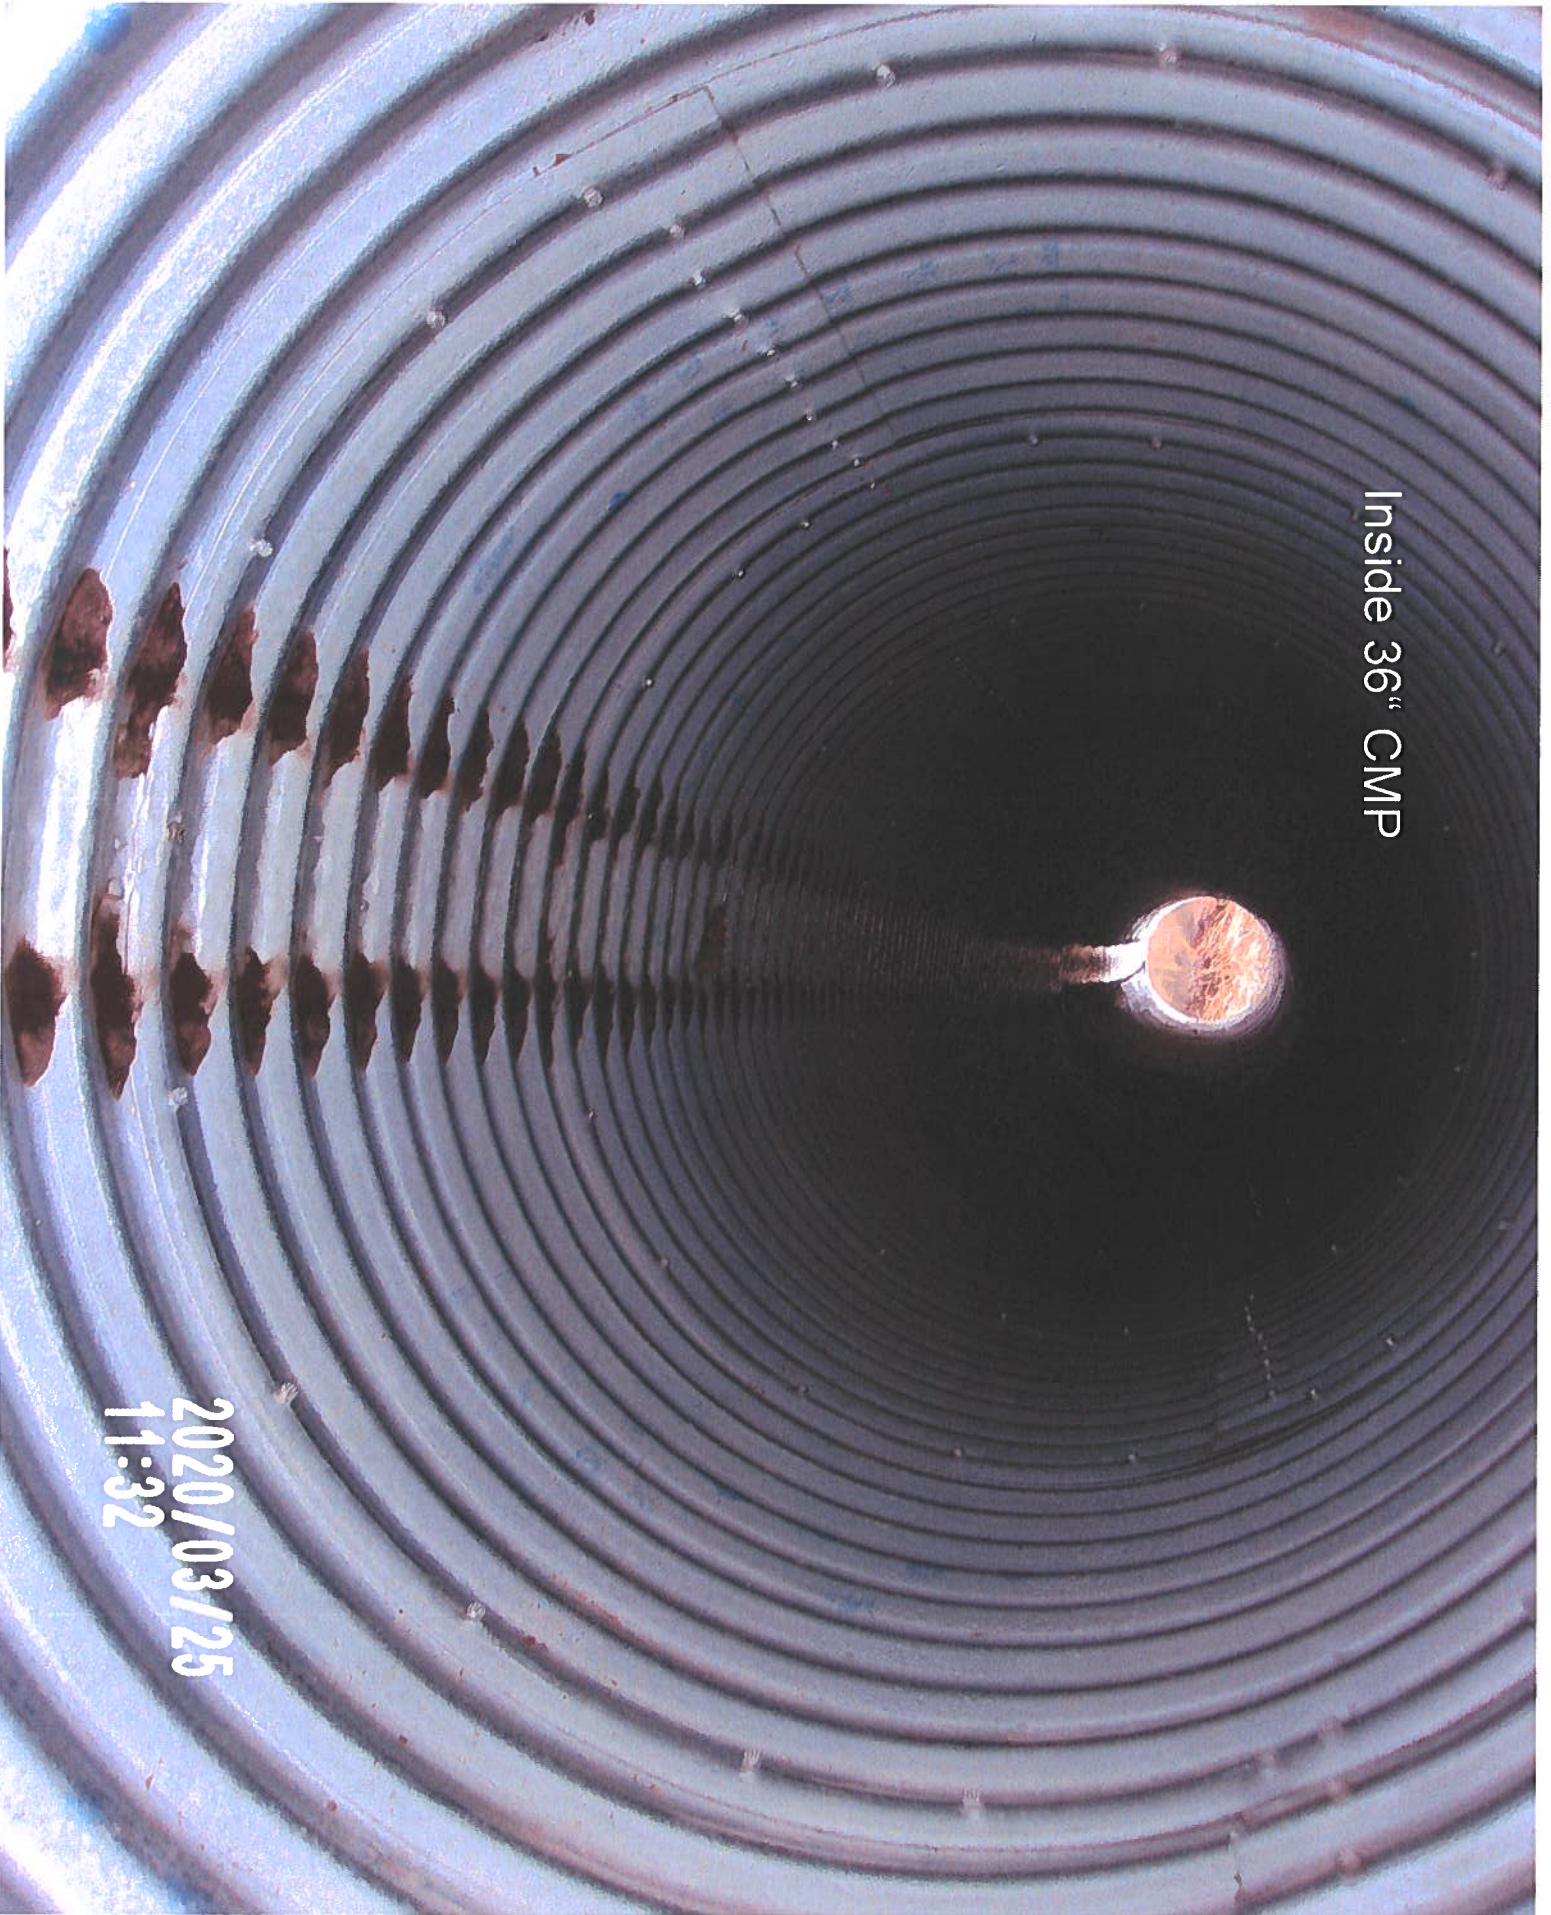
Inside 36" CMP
