AGENDA
REGULAR DRAINAGE MEETING
Wednesday, August 19, 2020 9:30 AM
Large Conference Room

[DD 48 WO 237 - 6486.4 - REPAIR SUMMARY - 08_03_20.PDF](#)

[DD BIG 4 LAT 4 - WO 195 - 5585.1 - REPAIR SUMMARY - 08_03_2020.PDF](#)

[DD BIG 4 MAIN - WO 247 - 5734.1 - REPAIR SUMMARY - 08_03_2020.PDF](#)

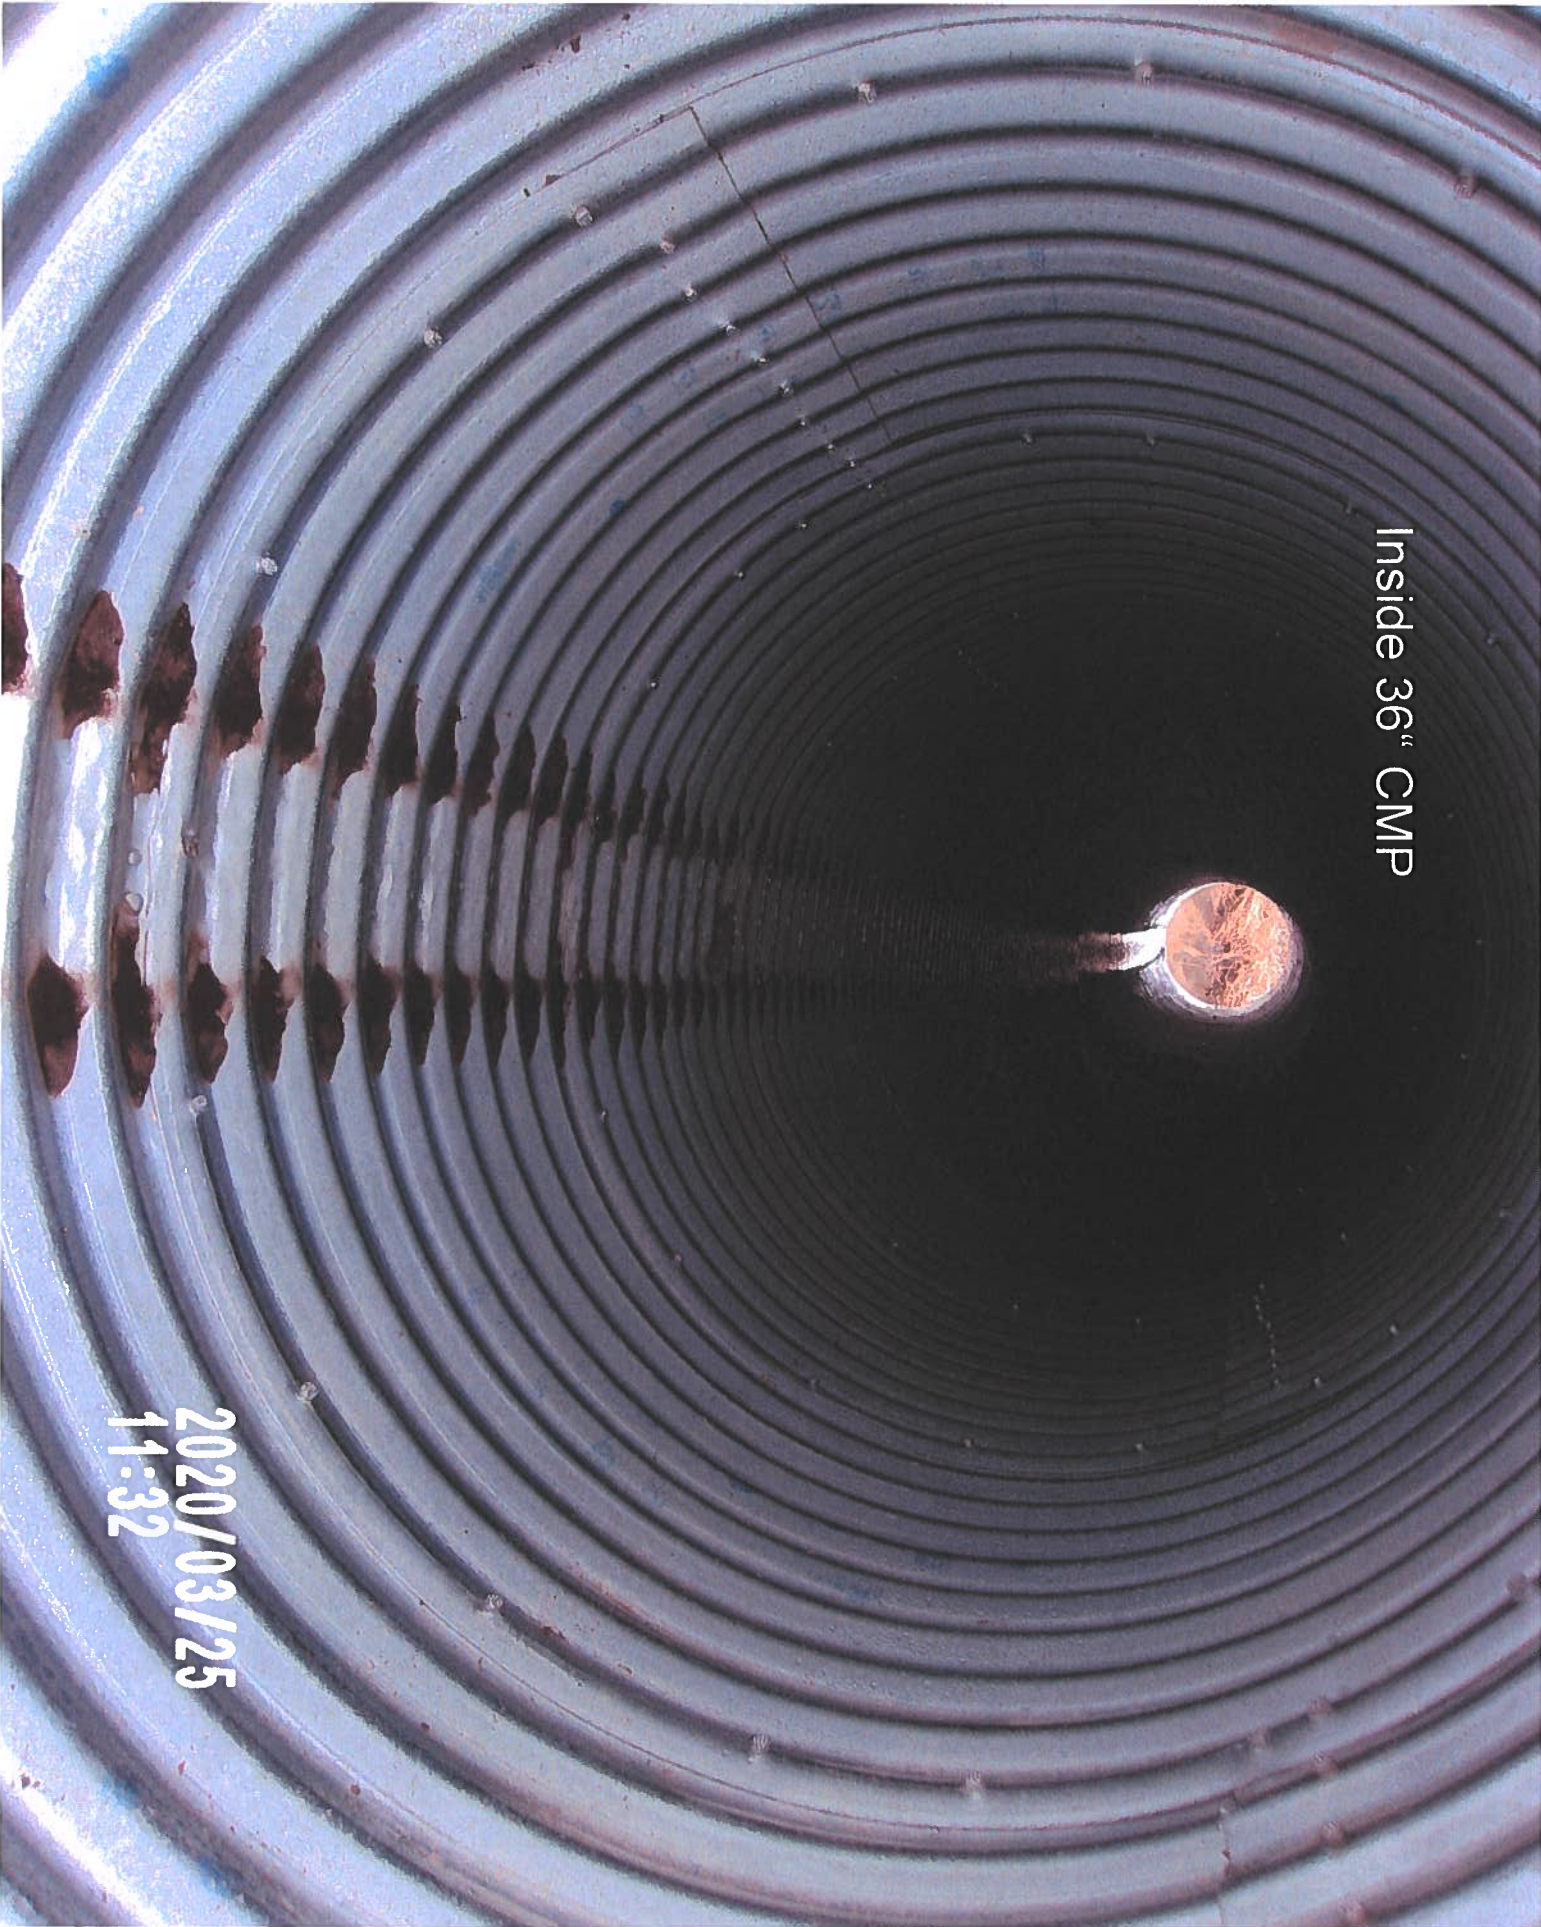
Inside 36" CMP

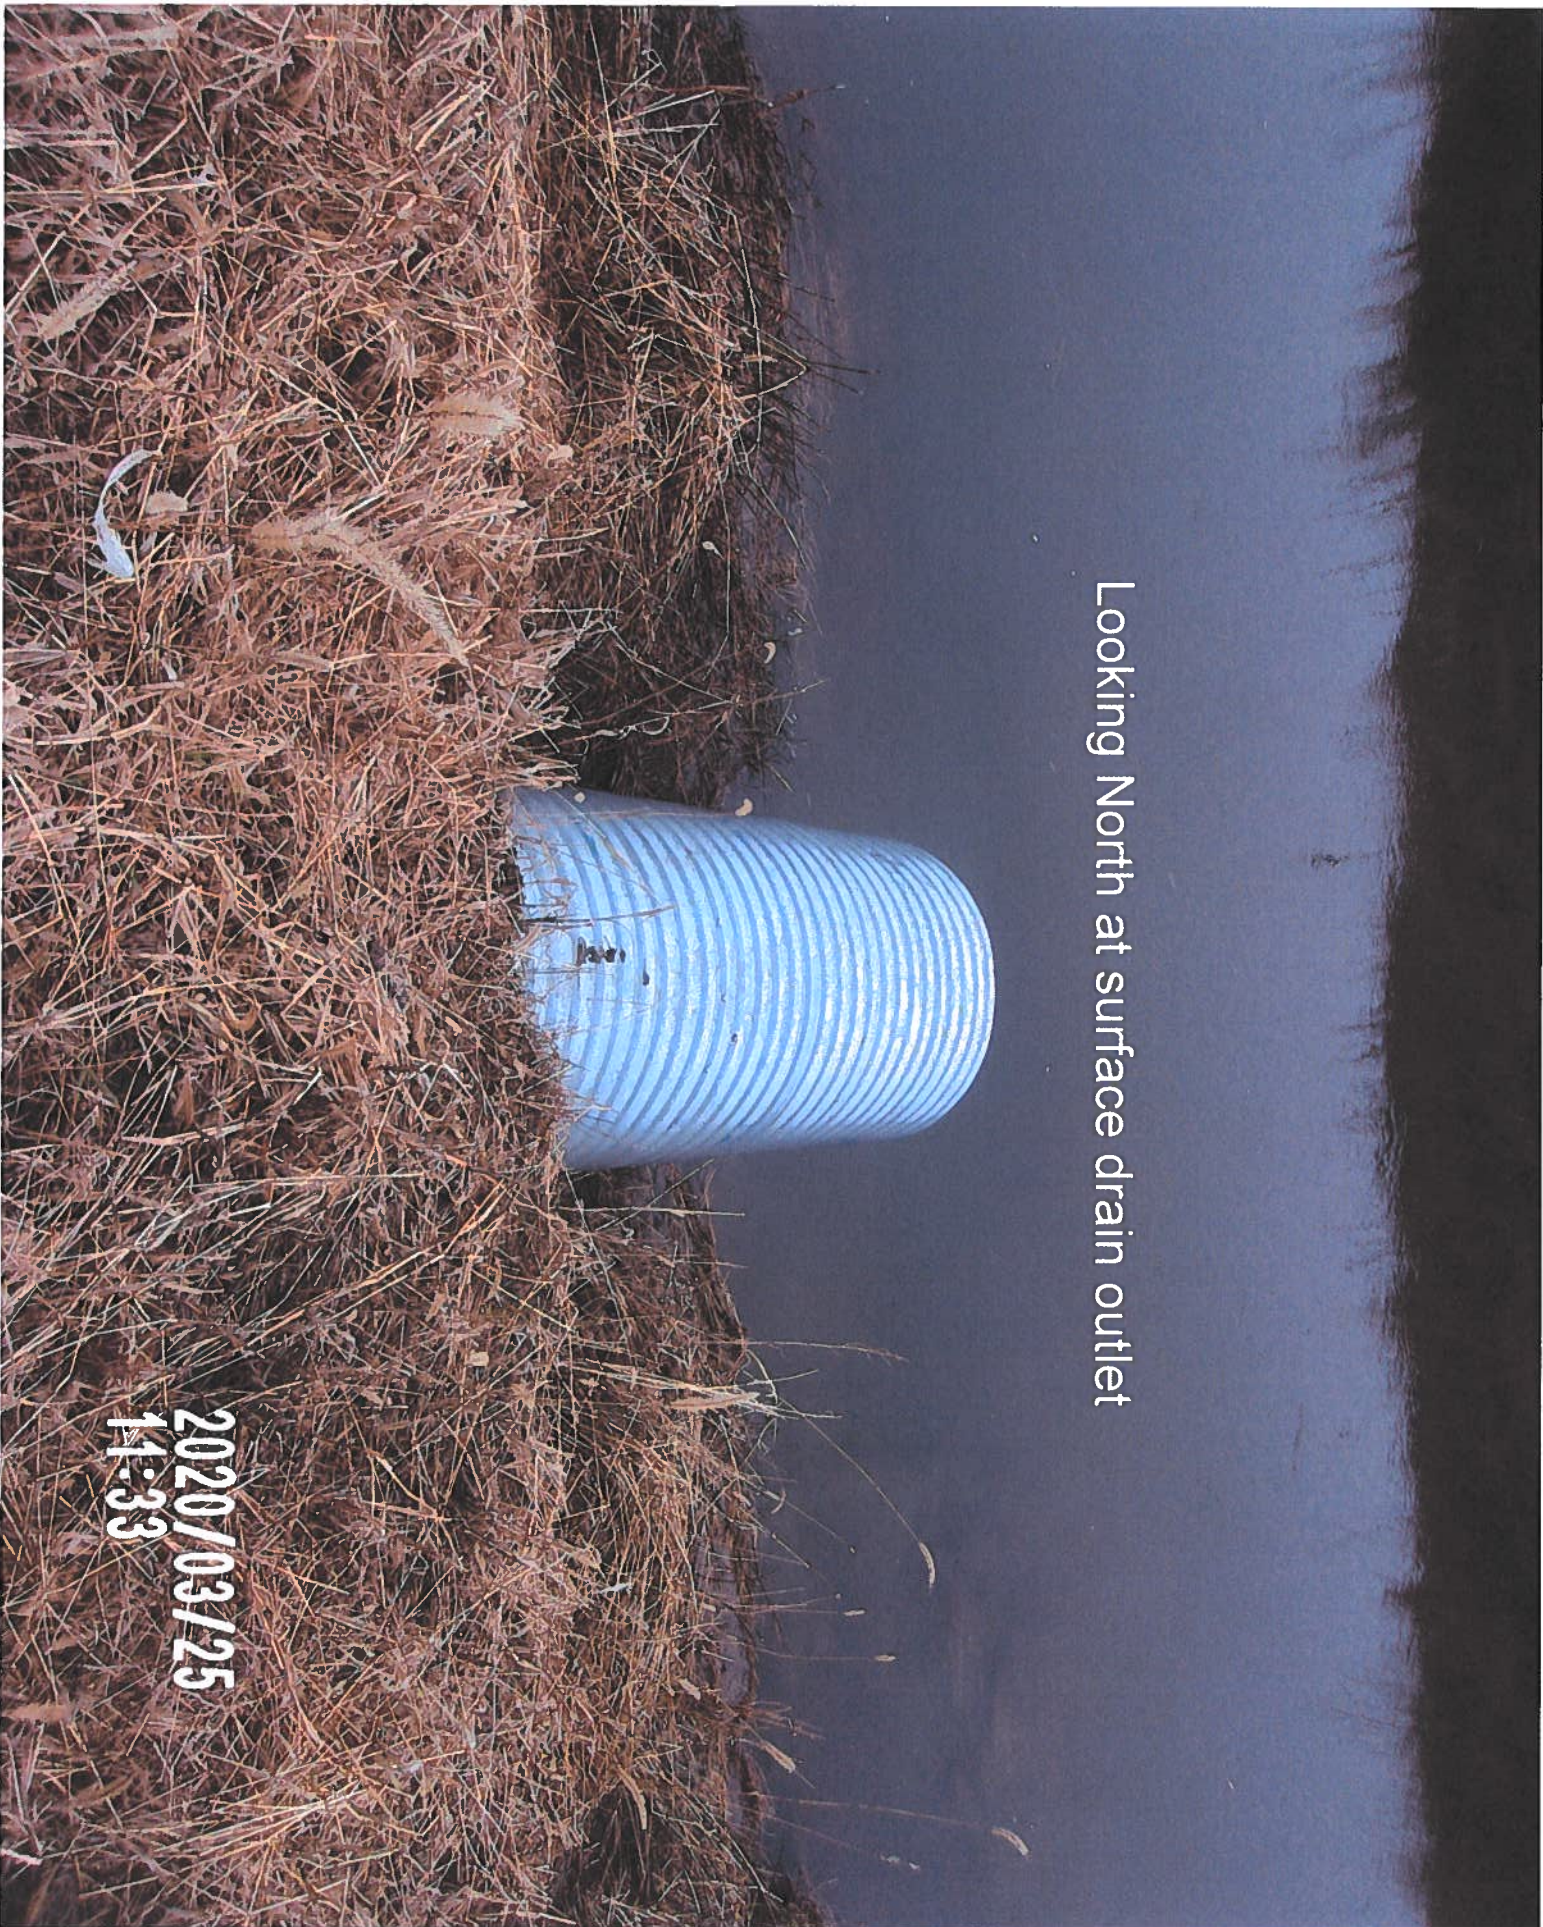
Looking North at surface drain outlet

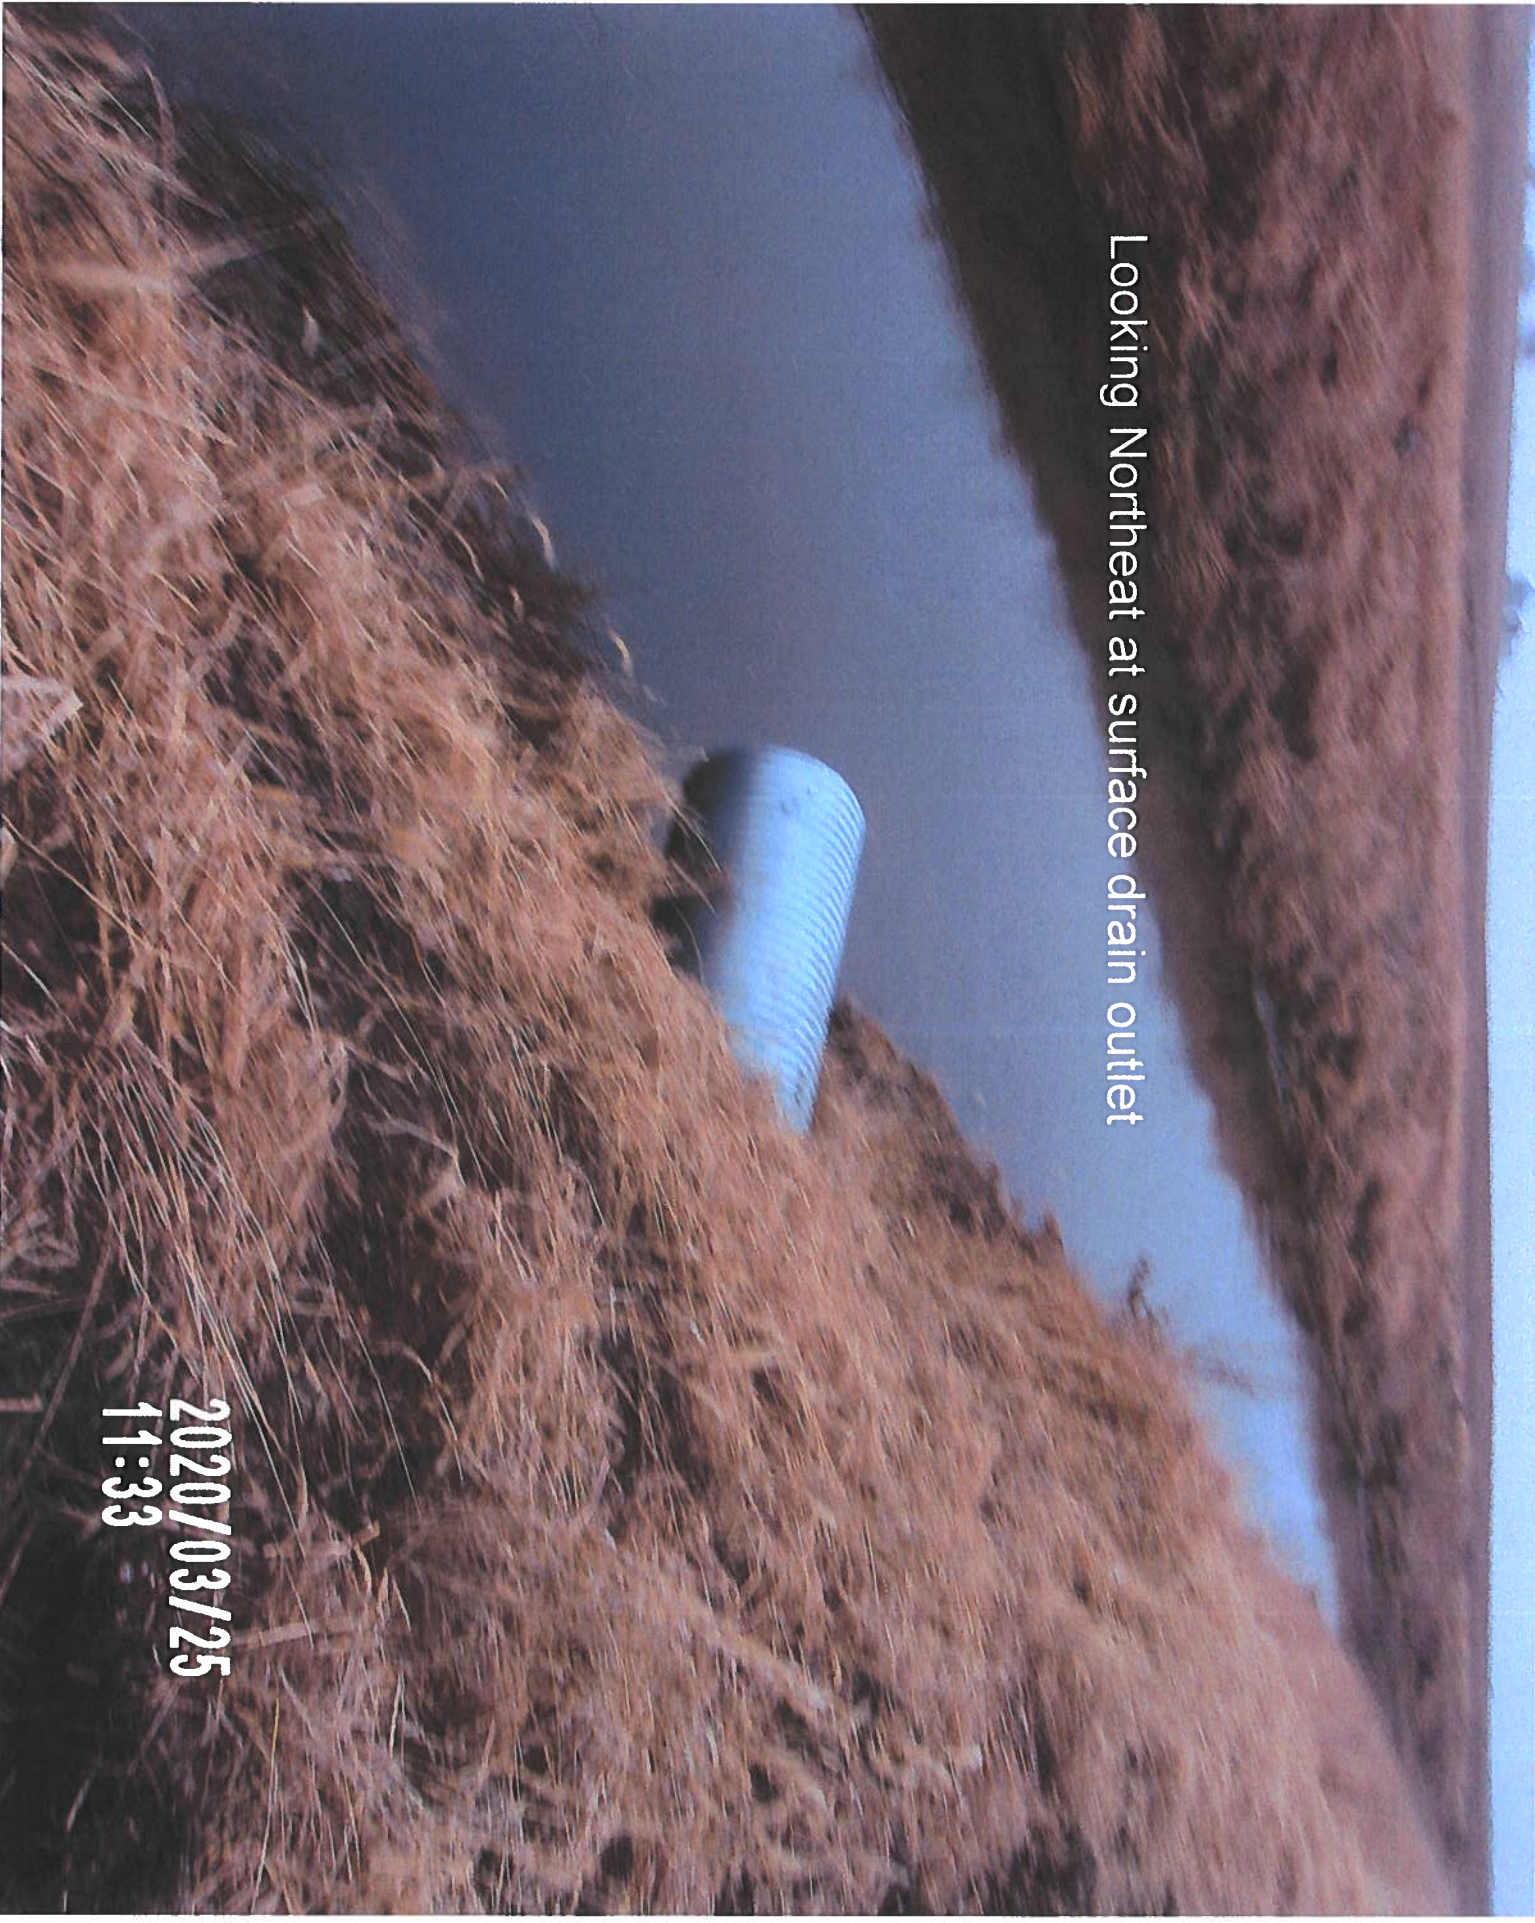
Looking Northeast at surface drain outlet

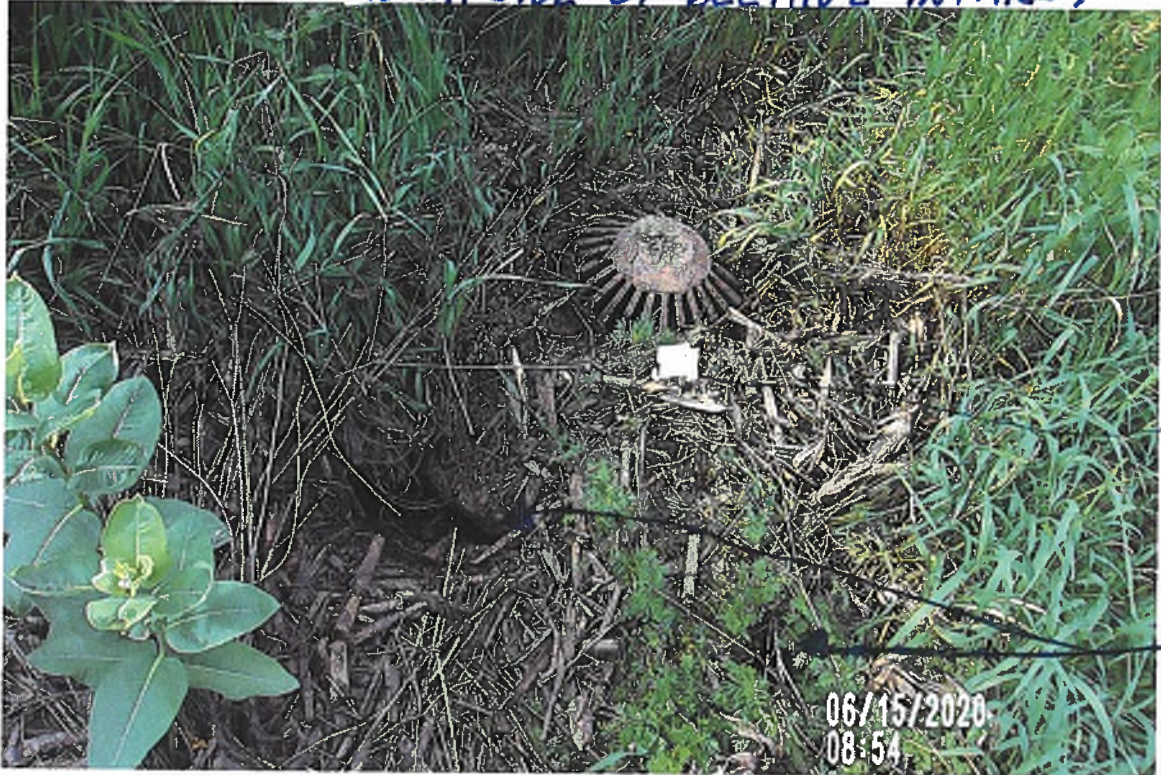
PICTURE# 3736 IS LOOKING SOUTH AT 24" BEEHIVE INTAKE IN WEST DITCH OF AA AVE 656' ± NORTH OF CO HWY D25 SHOWING BEEHIVE WAS COMPLETELY COVERED WITH CORN STALKS WITH SINKHOLES ON NORTH SIDE OF BEEHIVE INTAKE.

SINKHOLES
NORTH
SIDE OF
BEEHIVE
INTAKE

- Removed the beehive intake and repaired with an 8-inch Hickenbottom intake, 8-inch single wall HDPE, internal snap coupler, full concrete collar, and rock bedding and backfill.

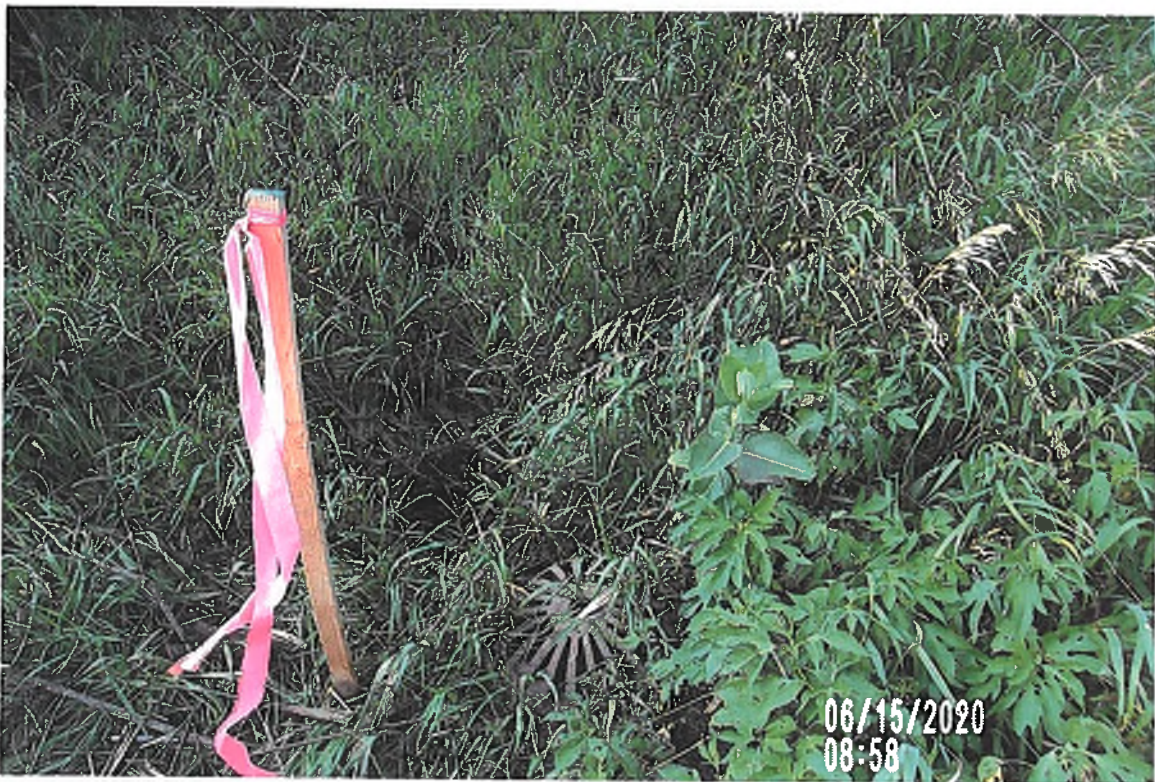
PICTURE# 3737 IS LOOKING SOUTH AT 15" BEEHIVE INTAKE IN WEST DITCH OF AA AVE 1312' ± NORTH OF CO HWY D25 WITH BLOWOUT ON WEST SIDE AT ONE TIME AND NOT DRAINING PROPERLY

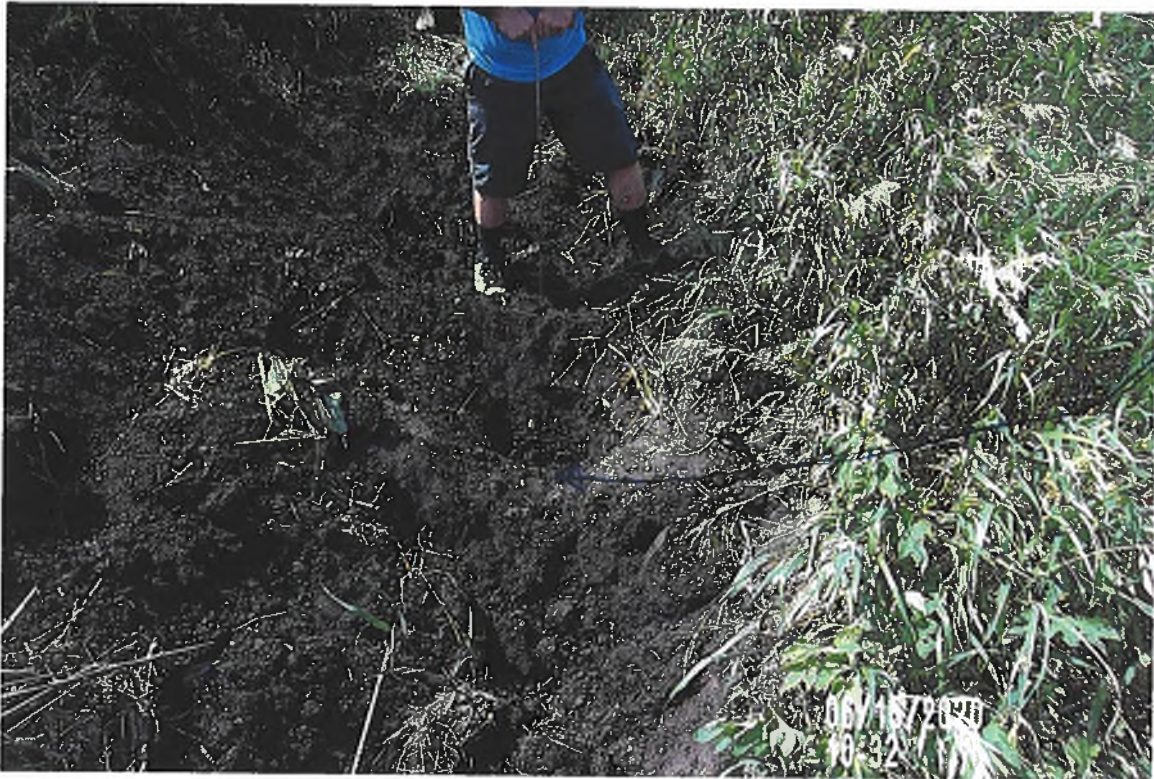
PICTURE# 3738 LOOKING SOUTH AT 15" BEEHIVE INTAKE IN WEST
DITCH OF RA#AVE 1312' NORTH OF HWY D 25 COMPLETELY
FULL OF SOIL WITH CREW REMOVING SOIL FROM INSIDE INTAKE

GPS# 1200
N RIM 15"
BEEHIVE

- Removed soil from the concrete intake and made a larger drain hole in the underlying 8-inch Branch 2CA concrete tile so that water can freely drain from the structure. Within said tile, water was found to be flowing freely. The surrounding road ditch was also graded to provide positive drainage towards the intake.

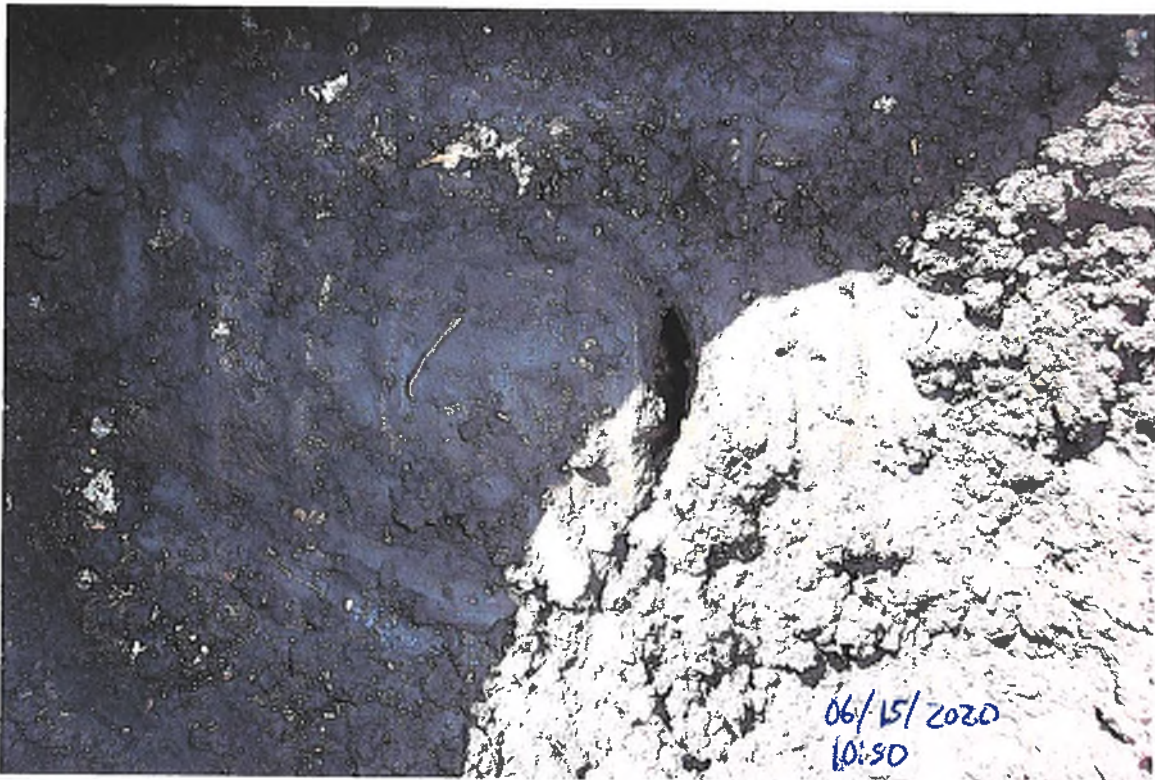
PICTURE# 3739 IS LOOKING SE INSIDE 15" BEEHIVE INTAKE
AFTER SOIL REMOVED SHOWING 1" X 3" HOLE IN 8" CONCRETE
TILE RUNNING THROUGH BEEHIVE TO DRAIN WATER.

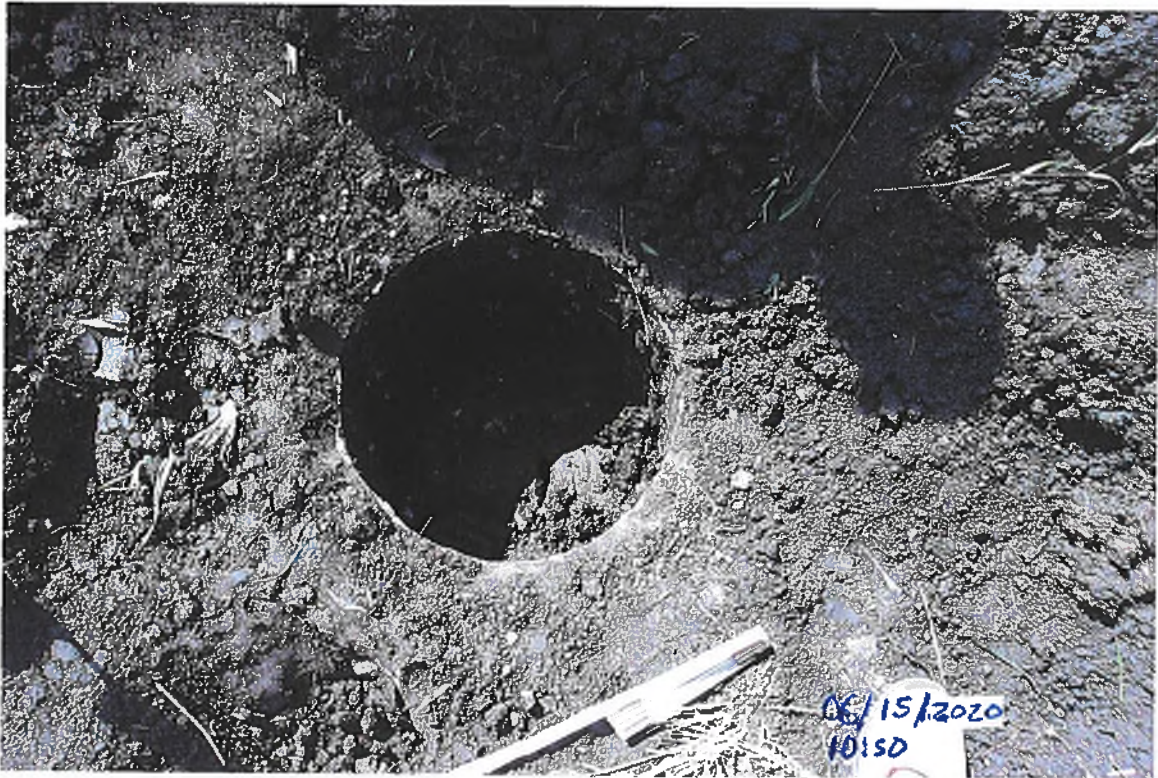
PICTURE # 3740 IS LOOKING SE AT TOP VIEW OF 15" BEEHIVE INTAKE SHOWING SMALL HOLE IN TILE TO DRAIN WATER THROUGH IN INTAKE.

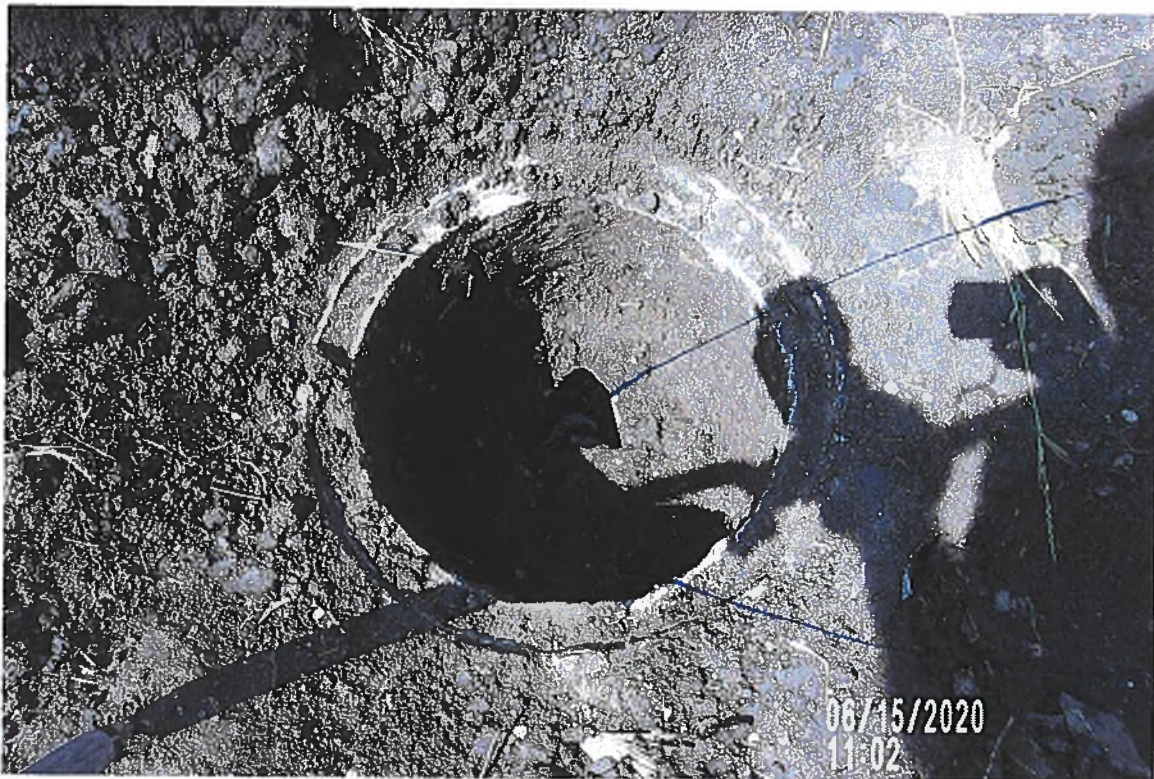
PICTURE # 3741 IS LOOKING SW INSIDE 15" BEEHIVE INTAKE SHOWING A 5" OPENING IN 8" CONCRETE TILE TO DRAIN INTAKE

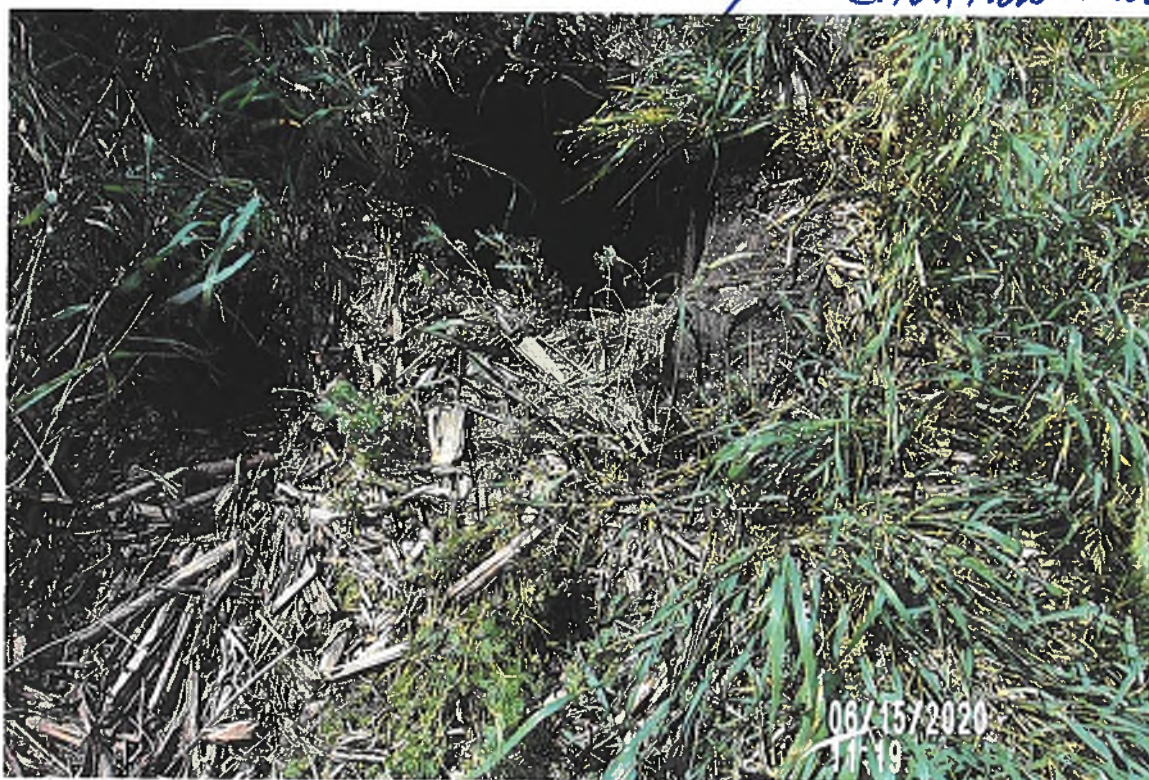
PICTURE # 3742 IS LOOKING SOUTH AT 24" BEEHIVE INTAKE WITH TOP OFF AND SINKHOLES ALONG BEEHIVE INTAKE ON NORTH SIDE BEFORE ANY EXCAVATION DONE.

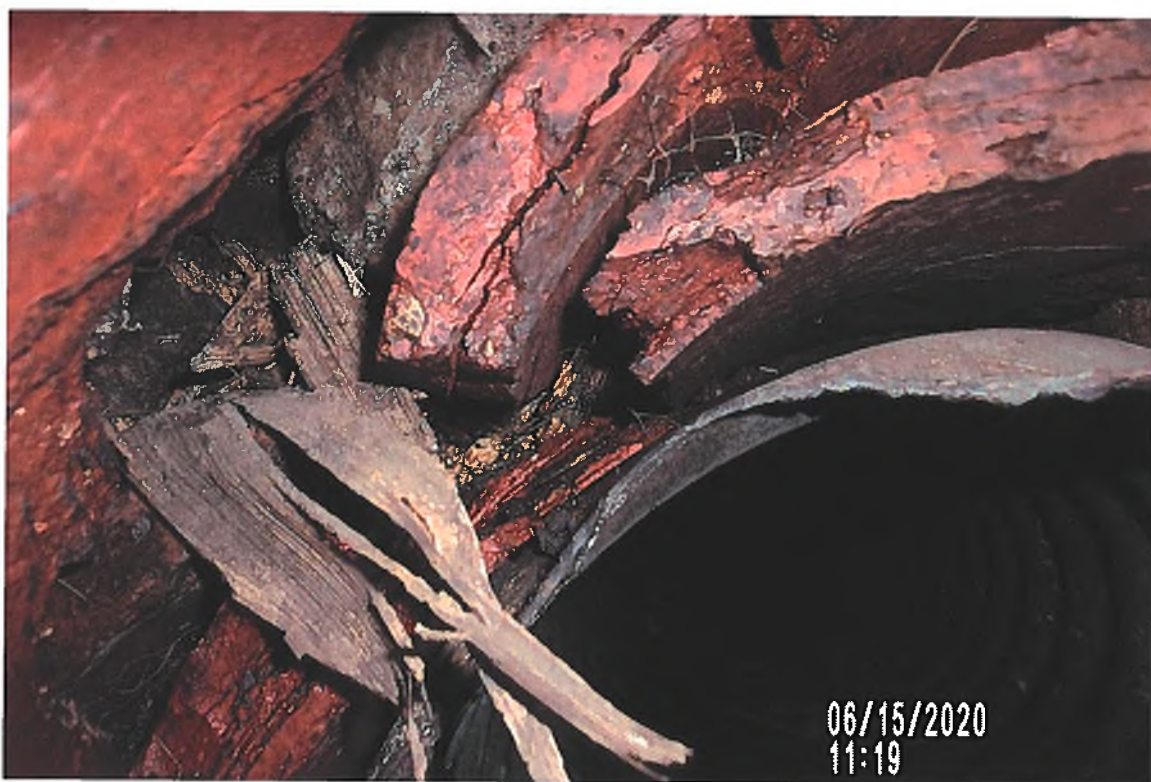
PICTURE # 3743 IS LOOKING NE INSIDE 24" BEEHIVE INTAKE SHOWING A POOR CONNECTION BETWEEN 8" CLAY TILE IN WALL OF BEEHIVE AND 8" SPIRAL CMP OUTLET, APPEARS SOIL HAS BEEN FLOWING THROUGH THE GAPS.

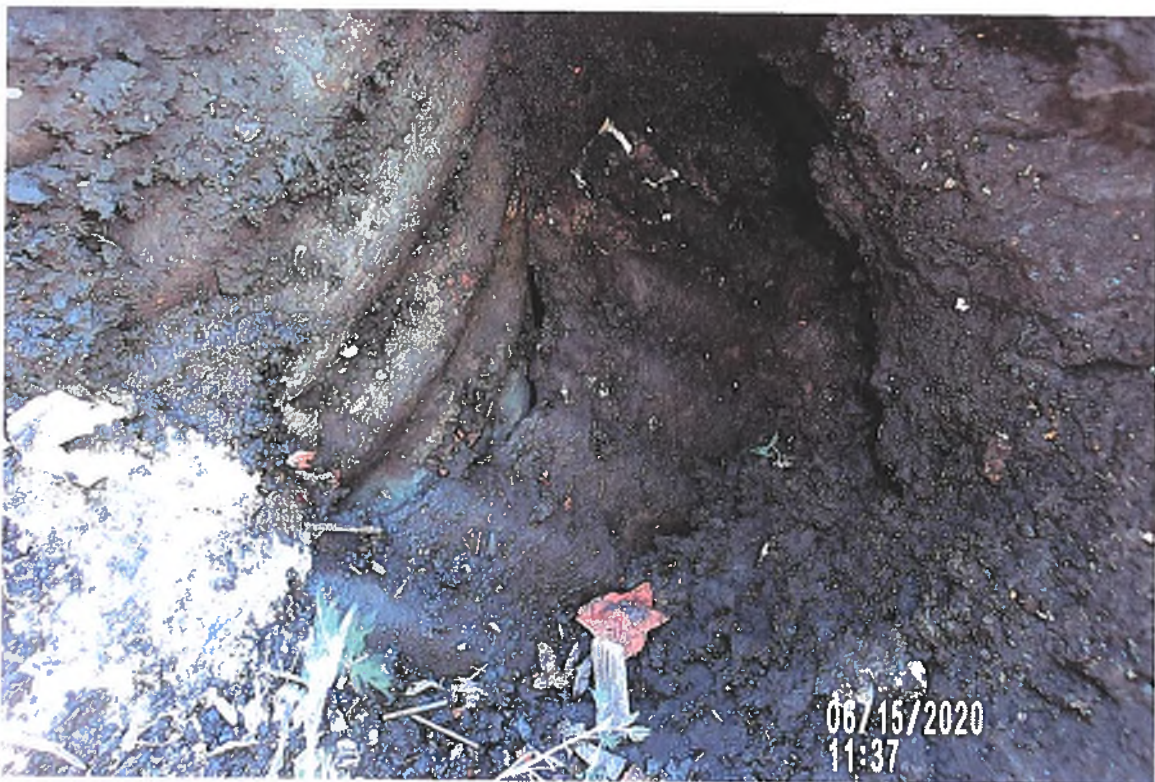
PICTURE #3745 IS LOOKING SE SHOWING GAP WHERE 6" SPIRAL CMP 90° OUTLET TIES INTO 8" SPIRAL CMP OUTLET TILE FROM BEEHIVE INTAKE WHERE CONCRETE COLLAR BROKE OUT.

- Repaired connection of private tile to the Branch 2B5 tile with a ¾ concrete collar.
- Excavations were then filled with on-site soil, and surrounding road ditch was graded to provide positive drainage slope towards the intake.

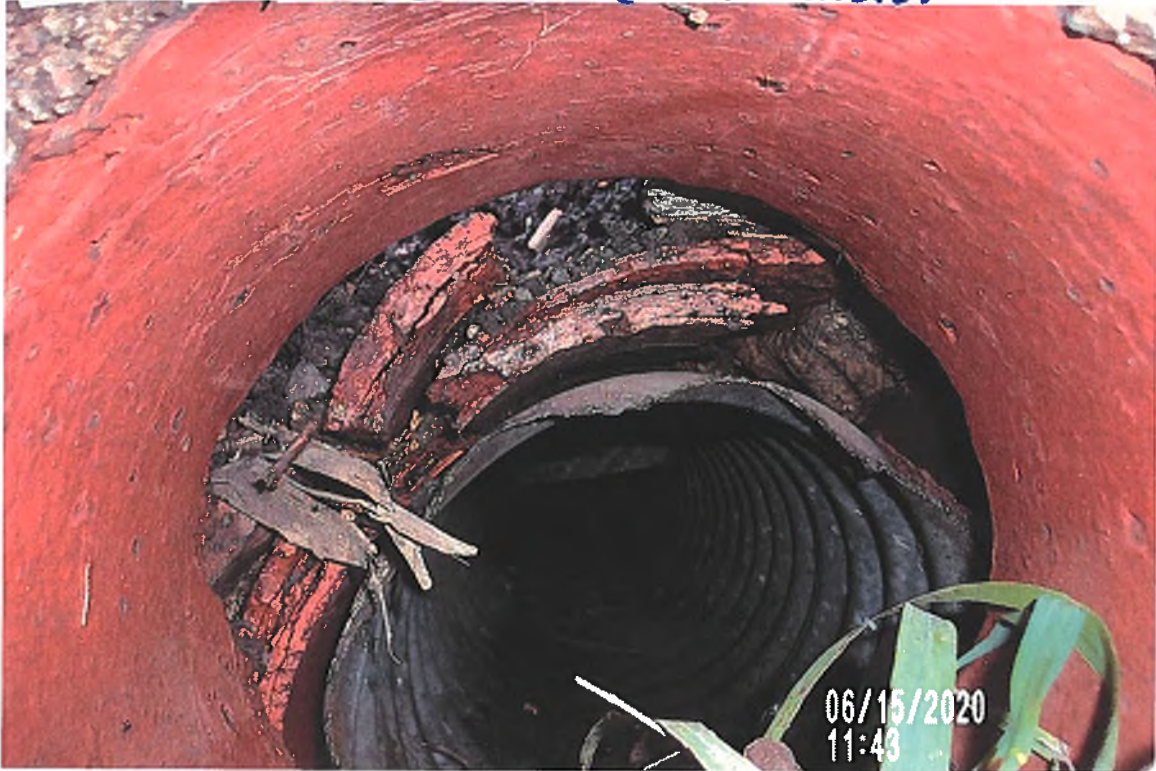
PICTURE # 3746 IS LOOKING NE INSIDE 8" CLAY TILE
INSIDE BEEHIVE INTAKE WALL, SHOWING 8" CMP SPIRAL CMP
SANK DOWN @ CONNECTION WITH CLAY TILE PIECES ON TOP.
SOIL & CORN STALKS VISIBLE @ CONNECTION.

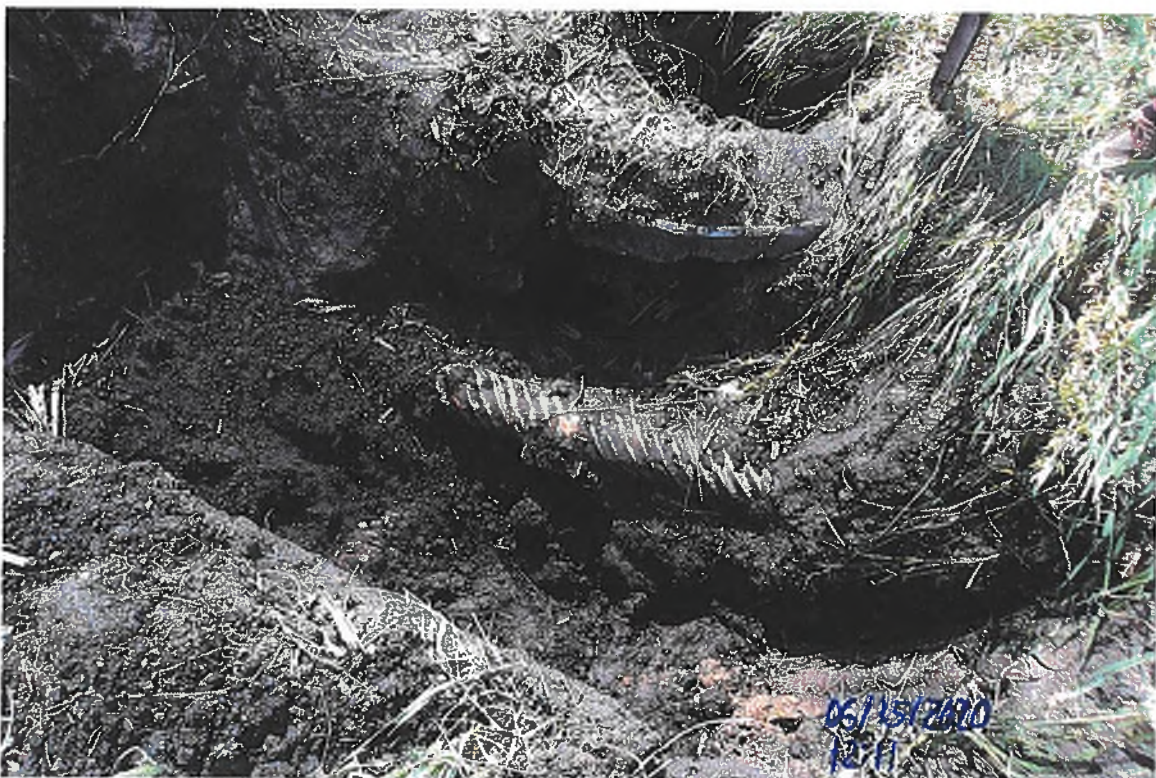
PICTURE # 3747 IS LOOKING SE SHOWING THAT 6" CMP SPIRAL
TILE WILL NOT ALLOW 8" CMP SPIRAL TILE TO BE LIFTED
BACK UP TO FIT 8" CLAY TILE OUTLET IN BEEHIVE WALL.

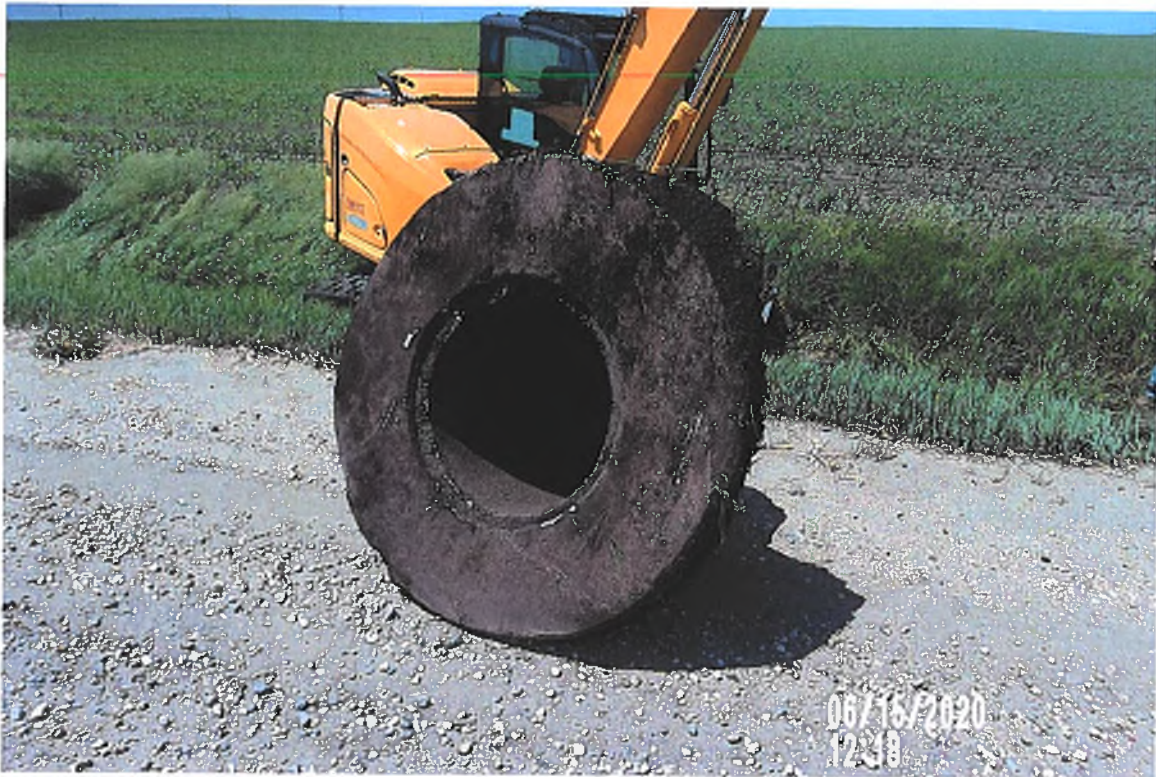
PICTURE # 3748 SHOWING 24" BEEHIVE INTAKE REMOVED
656'± NORTH OF HWY DLS ON WESTSIDE OF AA AVE.

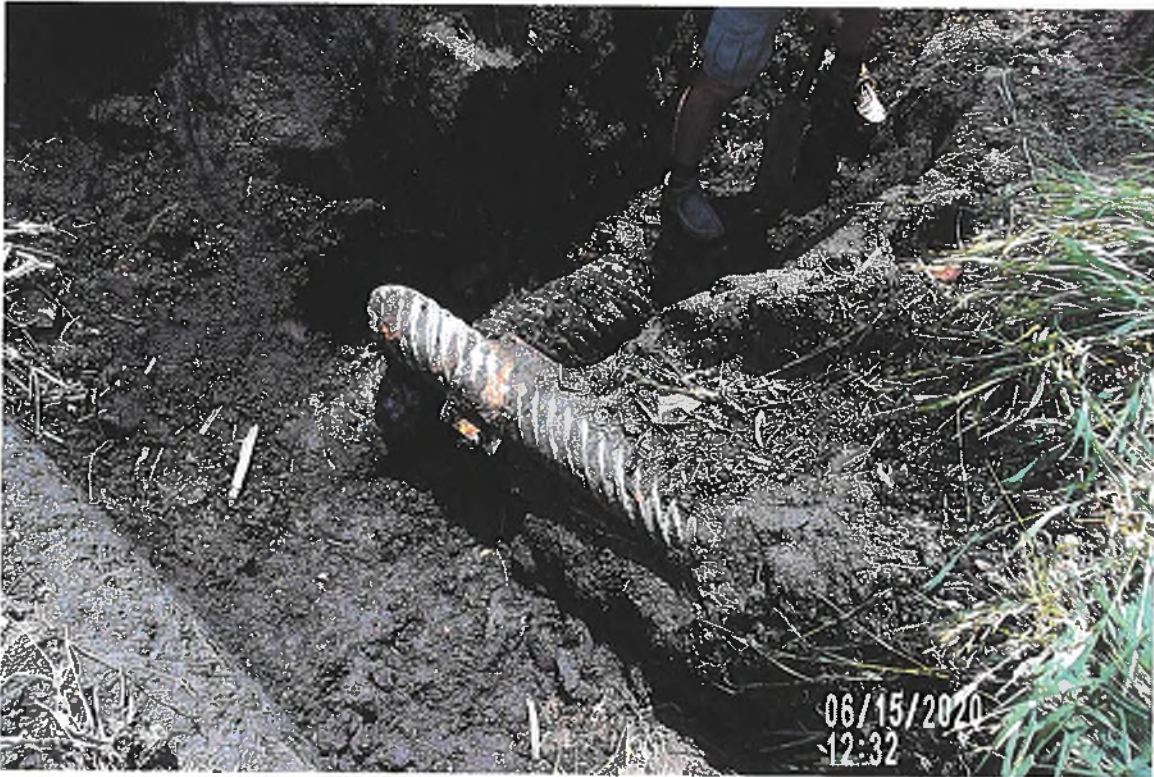
PICTURE # 3749 IS LOOKING SW AT 6" CMP SPIRAL FROM FIELD TIED INTO
8" CMP SPIRAL FROM BEEHIVE INTAKE AFTER BEEHIVE
INTAKE HAS BEEN REMOVED

PICTURE # 3750 IS LOOKING SE SHOWING 6" SPIRAL CMP TIED INTO 8" CMP SPIRAL FROM BEEHIVE INTAKE WITH BAND ON 6" CMP SPIRAL TO 6" CMP SPIRAL 90° ELBOW CONNECTION

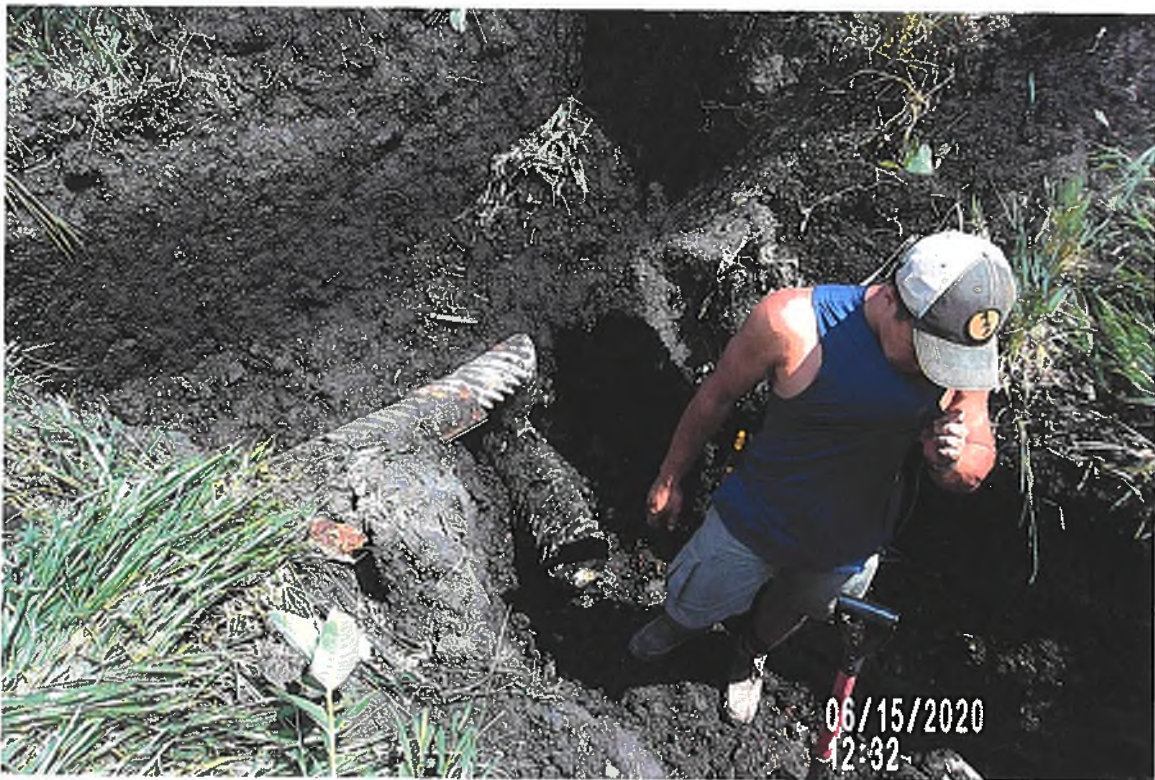
PICTURE #3751 IS LOOKING NE SHOWING 8" SPIRAL CMP AFTER BEEHIVE INTAKE REMOVED

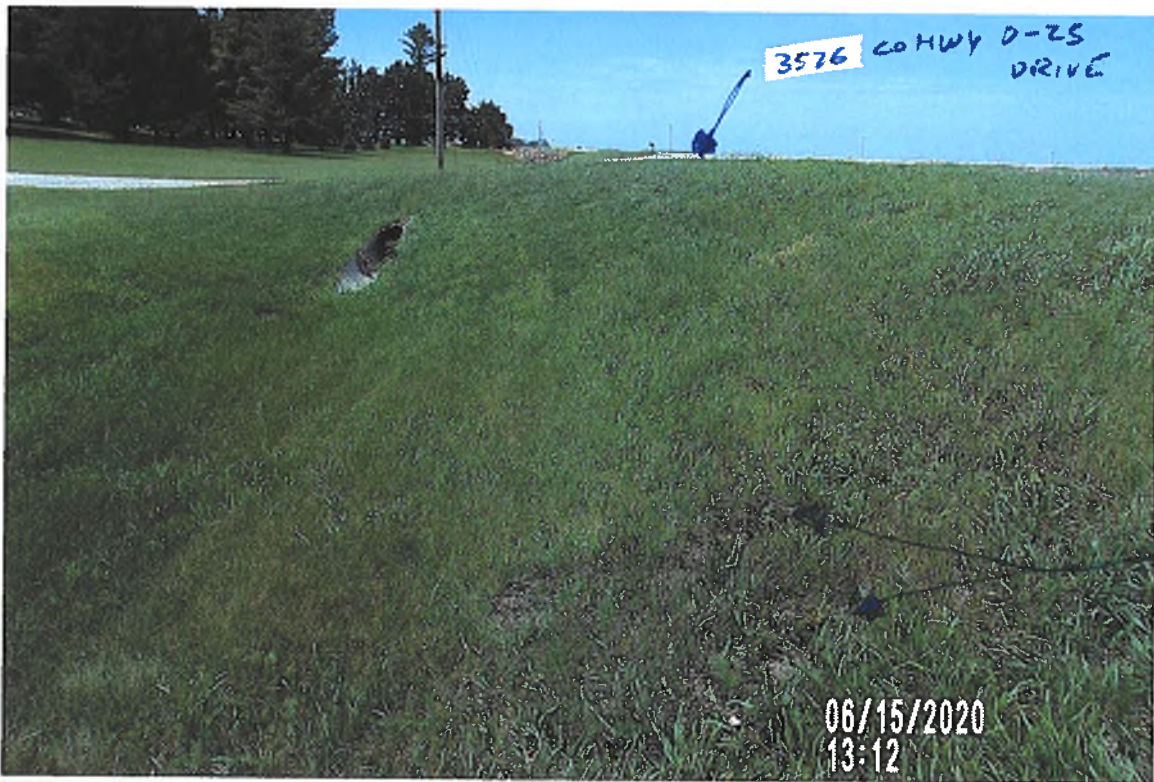
PICTURE#3753 IS LOOKING WEST AT HOLES IN RELATION TO
DRIVEWAY
