AGENDA
REGULAR DRAINAGE MEETING
Wednesday, August 19, 2020 9:30 AM
Large Conference Room

[DD 48 WO 237 - 6486.4 - REPAIR SUMMARY - 08_03_20.PDF](#)

[DD BIG 4 LAT 4 - WO 195 - 5585.1 - REPAIR SUMMARY - 08_03_2020.PDF](#)

[DD BIG 4 MAIN - WO 247 - 5734.1 - REPAIR SUMMARY - 08_03_2020.PDF](#)

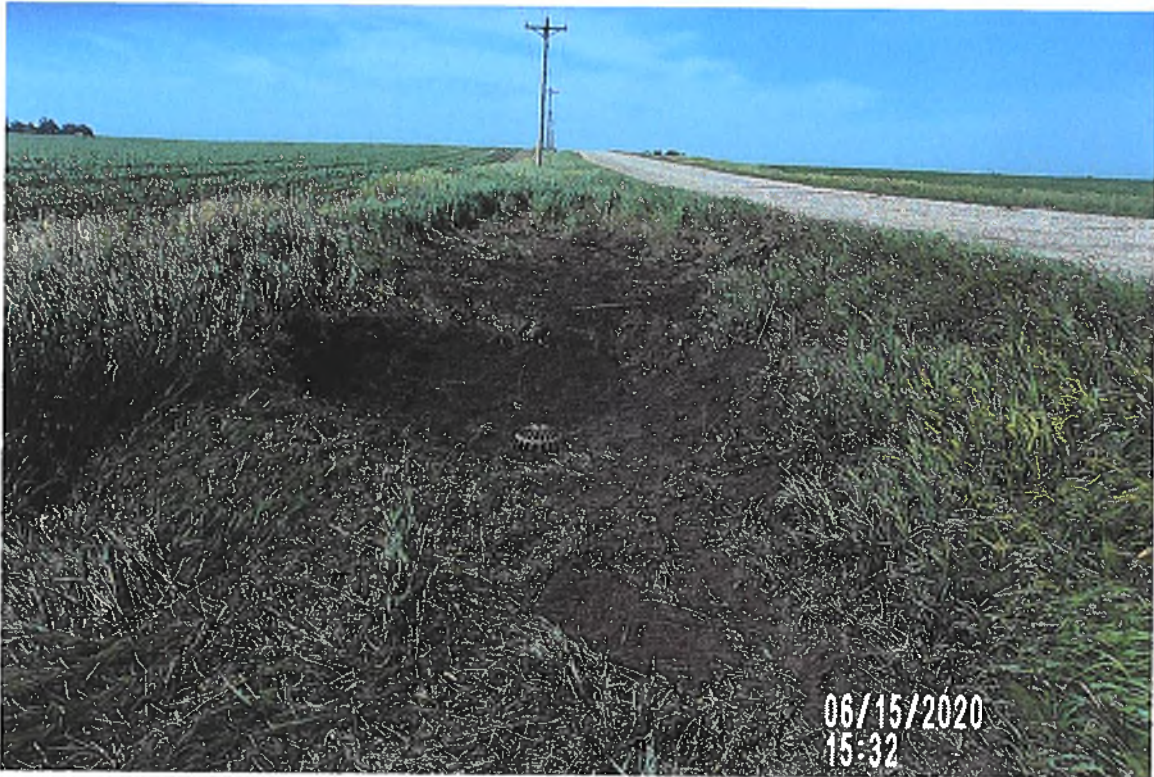
PICTURE # 3754 IS LOOKING NORTH AT 1312'± NORTH OF
60 HWY DLS IN WEST DITCH OF ARAVE SHOWING DITCH GRADED
TO 15" BEEHIVE INTAKE

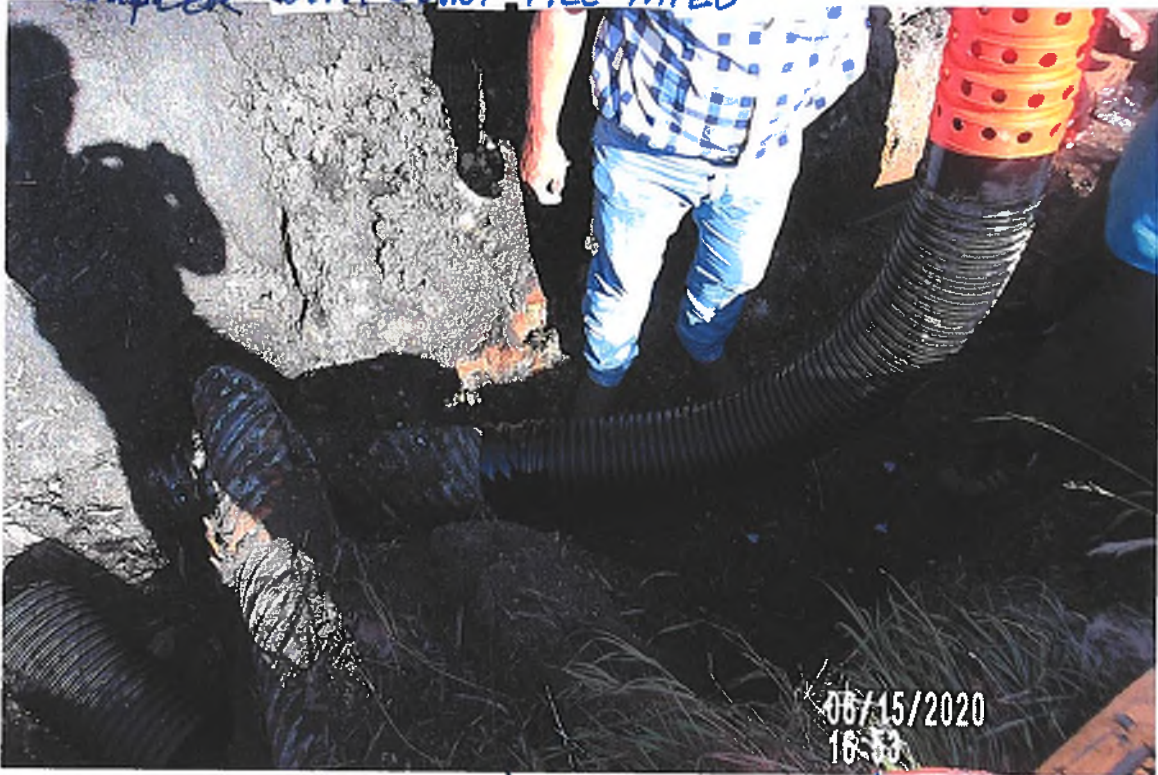
PICTURE # 3755 IS LOOKING SE SHOWING 8" HDPE INTERNAL COUPLER
INSIDE 8" CMP SPIRAL & TILE TAPED TO 8" CMP SPIRAL

PICTURE #3756 IS LOOKING SE SHOWING 4.5 LF OF 8" SW HOPE
 PERF TILE INSTALL ON 8" HOPE INTERNAL SNAP COUPLER (TILE TAPED)
 WITH 3.0' ORANGE HICKEN BOTTOM ON TOP WITH 8" INTERNAL SNAP
 COUPLER WITH JOINT TILE TAPED

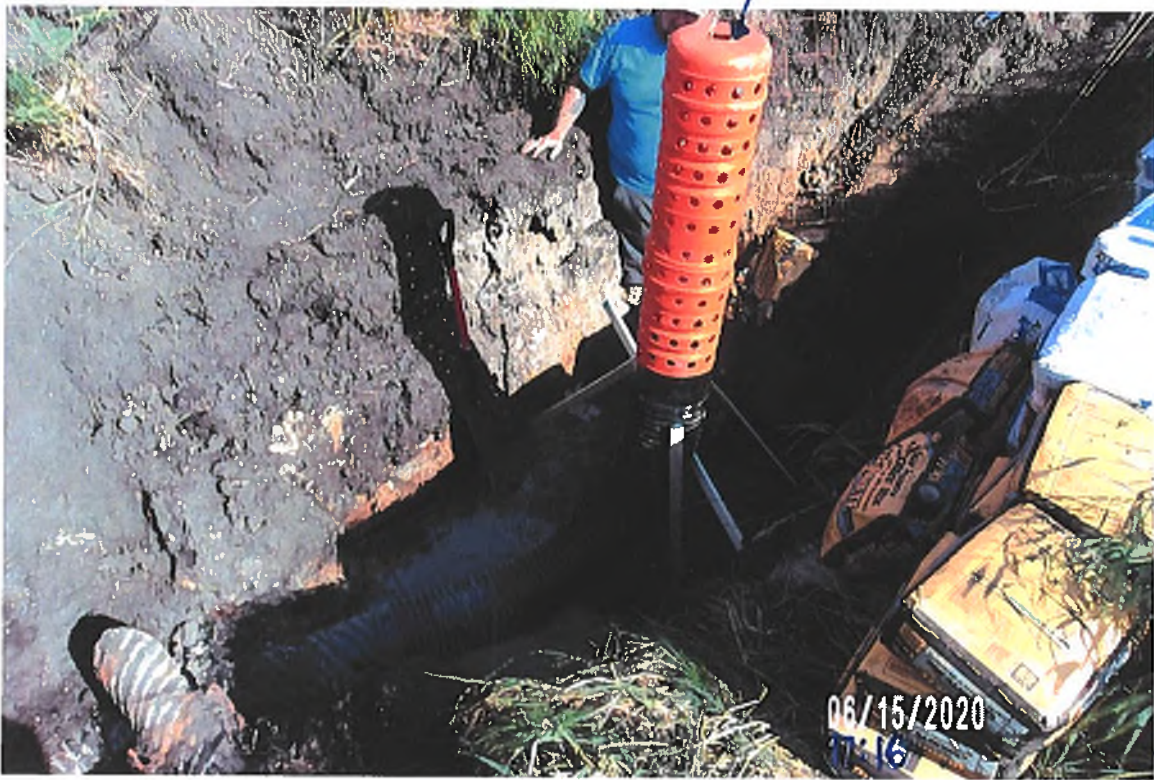
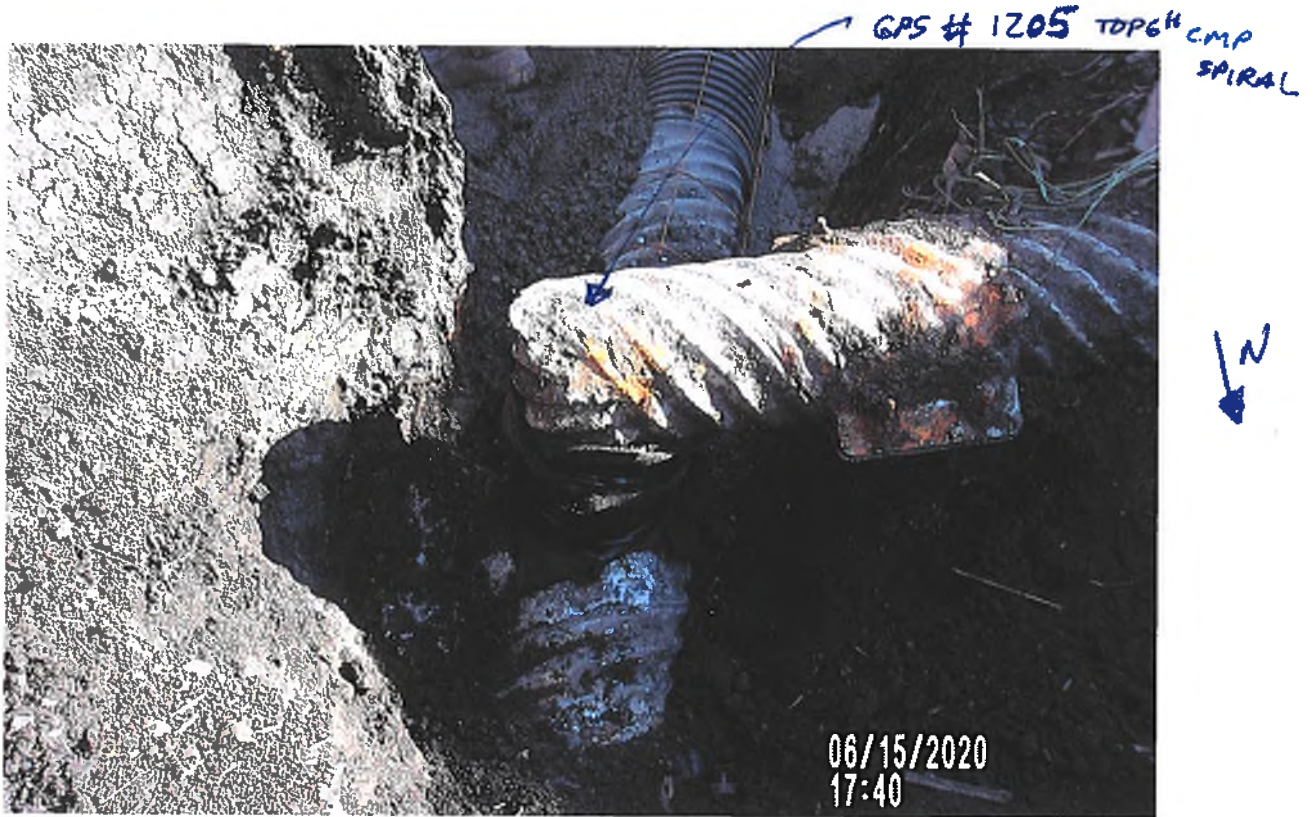
PICTURE # 3757 IS LOOKING SW SHOWING HICKEN BOTTOM BRACED
 UP. BOTTOM OF TRENCH HAD GOOD CLAY BOTTOM. CREW PLACED
 A QUICKRETE BAG DRY UNDER TILE FIRST.

PICTURE # 3758 IS LOOKING SE SHOWING 8" HICKEN BOTTOM SUPPORTED UP BEFORE CONCRETE POURED. GPS 1212 TOP 8" HICKEN BOTTOM

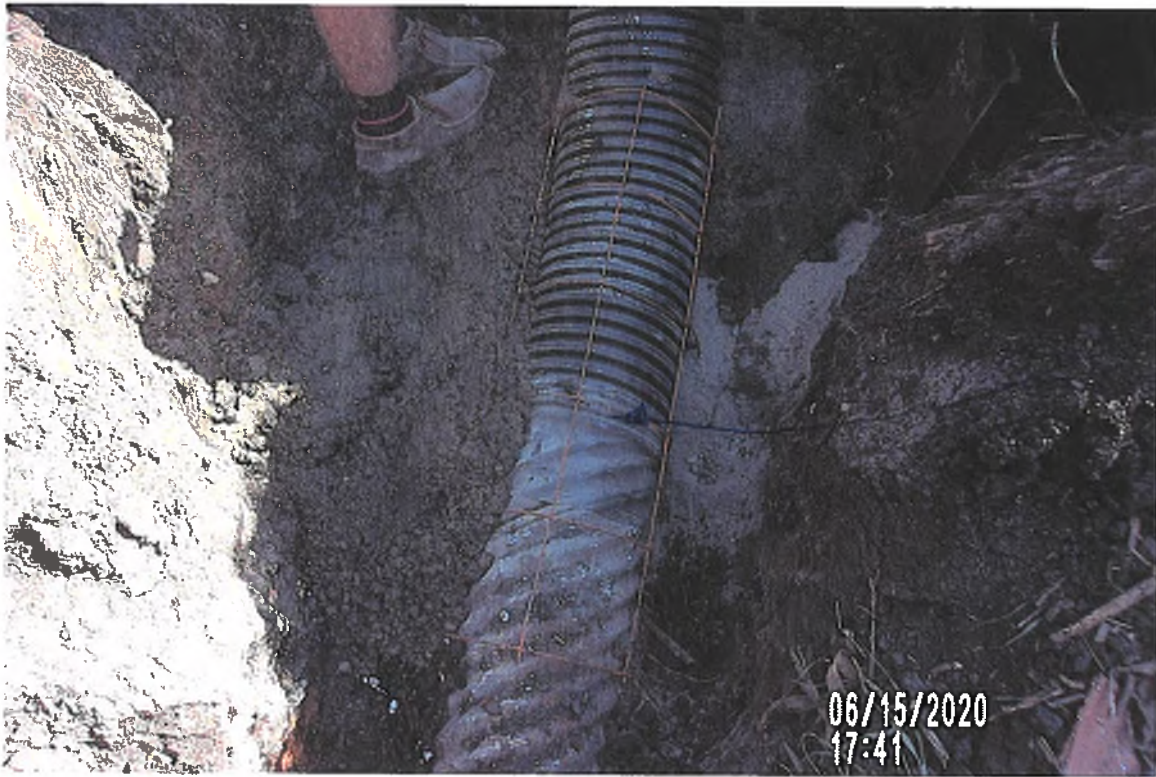
PICTURE # 3759 IS LOOKING SW SHOWING 6" 90° CMP SPIRAL TIE IN INTO 8" CMP SPIRAL WRAPPED WITH FABRIC & TILE TAPED BEFORE CONCRETE COLLAR POURED,

PICTURE # 3761 IS LOOKING SW SHOWING 1.5' X 2.5' 6" X 6" WIRE MESH AROUND CONNECTION BEFORE CONCRETE POURED

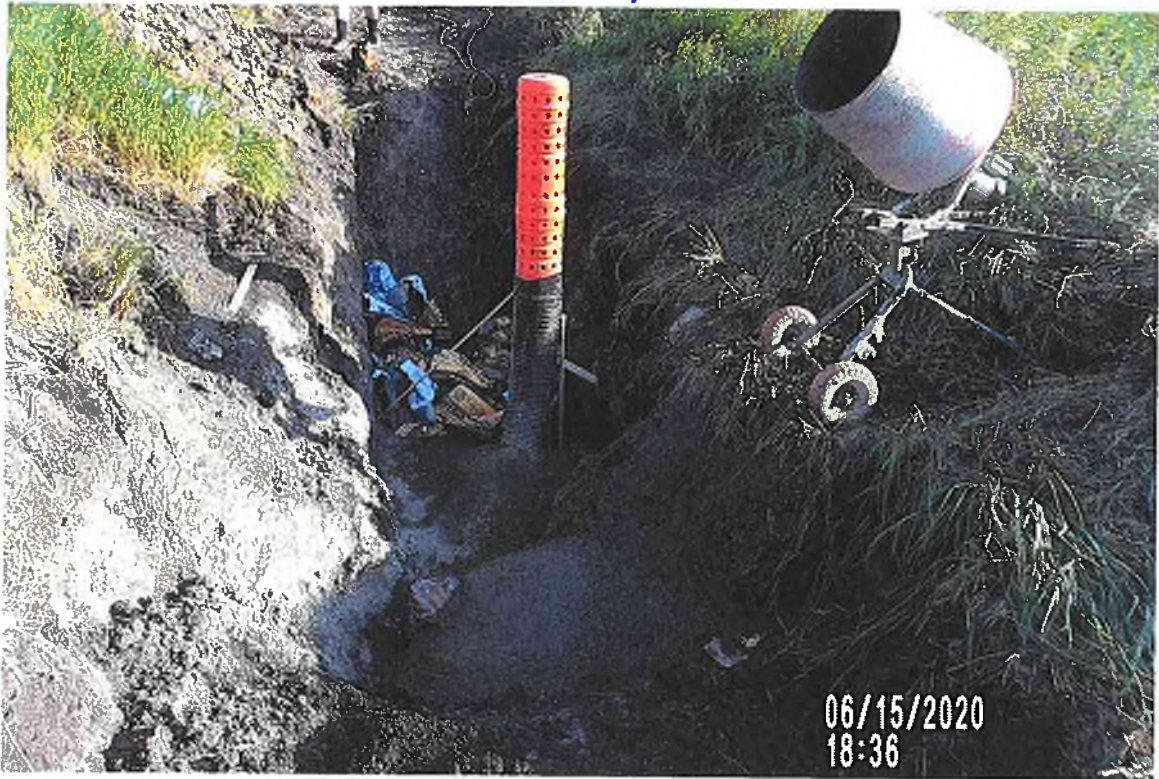
PICTURE # 3762 IS LOOKING SOUTH SHOWING 1.0' X 2.0' 6" X 6" WIRE MESH AROUND 6" TO 8" CMP SPIRAL CONNECTION BEFORE CONCRETE POURED.

PICTURE #3763 IS LOOKING SW SHOWING PARTIAL CONCRETE COLLARS POURED. CREW RAN OUT OF CONCRETE AND WILL FINISH TOMORROW,

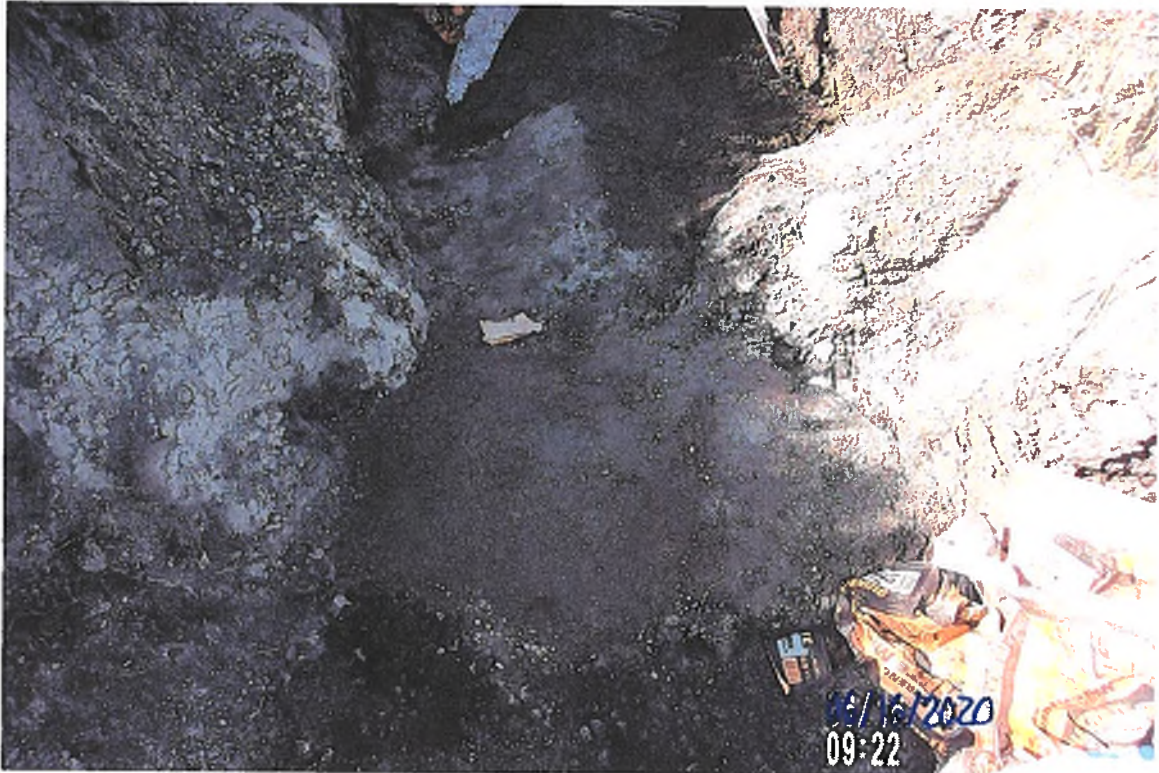
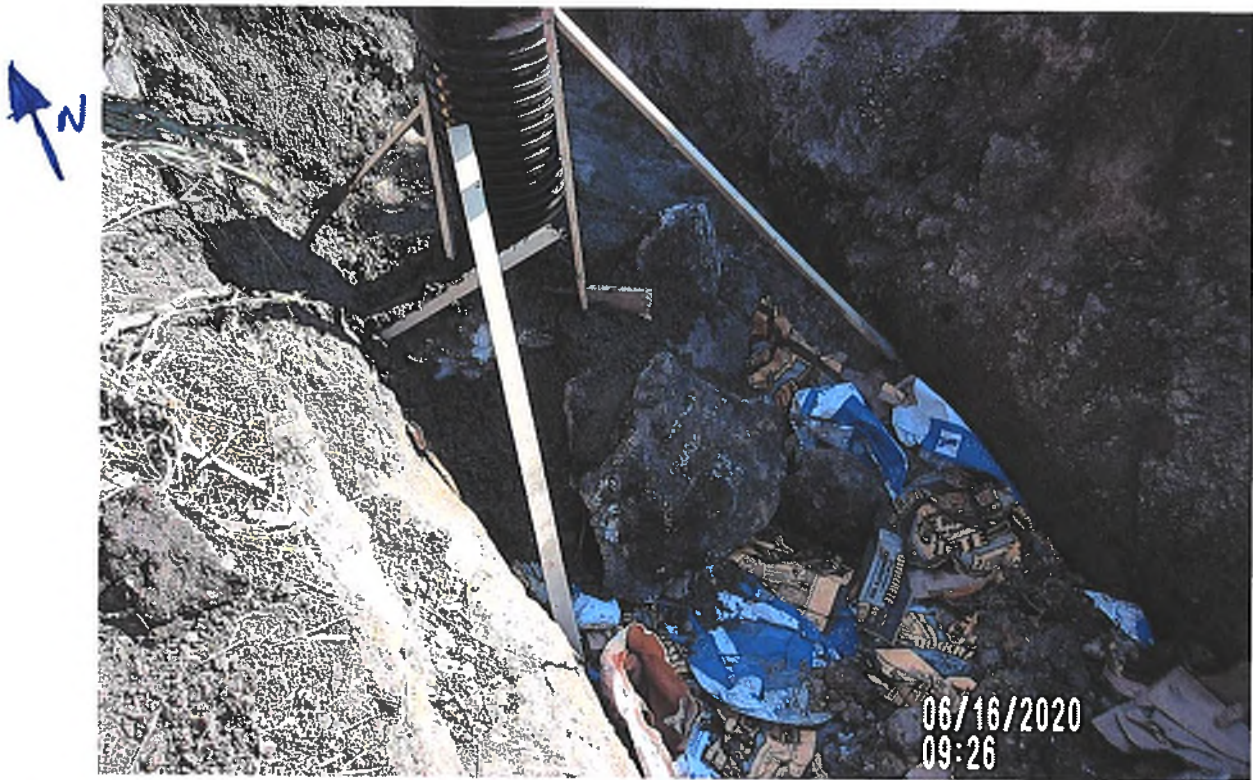
PICTURE # 3766 IS LOOKING SW SHOWING CONCRETE COLLAR FINISHED AROUND 6" 90° CMP SPIRAL ELBOW TO 8" CMP SPIRAL TO 8" HOPE SW PERF TILE.

PICTURE # 3767 IS LOOKING NE SHOWING OLD CONCRETE CHUNKS CONCRETED IN TO SUPPORT 8" SW HOPE PERF TILE FOR 8" HICKEN BOTTOM INTAKE.

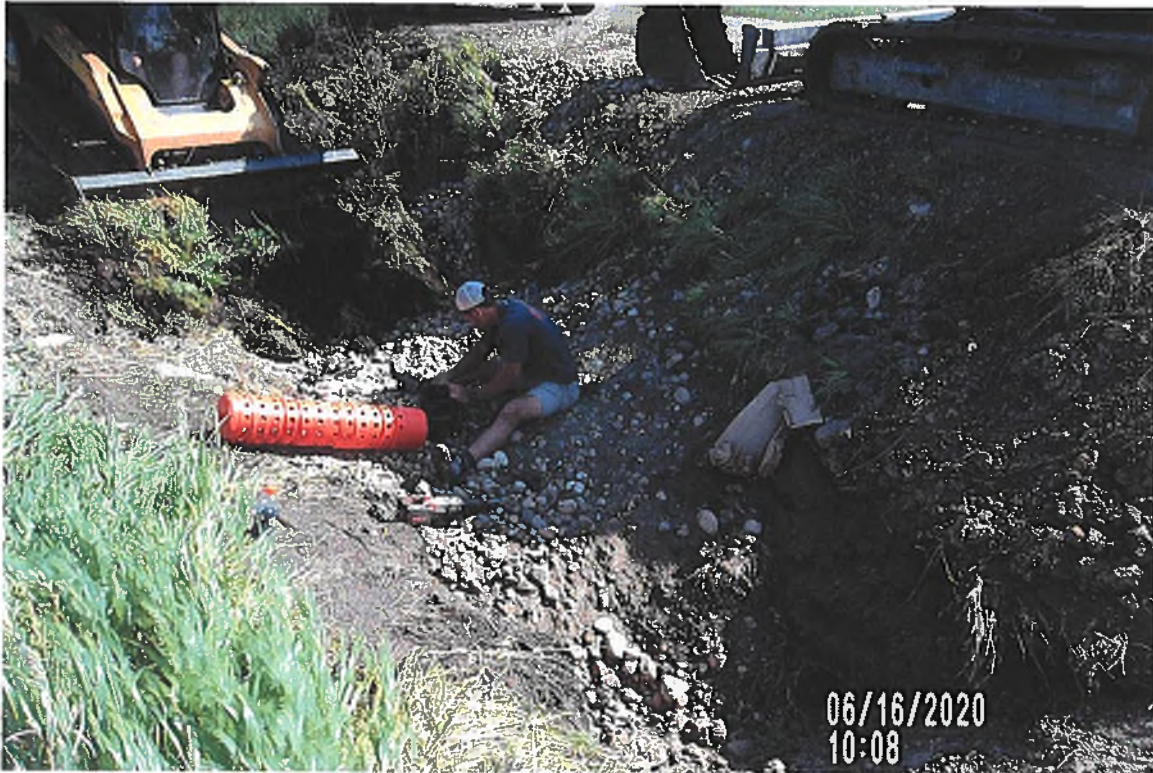
PICTURE # 3769 IS LOOKING NE SHOWING CREW TRIMMING DOWN 8" SW HOPE PERF TILE SO 3.0' HICKEN BOTTOM TOP SITS A LITTLE LOWER. PICTURE SHOWS CREW GRADING TO 8" HICKEN BOTTOM.

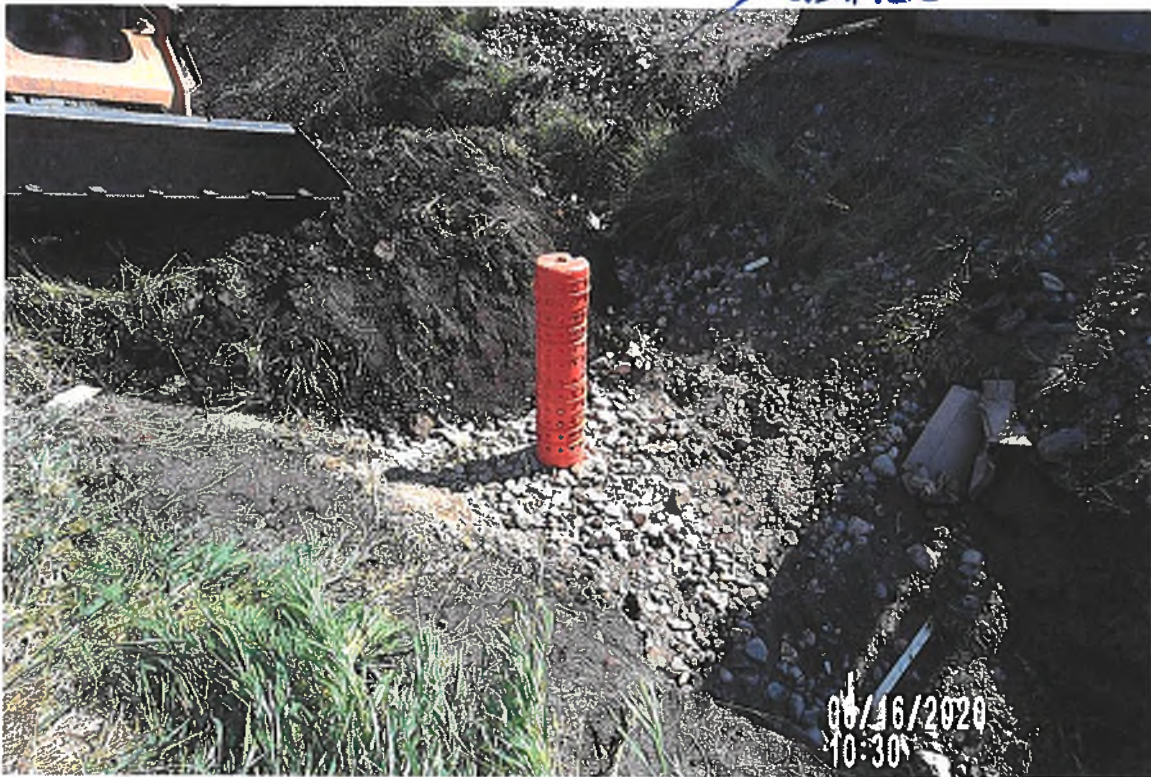
PICTURE # 3770 IS LOOKING NE SHOWING 8" HICKEN BOTTOM IN PLACE WITH OVERSIZED ROCK AROUND 8" HICKEN BOTTOM.

PICTURE # 3771 IS LOOKING SOUTH AT DITCH GRADED TO NEW 8" HICKEN BOTTOM INTAKE.

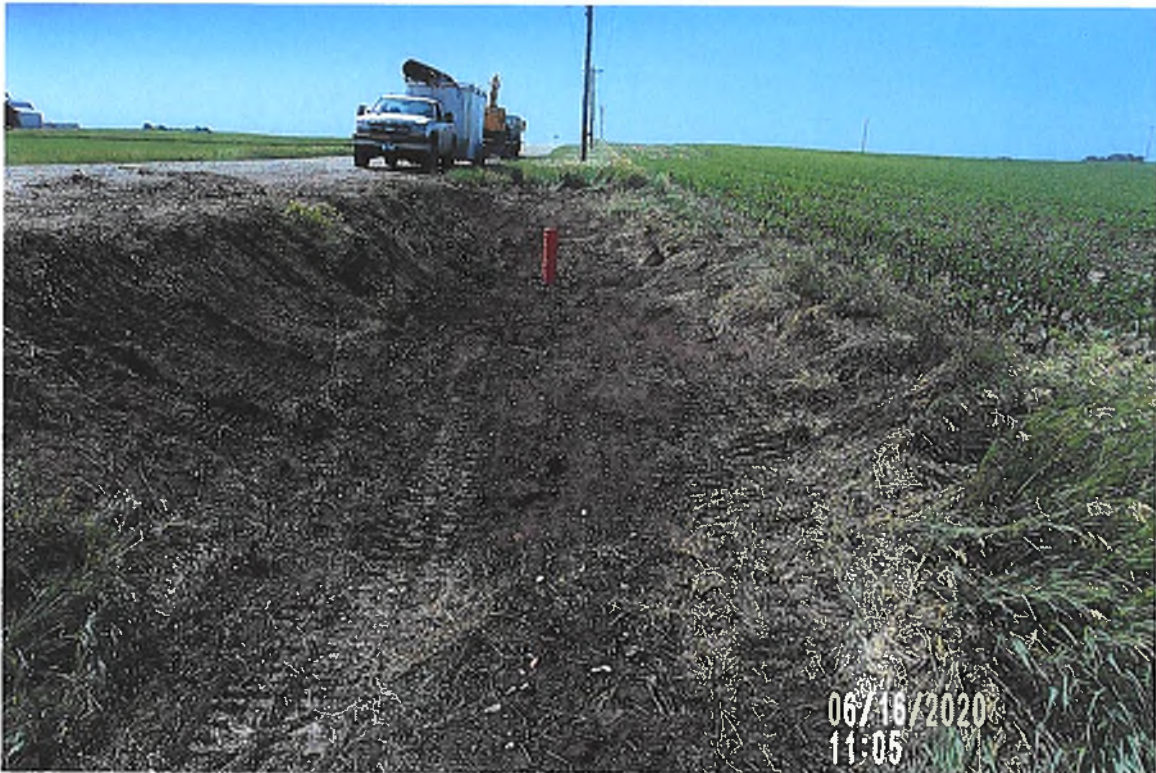
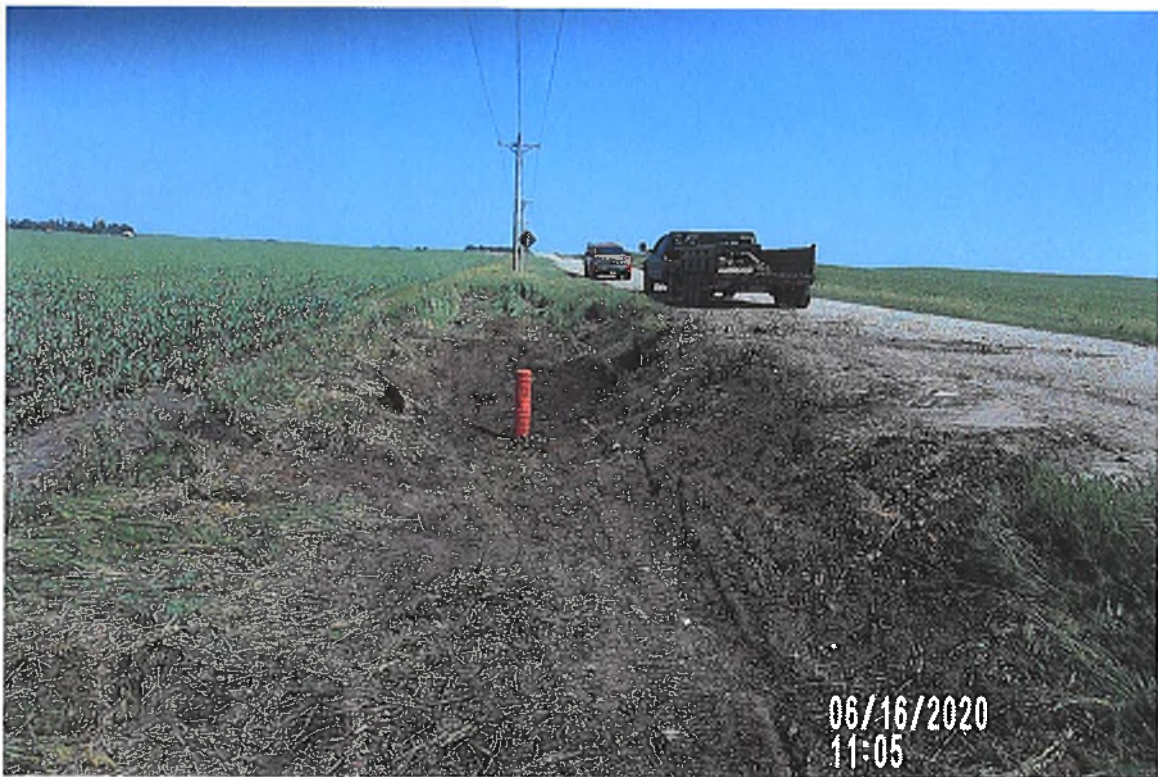
PICTURE # 3772 IS LOOKING NORTH SHOWING DITCH GRADED TO NEW 8" HICKEN BOTTOM INTAKE & SHOWS DITCH GRADED FROM 36" R/P TO NEW 8" HICKEN BOTTOM

PICTURE #1 ROCK USED TO BACK FILL
 AROUND NEW 8" HICKEN BOTTOM INTAKE,
