AGENDA
REGULAR DRAINAGE MEETING
Wednesday, August 26, 2020 9:30 AM

Repair Summary:

SE NE 30-88-22 REPAIR SMASHED
END OF EXISTING 24" CMP INLET &
INSTALL NEW 24" CMP WITH ANTISEEP COLLAR
IN BLOWOUT

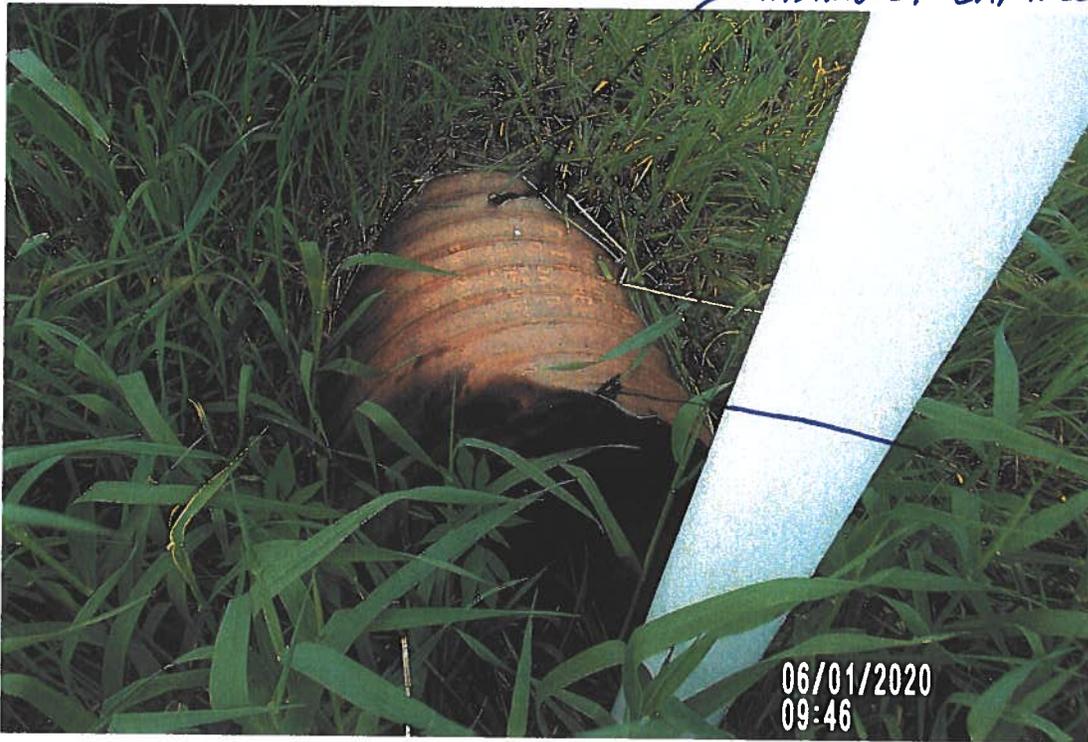
PICTURE# 3617 IS LOOKING SW SHOWING END OF 24" CMP ON SURFACE DRAIN INLET CRUSHED FROM (7 TO 2) AND ABOUT 1.5' BACK WITH A CUT FROM (12 TO 2) ON TOP, EXISTING 24" CMP INLET THAT

SOMETHING TORE INTO CMP.

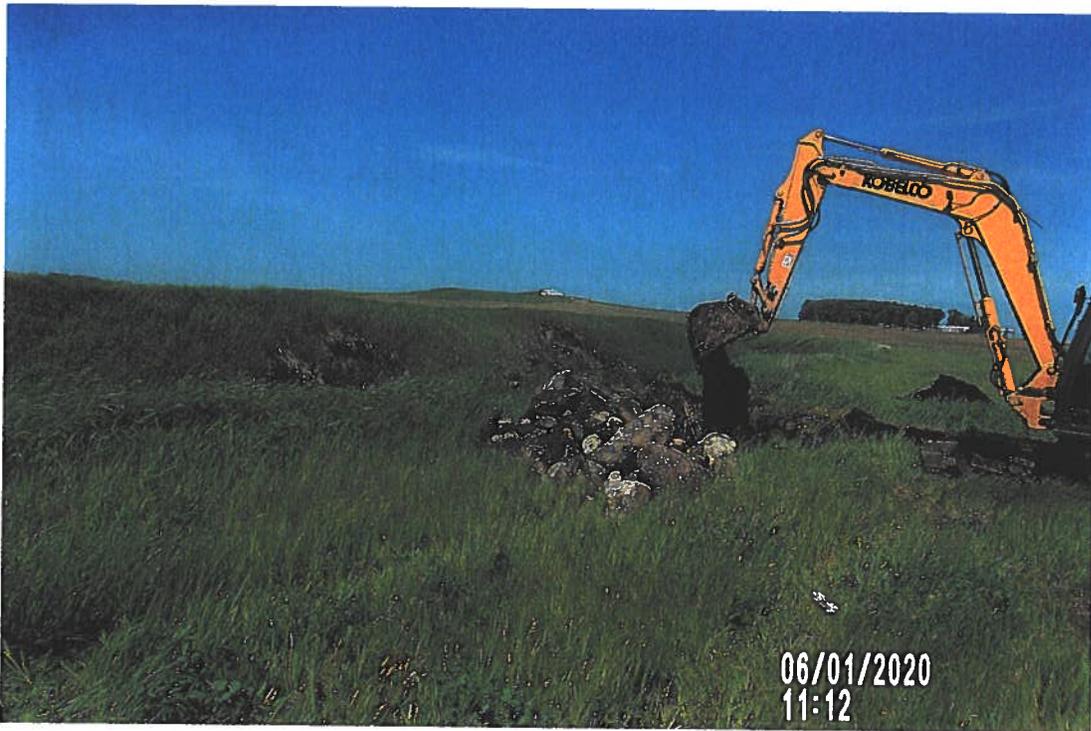
CPS #70500
FL EXISTING
24" CMP

PICTURE# 3618 IS LOOKING NW SHOWING CREW REMOVING BOULDERS SET IN DRAINAGE DITCH WASHOUT AND GRADING BOTTOM OF TRENCH FOR NEW 24" CMP SURFACE DRAIN.

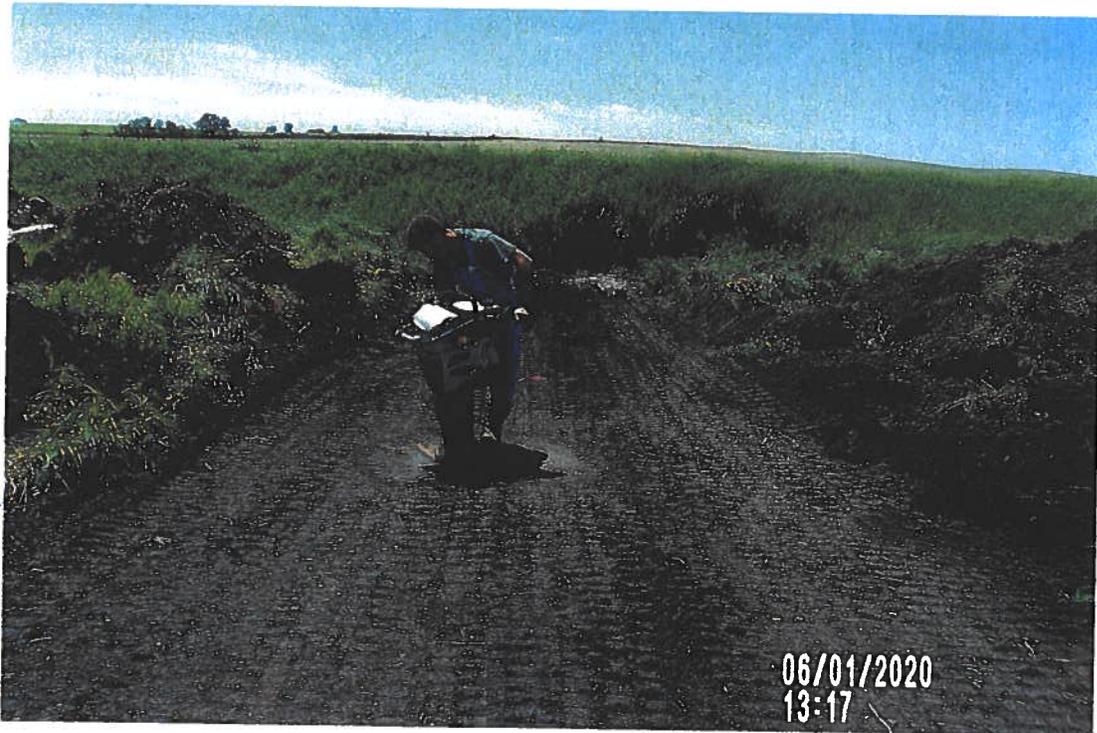
PICTURE# 3620 IS LOOKING SW SHOWING CREW JUMPING JACK COMPACTING BOTTOM OF TRENCH FOR NEW 24" CMP SURFACE DRAIN

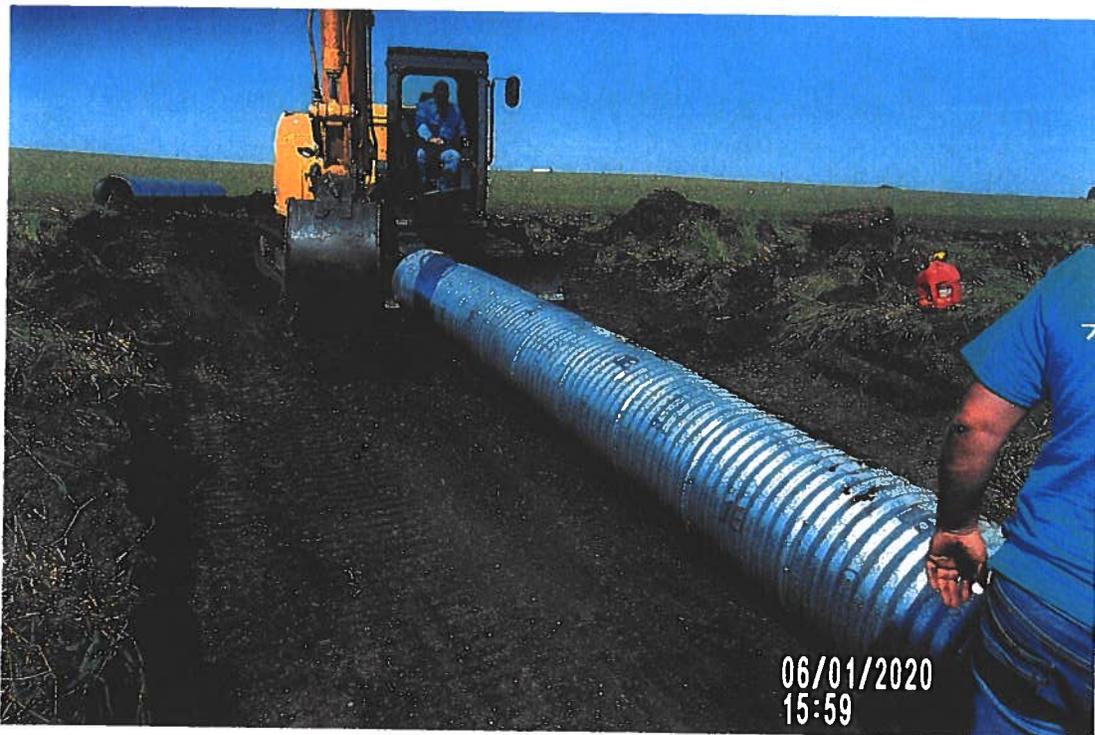
PICTURE #3622 IS LOOKING NE SHOWING CREW PUSHING IN NEW CMP AFTER BOTTOM OF TRENCH GRADED AND JUMPING JACK COMPACTED.

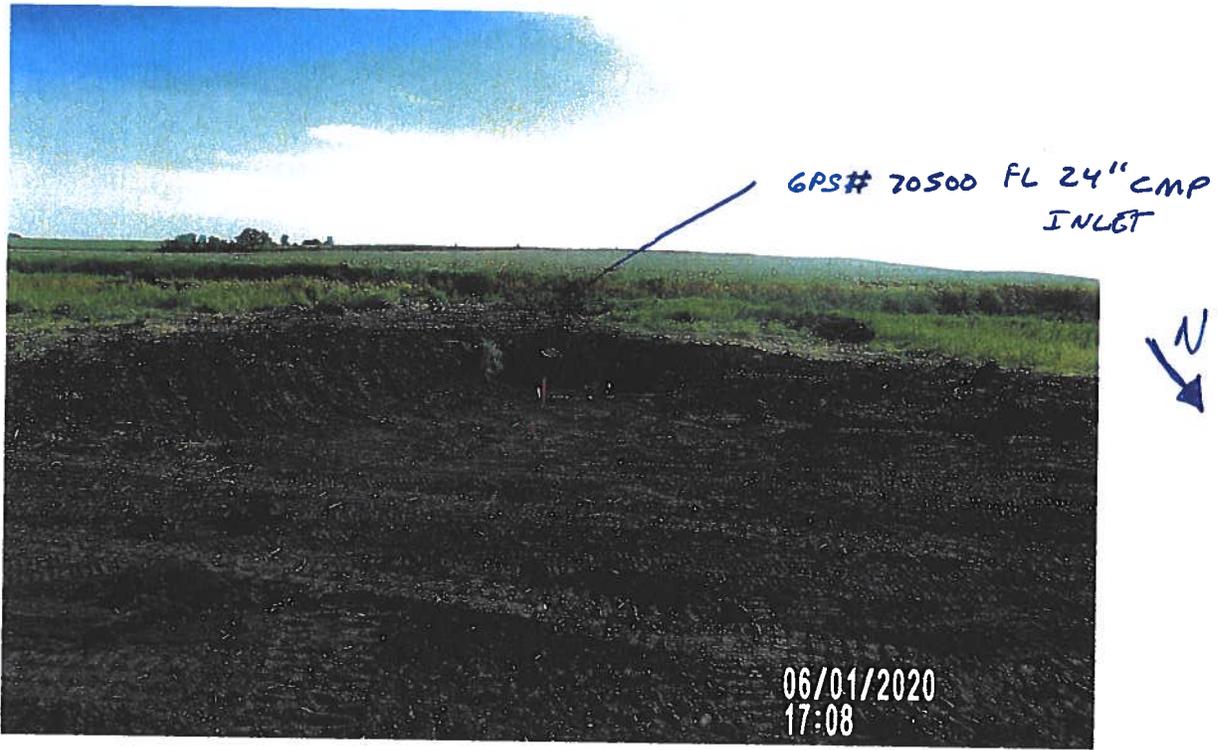
PICTURE # 3628 IS LOOKING SE AT OUTLET END OF NEW 24" CMP OUTLET INTO DITCH. PIPE IS BACKFILL AROUND PIPE AND STILL NEEDS MORE COMPACTING.

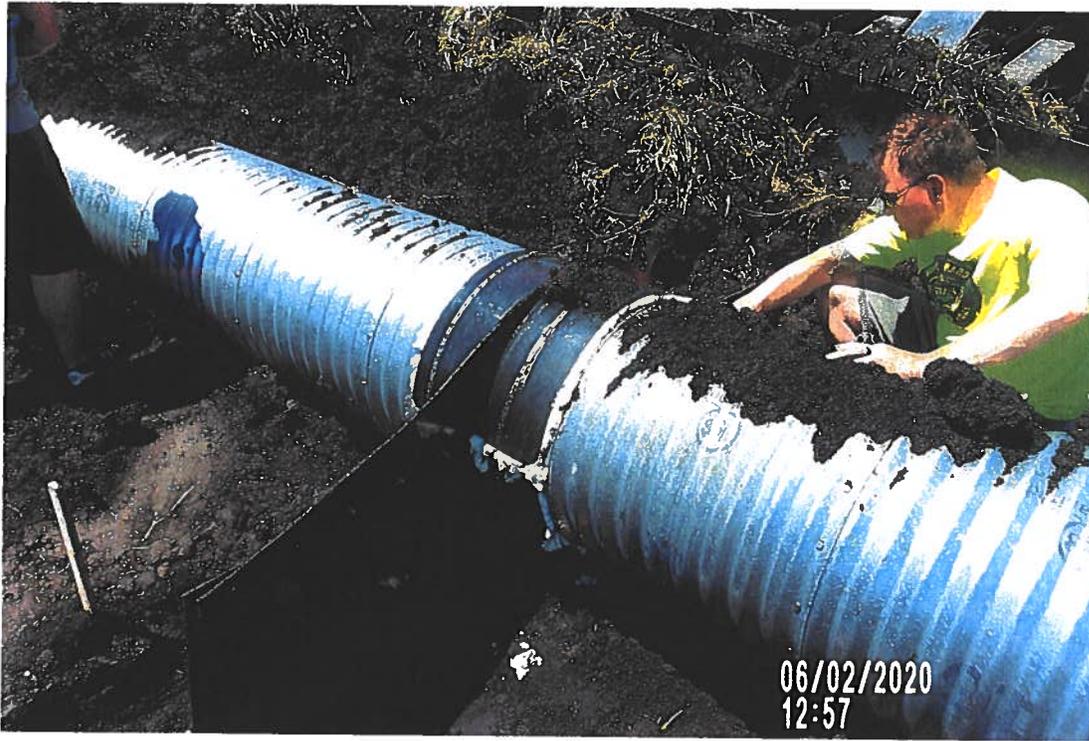
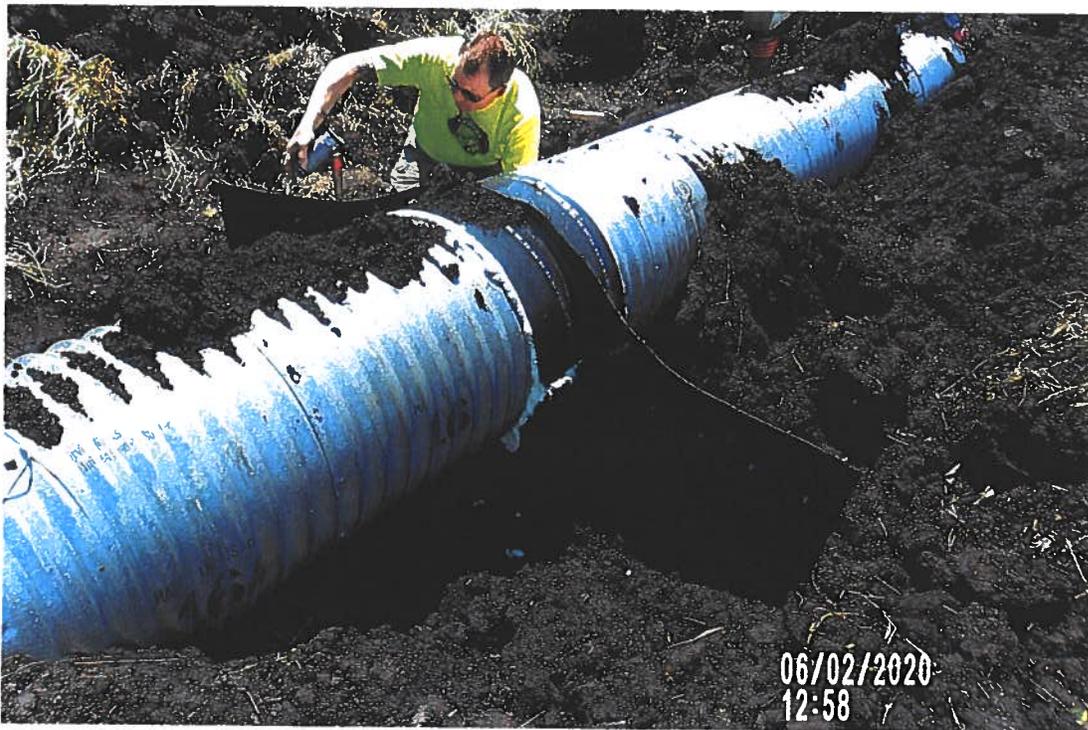
PICTURE # 3636 IS LOOKING EAST SHOWING CREW USING FOAM FILL TO SEAL BETWEEN HDPE ANTISEEP COLLAR AND 24" CMP SURFACE DRAIN, (SUDAS SHOWS SHOULD BE BITUMINOUS MATERIAL)

PICTURE # 3637 IS LOOKING SE SHOWING CREW USING FOAM FILL TO SEAL BETWEEN HDPE ANTISEEP COLLAR AND 24" CMP SURFACE DRAIN. (SUDAS SHOWS SHOULD BE BITUMINOUS MATERIAL)

PICTURE # 3638 SHOWING FOAM FILL USED TO SEAL VOID BETWEEN HDPE ANTISEEP COLLAR AND CMP SURFACE DRAIN (OBSERVER INFORMED CREW THAT SUDAS CALLS FOR BITUMINOUS MATERIAL AND THIS IS WHAT CREW BROUGHT BACK)

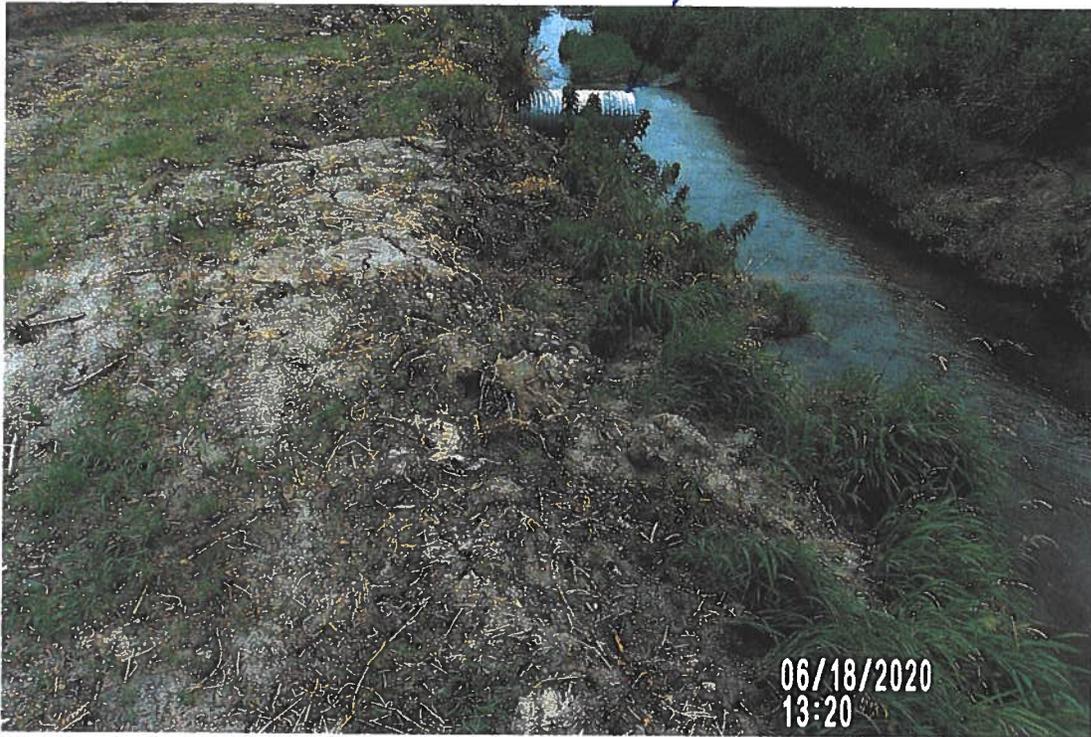
GPS 70506 NEW 24" CMP OUTLET

PICTURE# 3831 IS LOOKING SE SHOWING DD NORTH BANK
NEEDING DRESS UP YET

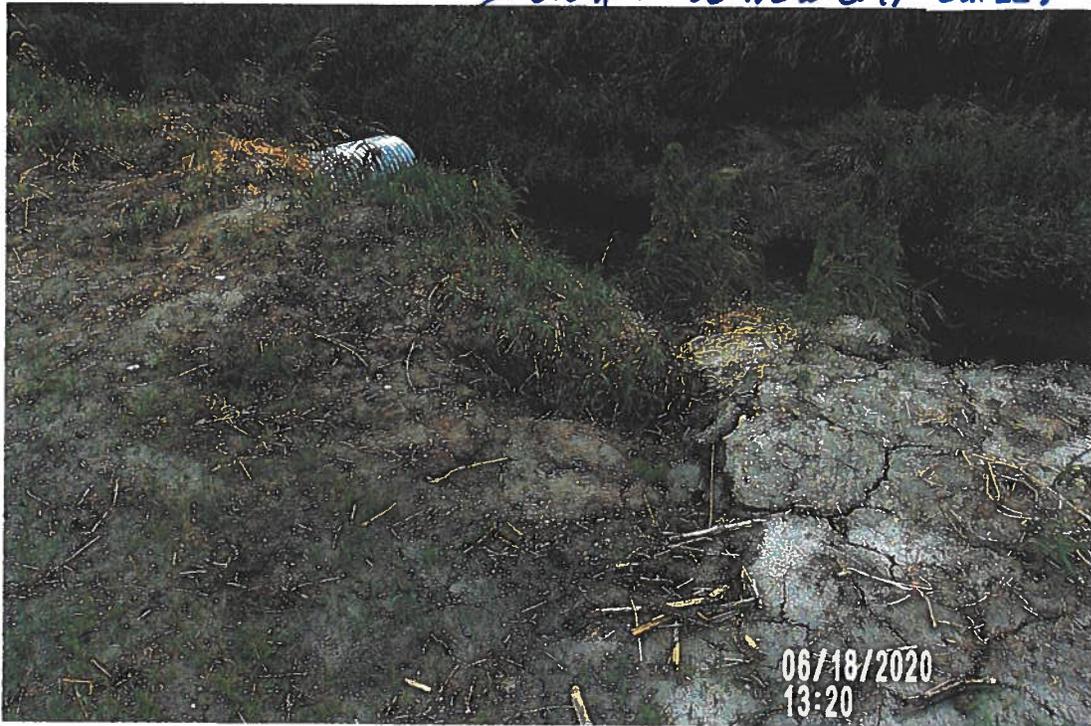
GPS # 70506 NEW CMP OUTLET

PICTURE# 3832 IS LOOKING SE SHOWING DD NORTH BANK
NEEDING DRESSED UP ON WEST SIDE OF NEW CMP
OUTLET

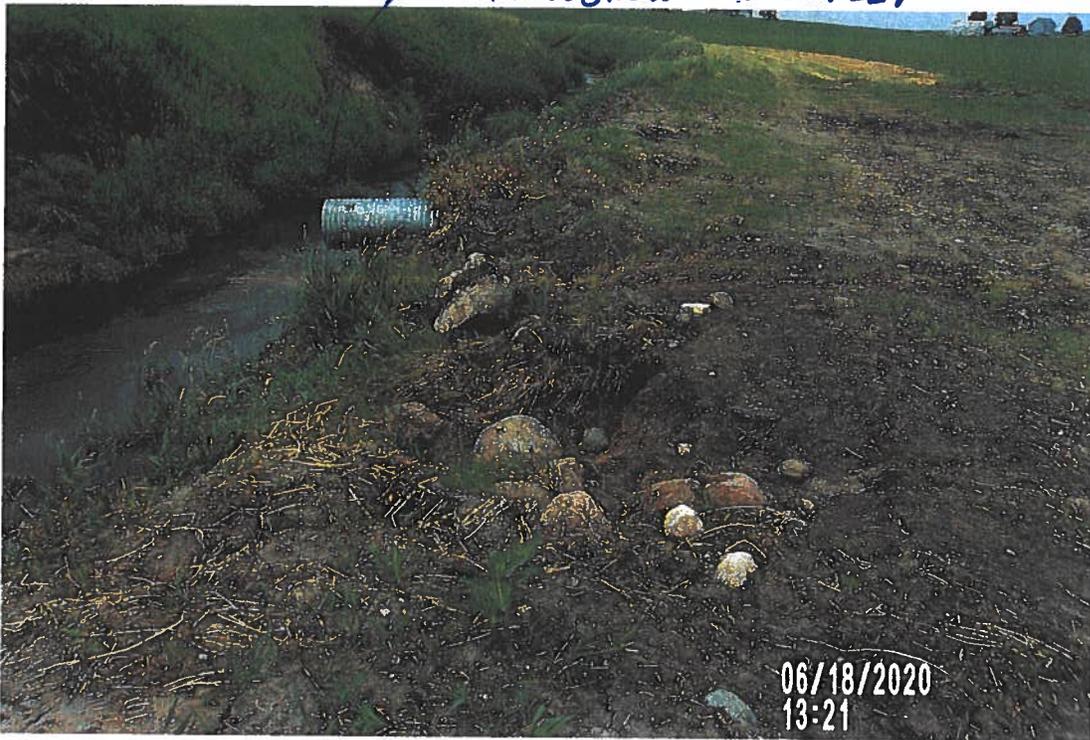
PICTURE #3833 IS LOOKING NW SHOWING BOULDERS IN DD BANK FOR A FILLED IN WASHOUT BETWEEN NEW AND EXISTING SURFACE DRAIN. NEEDS DRESSED UP / GPS#70506 NEW CMP OUTLET

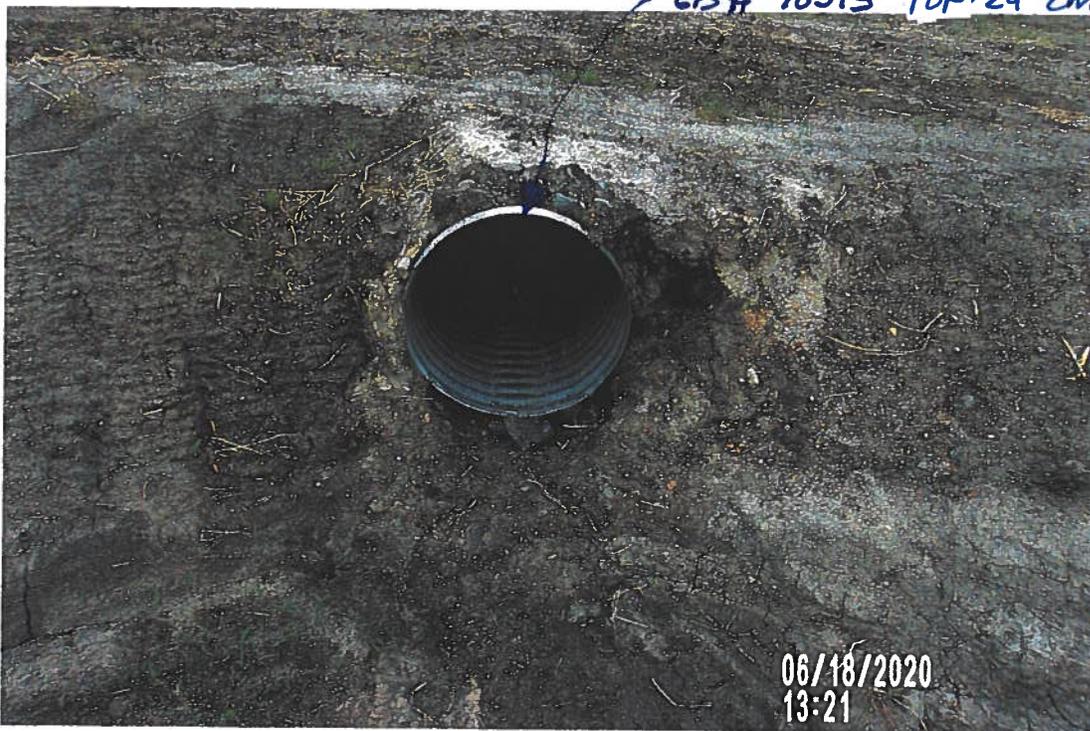
GPS# 70515 TOP 24" CMP INLET
2.05' TOP TO FL

PICTURE #3834 IS LOOKING SW AT NEW SURFACE DRAIN INLET WITH WATER STARTING TO ERODE UNDER CMP

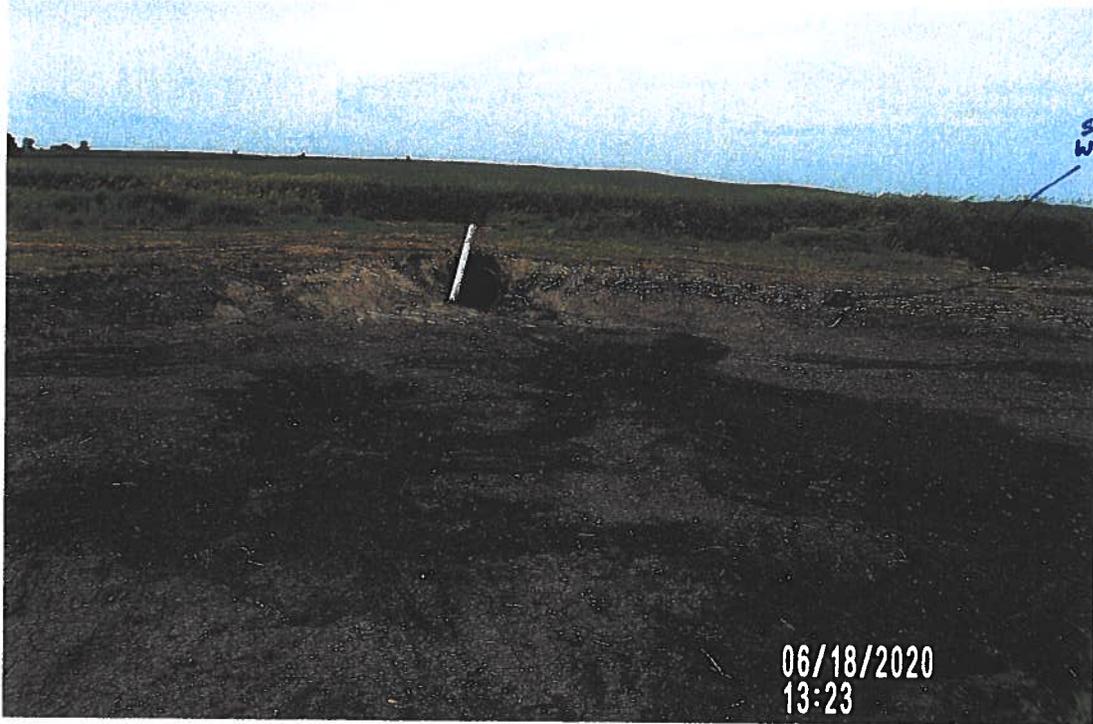
AREA SETTLED WHERE CREW EXCAVATED FOR SOME BETTER SOIL TO BACKFILL AROUND SURFACE DRAINS

SMALL WASHOUT WITH ROCKS IN IT

CORN STALKS ON TOP WHERE WATER WENT OVER AND RAN TO WASHOUT

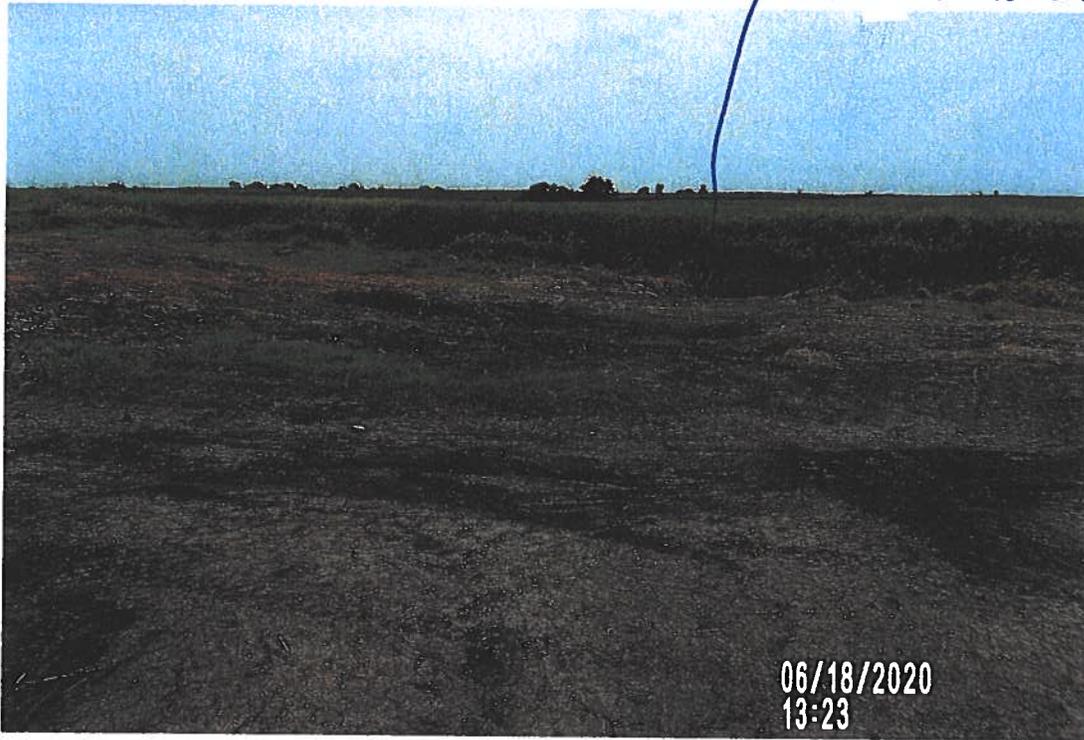
PICTURE # 3837 LOOKING SOUTH AT LOW AREA WHERE GRASS NOT GROWING VERY WELL,

DD BANK ERODED FROM WATER RUNNING TO DD SMALL WASHOUT WITH BOULDERS MAY NEED TO GRADE LOW AREA TO GET FLOW TO SURFACE DRAIN BY ADDING MORE SOIL

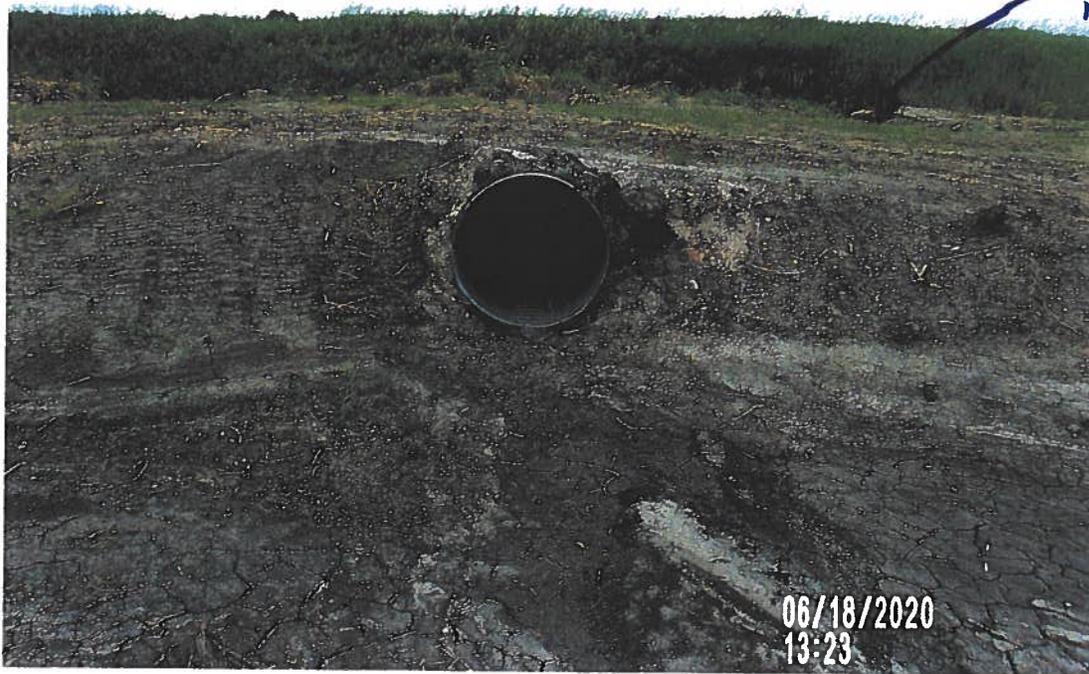
DD BANK NEEDS DRESSED UP

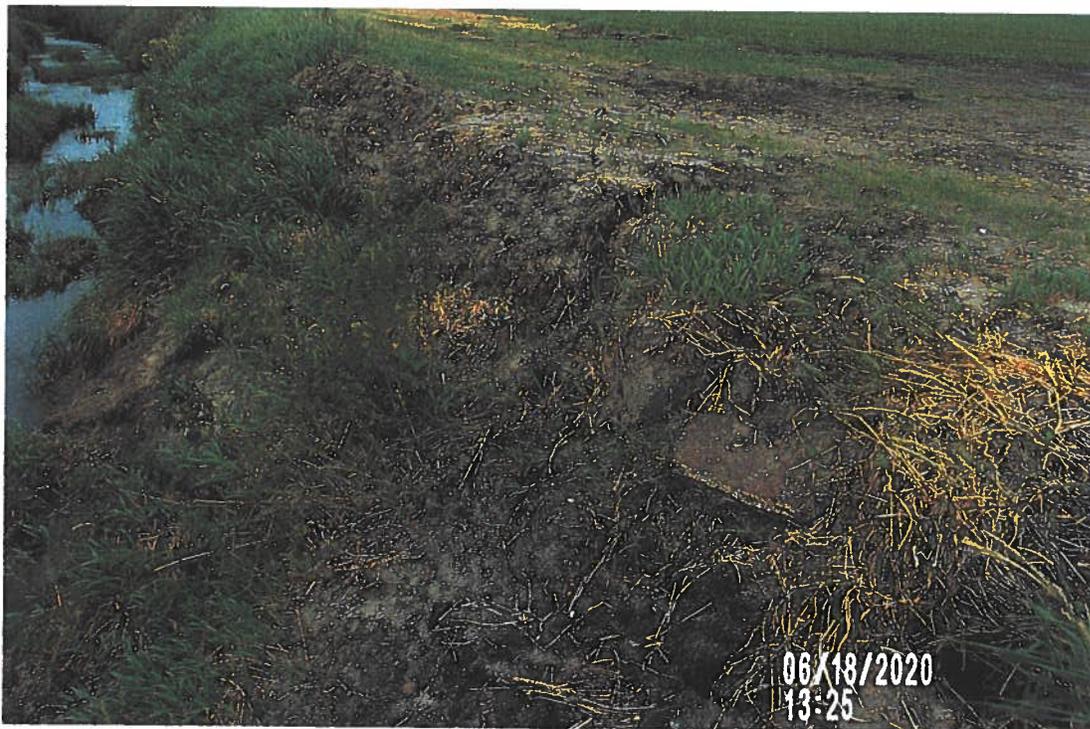
PICTURE # 3839 IS LOOKING NW SHOWING AREA
ALONG FIELD NW OF NEW 24" CMP WHERE GOOD SOIL
WAS EXCAVATED FOR BACK FILL AROUND CMP AND BACK FILLED

AREA
HAS
SETTLED
NOW

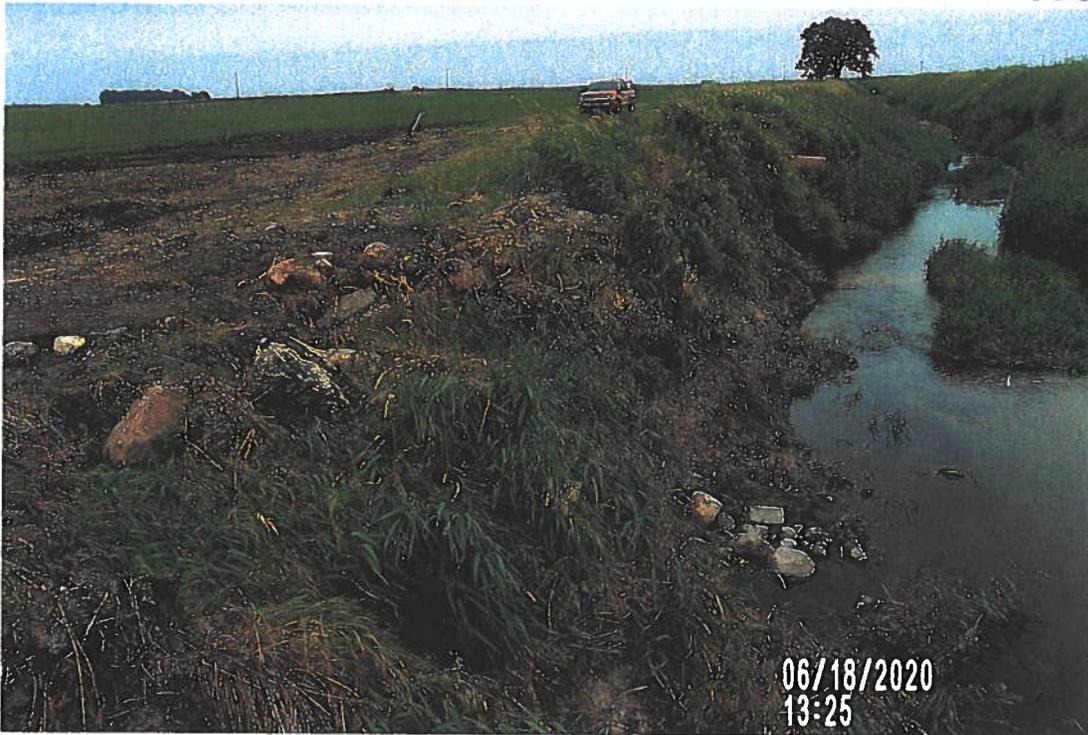
PICTURE #3841 IS LOOKING SE SHOWING DD BANK BETWEEN
EXISTING AND NEW OUTLET NEEDING DRESSED UP WITH SOIL IN
WASHOUT FILLED WITH BOULDER AND ALL BOULDERS TAPPED

INTO
BANK

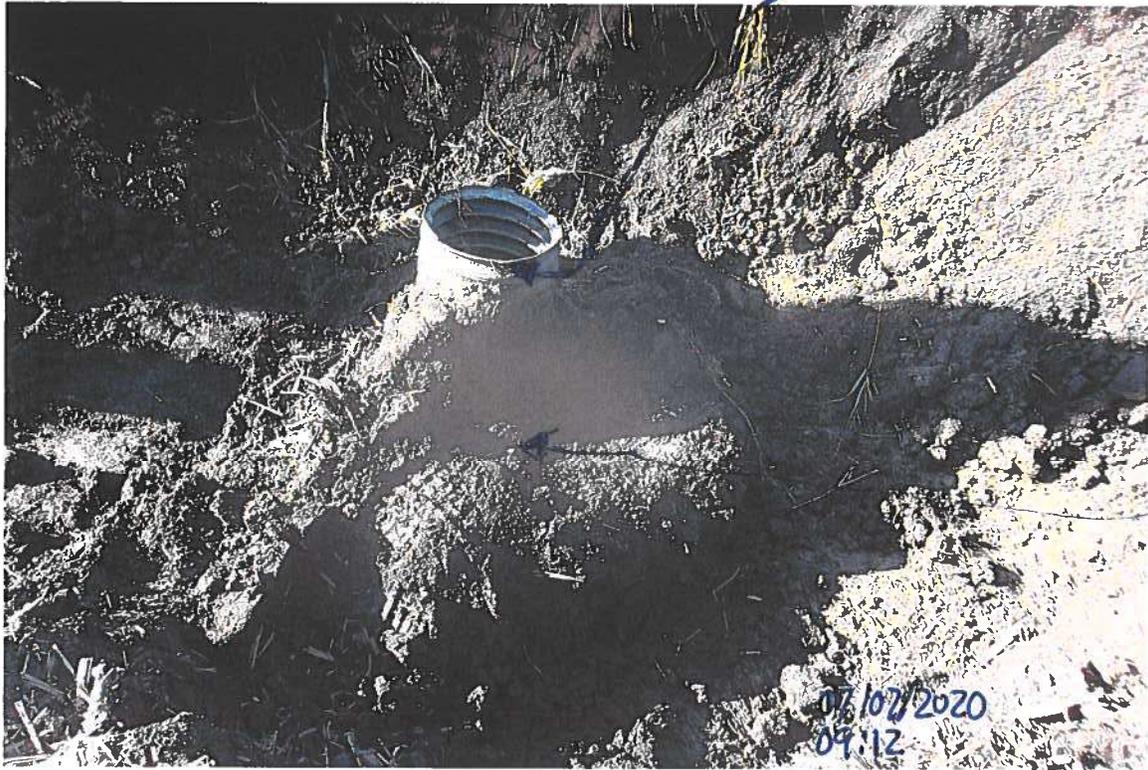
PICTURE # 4028 IS LOOKING SOUTH SHOWING ORIGINAL BEEHIVE INTAKE IN PLACE WITH 12" CLAY STAND PIPE WITH CONCRETE RIM ON TOP & 12" HOPE PERF TILE STAND PIPE STILL ON TOP GPS # 140 TOP 12" HOPE PERF

BROKEN
COLLAPSED
SECTION
OF TILE

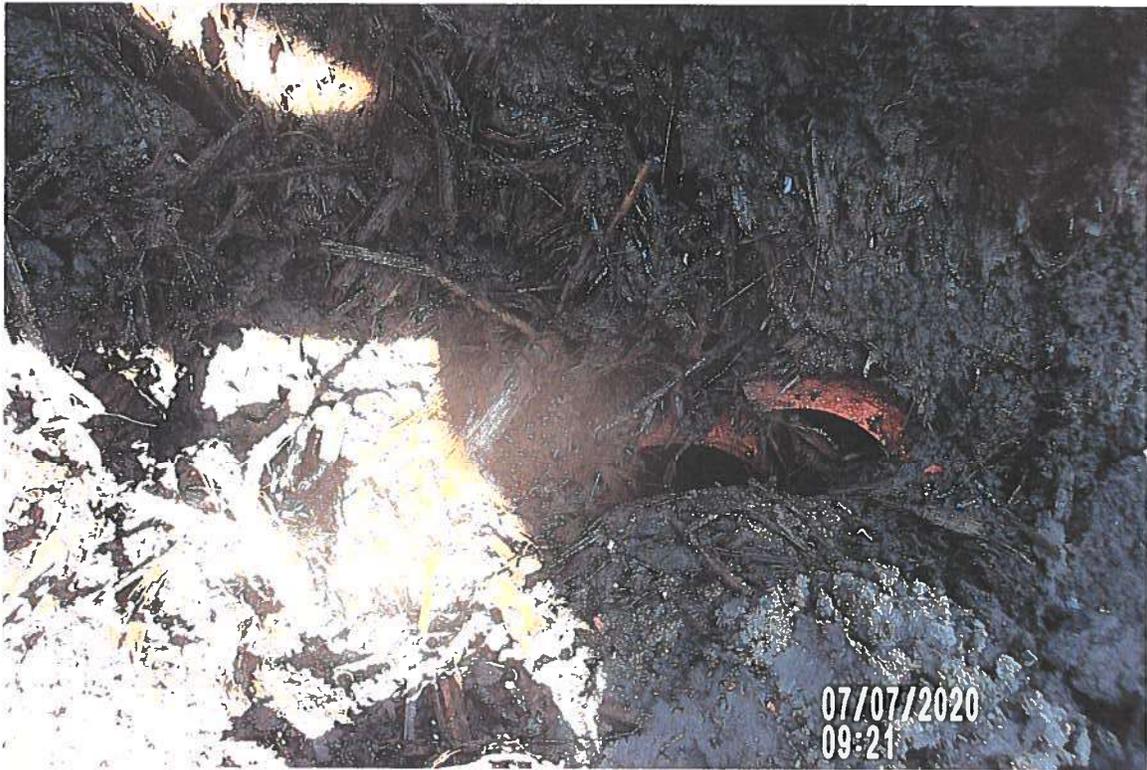
PICTURE # 4029 IS LOOKING SOUTH SHOWING BROKEN & COLLAPSED SECTION OF TILE JUST ON EAST SIDE OF ORIGINAL BEEHIVE INTAKE,

- Removed the original concrete intake and collapsed VCP tile sections until a fully intact piece of the VCP tile was found. The removed intake was replaced with rock bedding, a Hickenbottom intake, HDPE riser, HDPE Tee, and HDPE reducer attached to the section of intact 6-inch VCP tile. The connection was then solidified with a ¾ concrete collar, and rock backfill was installed.

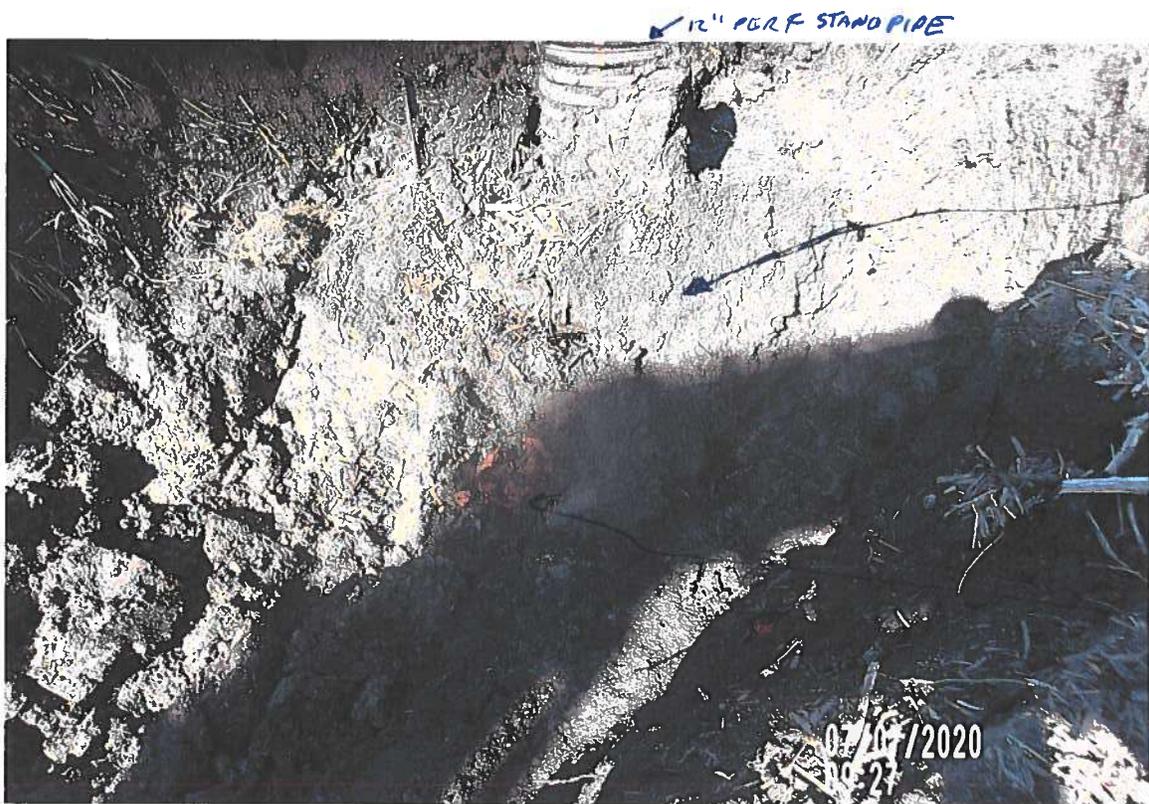
9:20 A.M. OBSERVER CONTACTED LEE ABOUT THE 6" CLAY TILE OUTLET
FROM BEEHIVE BEING BROKE & SUCKING SOIL ON EAST EDGE
OF ORIGINAL CONCRETE BEEHIVE INTAKE. LEE AGREED
TO REPLACE WITH AN 8" TO 10" HICKEN BOTTOM.

PICTURE #4031 IS LOOKING WEST SHOWING 6" CLAY TILE
OUTLET TILE FROM BEE HIVE INTAKE BROKEN & COLLAPSED.

BROKEN
6" CLAY
OUTLET
TILE

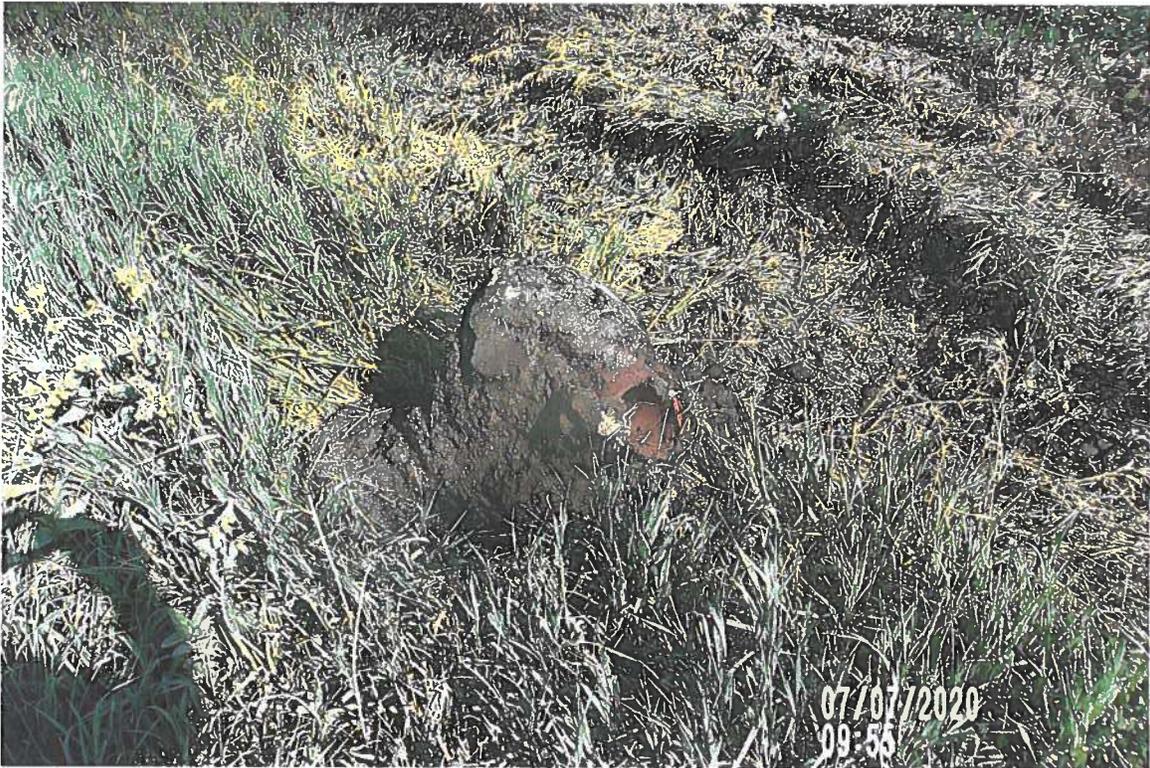
PICTURE #4034 IS LOOKING WEST AT ORIGINAL BEEHIVE
INTAKE. 1.5' TALL 12" SW PERF TILE WAS SET IN PLACE
ON TOP

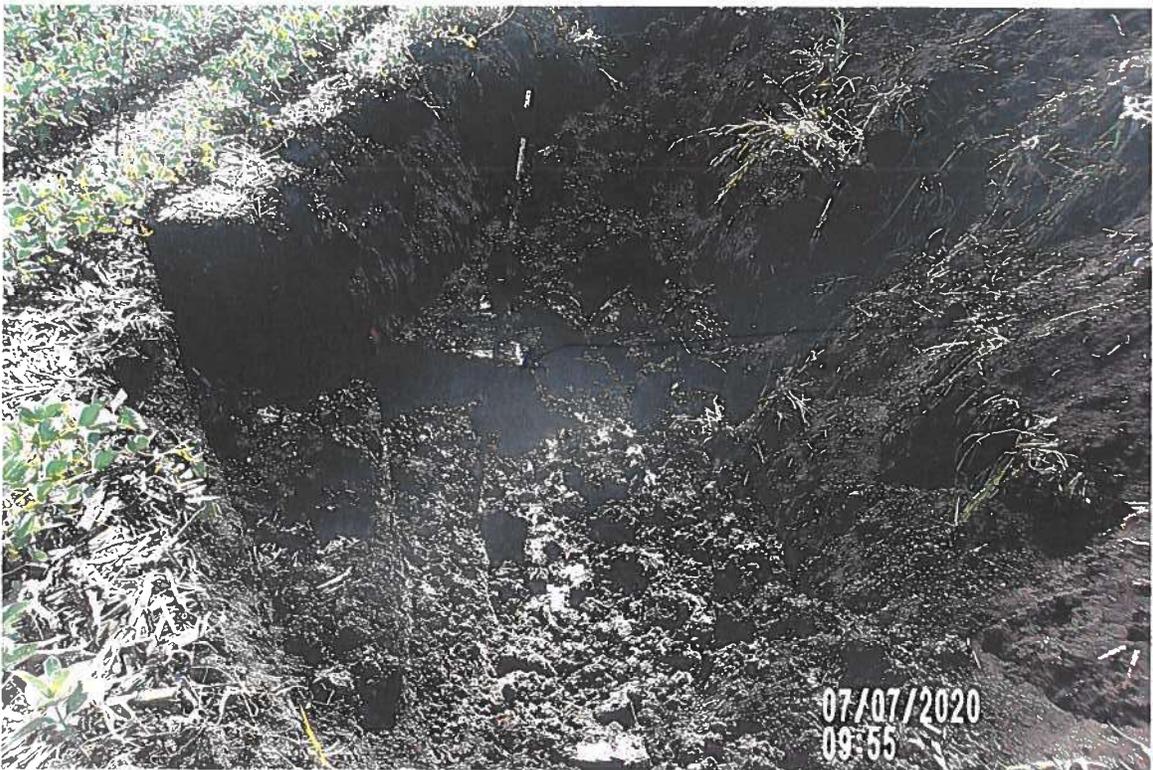
PICTURE #4035 SHOWING ORIGINAL CONCRETE BEEHIVE
INTAKE REMOVE AND READY TO BE HAULED OUT.

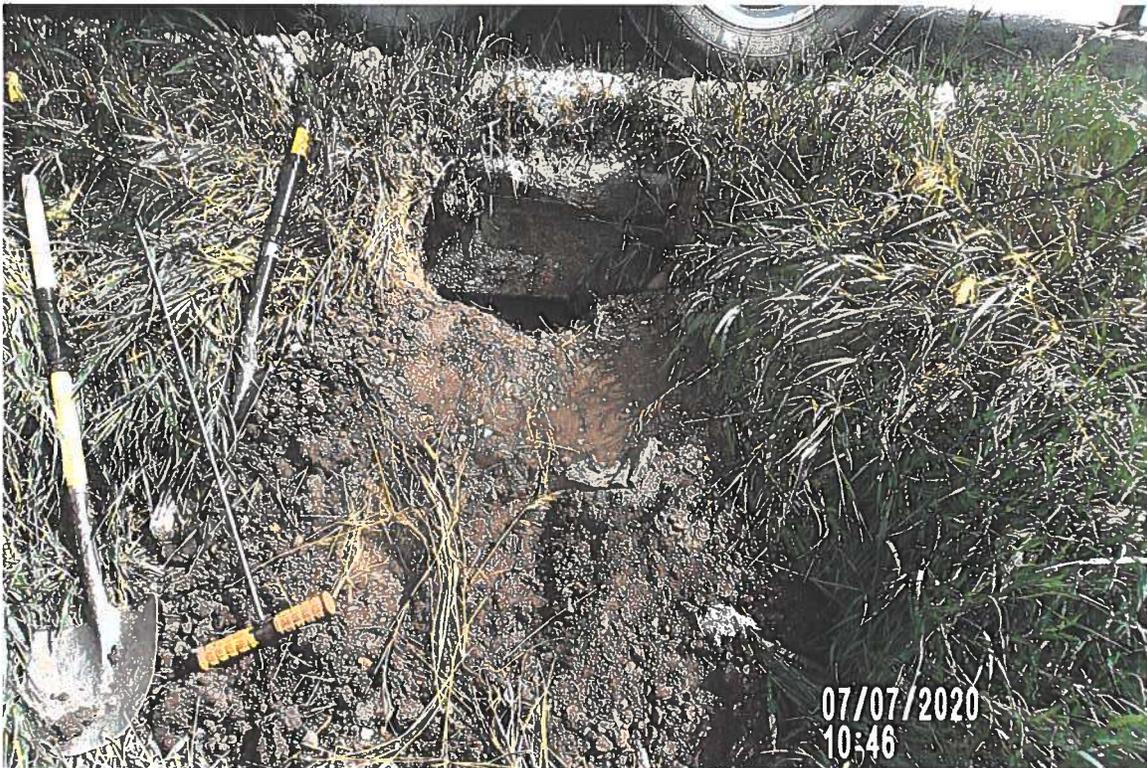
PICTURE#4037 IS LOOKING SOUTH AT NORTH END OF CONCRETE BOX
 CULVERT UNDER 110TH STREET HAVING 4.0' PLUS OF
 SOIL THAT NEEDS CLEANED OUT. (COUNTY NEEDS TO CLEAN OUT) CREW GRADED
 FROM FL CONCRETE BOX CULVERT

PICTURE#4038 IS LOOKING NORTH AT SOUTH END OF CONCRETE
 BOX CULVERT UNDER 110TH STREET HAVING 2.2' ± OF SOIL THAT NEEDS
 CLEANED OUT (COUNTY NEEDS TO CLEAN OUT) CONCRETE BOX CULVERT

- The surrounding road ditch on both sides of the road was found to be filled with excess sediment. Secondary roads should be contacted so that ditch can be cleaned out. The road box culvert had approximately 1-foot of sediment in its base that also needs to be cleaned out.
- After work was completed, no seeding was applied to the disturbed soil. Secondary Roads or the contractor should be informed that seeding needs to be done.
- Crop damage claims should be paid as submitted by landowners and verified as shown in the attached tabulation.

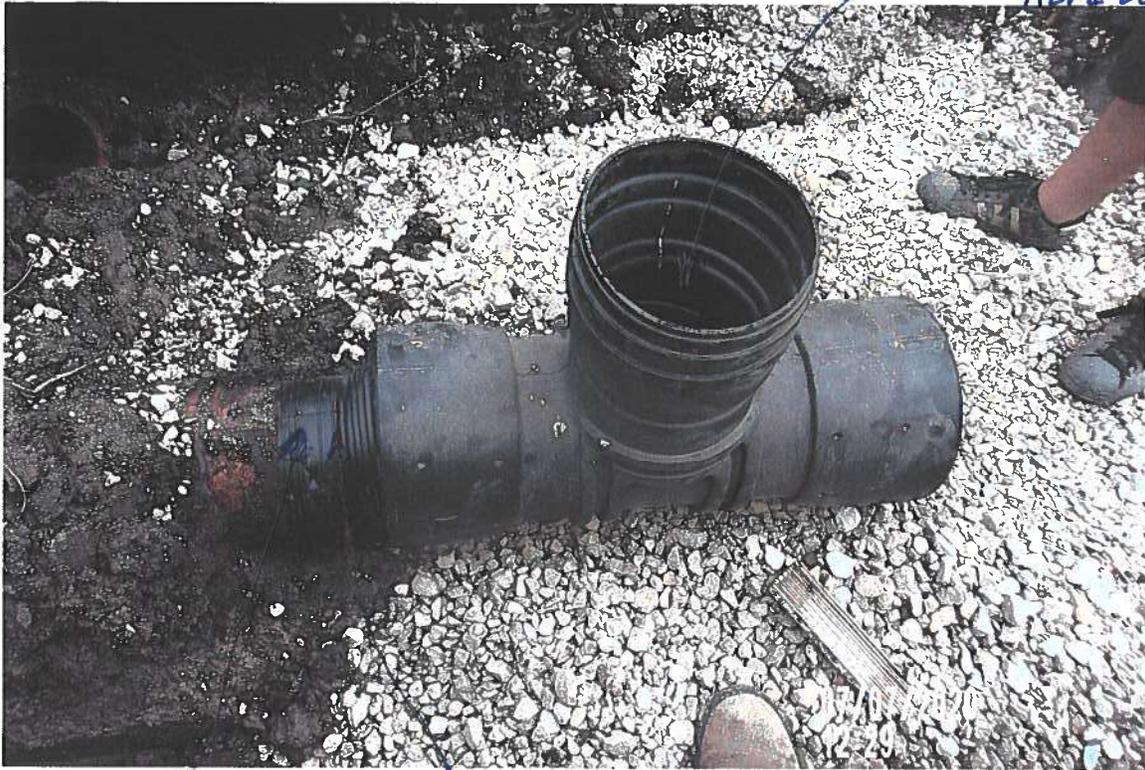
PICTURE# 4039 IS LOOKING SOUTH SHOWING 8"x8" HDPE DEAD
 END TEE WITH 8"x6" HDPE REDUCER INSTALLED ON EXISTING 6"
 CLAY TILE WITH 4" PLUS OF BEDDING ROCK UNDER TEE.

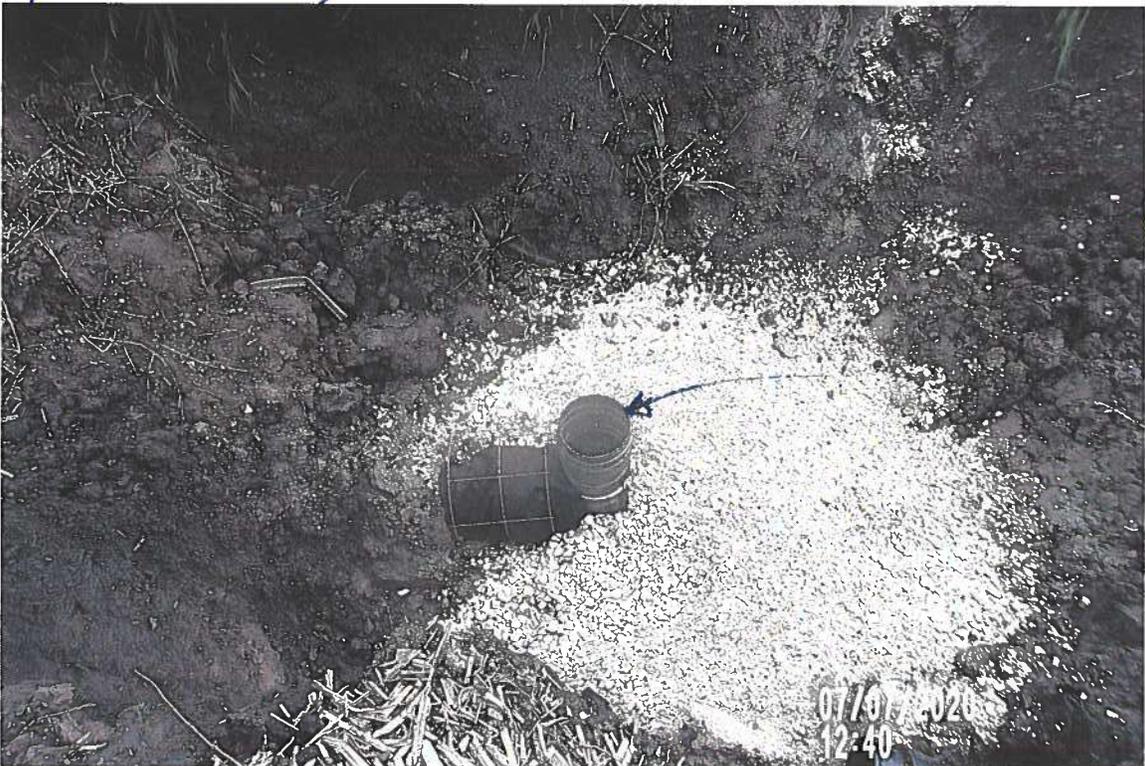
PICTURE# 4040 IS LOOKING SOUTH SHOWING TEE
 BEDDED WITH ROCK WITH 1.0' X 2.0' 6" X 6" SQUARE WIRE MESH
 & 2.0' X 2.0' ENGINEERING FABRIC OVER JOINT BEFORE 3/4 COLLAR POURED.

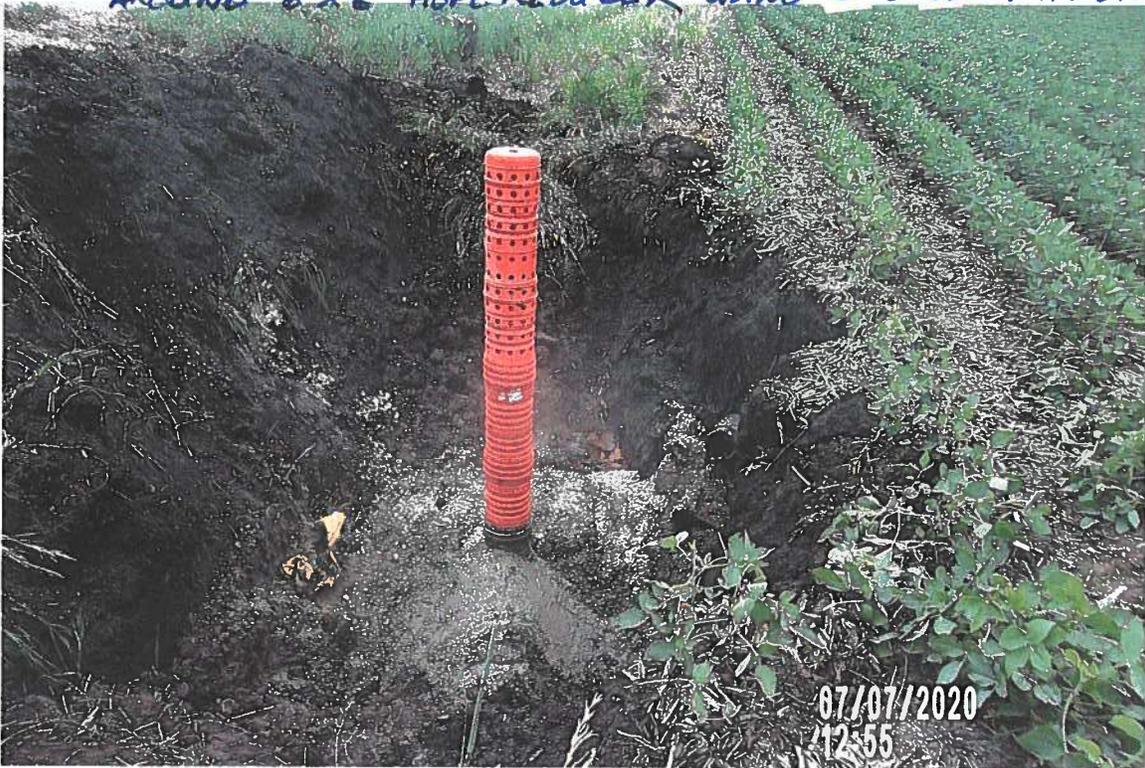
PICTURE #4042 IS LOOKING WEST SHOWING BOTTOM & TOP SECTION OF HICKENBOTTOM SET IN PLACE IN 8"x8" HOPE DEAD END TEE, ALSO SHOWS 3/4" CONCRETE COLLAR POURED AROUND 8"x6" HOPE REDUCER USING 8-60 LB QUIKRETE BAGS

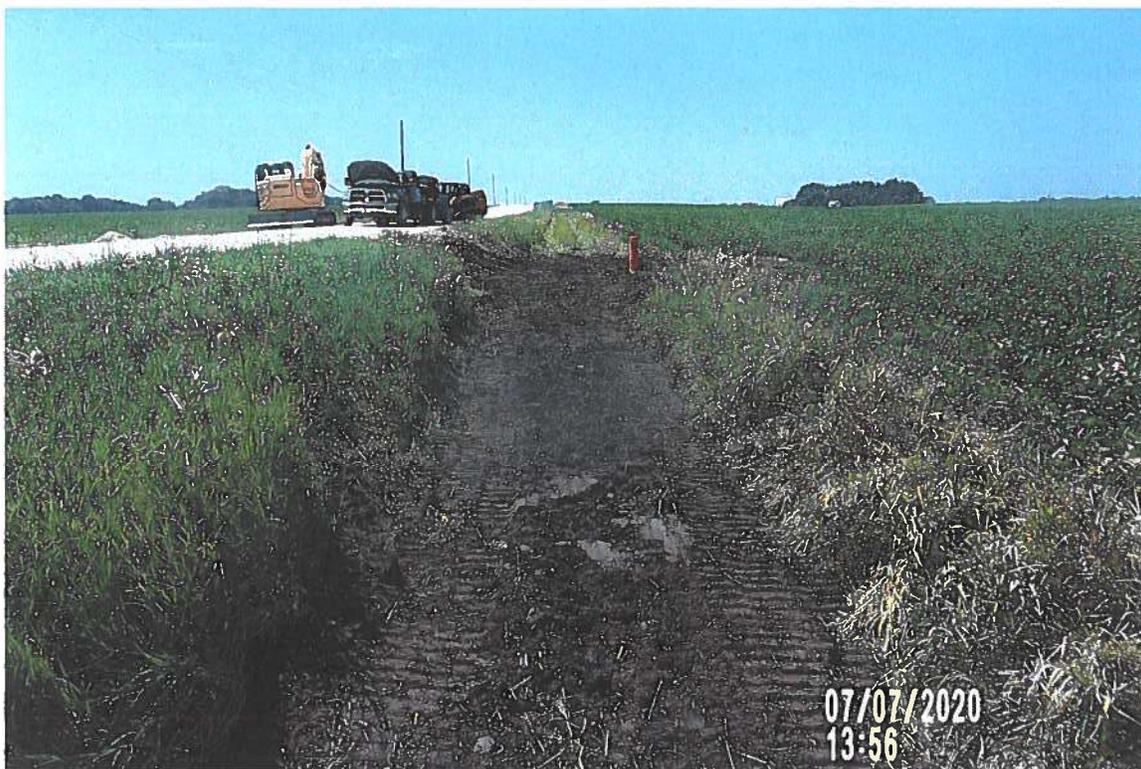
PICTURE# 4044 IS LOOKING WEST SHOWING FL IN NORTH
DITCH GRADED TO FL CONCRETE BOX CULVERT &
HICKEN BOTTOM
