AGENDA
REGULAR DRAINAGE MEETING
Wednesday, August 26, 2020 9:30 AM

Repair Summary:

SE NE 30-88-22 REPAIR SMASHED
END OF EXISTING 24" CMP INLET &
INSTALL NEW 24" CMP WITH ANTISEEP COLLAR
IN BLOWOUT

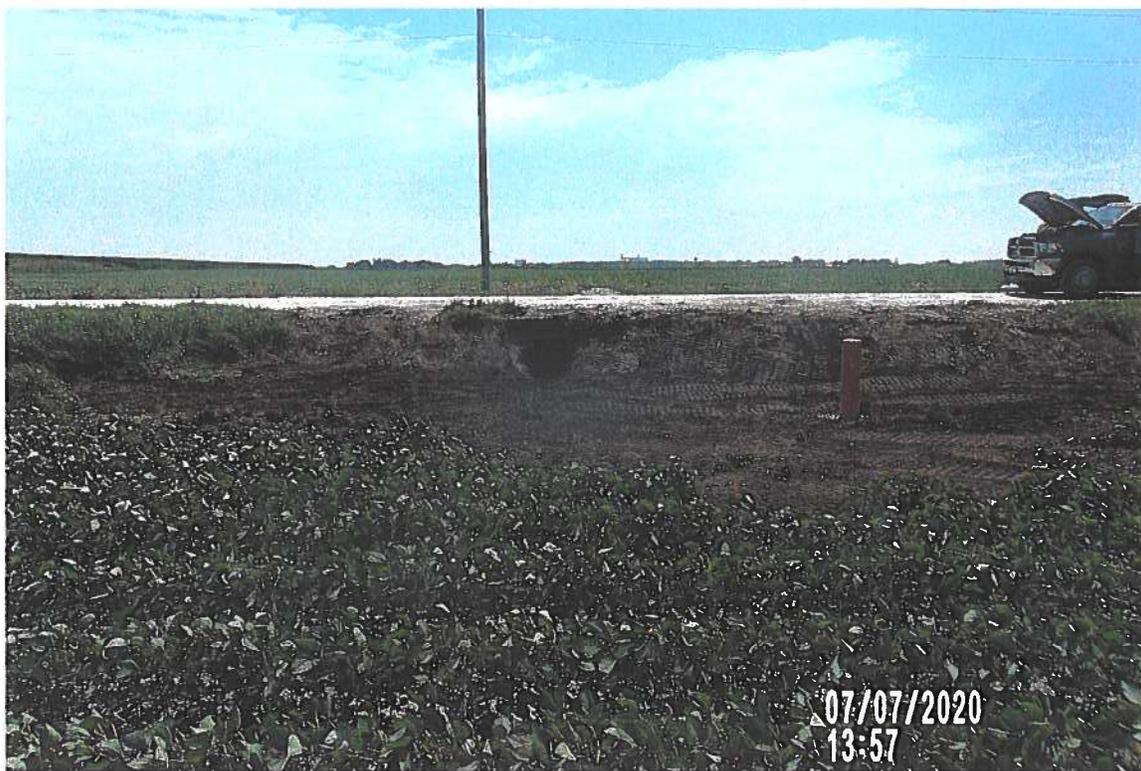
PICTURE# 4045 IS LOOKING SOUTH SHOWING BEAN
DAMAGE & DITCH GRADED TO HICKEN BOTTOM & FL
OF CONCRETE BOX CULVERT (SOIL STILL NEEDS CLEANED OUT.)

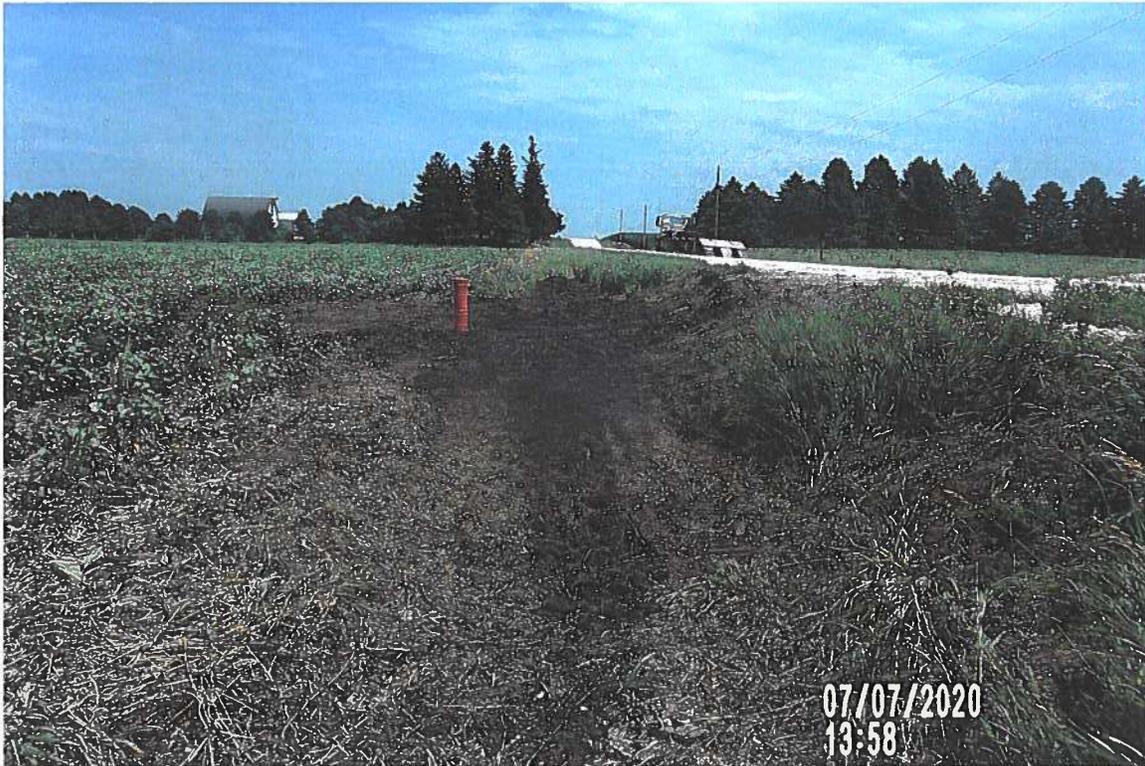
PICTURE # 4046 IS LOOKING EAST SHOWING RL NORTH
DITCH GRADED TO RL CONCRETE BOX CULVERT & HICKEN BOTTOM.

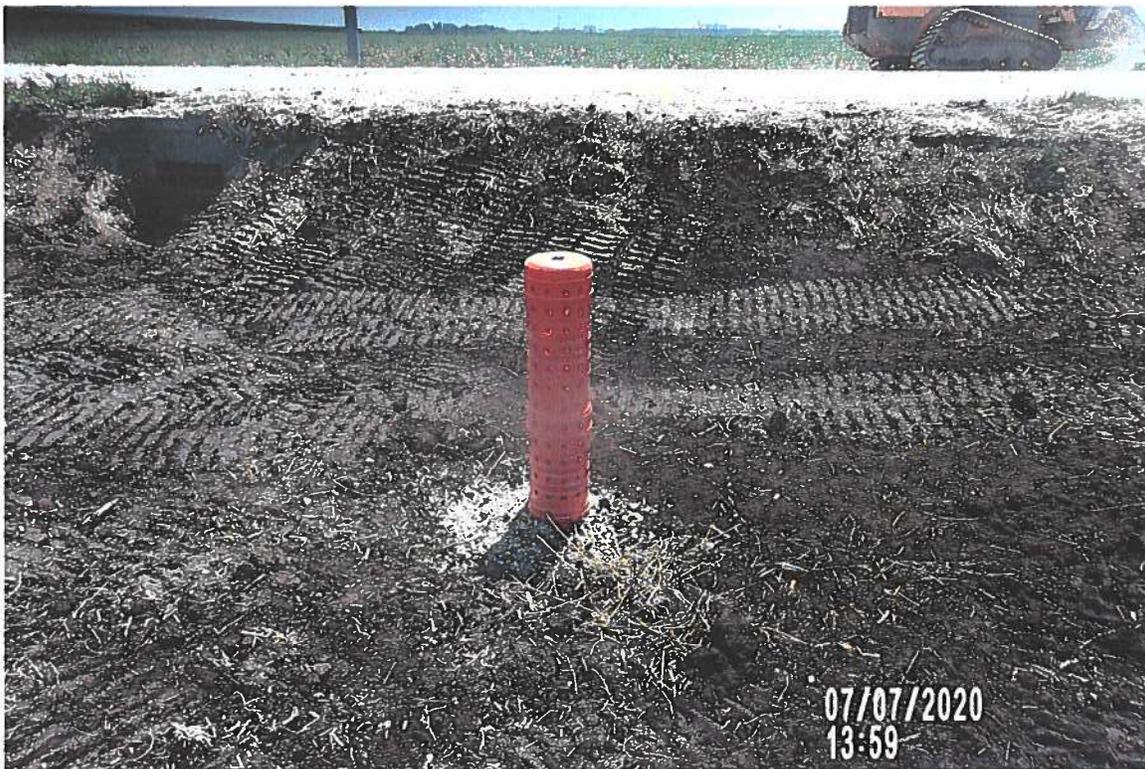
PICTURE # 4047 IS LOOKING SOUTH SHOWING ROCK BEDDED AROUND
HICKEN BOTTOM WITH NORTH DITCH GRADED TO HICKEN BOTTOM
& RL CONCRETE BOX CULVERT (STILL NEEDS SOIL REMOVED FROM CULVERT)

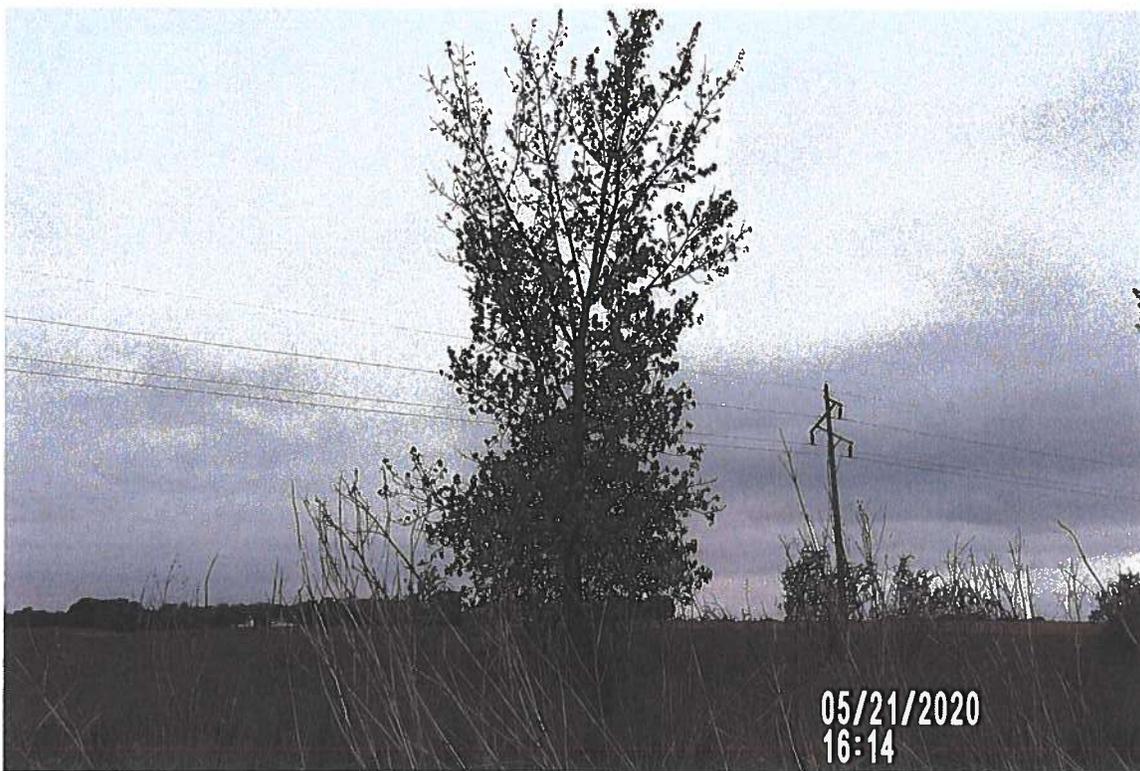
PICTURE#3590 IS LOOKING SW AT LONE 12" Ø TREE THAT WILL BE REMOVED (WITHIN 50 FT OF DISTRICT TILE)

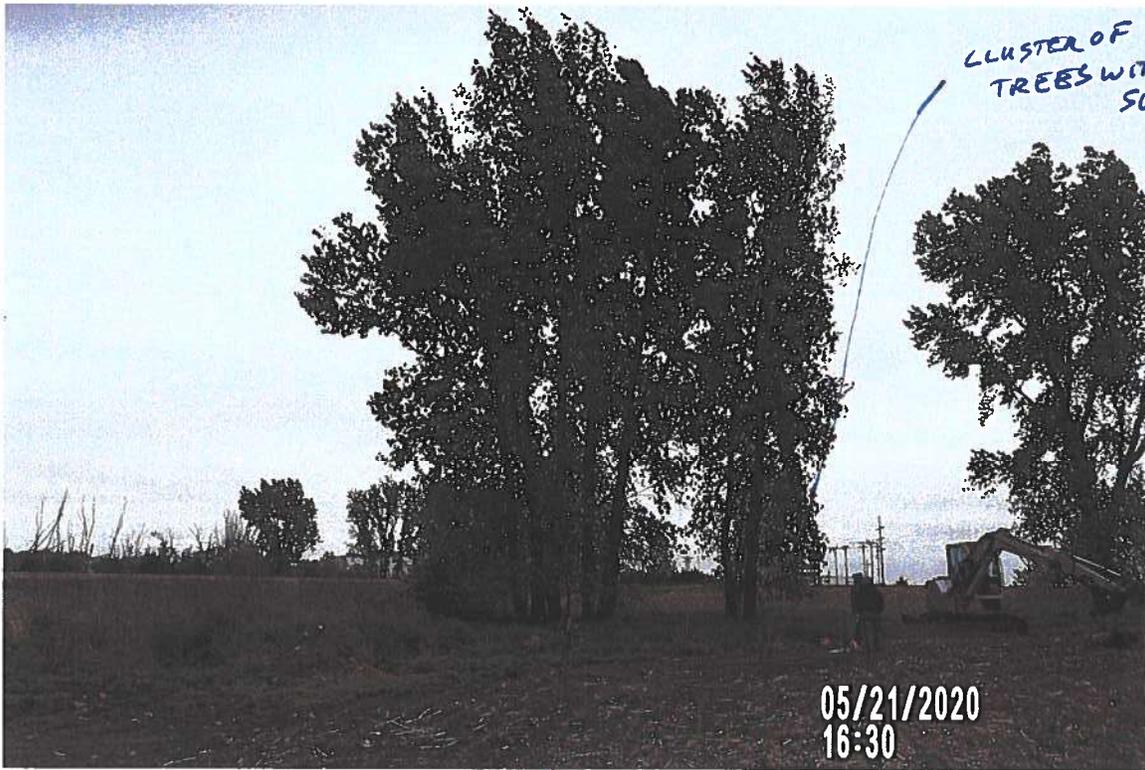
PICTURE # 3591 IS LOOKING NORTH ON EAST SIDE OF DISTRICT TILE SHOWING TREES THAT NEED REMOVED

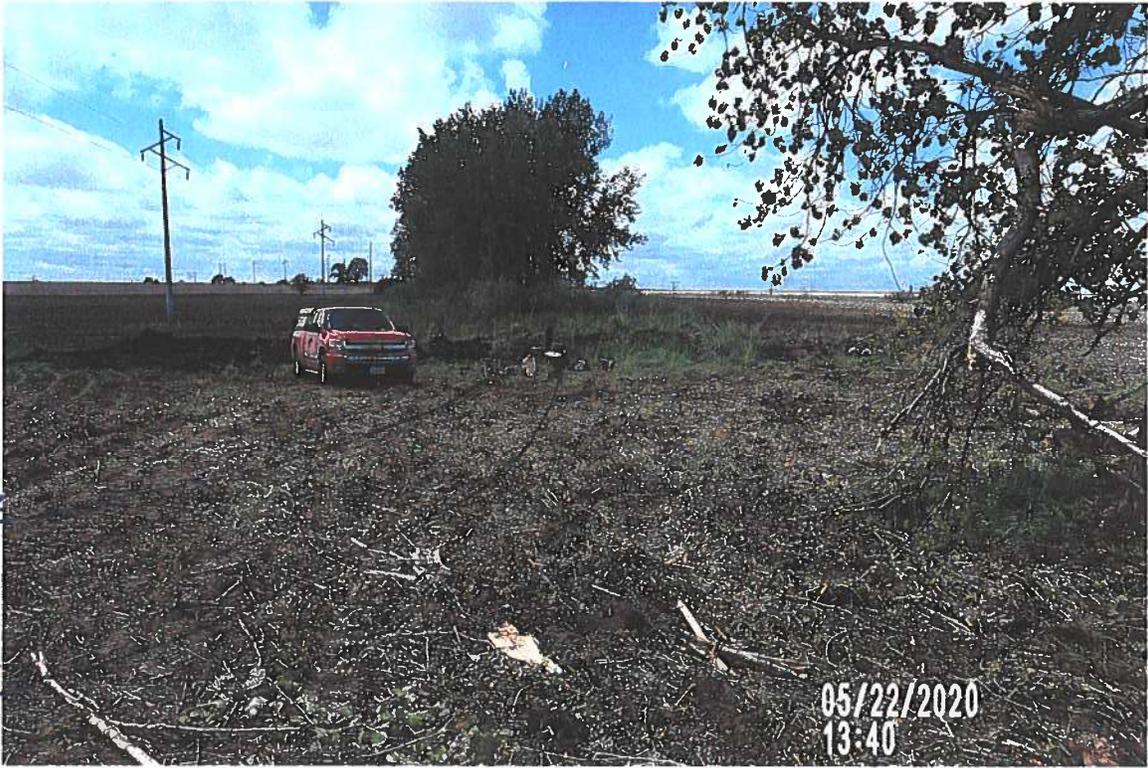
PICTURE #3616 IS LOOKING WEST AT TREE CLUSTER REMOVED ON EAST SIDE OF DISTRICT AND PRIVATE TILE TRENCH THAT NEEDS SOME REPAIRS.

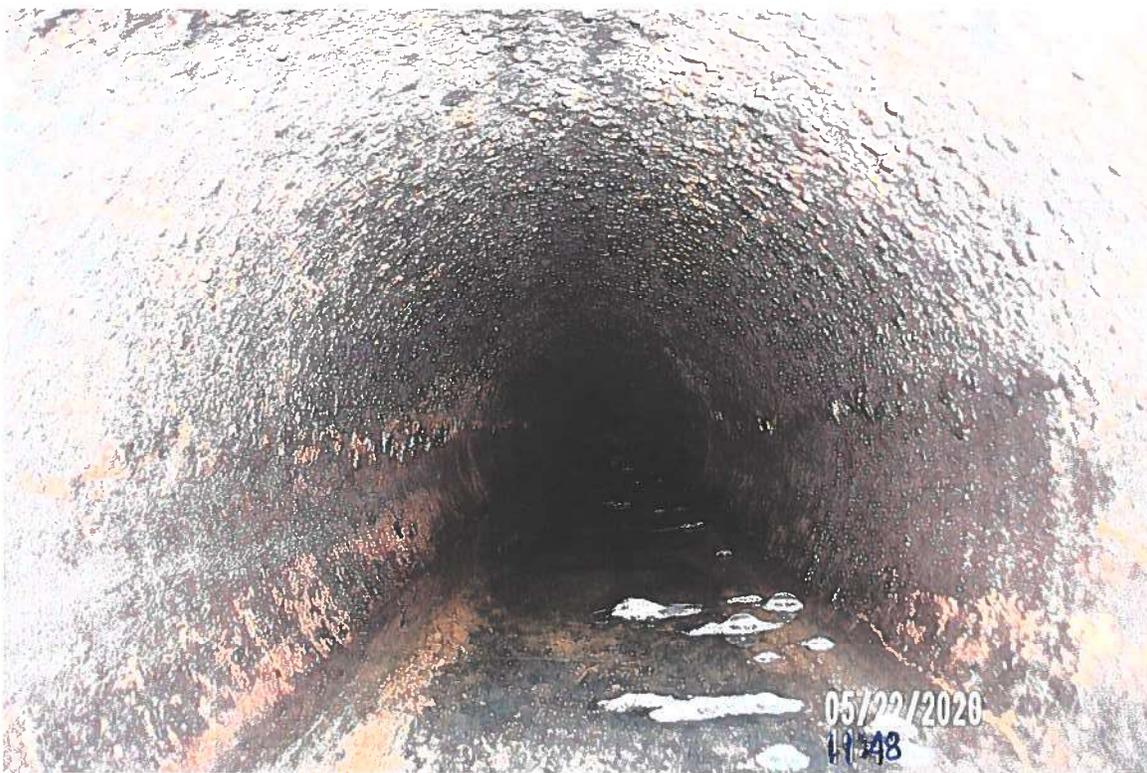
PICTURE 3594 IS LOOKING SOUTH DOWNSTREAM FROM GPS#15
TOP 12" CLAY TILE (1.05' TOP TO FL) SHOWING WATER LEVEL
AT 5" WITH ABOUT 3" OF MUCK IN FL & SOME OTHER DEBRIS.

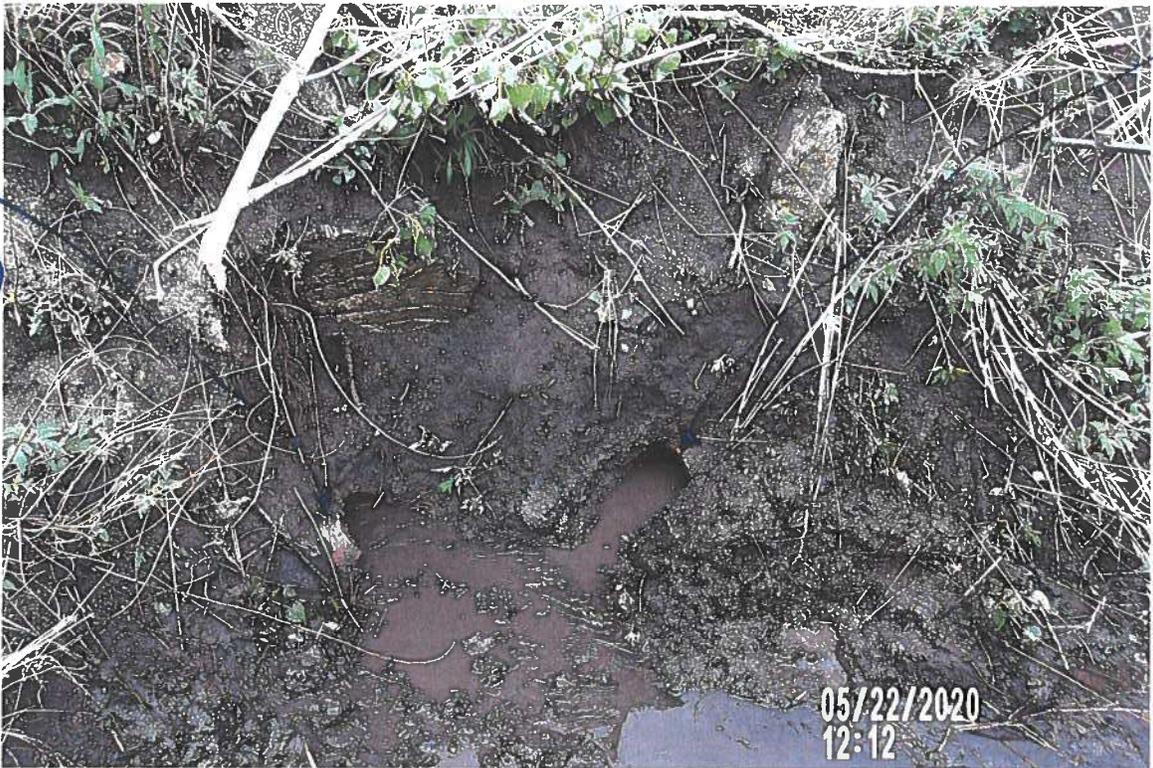
PICTURE # 3597 IS LOOKING NORTH SHOWING 12" CONCRETE TILE FLOWING INTO TRENCH WHERE 12" CONCRETE TILE WAS ALREADY REMOVED UP TO 12" CLAY TILE. THAT NEEDS REPAIRED.

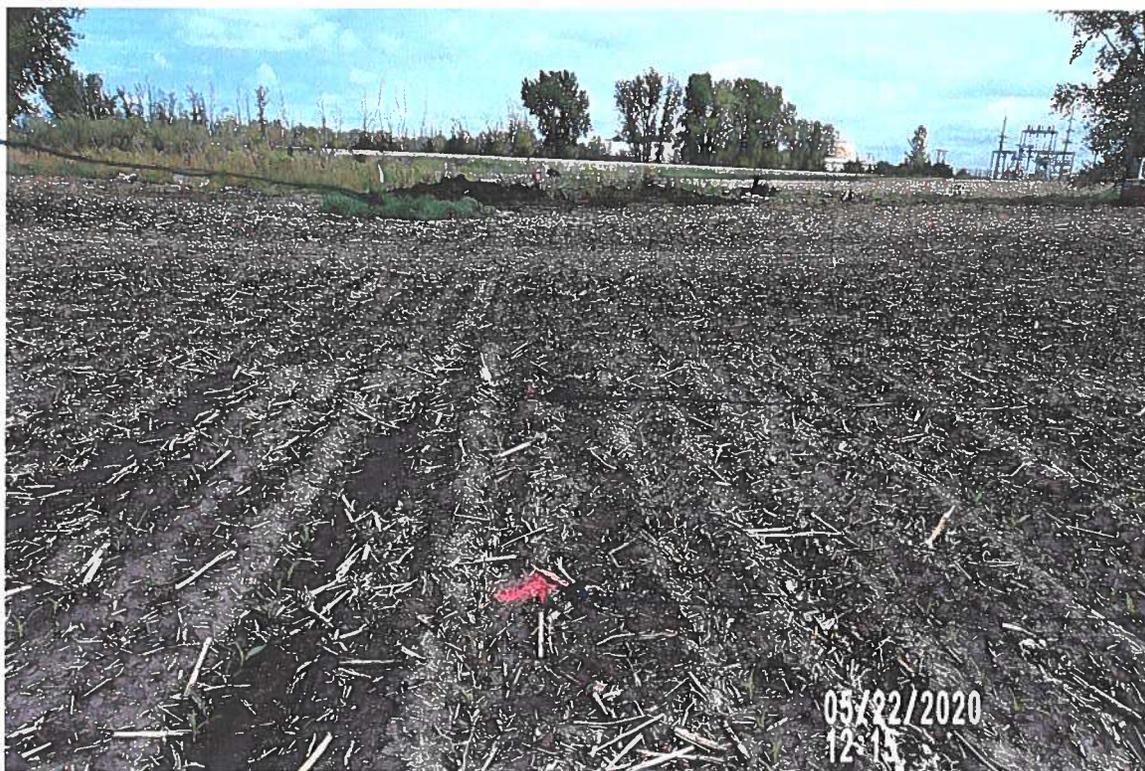
PICTURE # 3598 IS LOOKING WEST SHOWING WATER FLOWING FROM TRENCH INTO 12" CLAY TILE FROM LOCATION OF 12" CONCRETE TILE THAT WAS REMOVED, UPSTREAM 12" CLAY TILE (GPS # 20) THAT WAS COVERED BUT NOW UNCOVERED AND FLOWING THAT NEEDS REPAIRED.

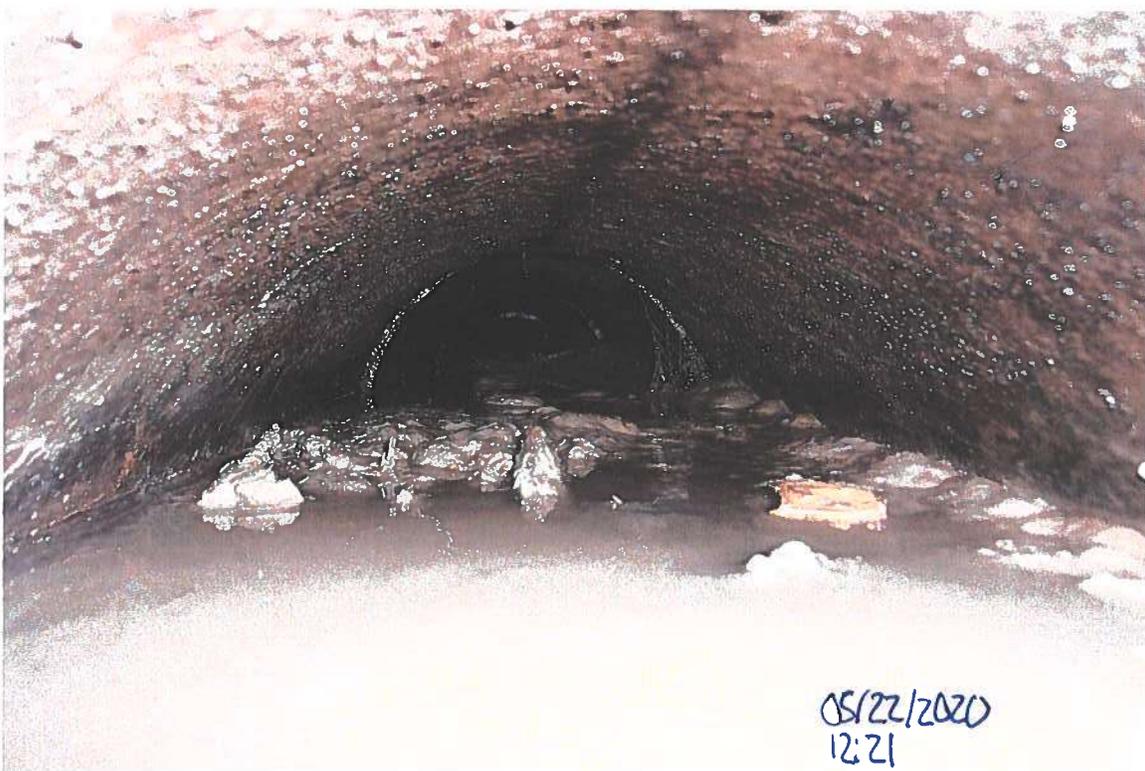
PICTURE # 3599 IS LOOKING NORTH AT 6S TILE LOCATES SOUTH OF GPS # 14 10" HDPE SW PERFORATED TILE (SOUTH END OF 12" CONCRETE TILE)

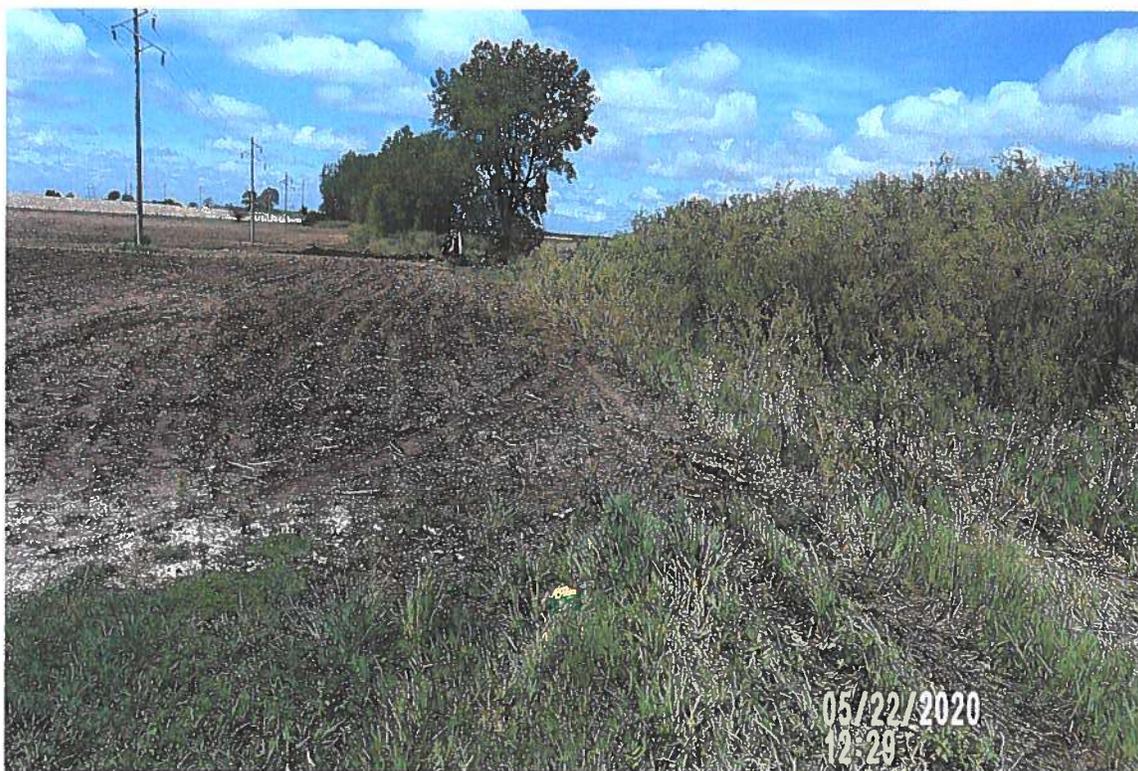
PICTURE # 3601 IS LOOKING EAST AT CORN DAMAGE

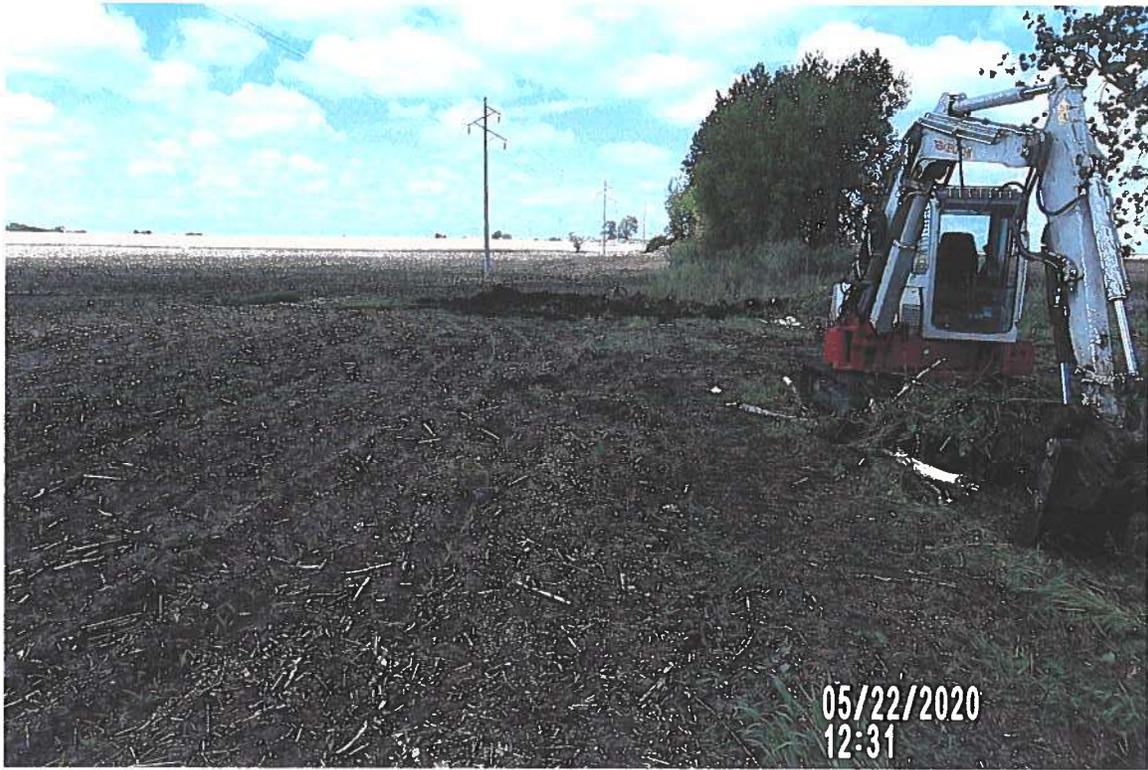
PICTURE # 3602 IS LOOKING WEST FROM DRIVE ENTRANCE
OFF CO HWY 545 SHOWING CORN DAMAGE

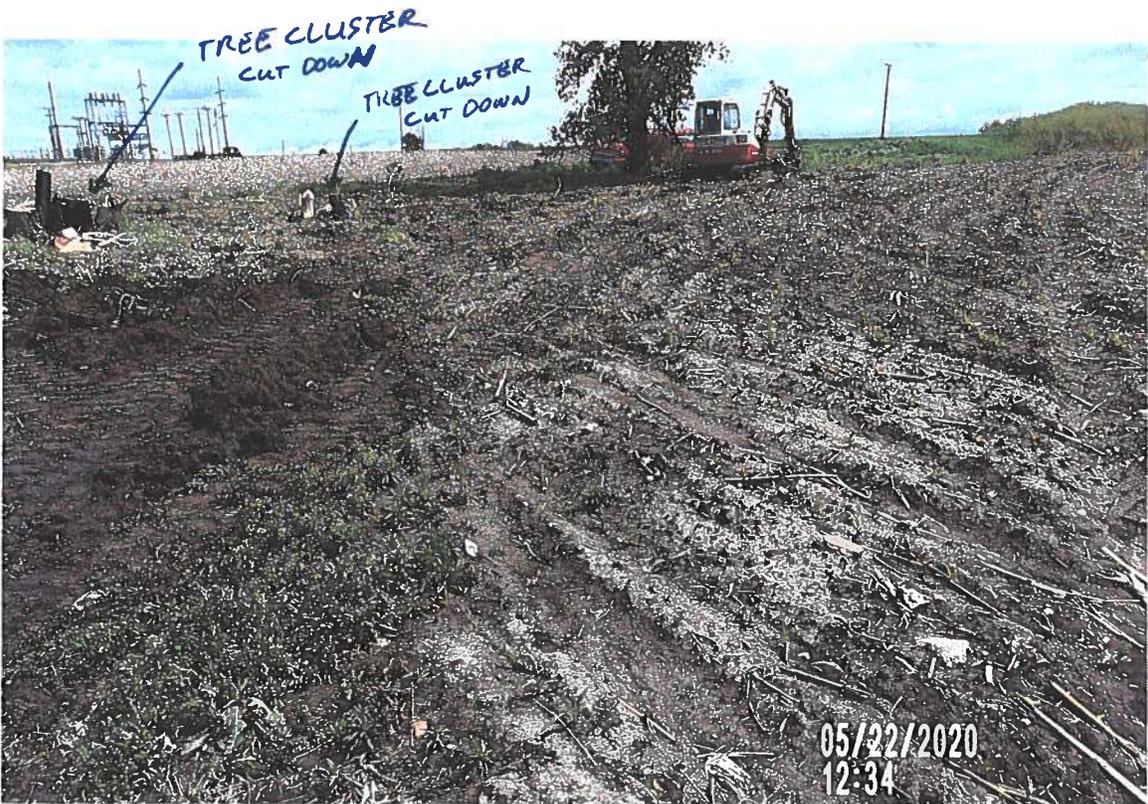
PICTURE # 3603 IS LOOKING WEST AT CORN DAMAGE,

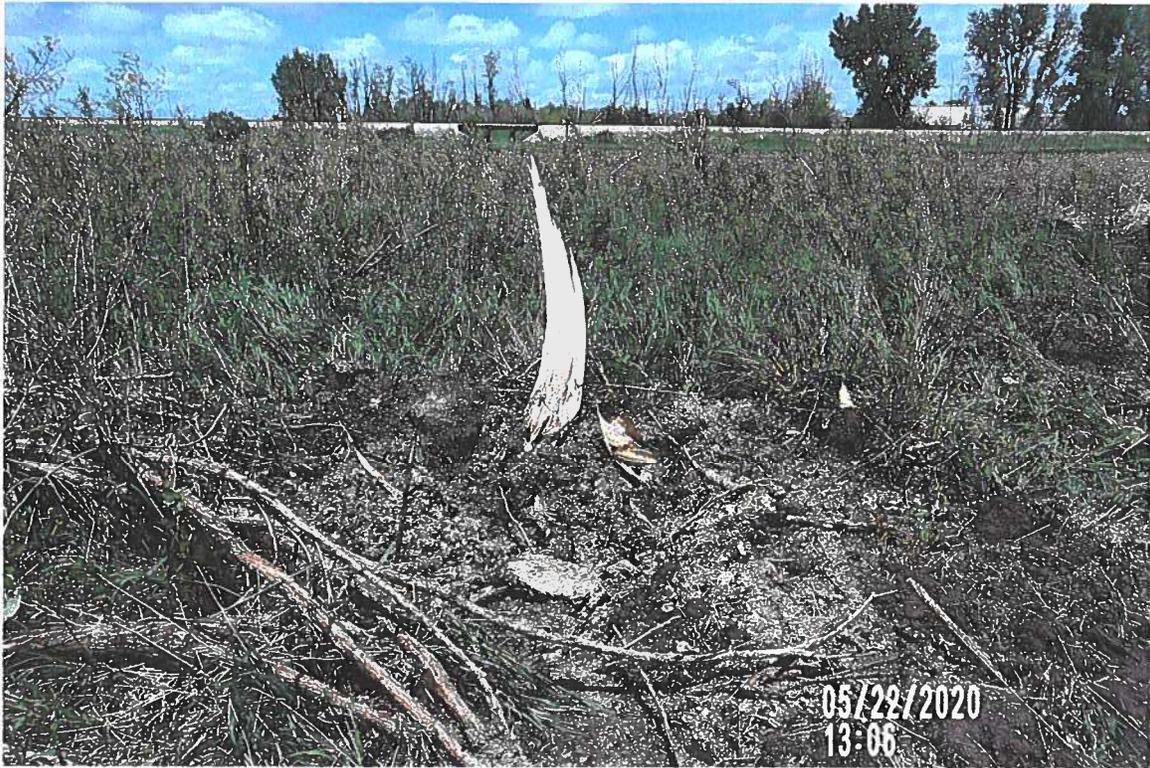
PICTURE #3607 IS LOOKING NORTH AT 12" ϕ TREE REMOVED
THAT WAS WITHIN 50' OF DISTRICT TILE.

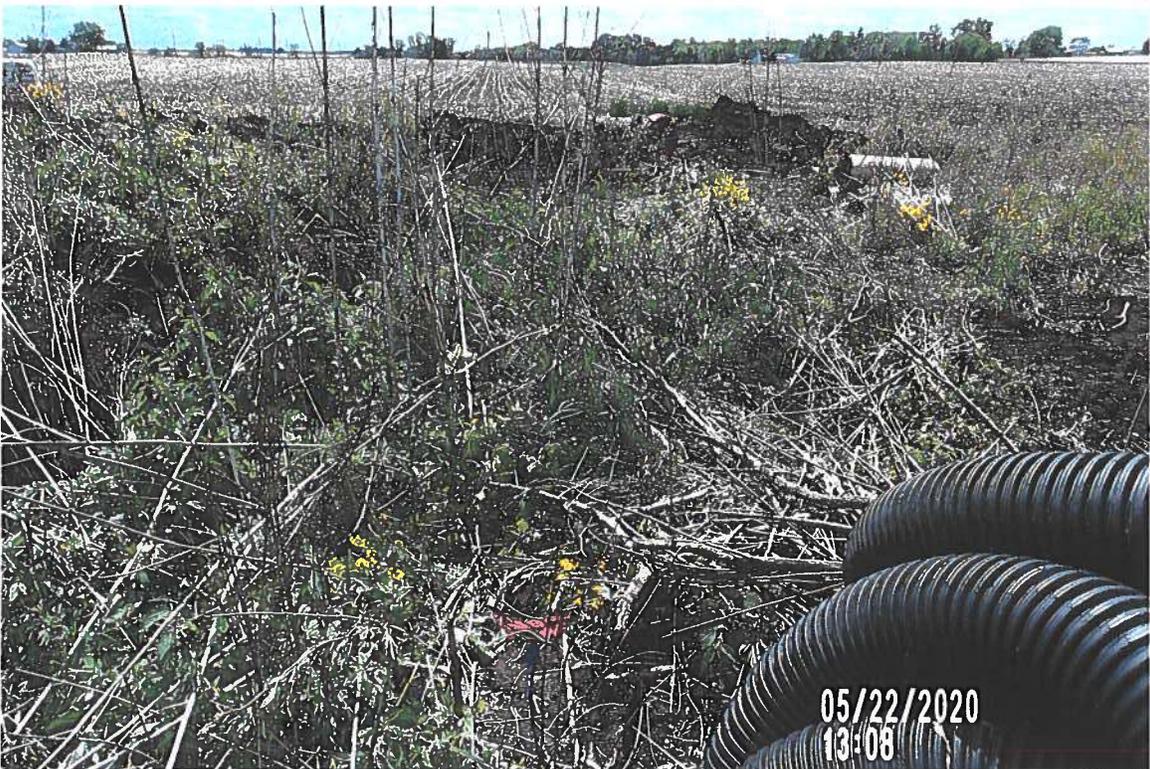
PICTURE #3608 IS LOOKING SOUTH SHOWING END OF TILE LOCATE
@ 34.1 LF FROM GPS# 20 UPSTREAM IN 12" CLAY TILE TILL
CABLE COULD NOT PUSH ANY FURTHER.

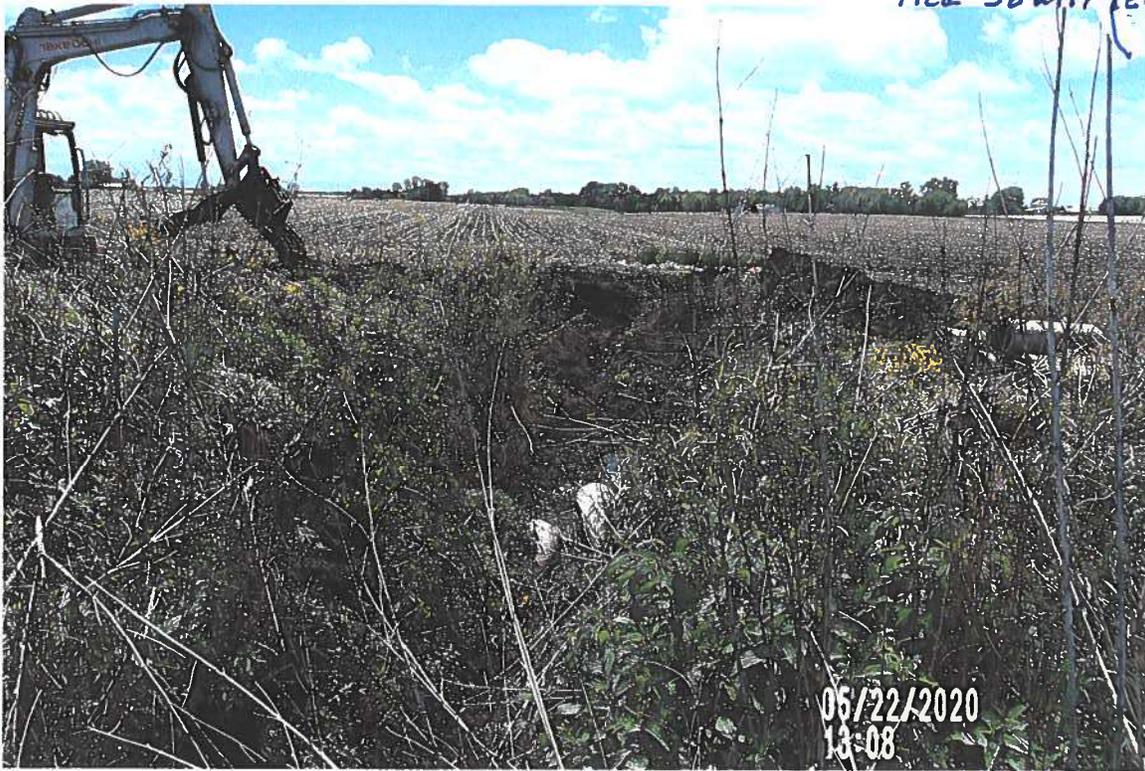
PICTURE #3609 IS LOOKING SOUTH AT OPEN TRENCH WITH WATER FLOWING TO 12" CLAY TILE (GPS# 15) FROM 12" CONCRETE TILE (GPS# 16 FROM NORTH. 10" SW HDPE PERF TILE SOUTH (EAST OF 12" CLAY TILE)

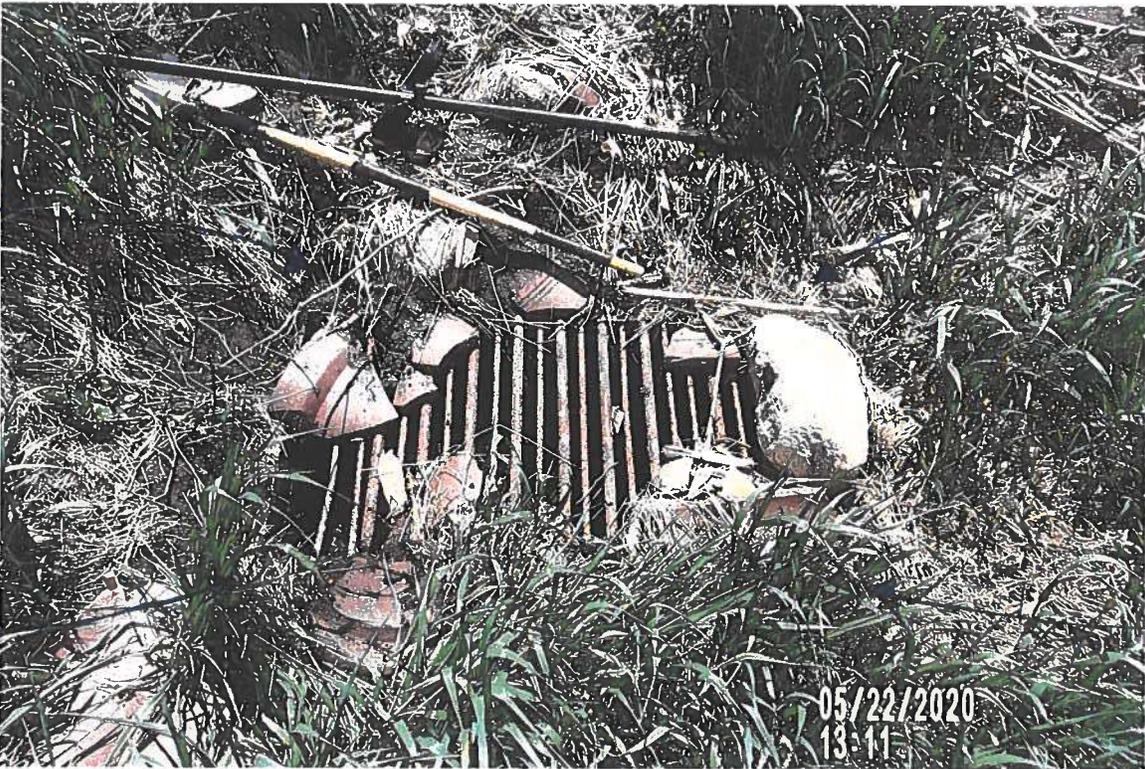
PICTURE # 3612 IS LOOKING SOUTH AT CONCRETE INTAKE BOX WITH 10" CLAY TILE SOUTH

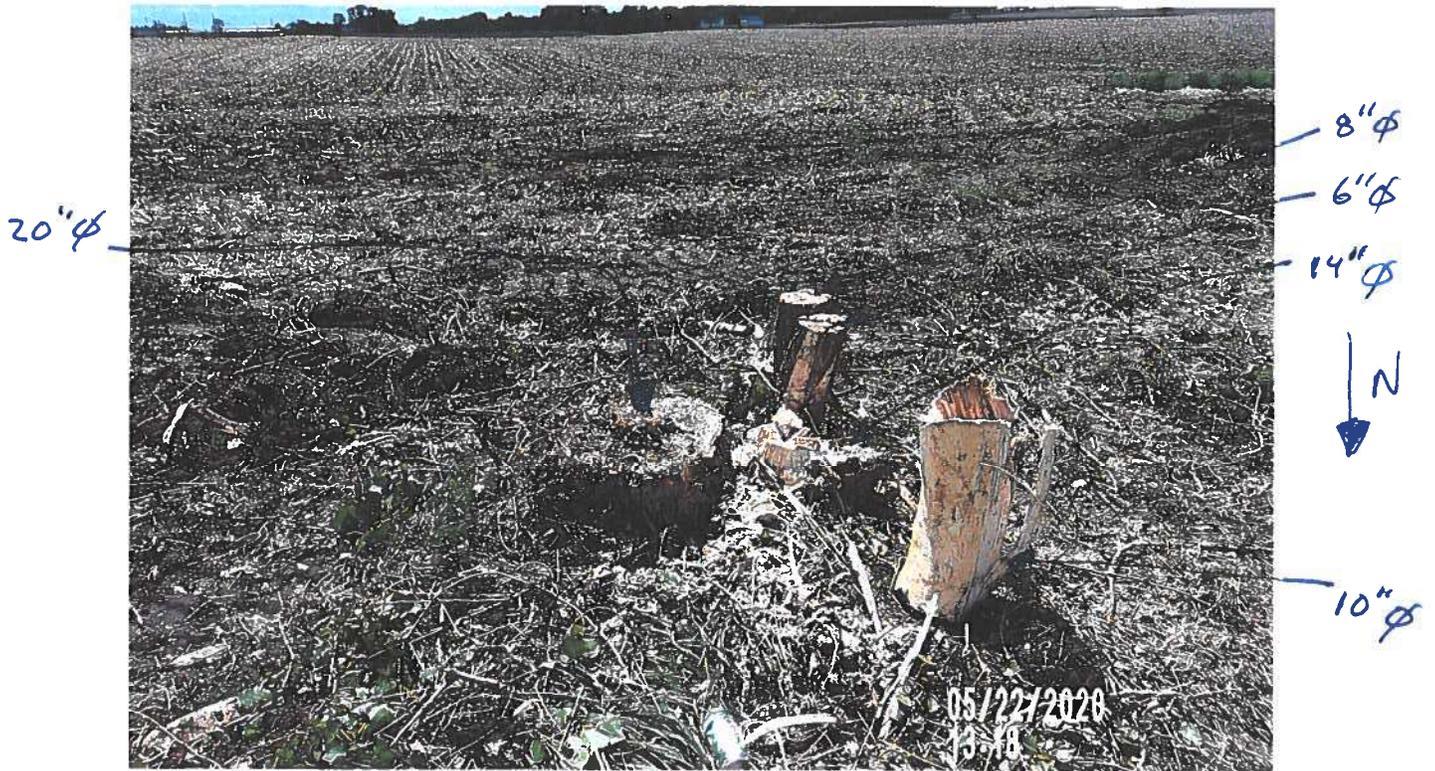
(EAST-EAST TREE CLUSTER)
 PICTURE #3614 IS LOOKING SOUTH AT TREE CLUSTER CUT DOWN
 & TORDON APPLIED TO STUMP SINCE TREES WERE WITHIN SOFT EAST
 OF DISTRICT TILE.

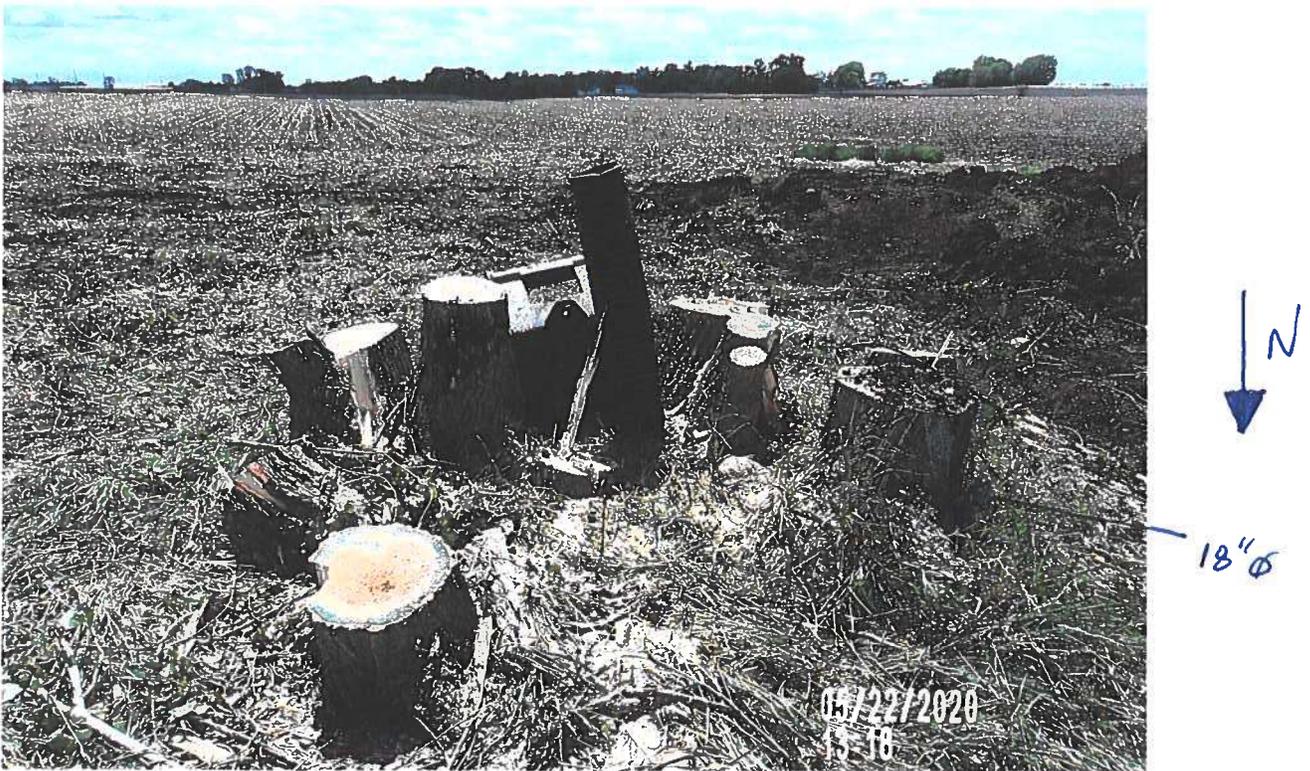
(WEST-EAST TREE CLUSTER)
 PICTURE #3615 IS LOOKING SOUTH AT TREE CLUSTER CUT DOWN
 AT TORDON APPLIED TO STUMP SINCE TREES WERE WITHIN SOFT
 EAST OF DISTRICT TILE
