AGENDA
REGULAR DRAINAGE MEETING
Wednesday, August 5, 2020 9:30 AM
Large Conference Room

9. DD 48 - WO 237 - Discuss W/ Possible Action - Repair Summary

[DD 48 WO 237 - 6486.4 - REPAIR SUMMARY - 08_03_20.PDF](#)

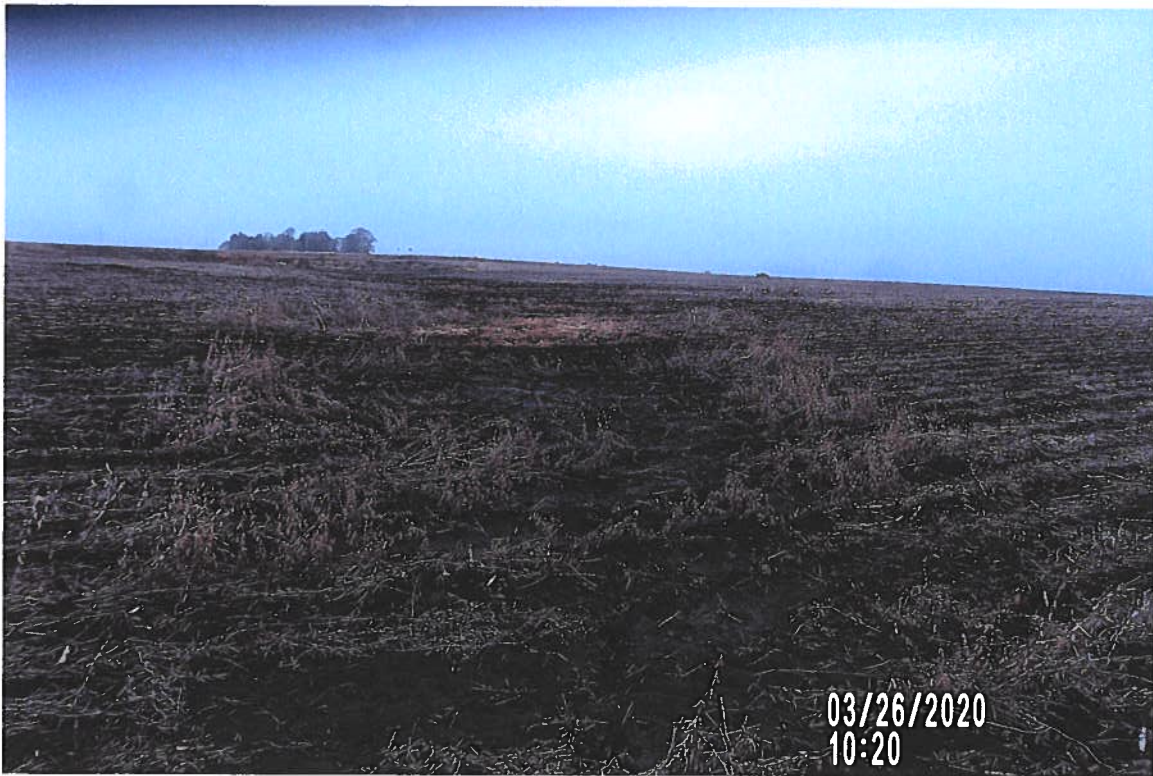
PICTURE # 3147 IS LOOKING NW WHERE SOIL IS WET SE OF STANDING WATER

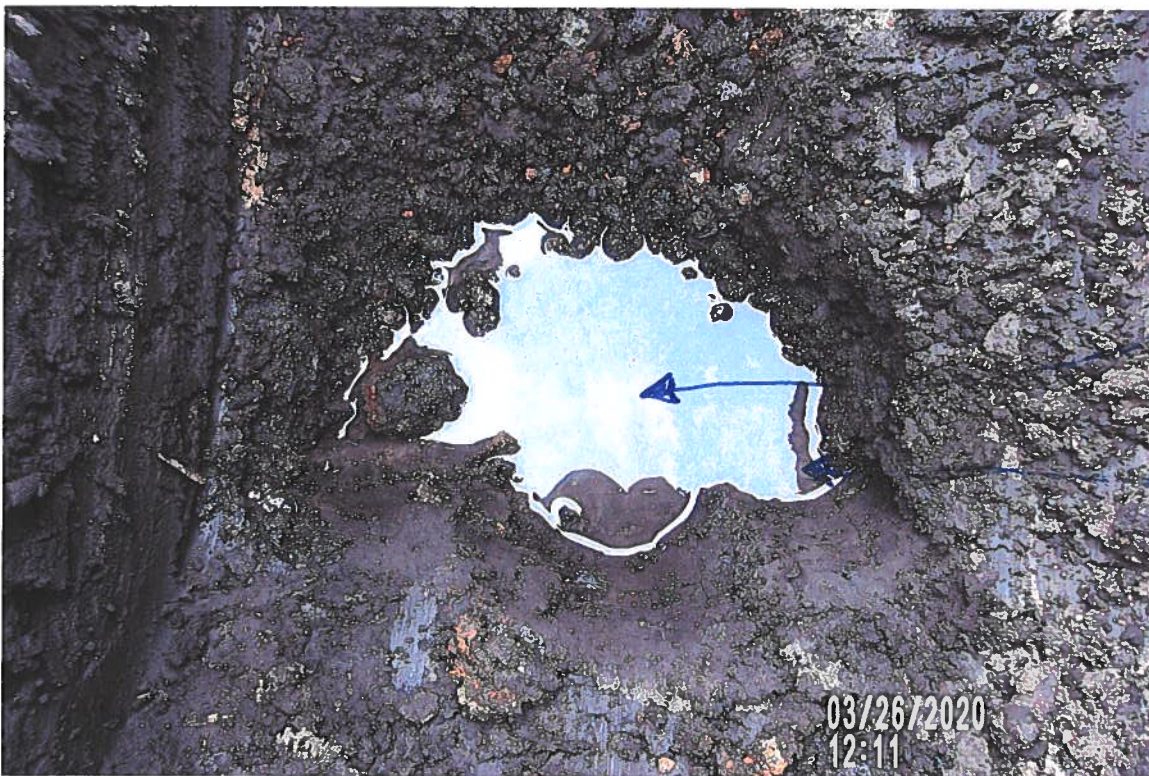
PICTURE # 3148 IS LOOKING SOUTH IN 3.0' WIDE X 8.0' LONG TRENCH WHERE TOP OF 8" CMP WAS EXPOSED ON SE EDGE OF GRASS AREA WHERE WATER WAS STANDING. TRENCH WAS DRY DURING EXCAVATION.

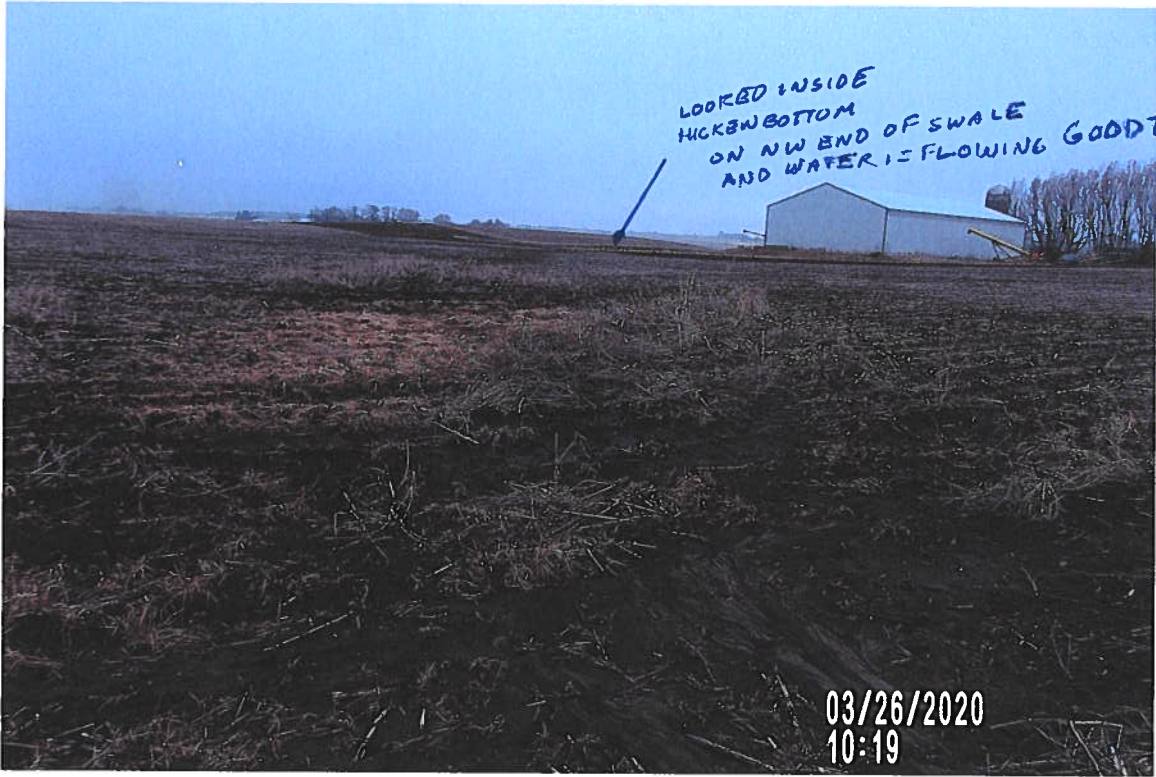
PICTURE # 3145 IS LOOKING SE SHOWING GRASS AREA WITH WATER STANDING. SOIL IS WET IN THIS AREA.

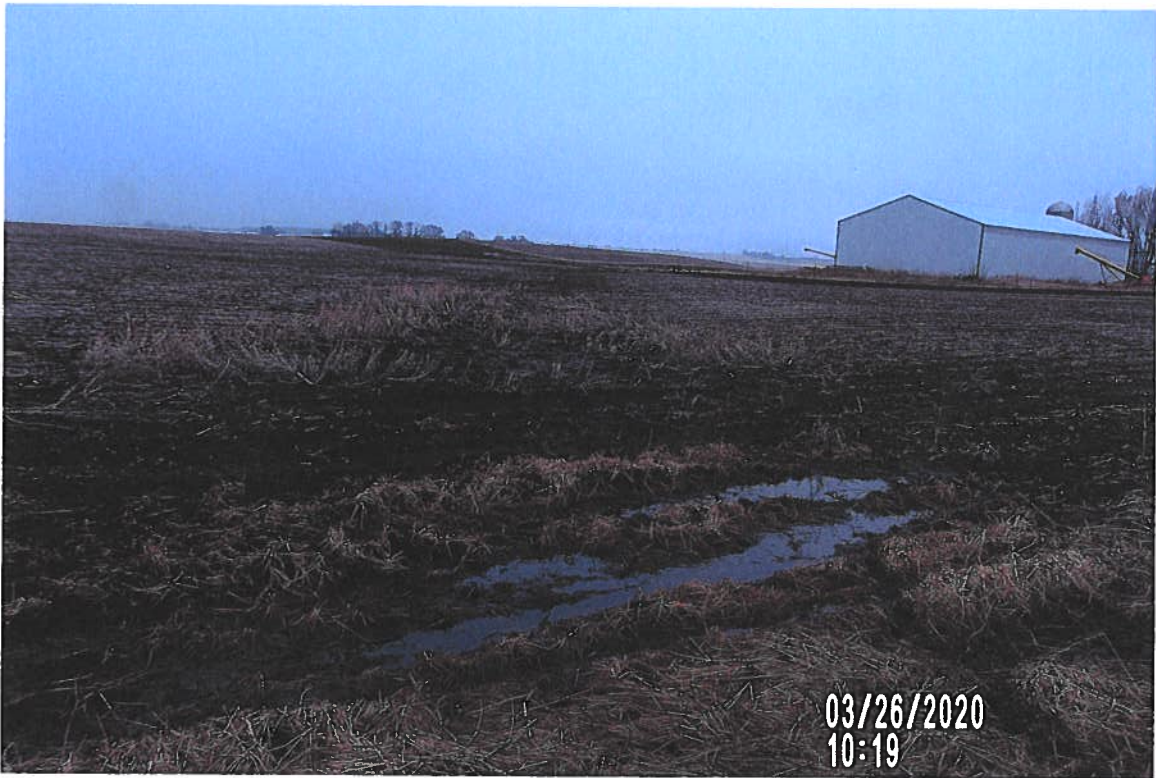
PICTURE # 3146 IS LOOKING SE SHOWING GRASS AREA WITH WATER STANDING IN GRASS AREA.

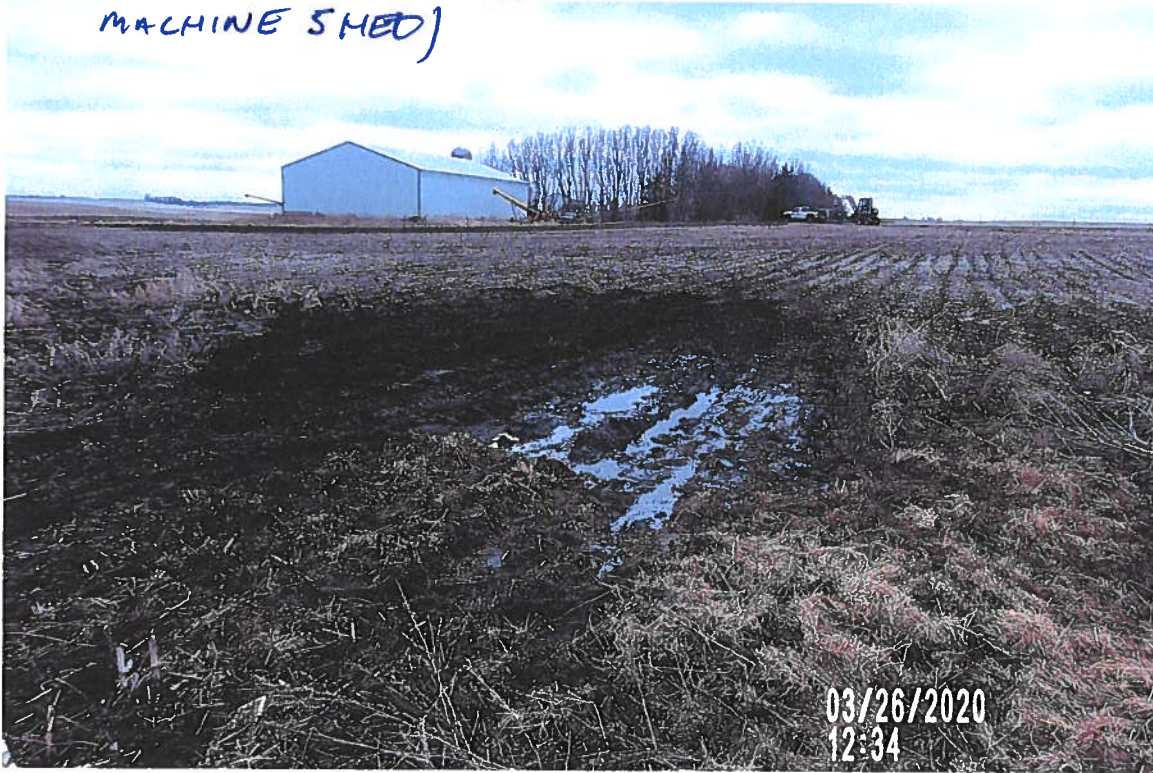
PICTURE #3151 IS LOOKING SE SHOWING TRENCH BACKFILLED WITH SOIL ON SOUTH EDGE OF WATER STAND AT GRASS AREA (245' NORTH & 241.2' WEST OF NE CORNER OF MACHINE SHED)

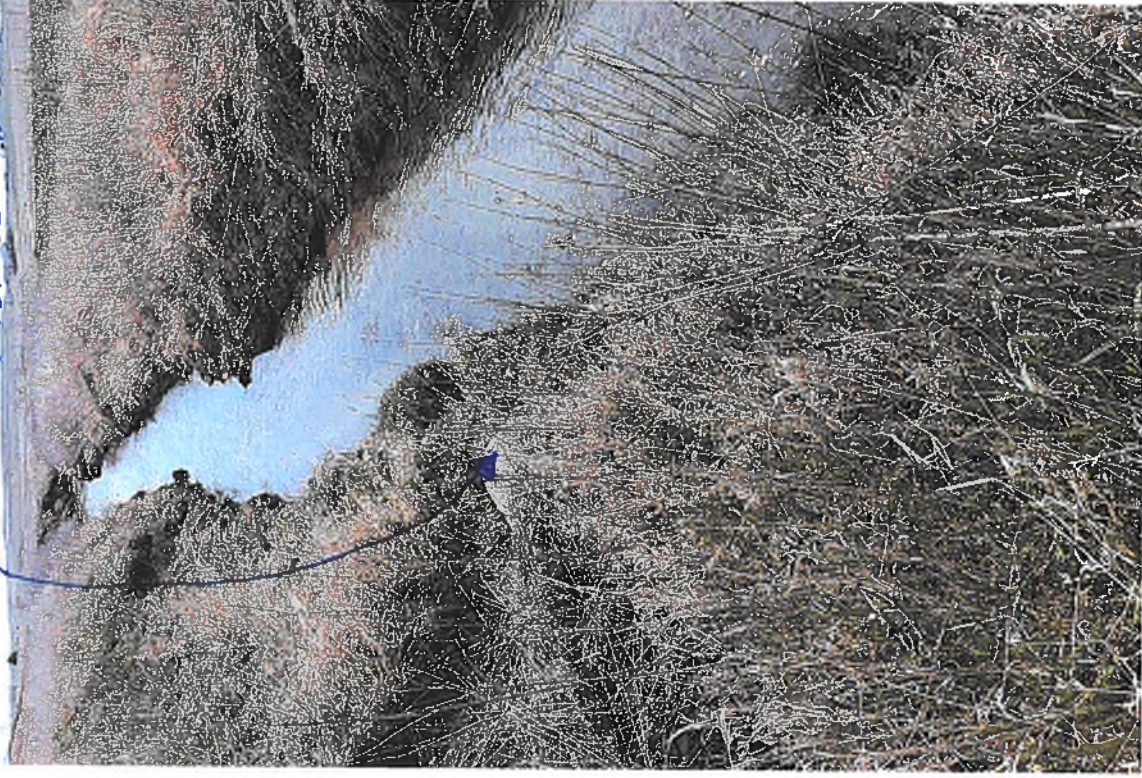
PICTURE #3 IS LOOKING SE SHOWING DRAINAGE DITCH & OUTLET OF 36" CMP WITH DRAINAGE BANK ERODED, GPS# 401 TOP 36" CMP 3.0' TOP TO FL

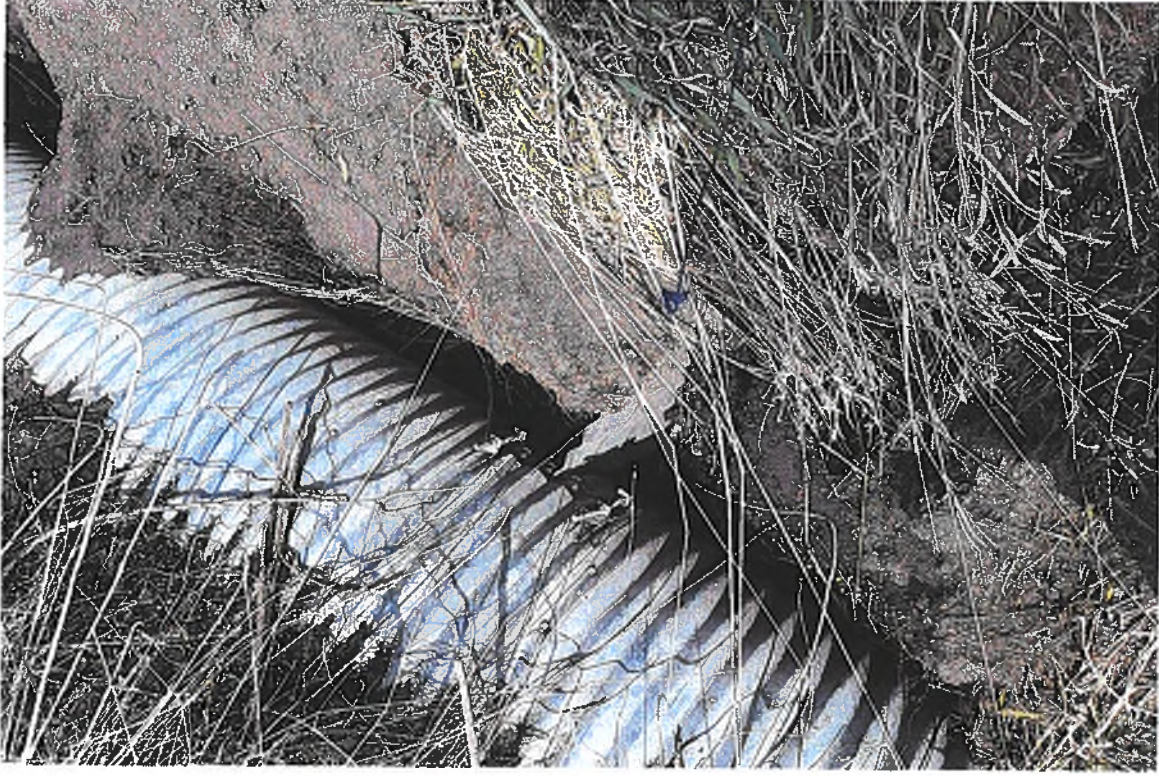
PICTURE # 5 IS LOOKING NW ON EAST SIDE
OF 36" CMP AT DRAINAGE DITCH ERODED
WITH METAL ANTI SEEP COLLAR EXPOSED

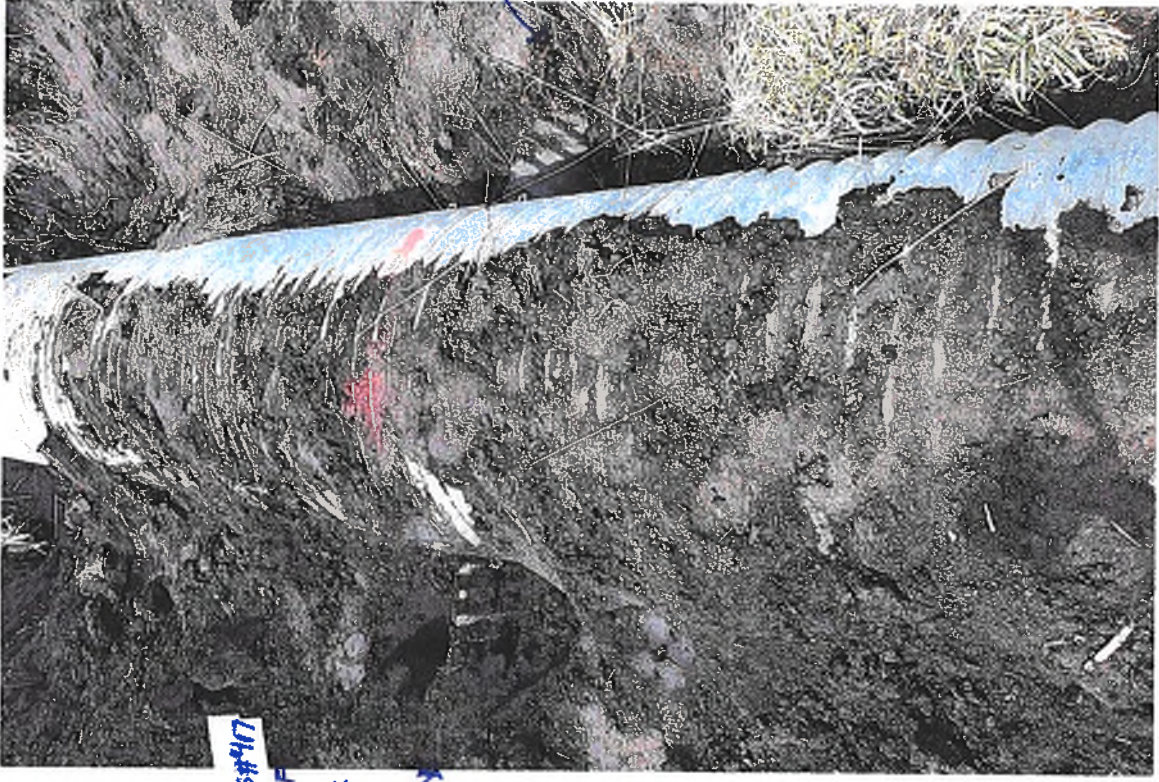
PICTURE #11 IS LOOKING NW AT EXISTING METAL ANTISEEP COLLAR EXPOSED 11.1' SE OF NORTH INLET

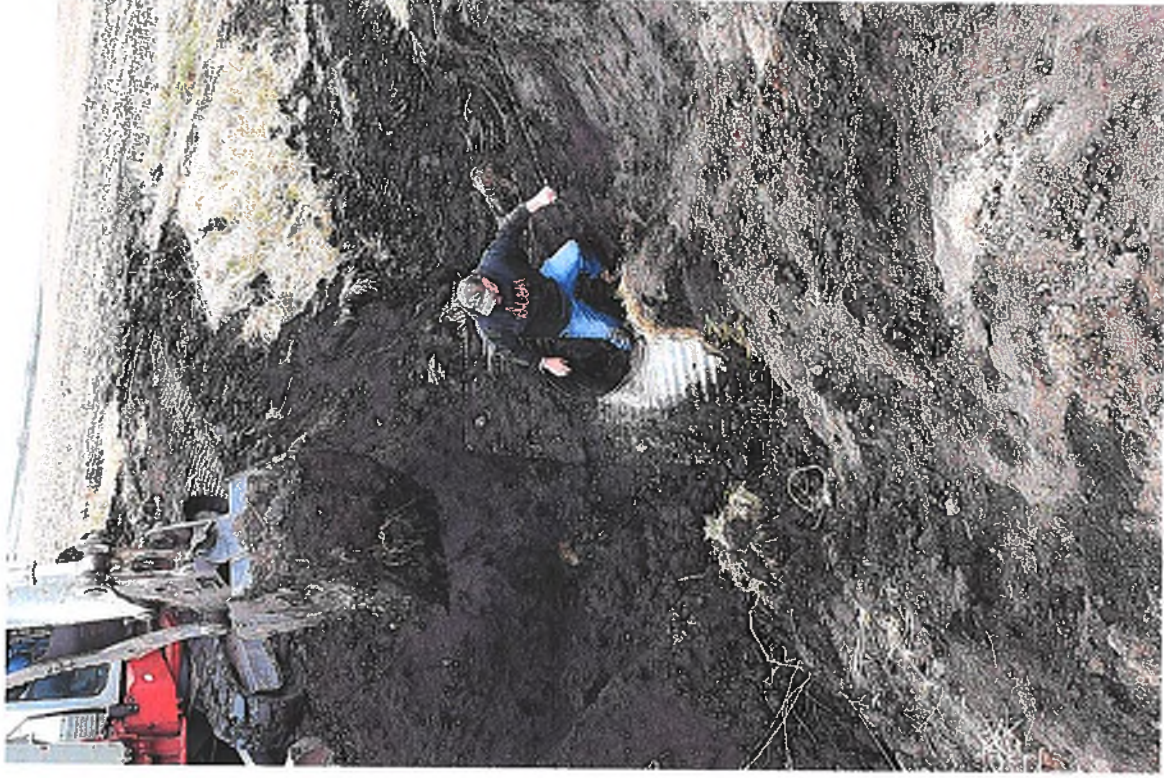
PICTURE # 17 IS LOOKING NW SHOWING
CREW REMOVING EXISTING METAL
ANTI SEEP COLLAR

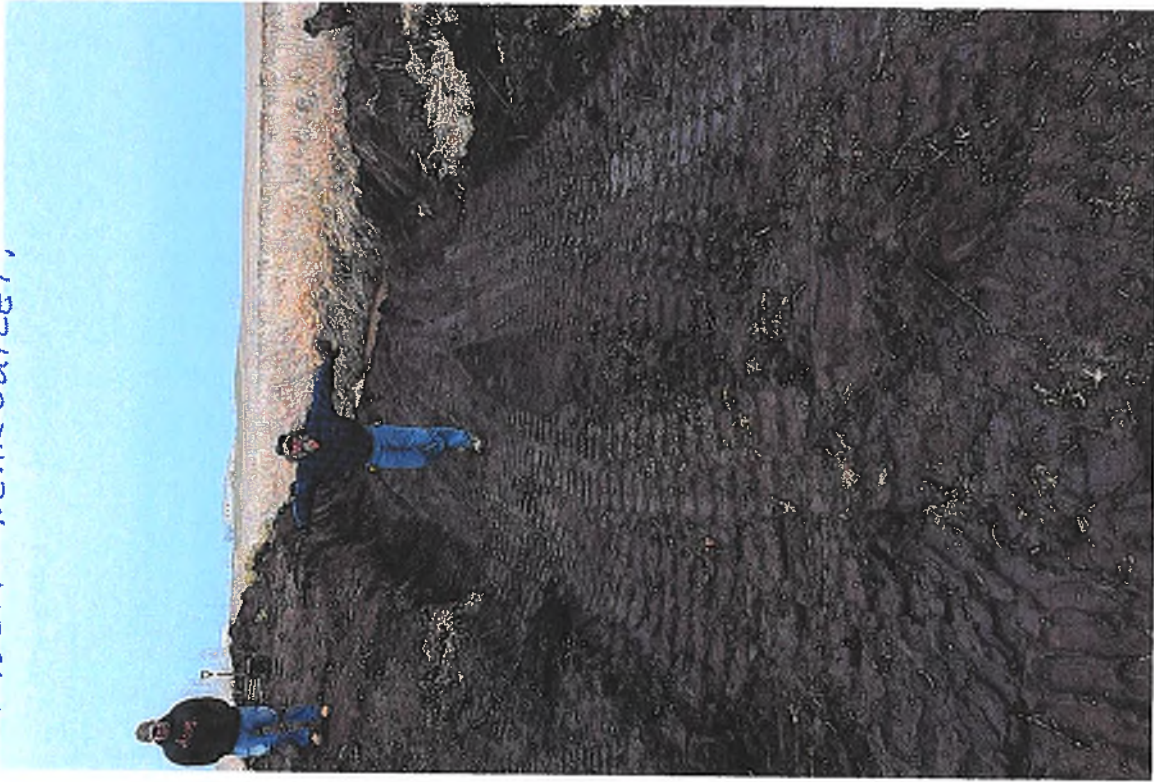
PICTURE# 18 IS LOOKING SE SHOWING
EXISTING SUBGRADE AFTER MINI
EXCAVATOR RAN OVER WITH TRACKS.
SOIL IS SOFT NEAR OUTLET,

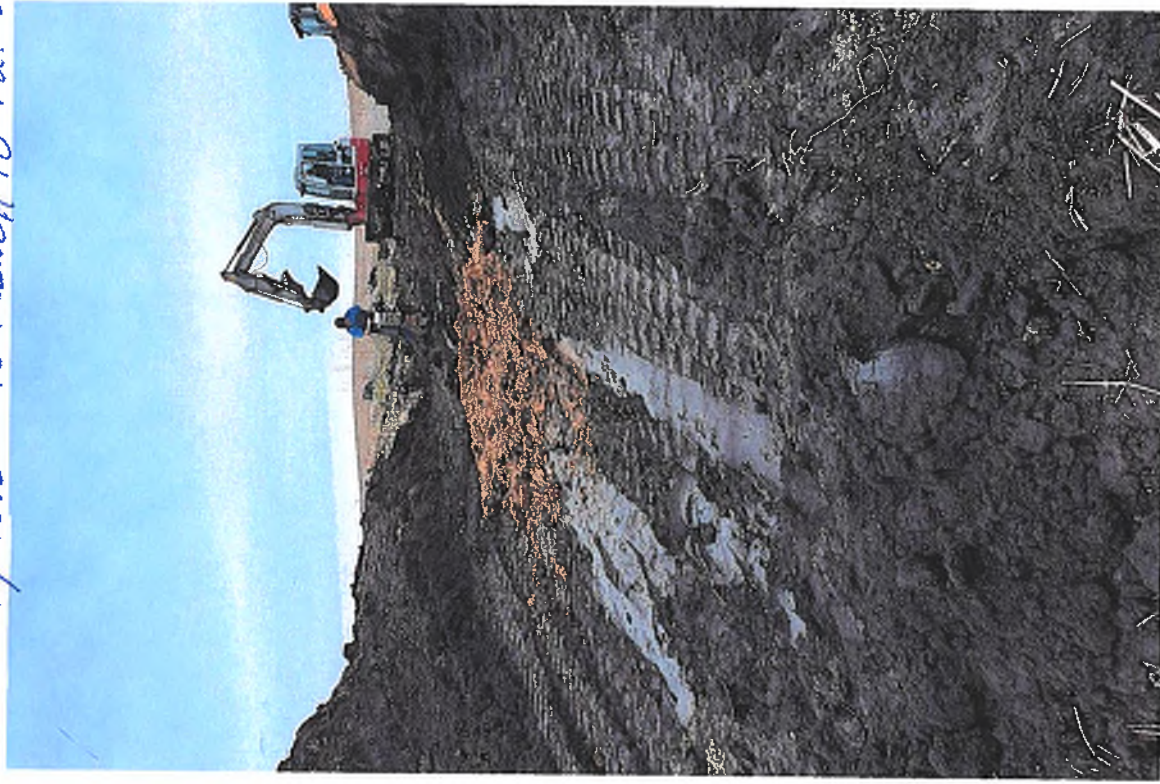
PICTURE# 19 IS LOOKING NW SHOWING CREW
COMPACTING SUBGRADE WITH JUMPING JACK
COMPACTOR & NOW CREW HAULING IN LIMY
CLAY SOIL INTO TRENCH TO PUT BELLYTILE

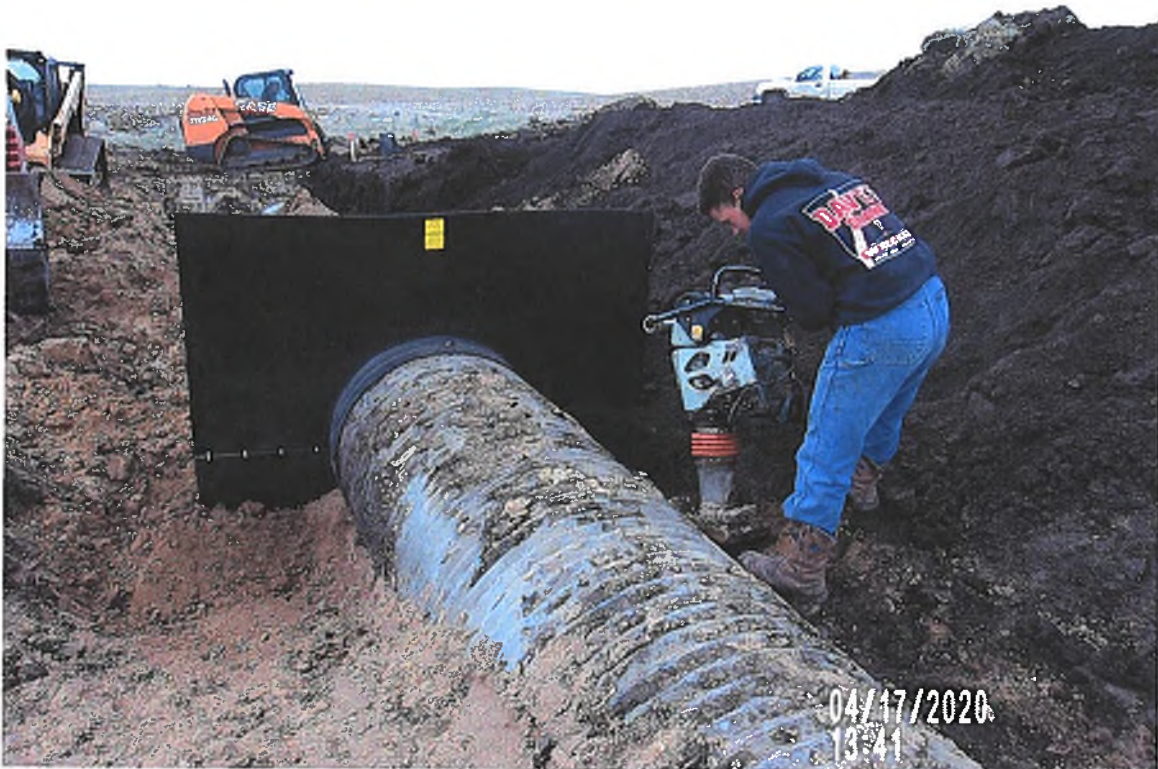
PICTURE # 3386 IS LOOKING NE SHOWING METAL BAND AROUND HDPE ANTI SEEP COLLAR TO HOLD IT ON 36" CMP SURFACE DRAIN.

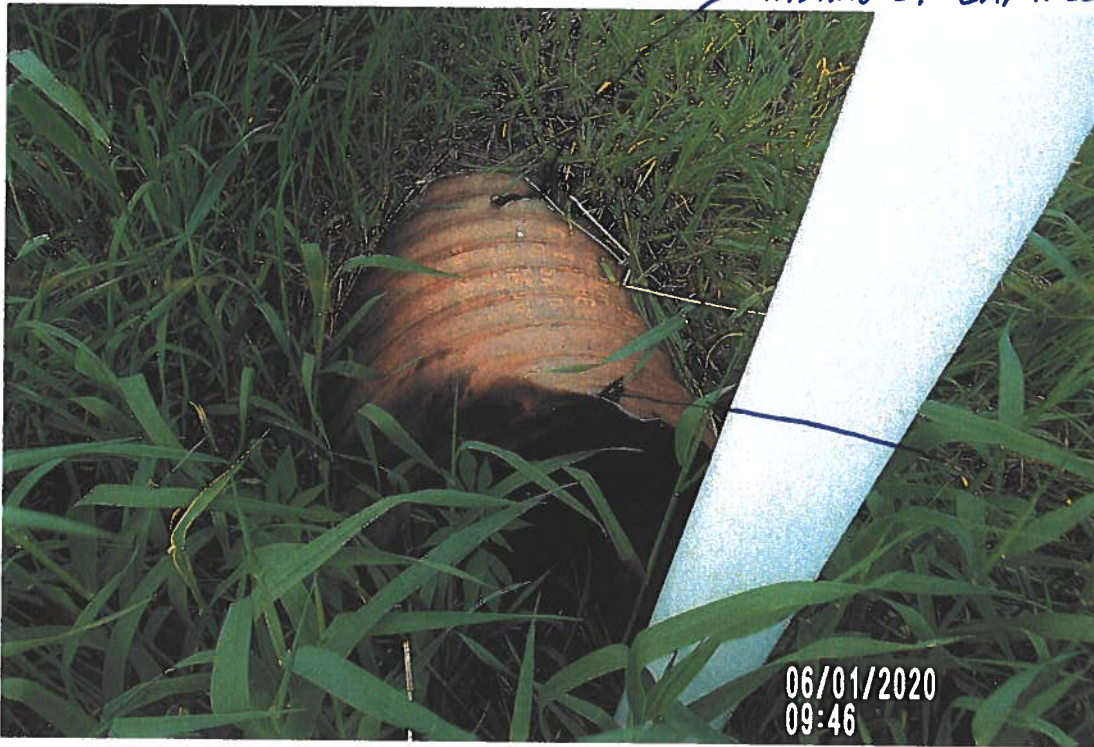
PICTURE# 3617 IS LOOKING SW SHOWING END OF 24" CMP ON SURFACE DRAIN INLET CRUSHED FROM (7 TO 2) AND ABOUT 1.5' BACK WITH A CUT FROM (12 TO 2) ON TOP, EXISTING 24" CMP INLET THAT

SOMETHING TORE INTO CMP.

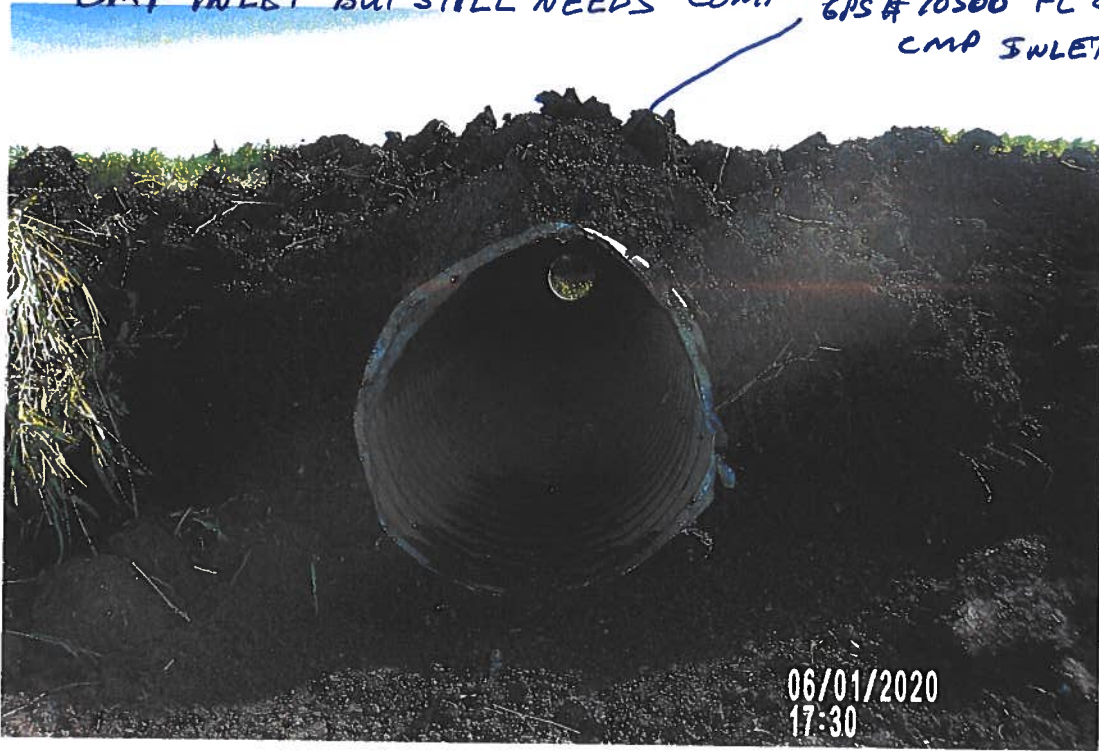
PICTURE # 3631 IS LOOKING SW SHOWING EXISTING 24" CMP
SURFACE DRAIN INLET WITH STRAIGHTENED MANGLED END.
LOOKS LITTLE ROUGH. CREW HAS BACKFILL SOIL AROUND
CMP INLET BUT STILL NEEDS COMPACTED.
GPS # 70500 FL 24"
CMP INLET

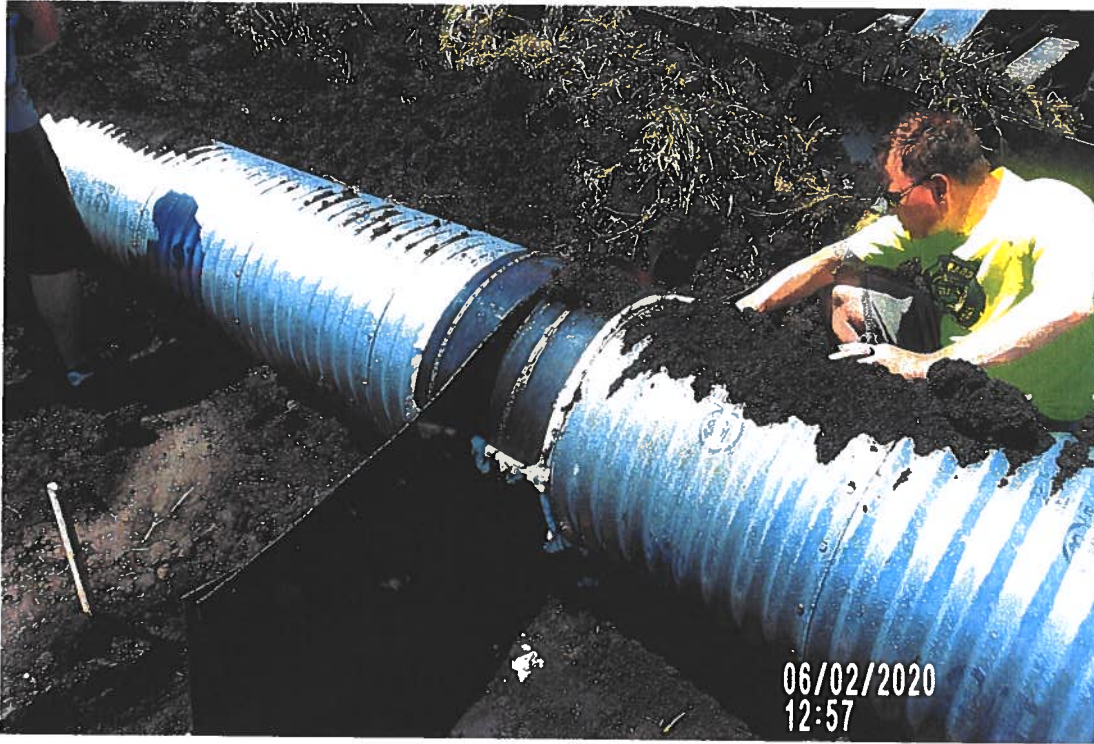
PICTURE # 3636 IS LOOKING EAST SHOWING CREW USING FOAM FILL TO SEAL BETWEEN HDPE ANTISEEP COLLAR AND 24" CMP SURFACE DRAIN, (SUDAS SHOWS SHOULD BE BITUMINOUS MATERIAL)

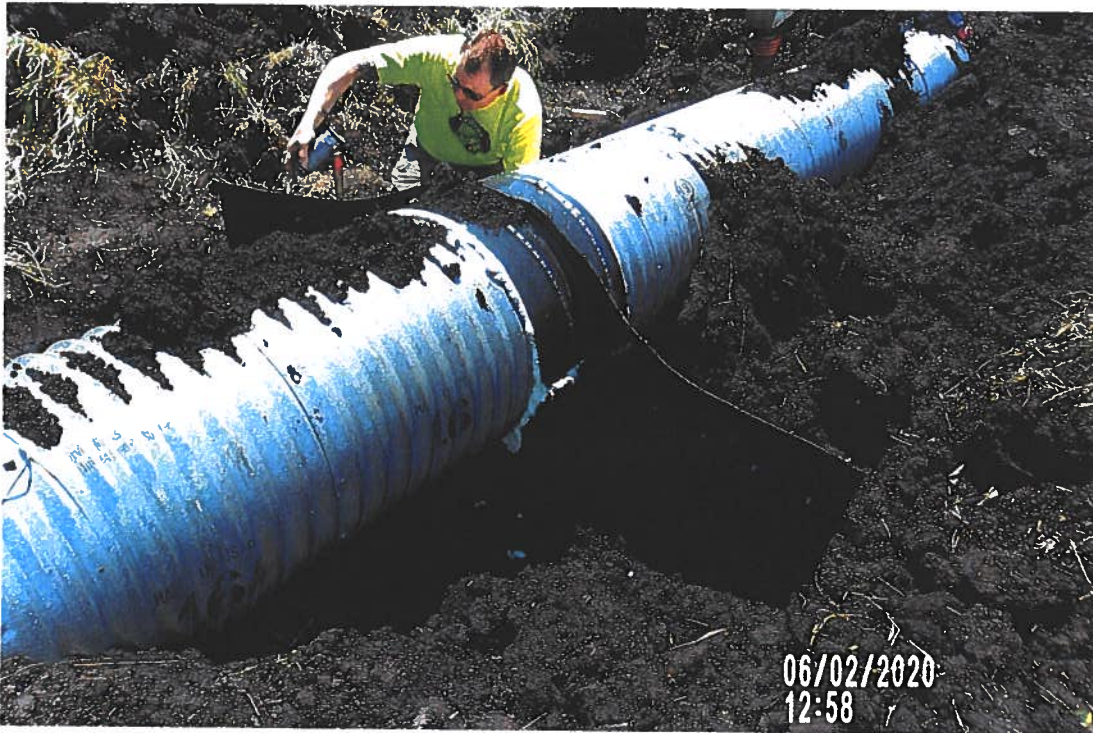
PICTURE # 3637 IS LOOKING SE SHOWING CREW USING FOAM FILL TO SEAL BETWEEN HDPE ANTISEEP COLLAR AND 24" CMP SURFACE DRAIN. (SUDAS SHOWS SHOULD BE BITUMINOUS MATERIAL)

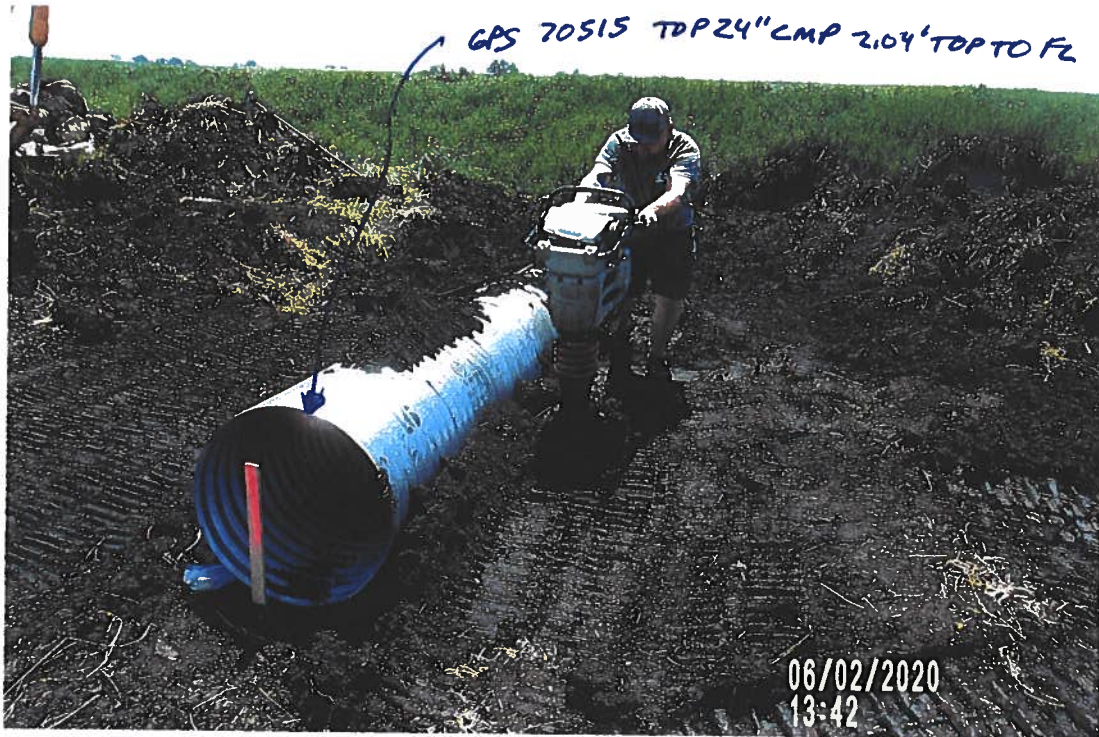
PICTURE # 3638 SHOWING FOAM FILL USED TO SEAL VOID BETWEEN HDPE ANTISEEP COLLAR AND CMP SURFACE DRAIN (OBSERVER INFORMED CREW THAT SUDAS CALLS FOR BITUMINOUS MATERIAL AND THIS IS WHAT CREW BROUGHT BACK)

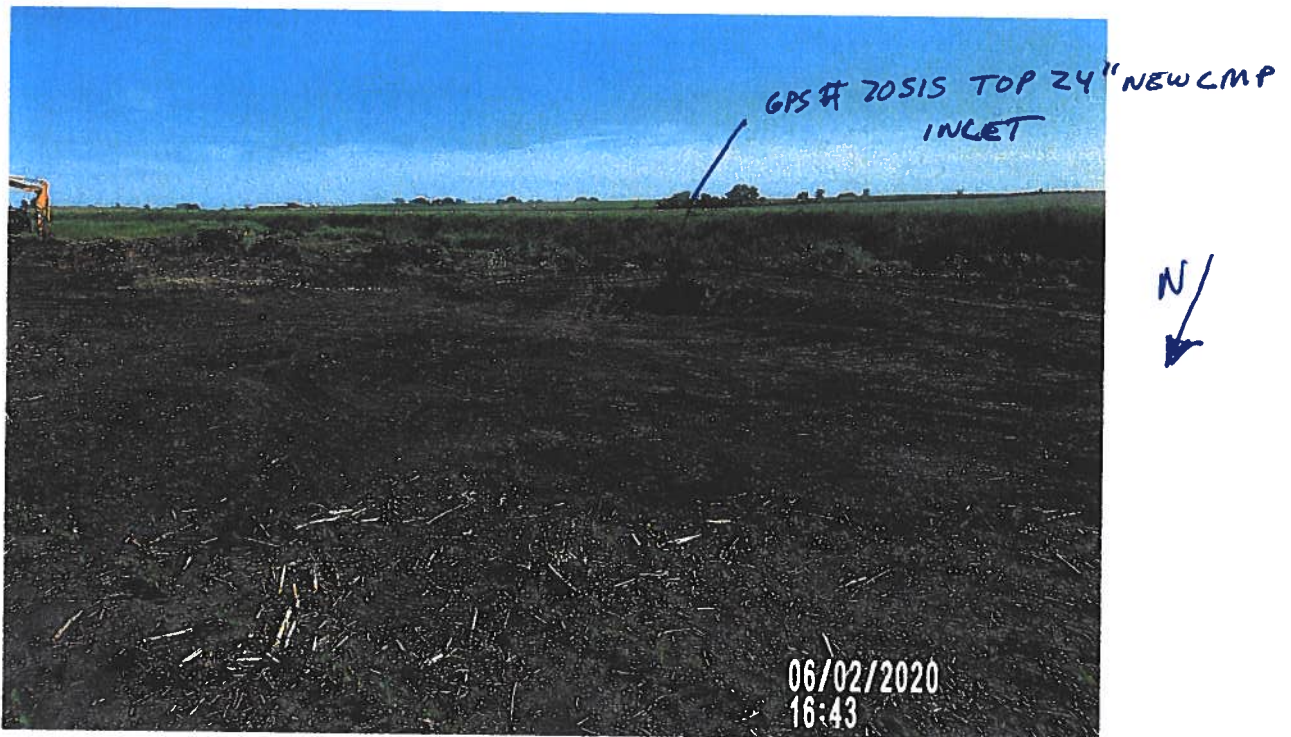
PICTURE #3641 IS LOOKING SE AT 0.14' AC OF BEAN
DAMAGE DURING REPAIR

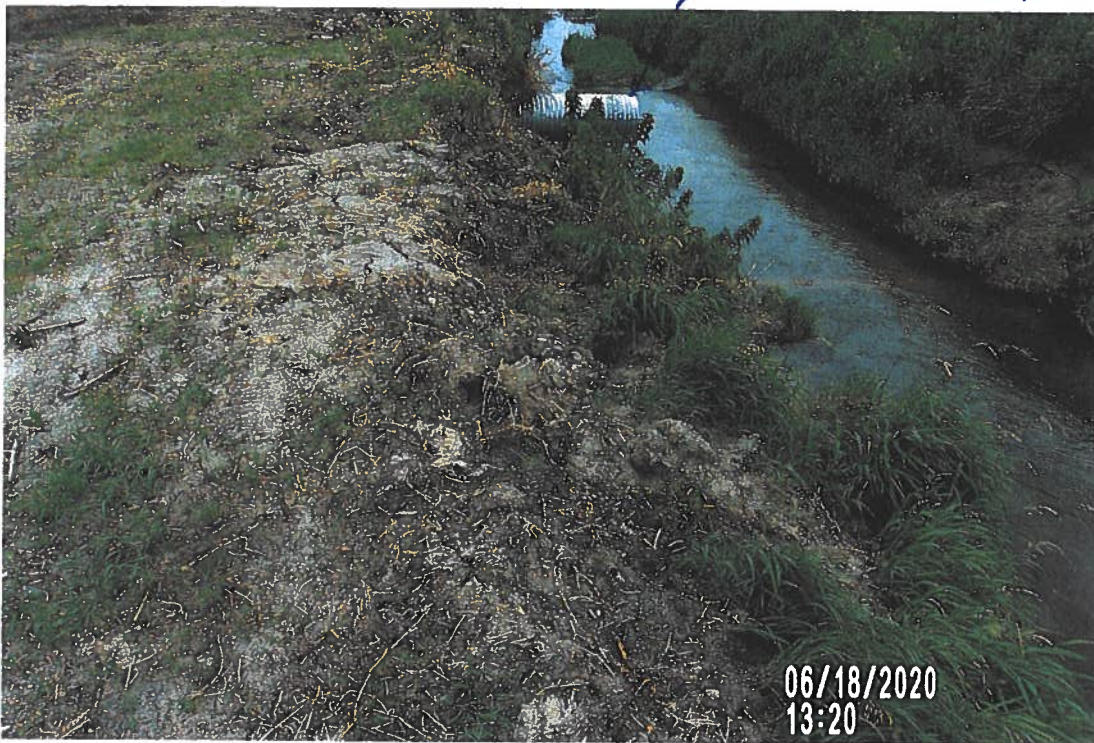
PICTURE# 3831 IS LOOKING SE SHOWING DD NORTH BANK
NEEDING DRESS UP YET

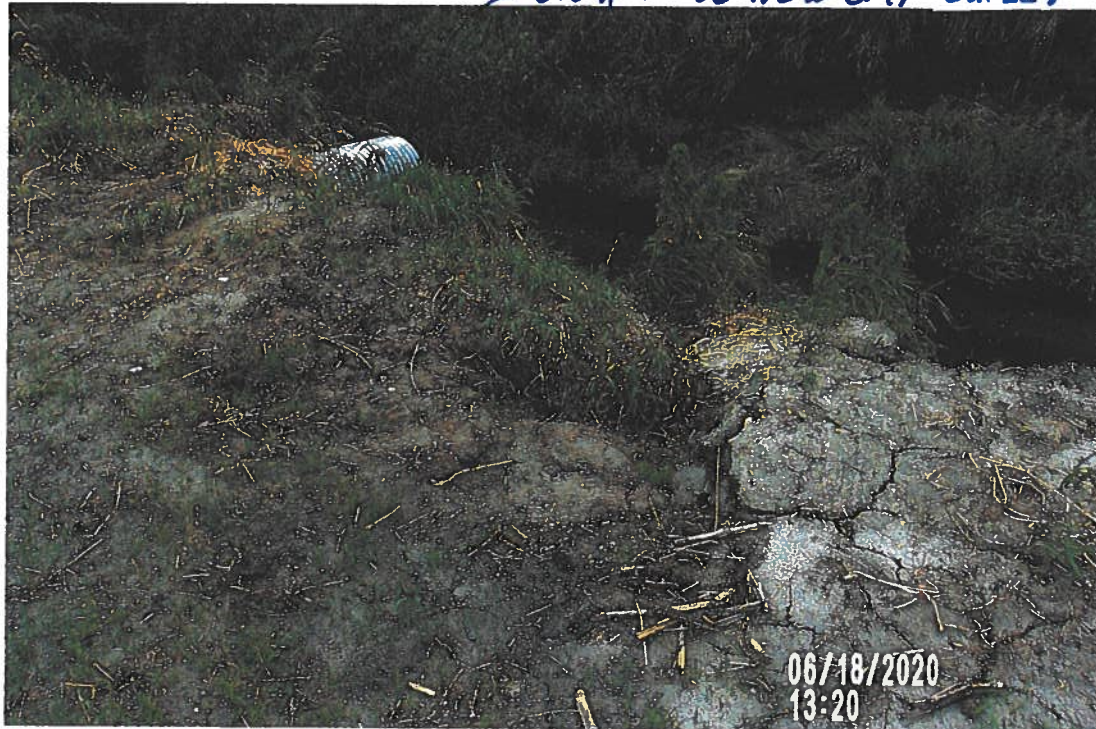
GPS # 70506 NEW CMP OUTLET

PICTURE# 3832 IS LOOKING SE SHOWING DD NORTH BANK
NEEDING DRESSED UP ON WEST SIDE OF NEW CMP
OUTLET

PICTURE #3833 IS LOOKING NW SHOWING BOULDERS IN DD BANK FOR A FILLED IN WASHOUT BETWEEN NEW AND EXISTING SURFACE DRAIN. NEEDS DRESSED UP / GPS#70506 NEW CMP OUTLET

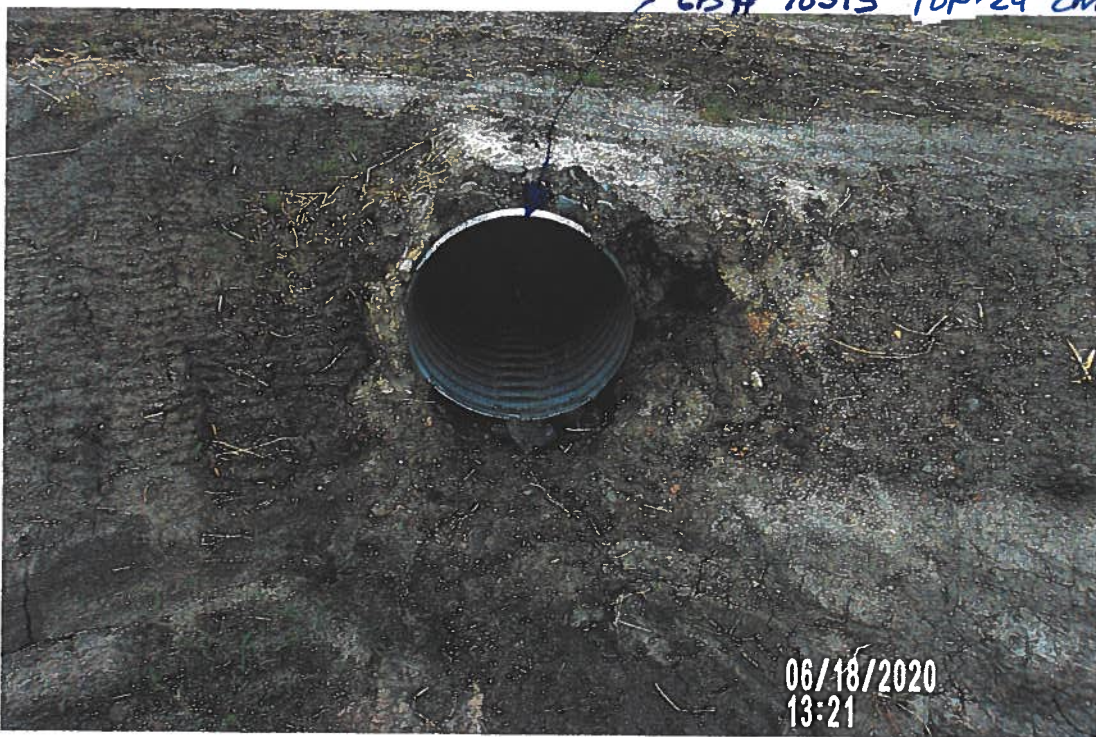
PICTURE #3834 IS LOOKING SW AT NEW SURFACE DRAIN INLET WITH WATER STARTING TO ERODE UNDER CMP

PICTURE # 3835 IS LOOKING NW SHOWING SOIL GRADED OVER SURFACE DRAINS AND CREW SAID THEY SEEDED IT

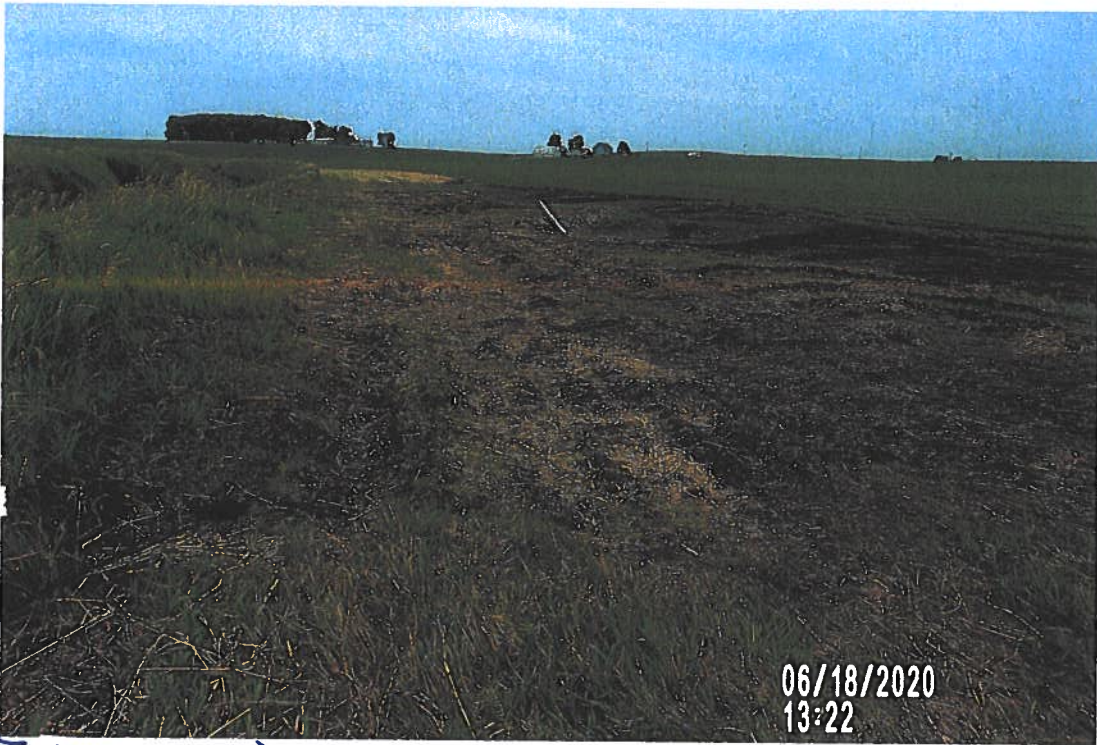
AREA SETTLED WHERE CREW EXCAVATED FOR SOME BETTER SOIL TO BACKFILL AROUND SURFACE DRAINS

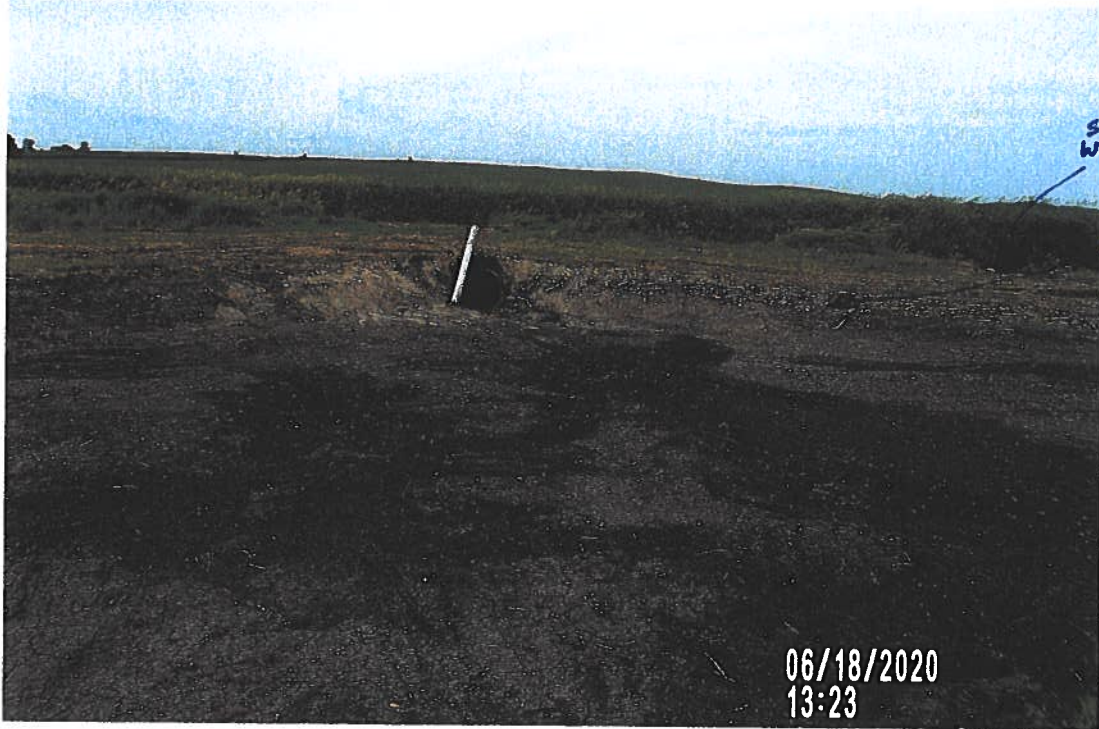
SMALL WASHOUT WITH ROCKS IN IT

CORN STALKS ON TOP WHERE WATER WENT OVER AND RAN TO WASHOUT

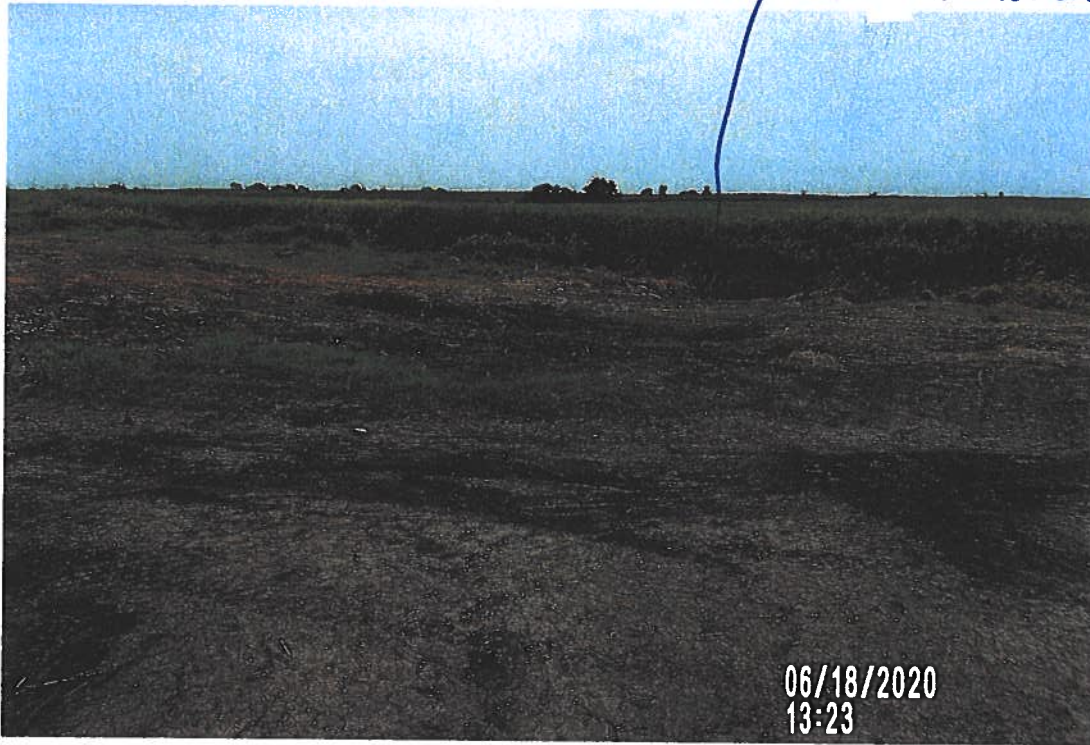
PICTURE # 3837 LOOKING SOUTH AT LOW AREA WHERE GRASS NOT GROWING VERY WELL,

DD BANK ERODED FROM WATER RUNNING TO DD SMALL WASHOUT WITH BOULDERS MAY NEED TO GRADE LOW AREA TO GET FLOW TO SURFACE DRAIN BY ADDING MORE SOIL

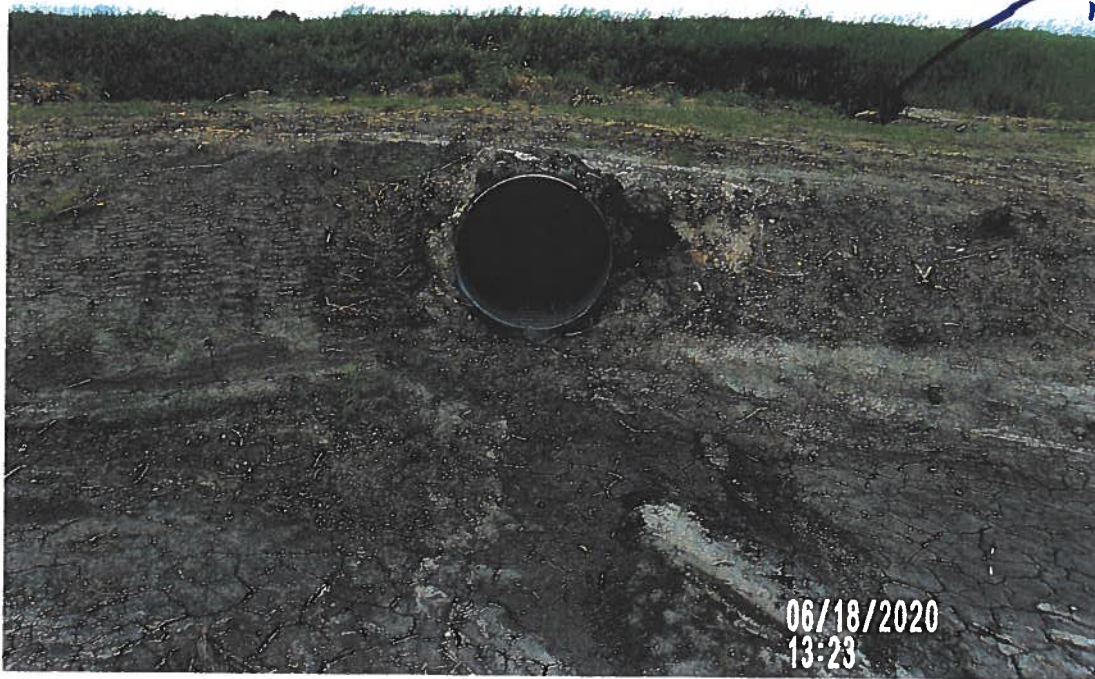
DD BANK NEEDS DRESSED UP

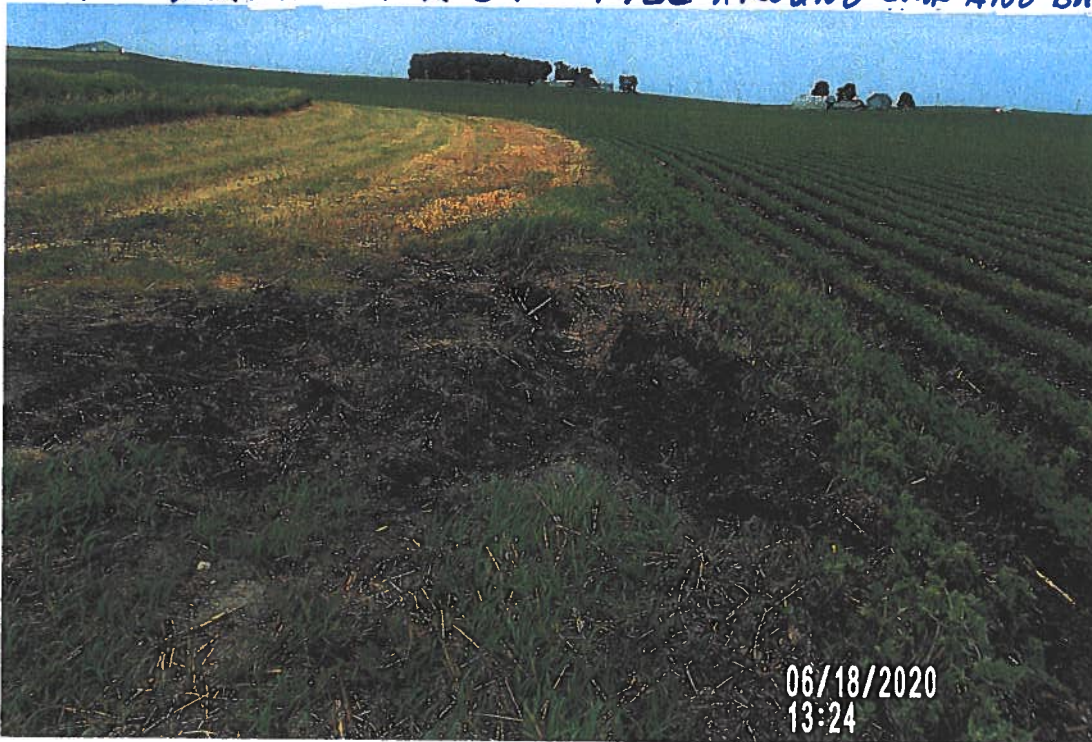
PICTURE # 3838 IS LOOKING SW SHOWING SOIL STARTING TO ERODE UNDER INLET OF NEW 24" CMP INLET. AND GRASS NOT GROWING.

PICTURE # 3839 IS LOOKING NW SHOWING AREA
ALONG FIELD NW OF NEW 24" CMP WHERE GOOD SOIL
WAS EXCAVATED FOR BACK FILL AROUND CMP AND BACK FILLED
