AGENDA
REGULAR DRAINAGE MEETING
Wednesday, August 5, 2020 9:30 AM
Large Conference Room

9. DD 48 - WO 237 - Discuss W/ Possible Action - Repair Summary

[DD 48 WO 237 - 6486.4 - REPAIR SUMMARY - 08_03_20.PDF](#)

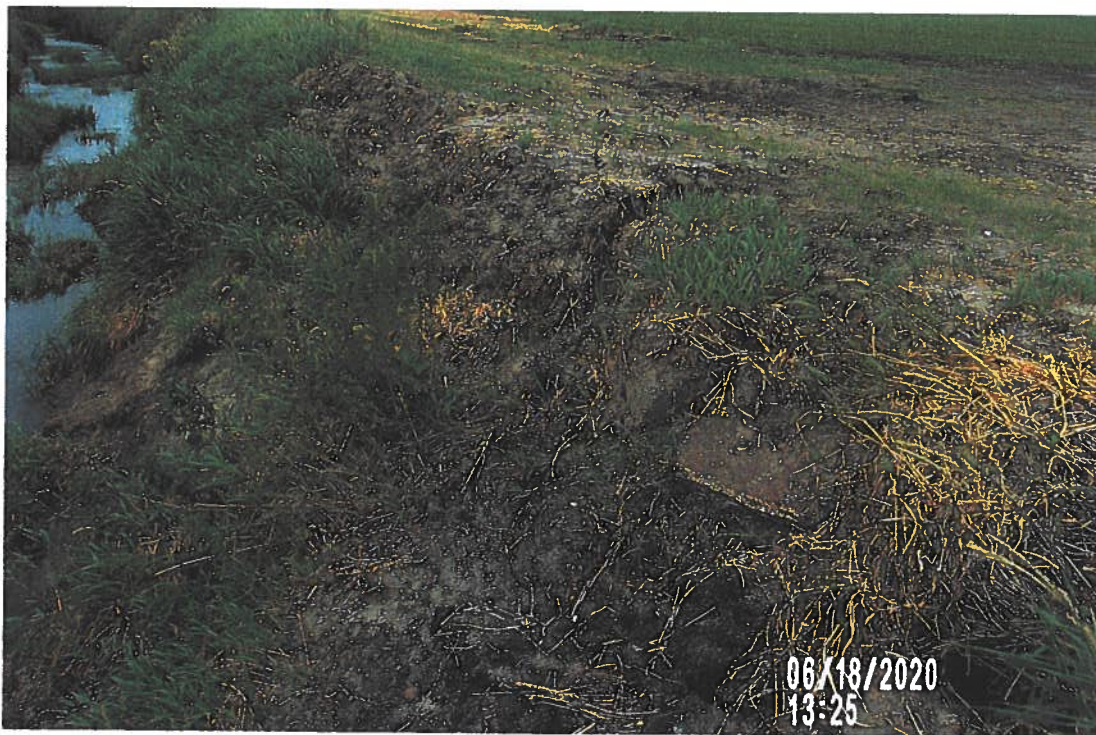
AREA
HAS
SETTLED
NOW

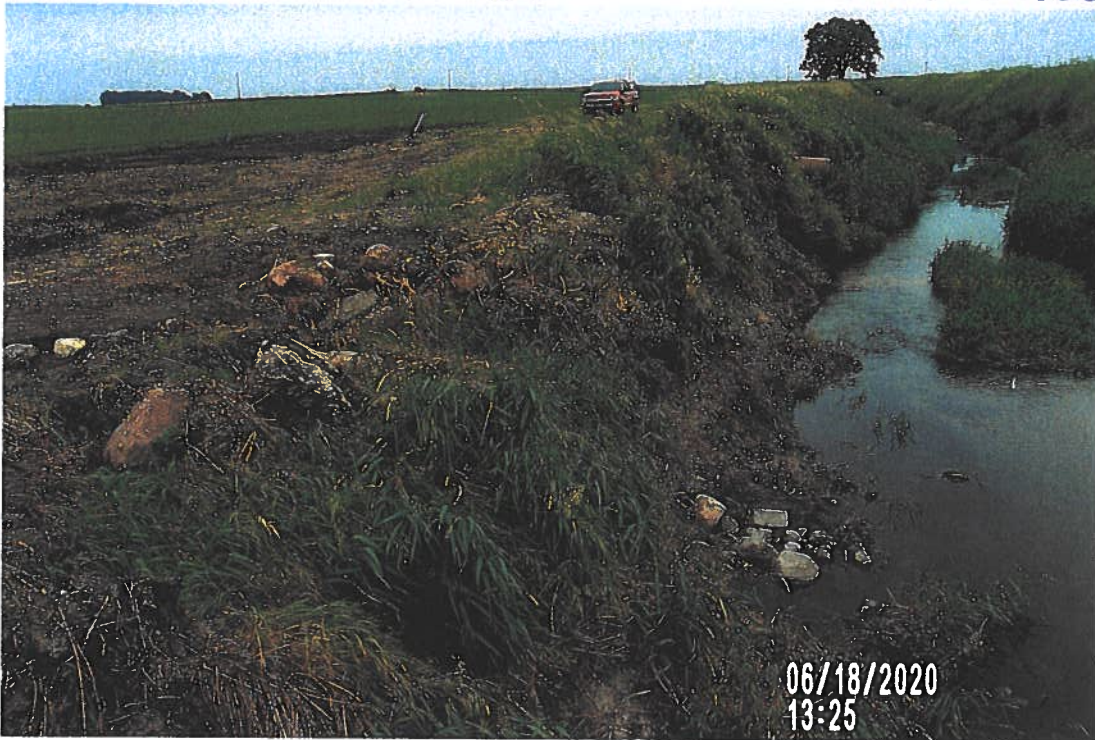
PICTURE # 3840 IS LOOKING NW OF NEW 24" SURFACE
DRAIN SHOWING NORTH BANK WEEDING DRESSED UP
AND SOIL PACKED IN.

PICTURE #3841 IS LOOKING SE SHOWING DD BANK BETWEEN
EXISTING AND NEW OUTLET NEEDING DRESSED UP WITH SOIL IN
WASHOUT FILLED WITH BOULDER AND ALL BOULDERS TAPPED

INTO
BANK

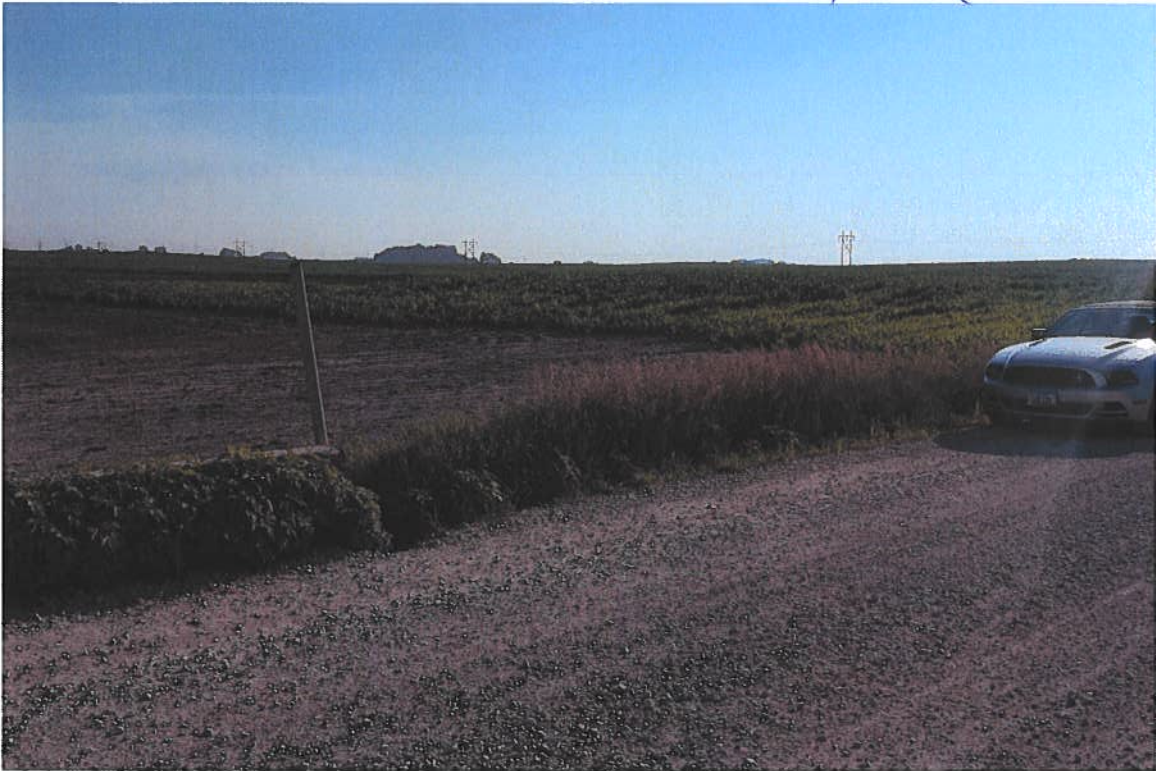
E end drawn spot @ 115+4

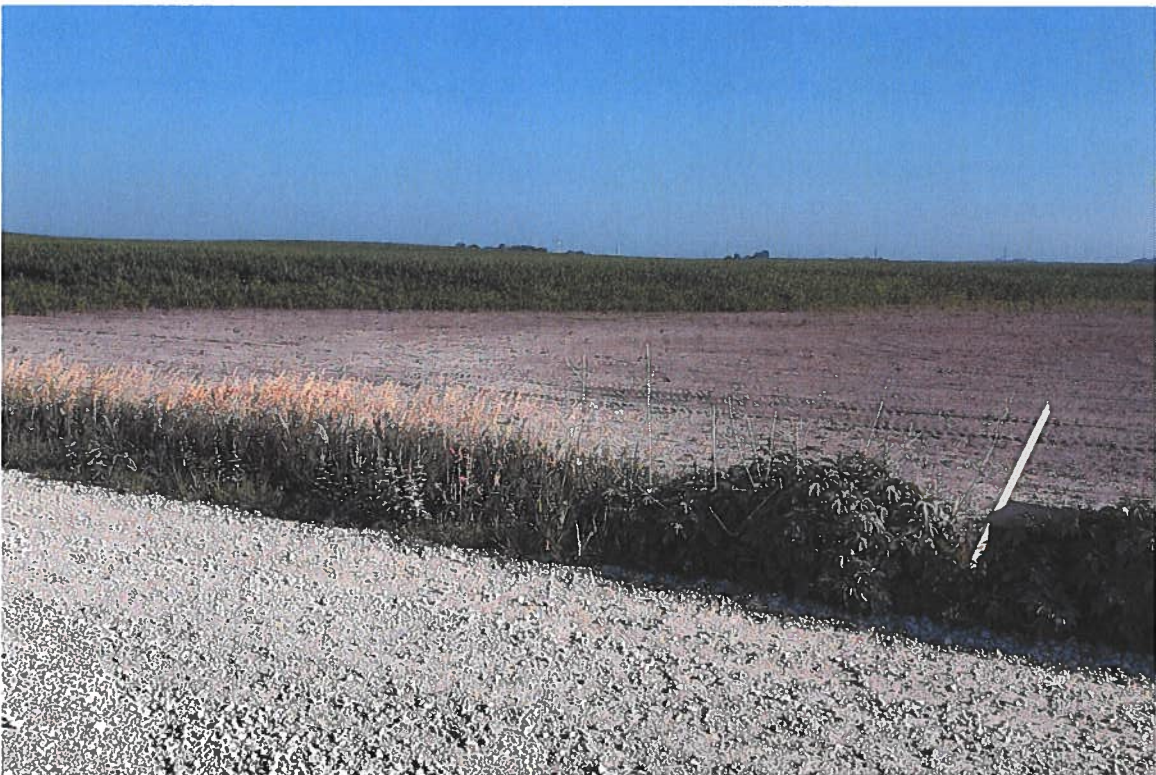
W end drawn spot @ 115+4

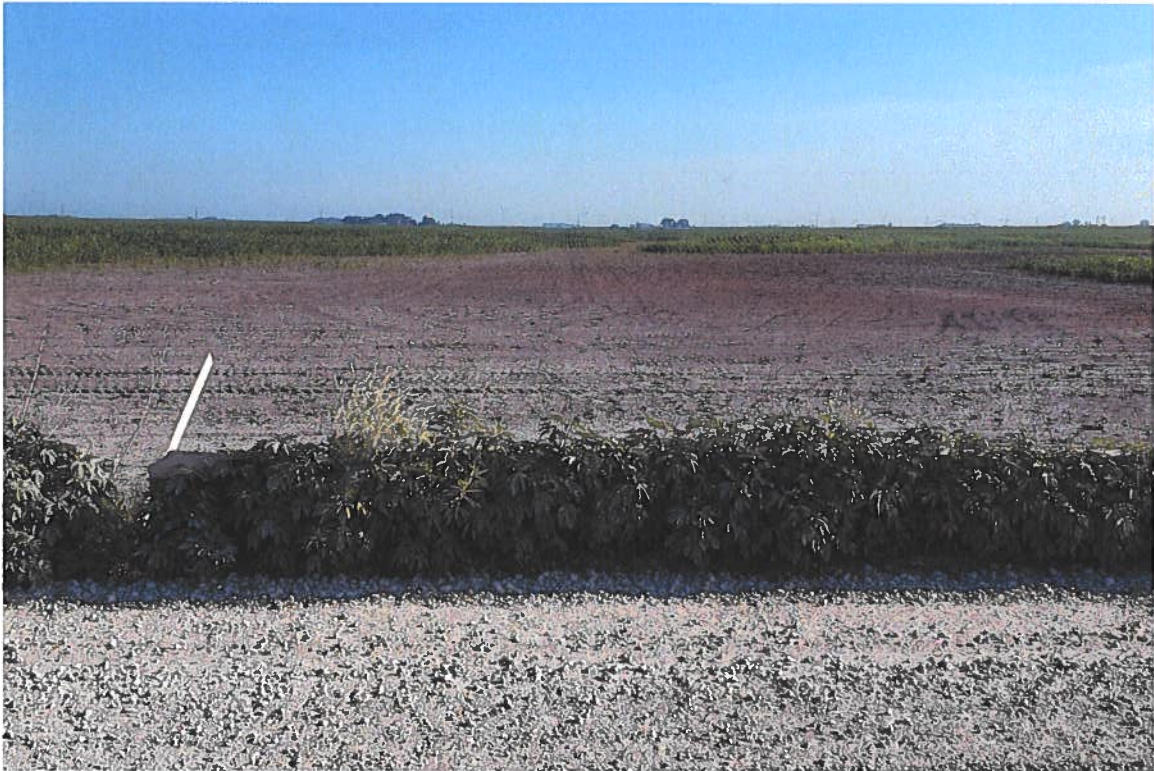
Middle drain spot @ 115ft

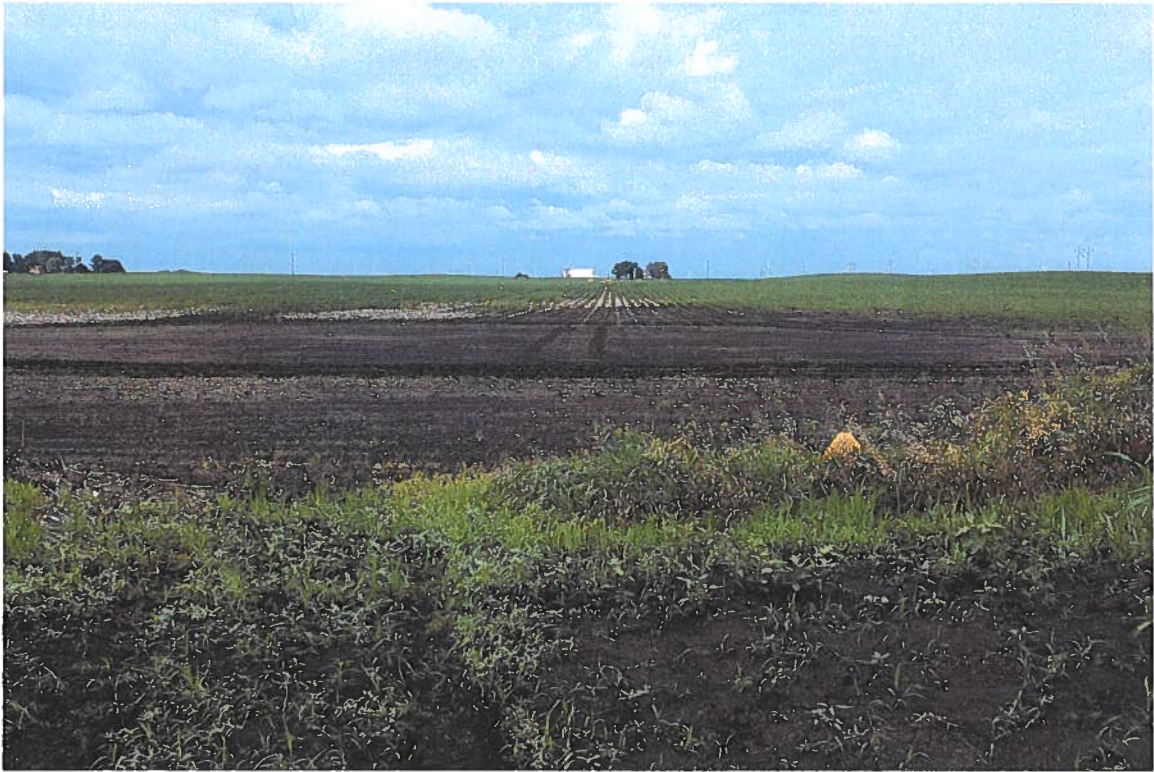
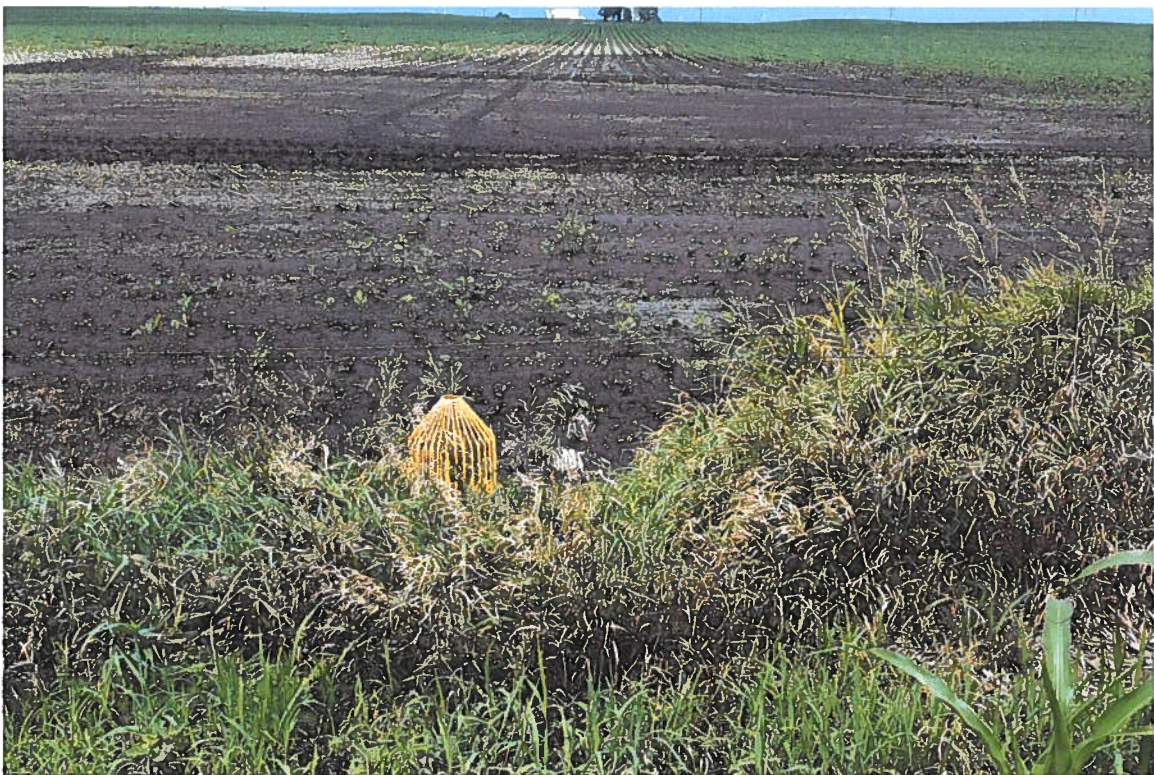
7-15-2020
Wet spot in adjoiners field

7-15-2020
Yellow topped intake just
north of fence line

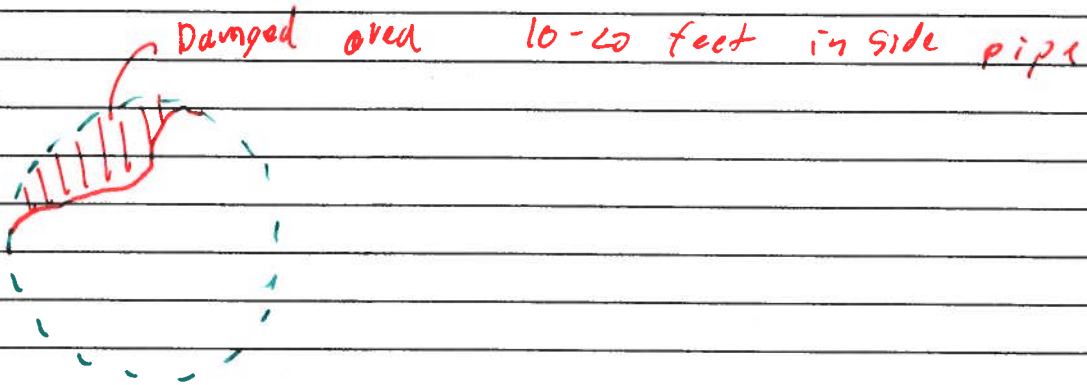
- pipe was backfilled & seeded

- pipe is damaged on inside (see photos)

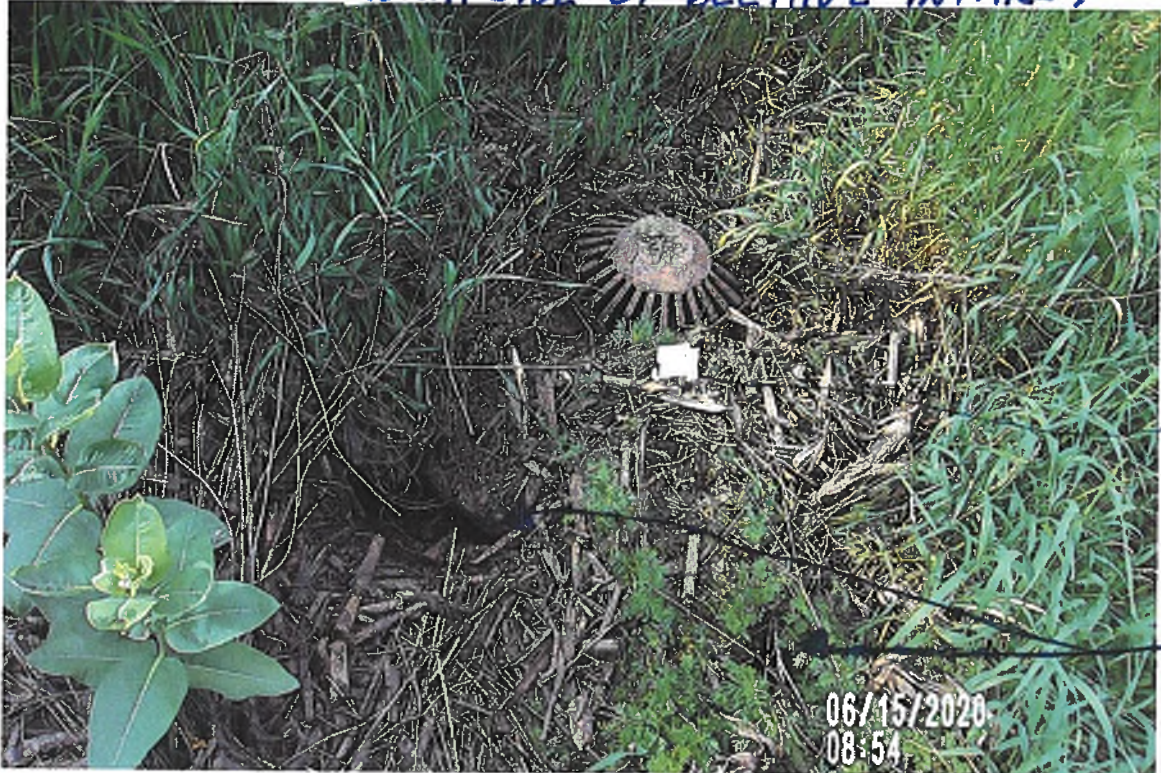
PICTURE# 3736 IS LOOKING SOUTH AT 24" BEEHIVE INTAKE IN WEST DITCH OF AA AVE 656' ± NORTH OF CO HWY D25 SHOWING BEEHIVE WAS COMPLETELY COVERED WITH CORN STALKS WITH SINKHOLES ON NORTH SIDE OF BEEHIVE INTAKE,

SINKHOLES
NORTH
SIDE OF
BEEHIVE
INTAKE

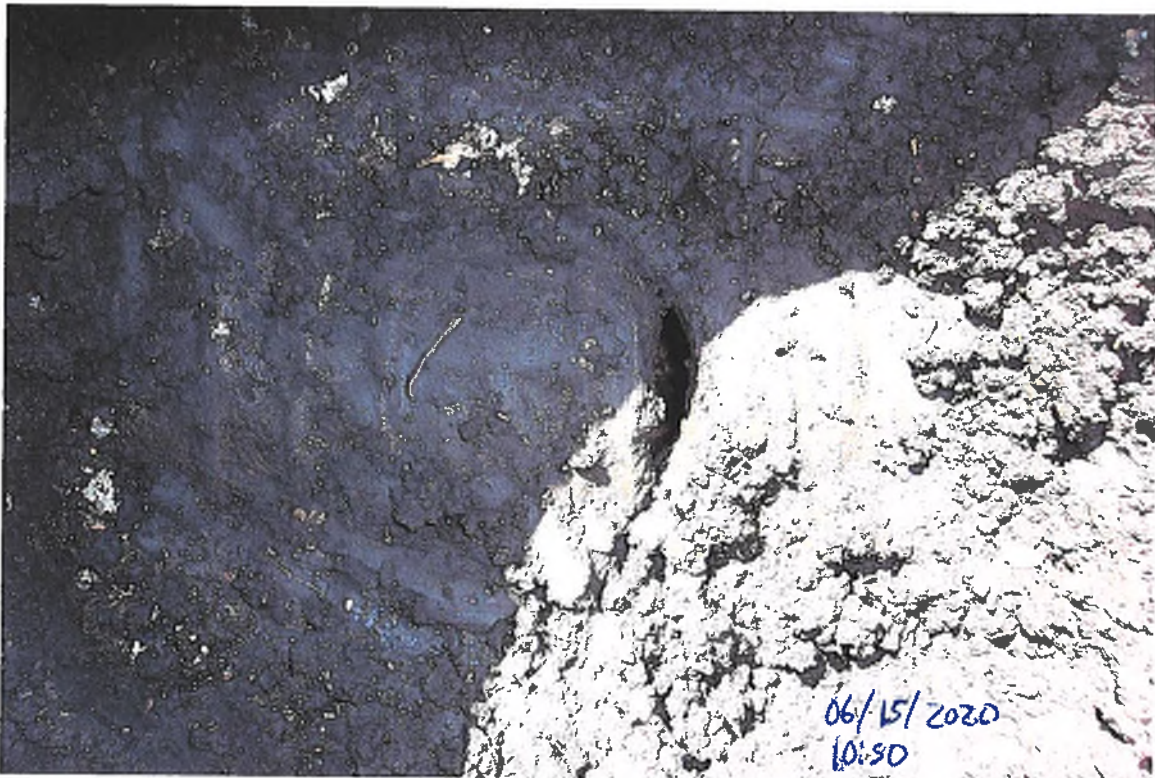
PICTURE# 3739 IS LOOKING SE INSIDE 15" BEEHIVE INTAKE
AFTER SOIL REMOVED SHOWING 1" X 3" HOLE IN 8" CONCRETE
TILE RUNNING THROUGH BEEHIVE TO DRAIN WATER.

- Removed soil from the concrete intake and made a larger drain hole in the underlying 8-inch Branch 2CA concrete tile so that water can freely drain from the structure. Within said tile, water was found to be flowing freely. The surrounding road ditch was also graded to provide positive drainage towards the intake.

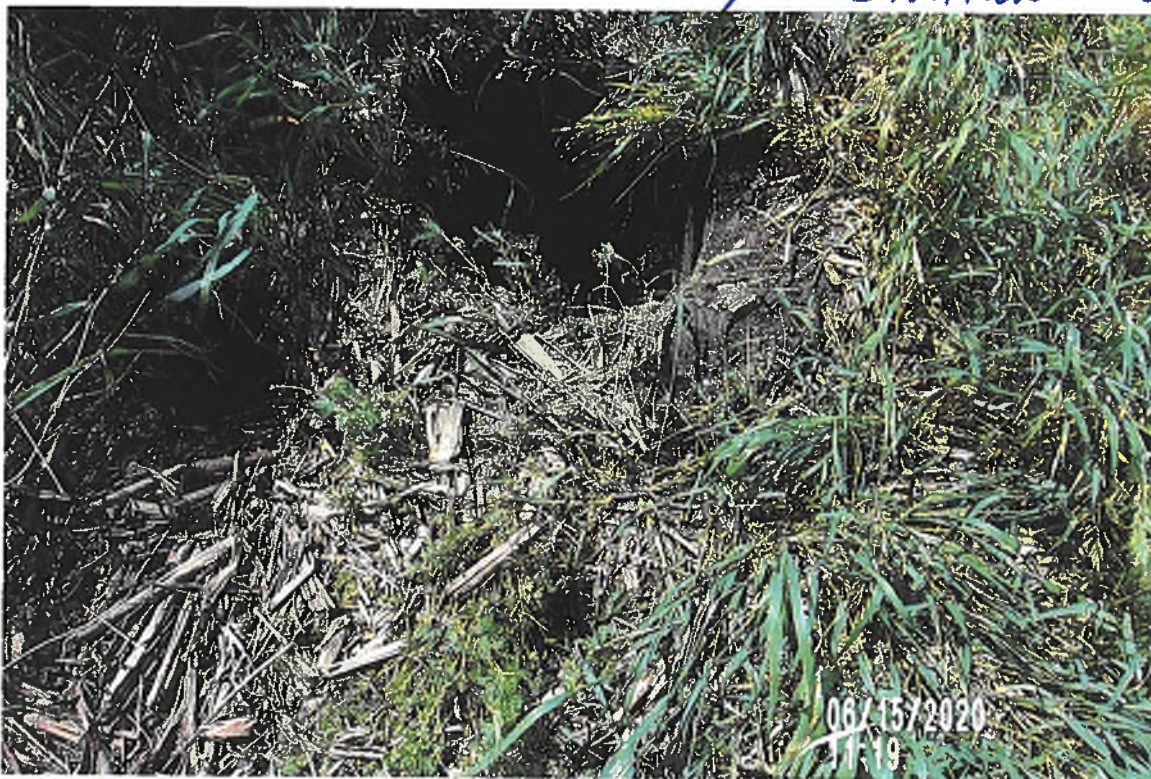
PICTURE # 3742 IS LOOKING SOUTH AT 24" BEEHIVE INTAKE WITH TOP OFF AND SINKHOLES ALONG BEEHIVE INTAKE ON NORTH SIDE BEFORE ANY EXCAVATION DONE.

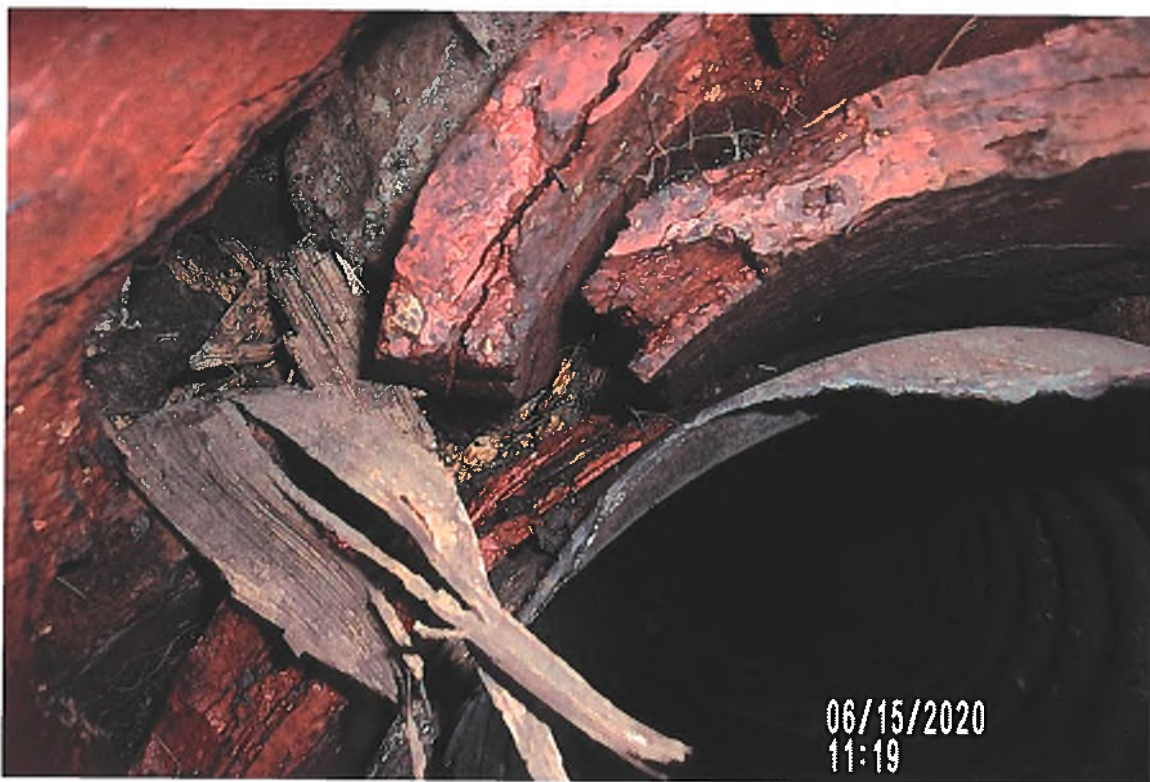
PICTURE # 3743 IS LOOKING NE INSIDE 24" BEEHIVE INTAKE SHOWING A POOR CONNECTION BETWEEN 8" CLAY TILE IN WALL OF BEEHIVE AND 8" SPIRAL CMP OUTLET, APPEARS SOIL HAS BEEN FLOWING THROUGH THE CONNECTION.

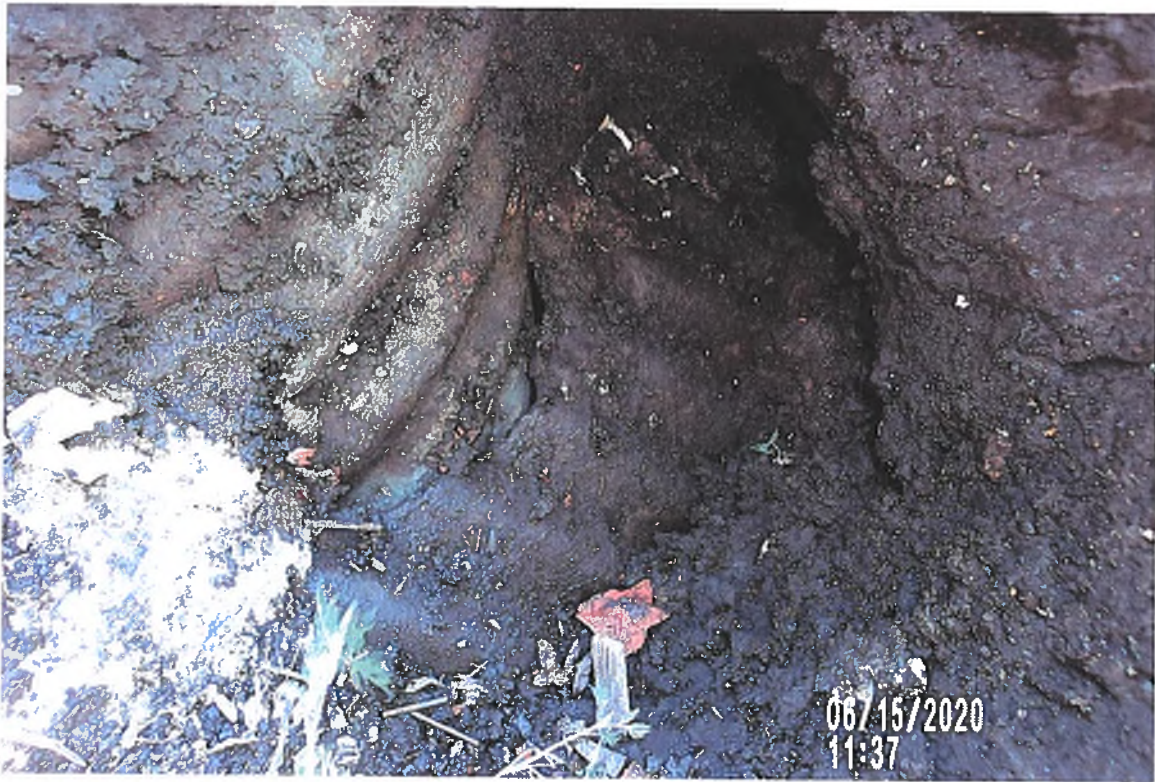
PICTURE #3745 IS LOOKING SE SHOWING GAP WHERE 6" SPIRAL CMP 90° OUTLET TIES INTO 8" SPIRAL CMP OUTLET TILE FROM BEEHIVE INTAKE WHERE CONCRETE COLLAR BROKE OUT.

- Repaired connection of private tile to the Branch 2B5 tile with a ¾ concrete collar.
- Excavations were then filled with on-site soil, and surrounding road ditch was graded to provide positive drainage slope towards the intake.

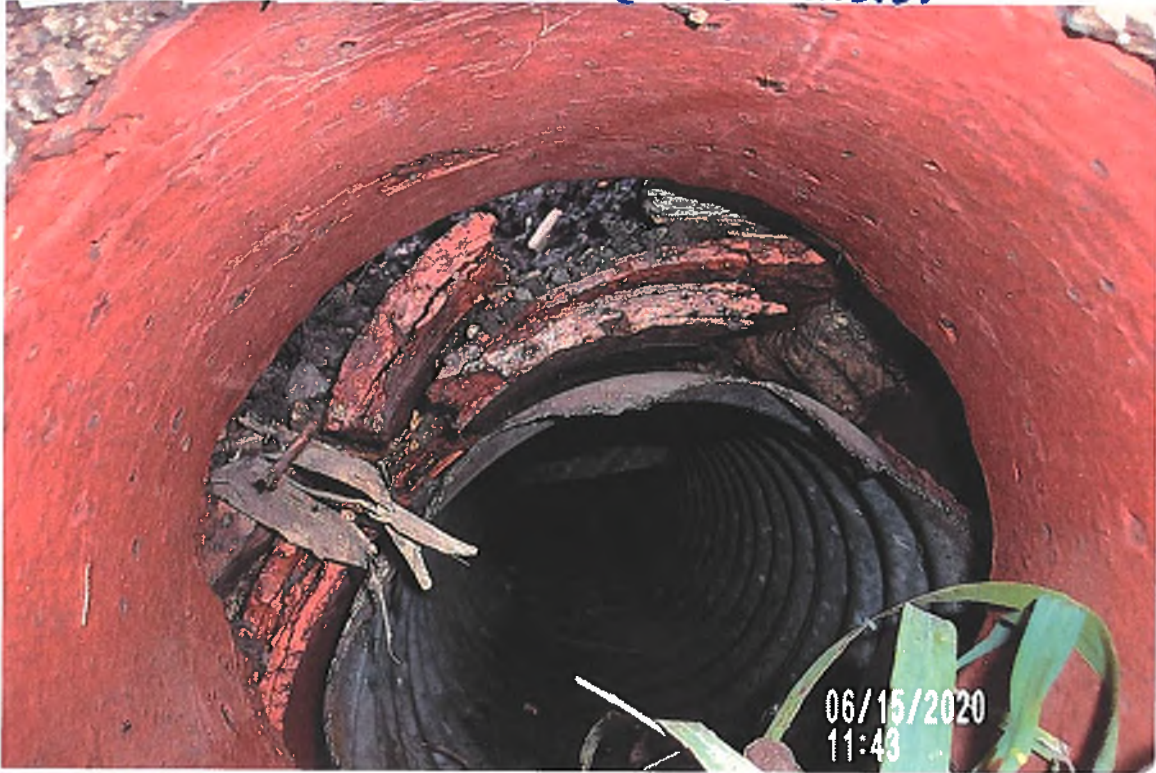
PICTURE # 3746 IS LOOKING NE INSIDE 8" CLAY TILE
INSIDE BEEHIVE INTAKE WALL, SHOWING 8" CMP SPIRAL CMP
SANK DOWN @ CONNECTION WITH CLAY TILE PIECES ON TOP.
SOIL & CORN STALKS VISIBLE @ CONNECTION.

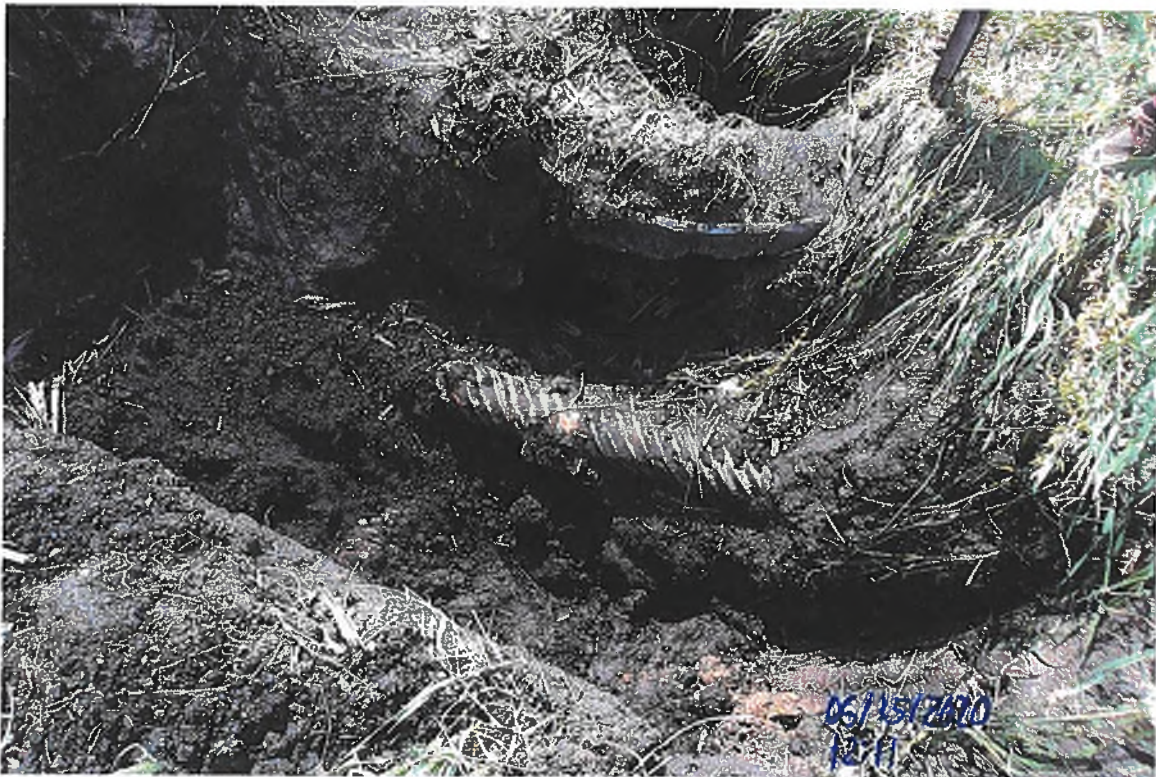
PICTURE # 3747 IS LOOKING SE SHOWING THAT 6" CMP SPIRAL
TILE WILL NOT ALLOW 8" CMP SPIRAL TILE TO BE LIFTED
BACK UP TO FIT 8" CLAY TILE OUTLET IN BEEHIVE WALL.
