**AGENDA**  
**REGULAR DRAINAGE MEETING**  
**February 12, 2020 9:30 AM**

**ENGINEER'S REPORT  
ON REPAIRS  
TO MAIN TILE  
DRAINAGE DISTRICT  
NO. 86  
HARDIN COUNTY,  
IOWA**

**SUPPLEMENT TO  
ENGINEER'S REPORT  
ON REPAIRS  
TO MAIN TILE  
DRAINAGE DISTRICT  
NO. 86  
HARDIN COUNTY,  
IOWA**

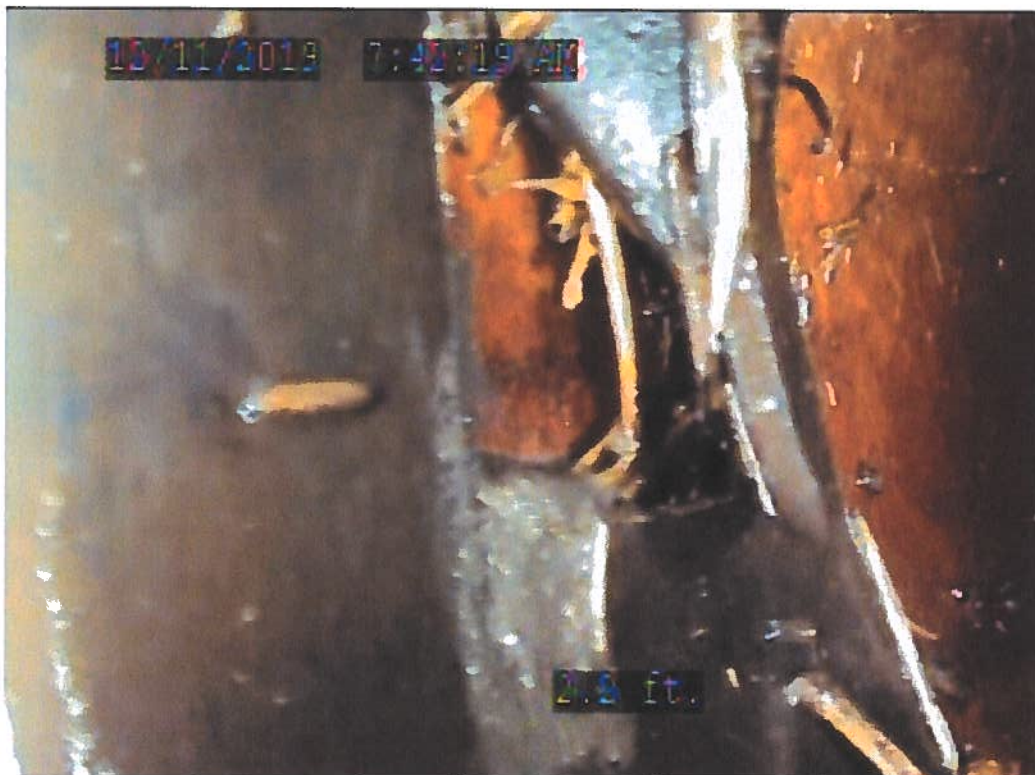
Figure 13: Single wall HDPE to VCP. Joint misshapen.

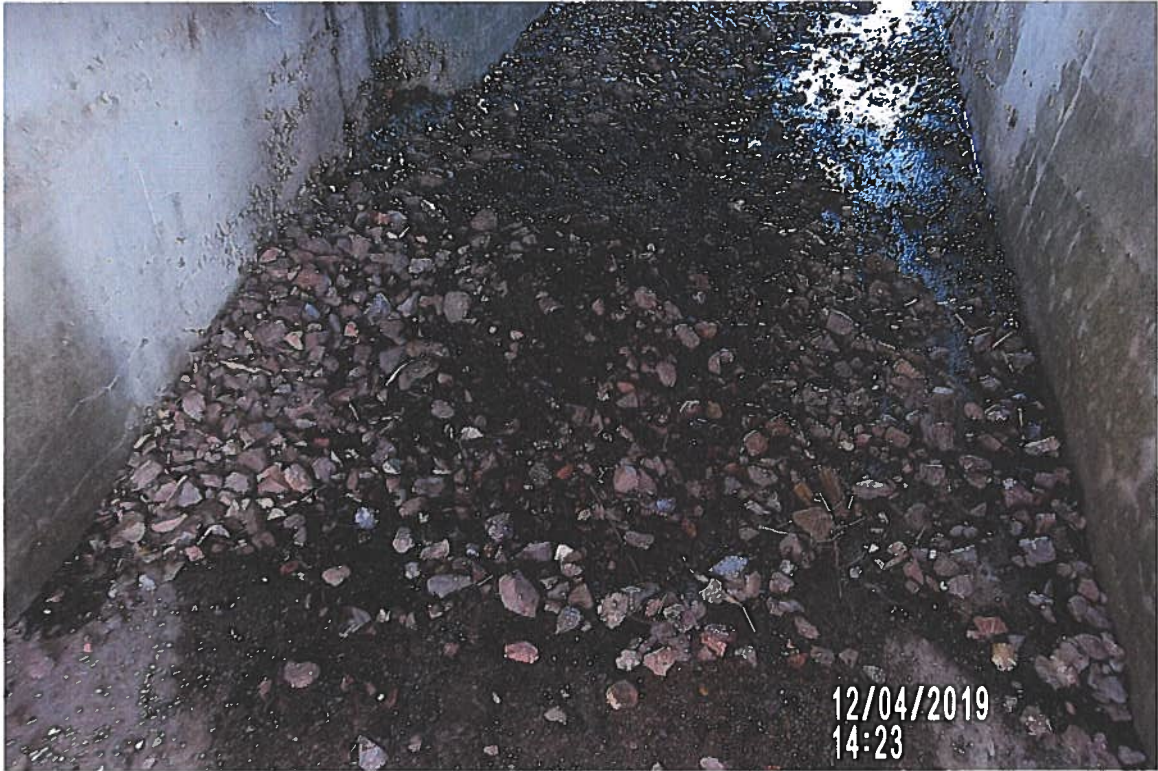
HOLE UNDER RR TRACKS

PICTURE BALLAST ROCK FALLING IN BOX CULVERT  
# 2460

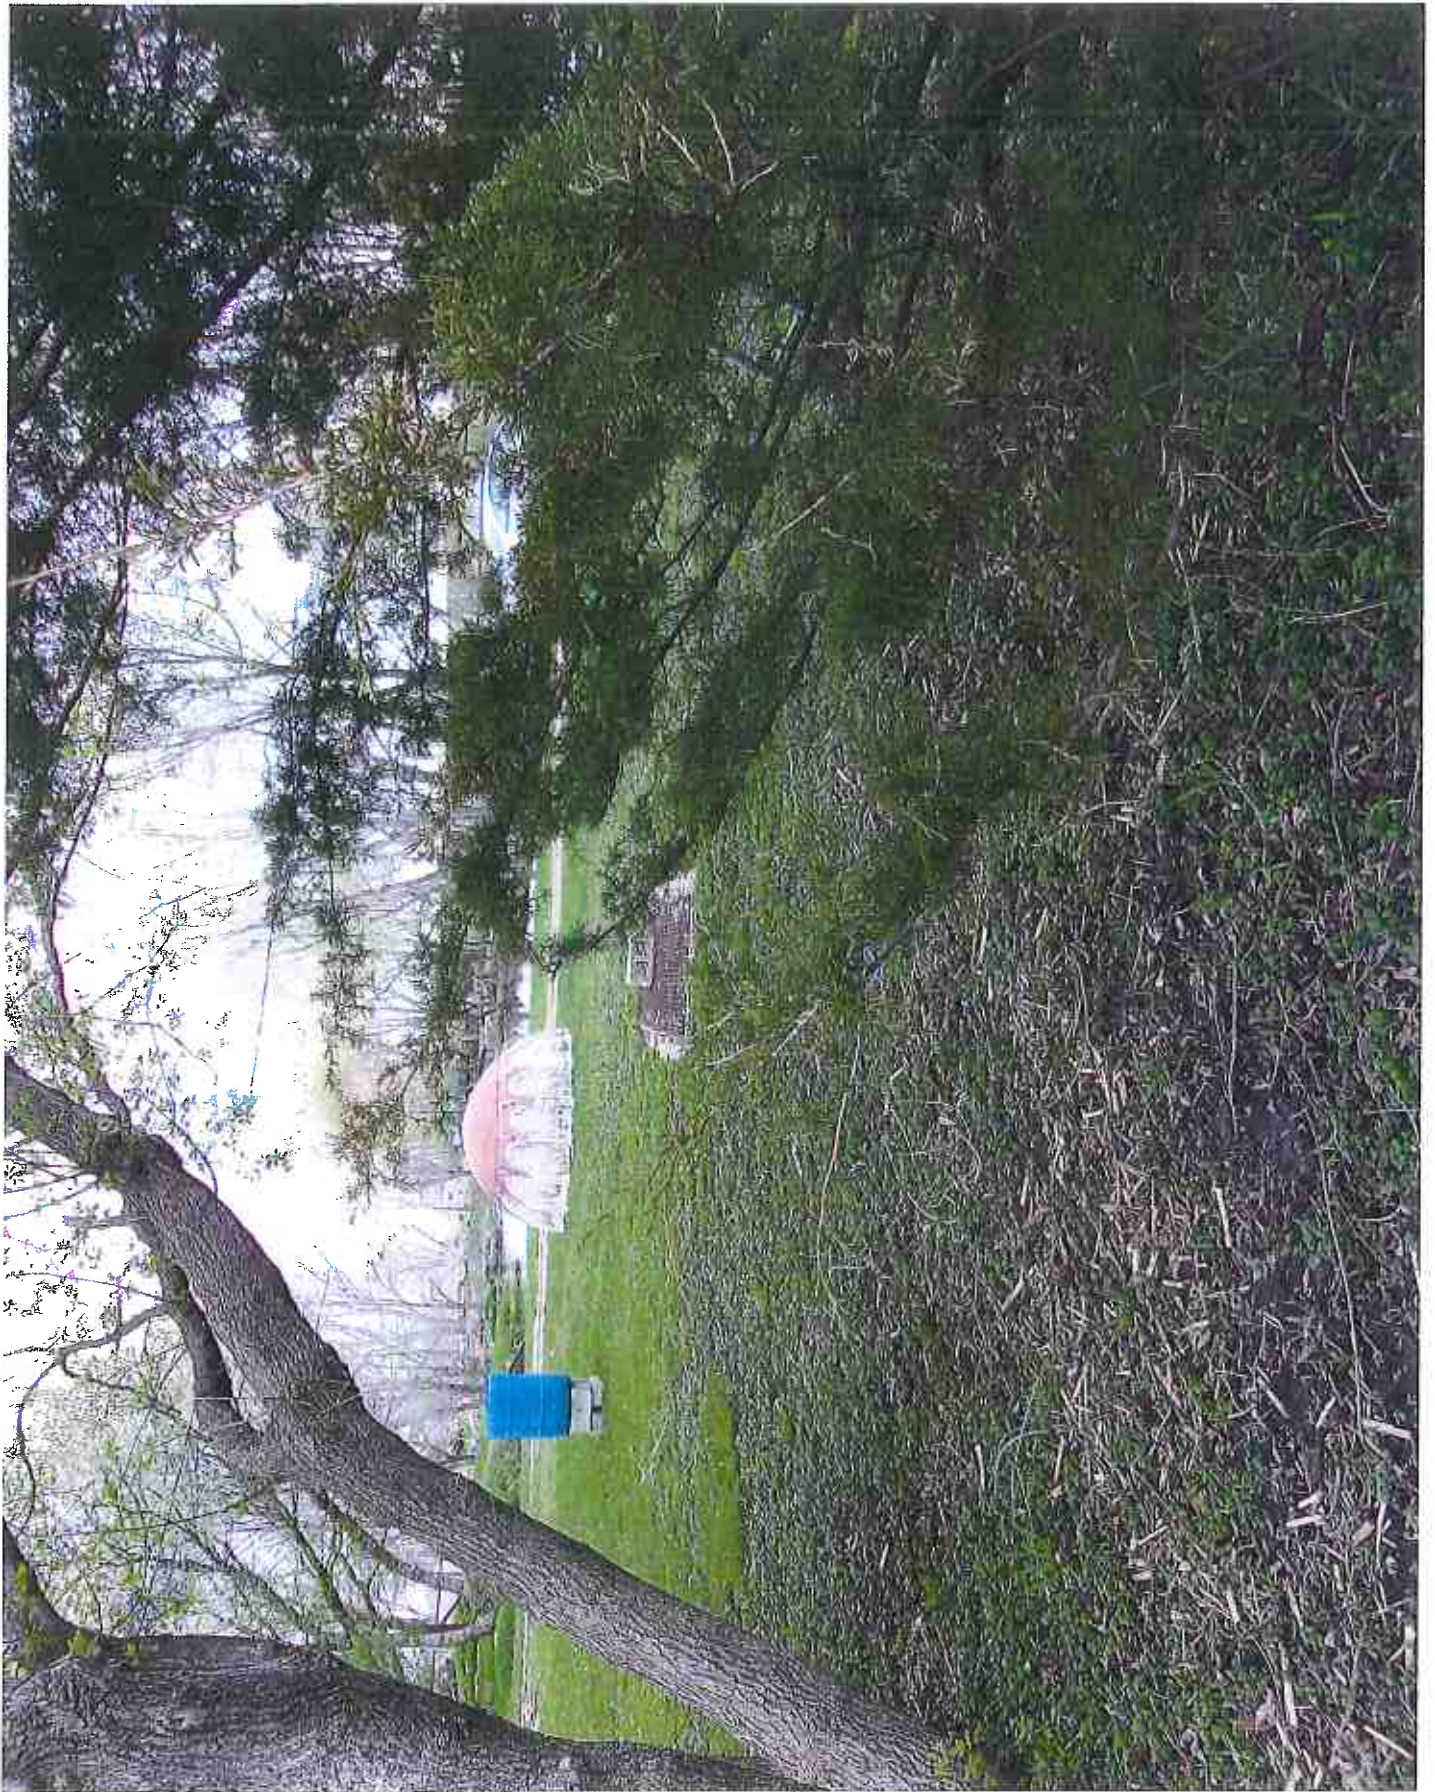
LOOKING W. FROM INTAKE

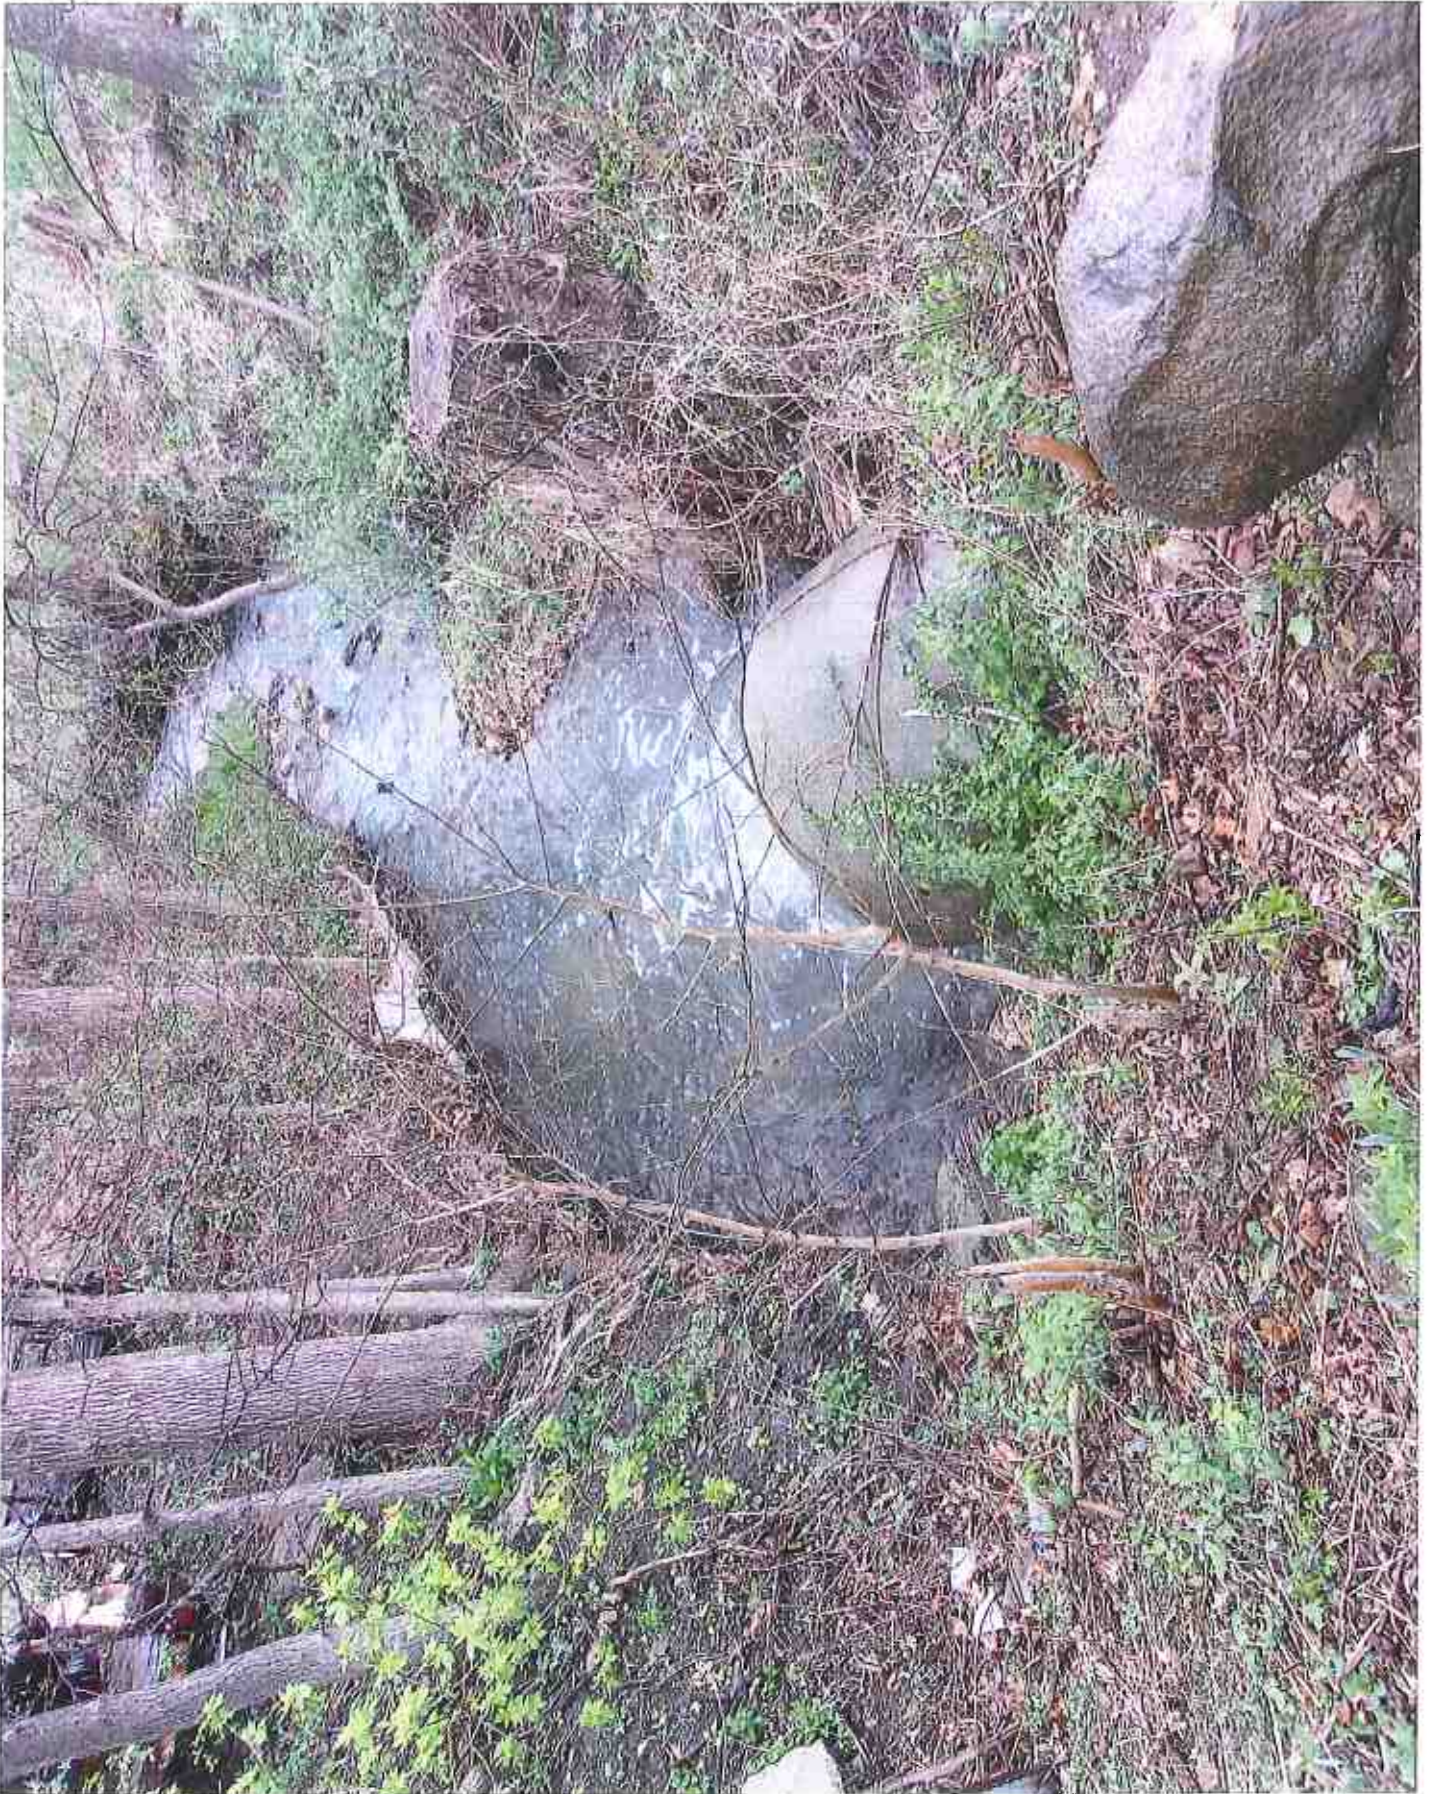
Looking upstream from City Storm Sewer Outlet
