**AGENDA**  
**REGULAR DRAINAGE MEETING**  
**Wednesday, October 21, 2020 9:30 AM**  
**Large Conference Room**

[DD 14 WO 291 INVESTIGATION SUMMARY 10\\_07\\_20.PDF](#)

## Investigation and Repair Summary:

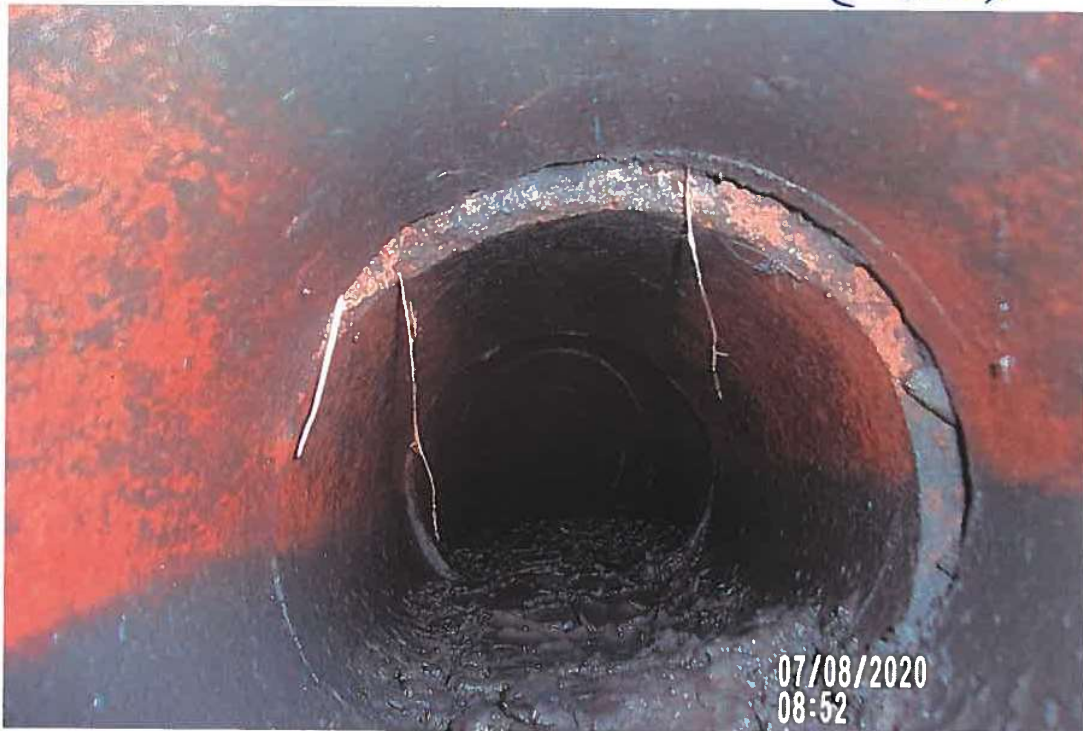
GPS# 252 TOP 14" CLAY TILE  
(4.9' ± DEEP)

PICTURE# 4052 IS LOOKING NW UPSTREAM INSIDE 8" CLAY TILE WITH 2" ± OF MUD IN FLOWLINE FROM GPS# 250. TILE IS IN GOOD SHAPE WITH FEW FINE ROOTS AND A FEW OFFSET JOINTS

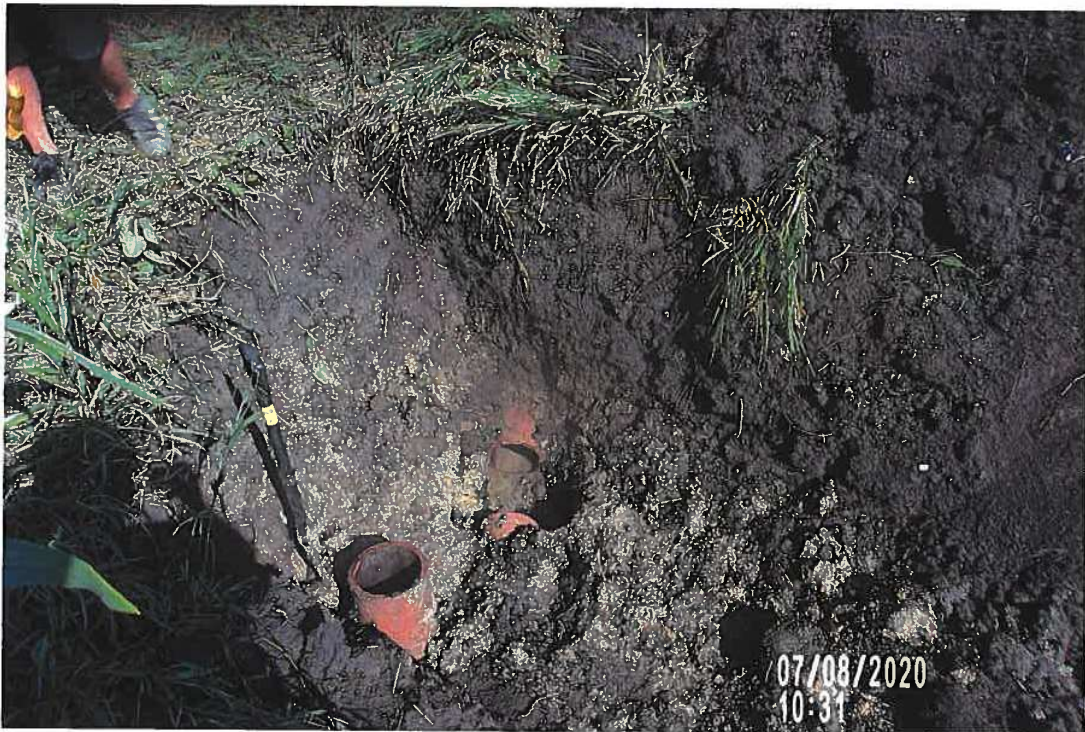
PICTURE# 4057 IS LOOKING NW SHOWING SECTION OF 8" CLAY  
TILE ROLLED OUT IN SOUTH DITCH OF CO HWY 041 NW OF BEEHIVE INTAKE  
FOR CREW TO RUN LOCATOR CABLE UPSTREAM TO FIND PLUG  
IN TILE.

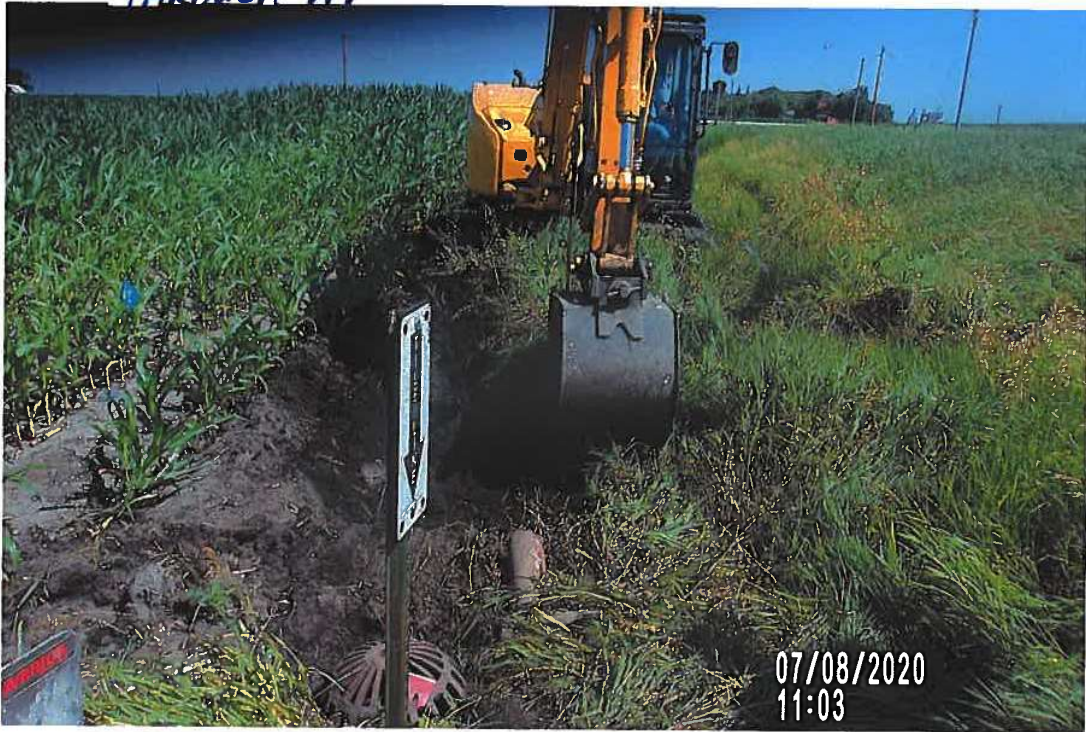
PICTURE # 4058 IS LOOKING NORTH - SHOWING CREW EXCAVATING ALONG FIELD EDGE IN WEST DITCH OF COHWYS-27 TO EXPOSE TILE TO CHECK CONDITION, FLOW AND RUN LOCATE CABLE THROUGH IT.

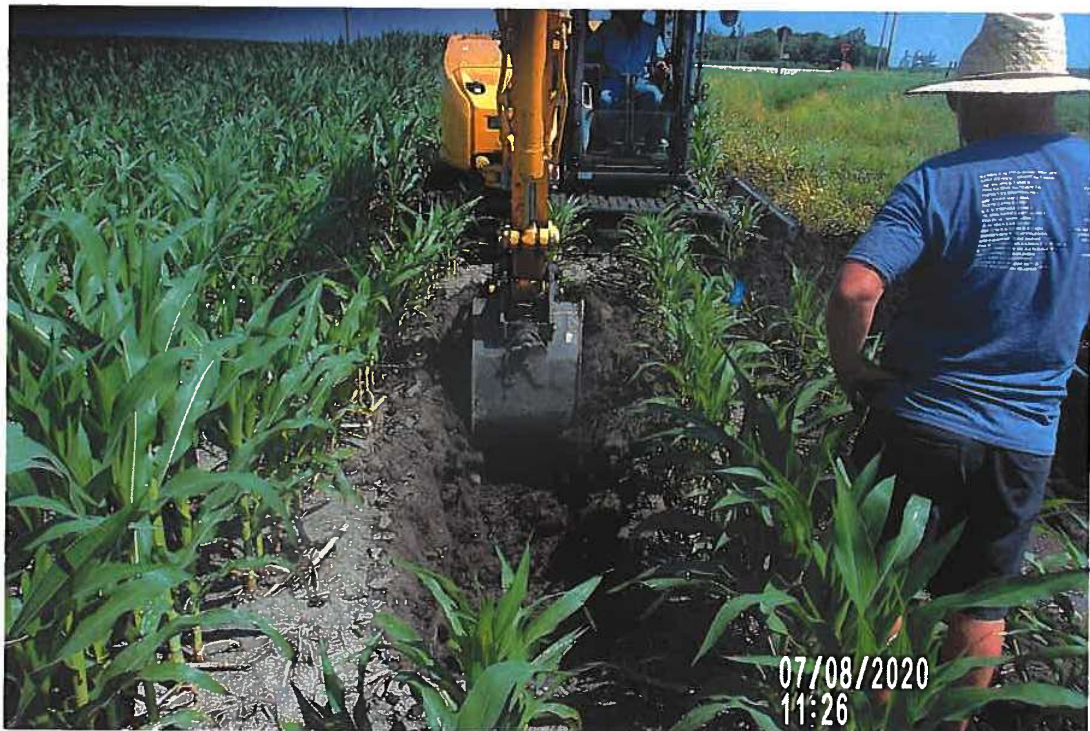
WATER FILLING UP IN HOLE, EXCAVATED ON EAST SIDE OF WATER MAIN

PICTURE # 4059 IS LOOKING NORTH SHOWING CREW NOW EXCAVATING ON WEST SIDE OF WATER MAIN TO CHECK IF WATER MAIN IS THE CAUSE.

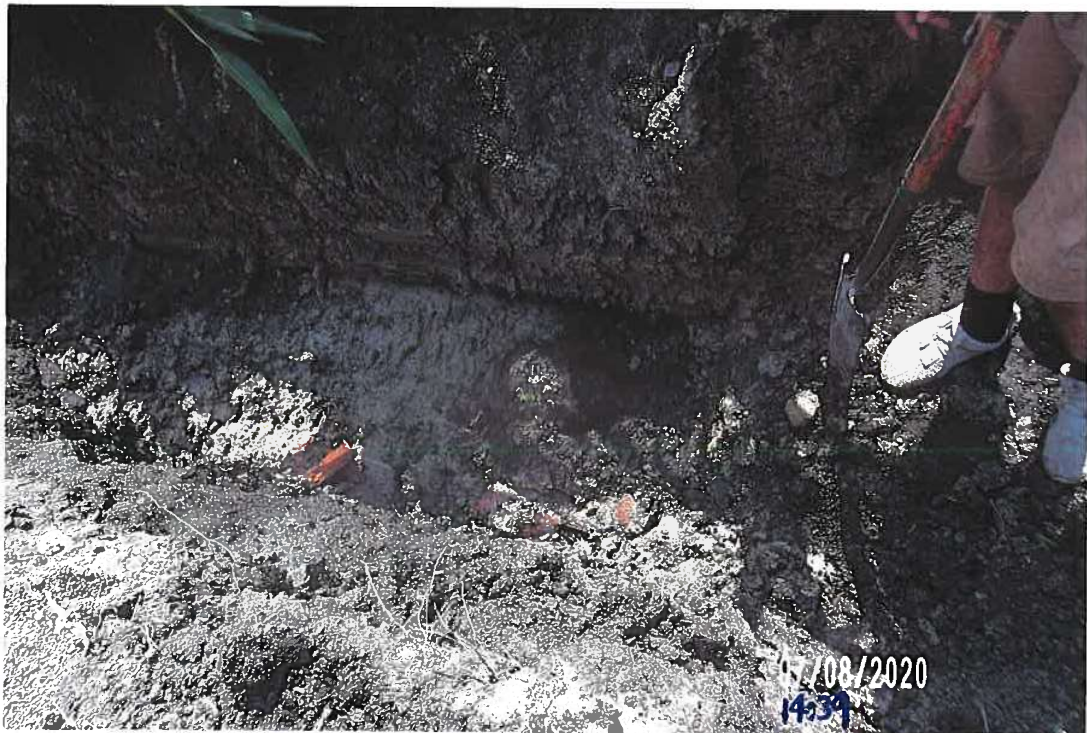
PICTURE # 4061 IS LOOKING SW AT EXPOSED LOCATION WHERE 5" HOPE SW PERF TILE FROM EAST & FROM WEST TIE INTO 8" CLAY TILE LATERAL 2

PICTURE # 4062 IS LOOKING SE AT TOP VIEW OF 5" HDPE SW PERF TILE FROM WEST & EAST TIEING INTO SAME LOCATION INTO BROKEN 8" CLAY TILE AND PLUGGED LINE

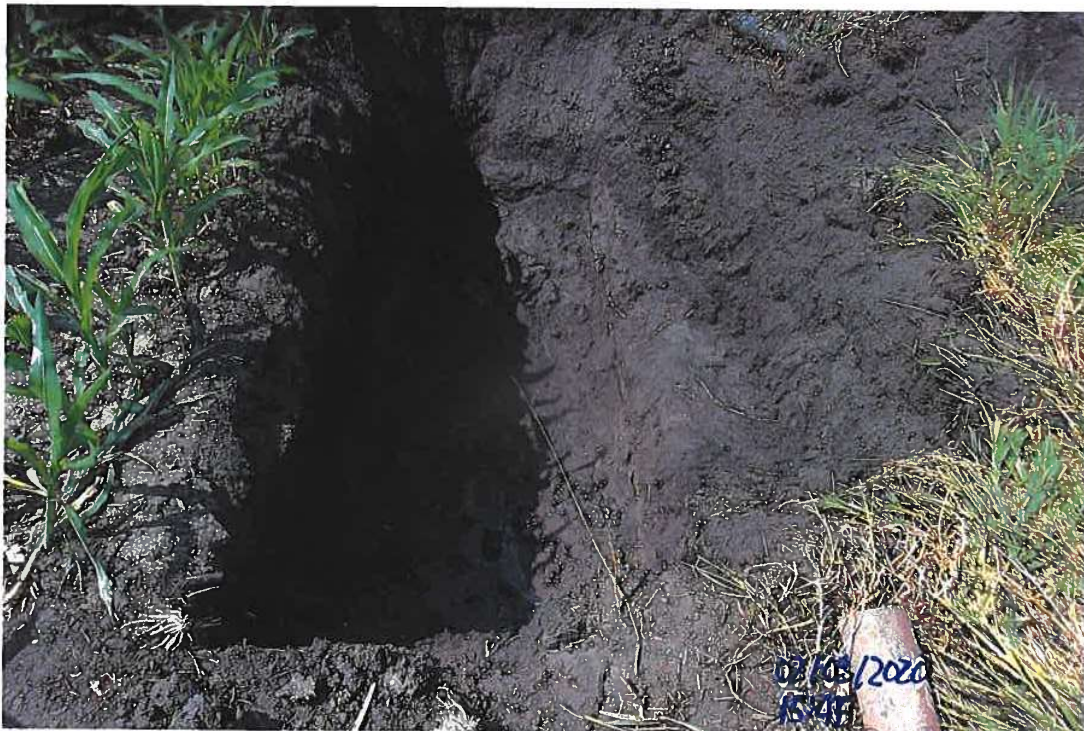
PICTURE# 4066 IS LOOKING NORTH SHOWING WATER GONE NOW IN EXCAVATED HOLE IN WEST DITCH OF COUNTY 527 ALONG FIELD EDGE EAST OF WATER MAIN N-S

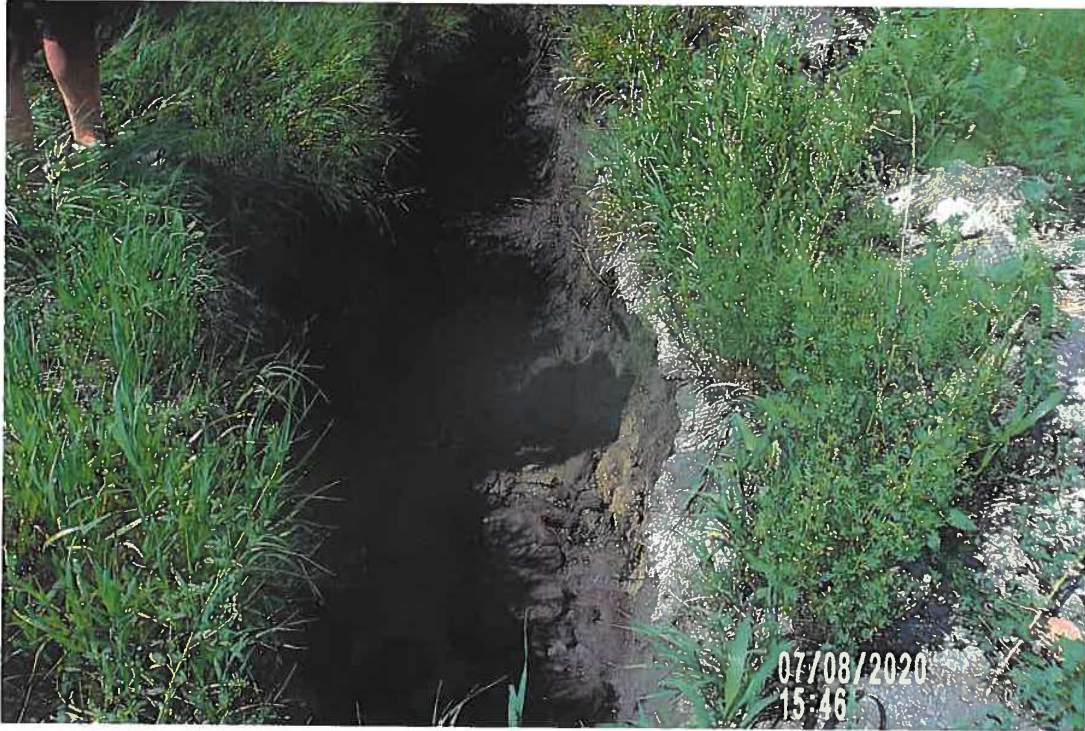
PICTURE#4067 IS LOOKING NORTH SHOWING PREVIOUSLY EXCAVATED HOLE EAST OF EAST ROW FENCE FOR CO. HWY 527 & SOUTH OF CO HWY D41

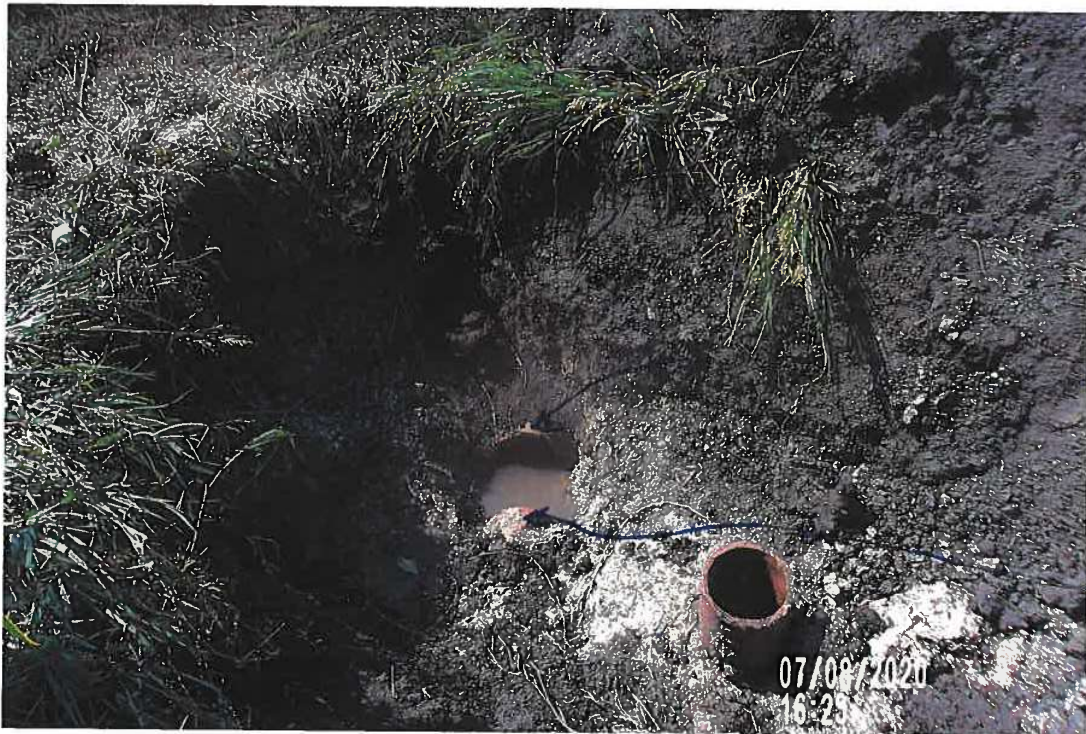
PICTURE# 4068 IS LOOKING NW SHOWING TILE FLOWING IN SOUTH DITCH OF CO HWY D41

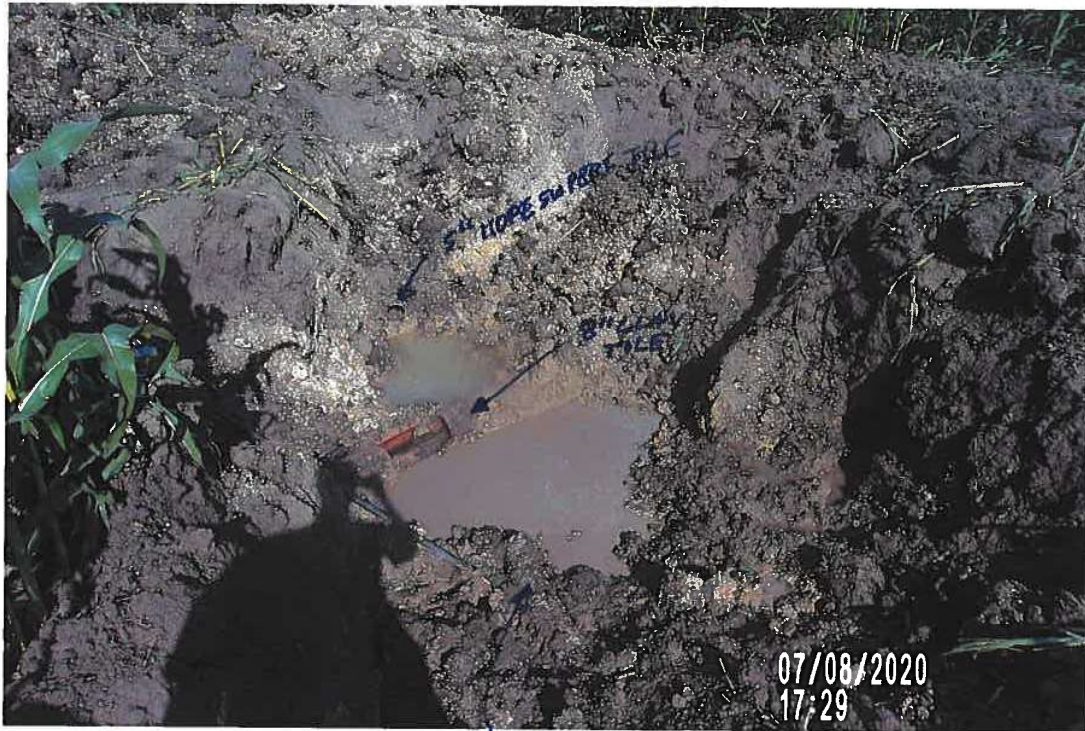
PICTURE # 4069 IS LOOKING EAST SHOWING 5" HOPE SW PERF TILE CONNECTION AREA. 8" CLAY TILE STILL FLOWING GOOD.

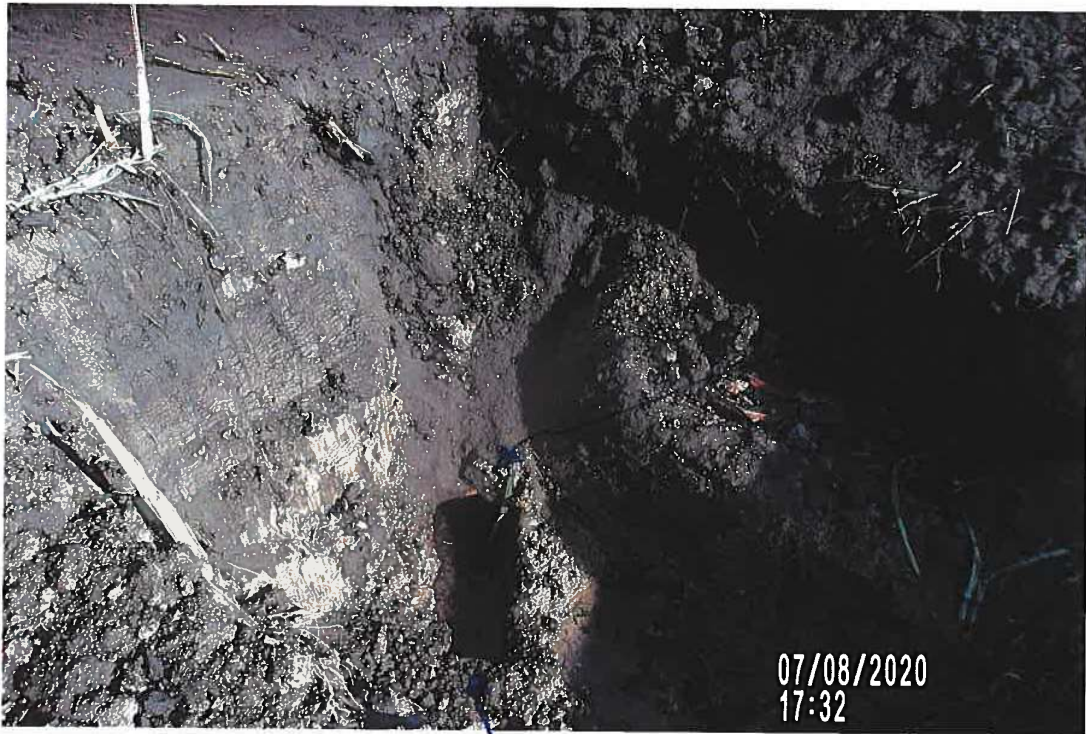
GPS#248  
TOP 14" CLAY  
(1.20' TO TOP)  
N  
↓

PICTURE # 4071 IS LOOKING SE TOWARDS CO HWY 04/  
SHOWING 14" CLAY TILE FLOWING GOOD

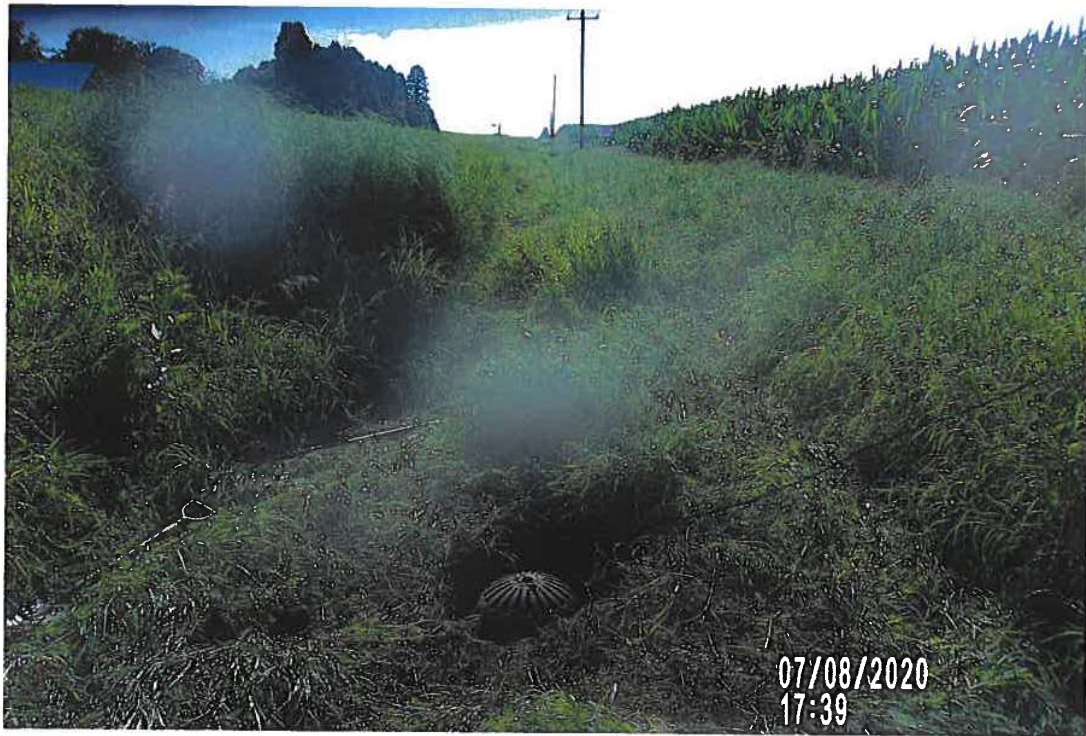
268  
NRIM  
BEEHIVE  
INTAKE  
N  
→

PICTURE # 4072 IS LOOKING WEST SHOWING BEEHIVE  
INTAKE IN NORTH DITCH OF CO HWY 04/ 170.8' ± WEST OF E  
CO HWY S-27

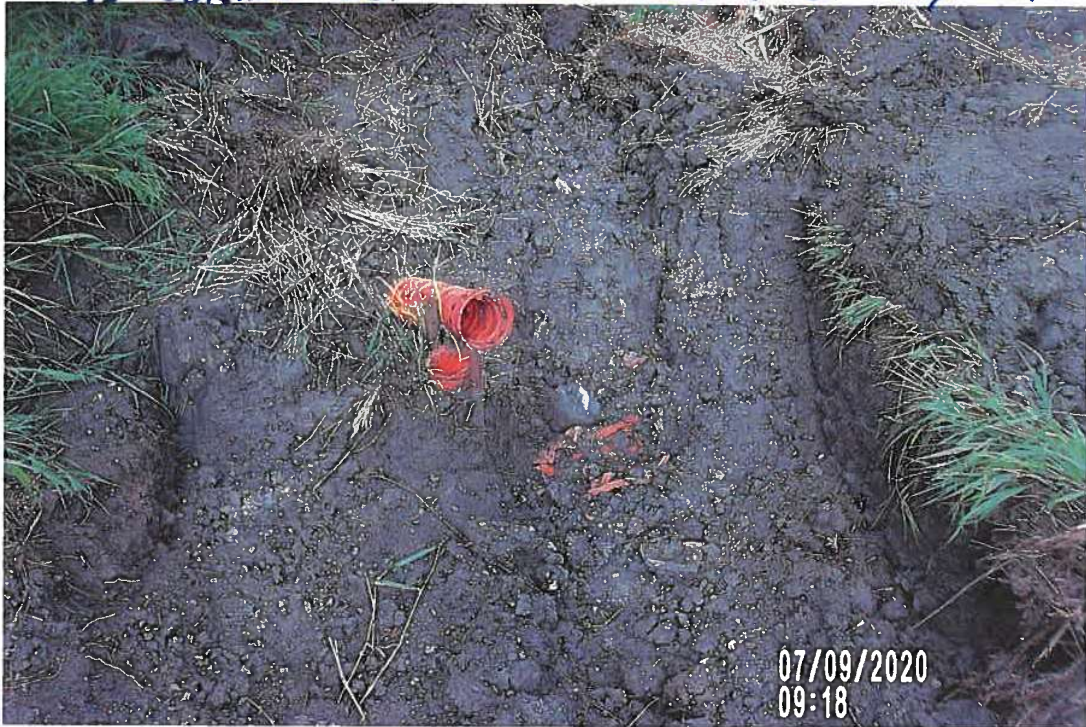
GPS # 88

6" HICKEN BOTTOM  
R<sub>2</sub> FULL OF  
SOIL &  
6" CLAY TILE  
OUTLET  
BROKEN  
& FULL  
OF SOIL

(GPS#269)  
PICTURE# 4090 SHOWING 6" HICKEN BOTTOM WITH TOP COMPLETELY  
BROKE OFF AND FL COMPLETELY FULL OF SOIL WITH 6" CLAY  
TILE OUTLET BROKE AND COMPLETELY FULL OF SOIL. PICTURE  
IS LOOKING WEST IN NORTH DITCH OF CO HWY 041

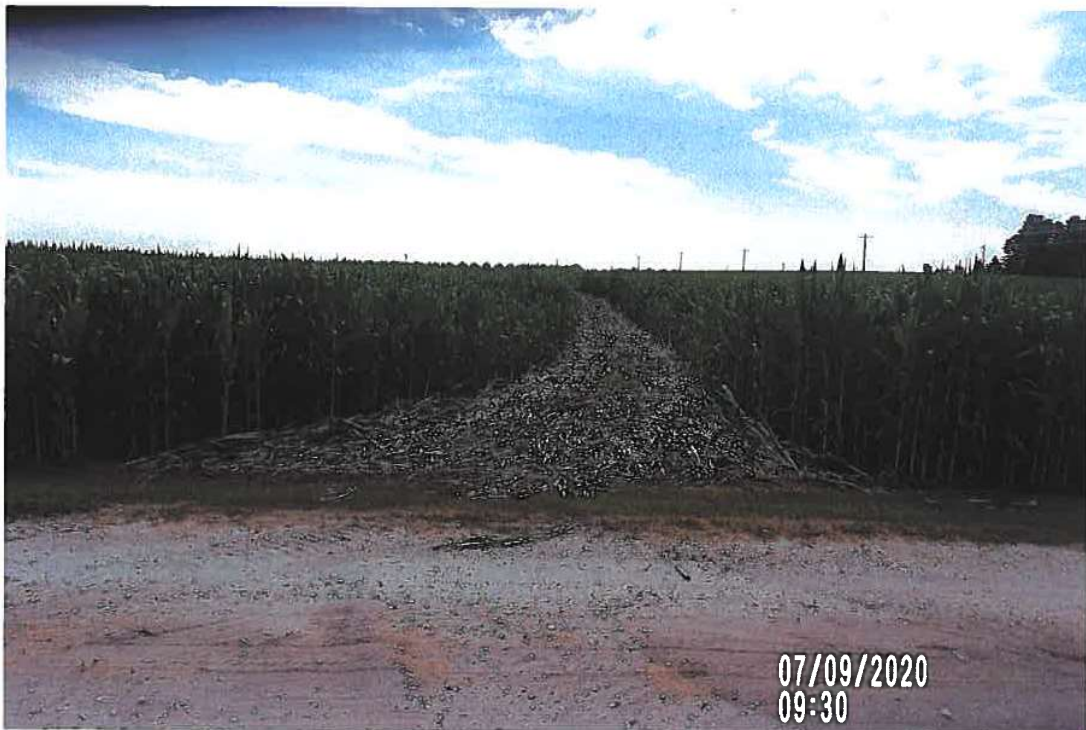
PICTURE#4091 IS LOOKING EAST FROM GRAVEL DRIVE FOR  
20825 CO HWY 527 OFF OF CO HWY 041 SHOWING CORN DAMAGE  
OUT TO TILE REPAIR.

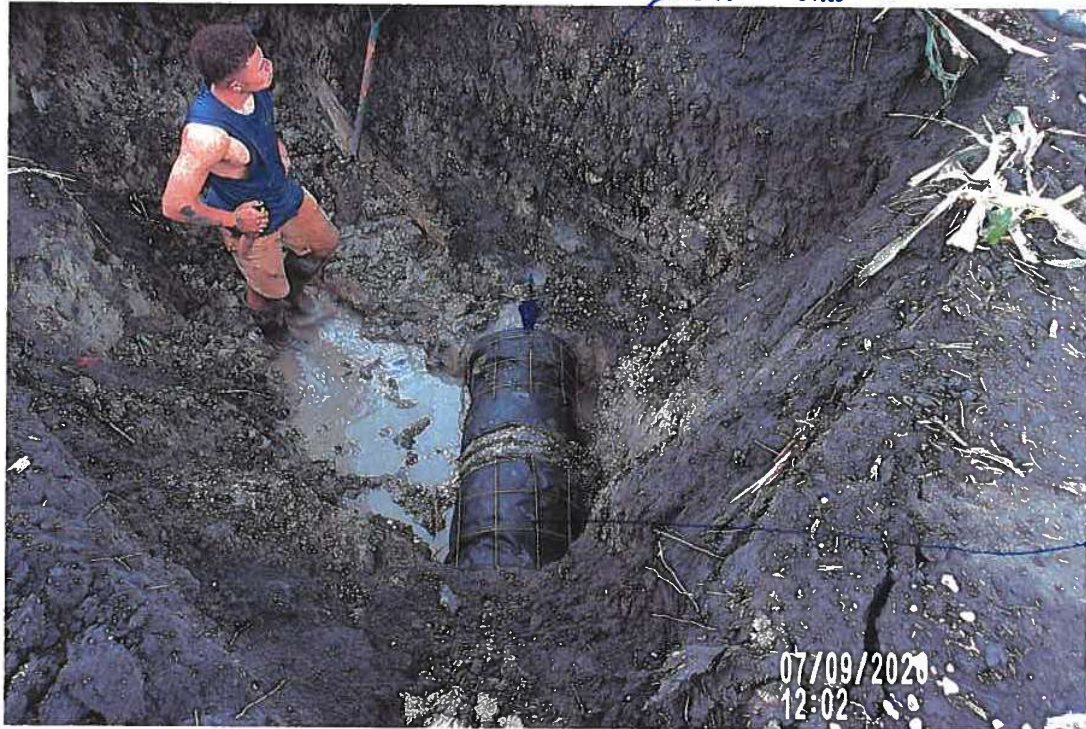
PICTURE# 4096 IS LOOKING NW SHOWING FABRIC & MESH OVER NORTH & SOUTH TIE IN JOINTS FOR 14" CLAY TILE REPAIR NORTH OF COMWAY D41

615# 2.0'x3.5' FABRIC WITH 1.0'x4.0' WIRE MESH OVER JOINT BEFORE COLLARS POURED

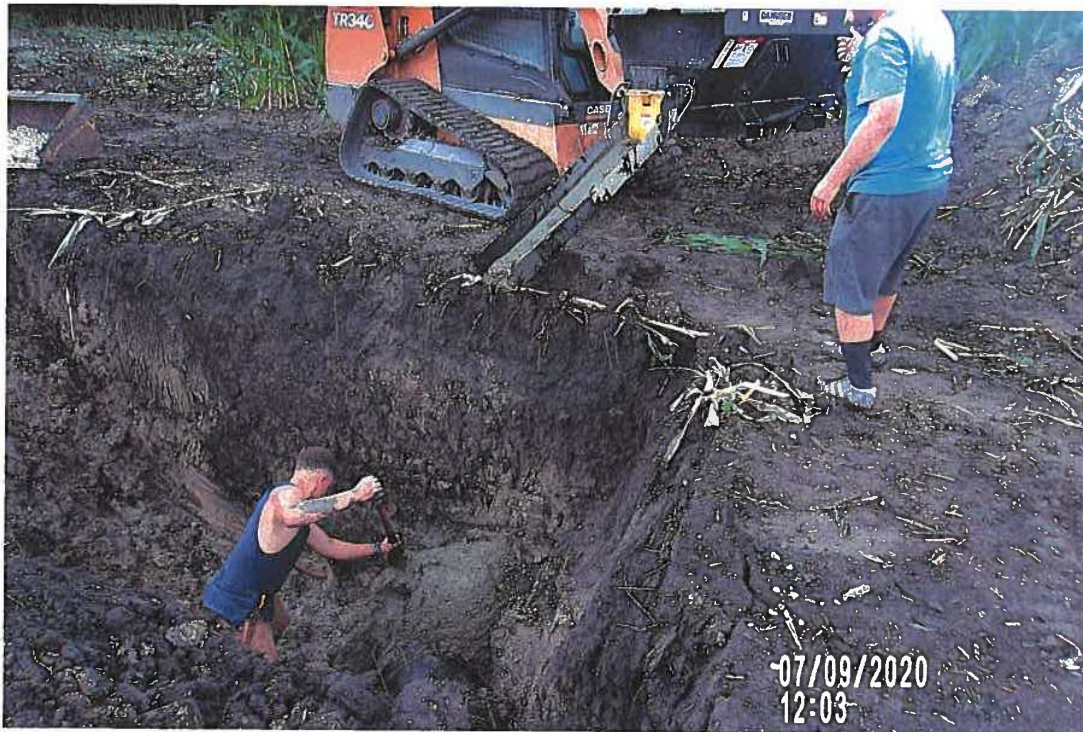
615# 2.0'x3.5' FABRIC & 1.5'x4.0' WIRE MESH OVER JOINT BEFORE COLLARS POURED

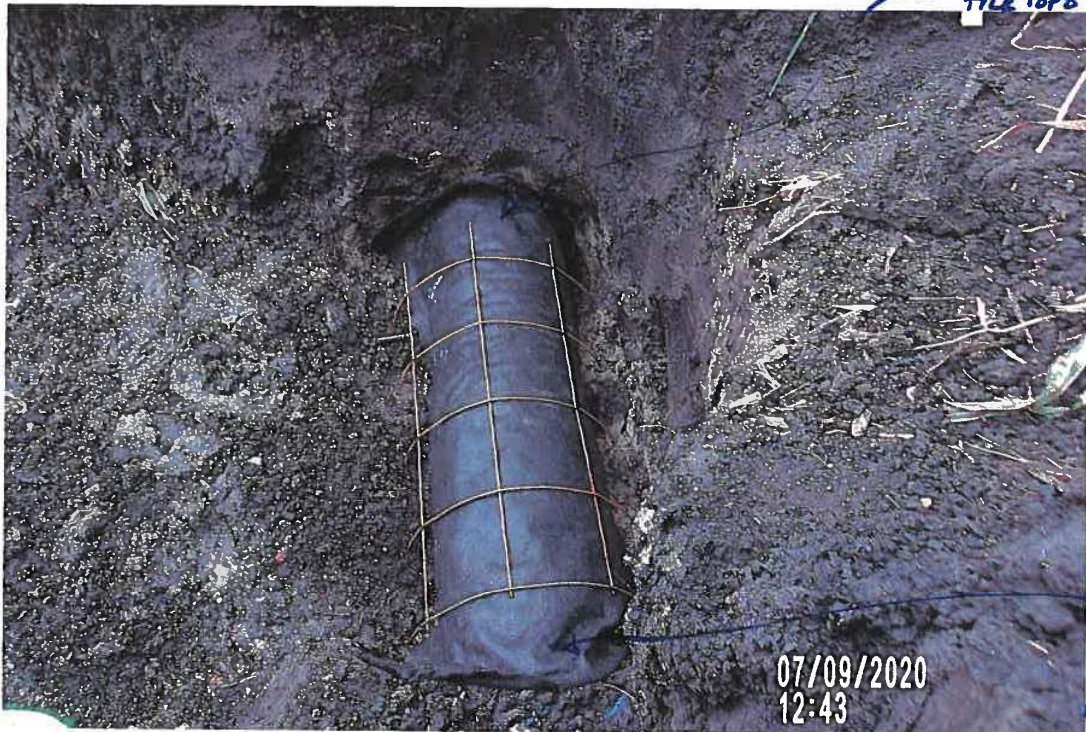
GPS #251  
 TILE TOP 8" CLAY  
 0.75' TOP TO FL  
 2" MUD IN FL  
 (3.7' ± DEEP)

PICTURE #4099 IS LOOKING SE SHOWING 2.1LF 8" OW HOPE PERP TILE  
 IN PLACE WITH 2.0' X 3.0' FABRIC & 1.5' X 2.0' 6" X 6" WIRE MESH  
 OVER JOINTS BEFORE 3/4 CONCRETE COLLAR POURED

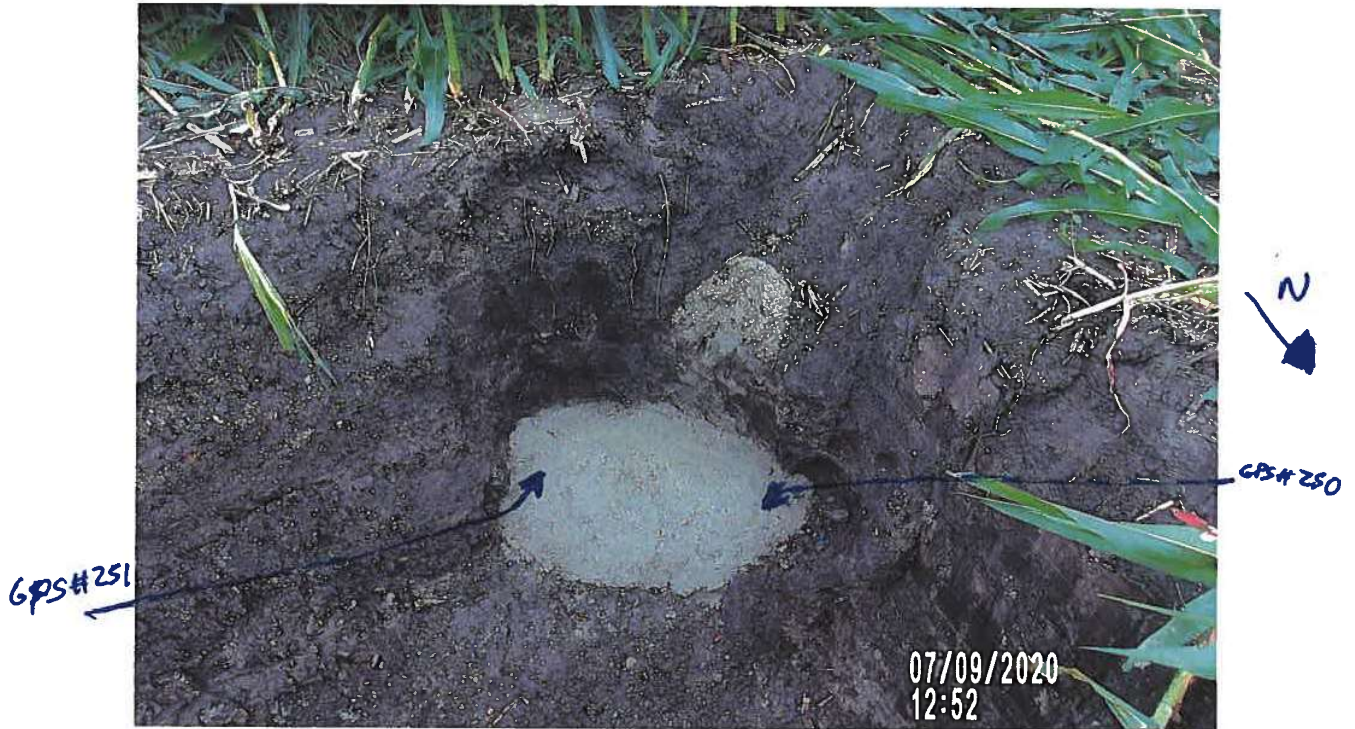
PICTURE # 4100 IS LOOKING SW AT FINISHED 3/4 CONCRETE COLLAR FOR 8" CLAY TILE REPAIR 55'± NORTH OF E HWY D41. CREW USED 8-60LB QUIKRETE HIGH STRENGTH CONCRETE BAGS.

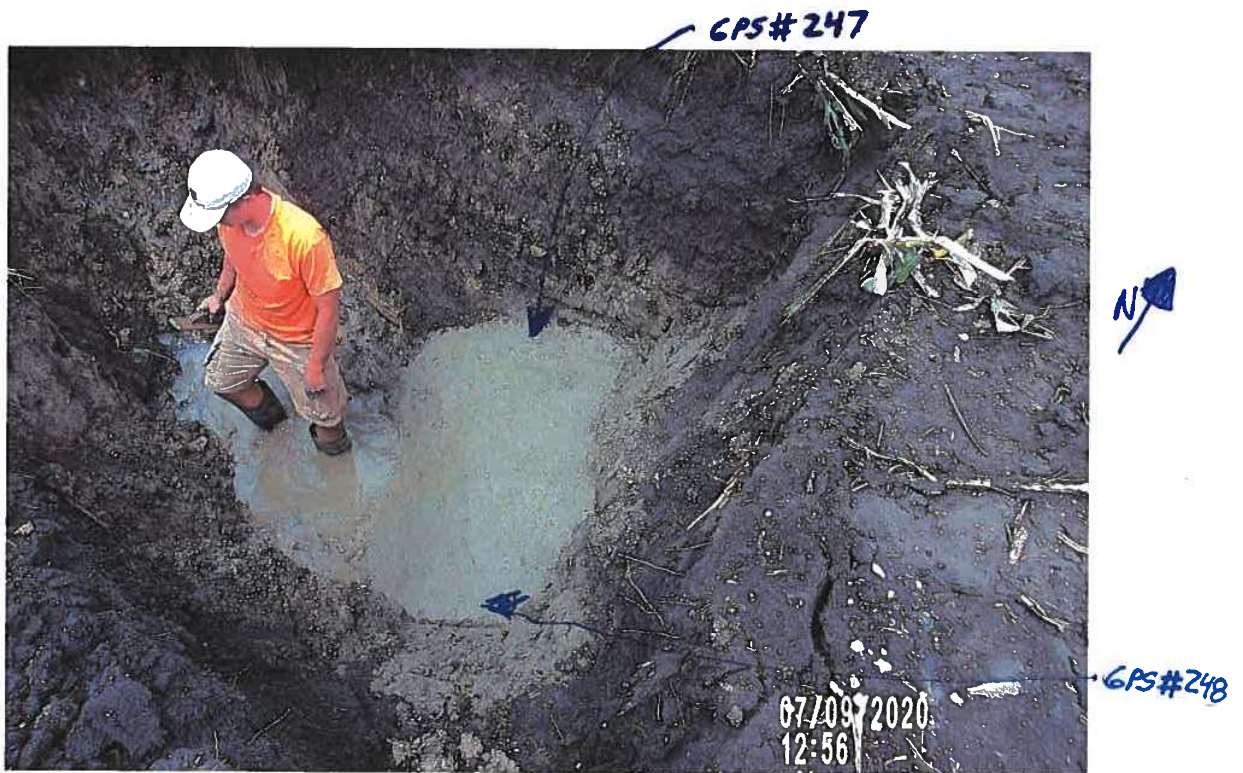
PICTURE #4101 IS LOOKING NW AT FINISHED 3/4 CONCRETE COLLAR FOR 14" CLAY TILE REPAIR 168'± NORTH OF E HWY D41. CREW USED 18-60LB QUIKRETE HIGH STRENGTH CONCRETE BAGS FOR CONCRETE COLLARS.

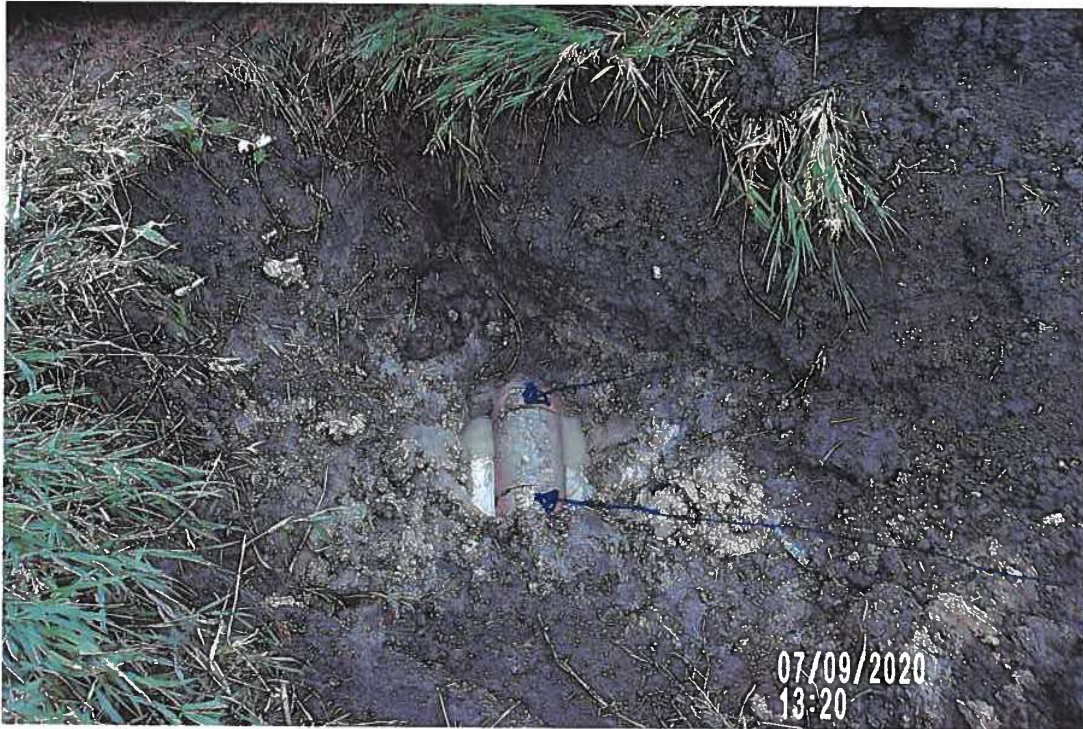
GPS#255  
 TOP 8" CLAY  
 TILE  
 (0.74' TOP TO FL)  
 3.1' ± DEEP

PICTURE #4102 IS LOOKING NW IN SOUTH DITCH OF CO HWY  
 041 9.5' ± WEST OF WEST RIM OF BEEHIVE INTAKE  
 SHOWING 8" CLAY TILE SECTION ROLLED BACK IN PLACE.

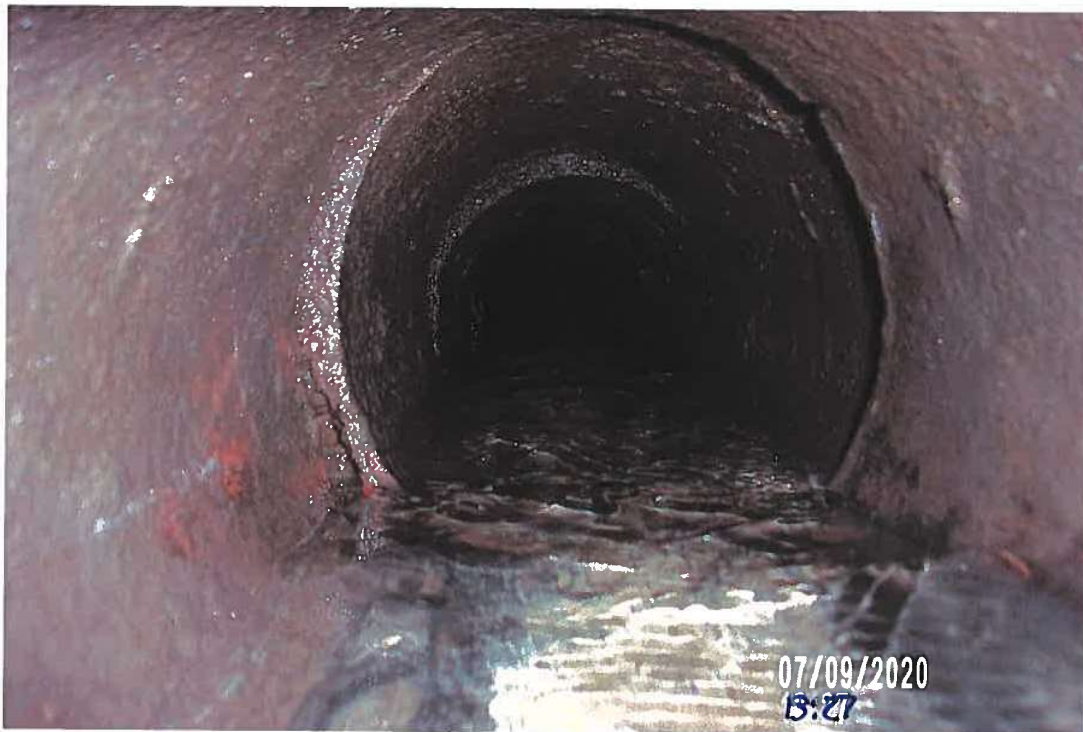
PICTURE #4103 IS LOOKING UPSTREAM INSIDE 8" CLAY TILE  
 WITH ABOUT 1" FLOW AT GPS #302 (TOP 8" CLAY TILE) (0.72' TOP  
 TO FL)

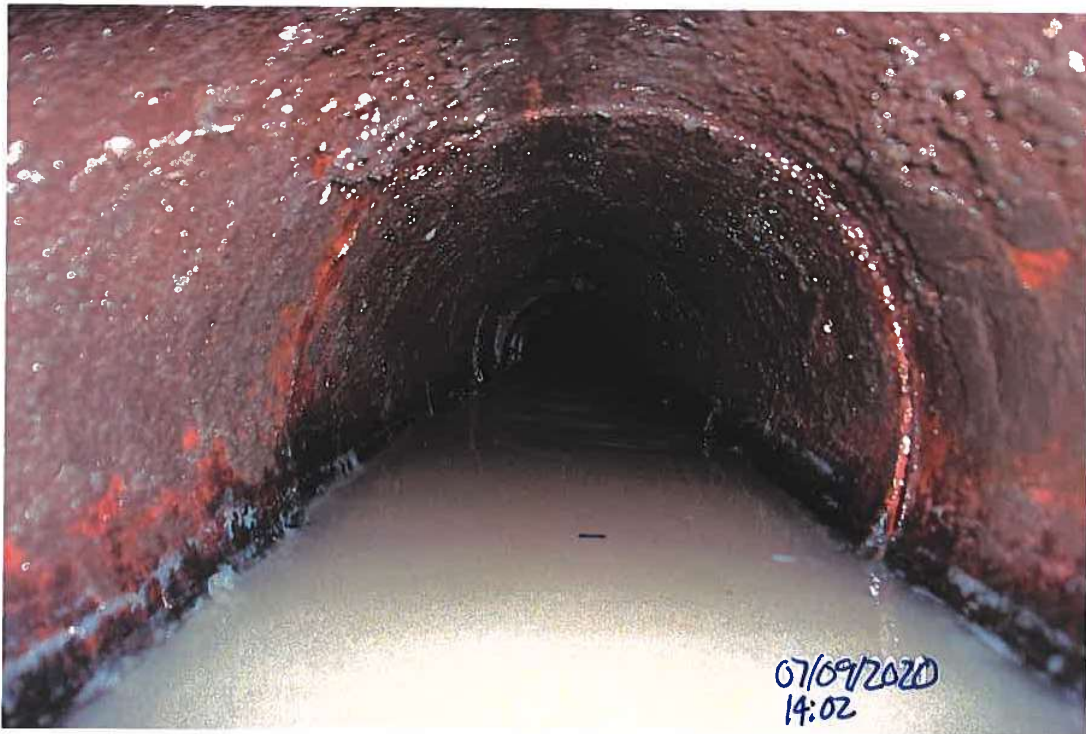
PICTURE #4105 IS LOOKING DOWN STREAM INSIDE 8" CLAY TILE WITH ABOUT 2"± OF SLOW WATER FLOW.

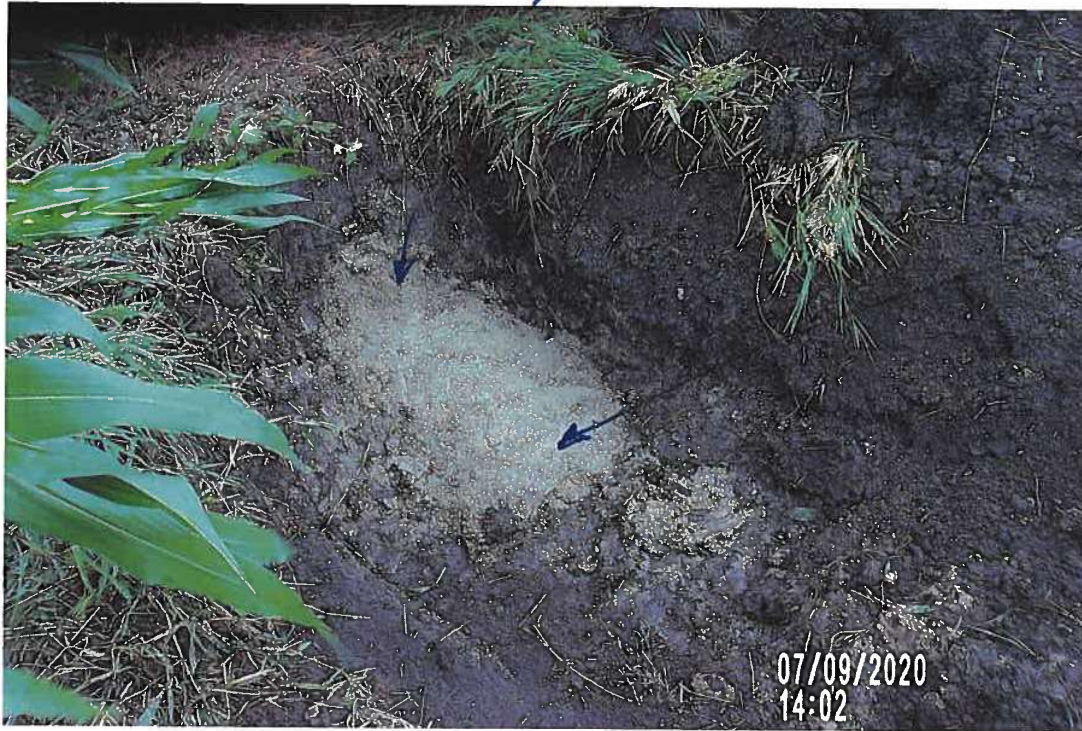
PICTURE # 4106 IS LOOKING NORTH SHOWING 3/4" CONCRETE COLLAR POURED FOR 8" CLAY TILE SECTION ROLLED BACK INTO PLACE WEST OF BEHIVE ENTIRE. CREW USED 5-60LB BAGS OF QUIKRETE HIGH STRENGTH / GP#255

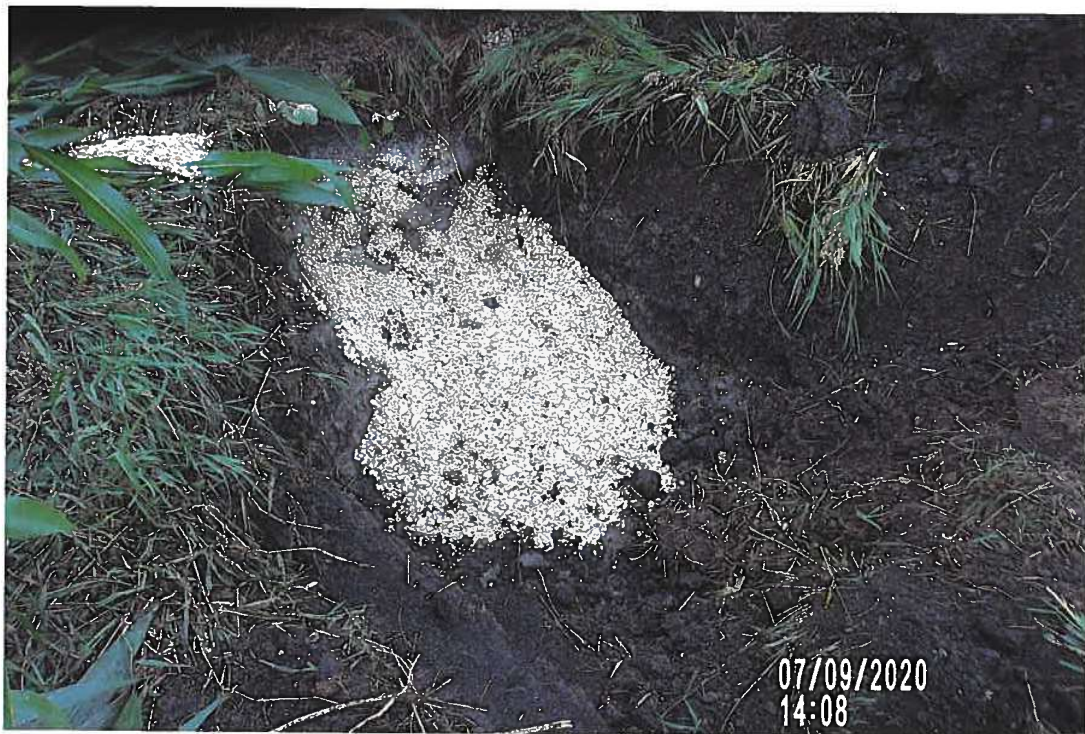
PICTURE # 4107 IS LOOKING NORTH SHOWING BEDDING ROCK BACKFILLED AROUND 3/4" CONCRETE COLLAR IN SOUTH DITCH OF COMHWY D41 FOR 8" CLAY TILE SECTION ROLLED BACK INTO PLACE.

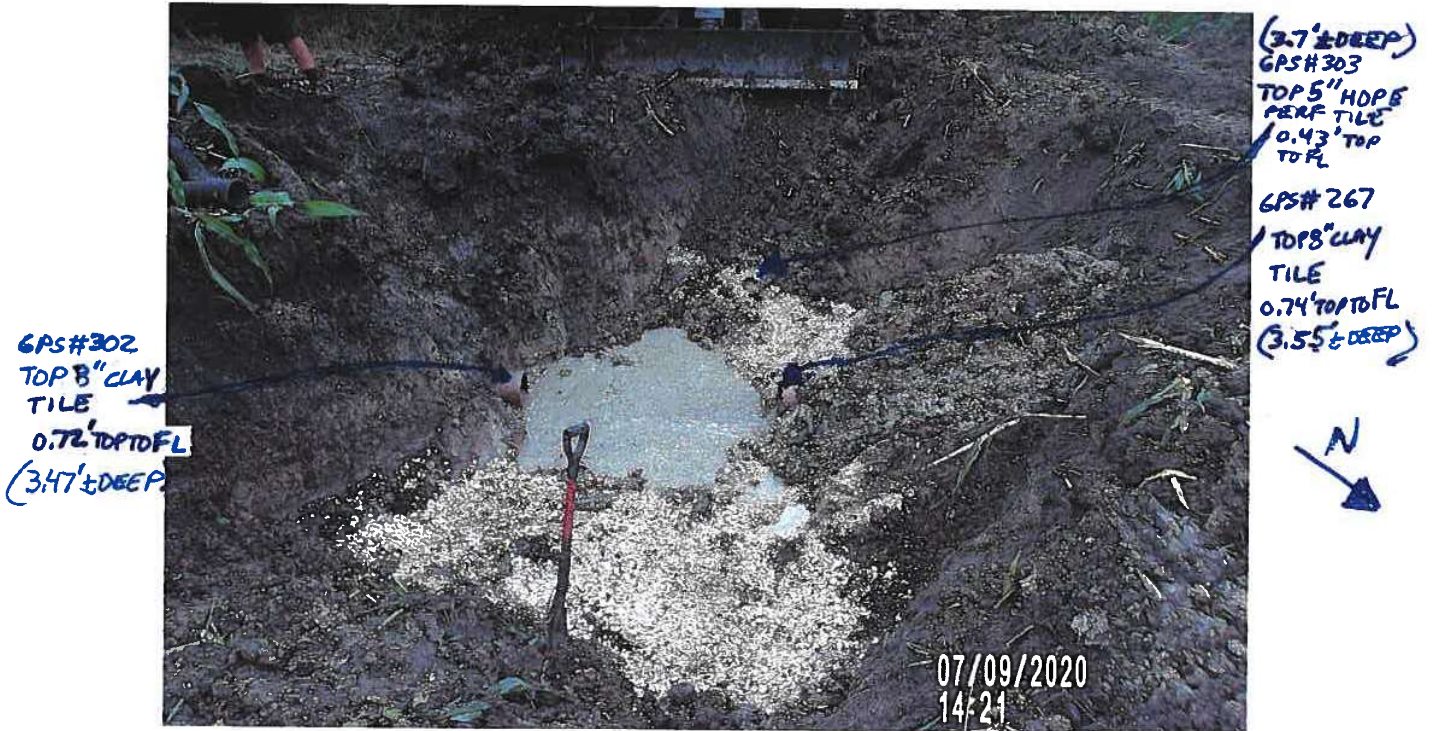
PICTURE # 4108 IS LOOKING SW SHOWING 8" CLAY TILE REMOVED WITH BEDDING ROCK IN PLACE TO TIE IN 5" SW HOPE PERF TILE LINES INTO 8" CLAY TILE LATERAL

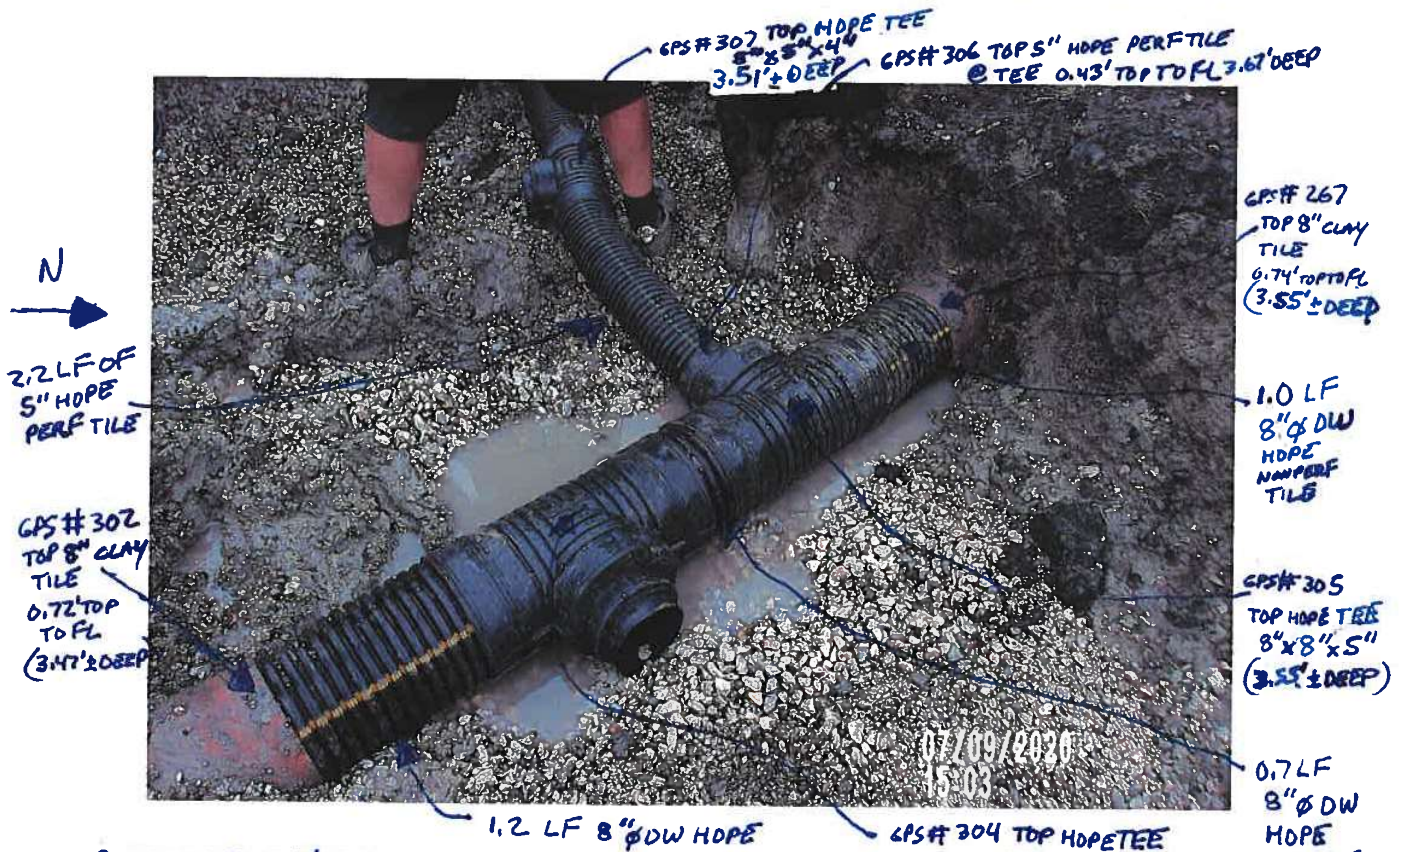
PICTURE # 4109 IS LOOKING WEST AT 8" DW HOPE NONPERF TILE INSTALLED WITH A 8" x 8" x 5" HOPE TEE EAST & WEST & 5" HOPE PERF TILE INSTALLED INTO TEE WITH 5" x 5" x 4" HOPE TEE INSTALLED ON IT WITH BEDDING ROCK UNDER CONNECTION.

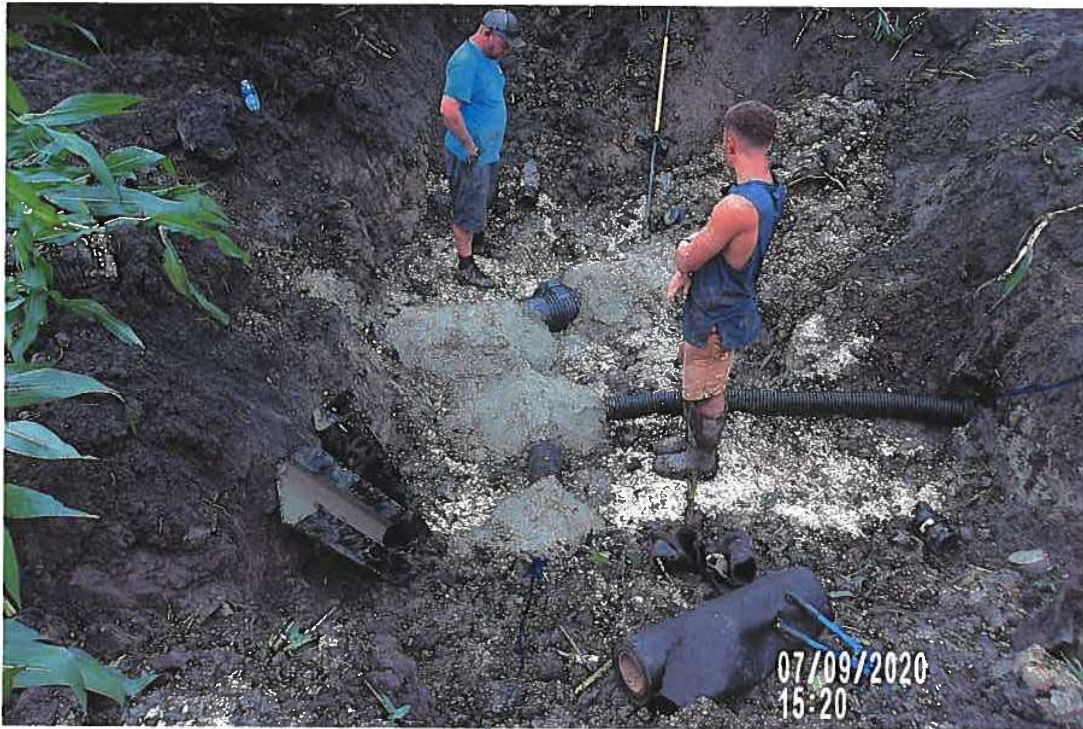
PICTURE #4111 IS LOOKING NW SHOWING 3/4 CONCRETE COLLARS  
 POURED AT CONNECTIONS FOR 5" HOPE SW PERF TILE TIE  
 INS. CREW USED 17-60 LB BAGS OF QUIKRETE HIGH STRENGTH
