**AGENDA**  
**REGULAR DRAINAGE MEETING**  
**Wednesday, October 21, 2020 9:30 AM**  
**Large Conference Room**

[DD 14 WO 291 INVESTIGATION SUMMARY 10\\_07\\_20.PDF](#)

## Investigation and Repair Summary:

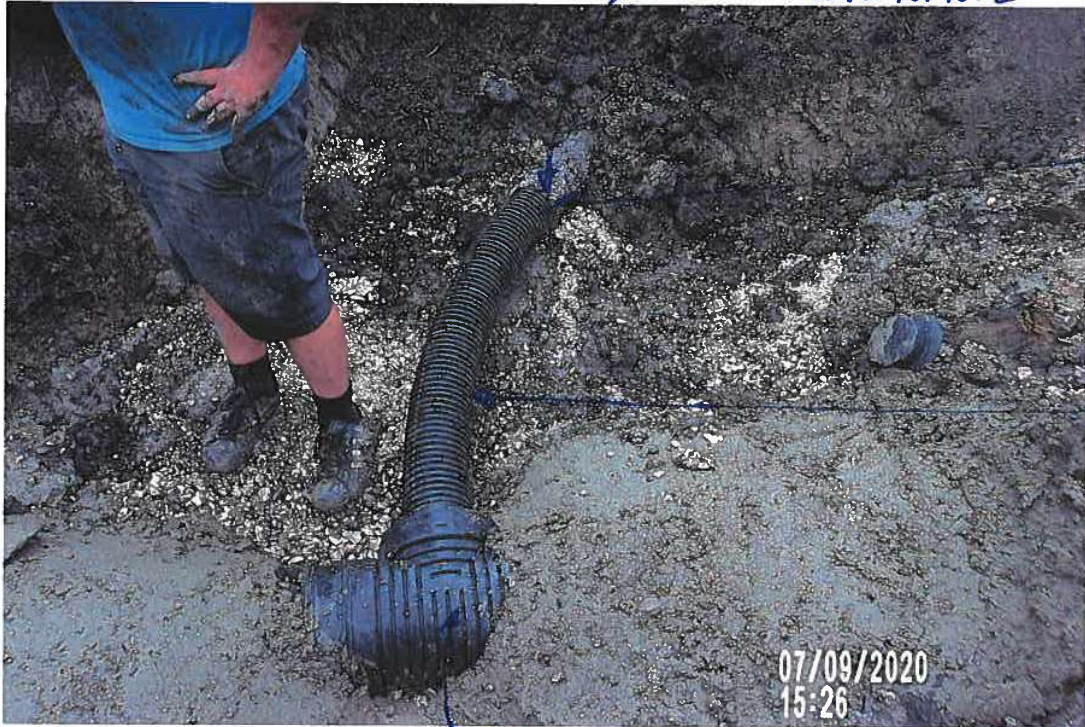
PICTURE #4114 IS LOOKING NE SHOWING 5" HDPE SW PERF TILE TIE IN CONNECTION INTO 8" HDPE LATERAL #2.

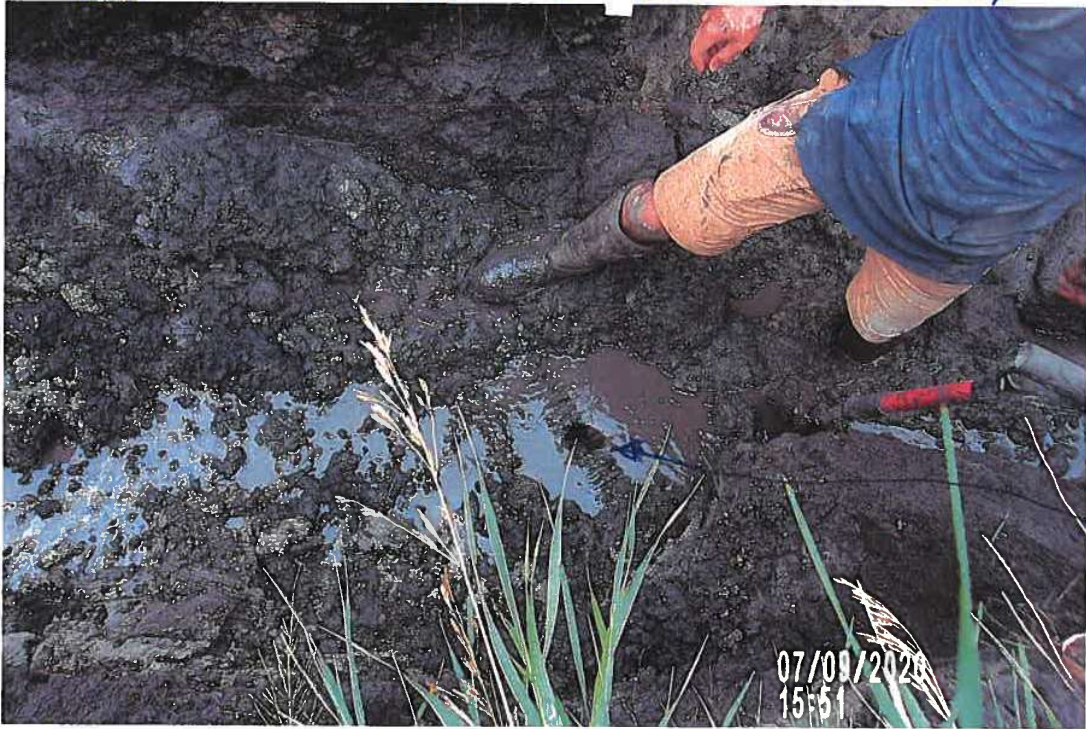
PICTURE # 4116 IS LOOKING EAST SHOWING HOLE IN TOP OF 8" HOPE NONPERF TILE EXCAVATED BY ANOTHER CONTRACTOR AND LEFT OPEN 322'E SOUTH OF COM HWY 041 & 9.6'±

EAST OF  
EAST ROW  
FENCE  
COM HWY  
S-27  
IN WETLAND  
AREA

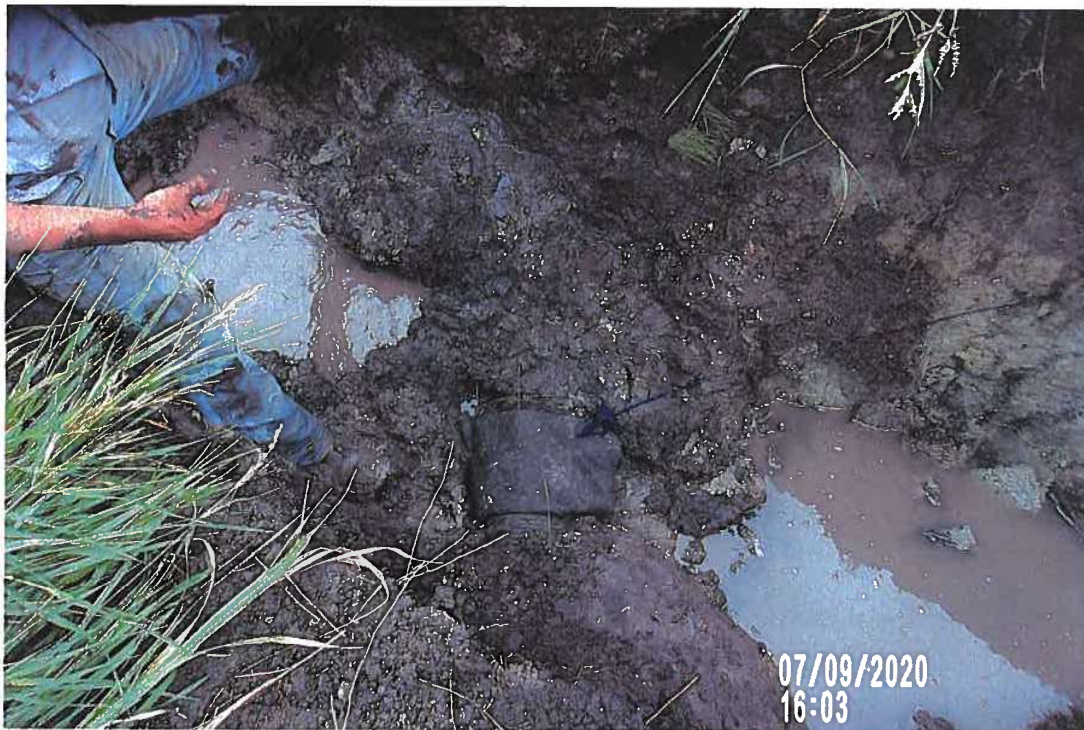
PICTURE # 4119 IS LOOKING UPSTREAM (FROM GPS #311) INSIDE 8" TILE  
SHOWING TILE IN GOOD SHAPE BUT CHANGED TO CLAY WITH  
WATER LEVEL AT 4" (SLOW FLOW). ALSO FLOWLINE HAS SOFT MUCK  
BUT SHOULD FLUSH OUT NOW THAT IT IS  
OPEN,

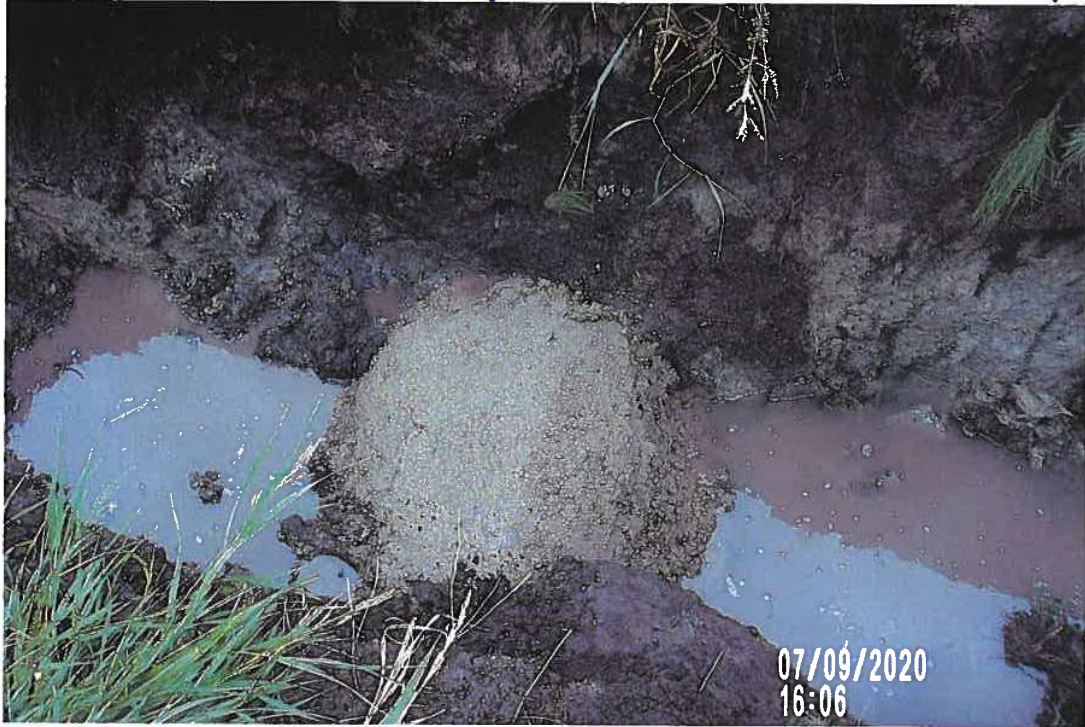
PICTURE #4121 IS LOOKING AT FINISHED 3/4 CONCRETE COLLAR OVER HOLE IN 8" DW HOPE NON PERF TILE. CREW USED 4 - 60 LB BAGS OF QUIKRETE HIGH STRENGTH CONCRETE ON COLLAR

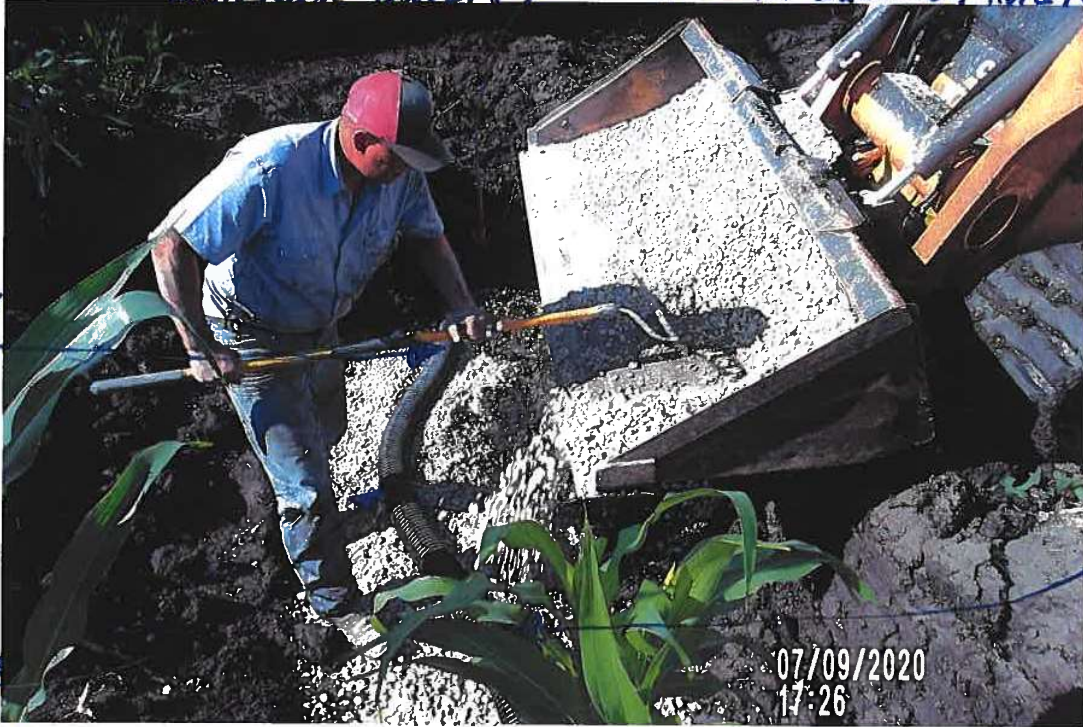
PICTURE # 4123 IS LOOKING NORTH SHOWING 9.8 LF OF 4" HDPE SW PERF TILE INSTALLED WITH 4" HDPE INTERNAL COUPLERS AND OFF TO SIDE SOME FOR FIRMER GROUND & BEDDED WITH ROCK UNDER. GPS # 312 TOP EXISTING 4" HDPE PERF TILE

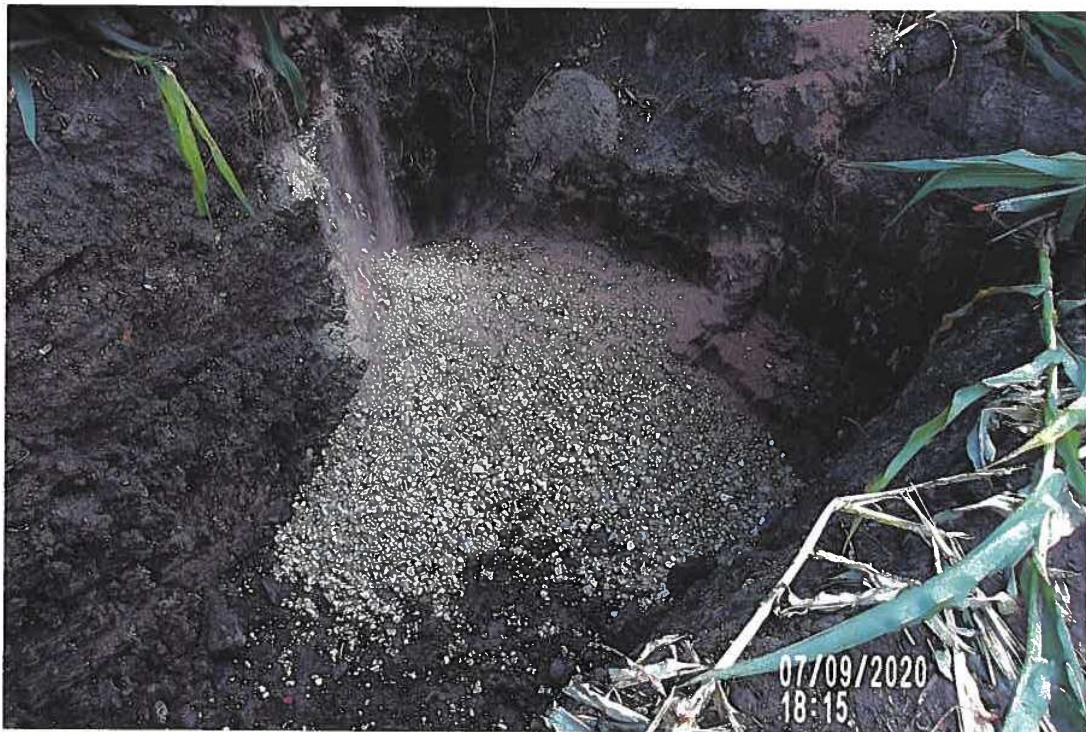
PICTURE # 4127 IS LOOKING EAST SOUTH OF SOUTH  
ROW OF COMWY D41 SHOWING A 5" HDPE PERF TILE  
THE INS BEDDED WITH ROCK TO TOP OF TILE

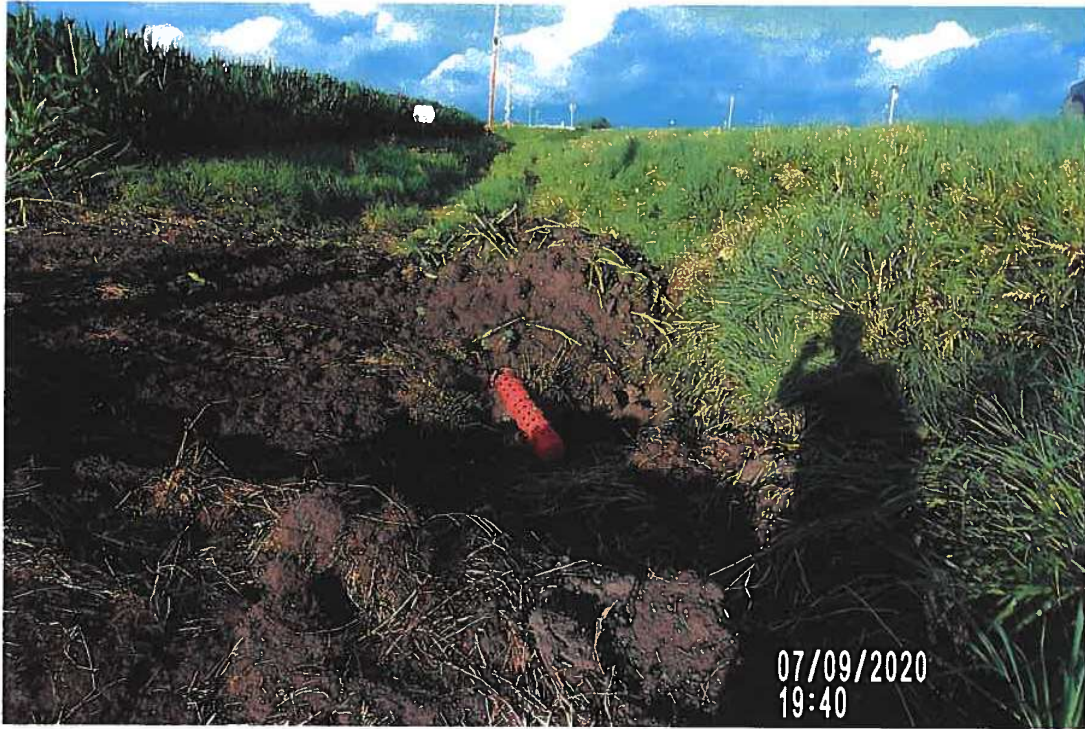
PICTURE # 4128 IS LOOKING NW SHOWING NORTH 14" CLAY TILE EXPOSED TRENCH WITH TILE BEDDED WITH ROCK TO TOP OF TILE

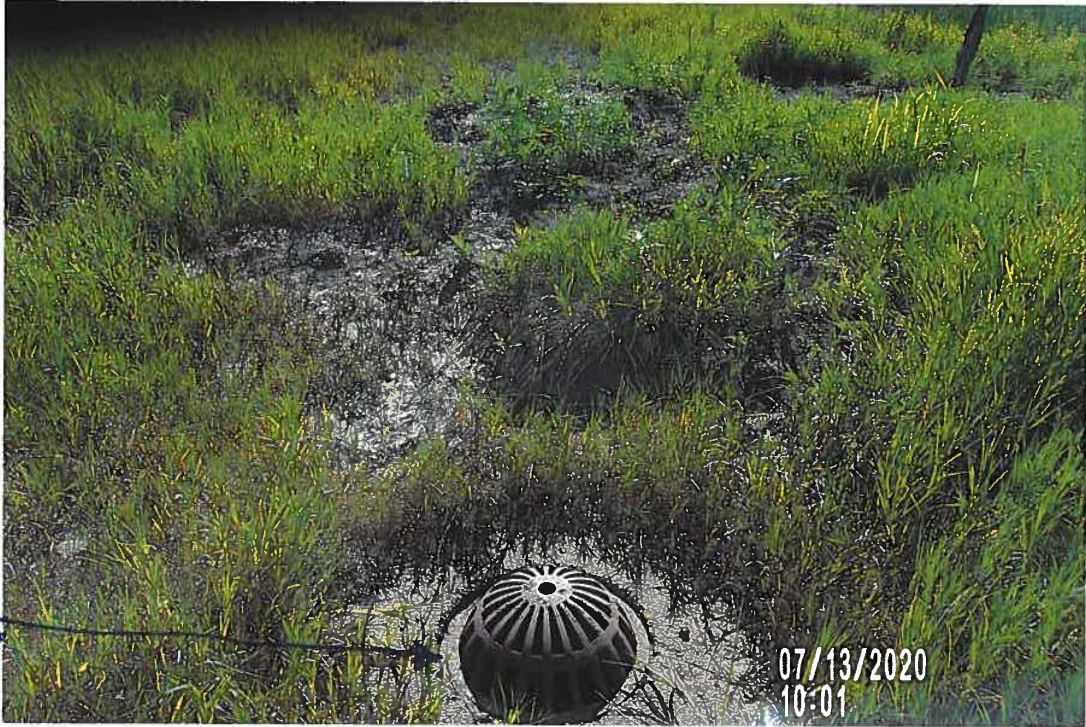
PICTURE# 4138 IS LOOKING EAST SHOWING SMALL  
SINKHOLE ON EAST SIDE OF BEEHIVE INTAKE PER RANDY'S REPORT  
AREA LOOKED LIKE IT HAD BEEN EXCAVATED AT ONETIME

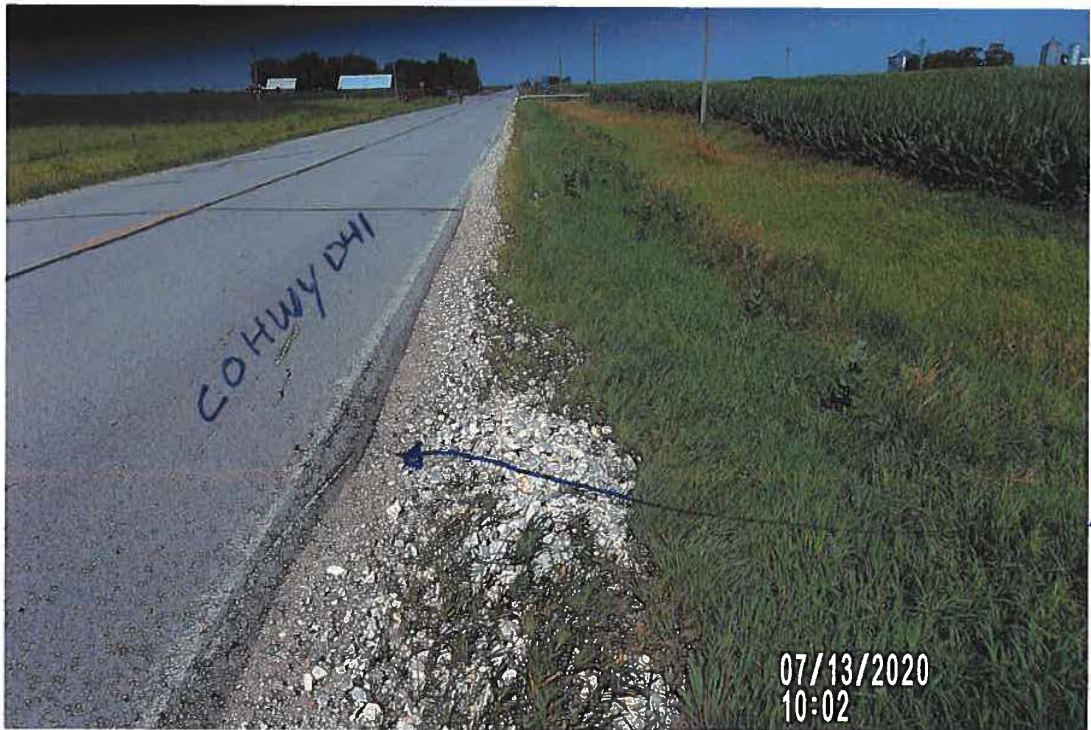
DIP IN  
GRAVEL  
SHOULDER  
WITH  
FRESH  
ROCK

PICTURE# 4139 IS LOOKING WEST ON NORTH SHOULDER  
OF CO HWY 241 SHOWING SINK HOLE PER RANDY'S REPORT  
WITH A LITTLE DIP IN ALL 2 GRAVEL AND APPEARS SOMEONE HAS  
PUT FRESH ROCK IN SINK HOLE.

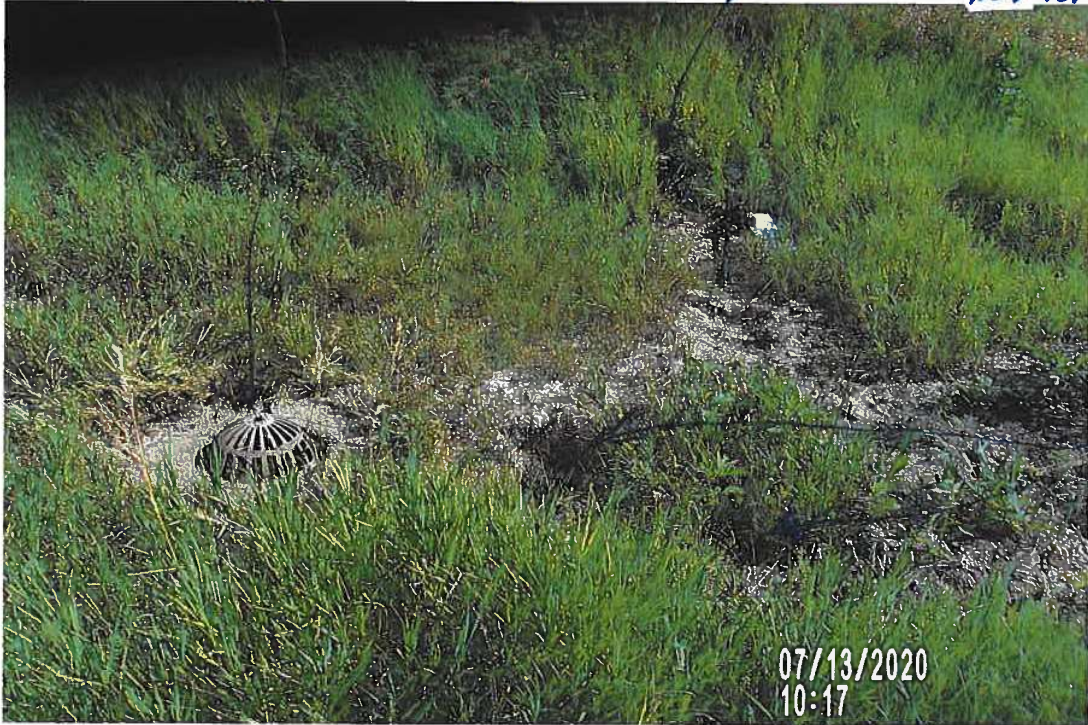
PICTURE# 4140 IS LOOKING NORTH TOWARDS CO HWY D41  
 SHOWING 18" CMP OUTLET FOR CULVERT UNDER CO HWY D41  
 & 18" BEEHIVE INTAKE IN SOUTH DITCH OF CO HWY D41 WITH SINKHOLE  
 GPS# 337 NRM BEEHIVE INTAKE GPS# 338 TOP 18" CMP TO EAST,  
 1.54' TO TOP FL

SINKHOLE  
 EAST OF  
 BEEHIVE  
 INTAKE

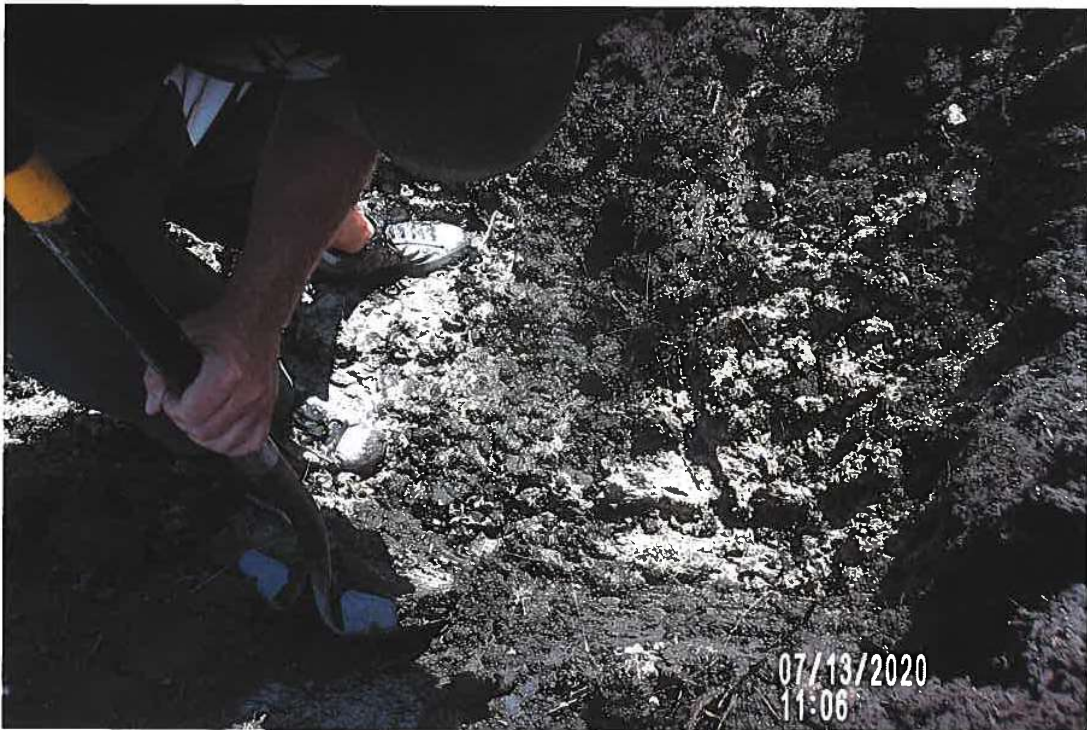
PICTURE# 4141 IS LOOKING EAST ON EAST SIDE OF  
 BEEHIVE INTAKE SHOWING 6" HDPE PERF TILE CONNECTION  
 TO 6" CLAY TILE OUTLET EAST FROM BEEHIVE INTAKE,

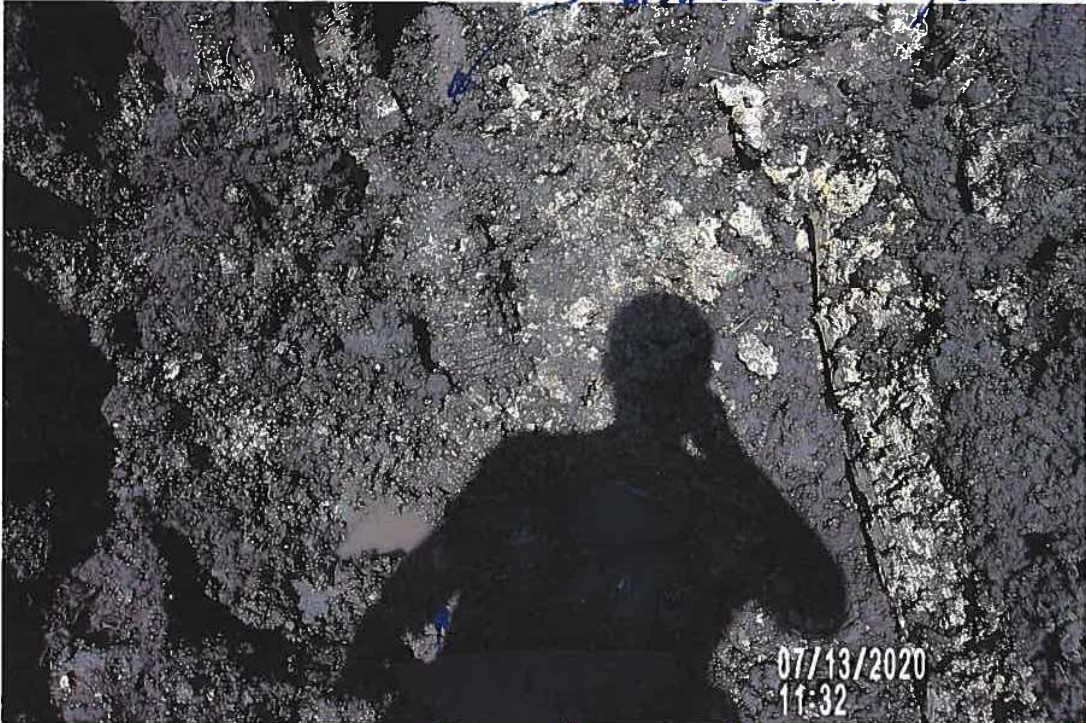
PICTURE # 4144 IS LOOKING WEST SHOWING 6"x6"x6" HOPE TEE CONNECTION & 6" HOPE PERFTILE / 6" CLAY TILE WITH ISSUE BETWEEN PLASTIC & CLAY TILE

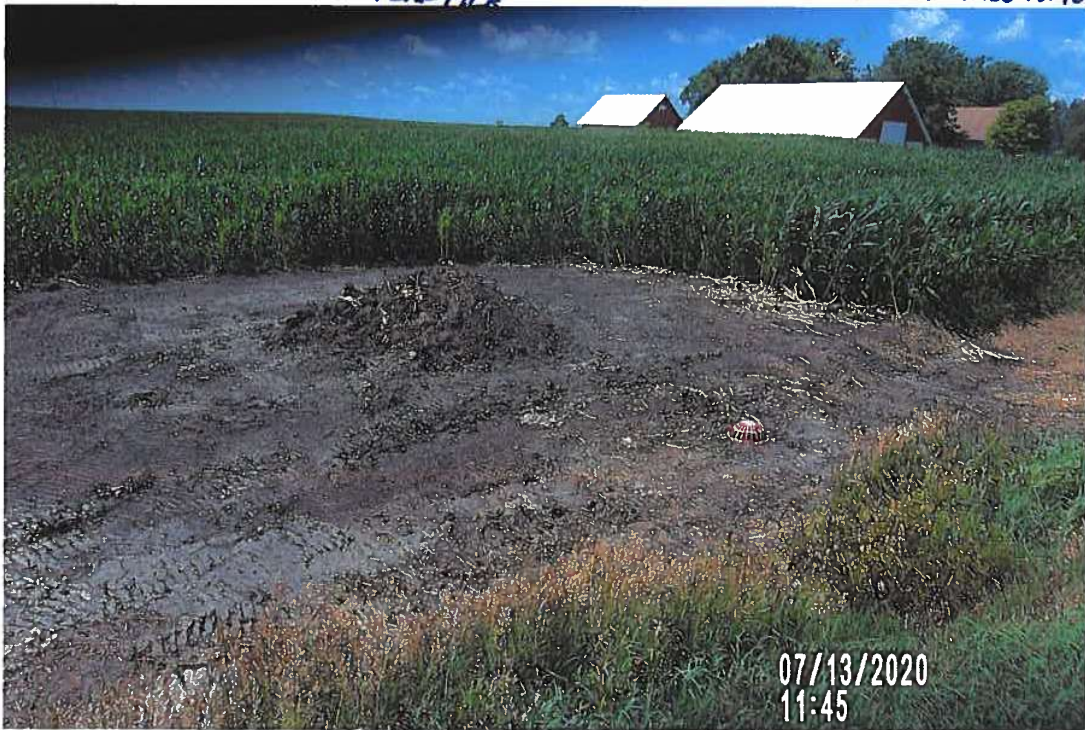
PICTURE # 4145 IS LOOKING SW ON SOUTH SIDE OF HWY 041 SHOWING DITCH GRADED TO INTAKE & TRENCH BACKFILL & GRADED. EXTRA SOIL PILED UP. BLEND EXTRA SOIL AROUND

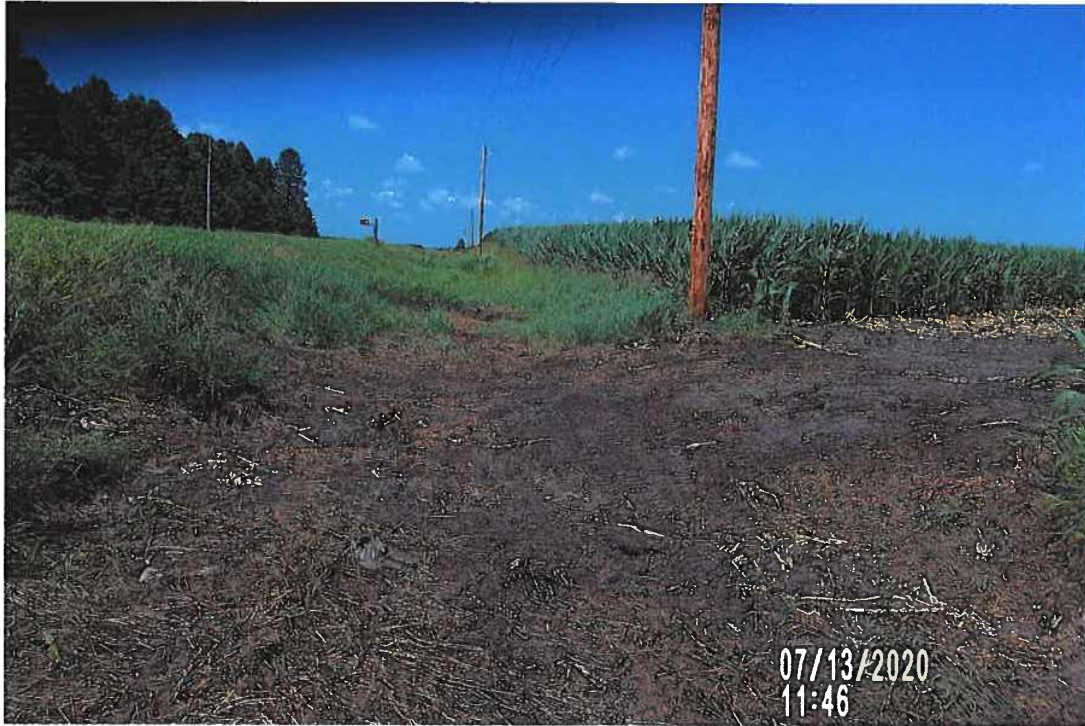
PICTURE #4147 IS LOOKING WEST SHOWING NORTH DITCH  
GRADED ABOVE TRENCH

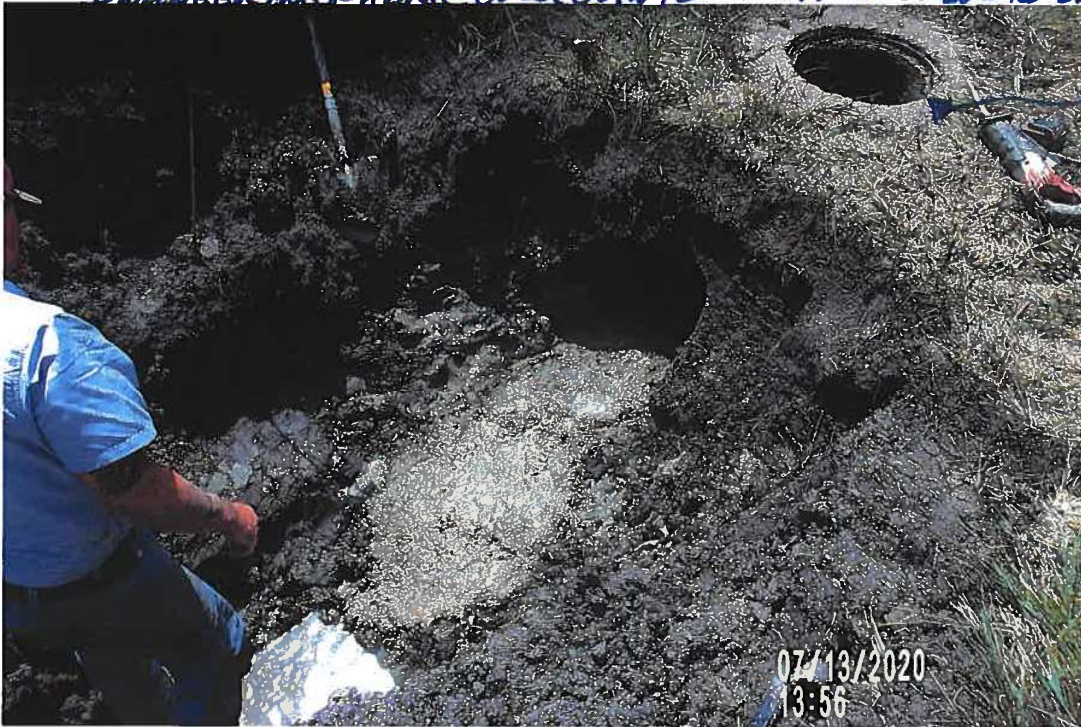
PICTURE# 4149 IS LOOKING SW SHOWING  $\frac{3}{4}$  CONCRETE COLLAR  
 POURED ON BEEHIVE INTAKE TILE OUTLET TIE IN WITH  
 3 - 20 X 15' 6" X 6" WIRE MESHES OVER JOINTS & 3 - 1.5 X 20'  
 FIBERGLASS FABRIC OVER JOINTS WITH 5-60 LB BAGS OF HIGH STRENGTH  
 CONCRETE

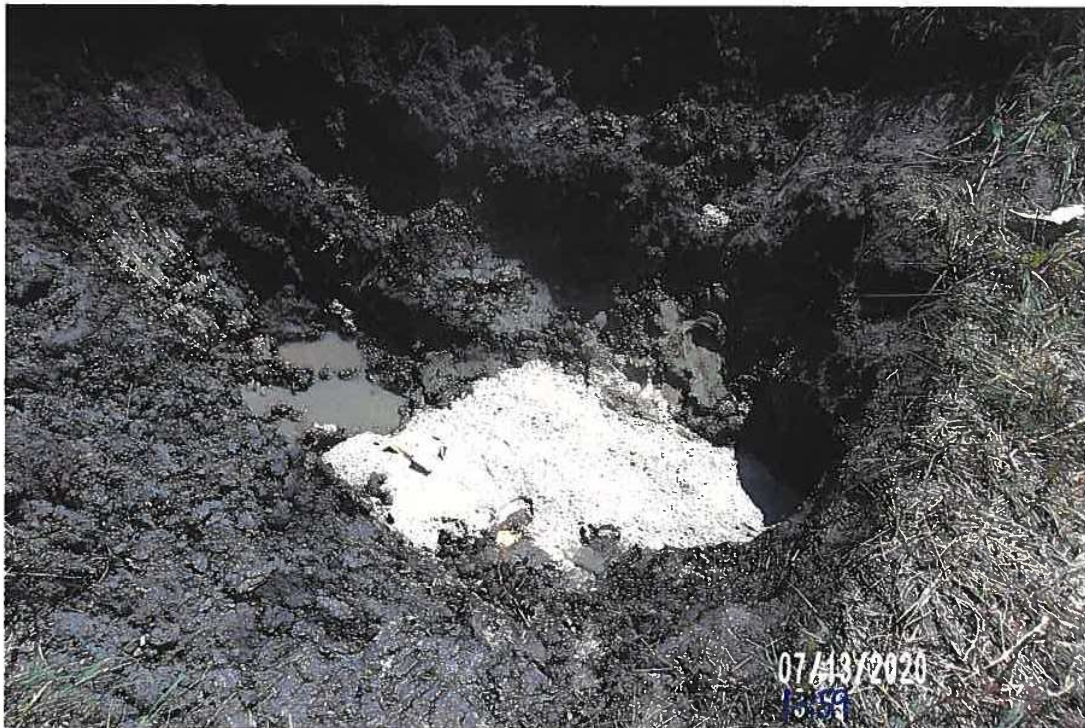
PICTURE# 4150 IS LOOKING SE SHOWING:  $\frac{3}{4}$  CONCRETE COLLAR  
 POURED OVER BEEHIVE OUTLET TILE TIE IN CONNECTION.

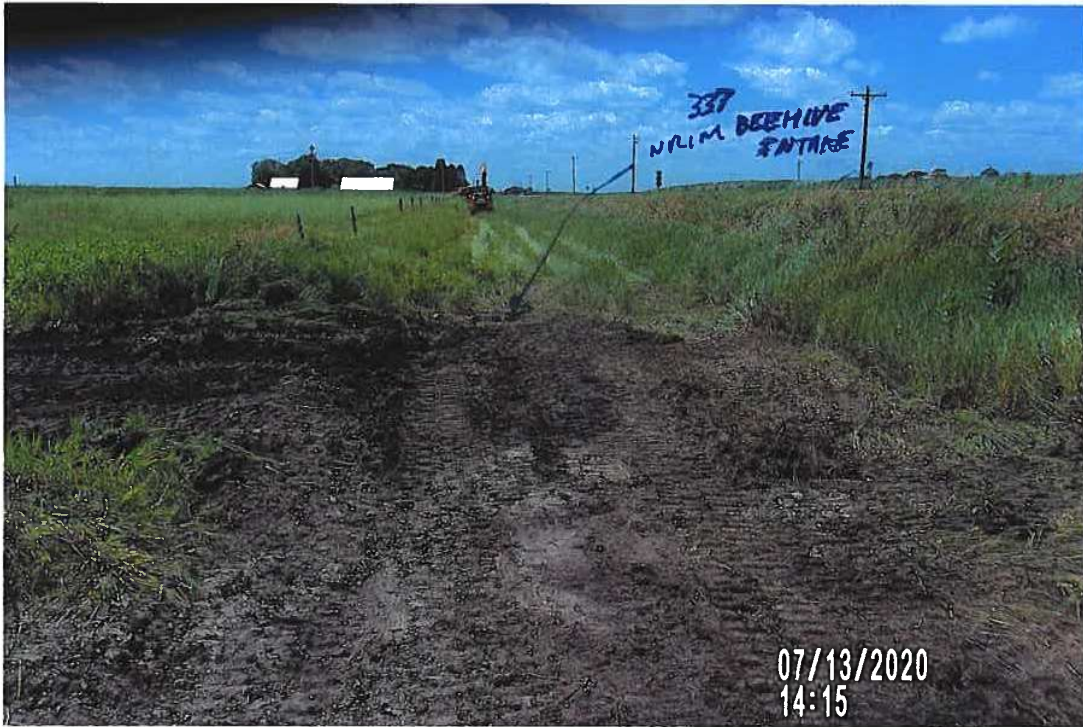
PICTURE# 4151 IS LOOKING WEST SHOWING DITCH  
GRADED TO BEEHIVE INTAKE

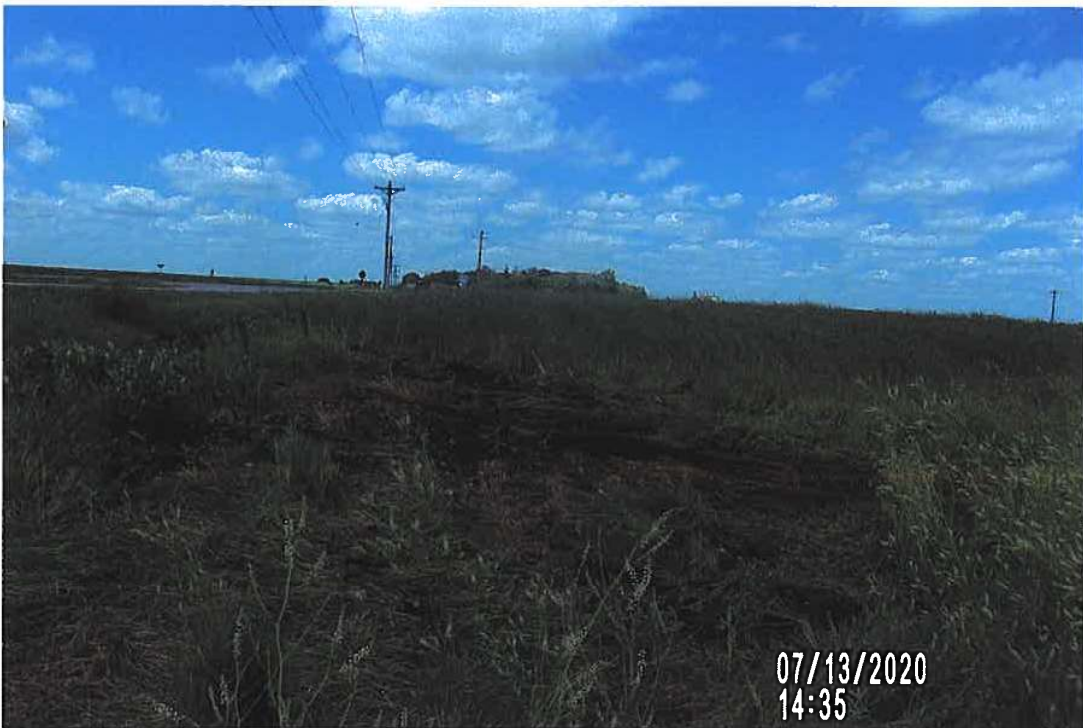
PICTURE# 4152 IS LOOKING NORTH SHOWING TRENCH  
BACKFILLED EAST OF EAST ROW HIGHWAY 27 & SOUTH D41  
IN WETLAND DUG BY PREVIOUS CONTRACTOR

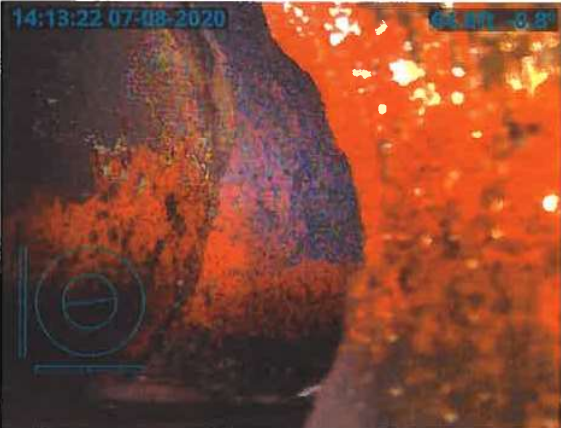
BR 2020\_07\_08-14\_13\_23\_027.jpg
