**AGENDA**  
**REGULAR DRAINAGE MEETING**  
**Wednesday, September 2, 2020 9:30 AM**  
**Large Conference Room**

4. DD 14 WO 290 - Discuss W Possible Action - Investigation Summary

[DD 14 WO 290 - 6844.4 - INVESTIGATION REPORT - 2020-08-31.PDF](#)

**COMPLETION REPORT ON  
MAIN TILE REPAIRS TO  
DRAINAGE DISTRICT 22  
FACILITIES  
HARDIN COUNTY, IOWA  
(PROJECT NOS. DD-6532.2 AND 8712)**

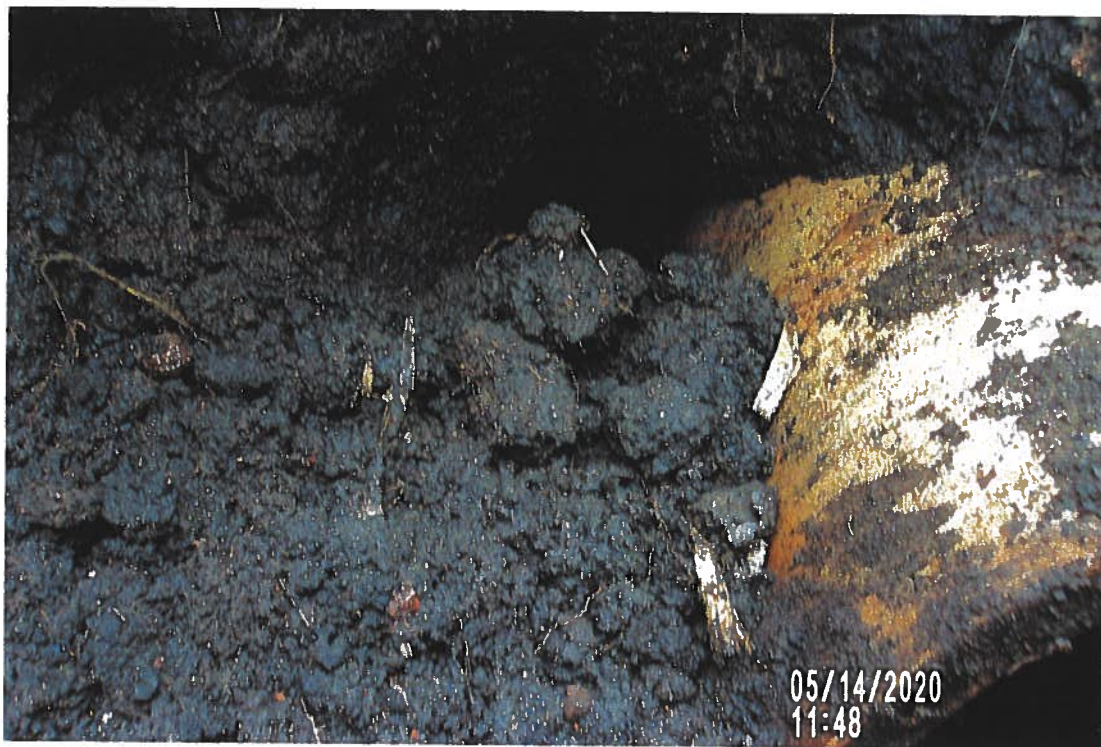
PICTURE # 3544 IS LOOKING SW ON EAST SIDE OF TILE AT 5.5' LONG  
SOIL ERODED CAVITY IN BLOWOUT # 28 FROM GPS # 118
