**AGENDA**  
**REGULAR DRAINAGE MEETING**  
**Monday, February 8, 2021 9:30 AM**  
**Large Conference Room**

**This will be a joint meeting with the Franklin County Board of Supervisors acting as Drainage Trustees for DD H-F 4-53.**

## Drainage District:

## Investigation Summary:

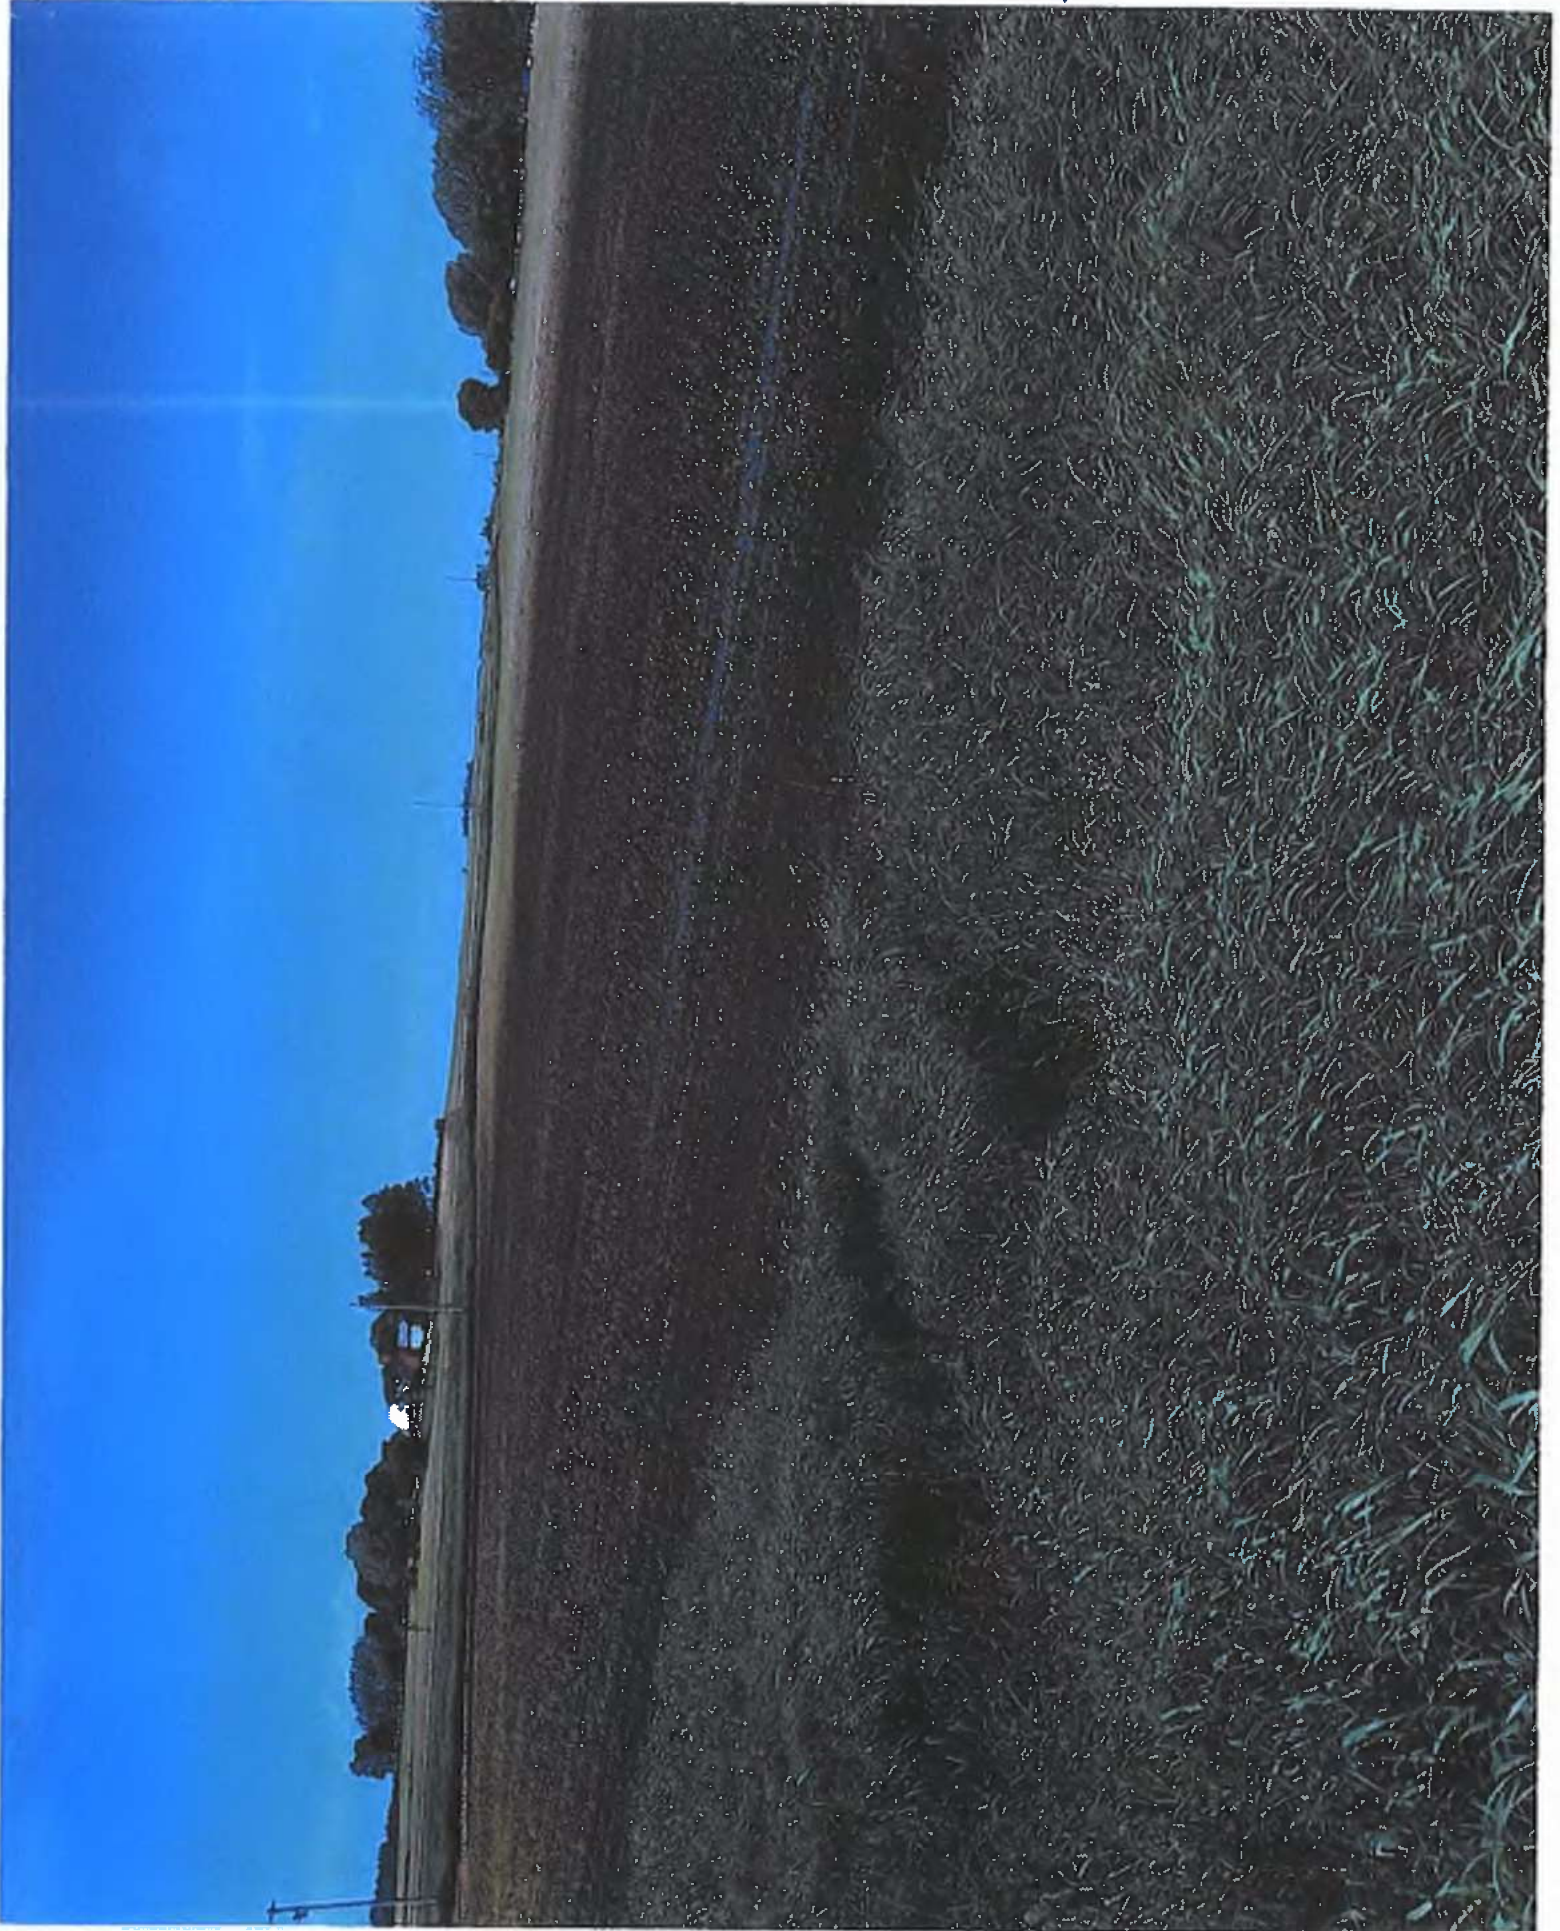
LOOKING DOWNSTREAM ON LOT 4B @ OLD RR. TIM CHARD (Purple)
