**AGENDA**  
**REGULAR DRAINAGE MEETING**  
**Wednesday, March 3, 2021 9:30 AM**  
**Large Conference Room**

5. DD 14 WO 290 - Discuss W Possible Action - Landowner Concerns

[DD 14 WO 290 INVESTIGATION SUMMARY 05\\_11\\_20.PDF](#)  
[DD 14 WO 290 - 6844.4 - INVESTIGATION REPORT - 2020-08-31.PDF](#)

CONSTRUCTION ENGINEERING  
OBSERVATION REPORT

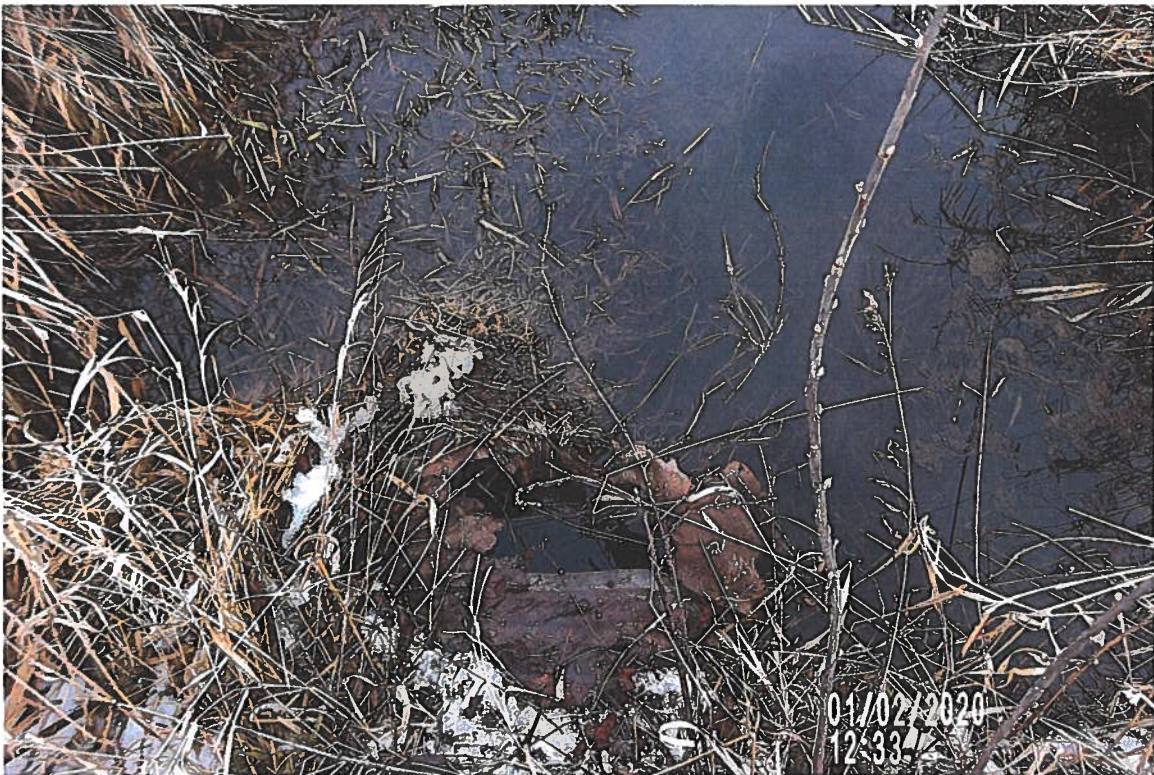
PICT# 2619 TOP VIEW OF MANGLED 30" CMP OUTLET ON N SIDE  
OF RR ACCESS DRIVE

- Due to the deteriorated condition of the Main tile junction structure, and the mangled and rusted culvert downstream of such, CGA recommends a new outlet structure be considered. The adjacent CMP culvert needs to be either removed or replaced before it collapses and restricts drainage.
- The Main open ditch of D.D. 155 (downstream of the D.D. 160 outlet) appears to be in need of a cleanout due to the buildup of excess sediment (possibly as far north as 110<sup>th</sup> St.). CGA recommends an investigation be conducted to determine the scope and extent of sedimentation within the flowline of said open ditch to determine if a cleanout is needed.
