**Regular Drainage Meeting**

4. DD 11 WO 331 - Discuss W Possible Action - Investigation Summary

#11

## Investigation/Repair Summary:

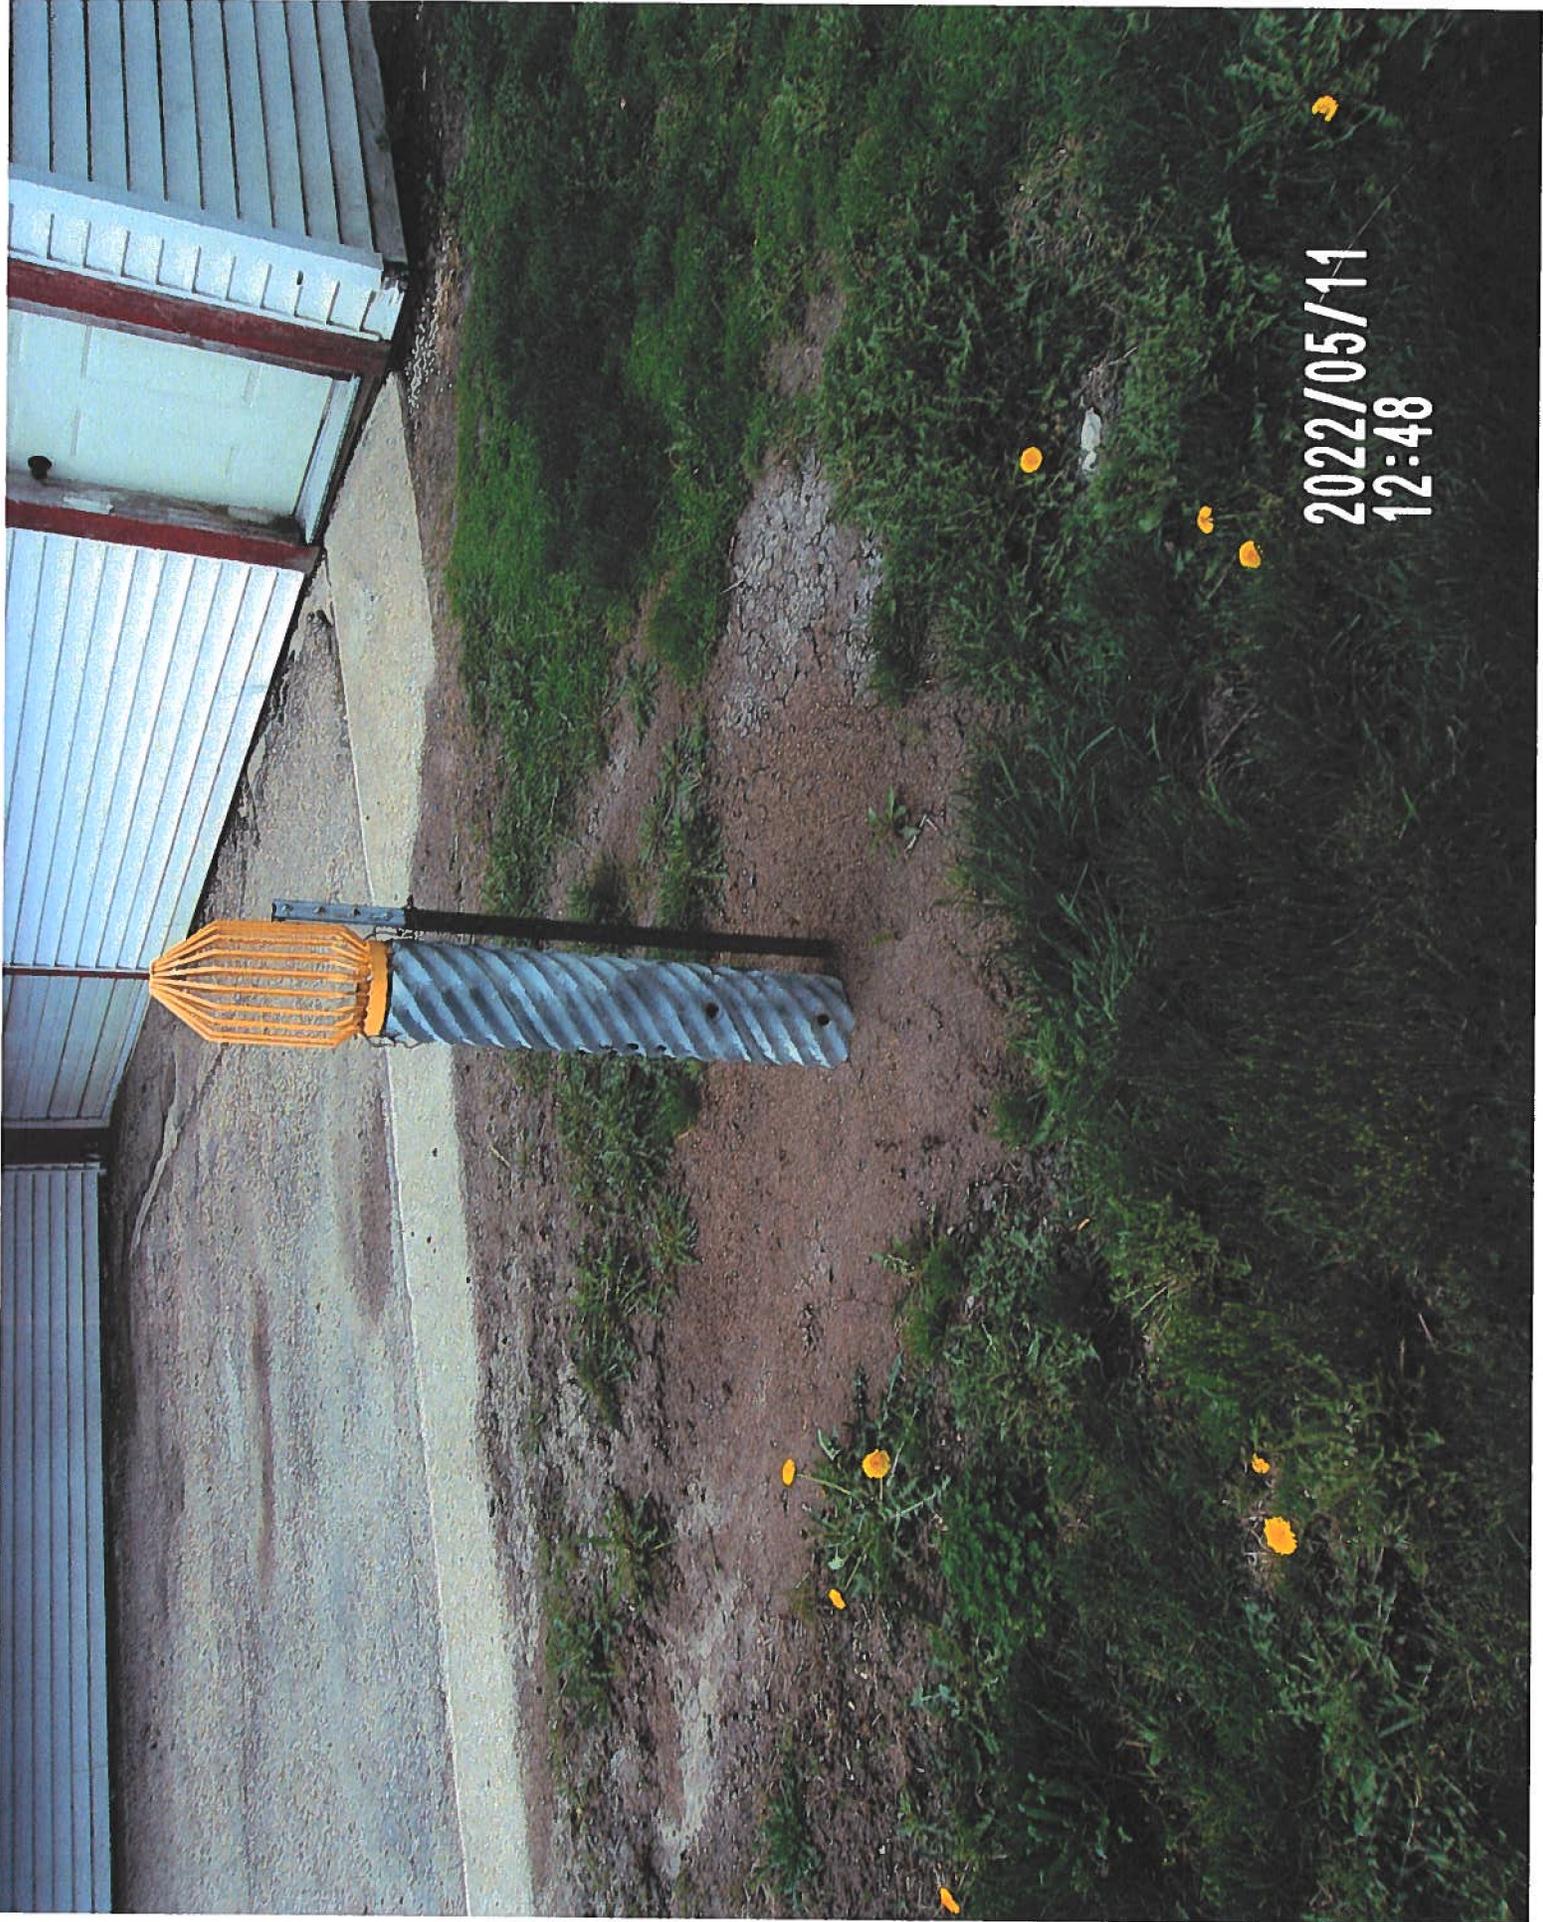
- Employee of landowner in town of Buckeye reported broken tile intake in Block 10.
- Visual observation found a 3 foot +/- diameter blowout/sinkhole around the 12 inch metal intake on Main tile with water visible swirling in intake above the Main tile itself.
- Downstream of intake in Block 10, there are several large maple trees in close proximity of the assumed Main tile route.

- Verify that the roots are the cause of the Main tile restriction either through CCTV or location/excavation of the Main tile at intervals and perform repairs as needed based on these results.  
OR
- Assume that tree roots are the cause of the Main tile restriction and have all trees within 50 feet of the Main tile removed and the remaining stumps treated along with replacing the Main tile that is restricted.
