**AGENDA**  
**DRAINAGE DISTRICT 14 LANDOWNER MEETING**  
**Wednesday, November 18, 2020 12:00 PM**  
**Large Conference Room**

# Drainage Work Order Request For Repair

LOCATION: DD14 MARIETTA TILE LOCATED SWNE & NWSE  
34-88-22 HARDIN COUNTY  
INVESTIGATE & TEMPORARILY REPAIR 3 TILE BLOWOUTS

## Investigation and Repair Summary:

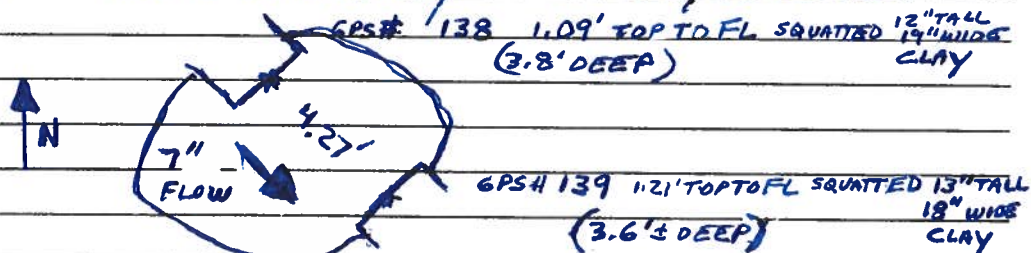
BLOWOUT #2N IN GRASS WATER WAY 443.5' NORTH OF GRASS WATER  
WAY TO ACREAGE

5.0' Ø TILE BLOWOUT  
2 SECTIONS OF TILE  
COLLAPSED

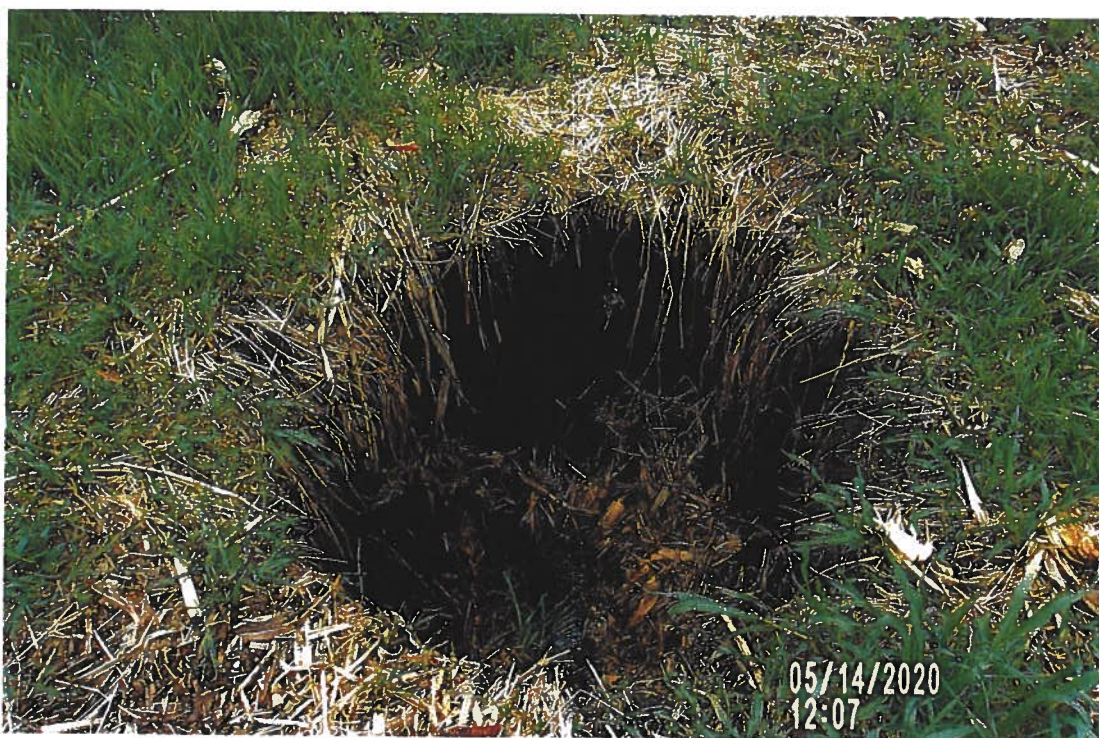
PICTURE# 3546 IS LOOKING SOUTH AT BLOWOUT 2N (5' Ø HOLE) IN GRASS  
WATERWAY BACK TOWARDS GRASSLANE TO ACREAGE

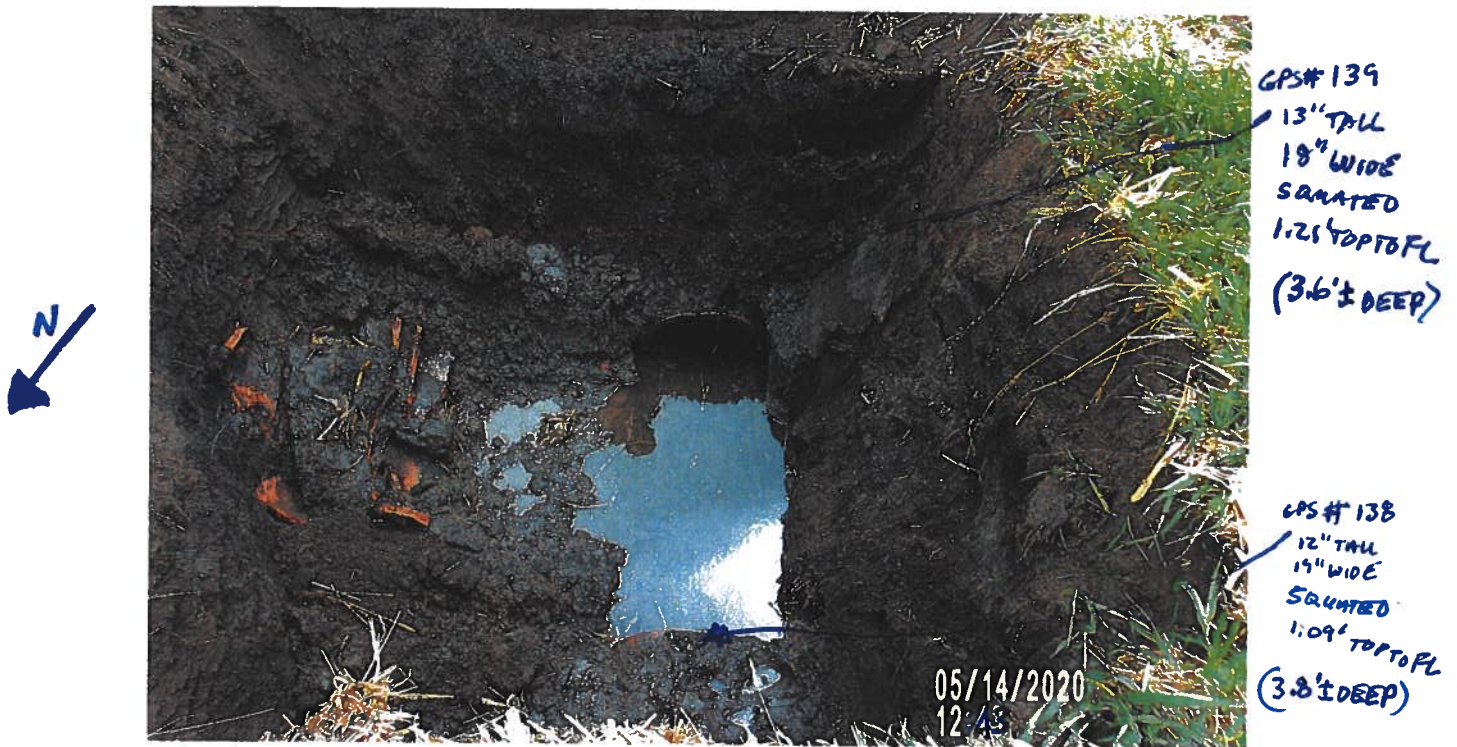
PICTURE# 3549 IS LOOKING NW SHOWING VOID UNDER GRASS  
WATERWAY THAT HAD NEVER SURFACED YET. ONLY 1.0'  
TO 1.5' OF SOIL OVER VOID @ 537.1' WHERE TILE COMPLETELY

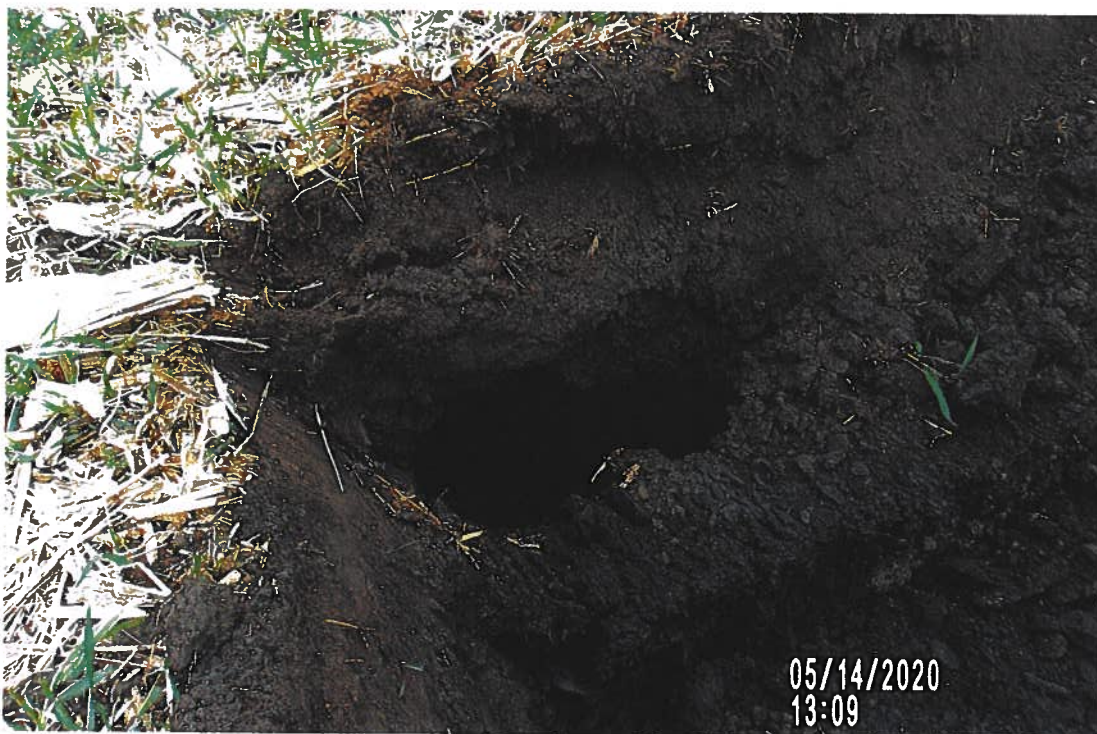
PICTURE # 3550 IS LOOKING NW SHOWING VOID UNDER GRASS WATERWAY  
@ 537.1' WHERE TILE COMPLETELY COLLAPSED.

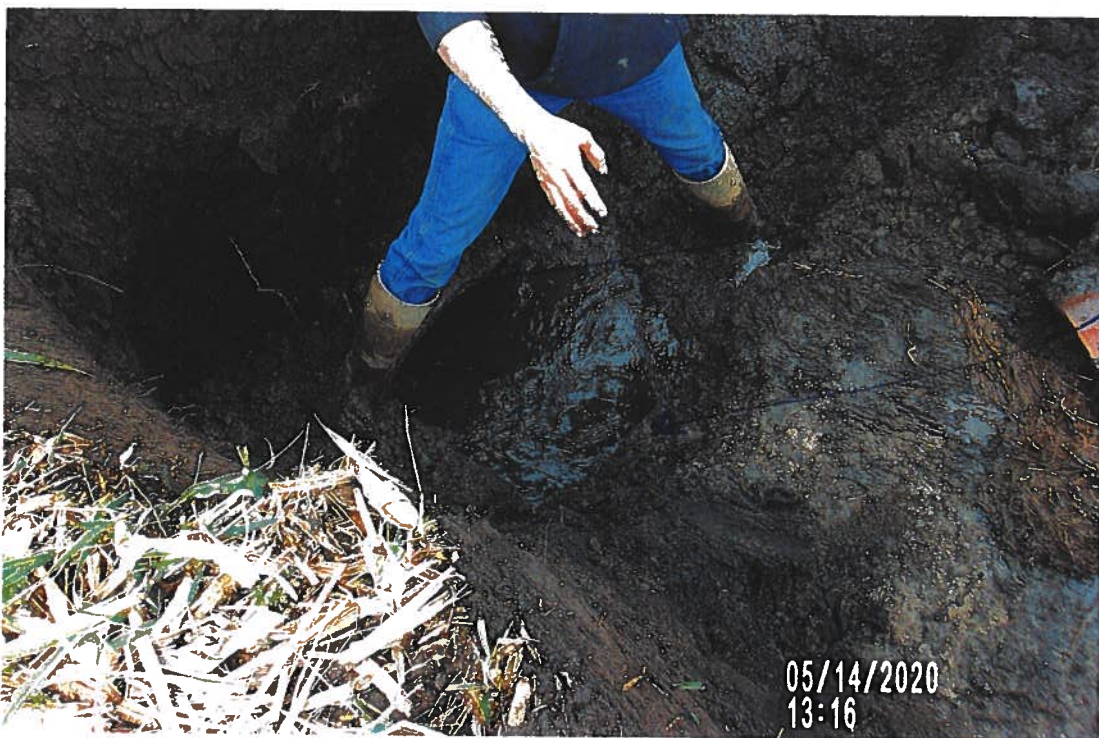
CPS# 147  
12" TALL  
19" WIDE  
SANDY CLAY  
1.05' TOP TO FL:  
3.5' ± DEEP

CPS# 146  
15" TALL  
17" WIDE  
CLAY  
1.32' TOP TO FL  
3.3' ± DEEP

PICTURE # 3553 IS LOOKING NE SHOWING COLLAPSED SECTION OF  
TILE REMOVED AND NOW FLOWING GOOD IN BLOWOUT. IN

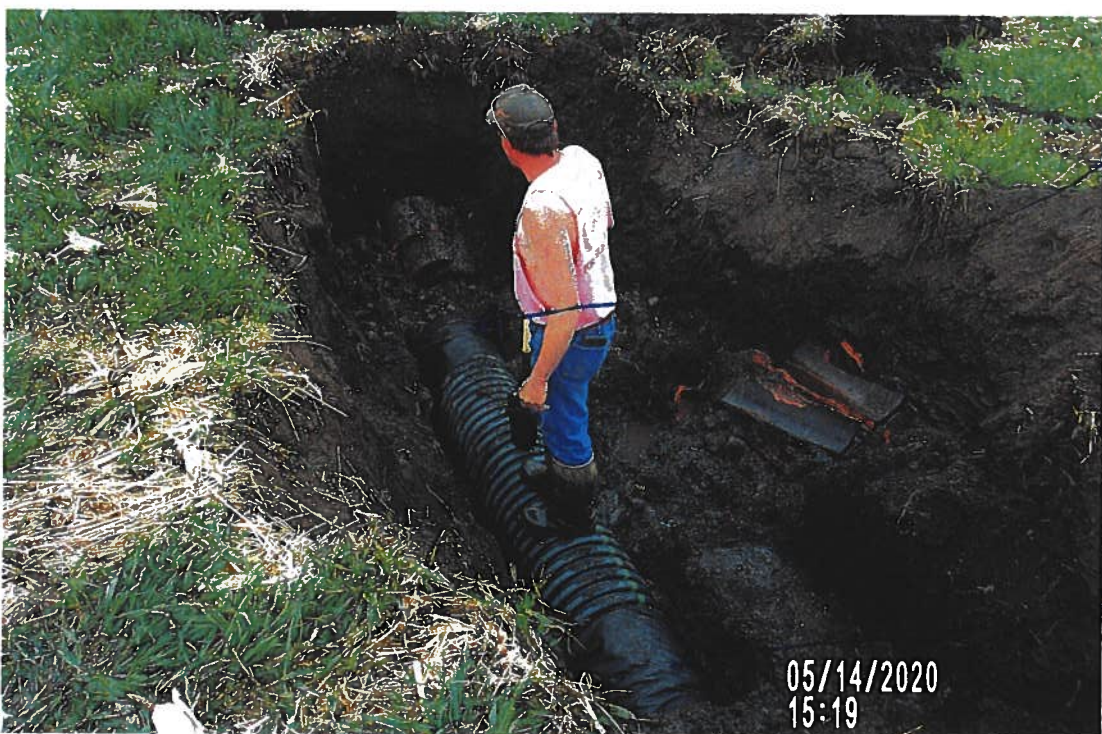
2 SECTIONS  
OF CLAY  
TILE ON  
NORTH END  
DUE TO NEXT  
SECTION  
COLLAPSING  
DURING  
REMOVAL  
N ↑

GPS#176  
15.75" TALL  
16" WIDE  
CLAY  
(1.36' TOP TO FL)  
N ↑

GPS#175  
15" TALL  
15.75" WIDE  
CLAY  
(1.36' TOP TO FL)

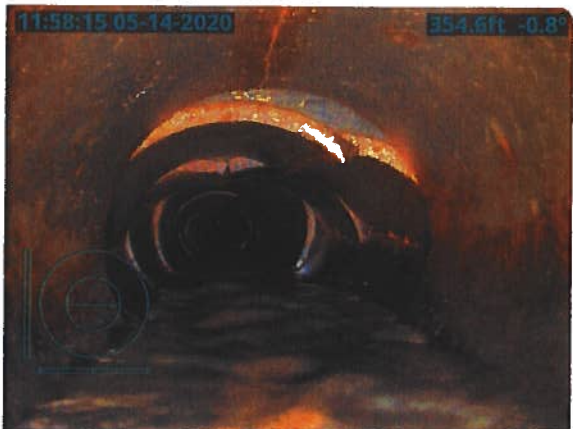
B 2020\_05\_14-11\_58\_15\_678.jpg

2020_05_14-11_58_15_678.jpg		11	12			MORE STELLAR CONDITION PIPE
0:37:47	366.3		CM

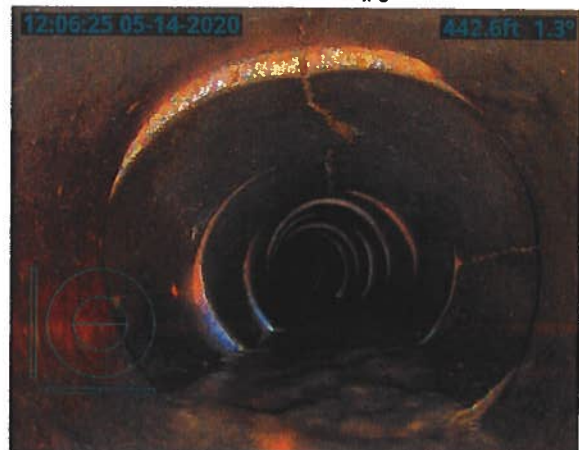
CM 2020\_05\_14-12\_06\_25\_077.jpg

2020_05_14-12_06_25_077.jpg		11	12			CRACKS ALL AROUND
0:44:01	470.4		CM

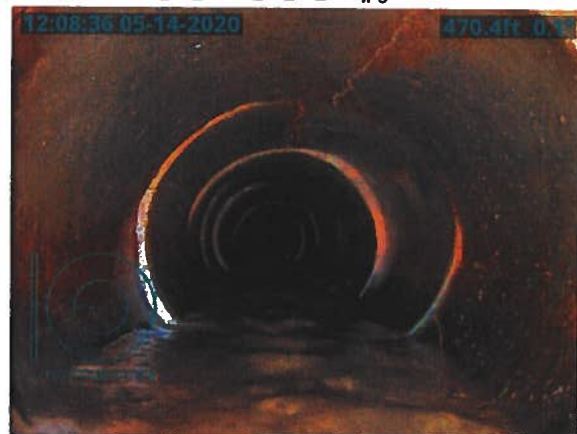
CM 2020\_05\_14-12\_08\_37\_024.jpg

2020_05_14-12_08_37_024.jpg		12	02			CRACKED TOP
0:46:09	498.8		DE

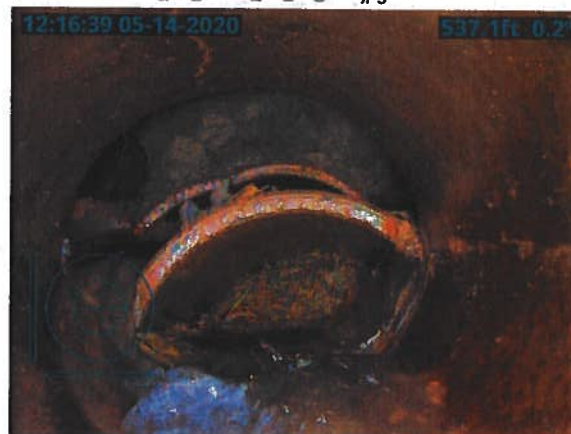
B 2020\_05\_14-12\_16\_39\_476.jpg

2020_05_14-12_16_39_476.jpg		08	03			BROKEN AND COLLAPSED
1:19:44	590.2		B

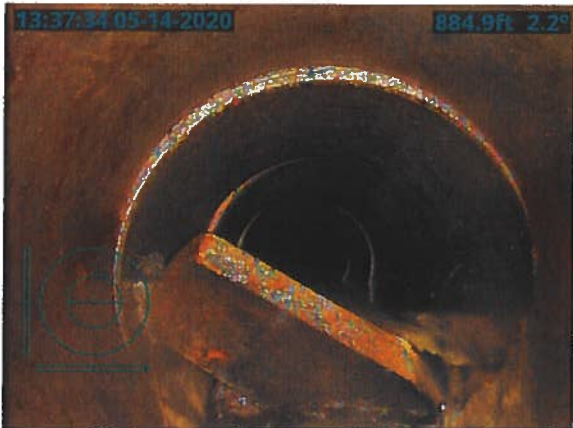
DE 2020\_05\_14-13\_37\_34\_943.jpg

2020_05_14-13_37_34_943.jpg				50%		BROKEN TILE IN FLOW LINE

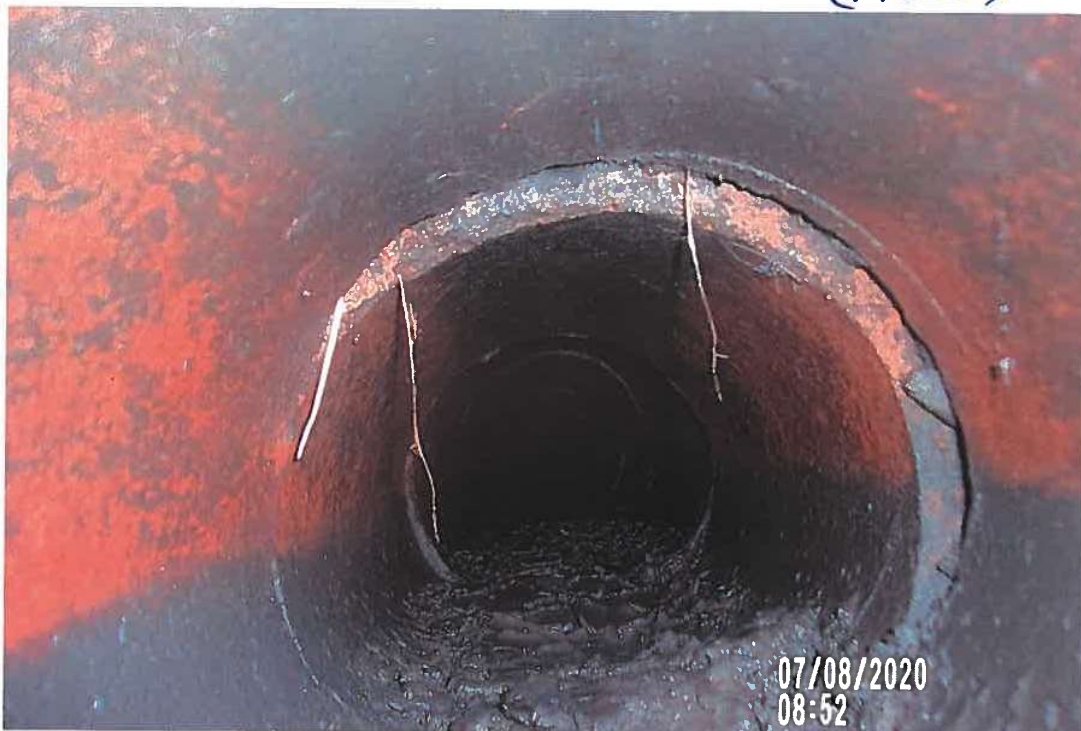
GPS# 252 TOP 14" CLAY TILE  
(4.9' ± DEEP)

PICTURE# 4052 IS LOOKING NW UPSTREAM INSIDE 8" CLAY TILE WITH 2" ± OF MUD IN FLOWLINE FROM GPS# 250. TILE IS IN GOOD SHAPE WITH FEW FINE ROOTS AND A FEW OFFSET JOINTS

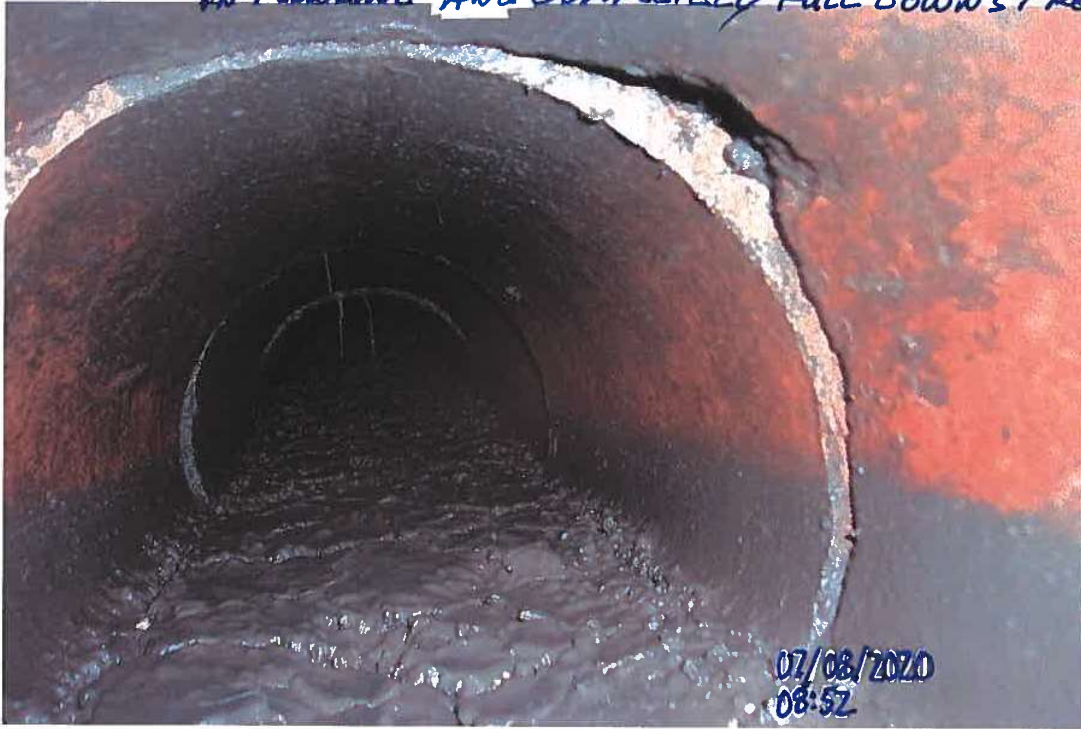
PICTURE # 4053 IS LOOKING SE DOWNSTREAM INSIDE 8" CLAY TILE  
WITH 2"± OF MUD IN FLOWLINE FROM GPS # 251. TILE HAS A  
LITTLE POPOUT AT NEXT JOINT AND IS IN GOOD SHAPE WITH 2" MUD  
IN FLOWLINE AND COMPLETELY FULL DOWNSTREAM. RON

THINKS  
THIS TILE  
IS  
ABANDONED

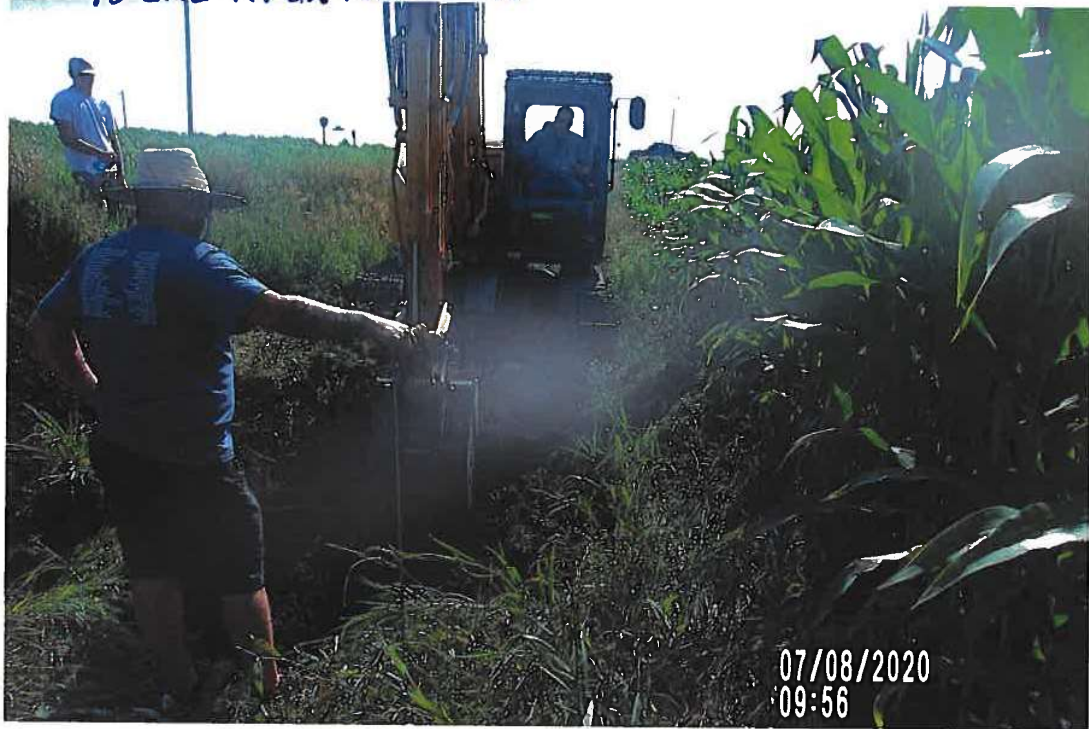
PICTURE #4054 IS LOOKING EAST IN SOUTH DITCH CO HWY 04/  
297<sup>±</sup> WEST OF E CO HWY 5-27 SHOWING CREW EXPOSING LATZ TILE  
WEST OF BEEHIVE INTAKE SO CREW CAN RUN LOCATE CABLE UPSTREAM  
TO CHECK FOR PLUGGED TILE.

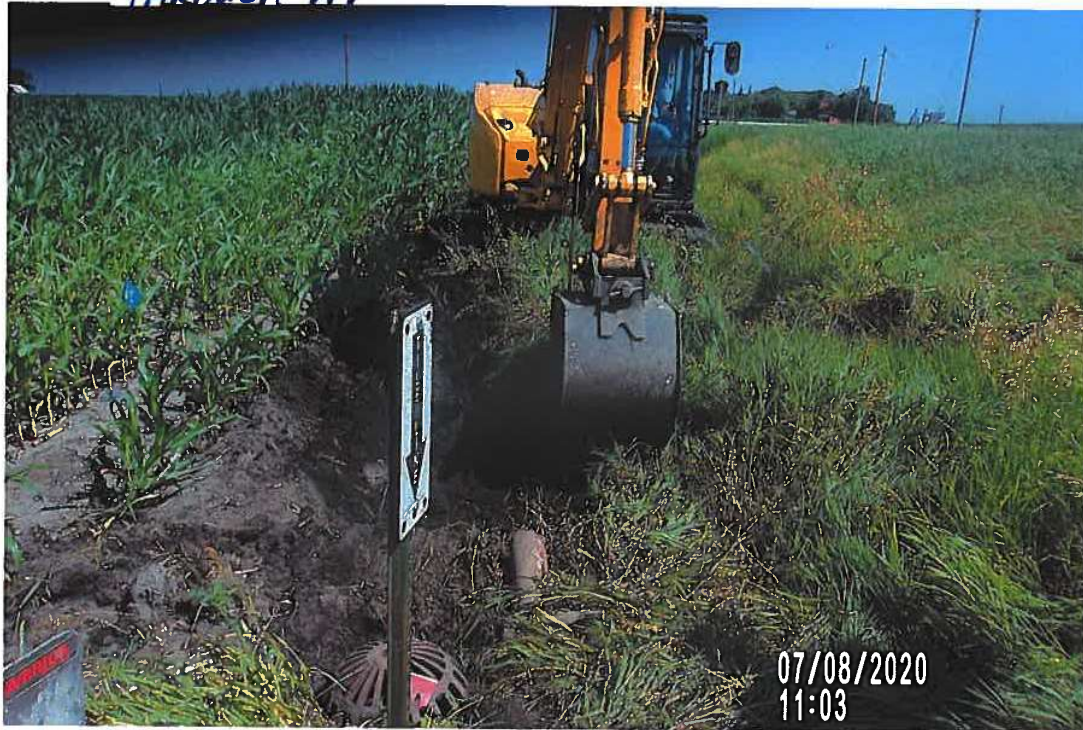
PICTURE# 4057 IS LOOKING NW SHOWING SECTION OF 8" CLAY  
 TILE ROLLED OUT IN SOUTH DITCH OF CO HWY 041 NW OF BEEHIVE INTAKE  
 FOR CREW TO RUN LOCATOR CABLE UPSTREAM TO FIND PLUG  
 IN TILE.

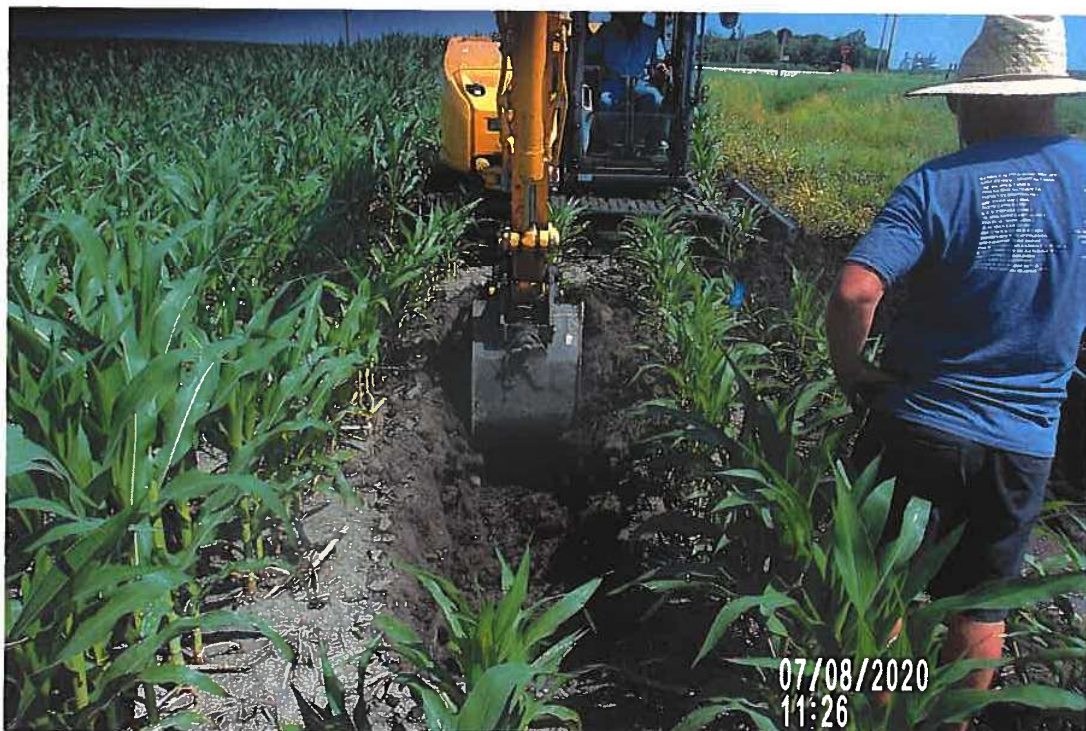
PICTURE #4058 IS LOOKING NORTH - SHOWING CREW EXCAVATING  
ALONG FIELD EDGE IN WEST DITCH OF HWY-27 TO EXPOSE  
TILE TO CHECK CONDITION, FLOW AND RUN LOCATE CABLE  
THROUGH IT.

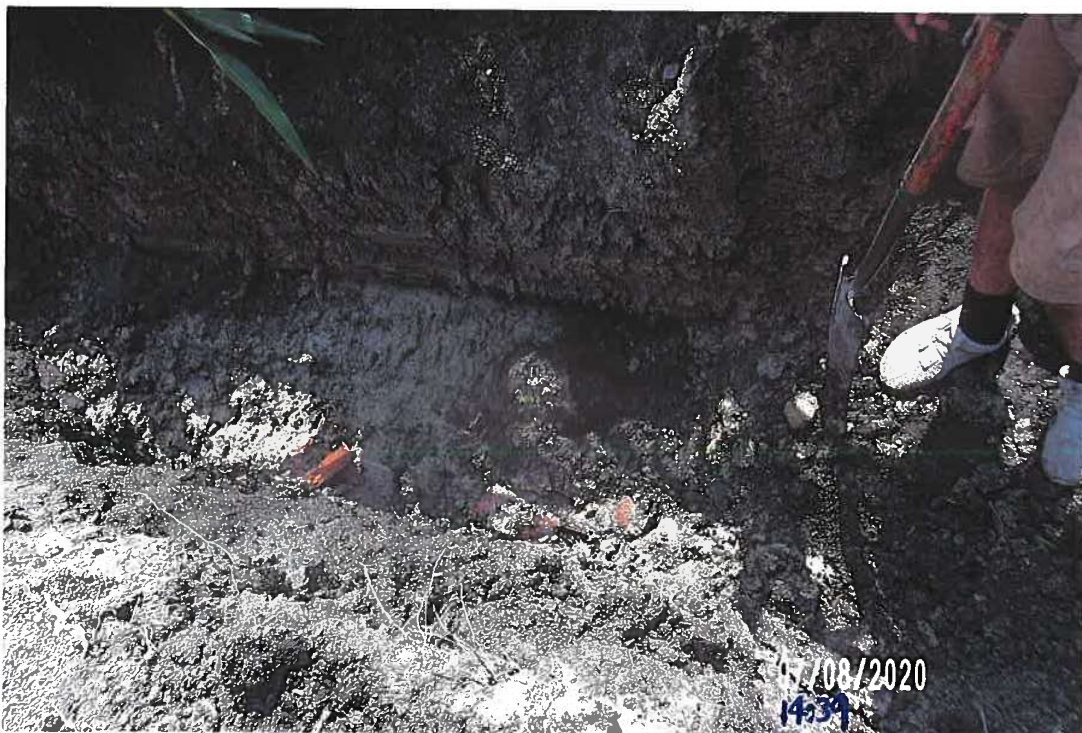
PICTURE # 4060 IS LOOKING UPSTREAM INSIDE 8" CLAY TILE @ 21.3' UPSTREAM FROM BEEHIVE INTAKE SHOWING 5" PERF SW HOPE TILE FROM EAST & FROM WEST CONNECTING AT SAME LOCATION WITH SIDES CRACKED AND TOP CAVING DOWN WITH TILE PLUGGED UPSTREAM WITH SOIL & ROOTS

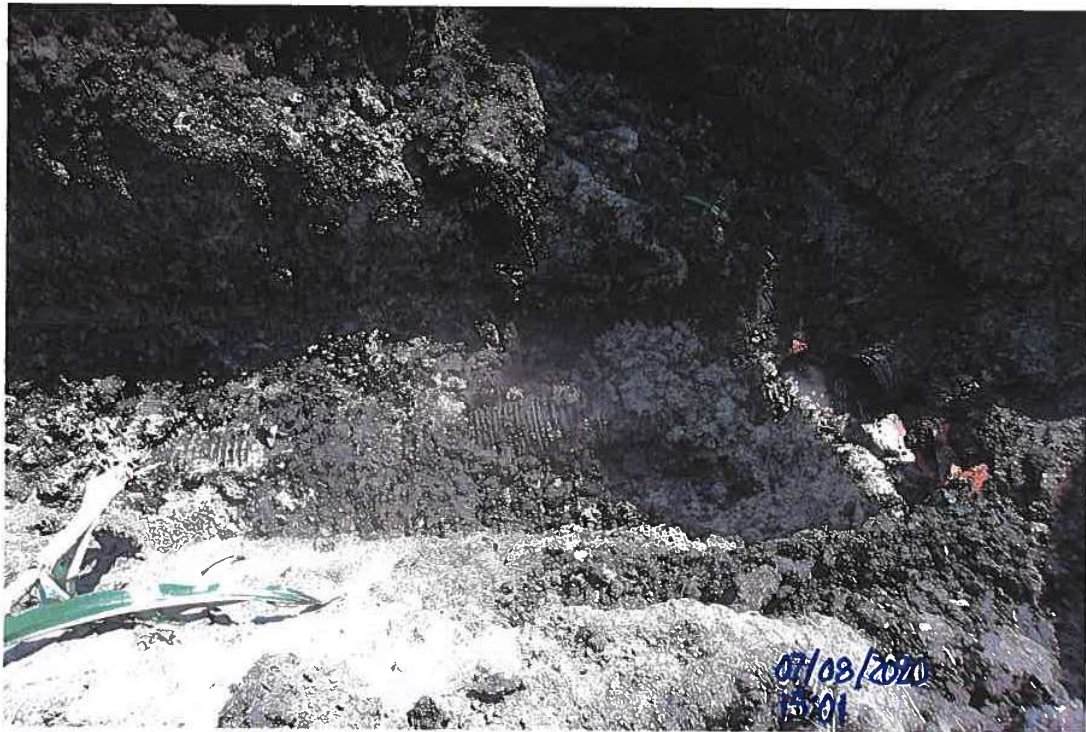
PICTURE # 4064 IS LOOKING SW SHOWING WATER GUSHING FROM  
UPSTREAM END OF 8" CLAY TILE AT 5" HDPE TILE CONNECTIONS  
AFTER BLOCKAGE REMOVED

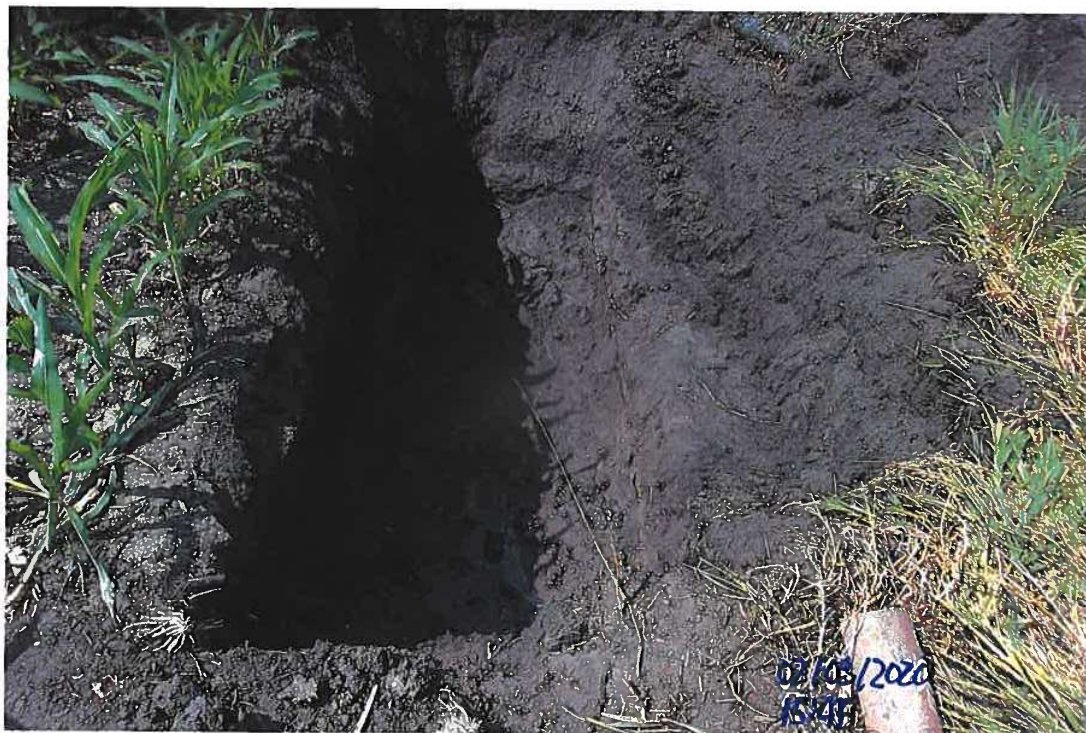
PICTURE# 4065 IS LOOKING SOUTH SHOWING 5" HOPE TILE CONNECTION WITH 5" HOPE TILE FROM WEST HAVING A SAC OR HUMPE UP IN A SPOT.

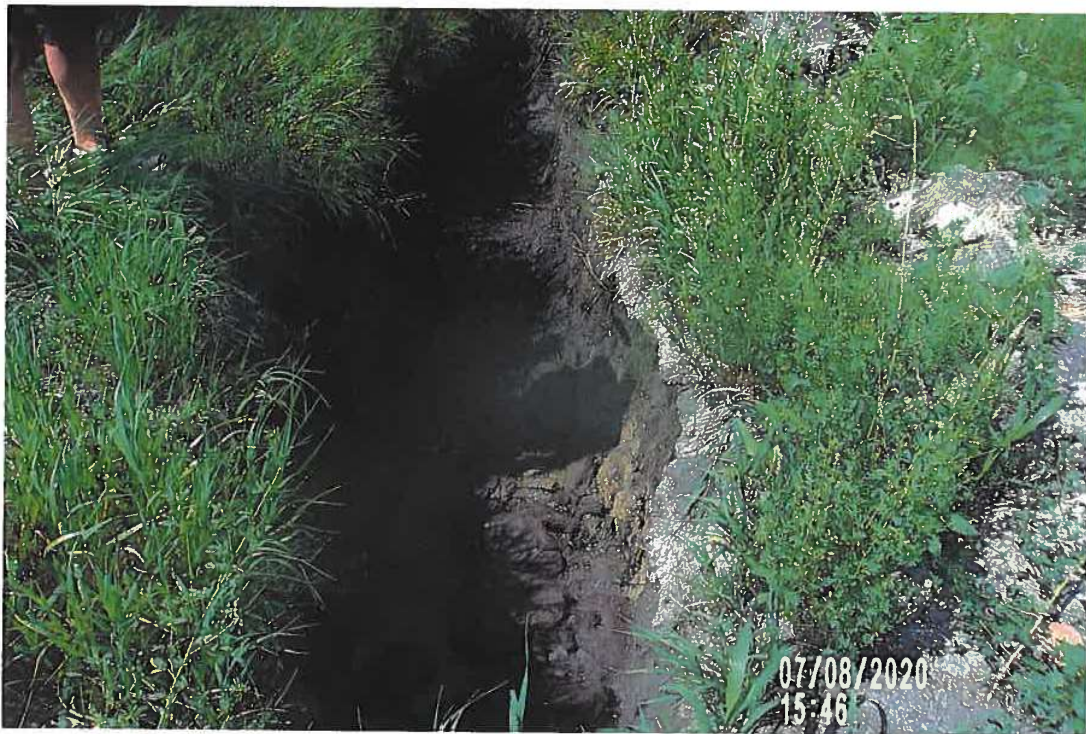
PICTURE# 4066 IS LOOKING NORTH SHOWING WATER GONE NOW IN EXCAVATED HOLE IN WEST DITCH OF CO HWY 527 ALONG FIELD EDGE EAST OF WATER MAIN N-S

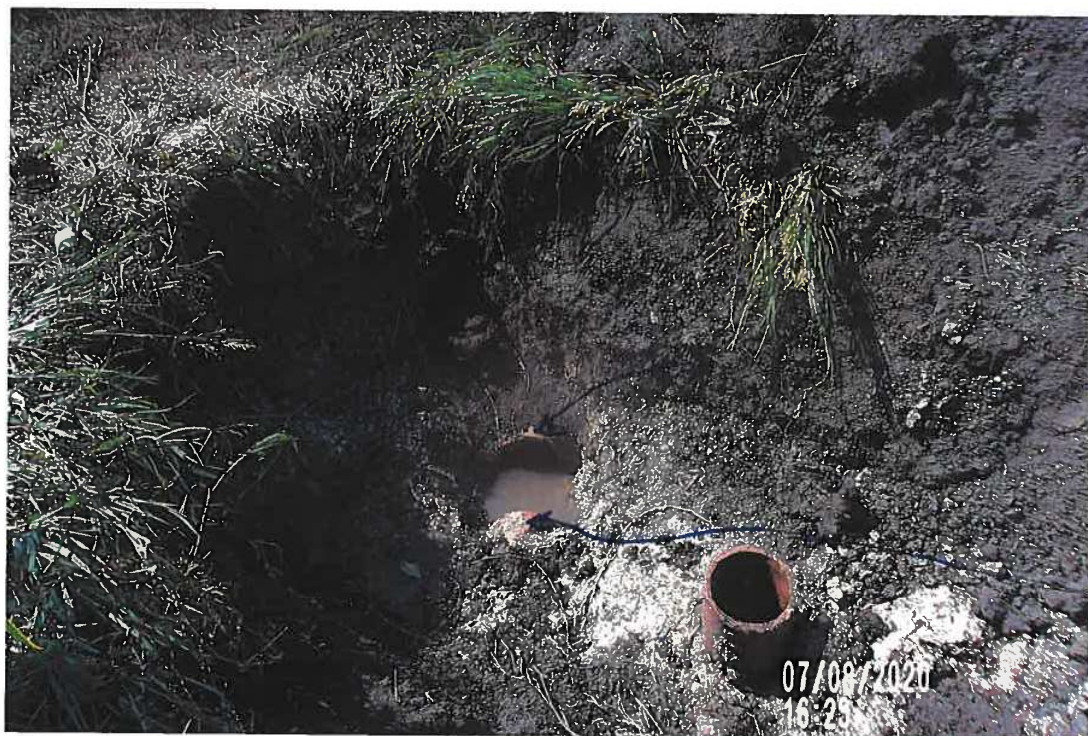
PICTURE#4067 IS LOOKING NORTH SHOWING PREVIOUSLY  
EXCAVATED HOLE EAST OF EAST ROW FENCE FOR CO. HWY  
527 & SOUTH OF CO HWY D41

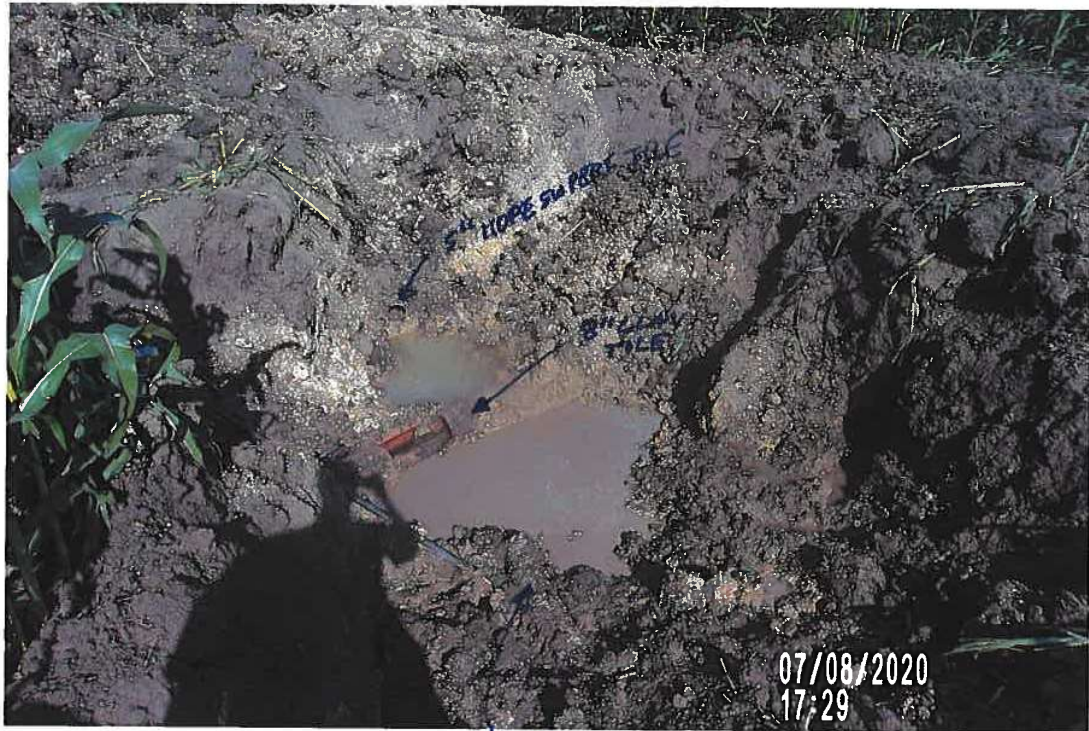
PICTURE #4069 IS LOOKING EAST SHOWING 5" HOPE SW PERF  
TILE CONNECTION AREA. 8" CLAY TILE STILL FLOWING  
GOOD.

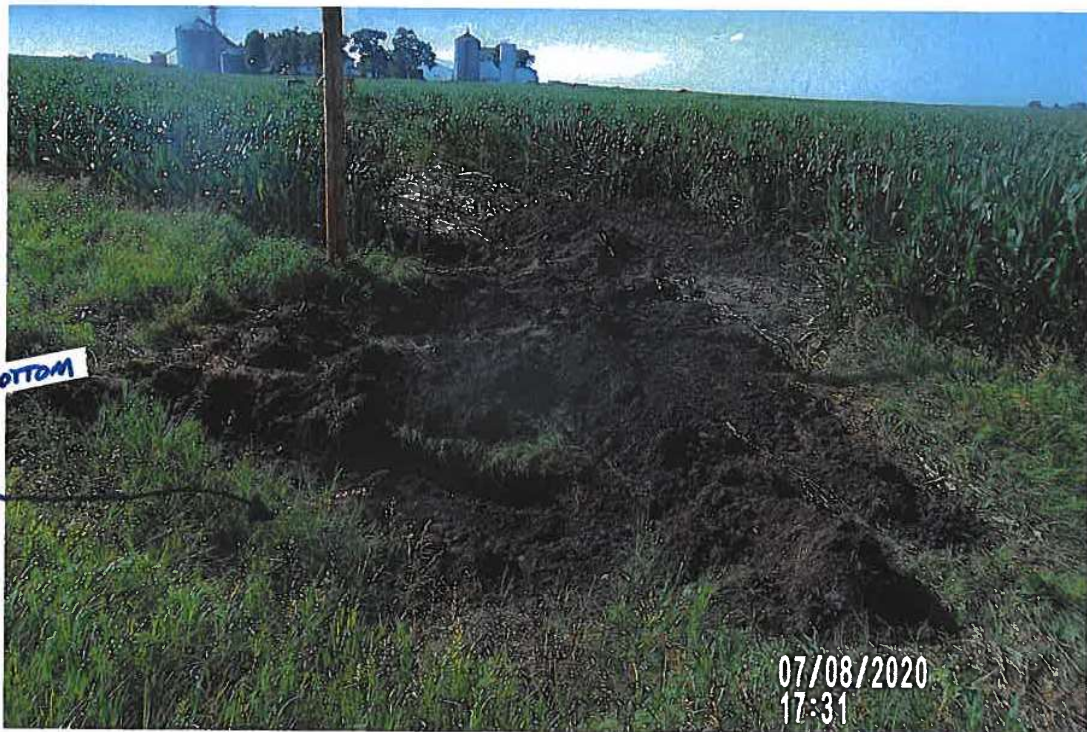
PICTURE #4070 IS LOOKING NW FROM CO HWY 041  
SHOWING AREA IN NORTH DITCH EXCAVATED AND HOLE EXCAVATED  
IN FIELD AT TILE/WATERMAIN CROSSING.

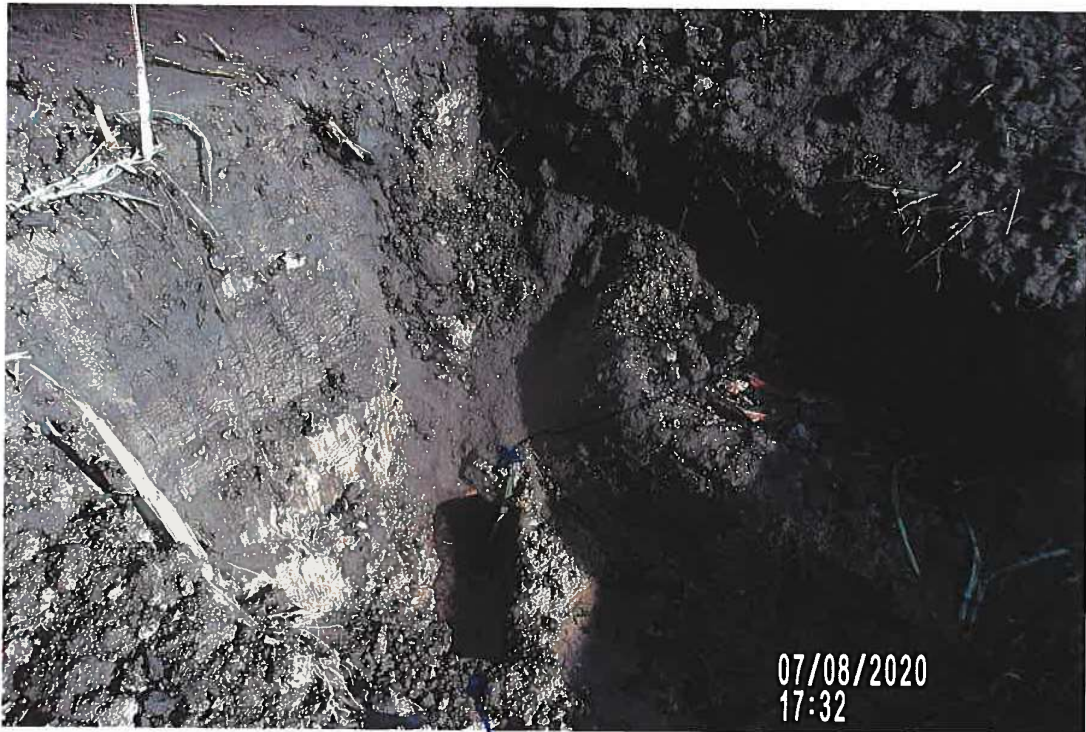
PICTURE # 4071 IS LOOKING SE TOWARDS CO HWY 04/  
SHOWING 14" CLAY TILE FLOWING GOOD

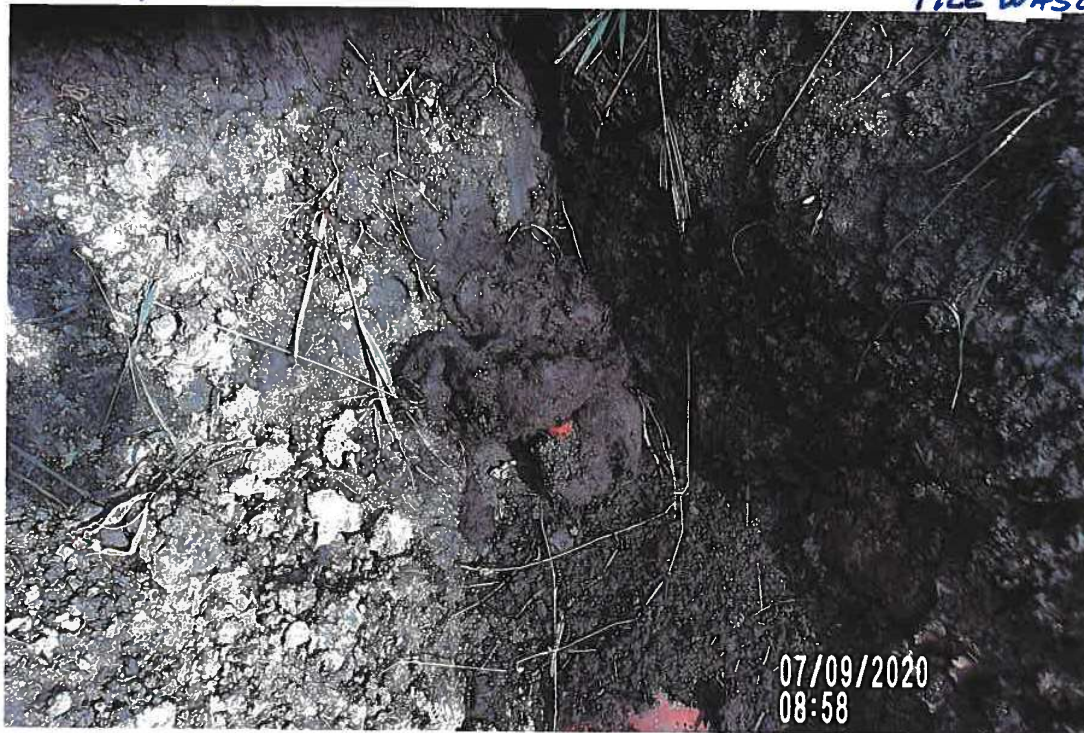
PICTURE # 4088 SHOWING PILE OF DEBRIS PULLED OUT OF TILE  
 (WHERE 8" CLAY TILE SECTION WAS ROLLED OUT IN SOUTH DITCH OF  
 CO HWY D41) BEFORE IT WENT DOWNSTREAM AFTER PLUGGED  
 TILE WAS OPENED

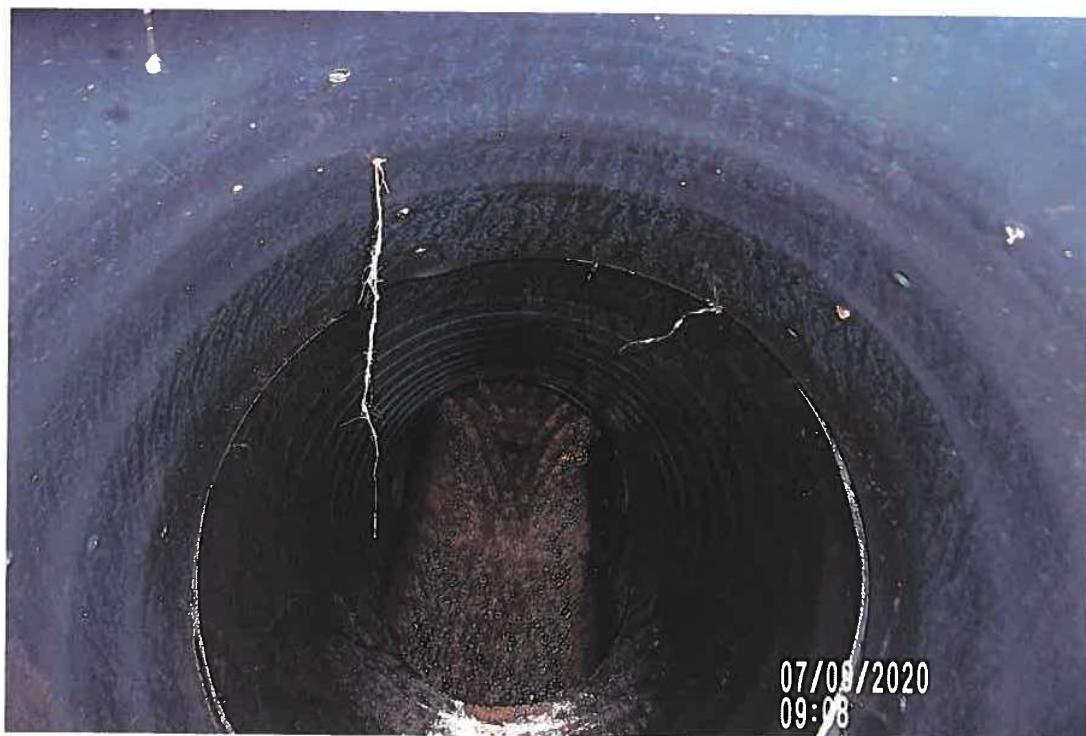
PICTURE # 4089 IS LOOKING NE INSIDE TILE WYE ACCESS LID  
 ON SOUTH SIDE OF CO HWY D41 1195.6' ± WEST OF E CO HWY S27  
 SHOWING TILE IS STILL FLOWING GOOD AT THIS LOCATION

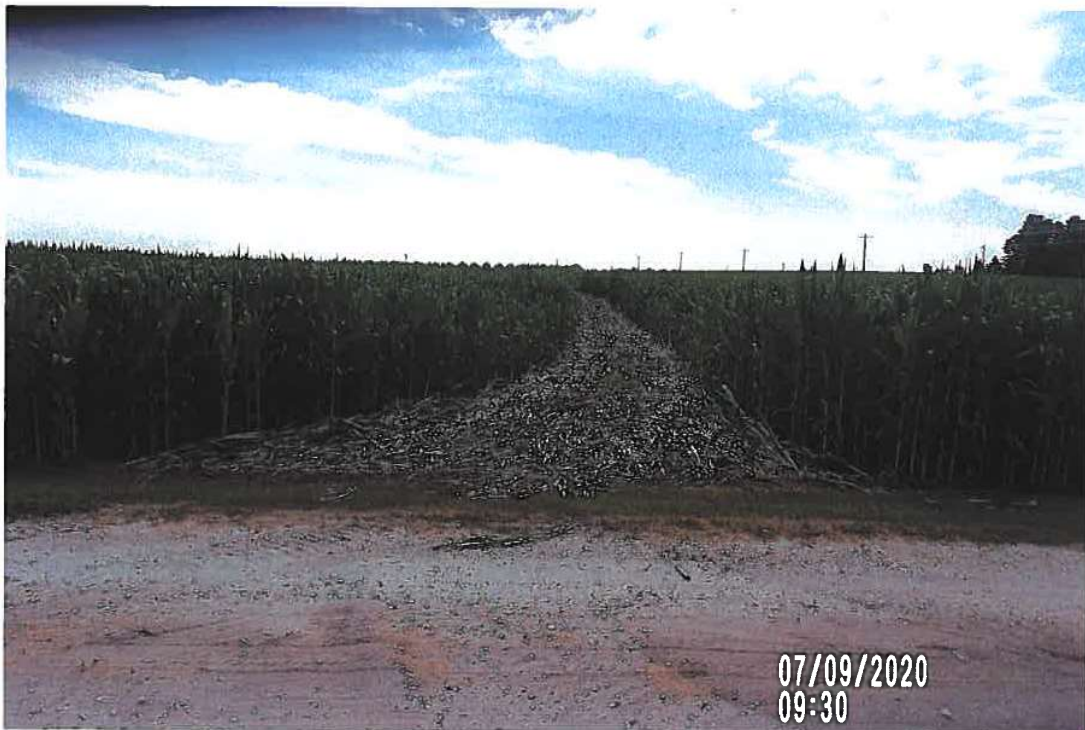
(GPS#269)  
 PICTURE# 4090 SHOWING 6" HICKEN BOTTOM WITH TOP COMPLETELY  
 BROKE OFF AND FL COMPLETELY FULL OF SOIL WITH 6" CLAY  
 TILE OUTLET BROKE AND COMPLETELY FULL OF SOIL. PICTURE  
 IS LOOKING WEST IN NORTH DITCH OF CO HWY 041

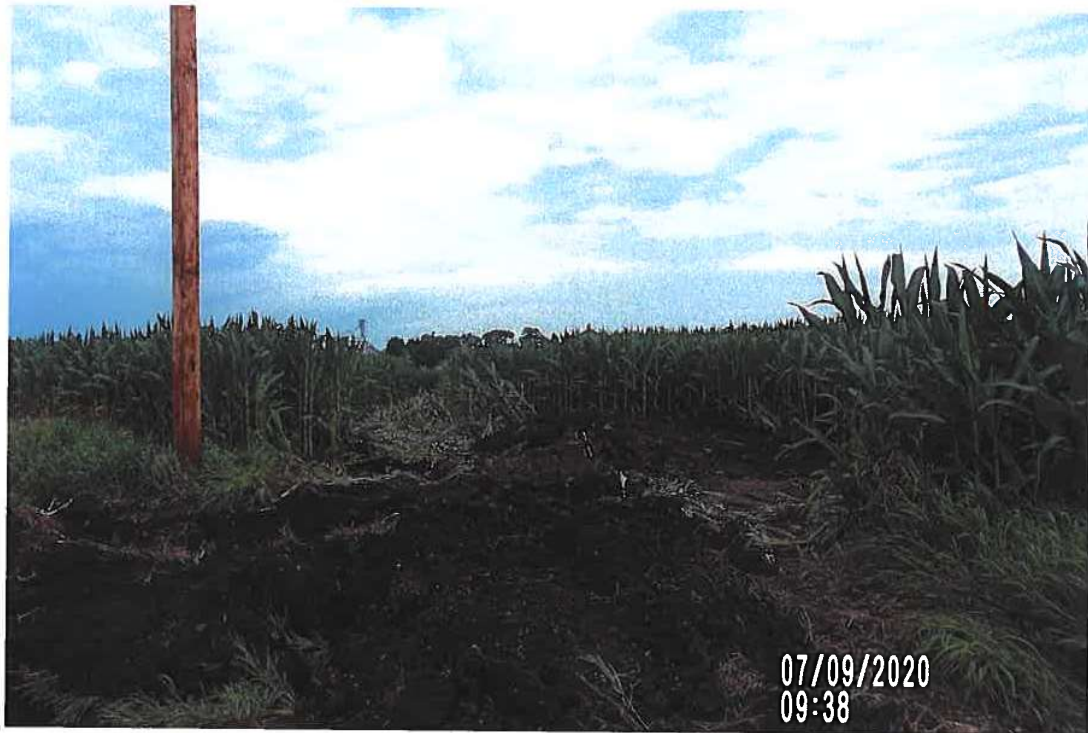
PICTURE# 4092 IS LOOKING NW FROM SOUTH DITCH  
OF CO HWY D41 SHOWING CORN DAMAGE OUT TO  
TILE REPAIR.

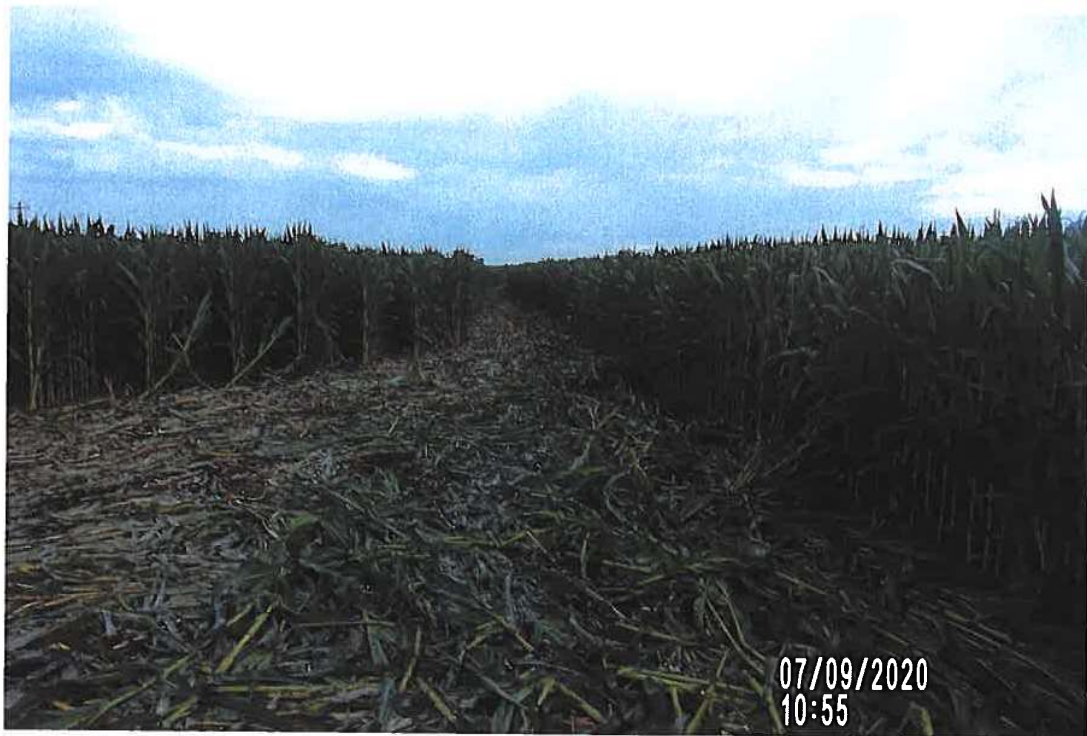
PICTURE# 4093 IS LOOKING WEST SHOWING CORN DAMAGE  
TO TILE REPAIR - LOOKING TOWARDS 20825<sup>th</sup> CO HWY 527  
GRAVEL DRIVE OFF CO HWY D41.

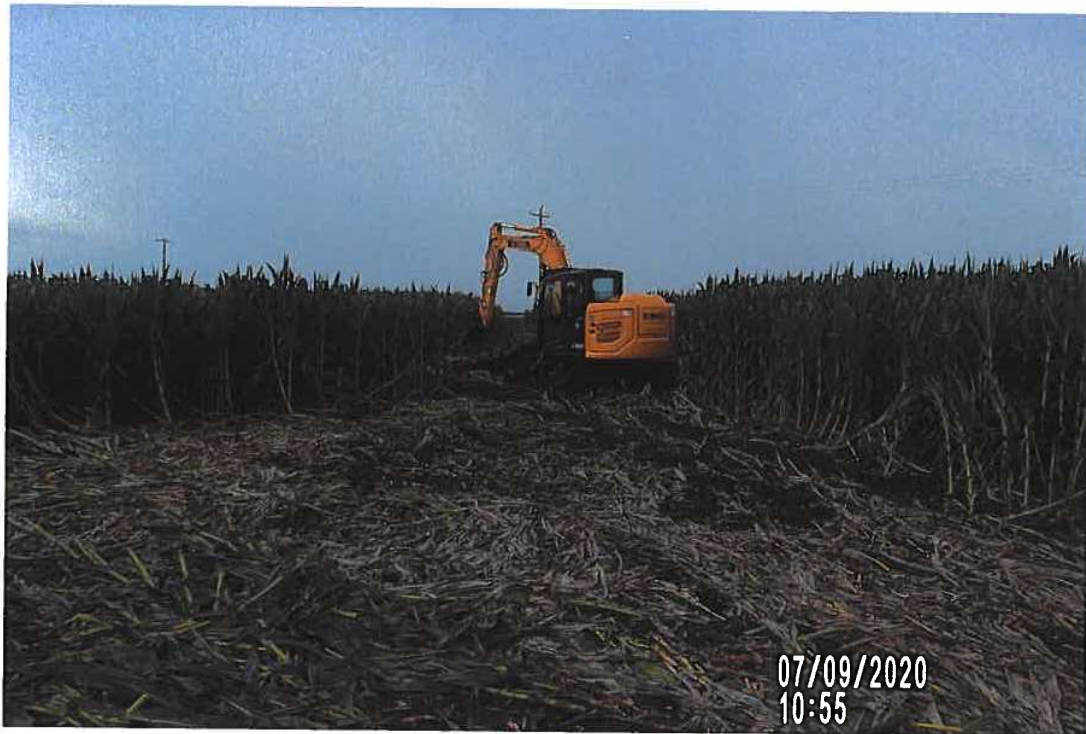
PICTURE # 4094 IS LOOKING SE TOWARDS CONWYD4  
 @ CORN DAMAGE / TO TILE REPAIR

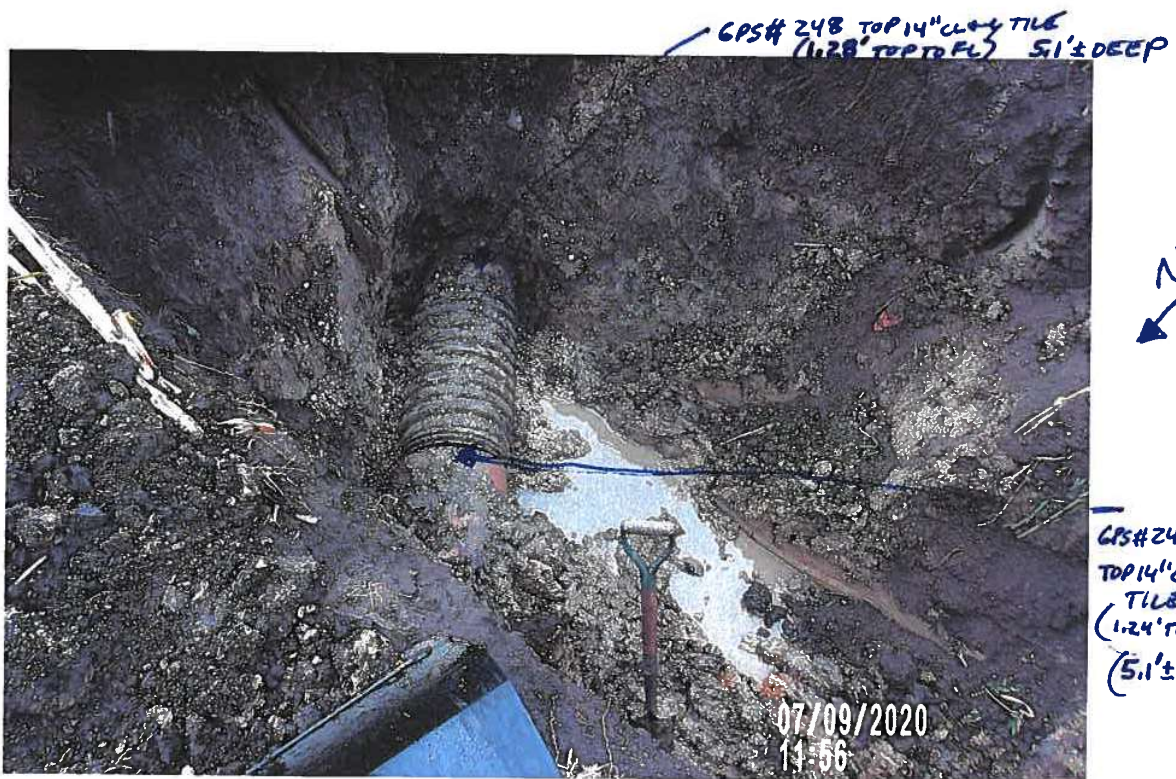
PICTURE # 4095 IS LOOKING SE SHOWING 2.6 LF. PIECE  
 OF 15" Ø DW HDPE NONPERF TILE IN PLACE FOR REPAIR  
 WITH BEDDING ROCK UNDER TILE
