**AGENDA**  
**DRAINAGE DISTRICT 14 LANDOWNER MEETING**  
**Wednesday, November 18, 2020 12:00 PM**  
**Large Conference Room**

# Drainage Work Order Request For Repair

LOCATION: DD14 MARIETTA TILE LOCATED SWNE & NWSE  
34-88-22 HARDIN COUNTY  
INVESTIGATE & TEMPORARILY REPAIR 3 TILE BLOWOUTS

## Investigation and Repair Summary:

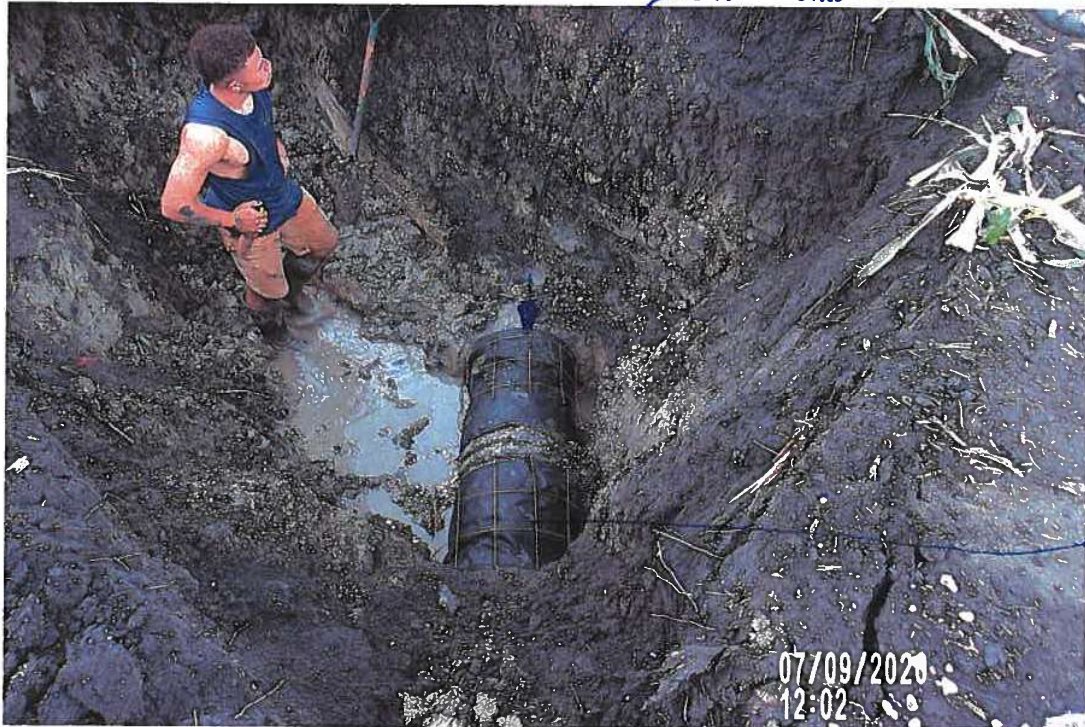
PICTURE# 4096 IS LOOKING NW SHOWING FABRIC & MESH OVER NORTH & SOUTH TIE IN JOINTS FOR 14" CLAY TILE REPAIR NORTH OF HWY D41

615# 2.0'x3.5' FABRIC WITH 1.0'x4.0' WIRE MESH OVER JOINT BEFORE COLLARS POURED

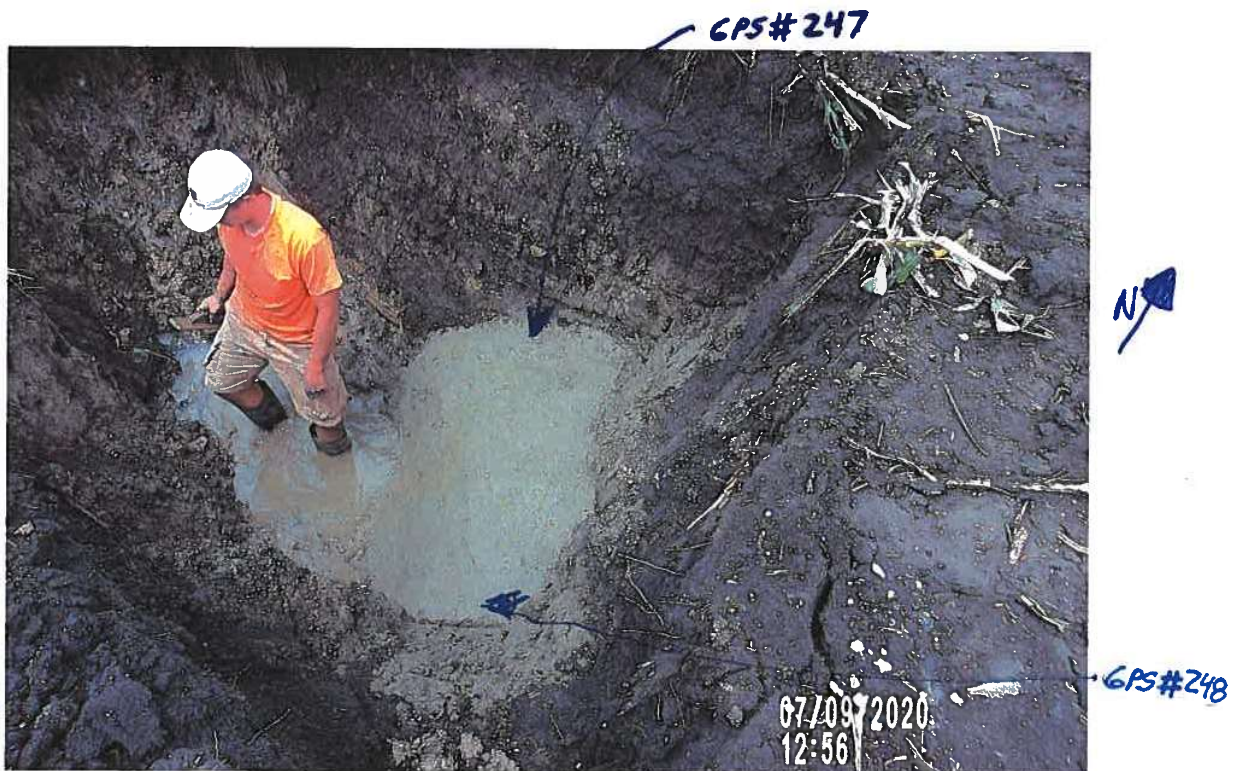
PICTURE # 4100 IS LOOKING SW AT FINISHED  $\frac{3}{4}$  CONCRETE COLLAR FOR 8" CLAY TILE REPAIR 55'± NORTH OF E HWY D41. CREW USED 8-60LB QUIKRETE HIGH STRENGTH CONCRETE BAGS.

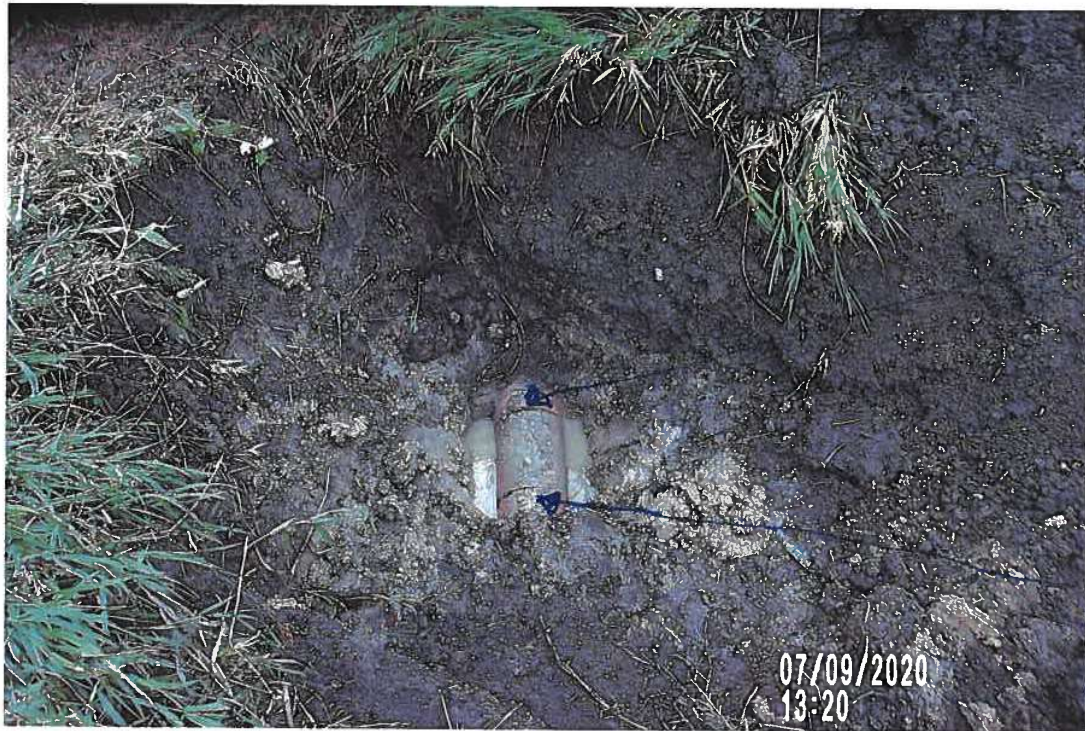
PICTURE #4102 IS LOOKING NW IN SOUTH DITCH OF CO HWY  
 041 9.5'± WEST OF WEST RIM OF BEEHIVE INTAKE  
 SHOWING 8" CLAY TILE SECTION ROLLED BACK IN PLACE.

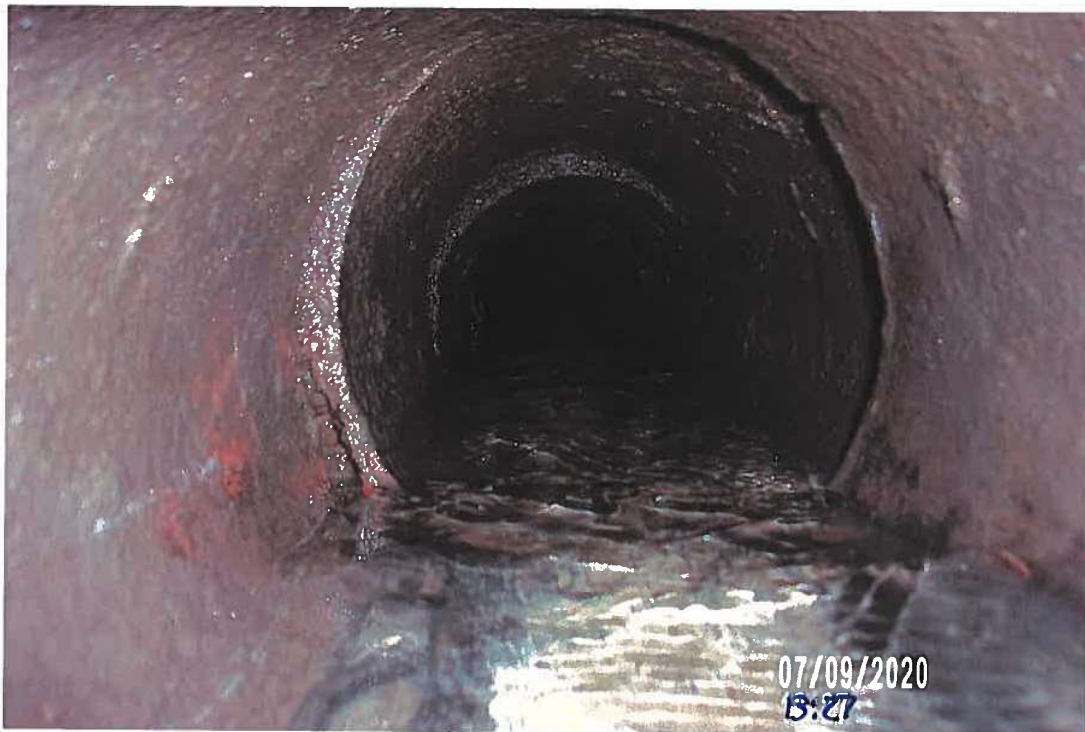
PICTURE #4103 IS LOOKING UPSTREAM INSIDE 8" CLAY TILE  
 WITH ABOUT 1" FLOW AT GPS #302 (TOP 8" CLAY TILE) (0.72' TOP  
 TO FL)

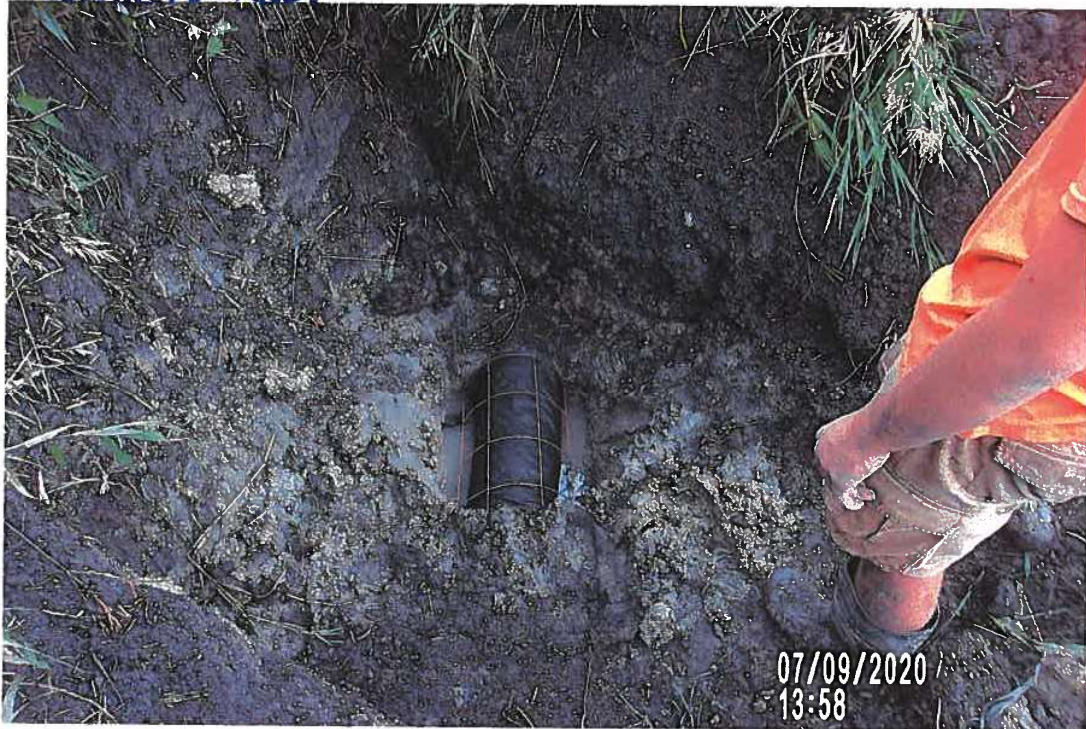
PICTURE #4104 IS LOOKING NW SHOWING 2.0'X2.0' ENGINEERING FABRIC & 1.5'X20' 6"X6" SQUARE WIRE MESH OVER JOINT FOR 8" CLAY TILE SECTION ROLLED BACK INTO PLACE BEFORE  $\frac{3}{4}$  CONCRETE COLLAR POURED.

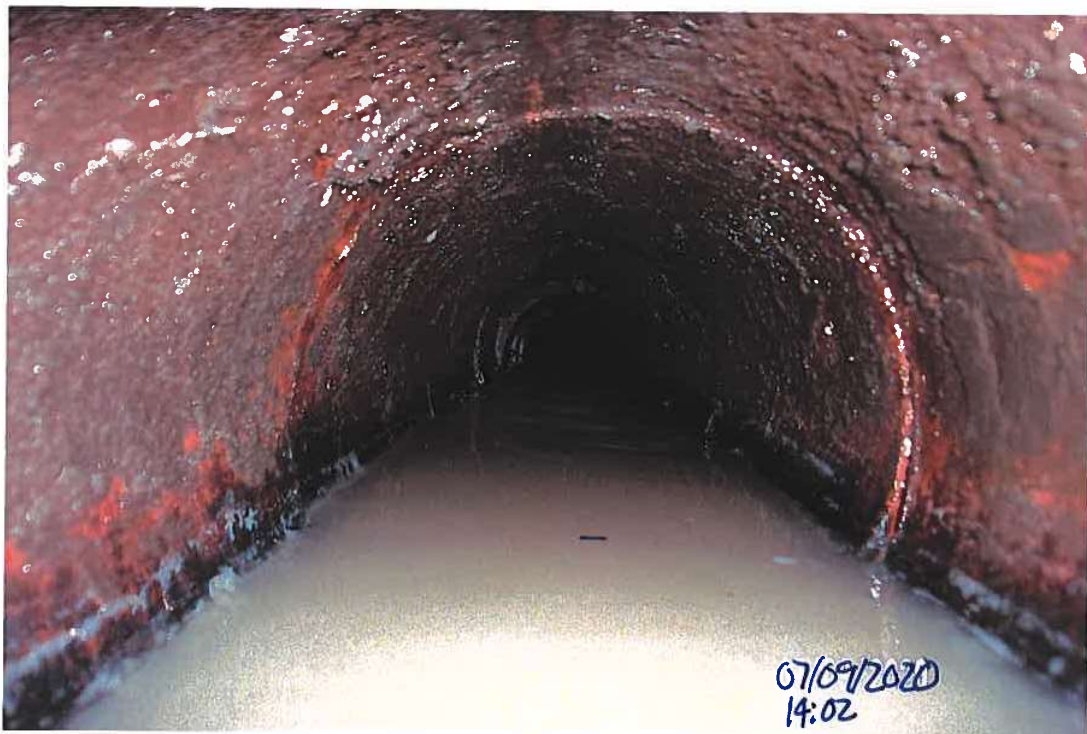
PICTURE #4105 IS LOOKING DOWN STREAM INSIDE 8" CLAY TILE WITH ABOUT 2"± OF SLOW WATER FLOW.

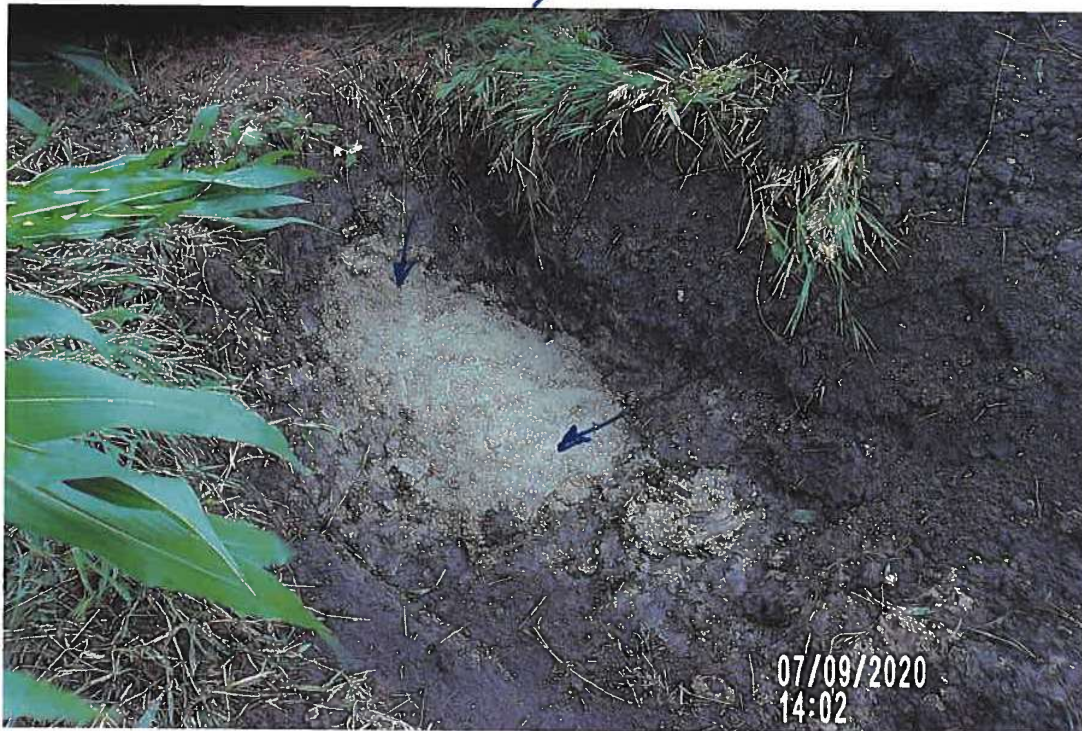
PICTURE # 4106 IS LOOKING NORTH SHOWING  $\frac{3}{4}$ " CONCRETE COLLAR POURED FOR 8" CLAY TILE SECTION ROLLED BACK INTO PLACE 9'5" WEST OF BEHIND ENTIRE. CREW USED 5-60LB BAGS OF QUIKRETE HIGH STRENGTH / GSH255

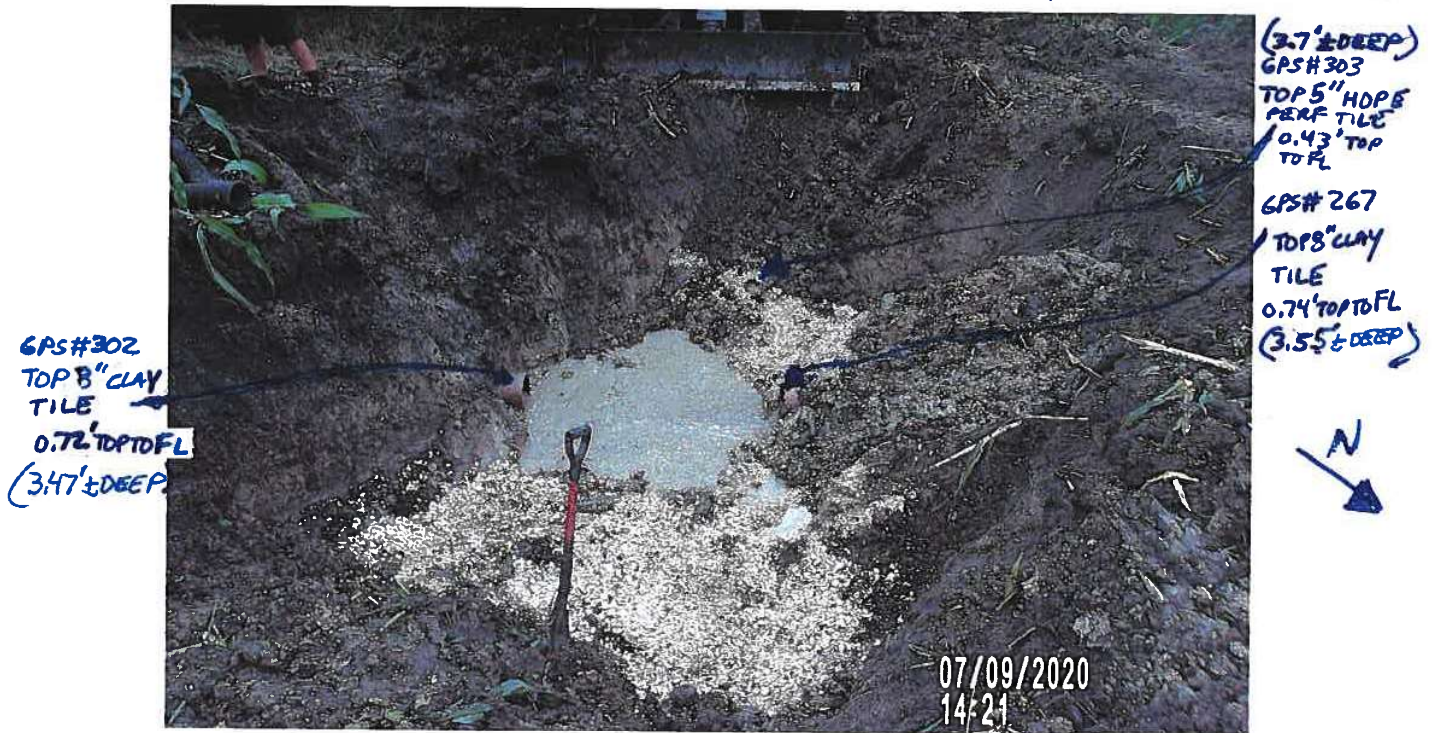
PICTURE # 4107 IS LOOKING NORTH SHOWING BEDDING ROCK BACKFILLED AROUND  $\frac{3}{4}$ " CONCRETE COLLAR IN SOUTH DITCH OF HWY D41 FOR 8" CLAY TILE SECTION ROLLED BACK INTO PLACE.

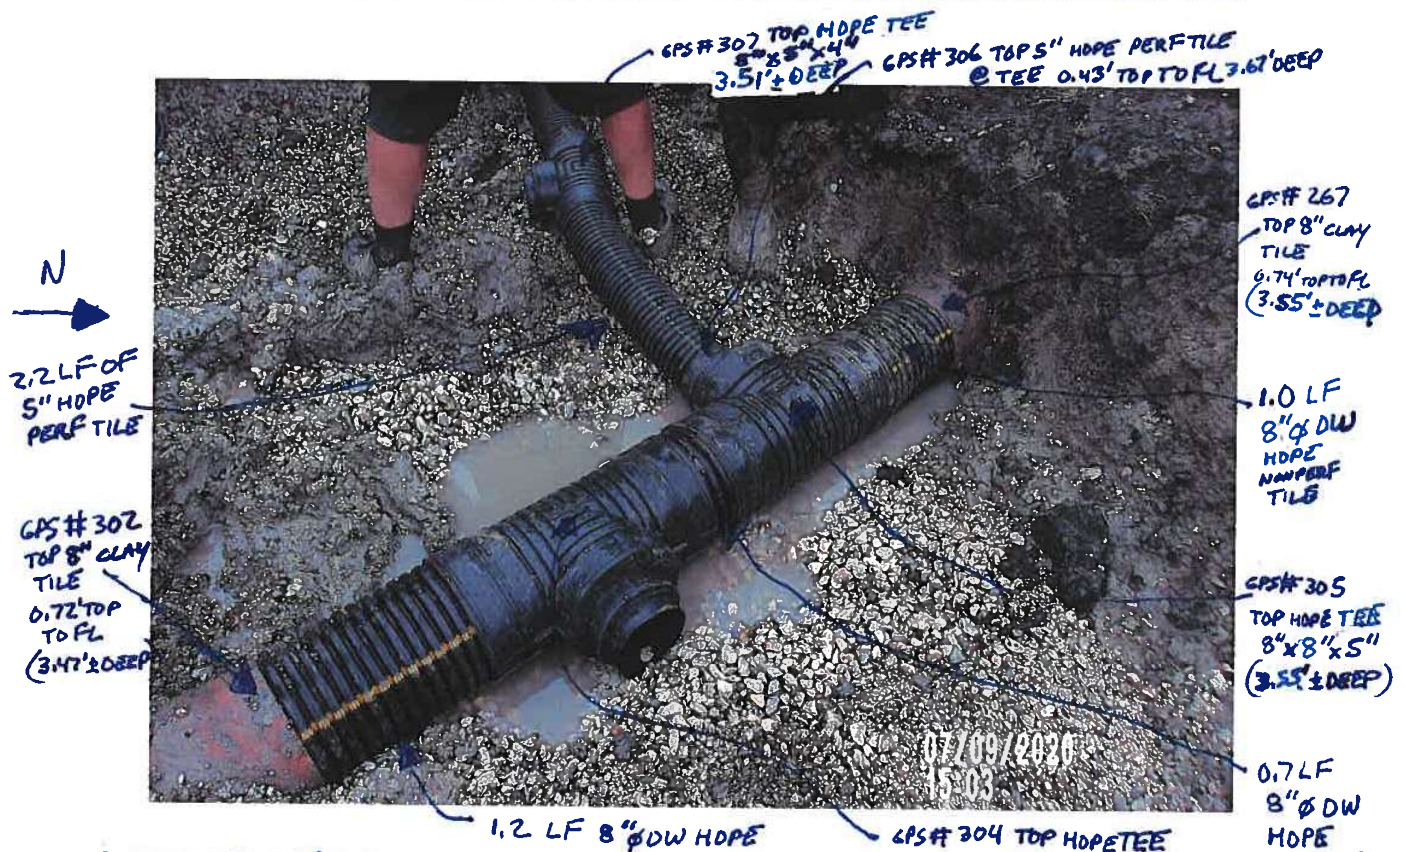
PICTURE # 4108 IS LOOKING SW SHOWING 8" CLAY TILE REMOVED WITH BEDDING ROCK IN PLACE TO TIE IN 5" SW HOPE PERF TILE LINES INTO 8" CLAY TILE LATERAL

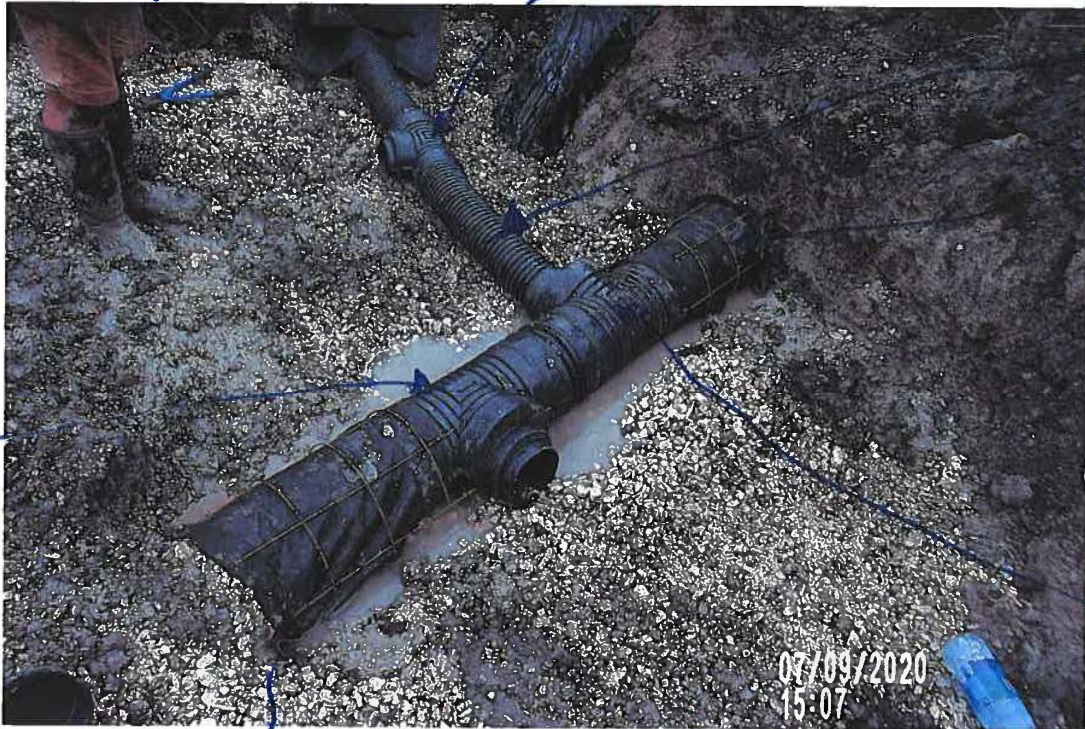
PICTURE # 4109 IS LOOKING WEST AT 8" DW HOPE NONPERF TILE INSTALLED WITH A 8" x 8" x 5" HOPE TEE EAST & WEST & 5" HOPE PERF TILE INSTALLED INTO TEE WITH 5" x 5" x 4" HOPE TEE INSTALLED ON IT WITH BEDDING ROCK UNDER CONNECTION.

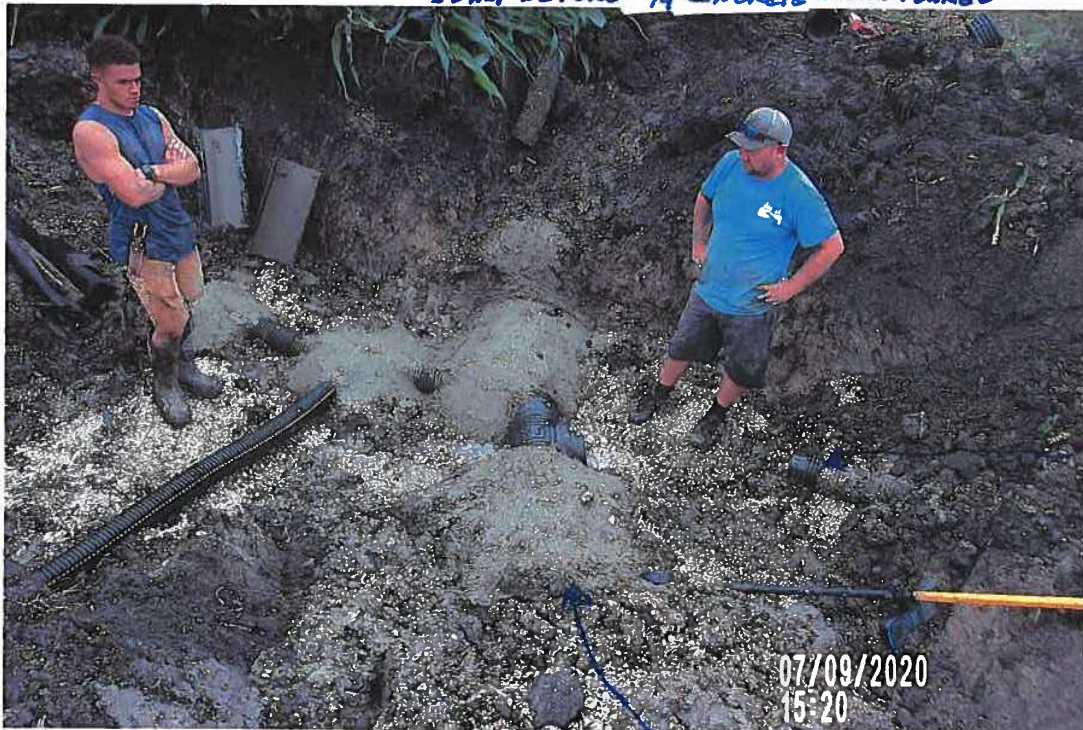
PICTURE #4110 IS LOOKING WEST AT NORTH & SOUTH TIES  
IN CONNECTIONS ON 8" LATZ BEFORE 3/4 CONCRETE COLLARS  
POURED

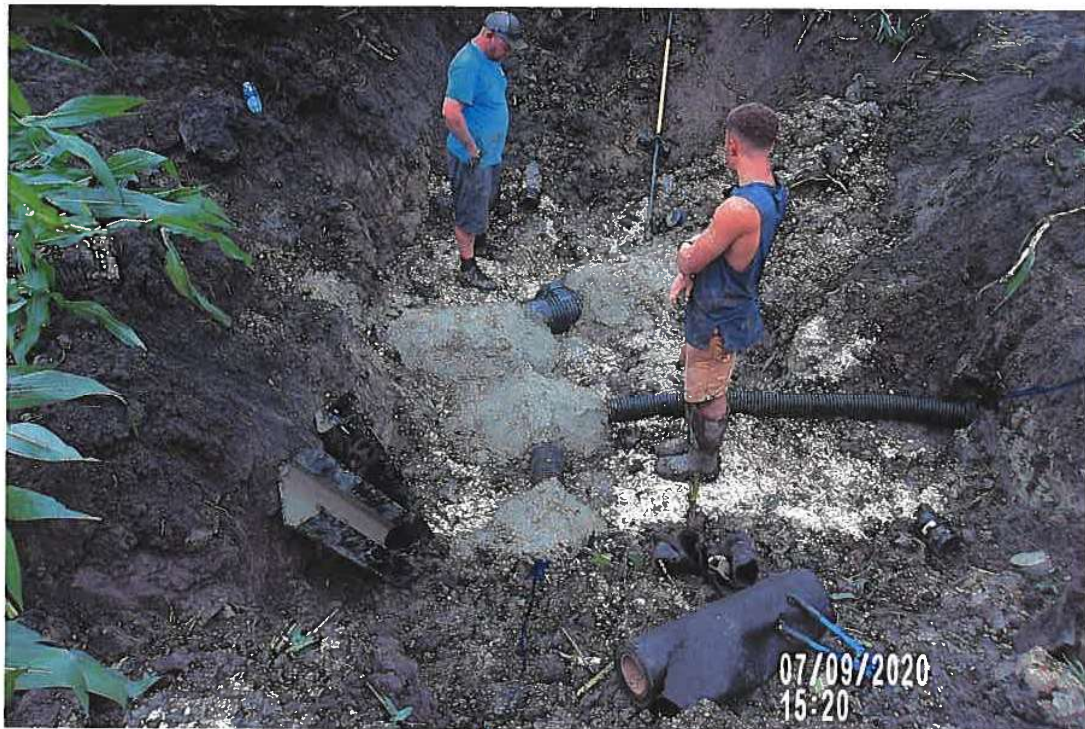
PICTURE #4111 IS LOOKING NW SHOWING 3/4 CONCRETE COLLARS  
POURED AT CONNECTIONS FOR 5" HOPE SW PERF TILE TIE  
INS. CREW USED 17-60 LB BAGS OF QUIKRETE HIGH STRENGTH

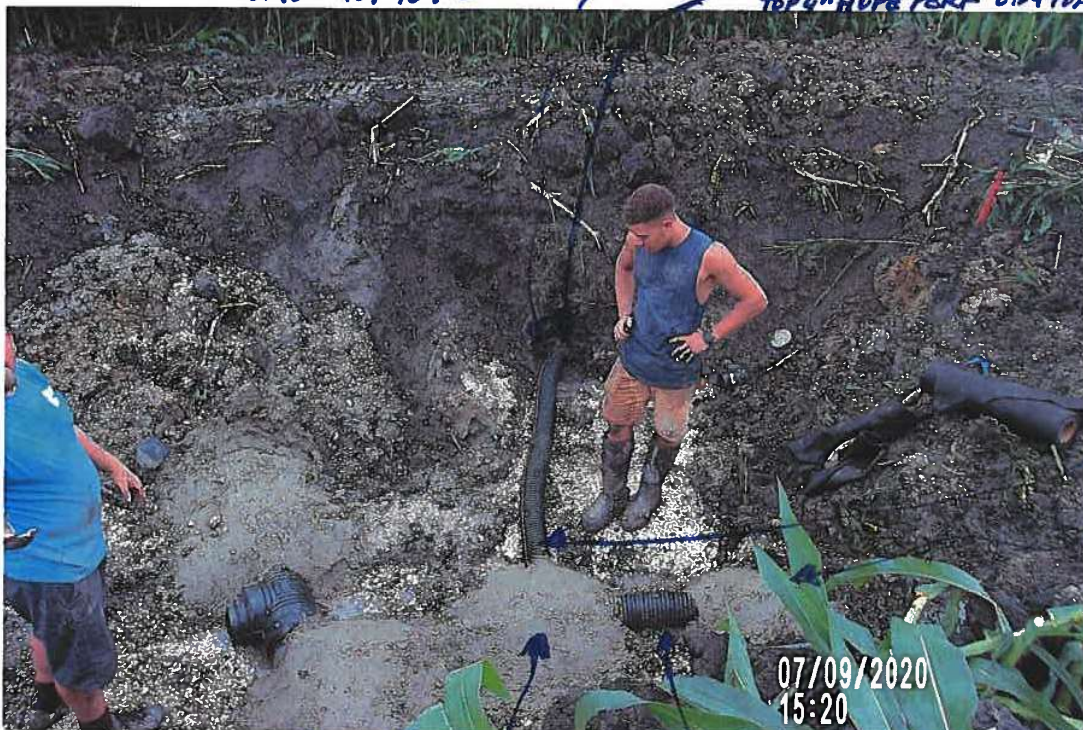
PICTURE #4112 IS LOOKING E EAST SHOWING  $\frac{3}{4}$  CONCRETE COLLARS POWRED (USED 17 QUIKRETE HIGH STRENGTH CONCRETE BAGS

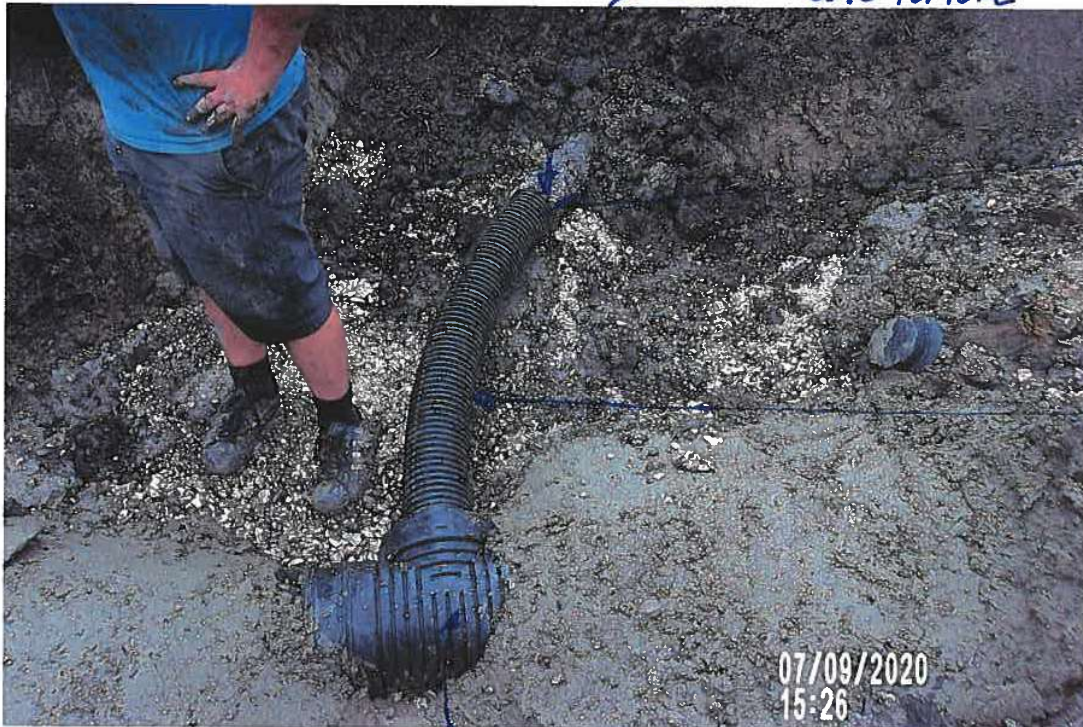
PICTURE #4114 IS LOOKING NE SHOWING 5" HDPE SW PERF TILE TIE IN CONNECTION INTO 8" HDPE LATERAL #2.

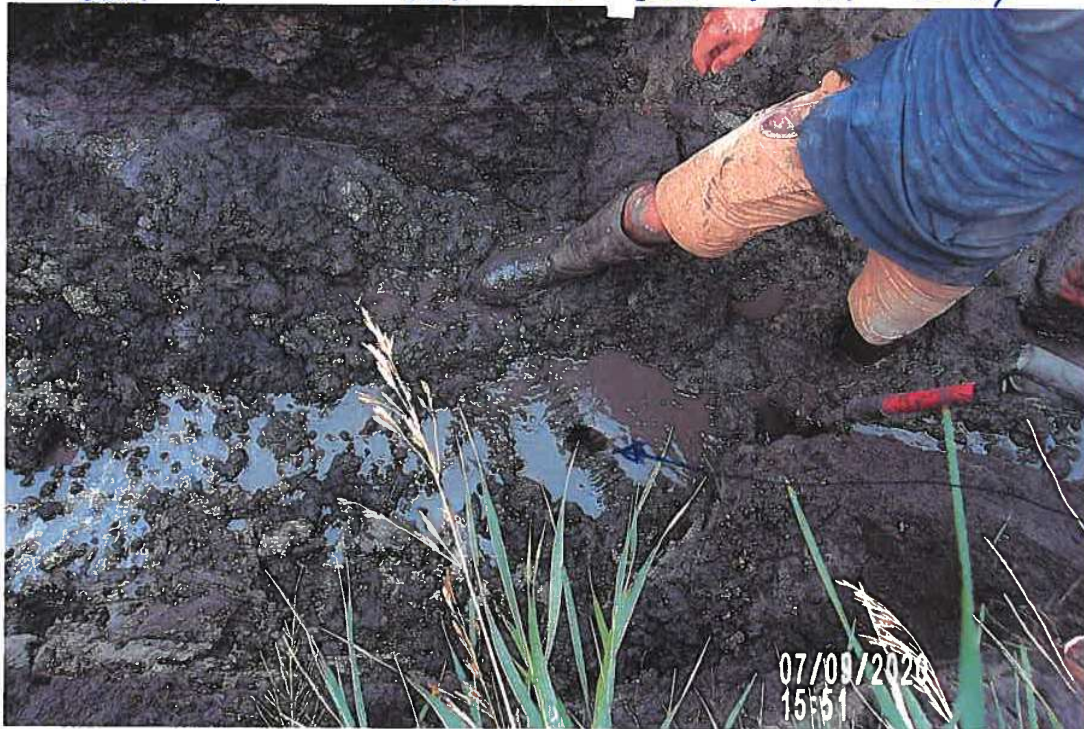
PICTURE # 4116 IS LOOKING EAST SHOWING HOLE IN TOP OF 8" HOPE NONPERF TILE EXCAVATED BY ANOTHER CONTRACTOR AND LEFT OPEN 322'± SOUTH OF COM HWY 041 & 9.6'±

EAST OF  
EAST ROW  
FENCE  
COM HWY  
S-27  
IN WETLAND  
AREA

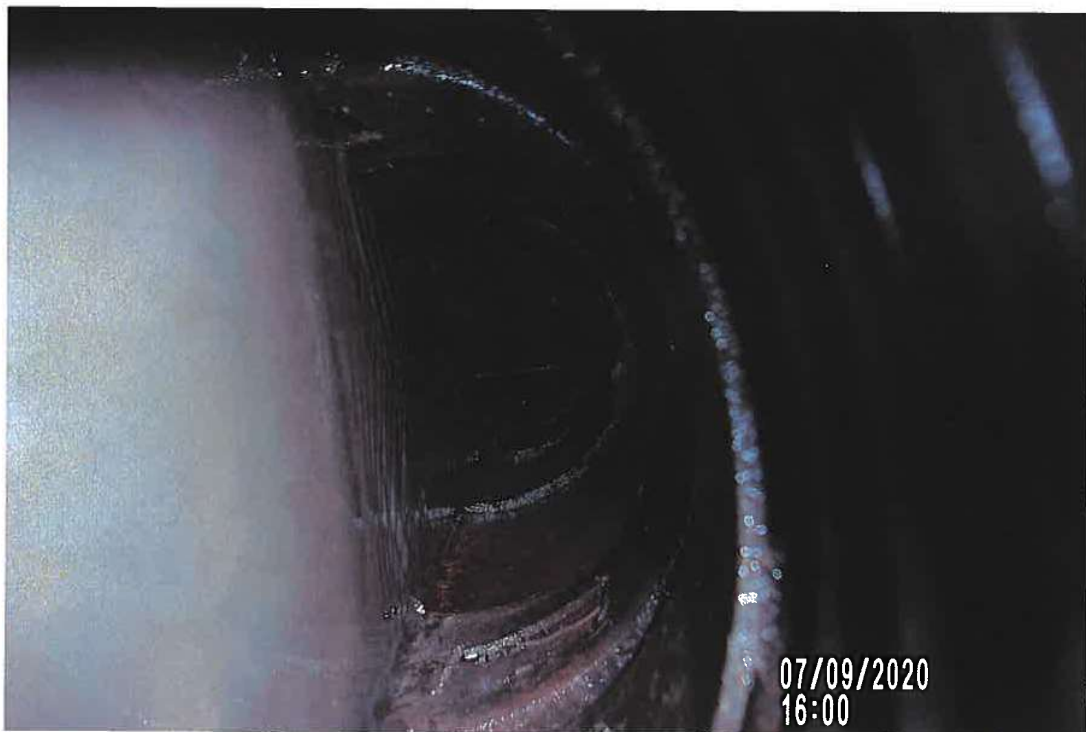
GPS #311  
TOP 8" HOPE  
NONPERF

PICTURE # 4117 IS LOOKING DOWNSTREAM (FROM GPS #311) INSIDE 8" TILE SHOWING CHANGE OF MATERIAL. TILE LOOKS GOOD SHAPE WITH WATER LEVEL AT 4" (SLOW FLOW). ALSO FLOWLINE HAS SOFT MUCK BUT SHOULD FLUSH OUT NOW TILE OPEN.

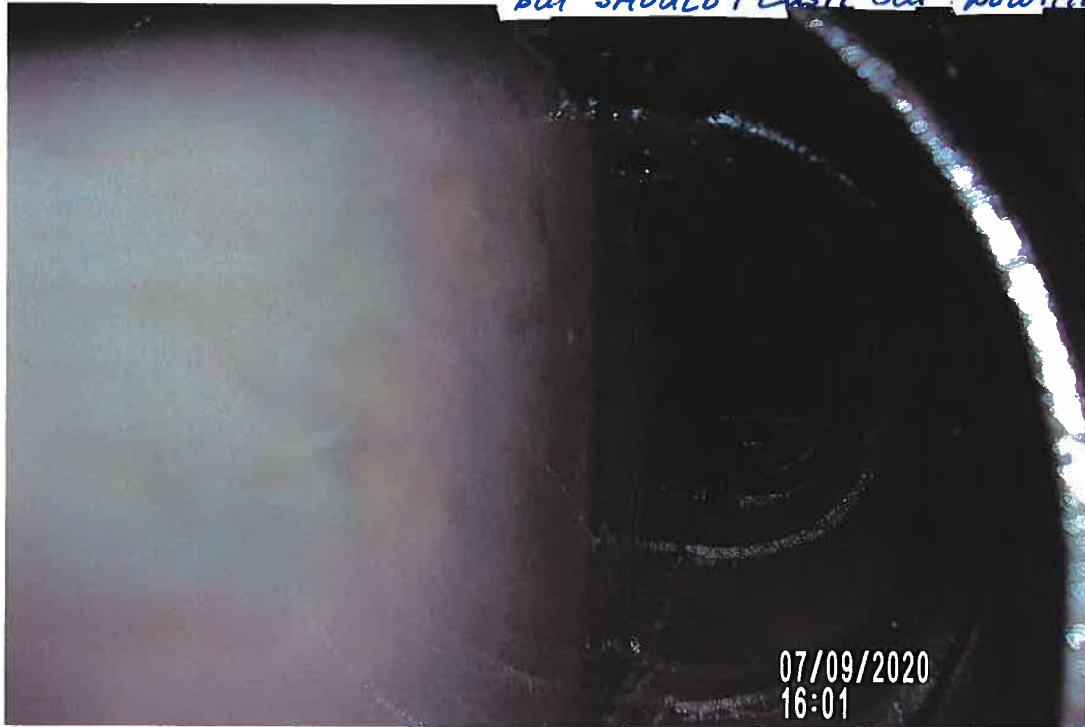
PICTURE # 4119 IS LOOKING UPSTREAM (FROM GPS #311) INSIDE 8" TILE  
 SHOWING TILE IN GOOD SHAPE BUT CHANGED TO CLAY WITH  
 WATER LEVEL AT 4" (SLOW FLOW). ALSO FLOWLINE HAS SOFT MUCK  
 BUT SHOULD FLUSH OUT NOW THAT IT IS  
 OPEN,

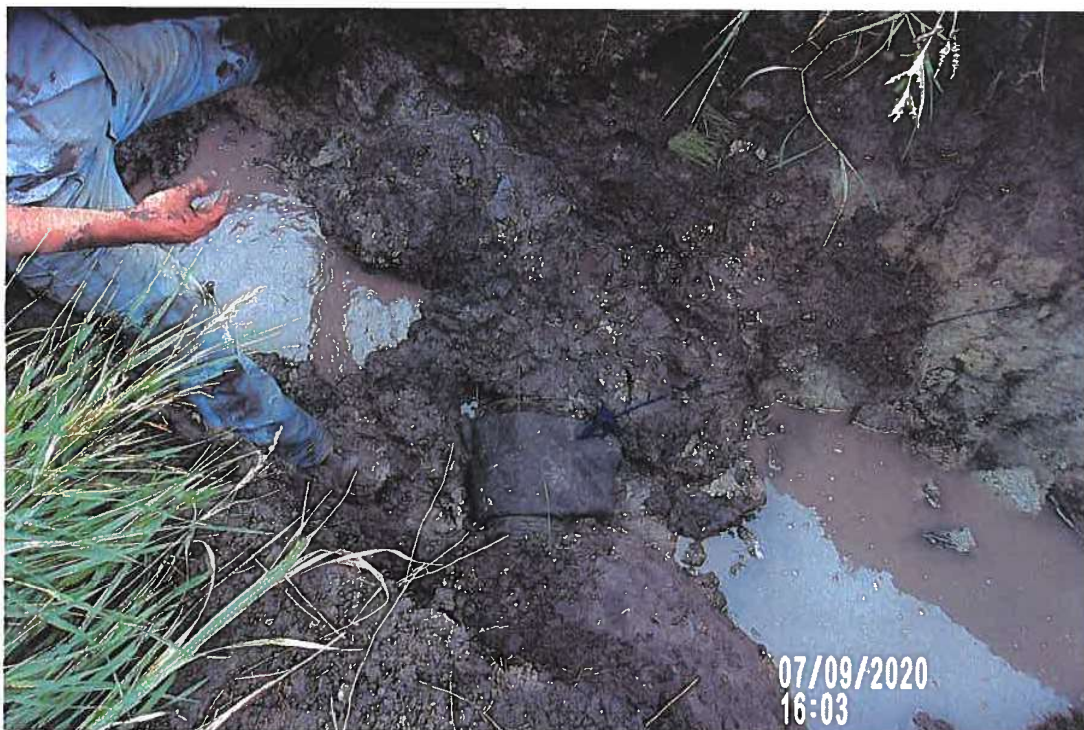
PICTURE # 4120 IS LOOKING EAST SHOWING FABRIC &  
 1.0' X 1.5' WIRE MESH OVER HOLE BEFORE  $\frac{3}{4}$  CONCRETE  
 COLLAR POURED OVER HOLE IN TILE.

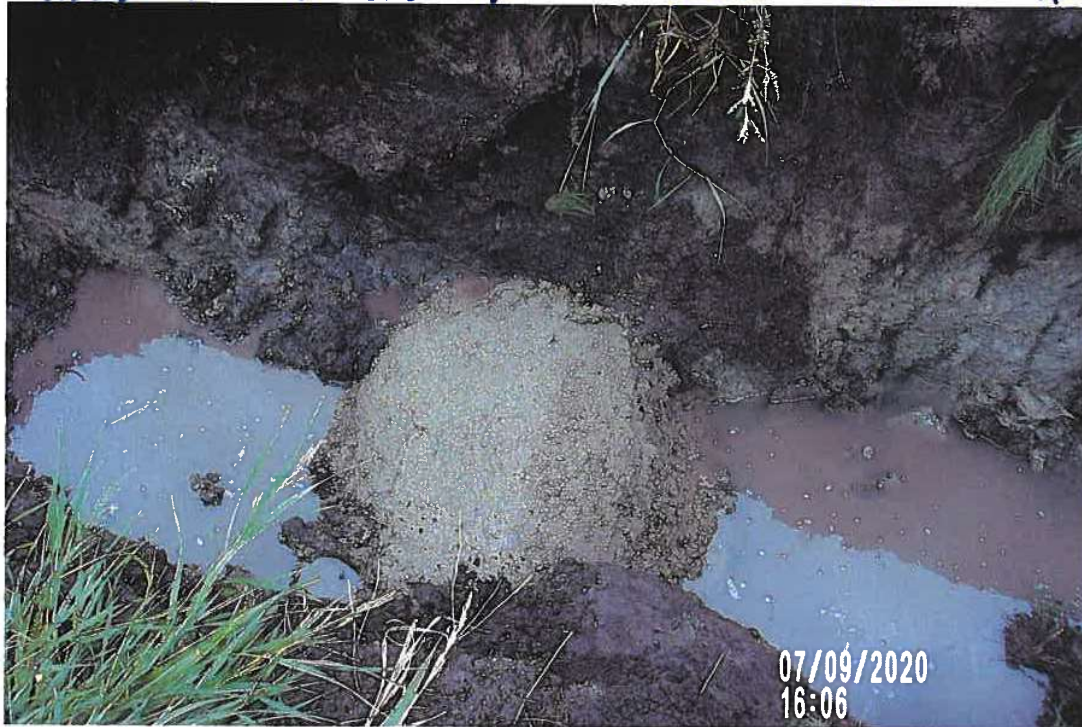
PICTURE #4121 IS LOOKING AT FINISHED  $\frac{3}{4}$  CONCRETE COLLAR OVER HOLE IN 8" DW HOPE NON PERF TILE. CREW USED 4 - 60 LB BAGS OF QUIKRETE HIGH STRENGTH CONCRETE ON COLLAR

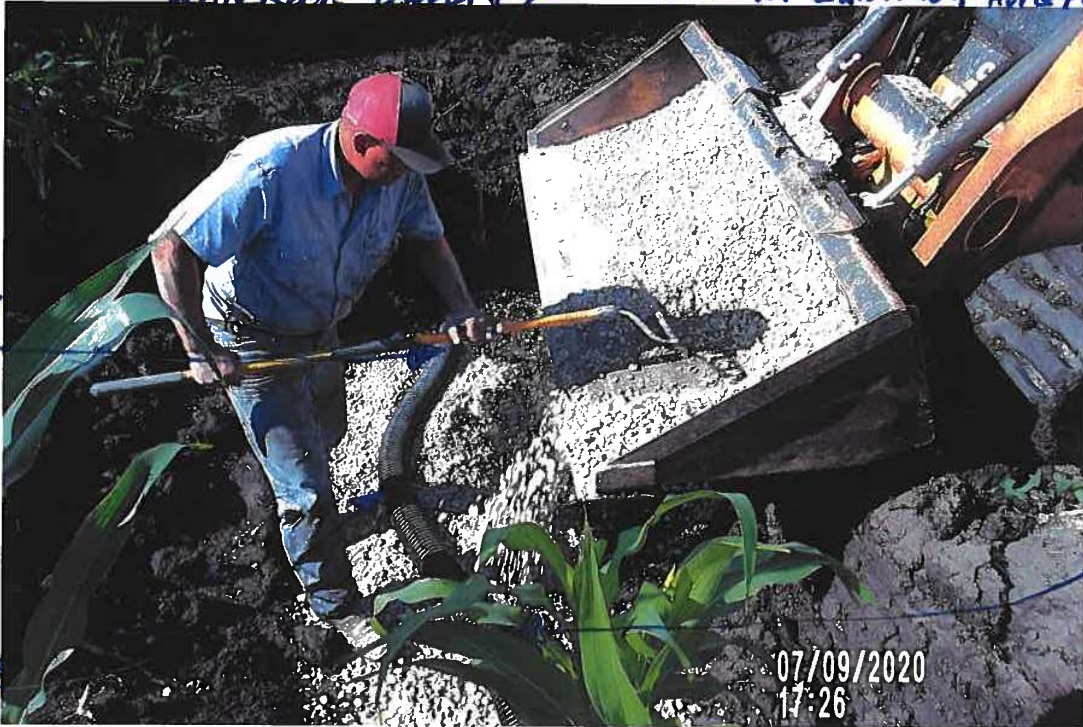
PICTURE #4122 IS LOOKING NW SHOWING 4" SW HOPE PERF TILE THAT NEEDS REPLACED AFTER CUTTING TILE WHILE EXCAVATING TO CHECK LAT #2 TILE FLOW STATUS ON EAST SIDE OF CO HWY S-27.

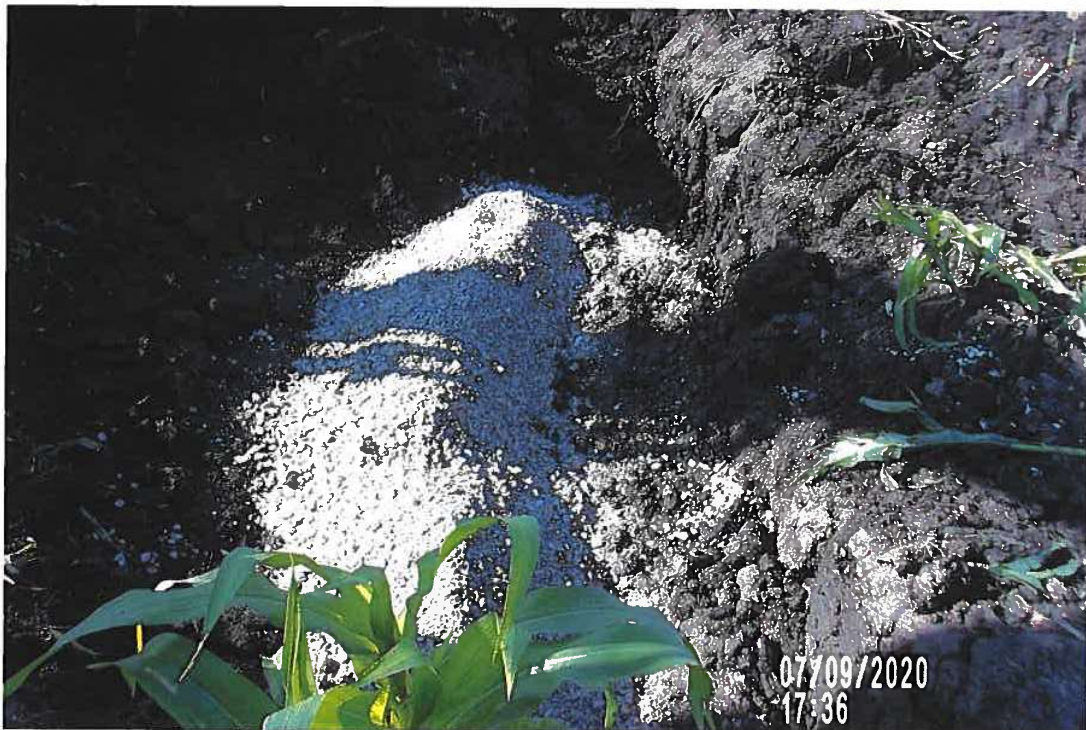
PICTURE # 4123 IS LOOKING NORTH SHOWING 9.8 LF  
 OF 4" HDPE SW PERF TILE INSTALLED WITH 4" HDPE  
 INTERNAL COUPLERS AND OFF TO SIDE SOME FOR FIRMER GROUND & BEDDED  
 WITH ROCK UNDER. GPS # 312 TOP EXISTING 4" HDPE PERF TILE

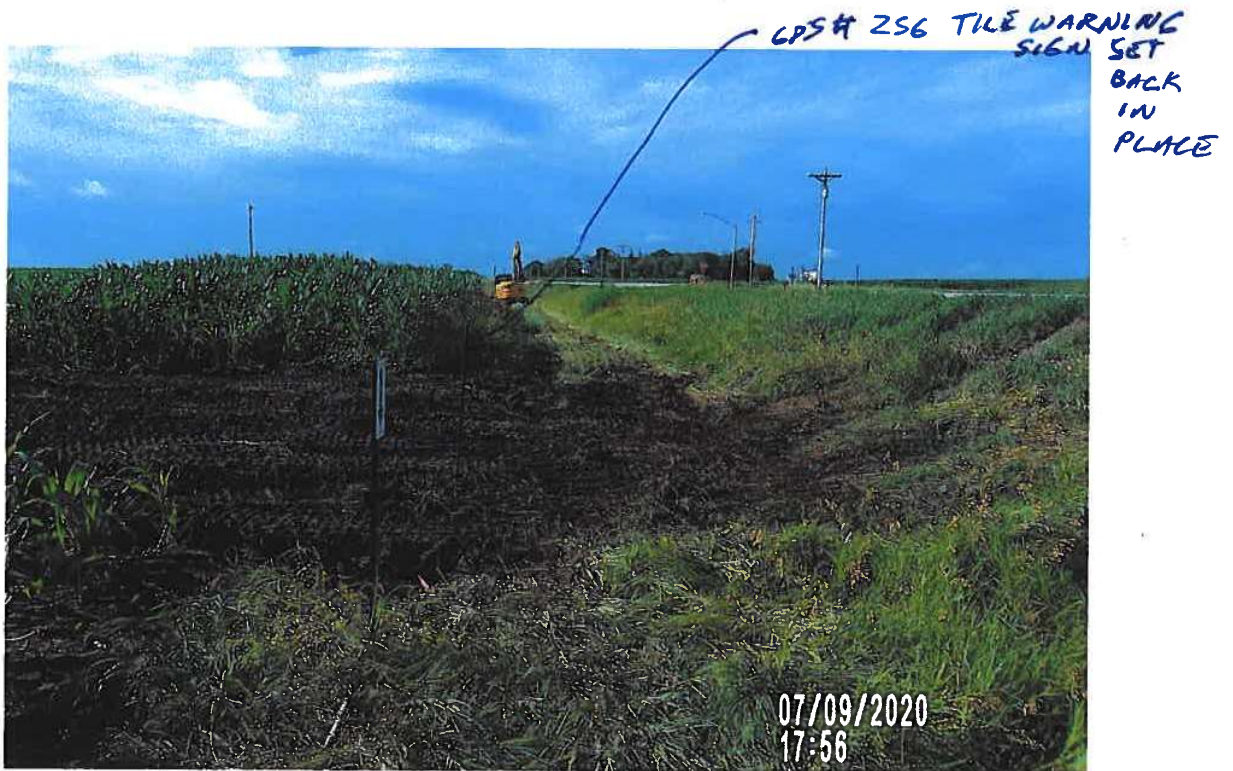
PICTURE # 4124 IS LOOKING NORTH WEST SIDE OF CO HWY 327  
 SHOWING 4" HDPE PERF TILE REPAIR BEDDED WITH ROCK.

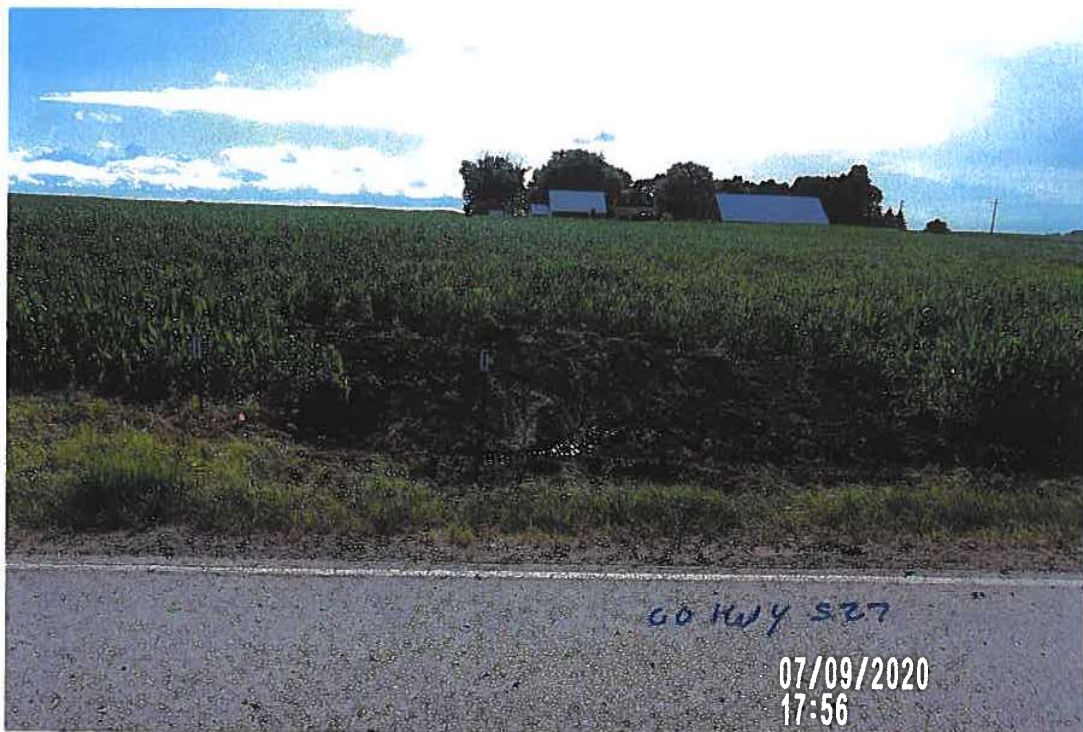
PICTURE#4125 IS LOOKING NORTH SHOWING DITCH WEST SIDE COMWY S-27 BACK FILLED & GRADED.

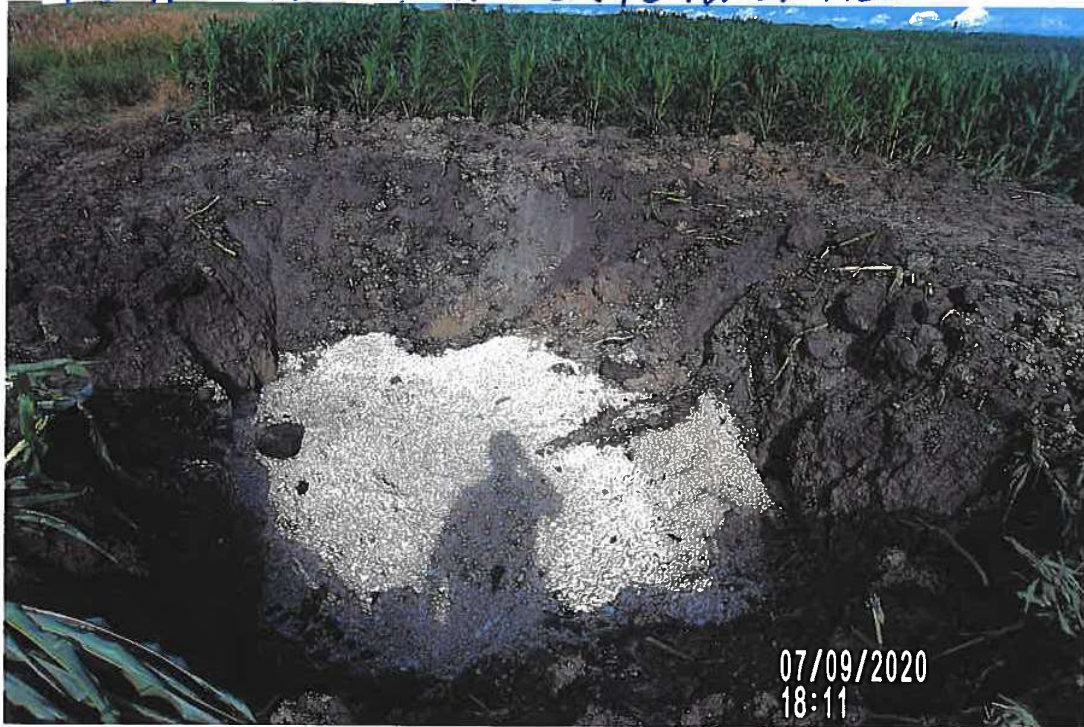
PICTURE#4126 IS LOOKING WEST FROM COMWY S27 ABOUT 330'± SOUTH E COMWY D41 SHOWING 4" HDPE SUPER TILE REPAIR BACK FILLED & GRADED. ALSO SHOWS 0.043 AC CORN DAMAGE (GPS# 320 - #324) DURING REPAIR.

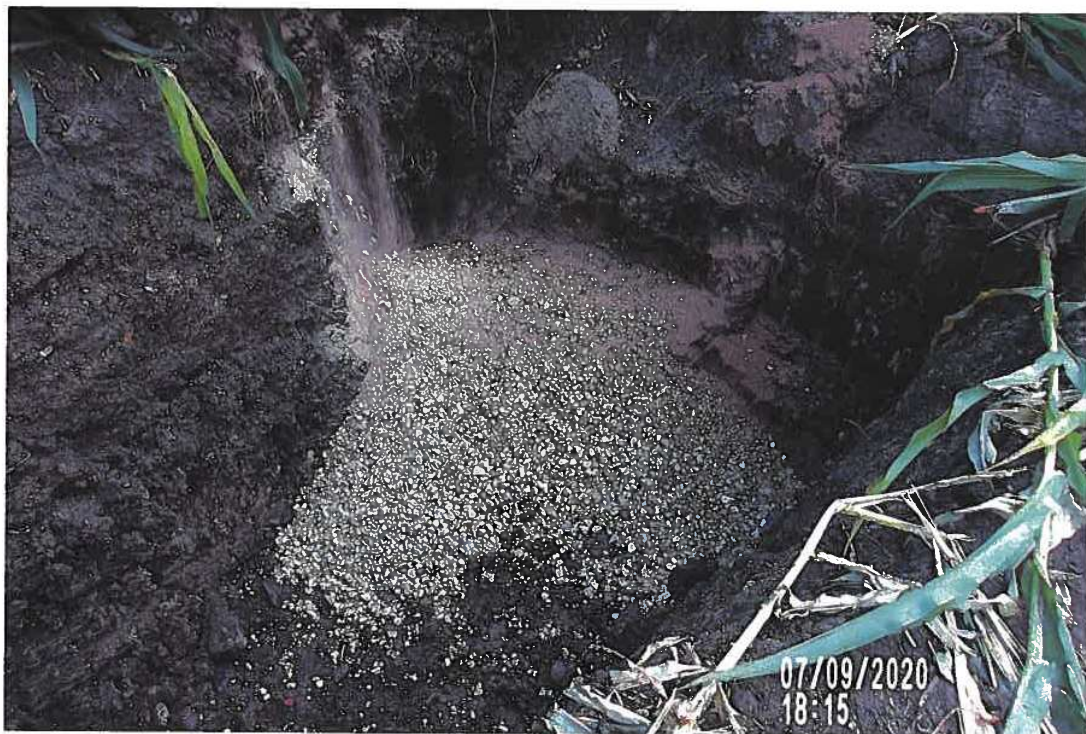
PICTURE# 4127 IS LOOKING EAST SOUTH OF SOUTH  
ROW OF COMWY D41 SHOWING 5" HDPE PERF TILE  
THE INS BEDDED WITH ROCK TO TOP OF TILE

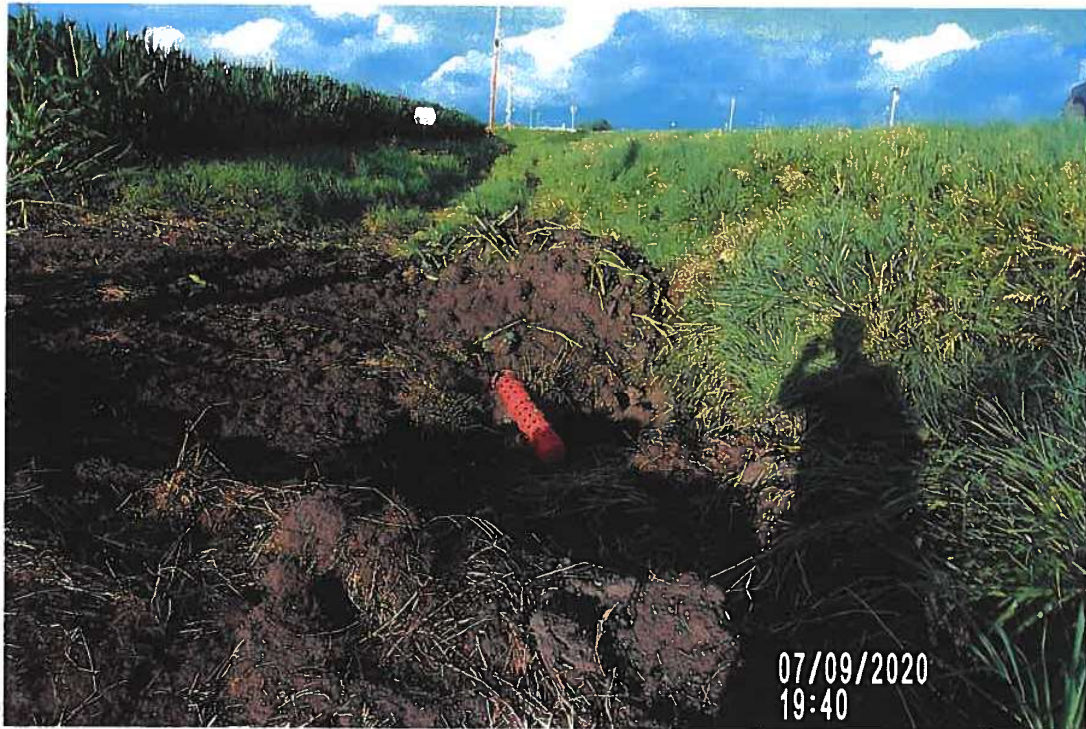
PICTURE# 4129 IS LOOKING EAST IN NORTH DITCH OF  
CO HWY D41 SHOWING DITCH STILL NEEDS GRADED.
