**AGENDA**  
**DRAINAGE DISTRICT 14 LANDOWNER MEETING**  
**Wednesday, November 18, 2020 12:00 PM**  
**Large Conference Room**

# Drainage Work Order Request For Repair

LOCATION: DD14 MARIETTA TILE LOCATED SWNE & NWSE  
34-88-22 HARDIN COUNTY  
INVESTIGATE & TEMPORARILY REPAIR 3 TILE BLOWOUTS

## Investigation and Repair Summary:

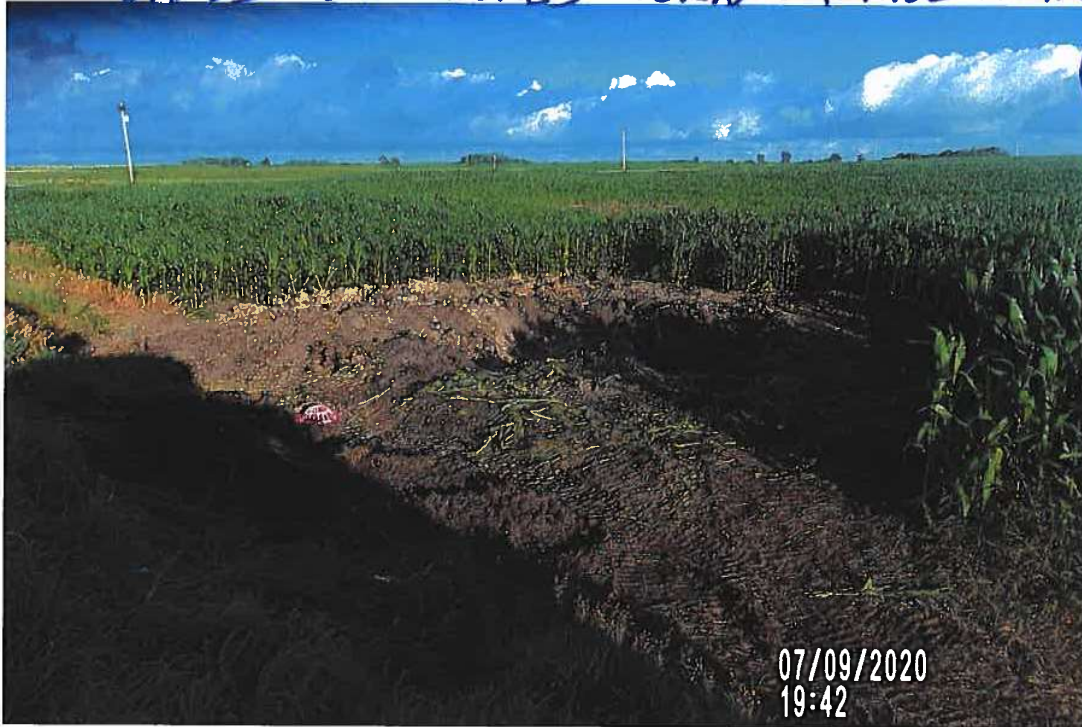
(GPS#331 TO  
GPS#330)

PICTURE#4131 IS LOOKING SE SHOWING 5" HOPE TIE IN  
TRENCH THAT NEEDS BACK FILLED YET. PICTURE  
SHOWS 0.051 ACRES CORN DAMAGE DURING REPAIR

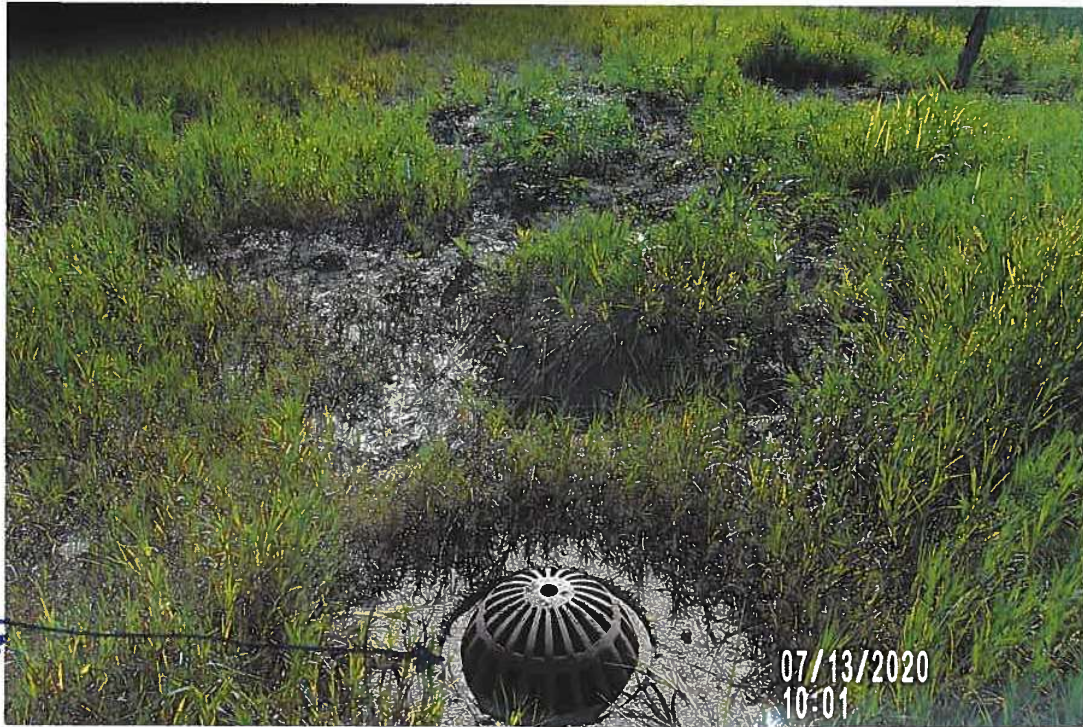
GPS# 337  
18" BEEHIVE  
INTAKE  
N RIM

PICTURE# 4138 IS LOOKING EAST SHOWING SMALL  
SINKHOLE ON EAST SIDE OF BEEHIVE INTAKE PER RANDY'S REPORT  
AREA LOOKED LIKE IT HAD BEEN EXCAVATED AT ONE TIME

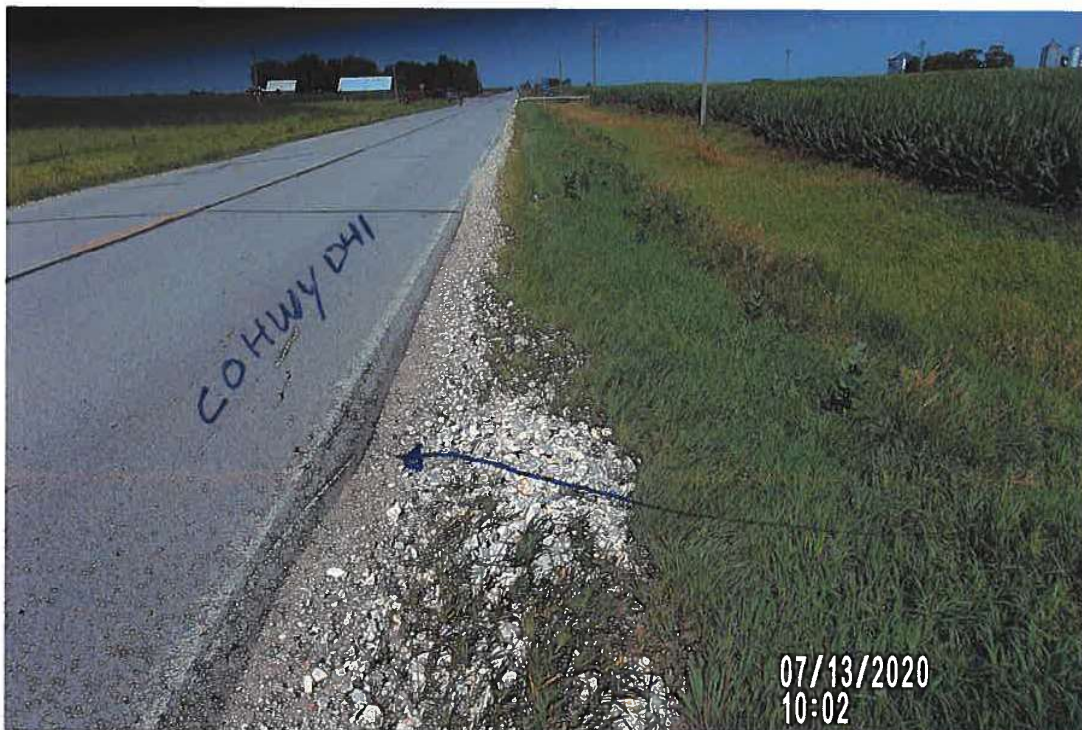
DIP IN  
GRAVEL  
SHOULDER  
WITH  
FRESH  
ROCK

PICTURE# 4139 IS LOOKING WEST ON NORTH SHOULDER  
OF CD HWY 41 SHOWING SINK HOLE PER RANDY'S REPORT  
WITH A LITTLE DIP IN ALL 2 GRAVEL AND APPEARS SOMEONE HAS  
PUT FRESH ROCK IN SINK HOLE.

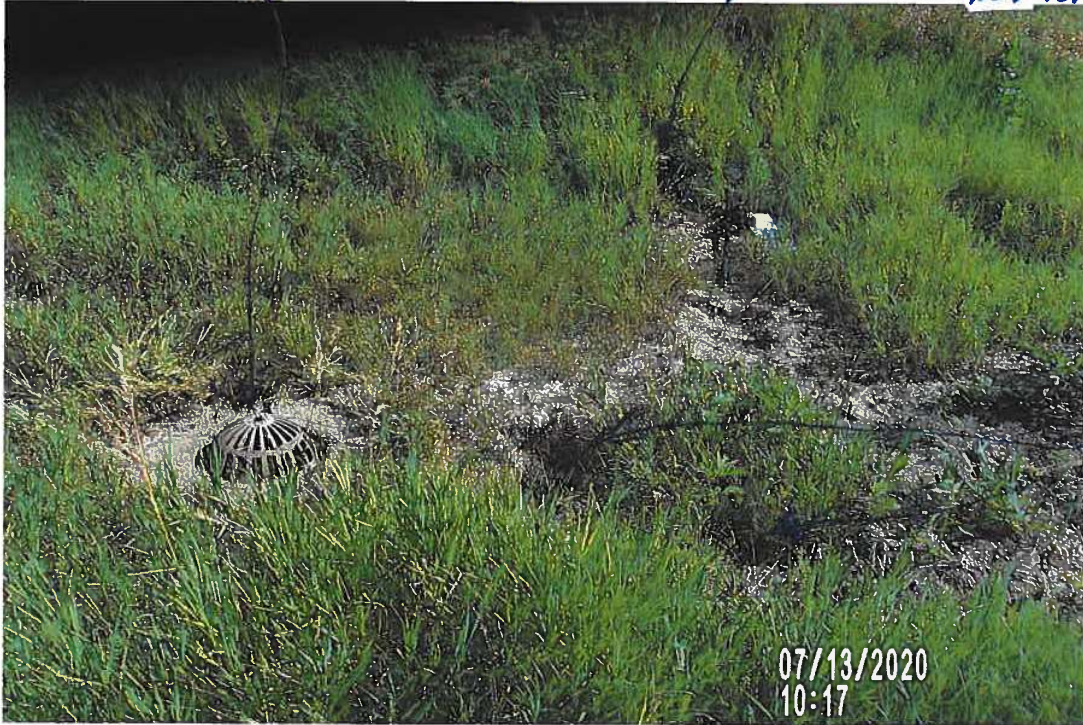
SINKHOLE  
 EAST OF  
 BEEHIVE  
 INTAKE

PICTURE# 4140 IS LOOKING NORTH TOWARDS CO HWY D41  
 SHOWING 18" CMP OUTLET FOR CULVERT UNDER CO HWY D41  
 & 18" BEEHIVE INTAKE IN SOUTH DITCH OF CO HWY D41 WITH SINKHOLE  
 GPS# 337 NRM BEEHIVE INTAKE GPS# 338 TOP 18" CMP TO EAST,  
 1.54' TO TOP FL

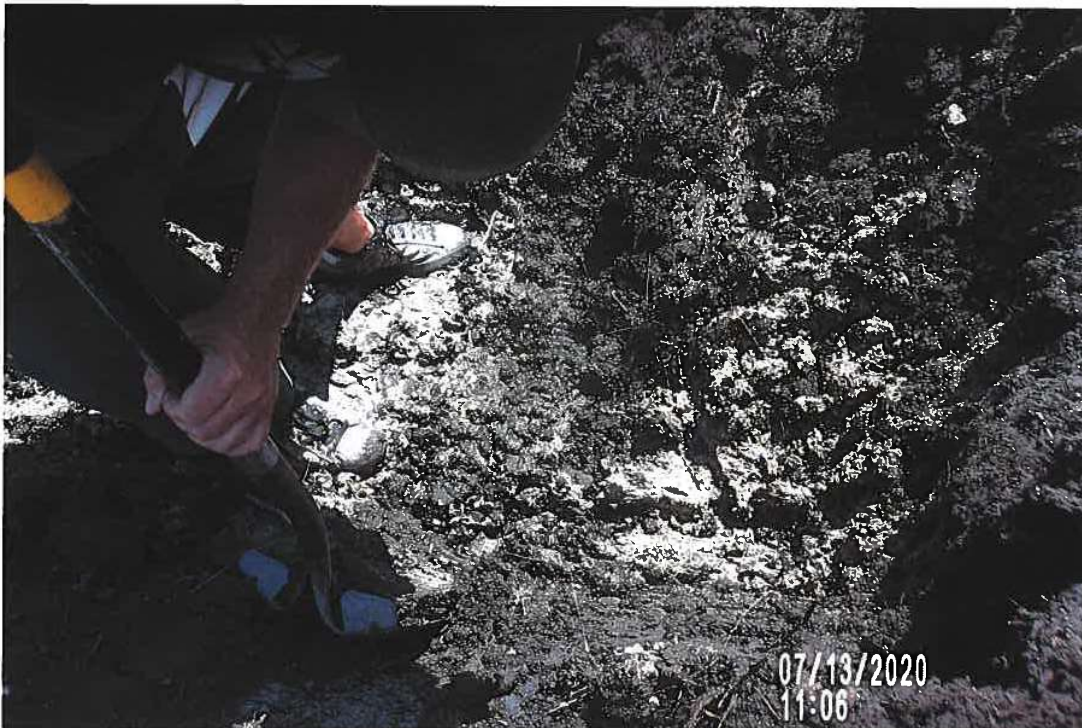
PICTURE# 4141 IS LOOKING EAST ON EAST SIDE OF  
 BEEHIVE INTAKE SHOWING 6" HDPE PERF TILE CONNECTION  
 TO 6" CLAY TILE OUTLET EAST FROM BEEHIVE INTAKE,

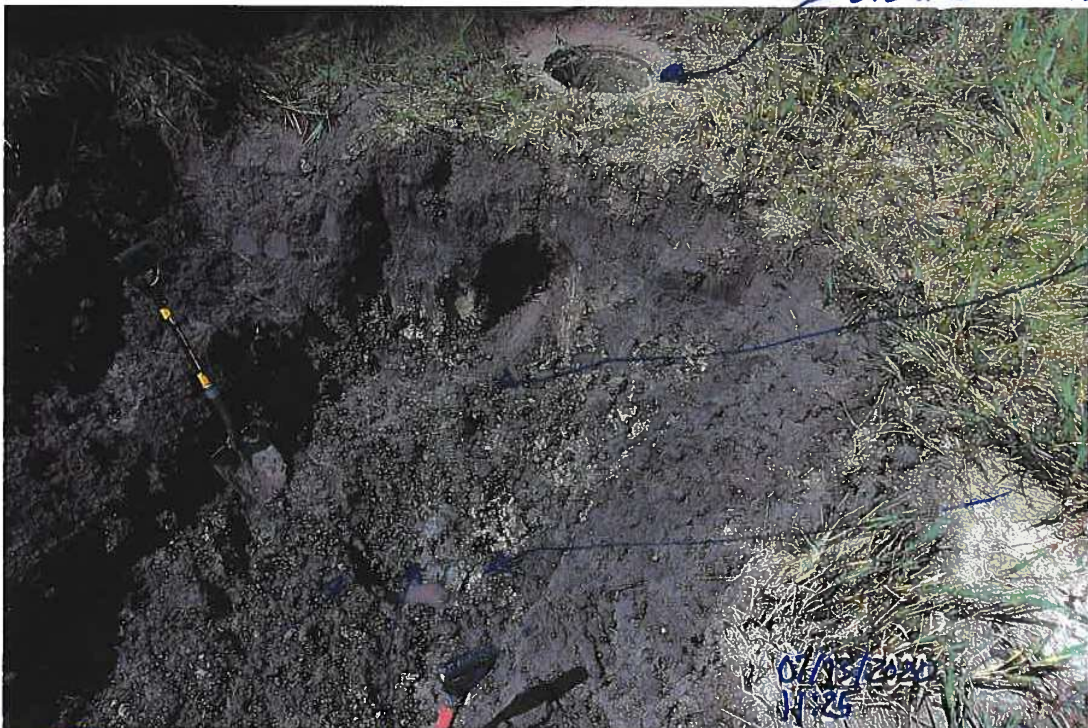
PICTURE# 4142 IS LOOKING SE SHOWING 6" HDPE PERF  
TILE CONNECTION TO 6" CLAY TILE EAST OF BEEHIVE  
INTAKE. PICTURE SHOWS CREW EXCAVATING TO CHECK  
ON TILE CONNECTION. 6" HDPE / 6" CLAY TILE CONNECTION CLAY  
TILE  
BROKE  
& WILL  
NEED  
REPLACED.

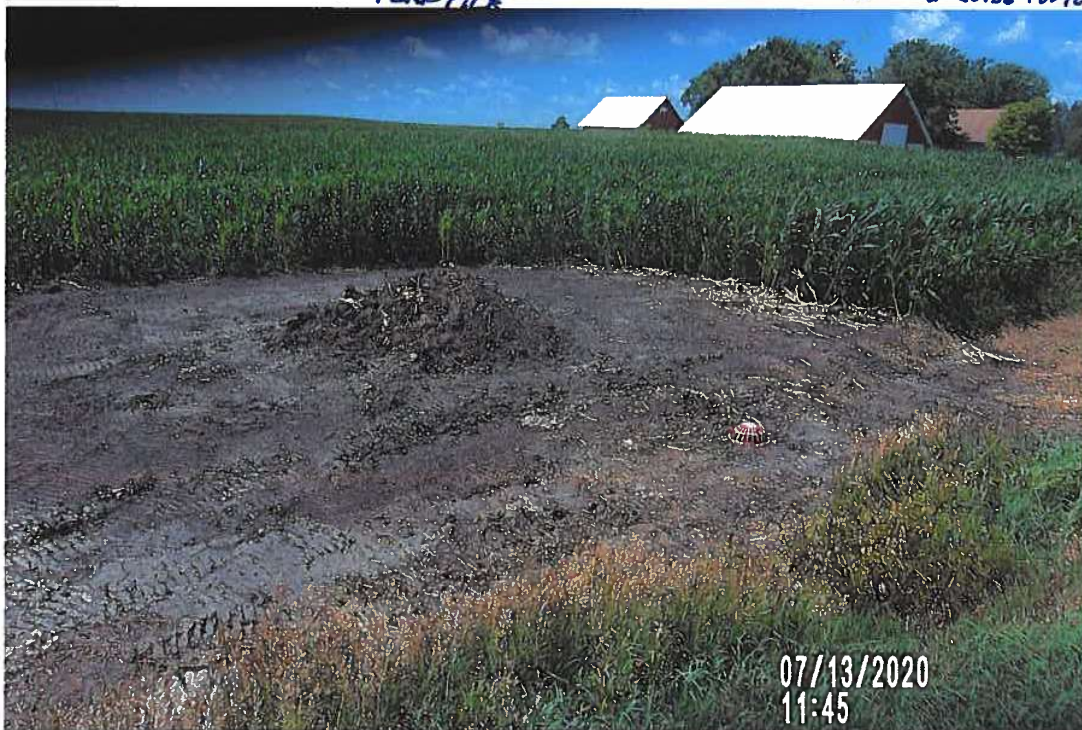
PICTURE # 4145 IS LOOKING SW ON SOUTH SIDE OF HWY 041 SHOWING DITCH GRADED TO INTAKE & TRENCH BACKFILL & GRADED. EXTRA SOIL PILED UP. BLEND EXTRA SOIL AROUND

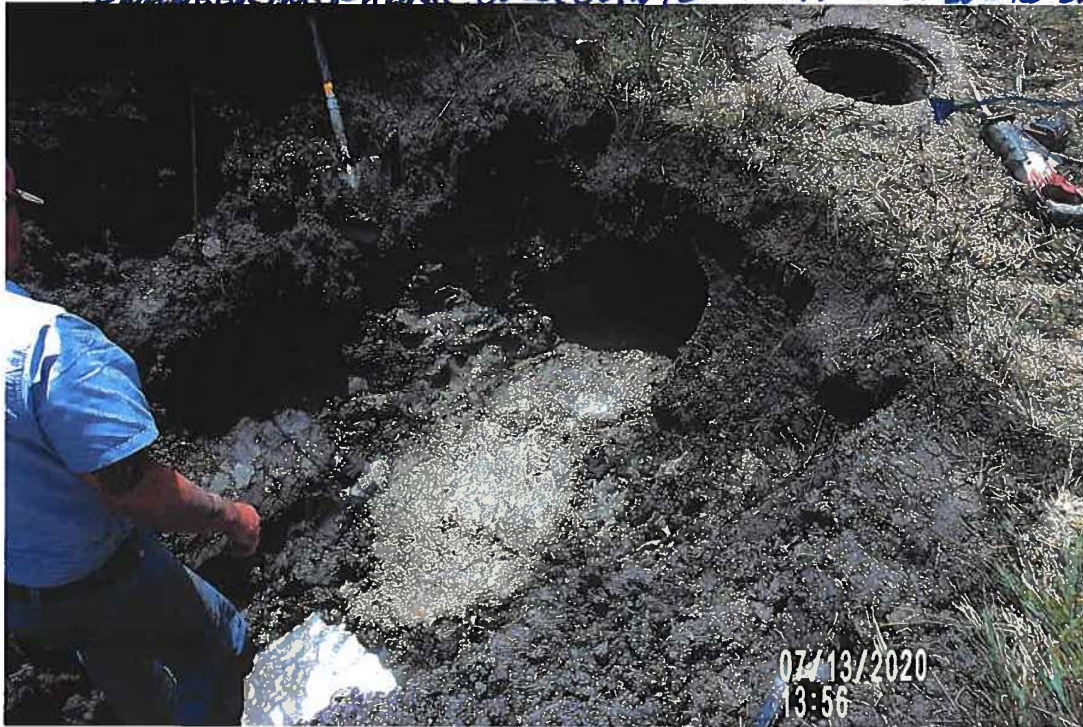
PICTURE# 4149 IS LOOKING SW SHOWING  $\frac{3}{4}$  CONCRETE COLLAR  
POURED ON BEEHIVE INTAKE TILE OUTLET TIE IN WITH  
3' - 20X15' 6"x6" WIRE MESHES OVER JOINTS & 3' - 1.5' X 20'  
FIBERGLASS FABRIC OVER JOINTS WITH 5-60 LB BAGS OF HIGH STRENGTH  
CONCRETE

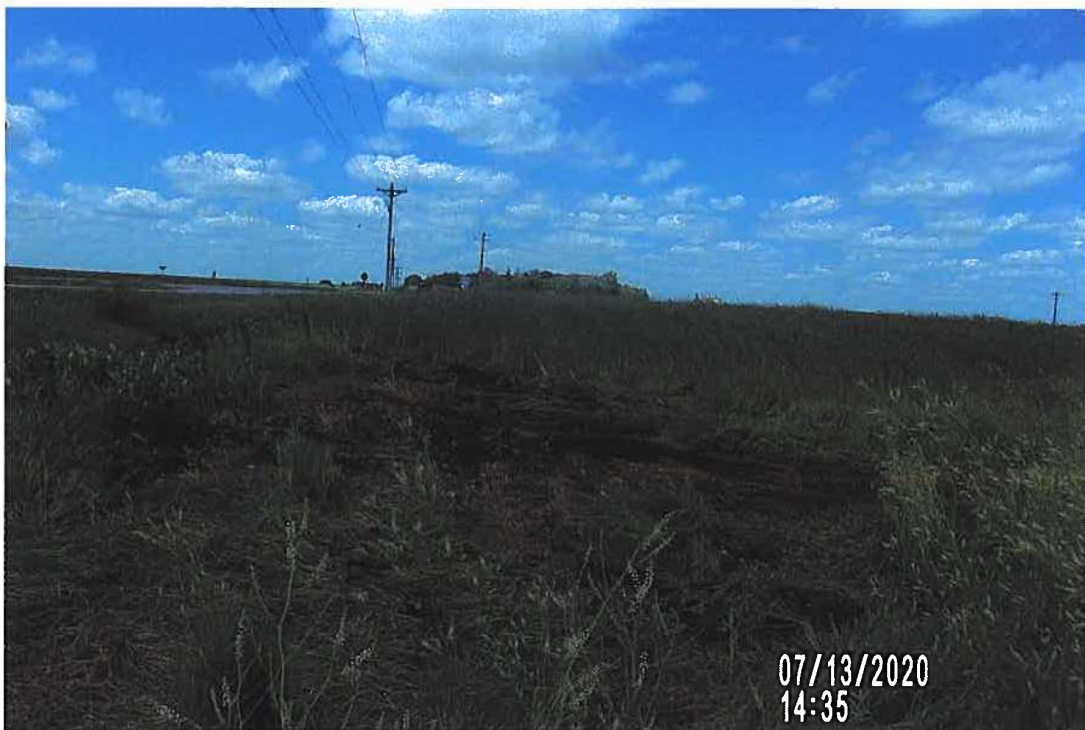
PICTURE# 4152 IS LOOKING NORTH SHOWING TRENCH  
BACKFILLED EAST OF EAST ROW LHWY 327 & SOUTH D41  
IN WETLAND DUG BY PREVIOUS CONTRACTOR

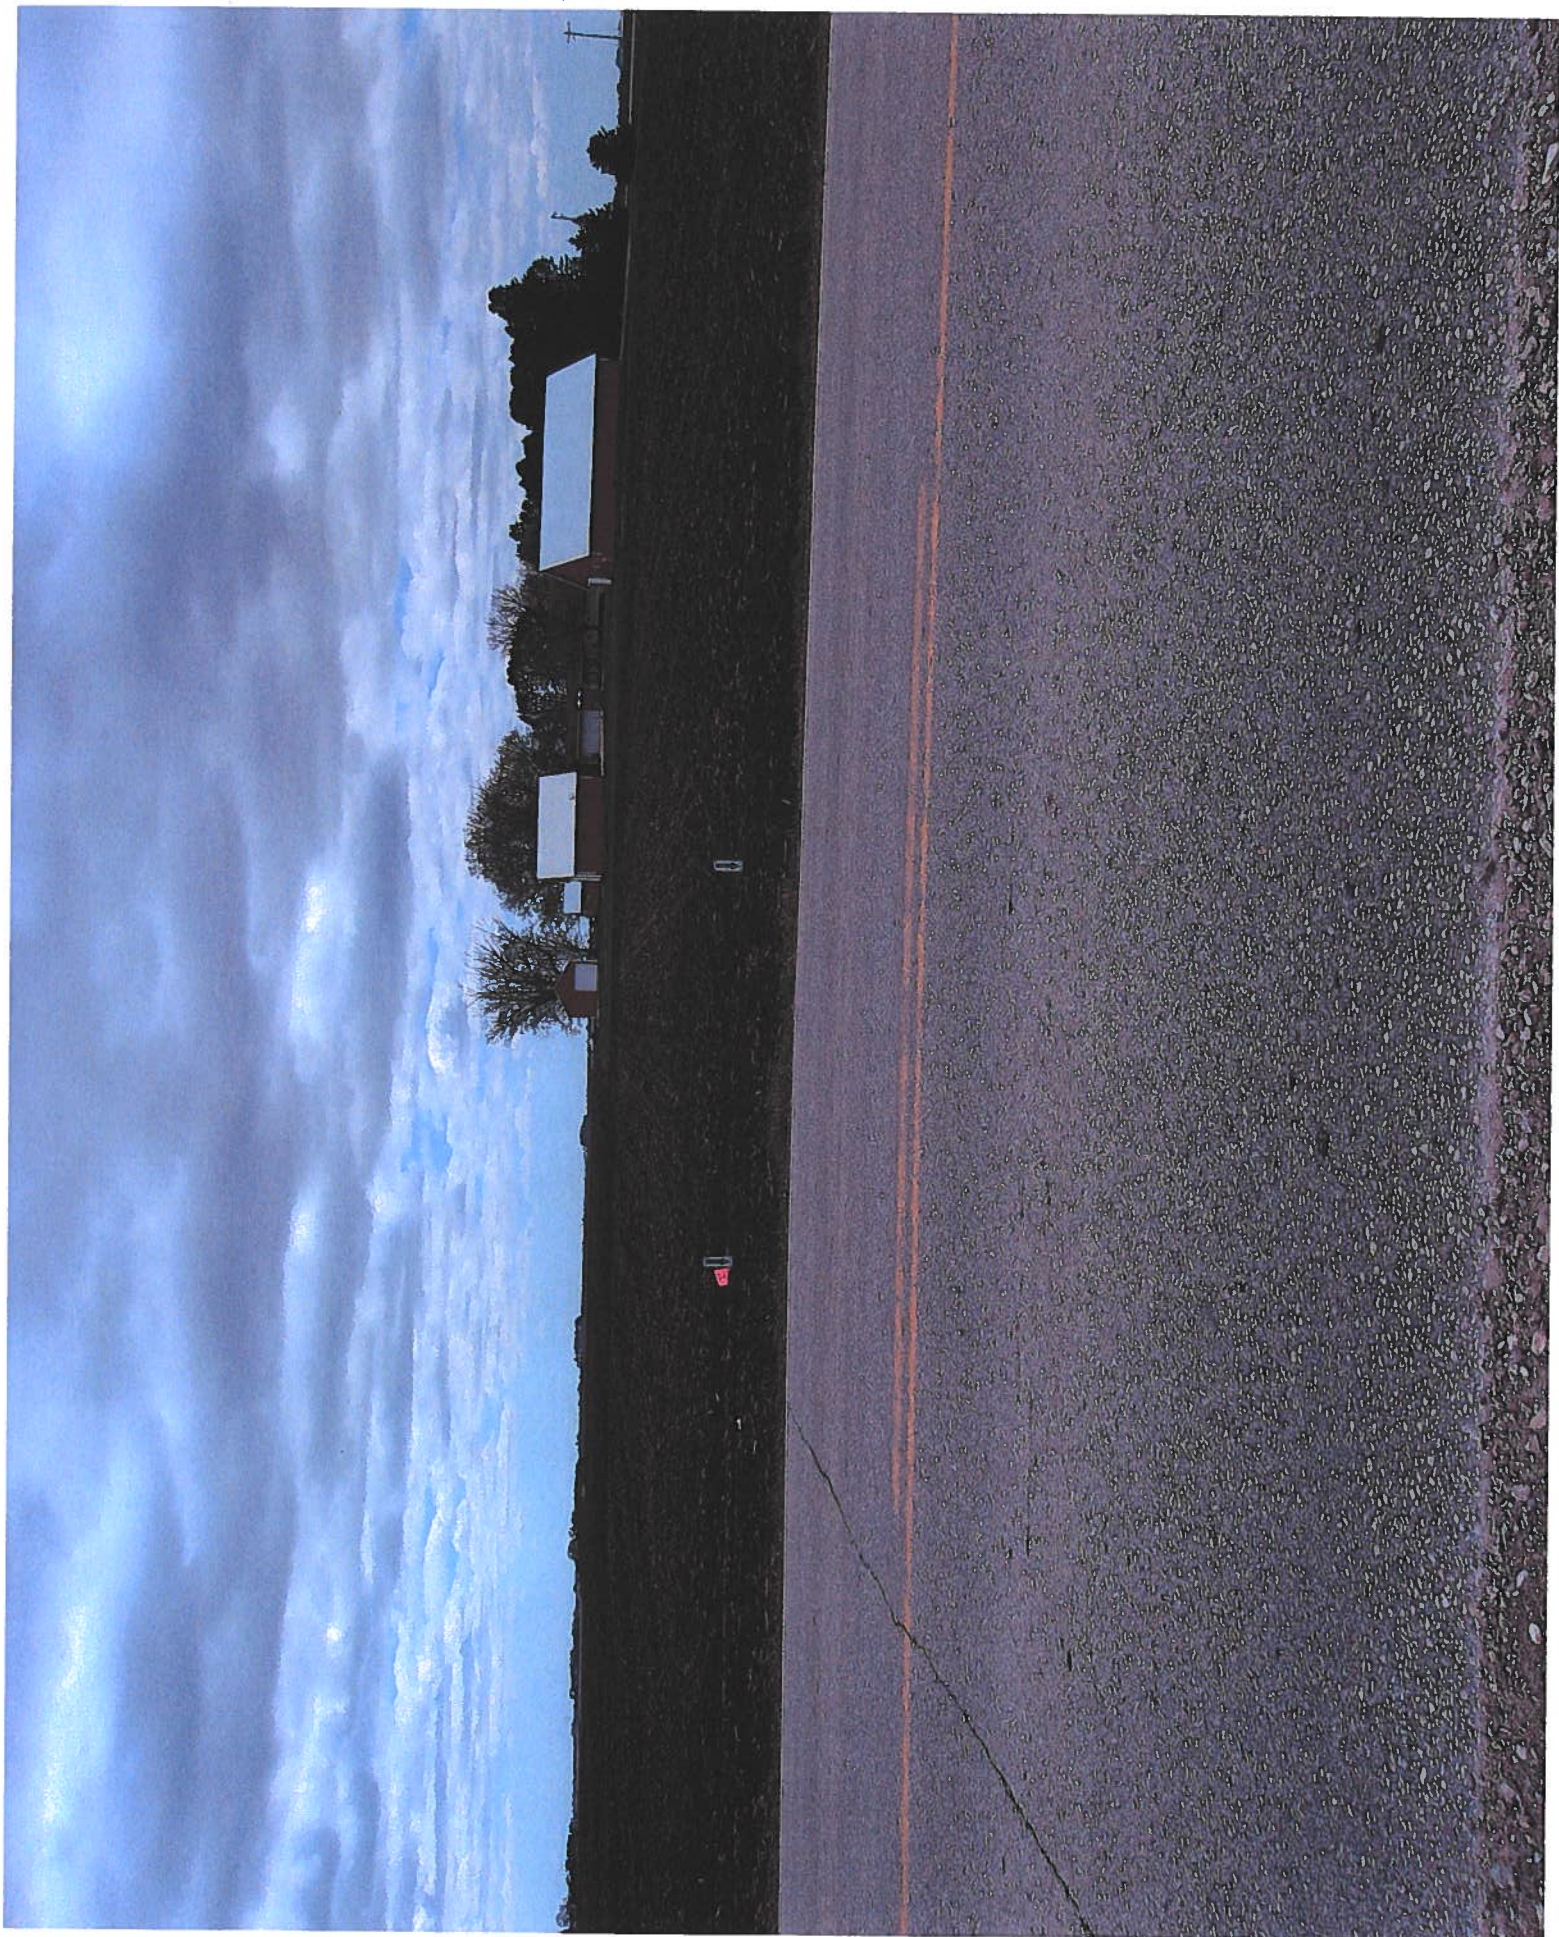
LOOKING WEST OVER S27 ON LATZ

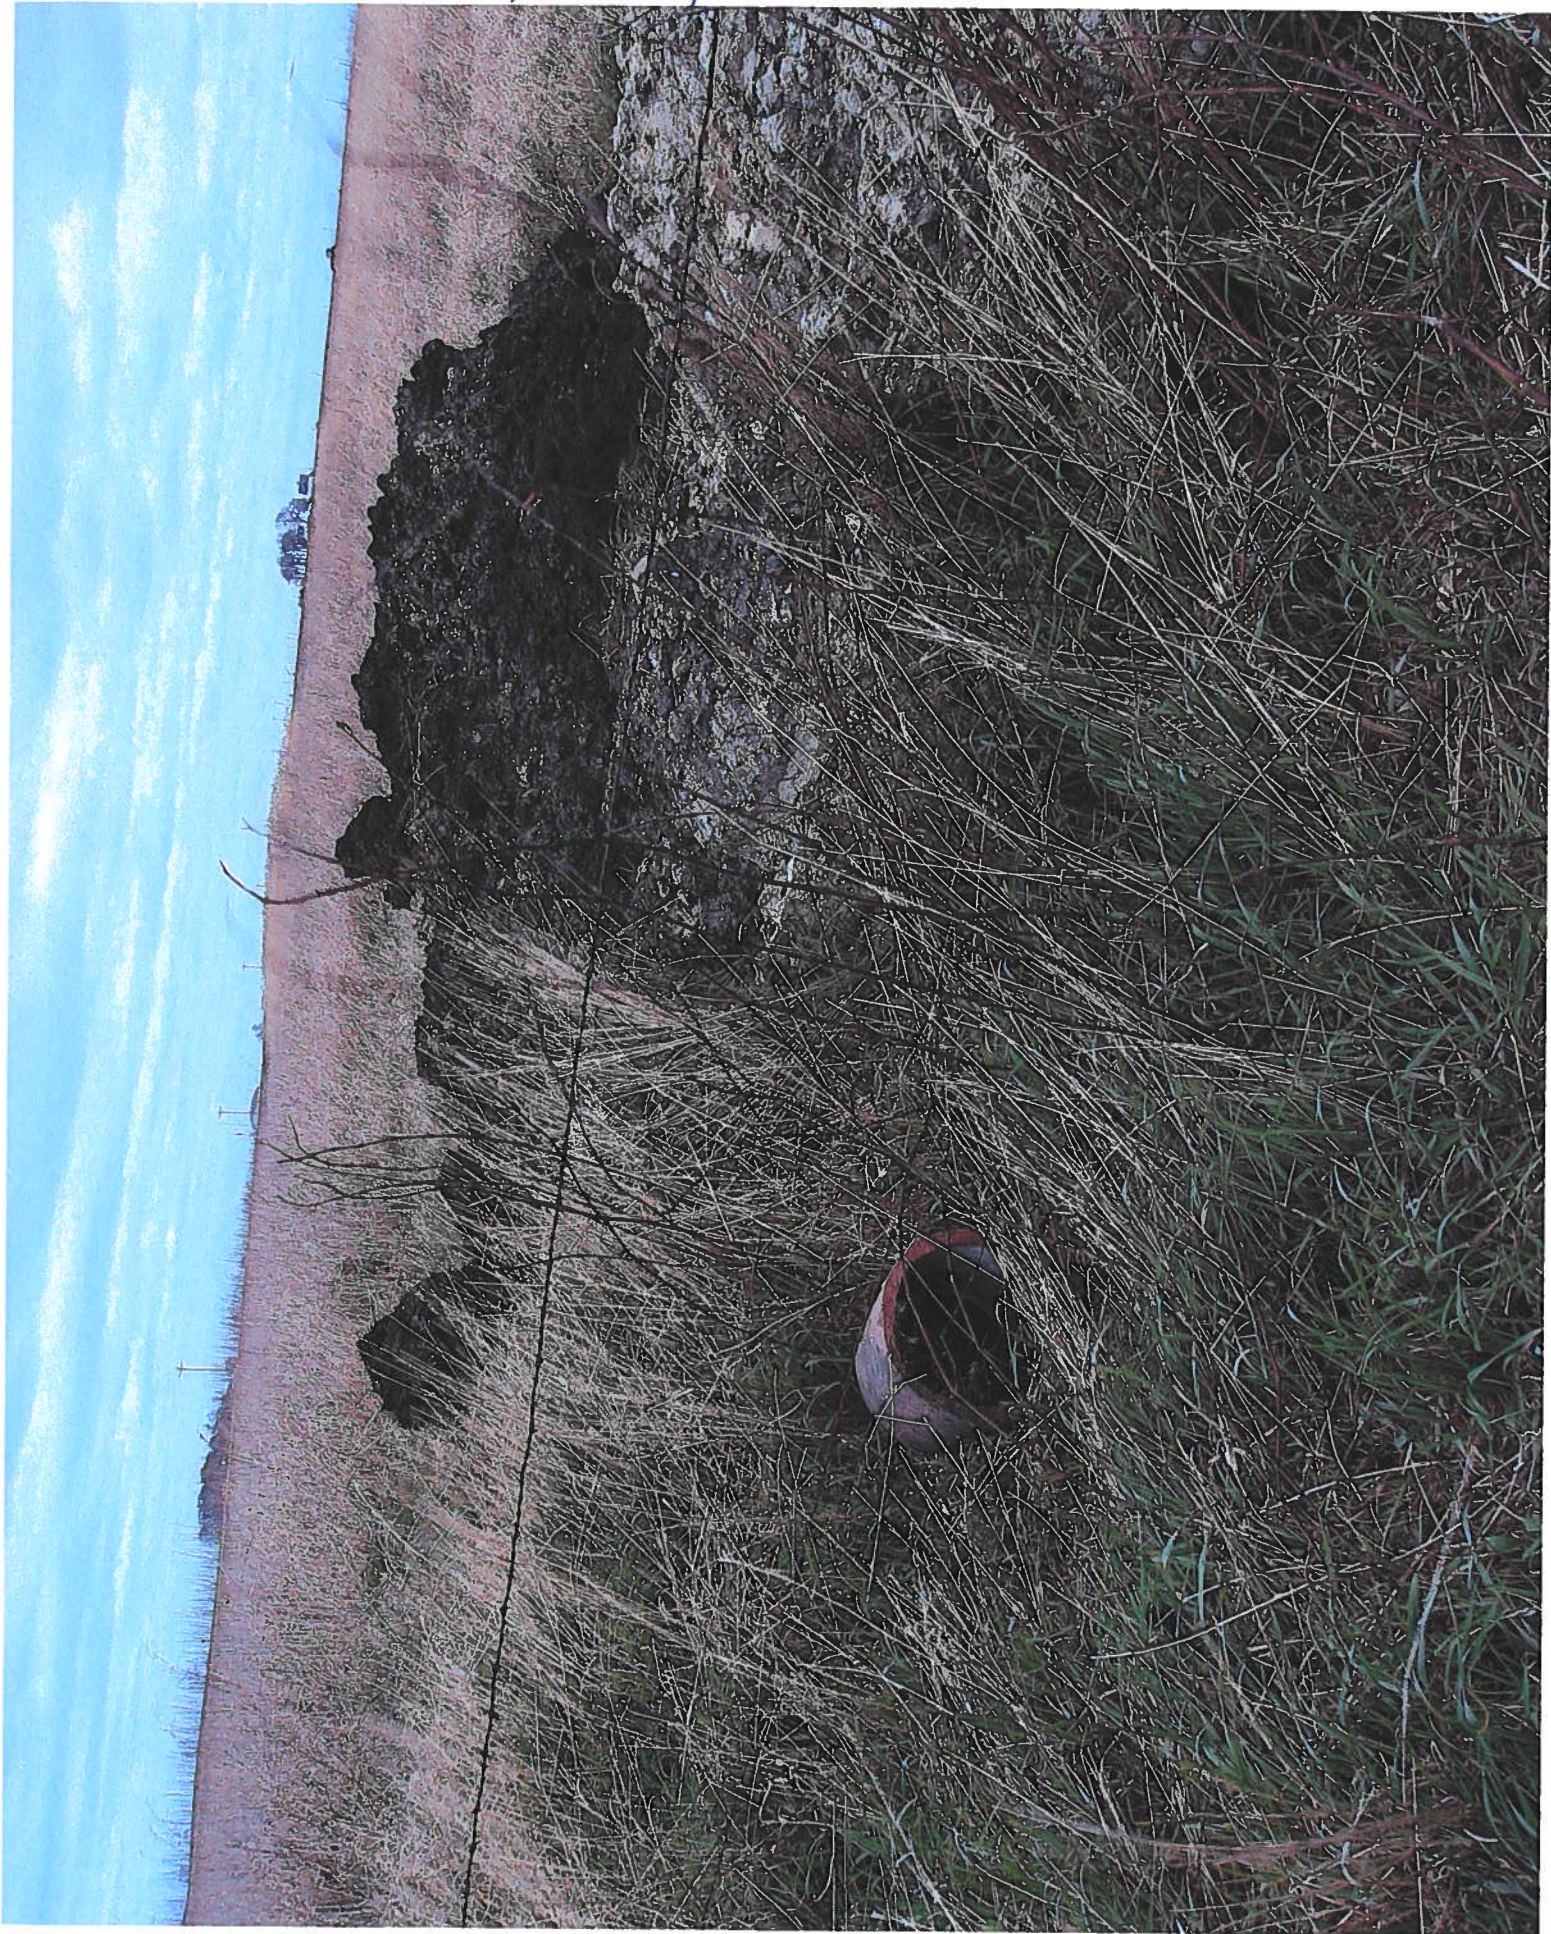
Looking E. @ 10" clay on lat 2, E. of S27

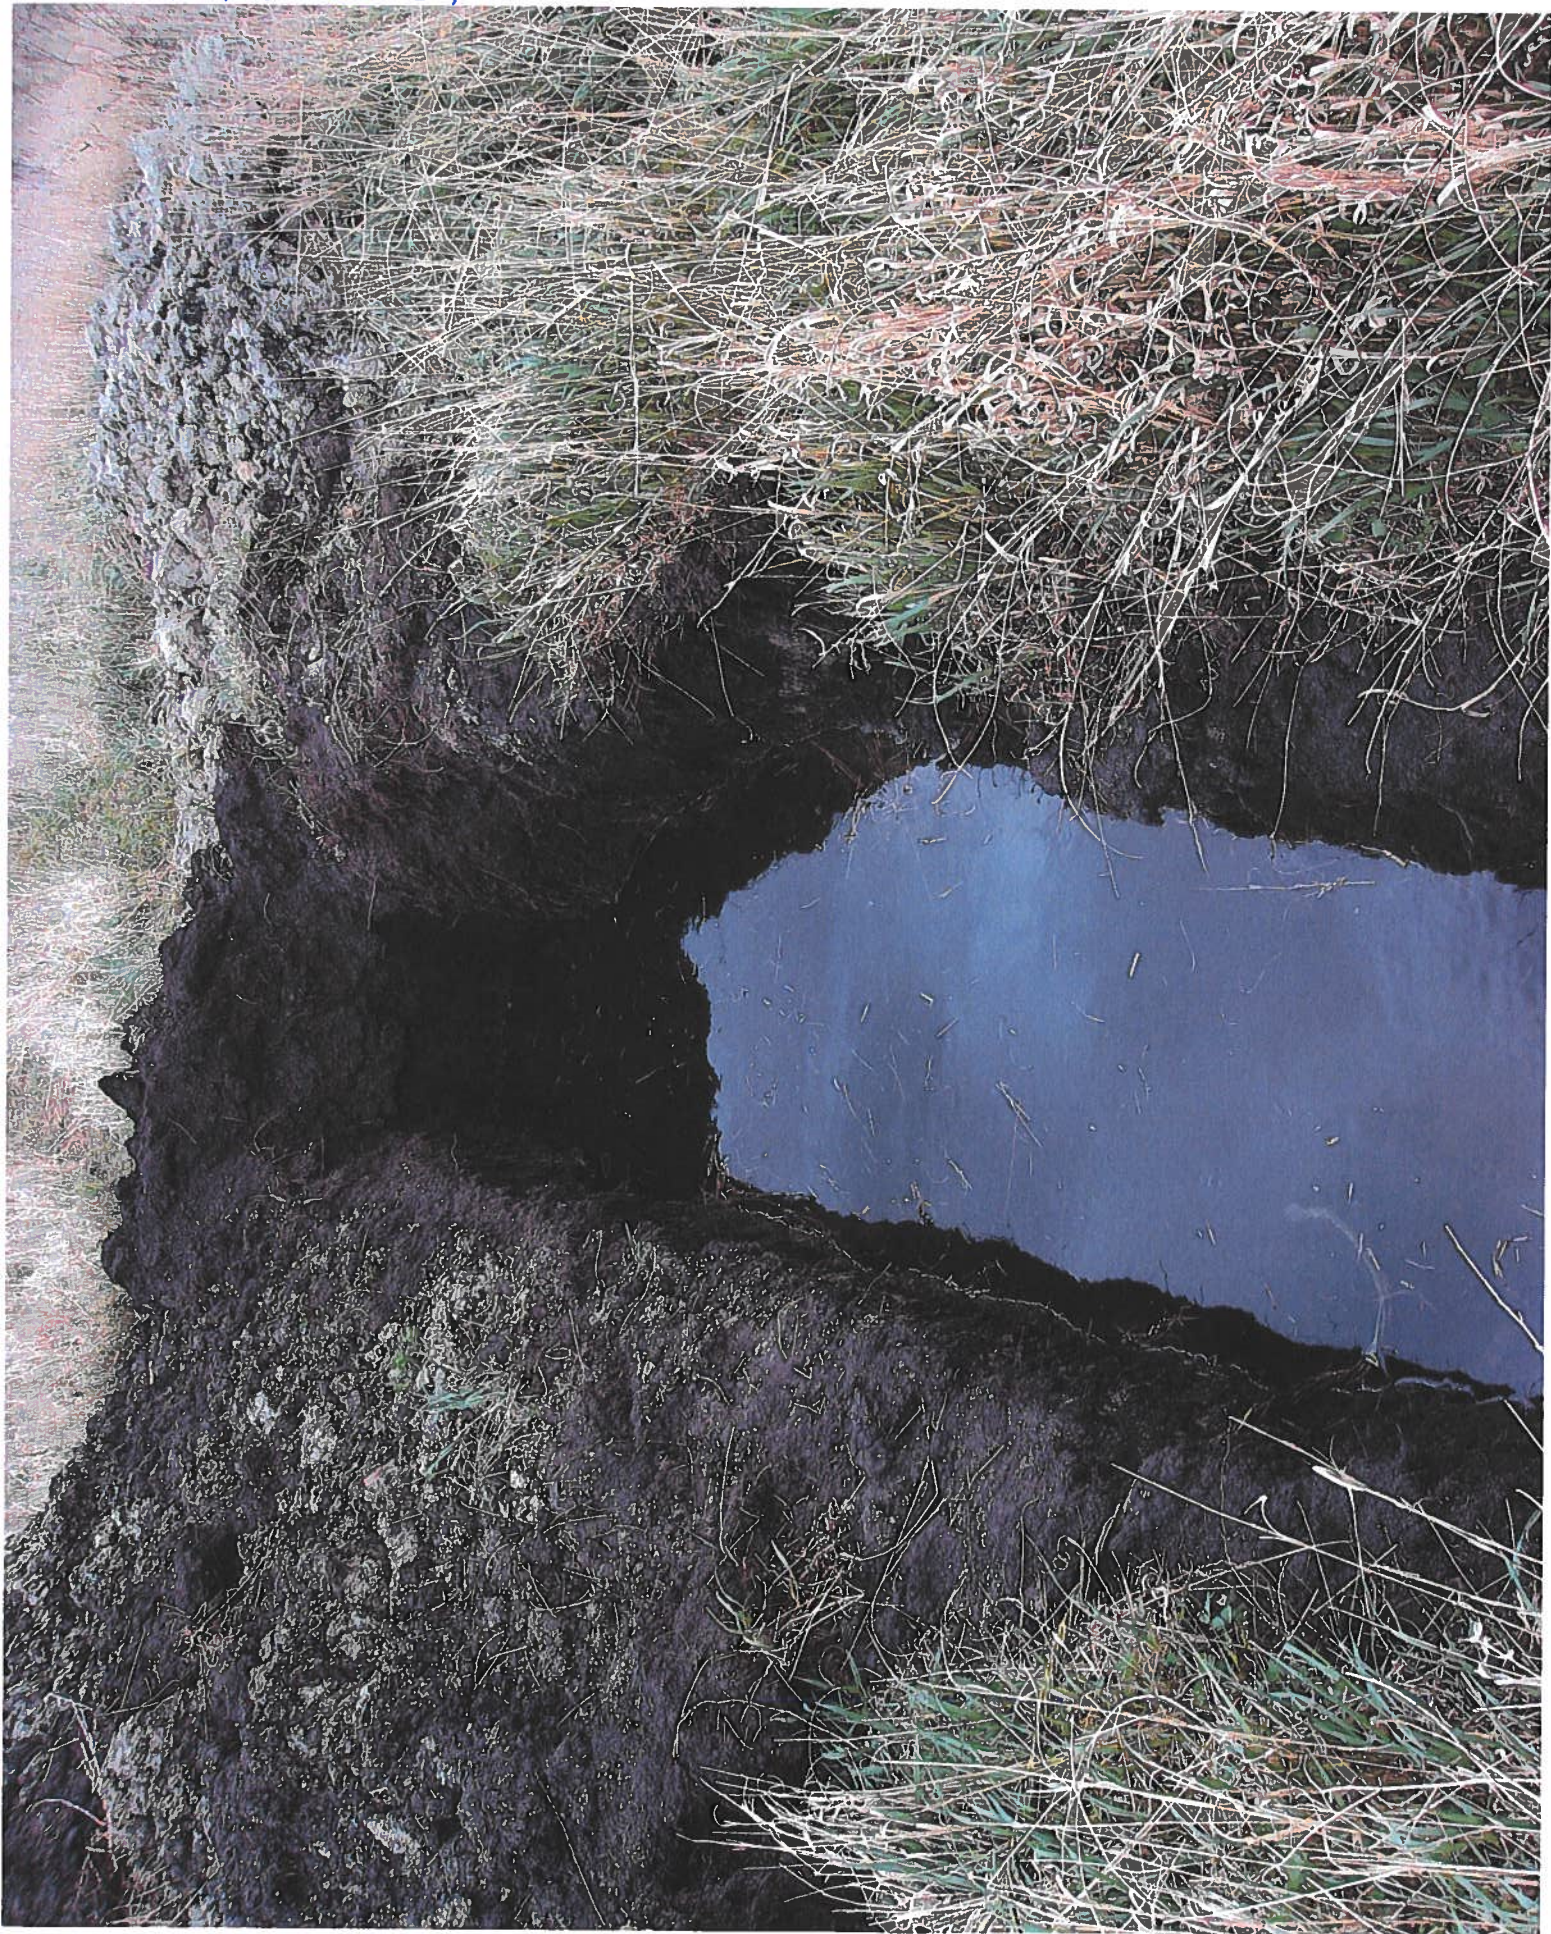
TRENCH ON LAT 2 , E SIDE S27

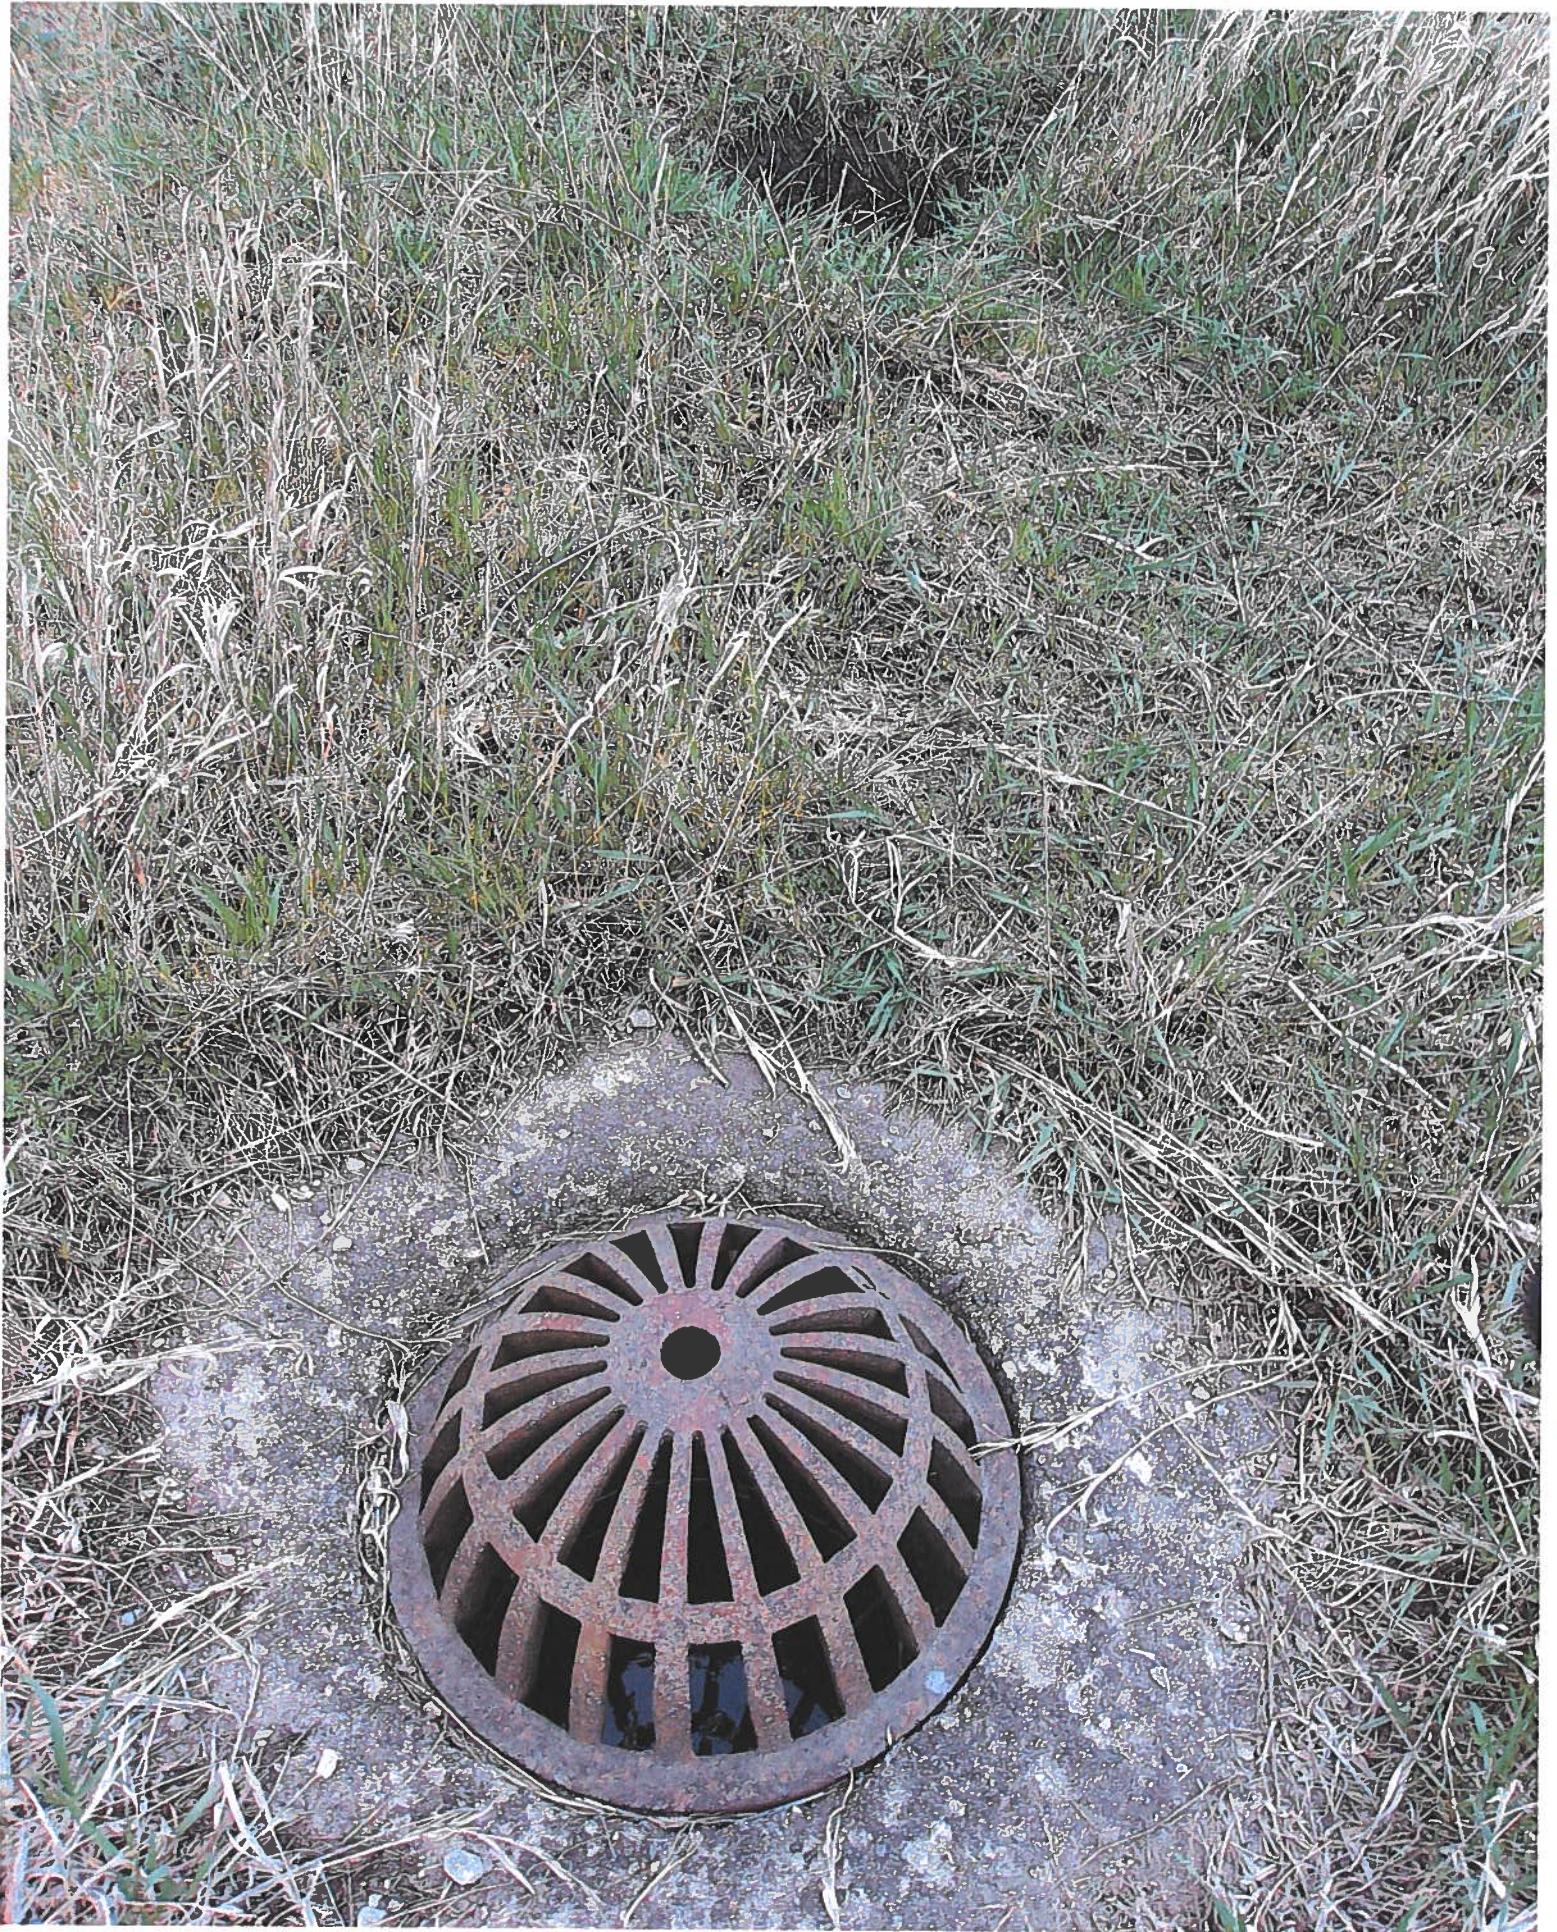
LOOKING EAST @ BEEHIVE WITH HOLE ON LAT2, S.SIDE D41 By CRP

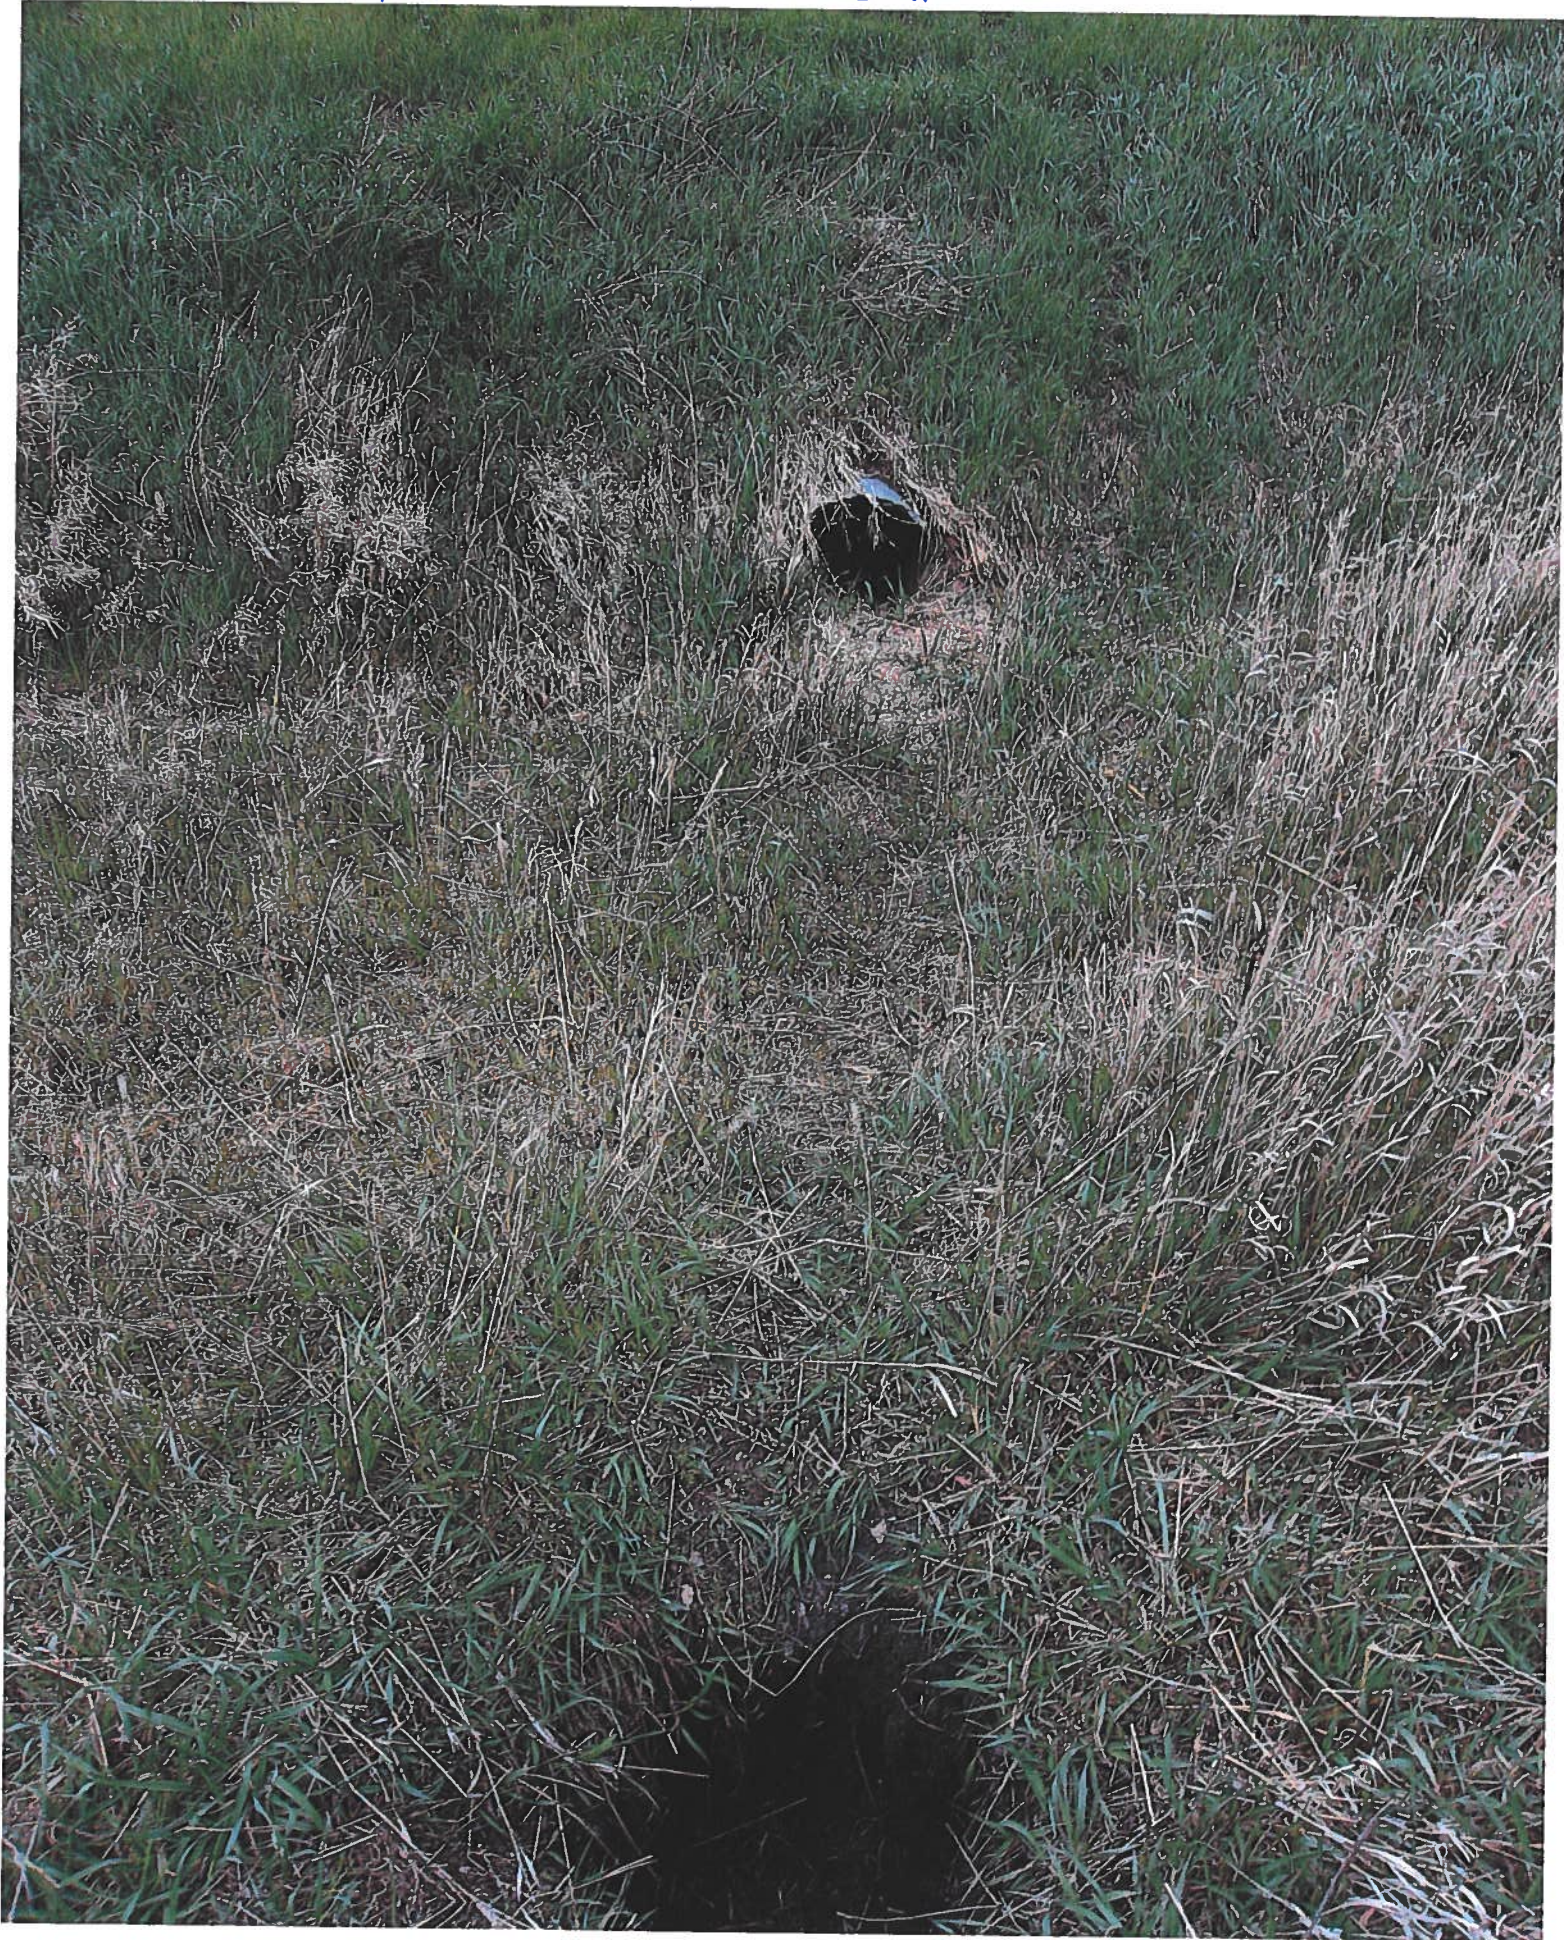
S. SIDE D41 , HOLE ON LAT 2 , LOOKING N.
