**AGENDA**  
**DRAINAGE DISTRICT 14 LANDOWNER MEETING**  
**Wednesday, November 18, 2020 12:00 PM**  
**Large Conference Room**

# Drainage Work Order Request For Repair

LOCATION: DD14 MARIETTA TILE LOCATED SWNE & NWSE  
34-88-22 HARDIN COUNTY  
INVESTIGATE & TEMPORARILY REPAIR 3 TILE BLOWOUTS

## Investigation and Repair Summary:

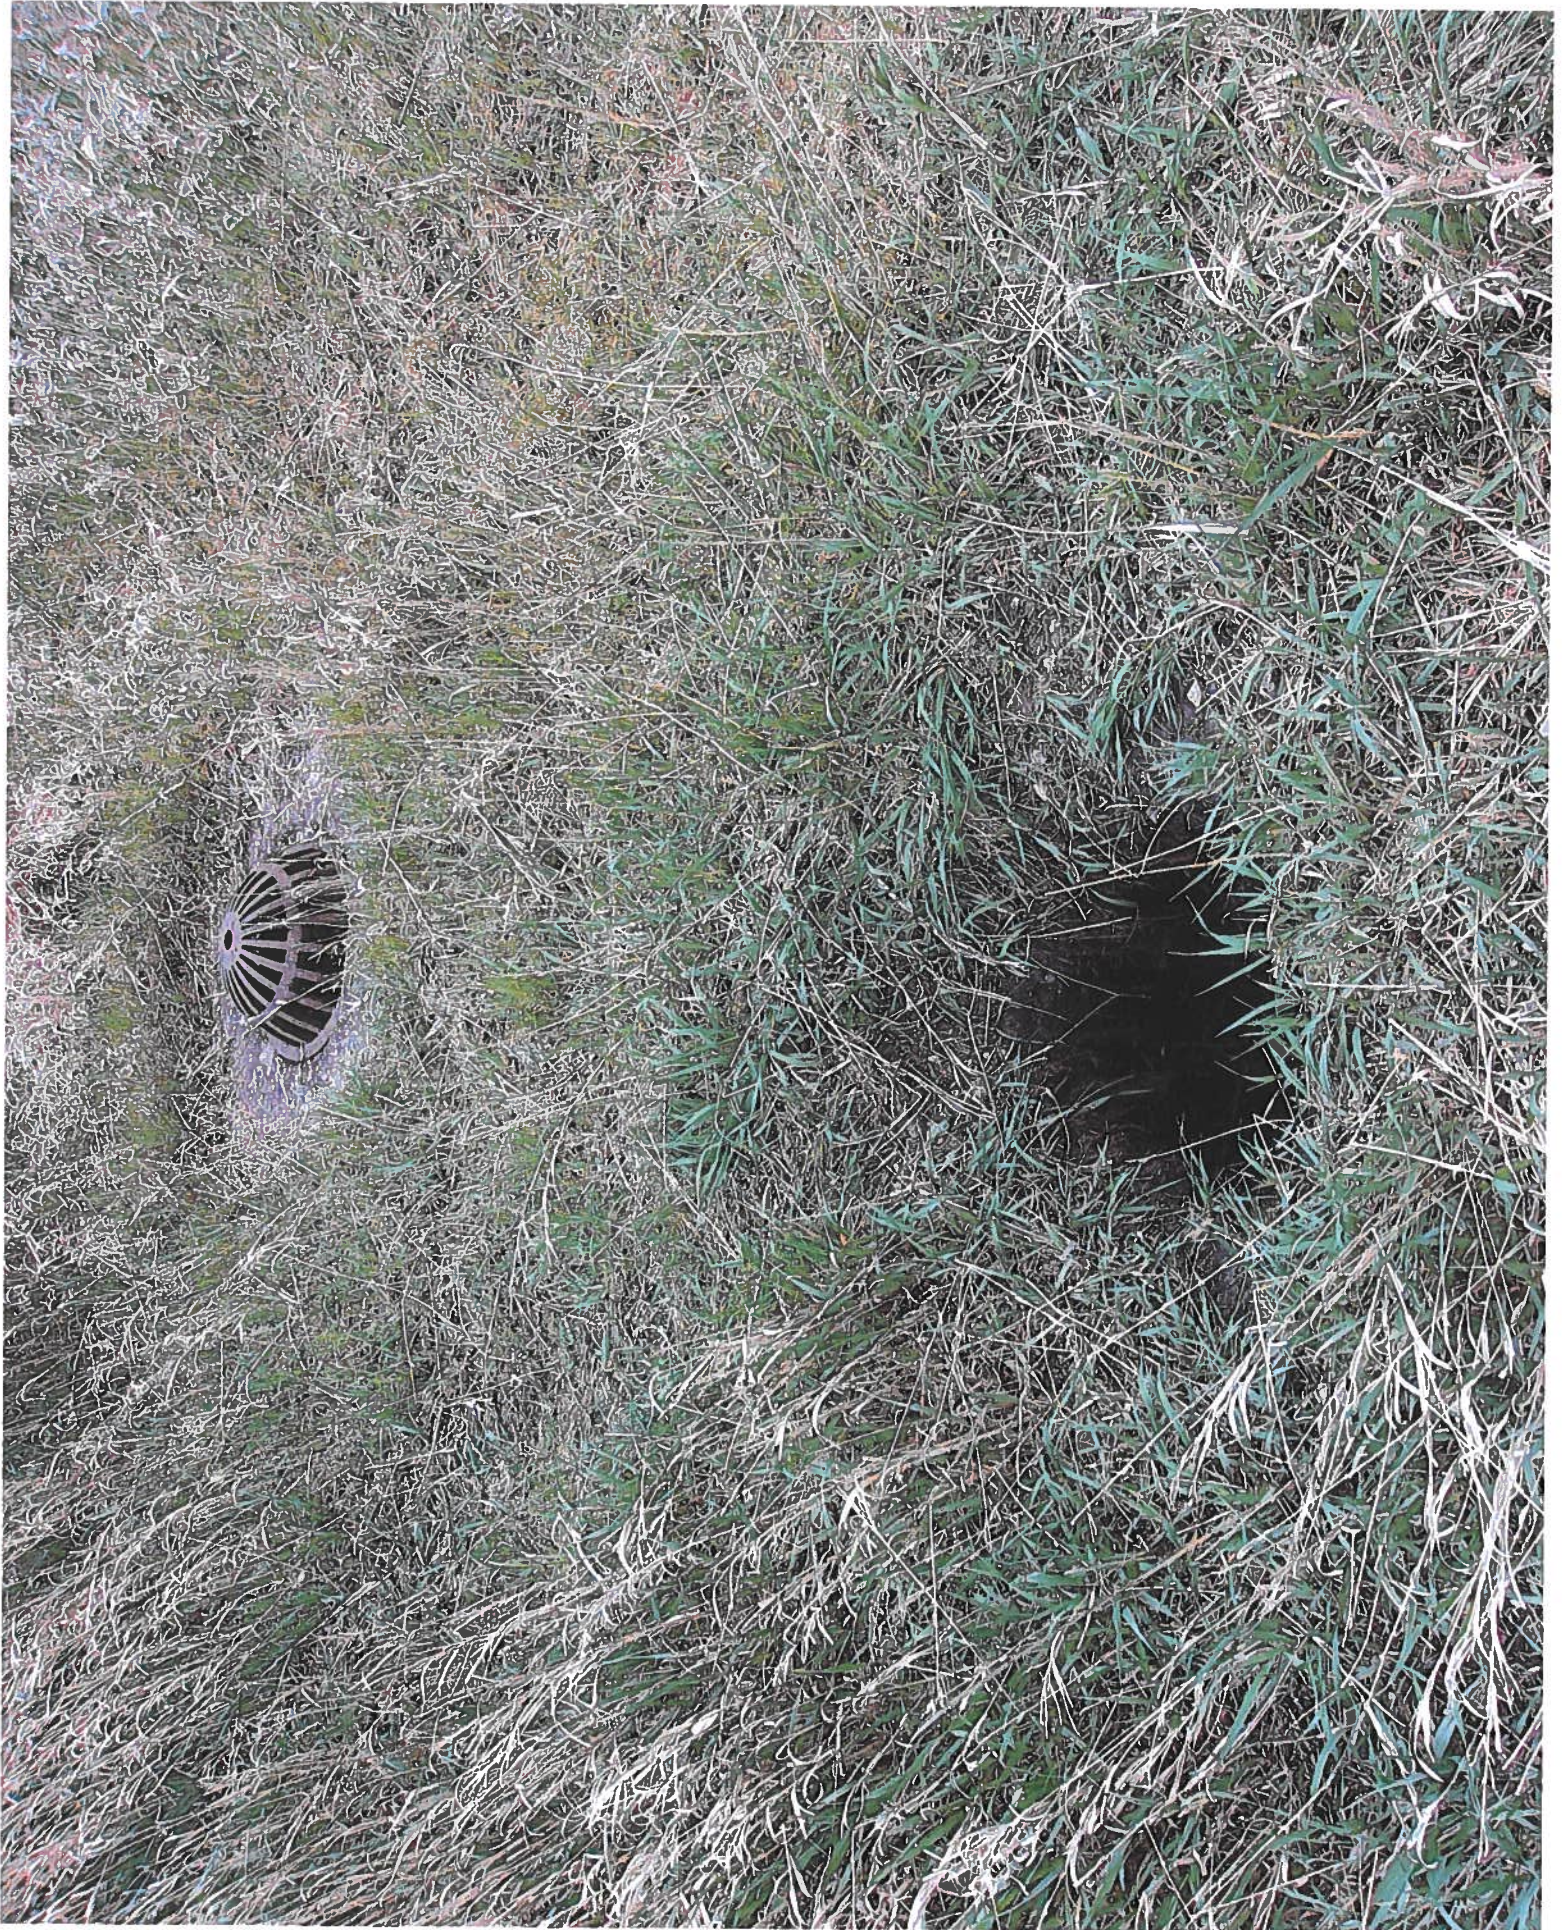
LOOKING WEST ON S. ditch D41

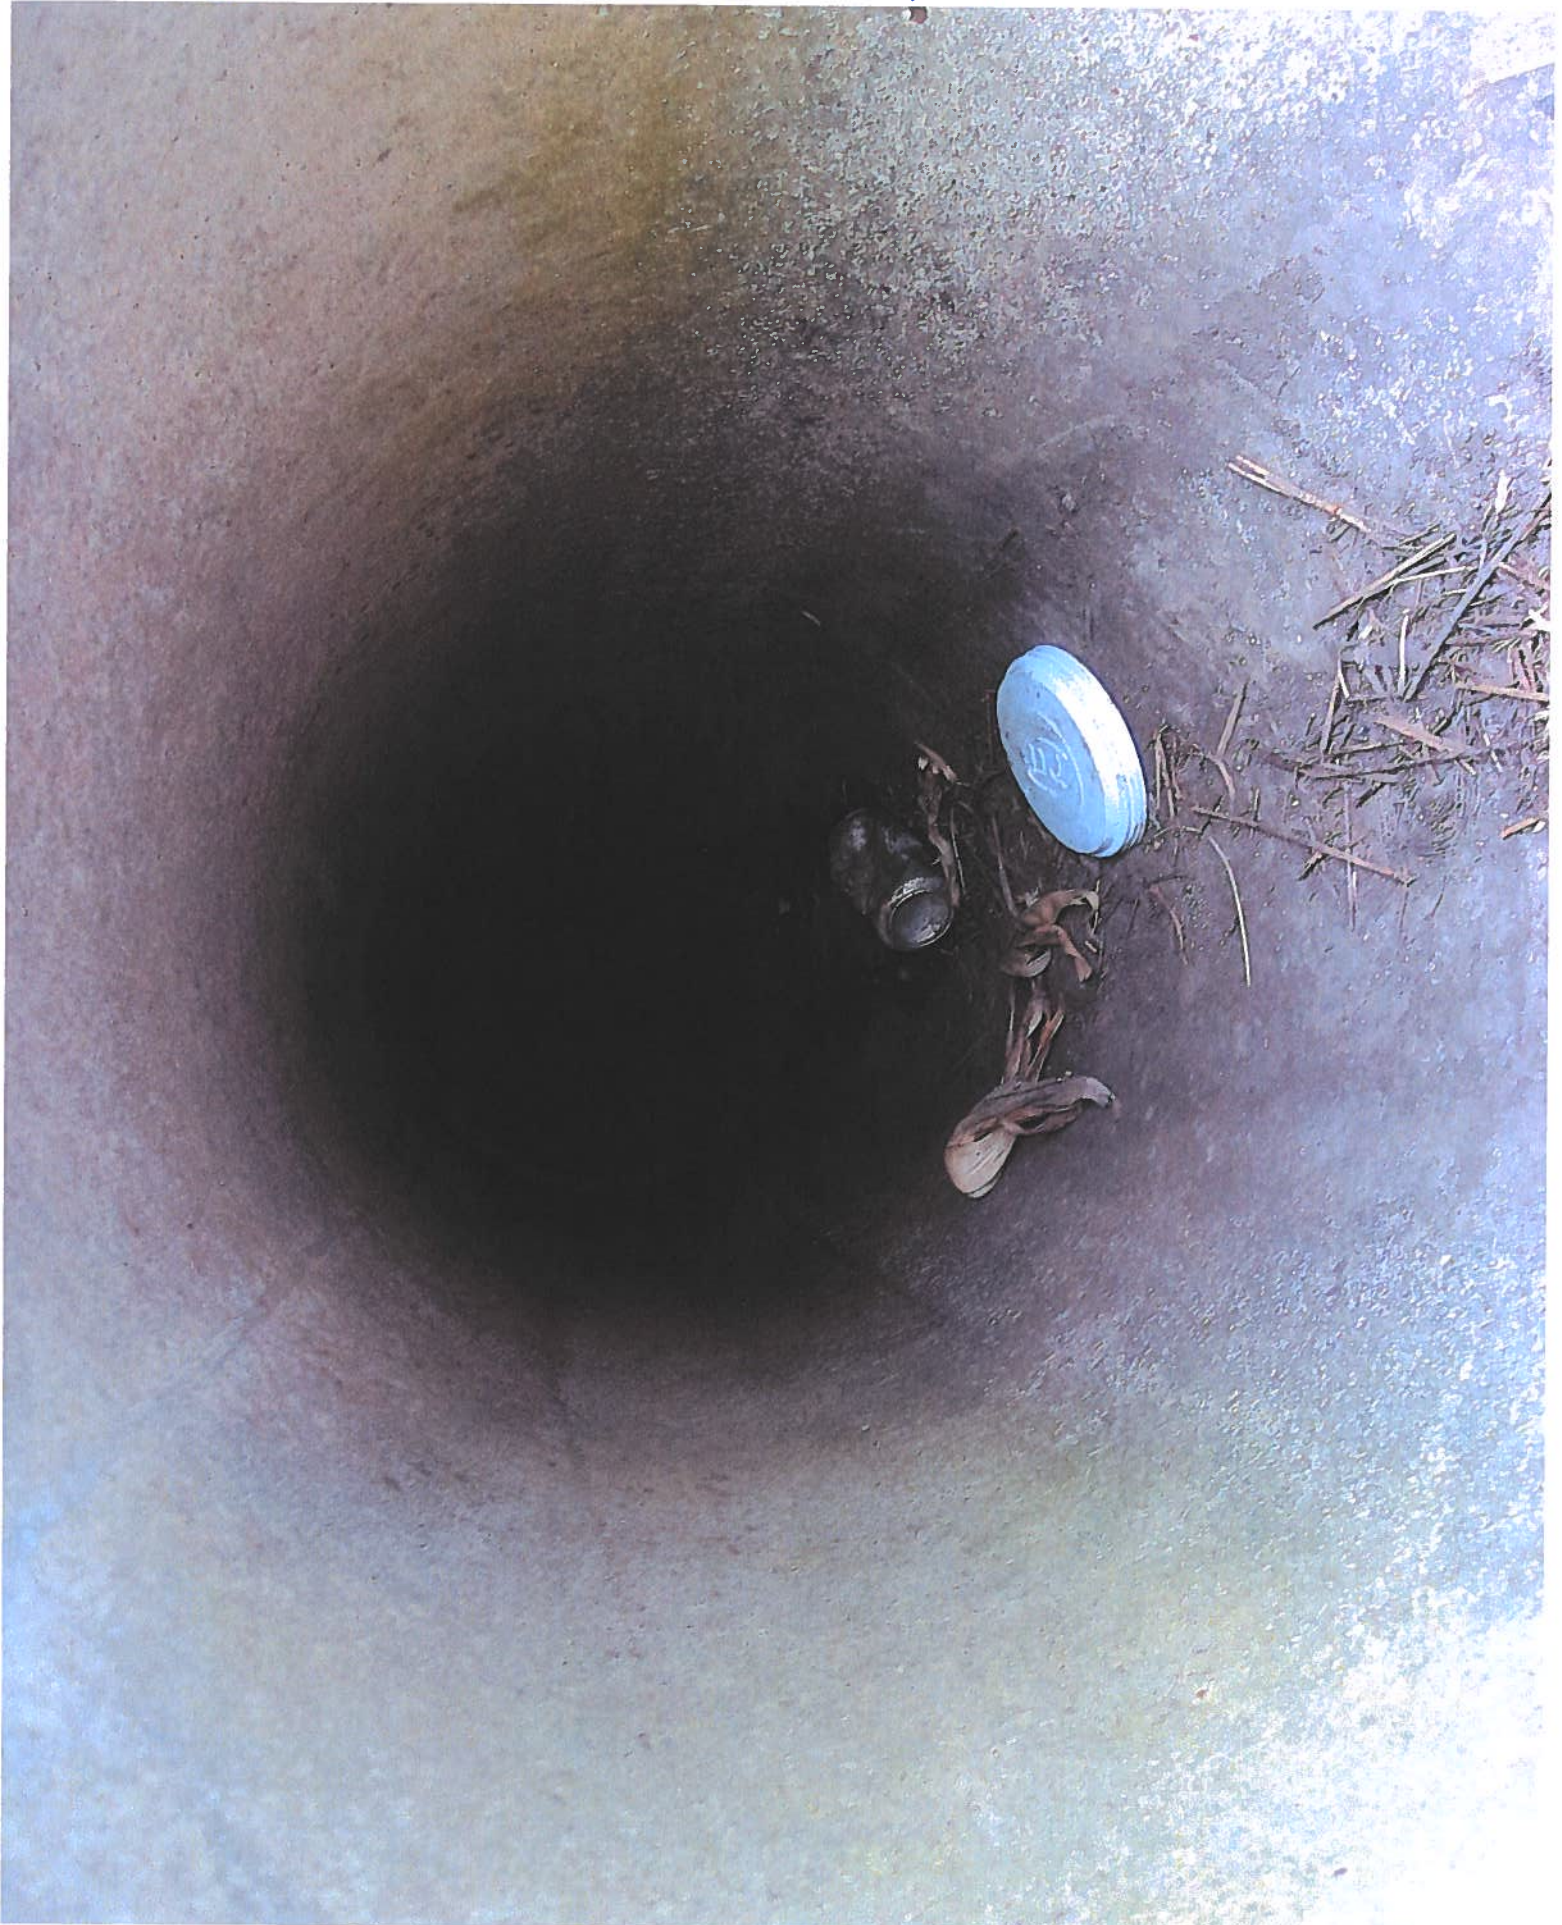
SURF. DRAIN RCP WITH SUCK HOLE OVER TOP RCP AND LAT 2

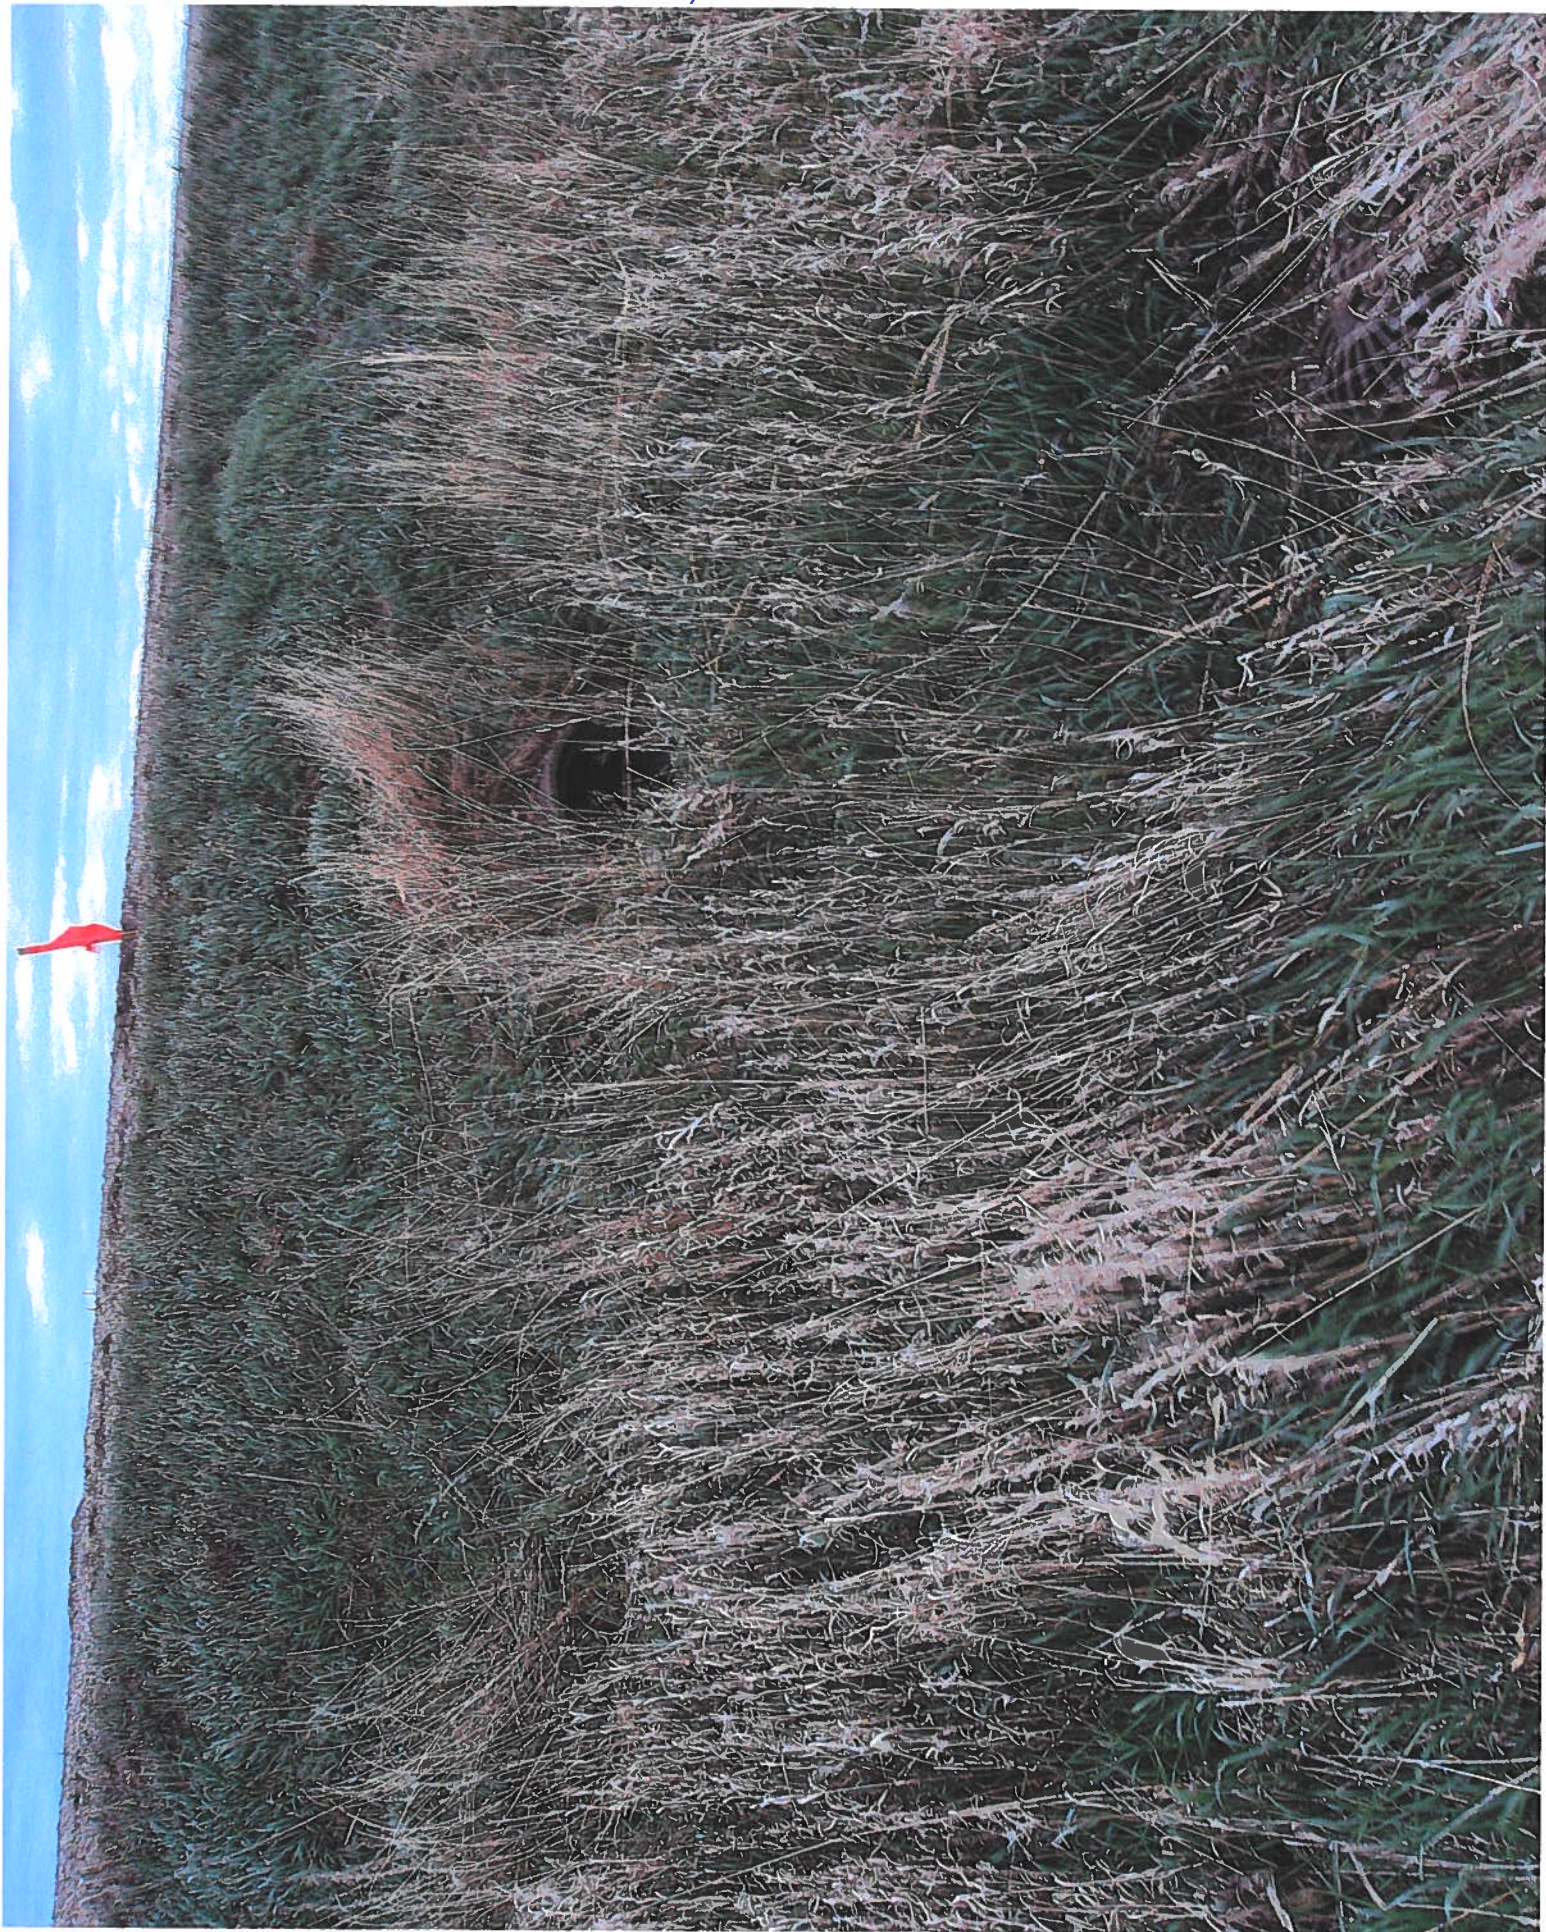
LOOKING S. ON LAT 2 ROUTE, FLAG ON SIXK HOLE ON N.S.H. D41

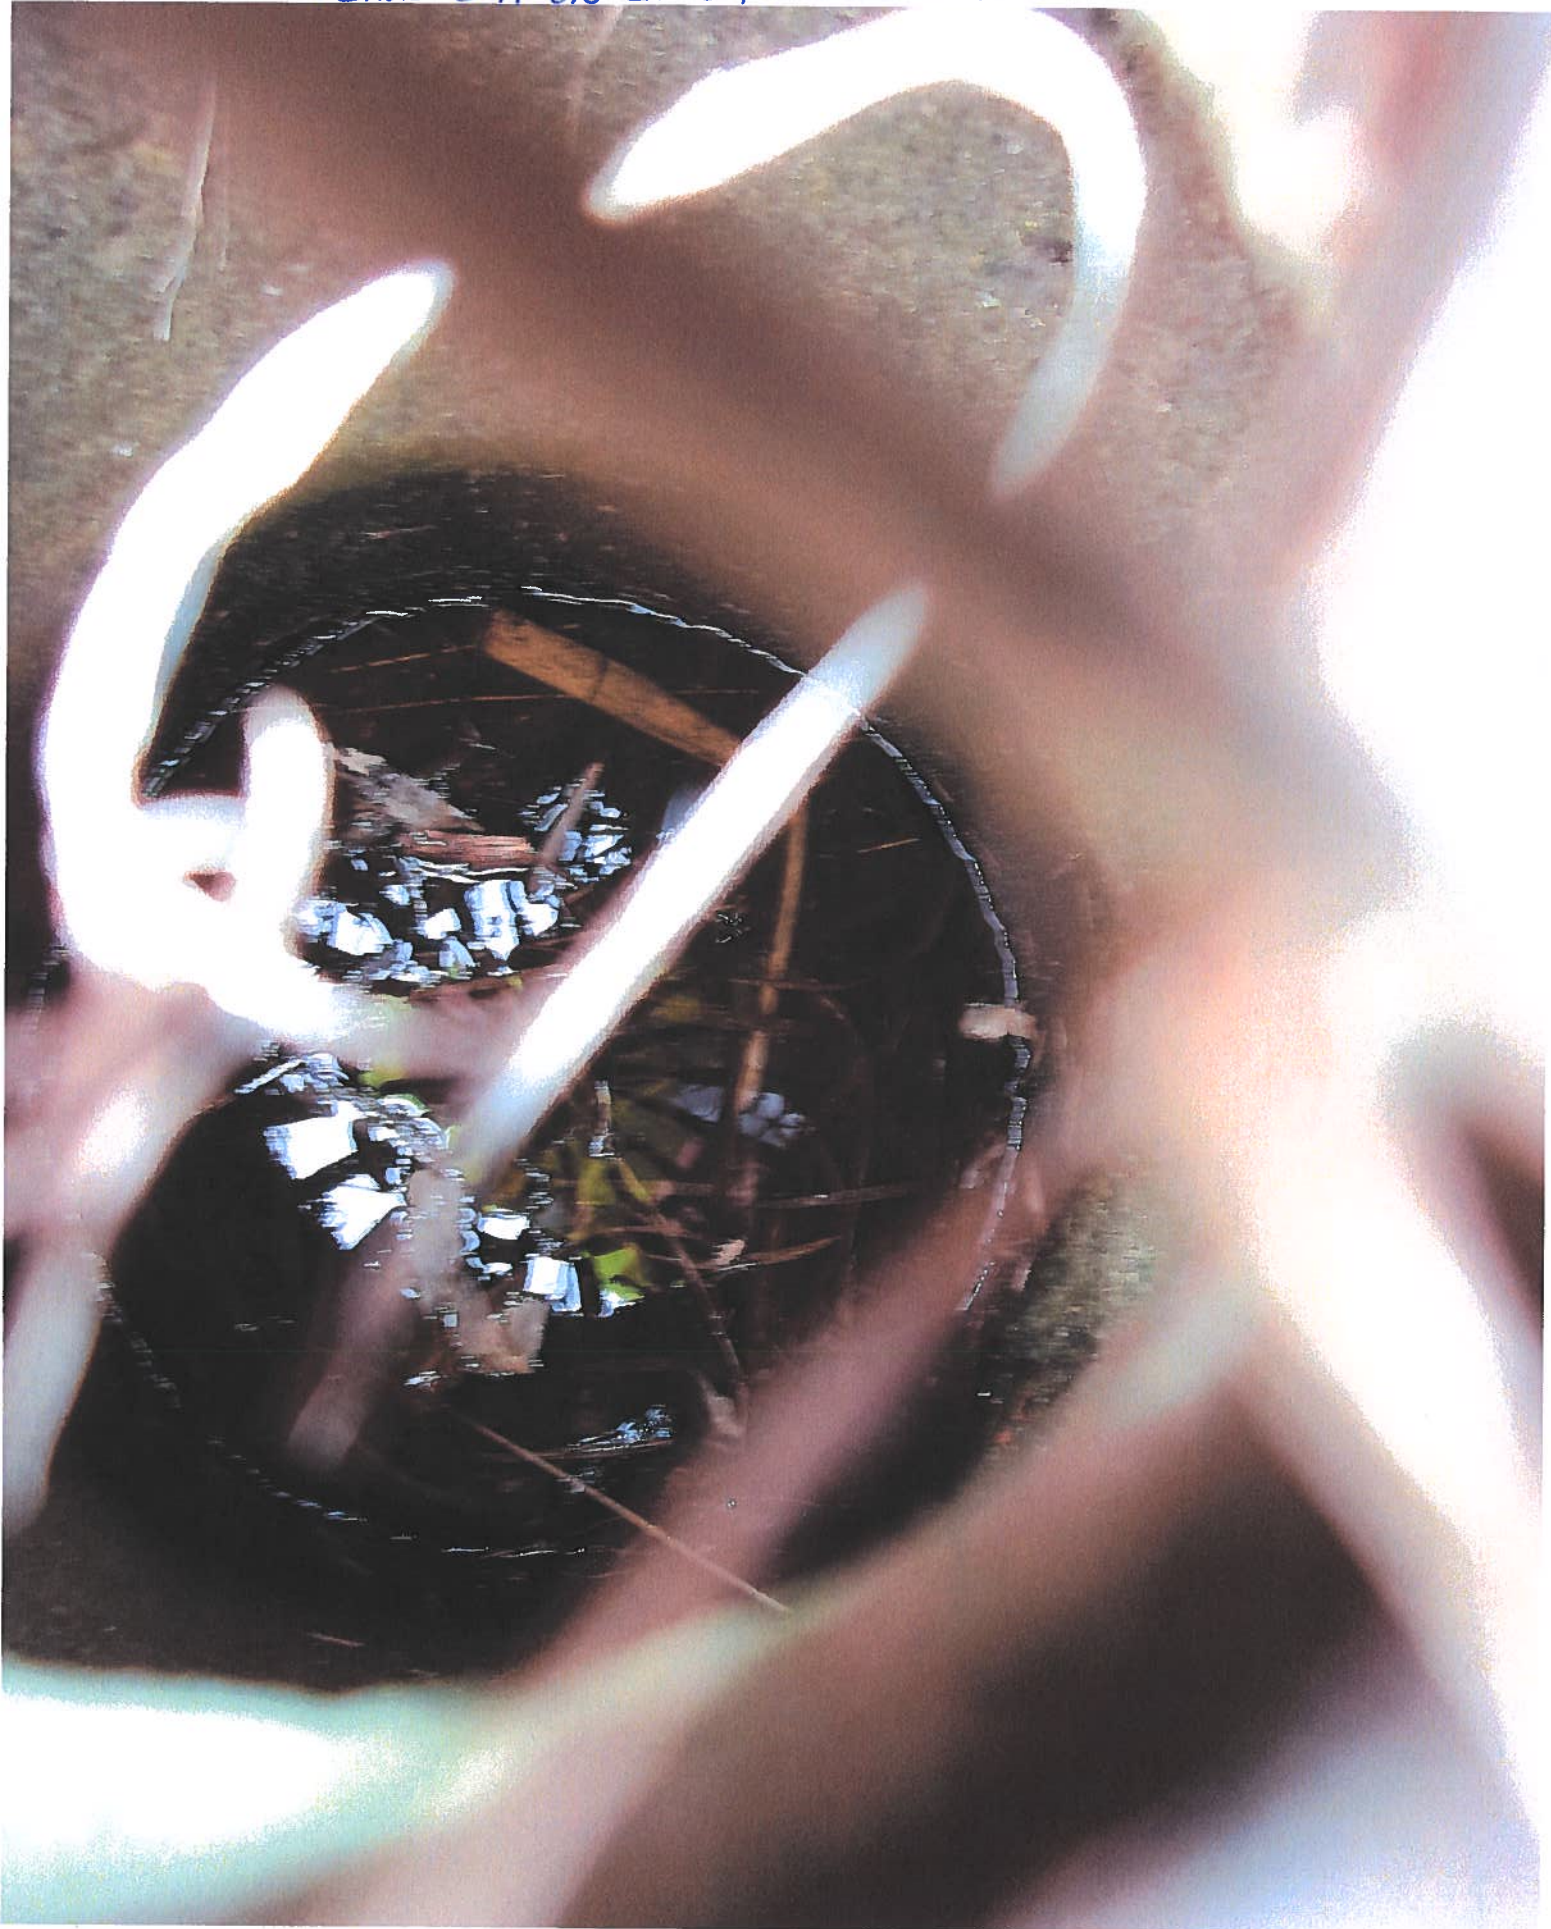
INTAKE ON N. SIDE D41 ON LAT 2, FULL OF WATER

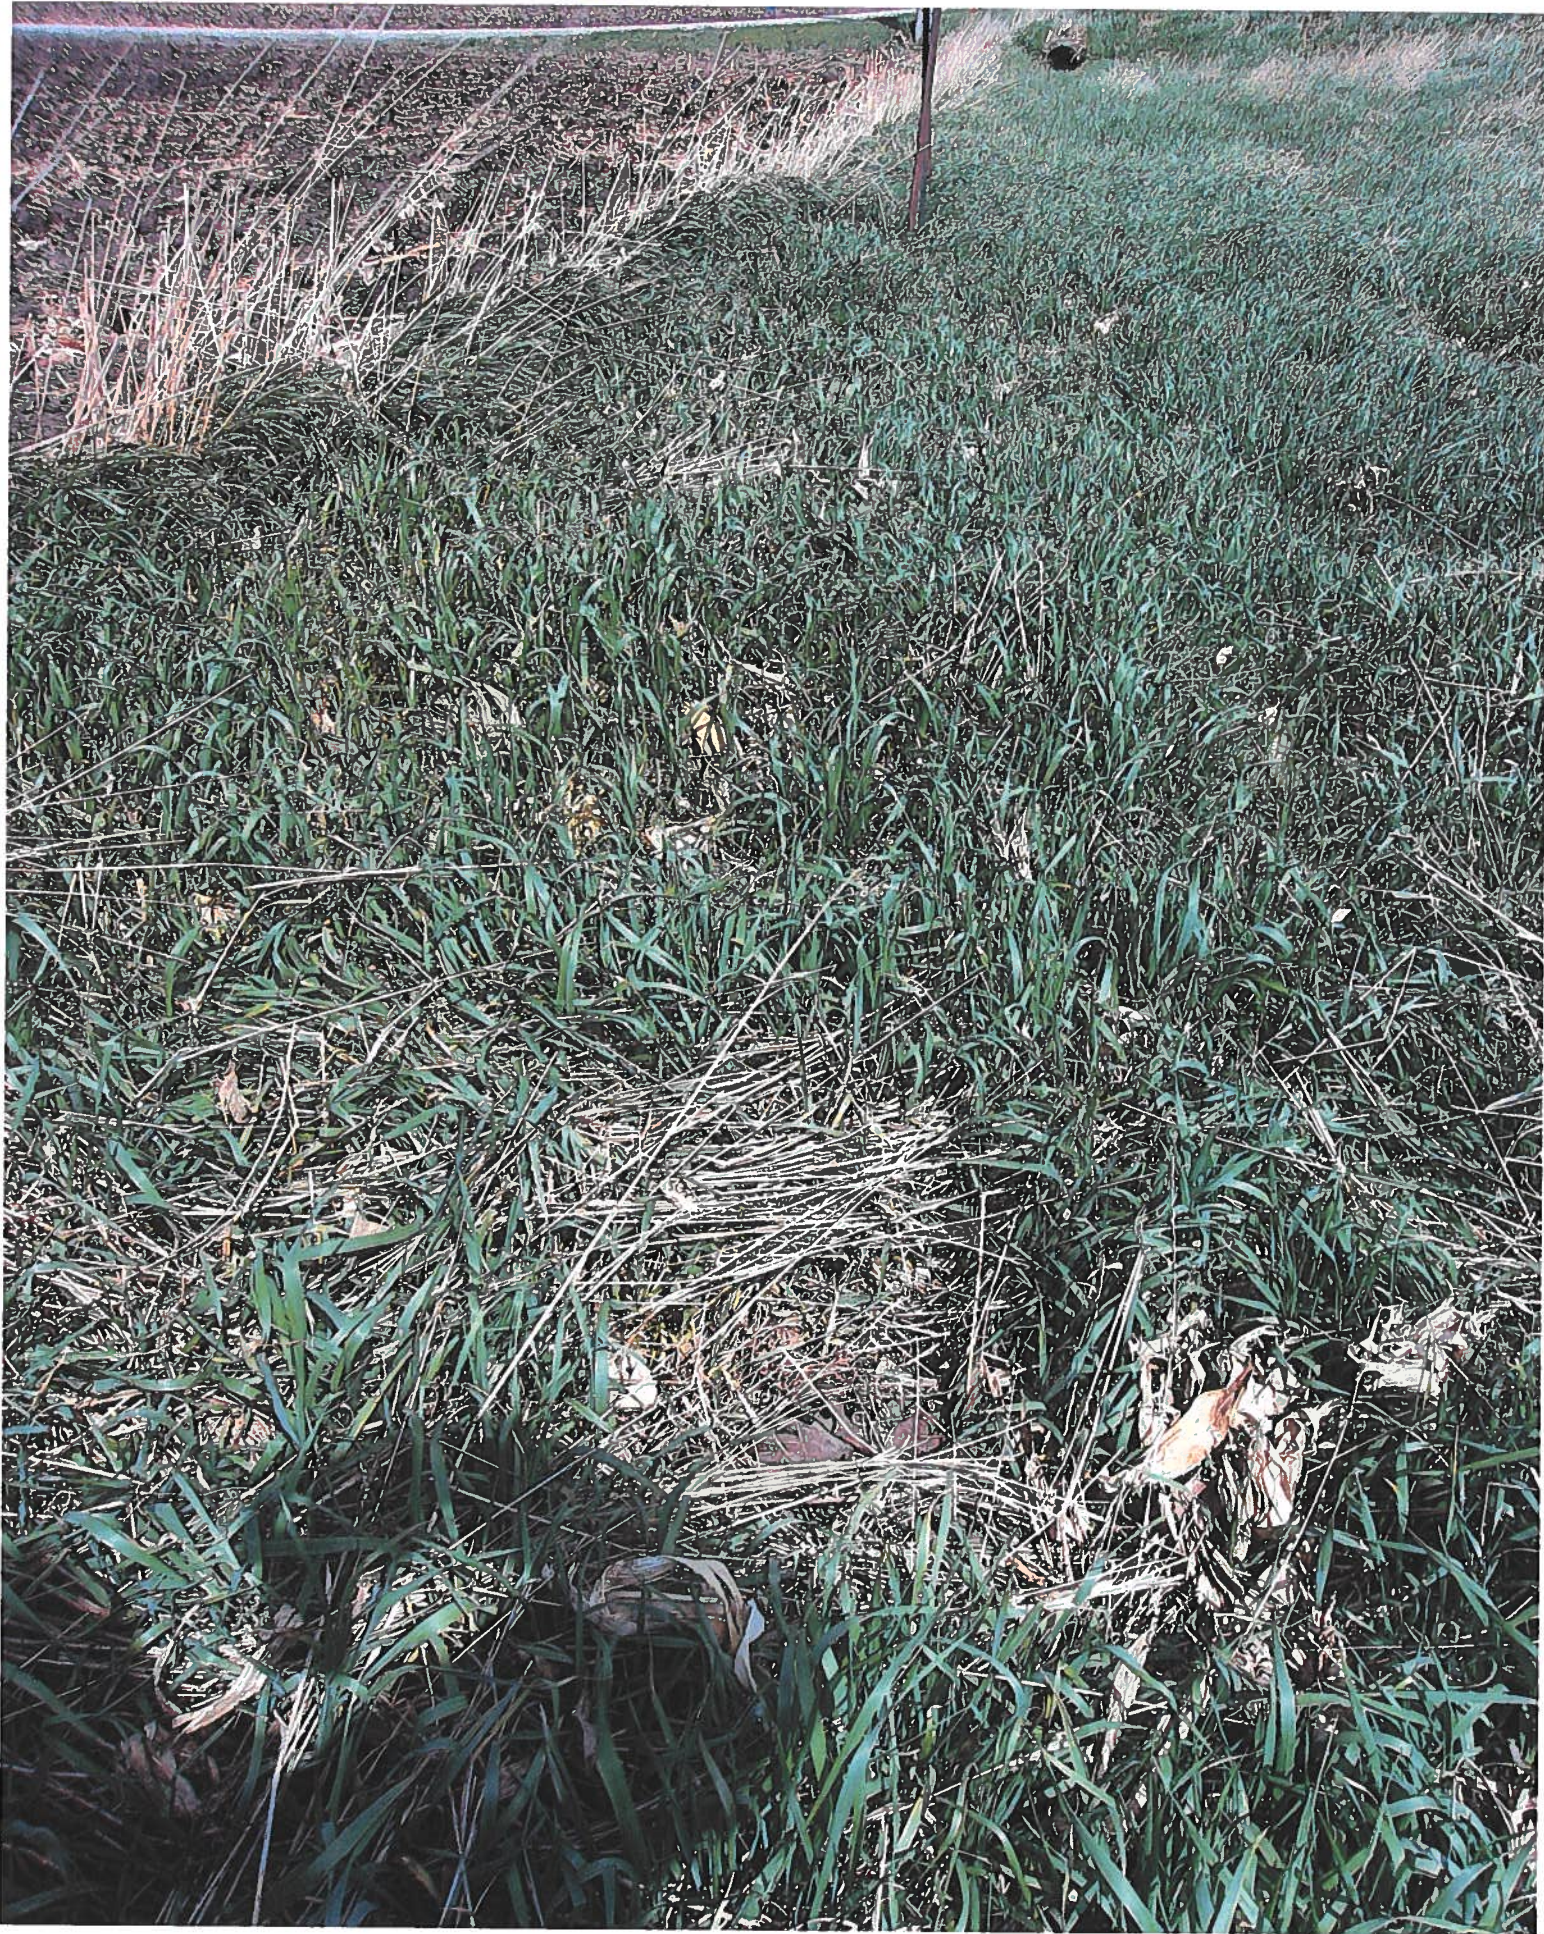
LOOKING E @ S27, BEEHIVE IN N DITCH D41

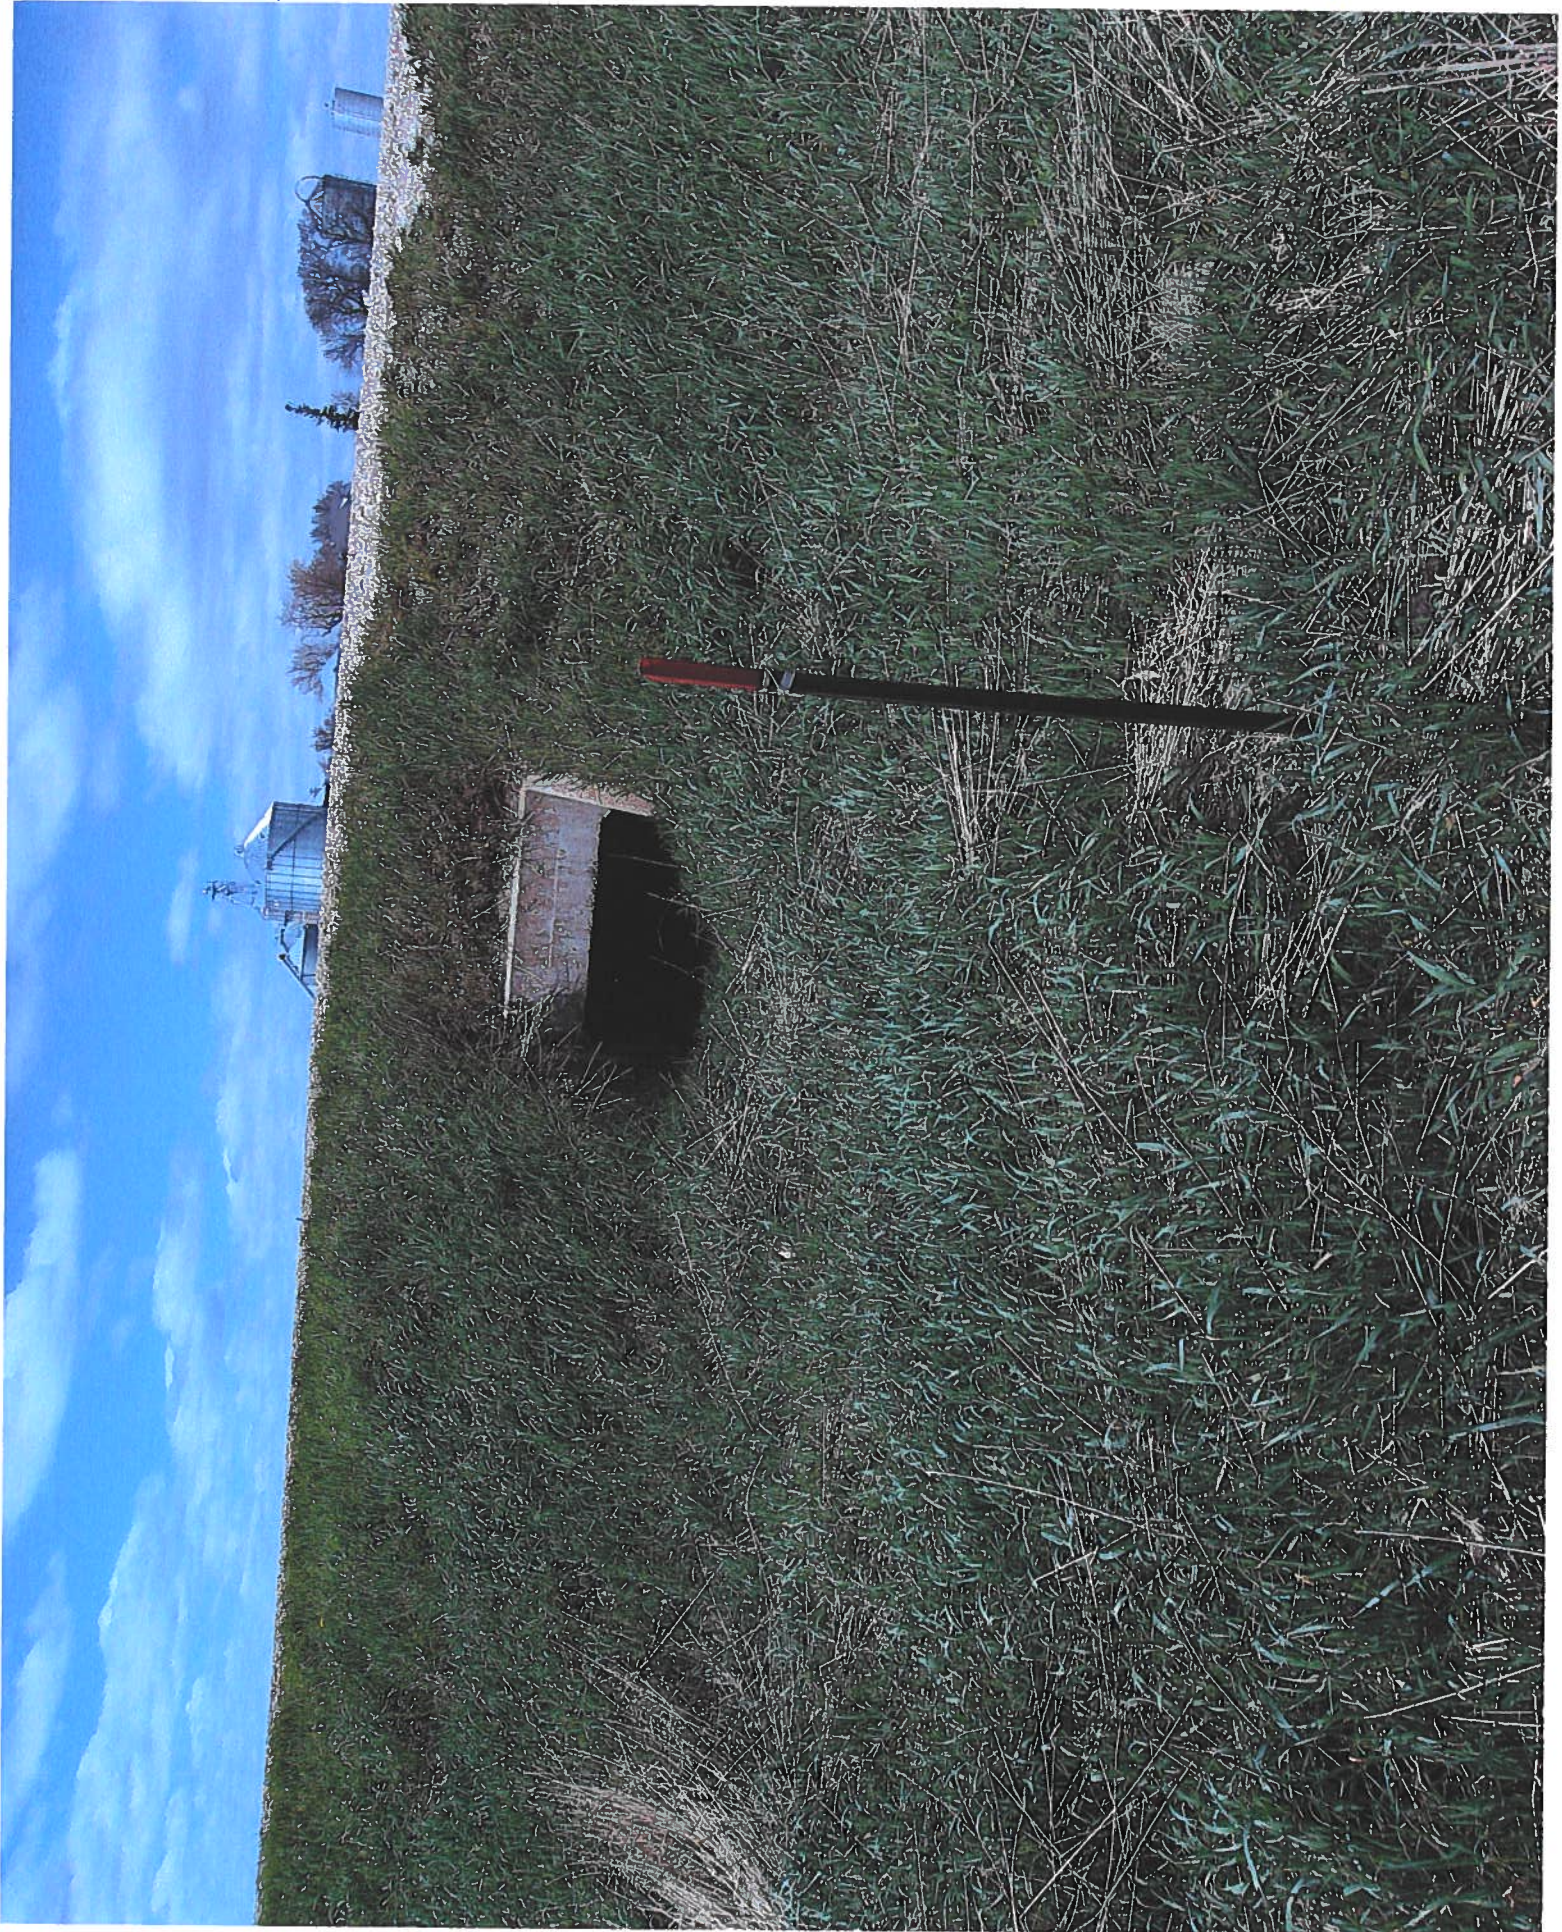
LOOKING UPSIDEAM ON MAIN, S. OF D41, T13T SET ON MAIN BY REPAIR

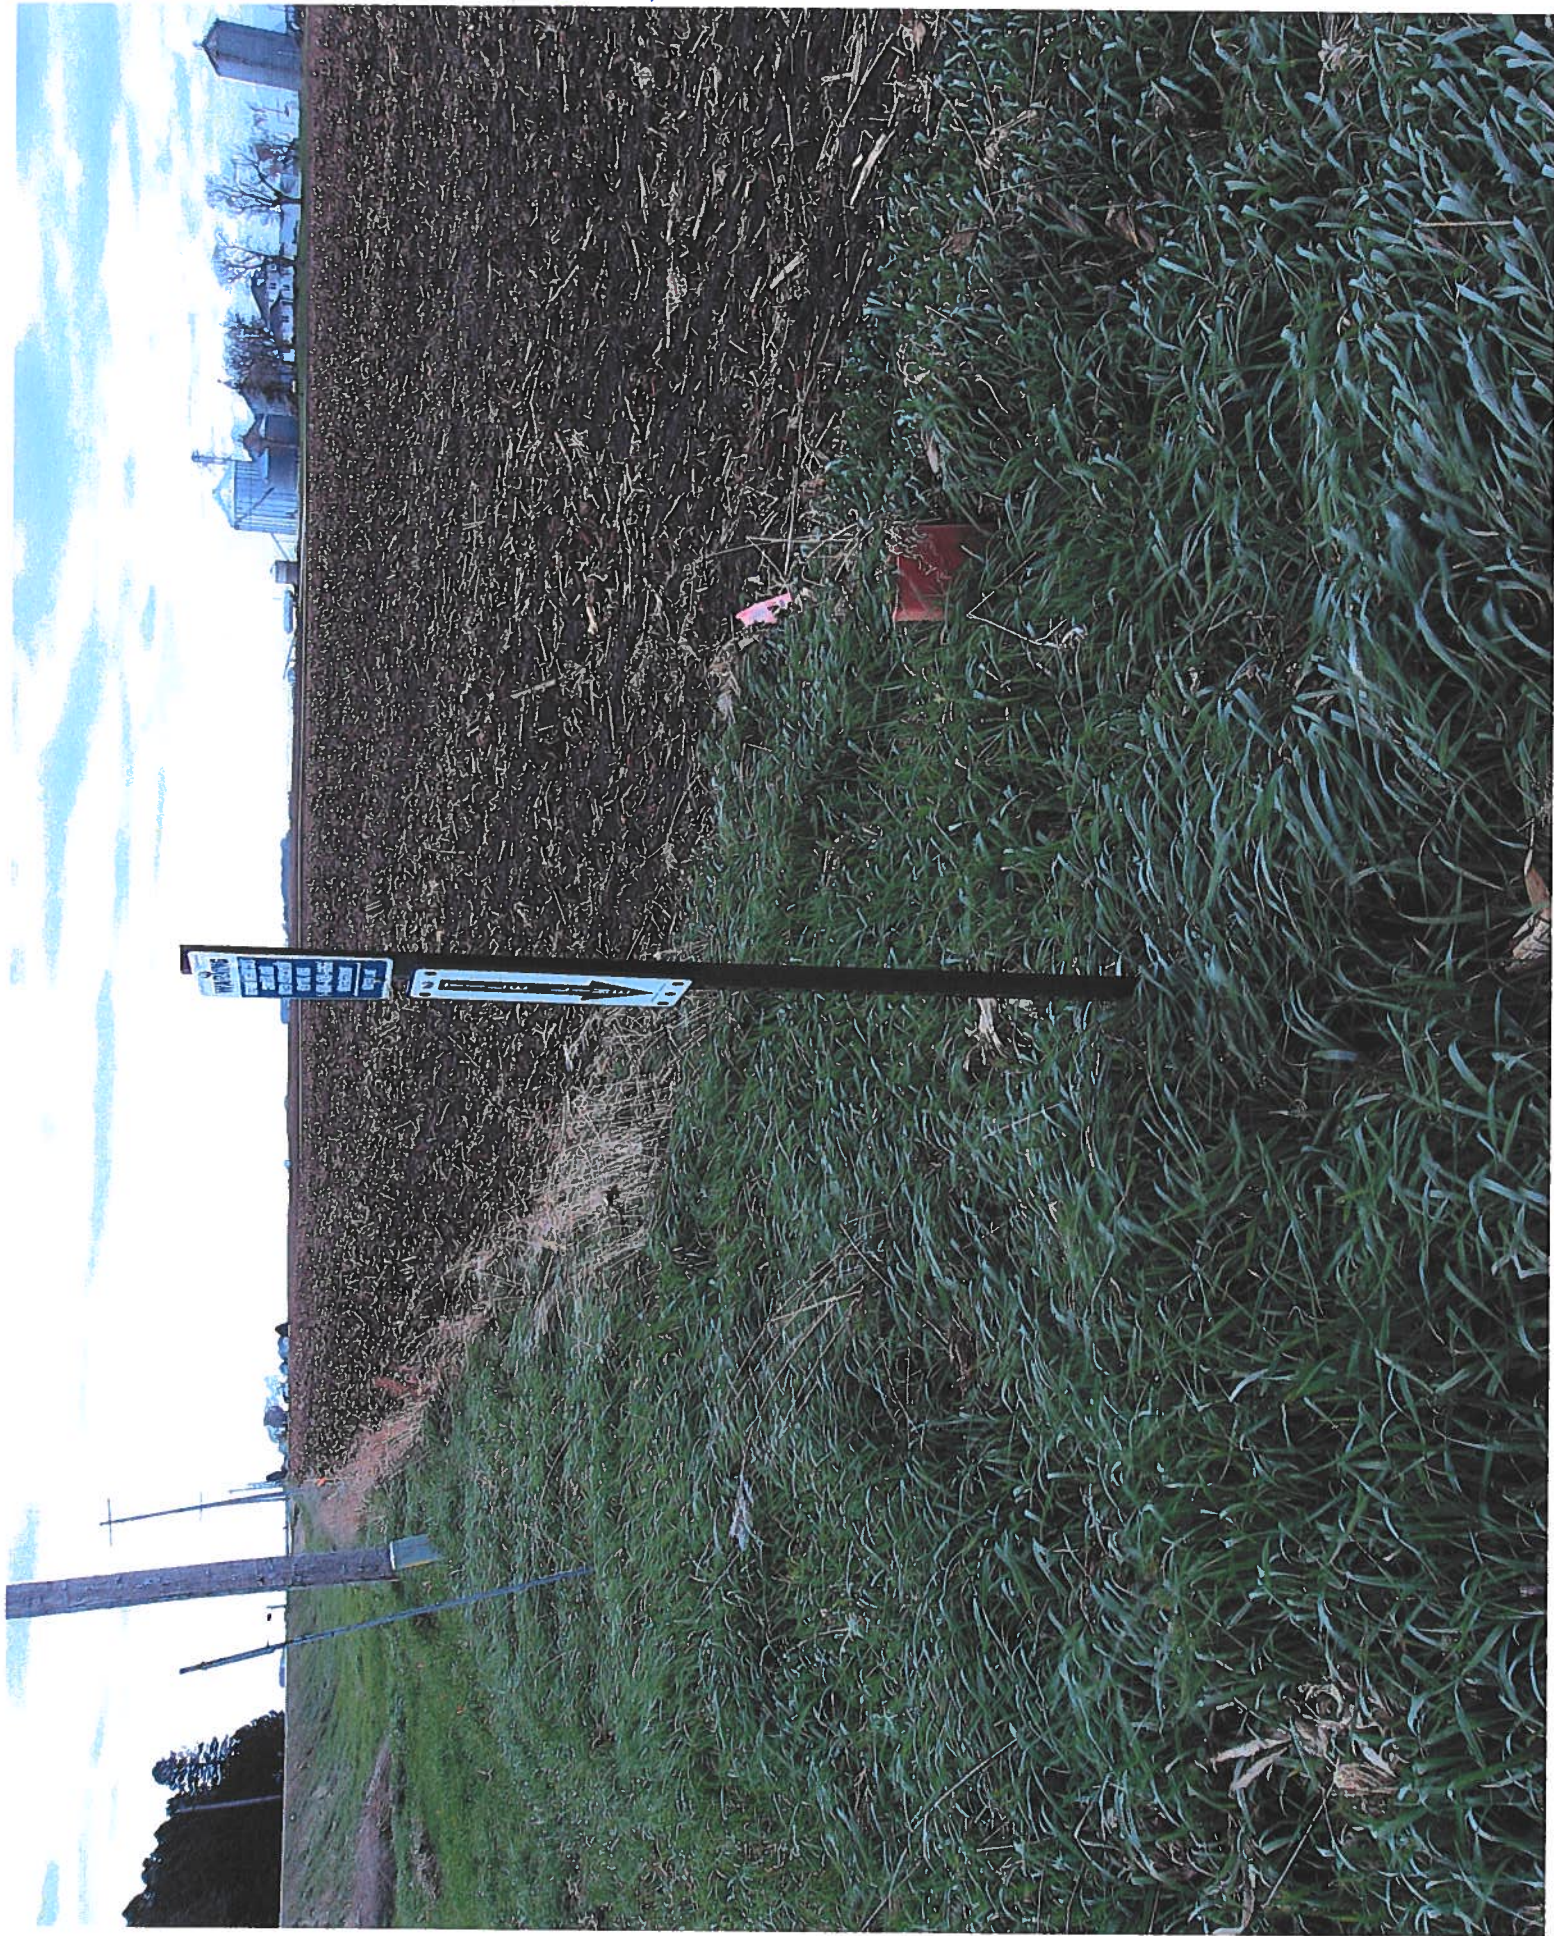
Looking W. on N<sup>R</sup>/<sub>4</sub> D41, Just W. of S27
