**AGENDA**  
**DRAINAGE DISTRICT 14 LANDOWNER MEETING**  
**Wednesday, November 18, 2020 12:00 PM**  
**Large Conference Room**

# Drainage Work Order Request For Repair

LOCATION: DD14 MARIETTA TILE LOCATED SWNE & NWSE  
34-88-22 HARDIN COUNTY  
INVESTIGATE & TEMPORARILY REPAIR 3 TILE BLOWOUTS

## Investigation and Repair Summary:

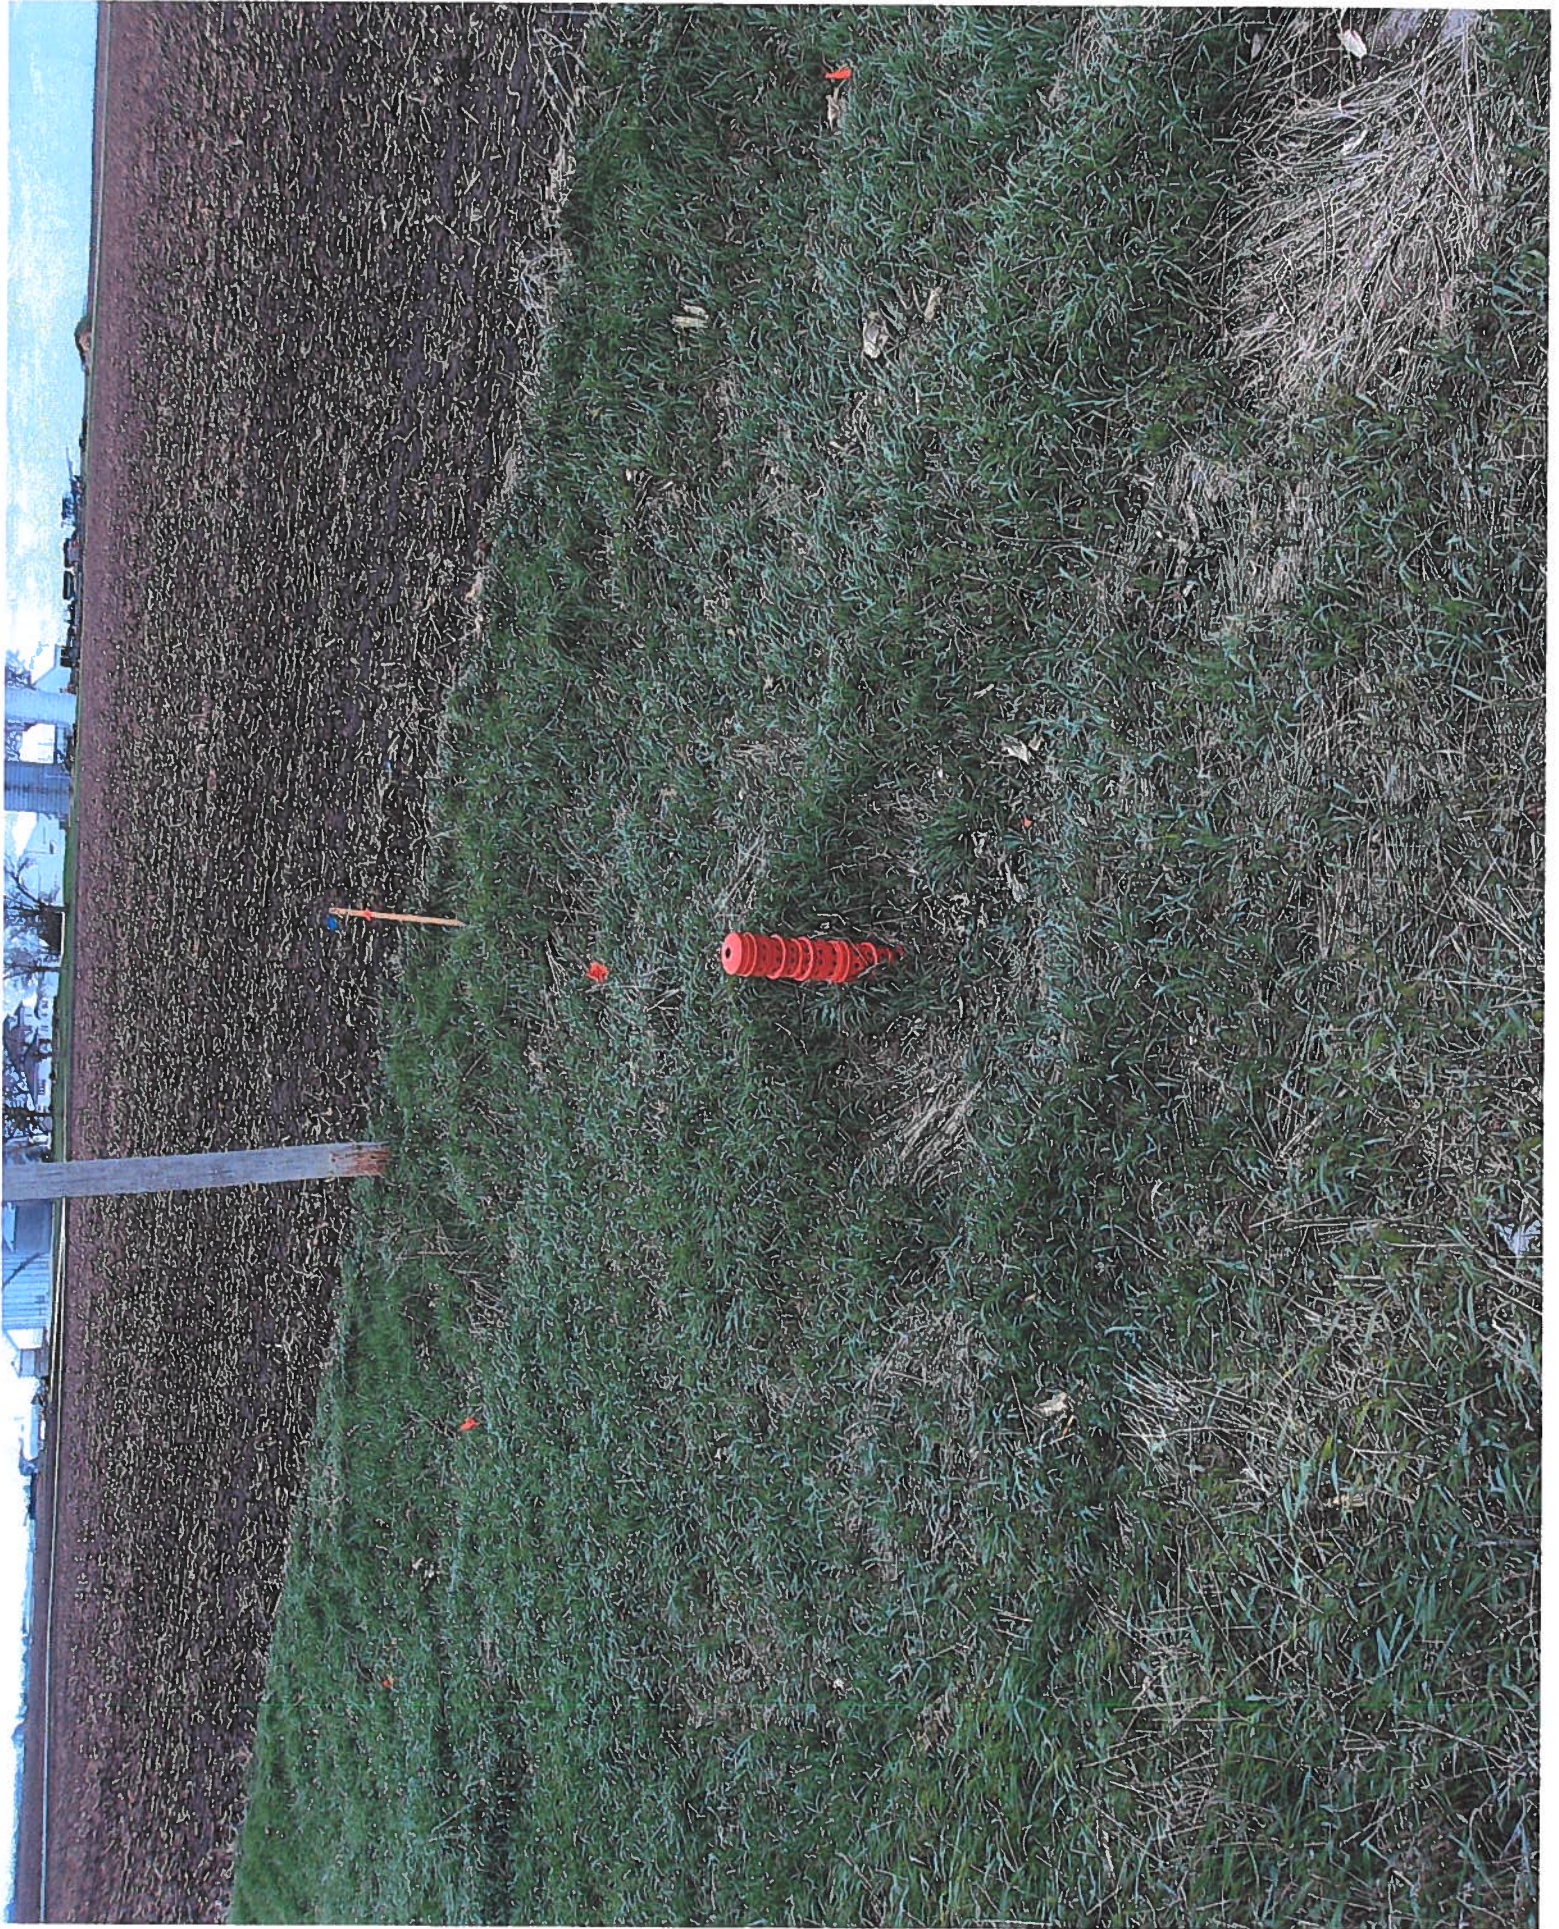
ORANGE HICK ON LAT 2? ON N ditch D41

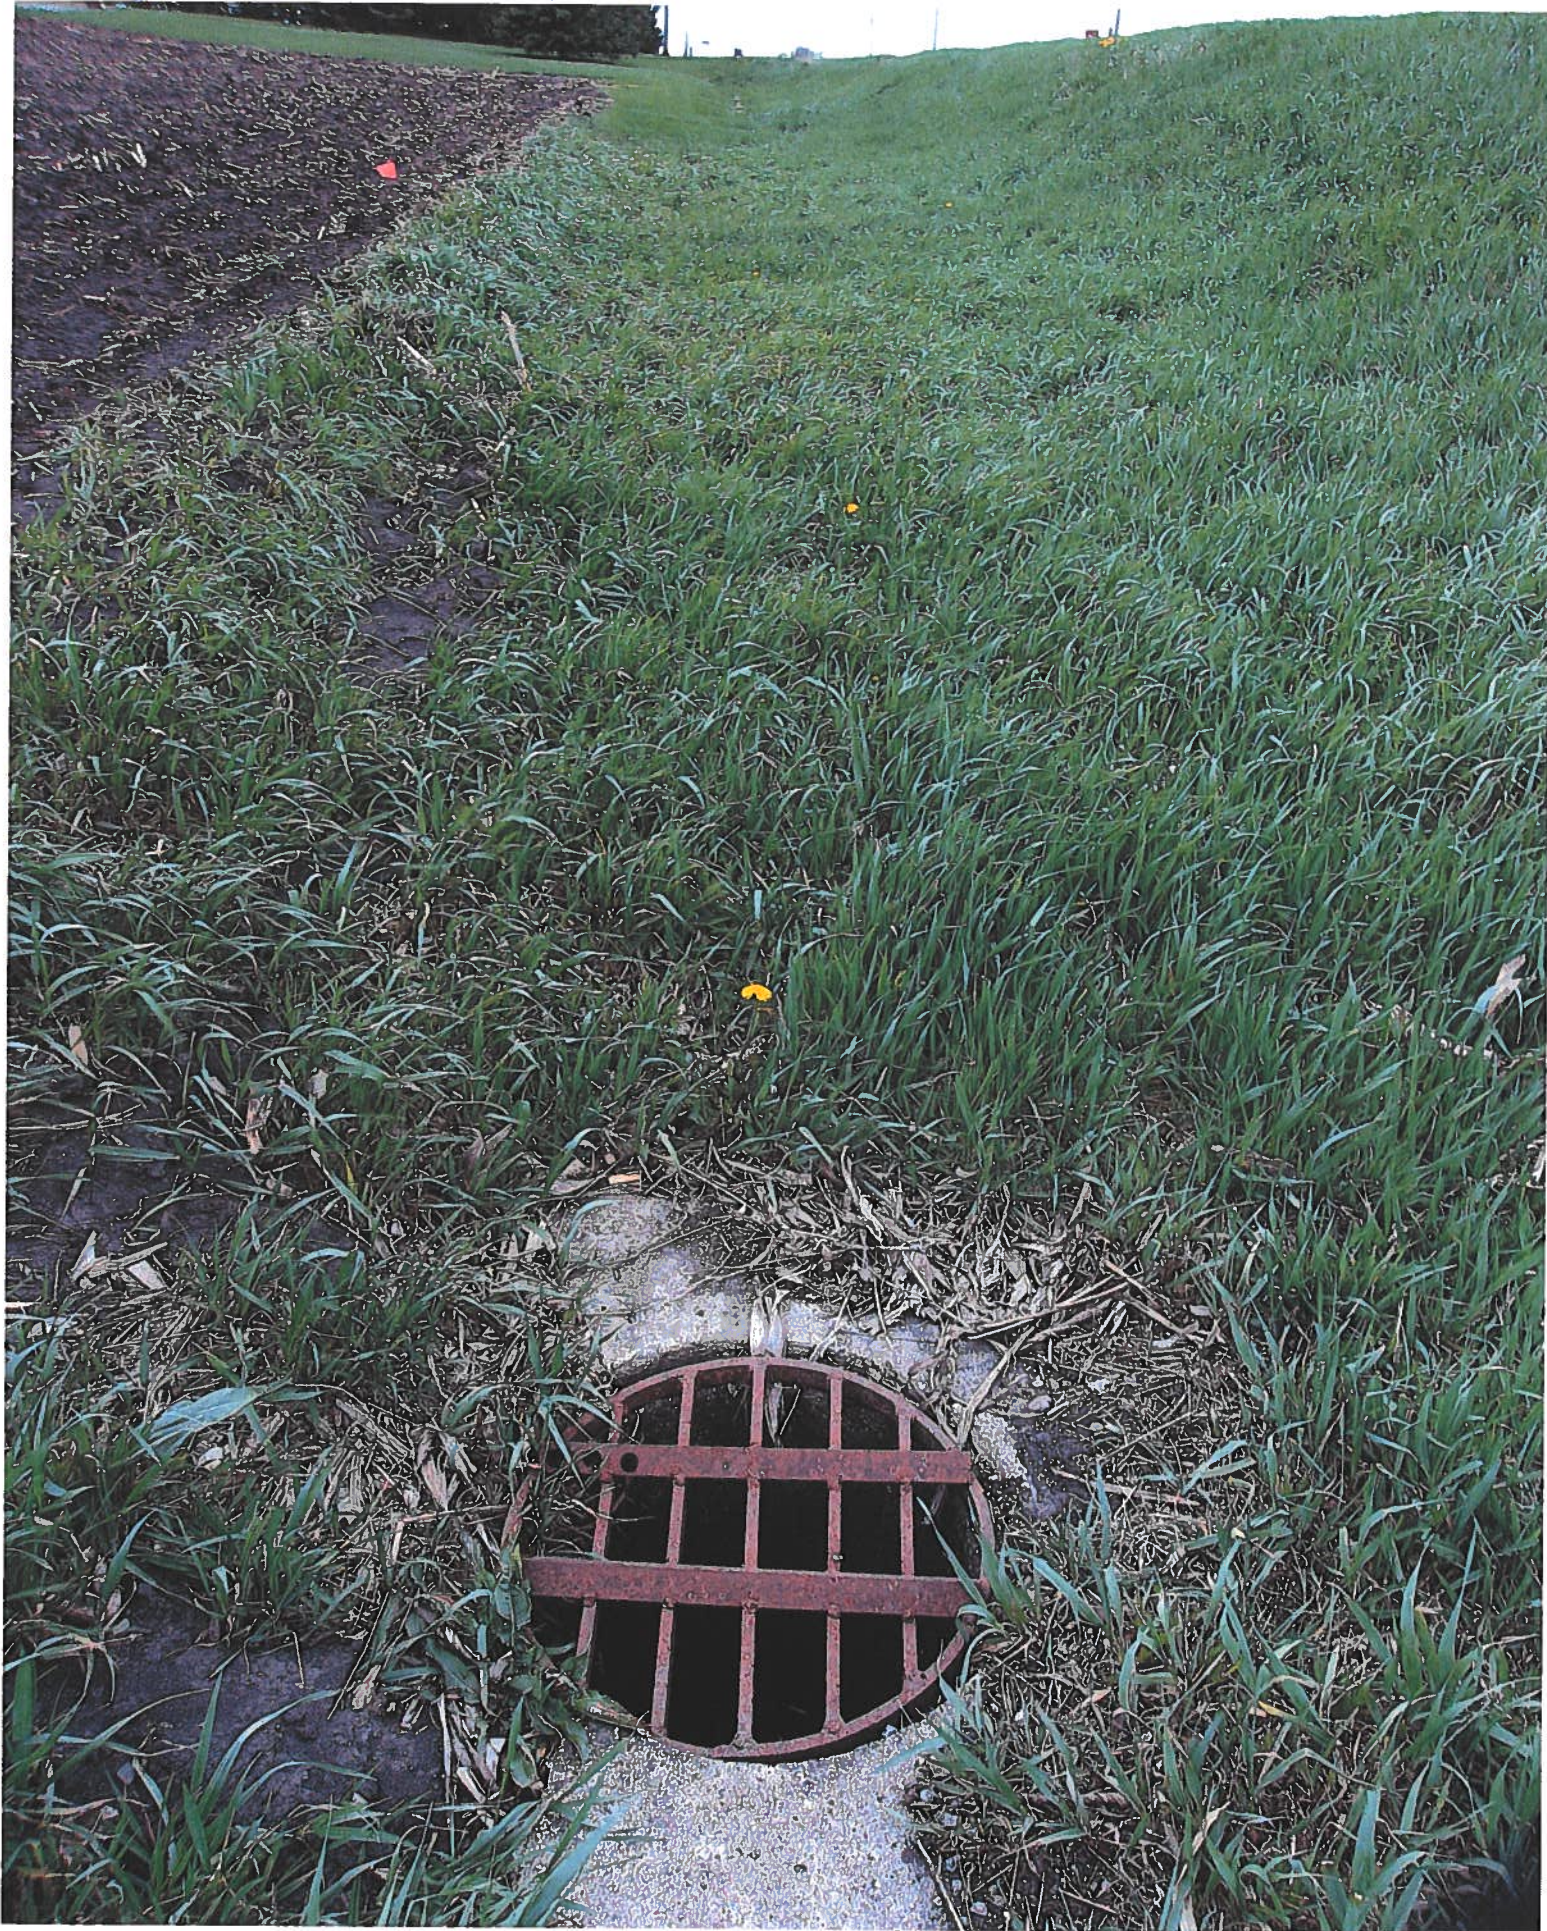
Dry INTAKE ON LAT 2 , S. ditch 041 (W. of S27)

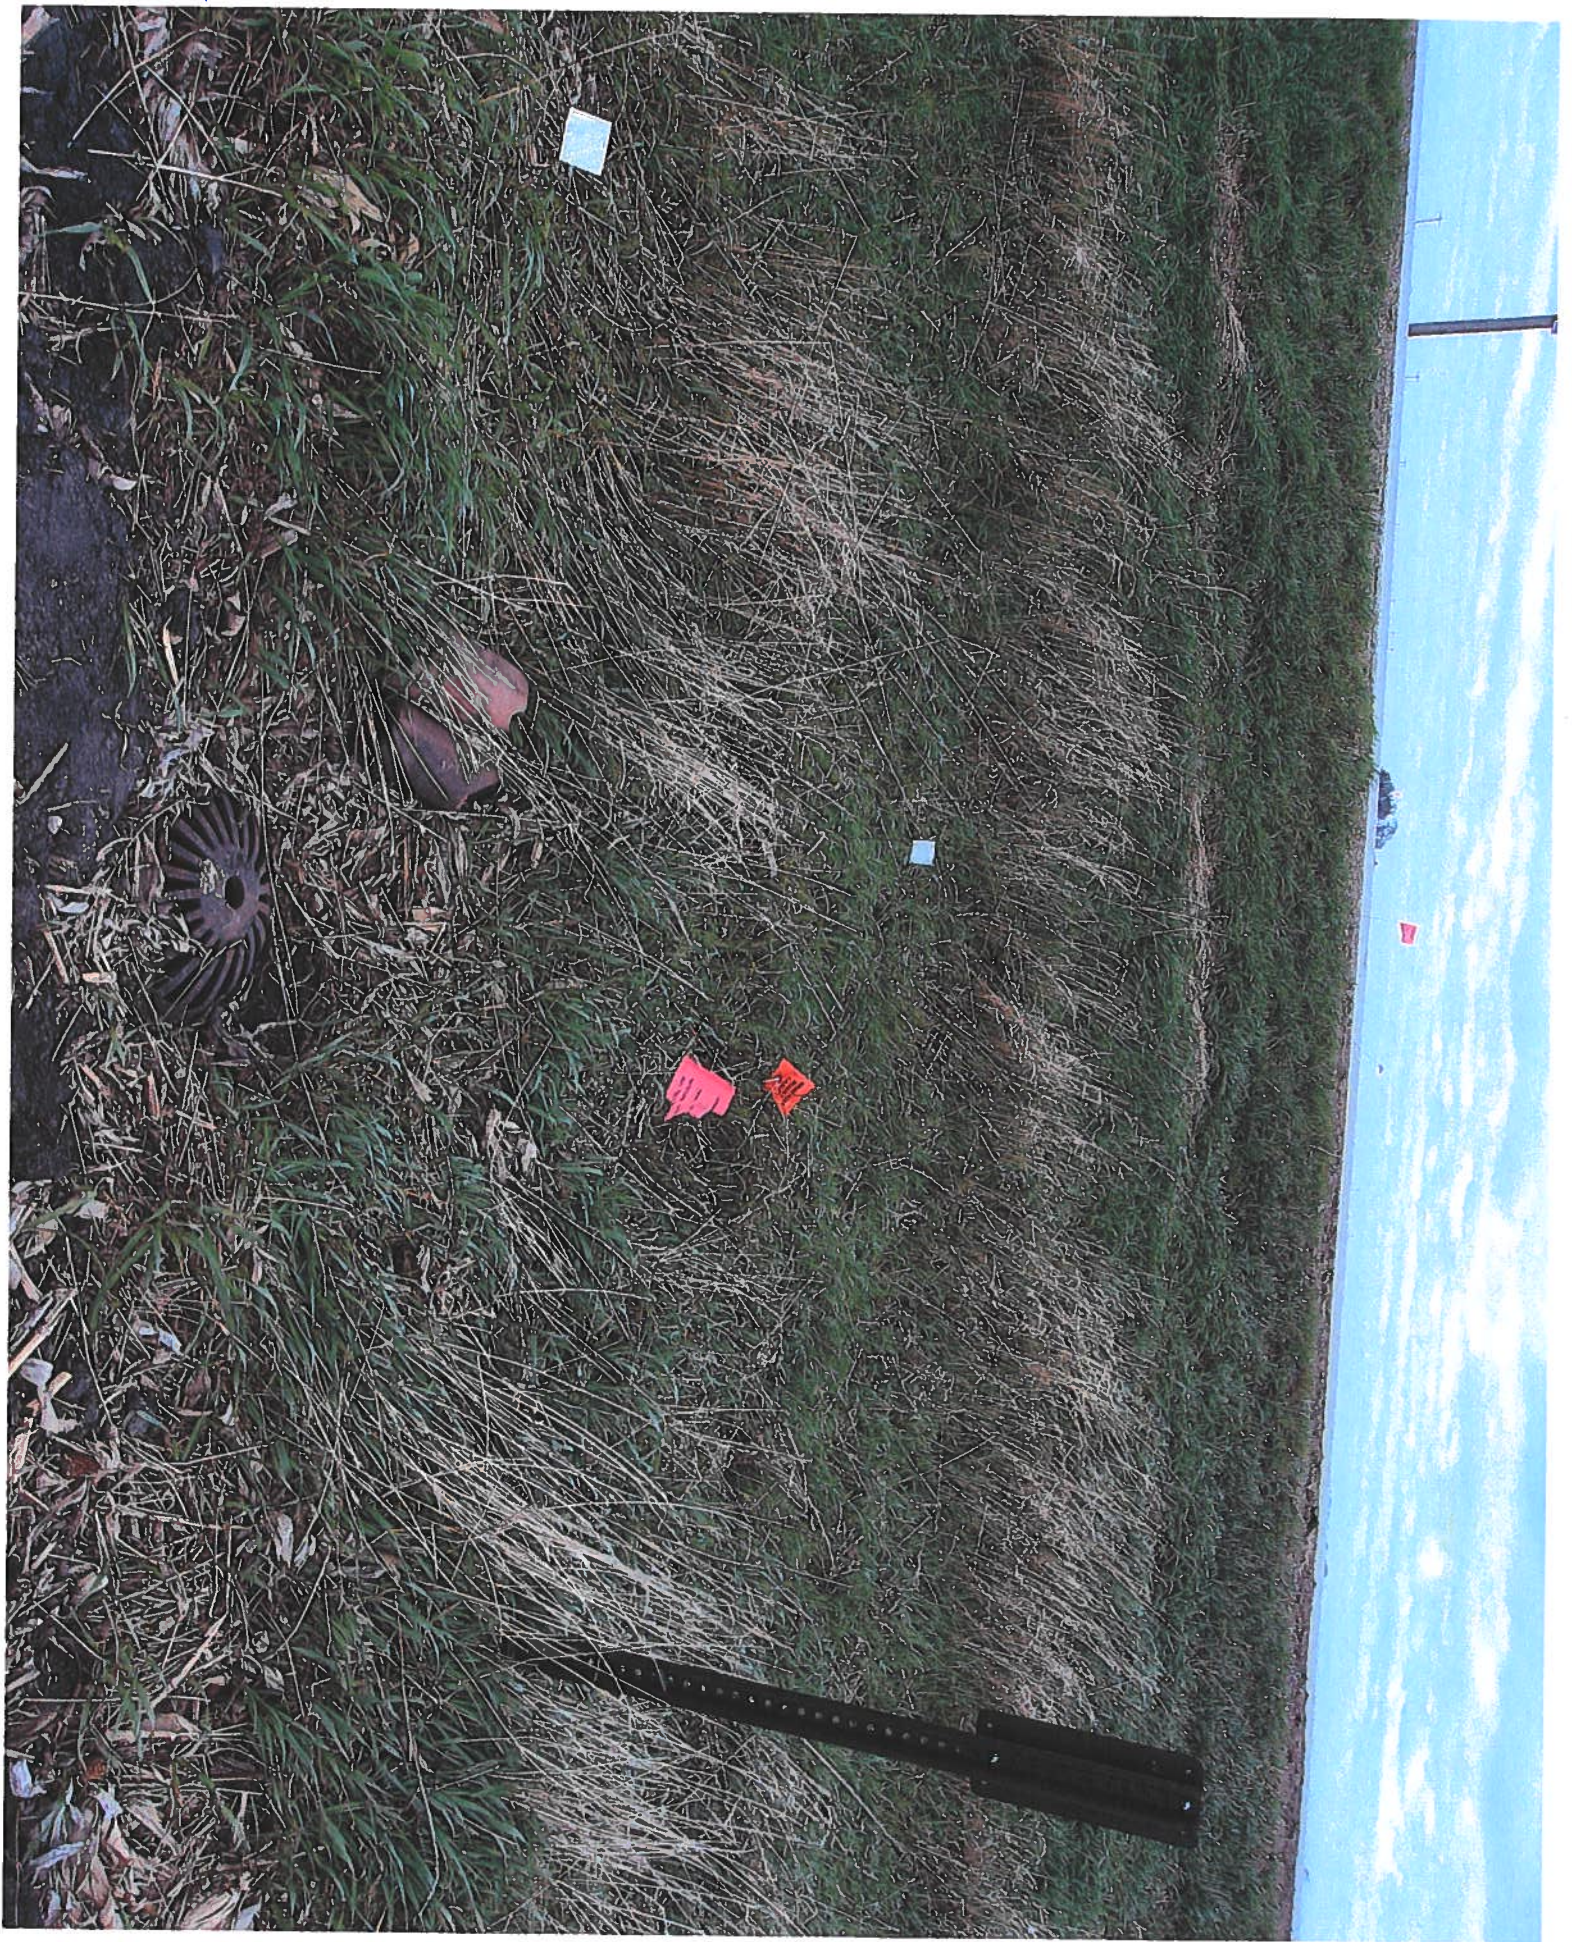
LAT 2, WET BEETHIVE, W. SIDE S27
